**DRAFT REPORT  
ROUND 10 DAM ASSESSMENT - MAY 31, 2011  
ALLIANT ENERGY – EDGEWATER GENERATING STATION  
SLAG POND, NORTH POND A, SOUTH POND A, POND B, POND F  
SHEBOYGAN, WISCONSIN**

RE: Assessment of Dam Safety of Coal Combustion Surface Impoundments at the Edgewater  
Generating Station

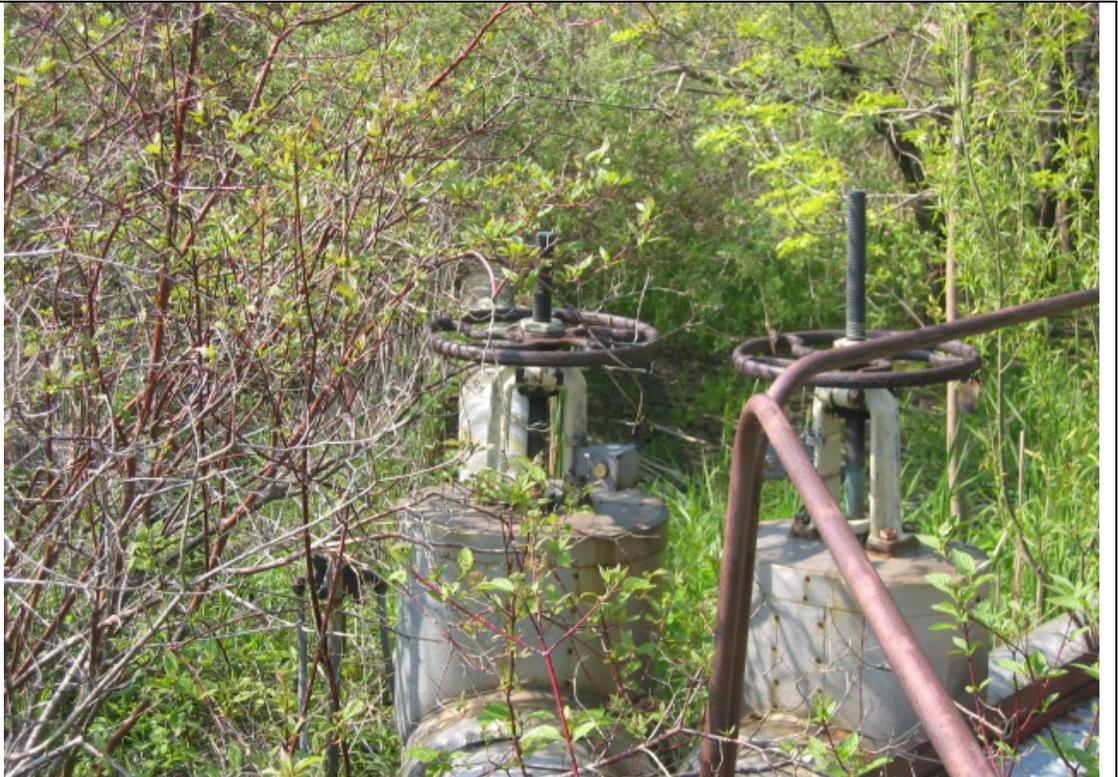
Photo No.  
**30**

**Description:**  
Valves to control flow of  
water to North Pond A and  
South Pond A.

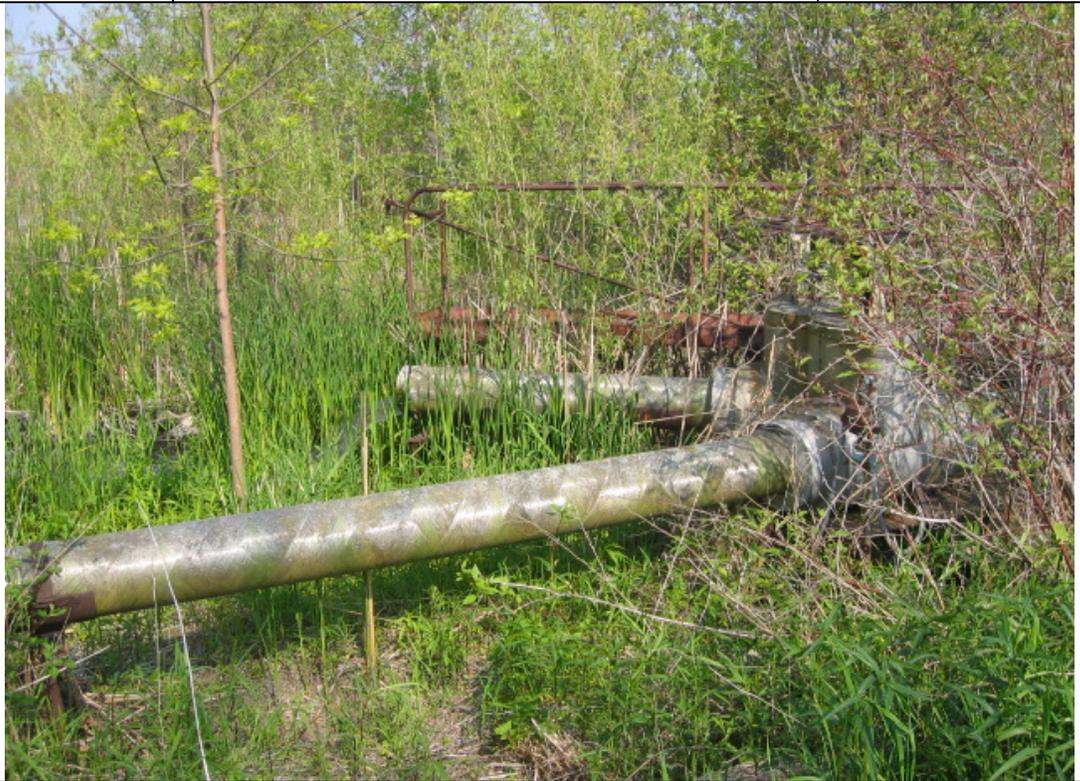
<b>Photo No.</b> <b>31</b>	<b>Date:</b> 5/31/11
<b>Direction Photo Taken:</b> West

**Description:**  
Sluice pipes and valves at the discharge point in the North Pond A..

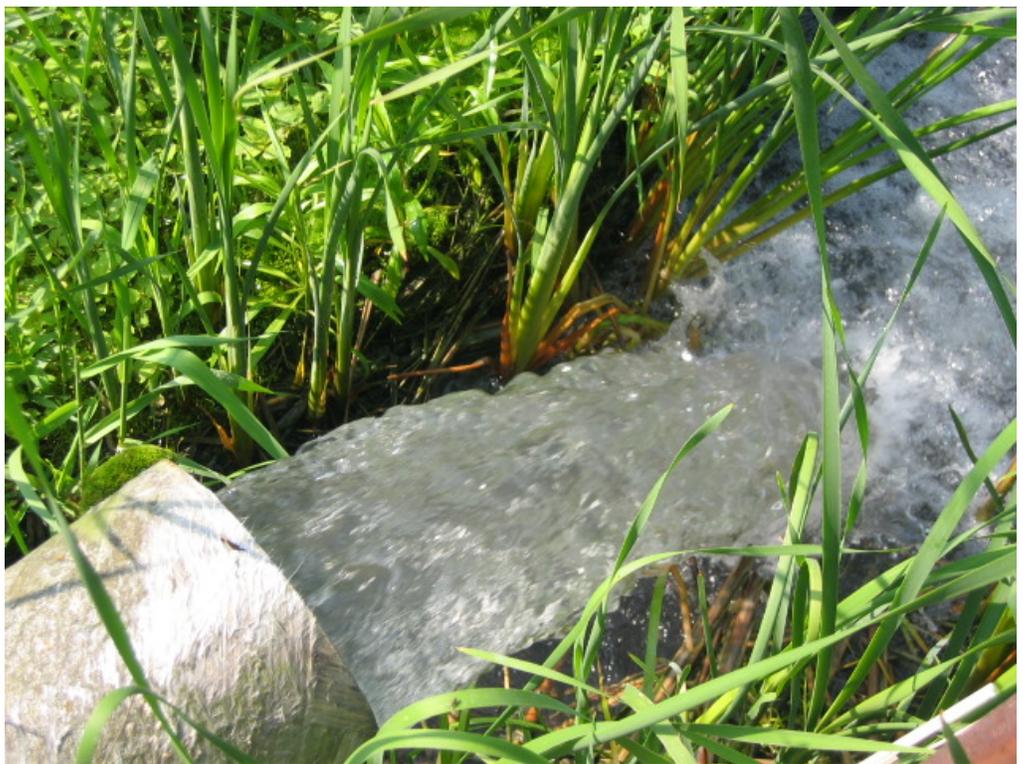
<b>Photo No.</b> <b>32</b>	<b>Date:</b> 5/31/11
<b>Direction Photo Taken:</b> Southwest

**Description:**  
Discharge of transport water into the North Pond A.

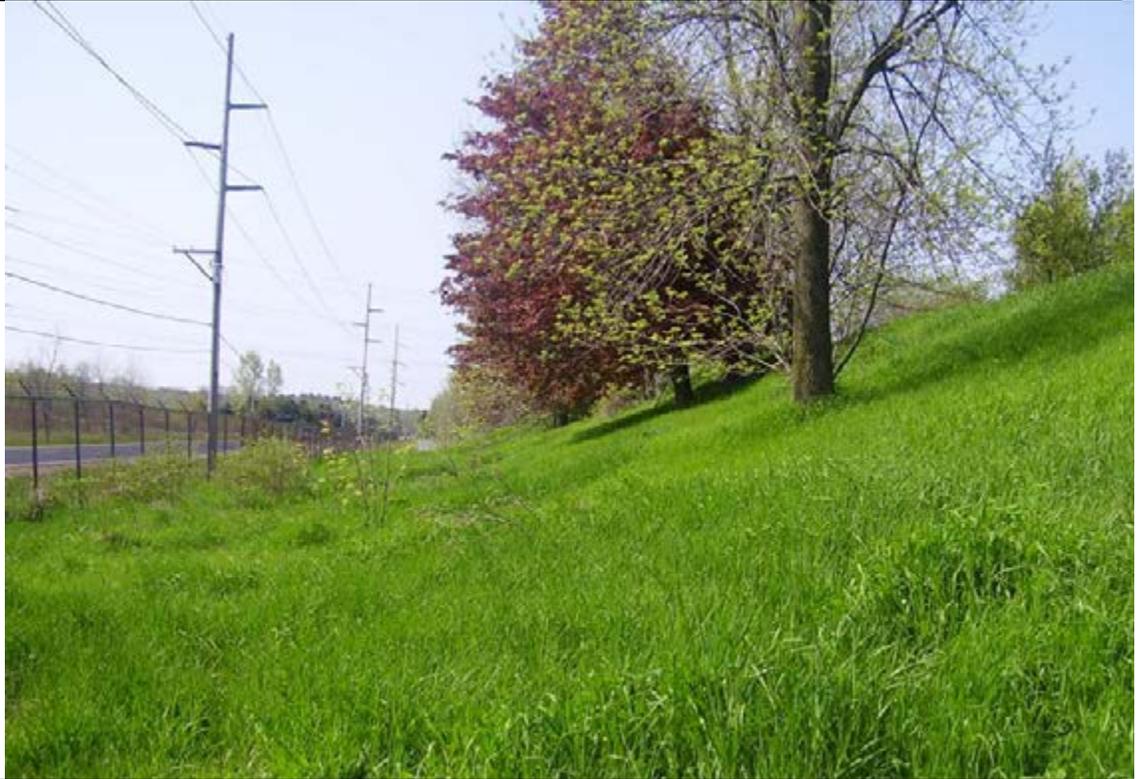
**Description:**  
Downstream slope and toe of the North Pond A.

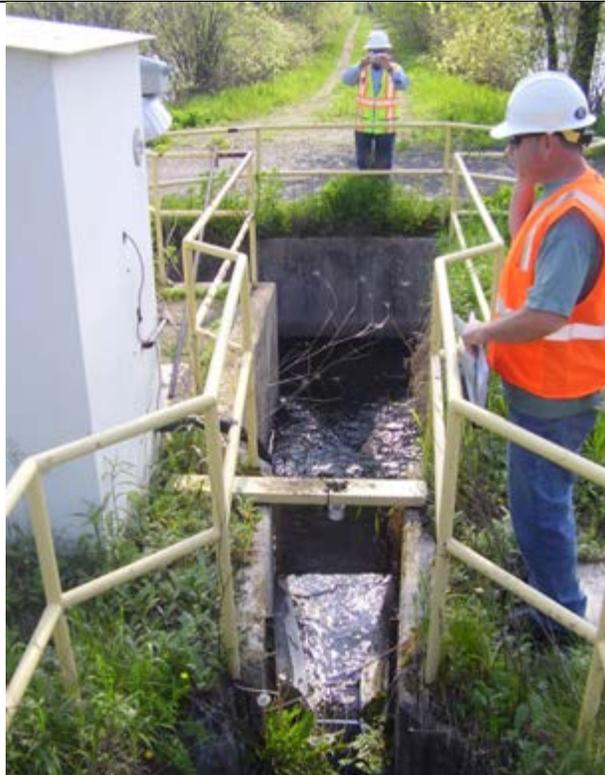
**Photo No.**  
**34**

**Description:**  
Flume where discharge from North Pond A and South Pond A converge and flow to Pond B.

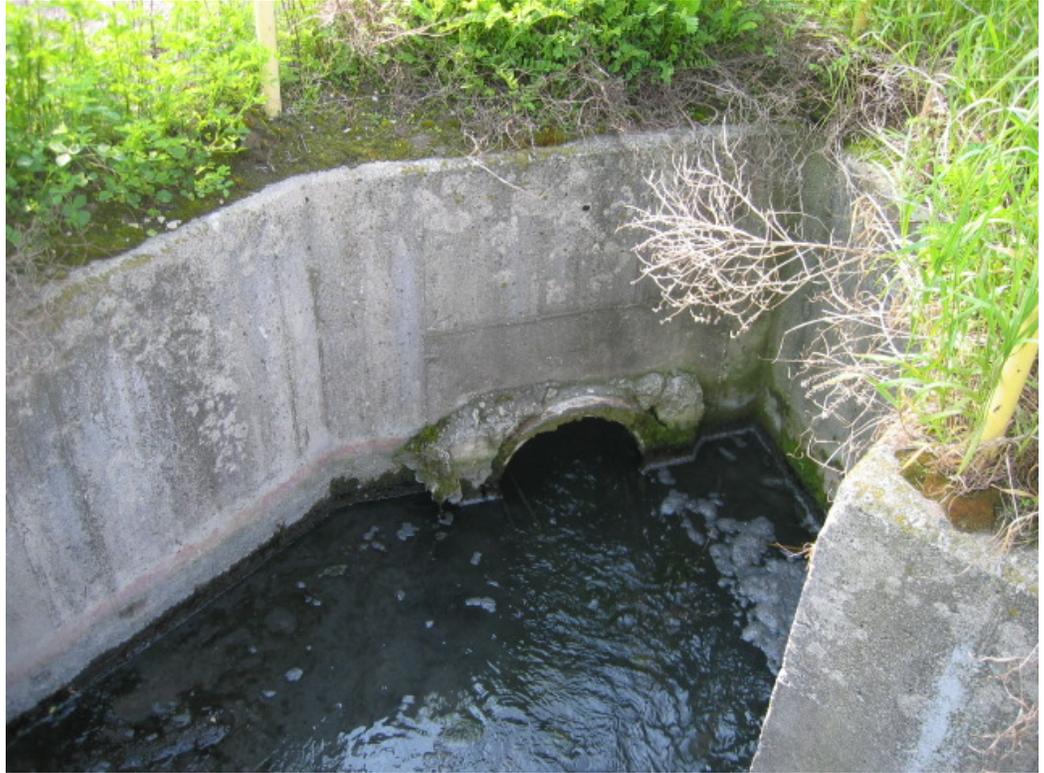
Description:  
Discharge pipe from North  
Pond A into flume.

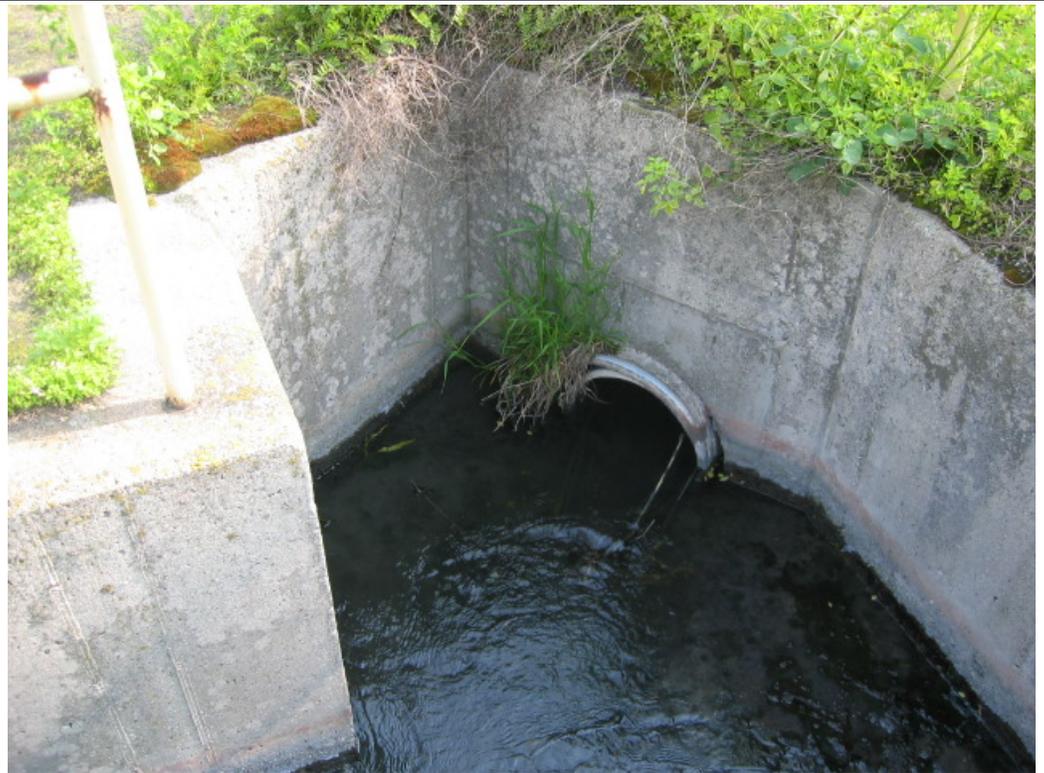
Photo No.  
**36**

Description:  
Discharge pipe from South  
Pond A into flume.

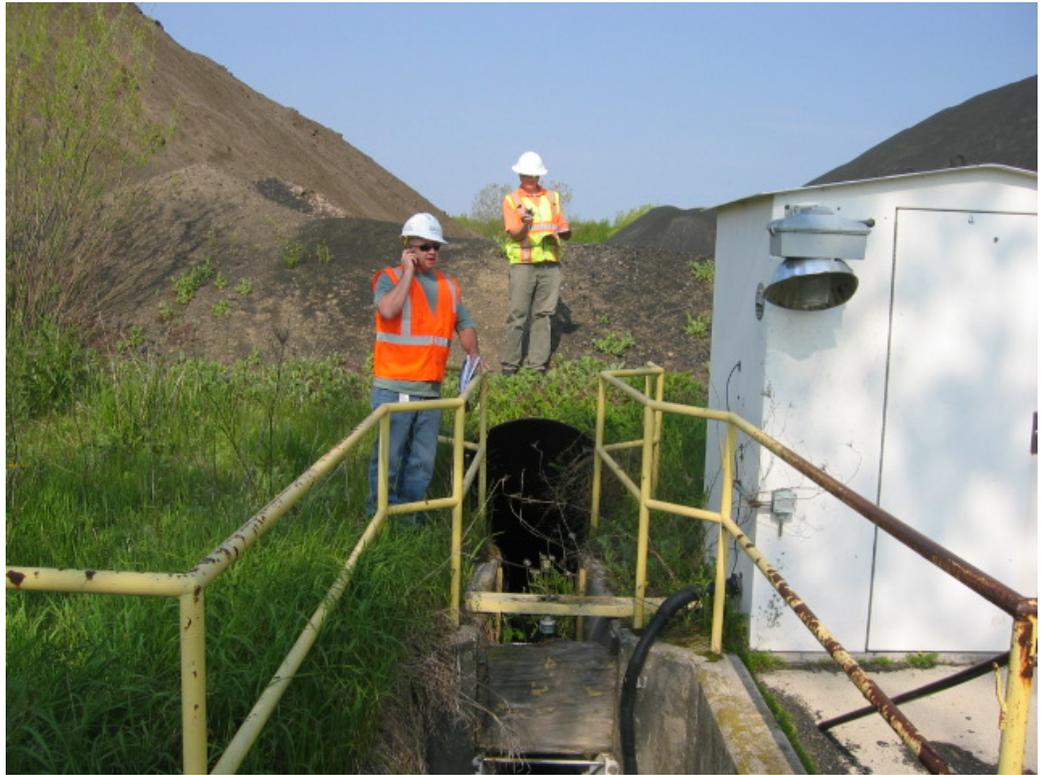
**Description:**  
Concrete flume conveying  
water from North Pond A  
and South Pond A.

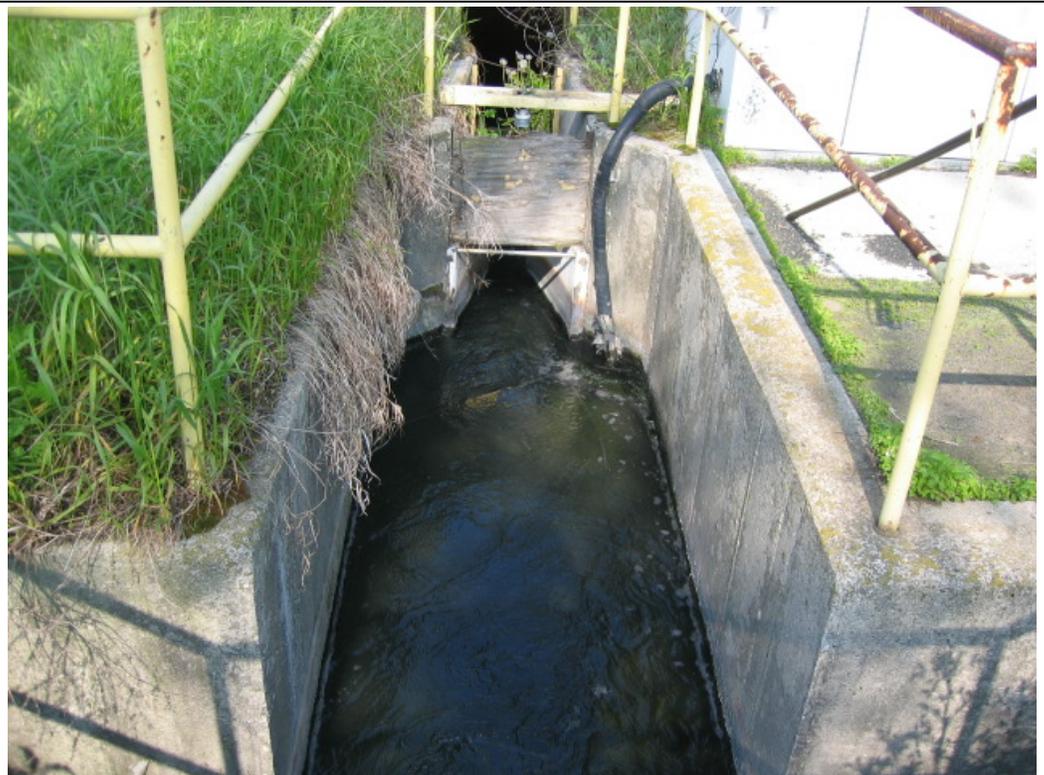
Photo No.  
**38**

**Description:**  
Concrete flume conveying  
water from North Pond A  
and South Pond A.

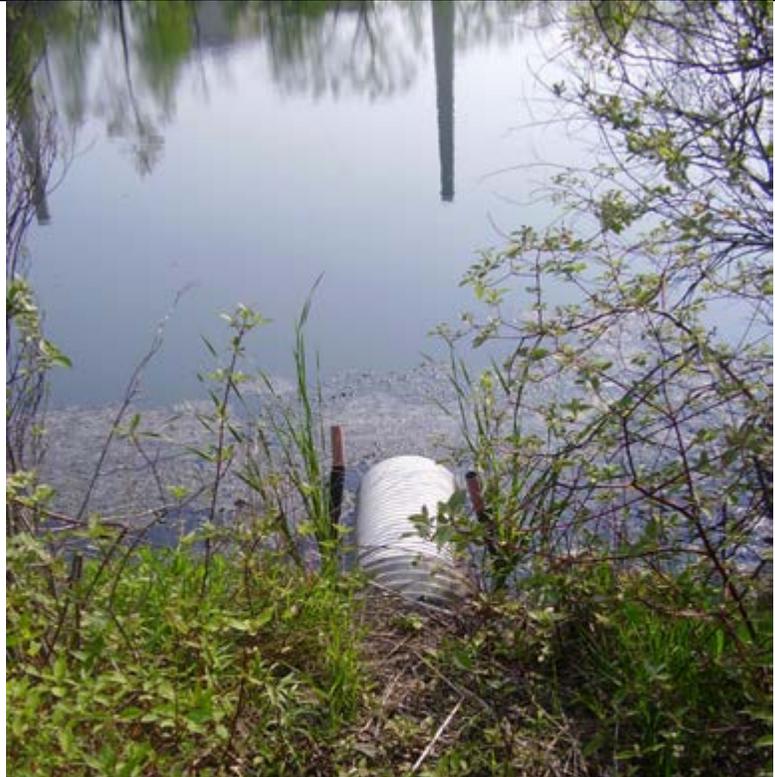
<b>Photo No.</b> <b>39</b>	<b>Date:</b> 5/31/11
<b>Direction Photo Taken:</b> East

**Description:**  
Decant pipe in the North Pond A.

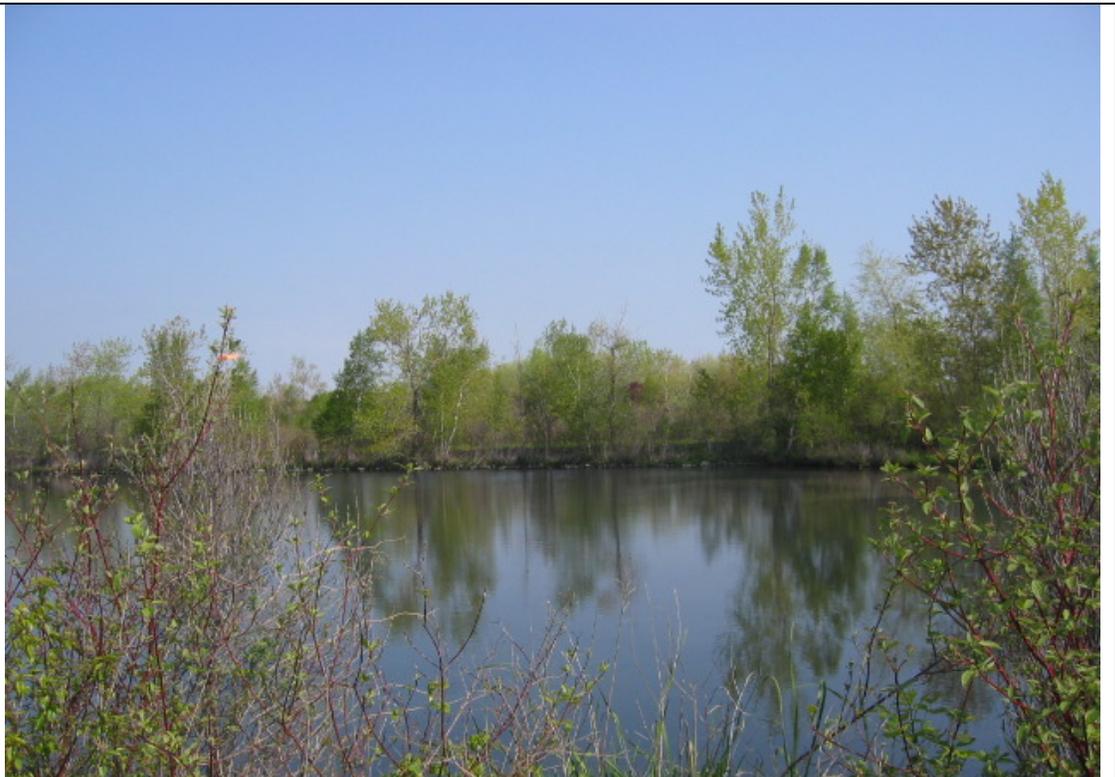
<b>Photo No.</b> <b>40</b>	<b>Date:</b> 5/31/11
<b>Direction Photo Taken:</b> Northwest

**Description:**  
Upstream slope of the South Pond A.

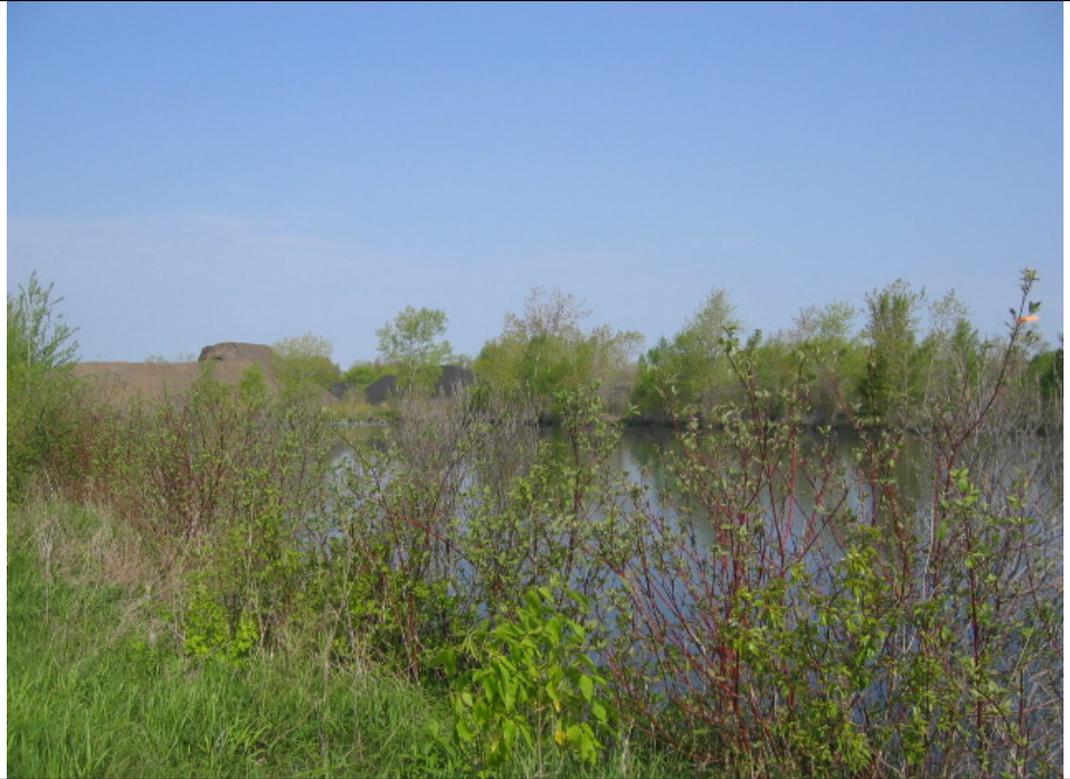
**Description:**  
Upstream slope of the South Pond A.

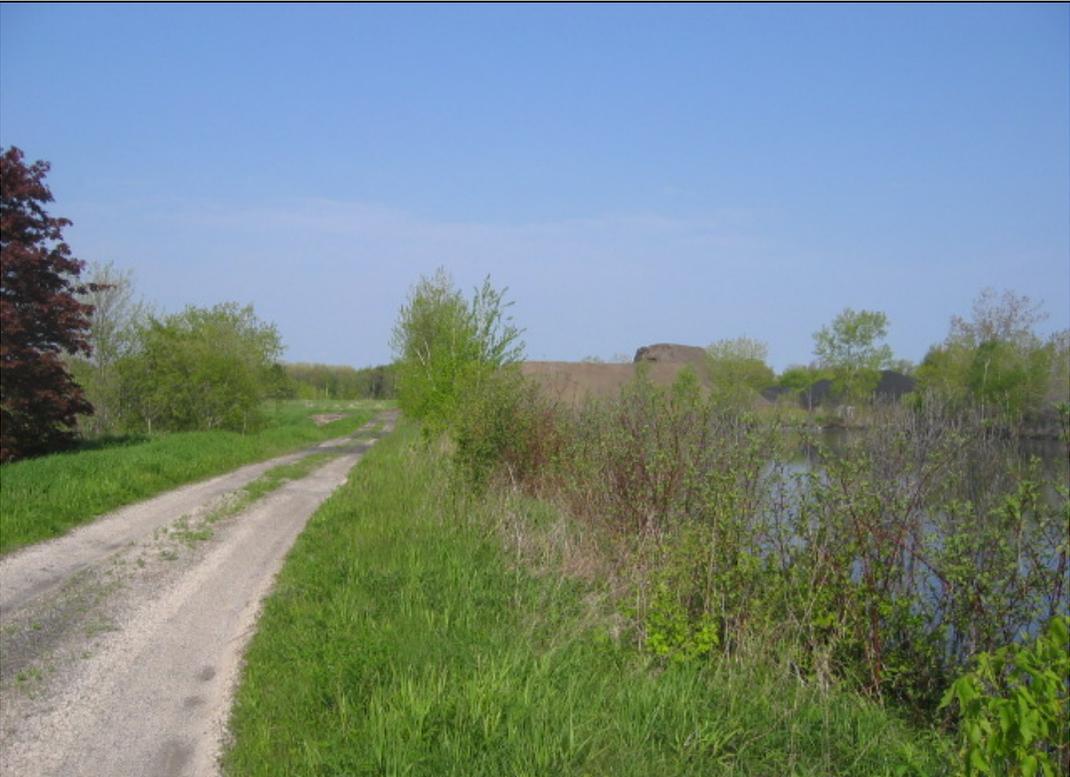
**Photo No.**  
**42**

**Description:**  
Upstream slope and crest of South Pond A.

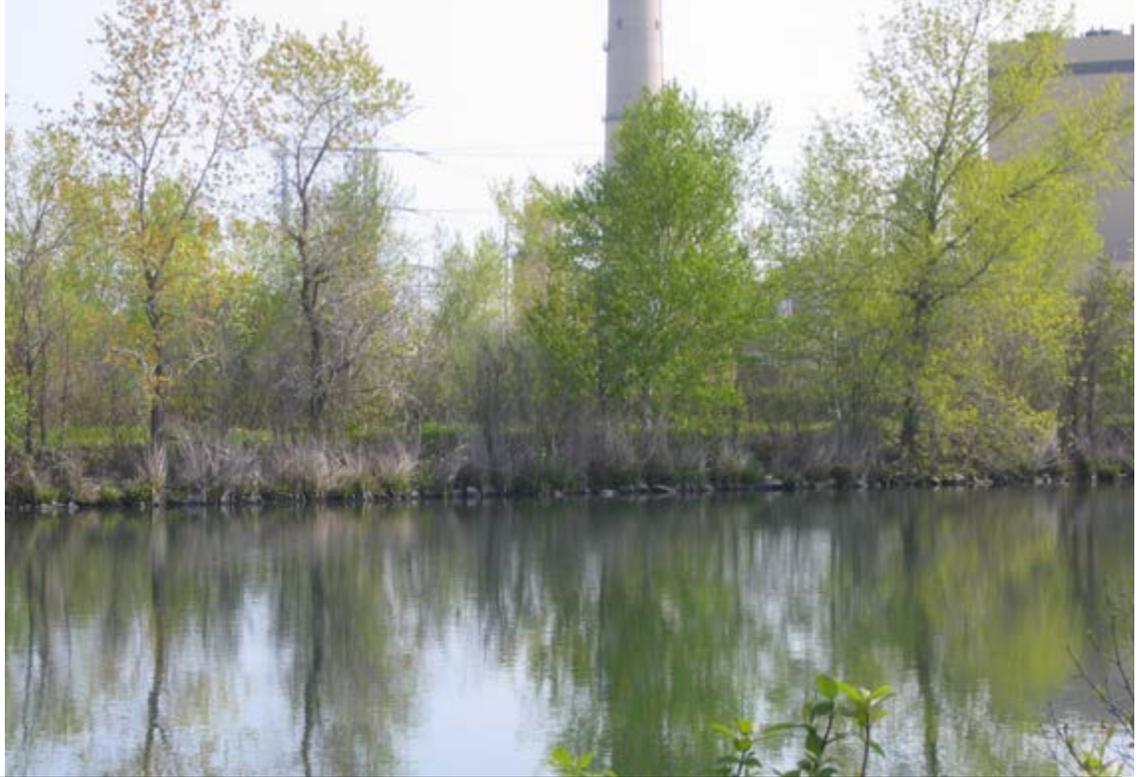
**Description:**  
Upstream slope of the South Pond A.

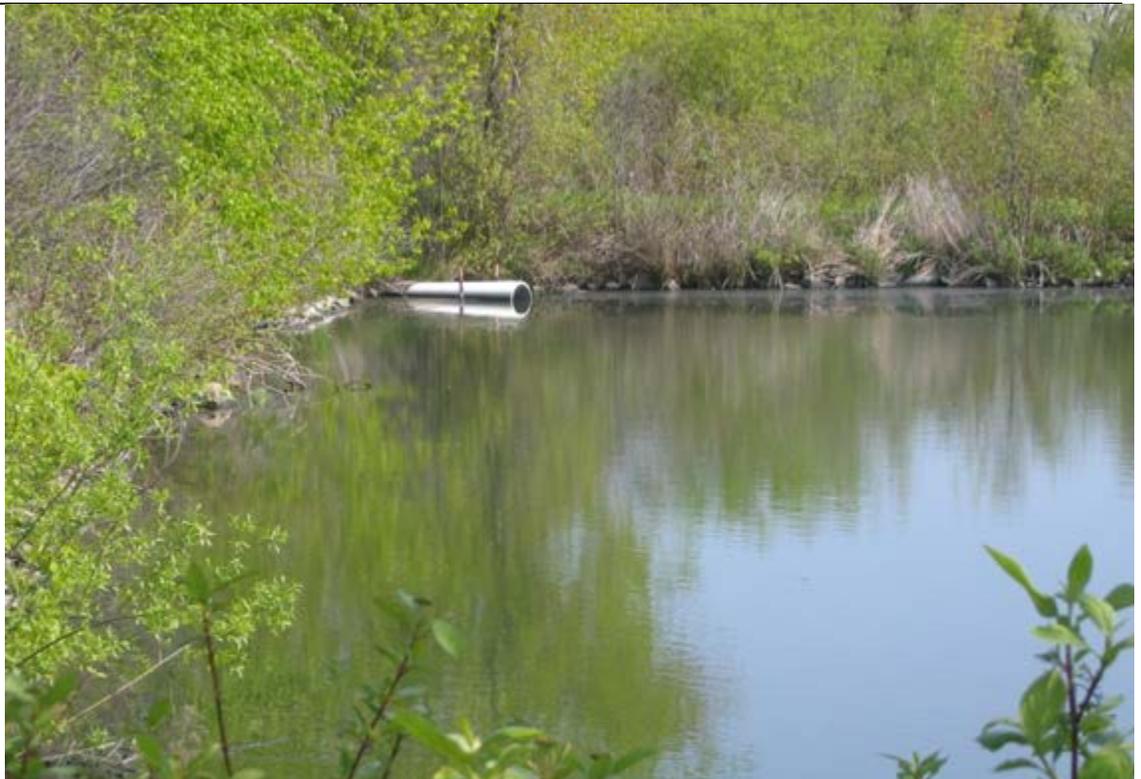
**Photo No.**  
**44**

**Description:**  
Upstream slope and decant pipe in the South Pond A.

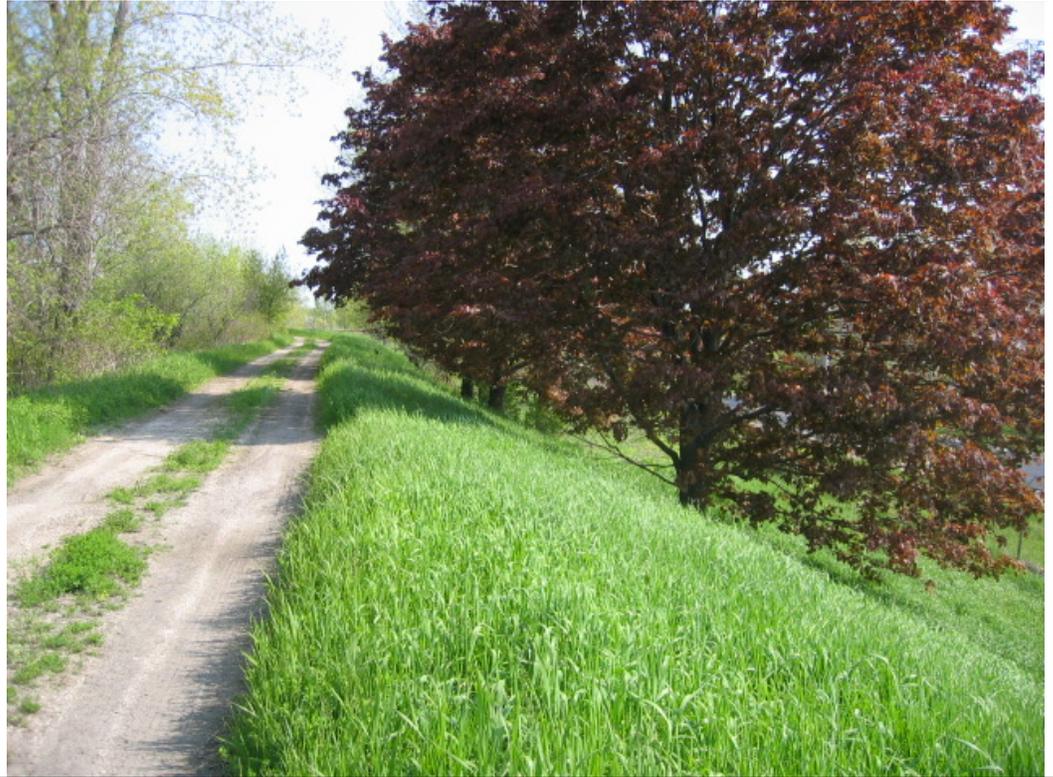
**Description:**  
Downstream slope and crest of the South Pond A.

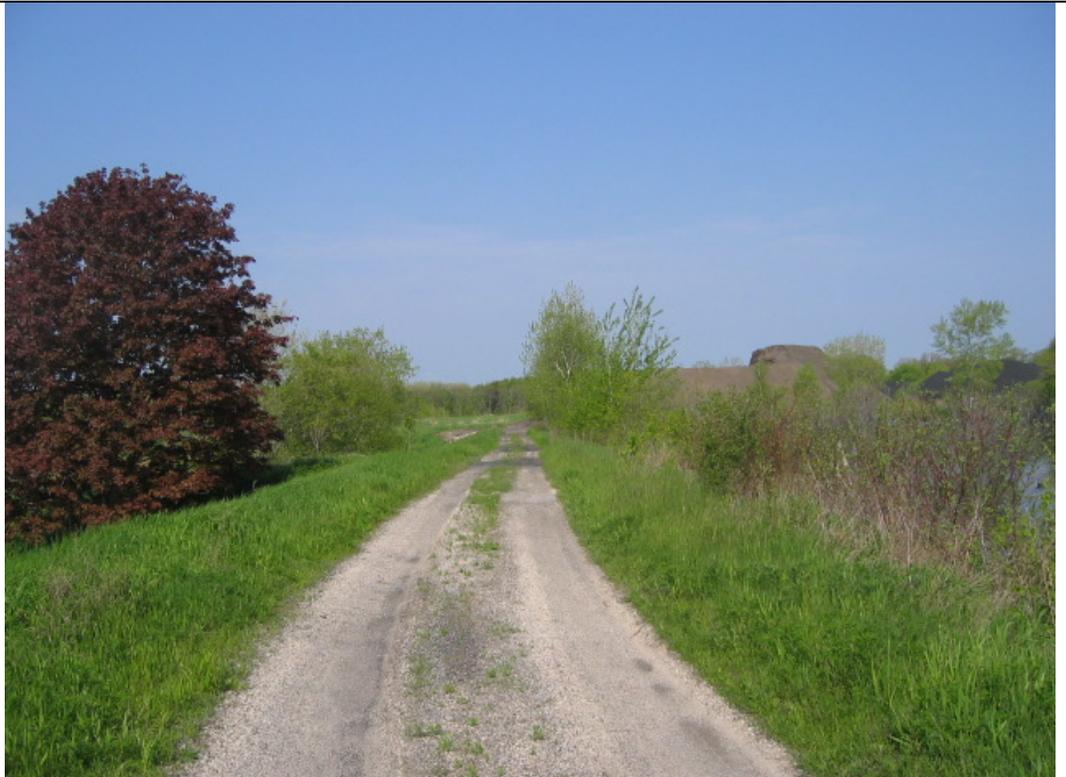
**Photo No.**  
**46**

**Description:**  
Crest of the embankment between South Pond A and Pond C.

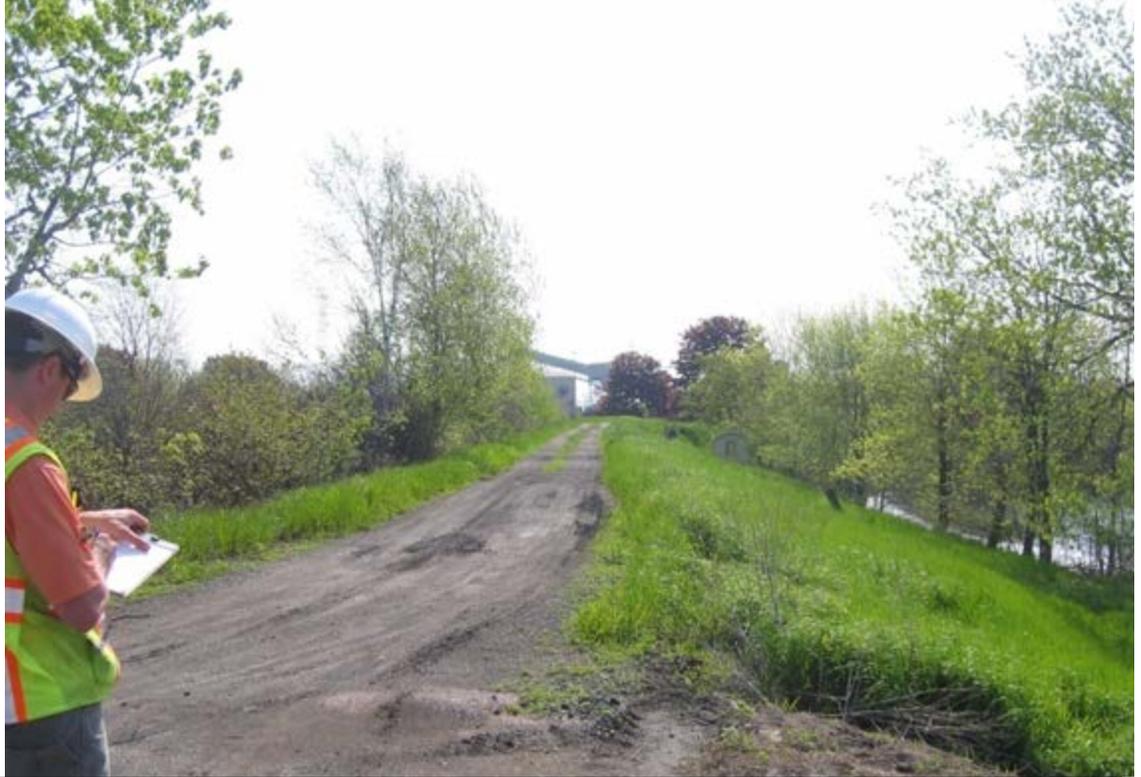
Description:  
Crest of the embankment  
between South Pond A and  
Pond B.

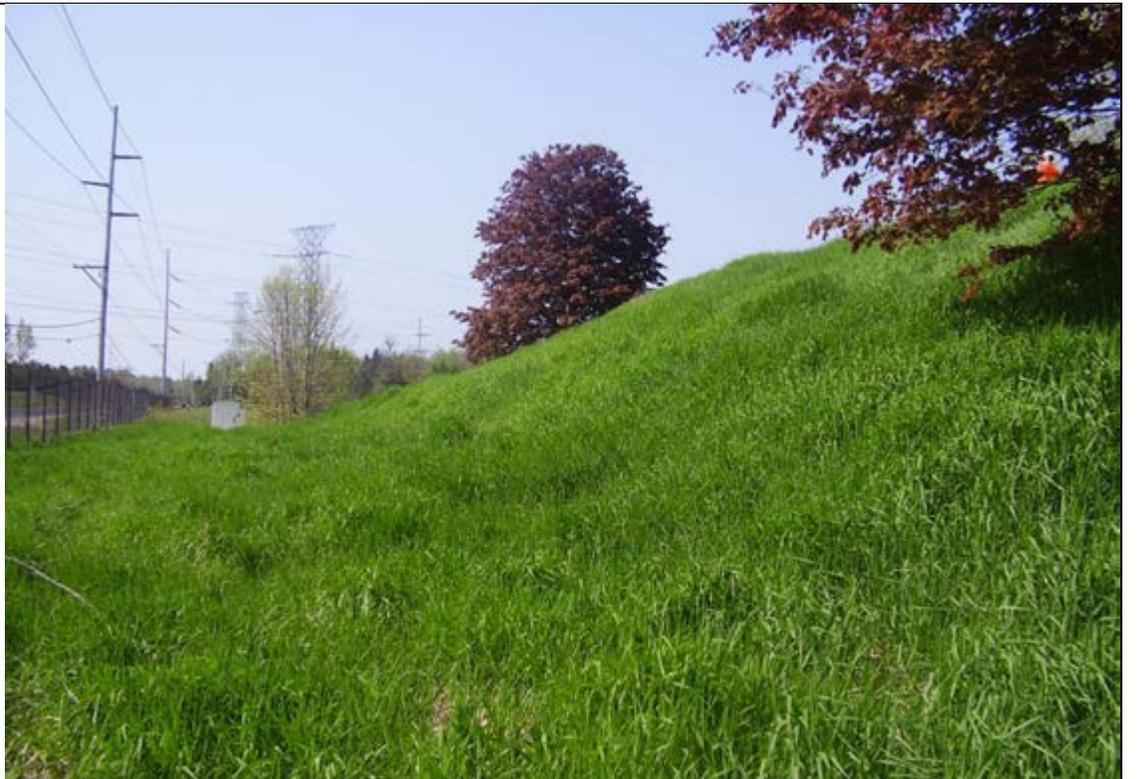
Photo No.  
**48**

Description:  
Downstream slope of South  
Pond A.

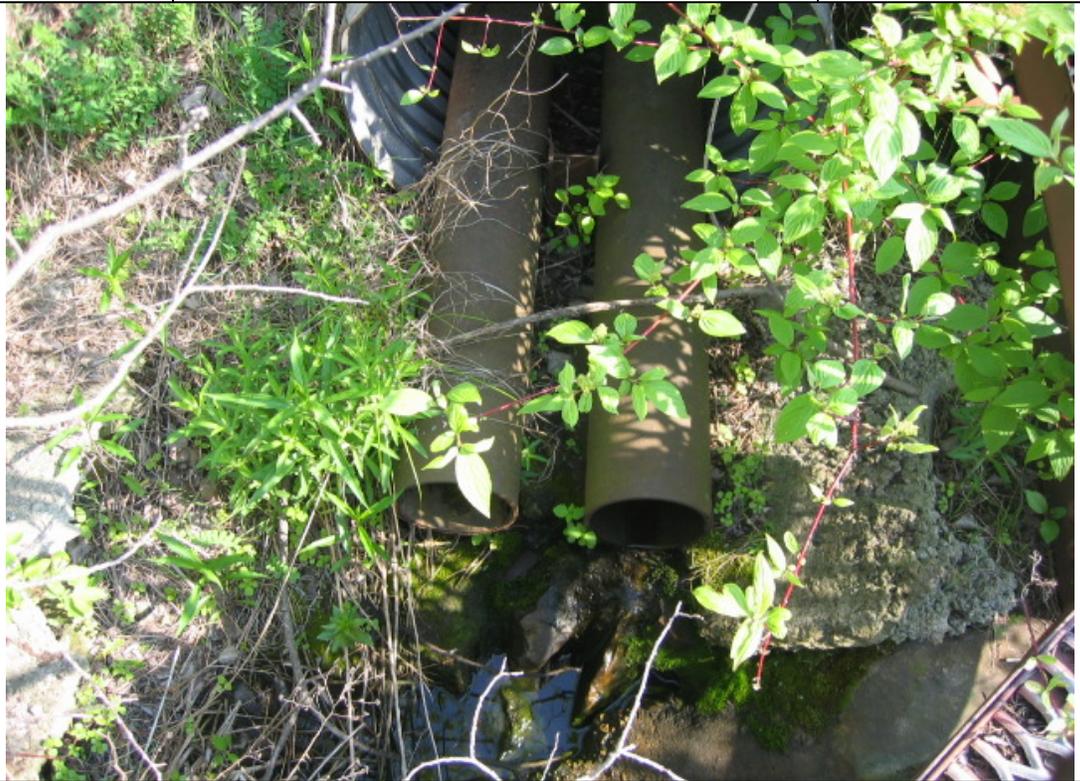
**Description:**  
Discharge pipes into South Pond A.

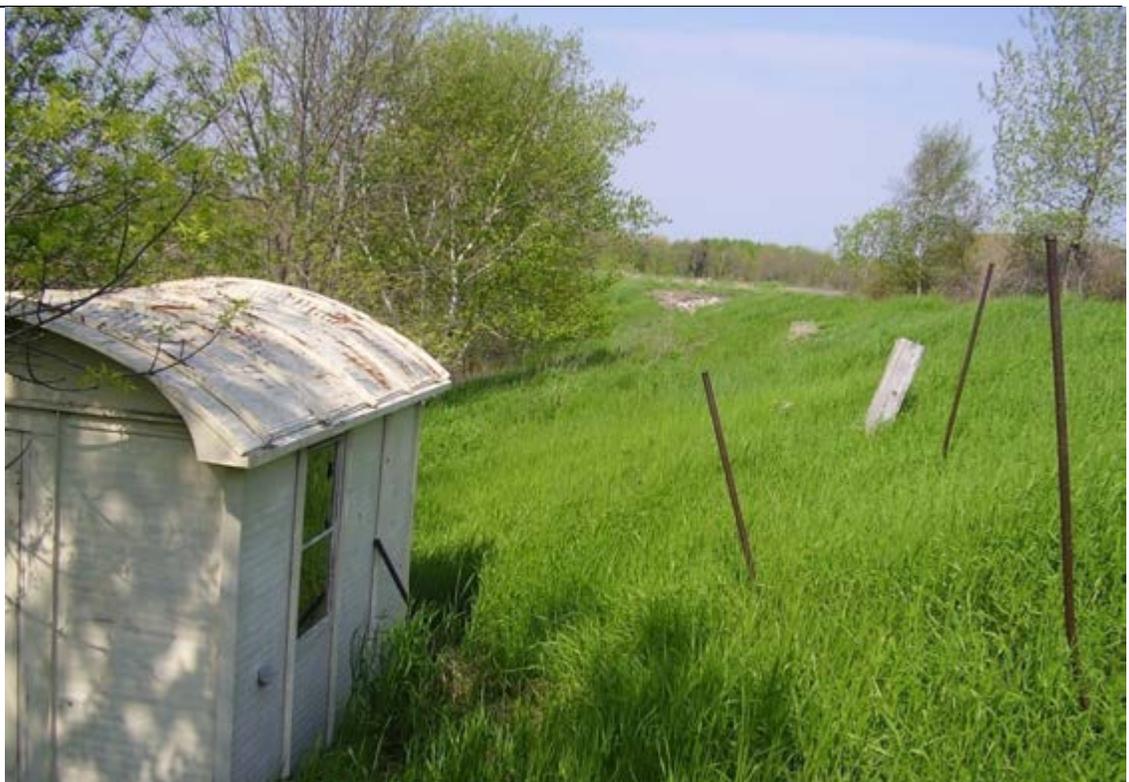
**Description:**  
Upstream slope of Pond B.

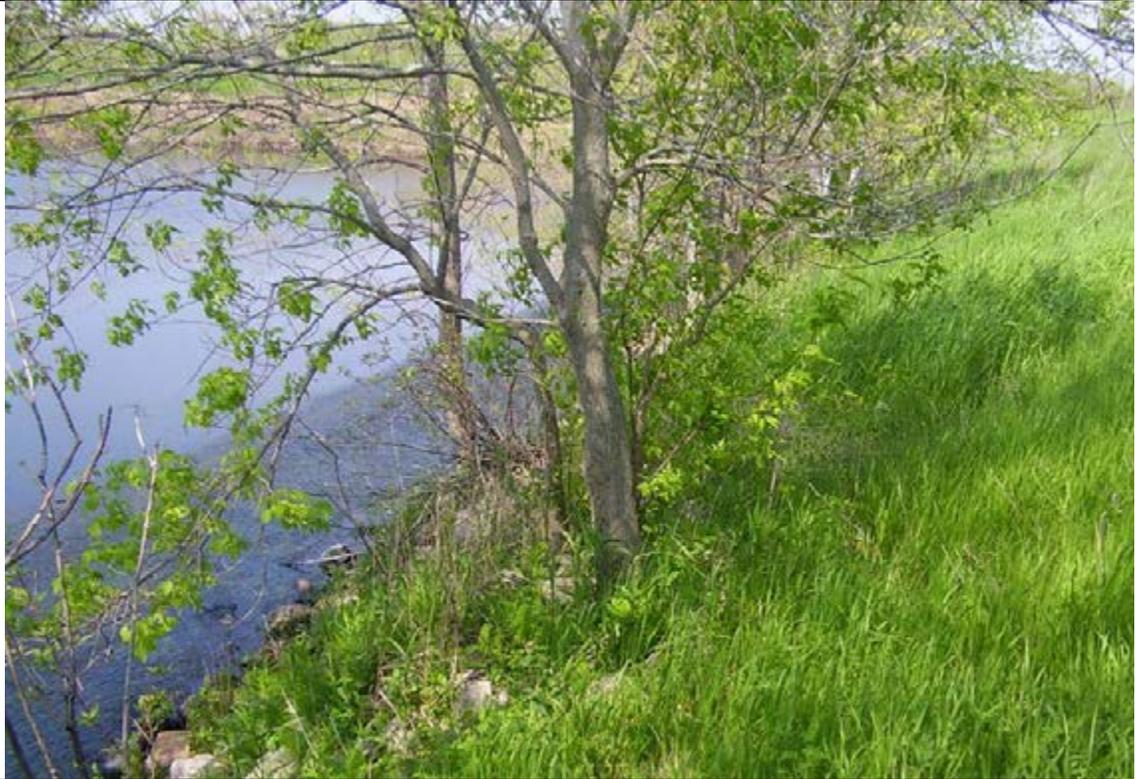
**Description:**  
Upstream slope of Pond B.

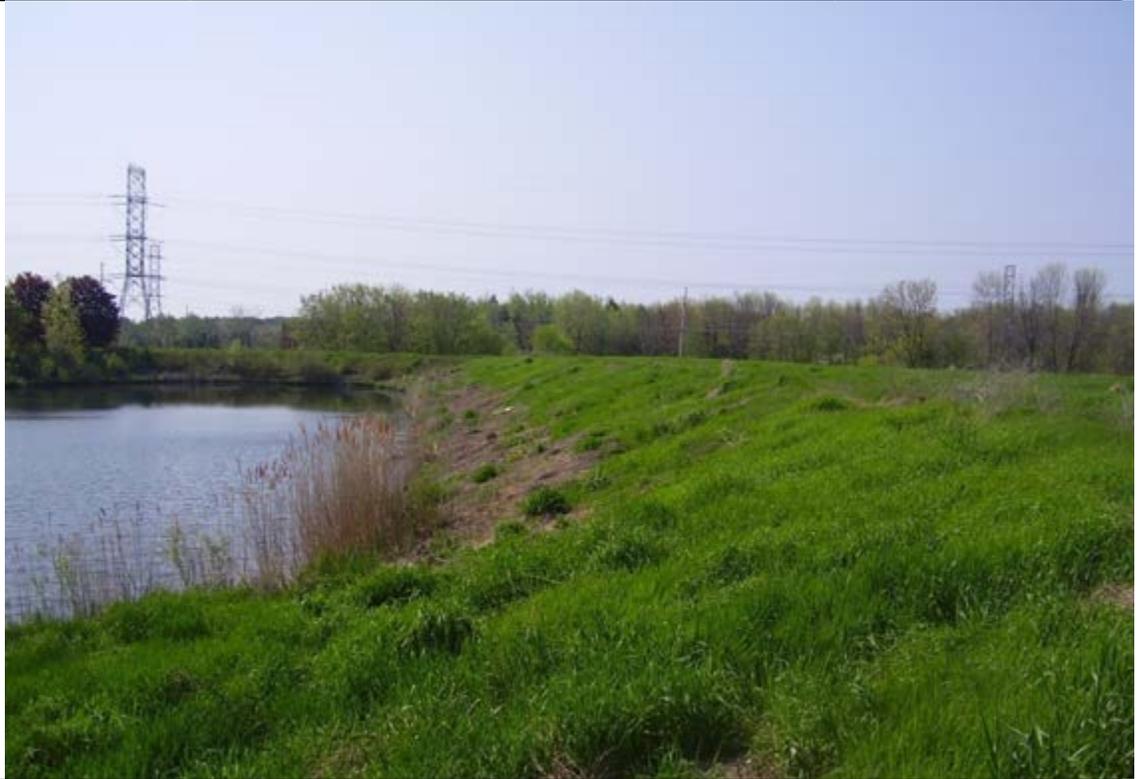
**Description:**  
Upstream slope of Pond B.

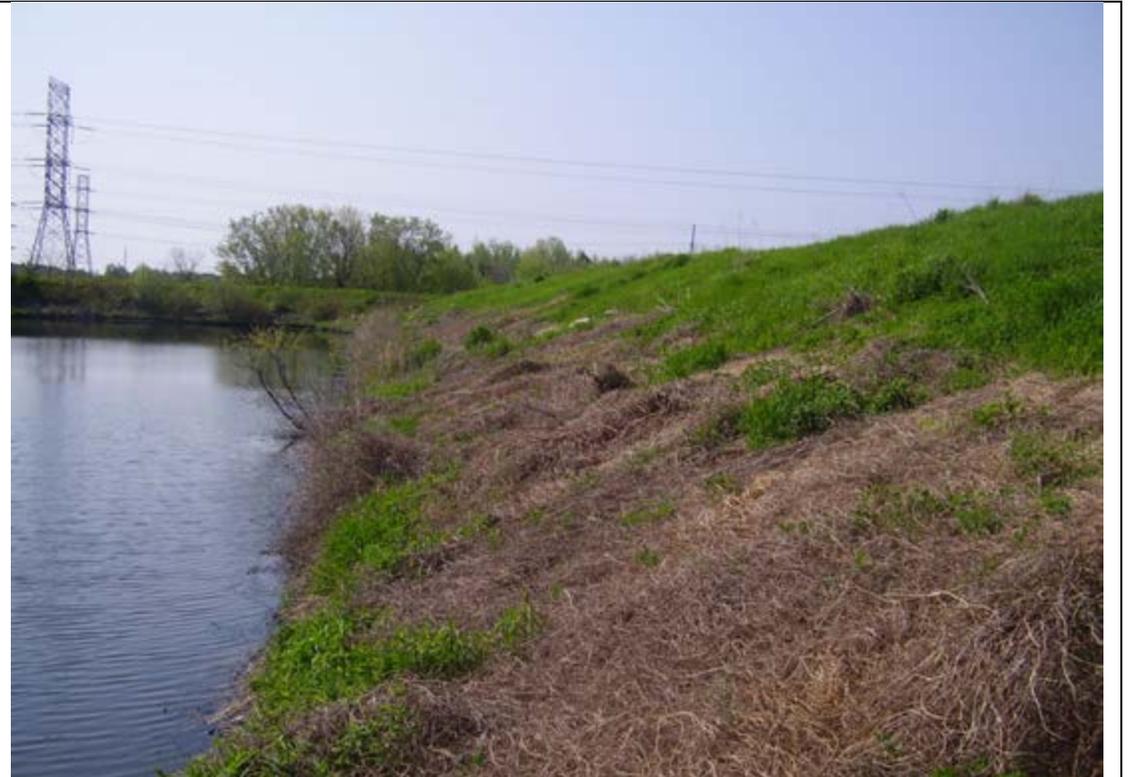
**Photo No.**  
**54**

**Description:**  
Upstream slope of Pond B.

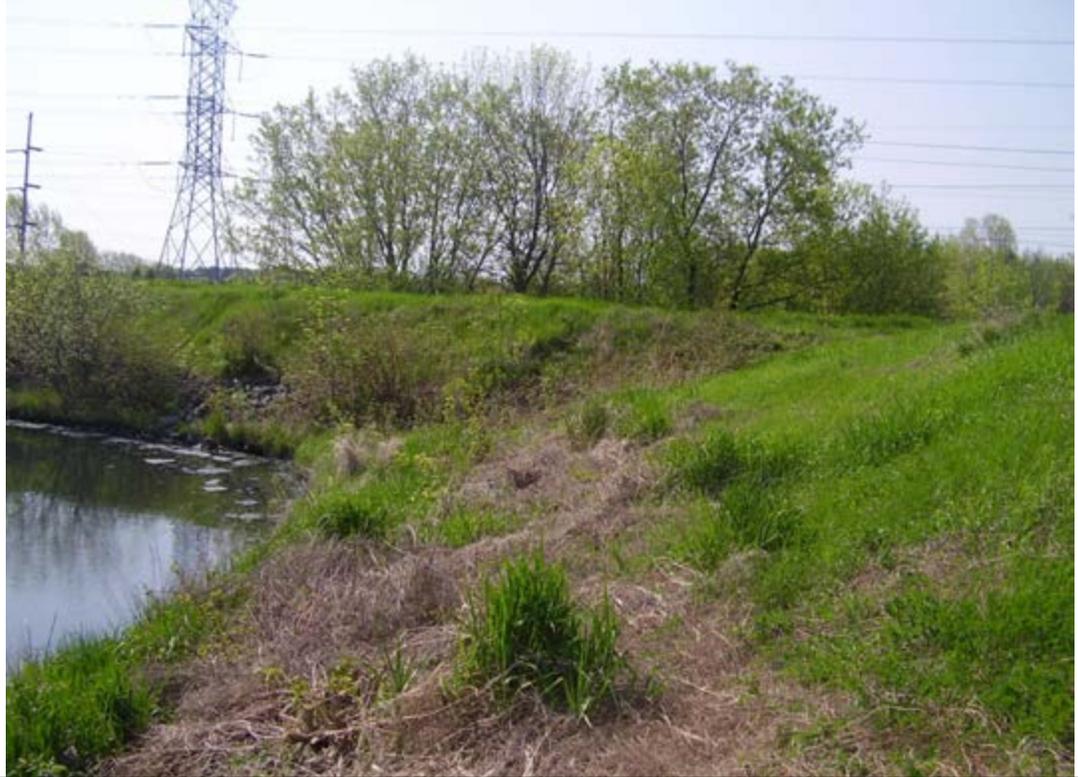
**Description:**  
Upstream slope of Pond B.

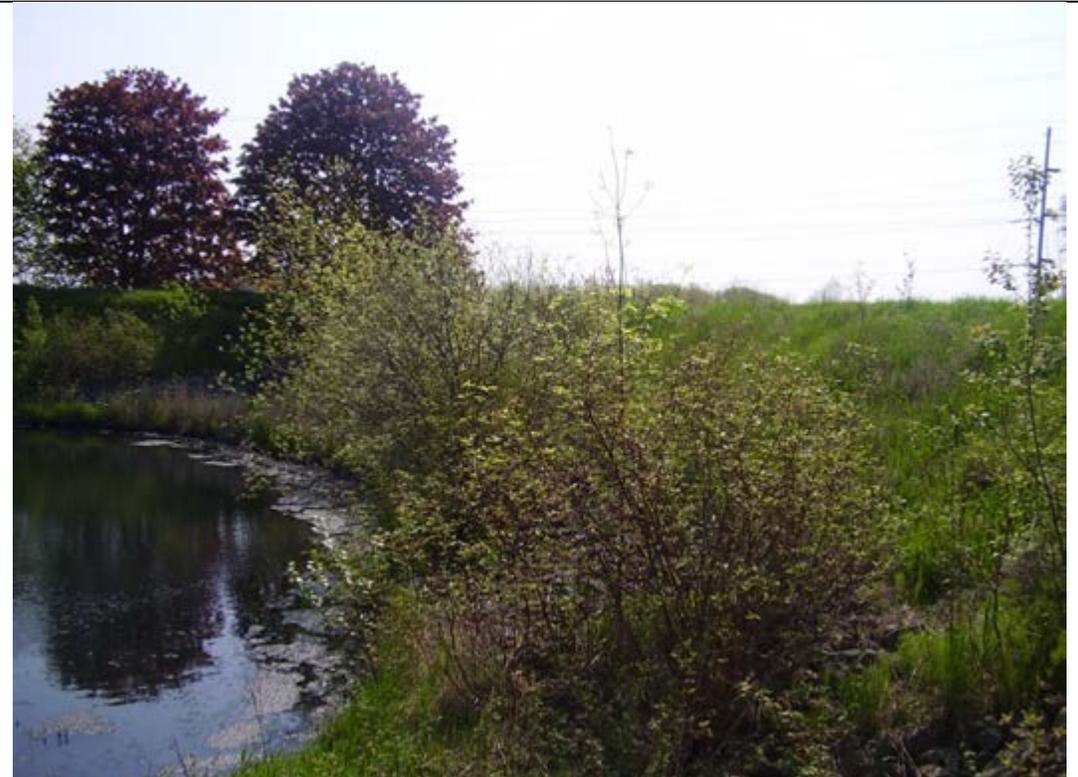
**Photo No.**  
**56**

**Description:**  
Upstream slope of Pond B.

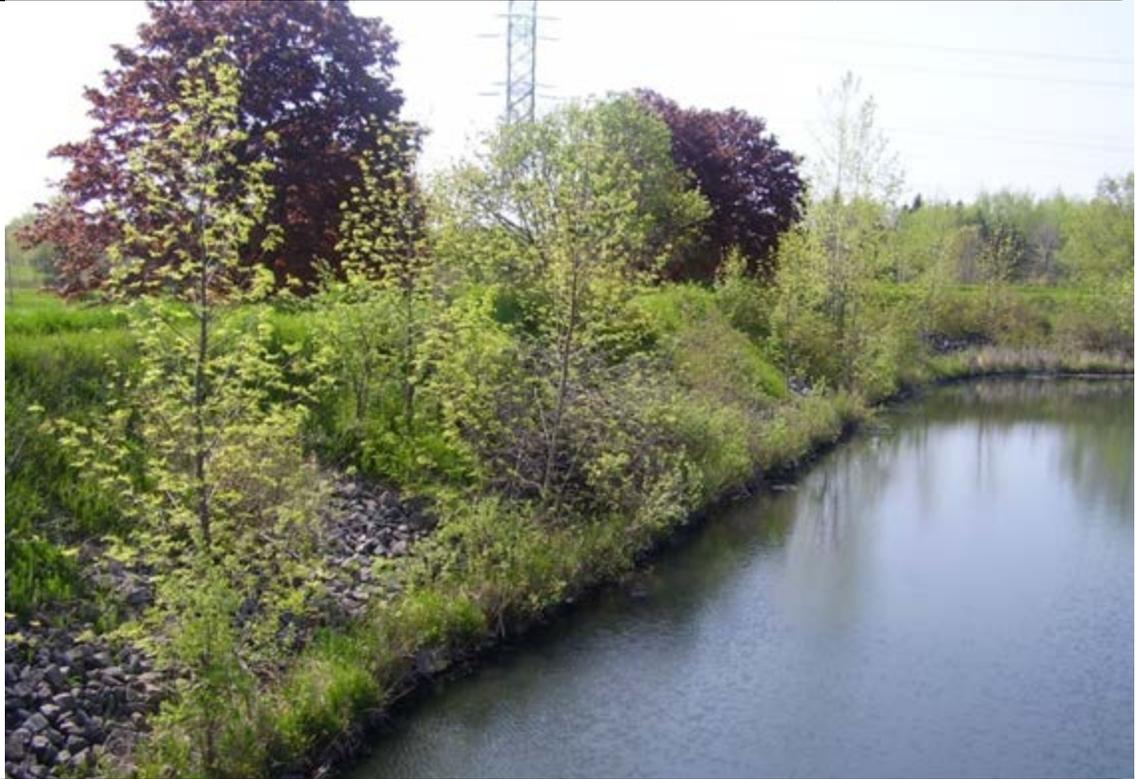
Description:  
Upstream slope of Pond B as  
seen from the decant  
structure platform.
