**DRAFT REPORT  
ROUND 10 DAM ASSESSMENT - MAY 31, 2011  
ALLIANT ENERGY – EDGEWATER GENERATING STATION  
SLAG POND, NORTH POND A, SOUTH POND A, POND B, POND F  
SHEBOYGAN, WISCONSIN**

RE: Assessment of Dam Safety of Coal Combustion Surface Impoundments at the Edgewater  
Generating Station

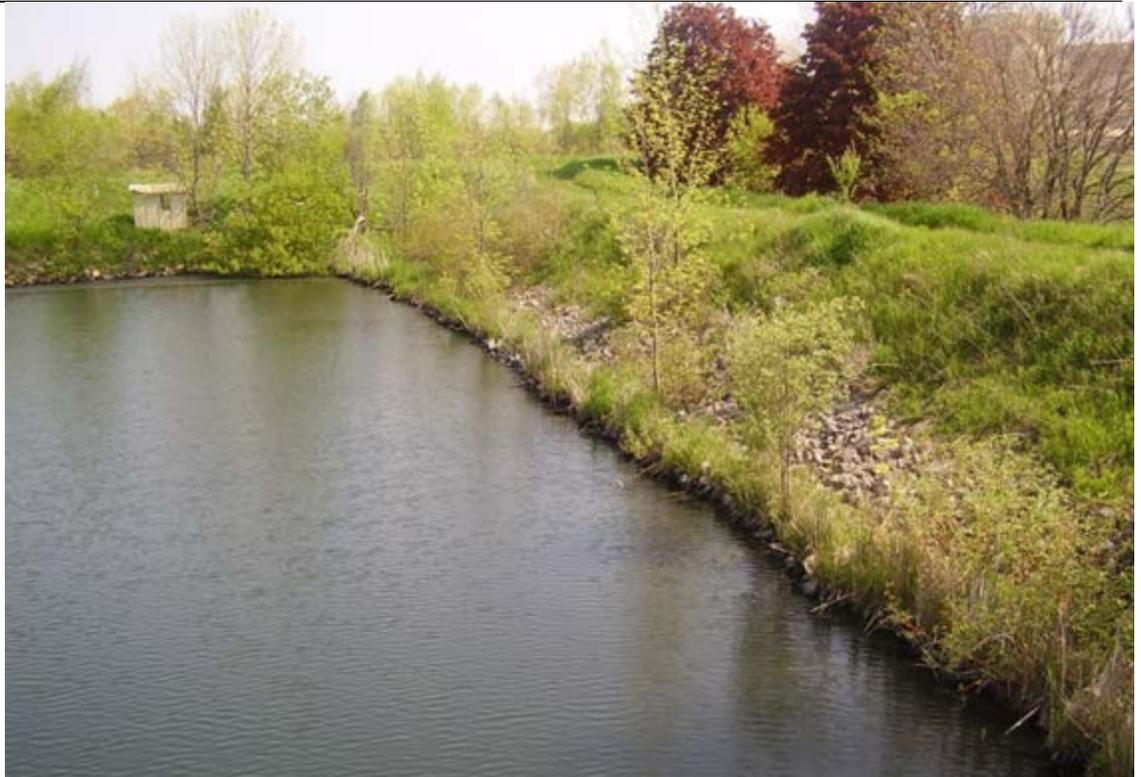
Photo No.  
**58**

Description:  
Upstream slope of Pond B as  
seen from the decant  
structure platform.

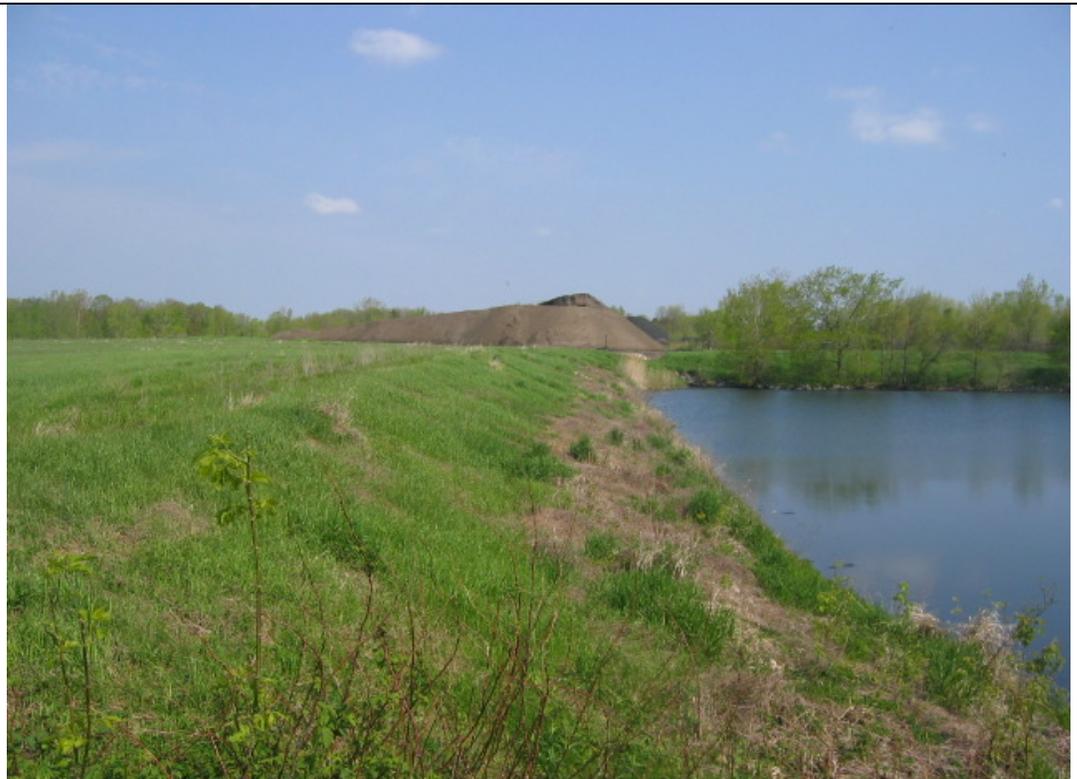
**Photo No.**  
**60**

**Description:**  
Crest and upstream slope of  
Pond B.

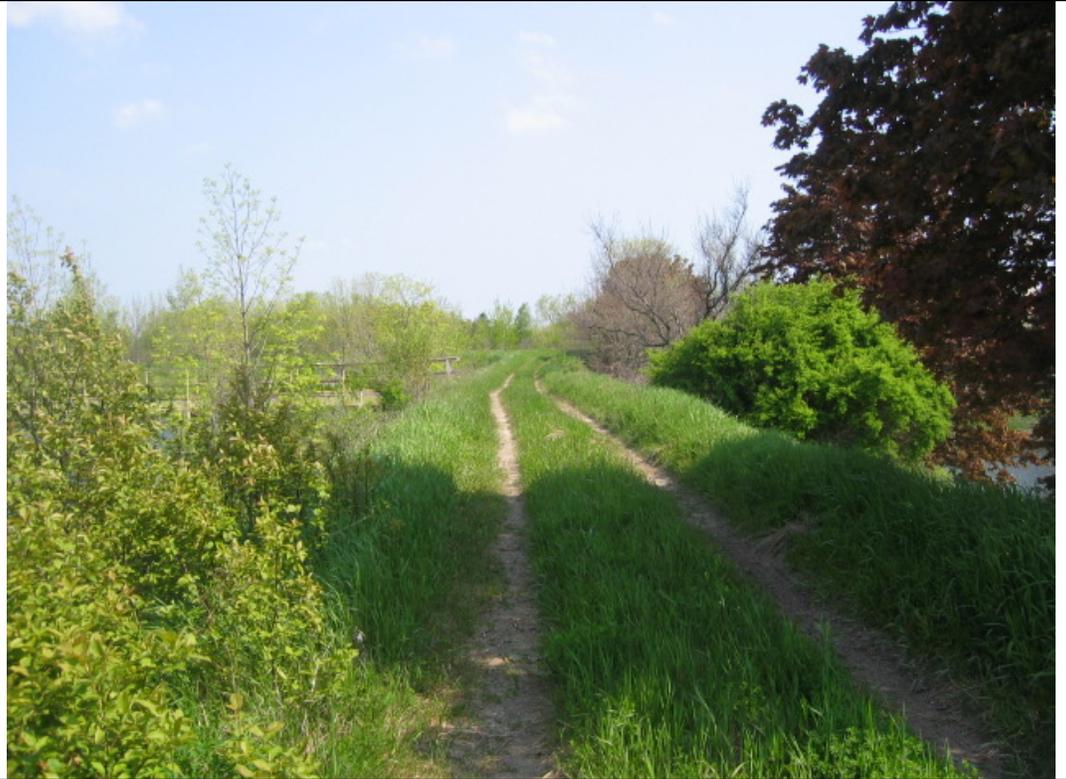
Description:  
Crest of Pond B.

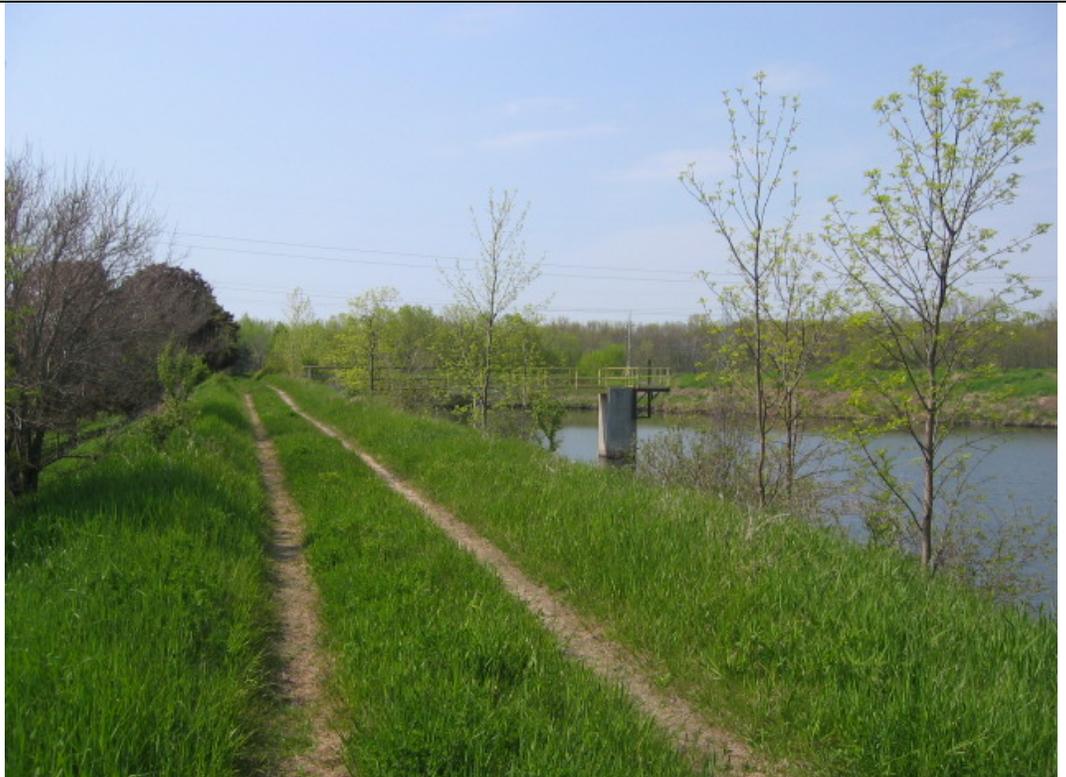
Photo No.  
**62**

Description:  
Crest of Pond B.

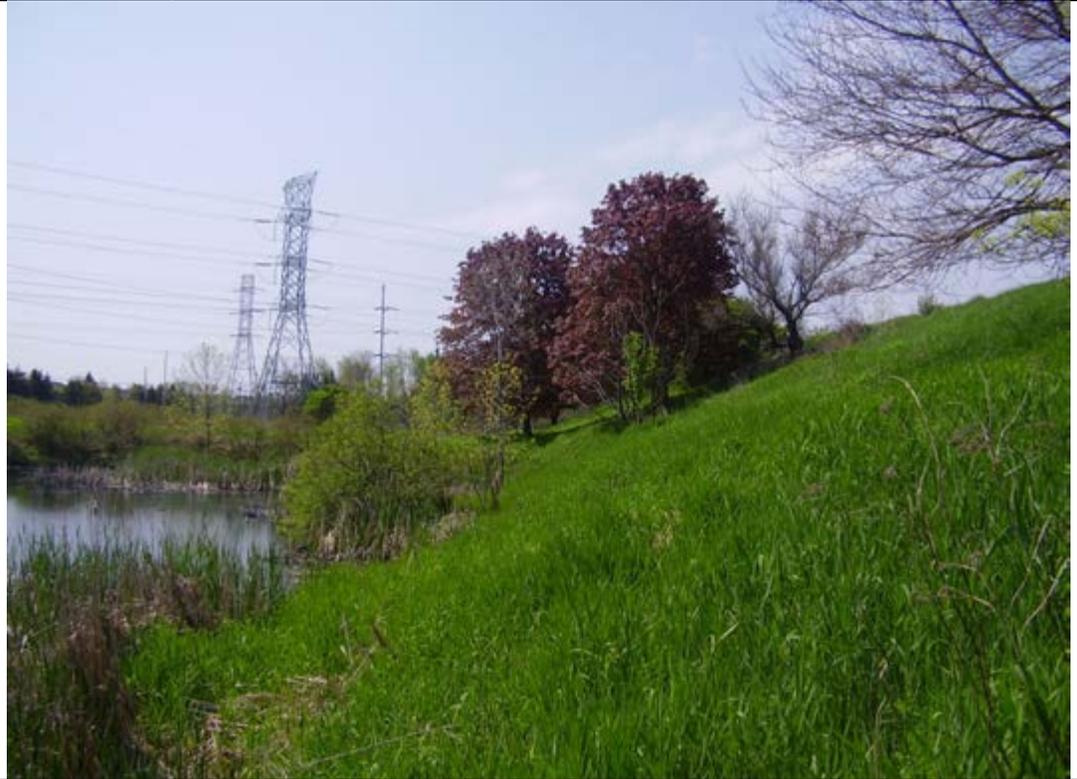
Description:  
Downstream slope of the  
embankment between Pond  
B and Pond C.

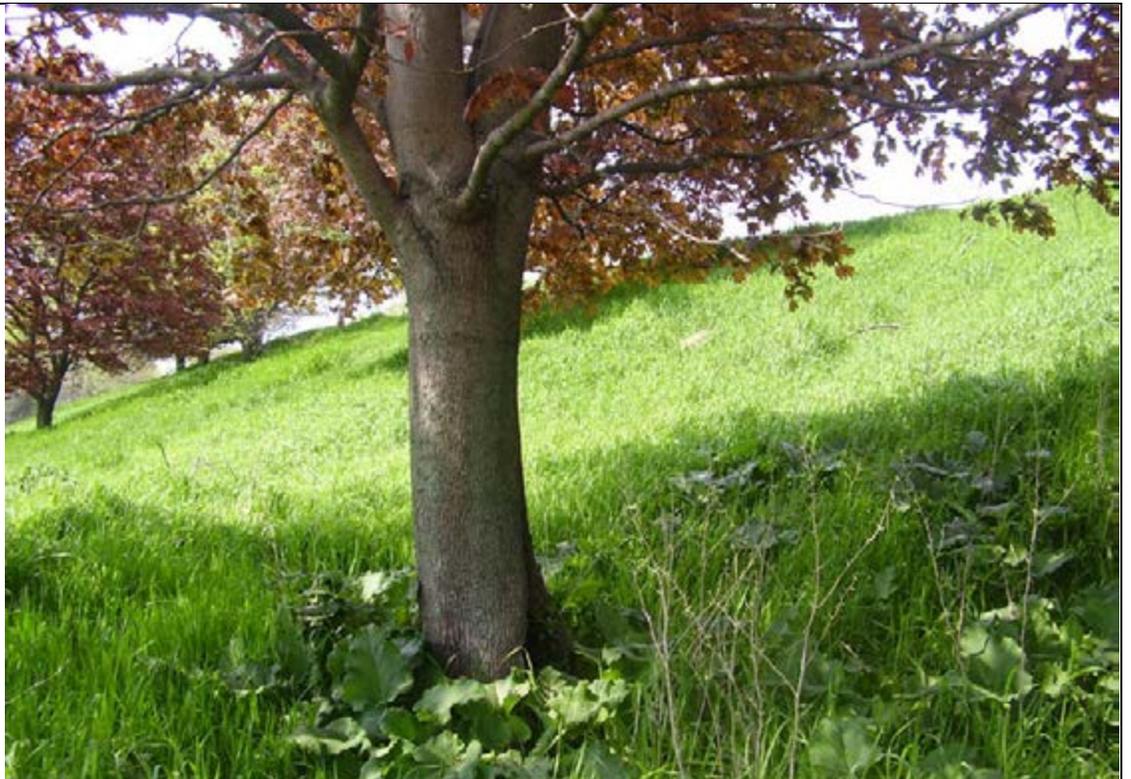
Photo No.  
**64**

Description:  
Downstream slope of Pond  
B.

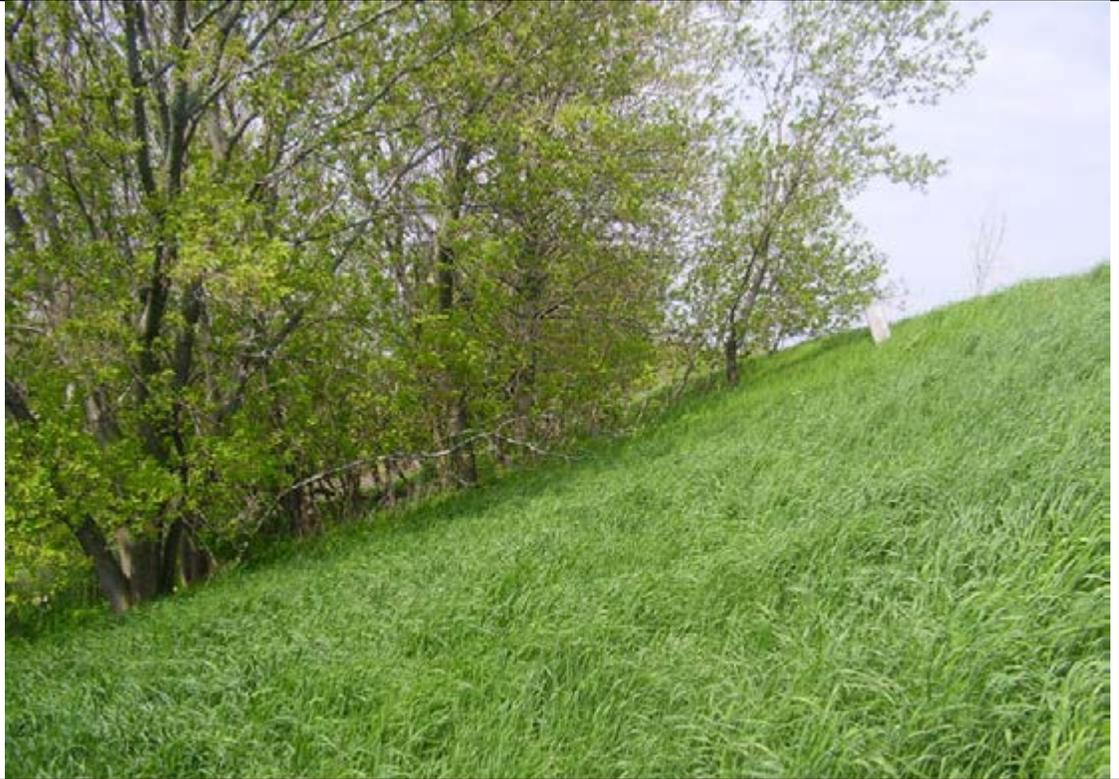
**Description:**  
Downstream slope of Pond B.

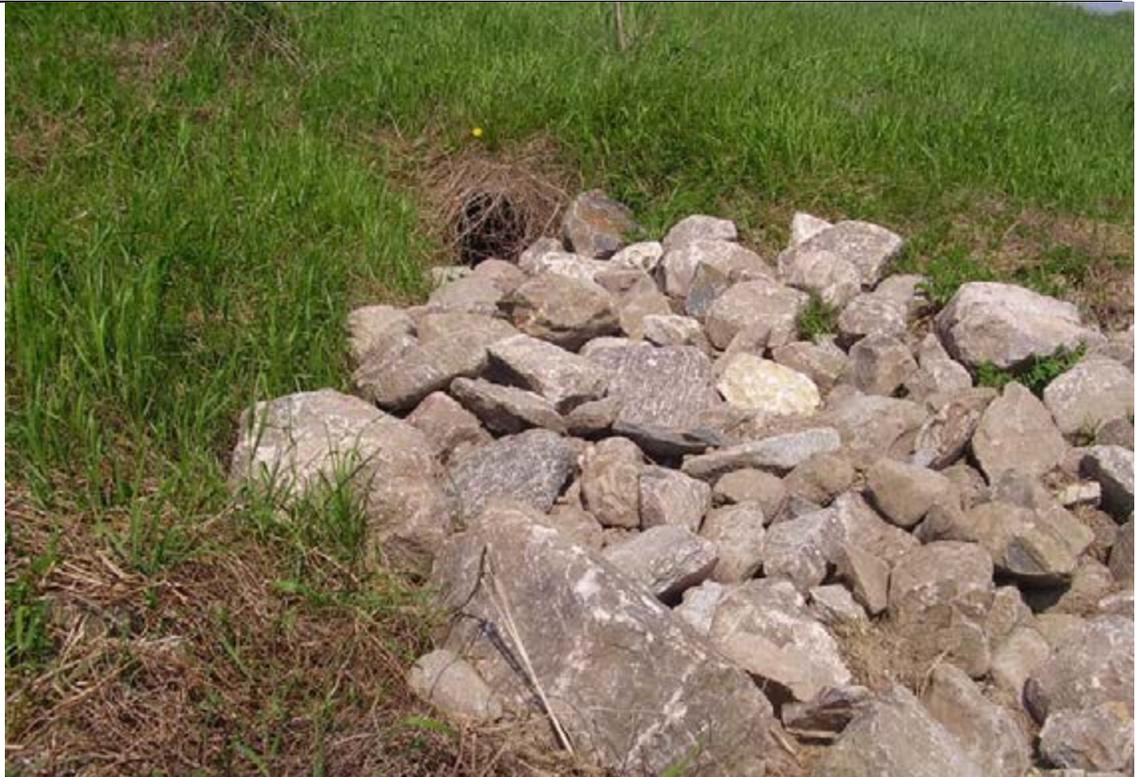
**Photo No.**  
**66**

**Description:**  
Stormwater discharge pipe from the Landfill portion of the Site.

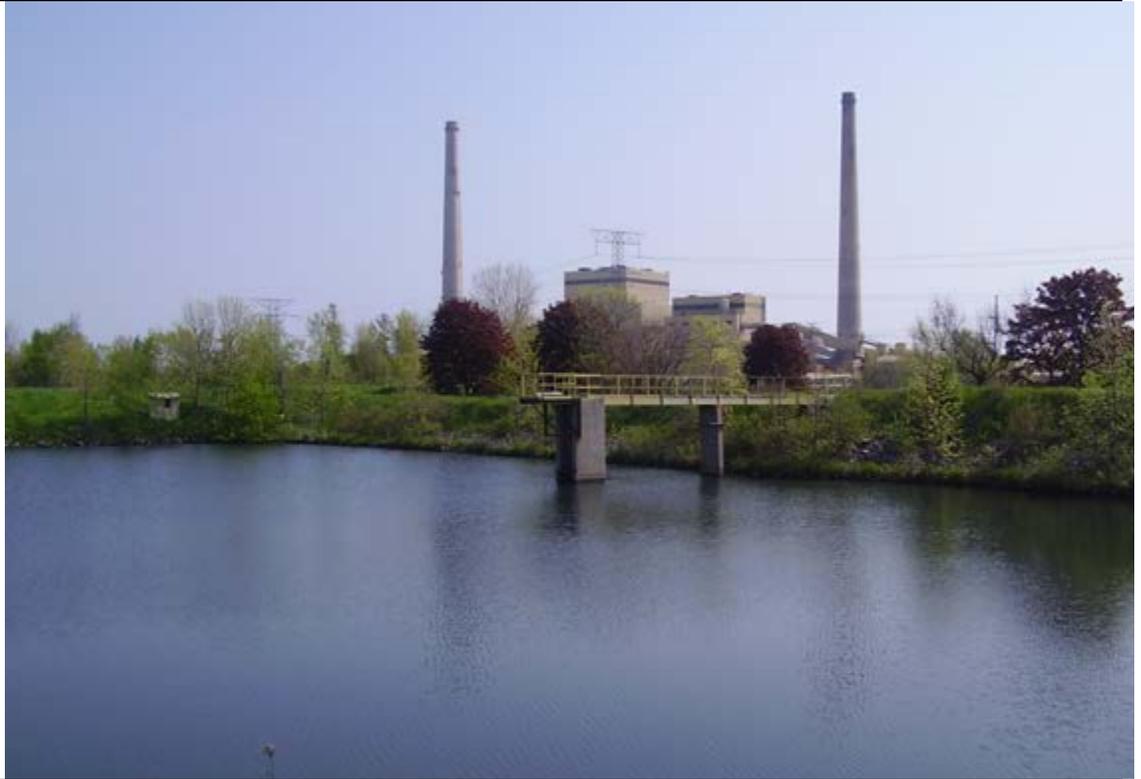
**Description:**  
Decant structure in Pond B.

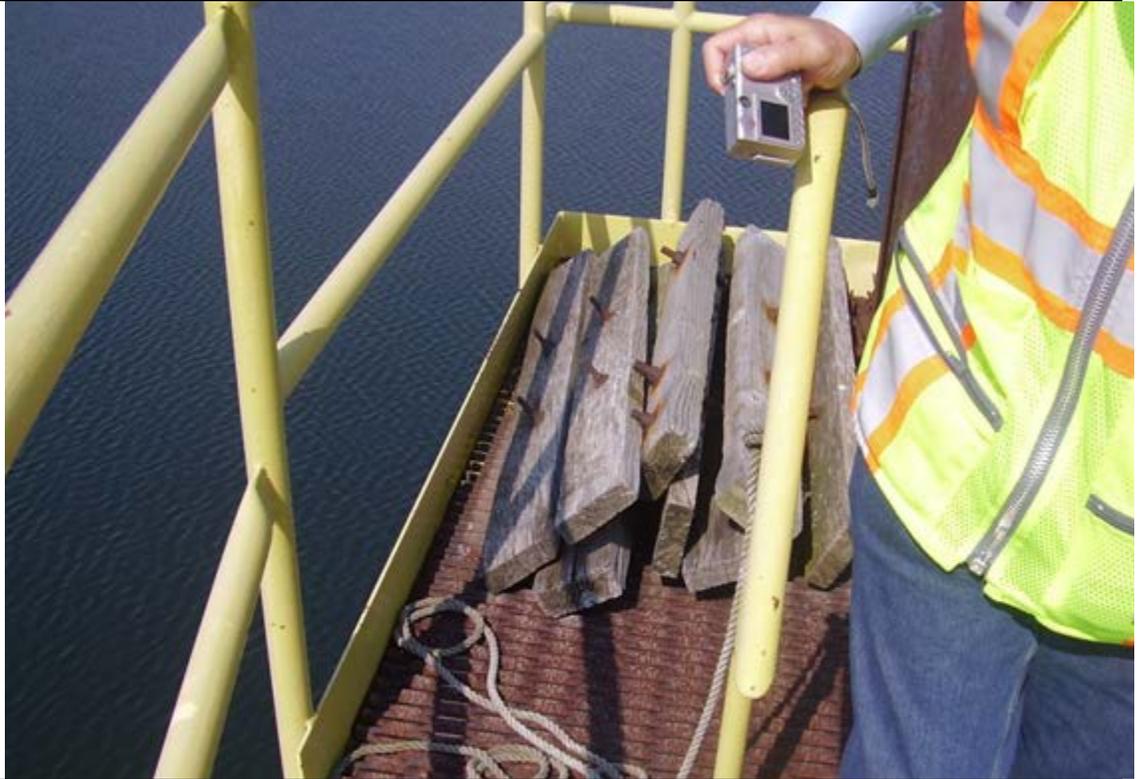
**Description:**  
Additional stop logs used at the Pond B decant structure.

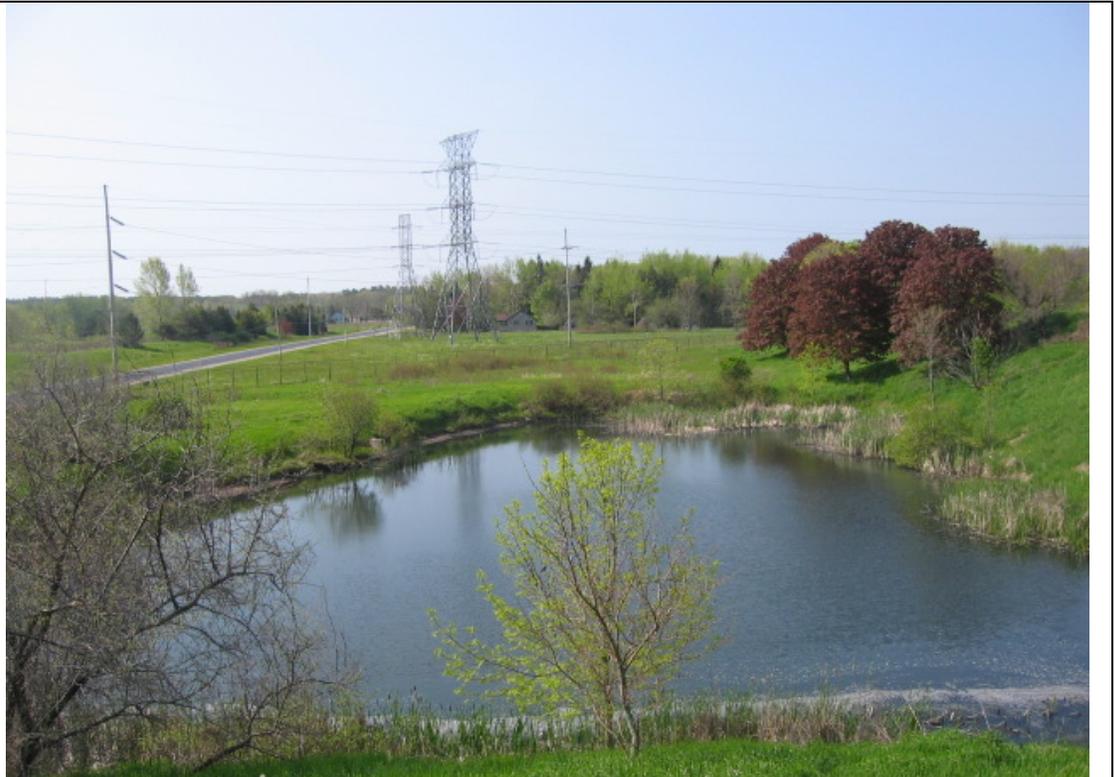
**Photo No.**  
**70**

**Description:**  
Pond C as seen from the embankment for South Pond A.

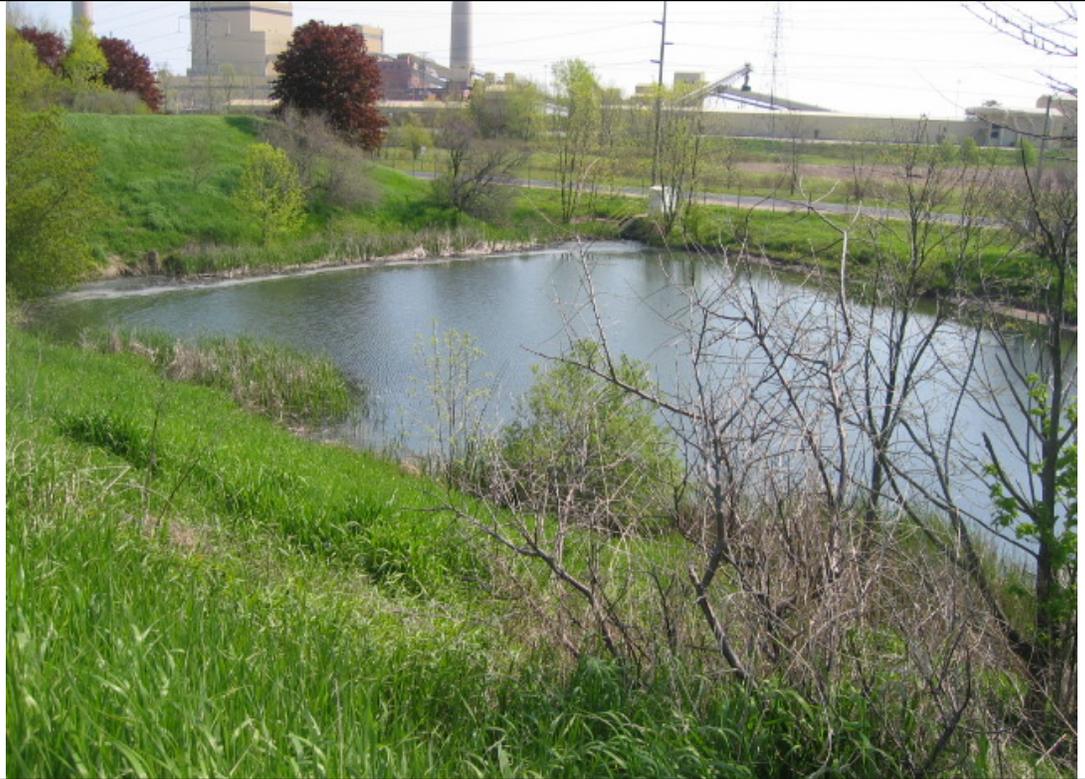
**Description:**  
Pond C as seen from the embankment for Pond B.

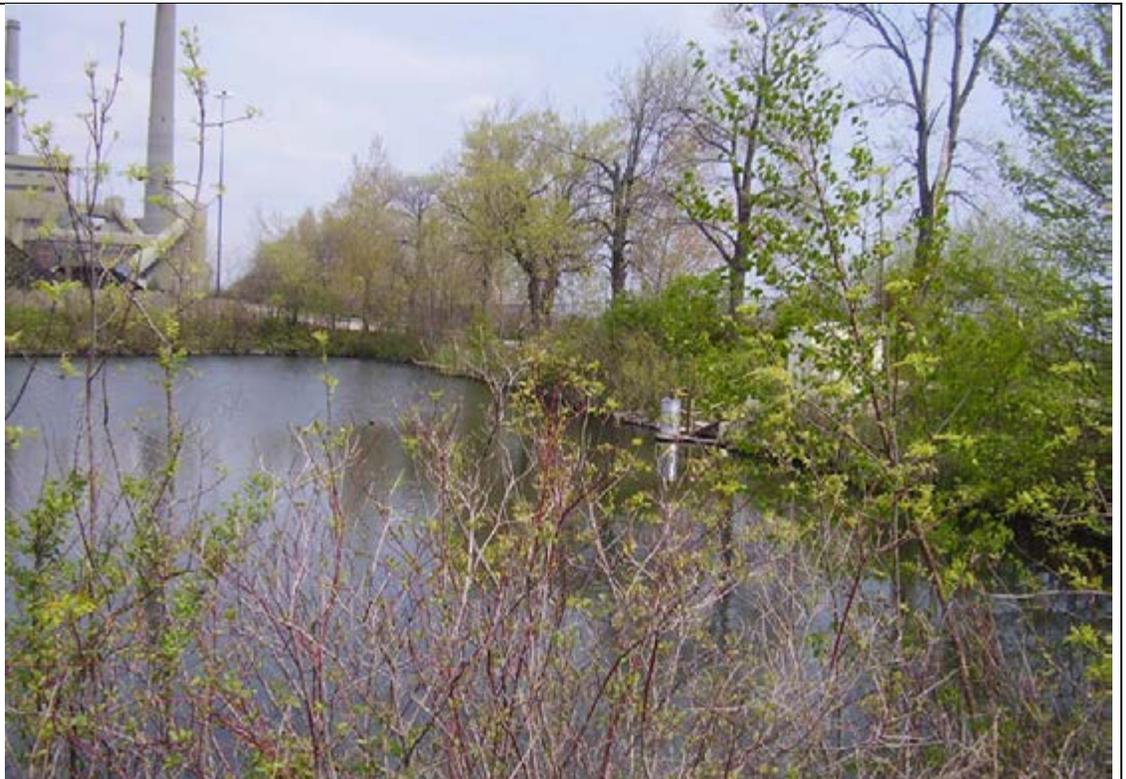
**Photo No.**  
**72**

**Description:**  
Upstream slope of Pond F.

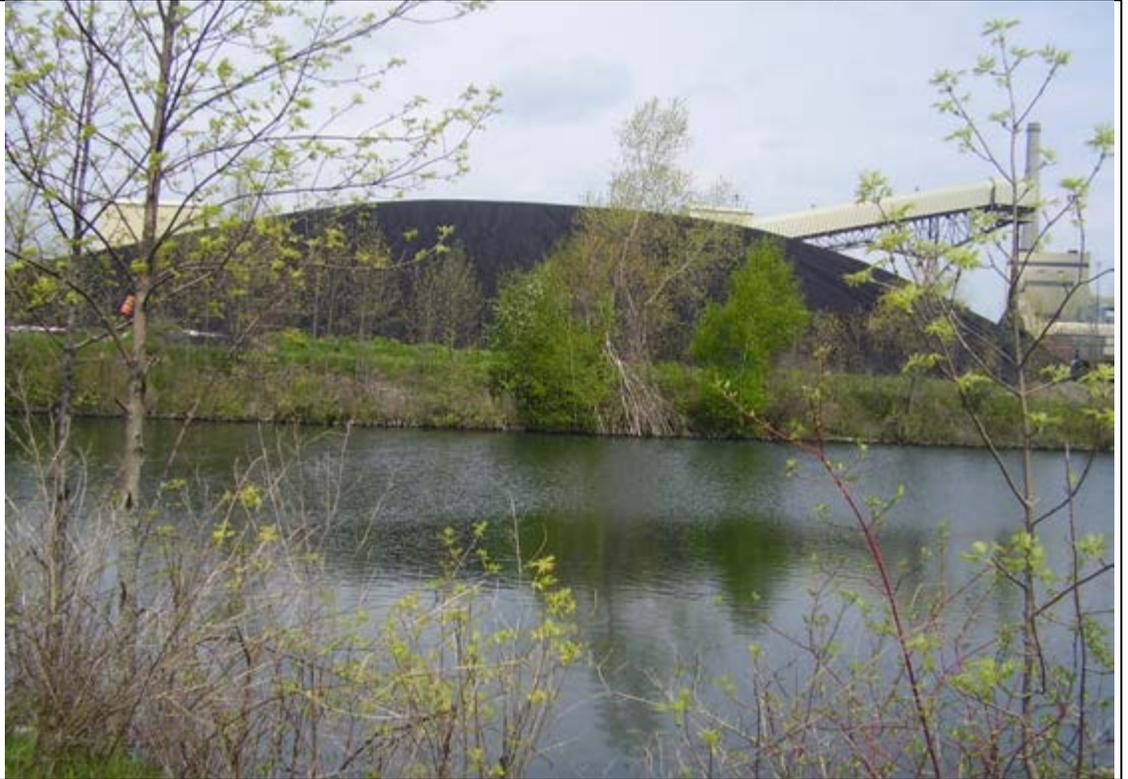
**Description:**  
Upstream slope of Pond F.

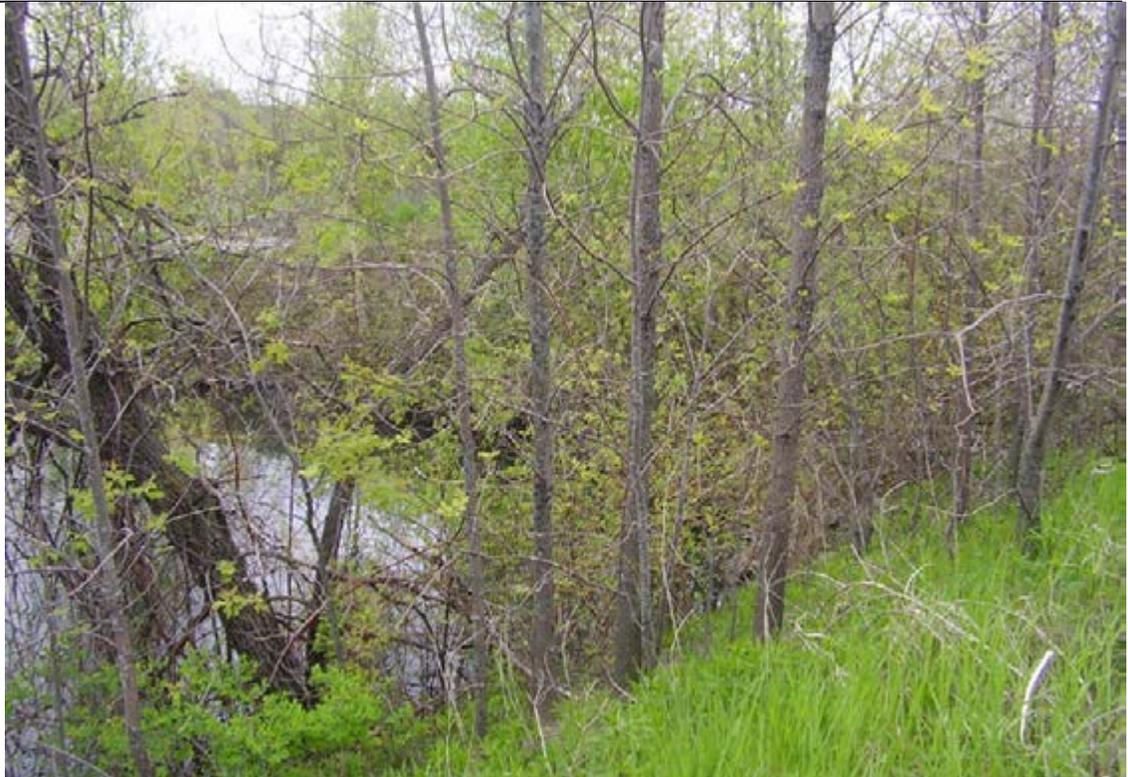
**Photo No.**  
**74**

**Description:**  
Upstream slope of Pond F.

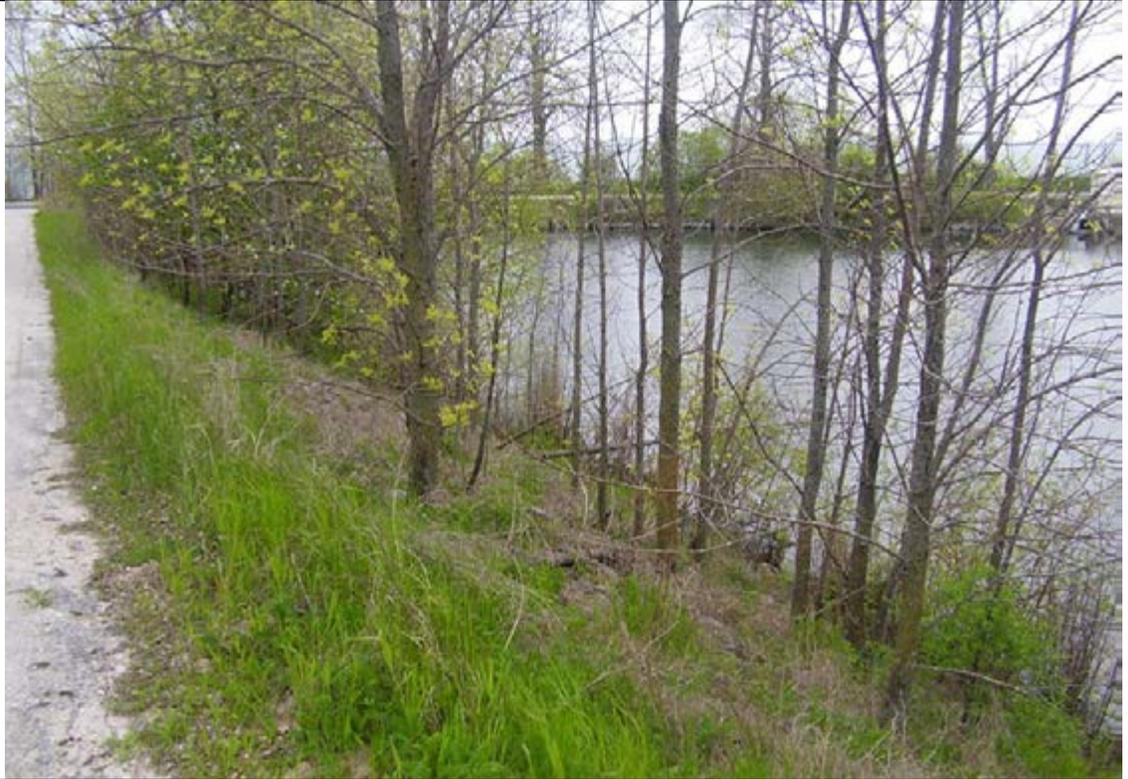
**Description:**  
Upstream slope of Pond F.

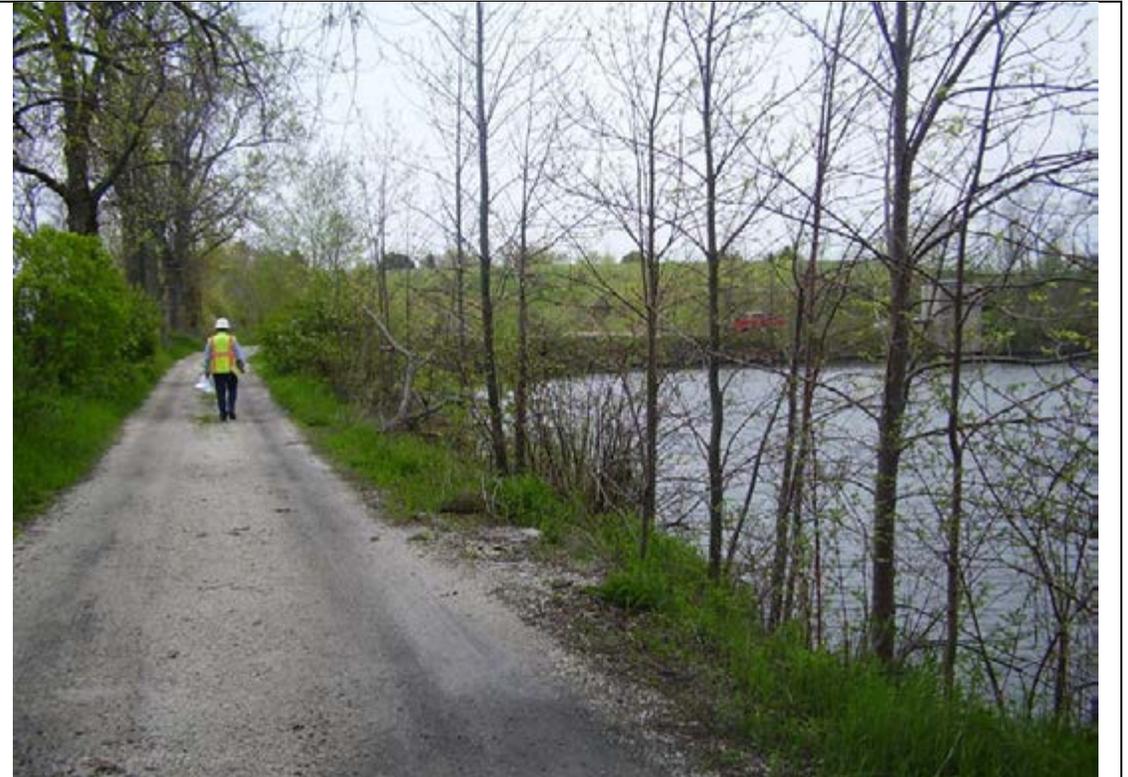
**Photo No.**  
**76**

**Description:**  
Upstream slope and crest of Pond F.

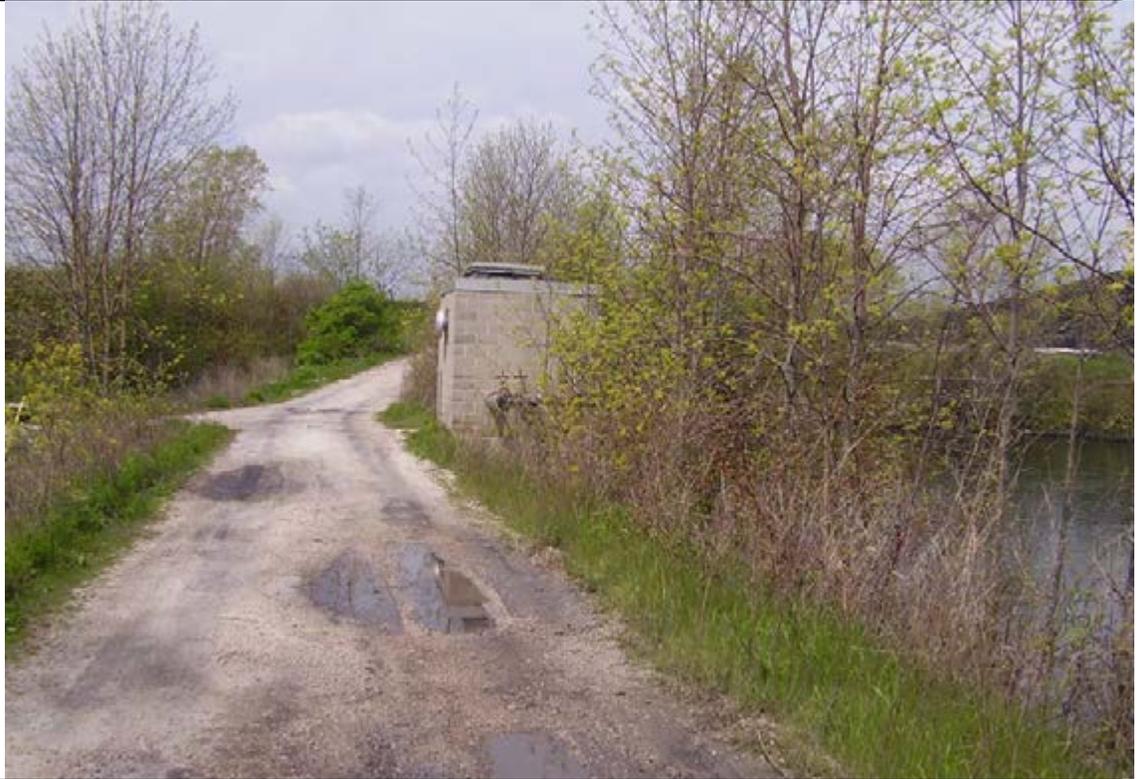
**Description:**  
Crest and Pump house for Pond F.

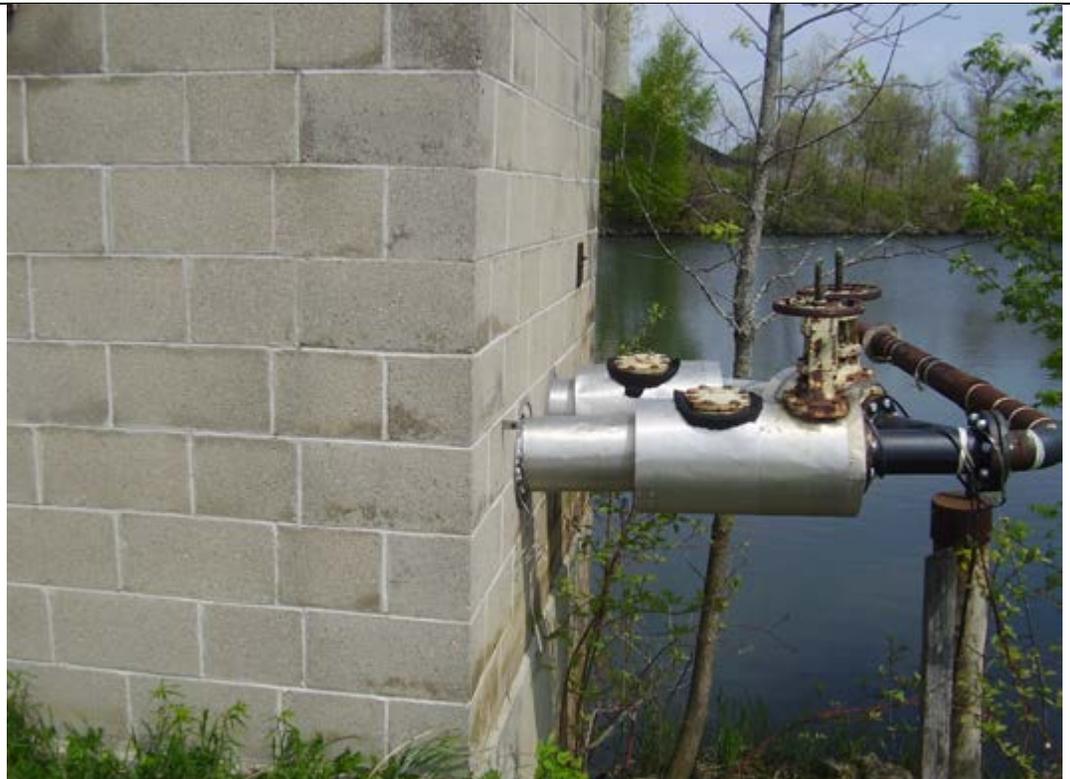
**Photo No.**  
**78**

**Description:**  
Discharge pipe from pump house on Pond F.

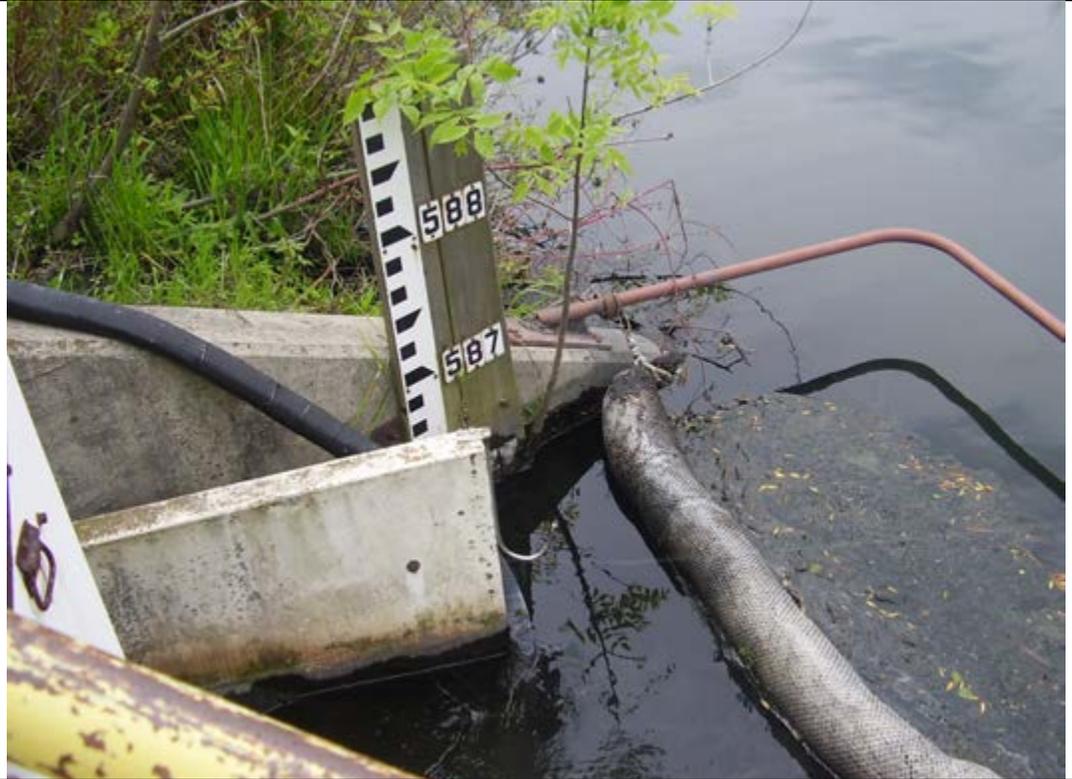
**Description:**  
Staff gauge at the decant structure in Pond F.

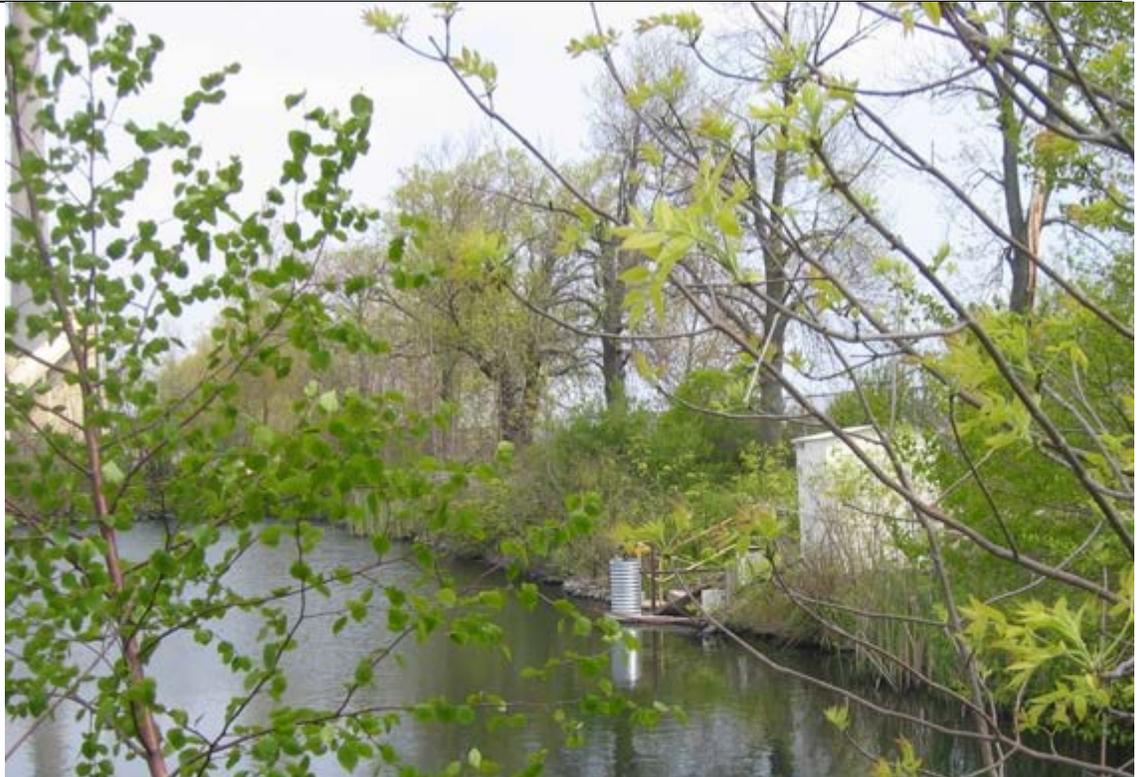
**Photo No.**  
**80**

**Description:**  
Decant structure at Pond F.

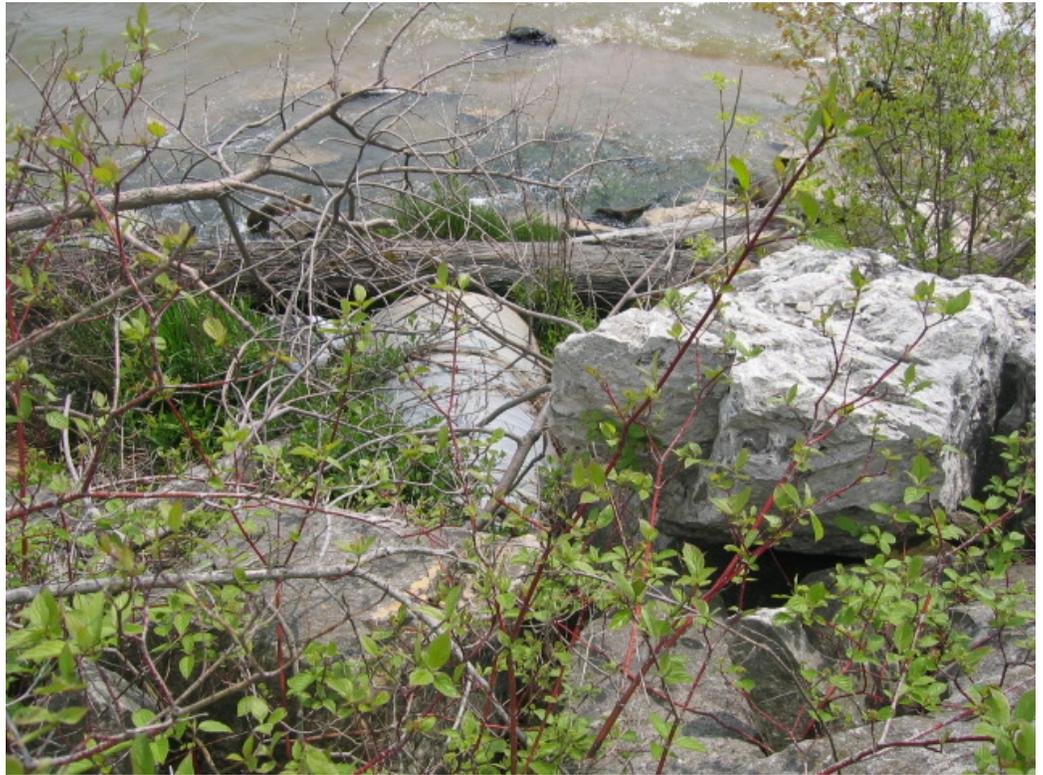
**Description:**  
Discharge pipe from Pond F to Lake Michigan.

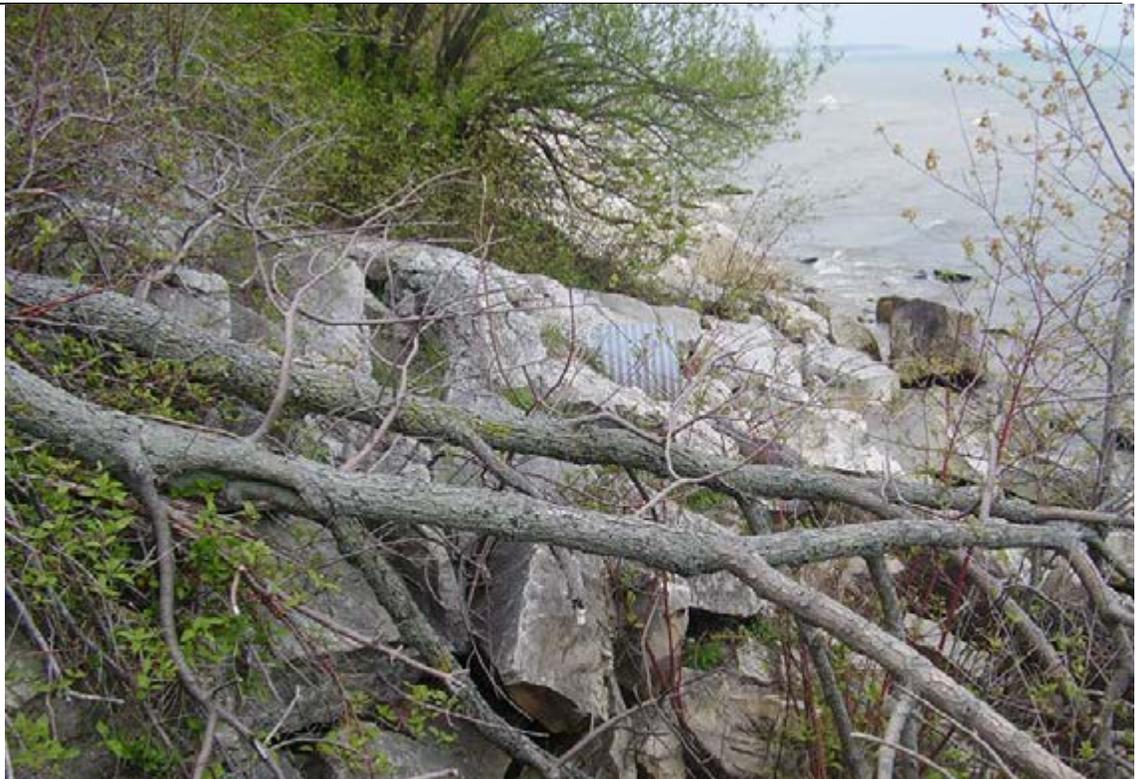
**Photo No.**  
**82**

**Description:**  
Downstream slope and discharge pipe from Pond F to Lake Michigan.

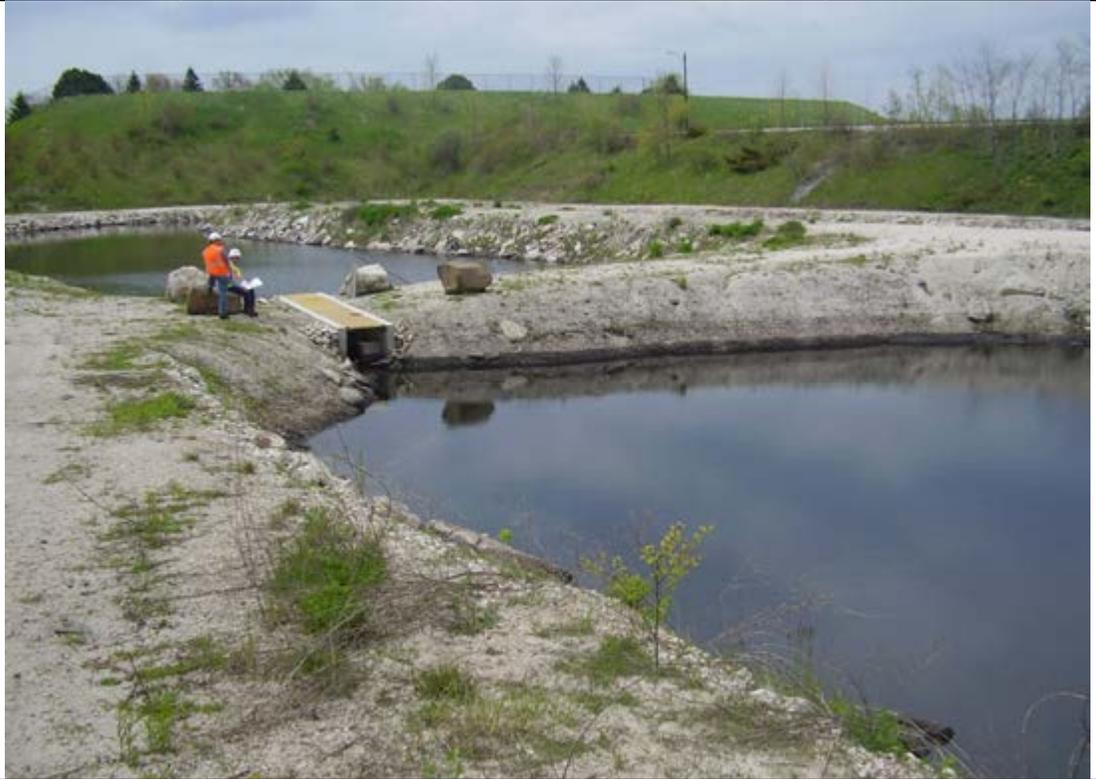
**Description:**  
View of Pond E from the north.

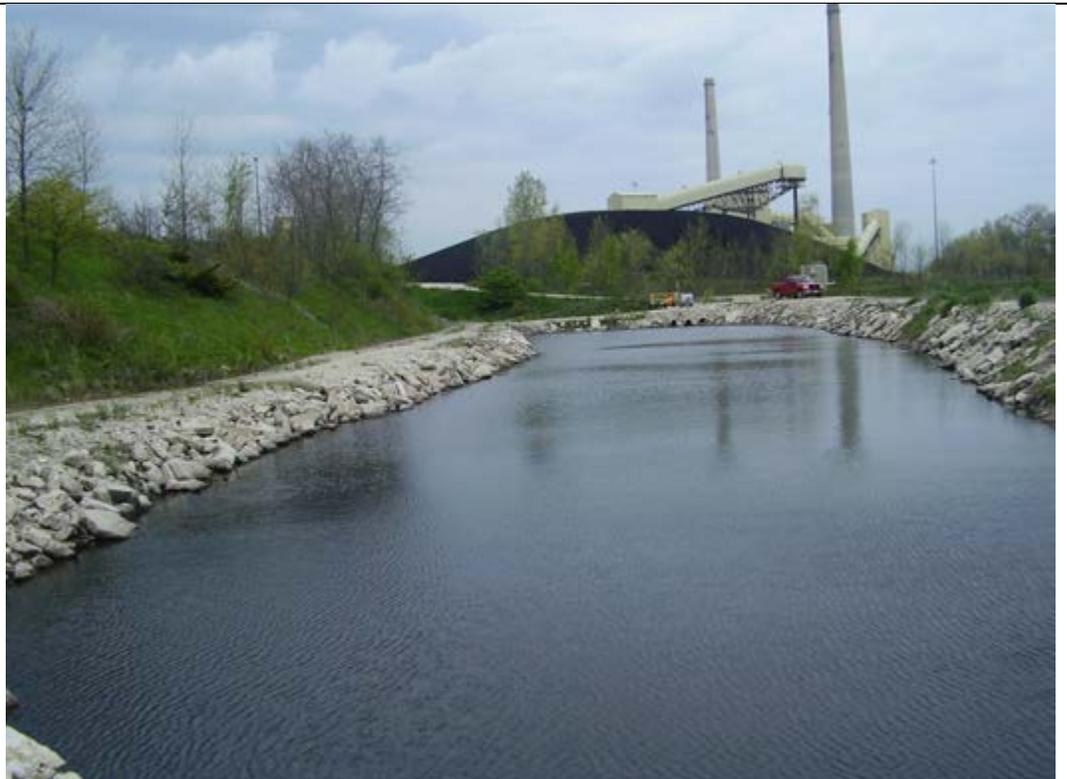
**Photo No.**  
**84**

**Description:**  
Southwestern portion of Pond D as seen from south.

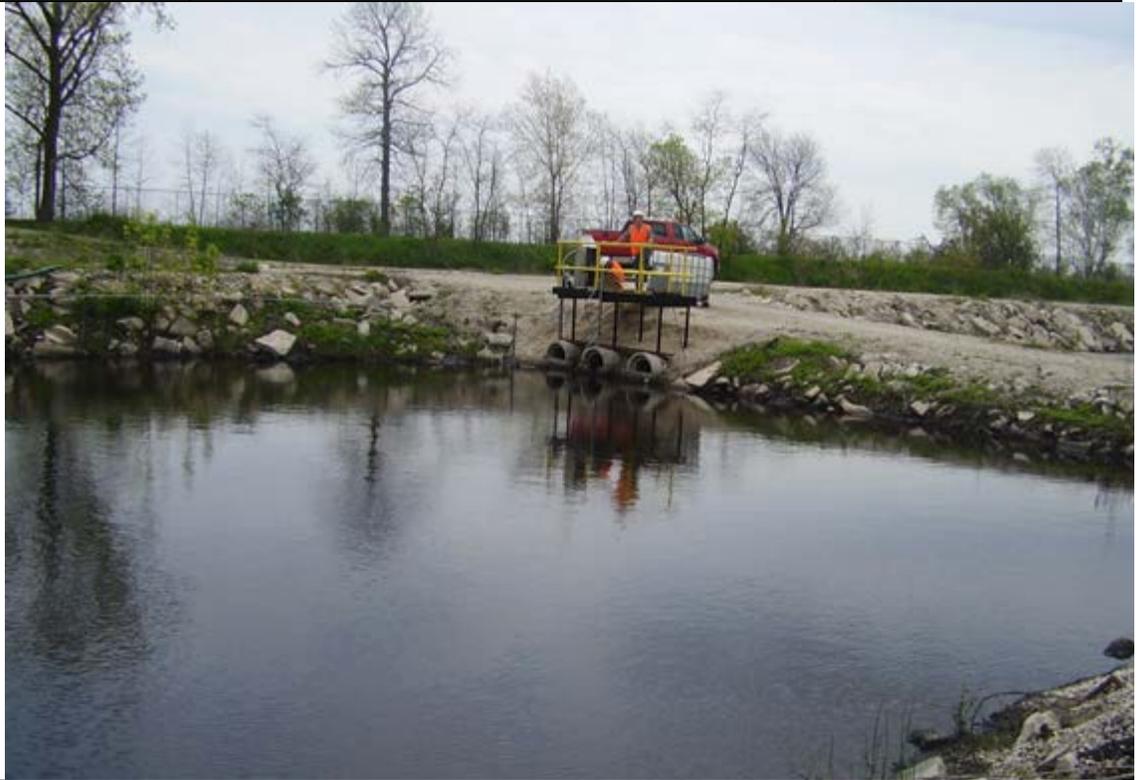
**Description:**  
Northwestern portion of  
Pond E.
