**DRAFT REPORT  
ROUND 10 DAM ASSESSMENT - MAY 31, 2011  
ALLIANT ENERGY – EDGEWATER GENERATING STATION  
SLAG POND, NORTH POND A, SOUTH POND A, POND B, POND F  
SHEBOYGAN, WISCONSIN**

RE: Assessment of Dam Safety of Coal Combustion Surface Impoundments at the Edgewater  
Generating Station

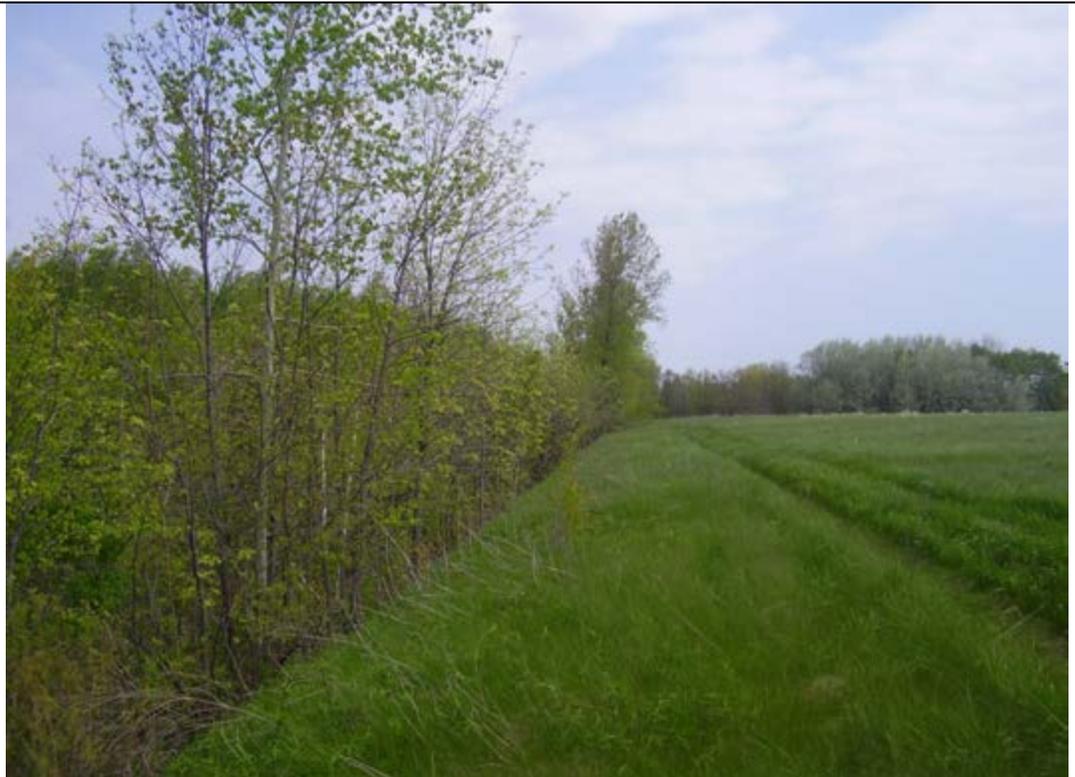
**Photo No.**  
**86**

**Description:**  
Crest of the Landfill.

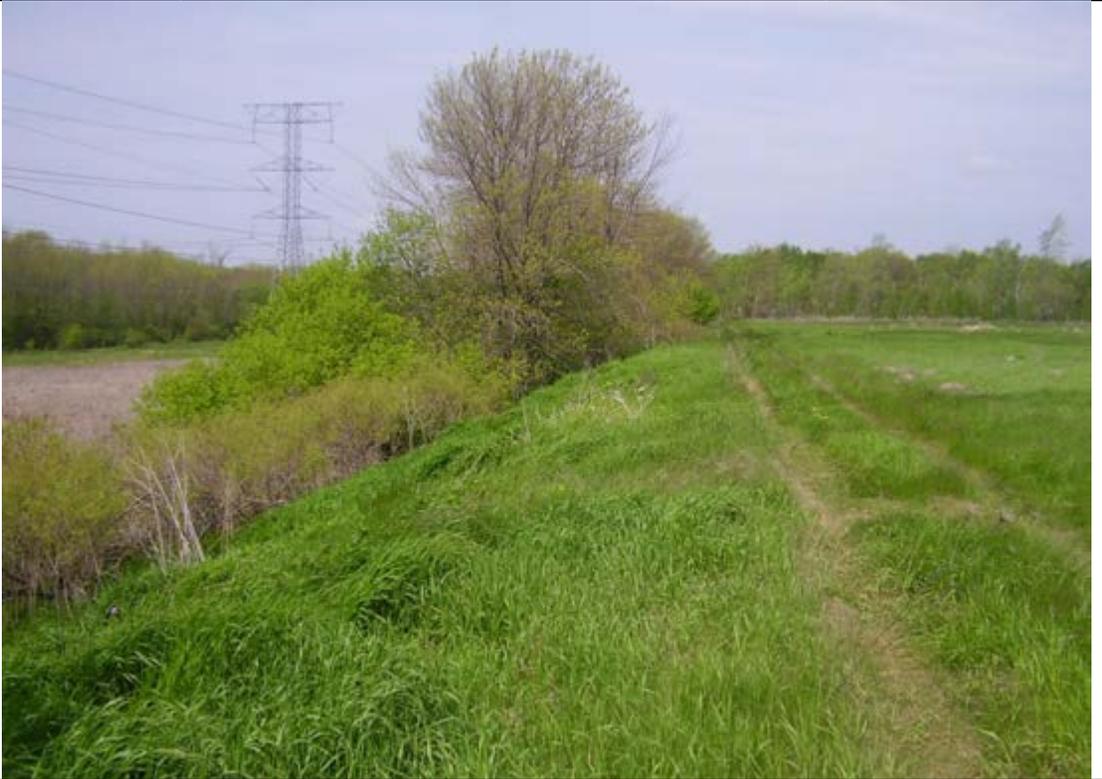
**Description:**  
Crest of the Landfill.

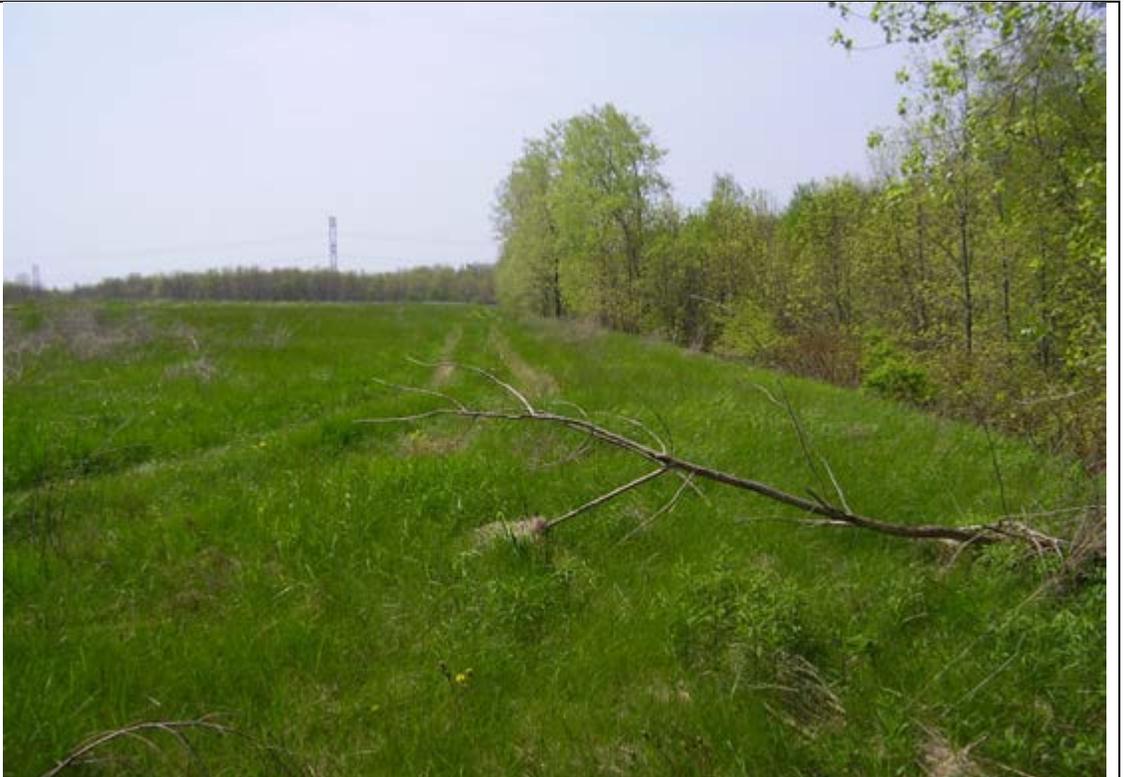
**Photo No.**  
**88**

**Description:**  
Crest of the Landfill.

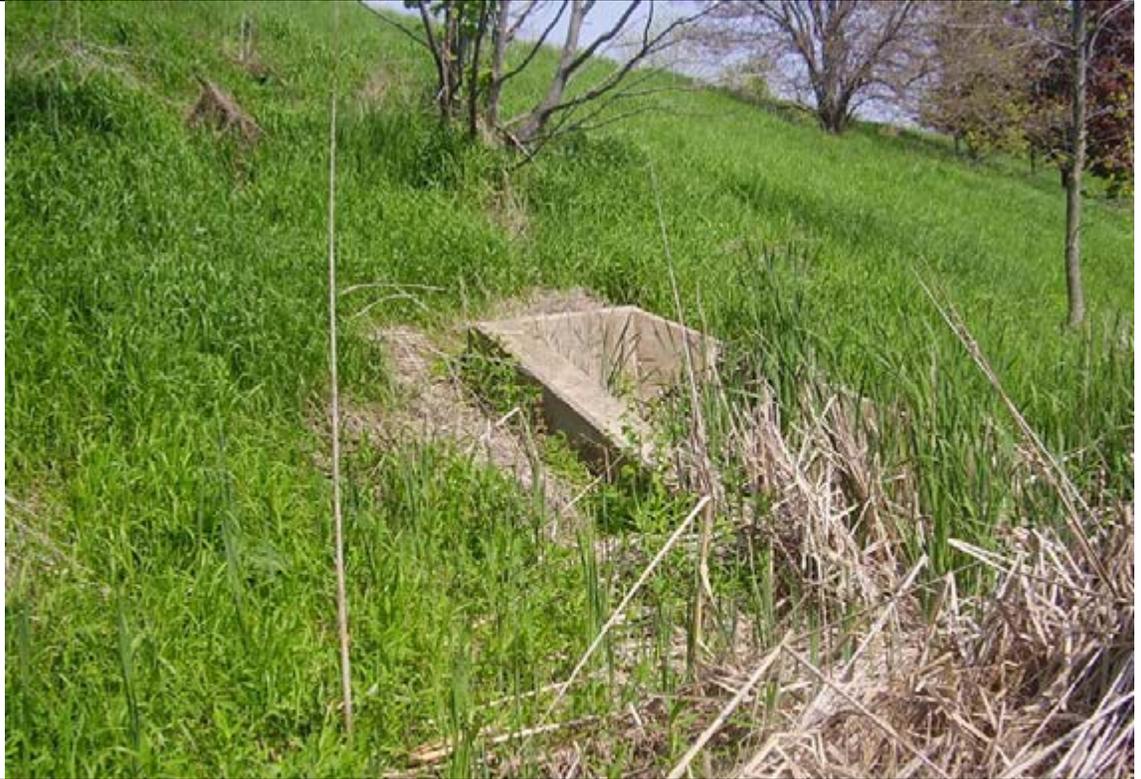
Description:  
Concrete discharge structure  
from Pond B to Pond C.

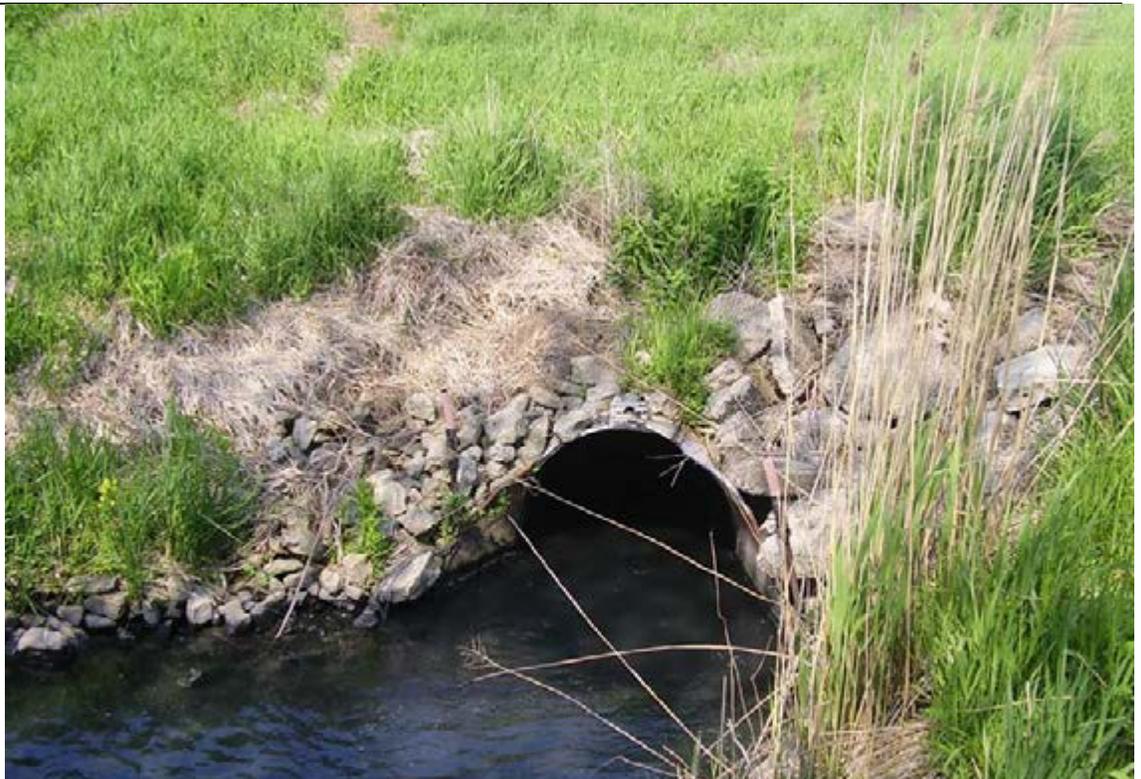
Photo No.  
**90**

Description:  
Discharge pipe from Slag  
Pond, North Pond A, and  
South Pond A into Pond B.
