**FINAL REPORT  
ROUND 10 DAM ASSESSMENT  
WISCONSIN POWER AND LIGHT COMPANY – EDGEWATER  
GENERATING STATION  
SLAG POND, NORTH POND A, SOUTH POND A, POND B, POND F  
SHEBOYGAN, WISCONSIN**

RE: Assessment of Dam Safety of Coal Combustion Surface Impoundments at the Edgewater  
Generating Station

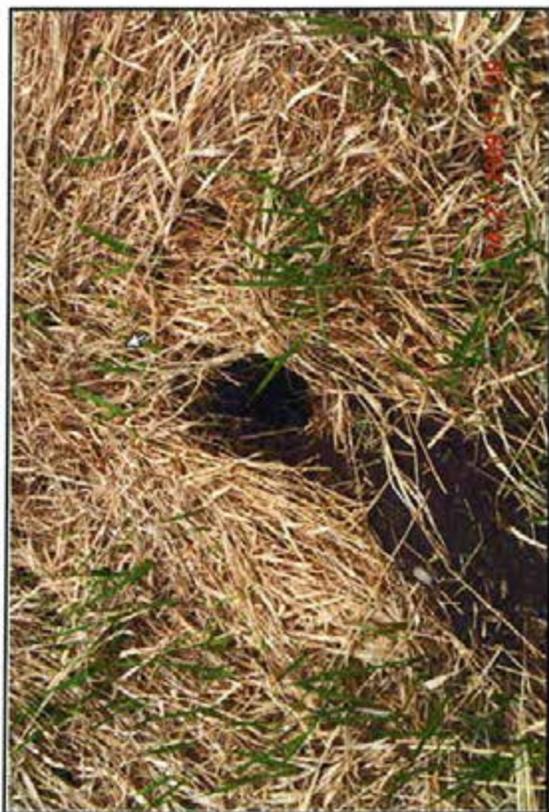
Edge - Picture 14:Animal Activity on C Pond Dike

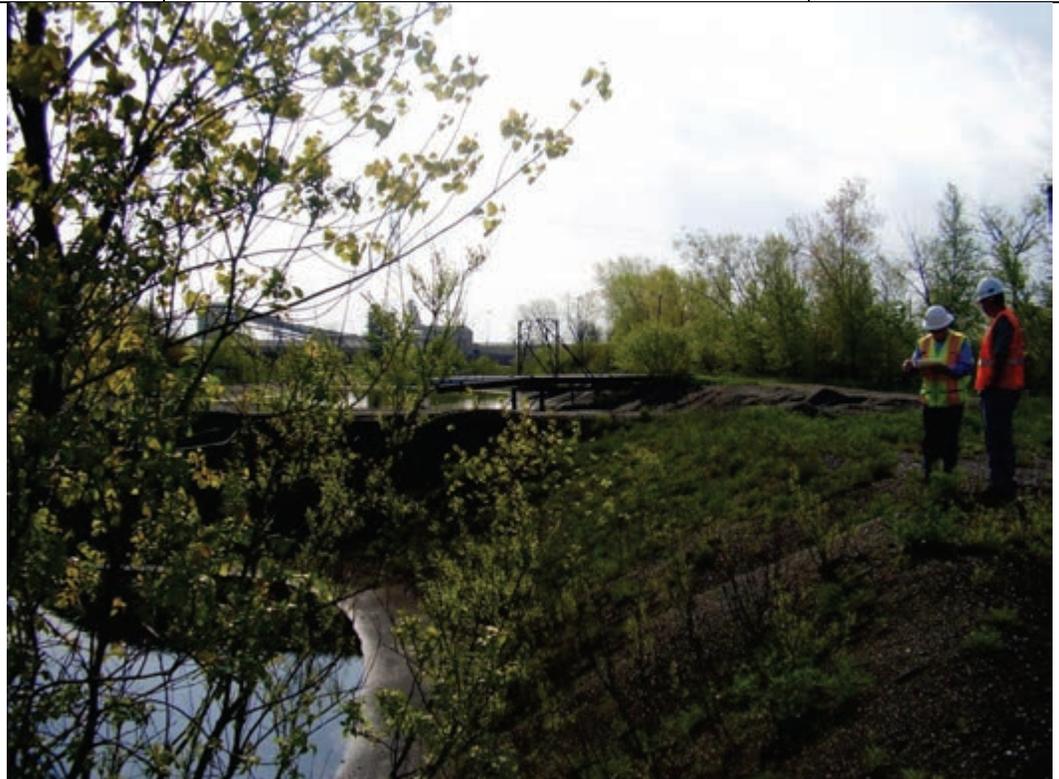
Upstream slope of the Slag Pond with the discharge pipe trestle in the background.

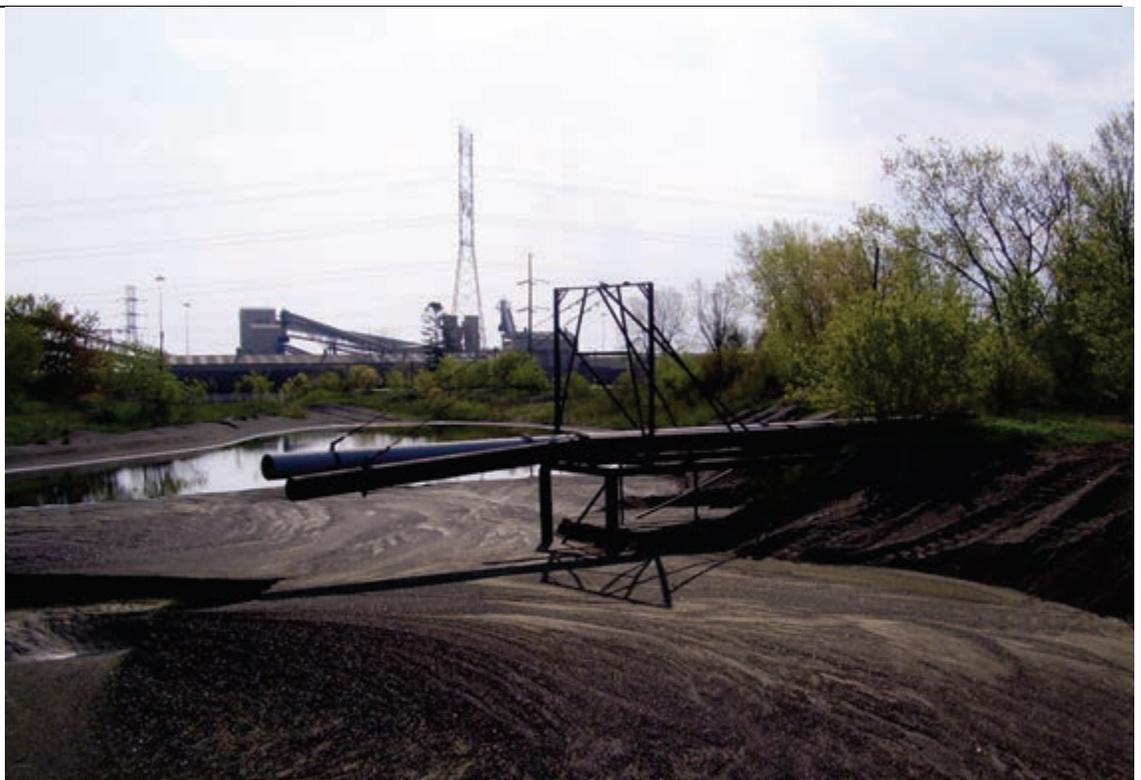
**Photo No.**  
2

Upstream slope of the Slag Pond with the discharge pipe trestle.

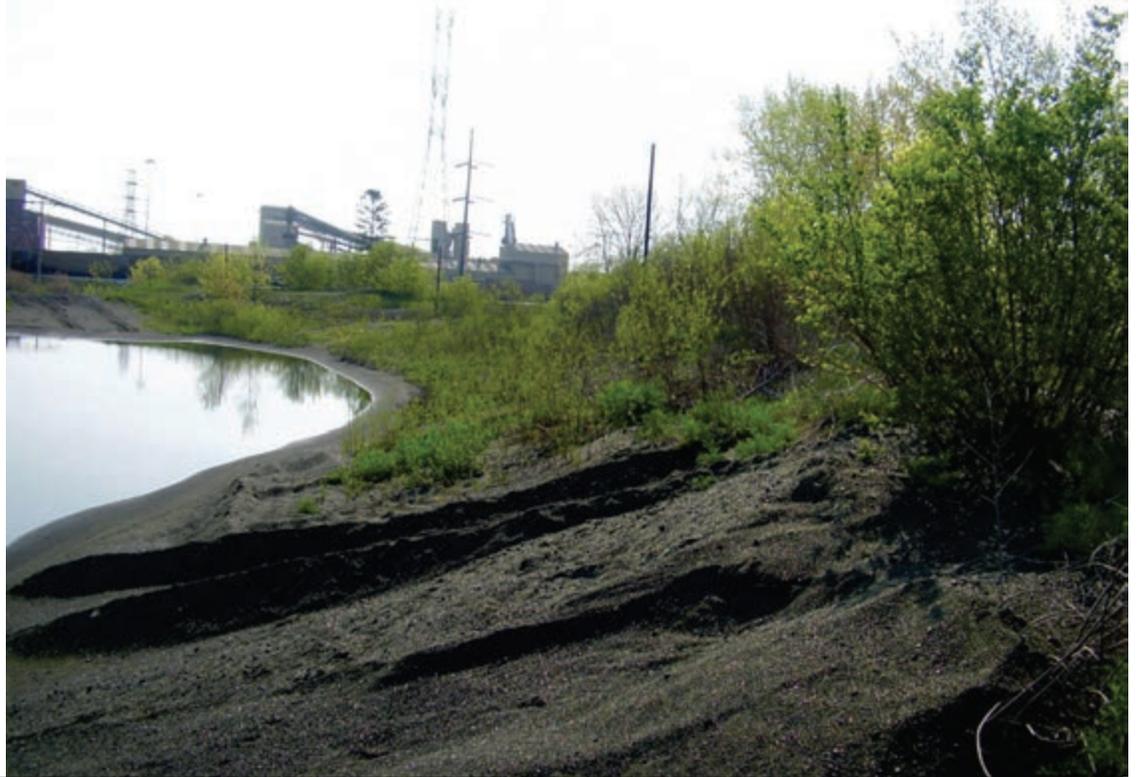
**Description:**  
Upstream slope of the Slag Pond.

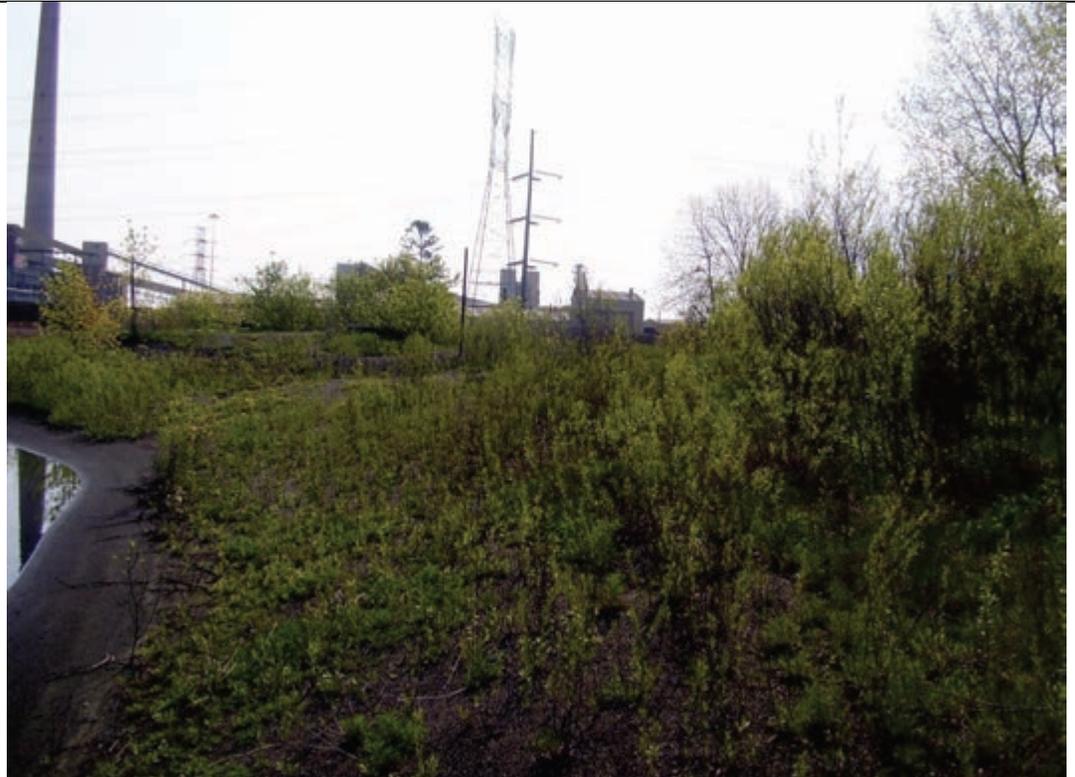
**Photo No.**  
**4**

**Description:**  
Upstream slope of the Slag Pond.

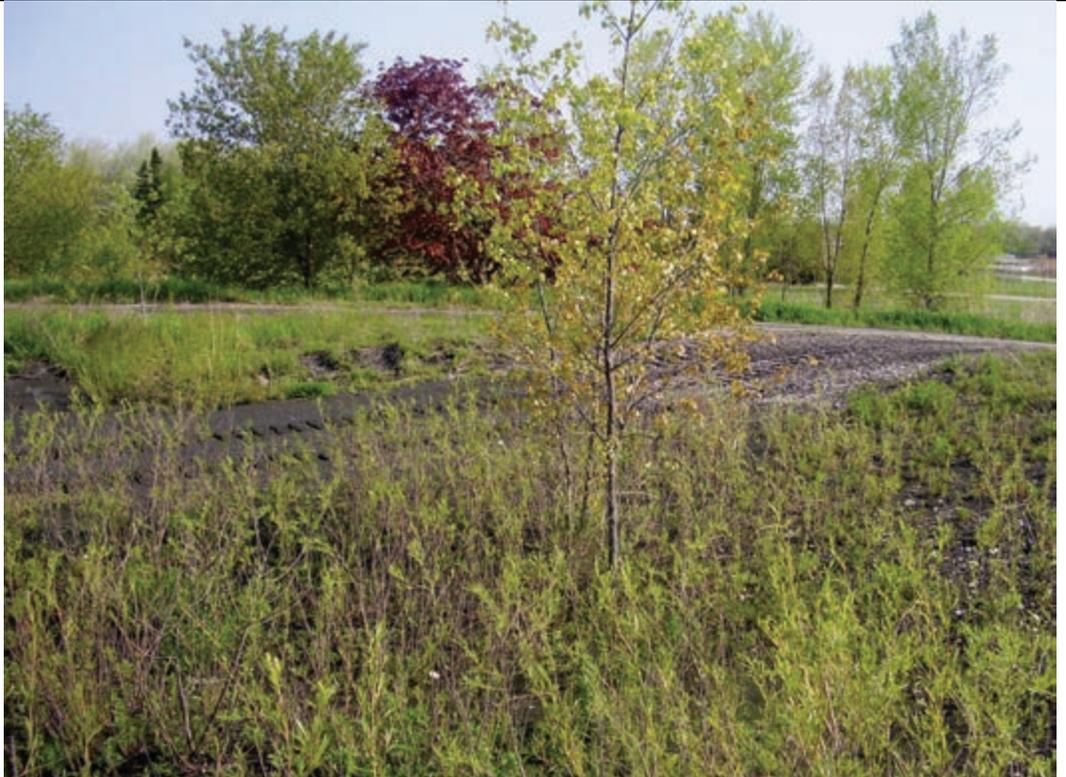
<b>Photo No.</b> <b>5</b>	<b>Date:</b> 5/31/11
<b>Direction Photo Taken:</b> North

**Description:**  
Upstream slope of the Slag Pond.

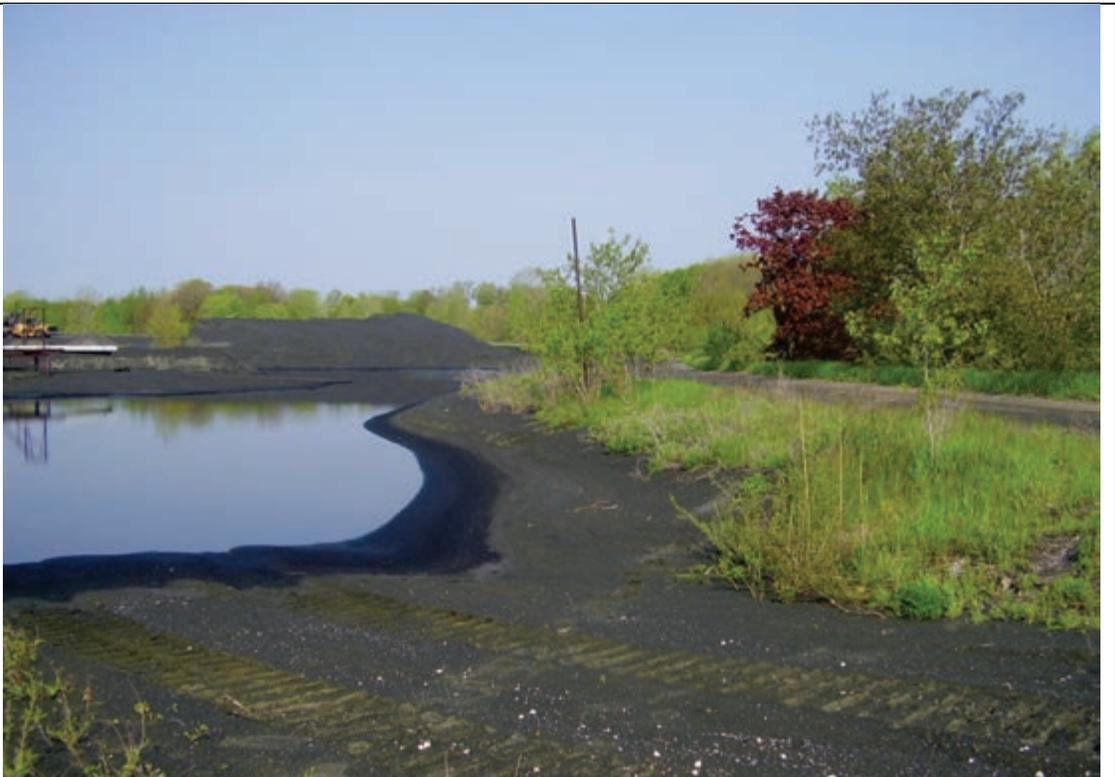
<b>Photo No.</b> <b>6</b>	<b>Date:</b> 5/31/11
<b>Direction Photo Taken:</b> West

**Description:**  
Upstream slope of the Slag Pond.

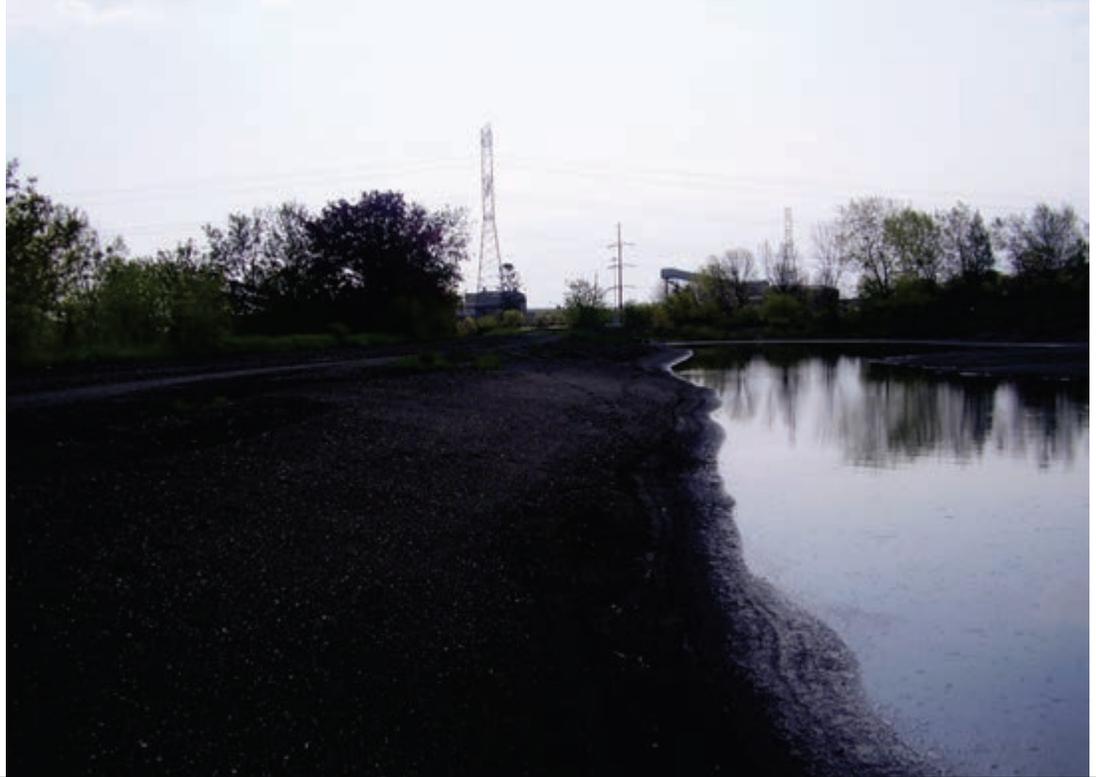
**Description:**  
Upstream slope of the Slag Pond.

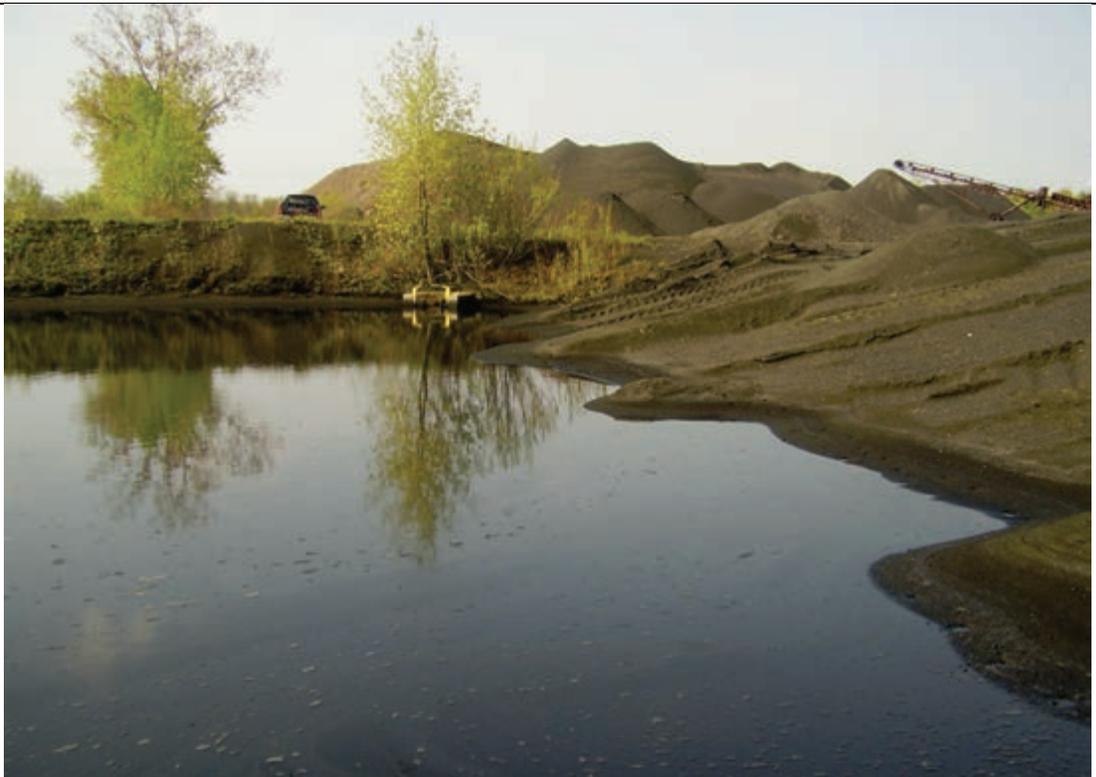
**Photo No.**  
8

**Description:**  
Upstream slope of the Slag Pond.

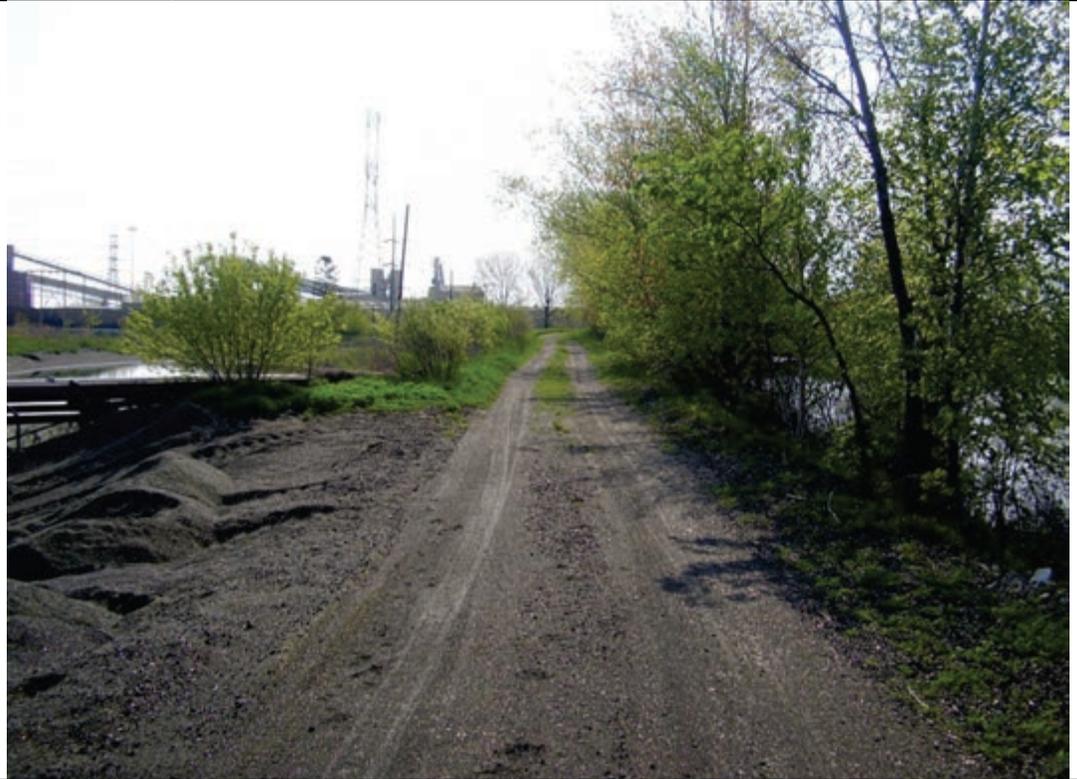
**Description:**  
Crest of the Slag Pond.

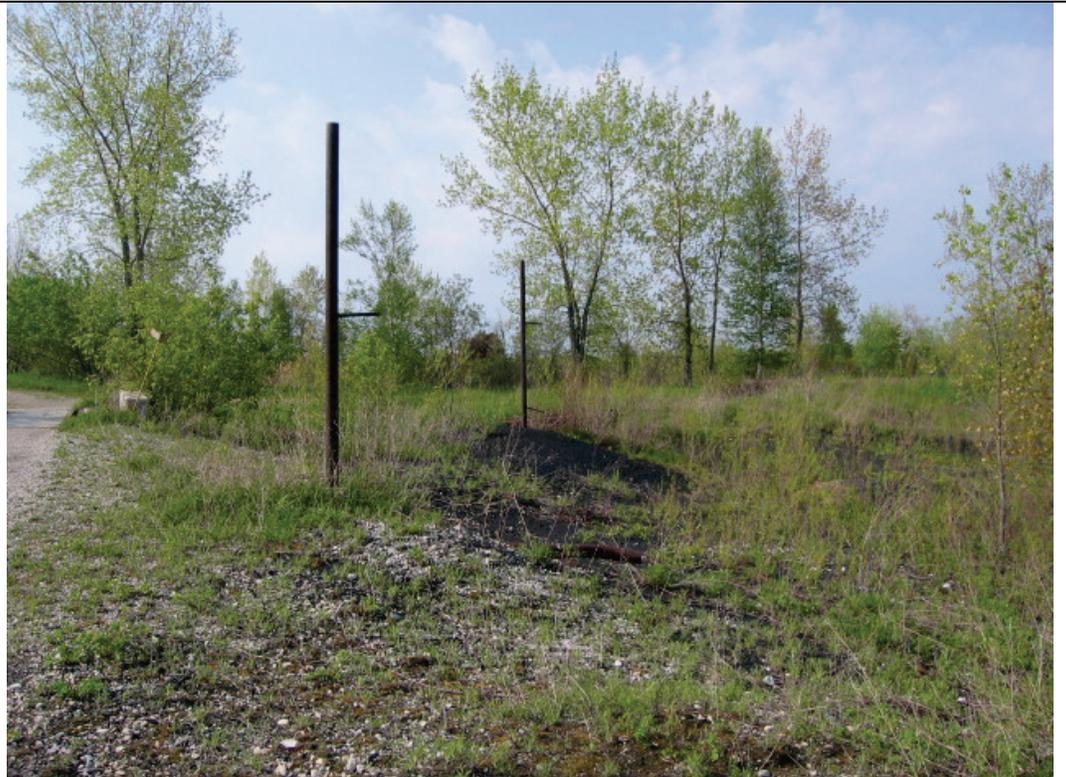
**Photo No.**  
**10**

**Description:**  
Crest of the Slag Pond.

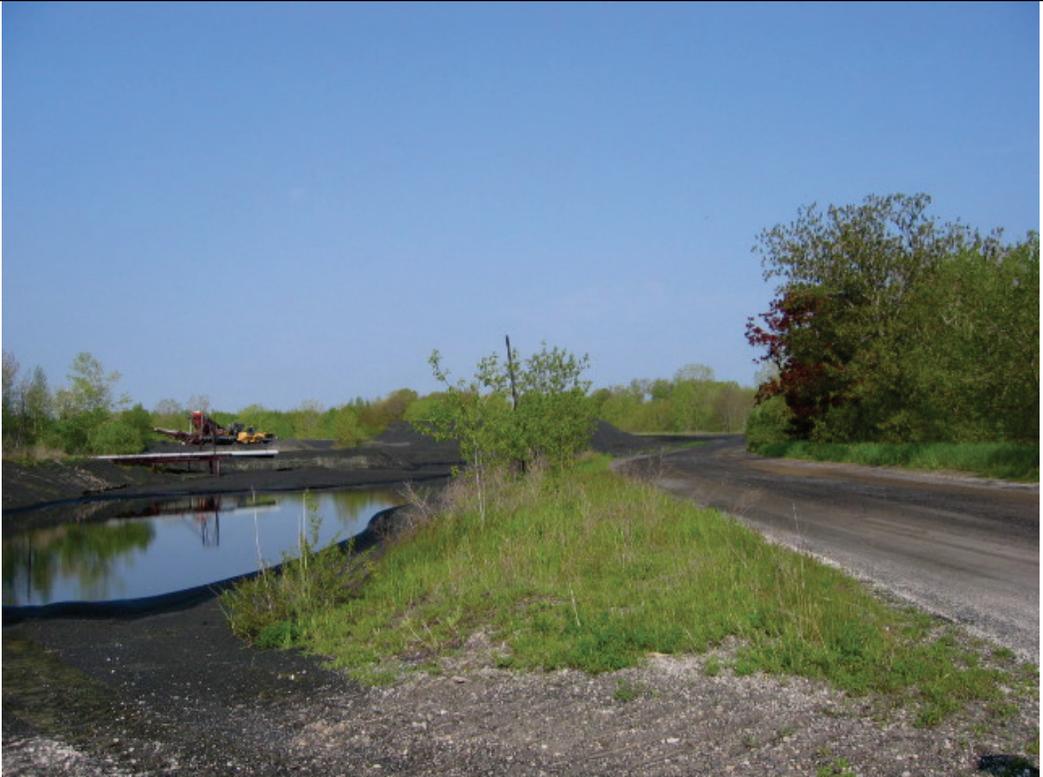
<b>Photo No.</b> <b>11</b>	<b>Date:</b> 5/31/11
<b>Direction Photo Taken:</b> North

**Description:**  
Crest and upstream slope of the Slag Pond.

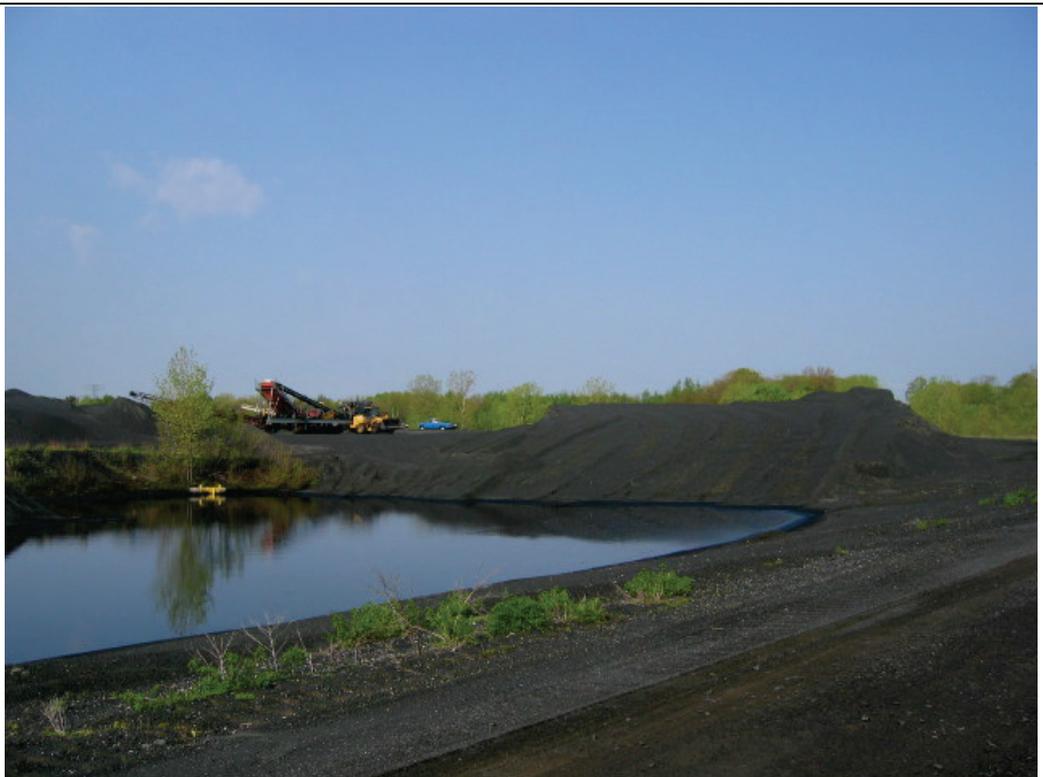
<b>Photo No.</b> <b>12</b>	<b>Date:</b> 5/31/11
<b>Direction Photo Taken:</b> West

**Description:**  
Crest and upstream slope of the Slag Pond.

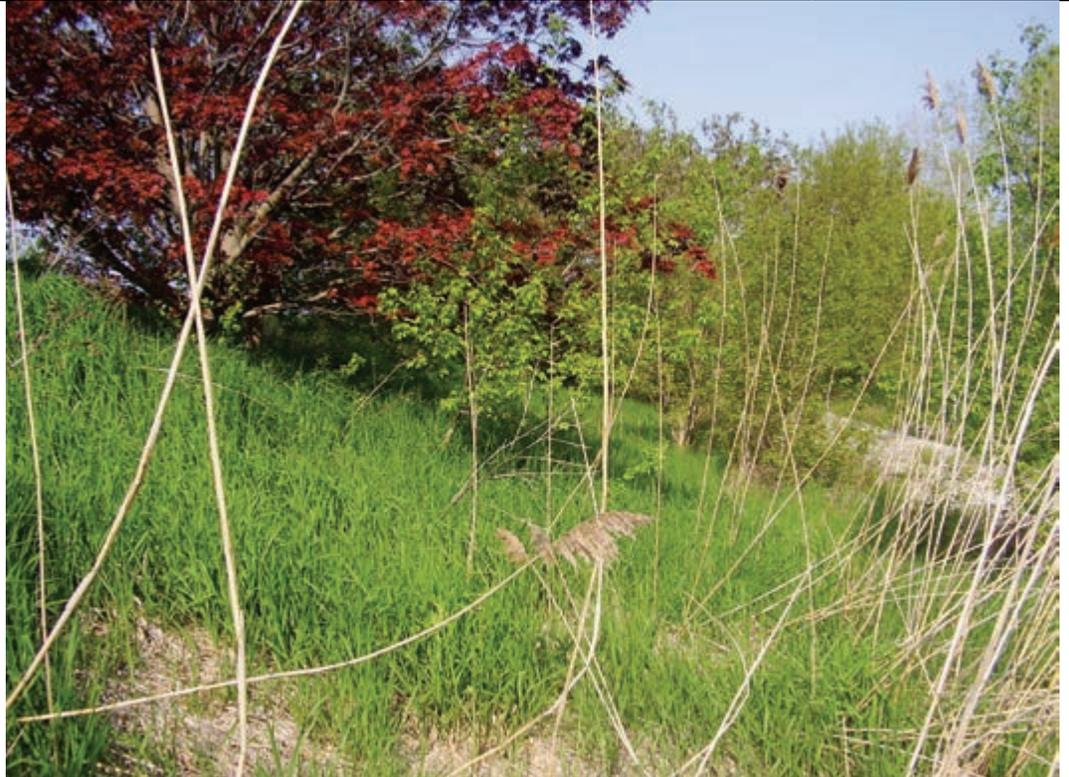
<b>Photo No.</b> 13	<b>Date:</b> 5/31/11
<b>Direction Photo Taken:</b> West

**Description:**  
Downstream slope of the northern embankment of the Slag Pond.

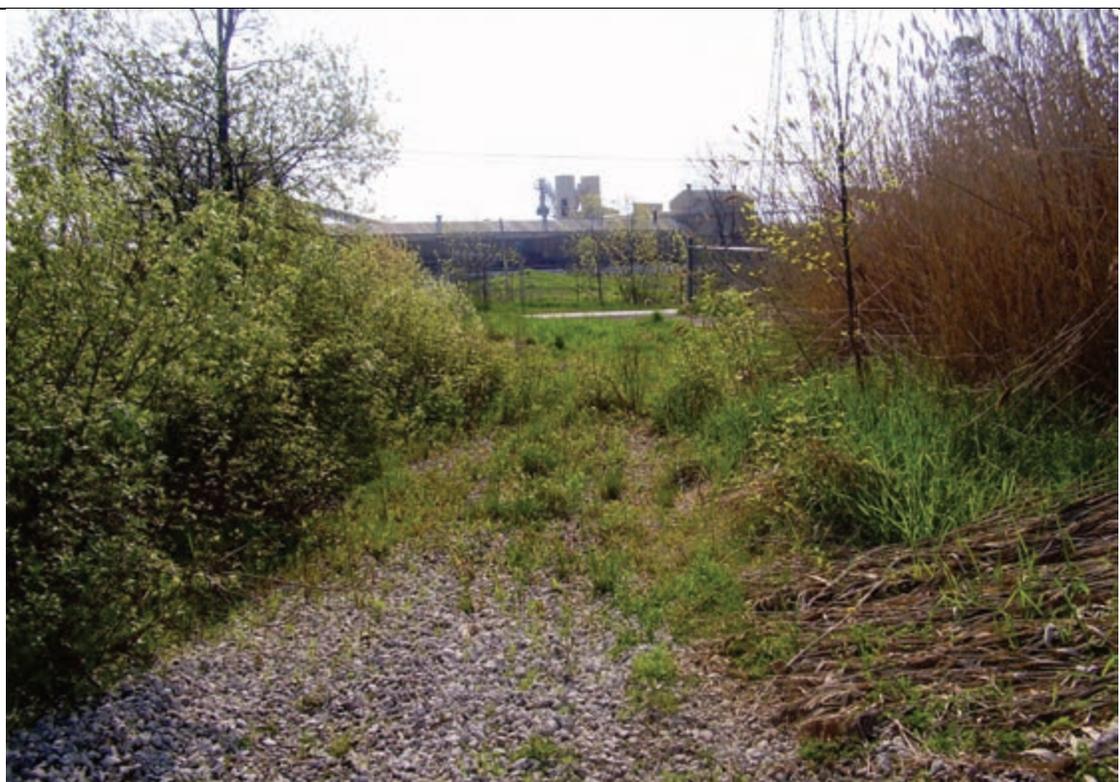
<b>Photo No.</b> 14	<b>Date:</b> 5/31/11
<b>Direction Photo Taken:</b> East

**Description:**  
Downstream slope and toe of the Slag Pond.

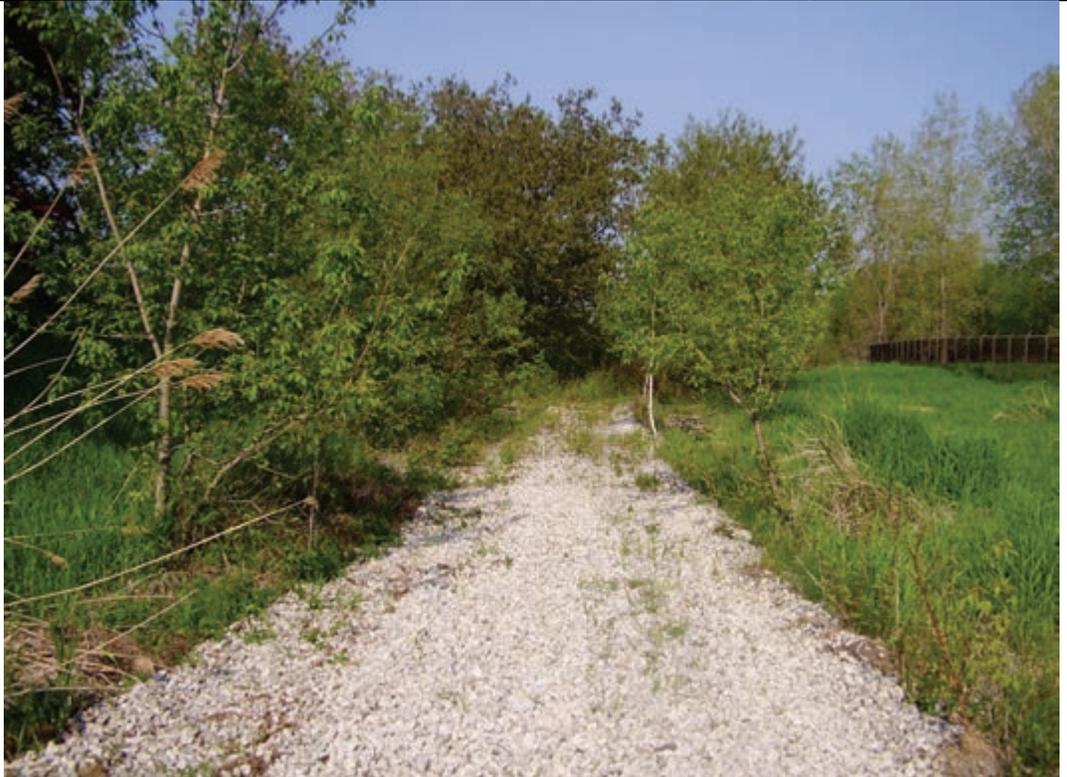
<b>Photo No.</b> <b>15</b>	<b>Date:</b> 5/31/11
<b>Direction Photo Taken:</b> West

**Description:**  
Downstream slope and toe of the Slag Pond.

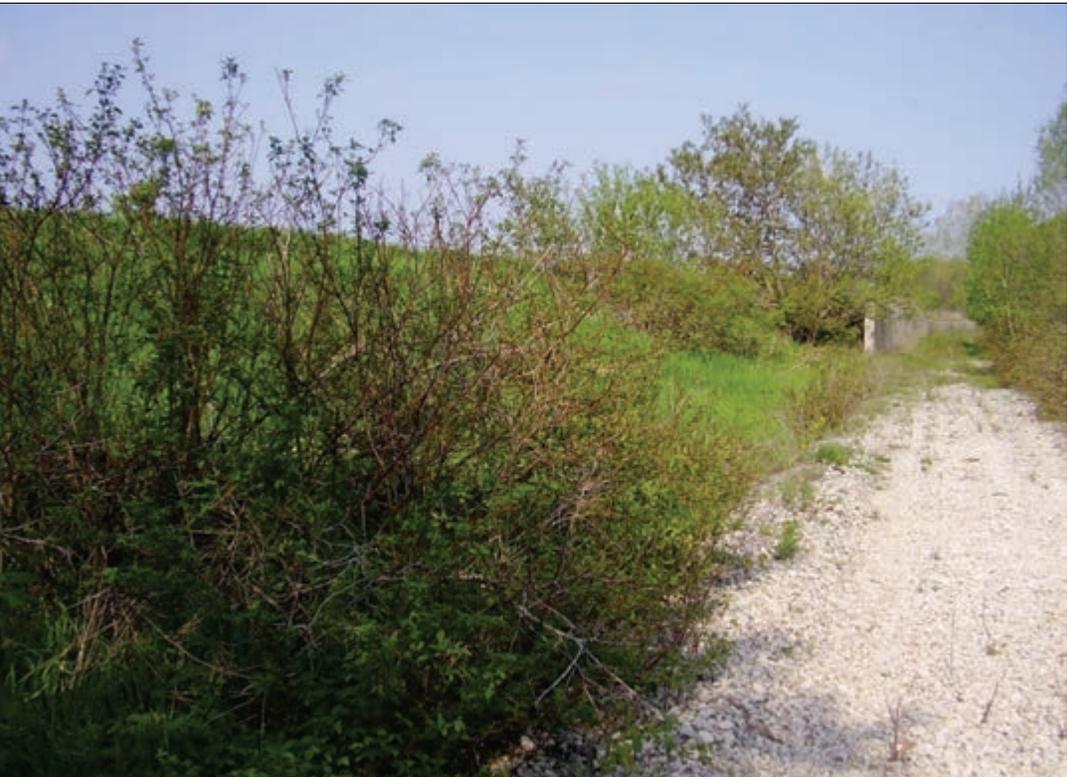
<b>Photo No.</b> <b>16</b>	<b>Date:</b> 5/31/11
<b>Direction Photo Taken:</b> West

**Description:**  
Downstream slope and toe of the Slag Pond.

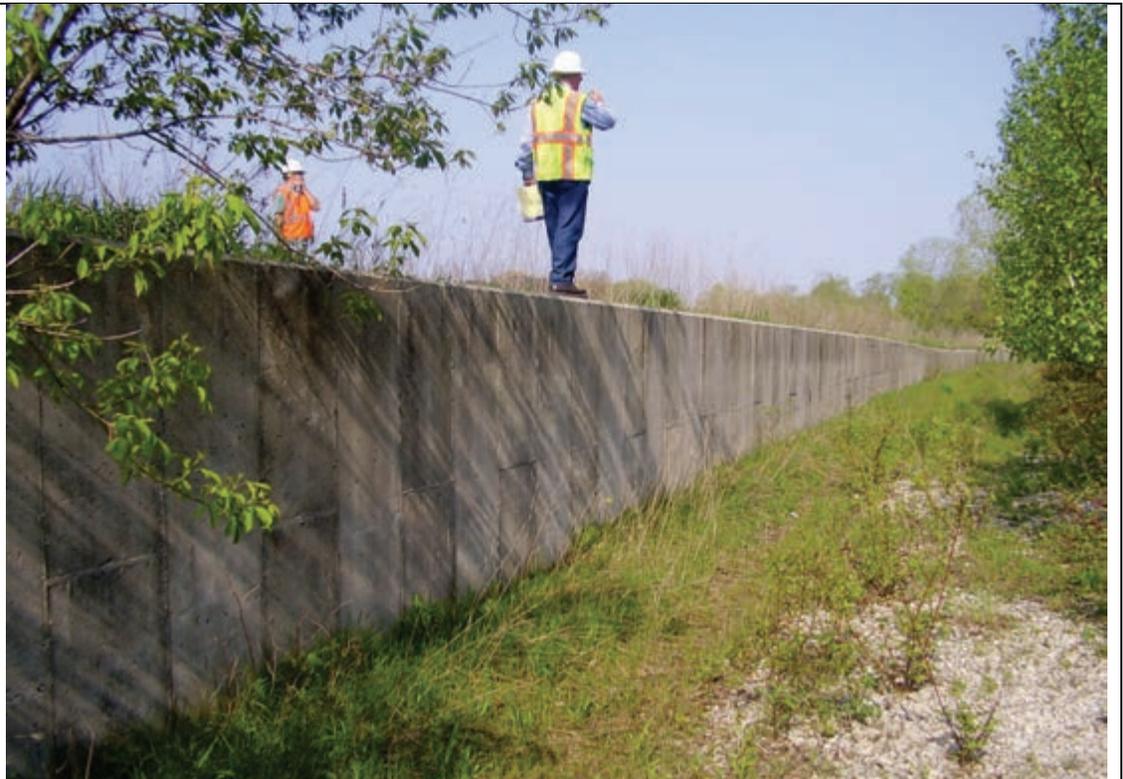
Cast-in-place concrete retaining wall on western portion of the downstream slope of Slag Pond.

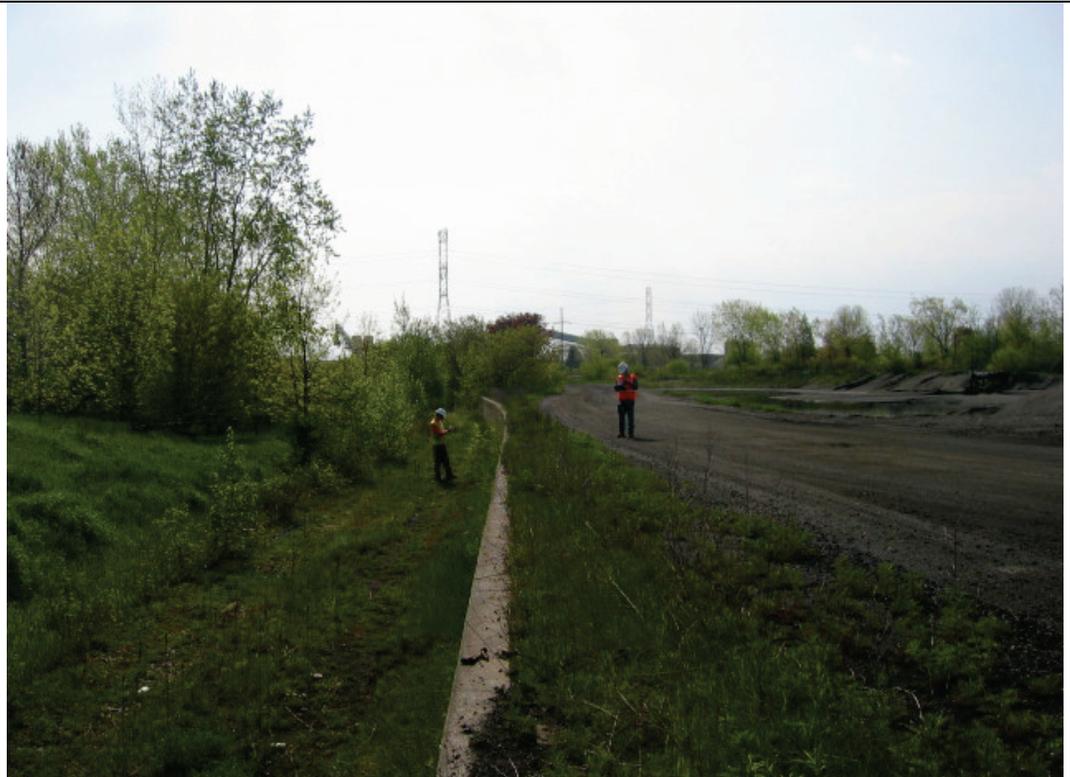
**Description:**  
Top of the concrete retaining wall.

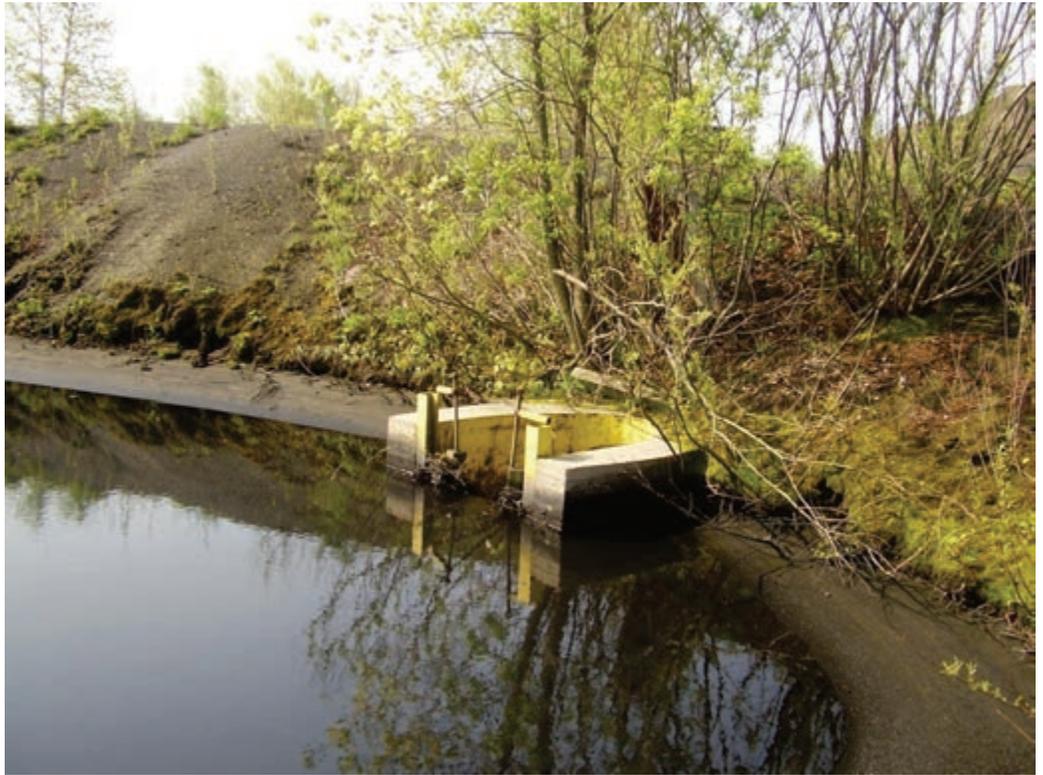
Description:  
Decant structure in the  
southwest corner of the Slag  
Pond.

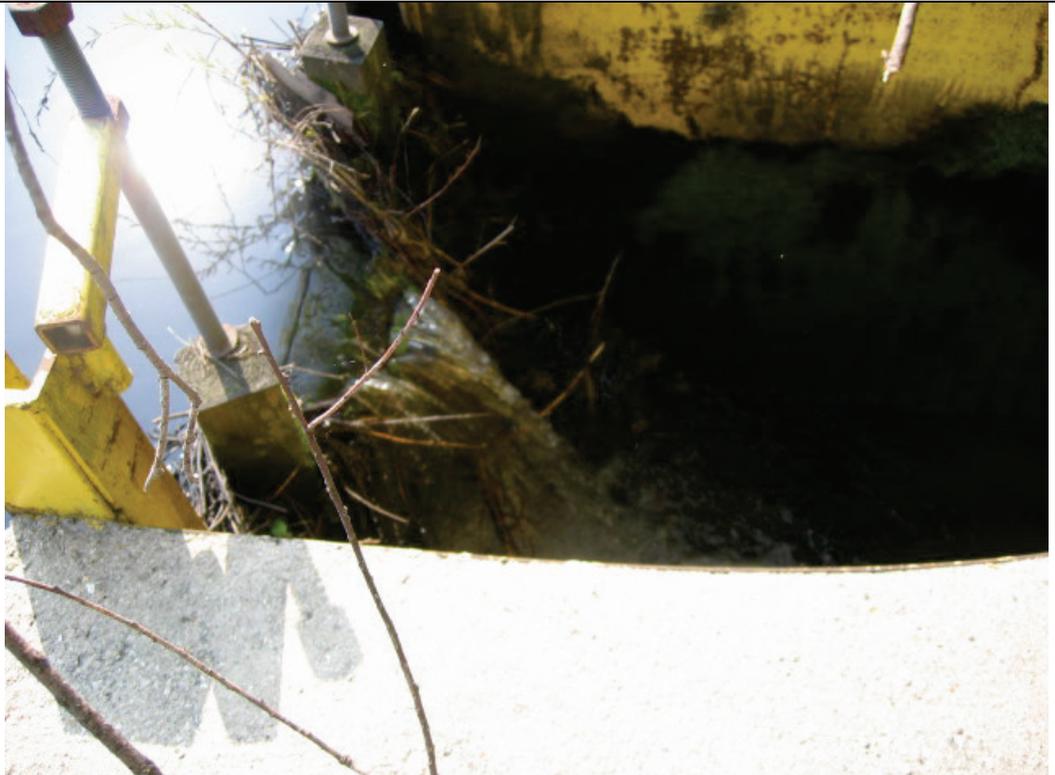
Photo No.  
**22**

Description:  
Decant structure in the  
southwest corner of the Slag  
Pond.

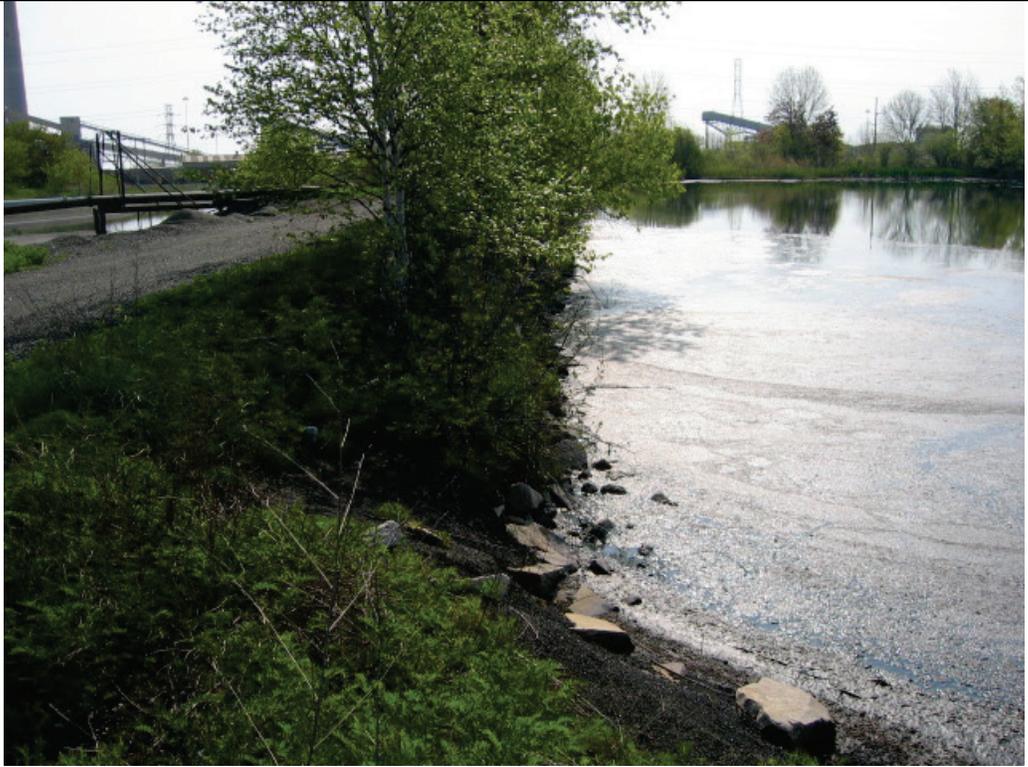
<b>Photo No.</b> <b>23</b>	<b>Date:</b> 5/31/11
<b>Direction Photo Taken:</b> East

**Description:**  
Upstream slope of the North Pond A.

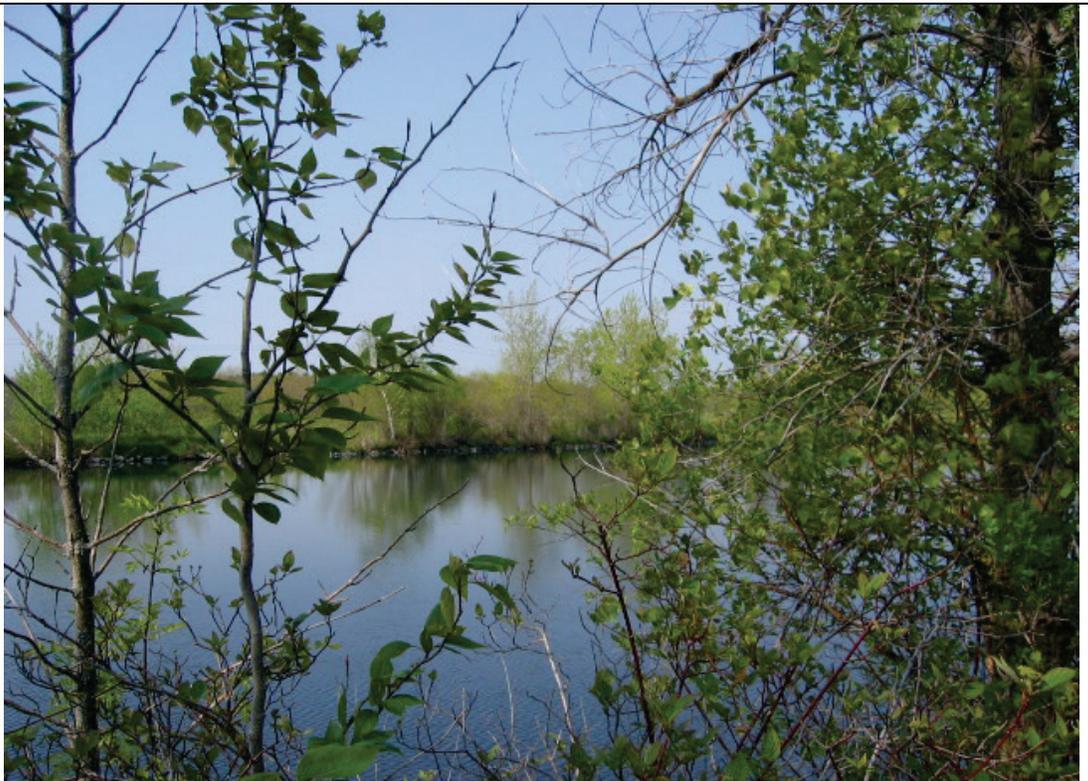
<b>Photo No.</b> <b>24</b>	<b>Date:</b> 5/31/11
<b>Direction Photo Taken:</b> Southwest

**Description:**  
Upstream slope of the North Pond A.

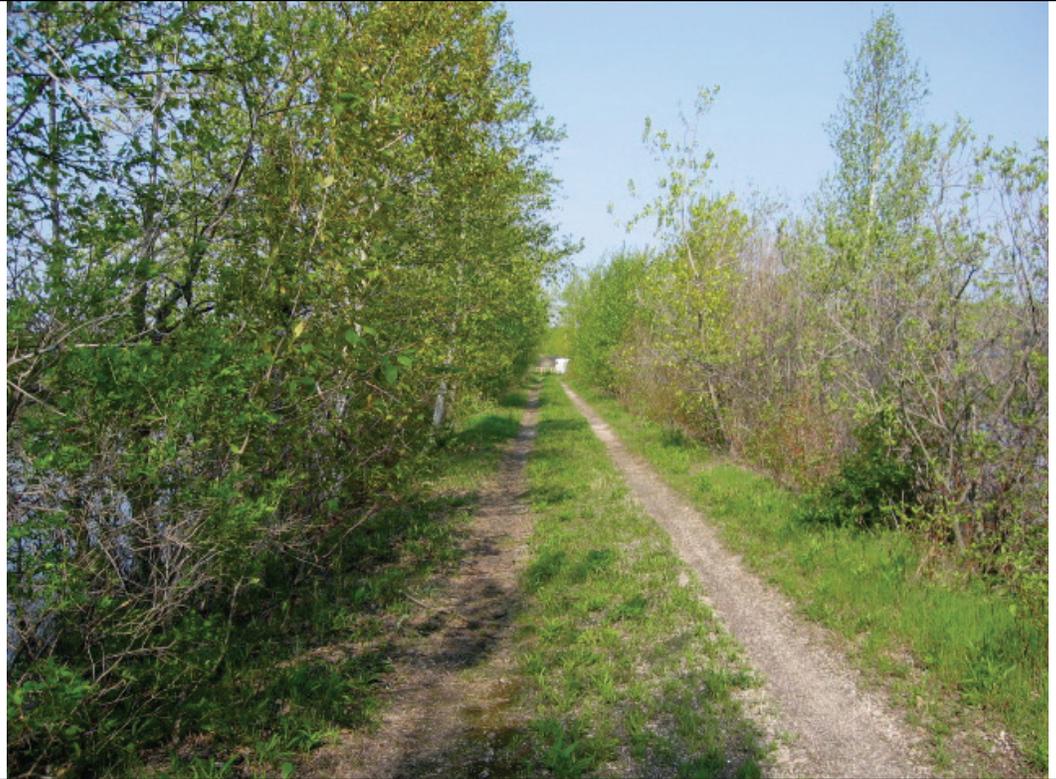
Description:  
Crest and Upstream slope of  
North Pond A and South  
Pond A.

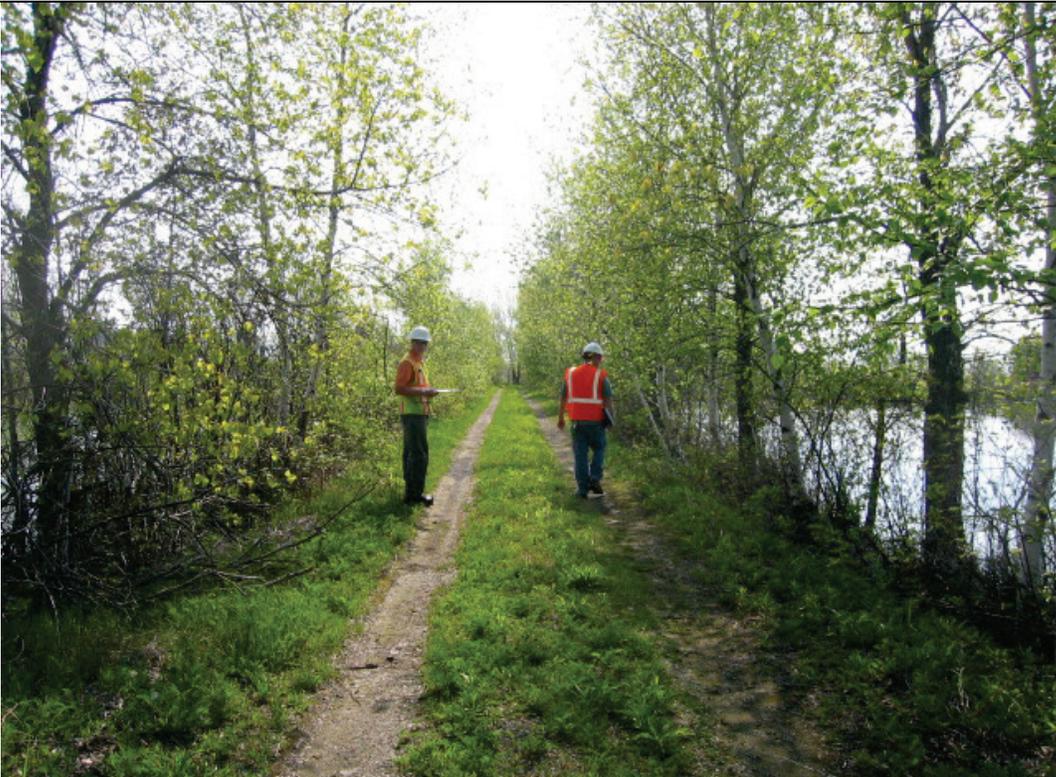
Photo No.  
26

Description:  
Crest and Upstream slope of  
North Pond A and South  
Pond A.

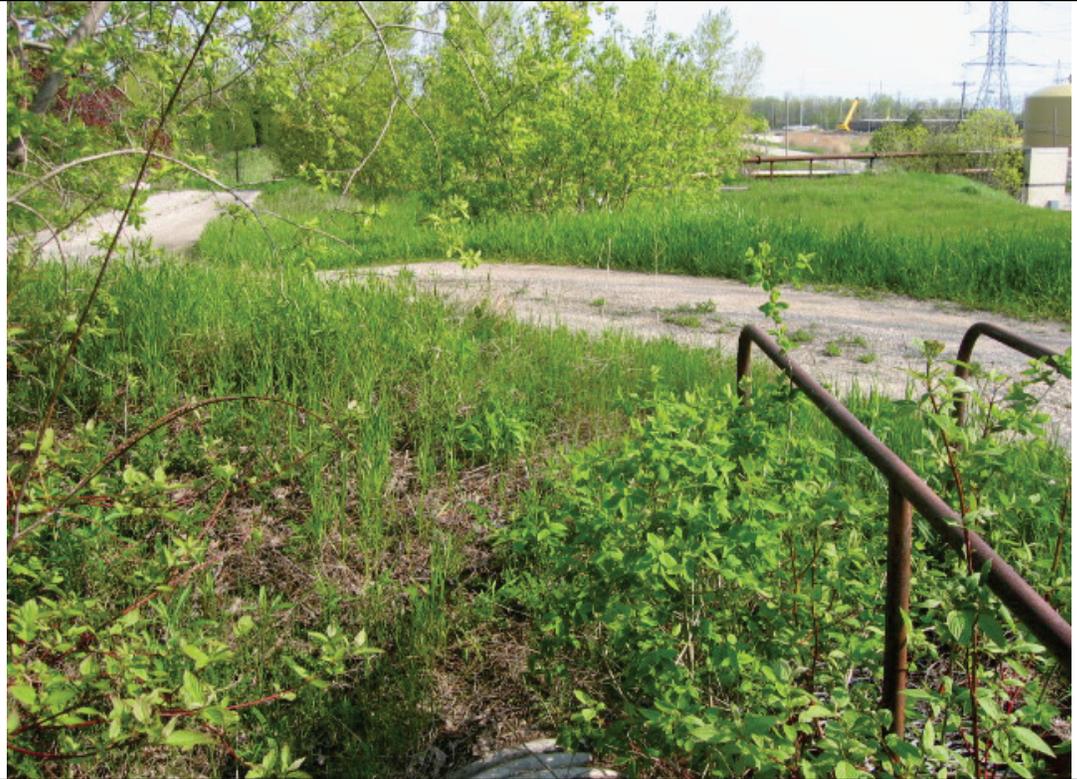
**Description:**  
Crest and Upstream slope of North Pond A.

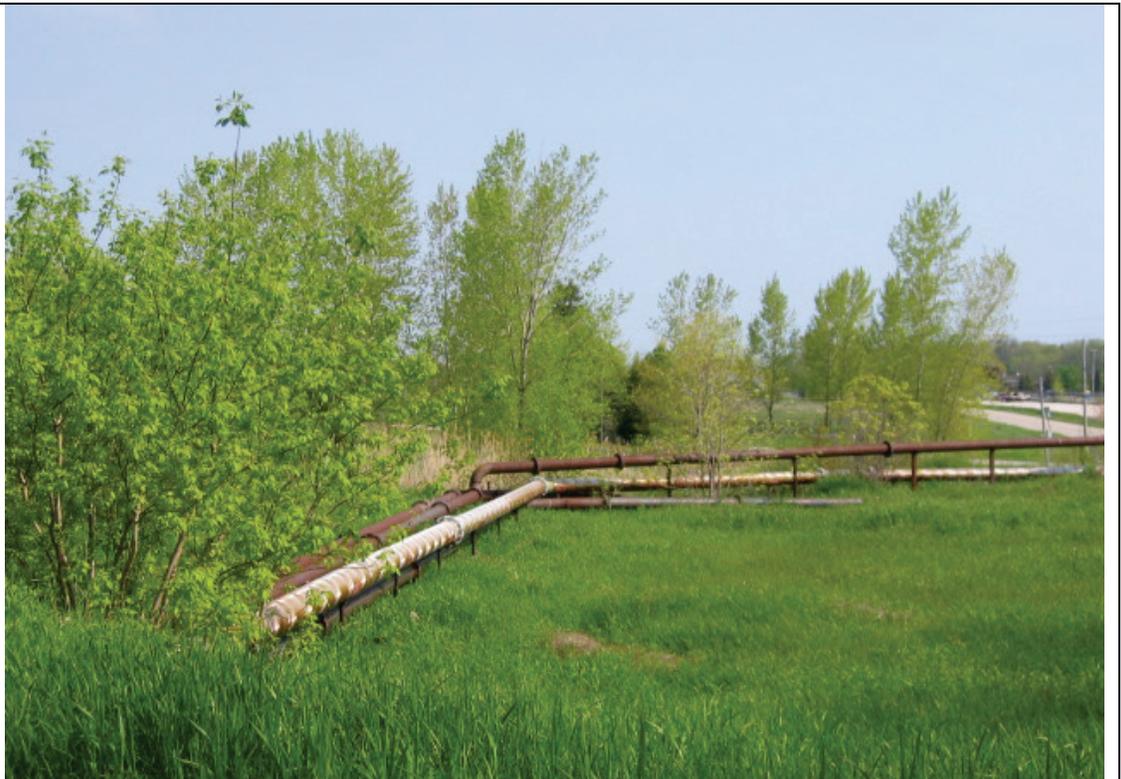
**Photo No.**  
**28**

**Description:**  
Sluice pipes for transporting water and Coal Combustion Waste from the plant.
