**FINAL REPORT  
ROUND 10 DAM ASSESSMENT  
WISCONSIN POWER AND LIGHT COMPANY – EDGEWATER  
GENERATING STATION  
SLAG POND, NORTH POND A, SOUTH POND A, POND B, POND F  
SHEBOYGAN, WISCONSIN**

RE: Assessment of Dam Safety of Coal Combustion Surface Impoundments at the Edgewater  
Generating Station

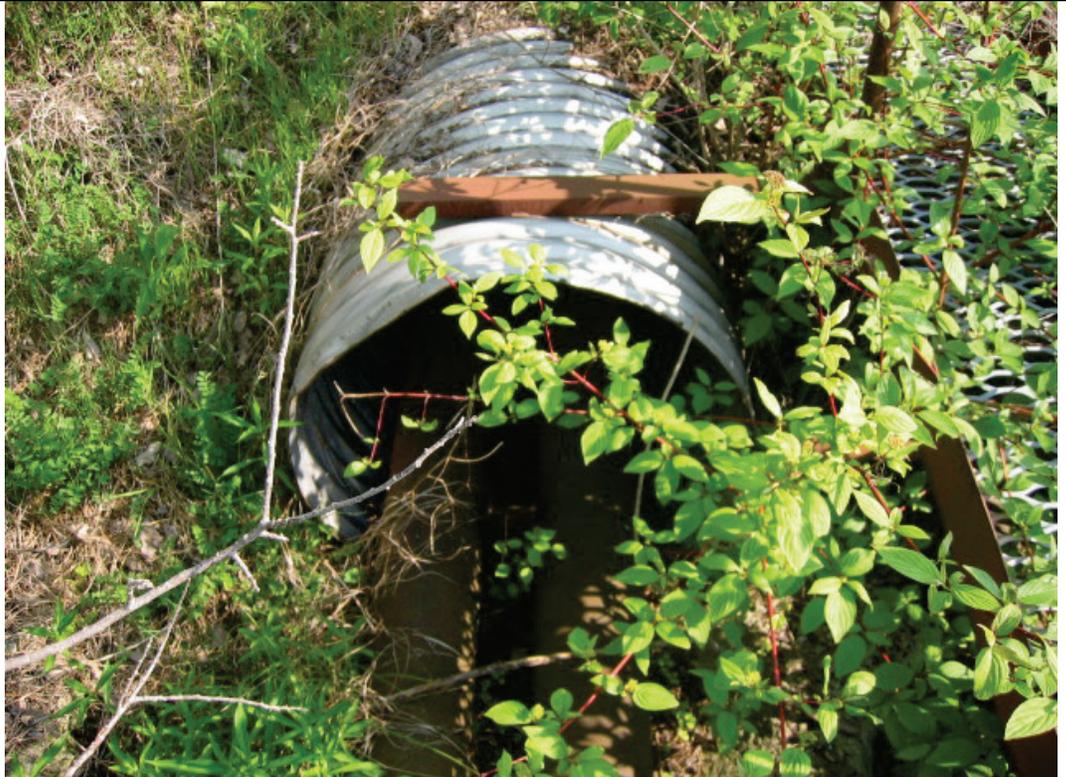
<b>Photo No.</b> <b>29</b>	<b>Date:</b> 5/31/11
<b>Direction Photo Taken:</b> North

**Description:**  
Sluice pipes where they penetrate the embankment to the North Pond A.

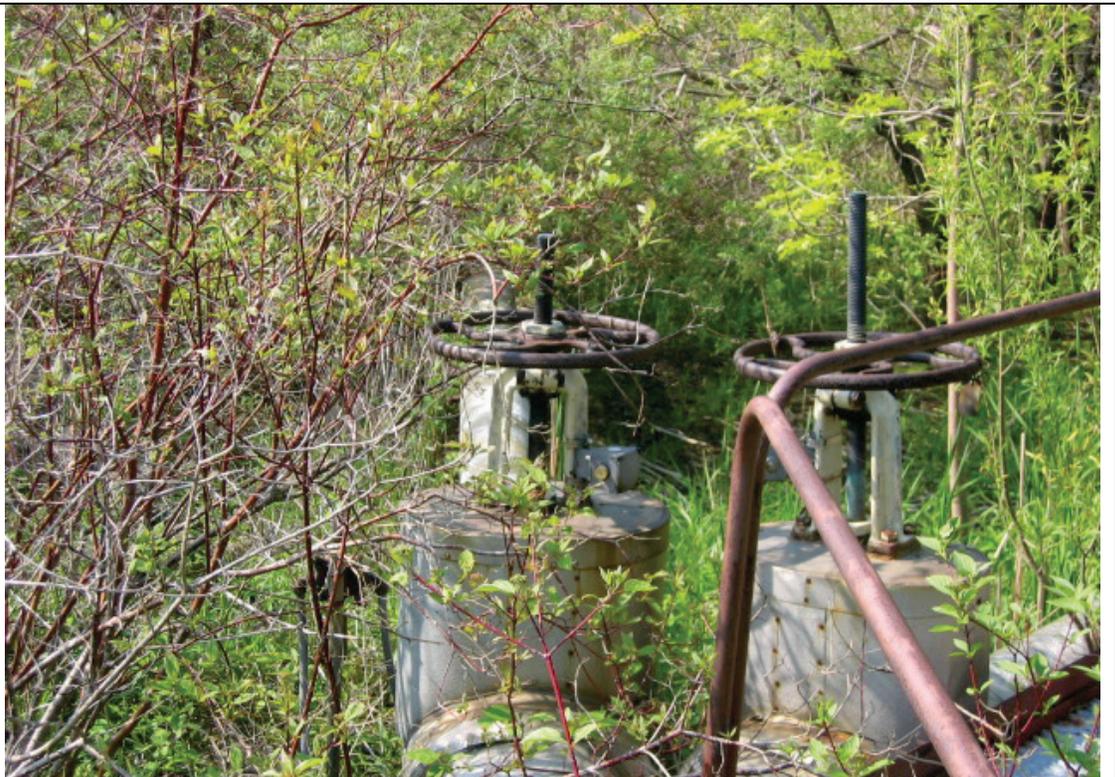
<b>Photo No.</b> <b>30</b>	<b>Date:</b> 5/31/11
<b>Direction Photo Taken:</b> South

**Description:**  
Valves to control flow of water to North Pond A and South Pond A.

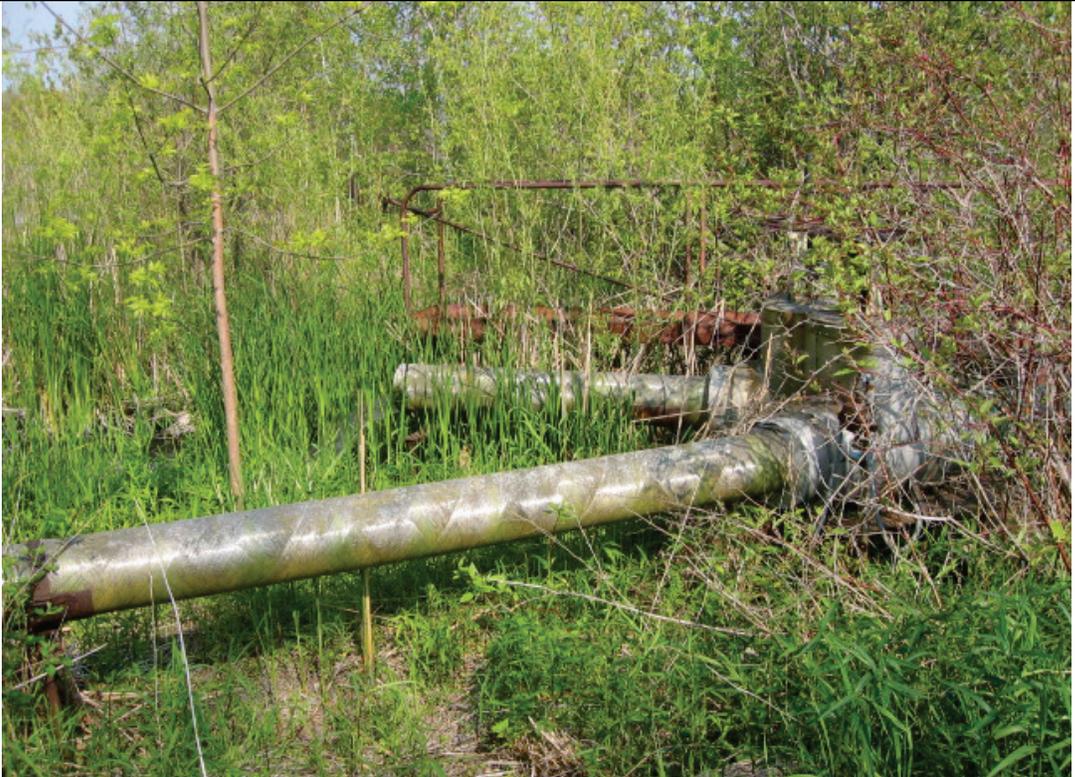
<b>Photo No.</b> 31	<b>Date:</b> 5/31/11
<b>Direction Photo Taken:</b> West

**Description:**  
Sluice pipes and valves at the discharge point in the North Pond A..

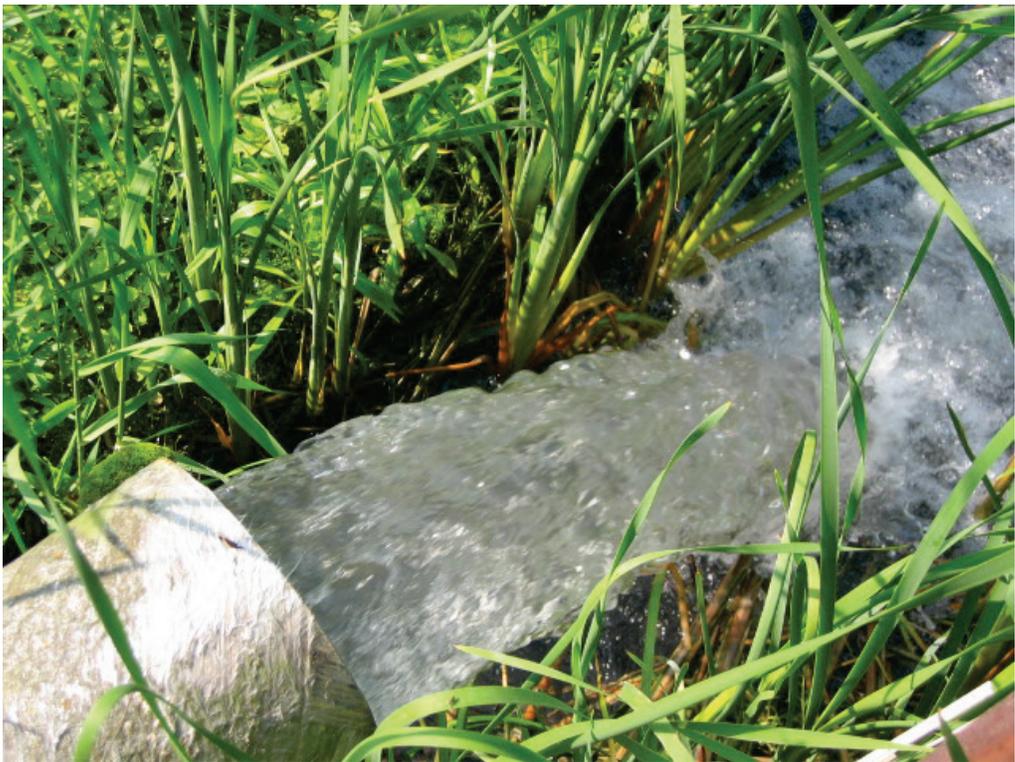
<b>Photo No.</b> 32	<b>Date:</b> 5/31/11
<b>Direction Photo Taken:</b> Southwest

**Description:**  
Discharge of transport water into the North Pond A.

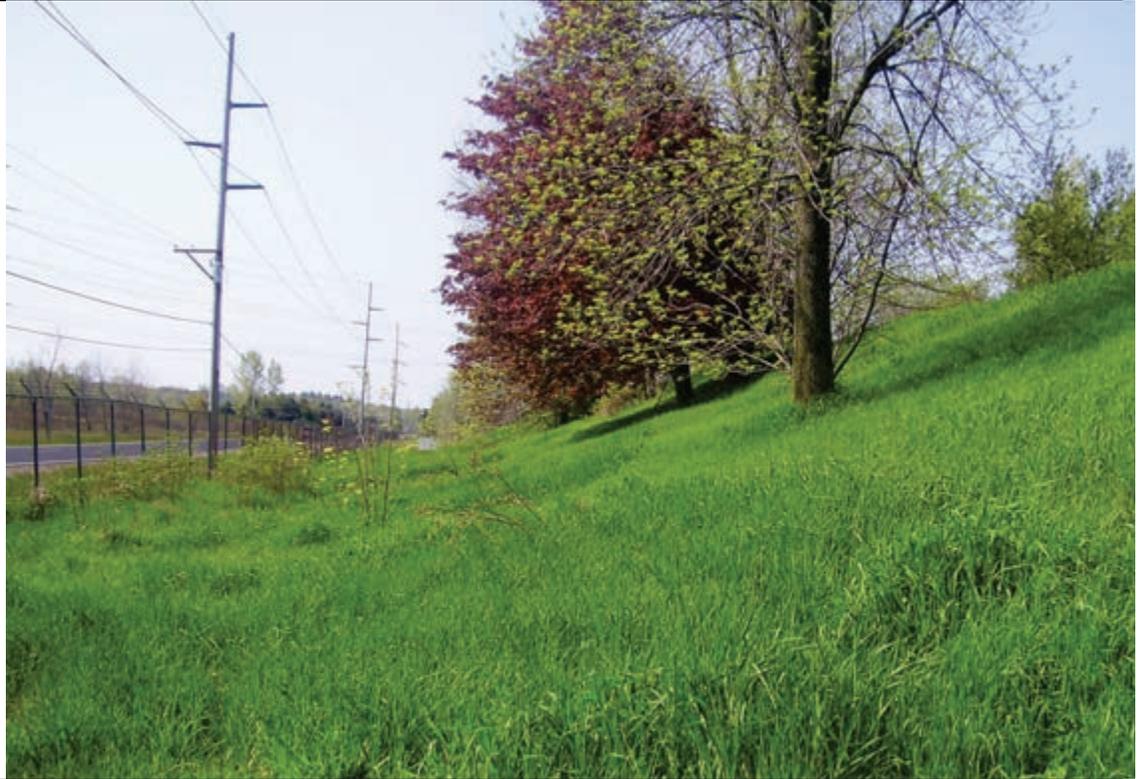
Downstream slope and toe of  
the North Pond A.

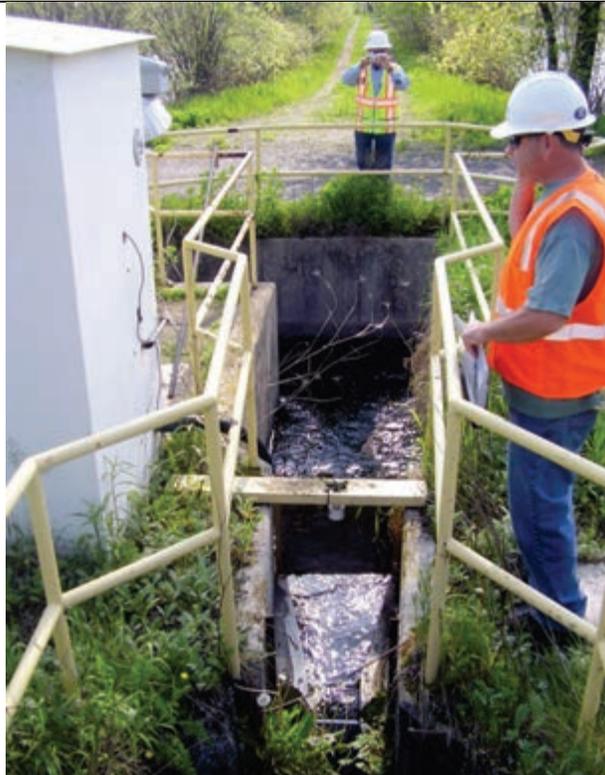
Photo No.  
**34**

Flume where discharge from  
North Pond A and South  
Pond A converge and flow to  
Pond B.

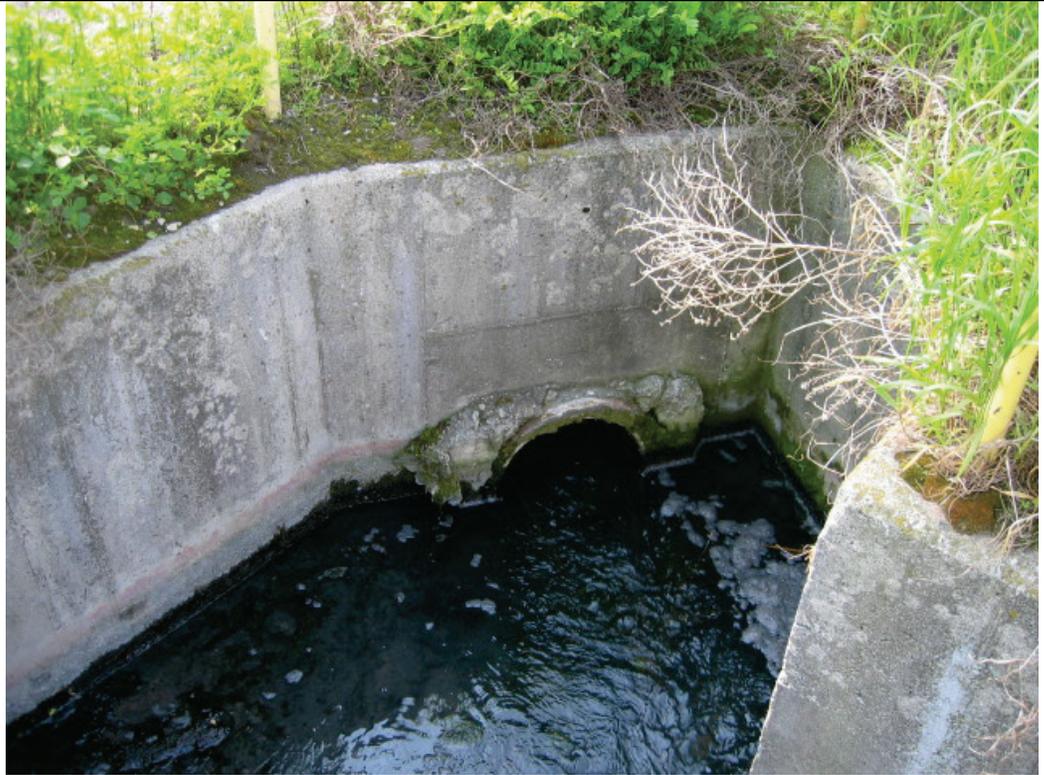
Description:  
Discharge pipe from North  
Pond A into flume.

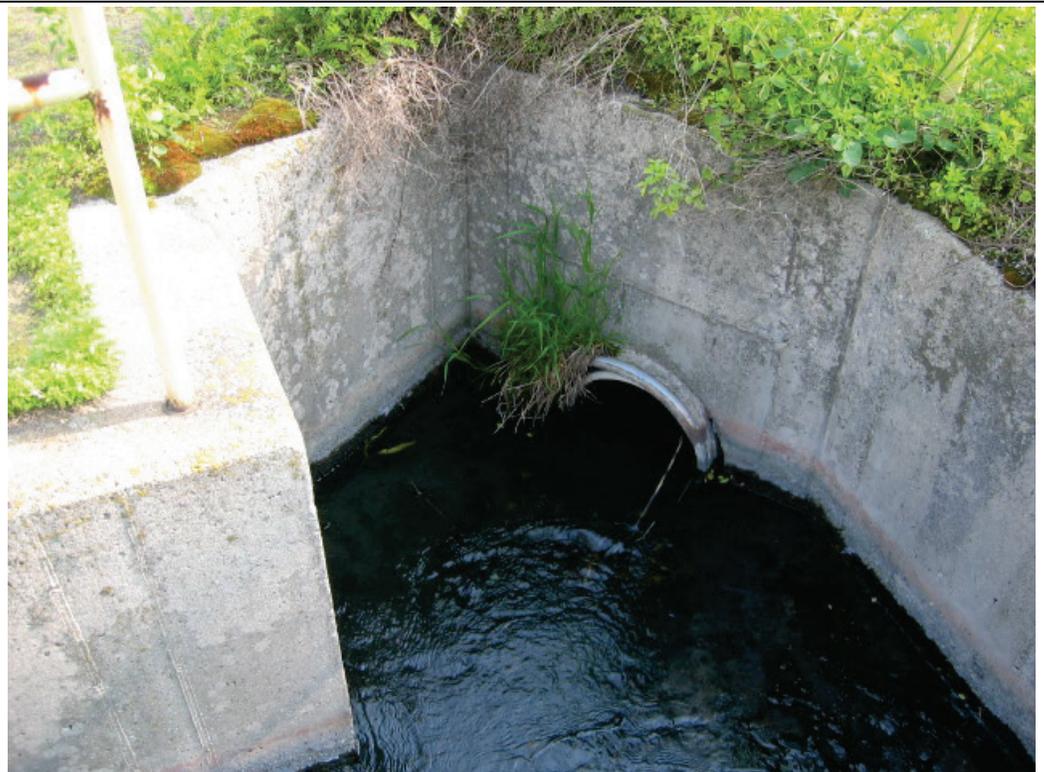
Photo No.  
**36**

Description:  
Discharge pipe from South  
Pond A into flume.

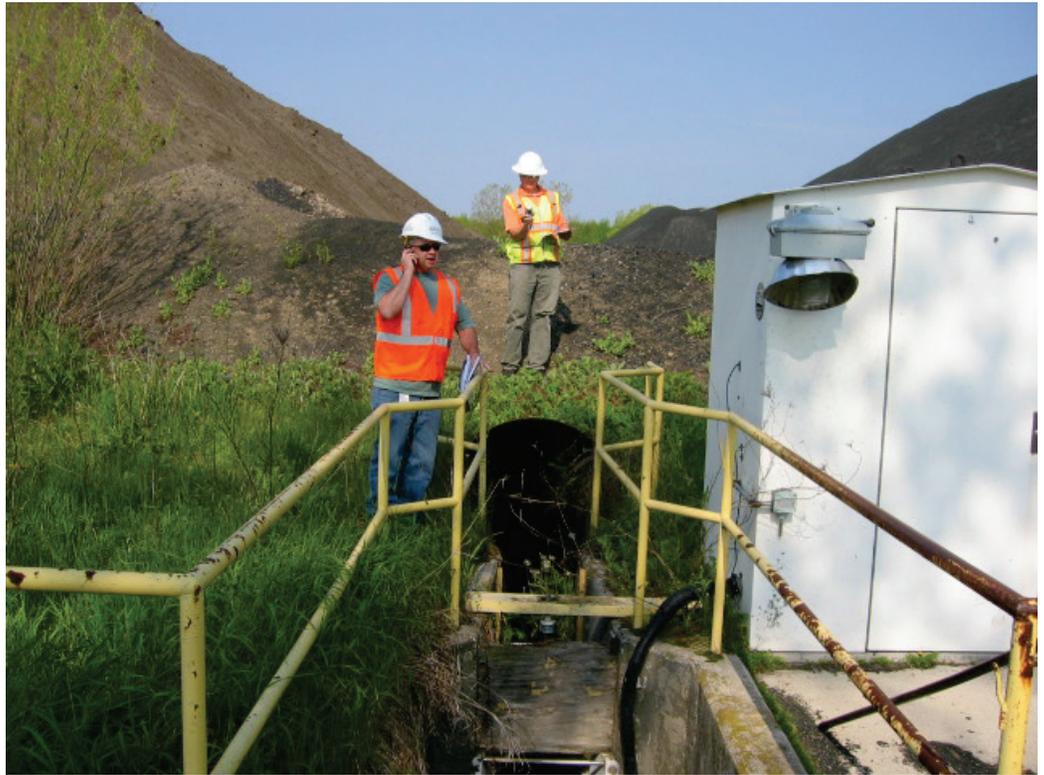
Description:  
Concrete flume conveying  
water from North Pond A  
and South Pond A.

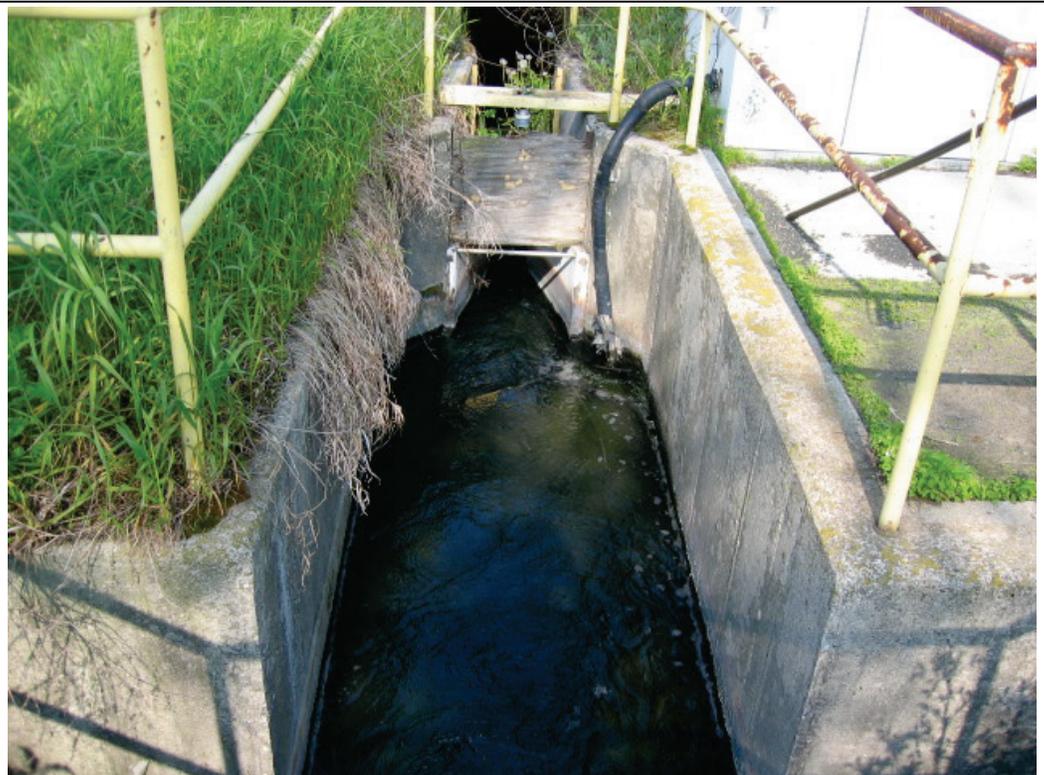
Photo No.  
38

Description:  
Concrete flume conveying  
water from North Pond A  
and South Pond A.

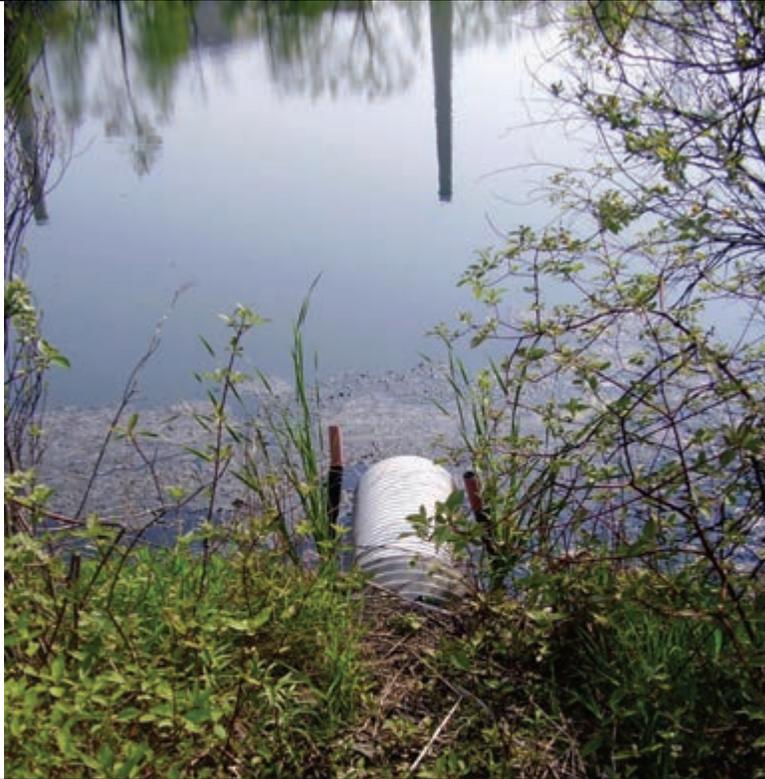
**Description:**  
Decant pipe in the North Pond A.

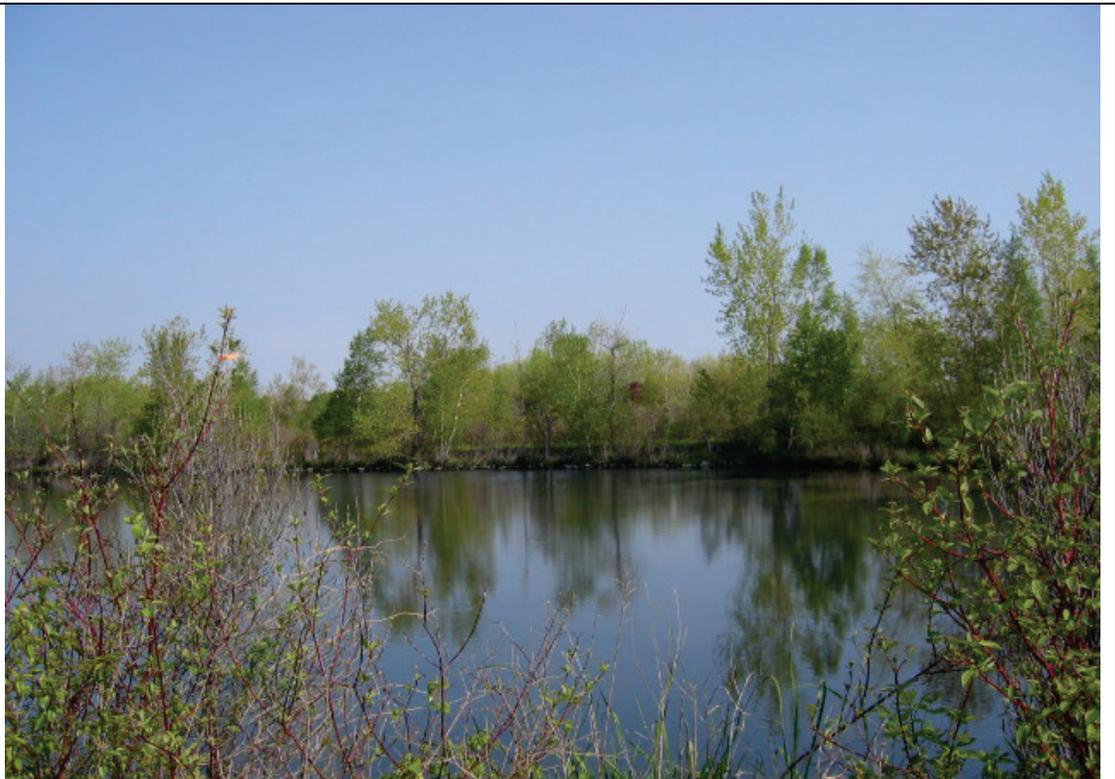
**Photo No.**  
**40**

**Description:**  
Upstream slope of the South Pond A.

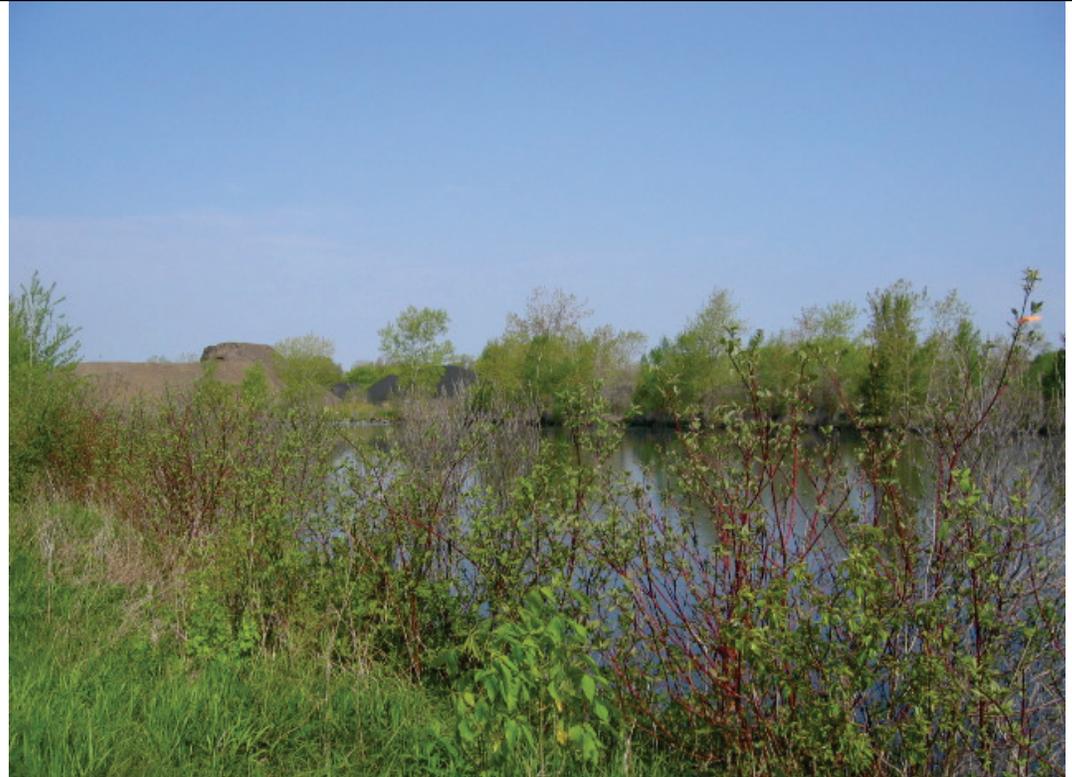
<b>Photo No.</b> <b>41</b>	<b>Date:</b> 5/31/11
<b>Direction Photo Taken:</b> Northwest

**Description:**  
Upstream slope of the South Pond A.

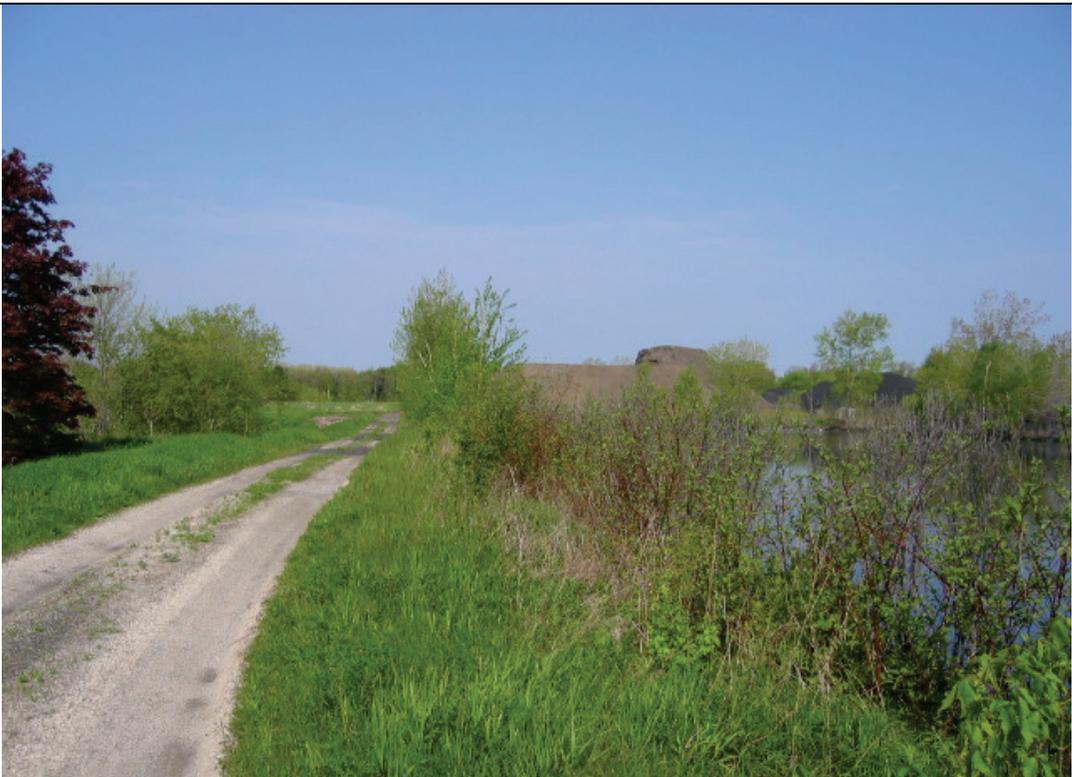
<b>Photo No.</b> <b>42</b>	<b>Date:</b> 5/31/11
<b>Direction Photo Taken:</b> West

**Description:**  
Upstream slope and crest of South Pond A.

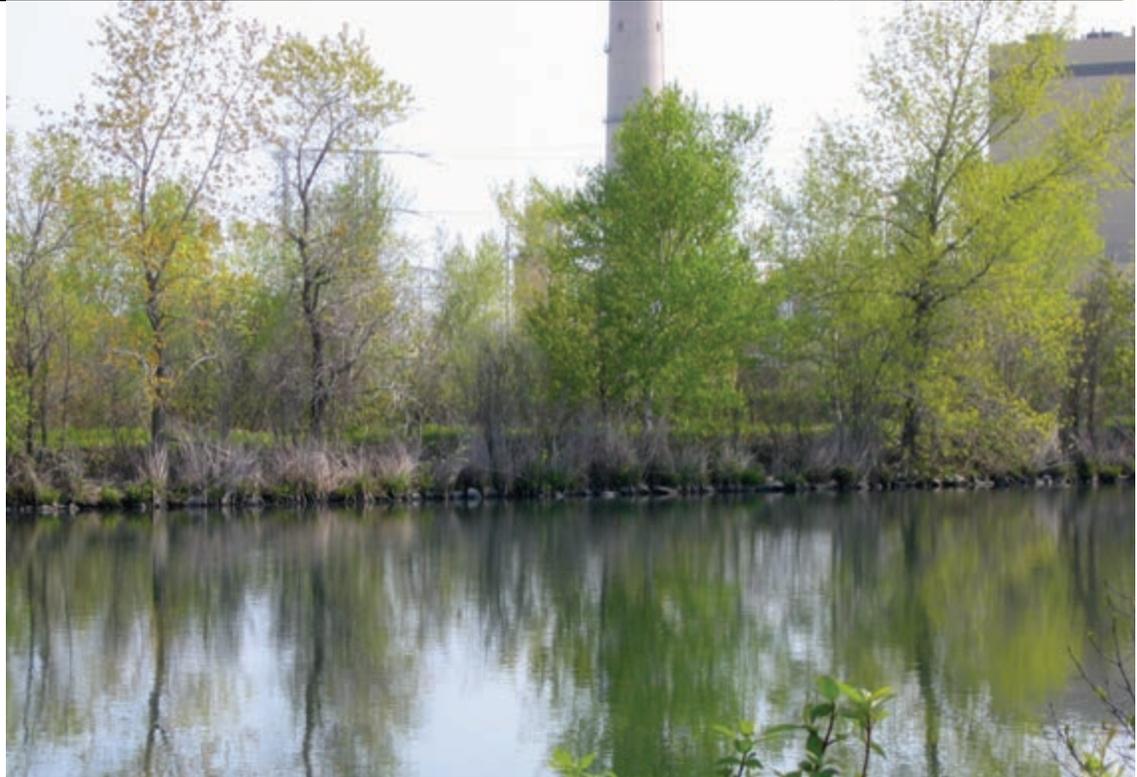
**Description:**  
Upstream slope of the South Pond A.

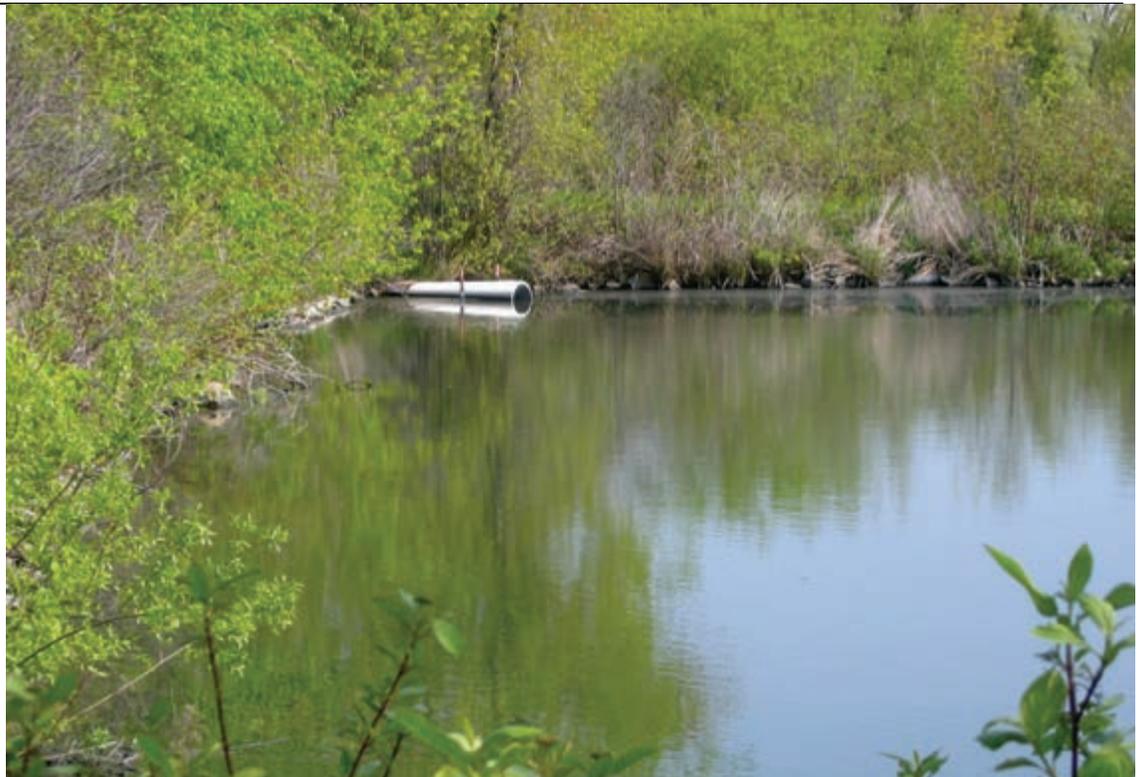
<b>Photo No.</b> 44	<b>Date:</b> 5/31/11
------------------------	-------------------------

**Description:**  
Upstream slope and decant pipe in the South Pond A.

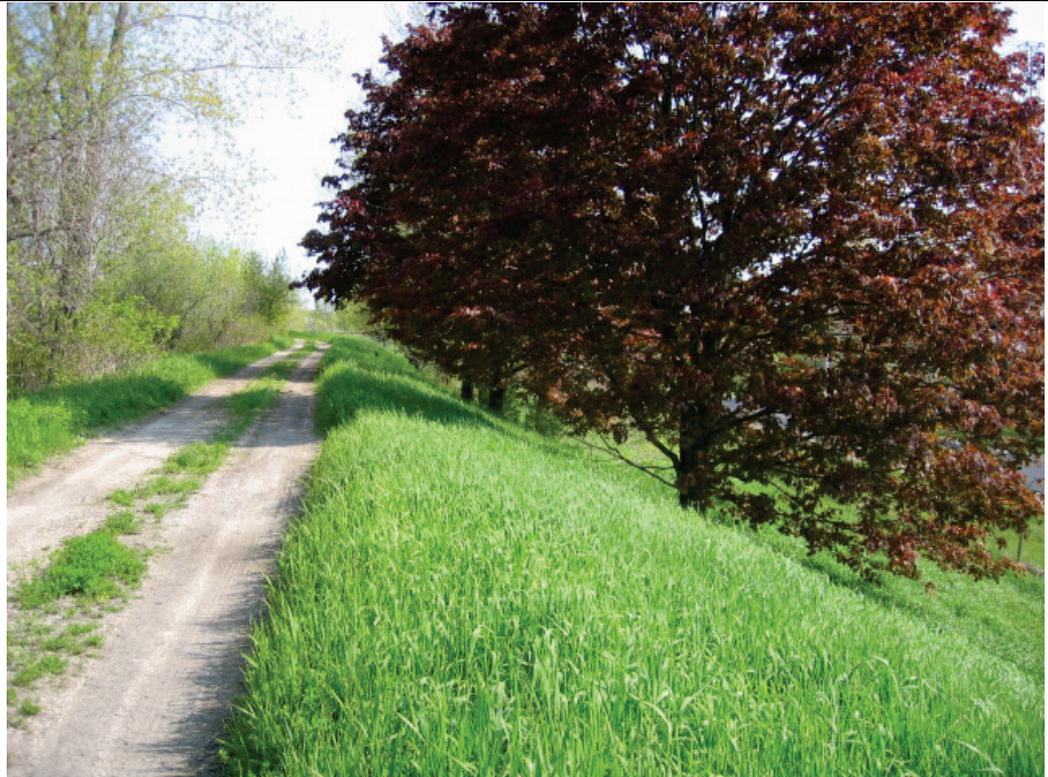
**Description:**  
Downstream slope and crest of the South Pond A.

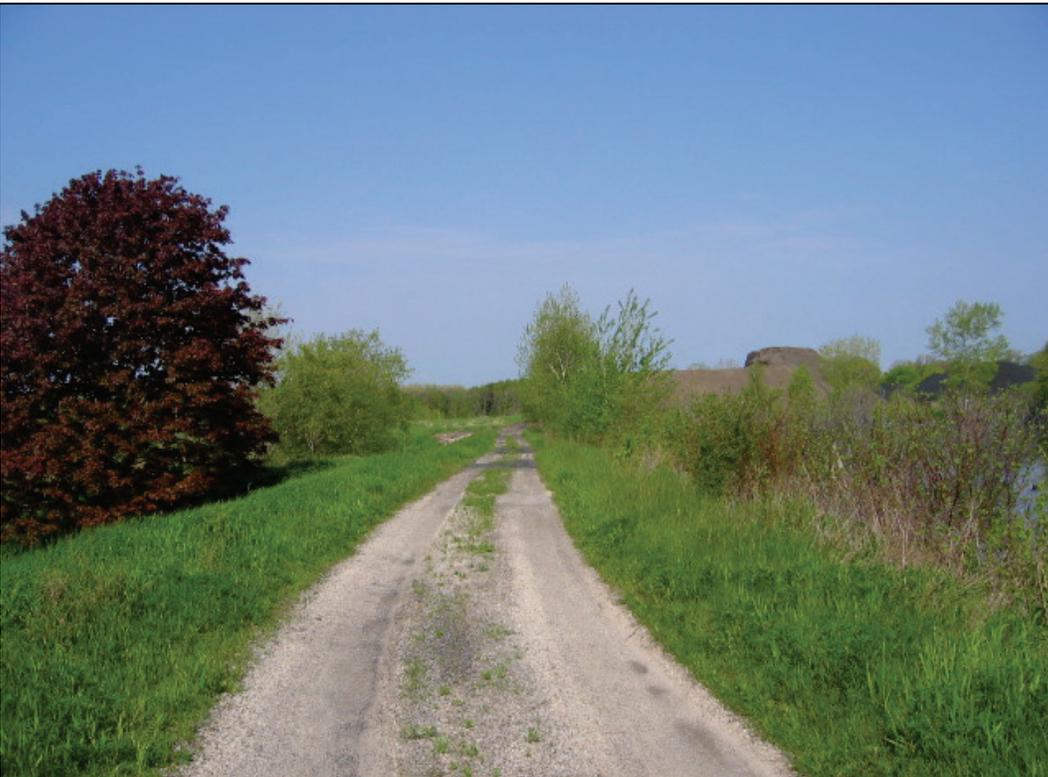
**Photo No.**  
**46**

**Description:**  
Crest of the embankment between South Pond A and Pond C.

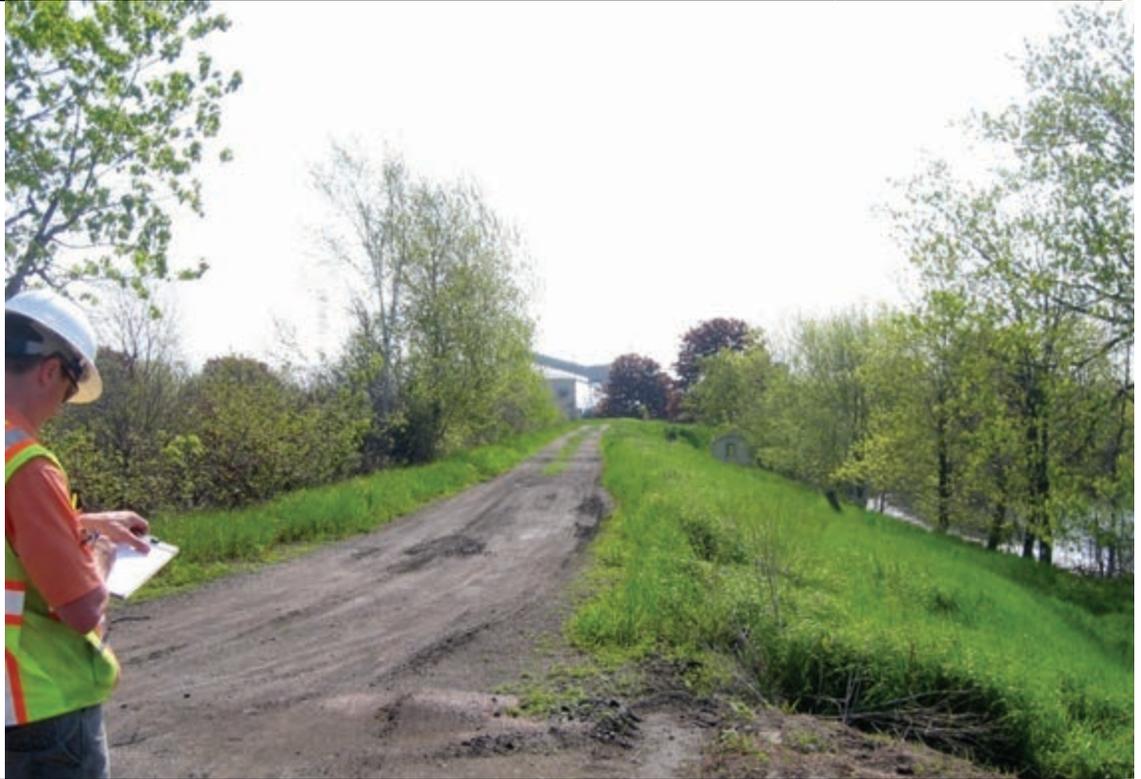
**Photo No.**  
**48**

**Description:**  
Downstream slope of South Pond A.

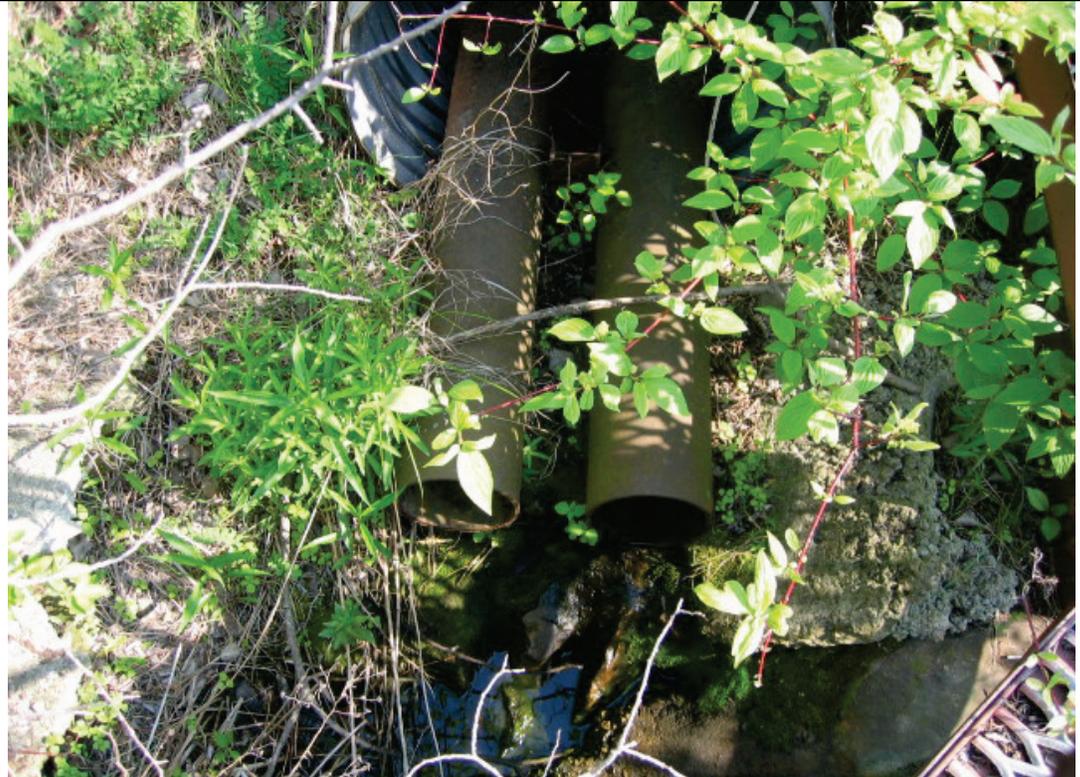
<b>Photo No.</b> 50	<b>Date:</b> 5/31/11
<b>Direction Photo Taken:</b> West

**Description:**  
Upstream slope of Pond B.

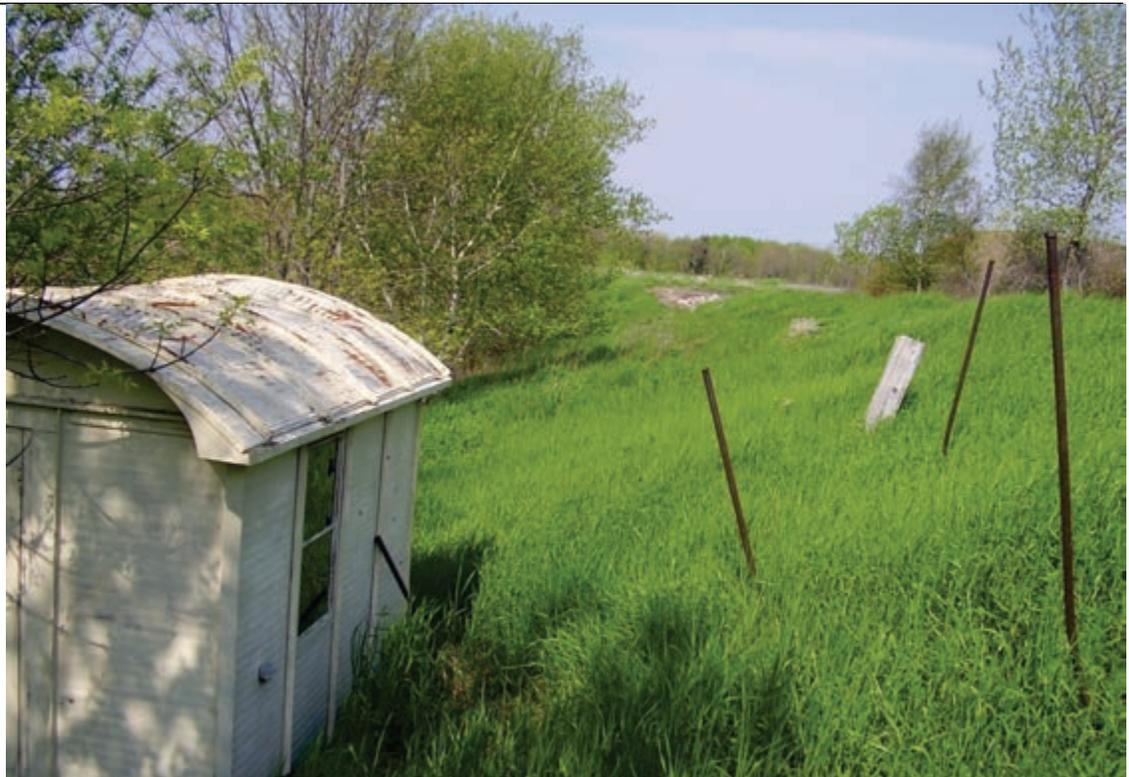
<b>Photo No.</b> <b>51</b>	<b>Date:</b> 5/31/11
<b>Direction Photo Taken:</b> Northwest

**Description:**  
Upstream slope of Pond B.

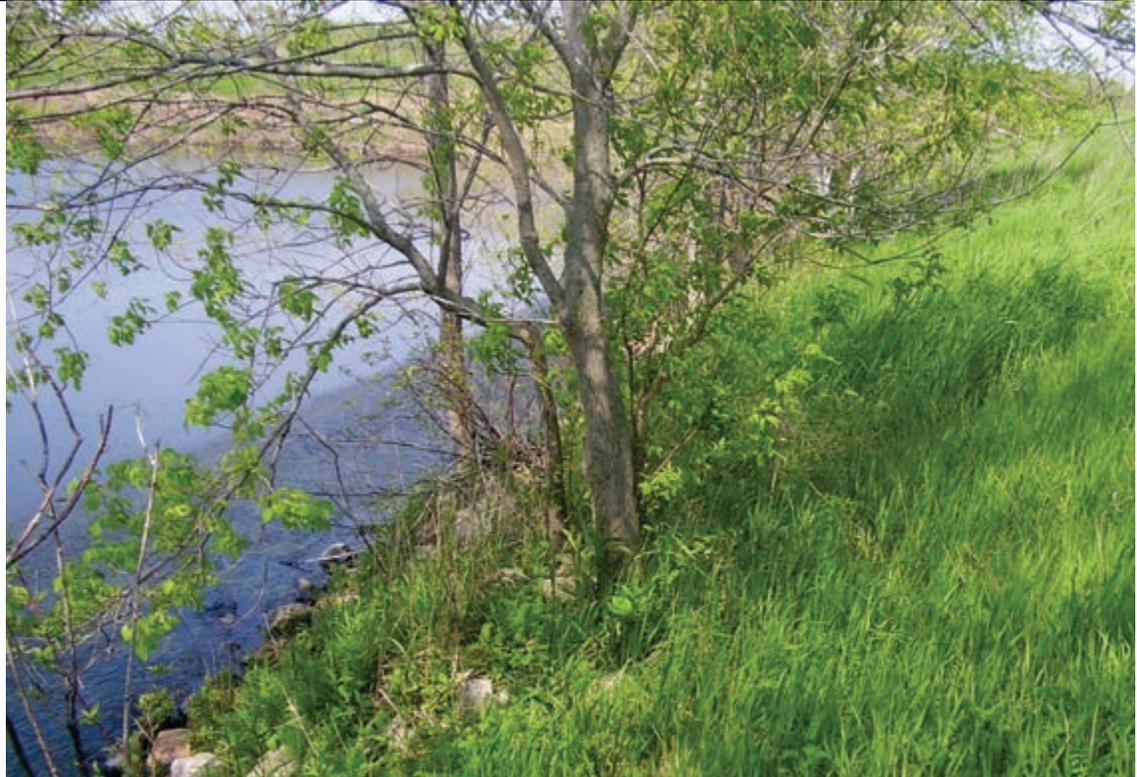
<b>Photo No.</b> <b>52</b>	<b>Date:</b> 5/31/11
<b>Direction Photo Taken:</b> Southwest

**Description:**  
Upstream slope of Pond B.

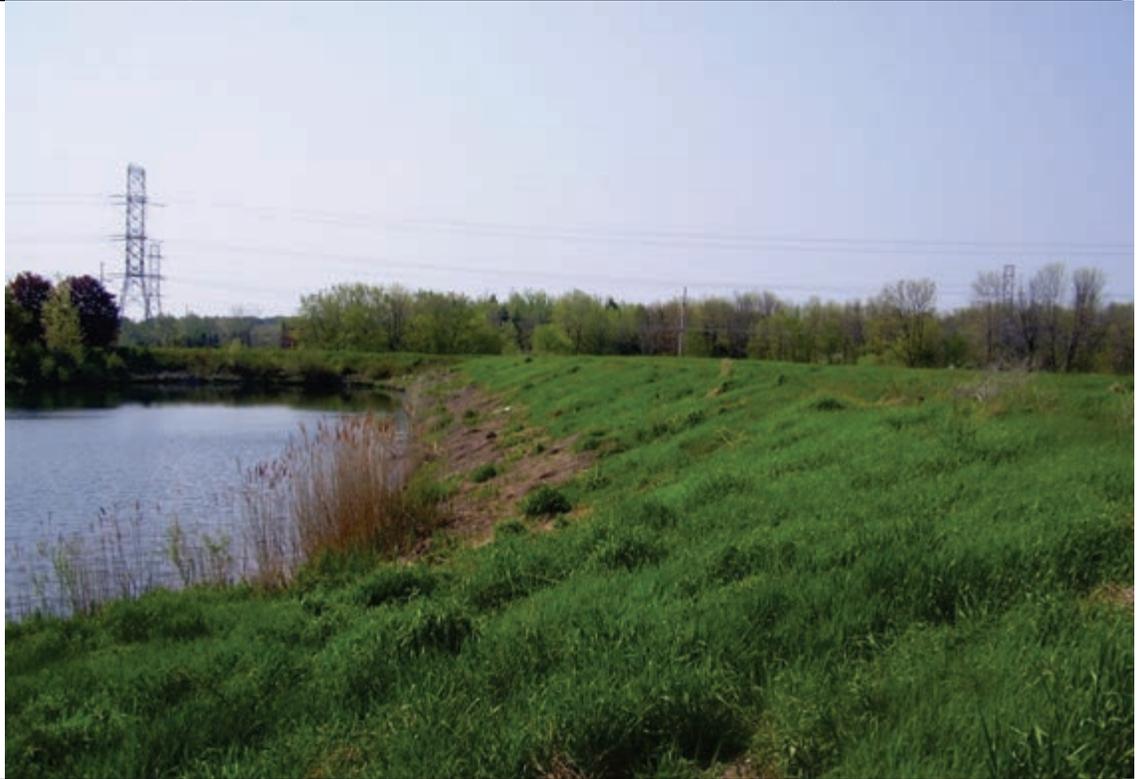
**Photo No.**  
**54**

**Description:**  
Upstream slope of Pond B.

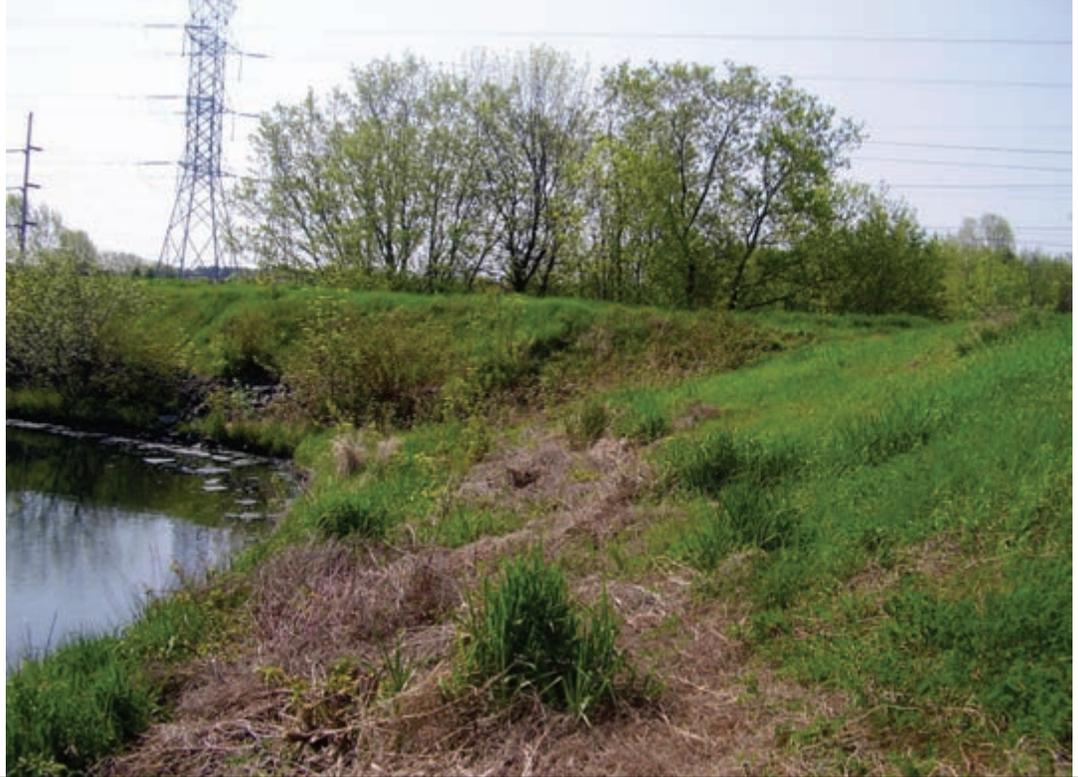
**Photo No.**  
56

**Description:**  
Upstream slope of Pond B.

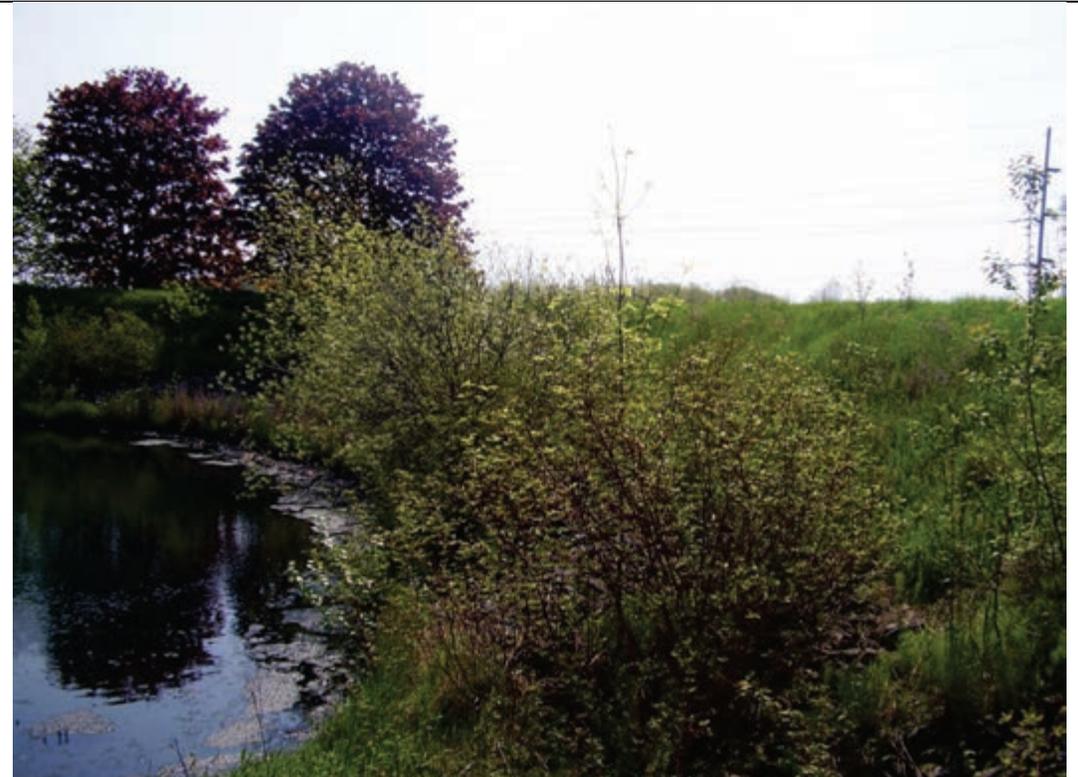
<b>Photo No.</b> <b>57</b>	<b>Date:</b> 5/31/11
<b>Direction Photo Taken:</b> Southeast

**Description:**  
Upstream slope of Pond B as seen from the decant structure platform.

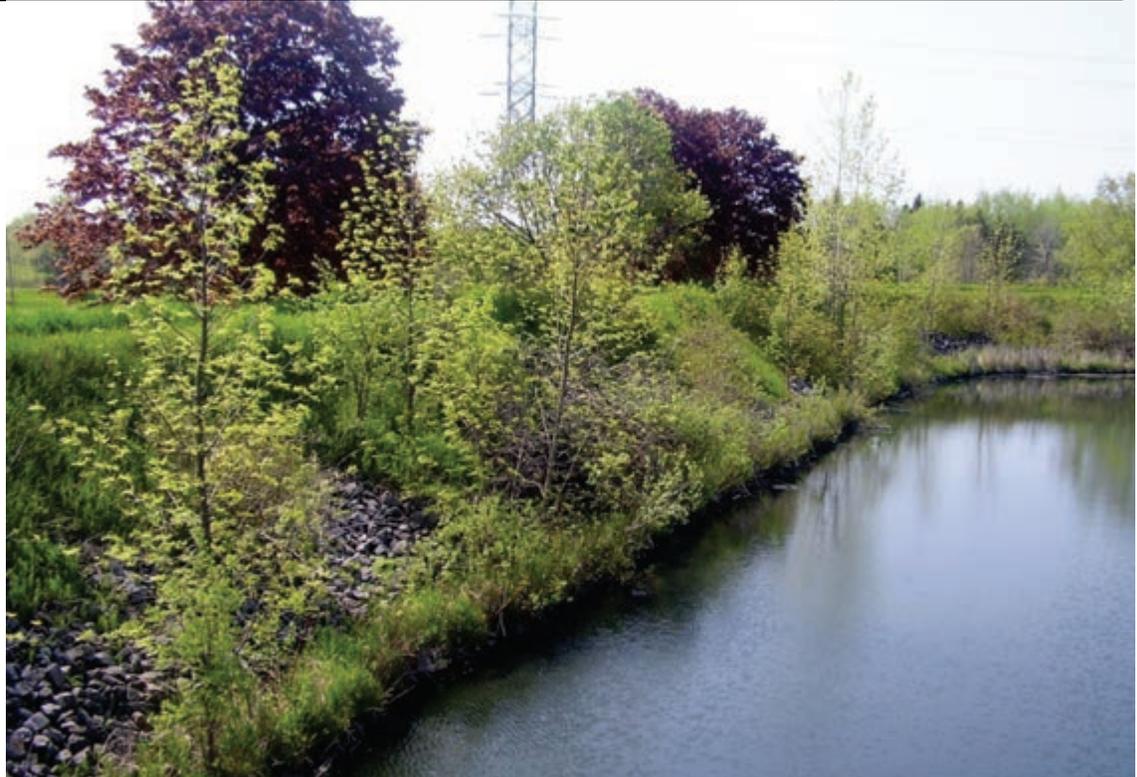
<b>Photo No.</b> <b>58</b>	<b>Date:</b> 5/31/11
<b>Direction Photo Taken:</b> Northeast

**Description:**  
Upstream slope of Pond B as seen from the decant structure platform.

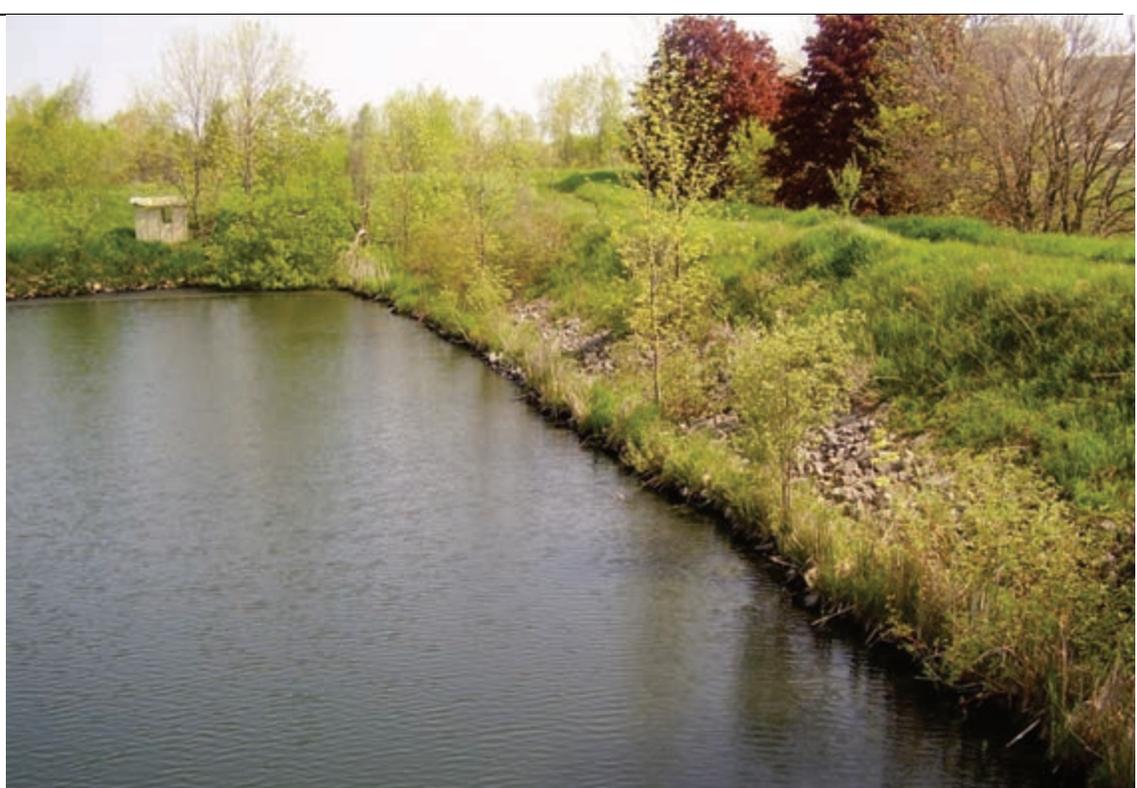
<b>Photo No.</b> <b>59</b>	<b>Date:</b> 5/31/11
<b>Direction Photo Taken:</b> South

**Description:**  
Crest of Pond B.
