**FINAL REPORT  
ROUND 10 DAM ASSESSMENT  
WISCONSIN POWER AND LIGHT COMPANY – EDGEWATER  
GENERATING STATION  
SLAG POND, NORTH POND A, SOUTH POND A, POND B, POND F  
SHEBOYGAN, WISCONSIN**

RE: Assessment of Dam Safety of Coal Combustion Surface Impoundments at the Edgewater  
Generating Station

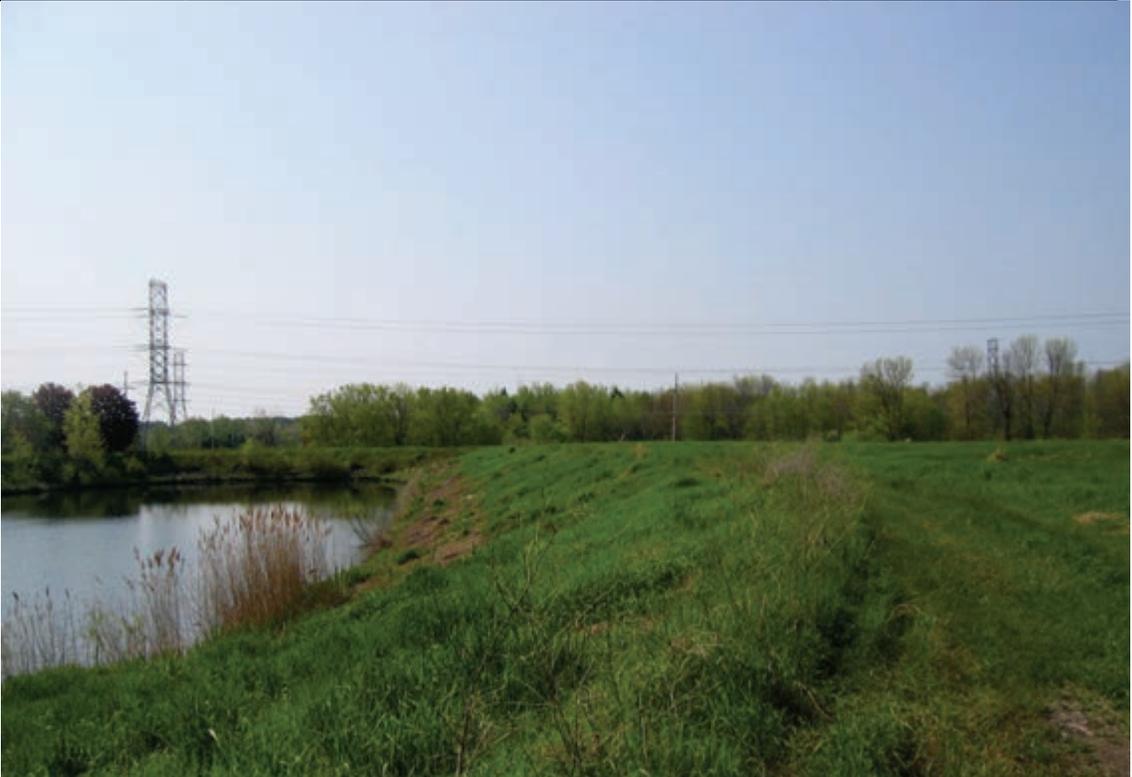
<b>Photo No.</b> <b>60</b>	<b>Date:</b> 5/31/11
<b>Direction Photo Taken:</b> North

**Description:**  
Crest and upstream slope of Pond B.

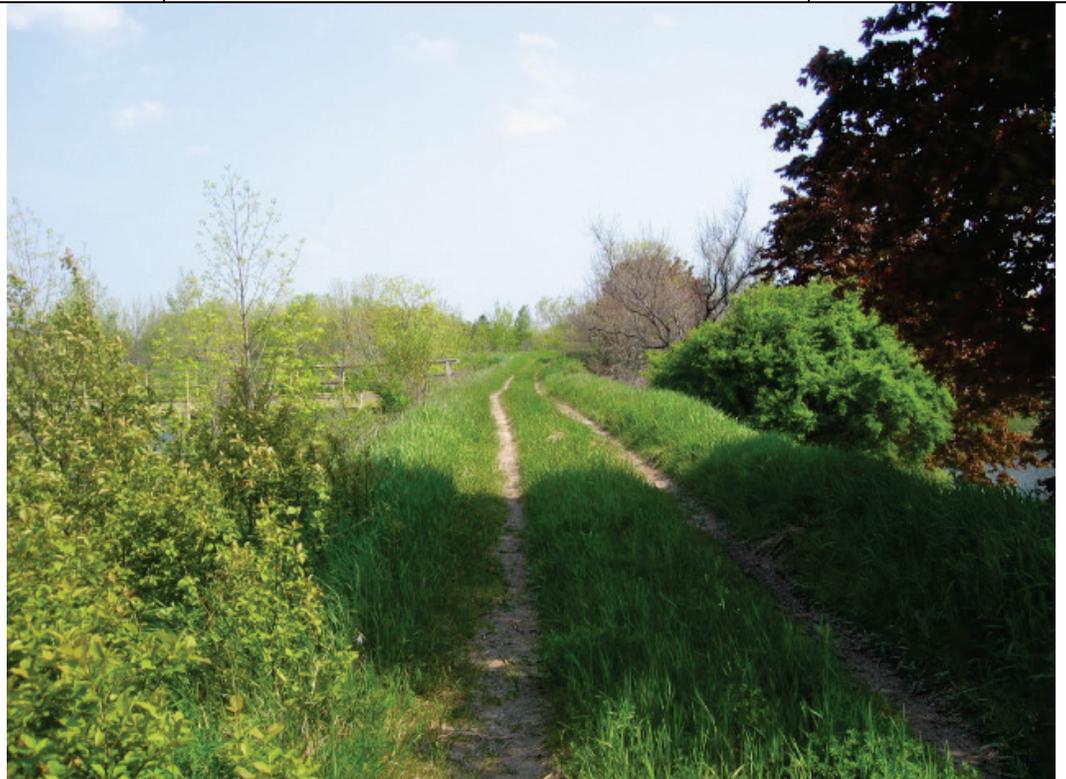
**Photo No.**  
62

**Description:**  
Crest of Pond B.

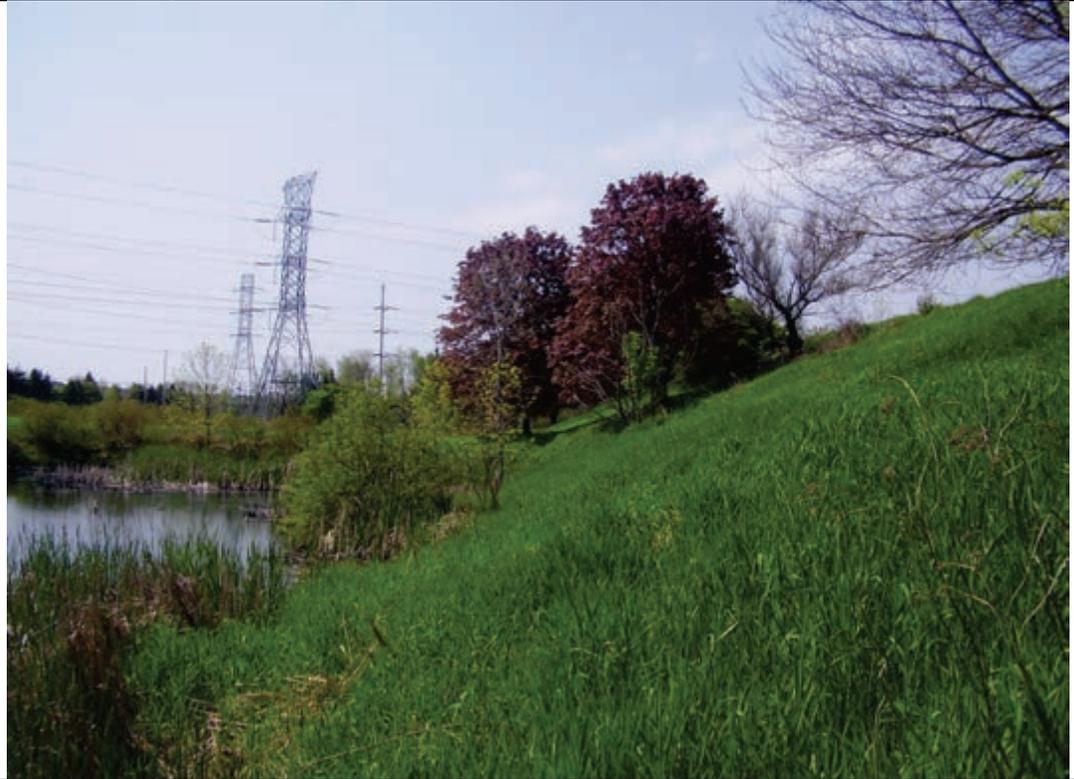
**Photo No.**  
**64**

**Description:**  
Downstream slope of Pond B.

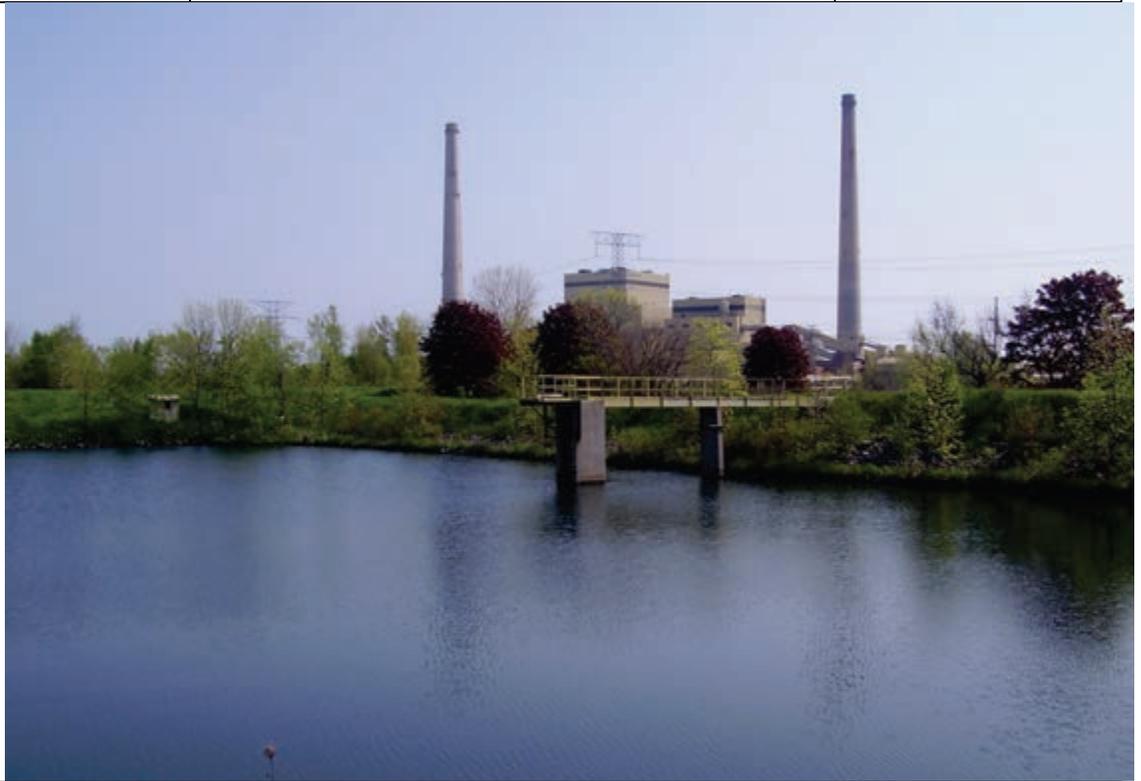
**Photo No.**  
68

**Description:**  
Staff gauge on decant structure in Pond B.

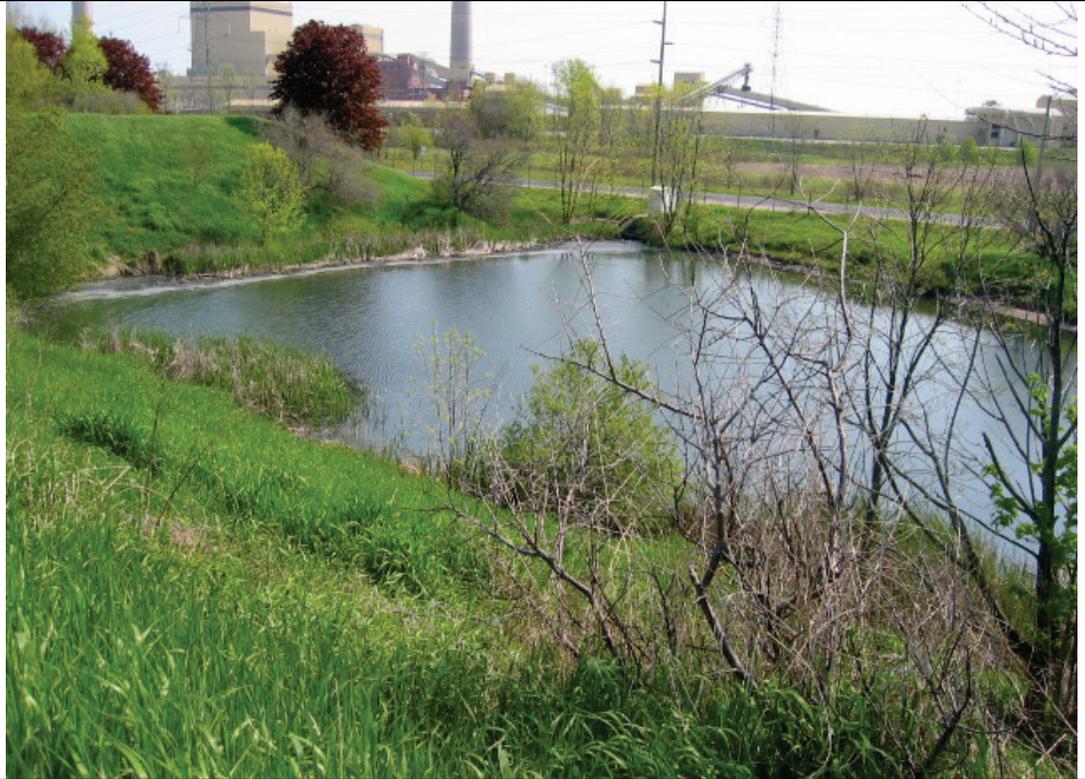
**Photo No.**  
**72**

**Description:**  
Upstream slope of Pond F.

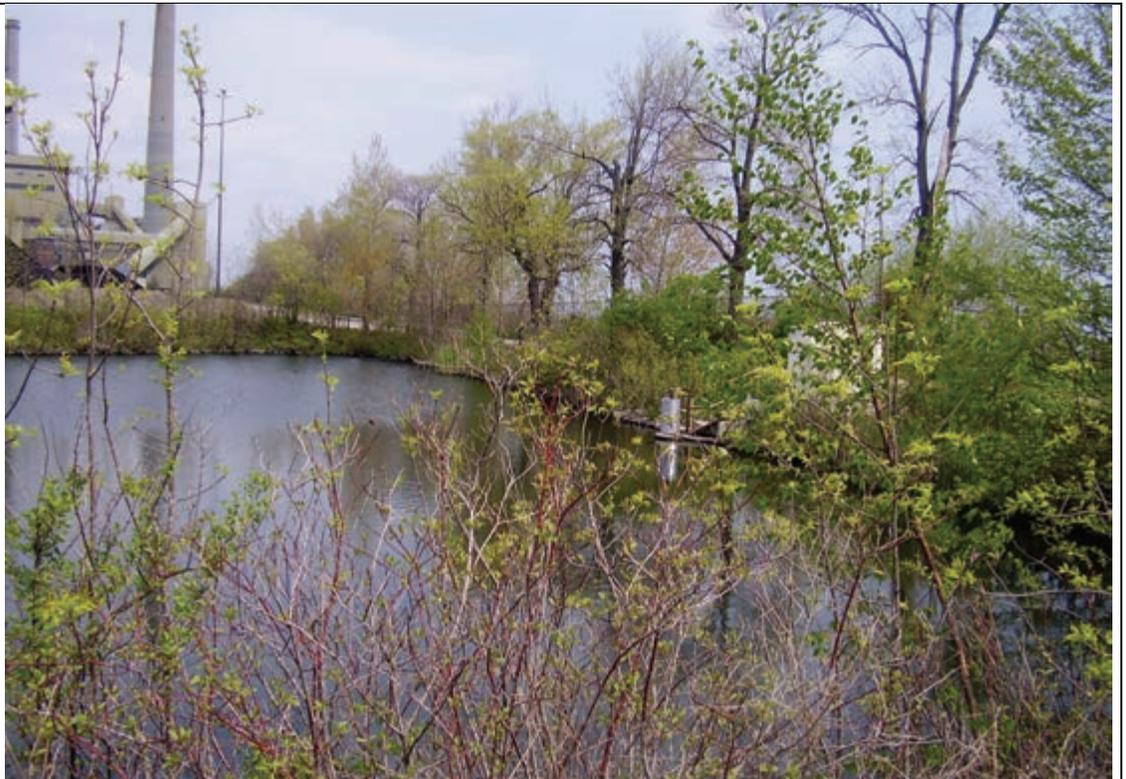
<b>Photo No.</b> 73	<b>Date:</b> 5/31/11
<b>Direction Photo Taken:</b> Northwest

**Description:**  
Upstream slope of Pond F.

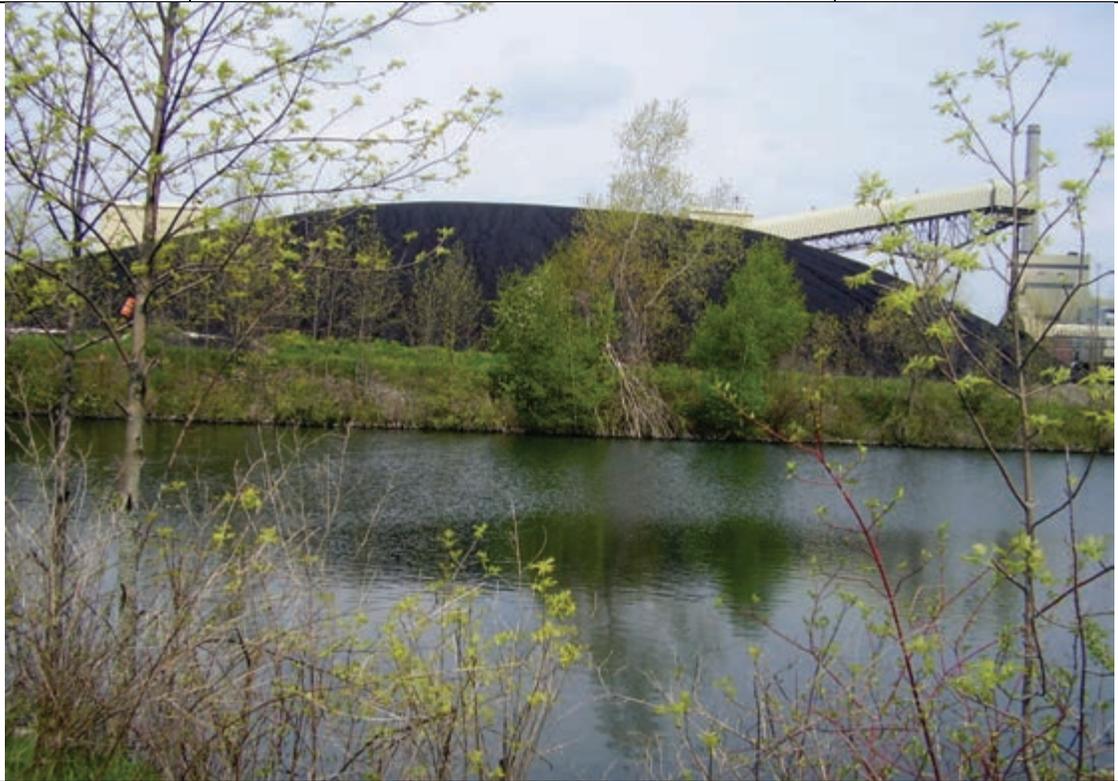
<b>Photo No.</b> 74	<b>Date:</b> 5/31/11
<b>Direction Photo Taken:</b> Southwest

**Description:**  
Upstream slope of Pond F.

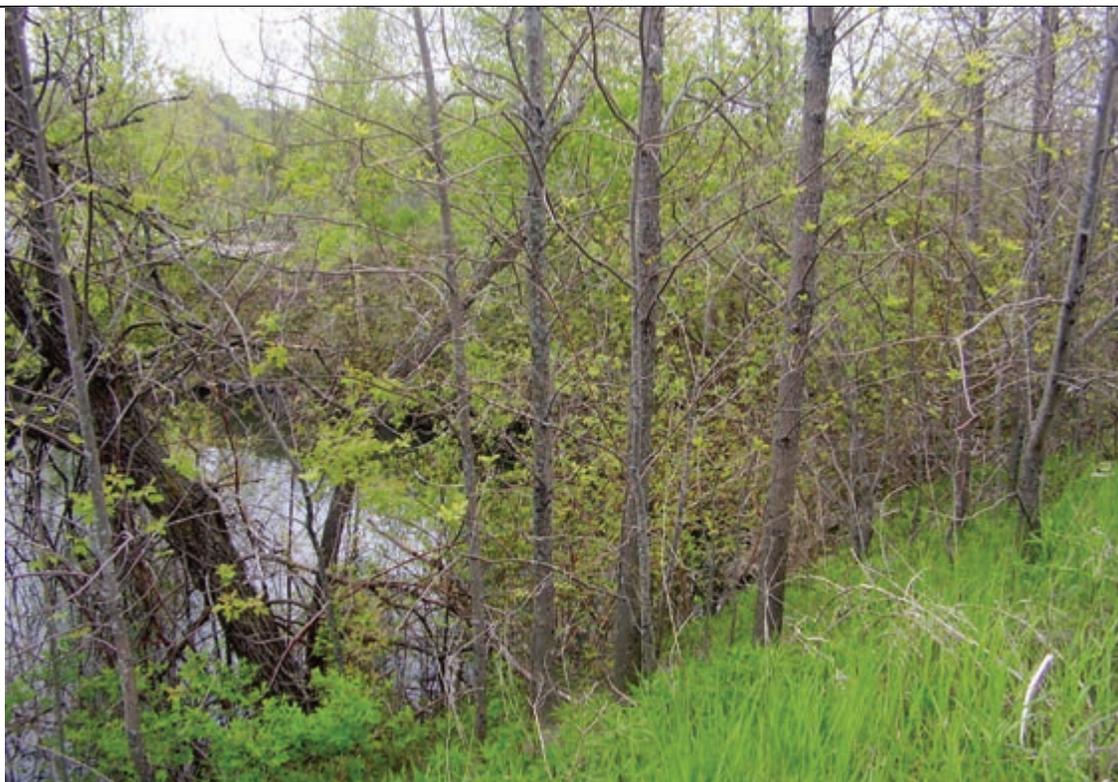
<b>Photo No.</b> <b>75</b>	<b>Date:</b> 5/31/11
<b>Direction Photo Taken:</b> East

**Description:**  
Upstream slope of Pond F.

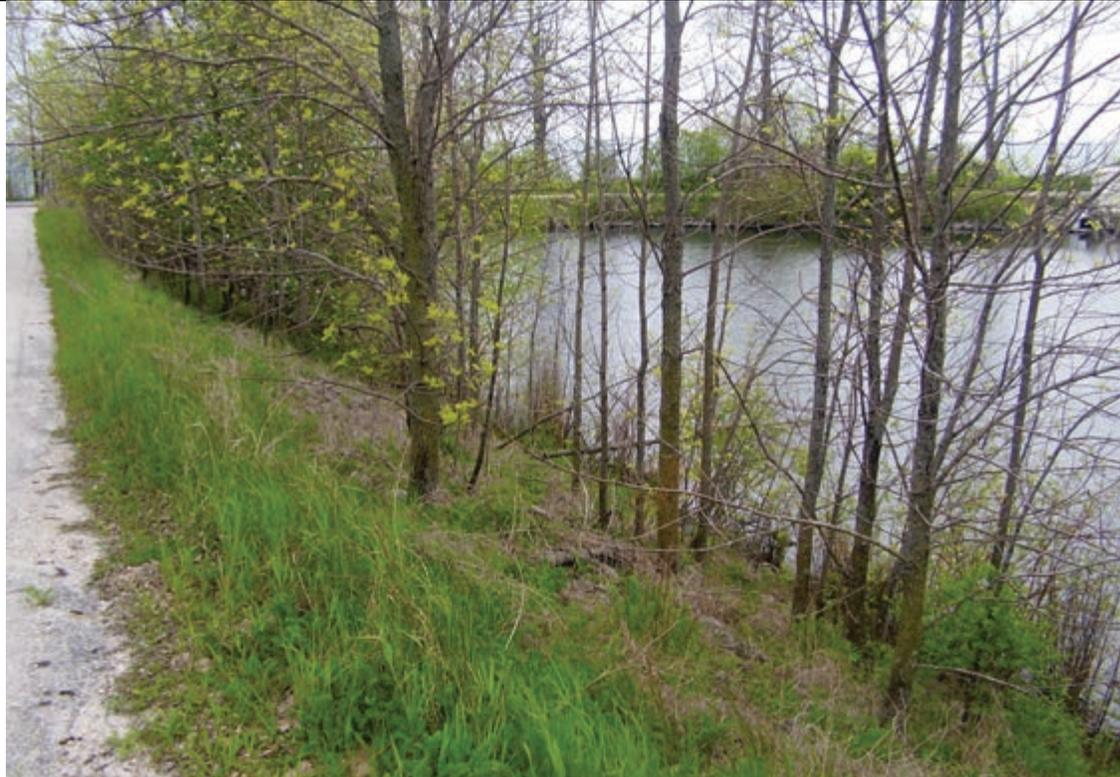
<b>Photo No.</b> <b>76</b>	<b>Date:</b> 5/31/11
<b>Direction Photo Taken:</b> South

**Description:**  
Upstream slope and crest of Pond F.

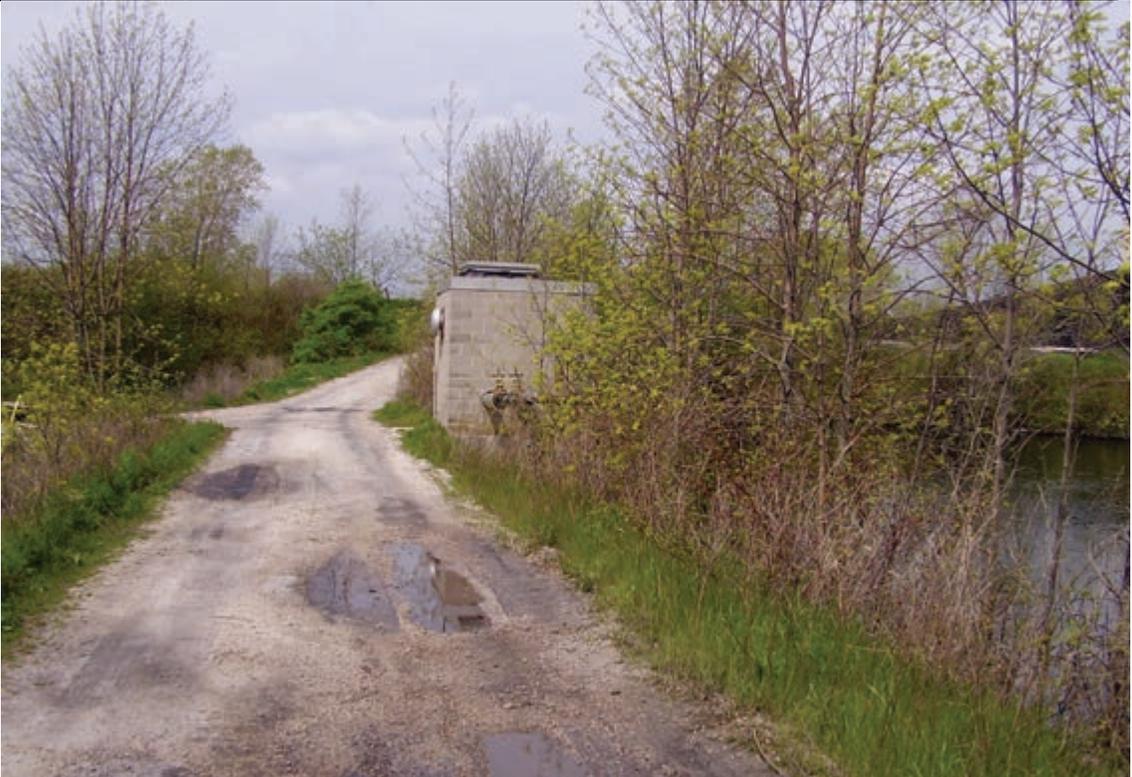
<b>Photo No.</b> <b>78</b>	<b>Date:</b> 5/31/11
-------------------------------	-------------------------

**Description:**  
Discharge pipe from pump house on Pond F.

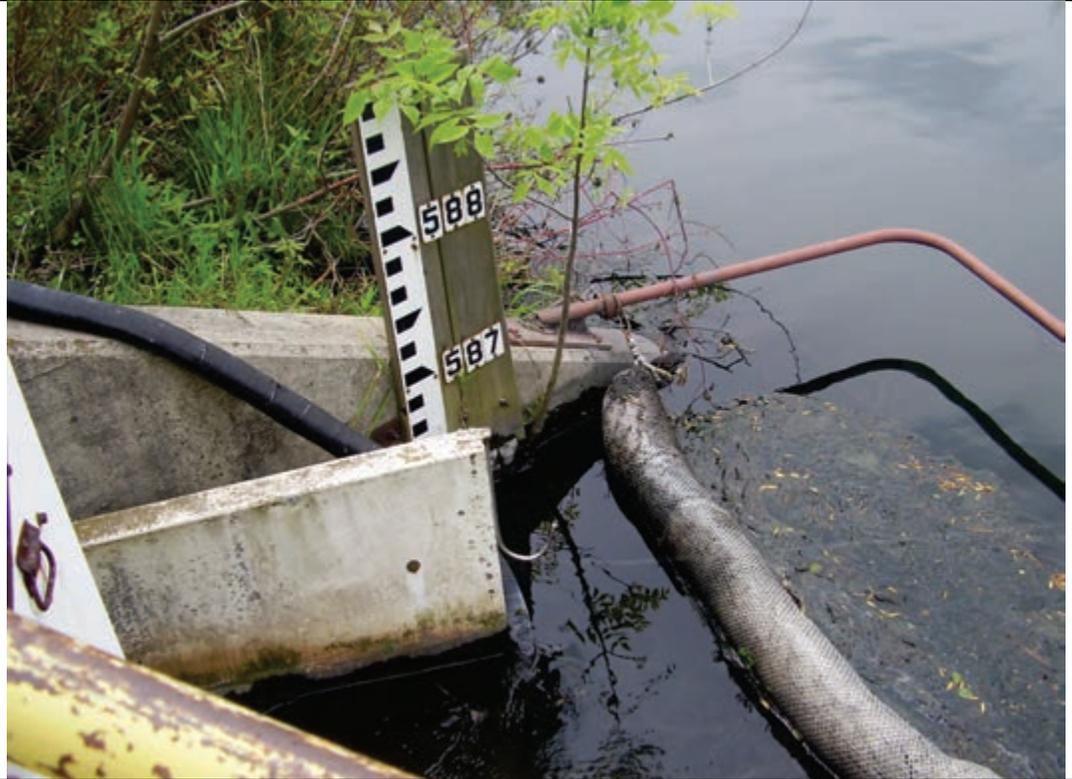
Photo No.  
80

Description:  
Decant structure at Pond F.

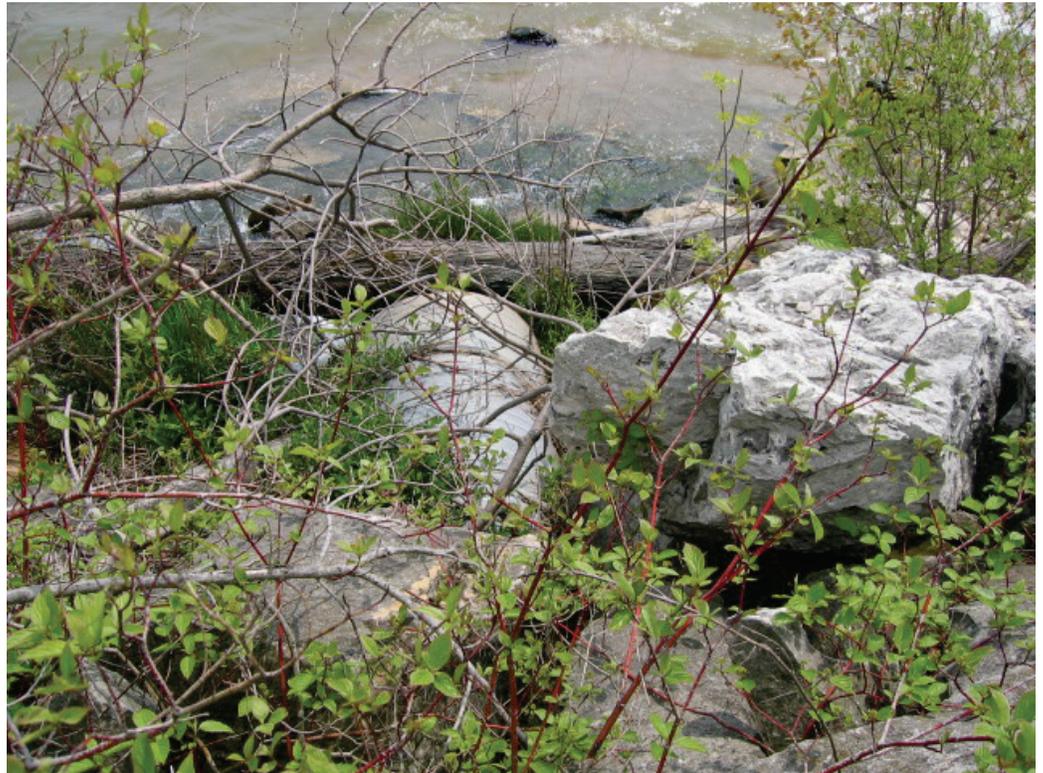
**Photo No.**  
**82**

**Description:**  
Downstream slope and discharge pipe from Pond F to Lake Michigan.

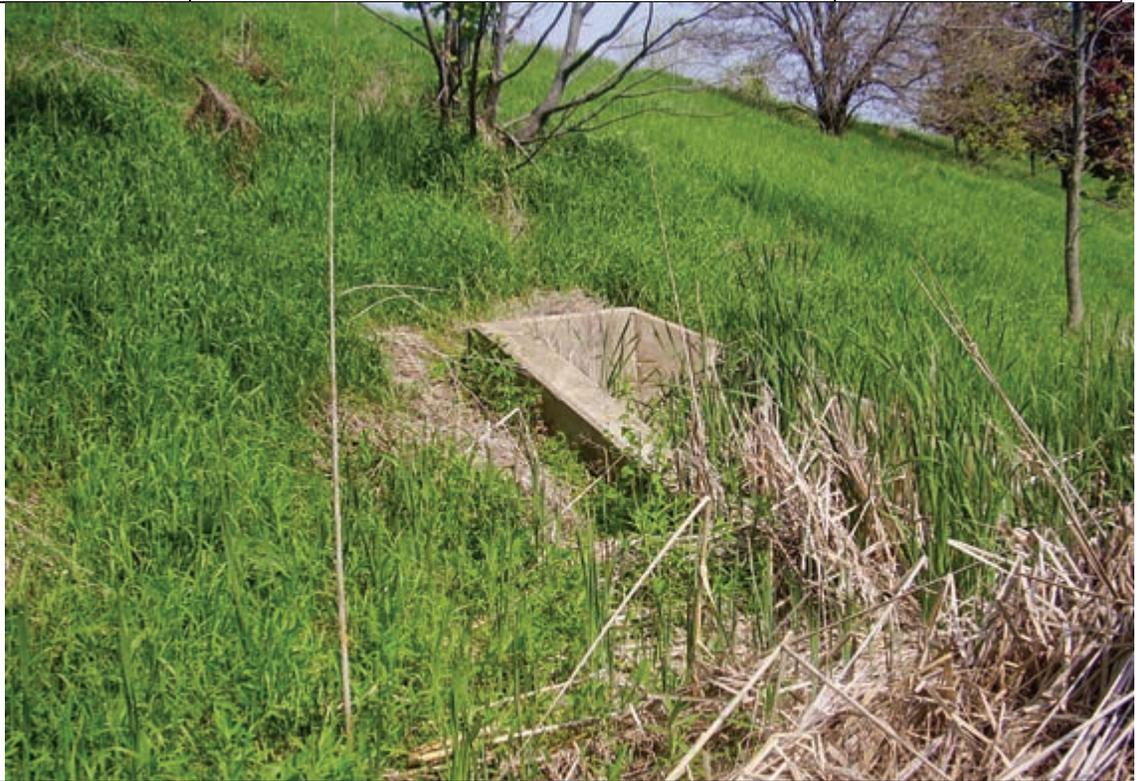
Photo No.  
**84**

Description:  
Discharge pipe from Slag  
Pond, North Pond A, and  
South Pond A into Pond B
