**DRAFT REPORT
ROUND 10 DAM ASSESSMENT - JUNE 8, 2011
ALLIANT ENERGY - ROCK RIVER GENERATING STATION
WPDES POND 1, WPDES POND 2, SLAG POND, FINAL WPDES POND
BELOIT, WISCONSIN**

RE: Assessment of Dam Safety of Coal Combustion Surface Impoundments at the Rock
River Generating Station

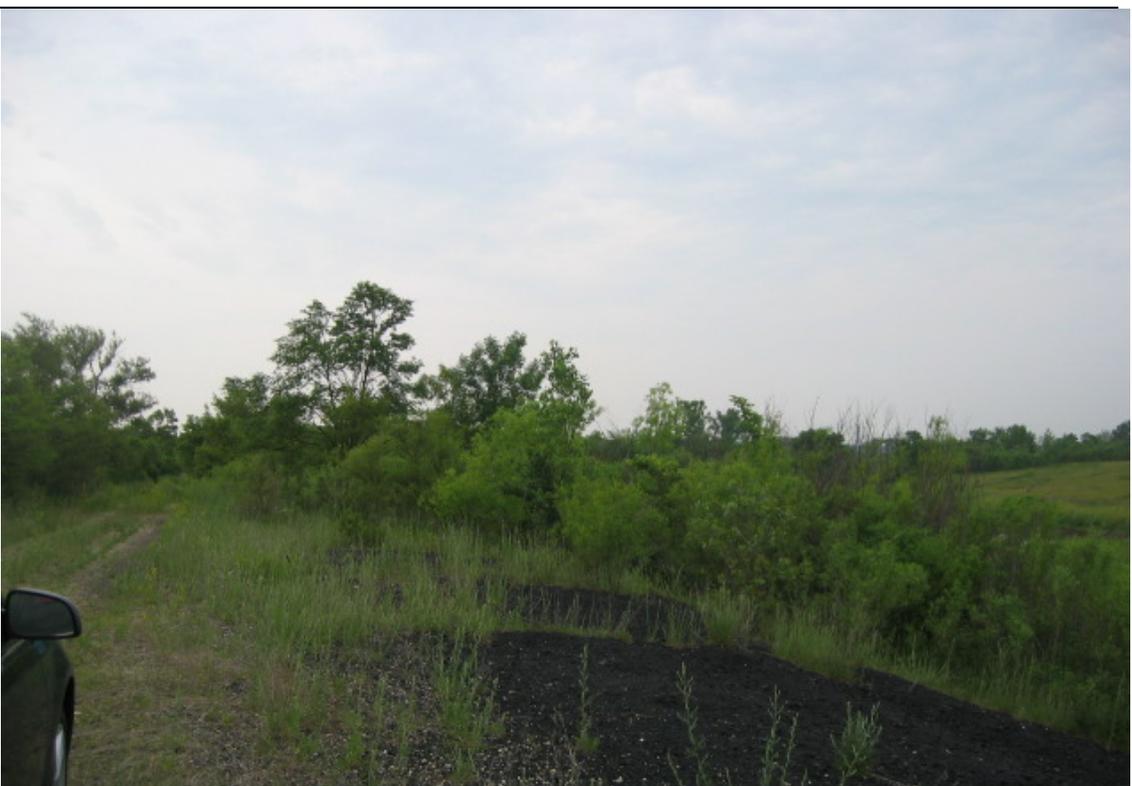
Photo No. 14	Date: 6/8/11
Direction Photo Taken: South

Description:
Crest of the WPDES Pond 1.

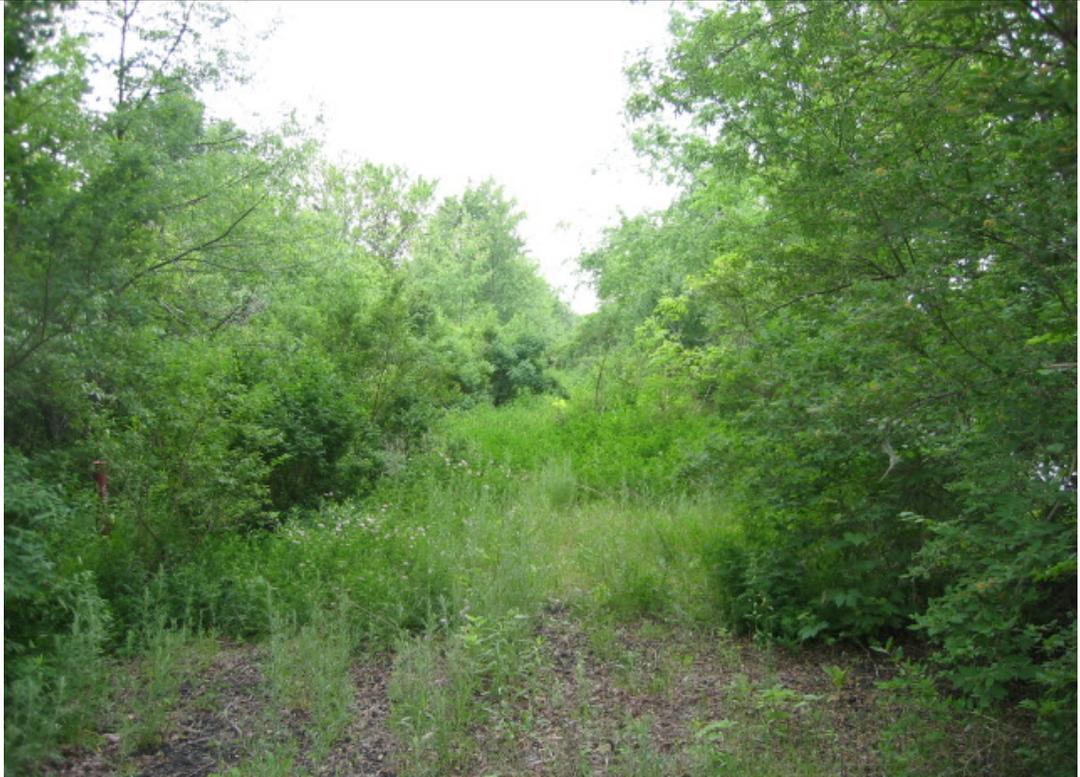
Photo No. 15	Date: 6/8/11
Direction Photo Taken: South

The downstream slope of the impoundment was generally covered in thick vegetation making it difficult to observe during our inspections, as shown in Photo 15. In addition, the Rock River was present at the toe of the eastern embankment making it a potential personal safety issue to walk along the downstream slope. Based on observations made from the top of the impoundment, no seepage or sloughing were present on the downstream slope.

Description:
Crest of the WPDES Pond 1.

1. Clear inappropriate woody vegetation, including trees and brush and maintain grass cover on the crest, upstream and downstream slope and approximately 15 feet beyond the toe area. USACE recommends vegetation be kept less than 12 inches in height on embankments.

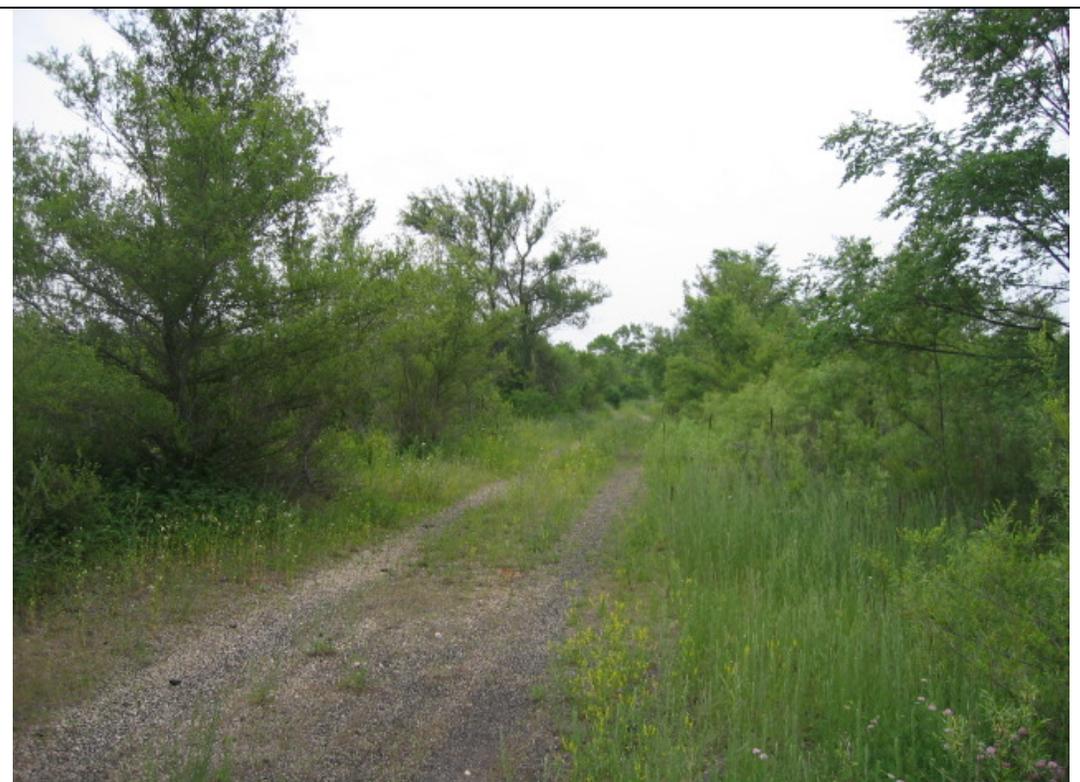
Photo No. 16	Date: 6/8/11
Direction Photo Taken: North

Description:
Upstream slope and crest of the WPDES Pond 1.

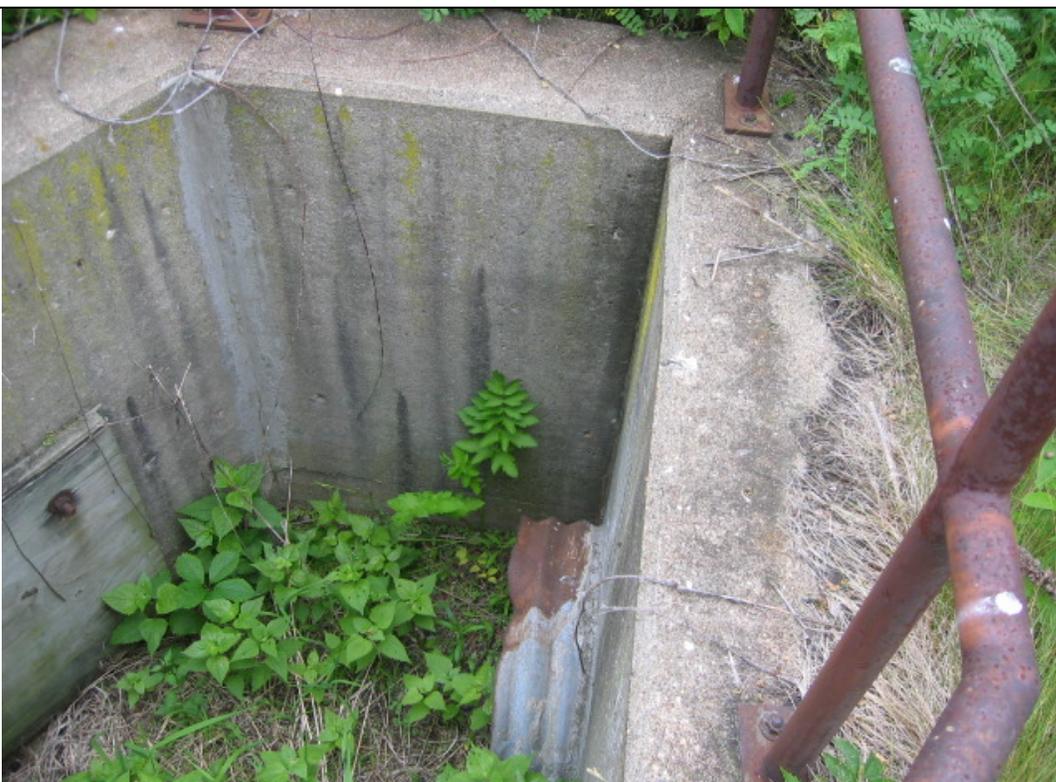
Photo No. 18	Date: 6/8/11
Direction Photo Taken: North

Description:
Outfall of WPDES Pond 1.

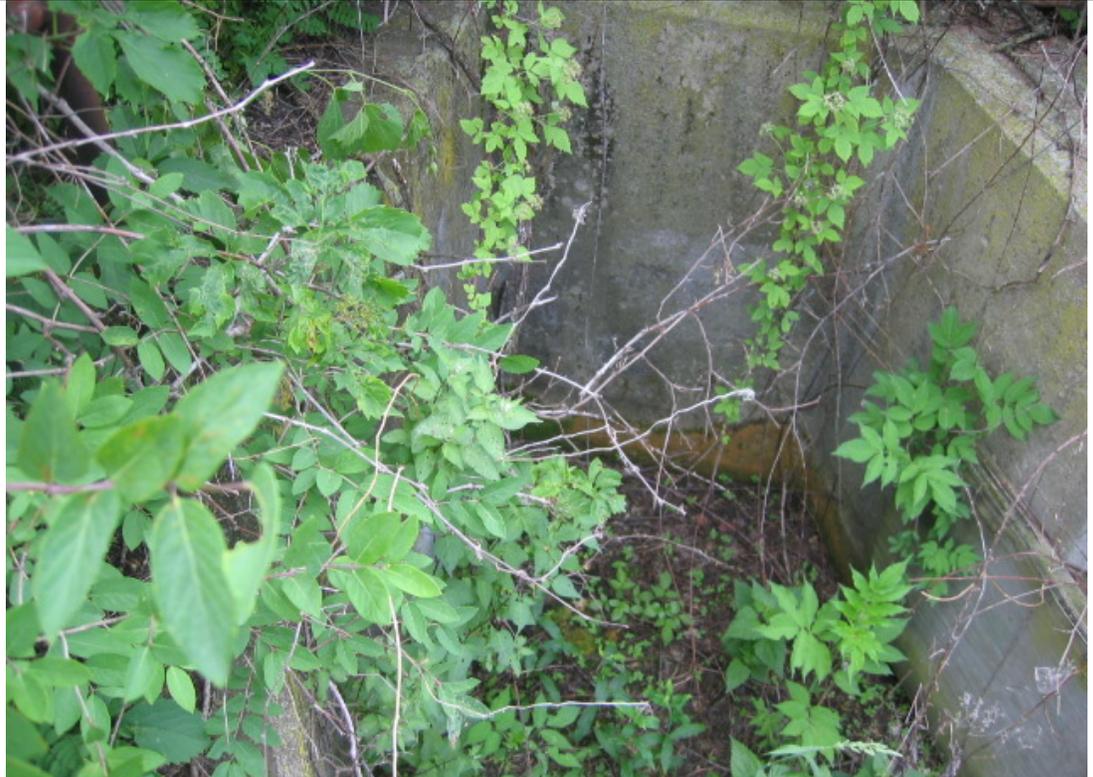
Photo No. 19	Date: 6/8/11
Direction Photo Taken: Northeast

Description:
Outfall structure of WPDES Pond 2.

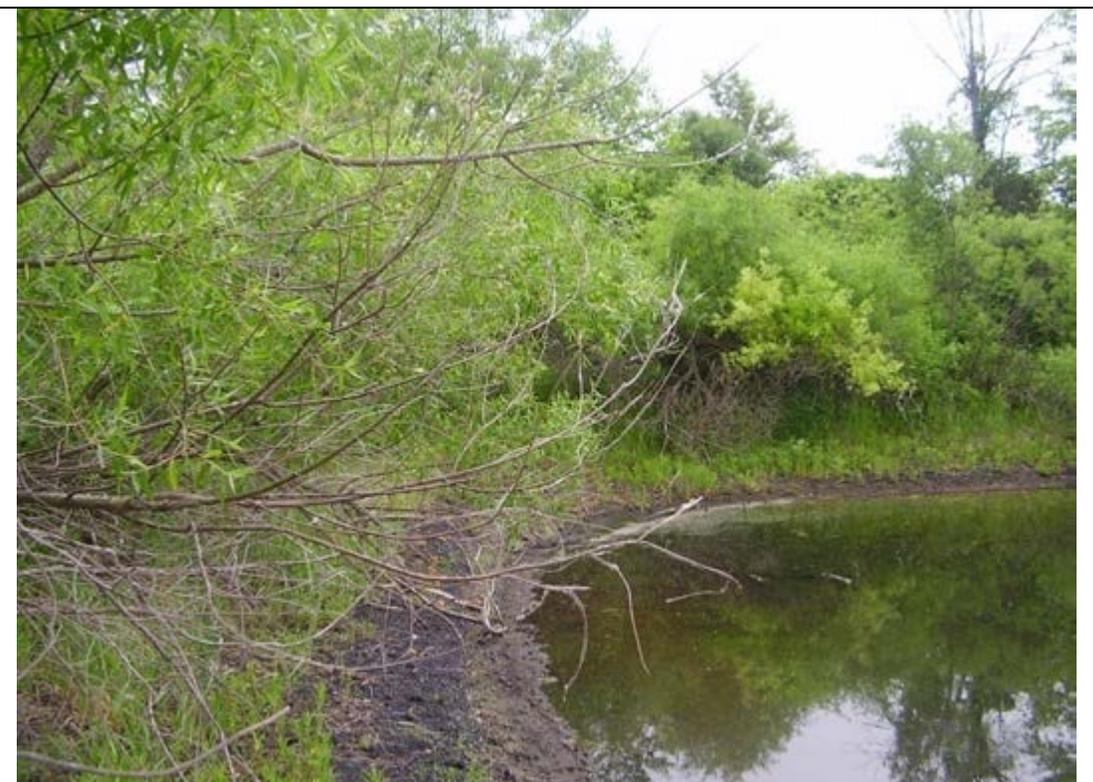
Photo No. 20	Date: 6/8/11
Direction Photo Taken: East

Description:
Upstream slope of the WPDES Pond 2.

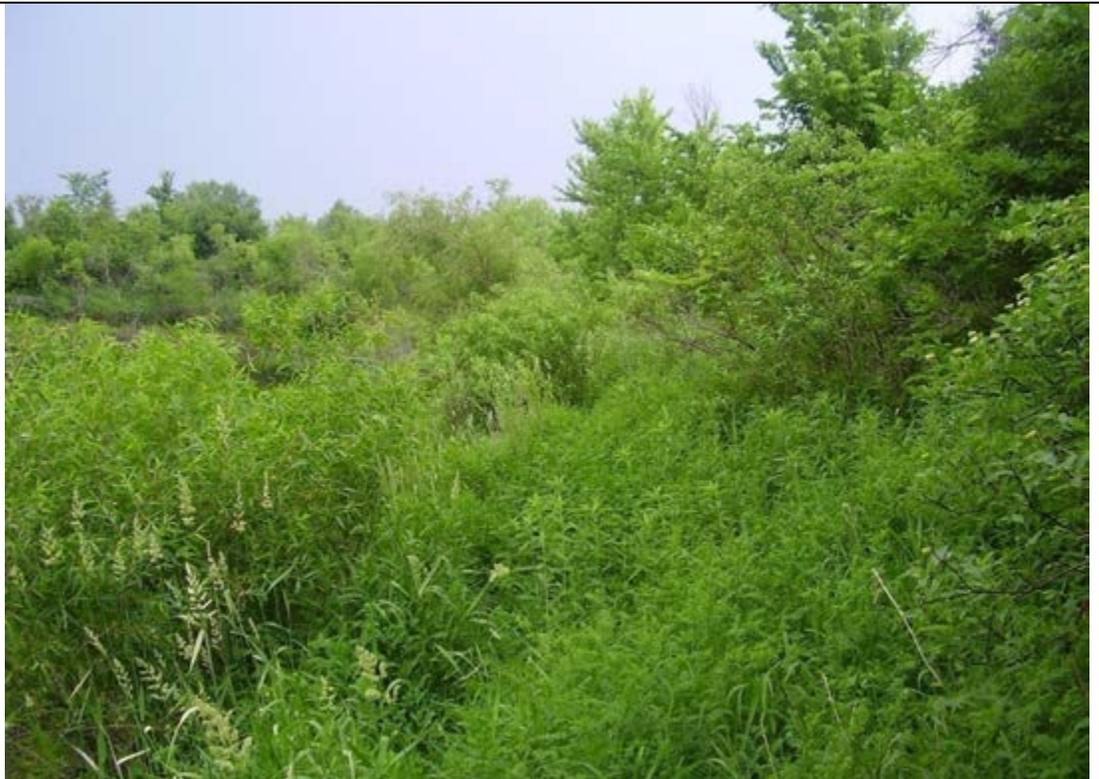
Photo No.
22

Description:
Upstream slope of the
WPDES Pond 2

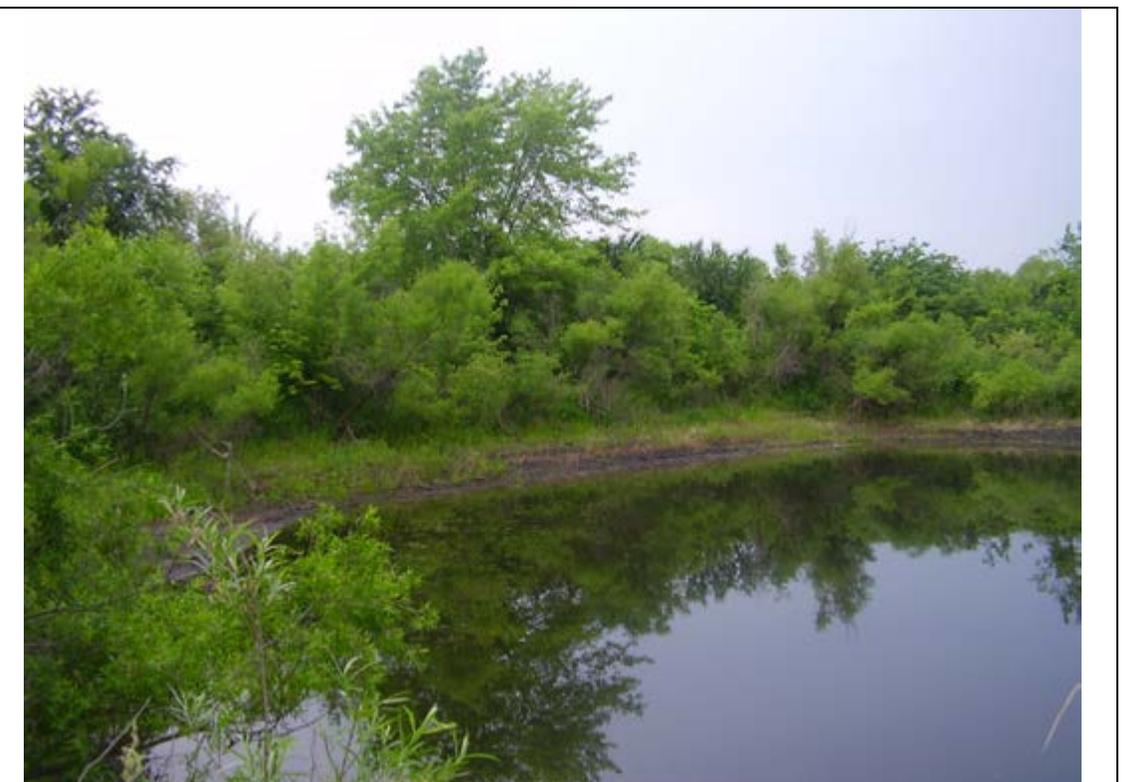
Photo No. 24	Date: 6/8/11
-------------------------------	------------------------

Description:
Upstream slope of the
WPDES Pond 2.

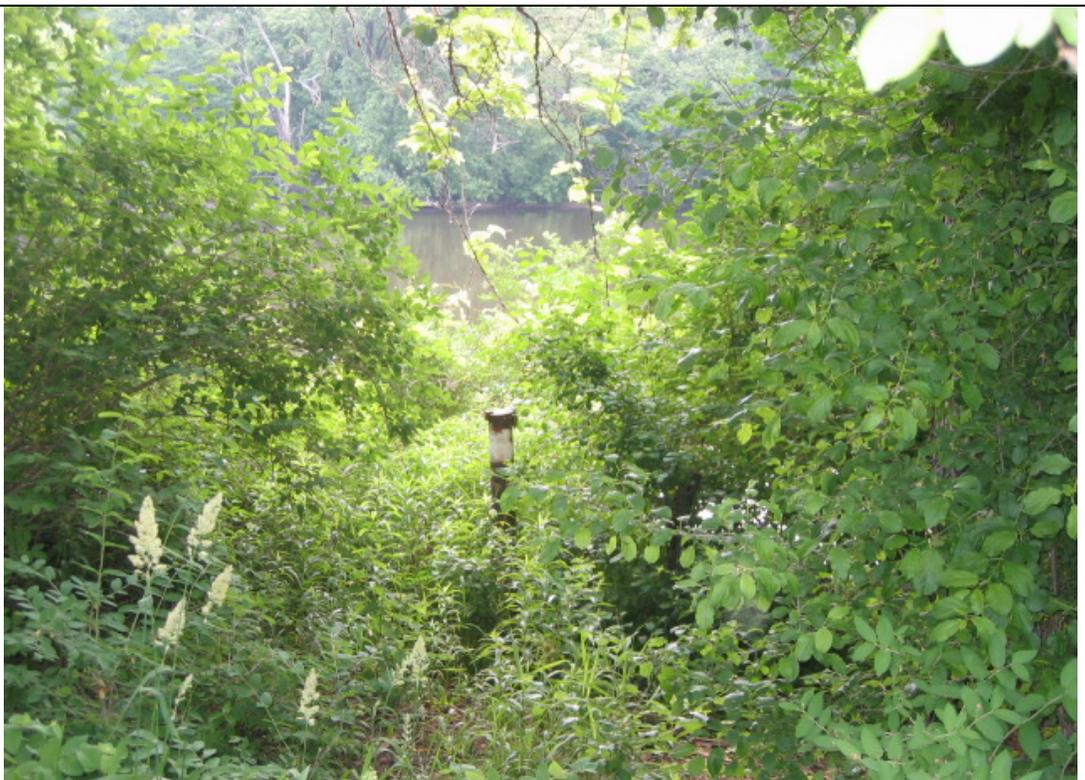
Photo No.
30

The water surface elevation of the Rock River on the downstream slope at the time of inspection was at elevation 748 feet MSL. Therefore, the lower portion of the downstream slope was underwater and not visible. Thick vegetation, shrubs and trees were present along portions of the downstream slope above the water, as shown on Photos 42 and 43, making it difficult to inspect. No unusual movement or sloughing were observed on the visible portions of the slope.

Description:
Downstream slope of the
Final WPDES Pond and
monitoring well.

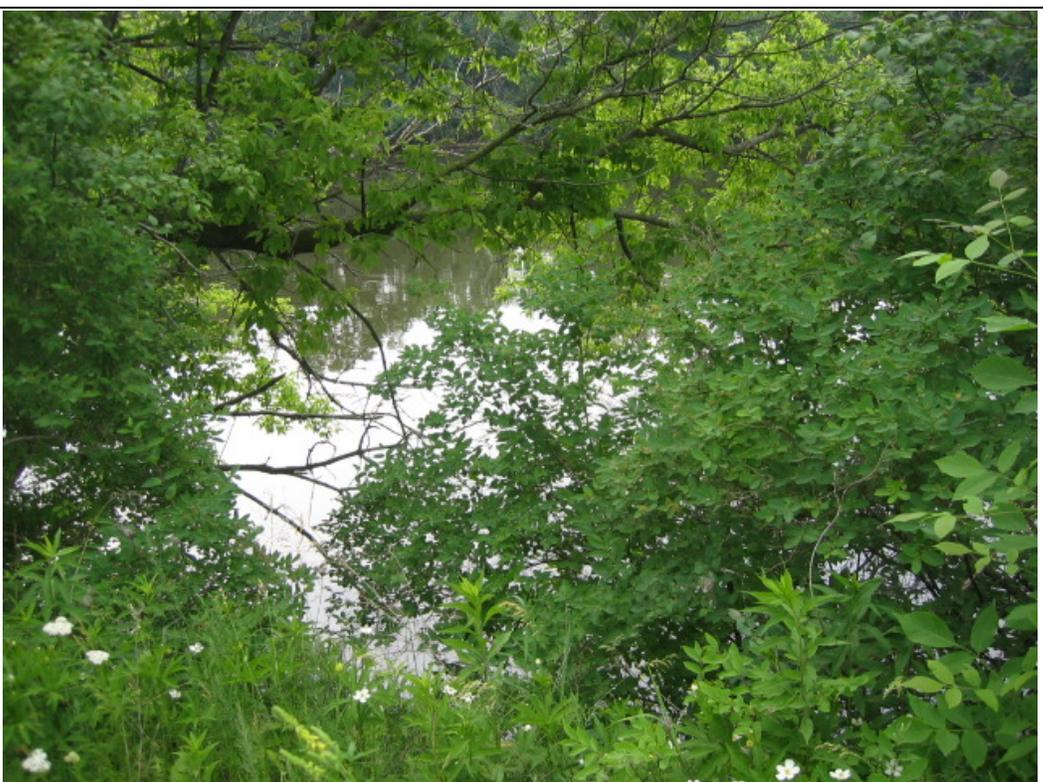
Photo No. 32	Date: 6/8/11
Direction Photo Taken: South

Description:
Looking downstream of the Final WPDES Pond at the water level in the adjacent Rock River.

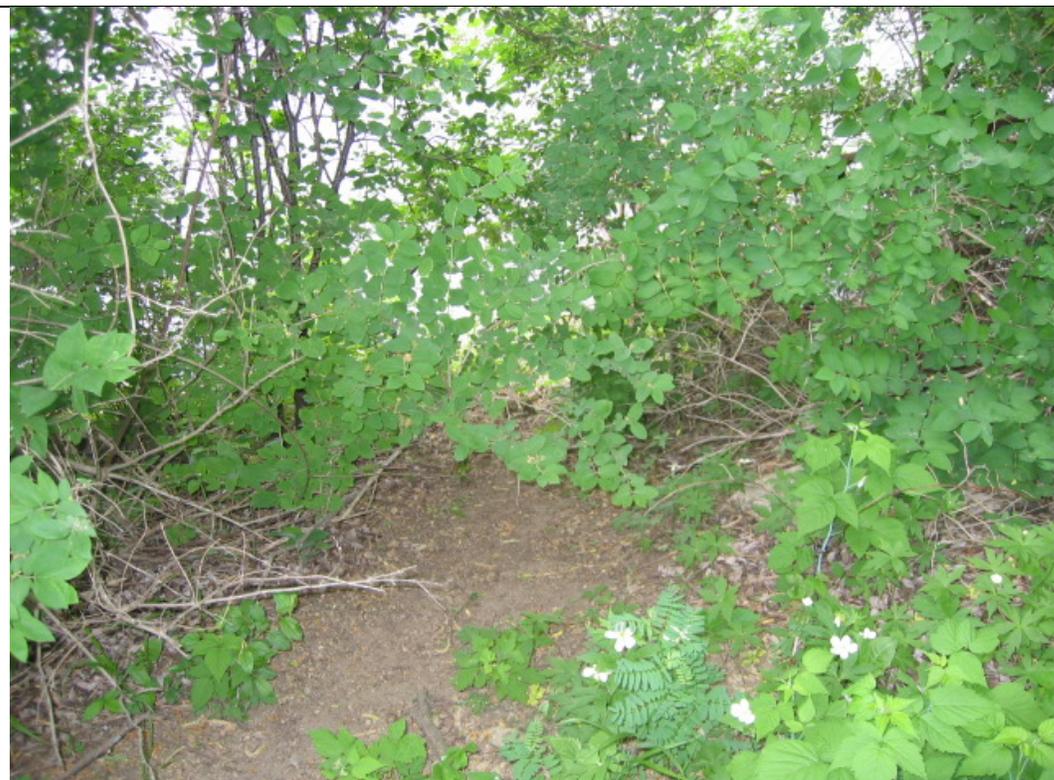
Photo No.
42

Description:
Downstream slope of the
Final WPDES Pond.

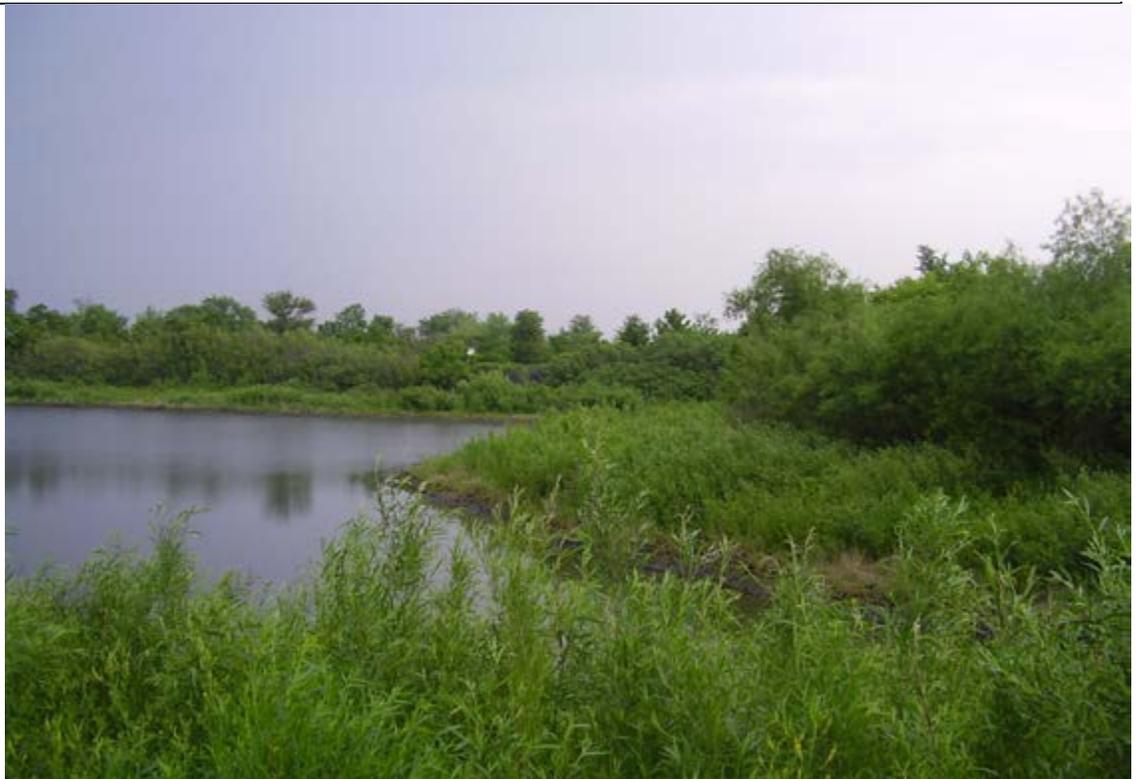
Photo No.
48

Description:
Upstream slope of the Slag Pond.

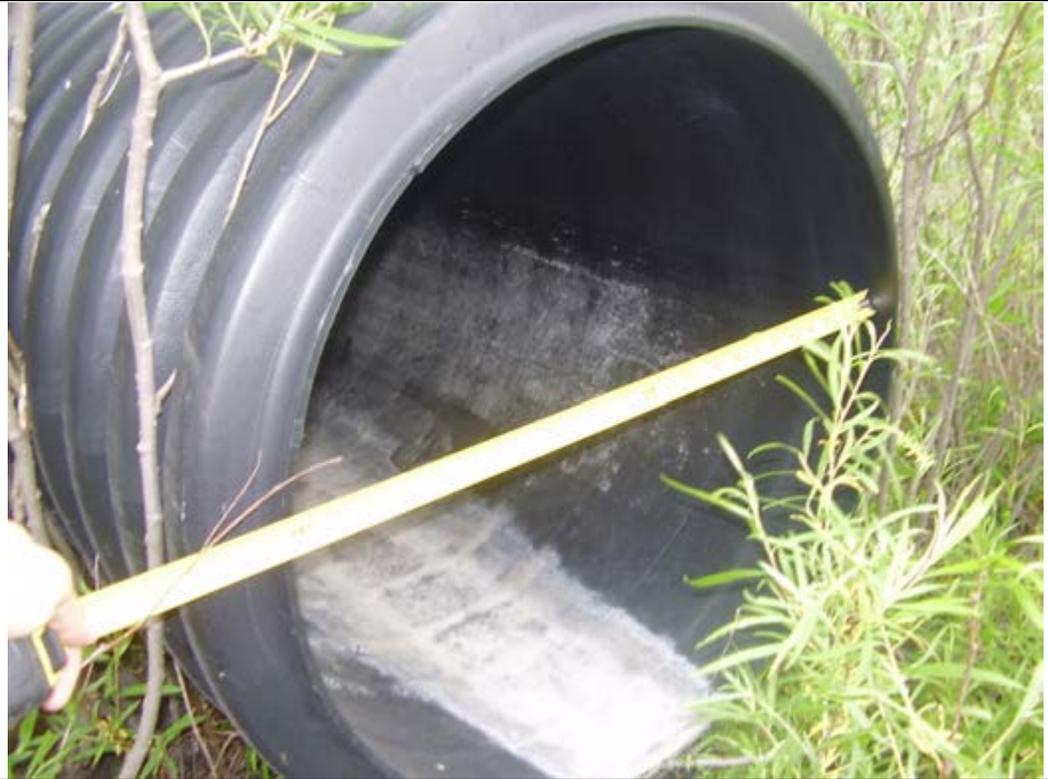
Description:
Discharge Pipe from the
Coal Pipe Runoff Pond.

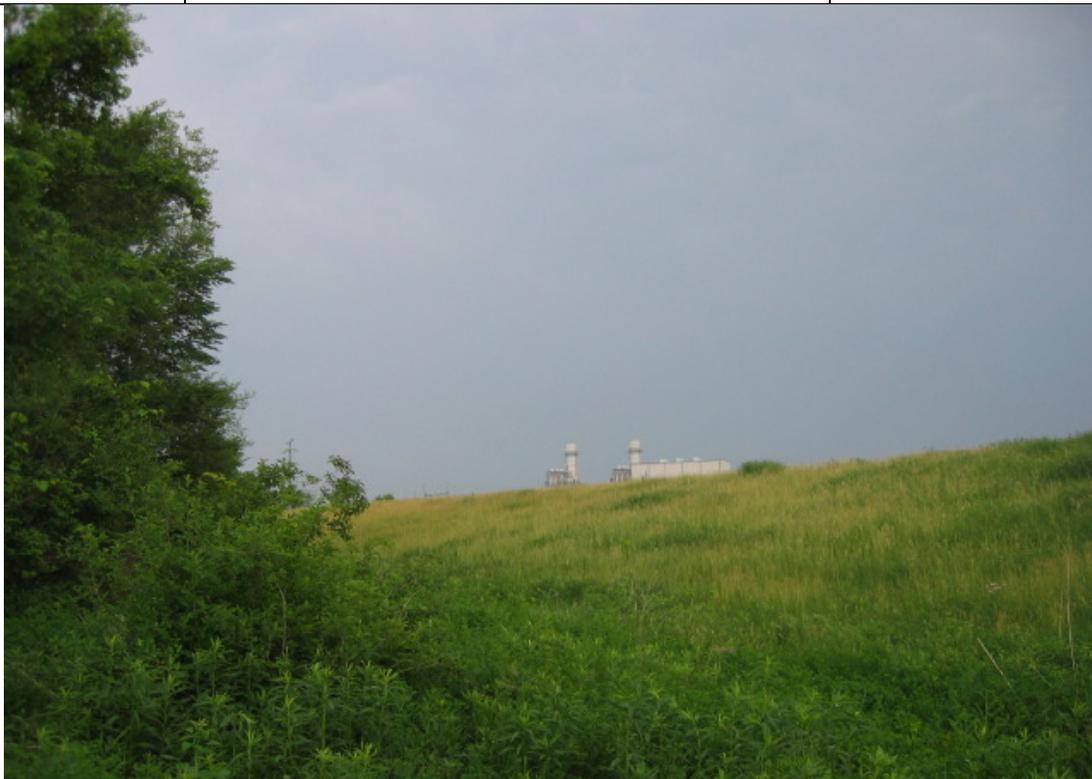
Description:
Upstream slope of the
Landfill.

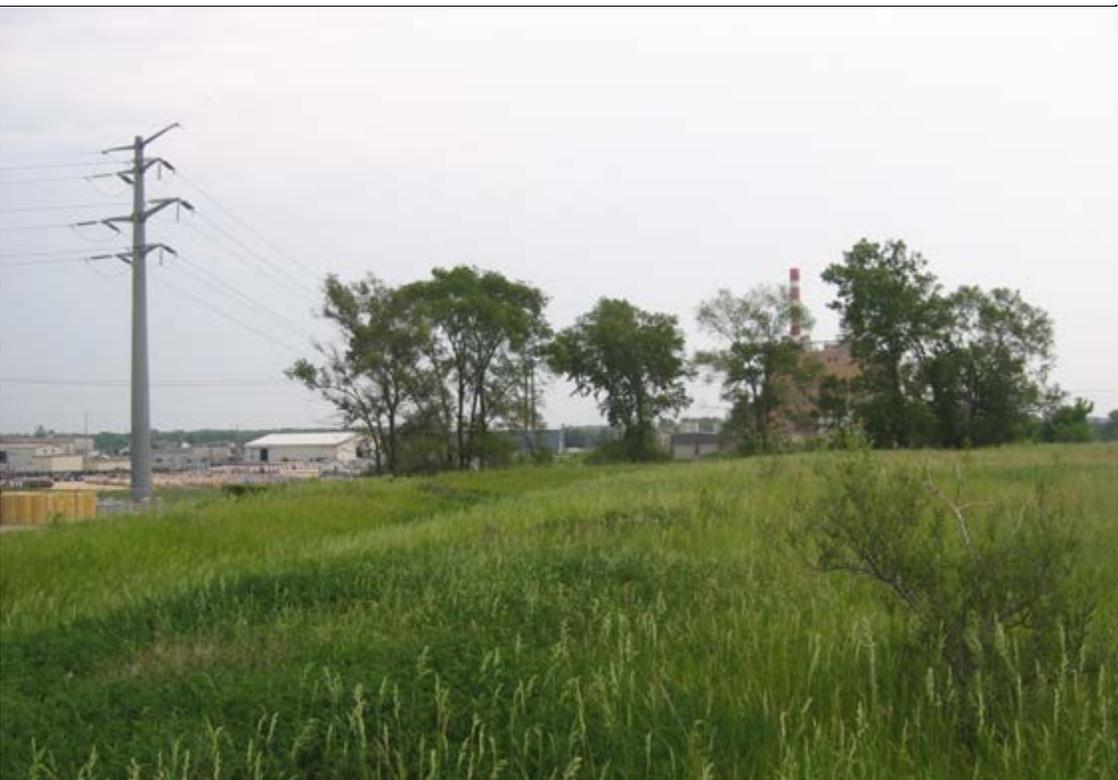
Photo No.
56

Description:
Upstream slope of the
Landfill.

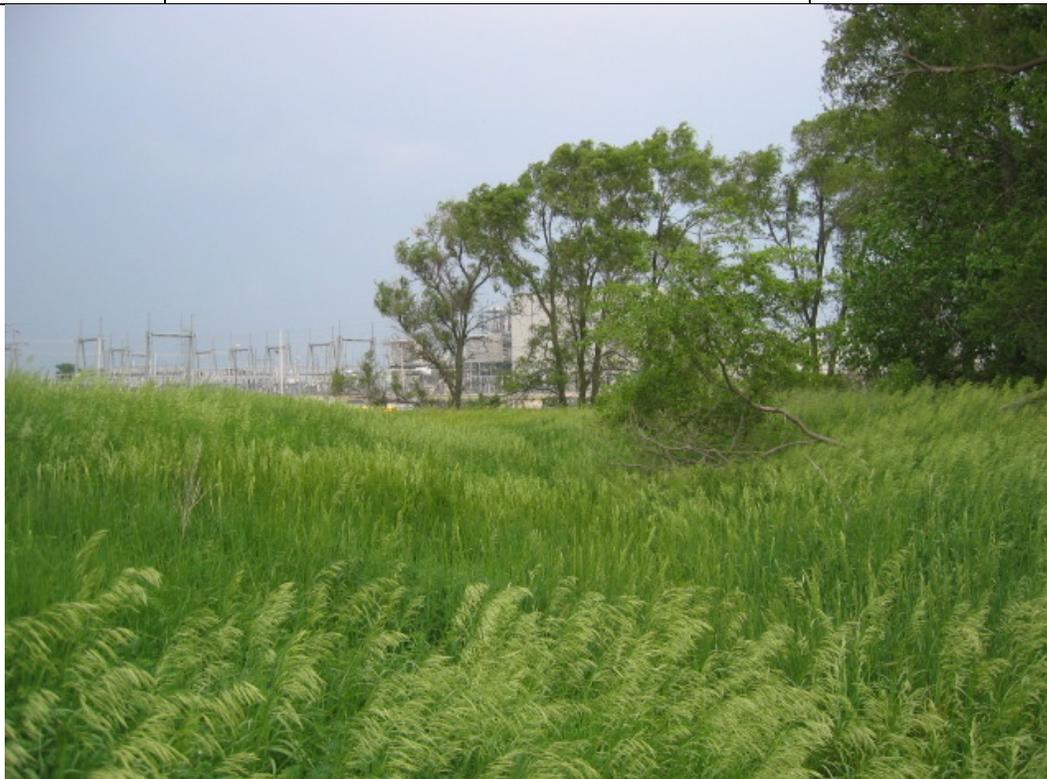
Description:
Upstream slope of the
Landfill.

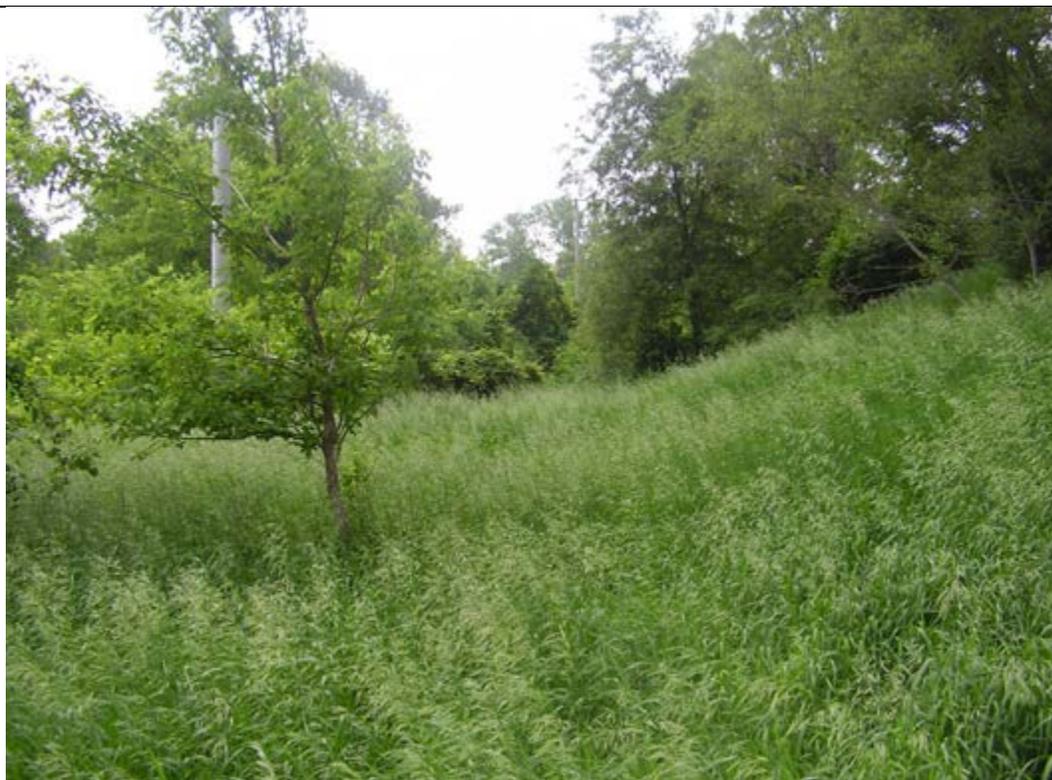
Photo No.
58

Description:
Toe of the Landfill

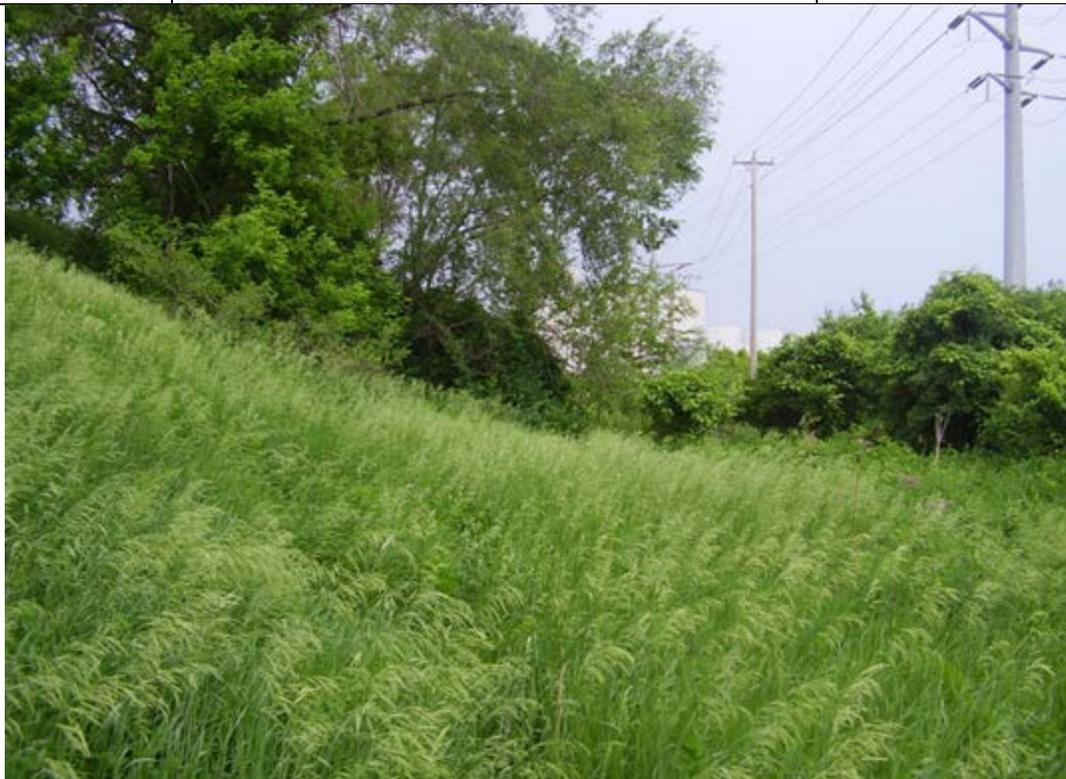
Description:
Toe of the Landfill.

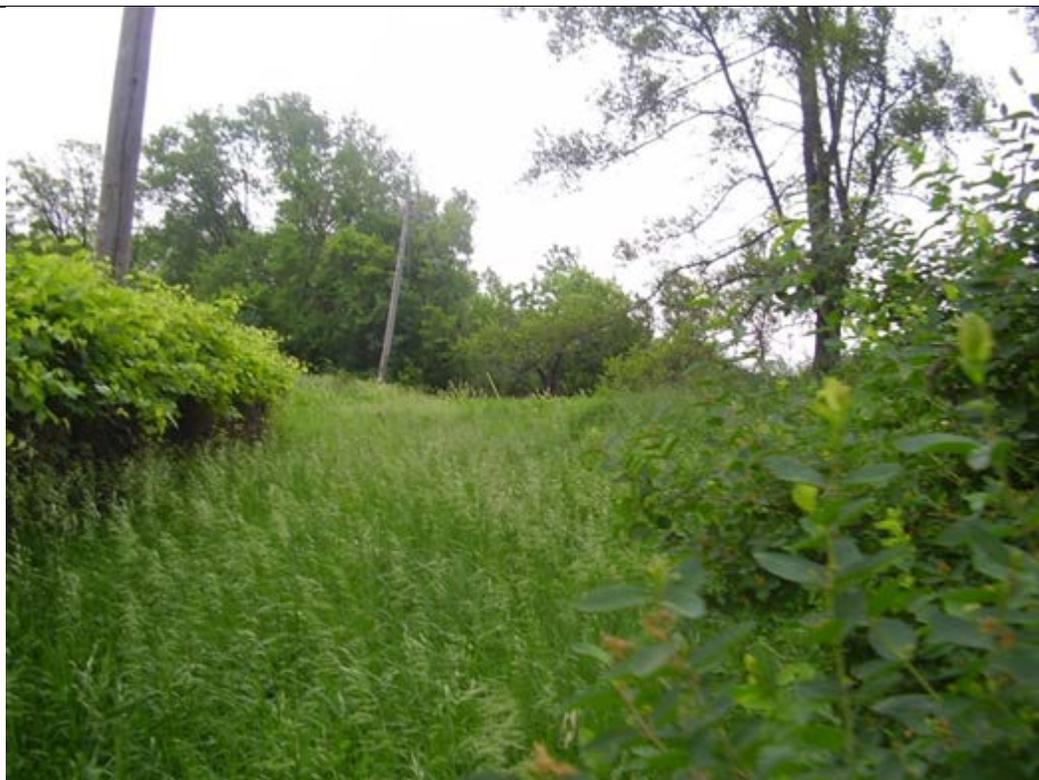
Photo No.
60

Description:
Toe of the landfill.
