Report of Dam Safety Assessment of Coal Combustion
Surface Impoundments
Interstate Power and Light Company
Sutherland Generating Station
Marshalltown, IA

AMEC Project No. 3-2106-0191

July 2011

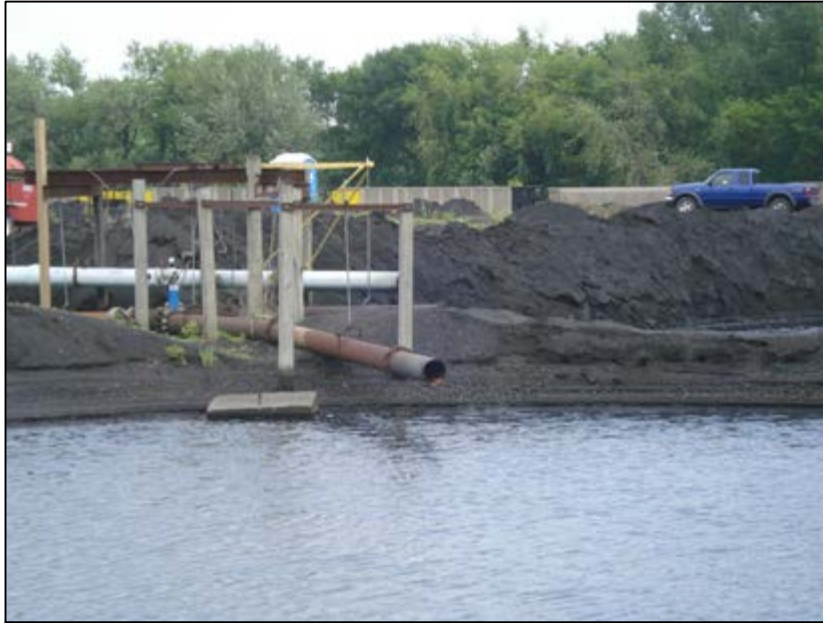
SP-1
LOOKING NORTH AT CCW INLET PIPE TO SOUTH POND.
NORTH POND ABOVE AND TO THE RIGHT

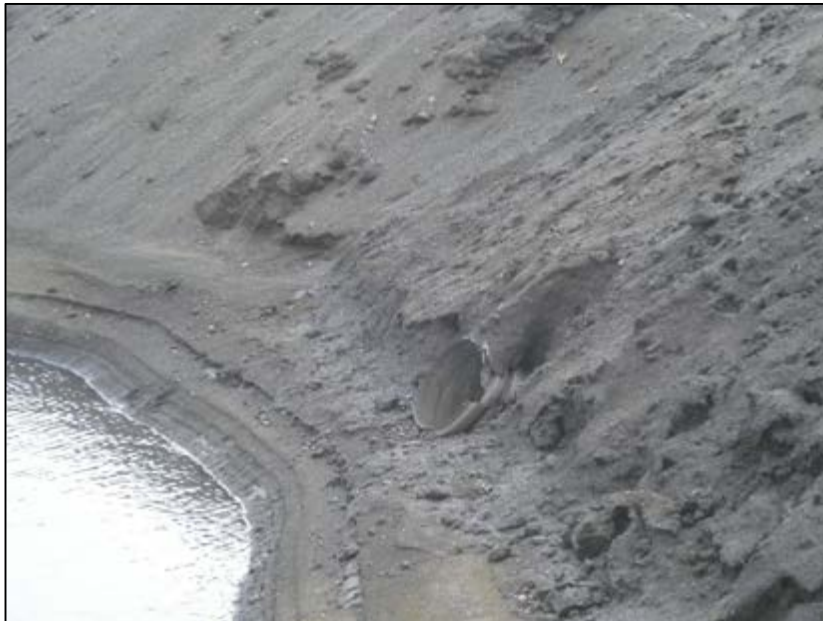
SP-2
FROM SOUTH CREST LOOKING EAST AT
INLET OF OUTLET PIPE FROM SOUTH POND

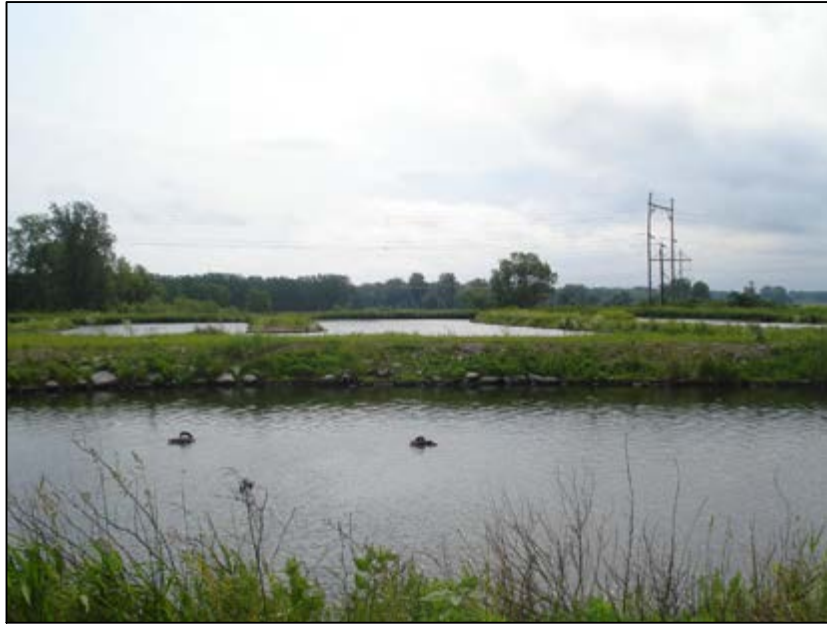
Stabilized and new fingers are primarily constructed of shot rock and/or recycled aggregate materials. Surface cover on the other areas of the interior embankments was generally good consisting of rip-rap and or grasses (Photos SECP-9 through SECP-11). Minor small woody vegetation was observed in isolated locations. Except for the areas at the North and South Primary Ponds, extensive at-grade areas exist behind the upstream embankment slopes and therefore there are no downstream slopes on the northwest and west portions of the pond (Photos SECP-1 and SECP-12). The road/crest separating the primary from the secondary pond is 20 to 25 feet wide. Any collapse of the embankments would only join the smaller primary pond to the much larger secondary pond (See Figure B-1 and SECP-12).

SECP-9
LOOKING EAST AT SOUTH INTERIOR OF SECONDARY POND.
INTERIOR FINGERS COMPLETED IN 2006 IN BACKGROUND

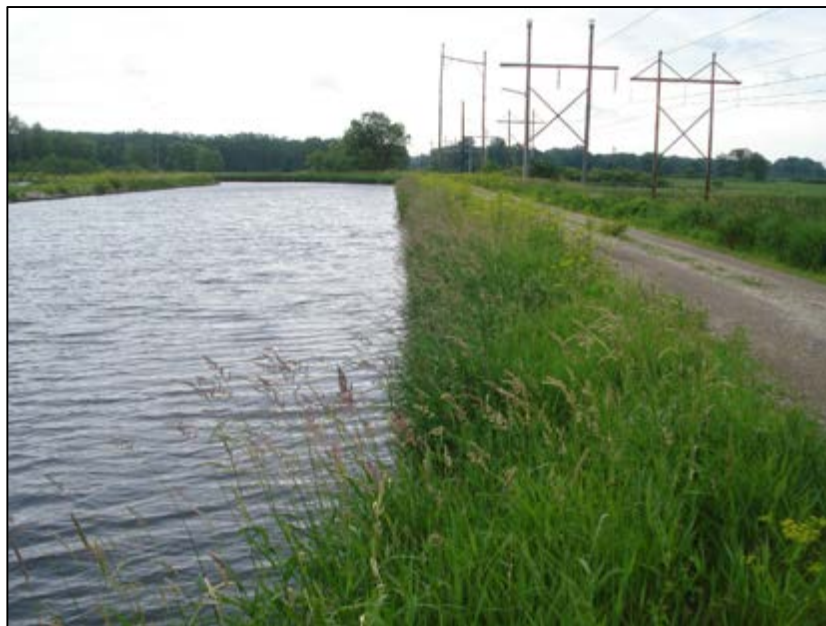
SECP-14

**LOOKING EAST AT US SLOPES OF SECONDARY POND,
TALL VEGETATION AND ISOLATED ERODED AREAS**
