**DRAFT REPORT  
ROUND 10 DAM ASSESSMENT – JUNE 2, 2011  
AMEREN ENERGY GENERATING COMPANY – HUTSONVILLE  
POWER STATION  
POND A, POND B, AND POND D  
HUTSONVILLE, ILLINOIS**

RE: Assessment of Dam Safety of Coal Combustion Surface Impoundments at the  
Hutsonville Power Station

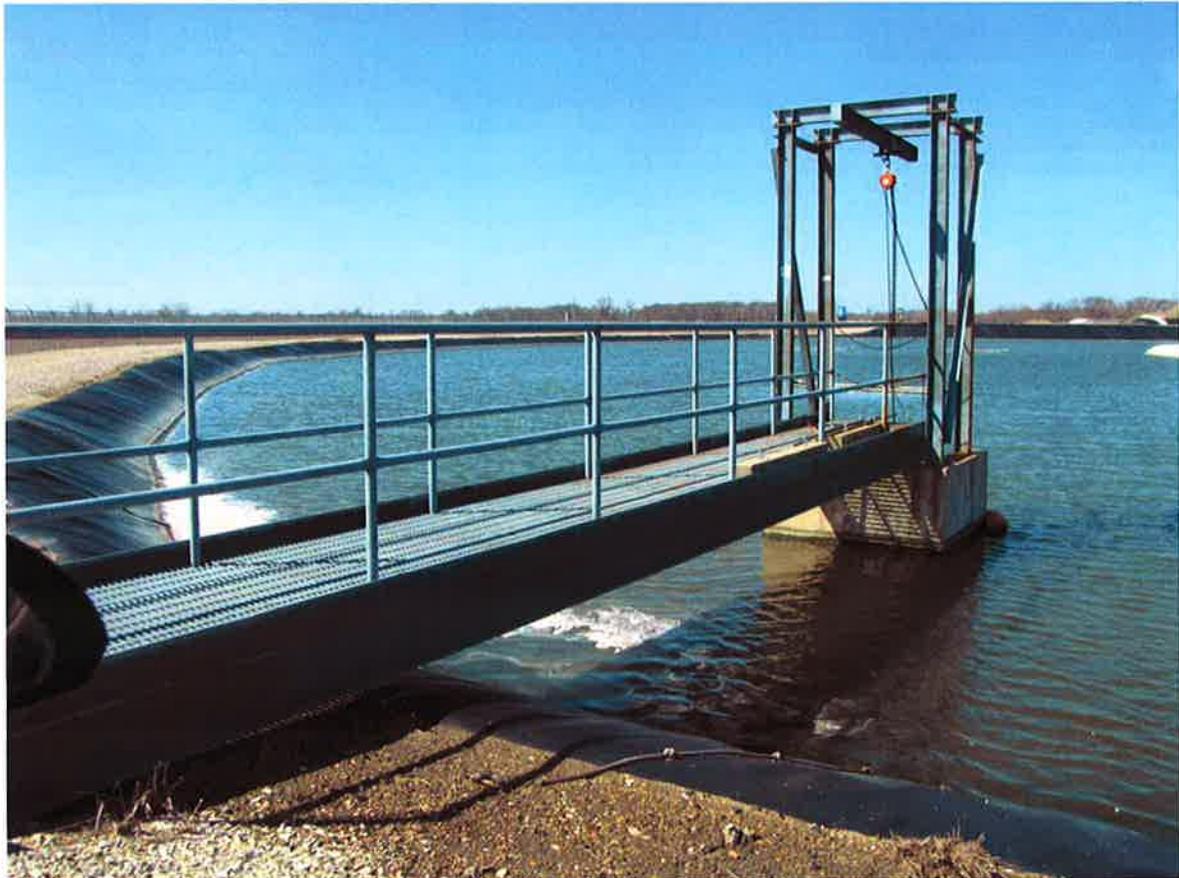
Photo #7 – Ash Pond B – South embankment looking west to Pond A in background

Slope Stability	GC	Slopes are in good condition.	
Vegetation	GC	Slopes have been mowed and appear to have been mowed at least once per year. There are no trees on the slopes of the berms or within 20 feet of the toe. See photos #7 and #8.	
Unusual Movement or Cracking At or Beyond Toe	NE		
Other

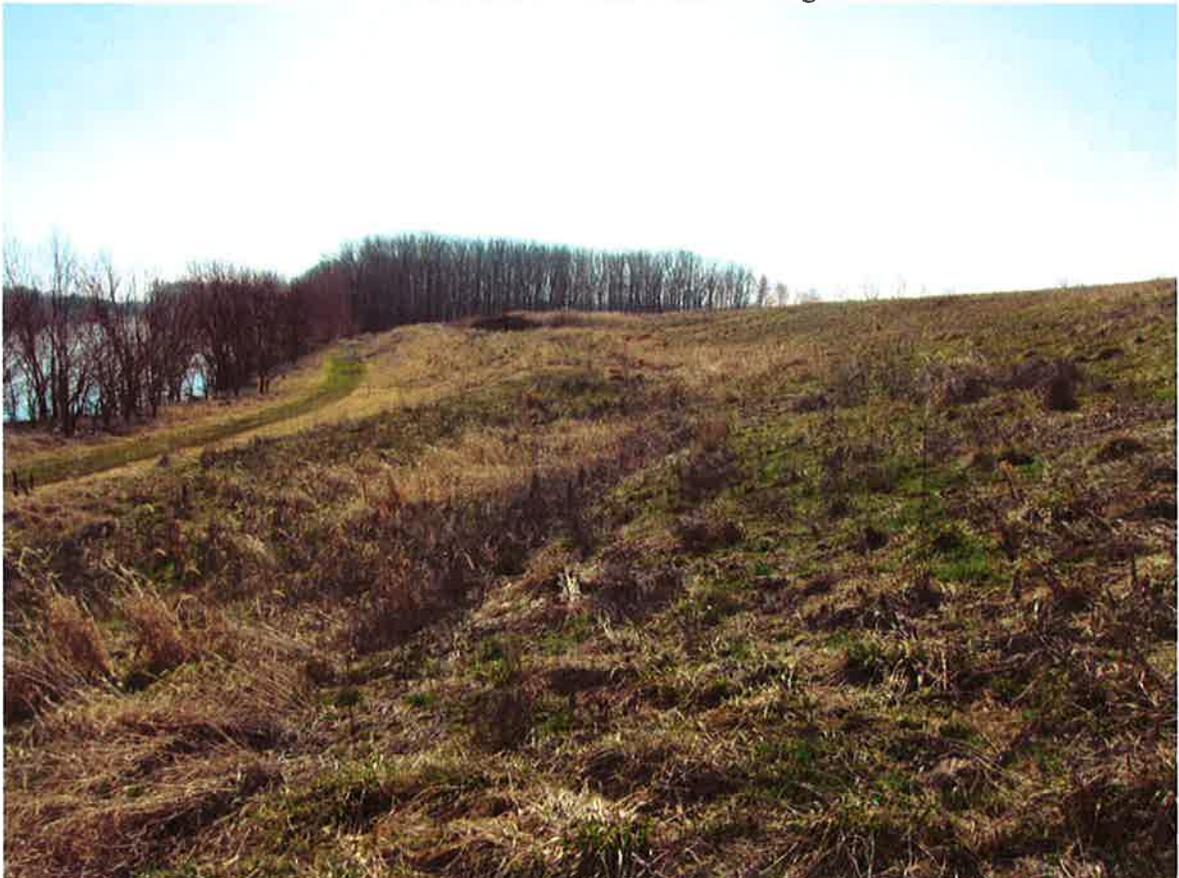
Photo #11 – Bottom Ash Pond – Northeast berm looking south

Erosion	GC	No erosion of slopes is evident.	
Slope Stability	GC	Slopes are in good condition.	
Vegetation	GC	Brush and trees have been removed from the berm. Seeding in some areas is a bit sparse. See photo #11.	
Unusual Movement or Cracking At or Beyond Toe	NE	Sloughing or cracking was not evident, but further inspection is required after clearing of the slope.	Reinspect after trees and brush are removed from the east berm.
Other		See photo #12.

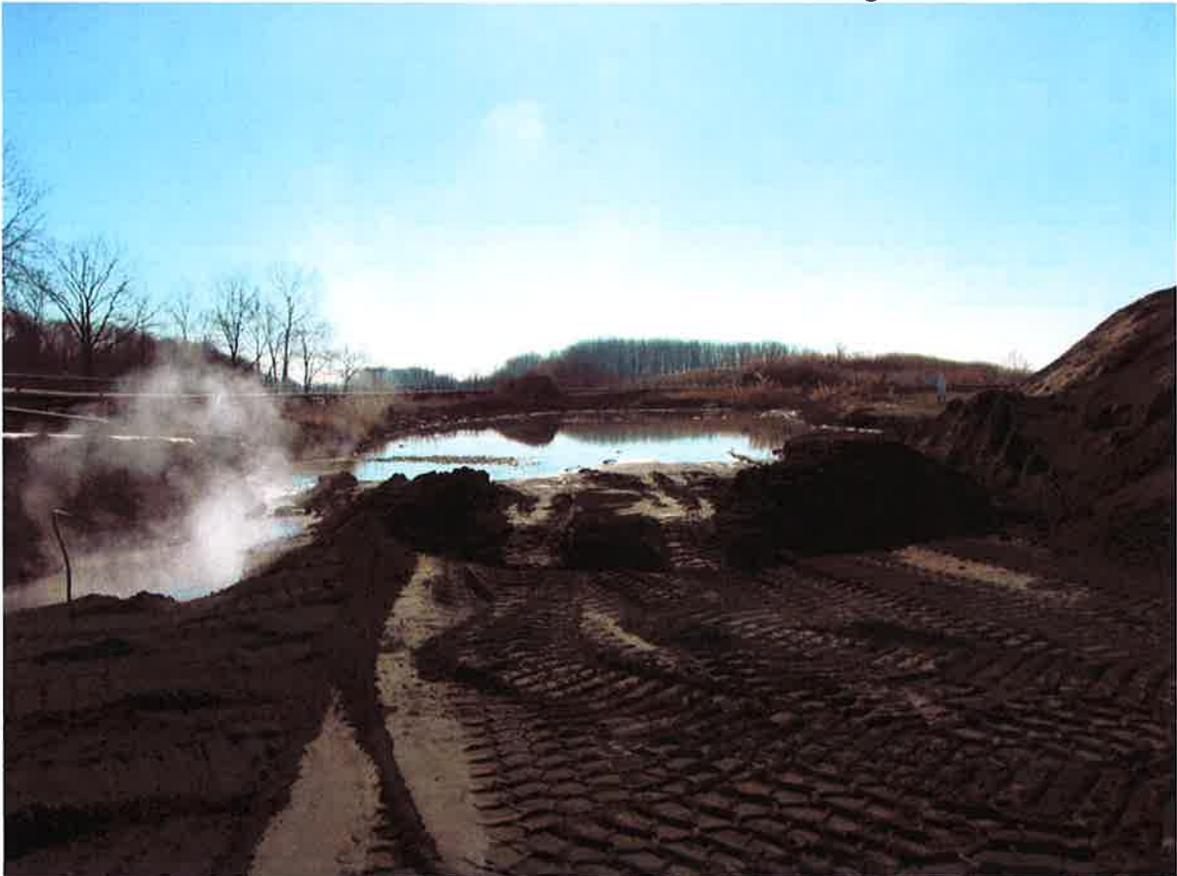
Photo #13 – Bottom Ash Pond - East berm looking south

Item	Condition Code *	Deficiencies	Recommended Remedial Measures and Implementation Schedule
Obstruction	NE		
Inlet Piping Supports	GC	Inlet pipe and supports are in good condition.	
Leakage	NE	Leakage at inlet/outlet is not evident.	
Outfall Structure Condition	n/a	No structure.	
Outfall Pipe	GC	Outlet pipe is in good condition.	
Other		Staff gauge is required to identify sudden changes in water level.	Provide staff gauge.
Vertical & Horizontal Alignment of Crest	GC	The alignment of the east berm did not show signs of shifting or settlement.	
Animal Damage	NE	Animal burrows were not identified.	
Surface Cracks	NE	Surface cracks were not identified.	
Pond Liner	n/a	Pond not lined with HDPE liner.	
Seepage	NI	The Wabash River had recently flooded and the ground adjacent to the toe of levee was saturated, making it difficult to observe seepage at the toe. There is no obvious or excessive seepage at the time of inspection. See photo #13.	AER to re-inspect levee for seepage when river recedes and ground adjacent to toe dries out.

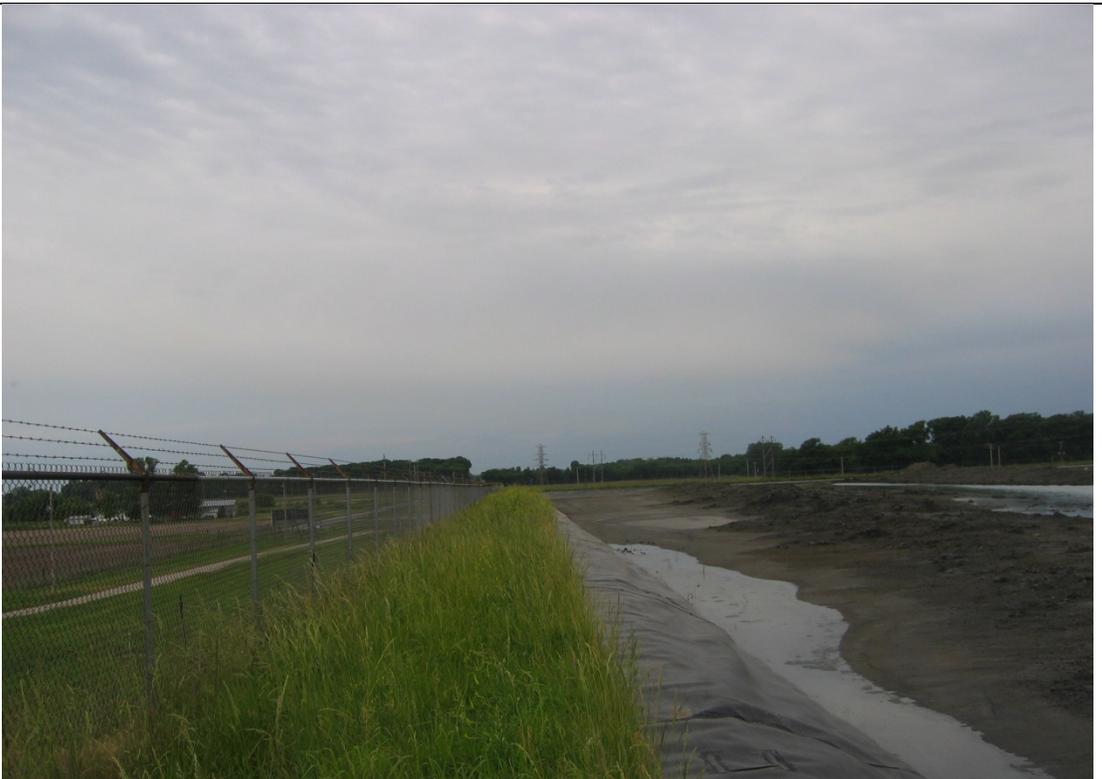
Upstream slope and crest of  
Pond A.

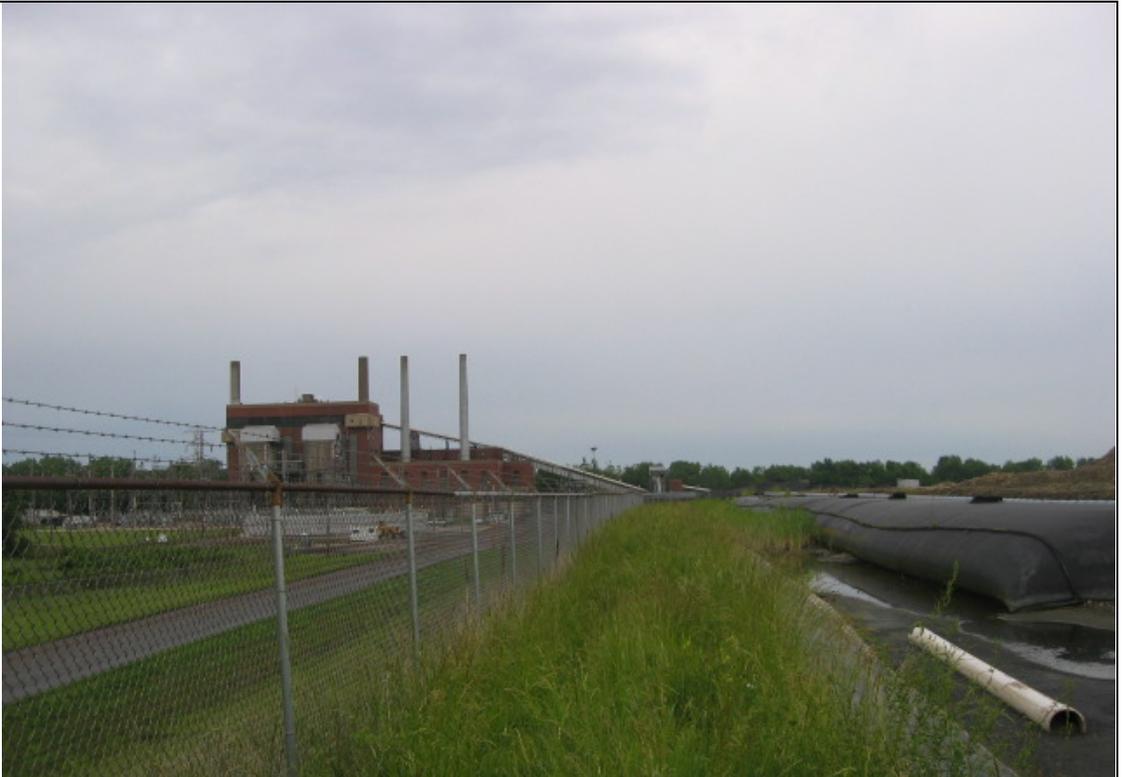
Description:  
Upstream slope and crest of  
Pond A.

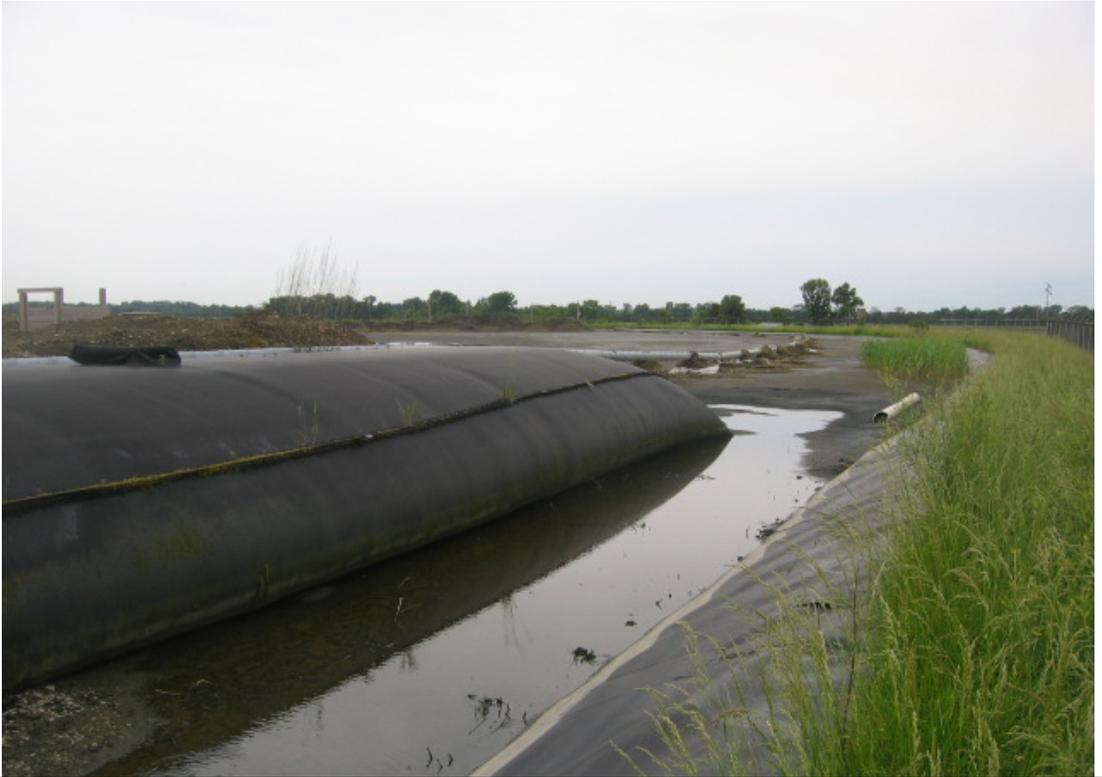
**Description:**  
Upstream slope and crest of Pond A.

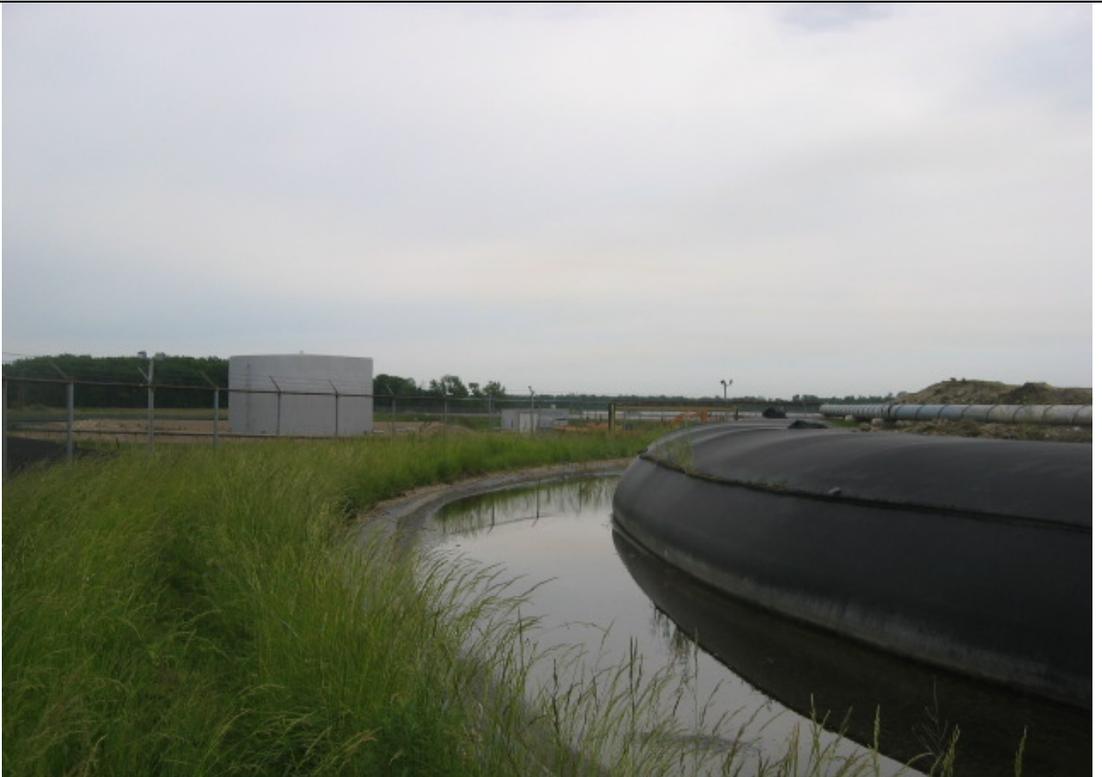
**Photo No.**  
**8**

**Description:**  
Upstream slope and crest of Pond A.

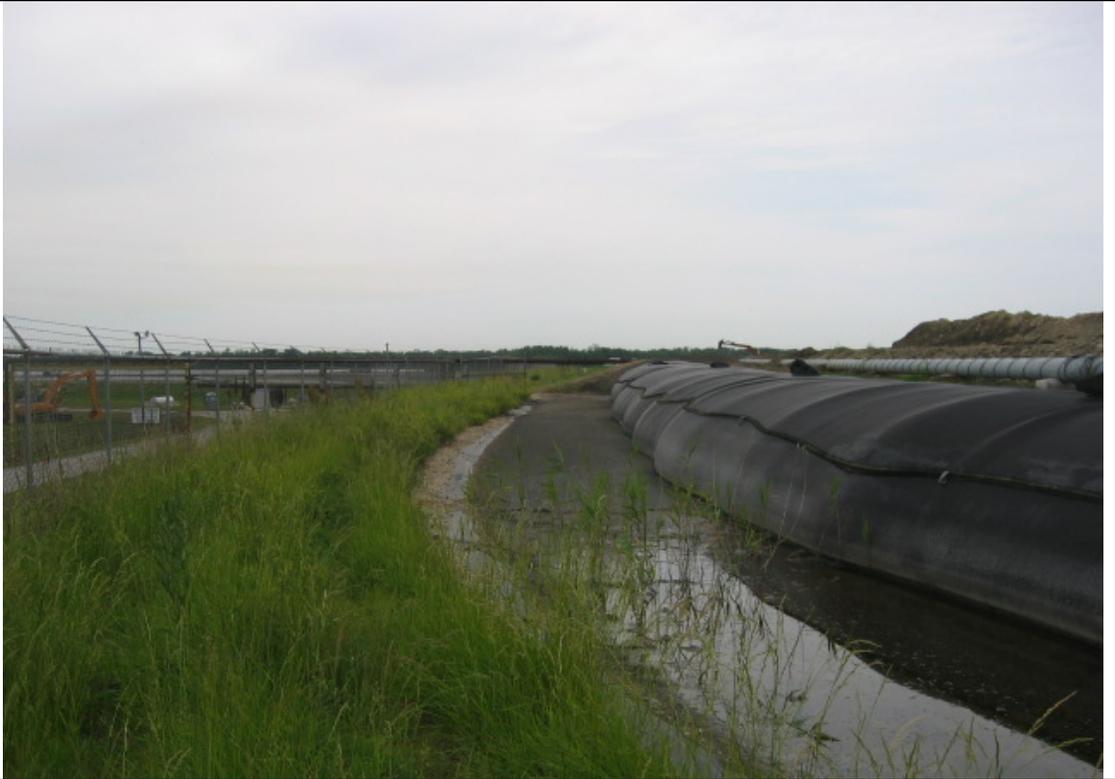
Description:  
Upstream slope and crest of  
Pond A.

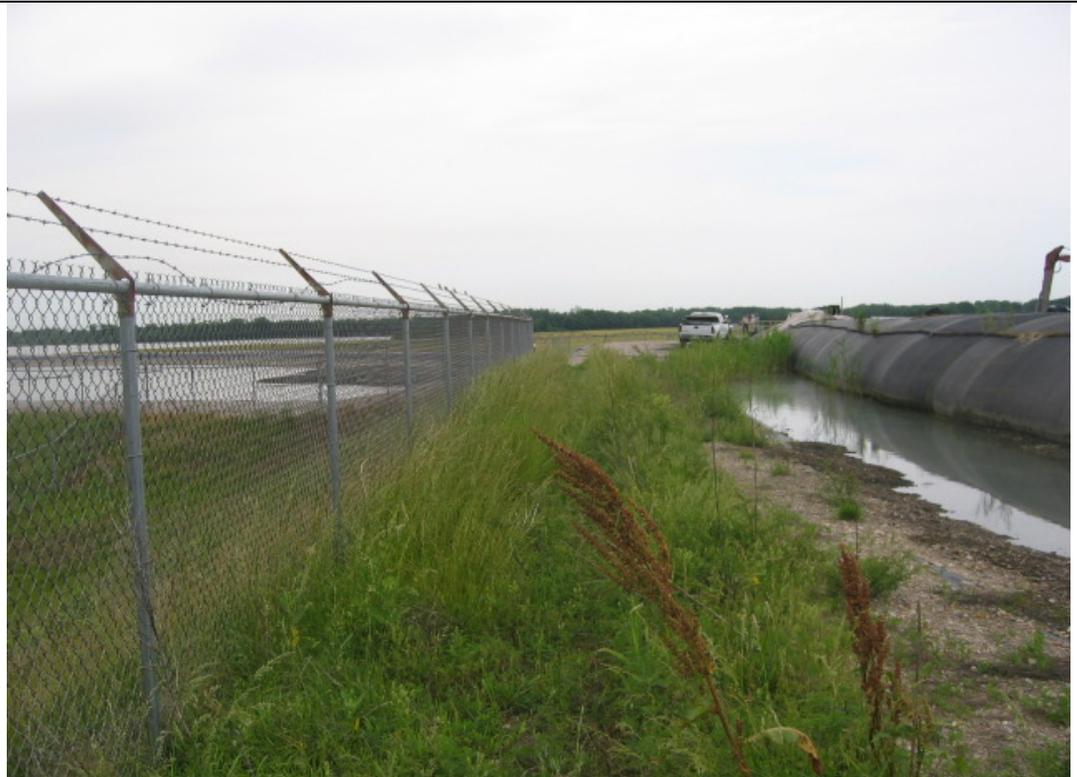
Photo No.  
**10**

Description:  
Upstream slope and crest of  
Pond A.

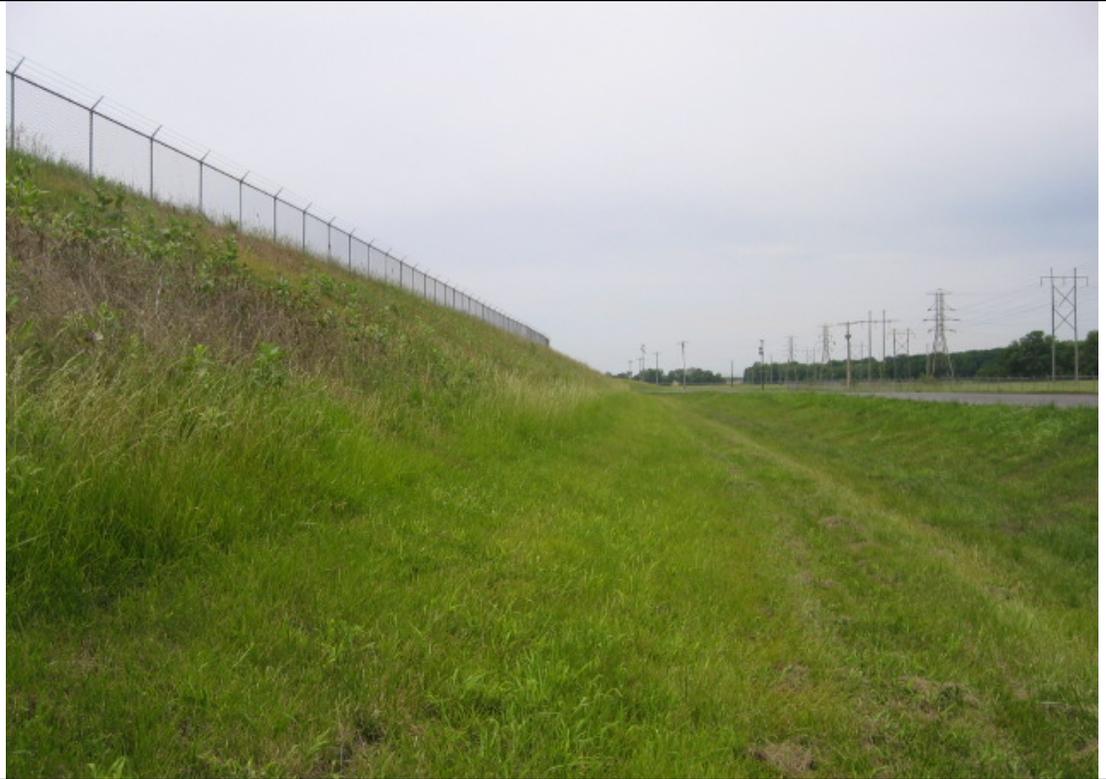
**Description:**  
Downstream slope of Pond A.

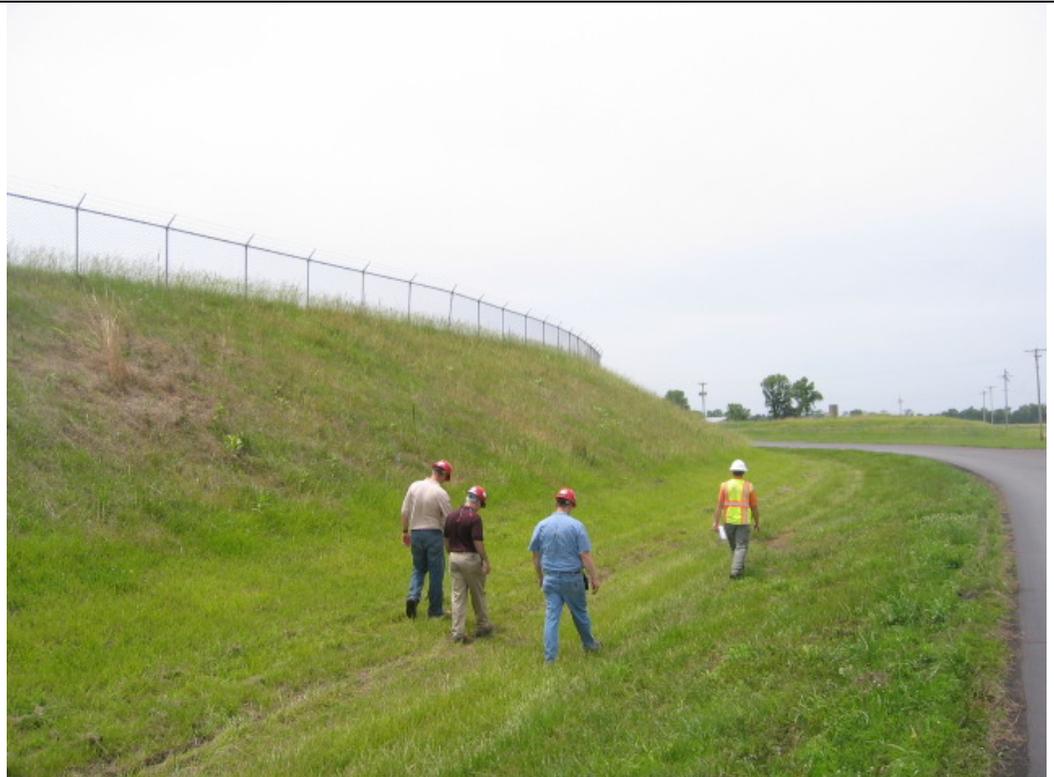
**Photo No.**  
**14**

**Description:**  
Downstream slope of Pond A.

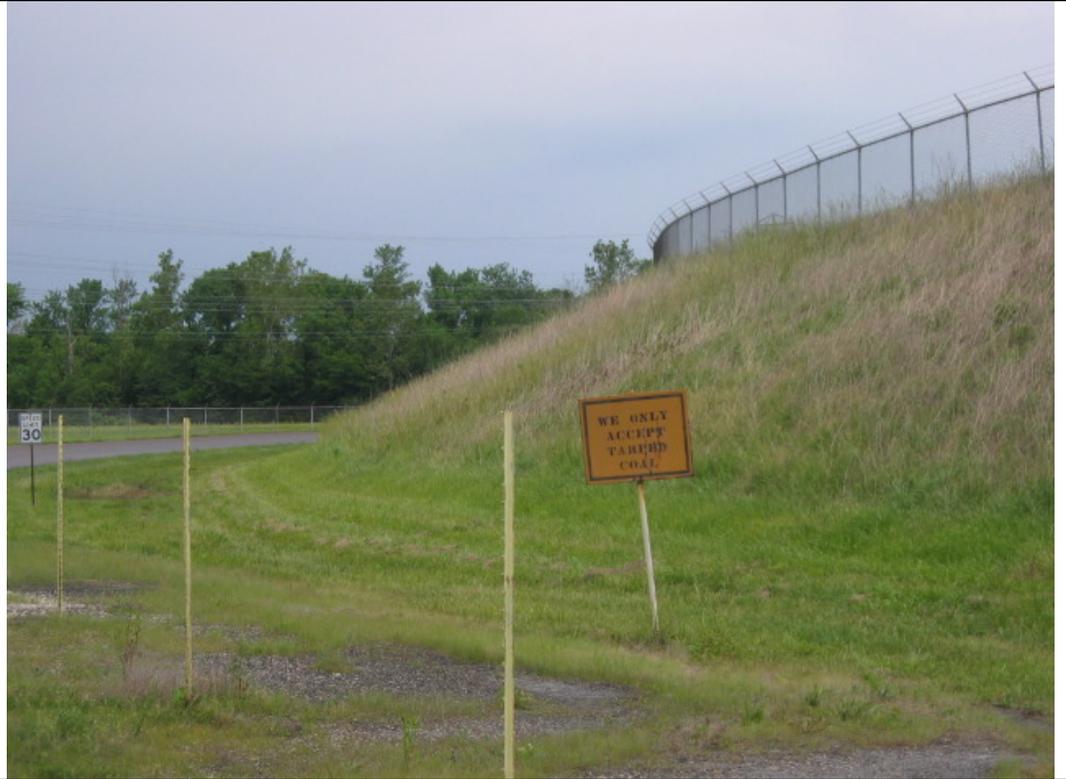
Description:  
Downstream slope of Pond  
A.

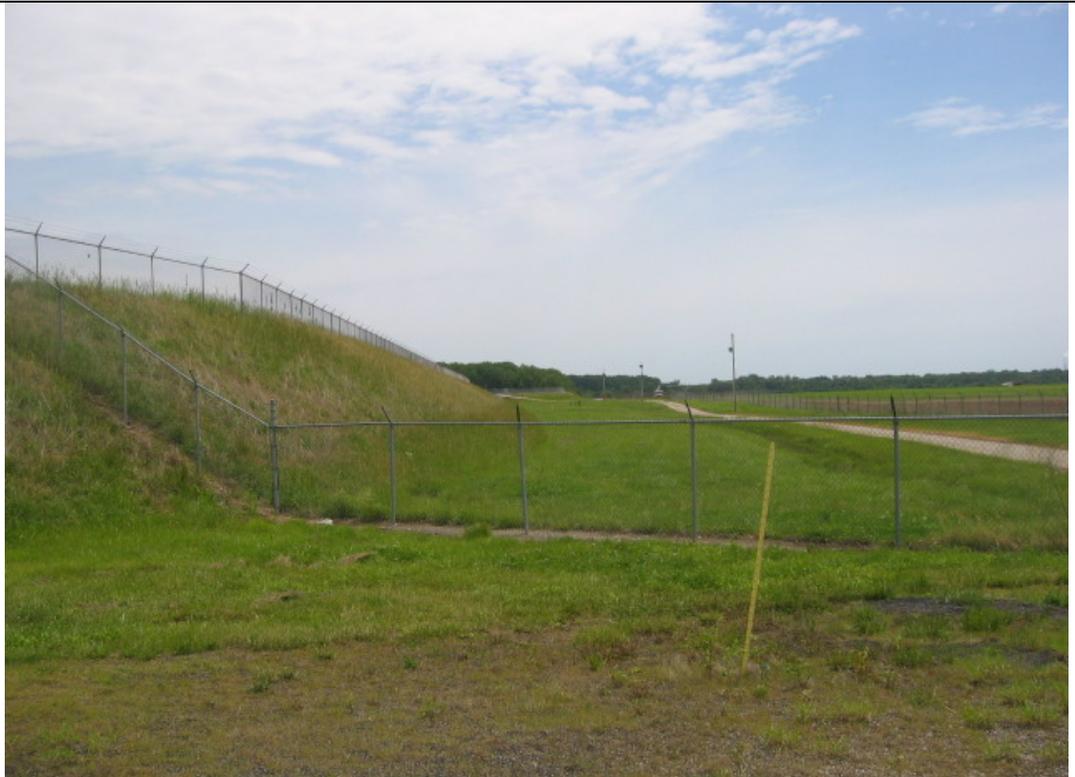
Photo No.  
**16**

Description:  
Downstream slope of Pond  
A.

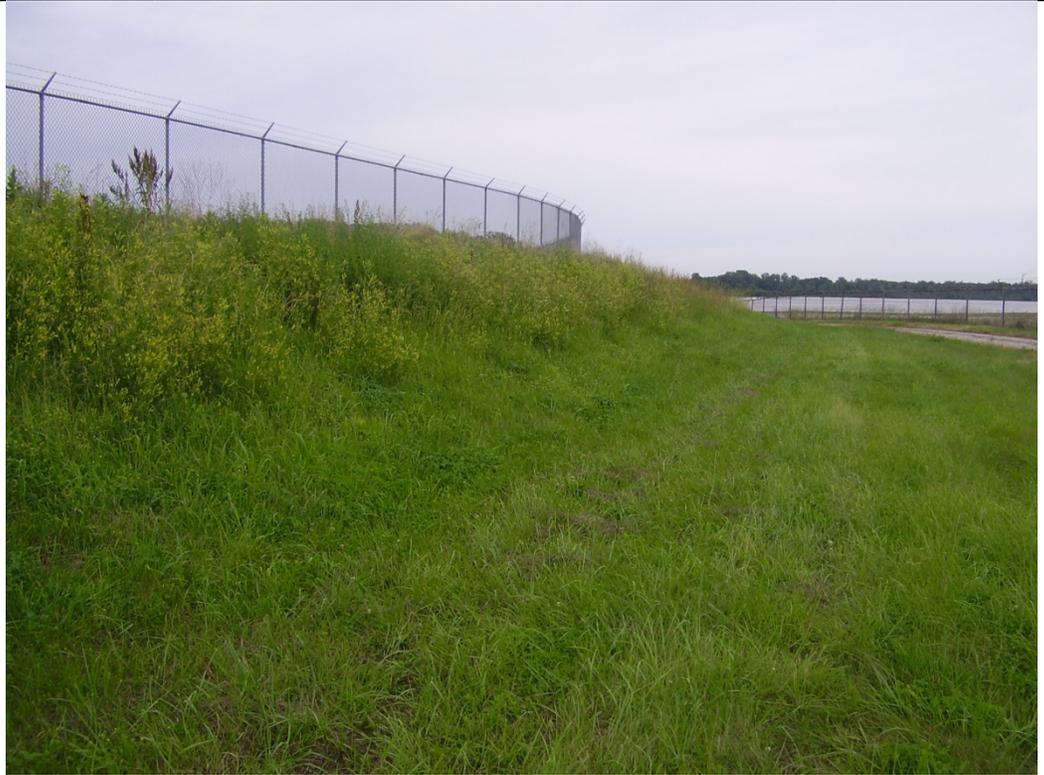
Description:  
Downstream slope of Pond  
A.

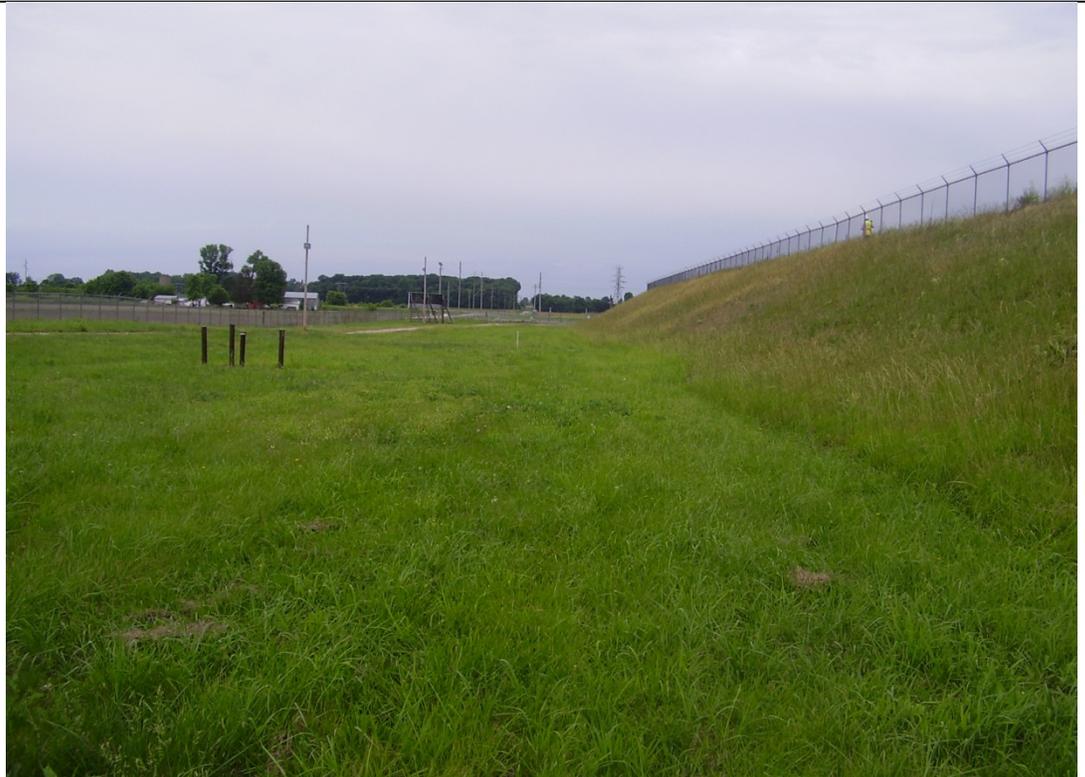
Photo No.  
**18**

Description:  
Downstream slope of Pond  
A.

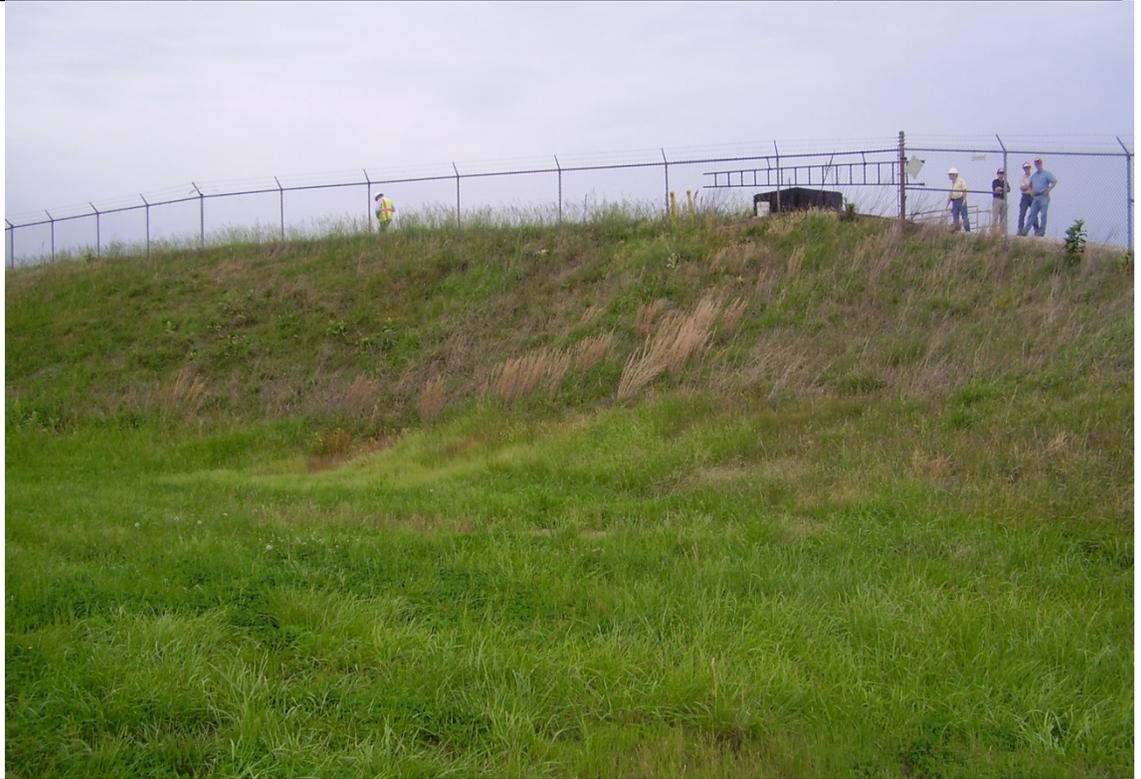
**Description:**  
Downstream slope of Pond A.

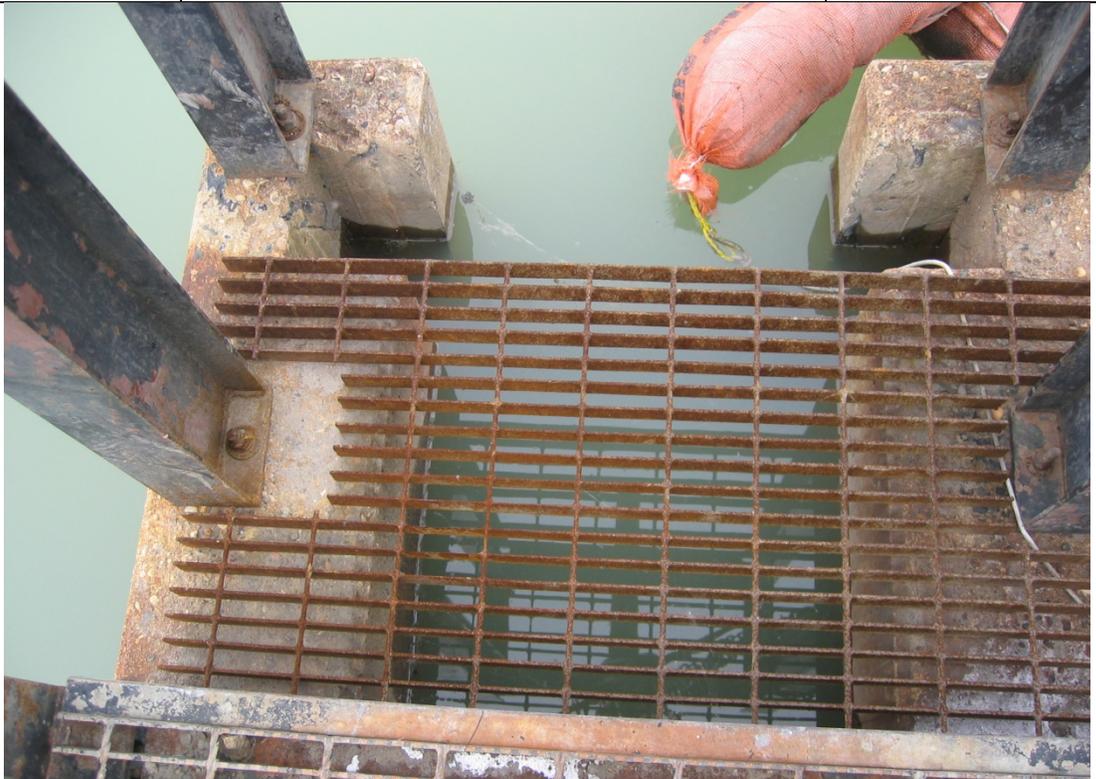
**Description:**  
Decant structure in Pond A.

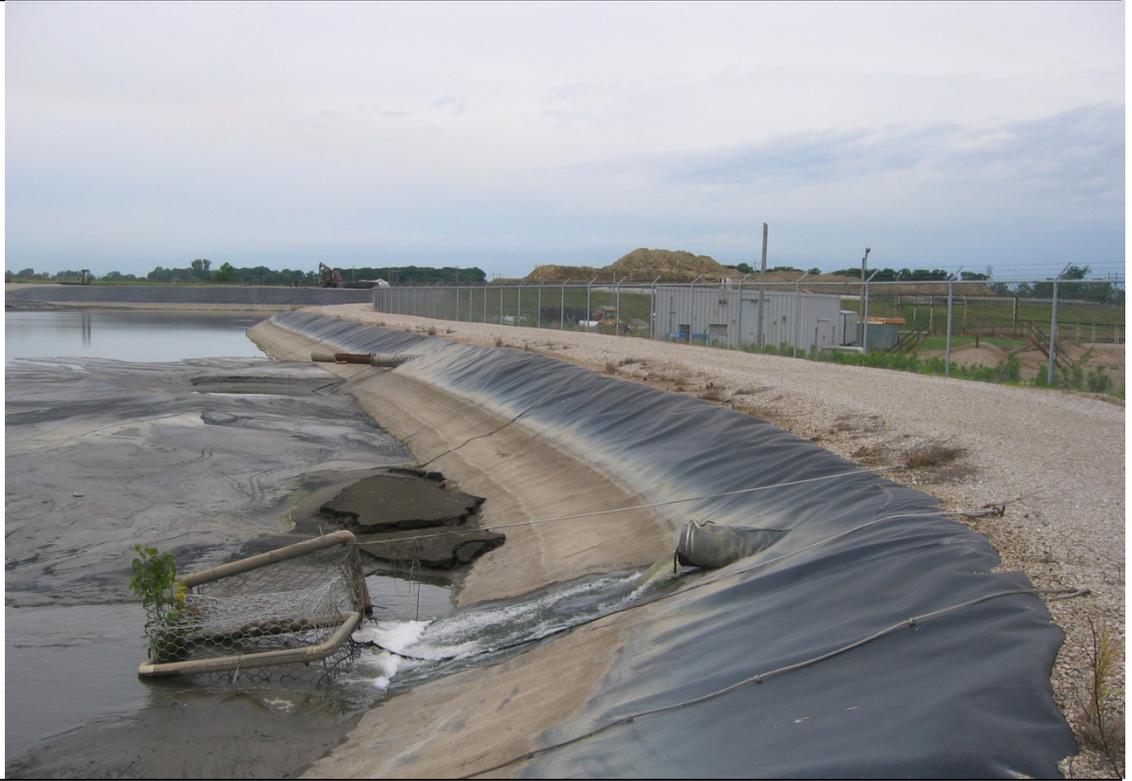
Description:  
Upstream slope and crest of  
Pond B.

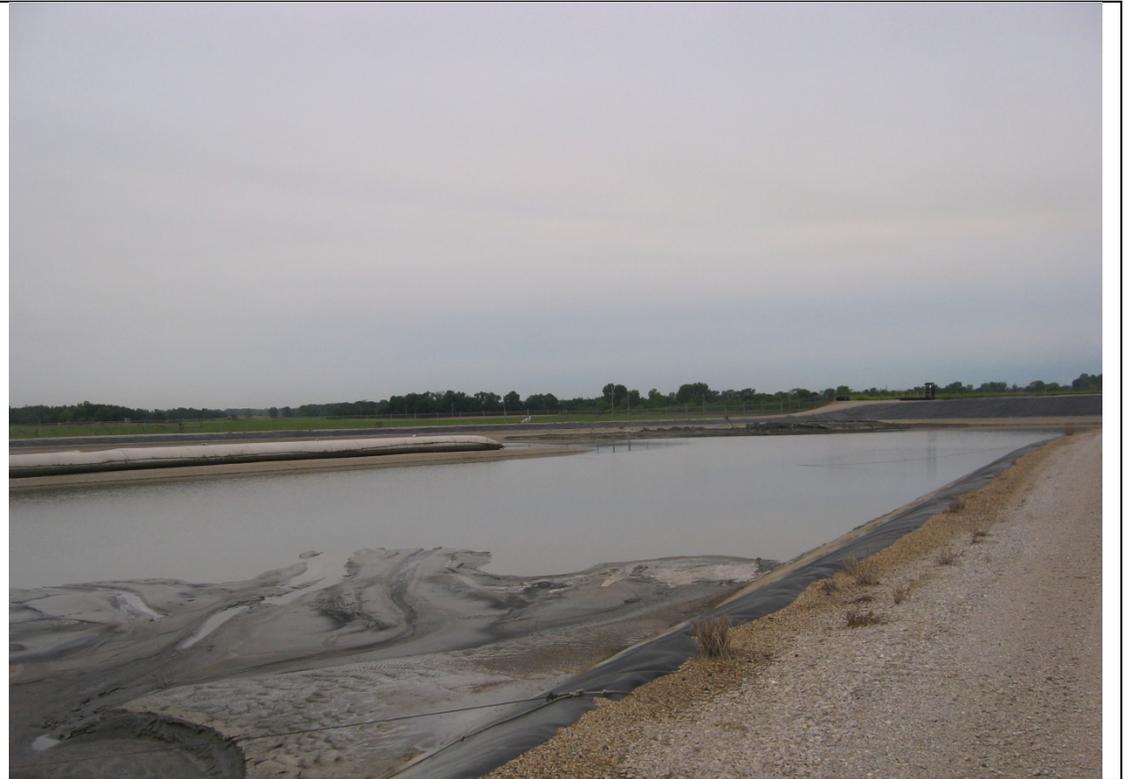
Photo No.  
**24**

Description:  
Upstream slope and crest of  
Pond B.

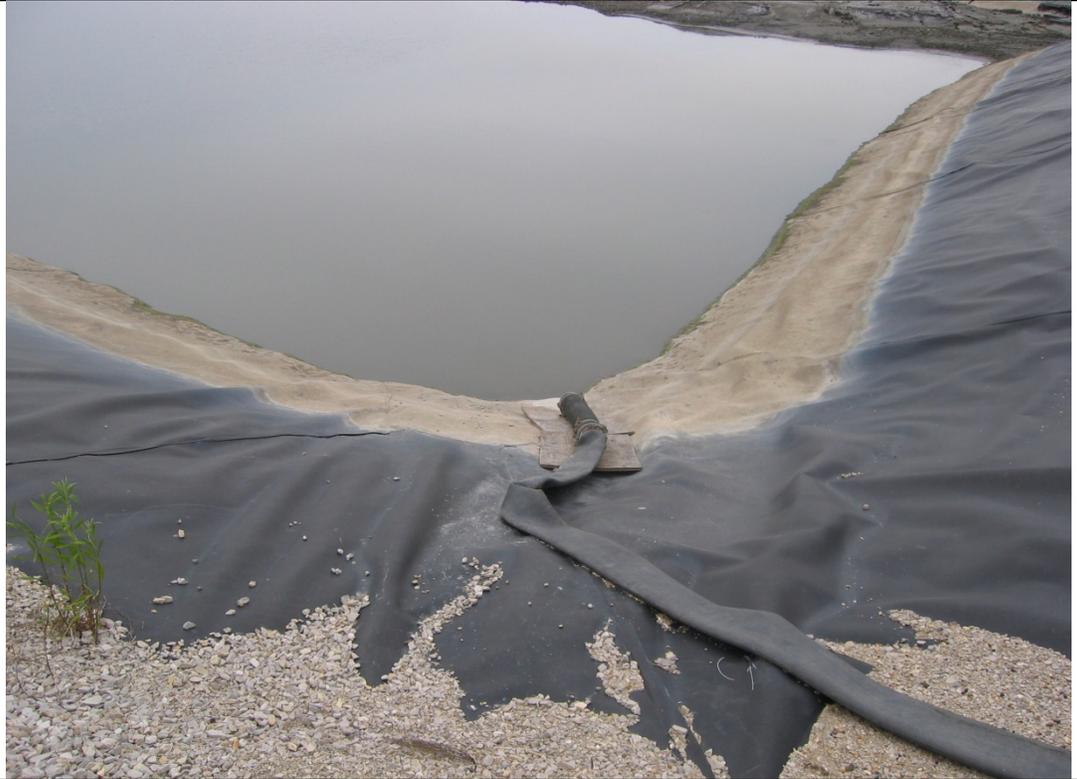
Description:  
Upstream slope of Pond B.

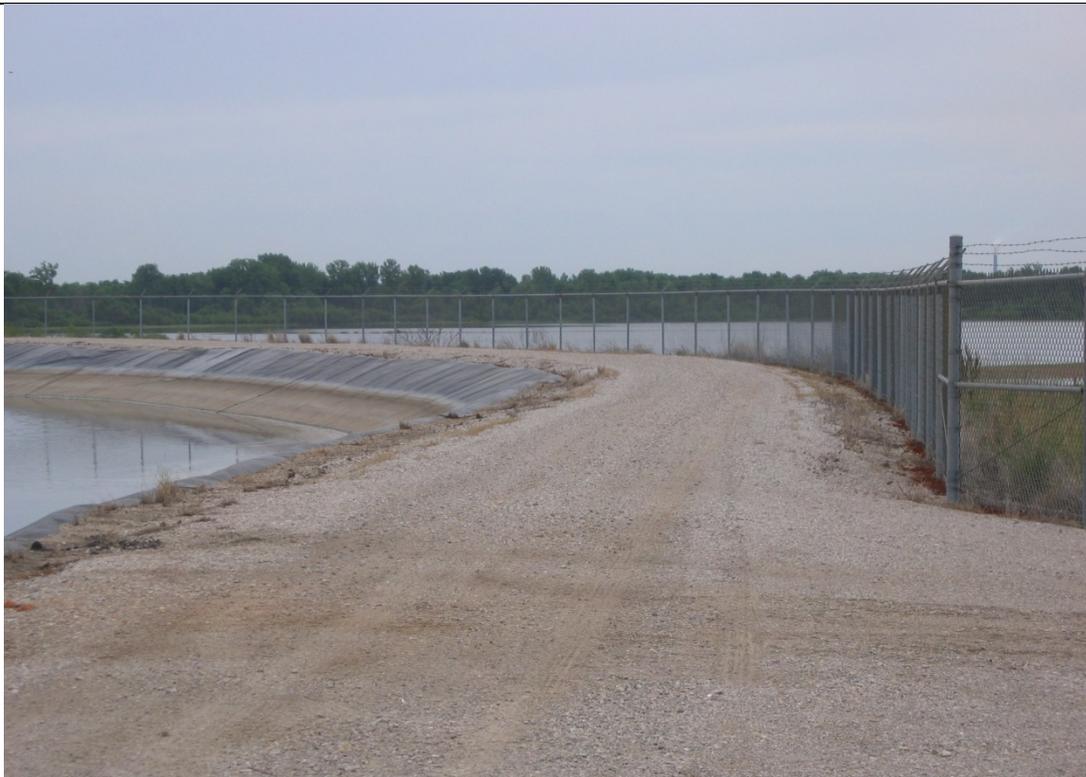
Photo No.  
**26**

Description:  
Upstream slope and crest of  
Pond B.

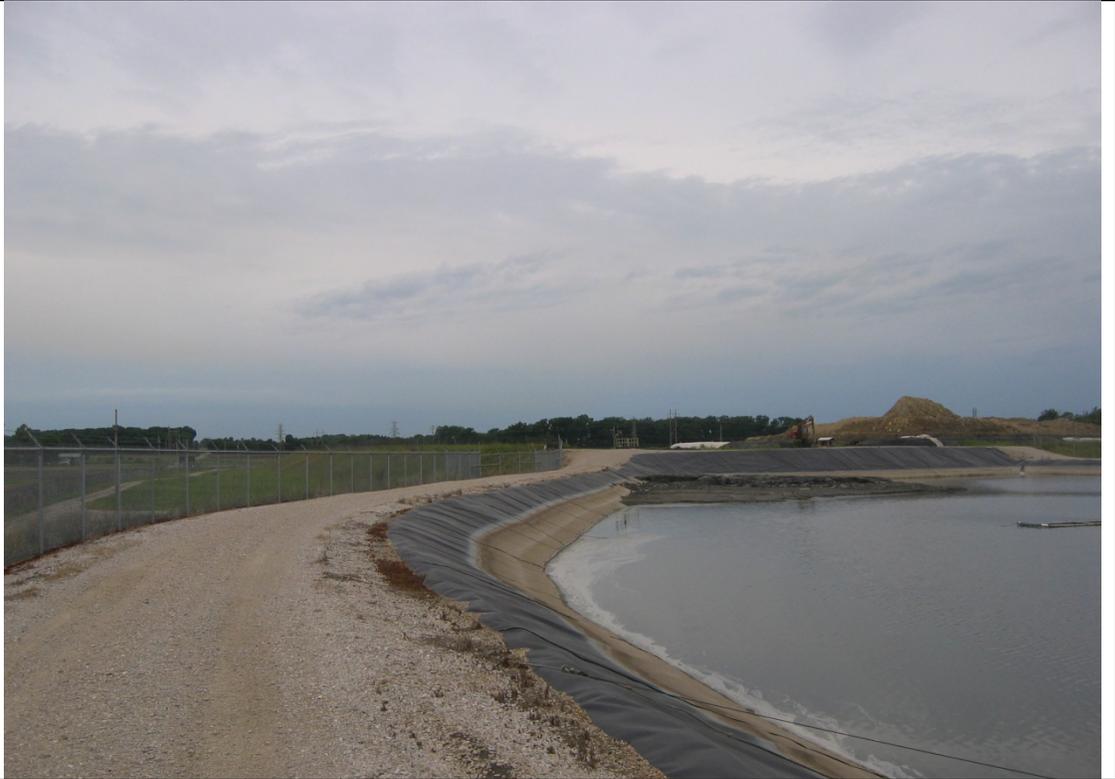
Description:  
Upstream slope and crest of  
Pond B.

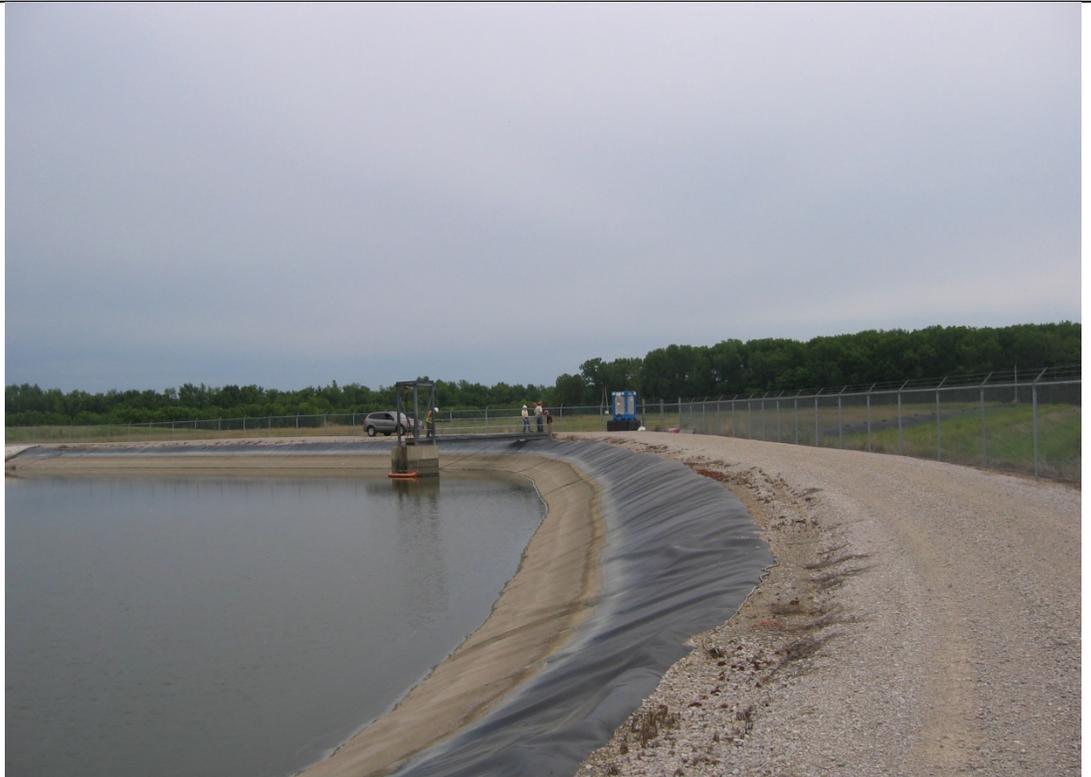
Photo No.  
**28**

Description:  
Upstream slope and crest of  
Pond B.

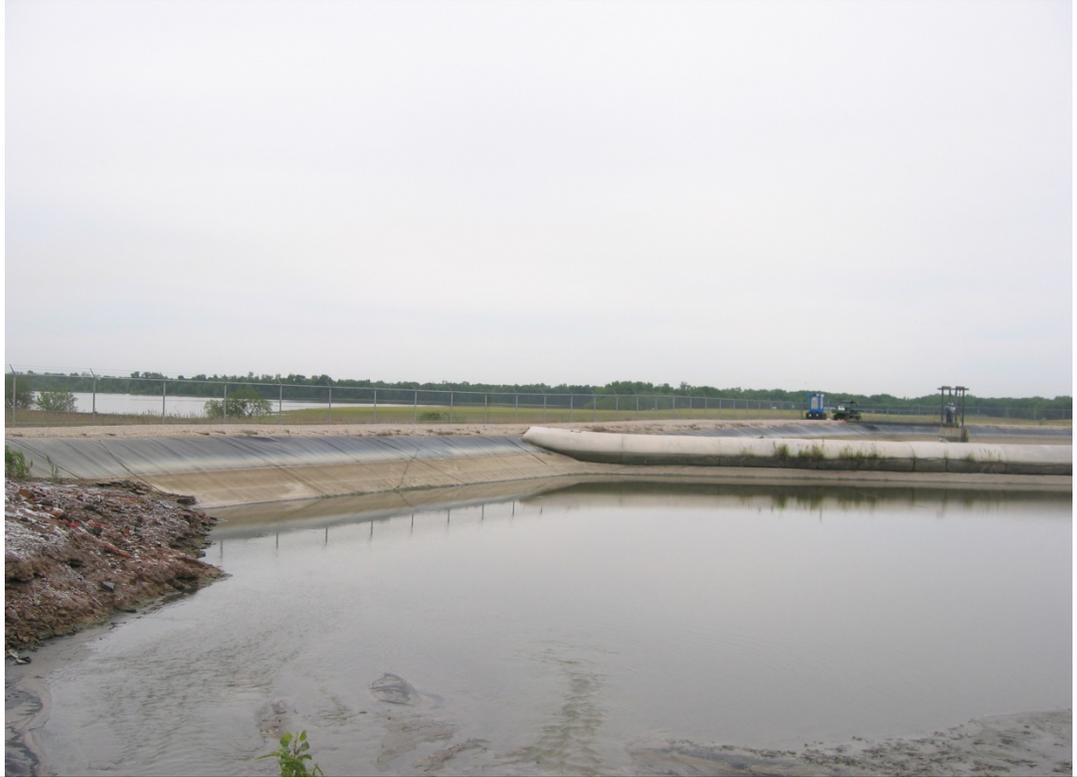
Description:  
Upstream slope of Pond B.

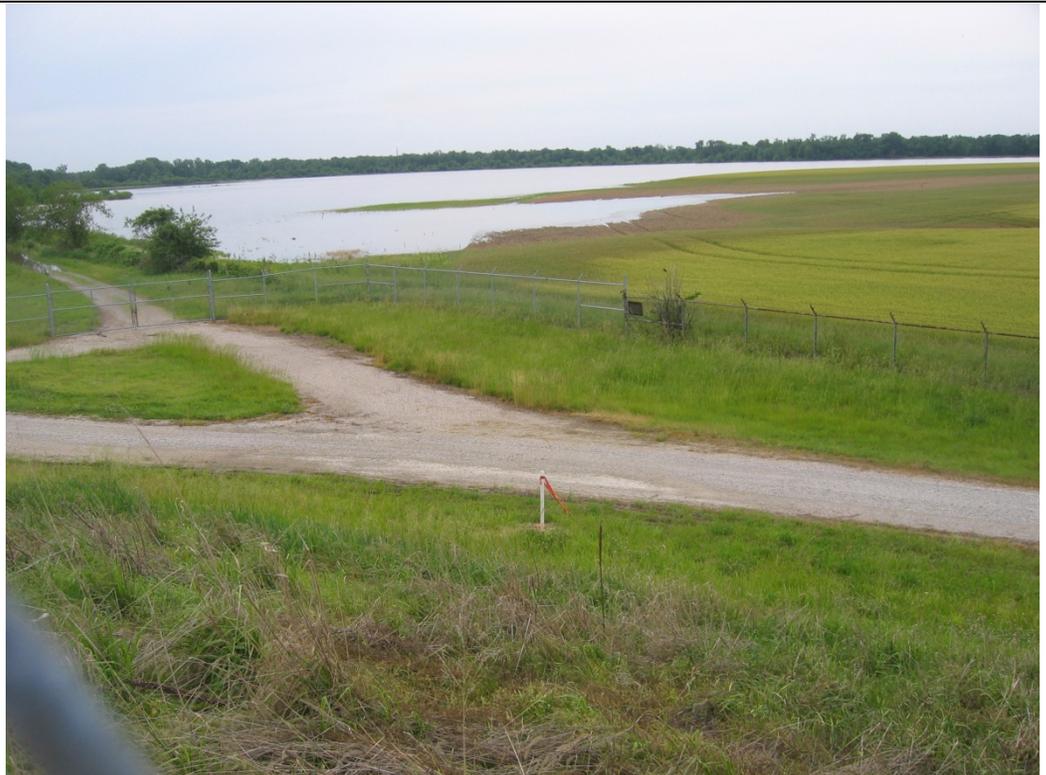
Photo No.  
**30**

Description:  
Downstream slope of Pond  
B.
