**DRAFT REPORT  
ROUND 10 DAM ASSESSMENT – JUNE 2, 2011  
AMEREN ENERGY GENERATING COMPANY – HUTSONVILLE  
POWER STATION  
POND A, POND B, AND POND D  
HUTSONVILLE, ILLINOIS**

RE: Assessment of Dam Safety of Coal Combustion Surface Impoundments at the  
Hutsonville Power Station

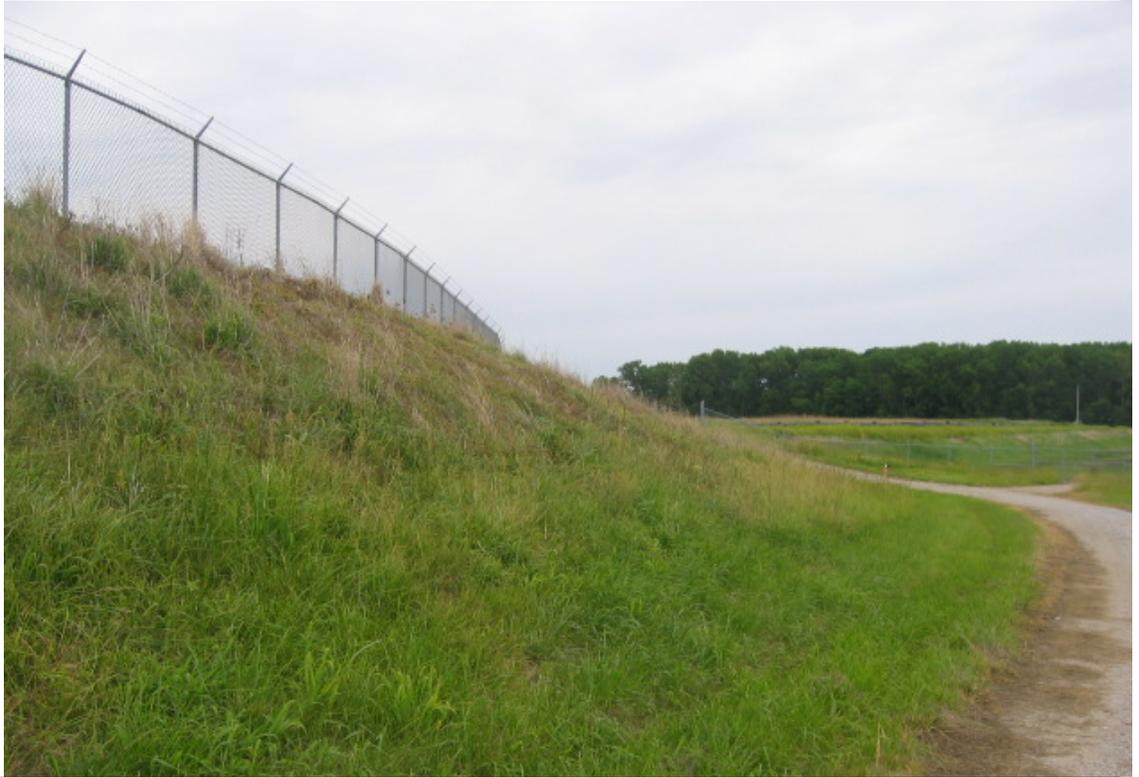
Description:  
Downstream slope of Pond  
B.

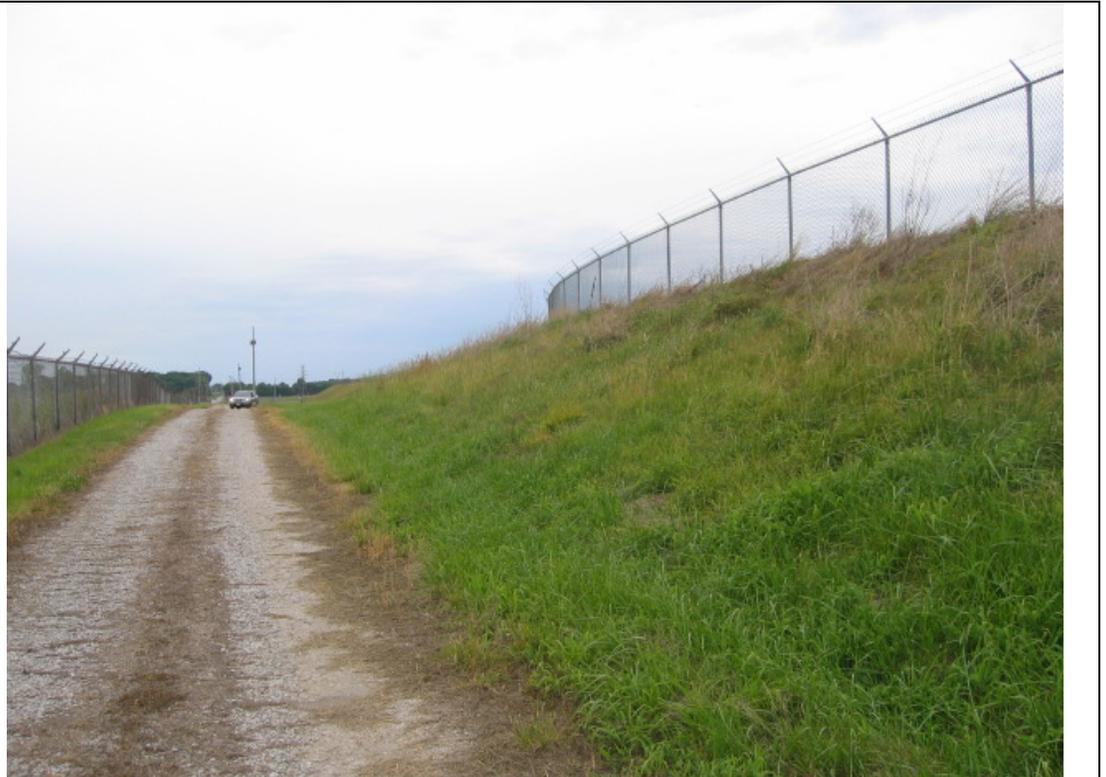
Photo No.  
**32**

Description:  
Downstream slope of Pond  
B.

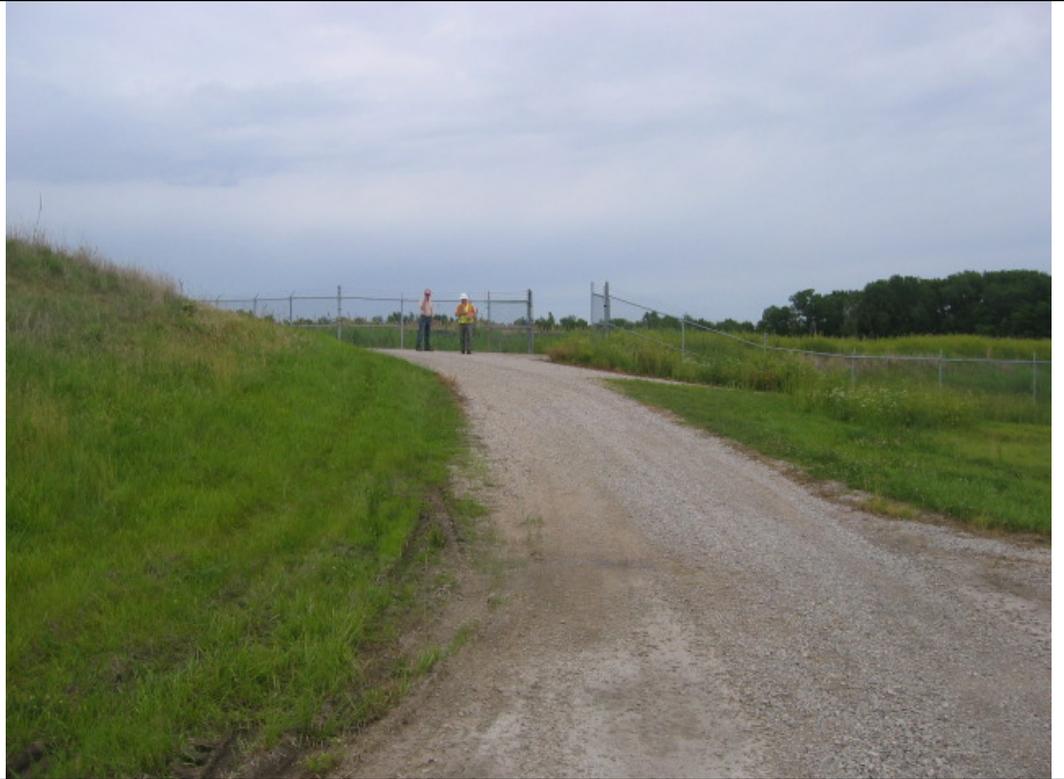
Description:  
Downstream slope of Pond  
B.

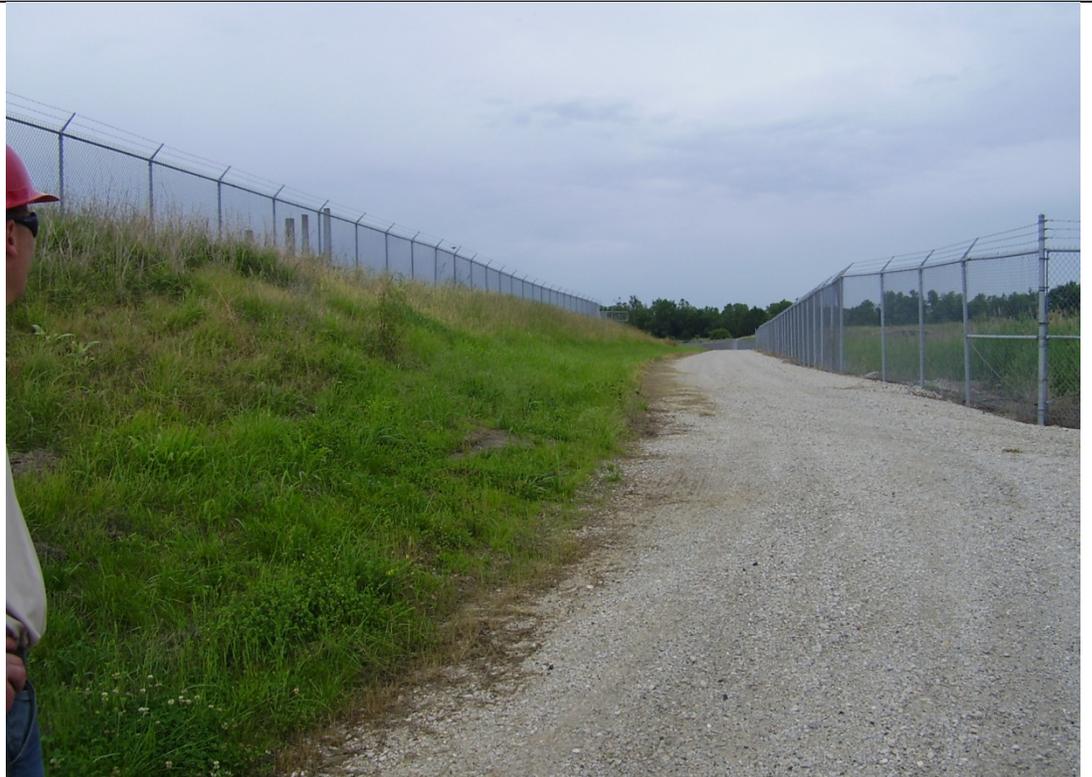
Photo No.  
**34**

Description:  
Downstream slope of Pond  
B.

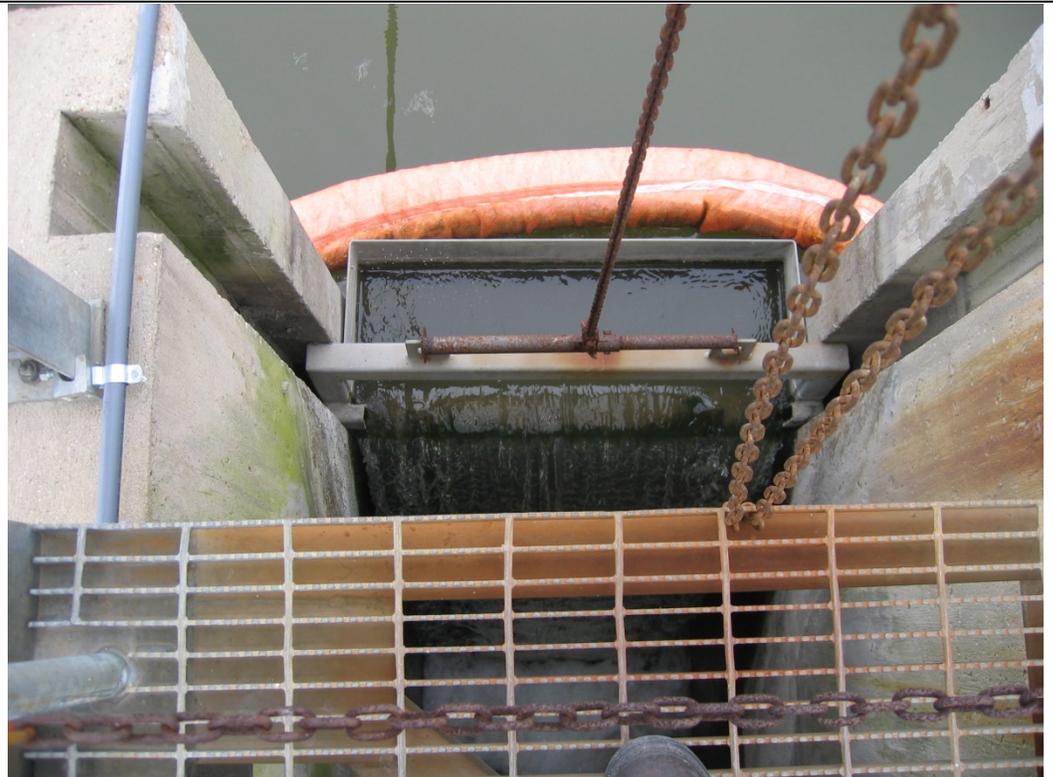
Description:  
Decant structure in Pond B.

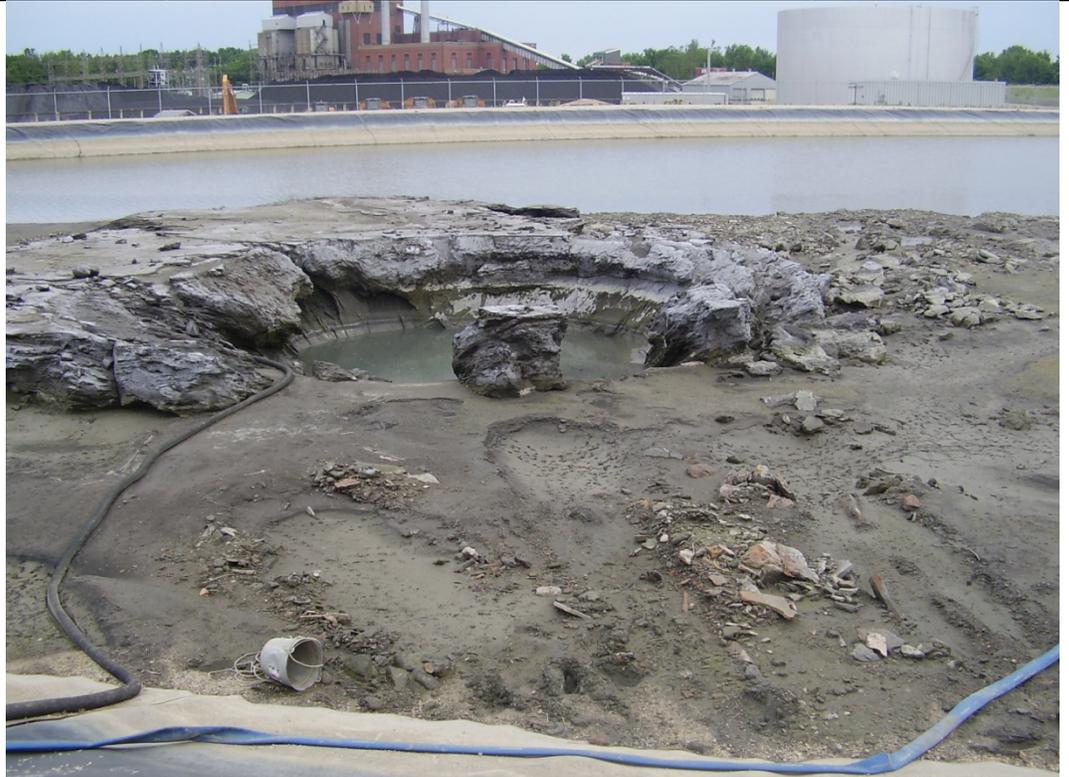
Location of discharge pipe from Pond A. At time of inspection no water was flowing through the pipe to support excavation and maintenance of the pipe.

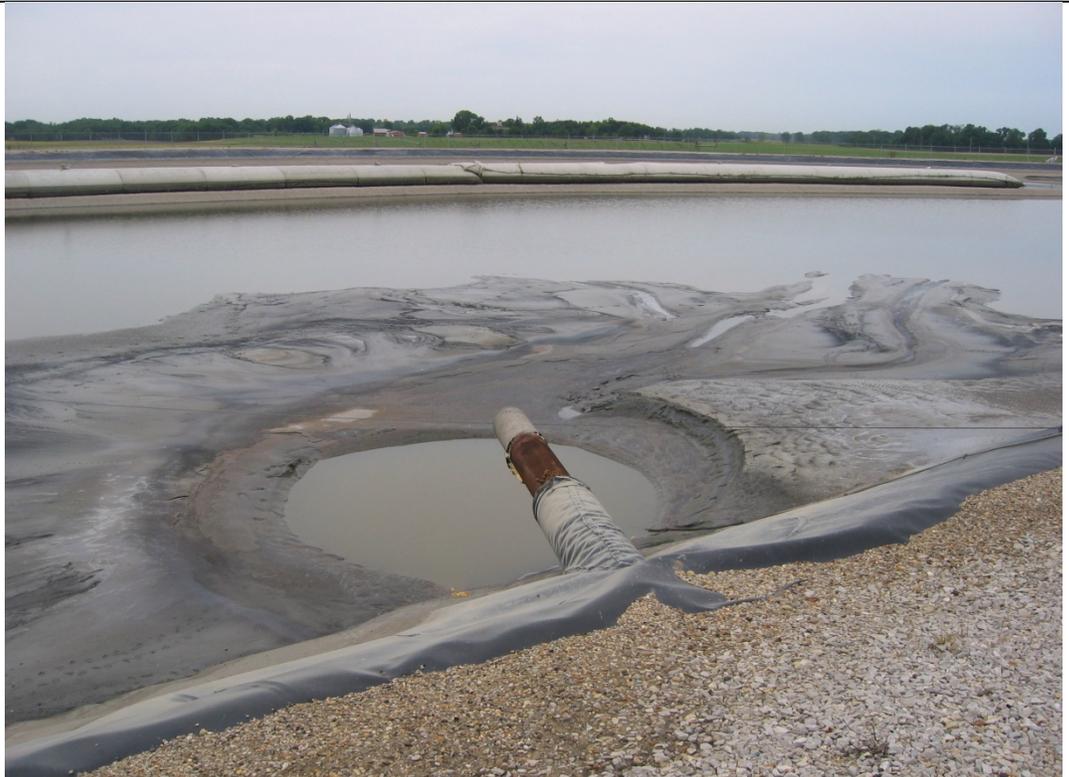
Photo No.  
**38**

Discharge pipe from the facility.

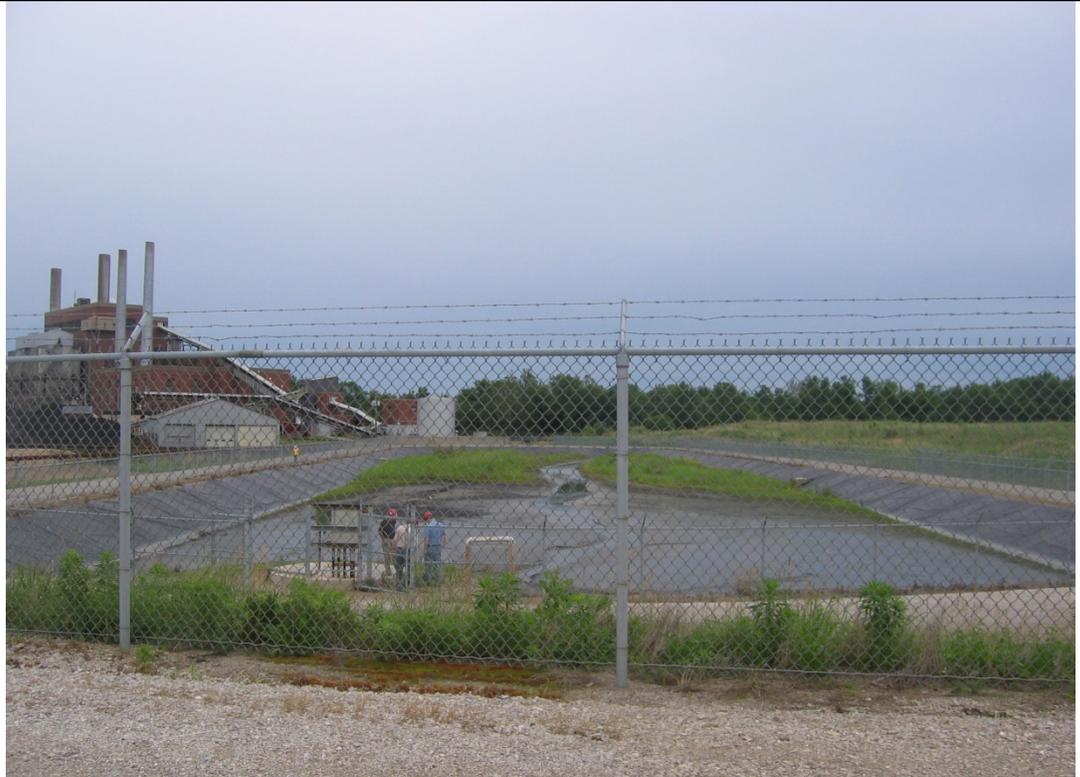
Description:  
Pond C as seen from south.

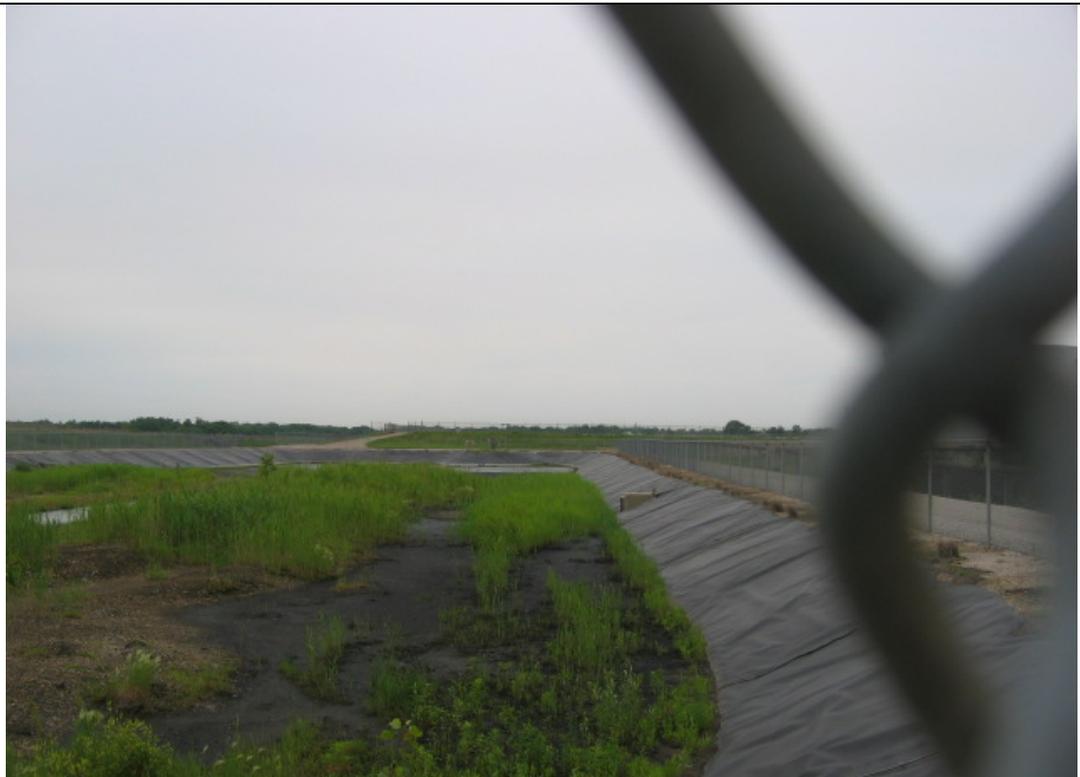
Photo No.  
**40**

Description:  
Pond C as seen from north.

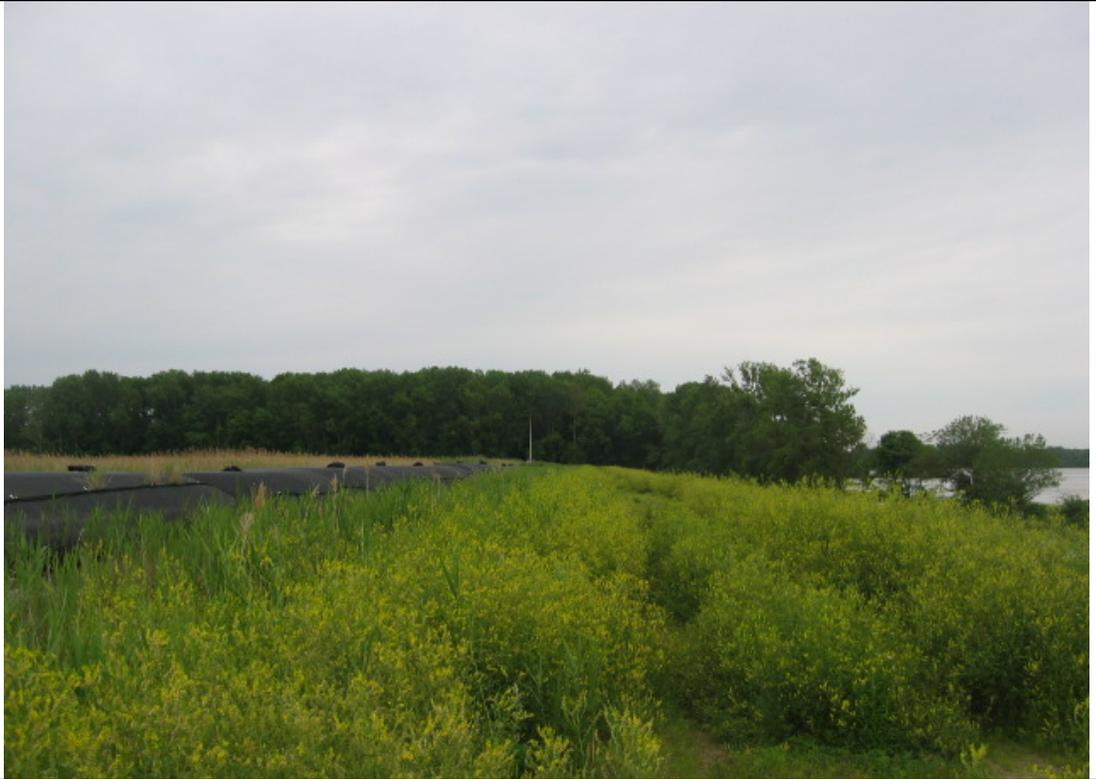
Description:  
Crest of the closed portion of  
Pond D as seen from the  
southwest corner.

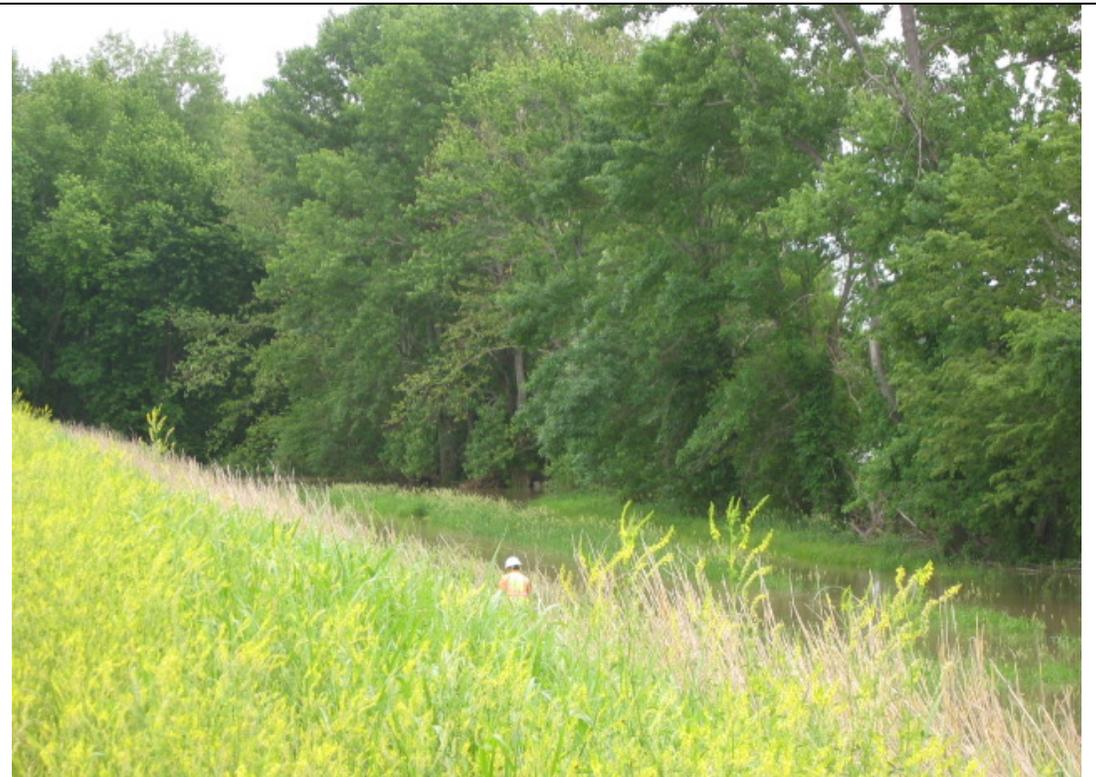
Photo No.  
**42**

Description:  
Downstream slope of the  
closed portion of Pond D as  
seen from the southeast  
corner.

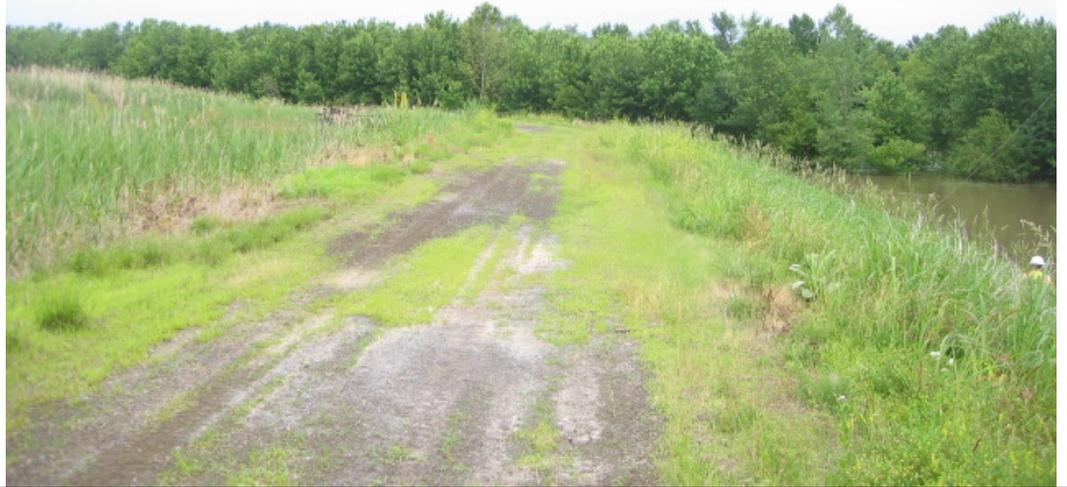
Description:  
Crest of the closed portion of  
Pond D.

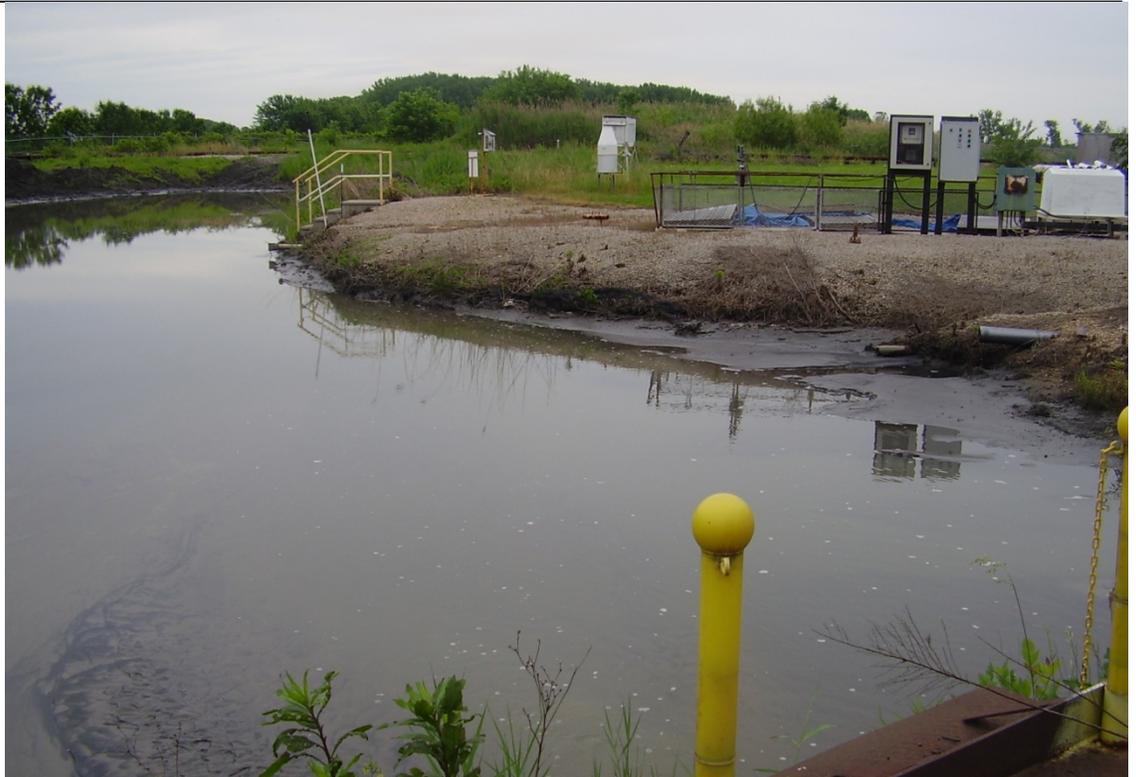
Photo No.  
**44**

Description:  
Upstream slope, crest and  
discharge pipes in the active  
portion of Pond D.

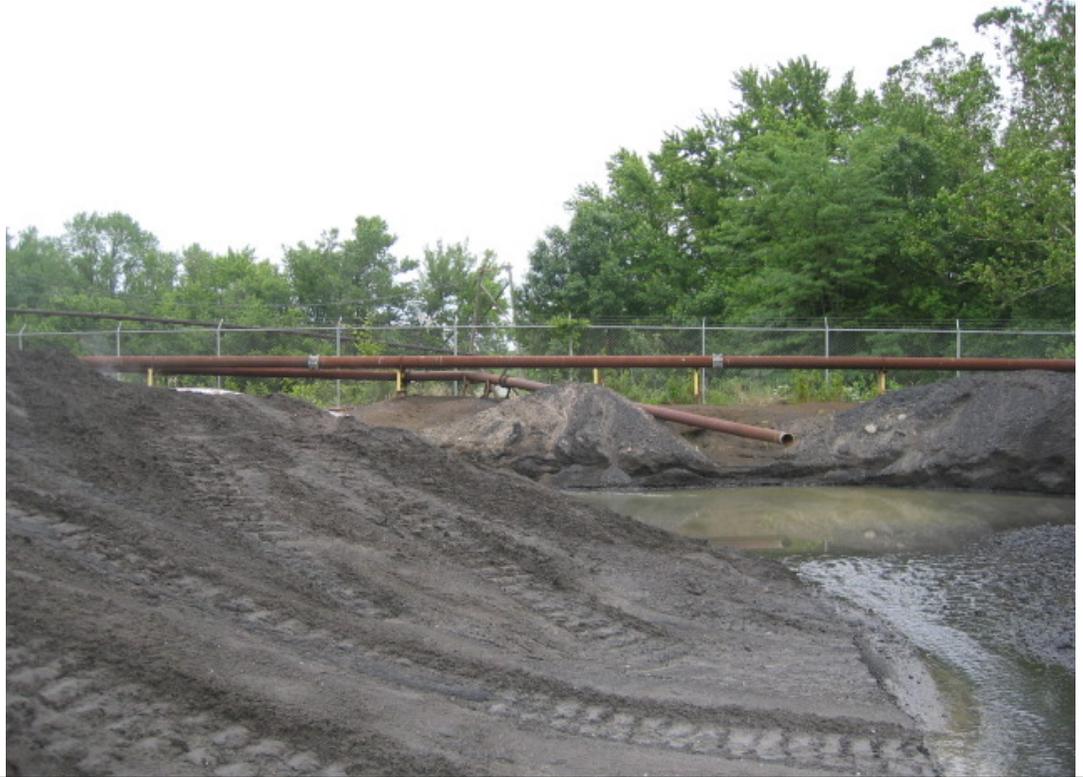
Description:  
Upstream slope and  
discharge pipe in active  
portion of Pond D.

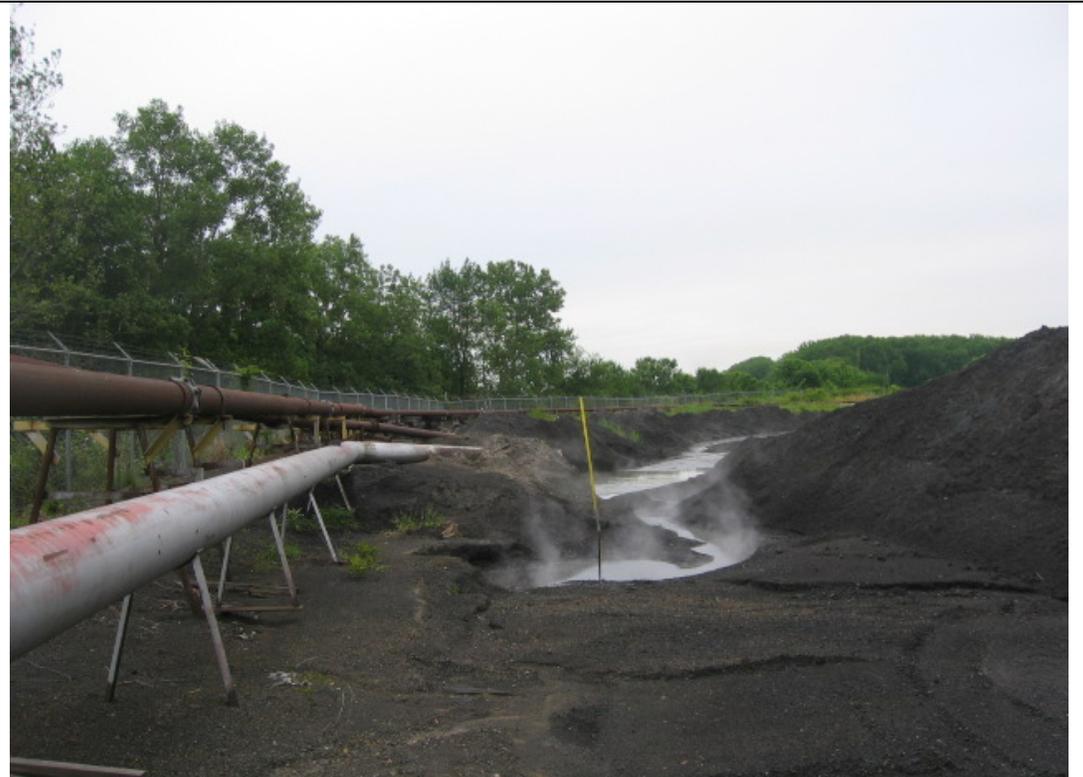
Photo No.  
**46**

Description:  
Upstream slope, crest, and  
discharge pipe in the active  
portion of Pond D.

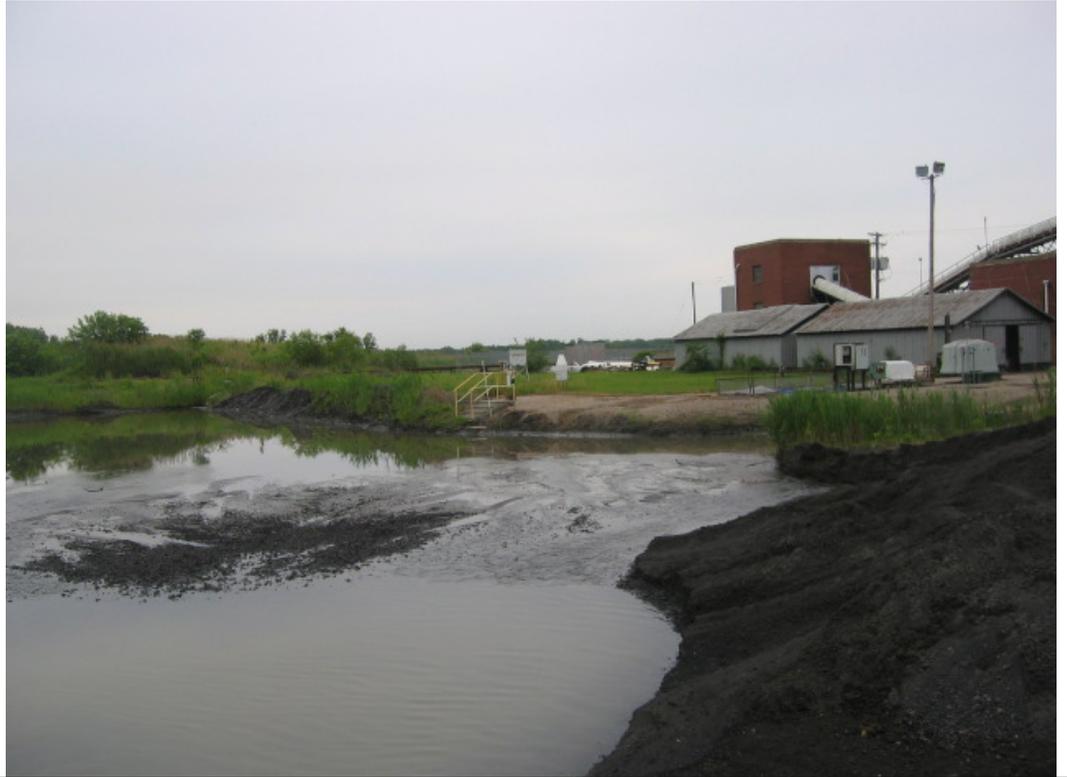
Description:  
Upstream slope and crest and  
in active portion of Pond D

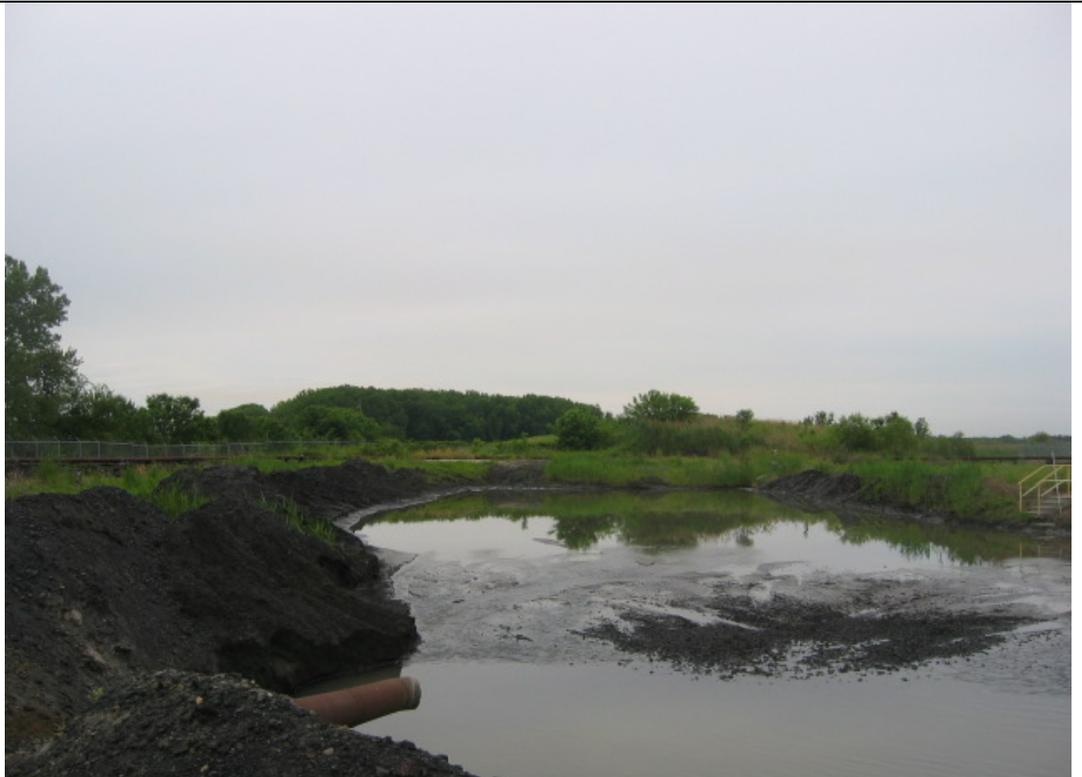
Photo No.  
**48**

Description:  
Upstream slope and crest in  
active portion of Pond D.

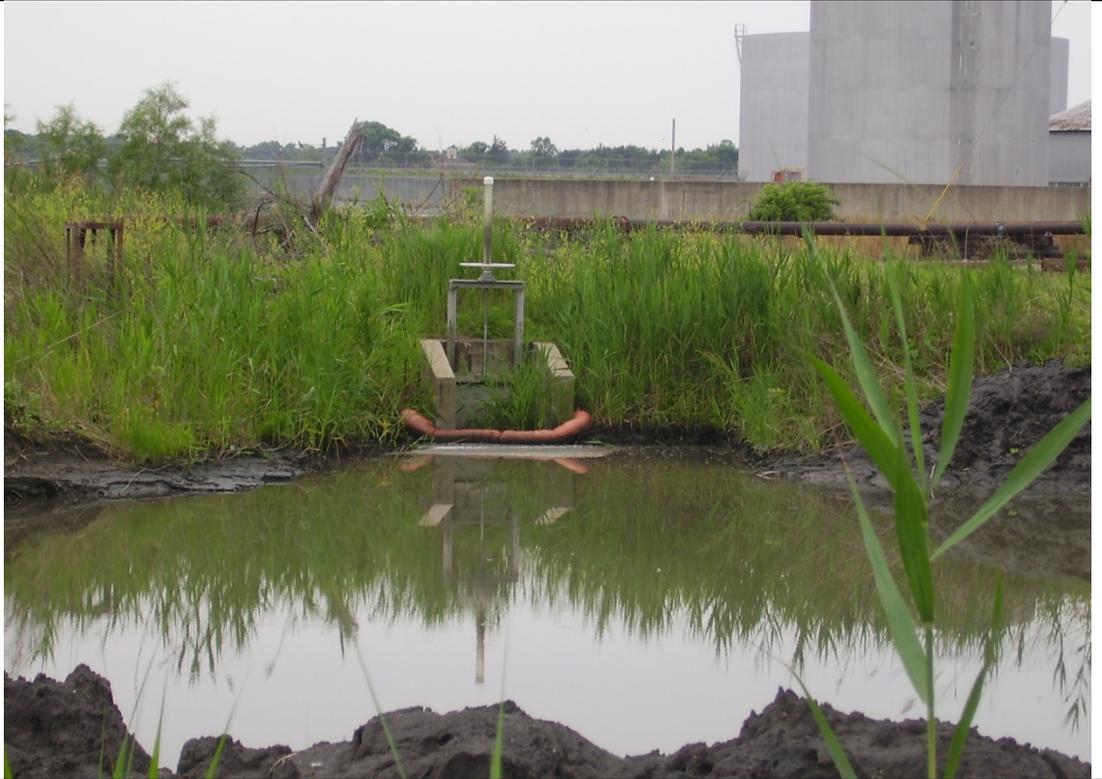
**Description:**  
Upstream slope and discharge structure in Pond D.

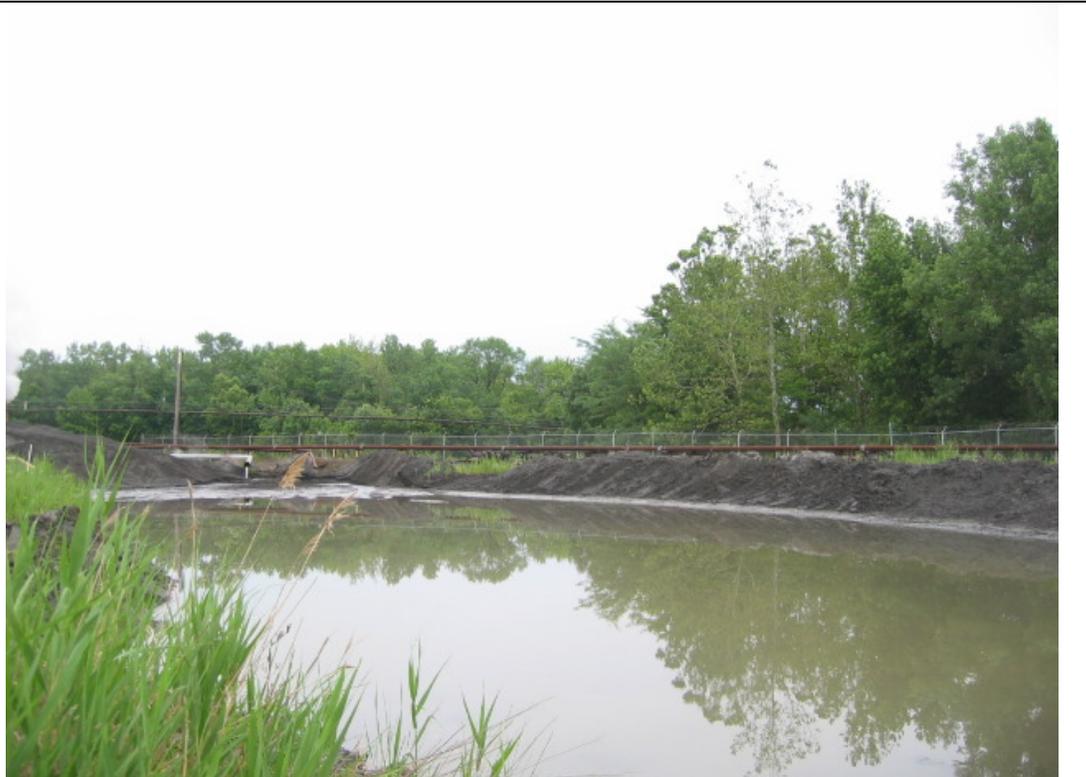
**Photo No.**  
**50**

**Description:**  
Upstream slope in Pond D.

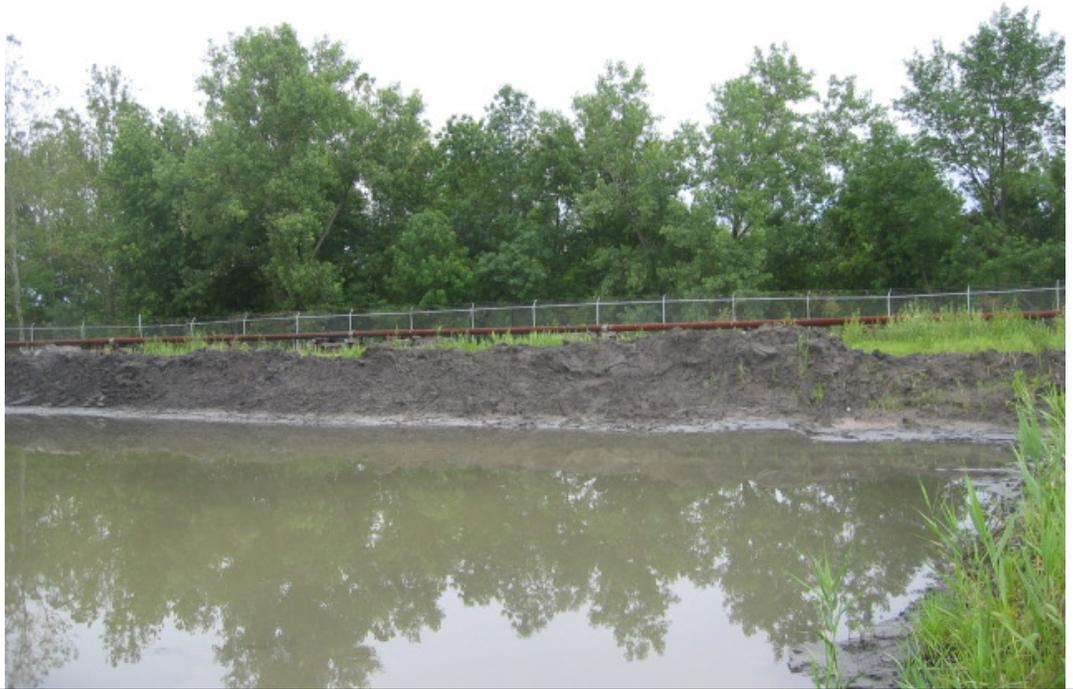
**Description:**  
Upstream slope in the active portion of Pond D.

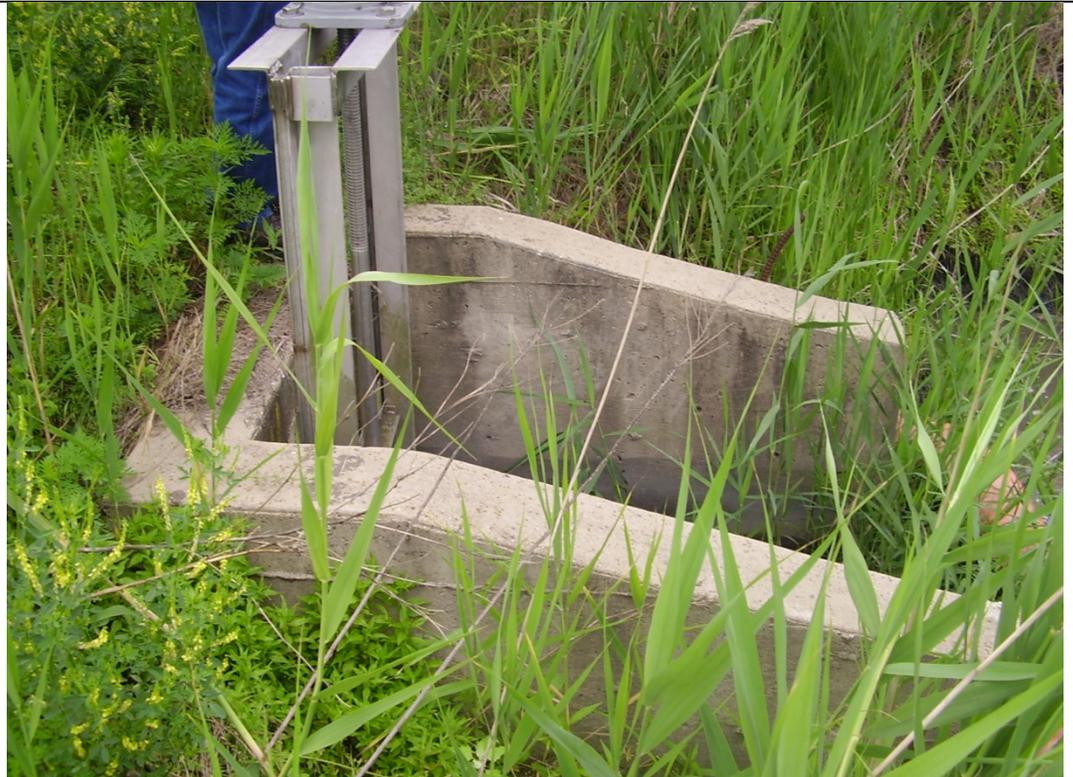
**Photo No.**  
**52**

**Description:**  
Decant structure in the active portion of Pond D.

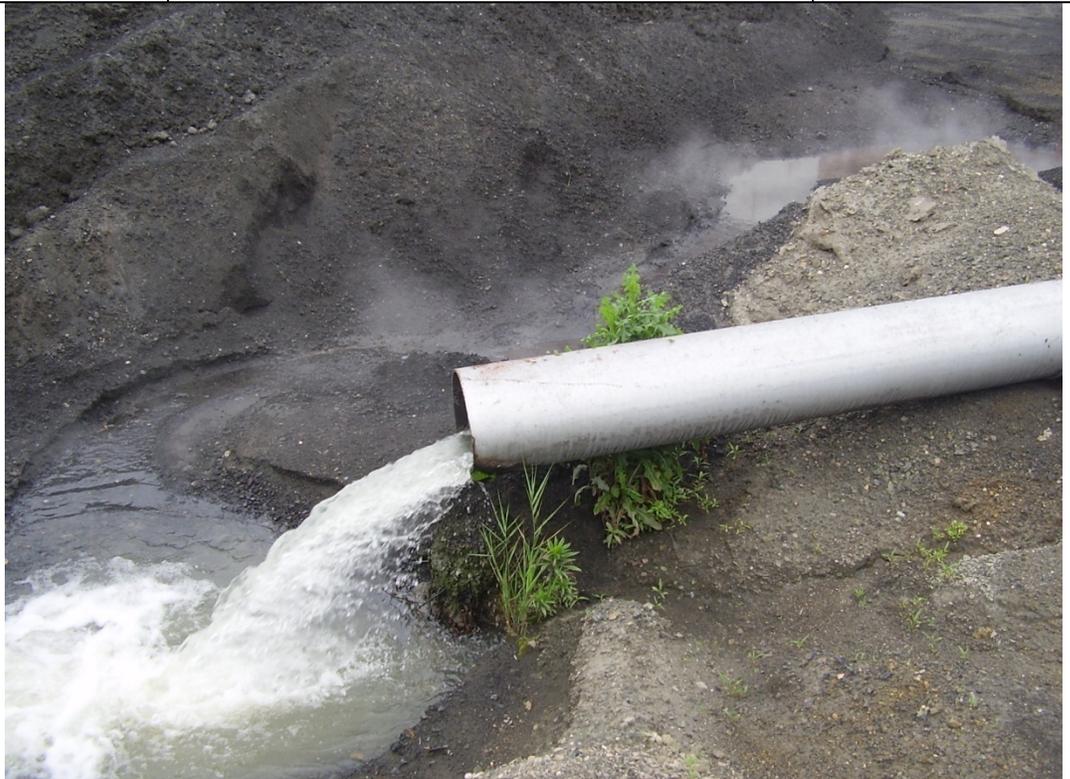
Description:  
Discharge pipe in active  
portion of Pond D.

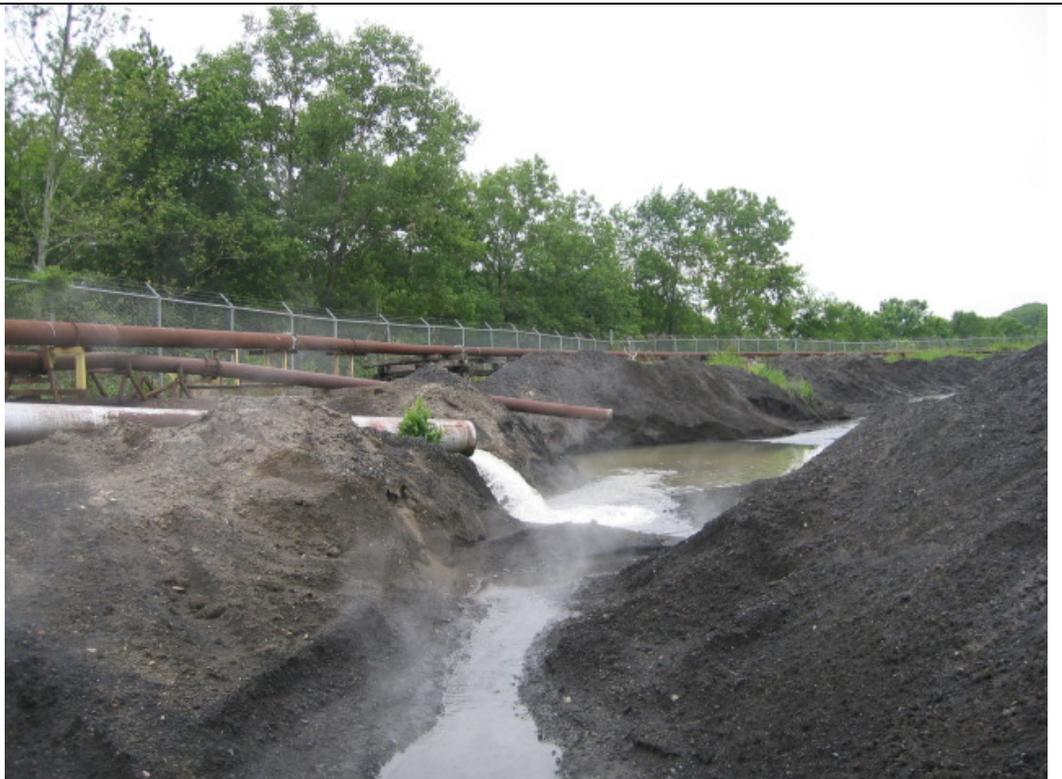
Photo No.  
**56**

Description:  
Discharge pipe in active  
portion of Pond D.
