**FINAL REPORT  
ROUND 10 DAM ASSESSMENT  
AMEREN ENERGY GENERATING COMPANY – HUTSONVILLE POWER  
STATION  
POND A, POND B, POND D  
HUTSONVILLE, ILLINOIS**

October 16, 2012  
GZA File No. 170142.30

RE: Assessment of Dam Safety of Coal Combustion Surface Impoundments at the  
Hutsonville Power Station

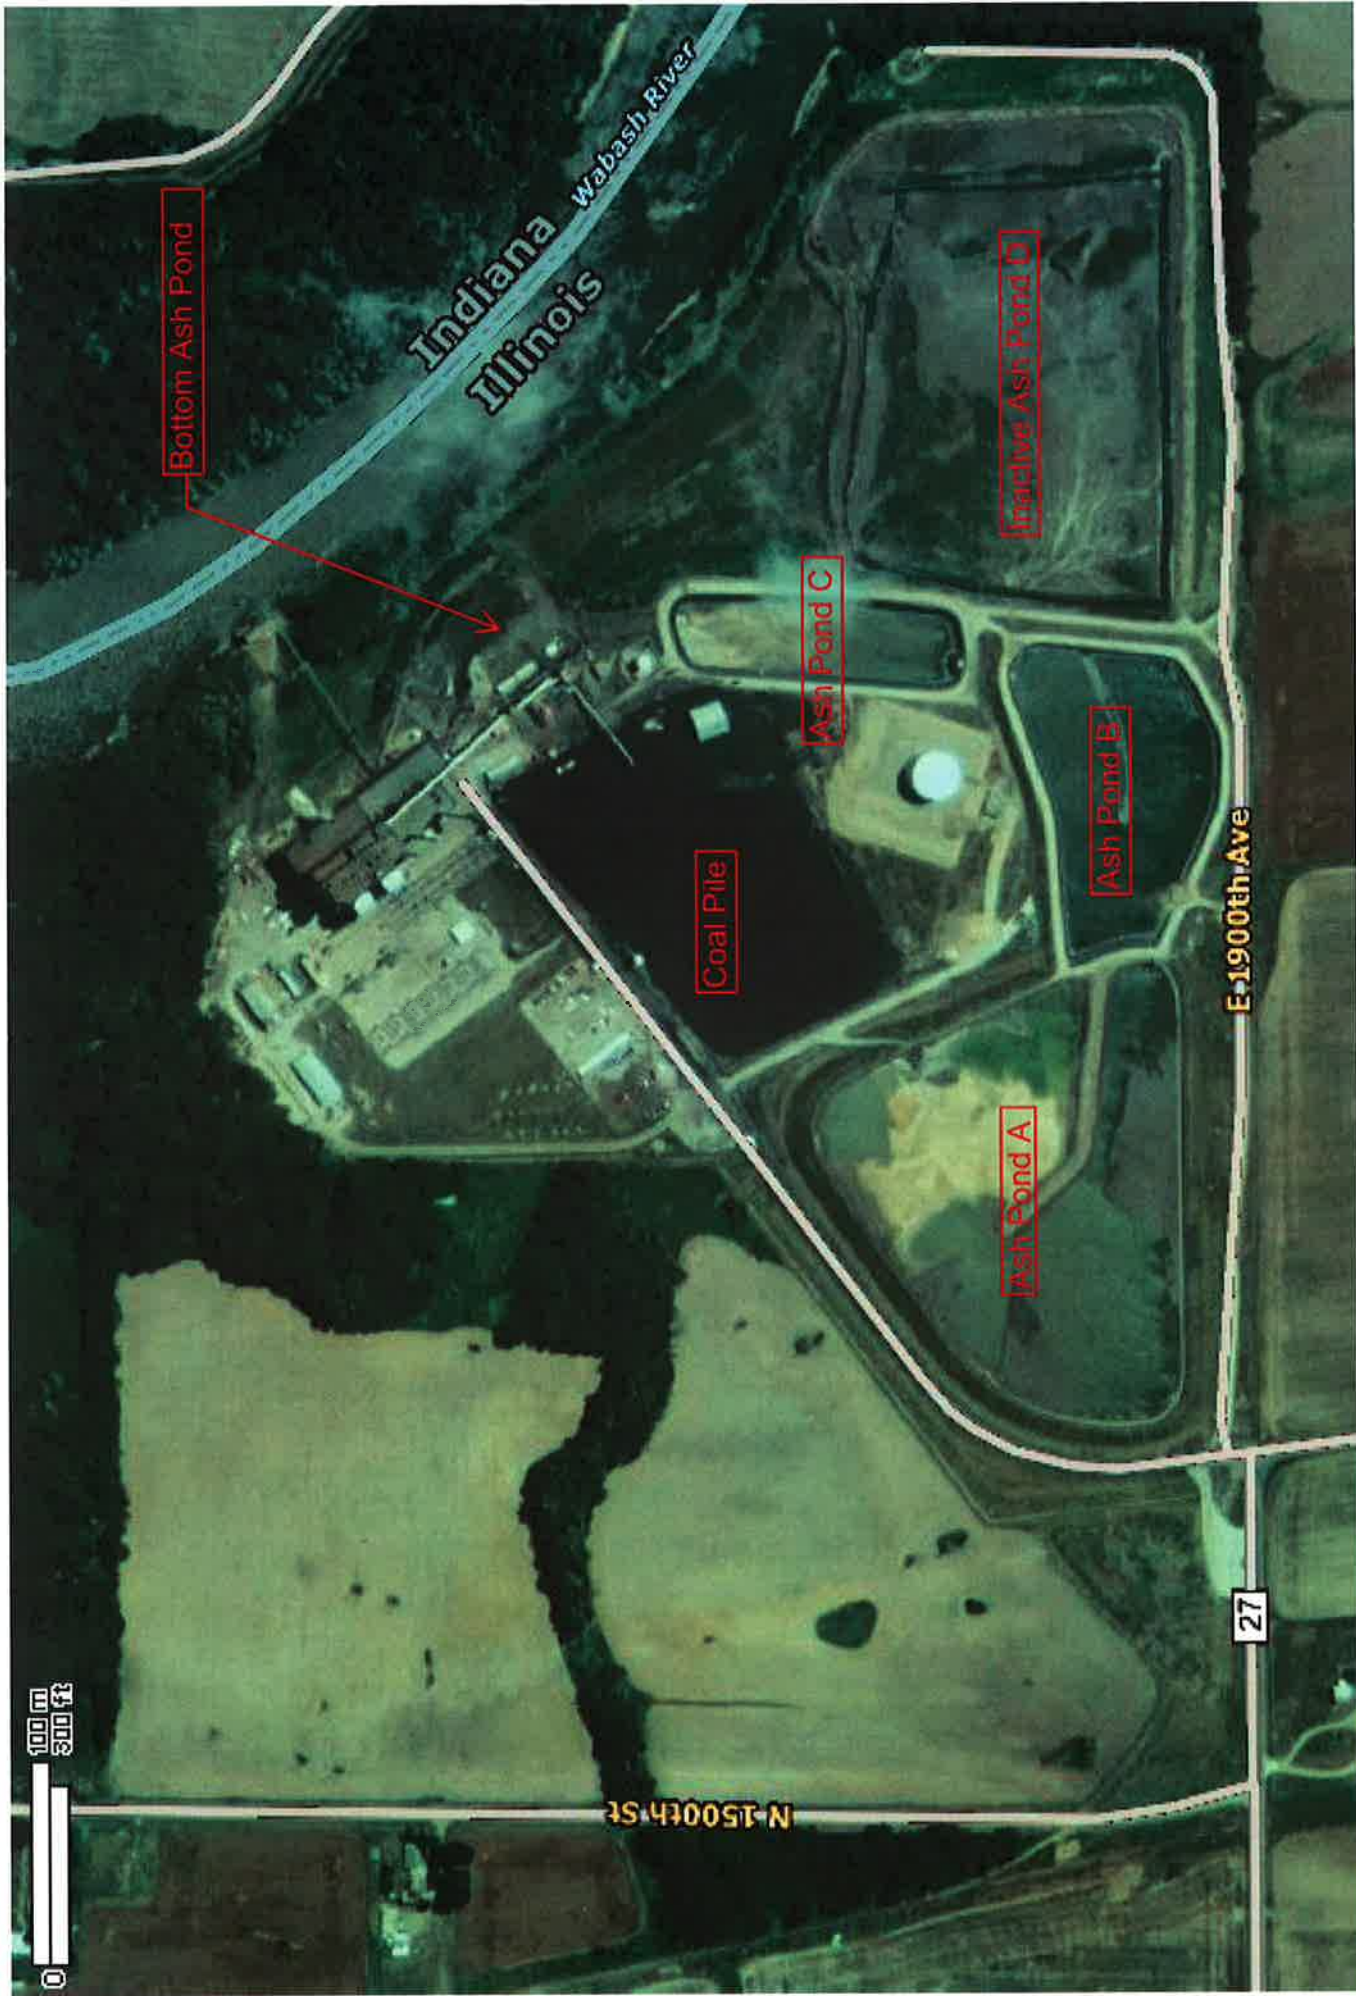
| Item | Condition Code * | Deficiencies | Recommended Remedial Measures and Implementation Schedule |
|---|---|---|---|
| | Other | MM | Pond appears to be near capacity. Stacking of ash has reduced the freeboard from 2 feet (recommended) to less than 1 foot in some areas around the edge of the pond. If goetubes are to be left in place, recommend removing ash from the perimeter ditches (pond interior) to re-establish drainage between the edge of pond and goetubes. See photos #1, #2, #3, and #4.<br>Re-grade ditches around interior perimeter of pond. |

Photo #1 – Ash Pond A – North berm looking northeast

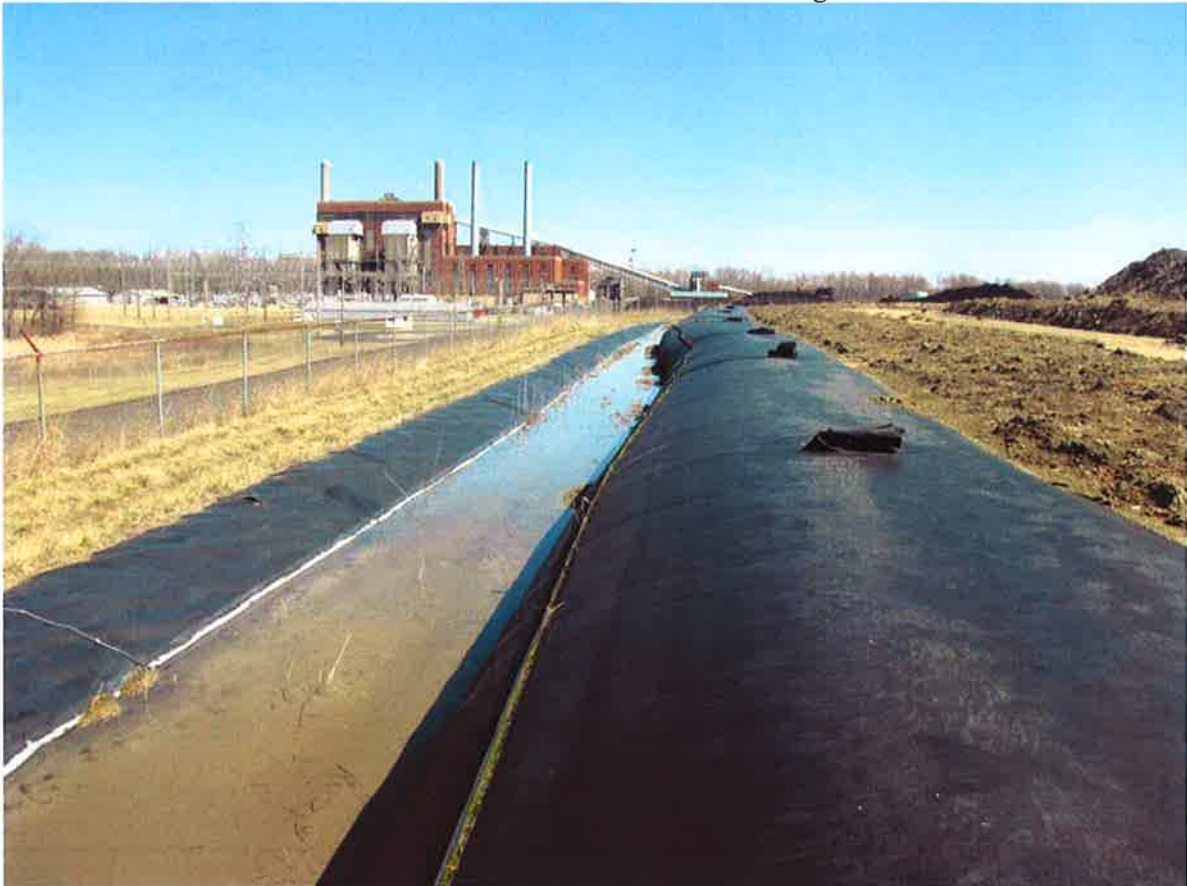
Photo #2 – Ash Pond A – East berm looking north

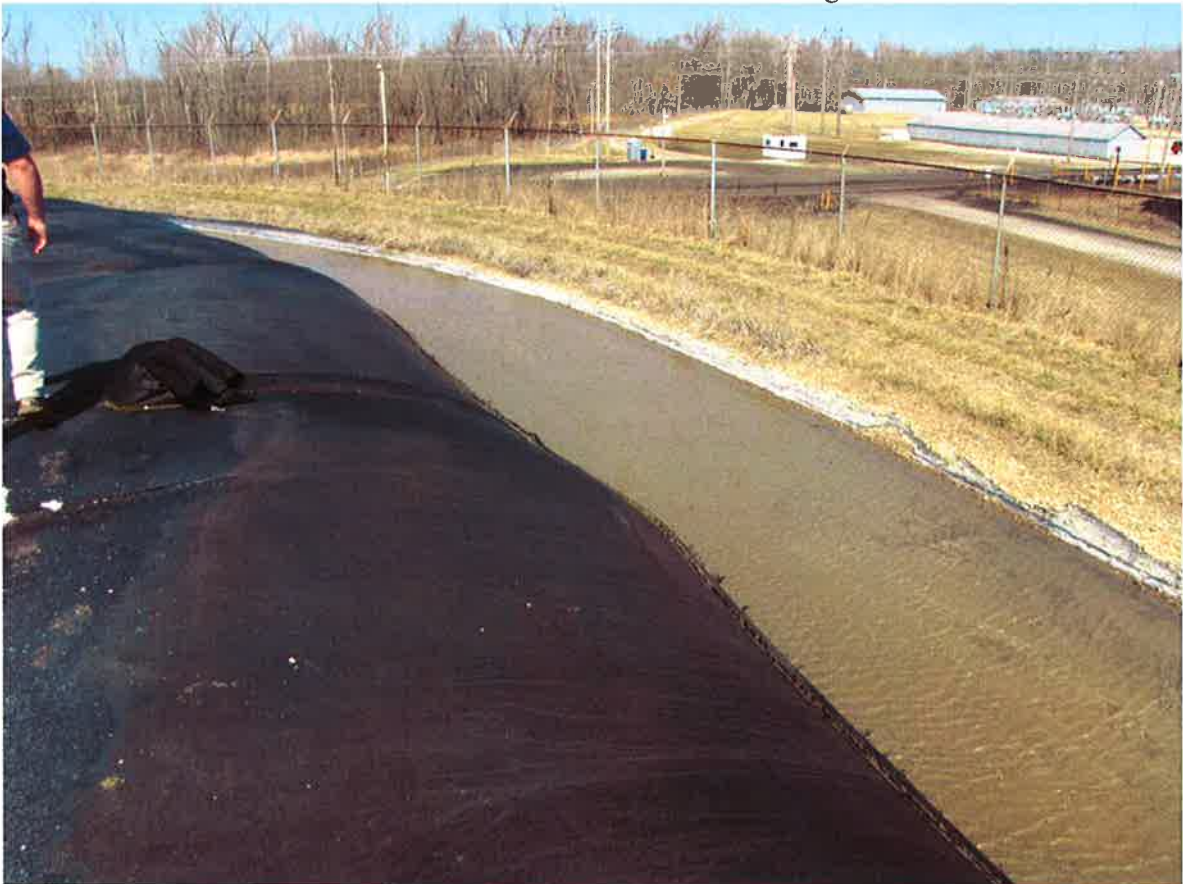
Photo #3 – Ash Pond A – East berm looking south

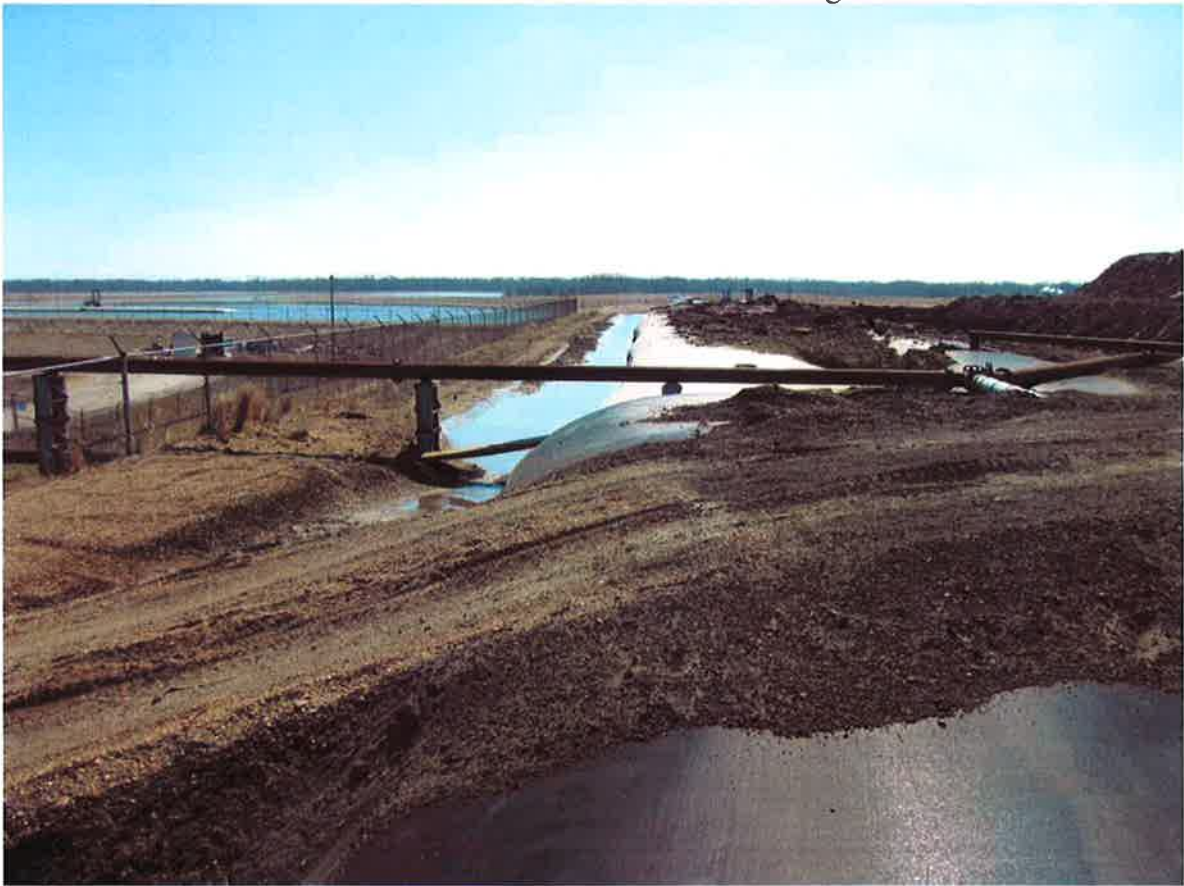
Photo #4 – Ash Pond A - East berm looking south

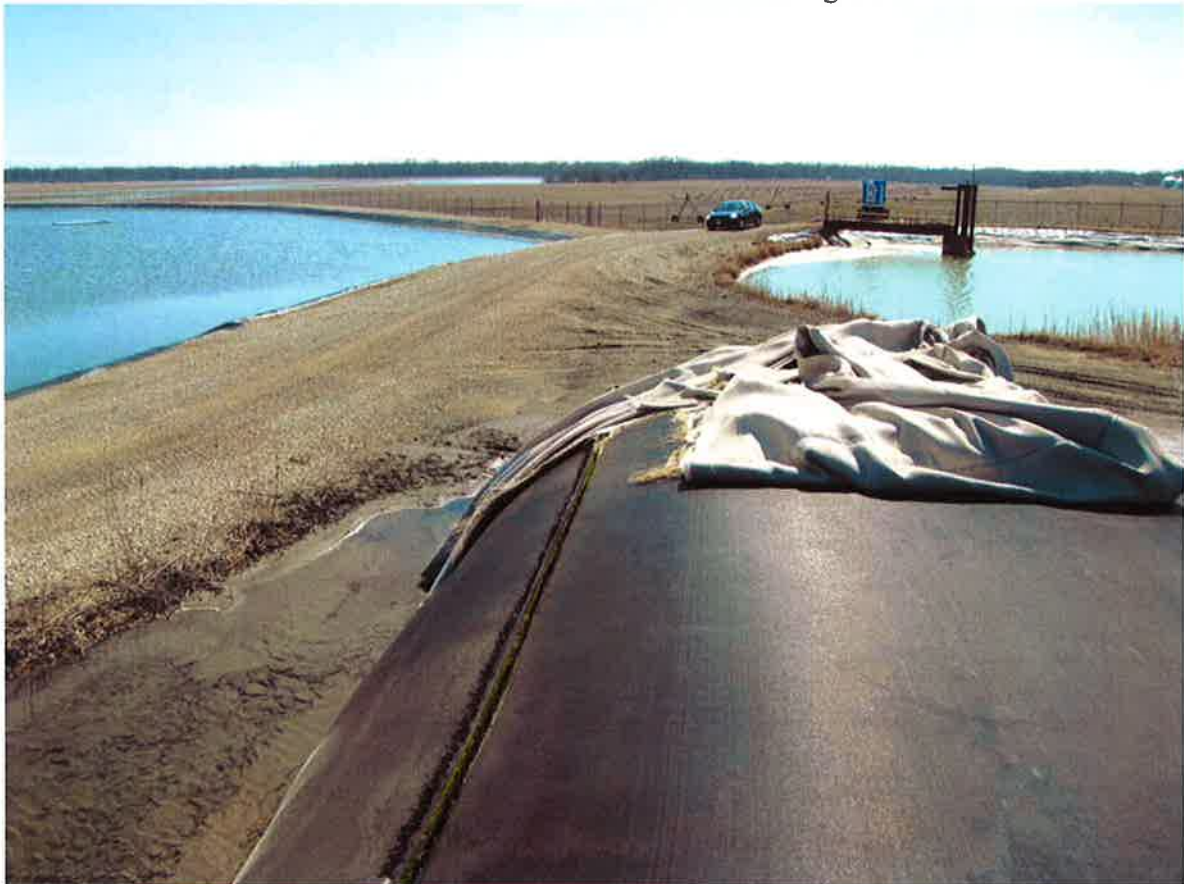
Photo #5 - Ash Pond A – Outlet structure

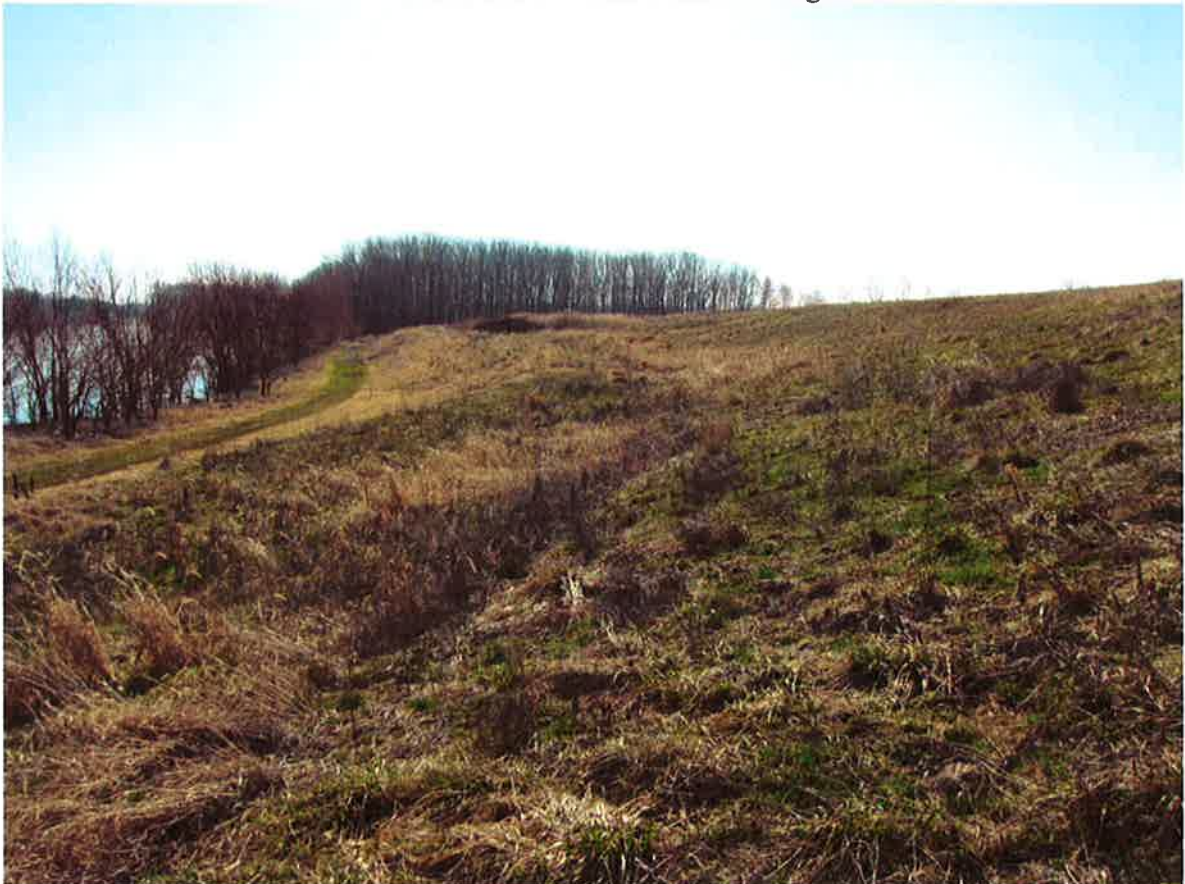
Photo #11 – Bottom Ash Pond – Northeast berm looking south

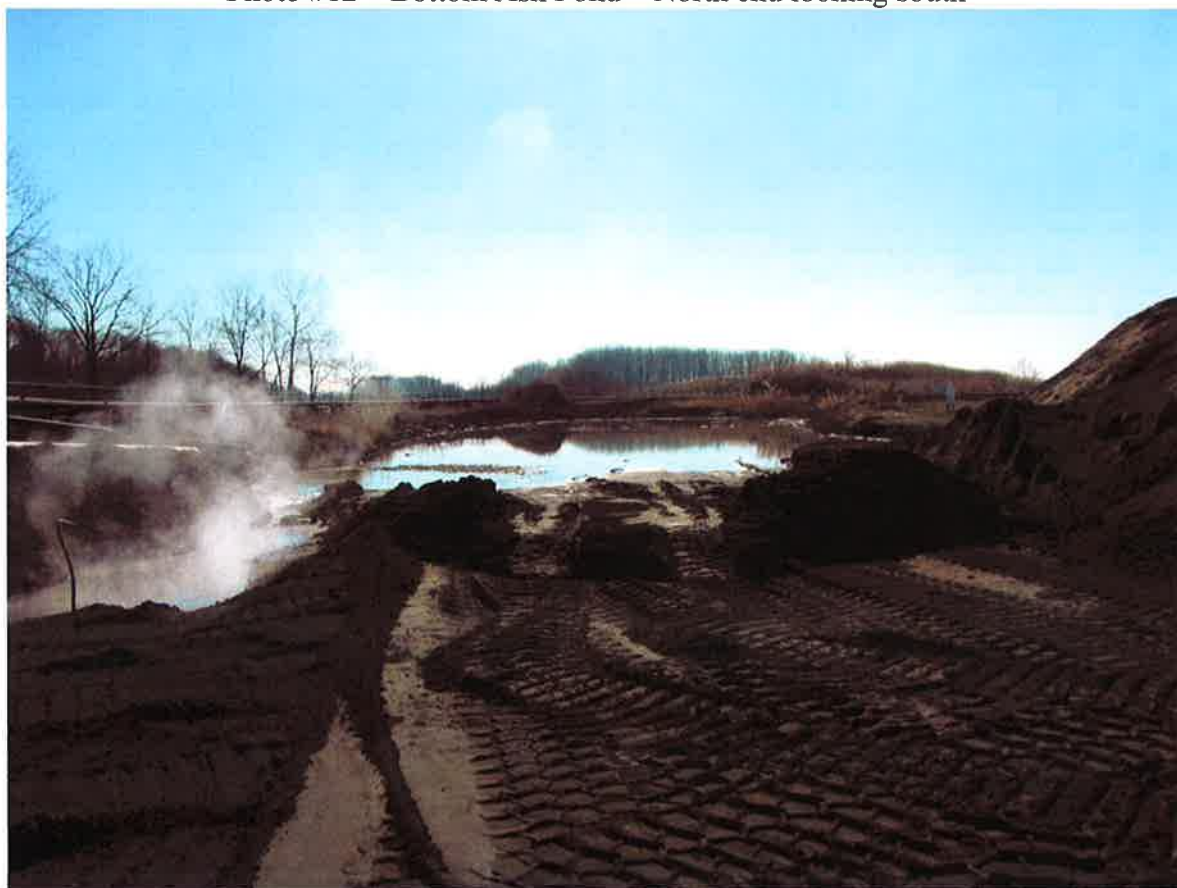
Photo #13 – Bottom Ash Pond - East berm looking south

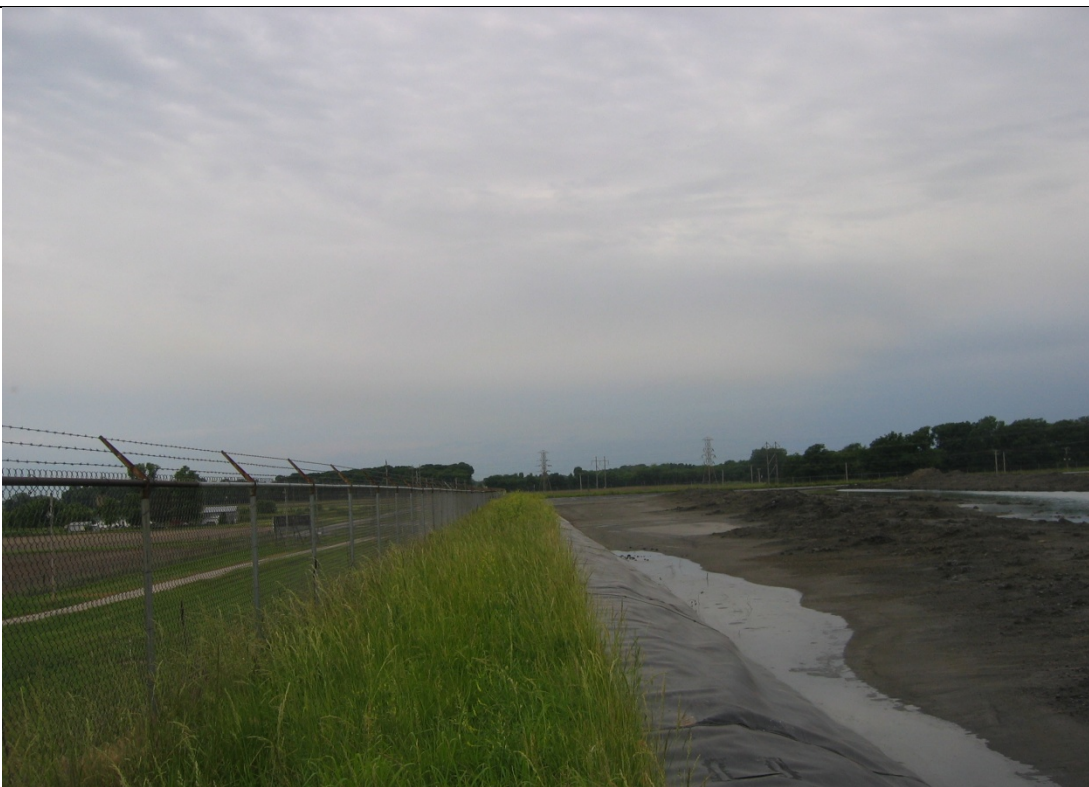
**Description:**  
Upstream slope and crest of  
Pond A.

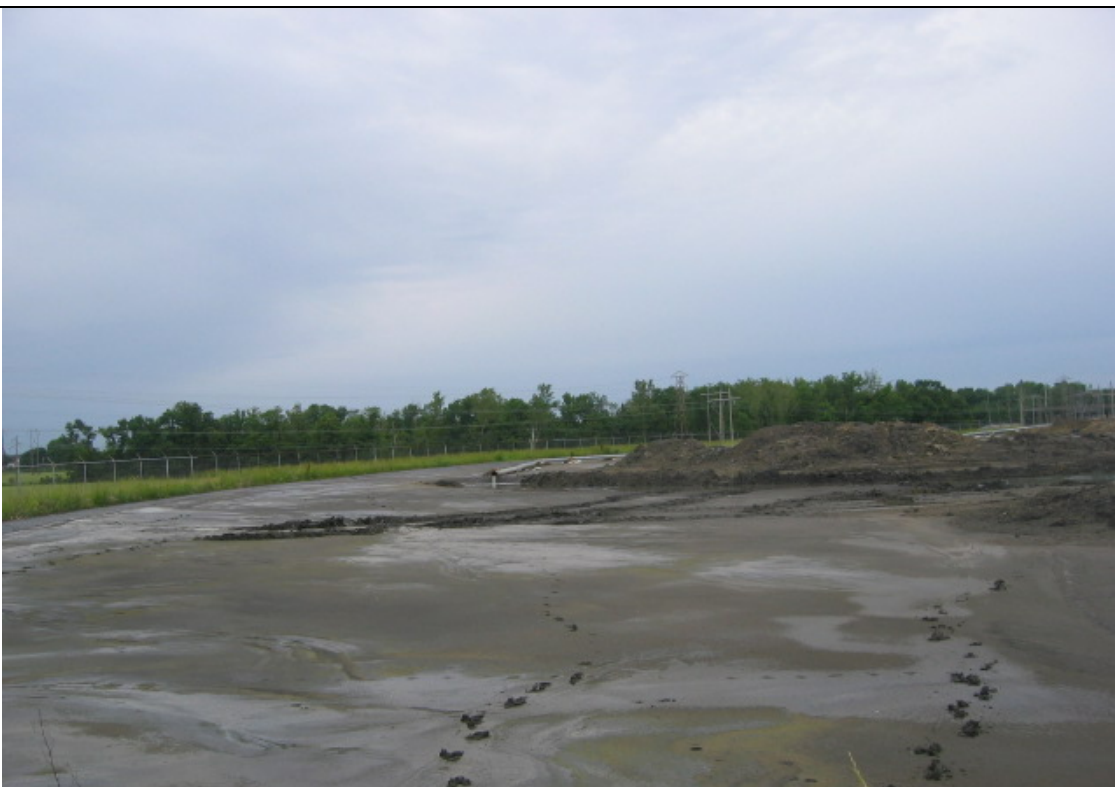
**Description:**  
Upstream slope and  
discharge pipe in Pond A.

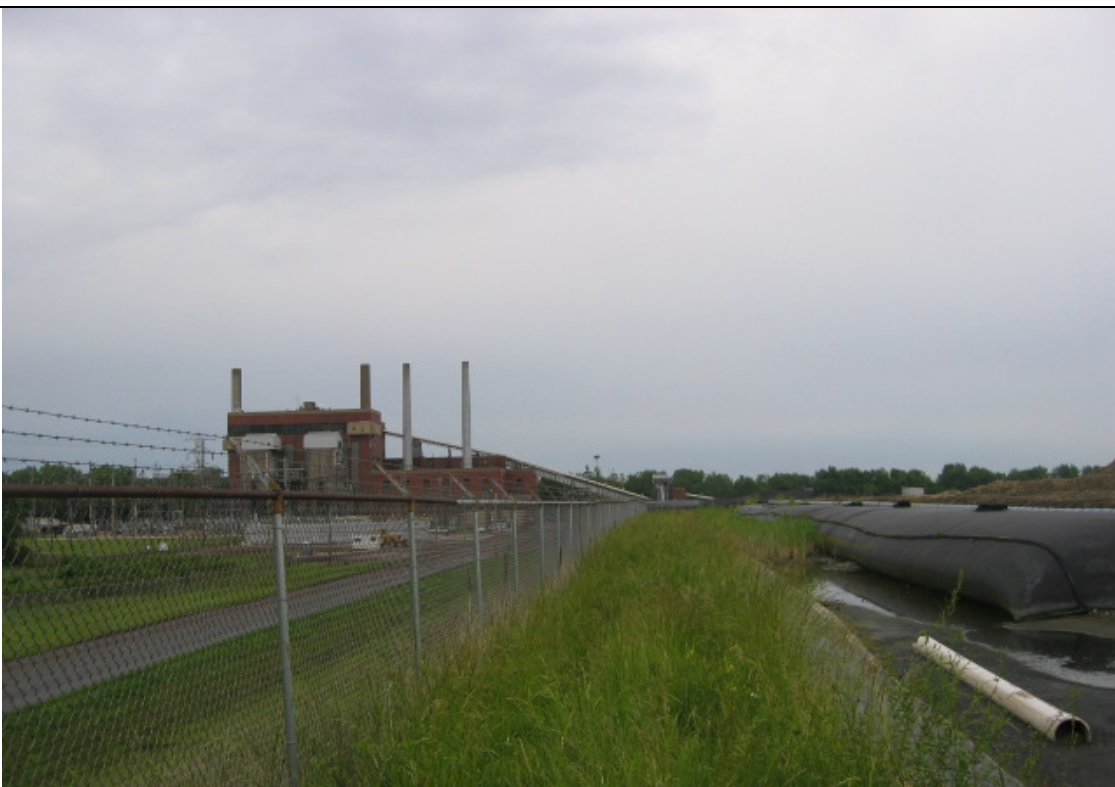
**Description:**  
Upstream slope and crest of  
Pond A.

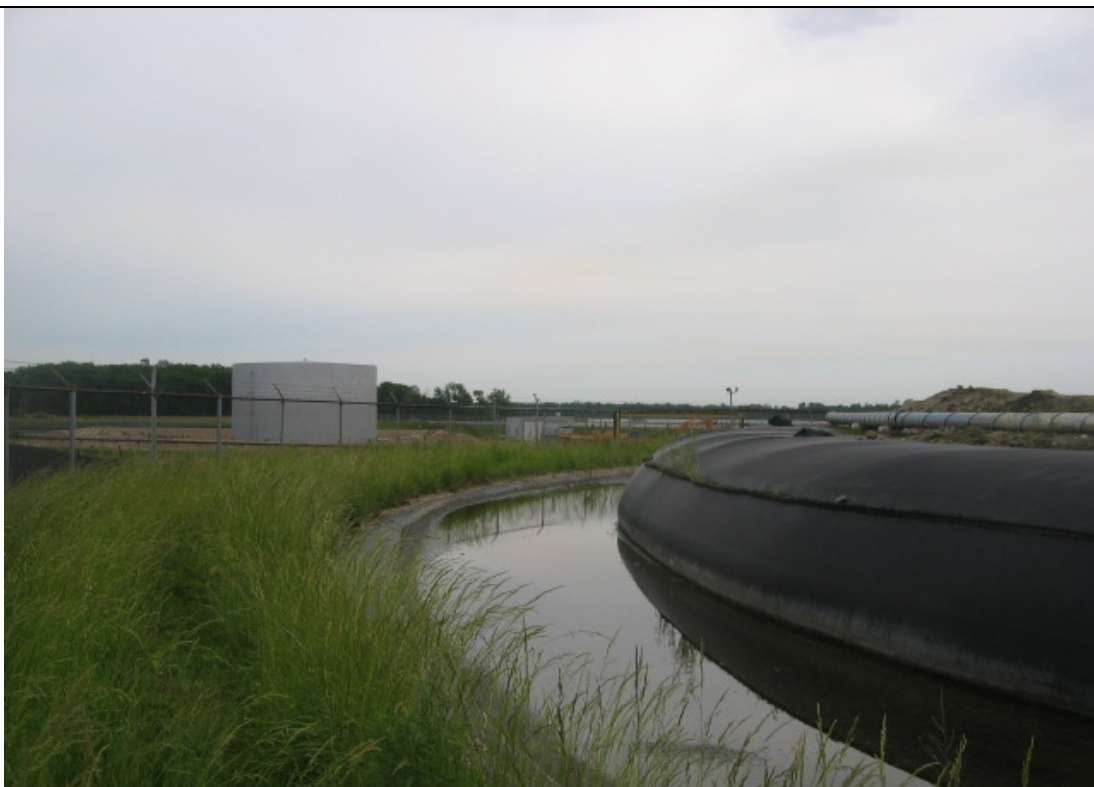
**Description:**  
Upstream slope and crest of  
Pond A.

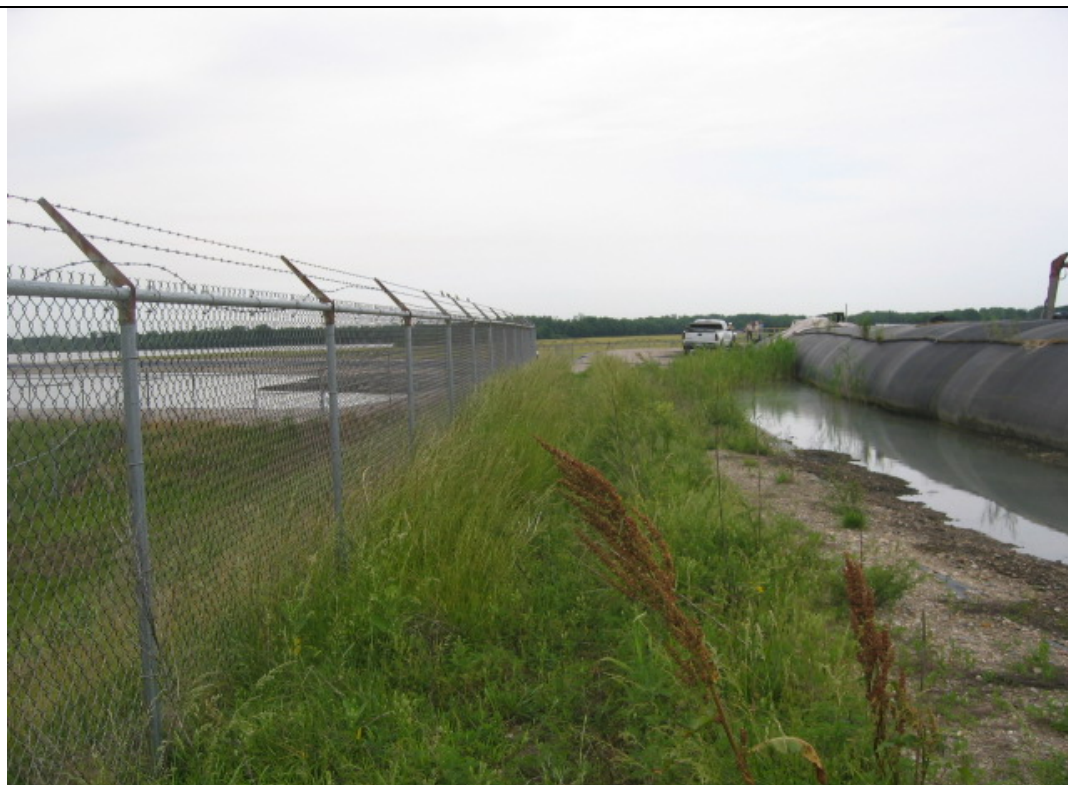
**Description:**  
Upstream slope and crest of  
Pond A.

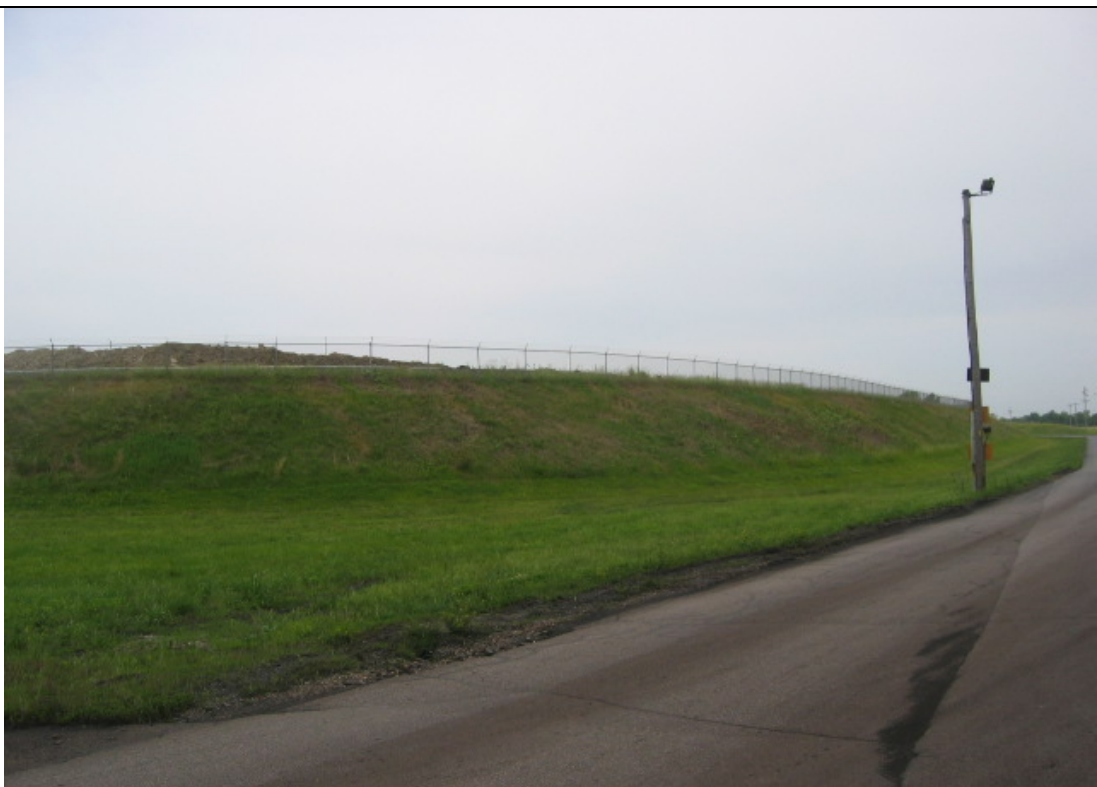
**Description:**  
Downstream slope of Pond  
A.

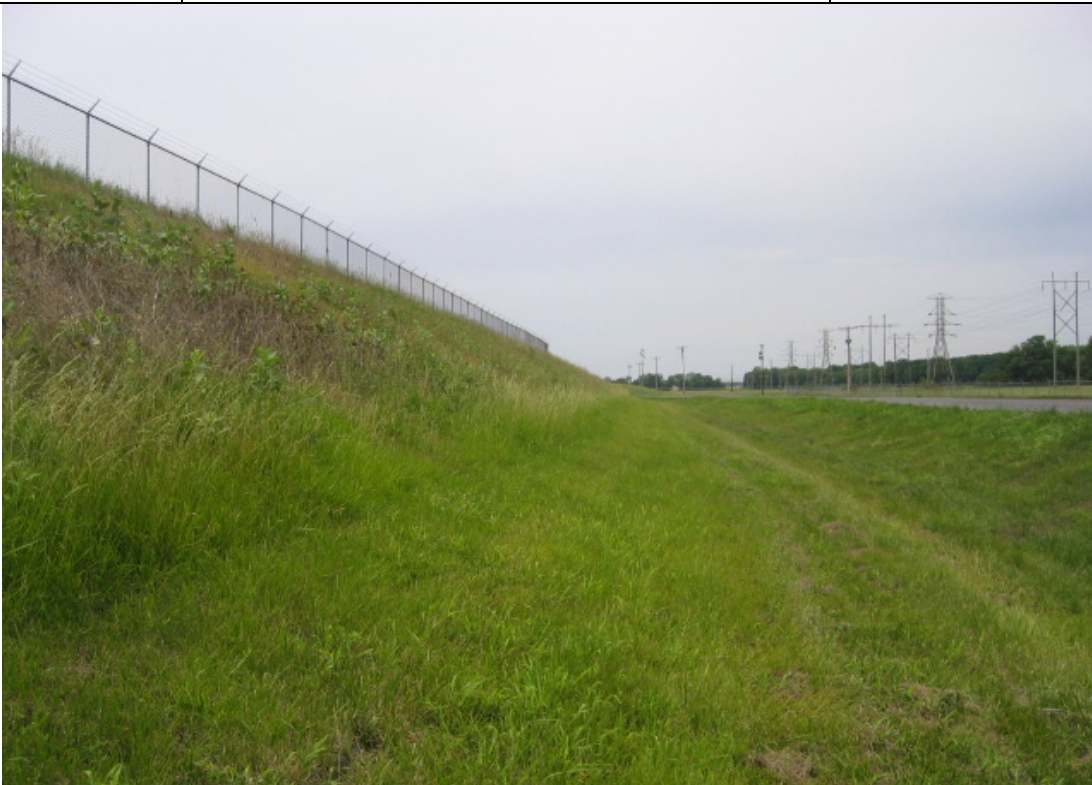
**Description:**  
Downstream slope of Pond  
A.

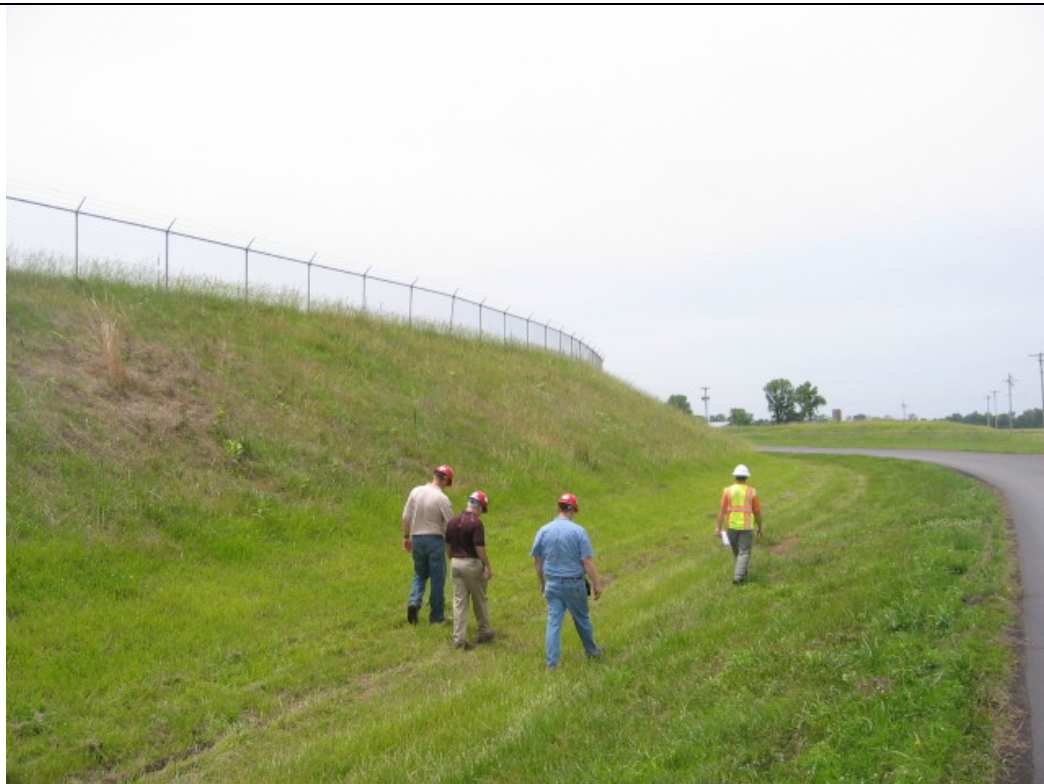
**Photo No.**  
**14**

**Description:**  
Downstream slope of Pond  
A.

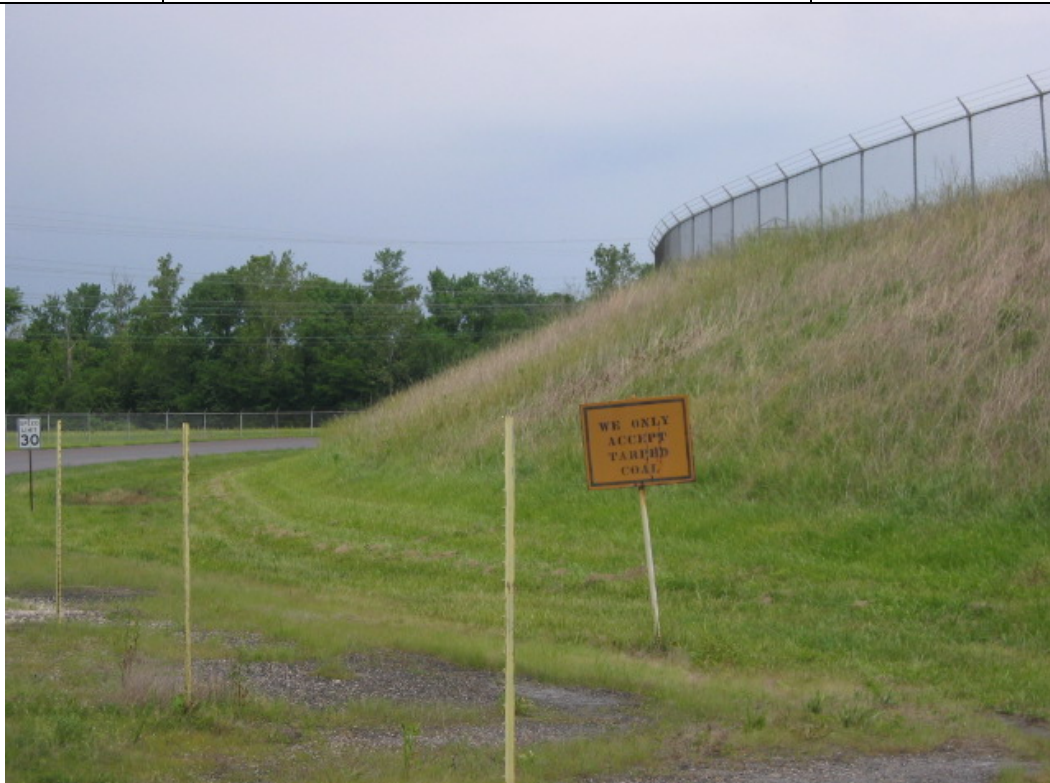
**Description:**  
Downstream slope of Pond  
A.

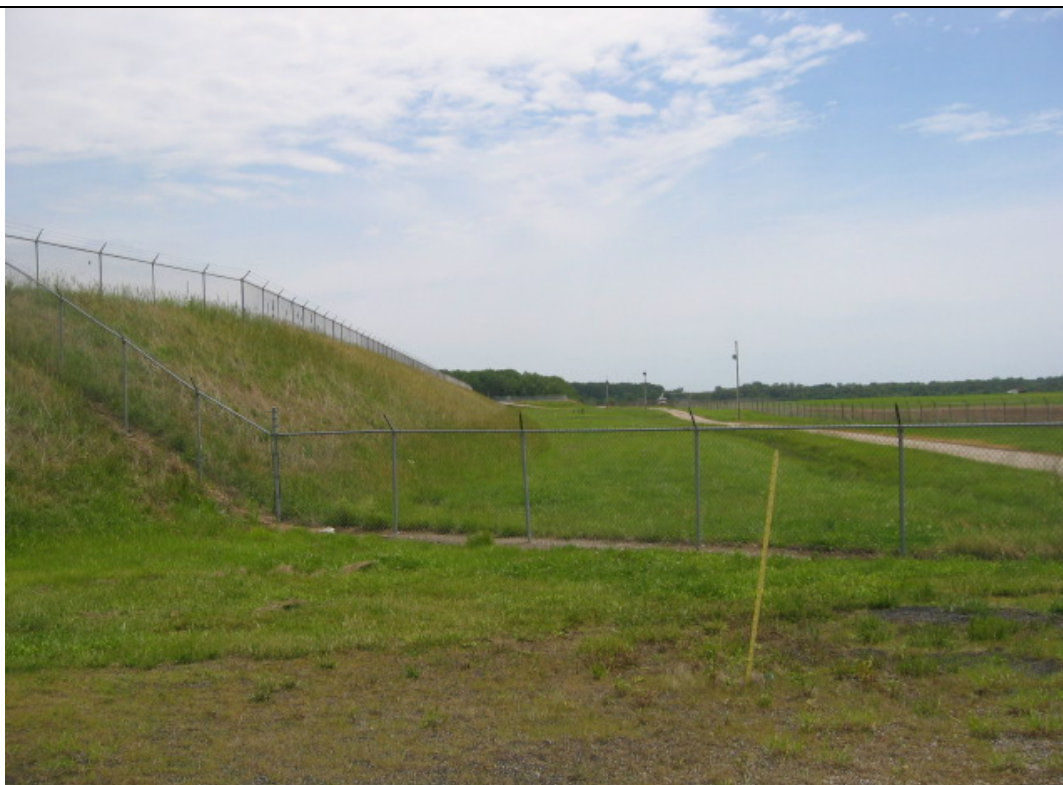
**Photo No.**  
**16**

**Description:**  
Downstream slope of Pond  
A.

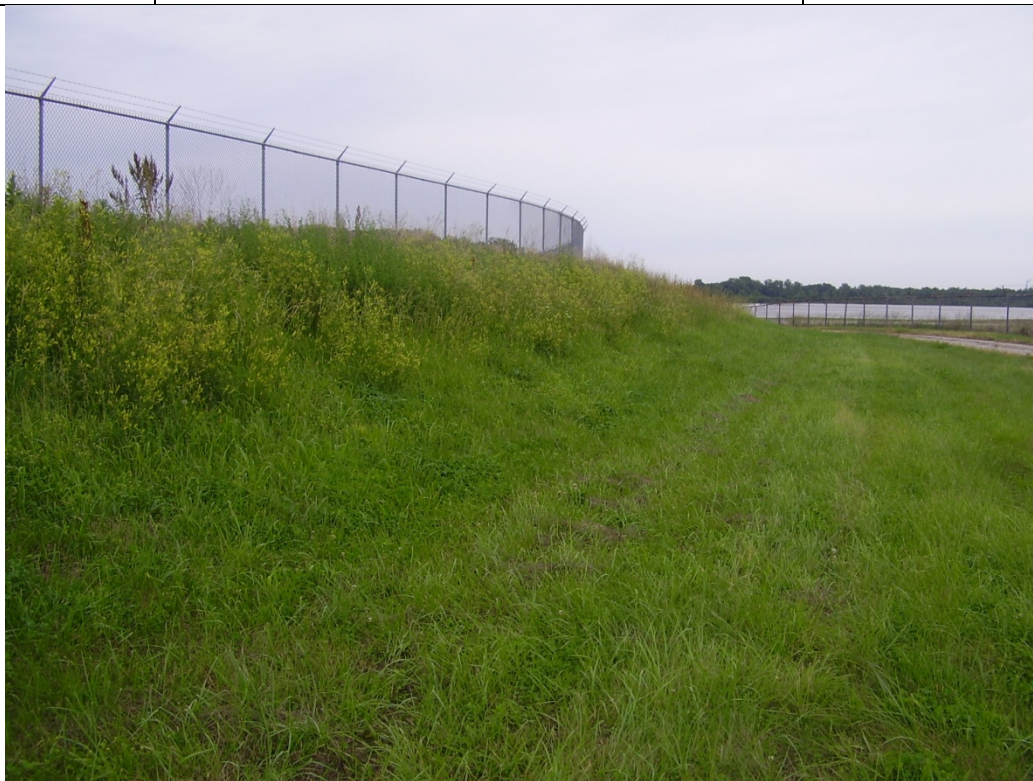
**Description:**  
Downstream slope of Pond  
A.

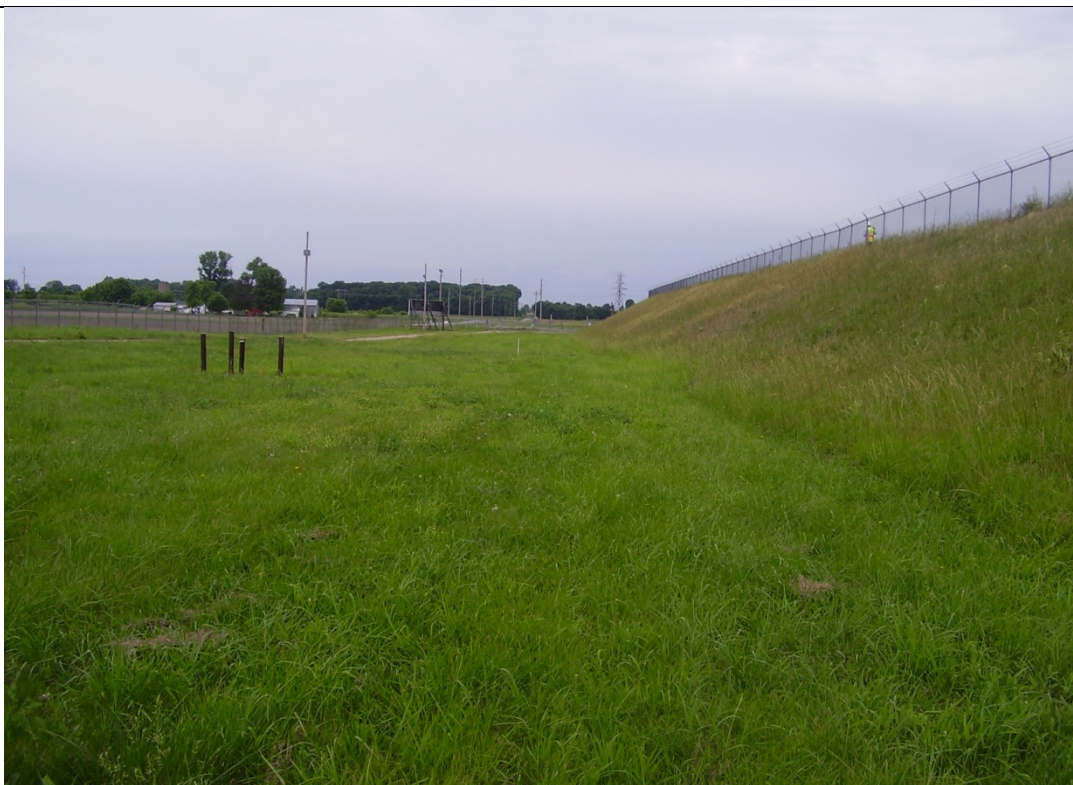
**Photo No.**  
**18**

**Description:**  
Downstream slope of Pond  
A.

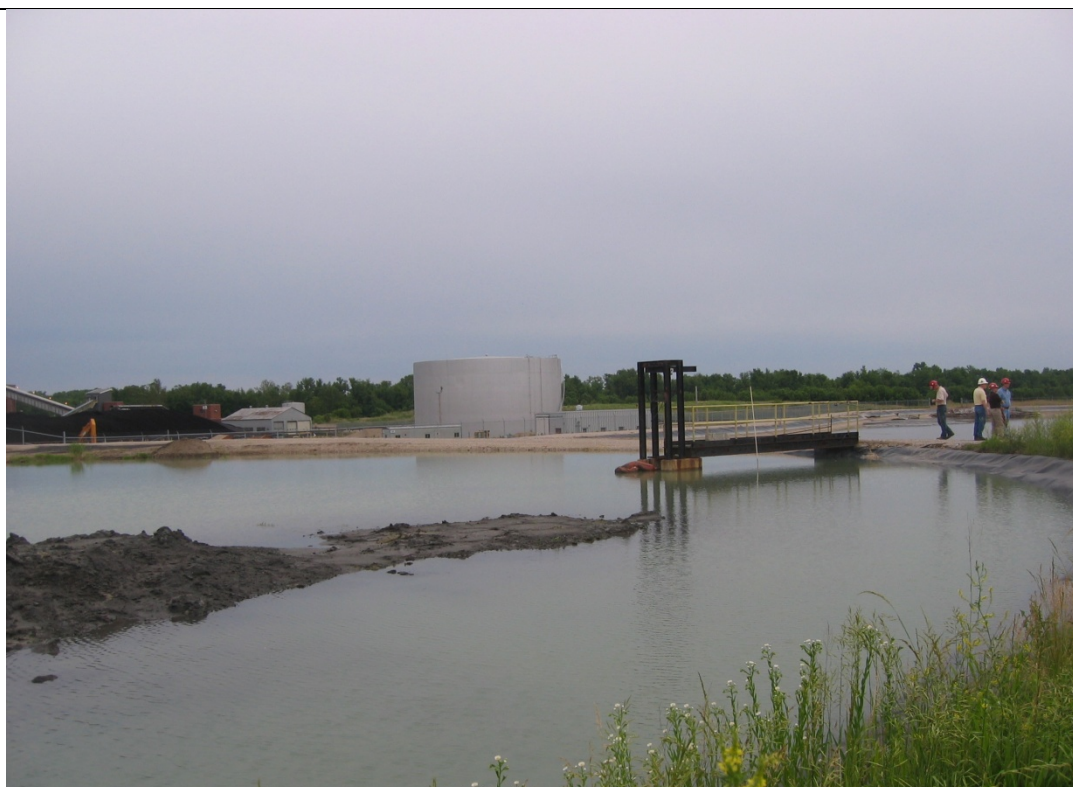
**Description:**  
Decant structure in Pond A.

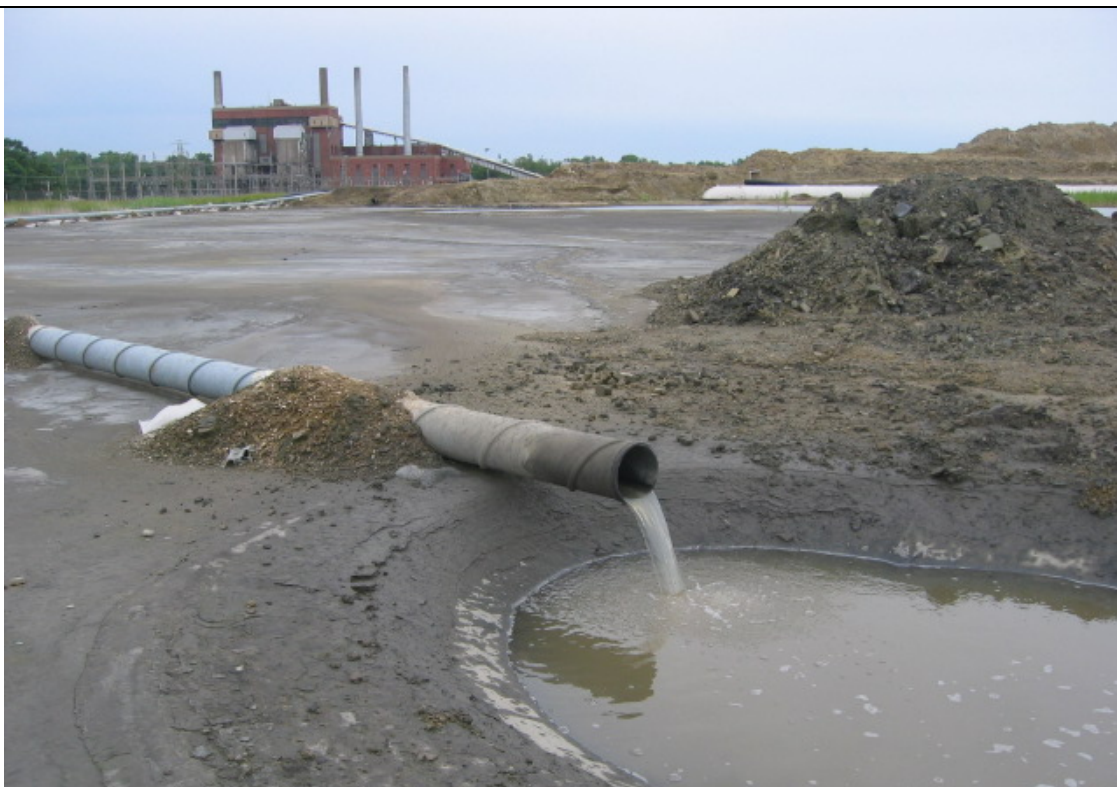
**Description:**  
Discharge pipe in Pond A.

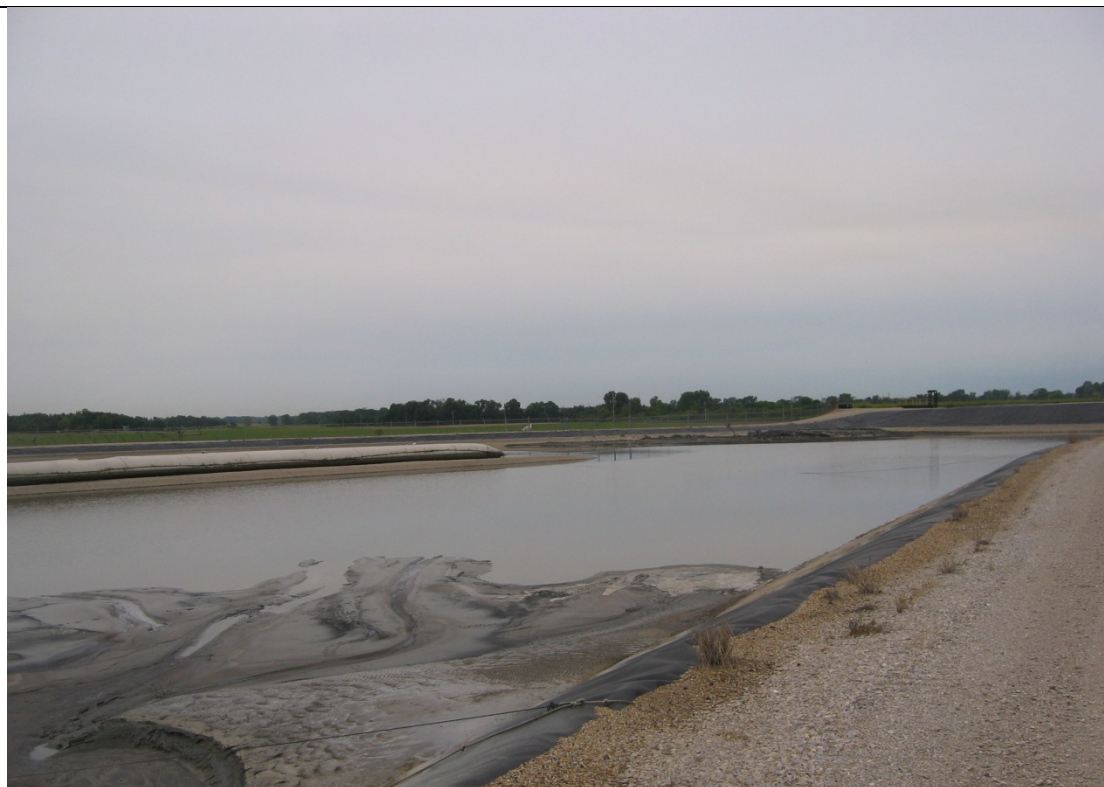
**Description:**  
Upstream slope and crest of  
Pond B.

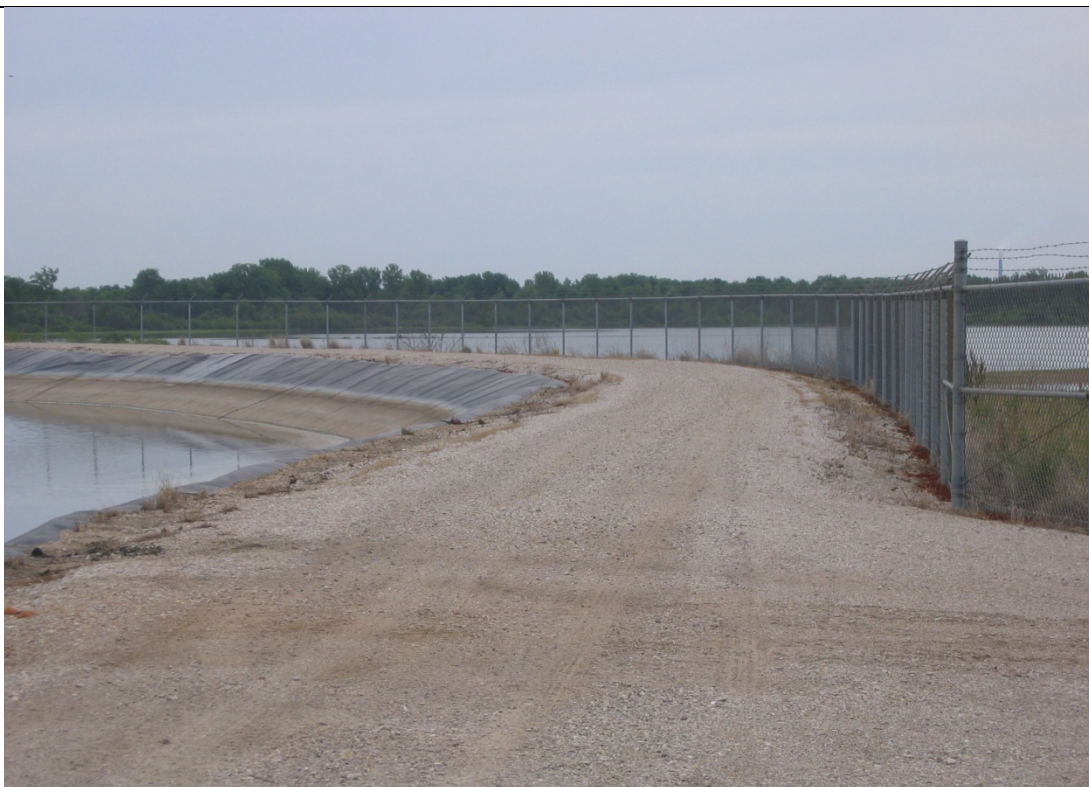
**Description:**  
Upstream slope and crest of  
Pond B.
