**FINAL REPORT  
ROUND 10 DAM ASSESSMENT  
AMEREN ENERGY GENERATING COMPANY – HUTSONVILLE POWER  
STATION  
POND A, POND B, POND D  
HUTSONVILLE, ILLINOIS**

October 16, 2012  
GZA File No. 170142.30

RE: Assessment of Dam Safety of Coal Combustion Surface Impoundments at the  
Hutsonville Power Station

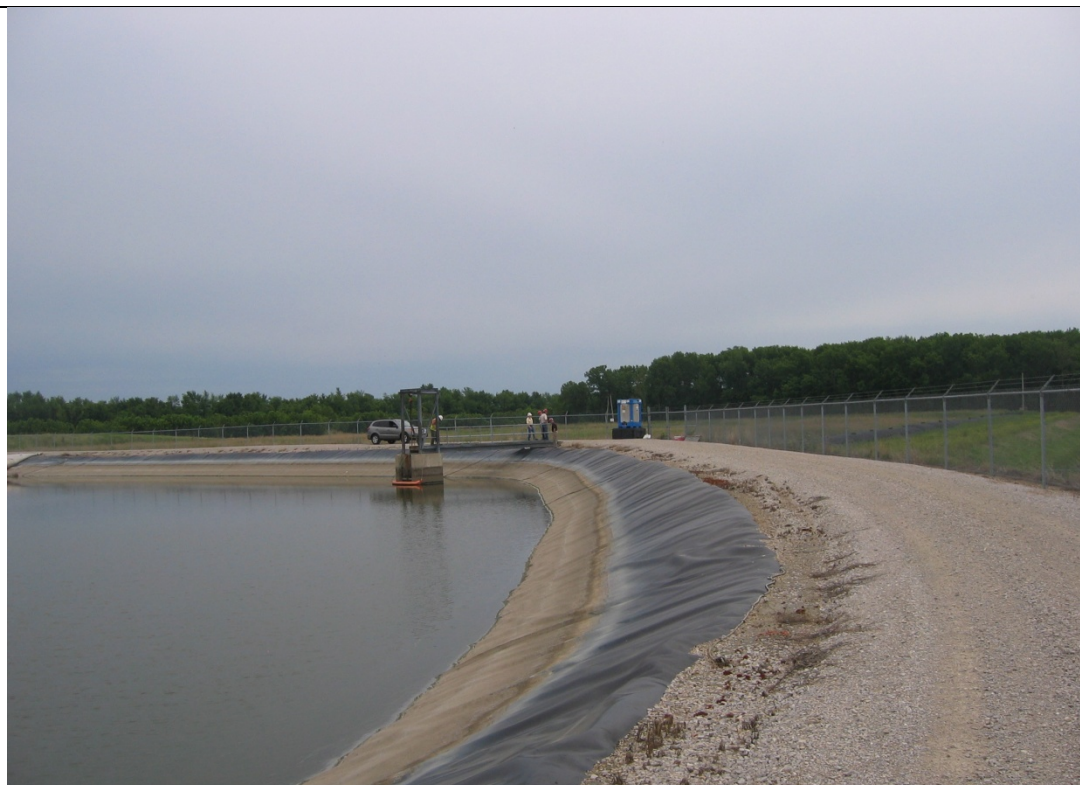
**Description:**  
Upstream slope and crest of  
Pond B.

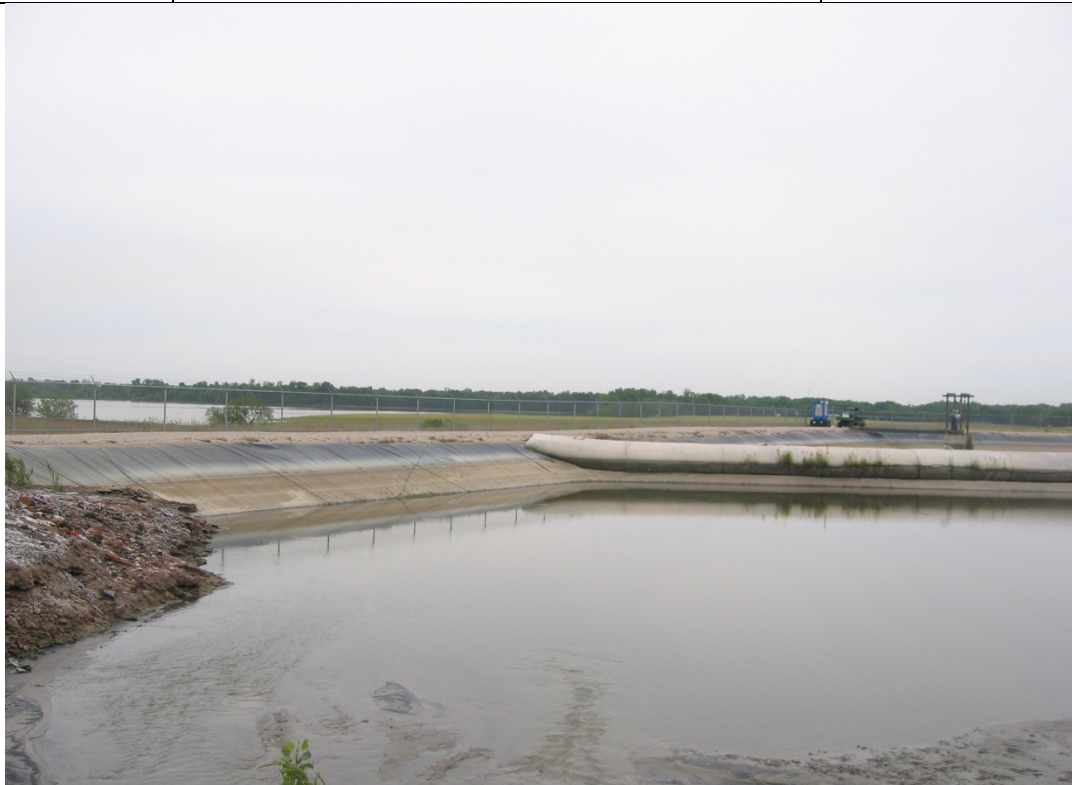
**Description:**  
Upstream slope of Pond B.

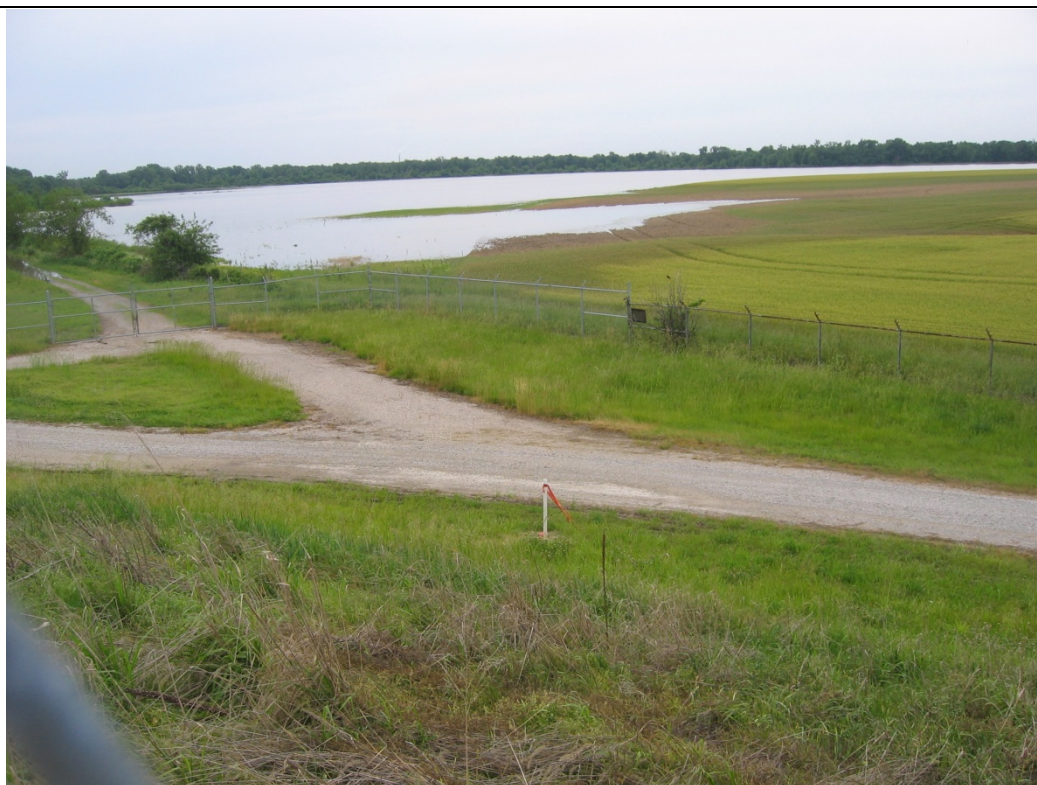
**Photo No.**  
**30**

**Description:**  
Downstream slope of Pond B.

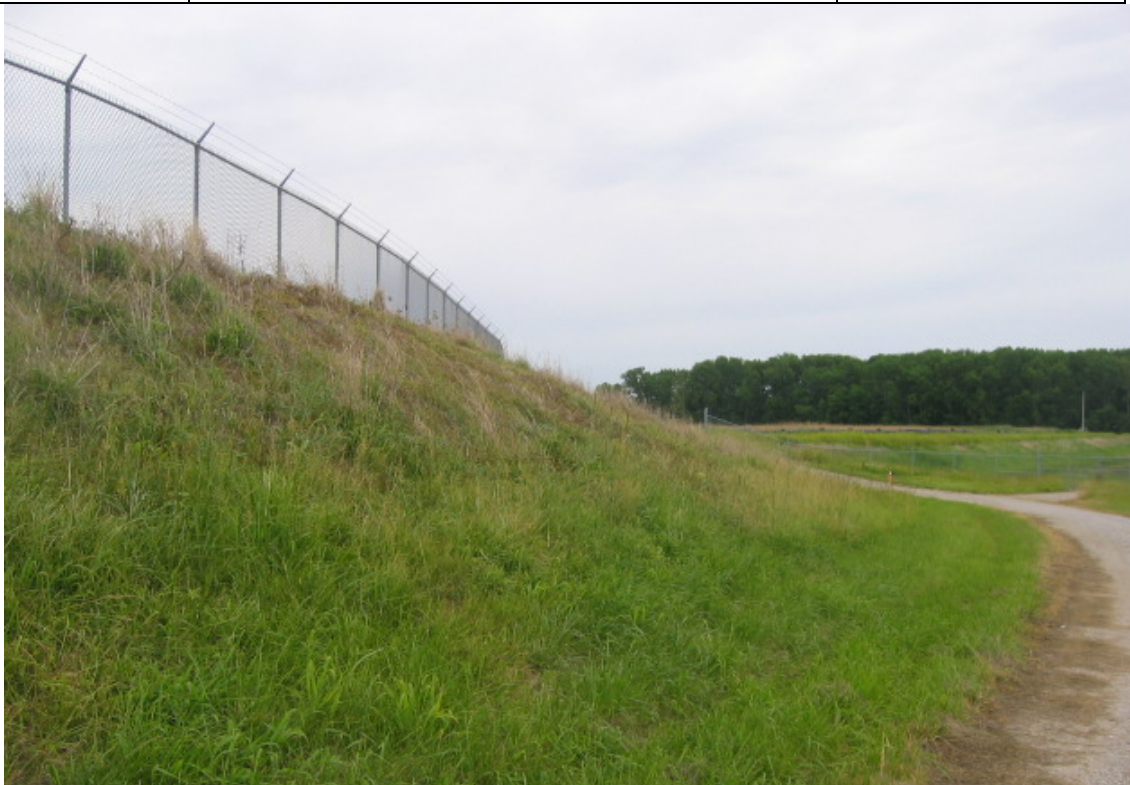
**Description:**  
Downstream slope of Pond  
B.

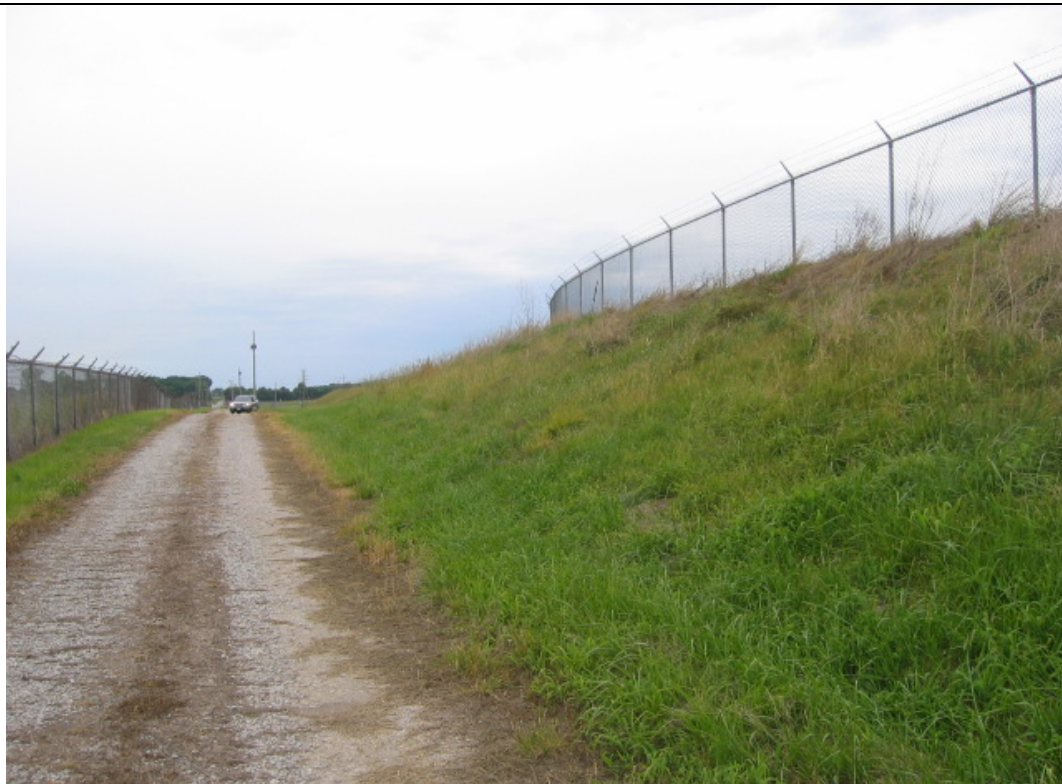
**Photo No.**  
**32**

**Description:**  
Downstream slope of Pond  
B.

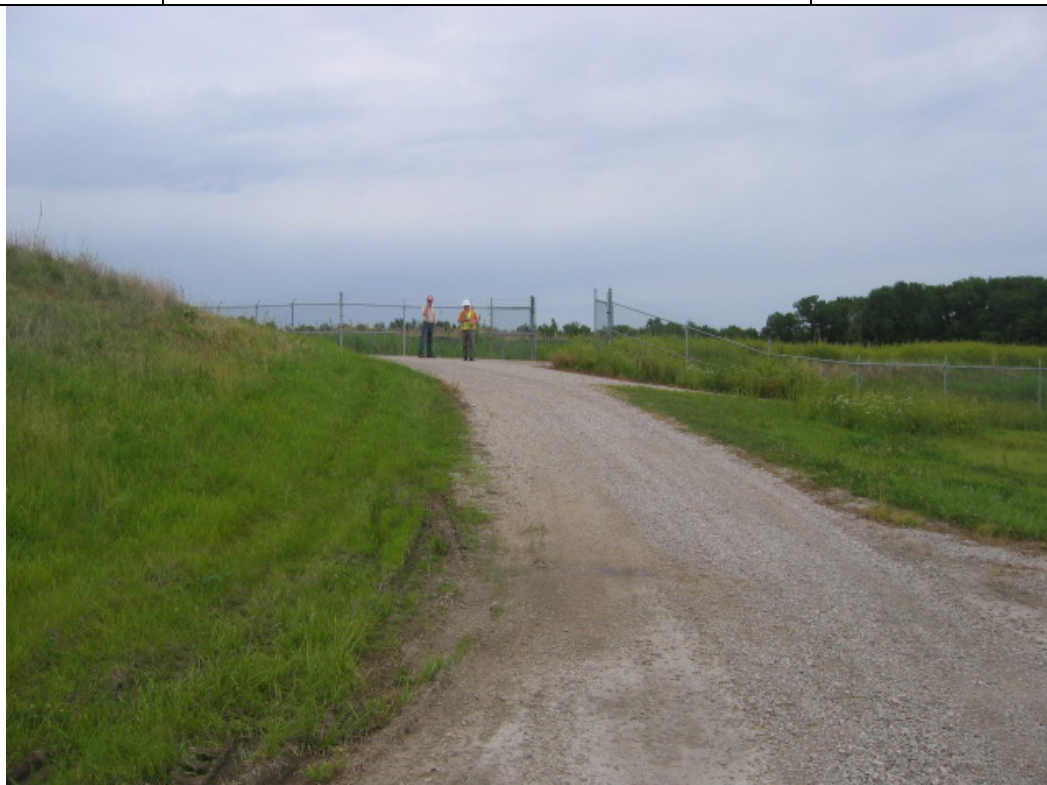
**Description:**  
Downstream slope of Pond  
B.

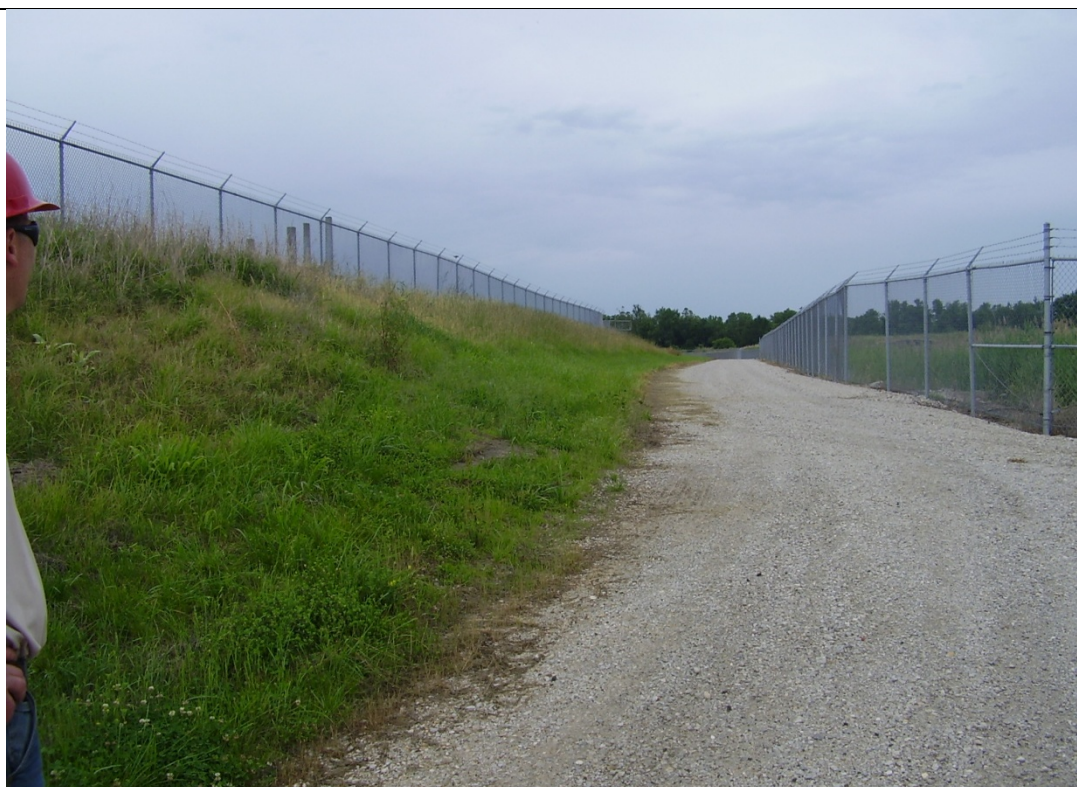
**Photo No.**  
**34**

**Description:**  
Downstream slope of Pond  
B.

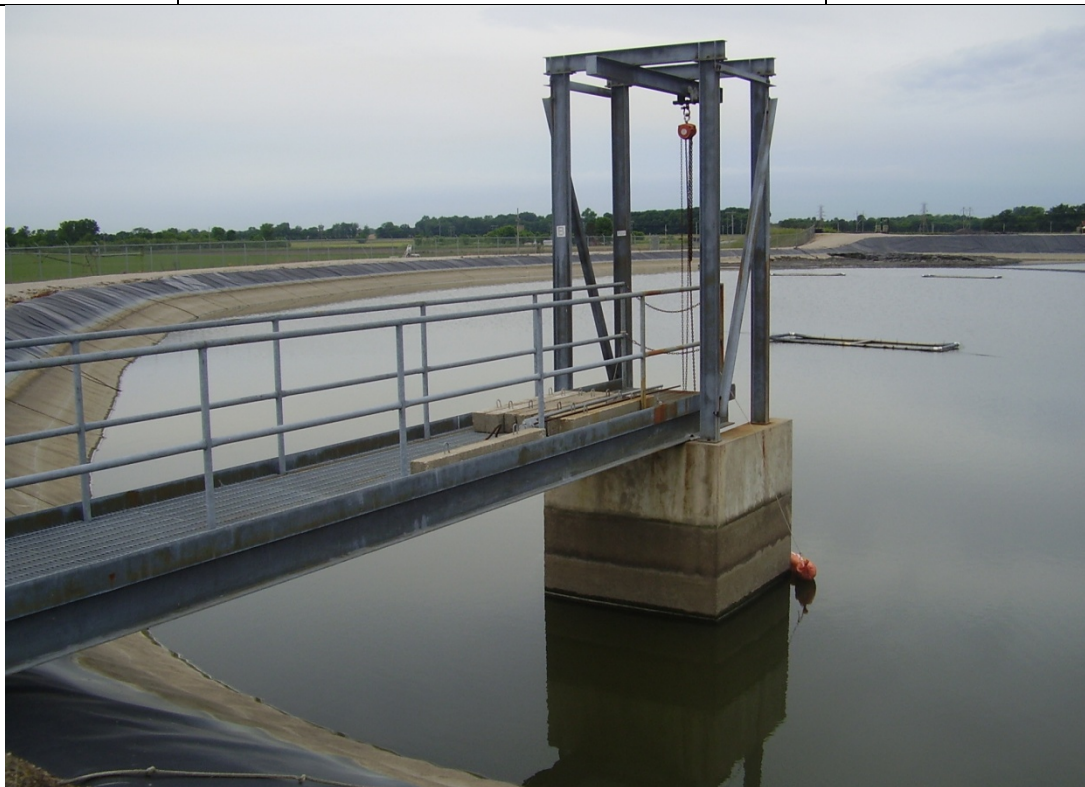
**Description:**  
Decant structure in Pond B.

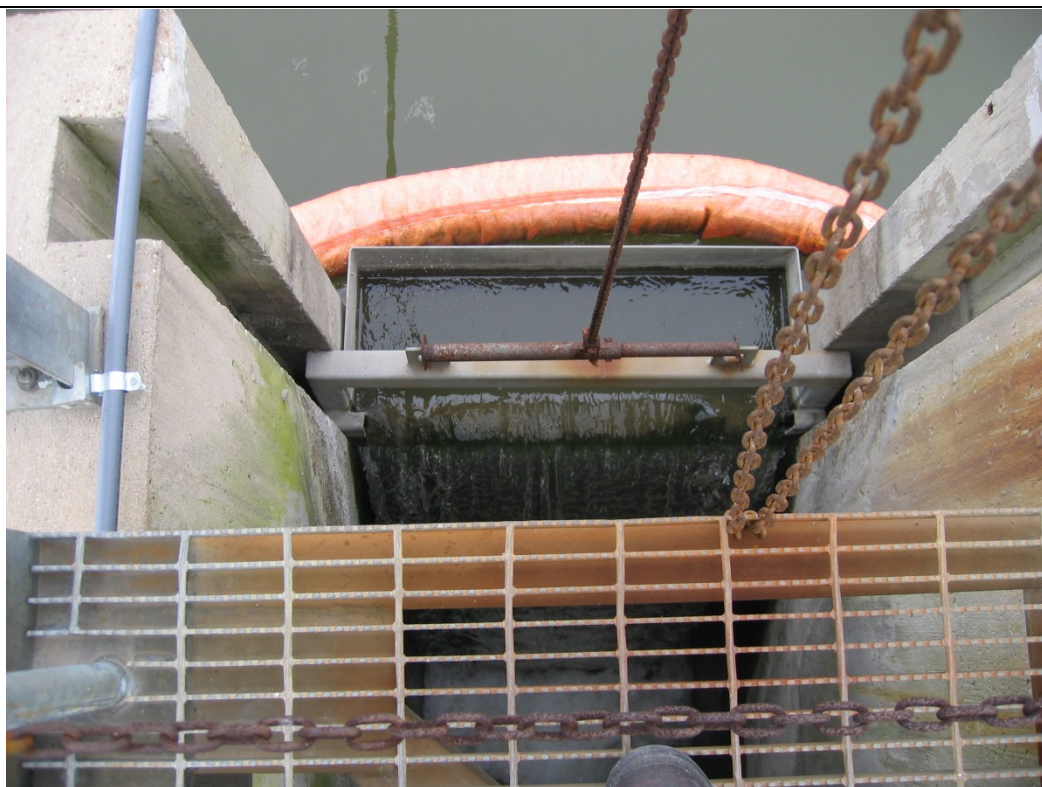
**Photo No.**  
**36**

**Description:**  
Decant structure in Pond B.

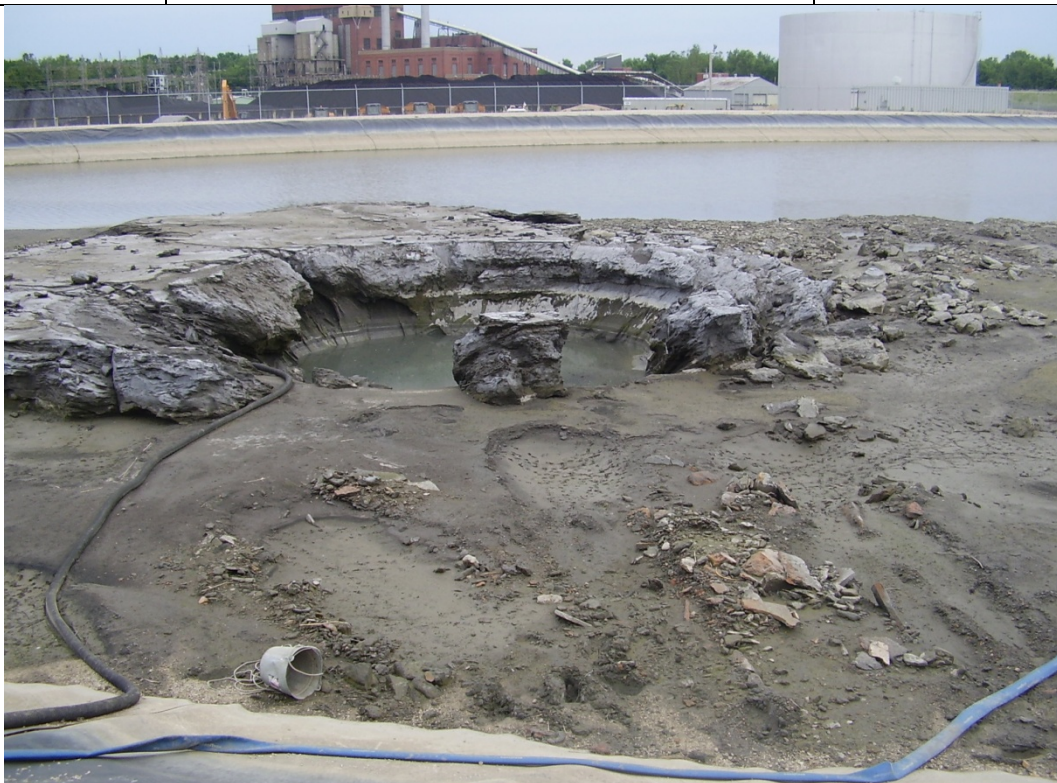
Location of discharge pipe  
from Pond A. At time of  
inspection no water was  
flowing through the pipe to  
support excavation and  
maintenance of the pipe.

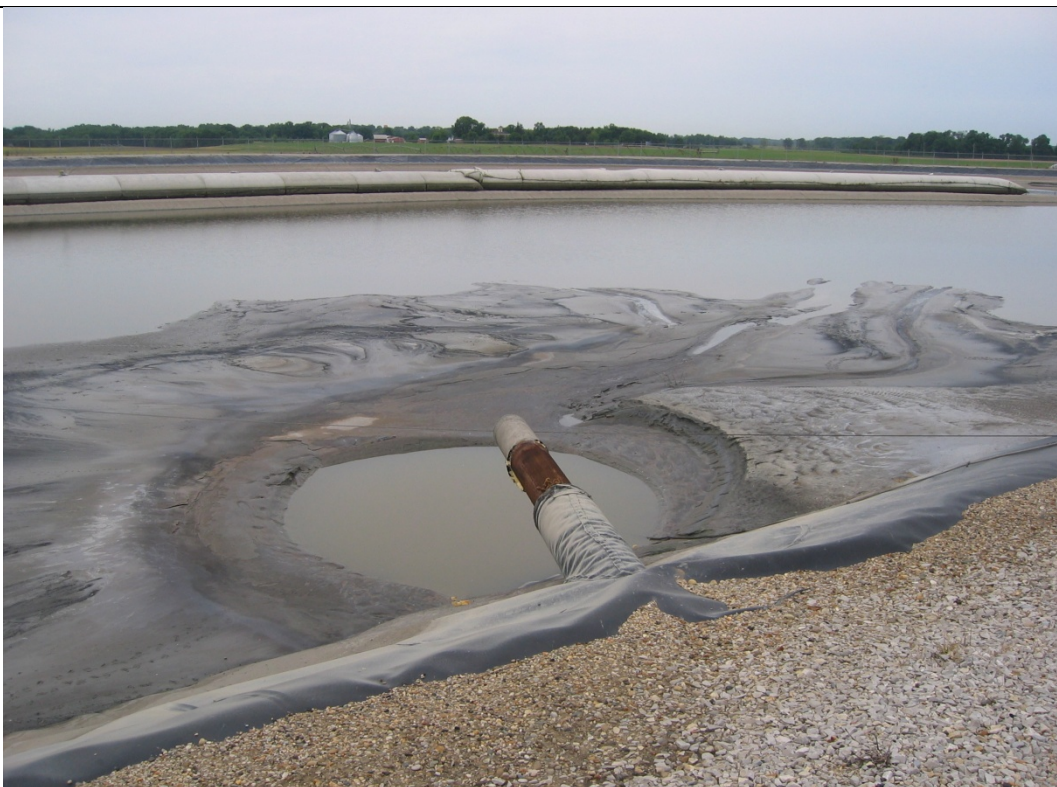
**Photo No.**  
**38**

Discharge pipe from the  
facility.

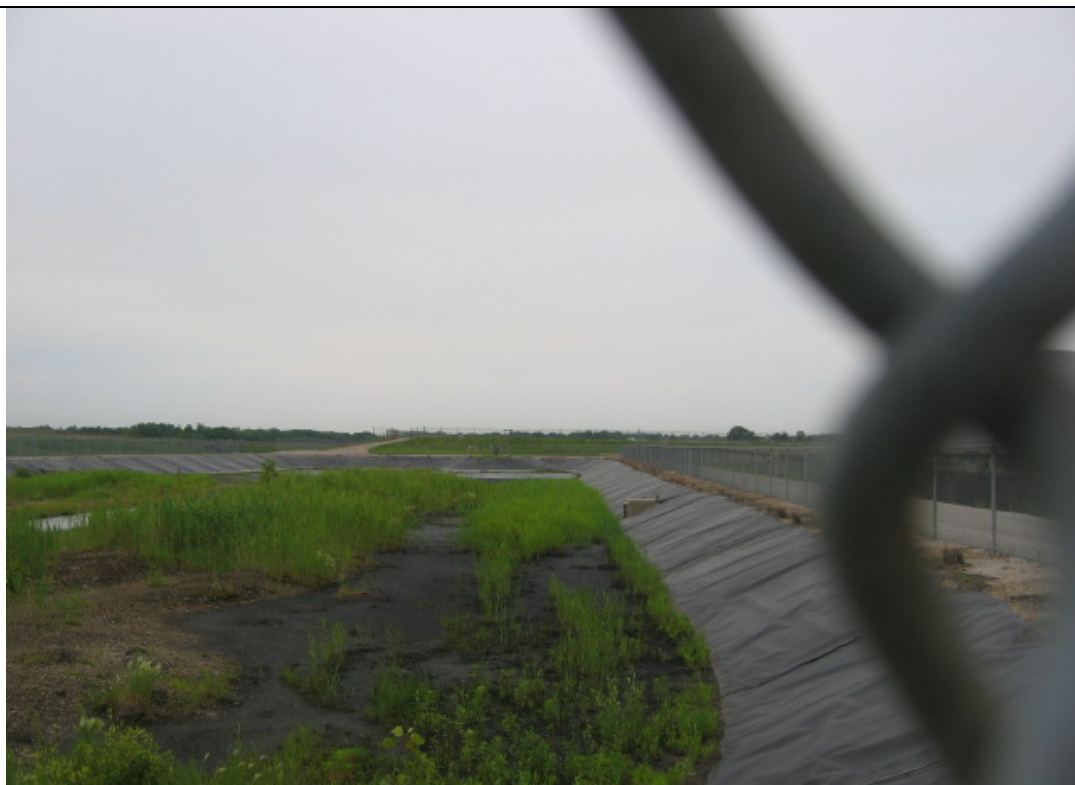
**Description:**  
Pond C as seen from north.

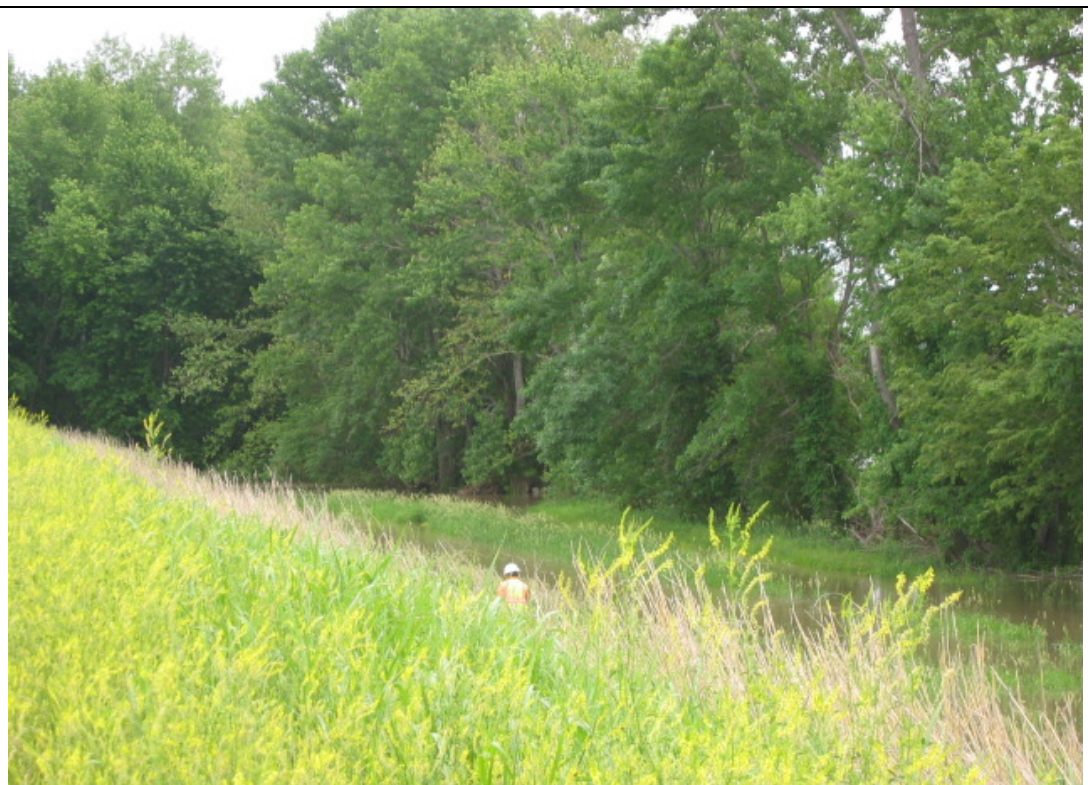
**Description:**  
Downstream slope of the  
closed portion of Pond D as  
seen from the southeast  
corner.

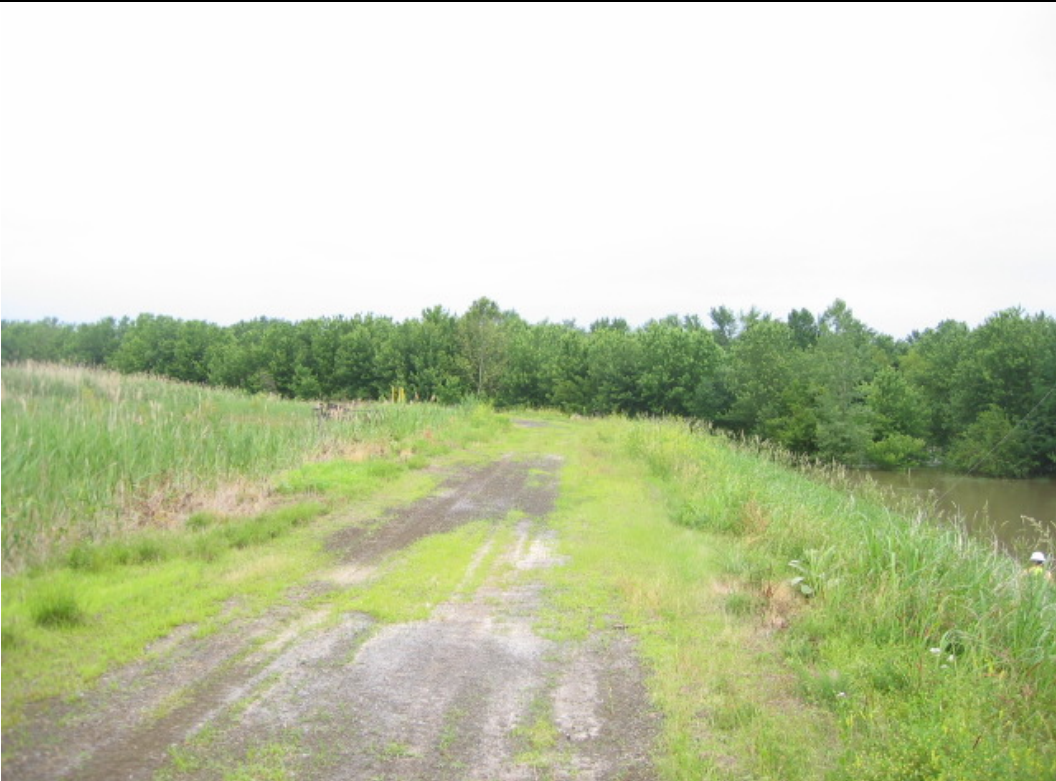
| <b>Description:</b><br>Crest of the closed portion of Pond D. | | | |

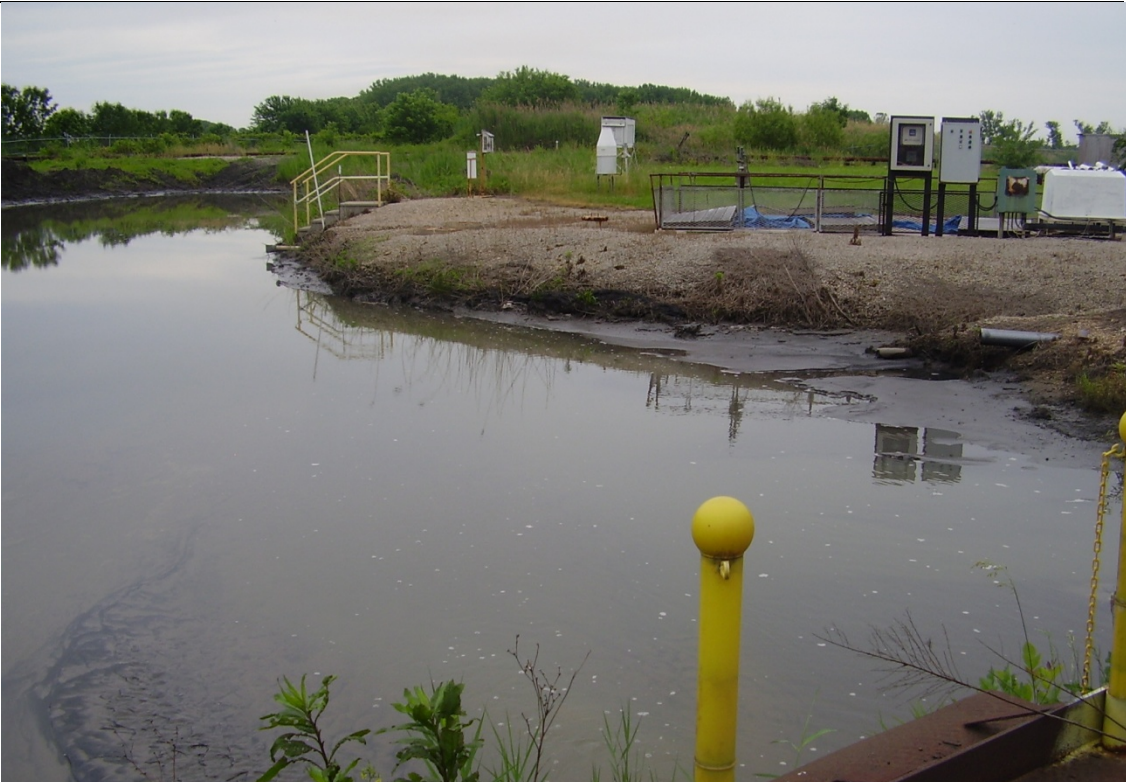
| <b>Description:</b><br>Upstream slope, crest and discharge pipes in the active portion of Pond D. | | |

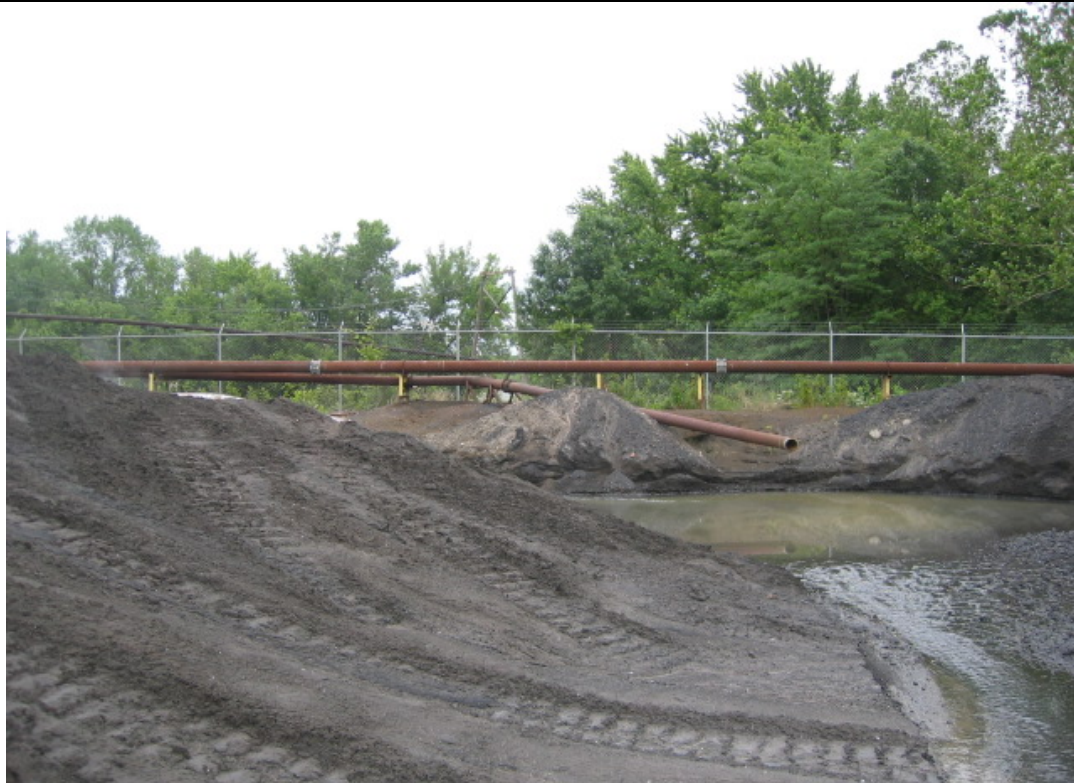
Upstream slope and  
discharge pipe in active  
portion of Pond D.

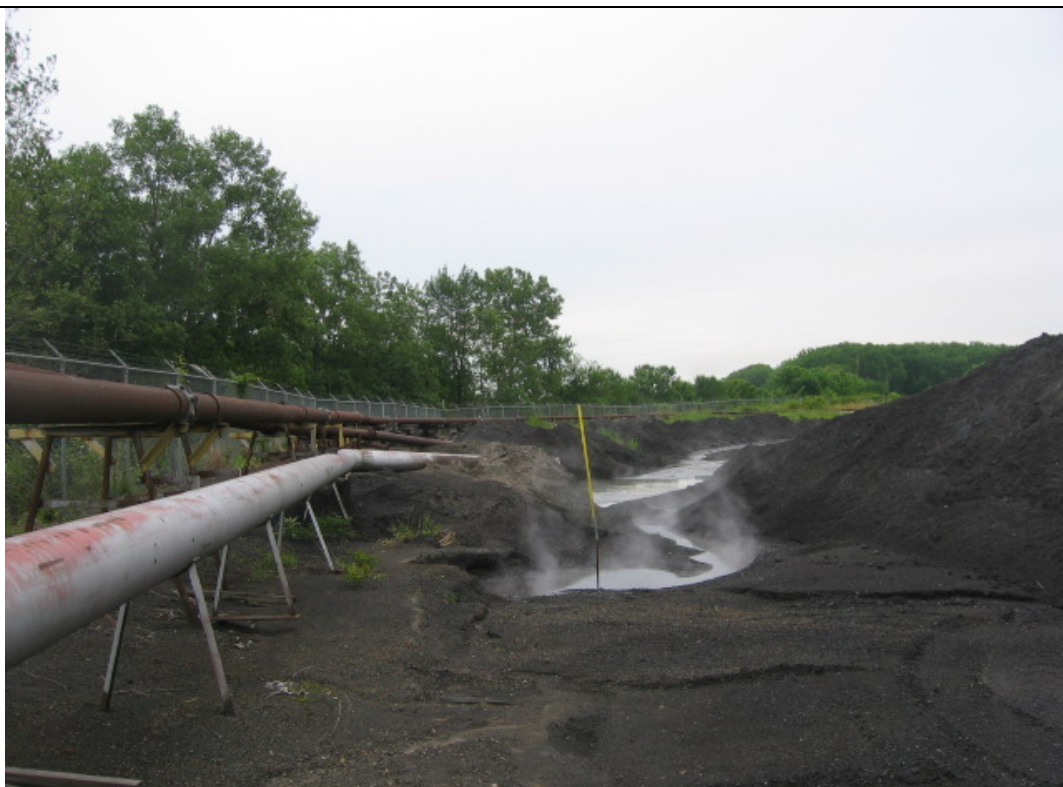
**Photo No.**  
**46**

Upstream slope, crest, and  
discharge pipe in the active  
portion of Pond D.

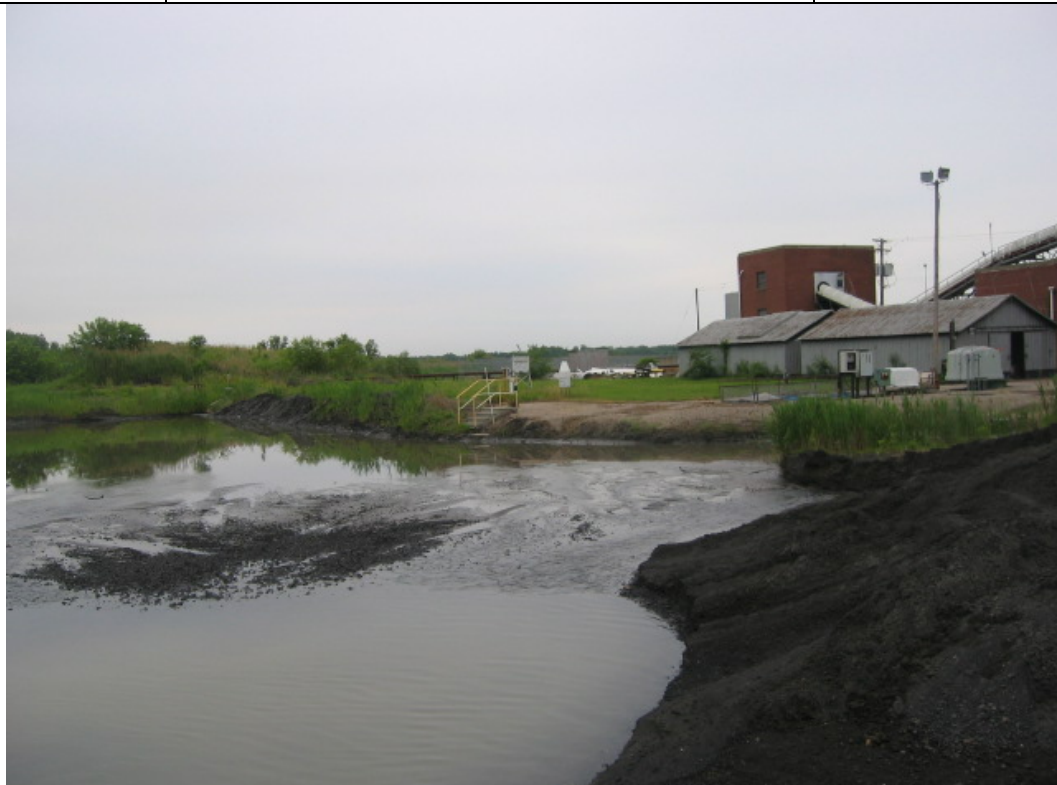
Upstream slope and crest and  
in active portion of Pond D

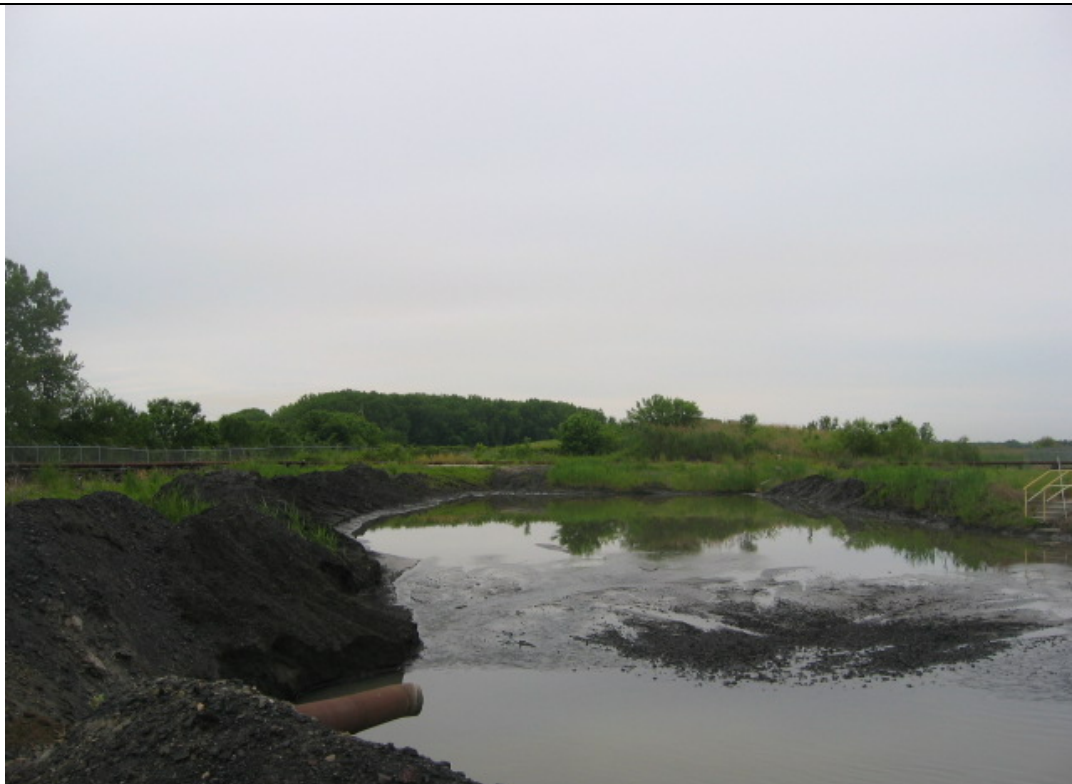
**Photo No.**  
**48**

Upstream slope and crest in  
active portion of Pond D.

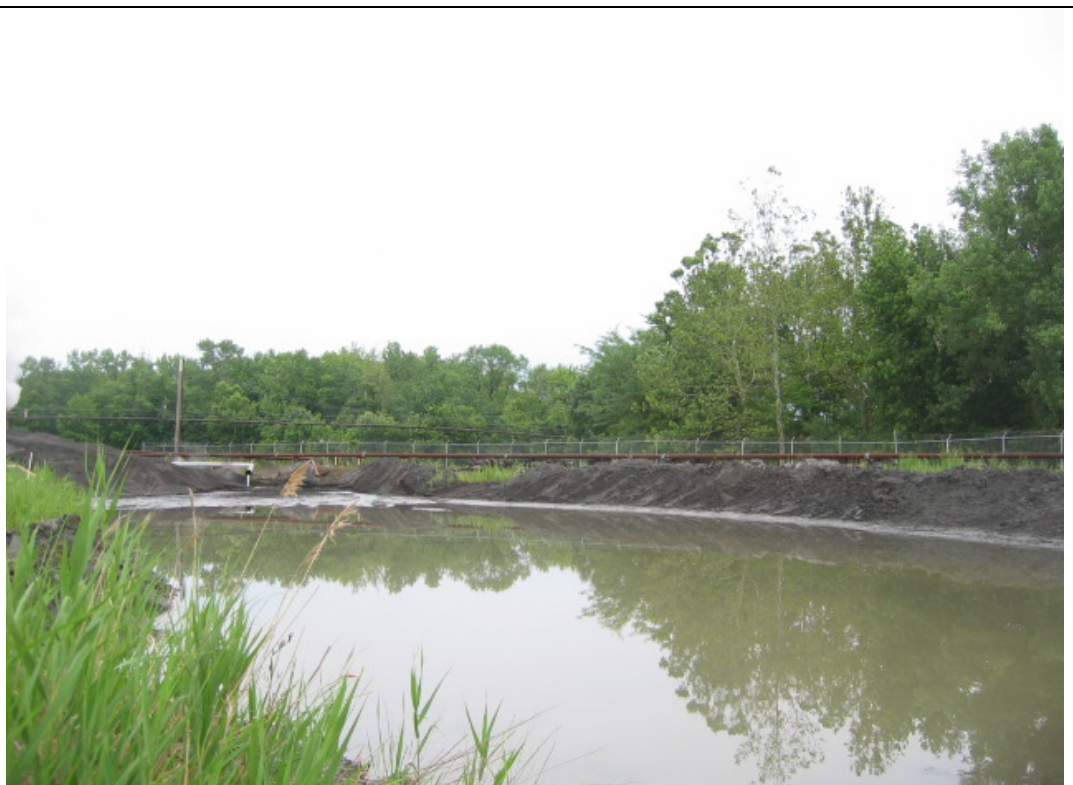
**Description:**  
Upstream slope in Pond D.

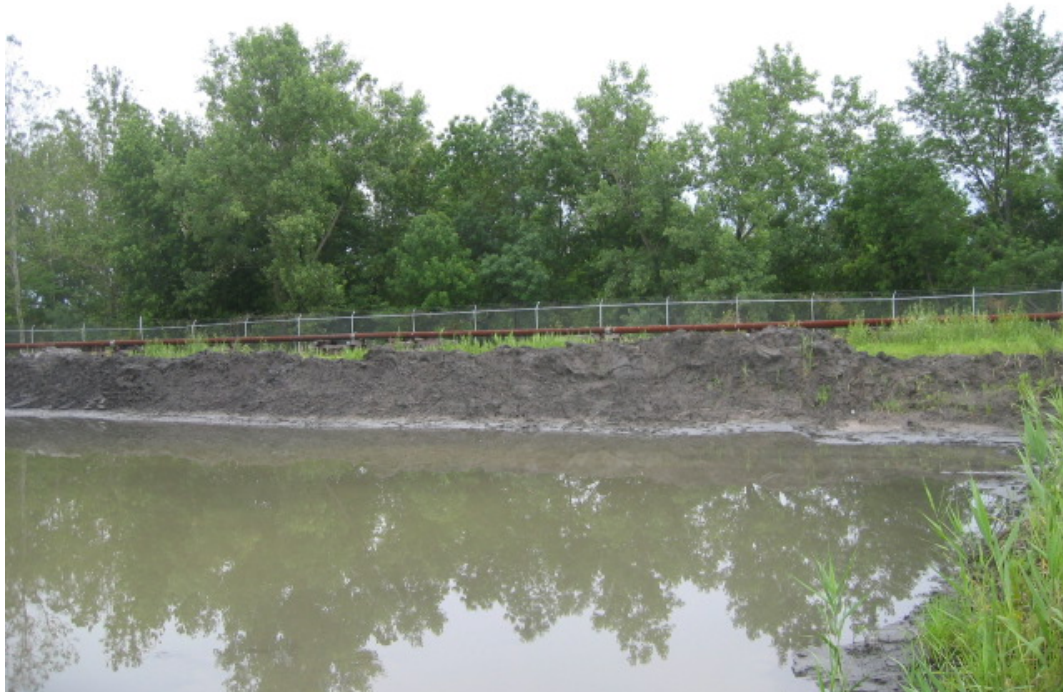
**Description:**  
Upstream slope in the active  
portion of Pond D.

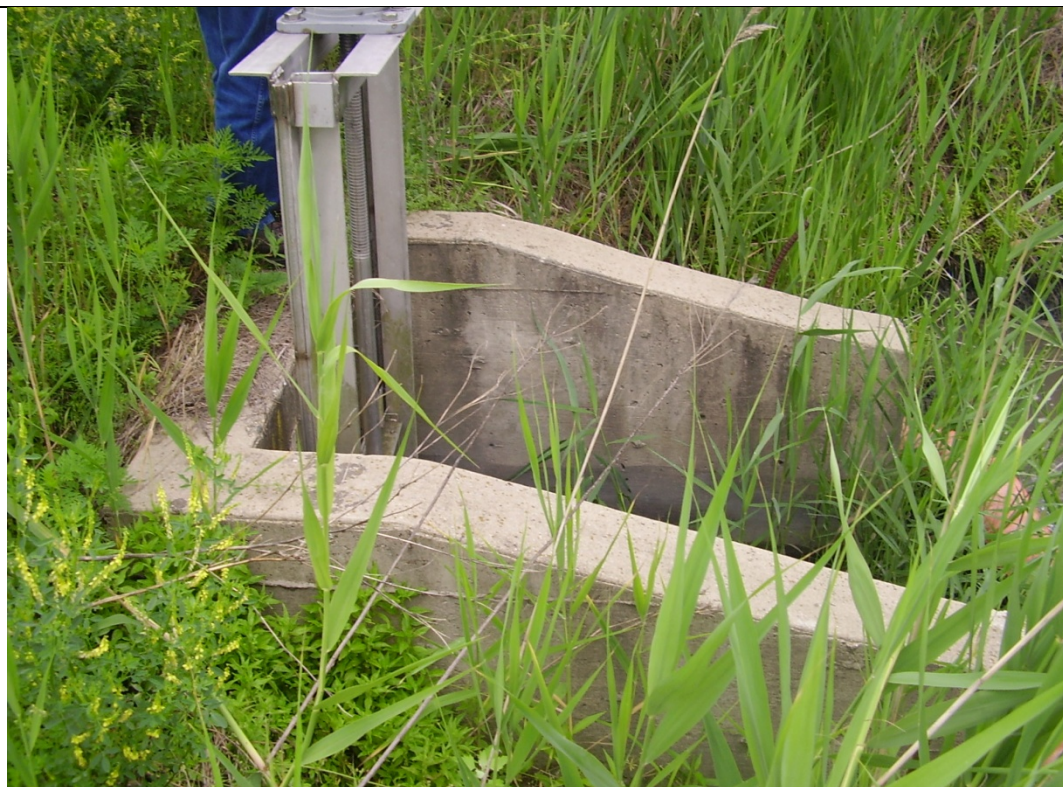
**Photo No.**  
**52**

**Description:**  
Decant structure in the active  
portion of Pond D.

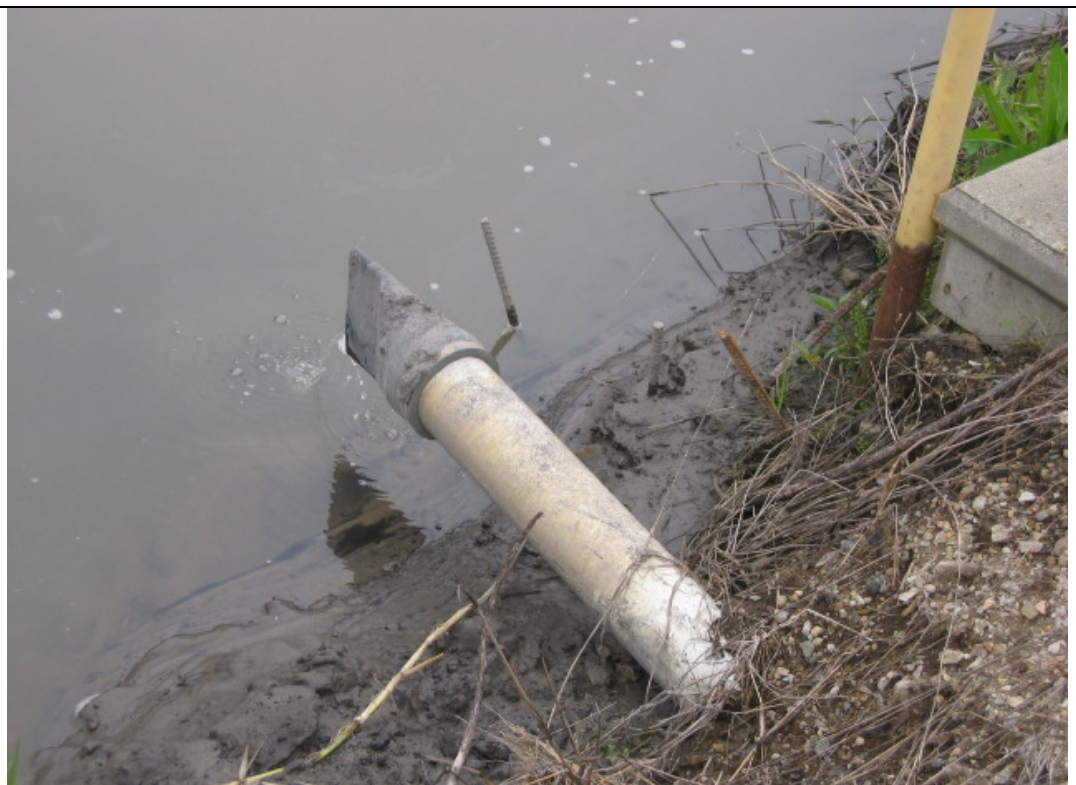
**Description:**  
Discharge pipe in active  
portion of Pond D.

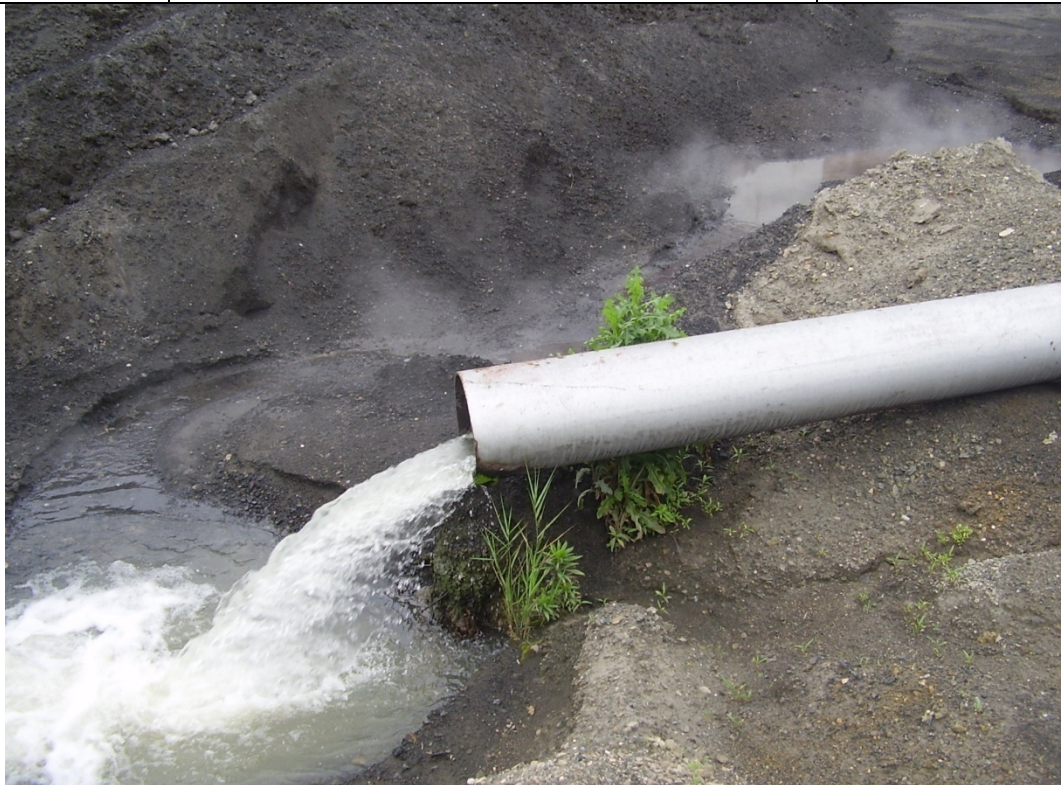
**Description:**  
Discharge pipe in active  
portion of Pond D.

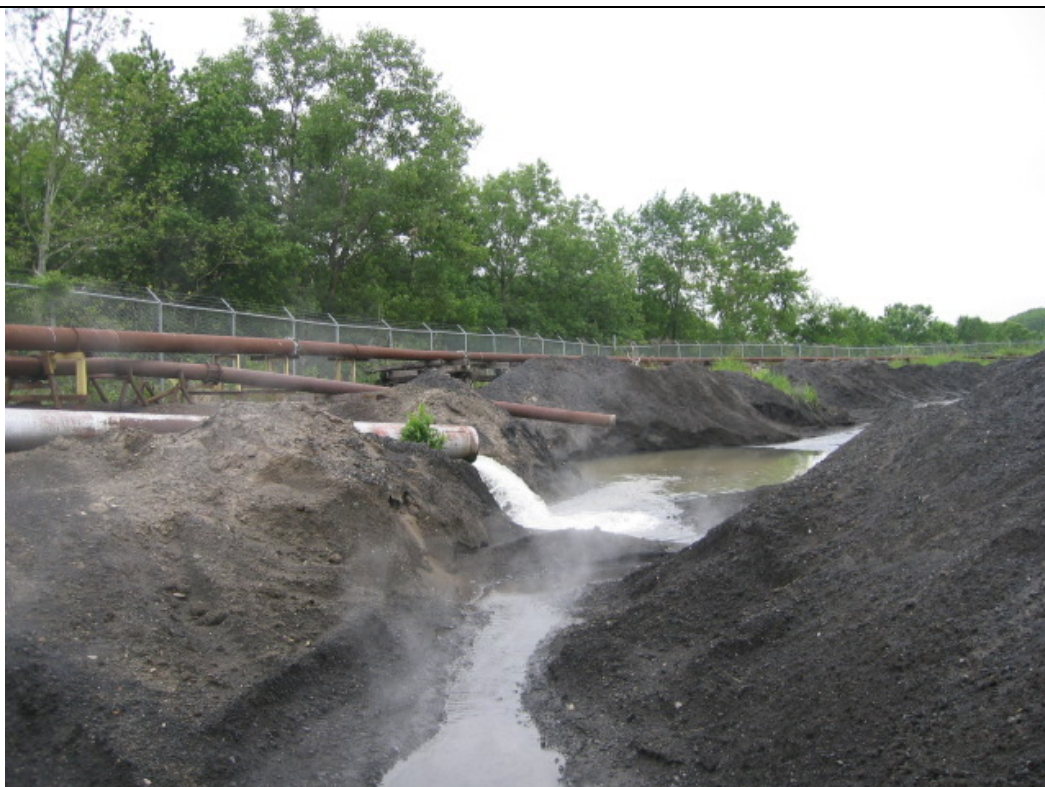
**Photo No.**  
**56**

**Description:**  
Discharge pipe in active  
portion of Pond D.
