**Coal Combustion Waste Impoundment  
Round 7 - Dam Assessment Report**

*Meramec Power Station*

*Ameren Missouri*  
**St. Louis, Missouri**

**June 2011**

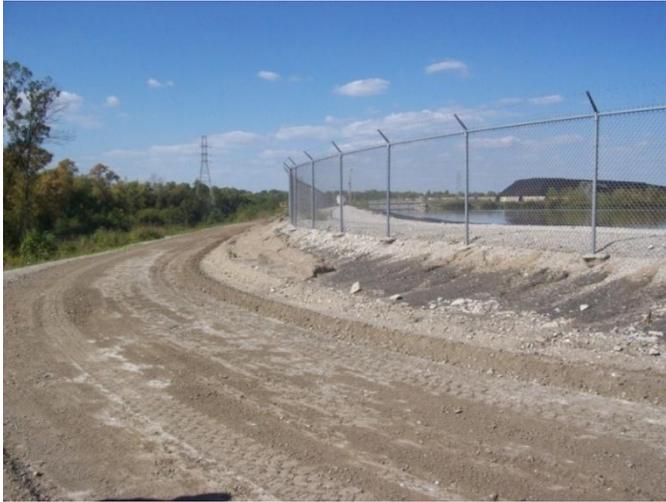
1. Looking west from access road at levee embankment at Pond 2.

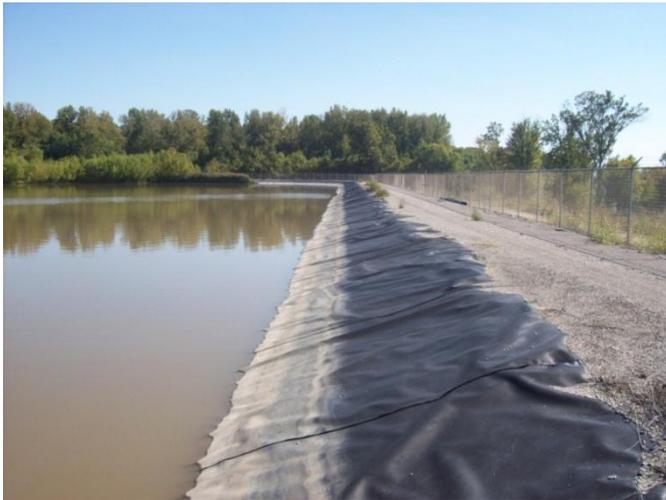
2. Looking east along internal side slope and crest of levee embankment of Pond 2. Note – liner in place.

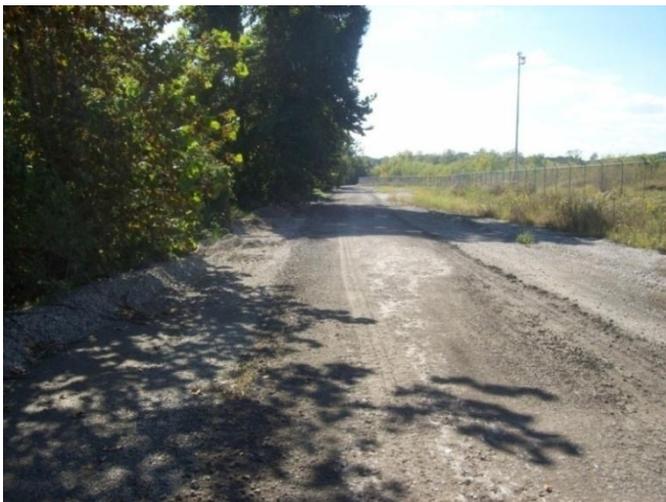
3. Looking south along embankment between railroad and Pond 2 (#489).

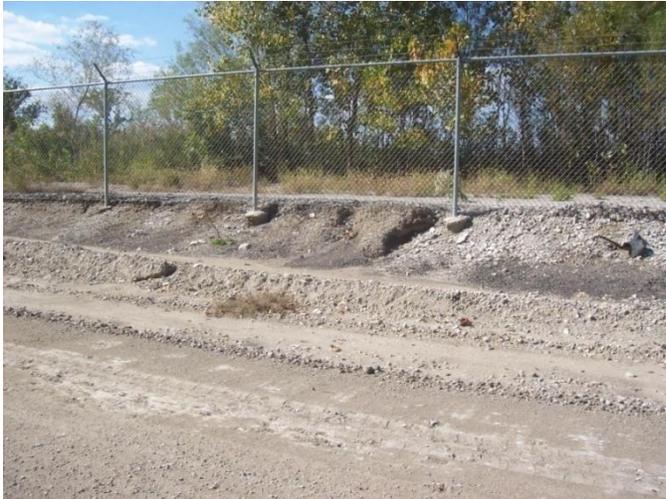
4. Looking Southwest at top of levee embankment of Pond 2 from access road.

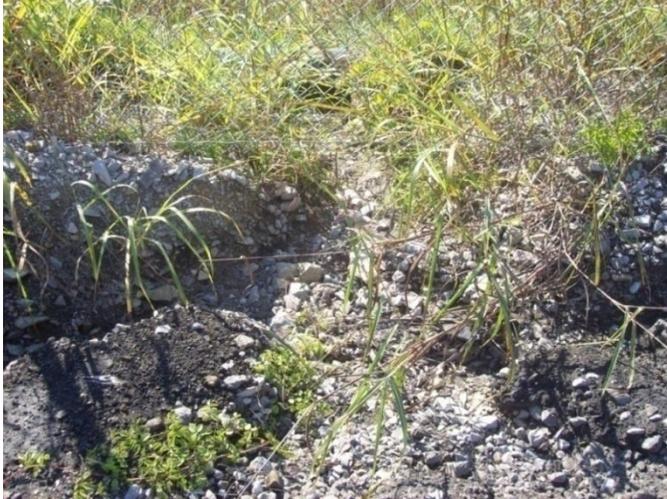
7. Runoff erosion from edge of crest of access road at Pond 2.

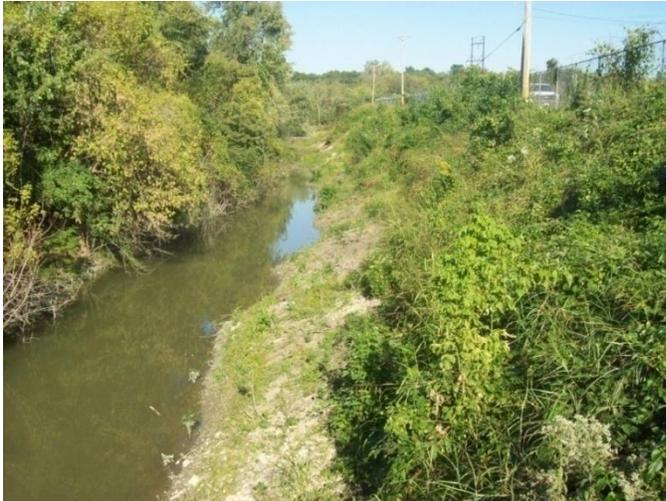
13. Looking northeast along outside slope and toe of the levee embankment along the tributary to Meramec River.

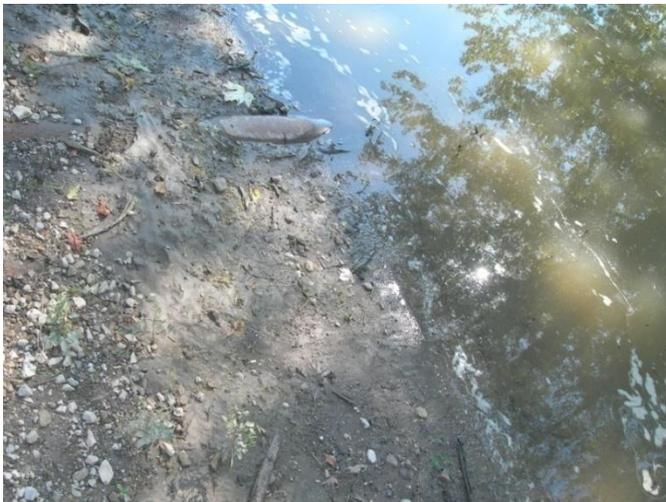
14. Looking at unknown pipe at the outside toe of Pond 2 levee embankment.

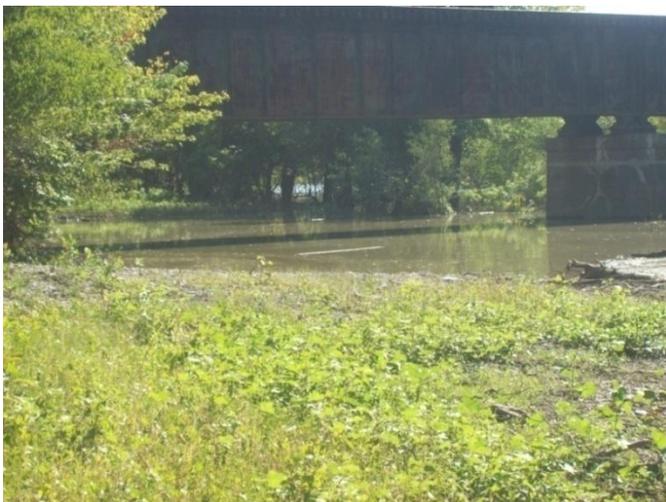
15. Looking southeast at railroad bridge. Location of submerged perimeter access road.

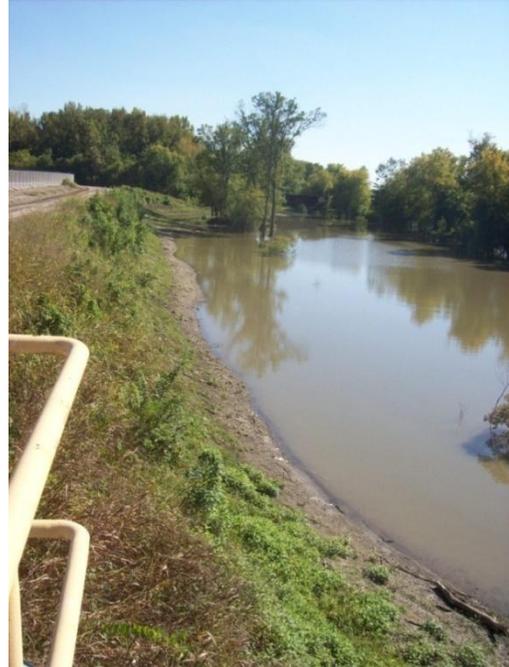
16. Looking southeast along perimeter levee embankment. Note - High water was observed in the Meramec River during site visit.

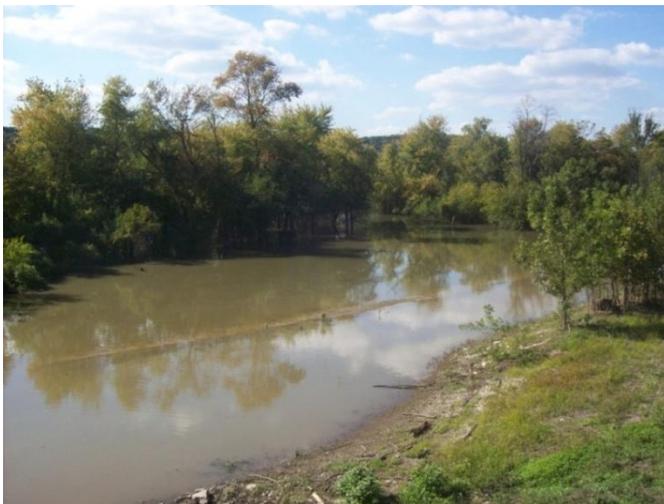
18. Looking southwest along toe of levee embankment where floodplain is flooded.

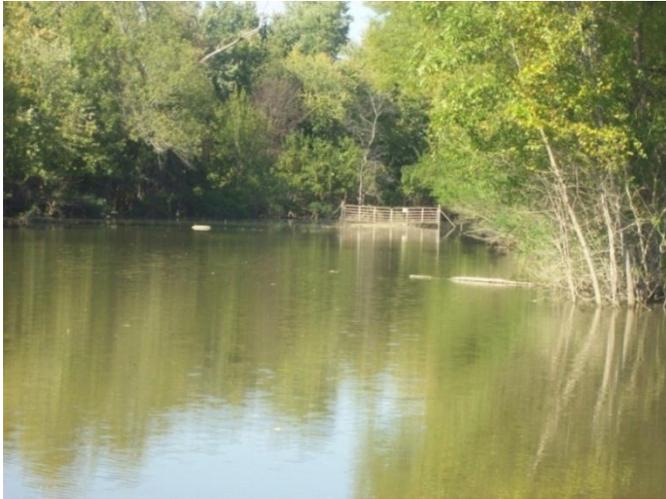
19. Looking north at perimeter access road gate. Road under water.

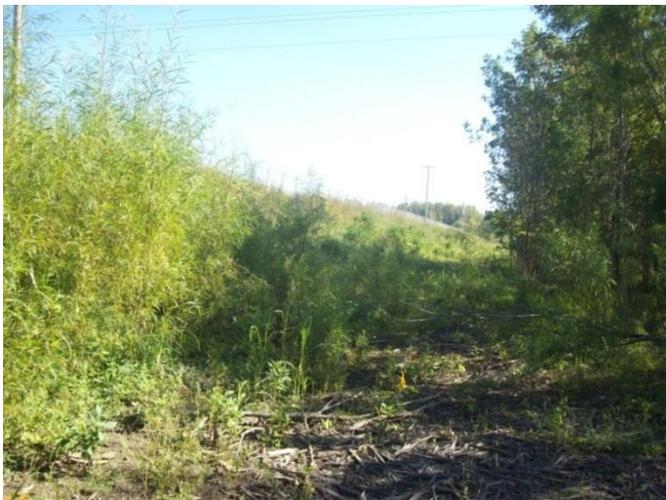
20. Looking south along outside toe of Pond 7.

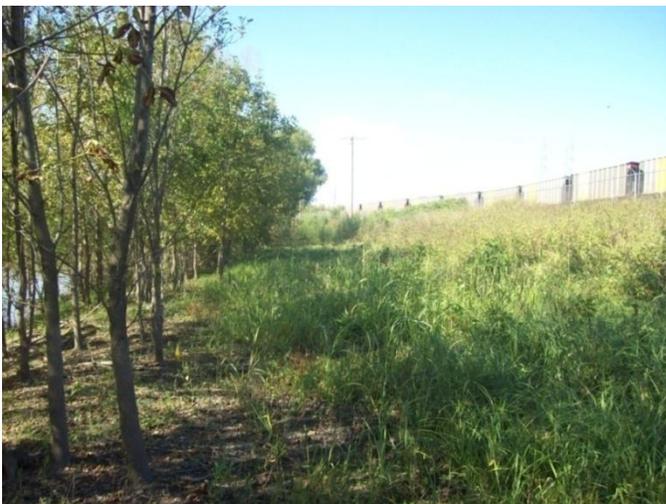
21. Looking northwest along outside toe and slope of levee embankment of Pond 7. Note - railroad tracks adjacent to top of embankment.

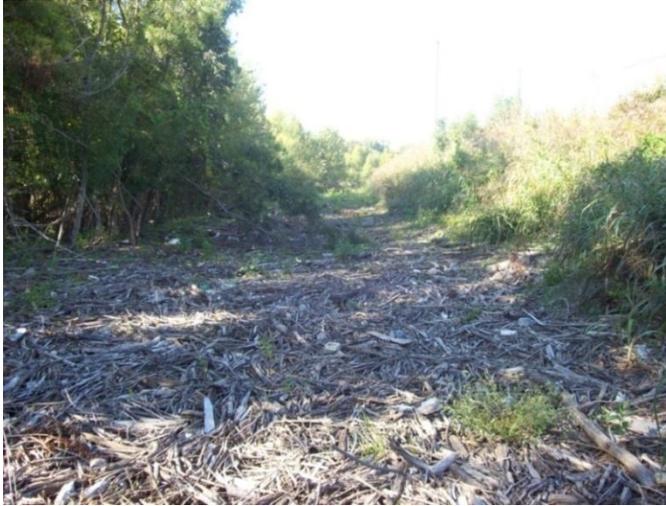
22. Looking northwest along outside toe of levee embankment at Pond 7.

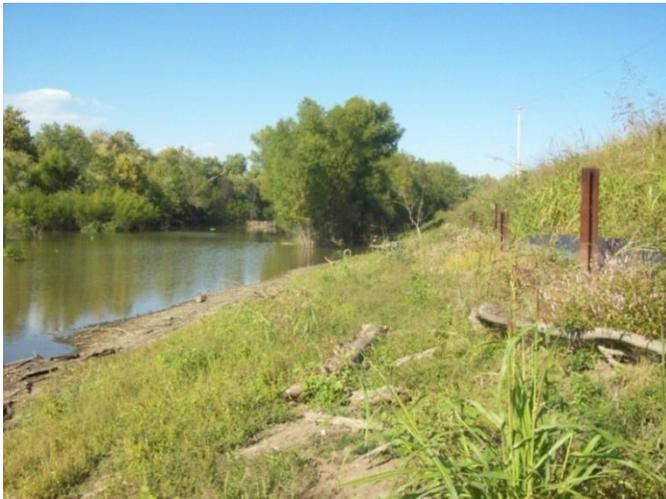
23. Looking north along outside toe of levee embankment at Pond 7.  
Note - gate for perimeter access road is submerged.

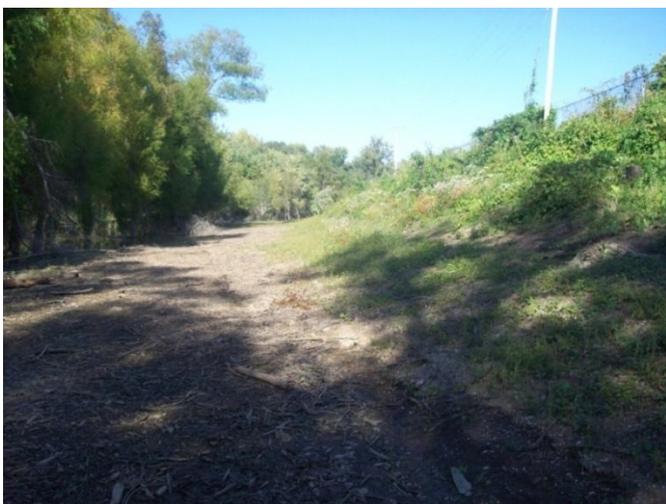
24. Looking northeast along outside toe of levee embankment at Pond 7.

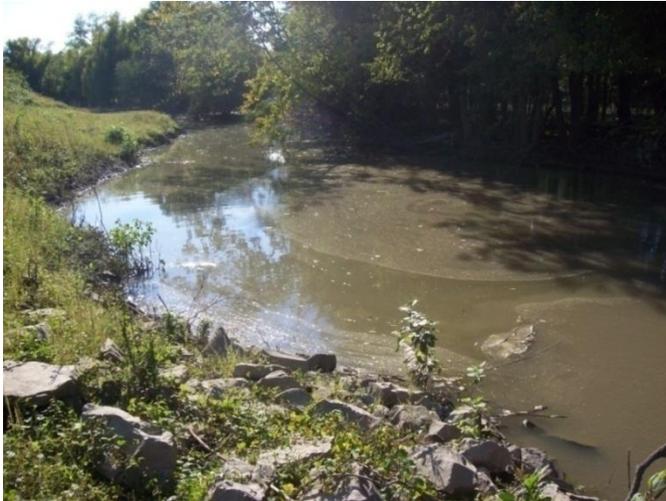
25. Looking southwest along Meramec River just outside from Pond 1 (retention pond) outlet.

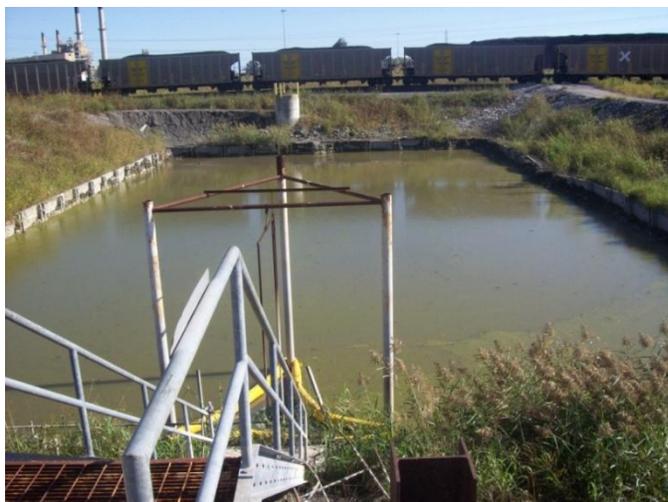
28. Looking southeast at Pond 1 (retention pond).

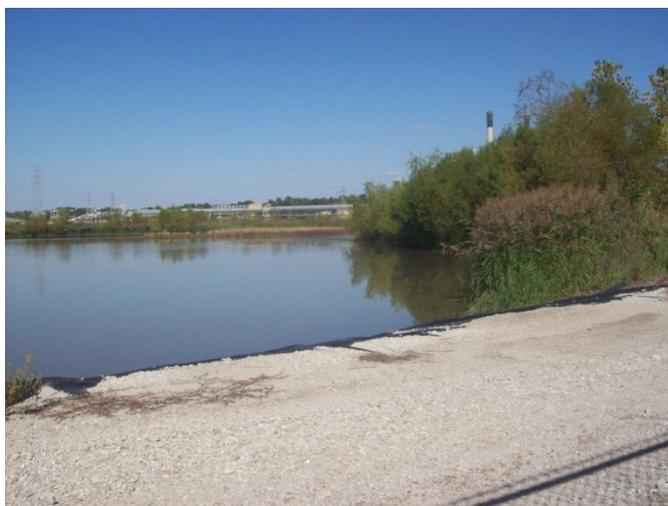
29. Looking northwest at Pond 2. Note – Unit has a slope liner.

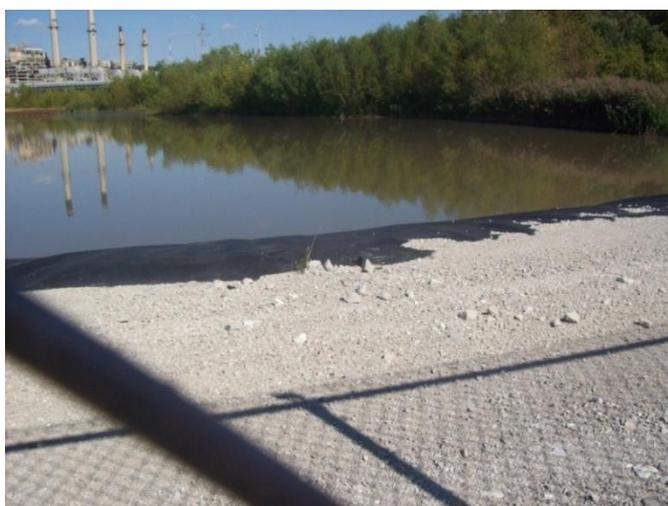
30. Looking north at Pond 2. Note – Unit has a slope liner.

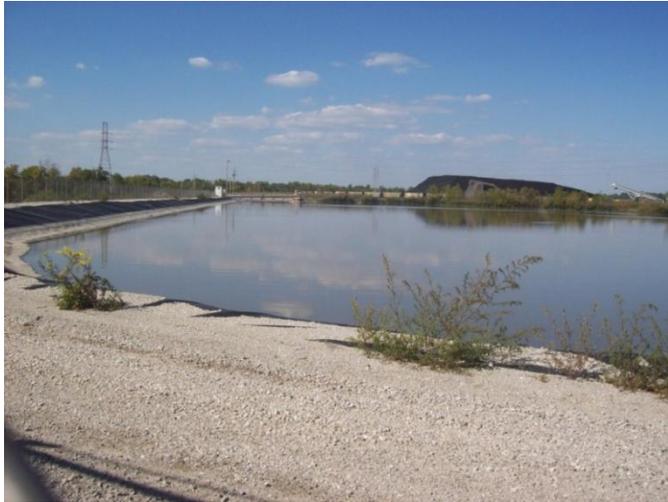
31. Looking at Pond 2 toward coal storage area. Note - liner with some vegetation.

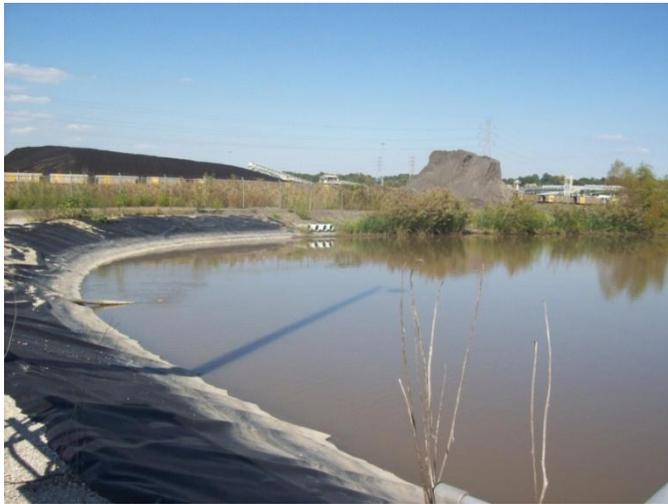
32. Looking north at overflow pipes and coal storage area. Note - pipe in water for taking water samples.

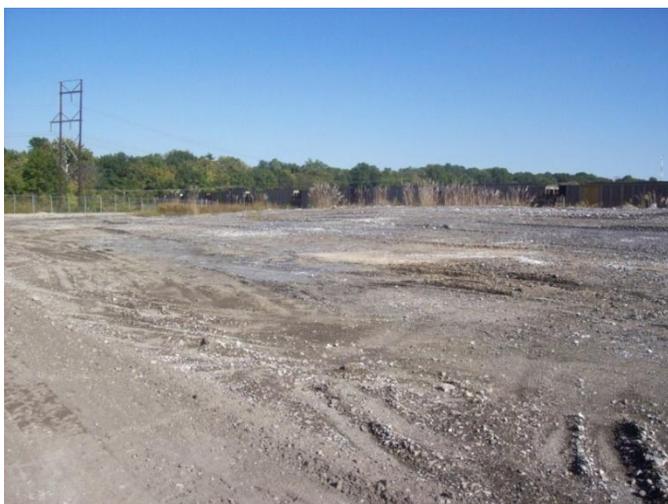
33. Looking at the Pond 3 ("New" Fly Ash Pond) area in the distance and the fill Fly Ash area to the northeast of Pond 1.

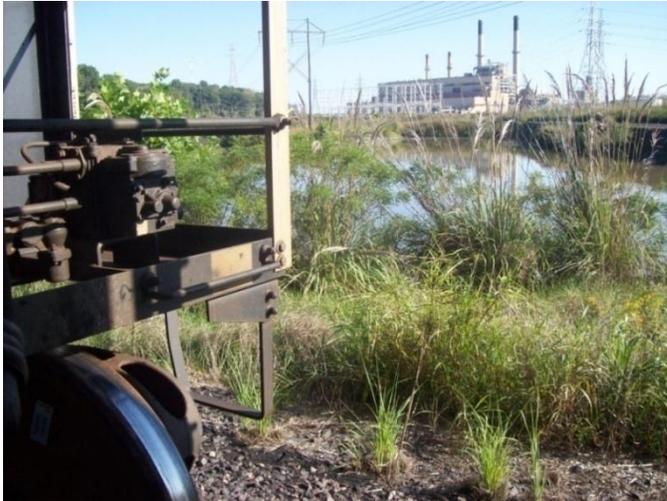
34. Looking through railroad track at southeast side of Pond 4 (Bottom Ash Pond).

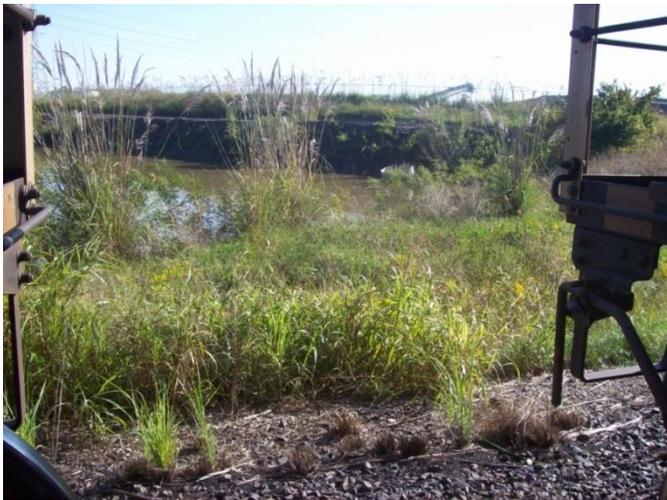
35. Looking through railroad tracks at southeast side of pond area of Pond 4.

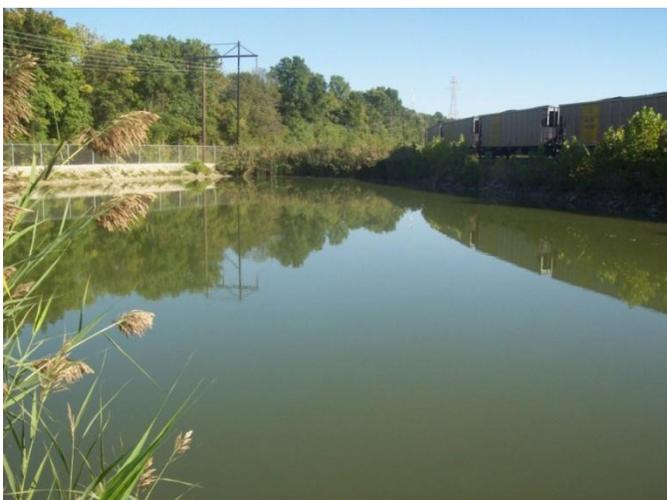
36. Looking north at northwest side of Pond 4.

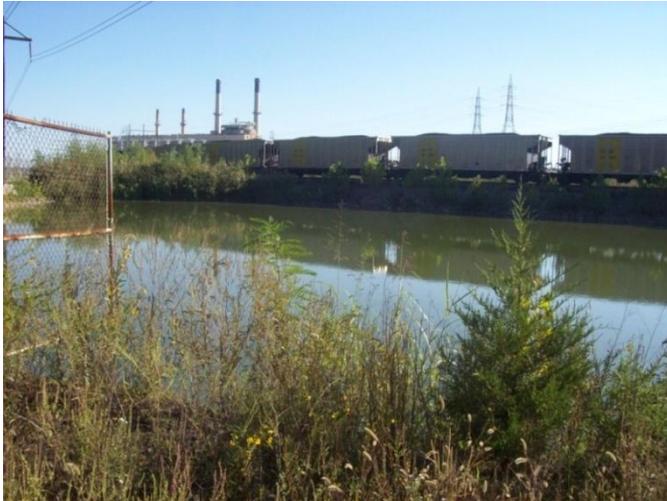
37. Looking southeast at railroad tracks between northwest & southeast Pond 4.

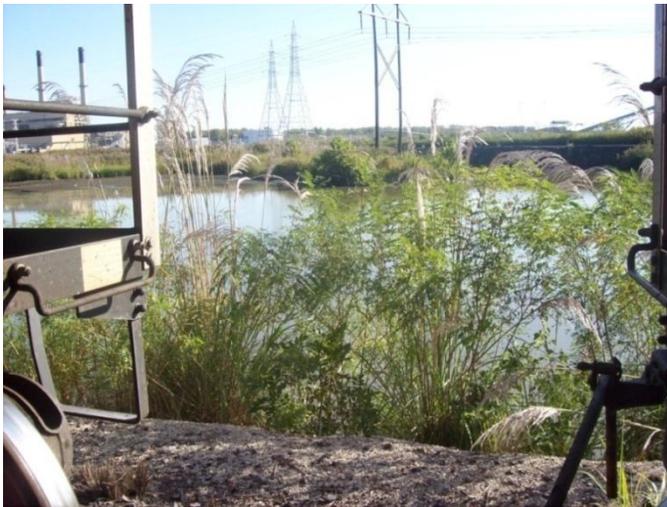
38. Looking southwest from railroad track at northwest Pond 4.

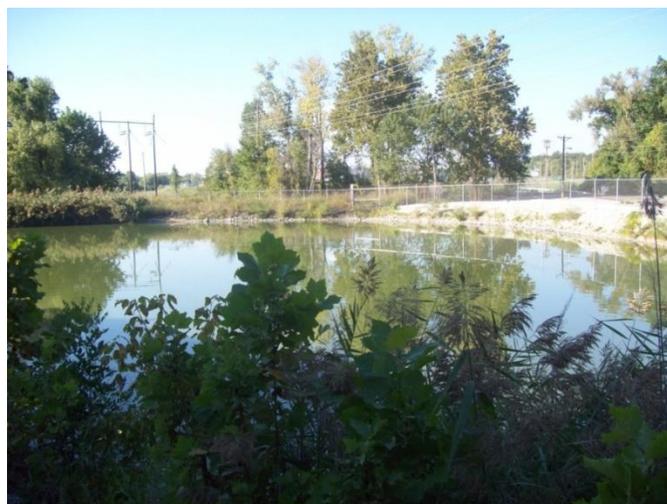
39. Looking north at southeast Pond 4 from railroad tracks.

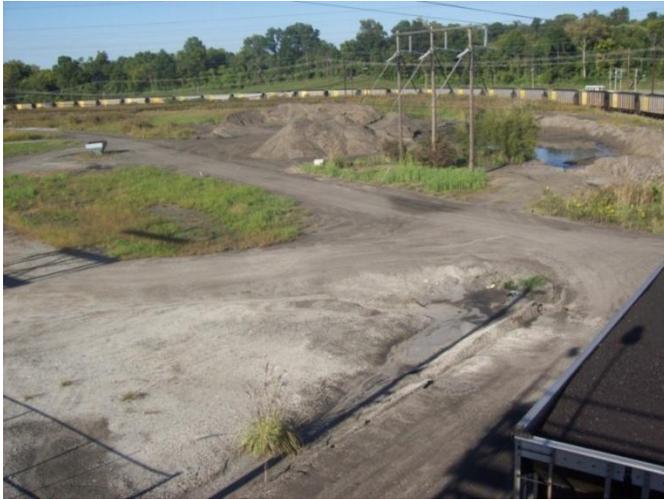
40. Looking towards Pond 5 and 6 (Bottom Ash Pond).

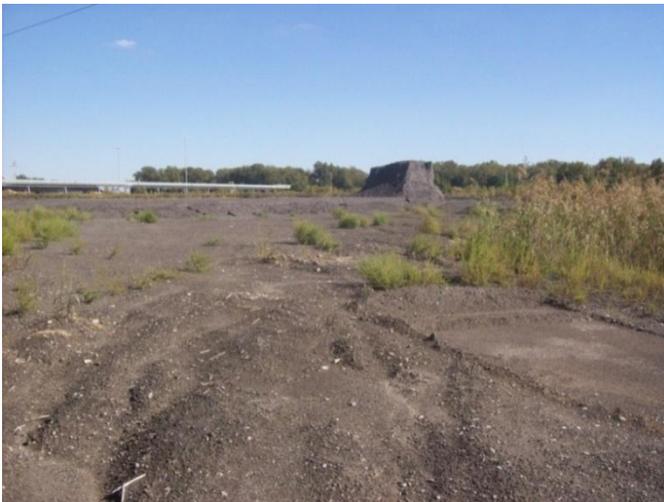
41. Looking northeast at completely filled and deactivated Pond 8 (Fly Ash Pond #495).

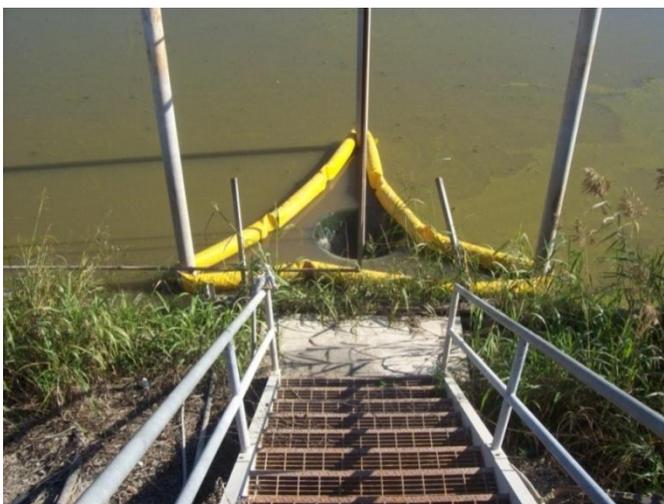
42. Looking at retention pond inlet.

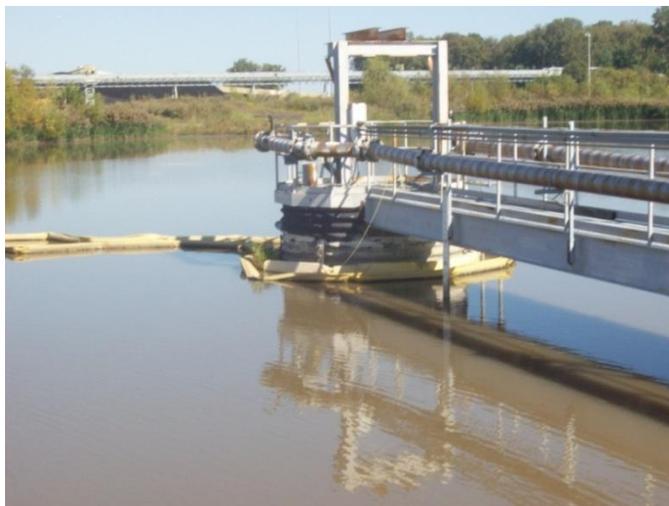
43. Looking at Pond 2 (#489) inlet structure.

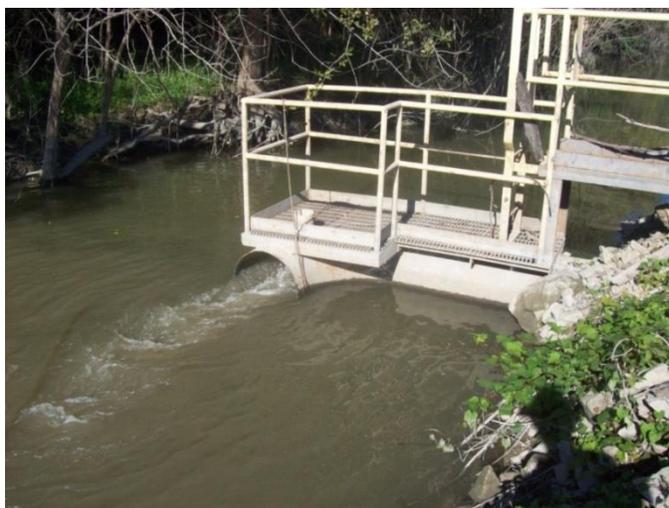
44. Looking northeast at outfall pipe from Pond 1.

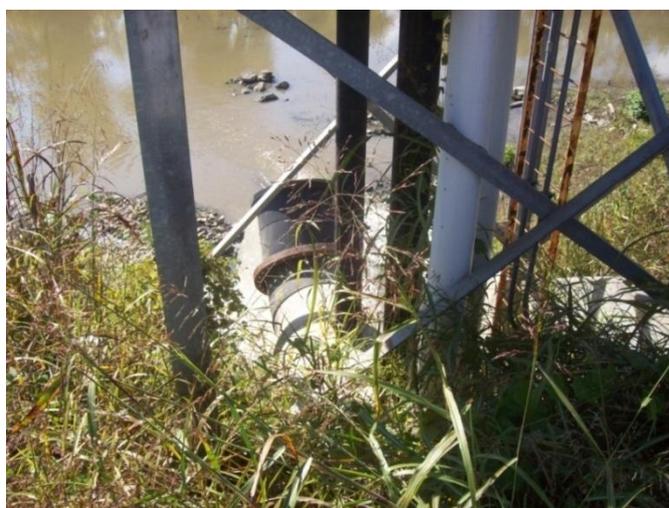
45. Looking west at outfall #009 at Pond 2 toward Meramec River.

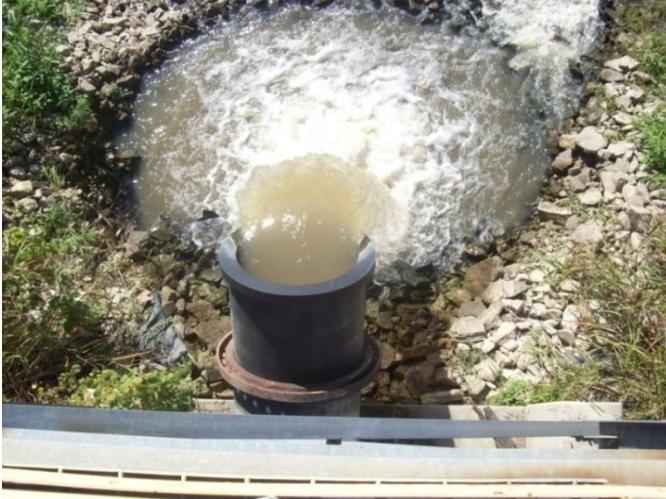
46. Outfall #009 from Pond 2.

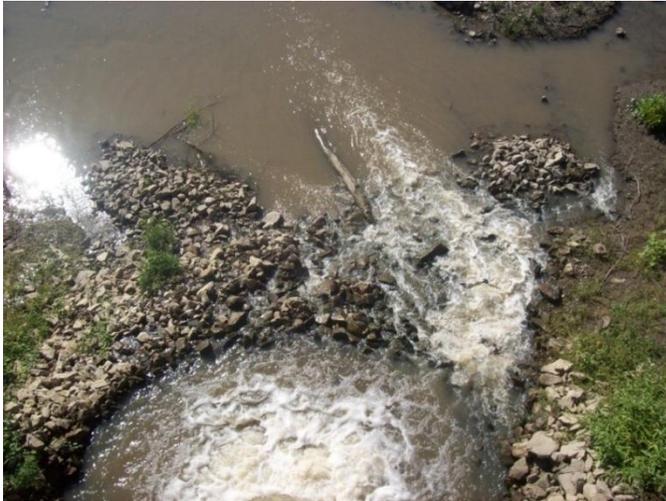
47. Plunge pool at outfall #009.
