## Coal Combustion Waste Impoundment Round 7 - Dam Assessment Report

Rush Island Power Station Ameren Missouri Festus, Missouri

Dewberry & Davis, LLC Fairfax, Virginia

Under Contract Number: EP-09W001727 June 2011

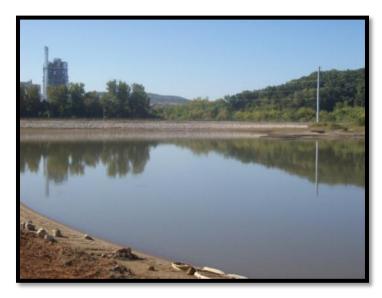
The inside embankment of the ash pond was under rehabilitation during the site assessment. Riprap armor was placed along inside slopes of pond to protect against wave action erosion. Figure 5.2.2-1 and Figure 5.2.2-2 show completed rehabilitation along interior slopes and groins on the south end of ash pond.

**Figure 5.2.2-1:** Riprap armored interior slopes of ash pond protected against wave action erosion, Southwest.

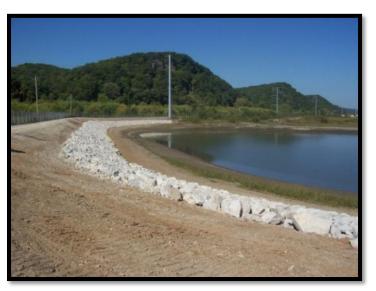
Figure 5.2.2-2: Riprap armored interior slope of ash pond.

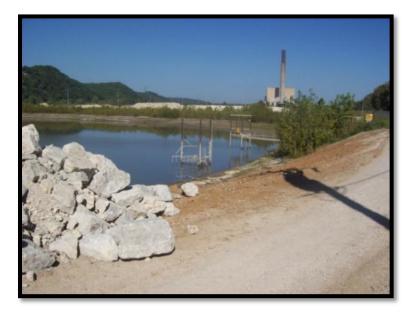
The pond outlet structure is located in the northeast corner of the ash pond. The ash pond discharges to the Mississippi River through an overflow structure consisting of a vertical riser and 24 inch HDPE outlet pipe. A skimmer boom is located around the riser and the structure is made accessible through a metal platform. The overflow structure was not completely visible at the time of the site assessment. Figure 5.3.1-1 shows both the active and inactive outlet structures for the ash pond.

**Figure 5.3.1-1:** Ash pond inactive (left) and active (right) overflow structures, Northwest.

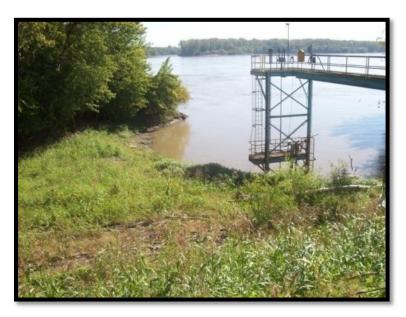
levels. Both ends of the conduit were fully submerged during the site visit. Figure 5.3.2-1 shows the discharge area of the ash pond outlet conduit.

Figure 5.3.2-1: Ash pond outlet to Mississippi River.

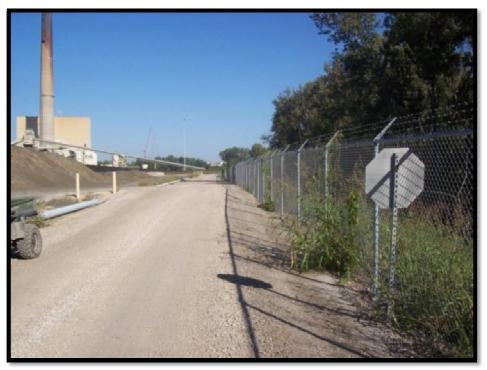
Figure 1: Perimeter road near ash disposal area, Northwest.

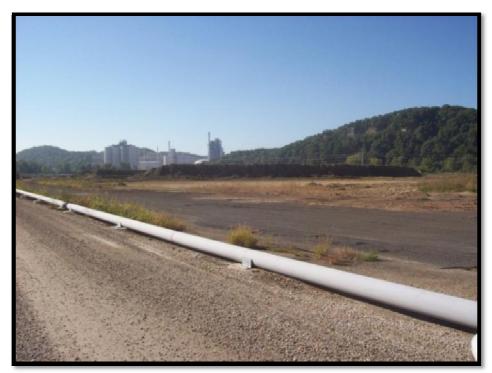
Figure 2: Ash disposal area, South.

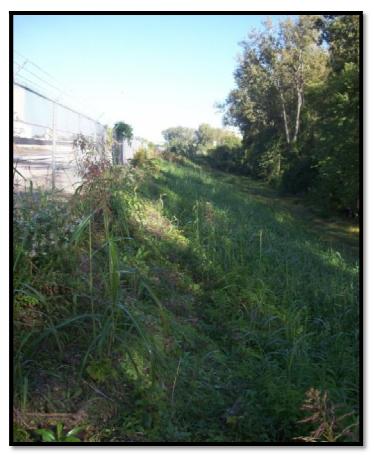
Figure 3: Ash pond external embankment with medium vegetation, Northwest.

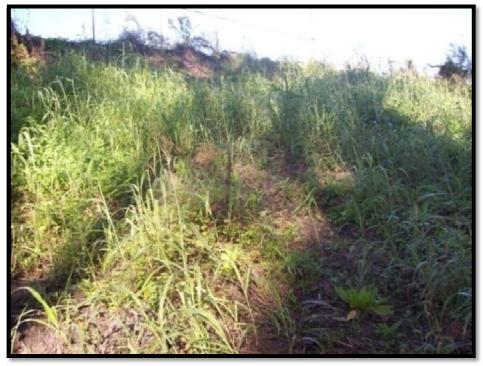
Figure 4: Ash pond external embankment with minimal ground cover and minor erosion from roadway runoff.

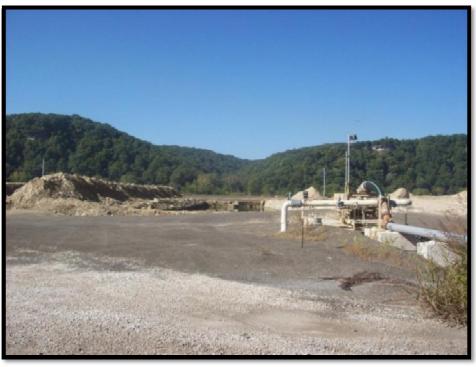
Figure 5: Ash disposal area near discharge to ash pond.

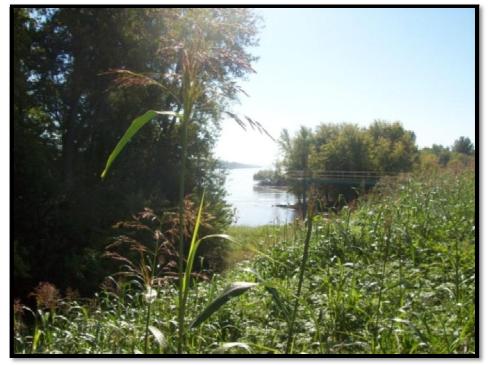
Figure 6: Ash pond outlet to Mississippi River, Southeast.

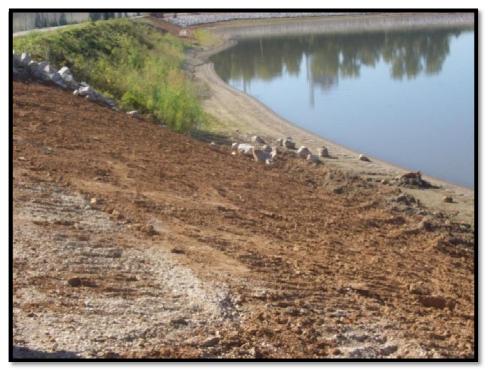
Figure 8: Interior slopes of ash pond currently under rehabilitation, South.

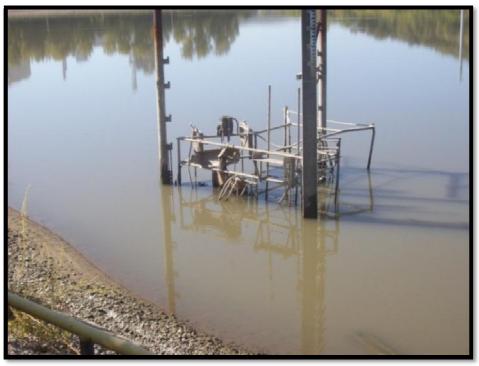
Figure 9: Inactive ash pond overflow structure.

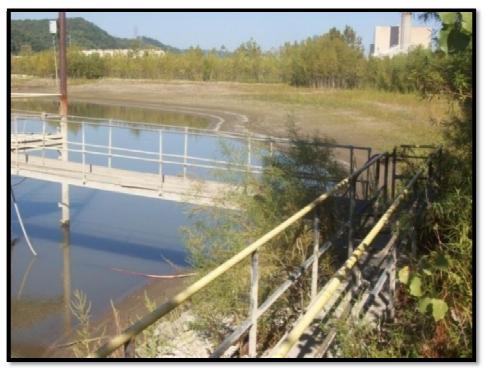
Figure 10: Access platform to ash pond overflow structure, Northwest.

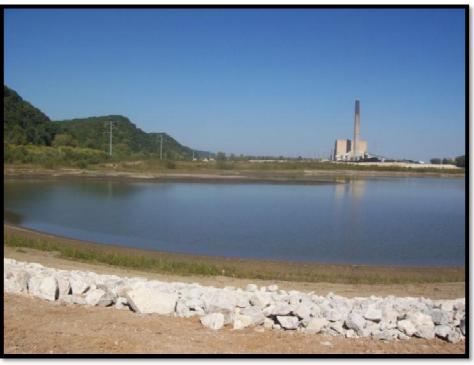
Figure 11: Ash pond, Northwest.

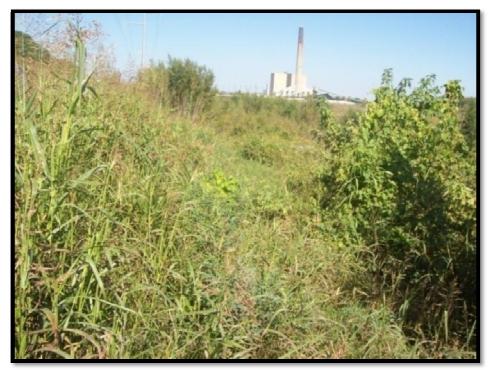
Figure 12: Ash pond exterior embankment with heavy vegetation, Northwest.

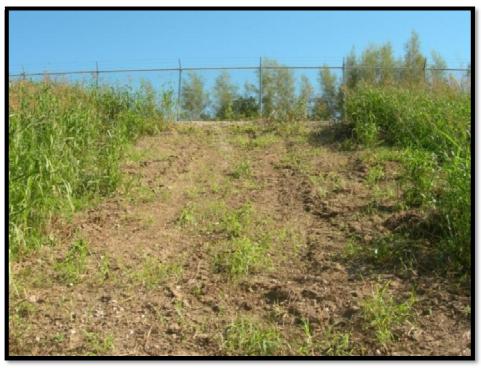
Figure 13: Ash pond exterior embankment erosion.

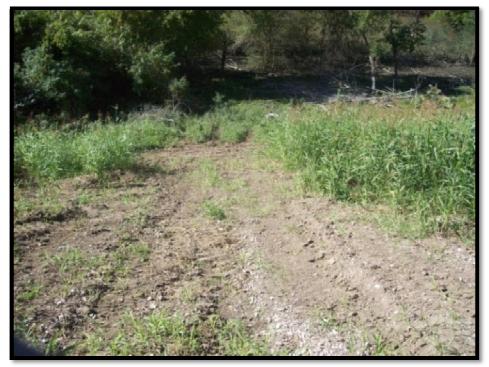
Figure 14: Heavily eroded area along exterior embankment of ash pond.

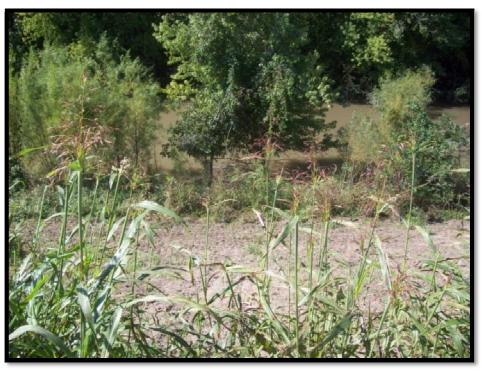
Figure 18: Ash disposal area, Northeast.

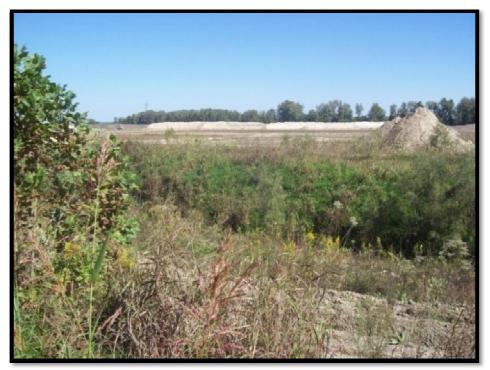
Figure 19: Perimeter road near ash disposal area, Northwest.

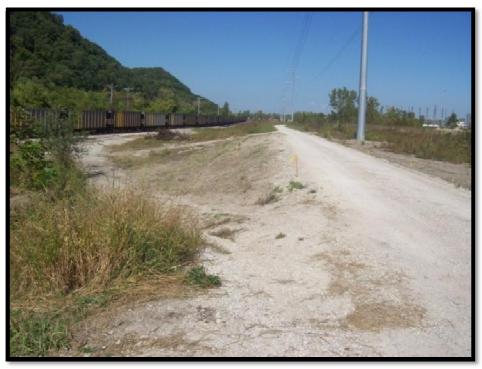
Figure 20: Perimeter road at top of the ash pond embankment, Southwest.
