Coal Combustion Waste Impoundment

Round 7 - Dam Assessment Report

Sioux Power Station (Site #001)

AmerenUE

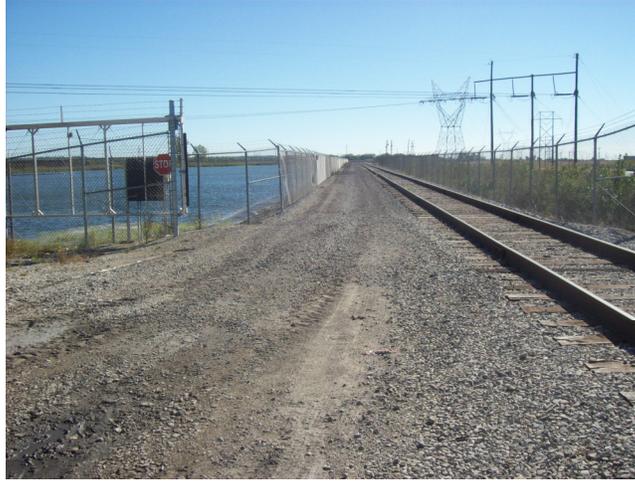
The southern embankment crest is much narrower in width, approximately 30 feet, than the western crest, and also contains a railroad bed that is used by the plant operators two to three times during the week (Fig. 5.2.1-2).

Figure 5.2.1-2: Photograph of Fly Ash Embankment, View to the East

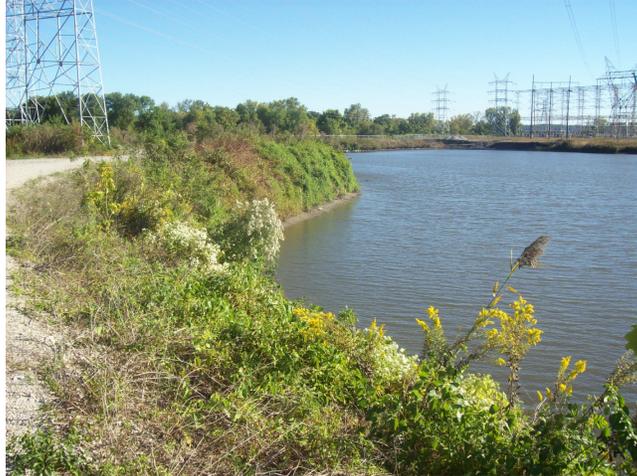
The upstream/inside slope is vegetated with various scrub/shrub species and tall grasses and wildflowers. There were no observed scarps, sloughs, bulging, cracks, depressions, or other signs of slope instability. Rip-rap had been placed along the interior slopes of the northern and northwestern portions of the embankment to enhance stability.

Figure 5.3.2-2: Photograph of Bottom Ash Pond Upstream/Inside Slope, View looking North

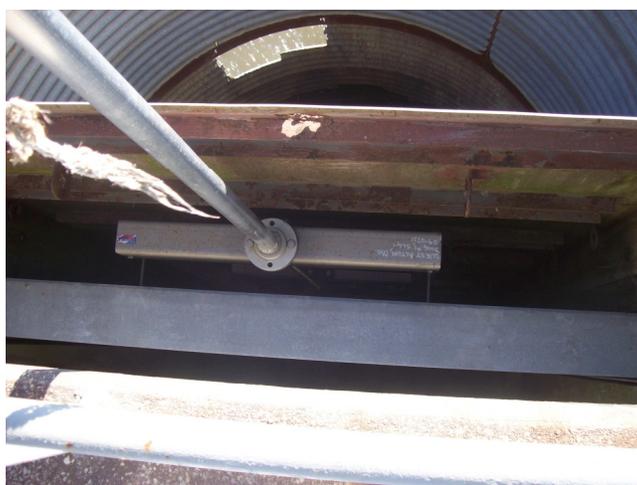
The Bottom Ash Pond has a concrete pit where pond water drains before discharging via a 30-inch concrete pipe. The outfall structure comprises a large diameter galvanized corrugated steel skimmer which is perforated to allow water to flow into the concrete pit (Fig 5.4.1-1).

Figure 5.4.1-1: Inlet control structure and emergency gate to the skimmer for the Bottom Ash Pond.

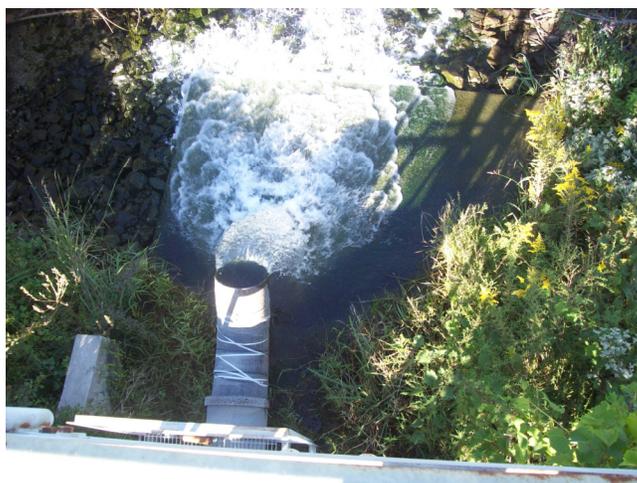
The Fly Ash Pond outfalls to Poeling Lake via an 18" HDPE pipe. The outlet conduit appeared to be in good shape and operating normally with no signs of clogging. Water discharging from the pipe appeared to be clear.

Figure 5.4.2-1: Photograph of Fly Ash Pond outfall (18" HDPE pipe) and stilling basin, Looking West

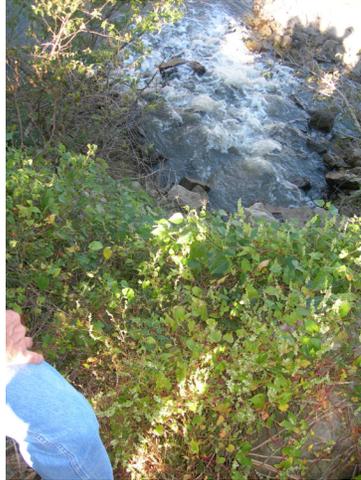
The 30-inch concrete pipe outlet conduit for the Bottom Ash Pond appeared to be in good shape and operating normally with no signs of clogging. Water discharging from the pipe appeared to be clear.

Figure 5.4.2-2: Photograph of Bottom Ash Pond outfall, Looking West

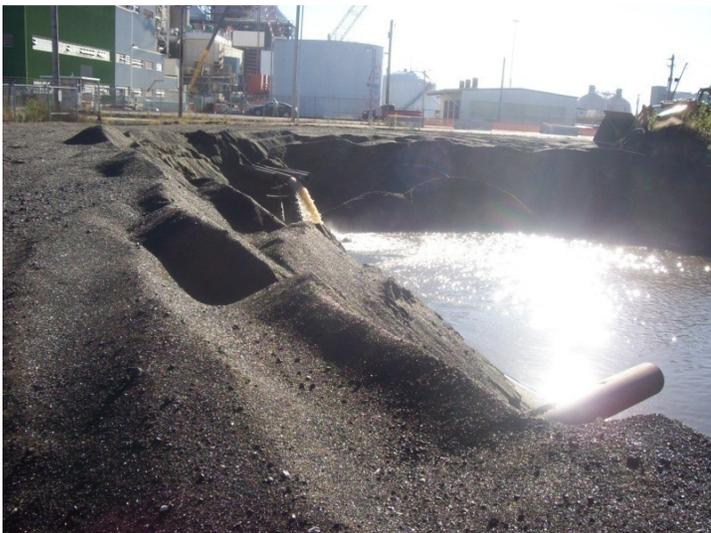
1. Looking at discharge to Bottom Ash channel from plant.

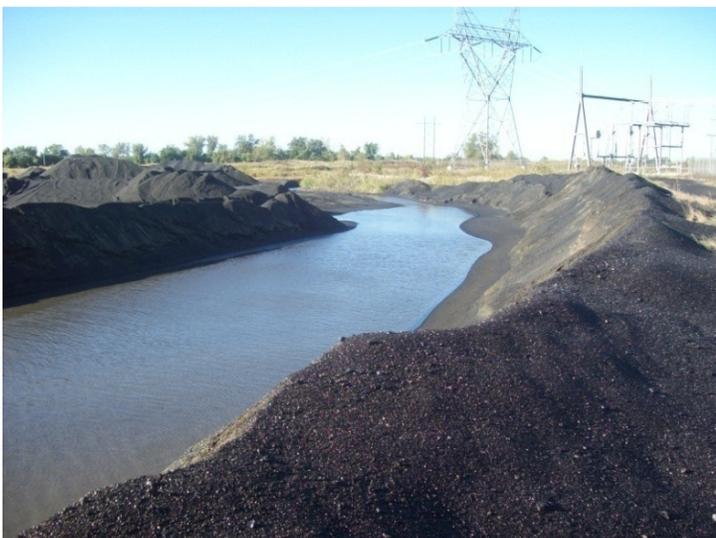
2. Looking at Bottom Ash channel from the plant discharge pipes.

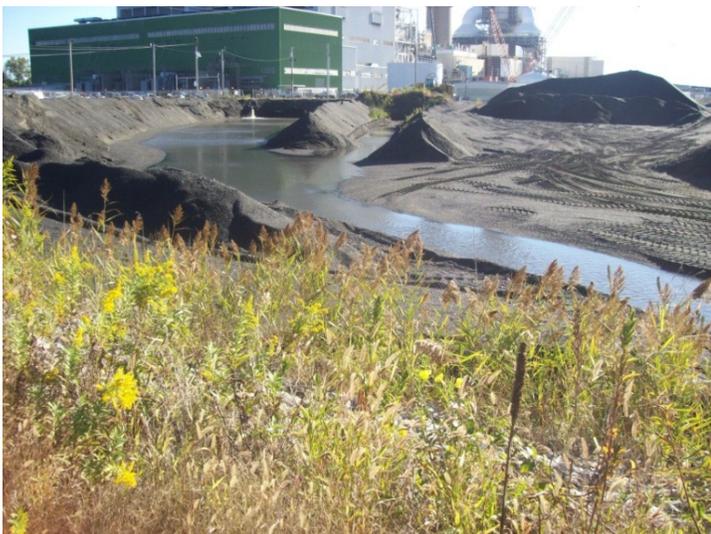
3. Looking at the discharge pipes and channel.

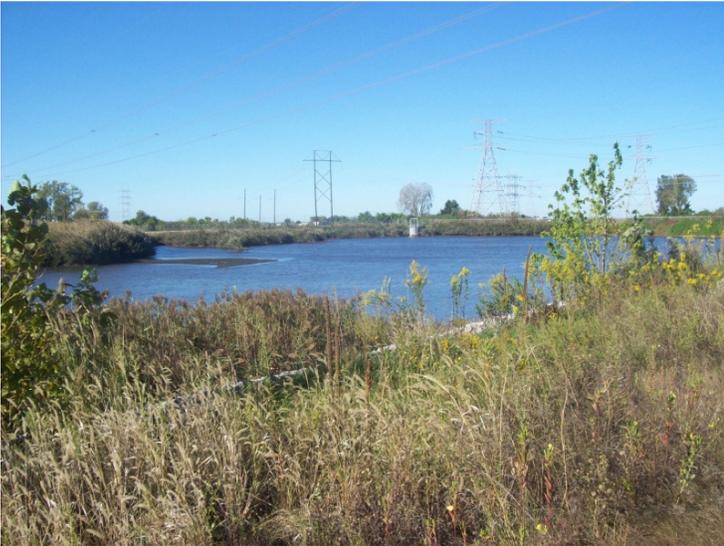
4. Looking West at inlet of permanent pool control device.

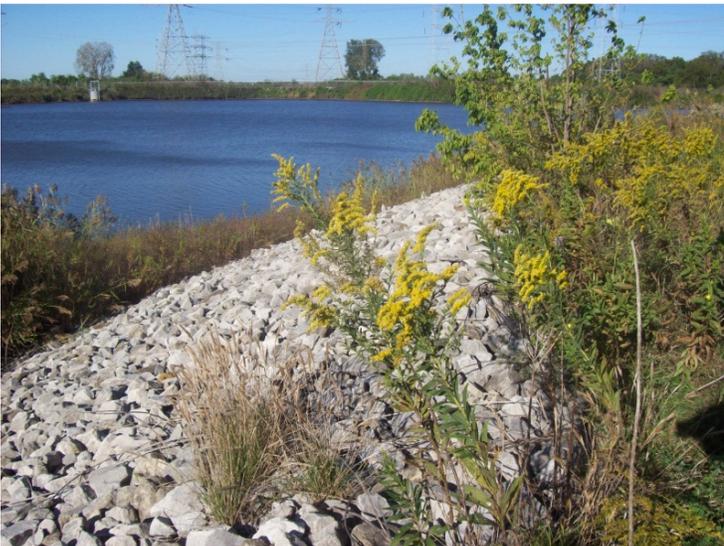
5. Looking at interior lined riprap slope problem.

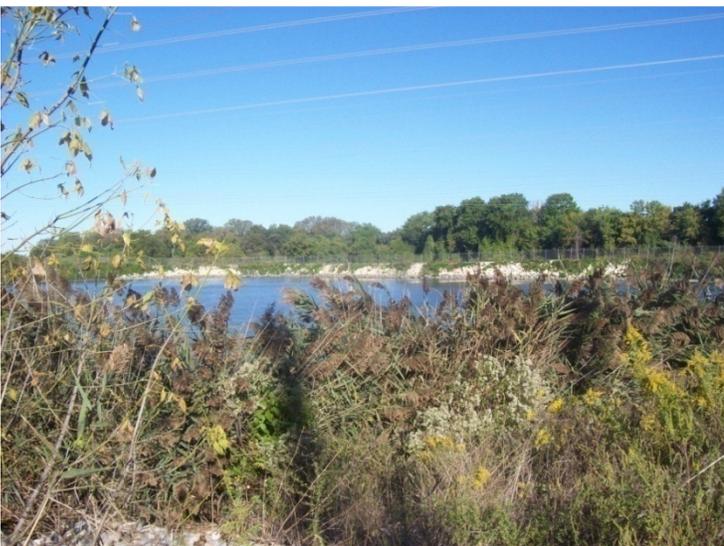
6. Looking Northwest at North side of Bottom Ash Pond.

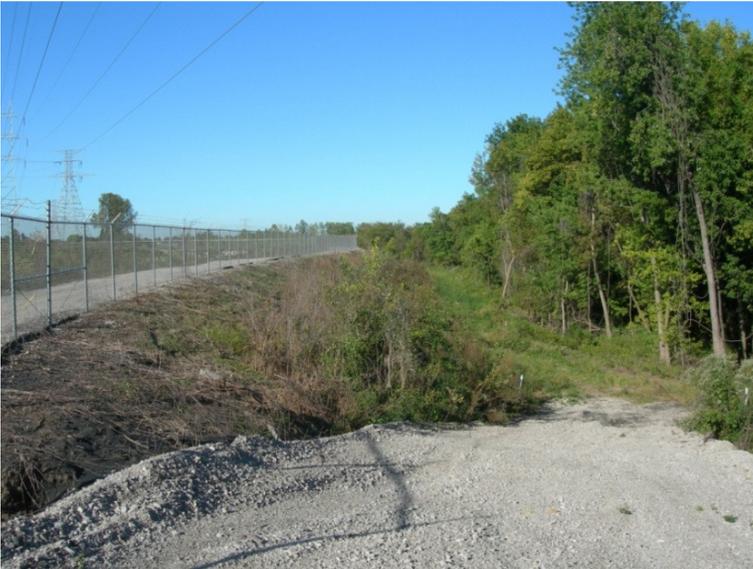
9A. Looking West along access road to bottom of embankment.

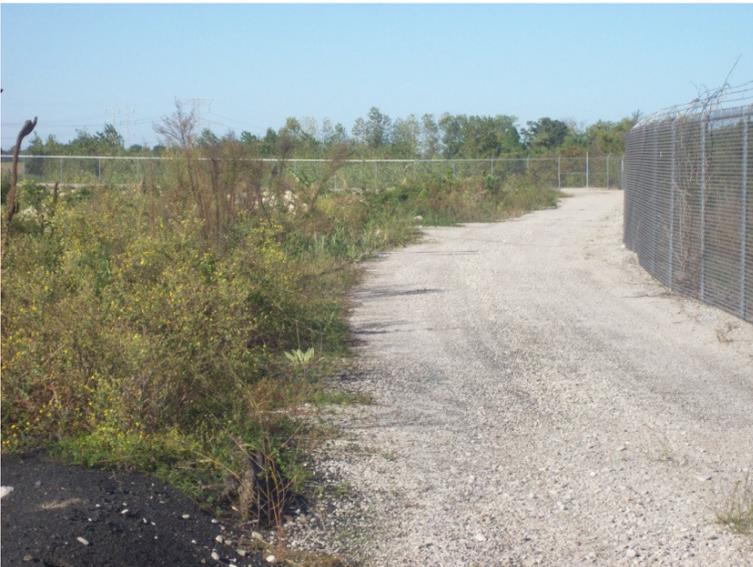
10. Looking West along embankment. Note – heavy vegetation along inside slope of embankment.

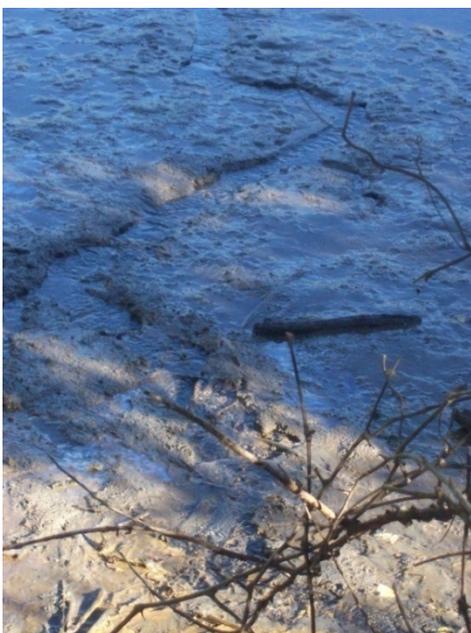
13. Seepage channel to Mississippi River.

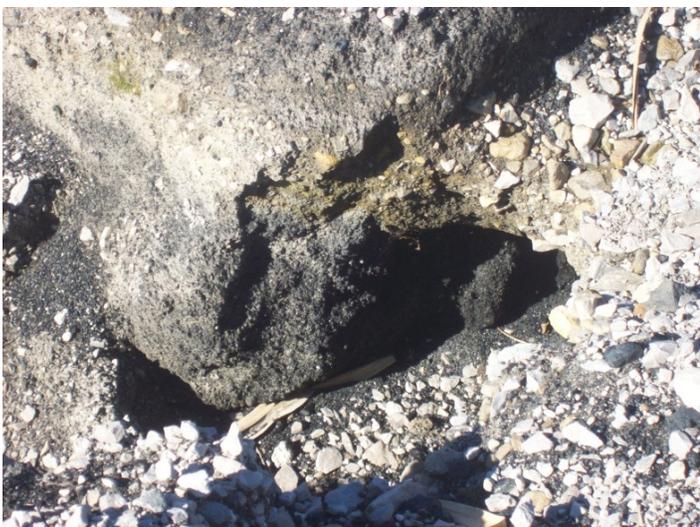
14. Erosion area by riprap. Note - material looks like bottom ash.

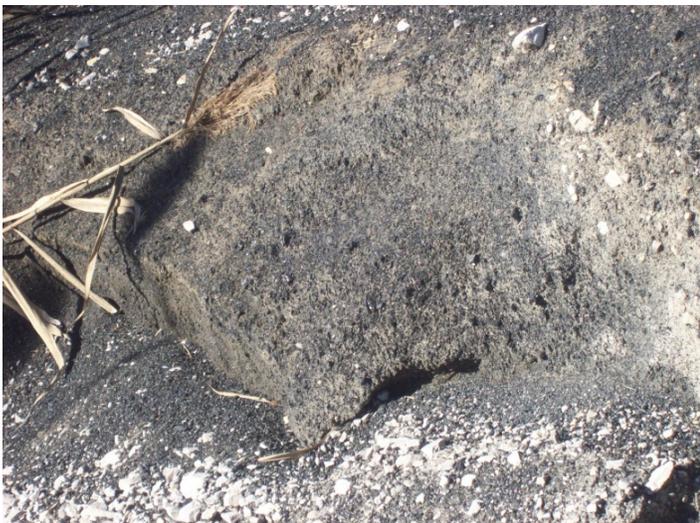
15. Erosion area by riprap. Note - material looks like bottom ash.

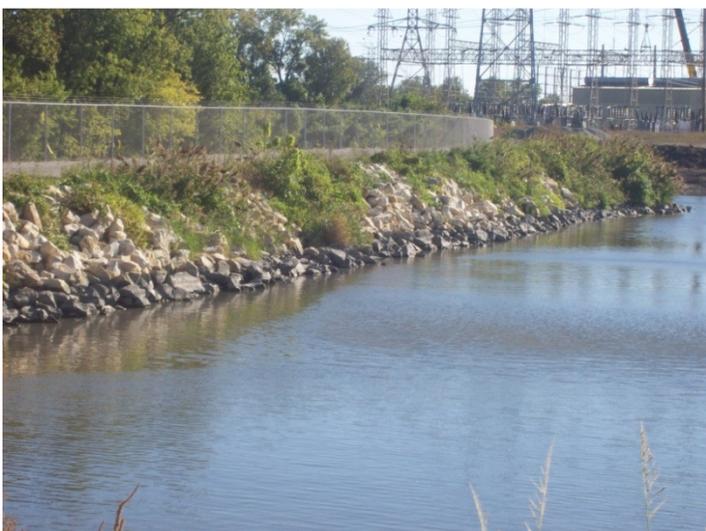
16. Looking West where the riprap slope problem stops. Note - vegetation along bank.

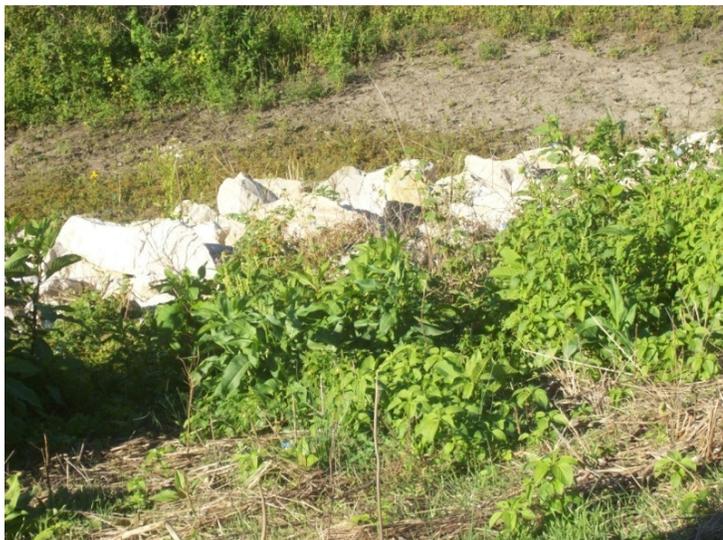
28A. Looking Southeast along toe of embankment. Riprap placed after major tree removal activity.

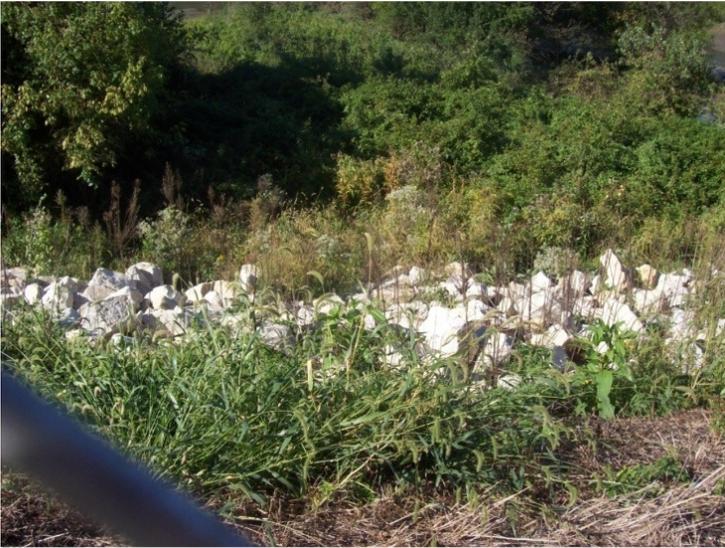
31. Repair of eroded area lined with riprap.

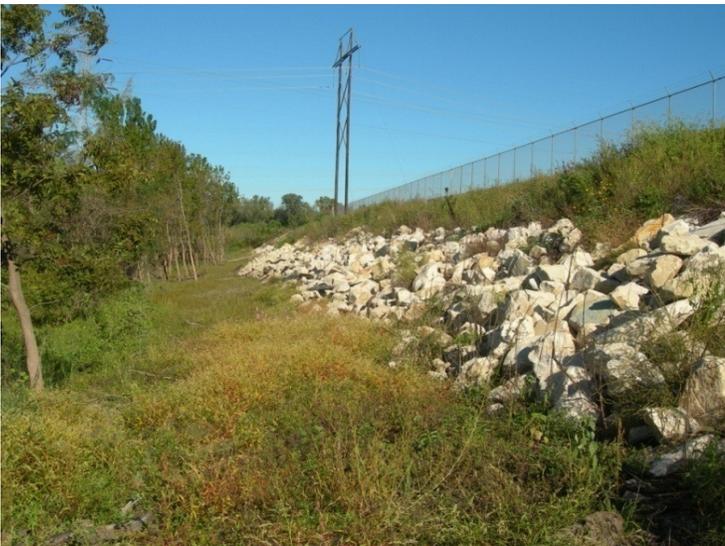
33. Looking Southeast along top of embankment. Note - some maintenance area to reduce runoff erosion.

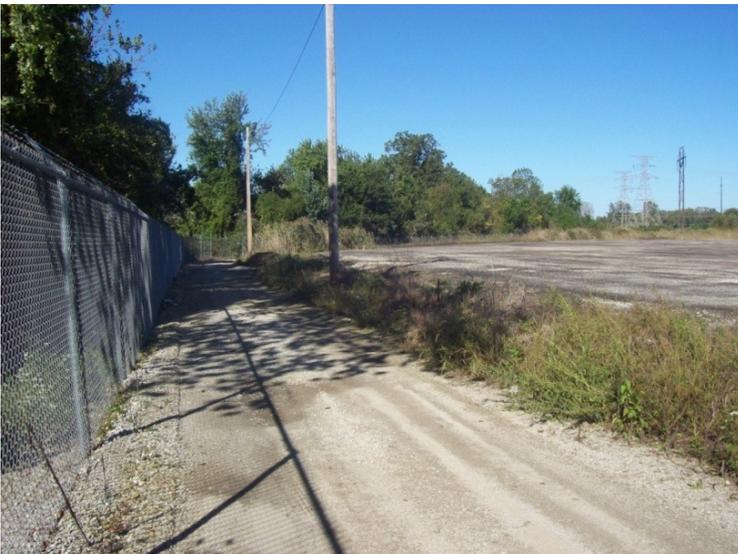
35. Erosion area caused by surface runoff.

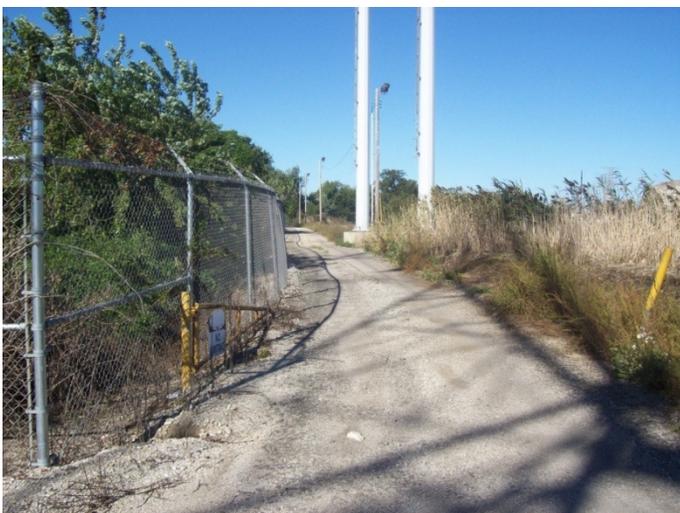
37. Maintenance of erosion area.

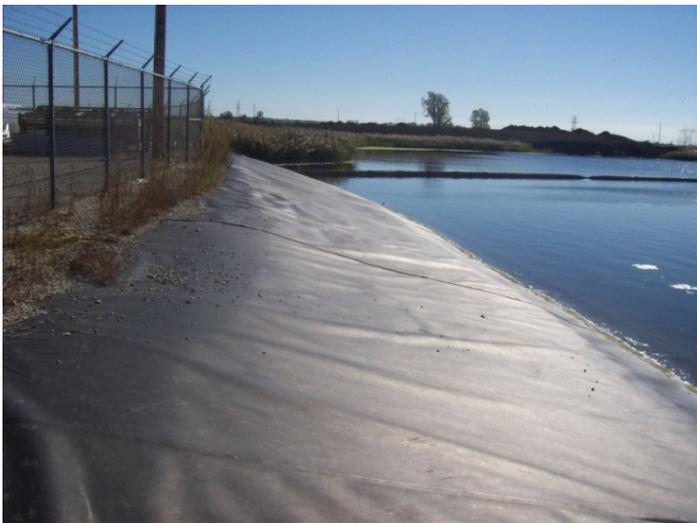
43. Fly Ash Pond outlet erosion control to reduce velocity.

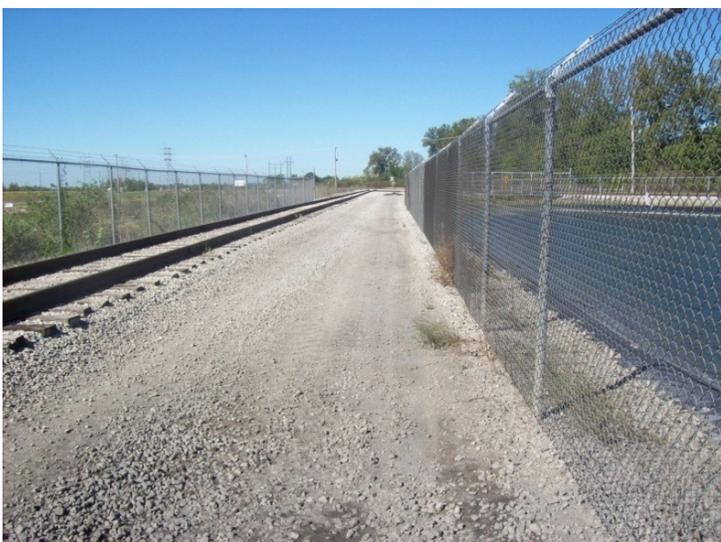
54. Looking West along top of embankment.

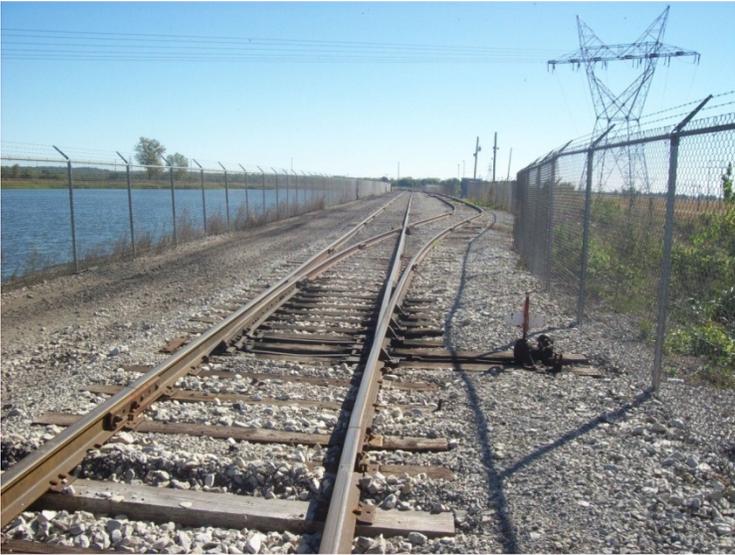
55. Looking East along top of embankment. Note - top width increases for 2x the width of the South side of the Fly Ash Pond embankment .

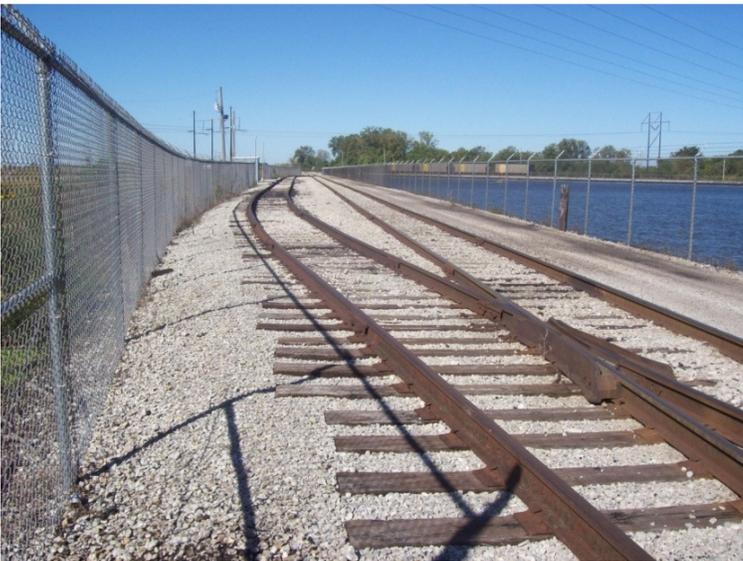
56. Looking East along embankment. Top width is approximately 40'.

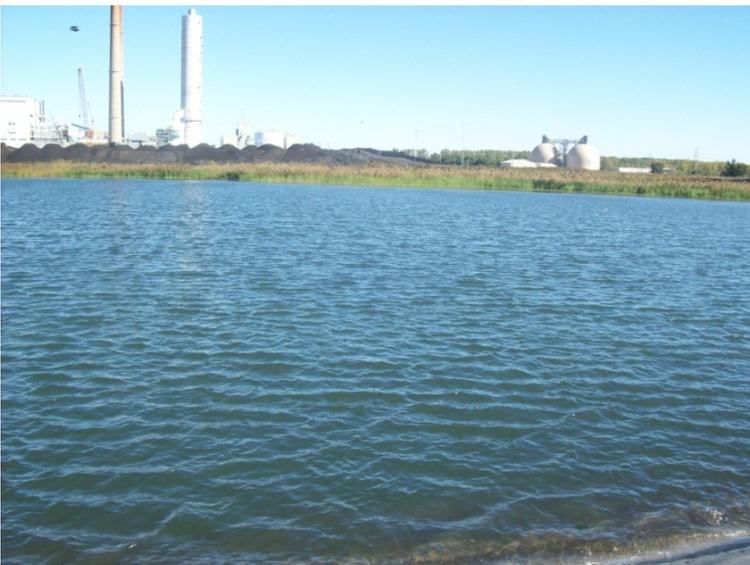
57. Looking North across Fly Ash Pond.

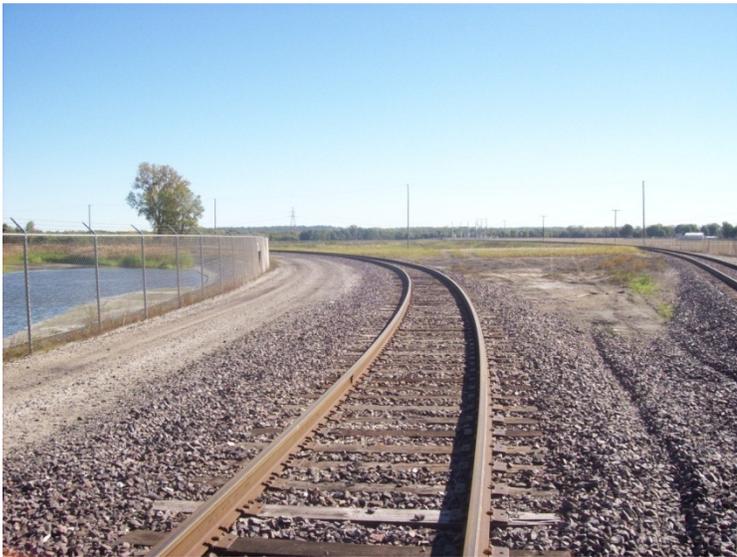
58. Looking at Southeast corner of Fly Ash Pond.

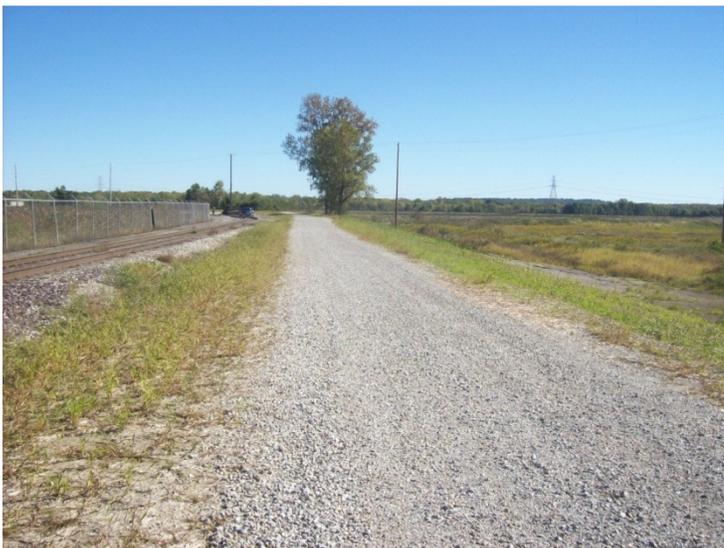
59. Looking Northeast along embankment. Note - wide top width.

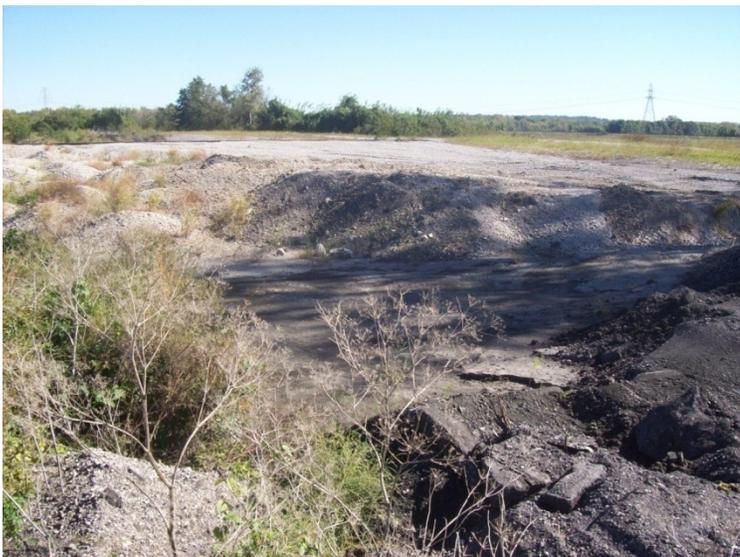
61. Looking toward the area to the East of the embankment.

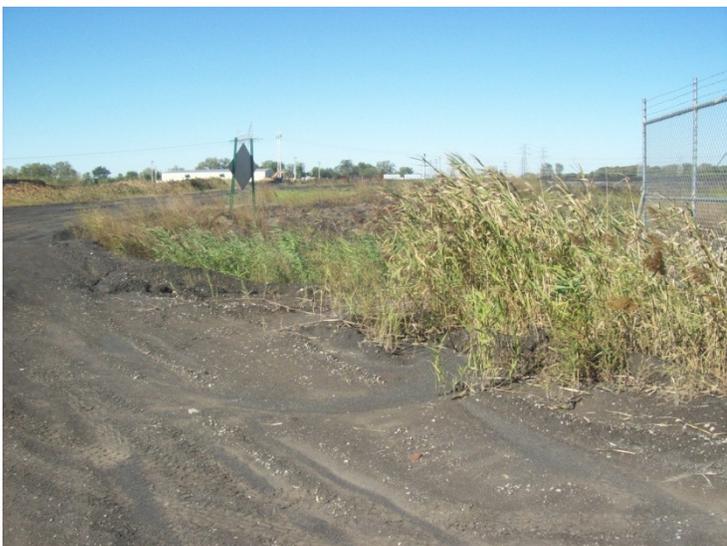
62. Looking Southeast at Fly Ash roadway.

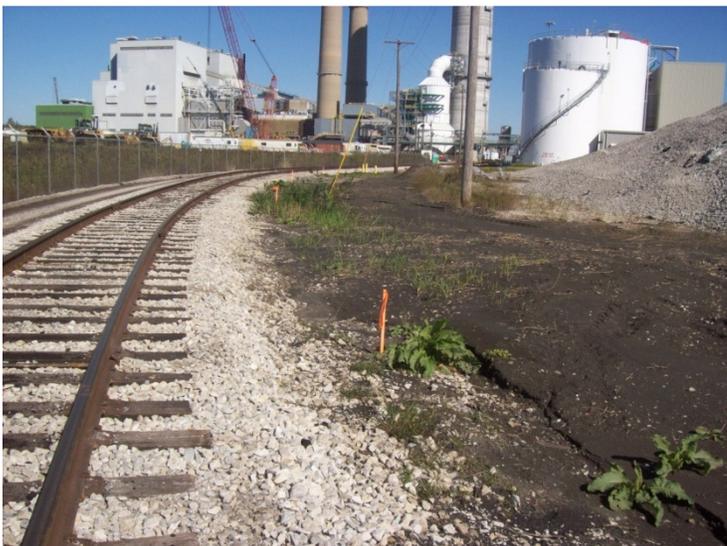
63. Looking Northwest along embankment.
Note - fill on both sides of embankment.

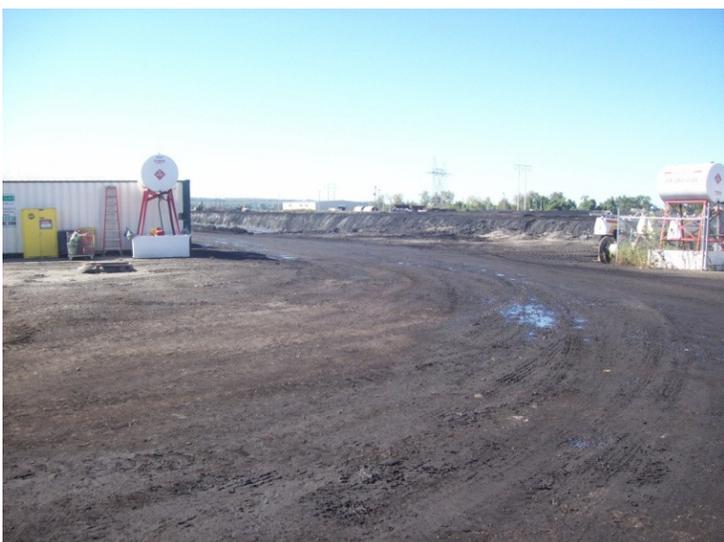
65. Looking at construction staging area within Fly Ash Pond.

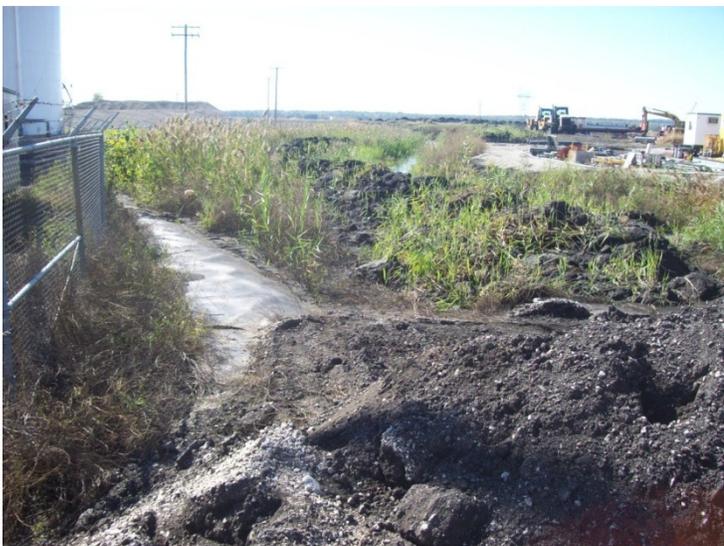
66. Looking South at channel in fill area. Note - channel flowing into pool area.

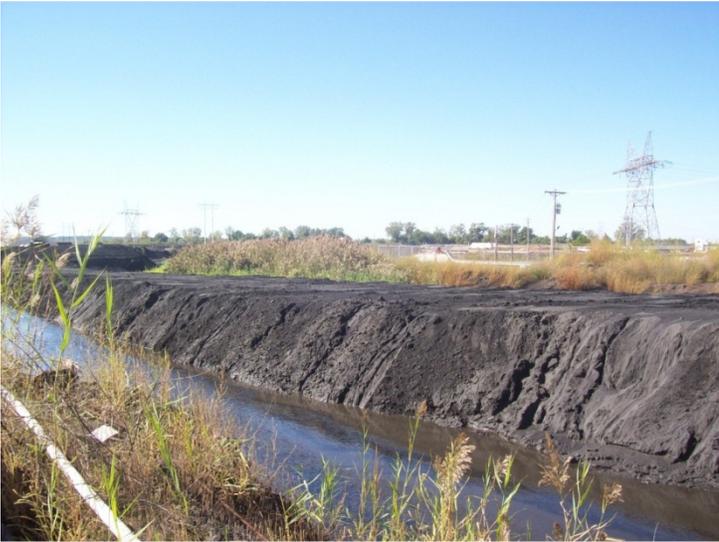
67. Outfall channel from plant into Fly Ash Pond.

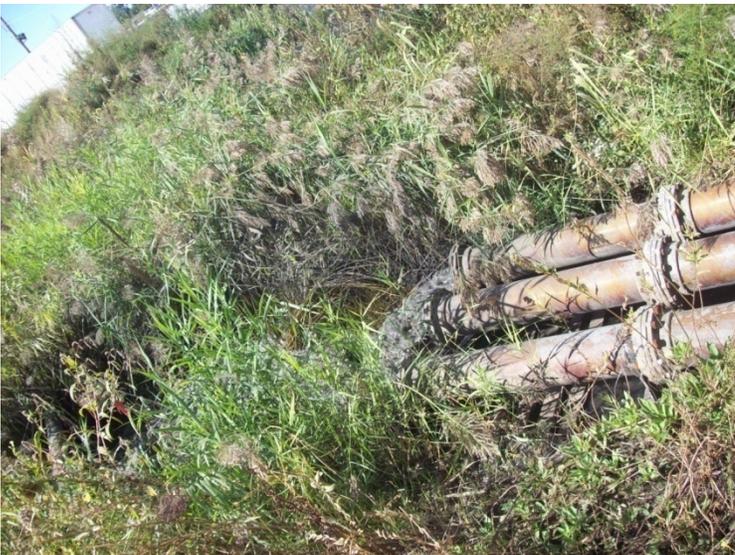
68. Outfall pipes.

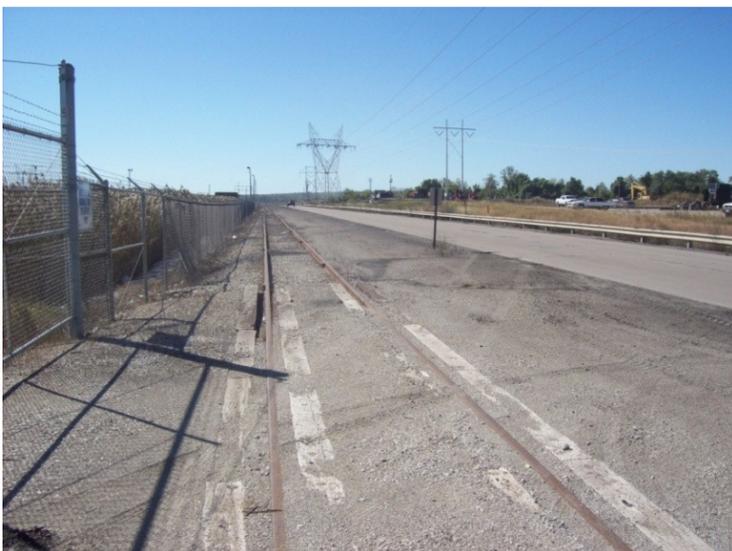
72. Looking South along embankment.

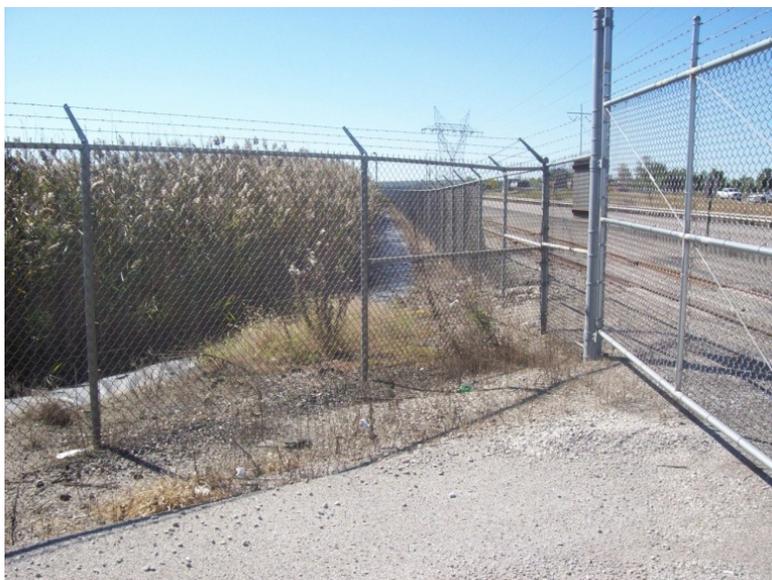
73. Looking at Northwest corner of Fly Ash Pond.
