**Coal Combustion Residue Impoundment
Round 9 - Dam Assessment Report**

Plant Gadsden

Fly Ash Dike

Alabama Power Company
Gadsden, Alabama

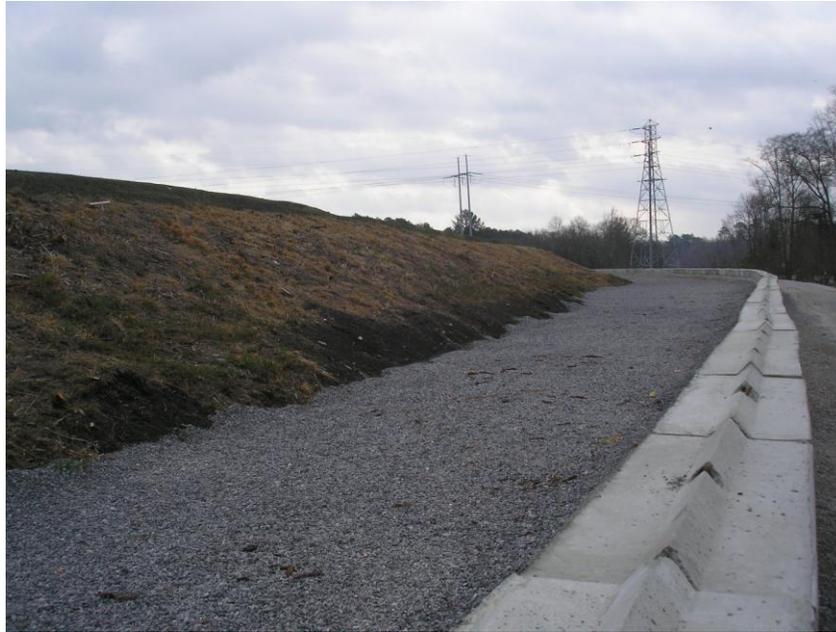
The exterior slope of the upper pond embankment is vegetated with various species of grass and short weeds. A new geotextile lined, subsurface toe drain and gravel ditch had been added along the roadway constructed to access the ash stockpile. Figure 5.2.3-3 shows the outside slope of the south embankment outside slope, the gravel lined toe ditch and the short concrete barrier separating the ditch from the stockpile access roadway.

Figure 5.3.2-3: Upper Pond South Embankment Outside Slope, Gravel Lined Toe Ditch and Concrete Barrier Separating Ditch and Ash Stockpile Access Road

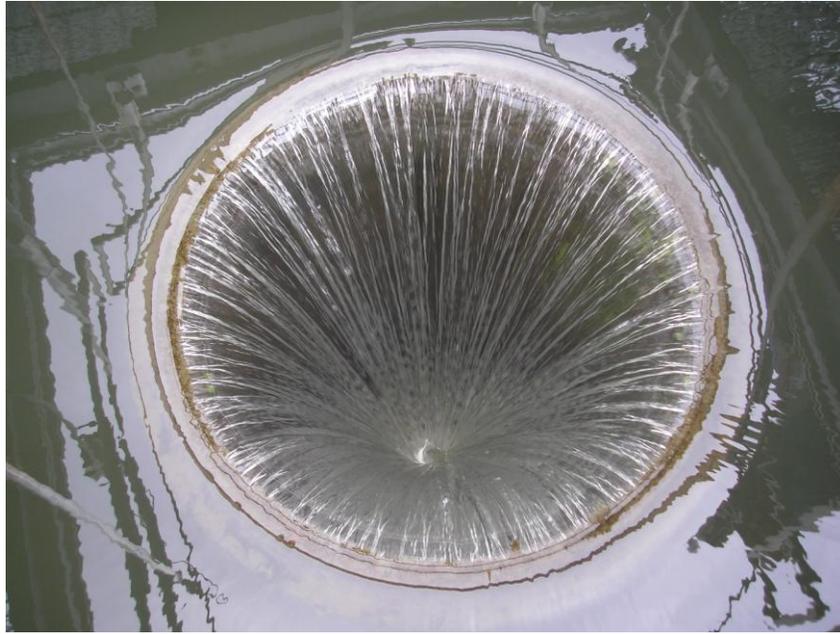
The impoundment primary overflow structure is located in the southeastern corner of the lower pond. The overflow consists of a 48-inch diameter reinforced concrete pipe with an overflow elevation of 523 ft and an invert elevation of about 512 ft. The overflow spillway discharge is a 36-inch diameter concrete pipe that discharges into a partially riprap-lined channel that flows a short distance to the Coosa River. Figure 5.3.1-1 shows the overflow riser and Figure 5.3.1-2 shows the discharge channel to the Coosa River.

Figure 5.3.1-1: Gadsden Plant CCR Impoundment Primary Overflow Riser

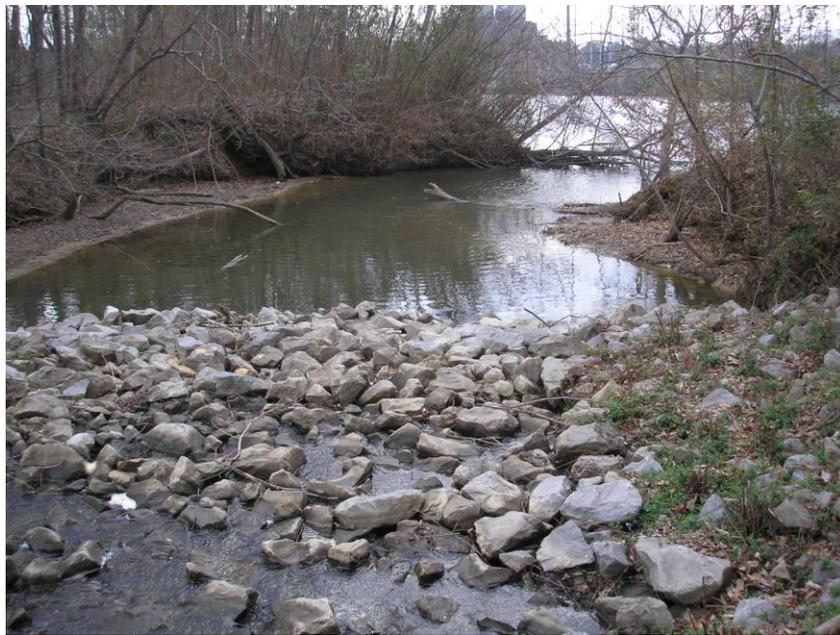
Figure 5.3.1-2: Gadsden Plant CCR Impoundment Primary Spillway Outfall Area.

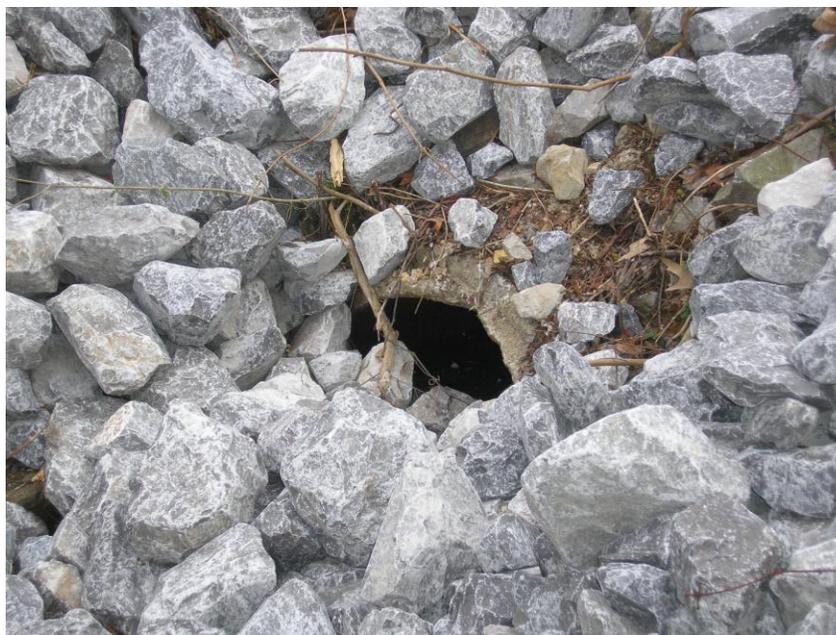
Figure 5.3.3-2: Gadsden Plant CCR Impoundment Emergency Spillway Outlet Conduit

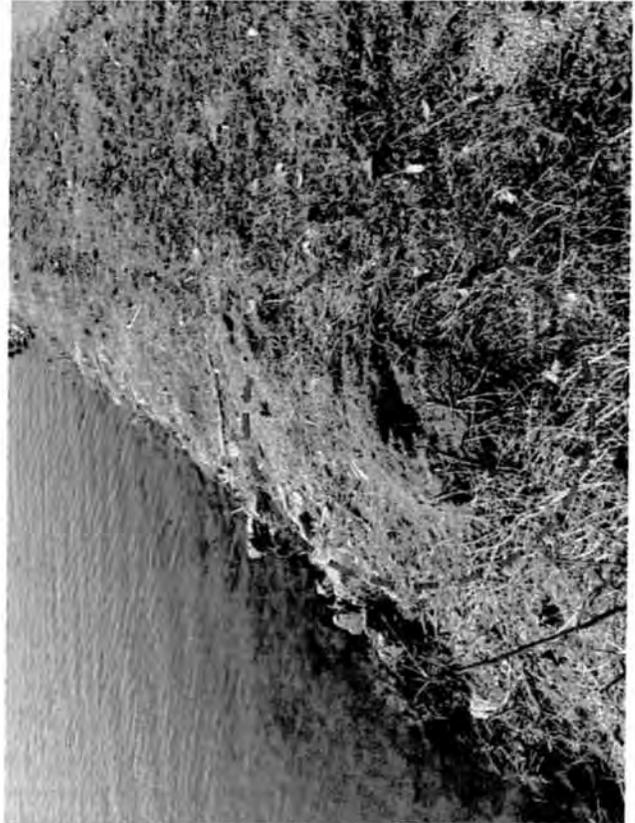
Photo 3: Ant Mounds on Upstream Side of Ash Pond Embankment (typical)

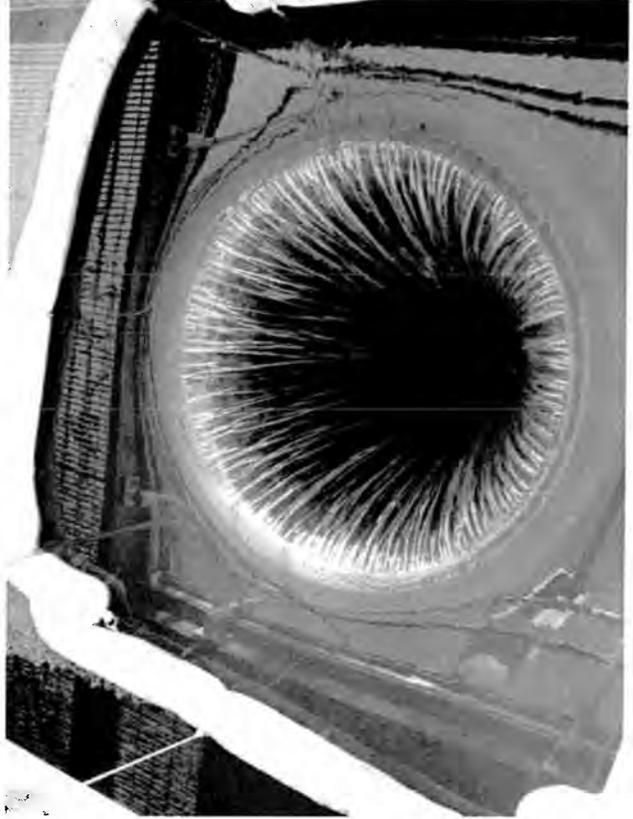
Photo 8: Discharge Pipe in Ash Pond

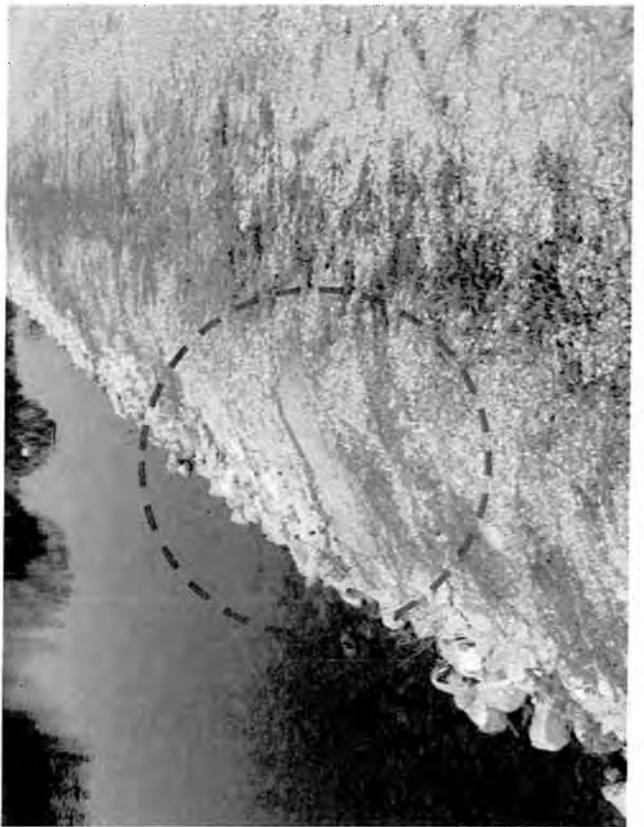
A fair number of sizable ant mounds were observed along the embankment crest (noted on Photo 3). It is recommended that efforts continue to control these mounds using pesticides.

Photo 3: Ant Mounds on Upstream Side of Ash Pond Embankment (typical)

No.	Description	Location
1	Eradicate all ant mounds on the embankments using pesticides.	1979 Extension Embankment (Photo 3)
2	Armor the upstream side of the crest of the embankment structures to protect against wave action induced erosion. The armoring can be achieved using riprap.	1979 Extension Embankment (Photo 4)
3	Clear vegetation and trees to a distance of 5 feet beyond the downstream toe of water-retaining embankments. At this time, large trees (i.e. greater than 4 inches in diameter) may be left in-place.	1979 Extension Embankment (Photo 5)
4	Remove fairly dense vegetation from northernmost corner of 1979 Extension Embankment (see Photo 6). The removal should be performed by bush-hogging (where accessible) or use of herbicides.	1979 Extension Embankment (Photo 6)

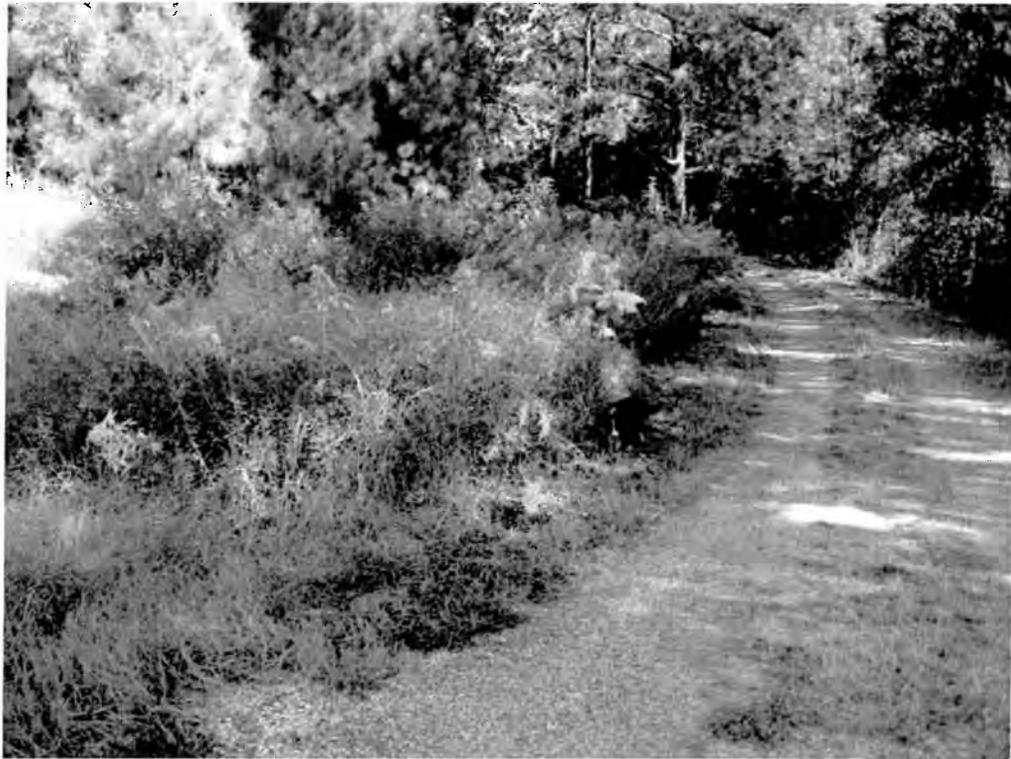
Photo 2 – Brush on Upstream Face of Original Dike, Typical

No.	Description	Location
1	The trees along the original ash pond embankment (upstream and downstream) should be removed. The trees on the downstream face should be removed to a distance of 20 feet downstream of the toe where practical.	Original Dike (see Photos 1, 2, and 3)
2	Drainage in the drainage ditch along the upstream face of the original ash pond embankment should be improved. As plans progress, the plant should continue to keep SCG Hydro Services informed.	Original Dike (see Photo 4)
3	The woody debris noted beneath the transmission line should be cleared to provide an unobstructed view of the embankment downstream face.	Original Dike (see Photo 5)
4	It is recommended that the level of maintenance observed along the 1979 Extension dike structure be continued for all ash handling structures at Gadsden SP.	All Structures
5	Stumps observed along the western edge of the 1979 Extension dike should be removed.	1979 Extension Dike (see Photo 9)

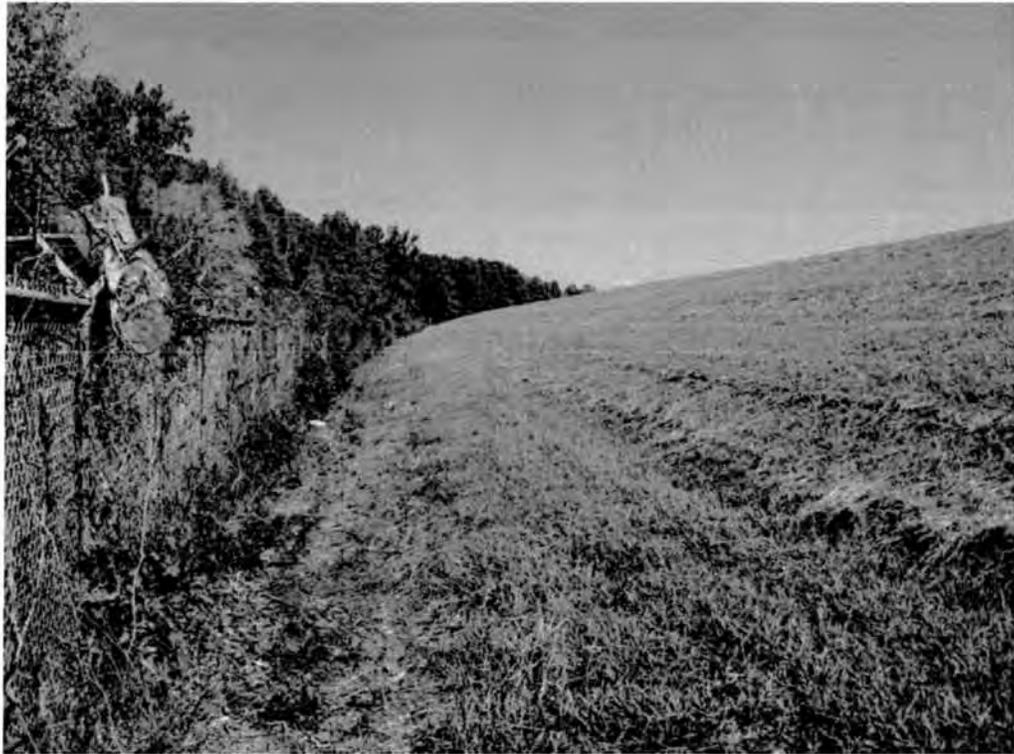
The 1979 Extension dike was found to be in excellent condition and is being well-maintained (see Photo 7). Vegetation maintenance along the dike is satisfactory. ***It is recommended that a similar level of maintenance be continued.*** The upstream face of the dam has been almost fully armored with riprap (see Photo 8), which appears to have remedied past issues with erosion of the upstream face of the crest.

Photo 7 – Condition of Downstream Face of 1979 Extension Embankment, Typical

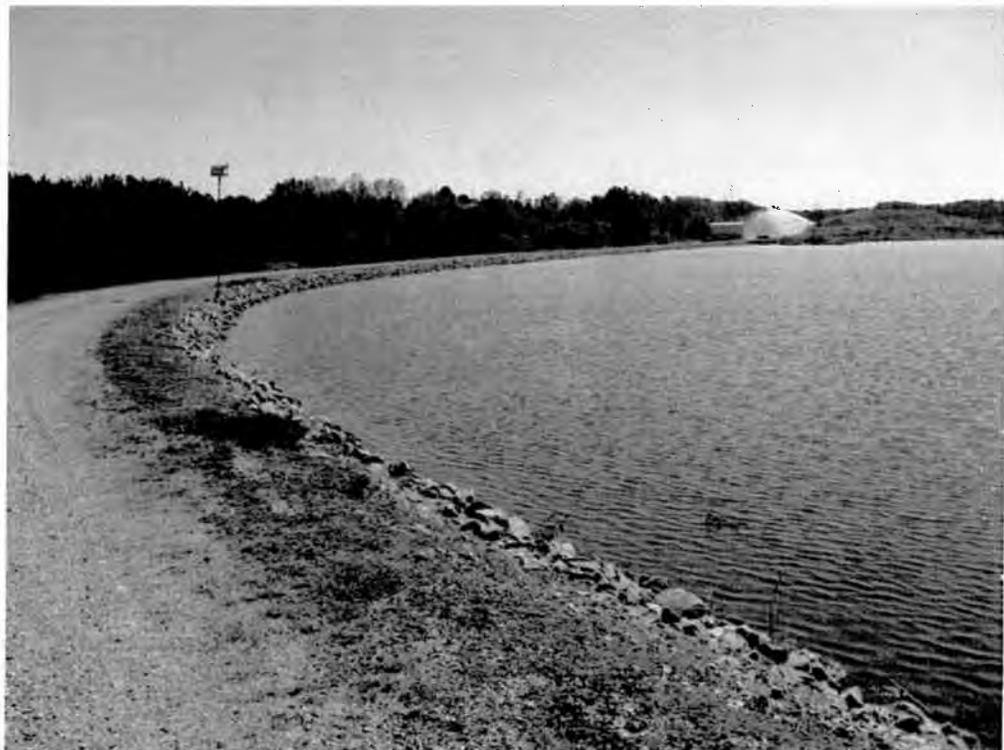
Photo 8 – Riprap Armoring on Upstream Face of 1979 Extension Embankment

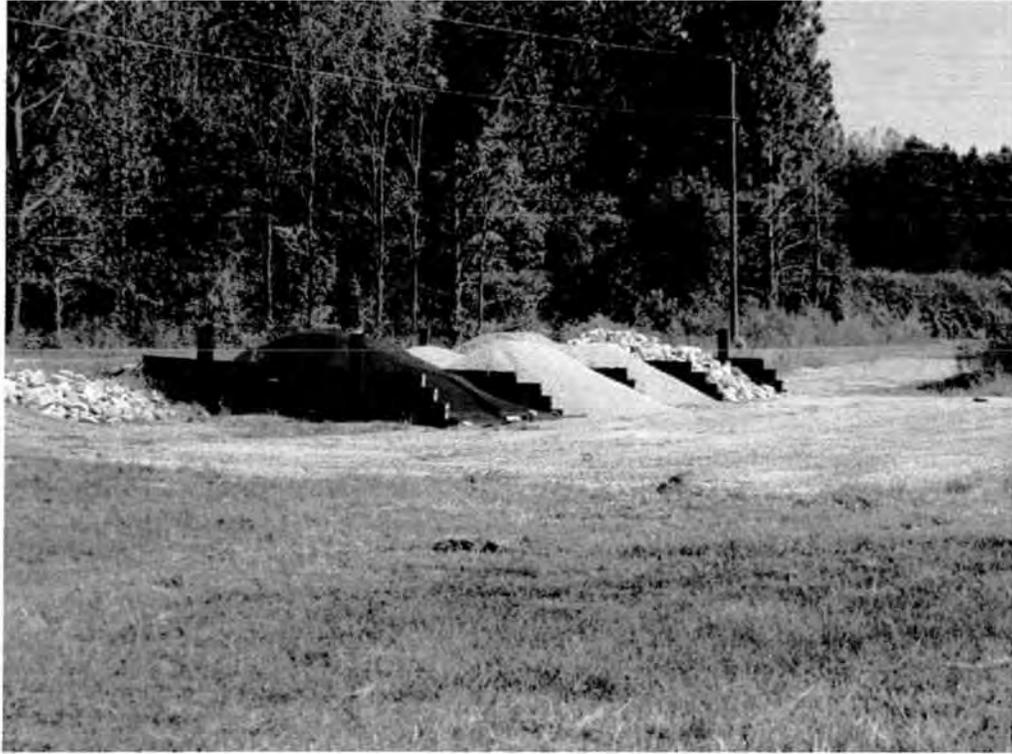
While at the plant, the inspection team verified the type and proper storage of the plant's emergency filter stockpile materials (see Photo 11).

Photo 11 – Condition of Emergency Filter Stockpiles
