FINAL
Coal Ash Impoundment -
Specific Site Assessment Report
Arizona Public Service
Four Corners Power Plant

Submitted by:
GEI Consultants, Inc.
6950 South Potomac Street, Suite 300
Centennial, CO 80112

September 2009
Project 091330

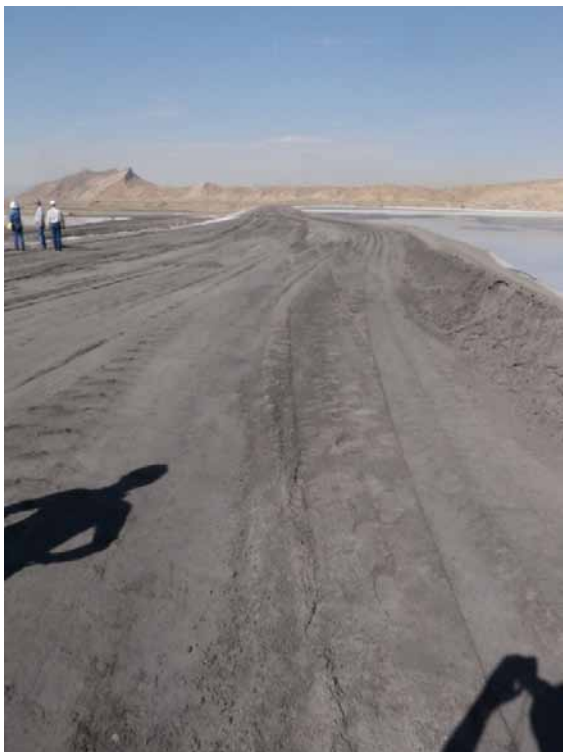
Photo 5 – LAI Dam crest on south dam, looking to left. Note small bottom ash 'berm' at slope crest for construction traffic safety.

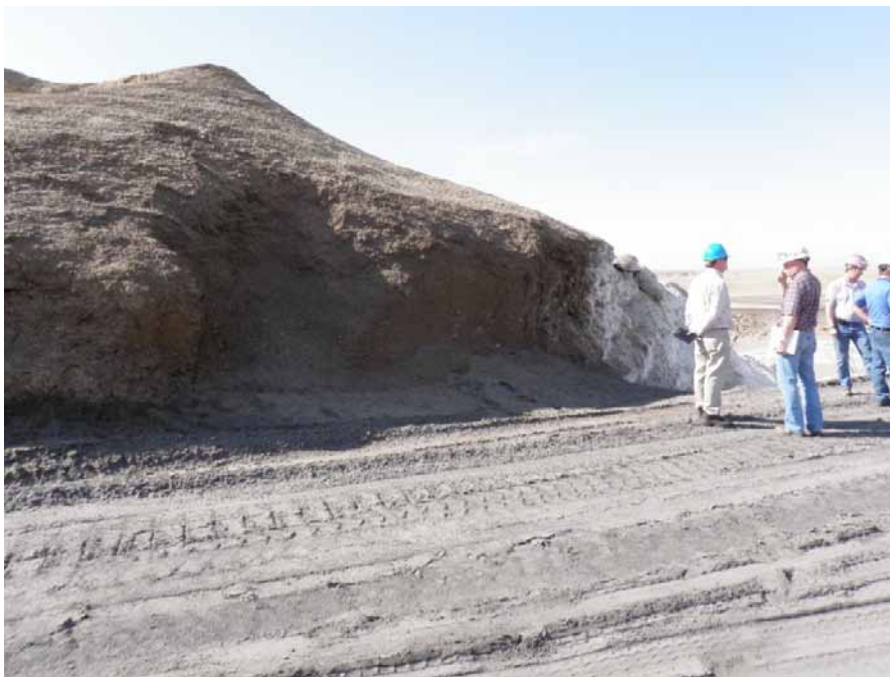
Photo 6 – LAI Exposed part of natural weathered shale that the south and east berm clay cores tie into for seepage control.

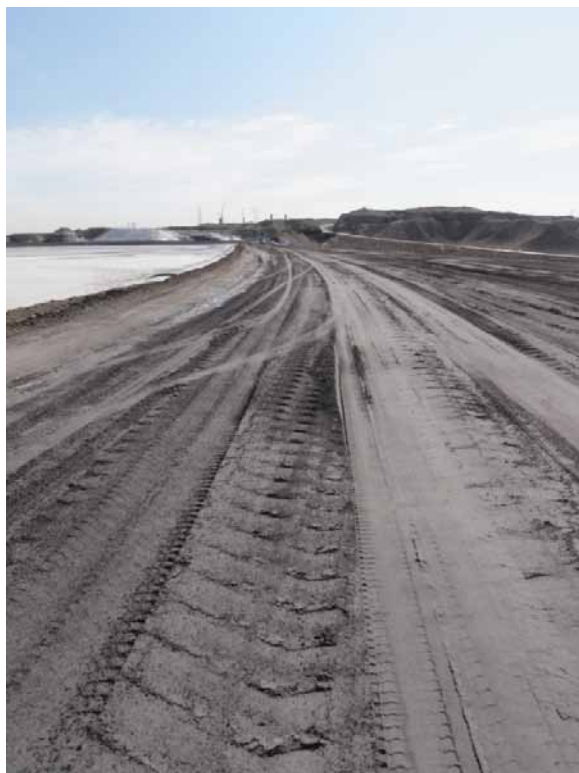
Photo 7 – LAI Dam crest on south dam, looking to the right and toward natural high ground and power plant in background.

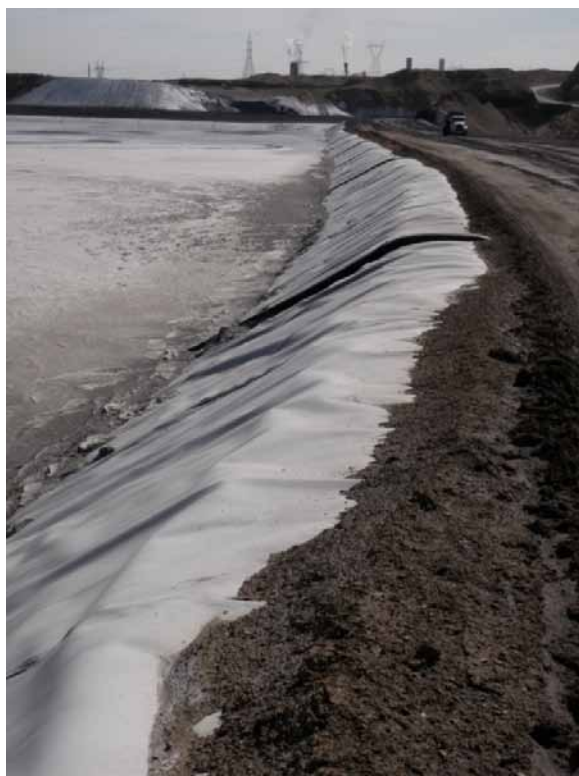
Photo 8 – LAI Upstream slope on south dam.

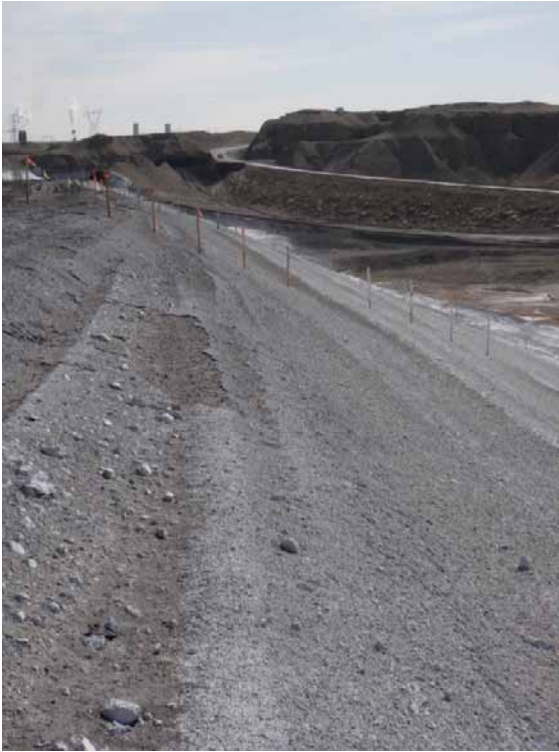
Photo 9 – LAI Downstream slope on south dam.

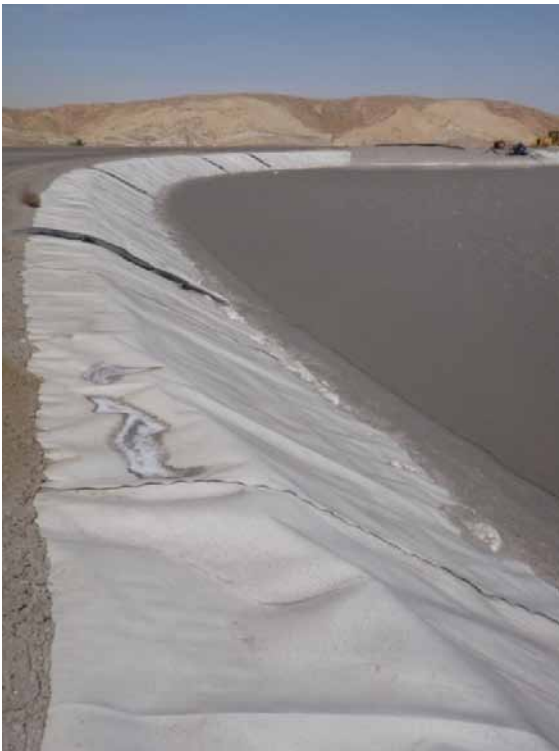
Photo 10 – LAI Upstream slope on south dam and southwest corner of impoundment. Note 'ash fill' placed on west upstream slope for pump to supply water for construction of LAI raise to El. 5258.

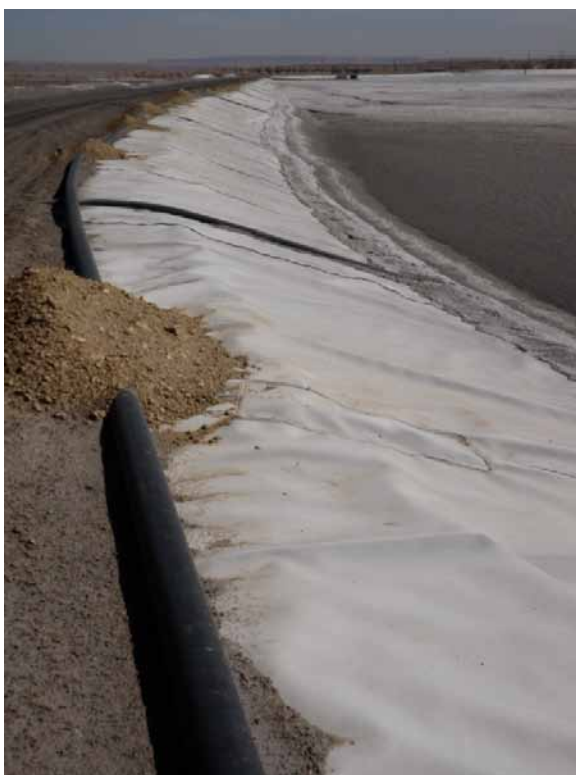
Photo 12 – LAI Upstream slope on west dam. HDPE pipe is to supply water for construction.

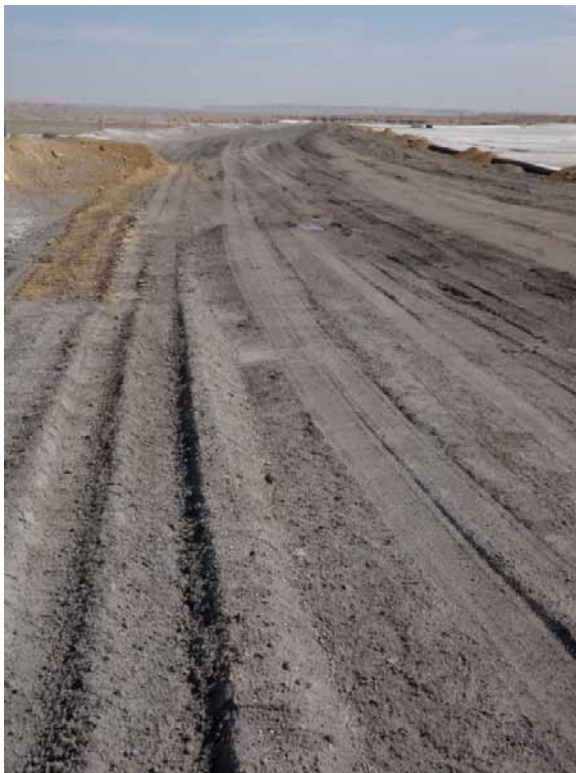
Photo 13 – LAI Crest of west dam. Note small construction material stockpile for dam raise.

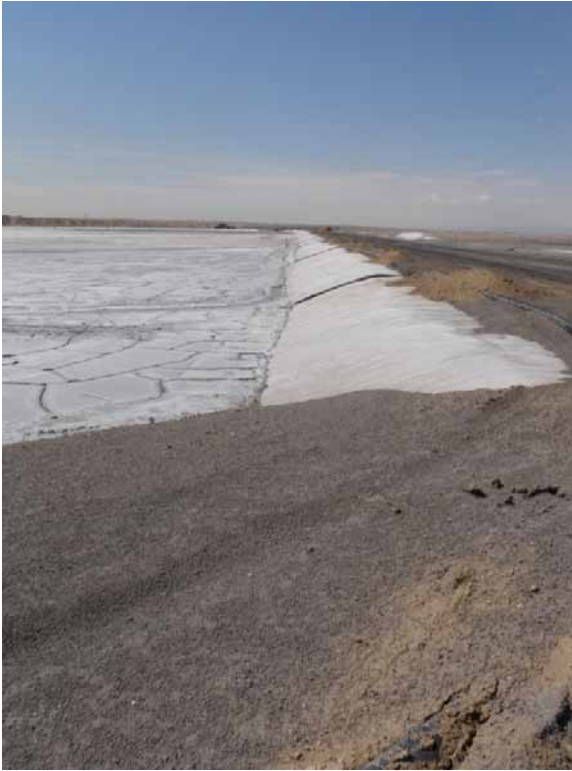
Photo 19 – LAI Upstream slope of west dam, looking right.

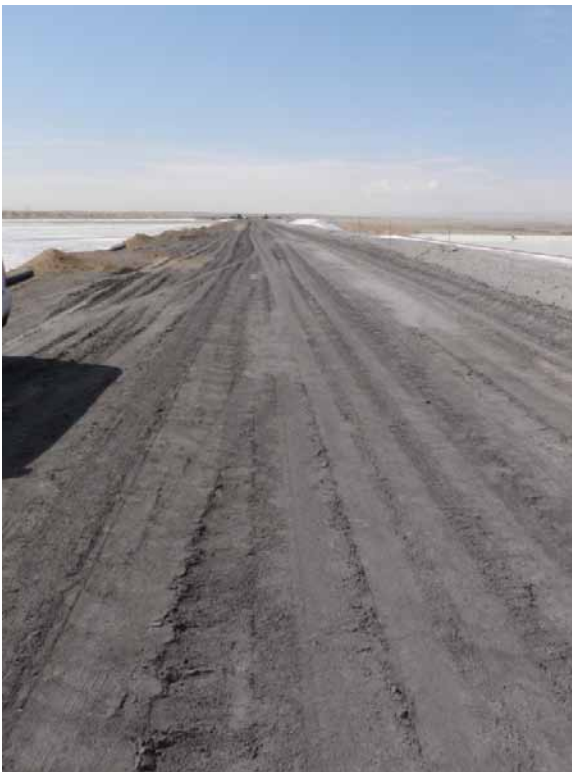
Photo 20 – LAI Crest of west dam, looking right.

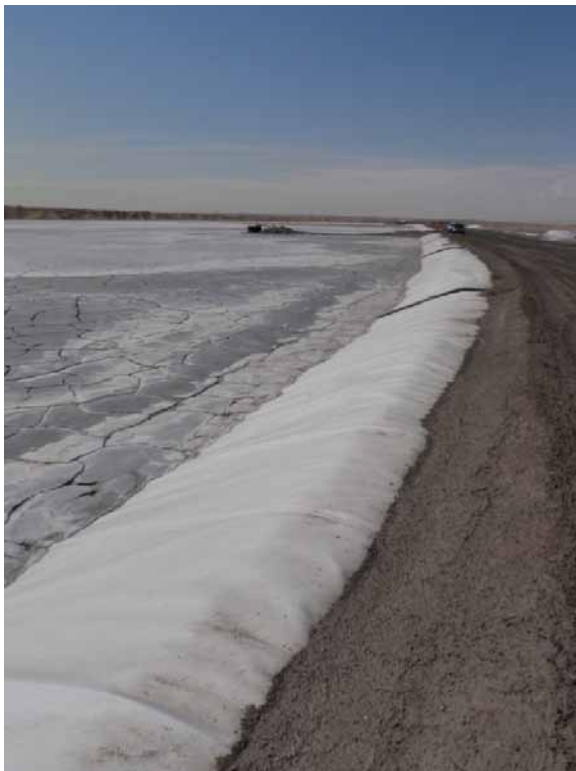
Photo 21 – LAI Upstream slope of west dam, looking right. Note berm to access decant drop inlet structure.

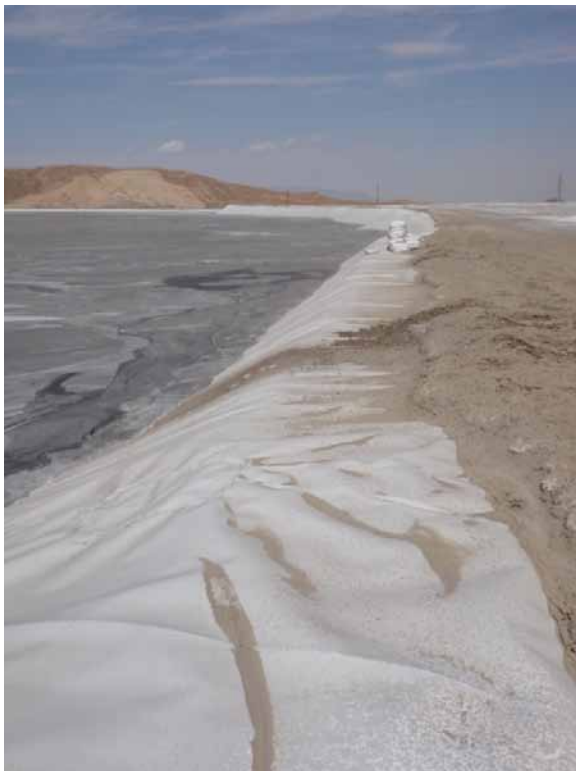
Photo 23 – LAI Upstream slope of north dam, looking left from near northeast corner of impoundment.

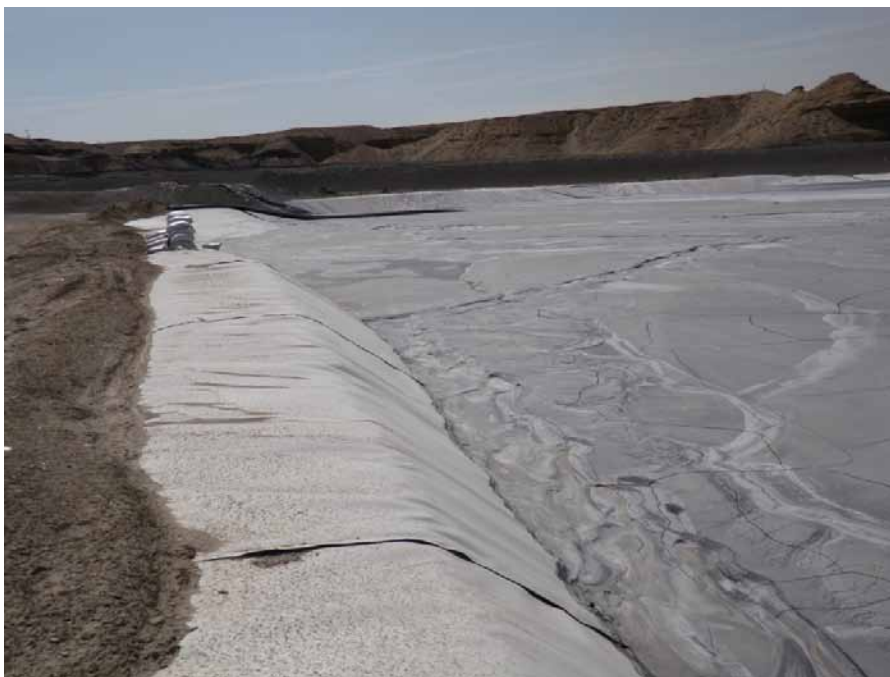
Photo 24 – LAI Upstream slope of north dam, looking right from near northeast corner of impoundment towards the ash slurry discharge into pond and natural high ground to east.

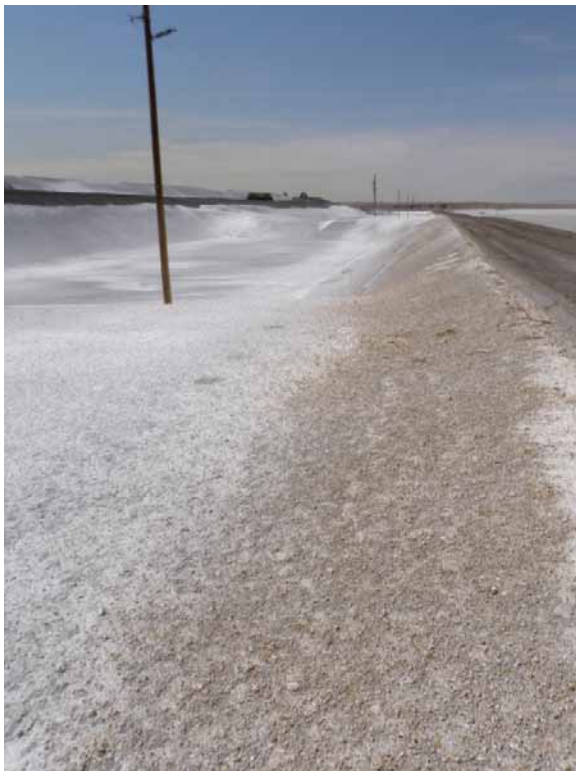
Photo 27 – LAI Downstream slope and toe of west dam on left, adjacent LDWI dam is on right.

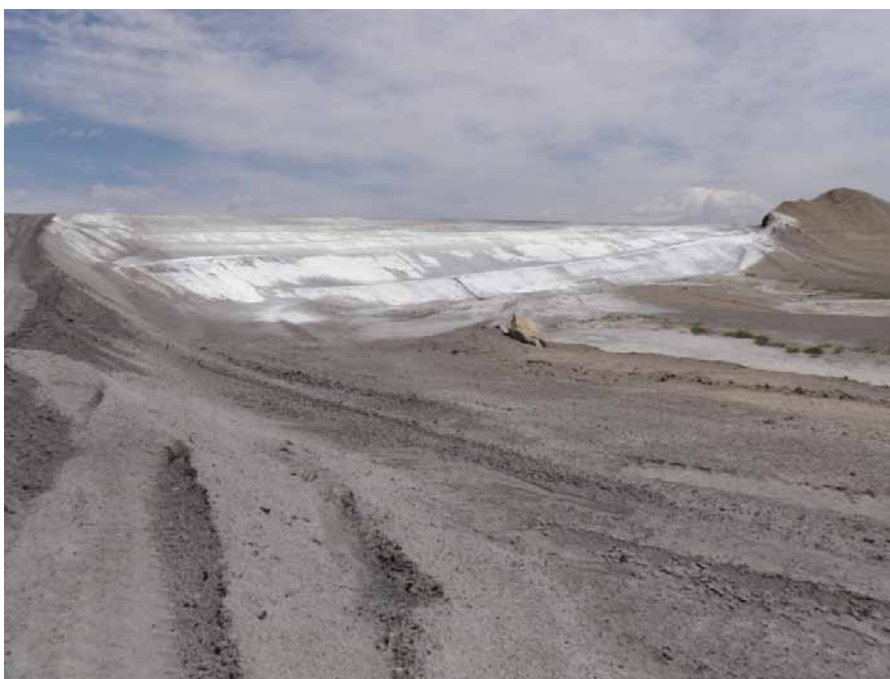
Photo 30 – LAI Downstream slope and toe of south dam, looking left toward the tie-in with natural weathered shale high ground.

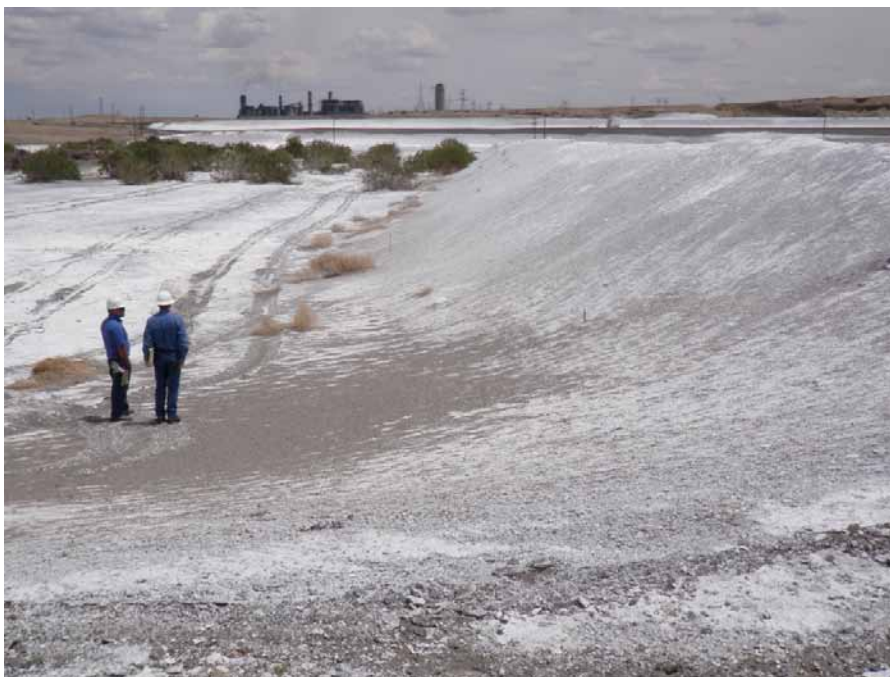
Photo 31 – LDWI Downstream slope of north dam, looking east to power plant.

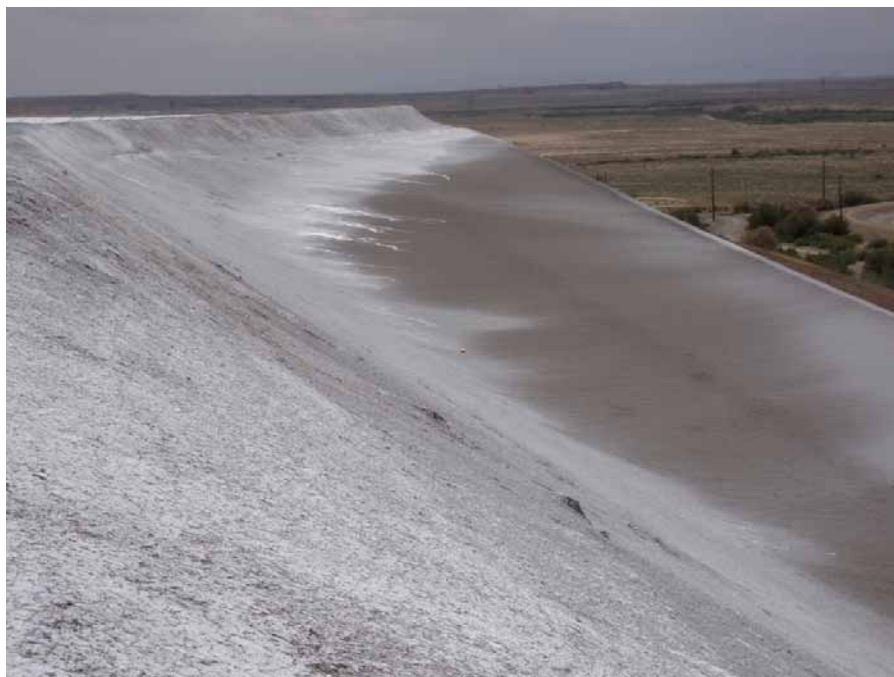
Photo 35 – LDWI downstream slope of west dam.

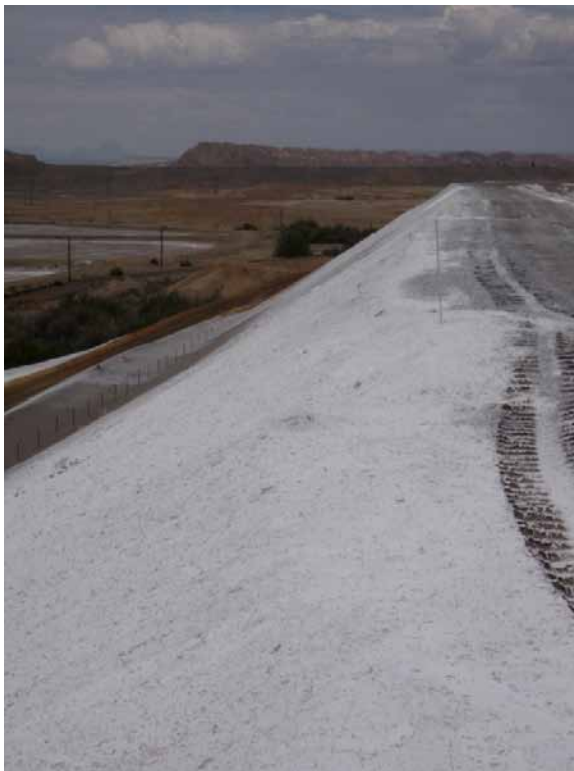
Photo 37 – LDWI downstream slope of west dam, looking north.

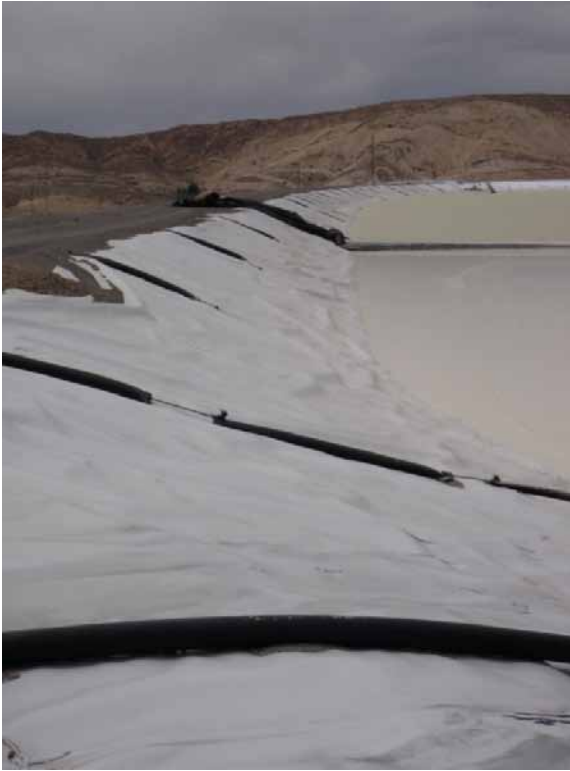
Photo 39 – LDWI Upstream slope of south dam. Note bladder dam used to divide reservoir to maintain depth of water over pumping system to convey water to power plant.

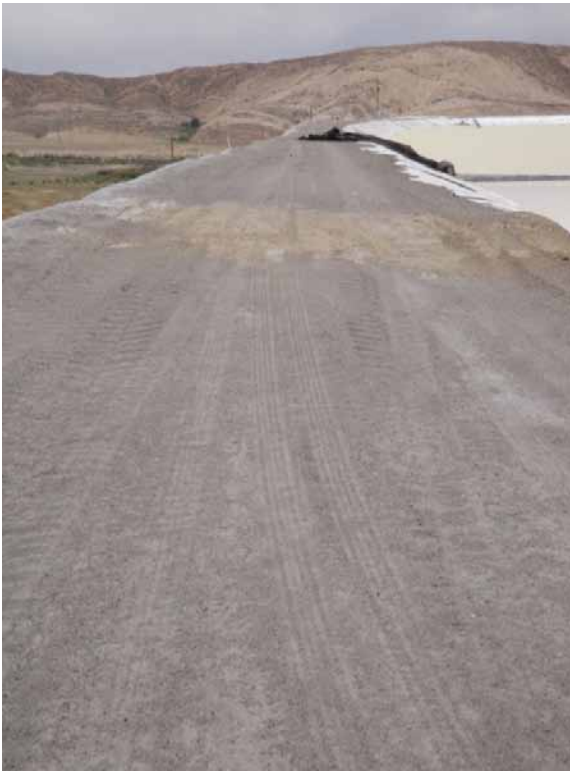
Photo 40 – LDWI Crest of south dam.

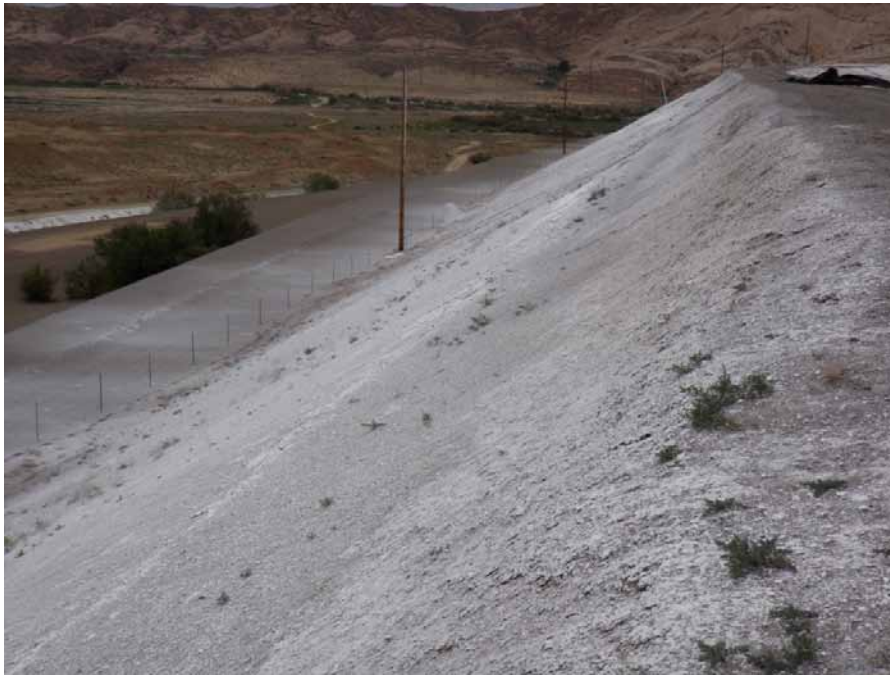
Photo 41 – LDWI Downstream slope of south dam.

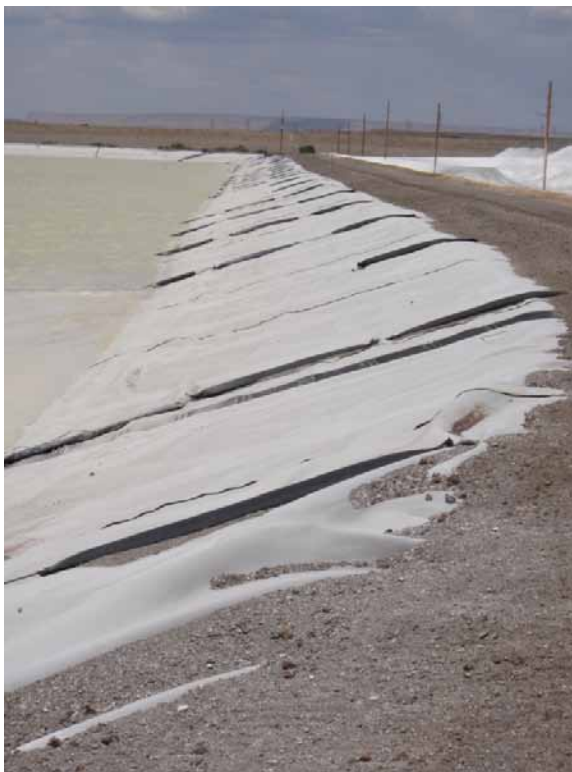
Photo 42 – LDWI Upstream slope of east dam, looking north.

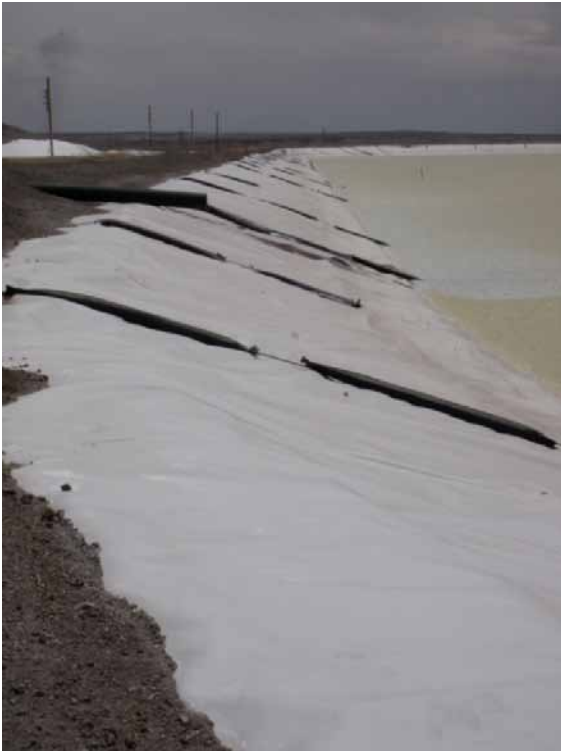
Photo 46 – LDWI Upstream slope of east dam, looking south. Note the 16 inch and 8 inch discharge pipes from the LAI decant intake that are routed across the top of the LDWI dam.

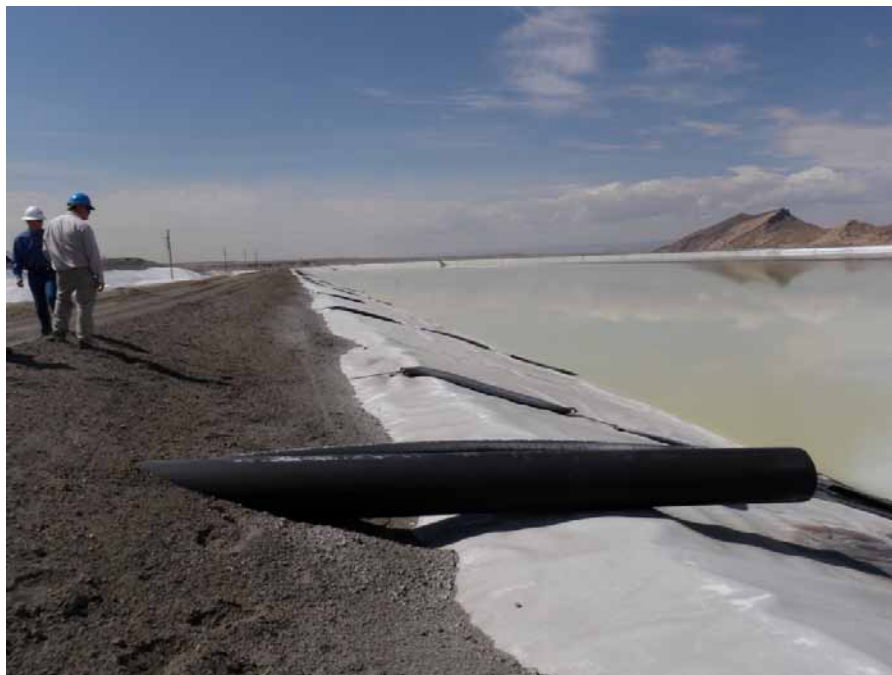
Photo 47 – LDWI Discharge end of 16" and adjacent 8" pipes with decant water from LAI.
