**DRAFT FINAL**  
**Coal Ash Impoundment**  
**Specific Site Assessment**  
**Report**  
**Arizona Public Service**  
**Cholla Power Plant**

Submitted by:  
**GEI Consultants, Inc.**  
6950 South Potomac Street, Suite 300  
Centennial, CO 80112

October 2009  
Project 091330

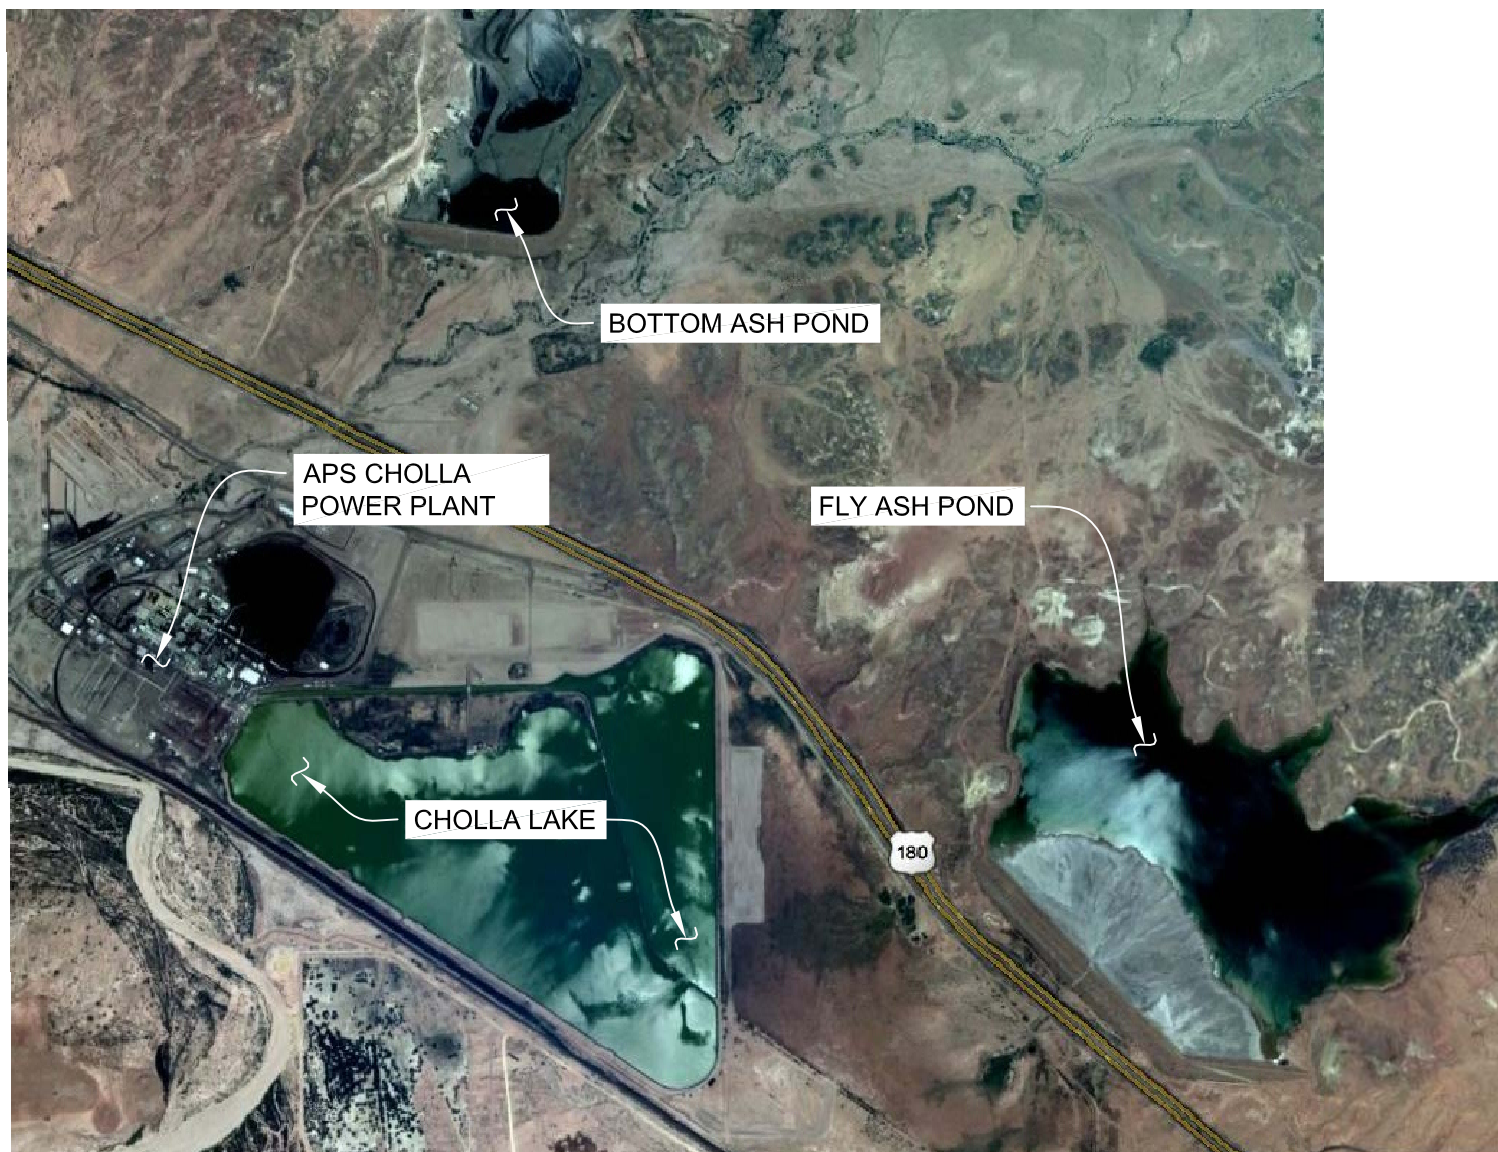
Figure 2

In addition to the on-site impoundments, the Cholla plant has two major impoundments located off site. The Fly Ash Pond is located approximately 1.5 miles east of the plant, and the Bottom Ash Pond is located approximately two miles north of the plant. Both units have been classified as high hazard impoundments due to the potential for loss of life in the event of a dam breach because of the close proximity of the Cholla power plant, U.S. Interstate 40, a freight railroad line and several residences downstream of the dams. An overall view of the onsite and offsite ponds is shown on the aerial photograph (Figure 2).

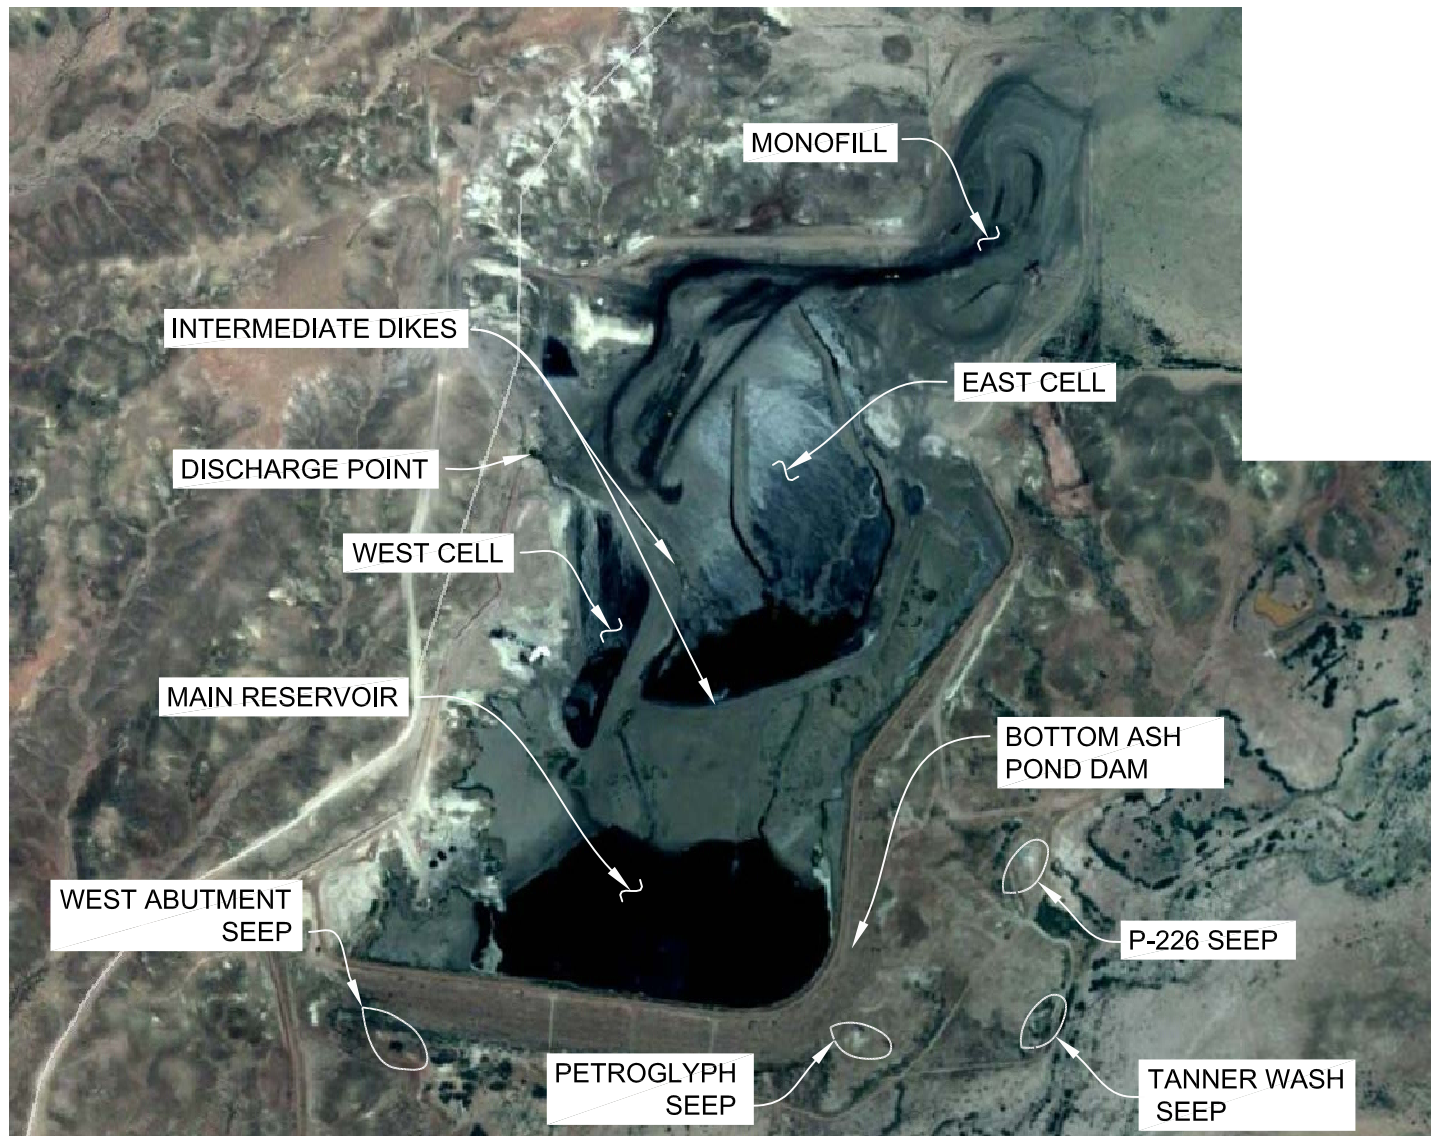
Figure 4

constructed to collect surface water and groundwater and return it to the ponds. An aerial photograph of the Bottom Ash Pond is shown in Figure 4. Drawings including a plan, profile and sections of the Bottom Ash Pond Dam are attached in Exhibit 4. A plan for the siphon system for the Bottom Ash Pond is attached in Exhibit 5. A profile of the Bottom Ash Pond Dam is attached in Exhibit 6.

An intermediate dike was constructed in 1993 to divide the upstream part of the reservoir into smaller cells (East Cell and West Cell), which were created to store bottom ash, see Figure 4. The intermediate dike was constructed with a lower part that consists of hydraulically placed bottom ash and an upper part that consists of compacted bottom ash. Stability analyses were not performed for the feasibility design (Dames & Moore, 1991), but its foundation design and side slope configuration was determined based on laboratory test strengths of the bottom ash material. According to the feasibility design report, shear strength for the compacted bottom ash was developed from consolidated-undrained triaxial compression tests with pore pressure measurements, and strength parameters for hydraulically-placed bottom ash and foundation bottom ash (hydraulically-placed bottom ash beneath the dike that has been consolidated) were estimated using empirical correlations. Dames & Moore assigned an effective stress friction angle ( $\phi'$ ) of 37 degrees for the compacted bottom ash and effective friction angles of 24 and 30 degrees for foundation and hydraulically-placed bottom ash, respectively. The bottom ash was assigned a unit weight of 85 psf.

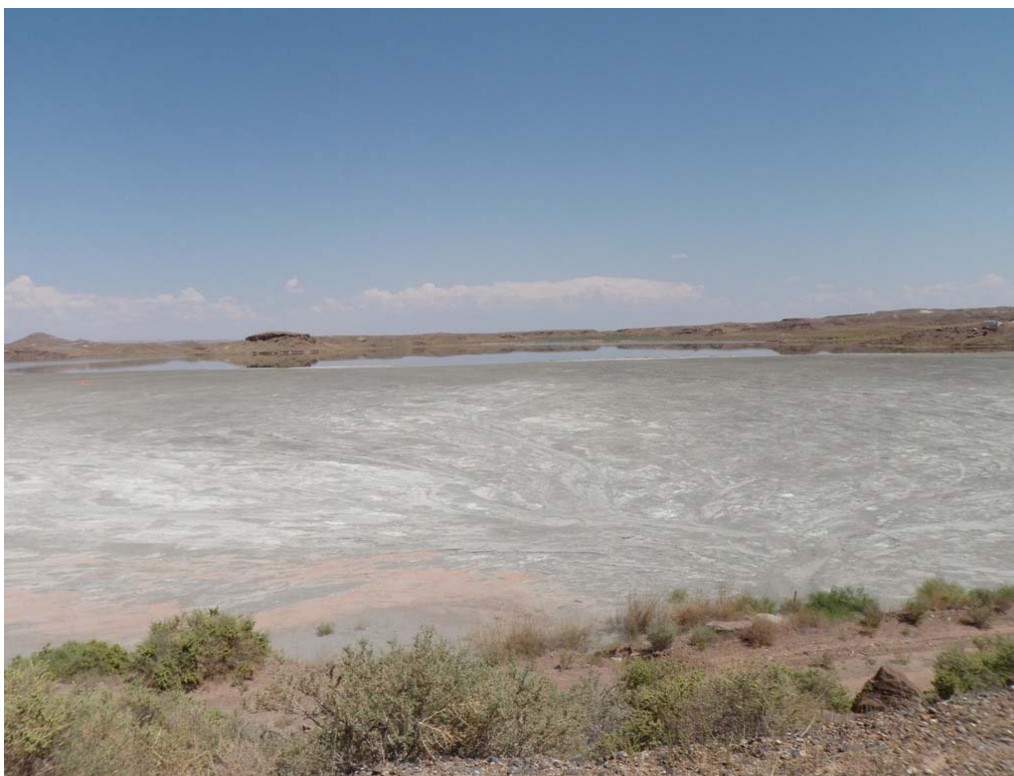
**Photo 1 –Fly Ash Pond: Overview looking north from embankment. Note downstream fly ash beach.**

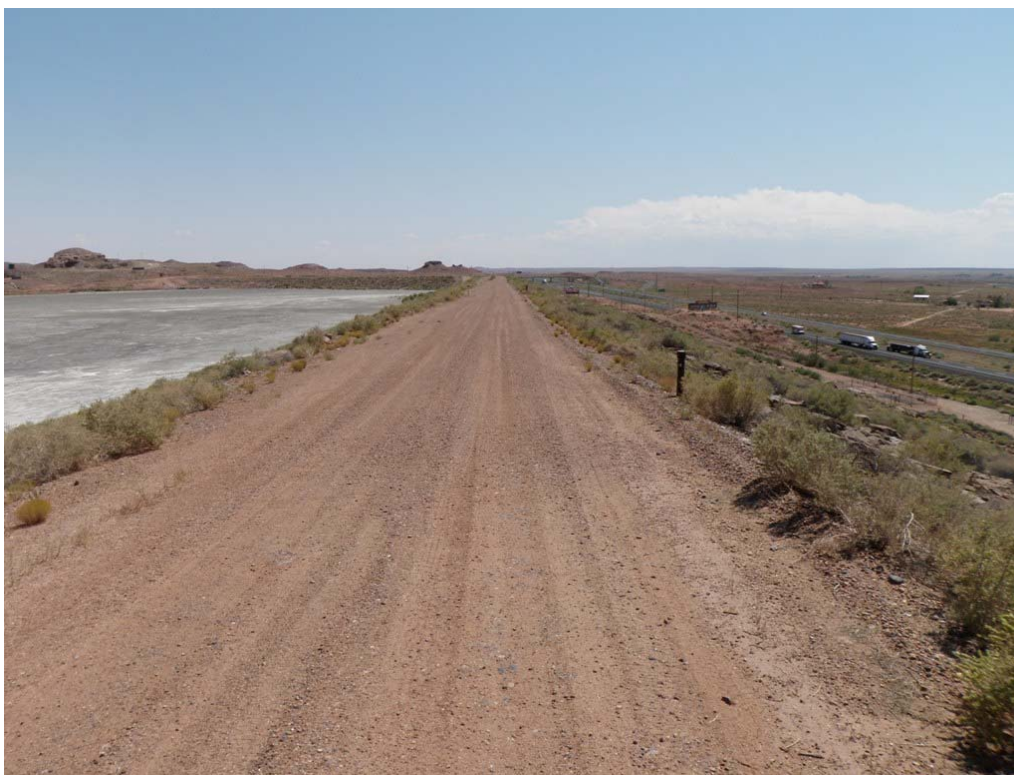
**Photo 2 –Fly Ash Pond Dam: Crest of embankment with dirt road, looking east.**

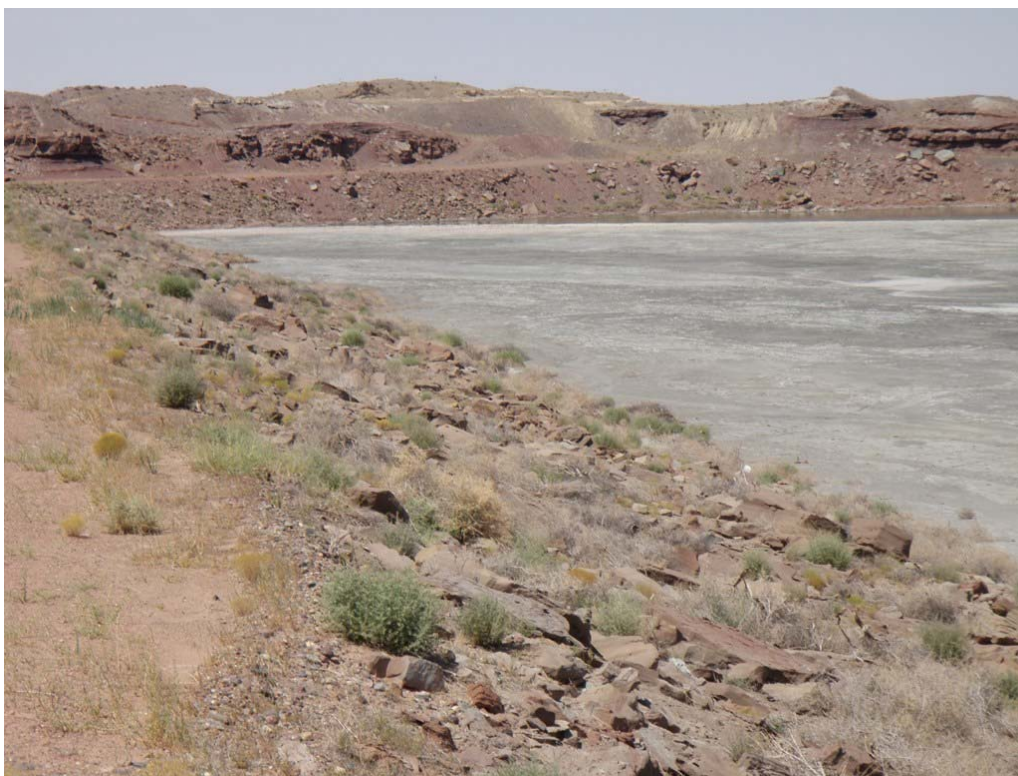
**Photo 5 –Fly Ash Pond Dam: Upstream slope, looking west. Note vegetation.**

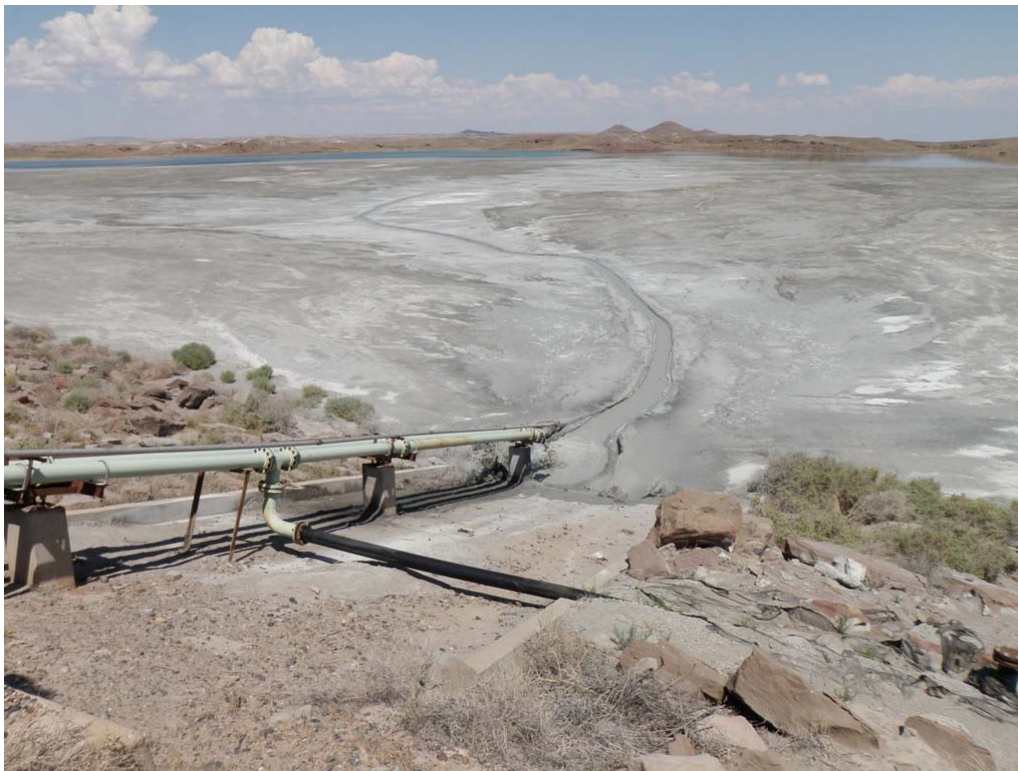
**Photo 6 – Fly Ash Pond Dam: Slurry discharge point on upstream face.**

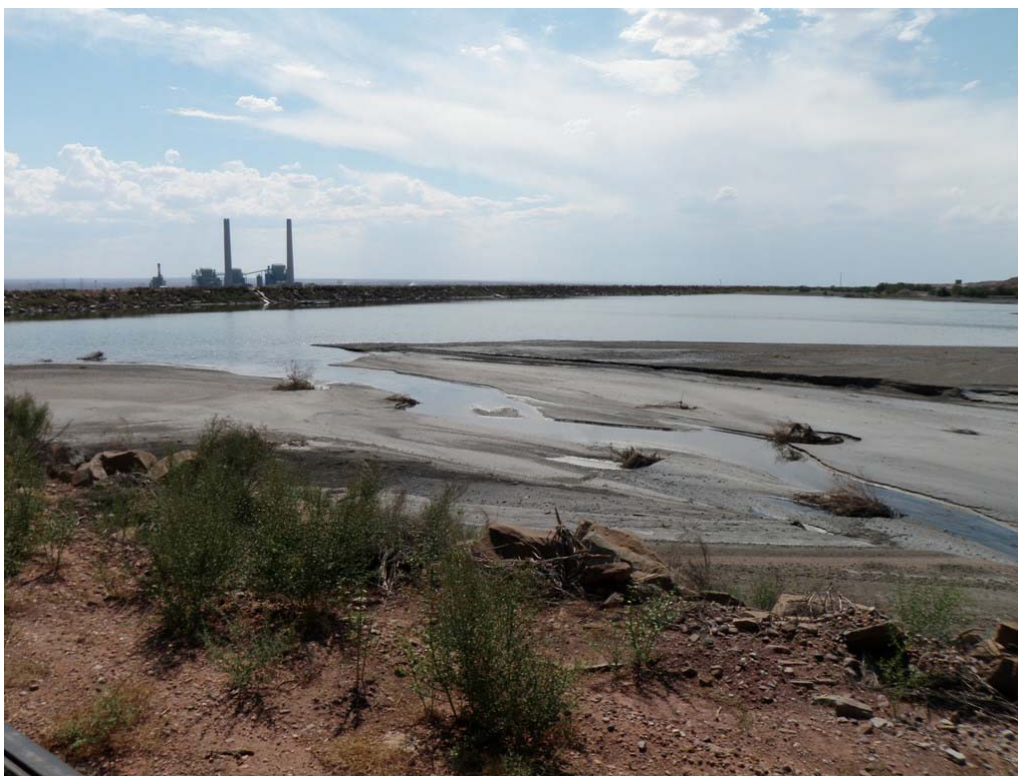
**Photo 9 – Bottom Ash Pond: Main reservoir, looking southwest from left abutment.**

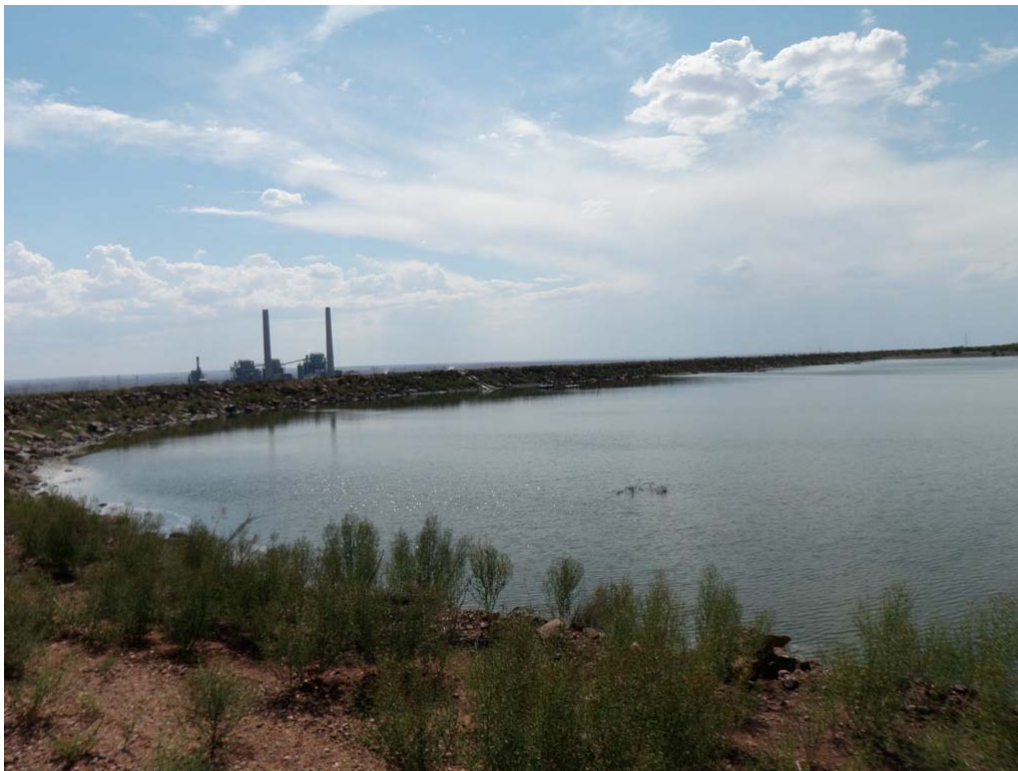
**Photo 10 – Bottom Ash Pond: Main Reservoir, looking west along upstream face of dam.**

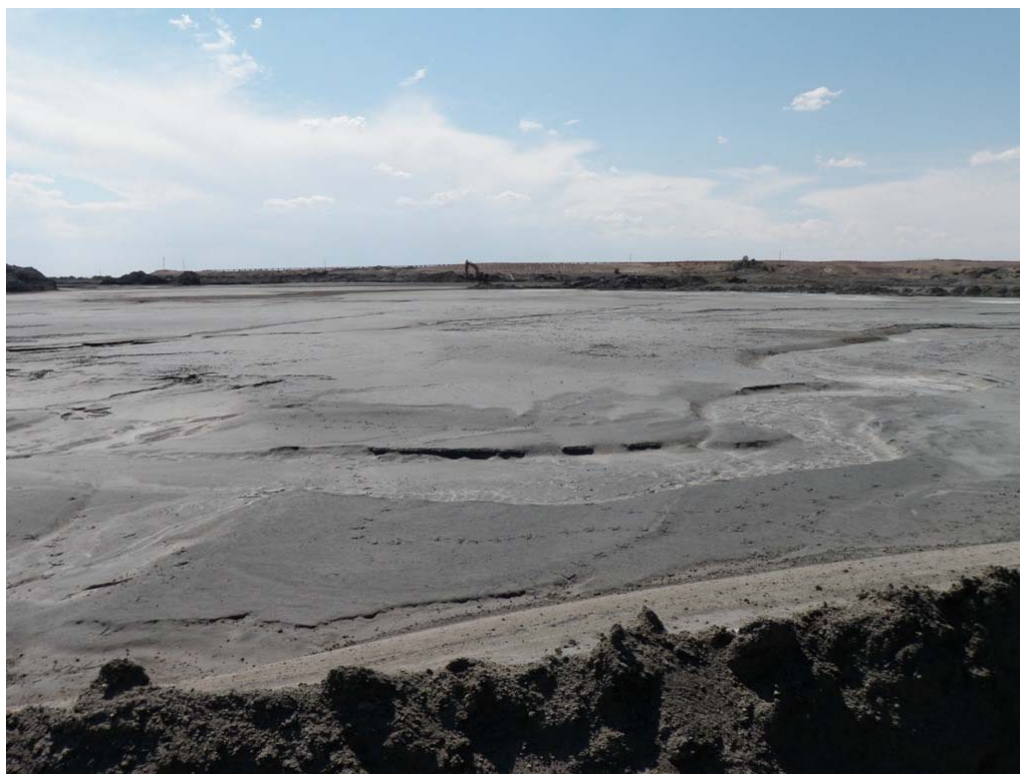
**Photo 11 – Bottom Ash Pond: East cell with drained bottom ash. Note construction operations moving bottom ash to monofill.**

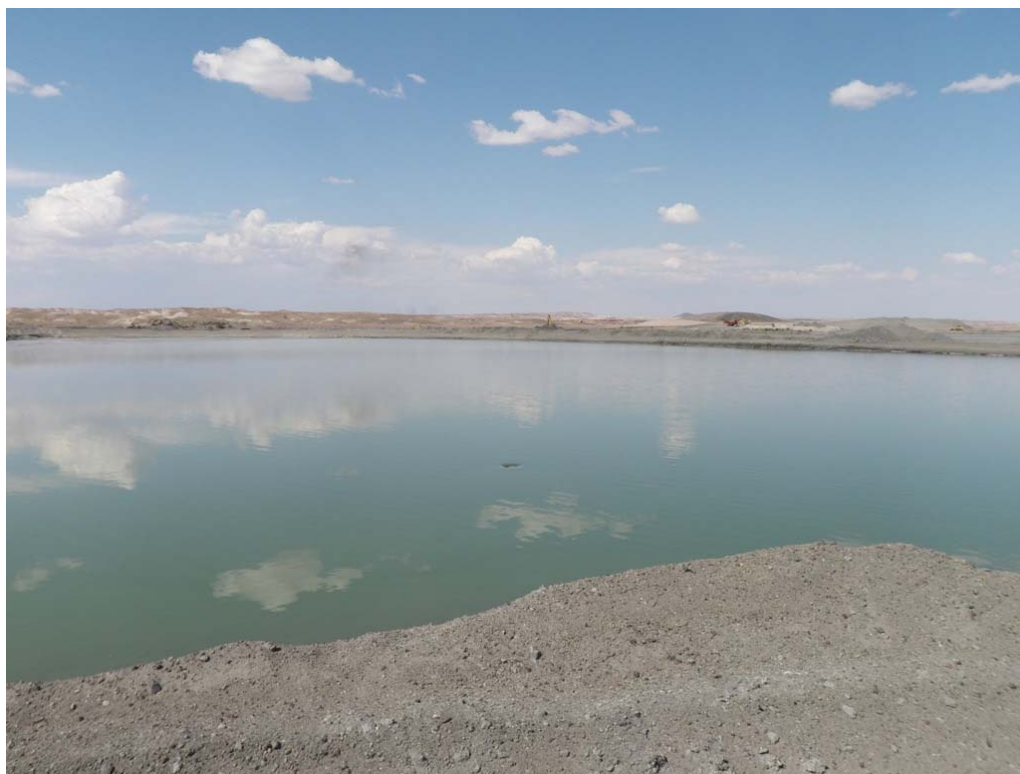
**Photo 12 – Bottom Ash Pond: West cell, which is currently being filled with bottom ash slurry. Note vortex through which water flows to main reservoir.**

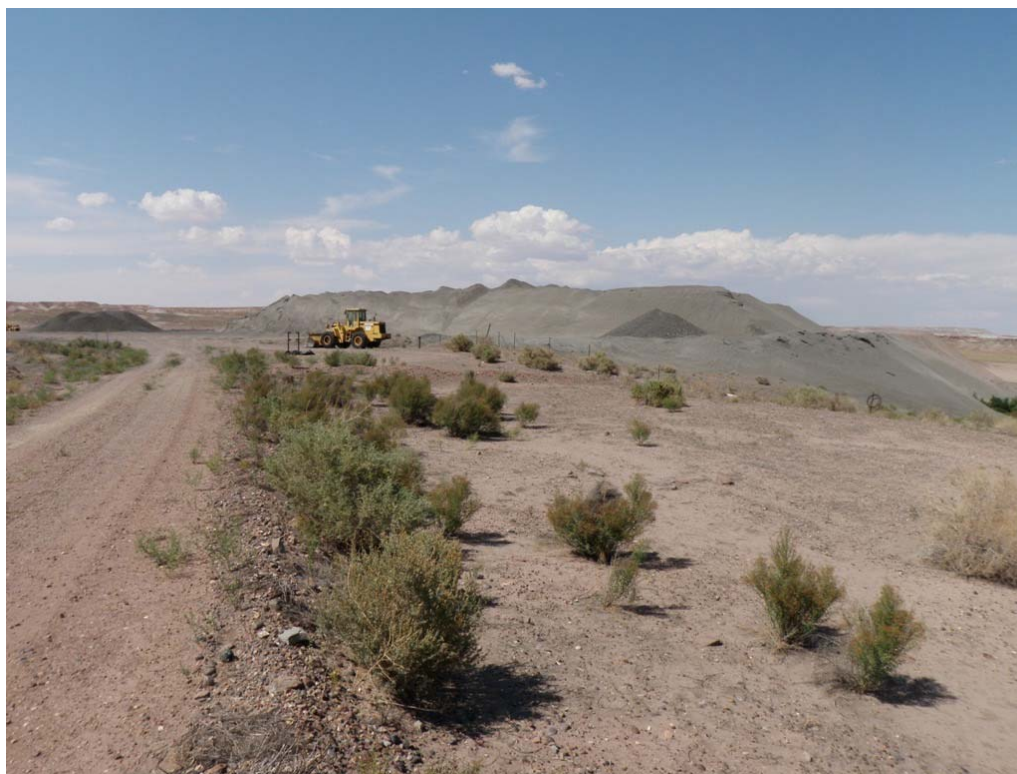
**Photo 13 – Bottom Ash Pond: Monofill for final storage of drained bottom ash.**

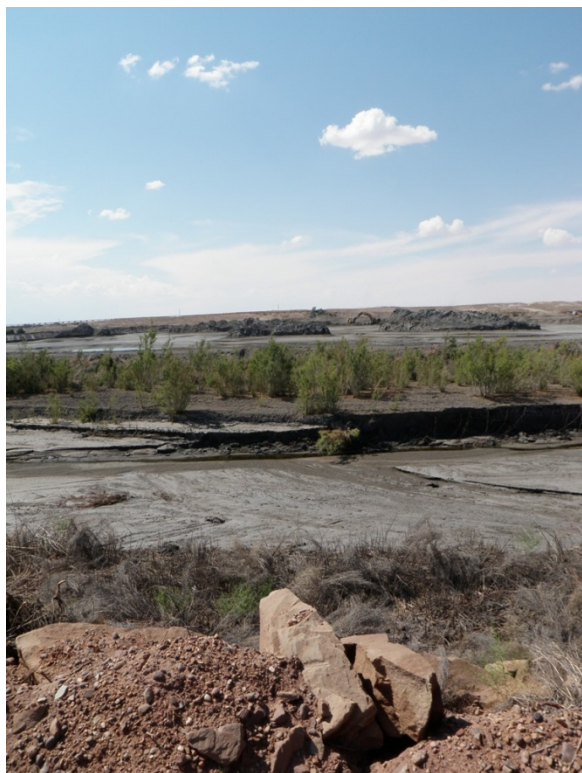
**Photo 14 – Bottom Ash Pond: Drainage way for overflow water from upstream cells to main reservoir.**

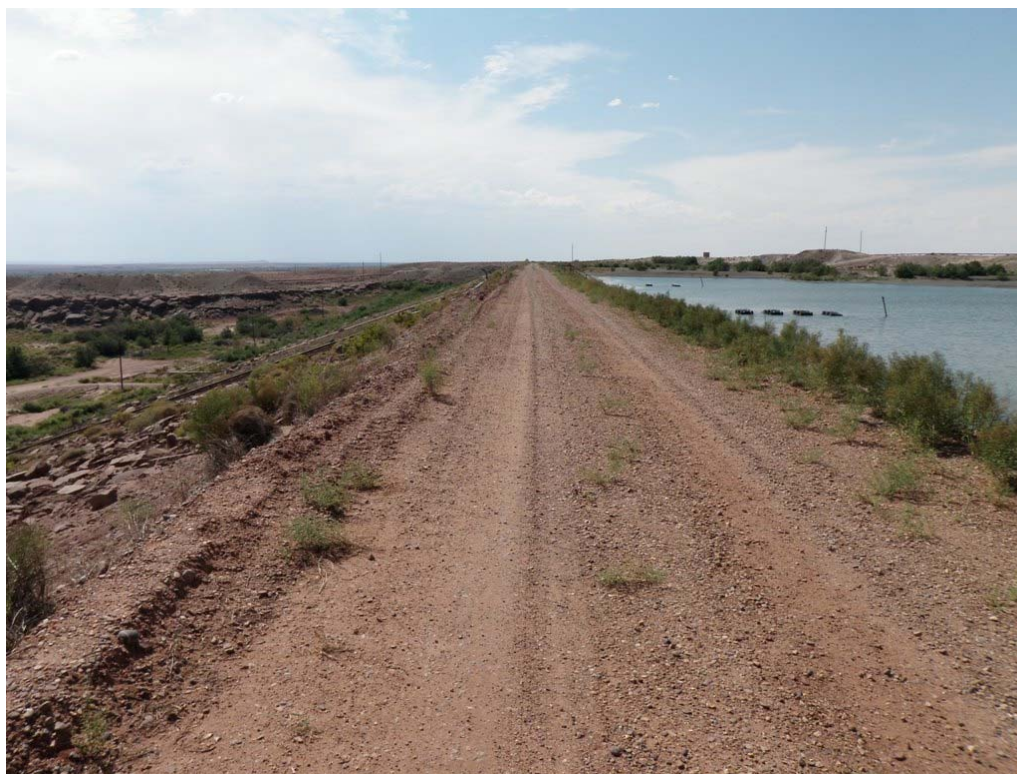
**Photo 15 – Bottom Ash Pond Dam: Crest of embankment with dirt road, looking west.**

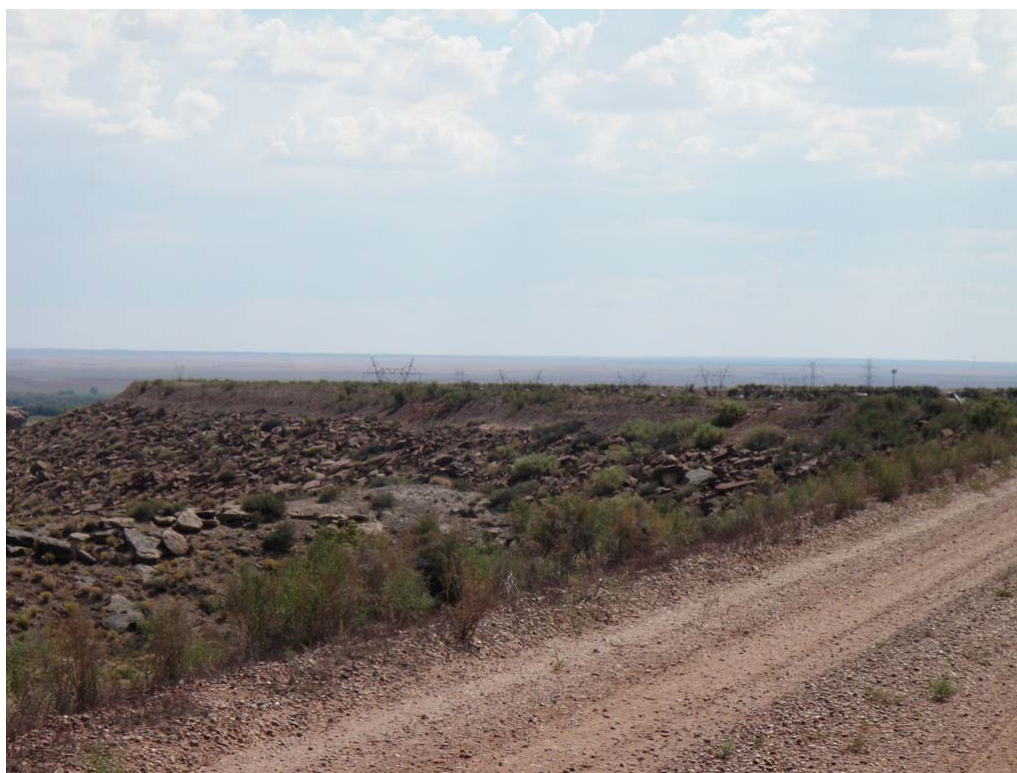
**Photo 16 – Bottom Ash Pond Dam: Crest near left abutment with dam raise visible.**

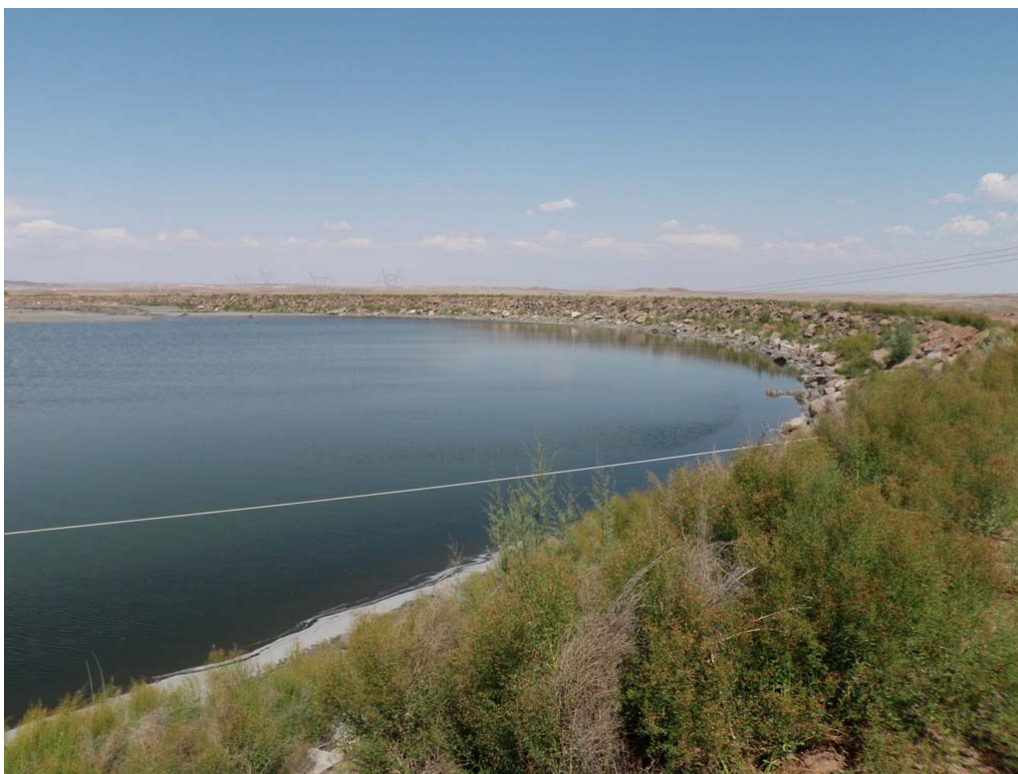
**Photo 17 – Bottom Ash Pond Dam: Upstream slope, looking east. Note vegetation.**

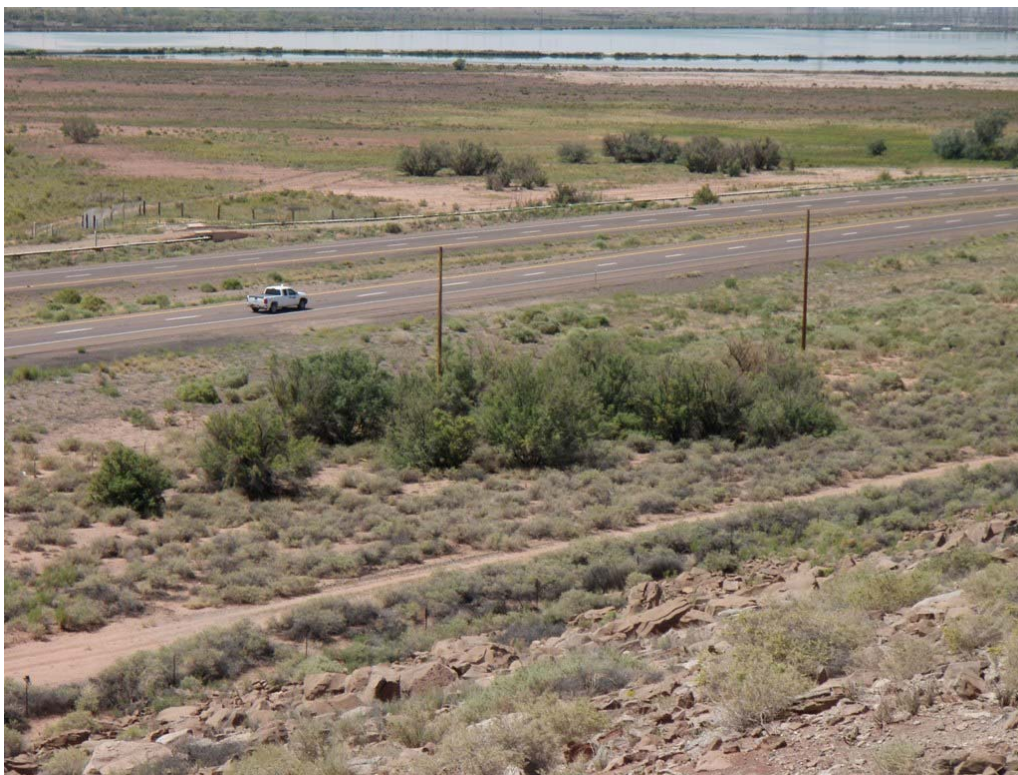
**Photo 19 – Fly Ash Pond: Salt patch associated with seepage near right abutment toe (known as the “Hoodoo Salt Patch”).**

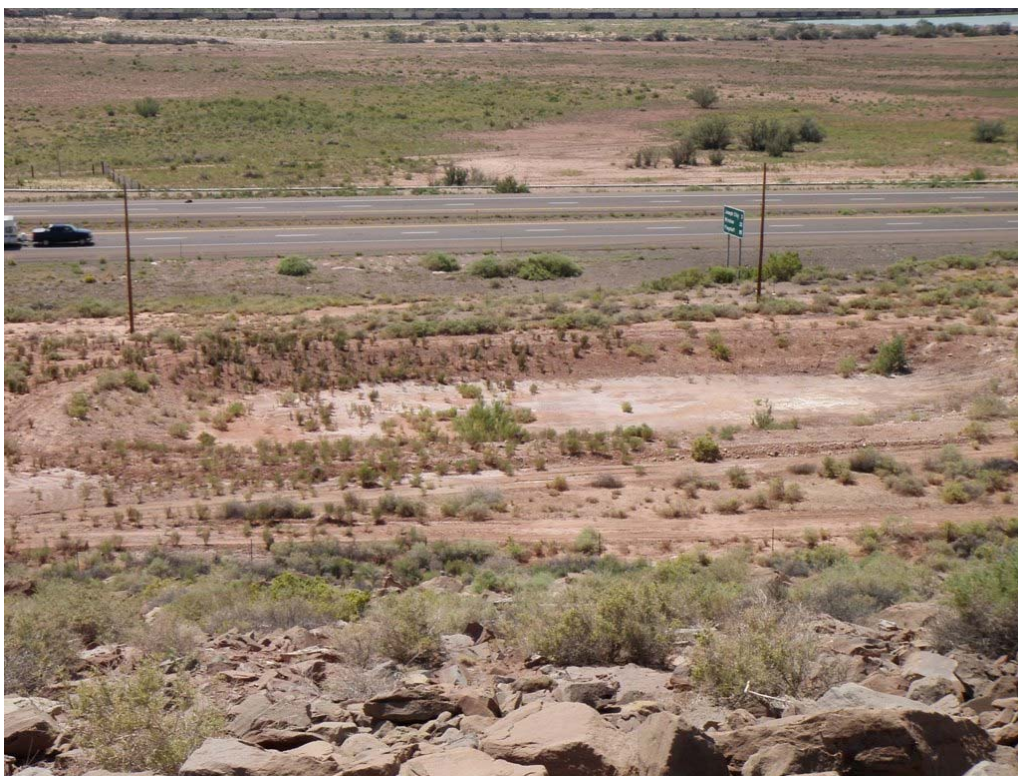
**Photo 20 – Fly Ash Pond: Tamarisks near downstream toe indicating seepage.**

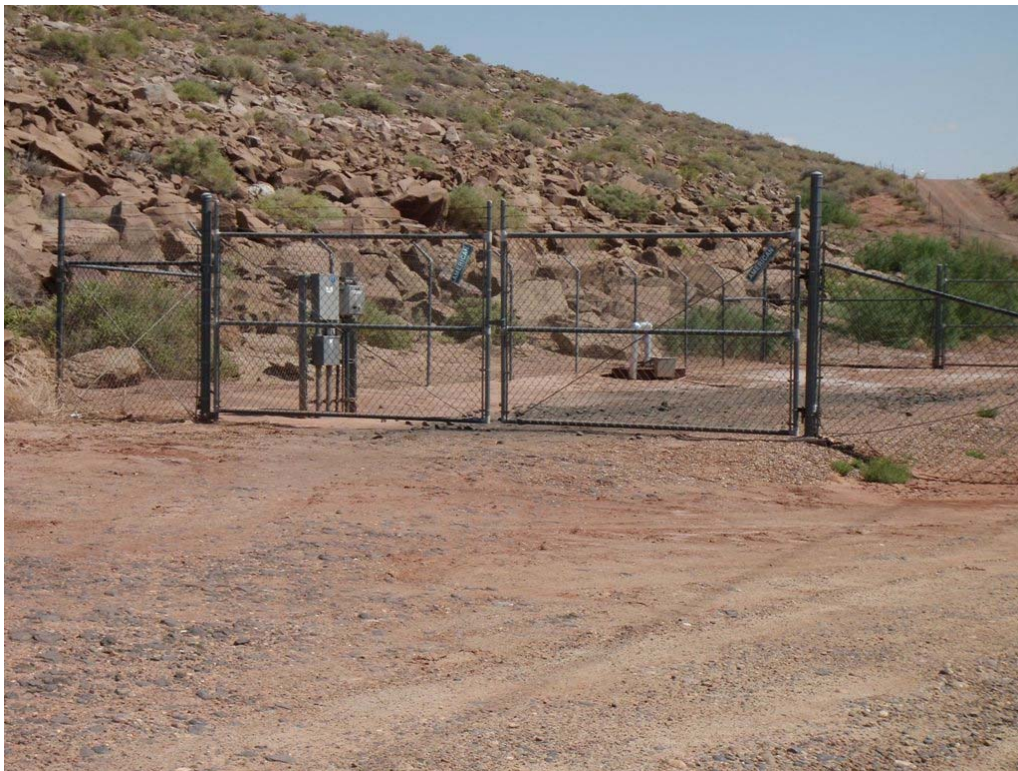
***I-40 Seep:*** The I-40 Seep is located just beyond the downstream toe of the Fly Ash Pond Dam at the right abutment. This seep does not have drain system to return water to the pond, but an evaporation pond was constructed to collect seepage in this area (Photo 21).

**Photo 21 – Fly Ash Pond: Evaporation Pond for I-40 Seep.**

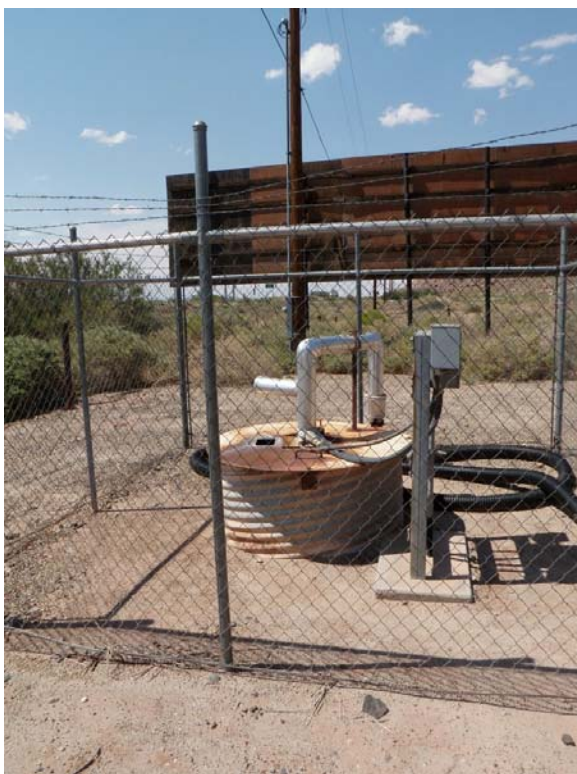
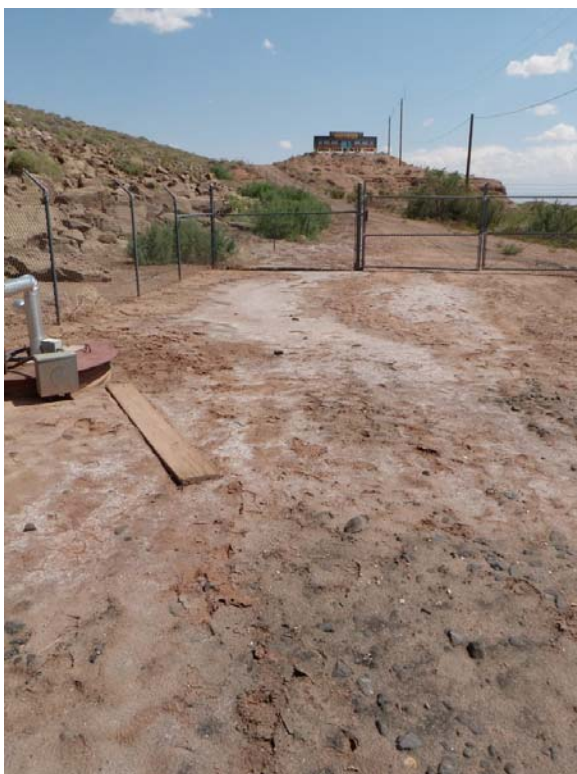
***Geronimo Seep:*** The Geronimo Seep is located less than 50 feet beyond the downstream toe of the Fly Ash Pond Dam, about 2,000 feet from the right abutment. An underground french drain system and wellpoints have been installed to monitor and collect the seepage in this area (Photos 22 and 23). Relatively large flows (up to about 47 gpm) have been measured at this location, but APS indicates that the totalizer at this location has malfunctioned recently and readings may not be accurate. No flowing surface water was observed at this seep location at the time of our assessment.

**Photo 22 – Fly Ash Pond: Seepage collection system for Gironimo Seep.**

**Photo 23 – Fly Ash Pond: Seepage collection system for Gironimo Seep.**

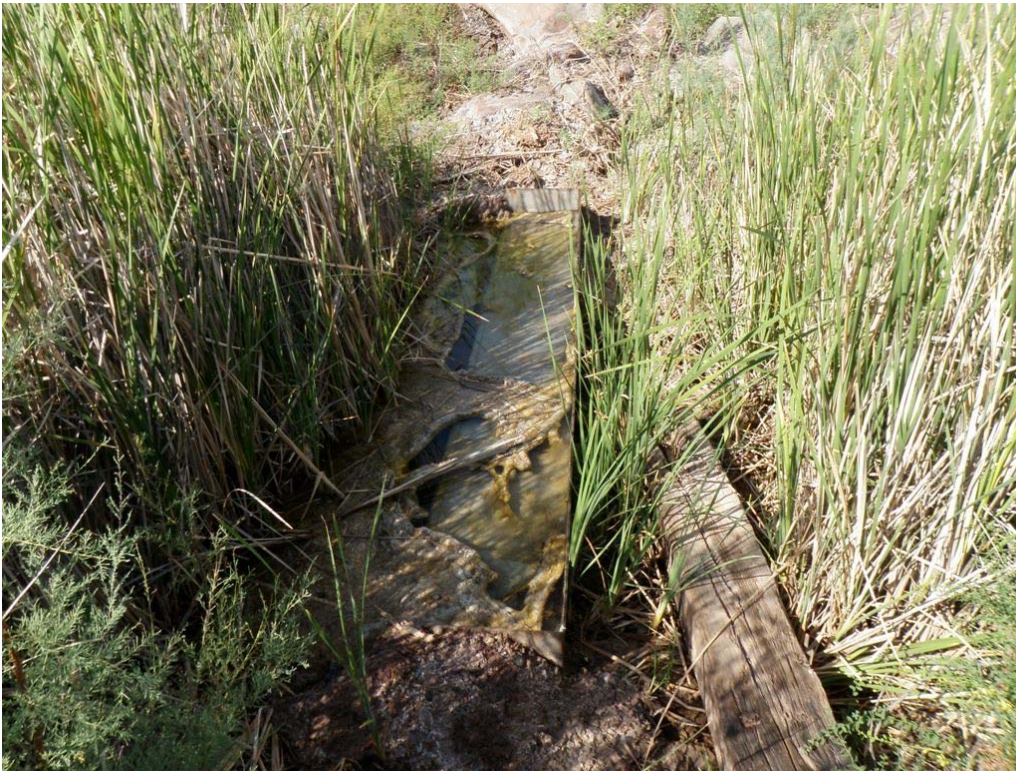
**West Abutment Seep:** The West Abutment Seep is located about 100 feet downstream of the Bottom Ash Pond Dam toe (Photo 25). APS monitors the flow that daylights in this area by means of a weir (Photo 26), in addition to an underground french drain system several hundred feet east along the face (Photo 27). The general West Abutment Seep area is shown in Photo 28. We observed water flowing through the weir at the time of our site visit, and a rough measurement indicated that the flow at this time was less than 2 gpm. Flows in the weir are typically 4 gpm or less, and the totalizer at this location has measured a maximum of about 16 gpm since 1996.

**Photo 25 – Bottom Ash Pond: West Abutment Seep from embankment crest. Siphon pipes (center) and siphon collection system (lower left) are also visible.**

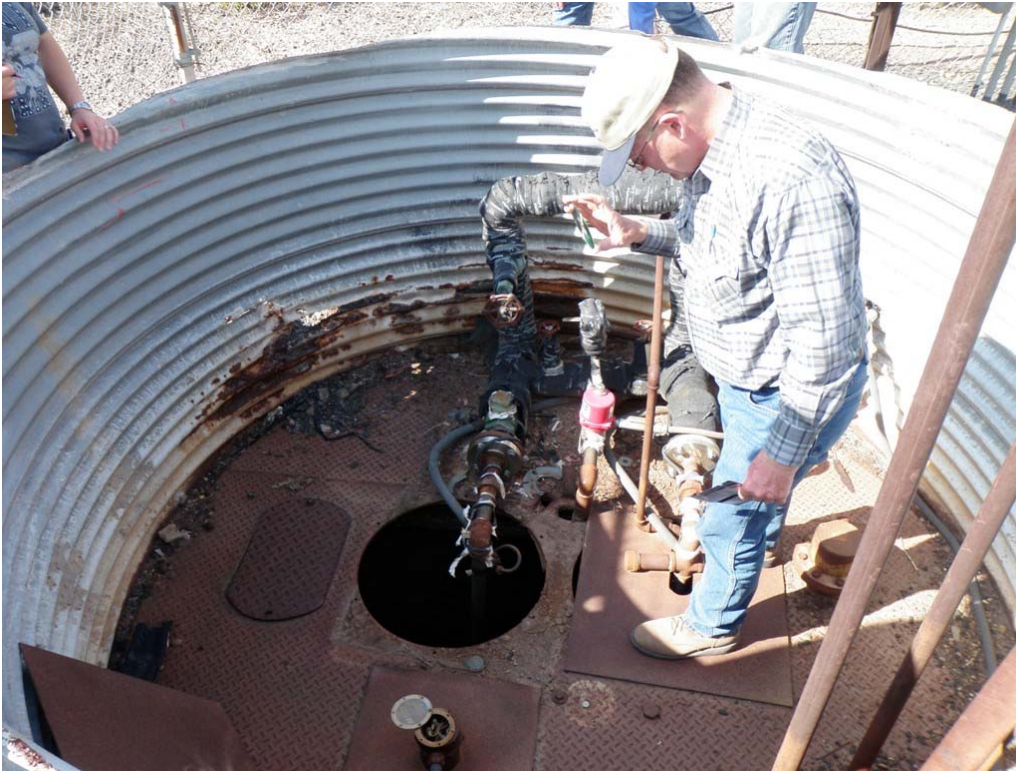
**Photo 26 – Bottom Ash Pond: Weir at West Abutment Seep.**

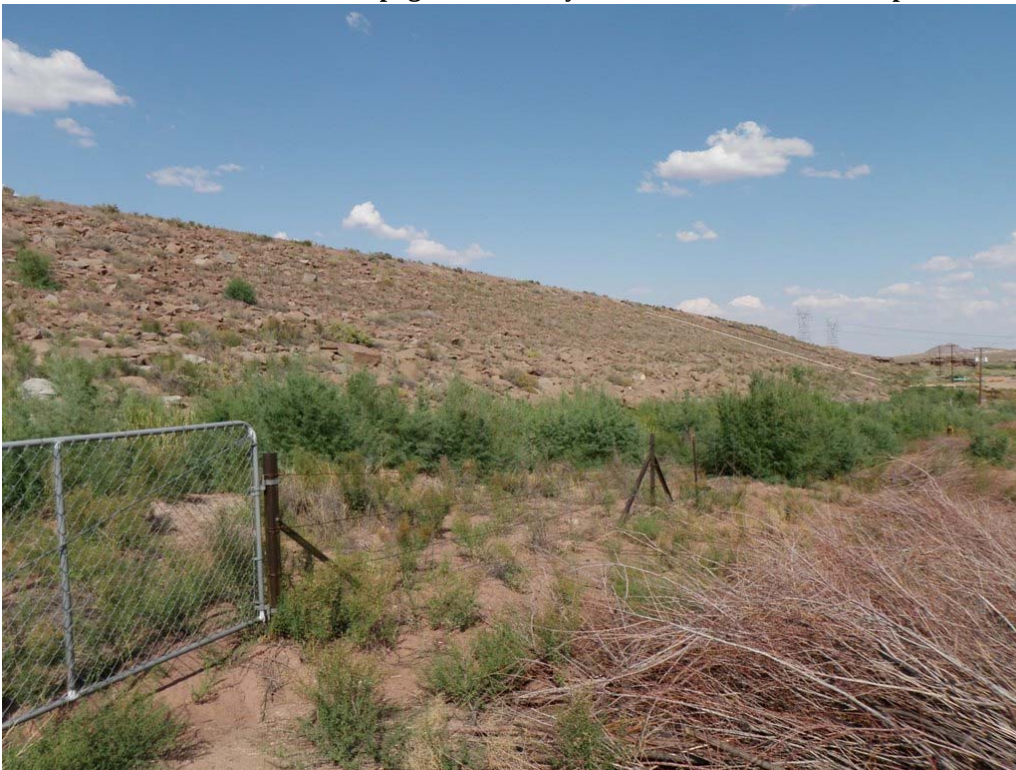
**Photo 27 – Bottom Ash Pond: Seepage collection system at West Abutment Seep.**

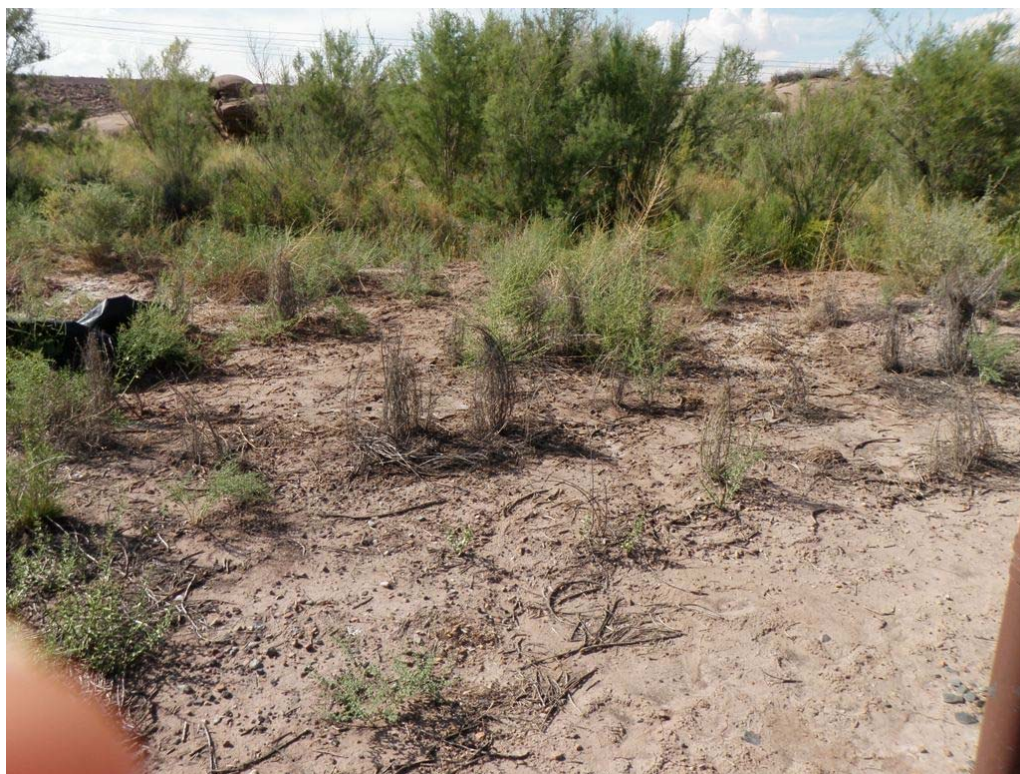
**Tanner Wash Seep:** The Tanner Wash Seep is located about 350 feet beyond the toe of the Bottom Ash Pond Dam near the left abutment. Seepage is collected and measured via an underground french drain system with a totalizer (Photo 29). Both salt patches (Photo 30) and flowing surface water (Photo 31) were observed at this seep at the time of our assessment. A maximum flow of about 15 gpm has been measured at this location since 1995. This seep is far enough from the dam that it is not considered a dam safety concern. This seep is of more environmental concern than others due to its vicinity to Tanner Wash (Photo 32).

**Photo 29 – Bottom Ash Pond: Seepage collection system for Tanner Wash Seep.**

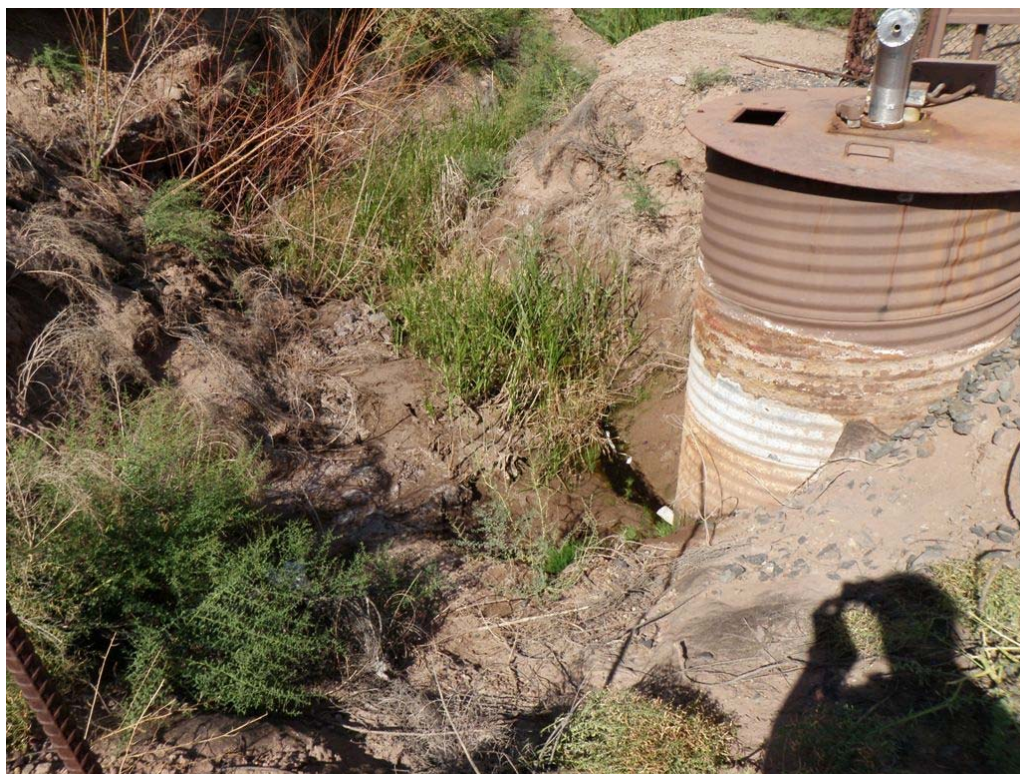
**Petroglyph Seep:** The Petroglyph Seep is located about 150 feet beyond the dam toe on the east side of the dam, south of the Tanner Wash Seep. Seepage is collected and measured via an underground french drain system with a totalizer (Photo 33). Flowing surface water was observed at this seep at the time of our assessment (Photo 34). A maximum flow of about 13 gpm has been measured at this location since 1993. This seep is far enough from the dam that it is not considered a dam safety concern.

**Photo 33 – Bottom Ash Pond: Seepage collection system for Petroglyph Seep.**
