**DRAFT FINAL**  
**Coal Ash Impoundment**  
**Specific Site Assessment**  
**Report**  
**Arizona Public Service**  
**Cholla Power Plant**

Submitted by:  
**GEI Consultants, Inc.**  
6950 South Potomac Street, Suite 300  
Centennial, CO 80112

October 2009  
Project 091330

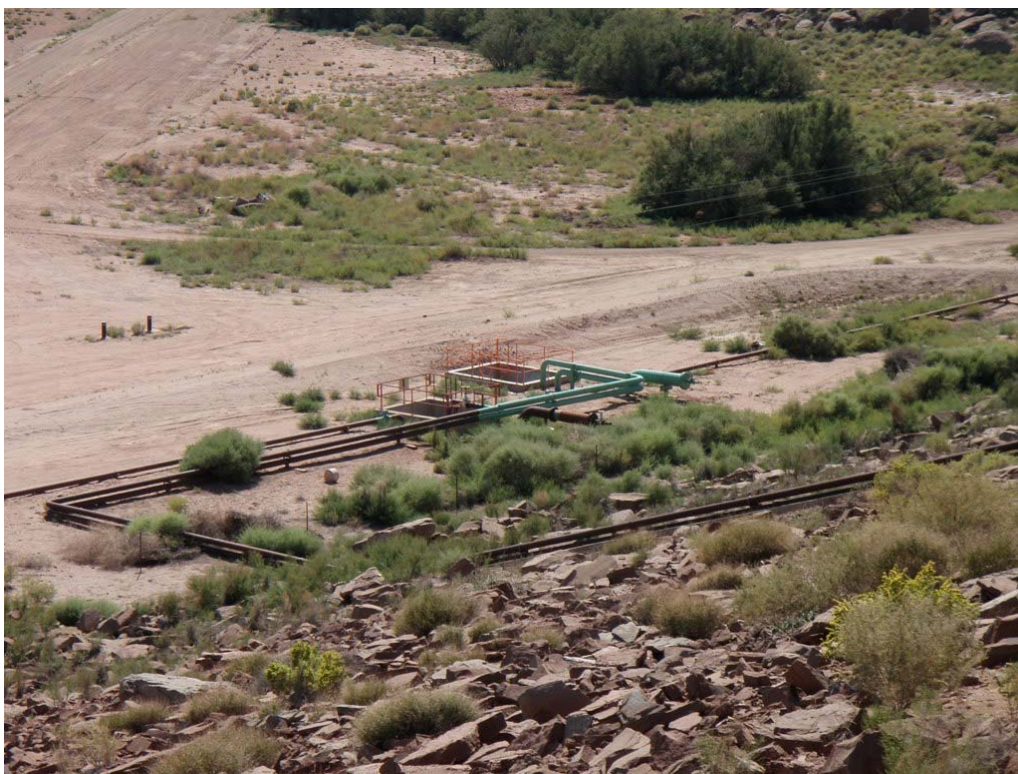
**Photo 37 – Bottom Ash Pond: Siphon pipes extending along downstream slope of dam.**

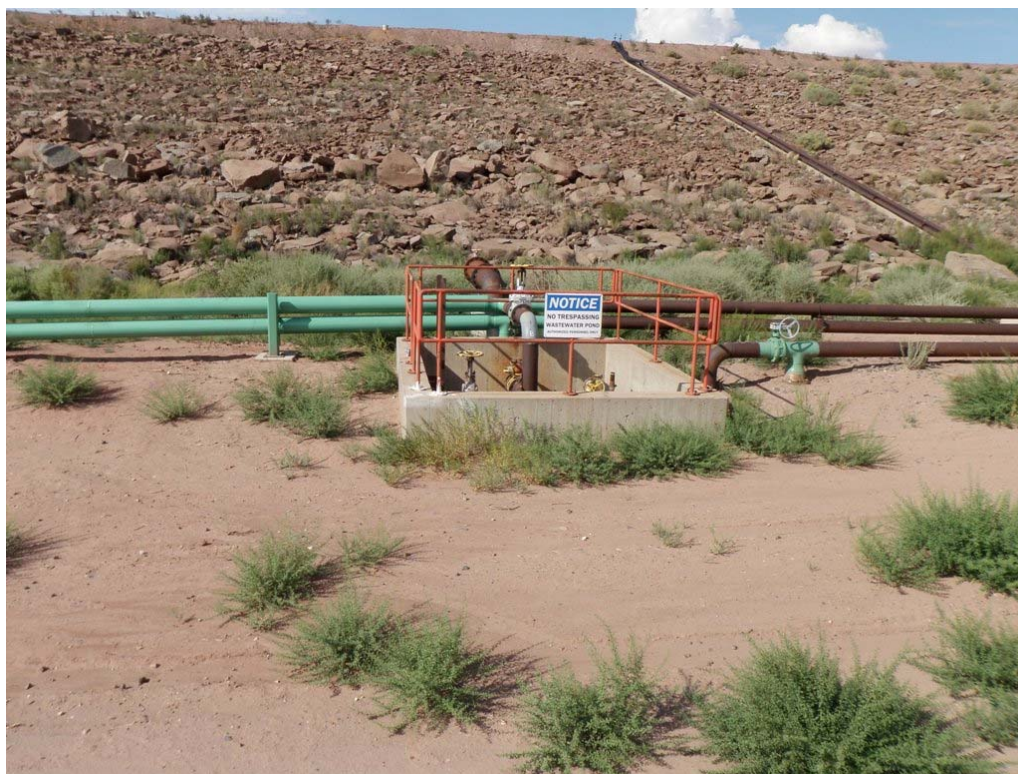
collection point, where water from the siphon pipes is combined and routed to the plant, is shown in Photos 38 and 39.

**Photo 38 – Bottom Ash Pond: Siphon collection station at toe of dam.**
