**DRAFT FINAL**  
**Specific Site Assessment for**  
**Coal Combustion Waste**  
**Impoundments at Arizona**  
**Electric Power Cooperative**  
**(AEPCO) Apache Power Plant**  
Cochise, Arizona

Submitted by:  
**GEI Consultants, Inc.**  
6950 South Potomac Street, Suite 300  
Centennial, CO 80112

October 2009  
Project 091330

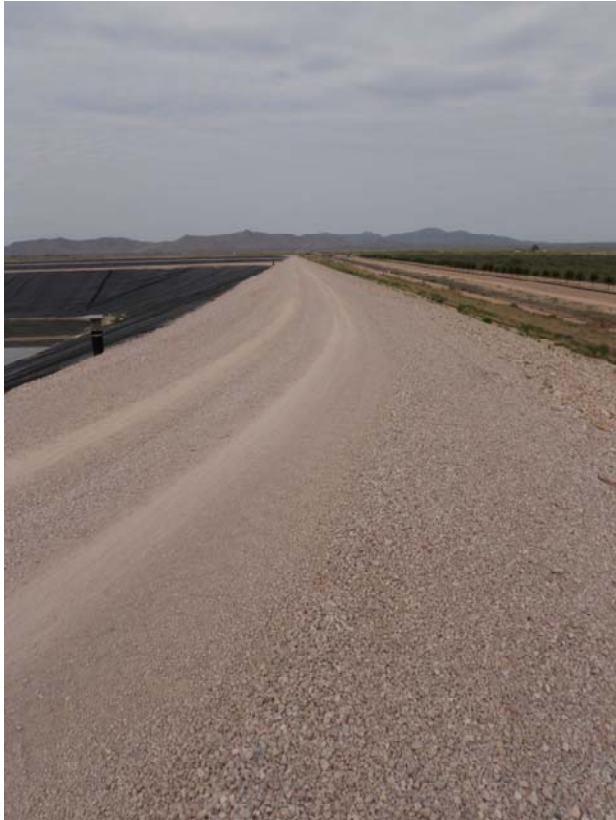
Photo 1: Crest of north embankment of Ash Pond 4 facing west.

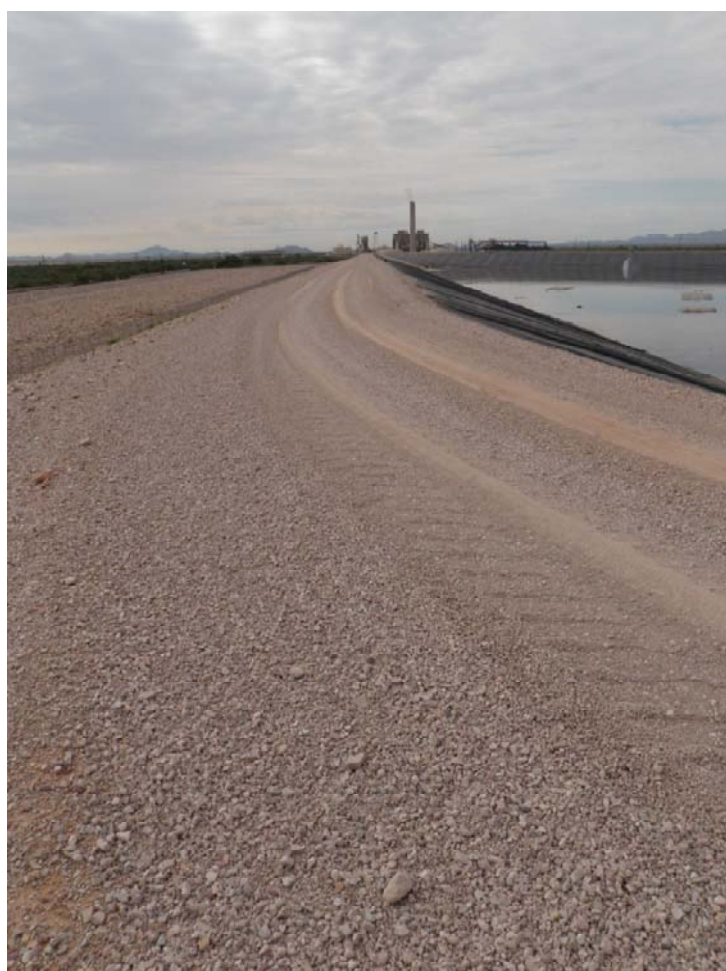
**Photo 4: Crest of east embankment of Ash Pond 4 facing south.**

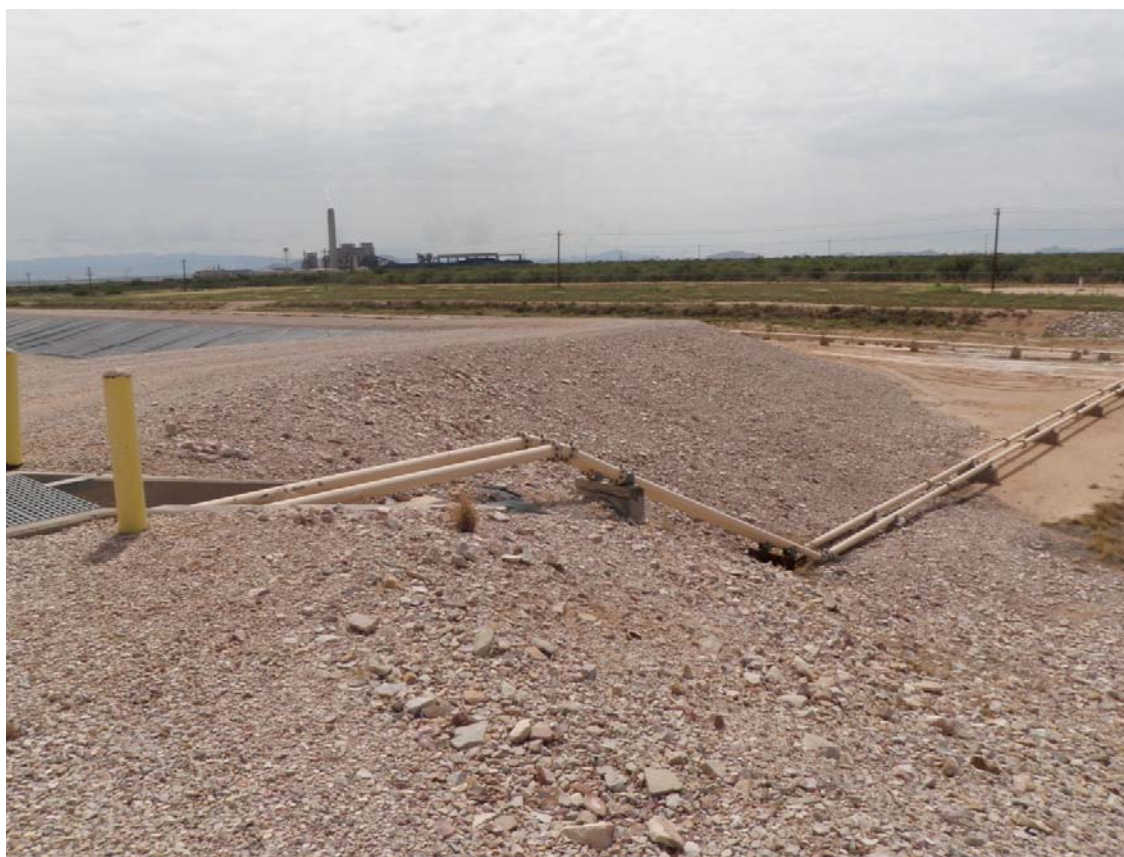
Photo 41: Pipes conveying scrubber sludge entering the facility at southwest corner of Scrubber Sludge Pond 1, looking southeast.

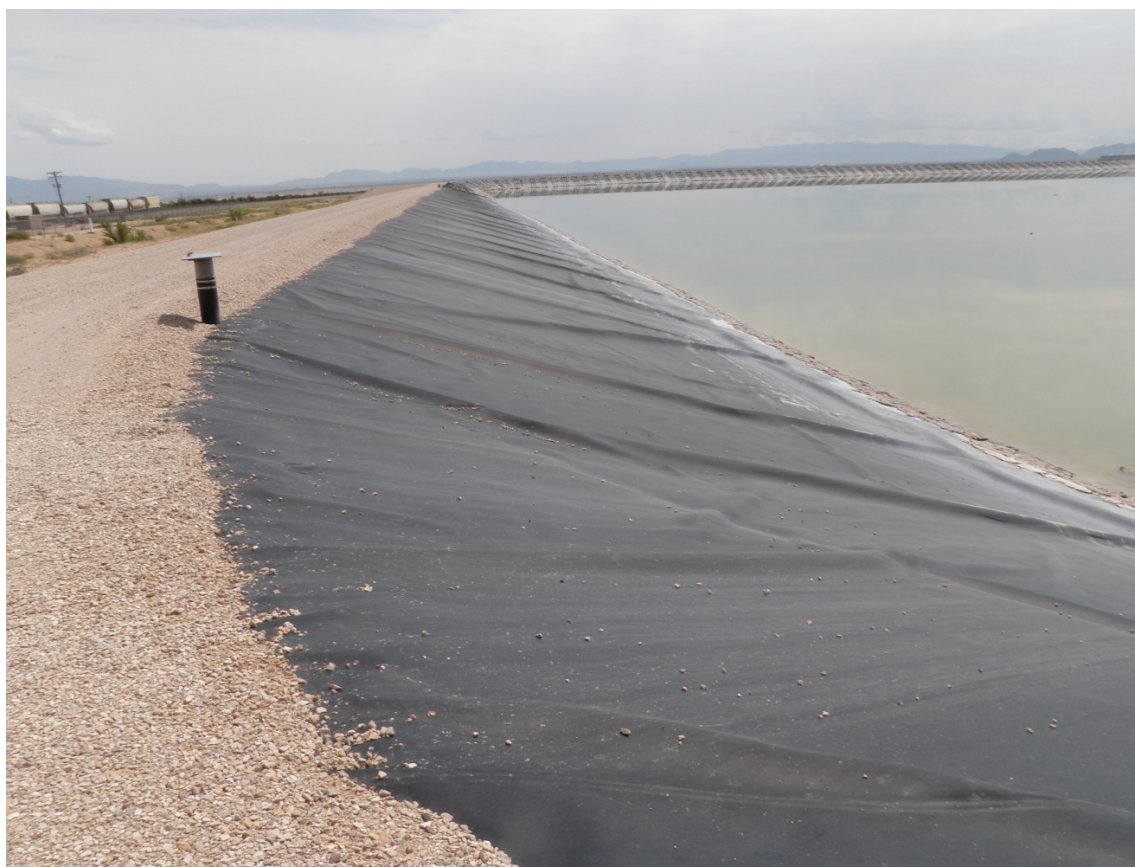
Photo 53: Upstream slope of north embankment of Scrubber Sludge Pond 2, looking east.

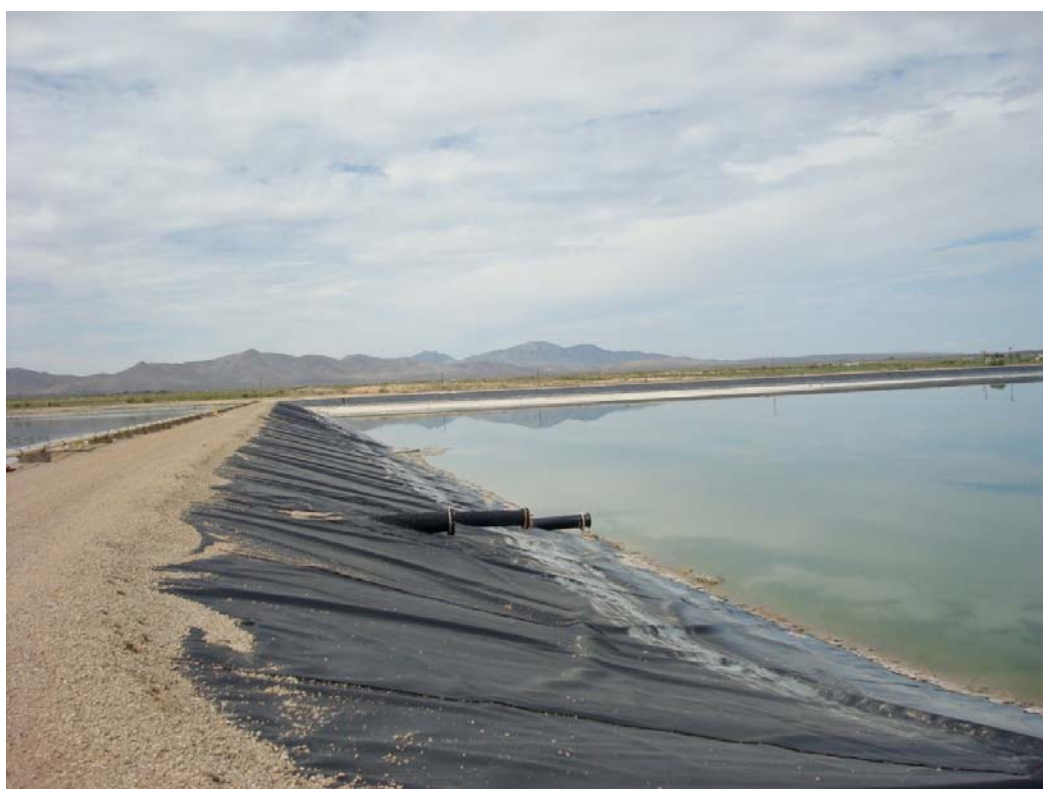
A potential outlet structure for SSP1 and SSP2 consists of three HDPE pipes that connect SSP1 and SSP2 at three different elevations (see Photo 54). The pipes are installed

A potential outlet structure for SSP1 consists of three HDPE pipes that connect SSP1 and SSP2 at three different invert elevations (see Photo 54). The pipes are installed horizontal. At the time of the assessment, these outlet pipes were closed with blind flanges on both ends of the pipes and were not operational. These pipes can only be used to provide an outlet under specific operating conditions, such as when the water level in one pond is higher than the other pond so that a flow can be established. With the exception of these pipes, the surface sludge impoundments have no outlet. The outlet pipes appeared to be in acceptable condition and are expected to function should AEPCO choose to operate them as an outlet to discharge from SSP1 to SSP2.

Photo 54: Upstream slope of the south embankment of Scrubber Sludge Pond 2, looking west. Note 3 HDPE pipes that connect Scrubber Sludge Pond 1 and Scrubber Sludge Pond 2. The pipes were closed with blind flanges at each end.

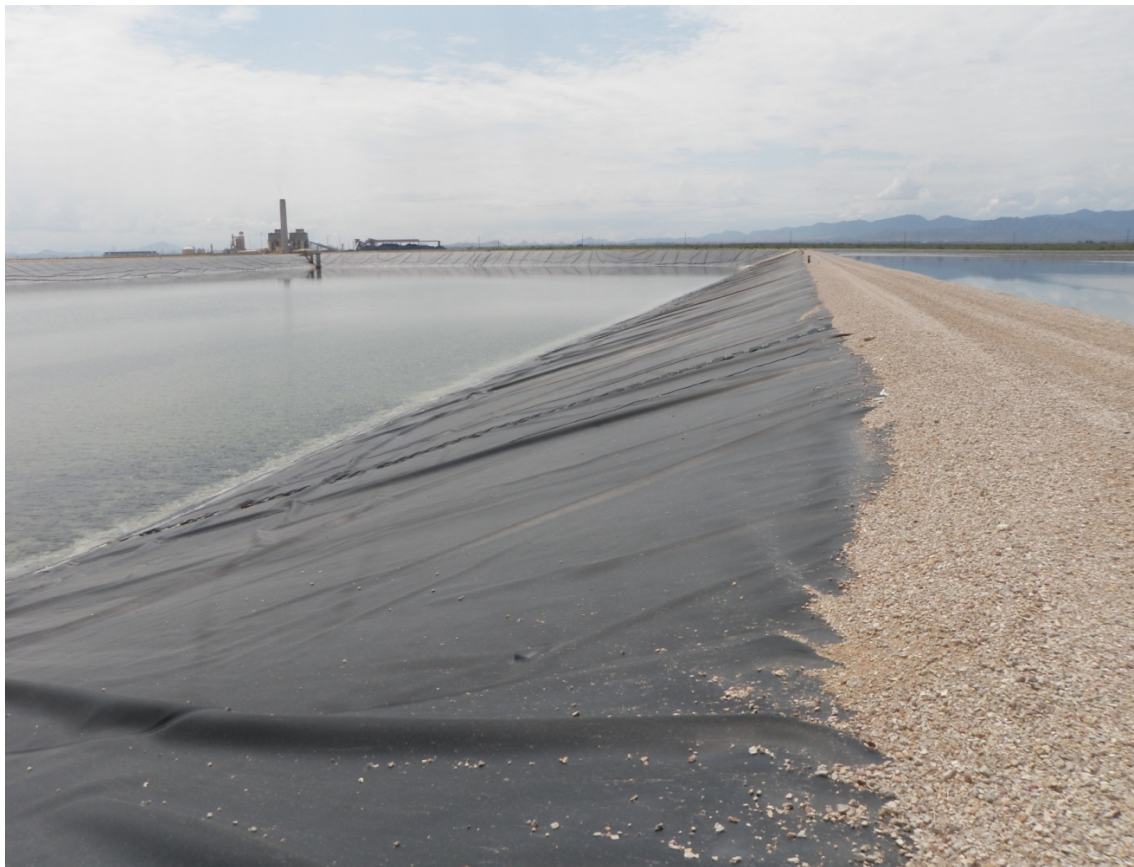
**Photo 57: Upstream slope of Ash Pond 3, west embankment, looking south. Evaporation Pond is at right side of photo.**

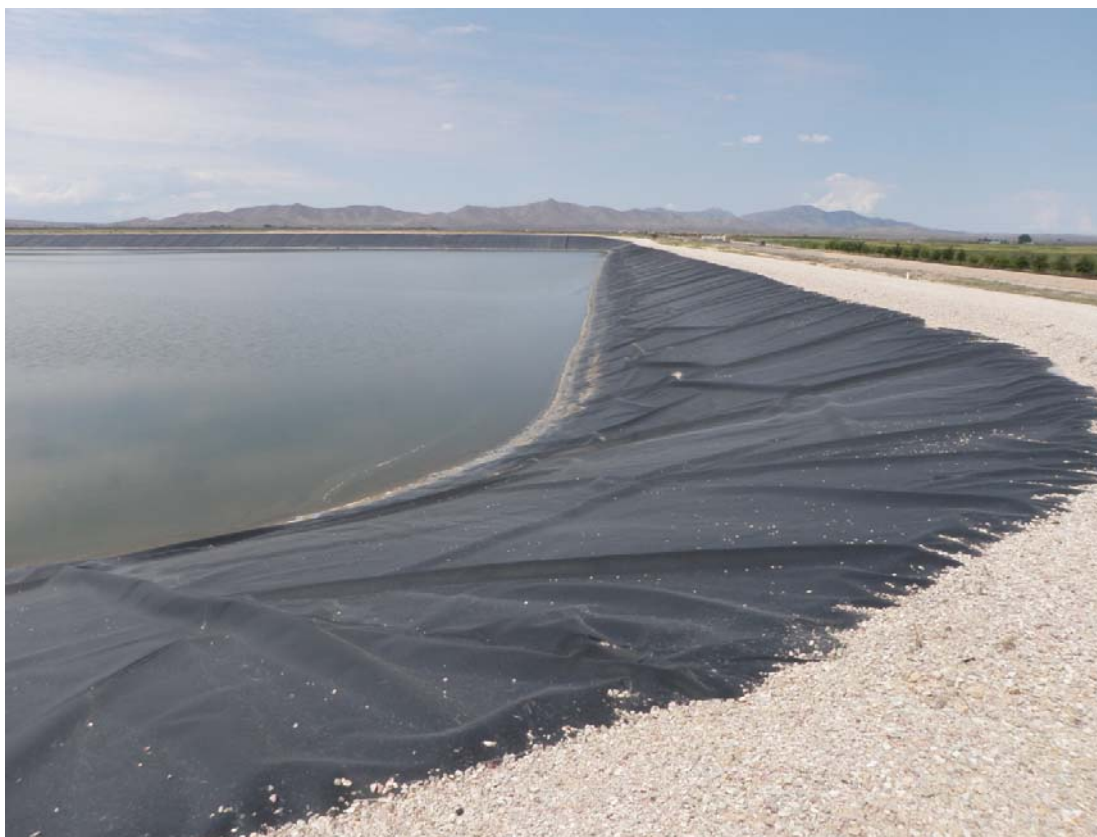
**Photo 58: Upstream slope of Evaporation Pond, north embankment, looking west.**

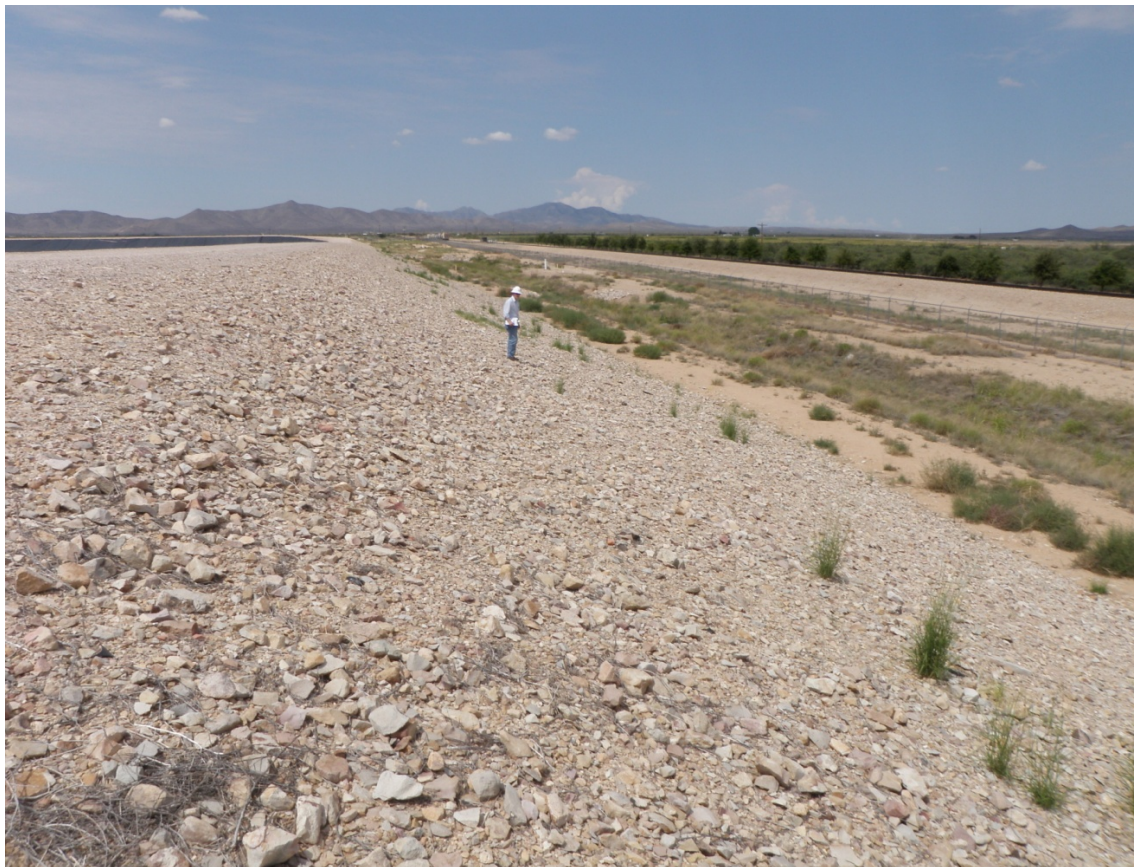
**Photo 59: Downstream slope of north embankment of Scrubber Sludge Pond 2, looking west.**

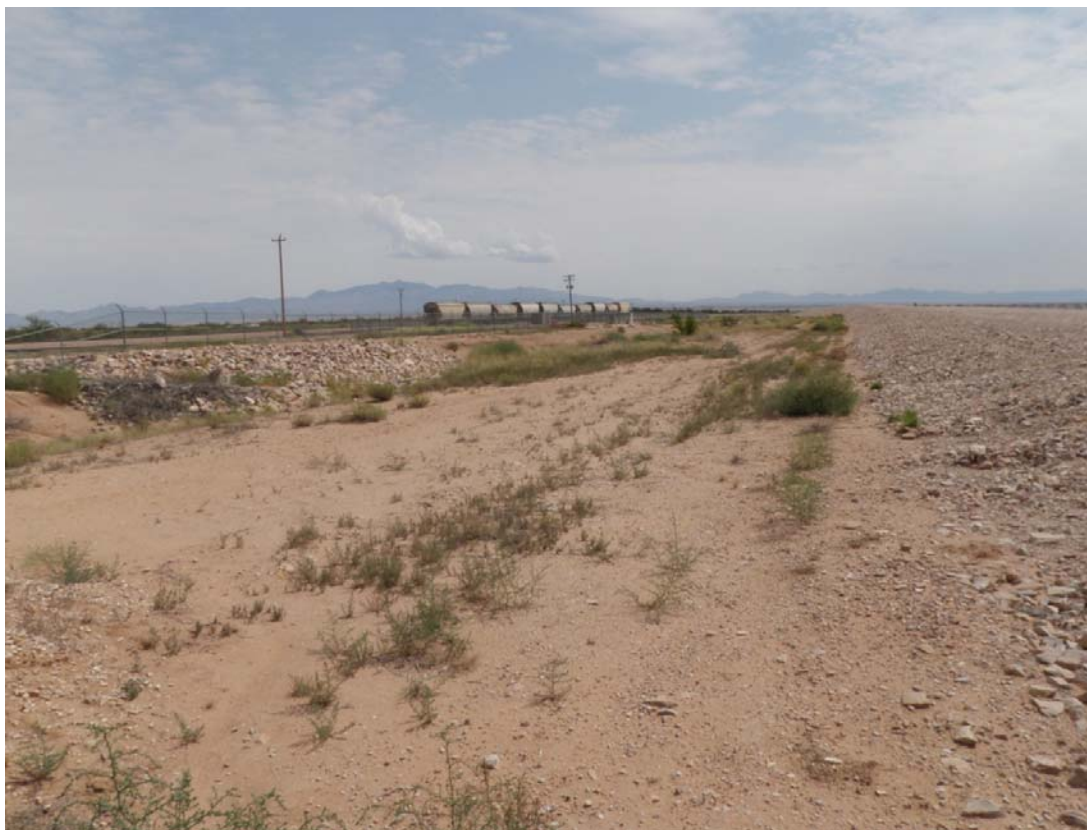
**Photo 60: Downstream slope of Scrubber Sludge Pond 2, north embankment, looking east.**
