FINAL

**Specific Site Assessment for
Coal Combustion Waste
Impoundments at Arizona
Electric Power Cooperative
(AEP CO) Apache Power Plant**

Cochise, Arizona

December 2009

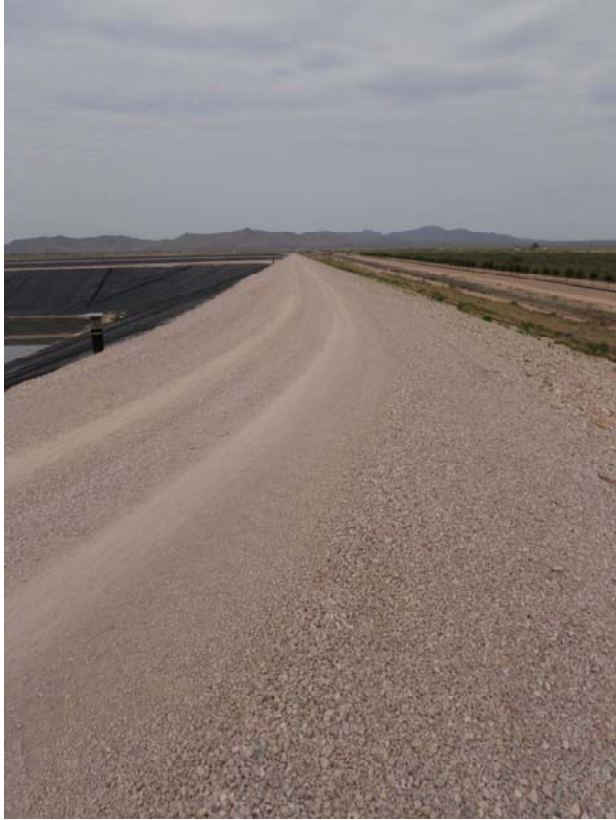
Photo 1: Crest of north embankment of Ash Pond 4 facing west.

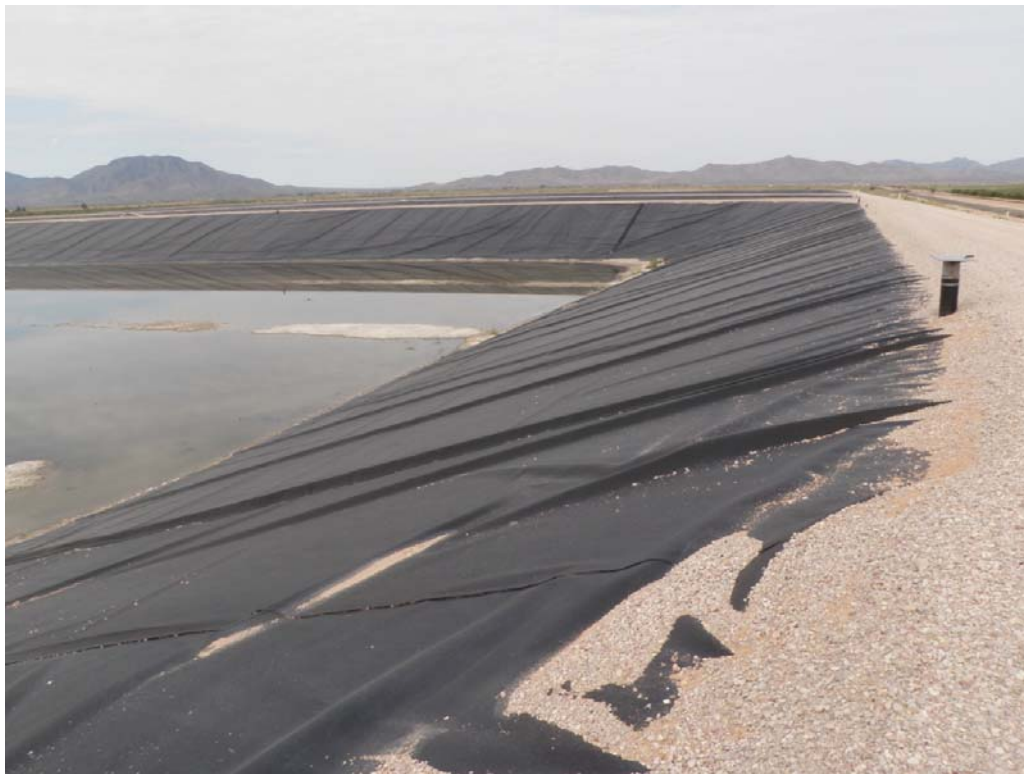
Photo 2: Upstream slope of north embankment of Ash Pond 4 facing west.

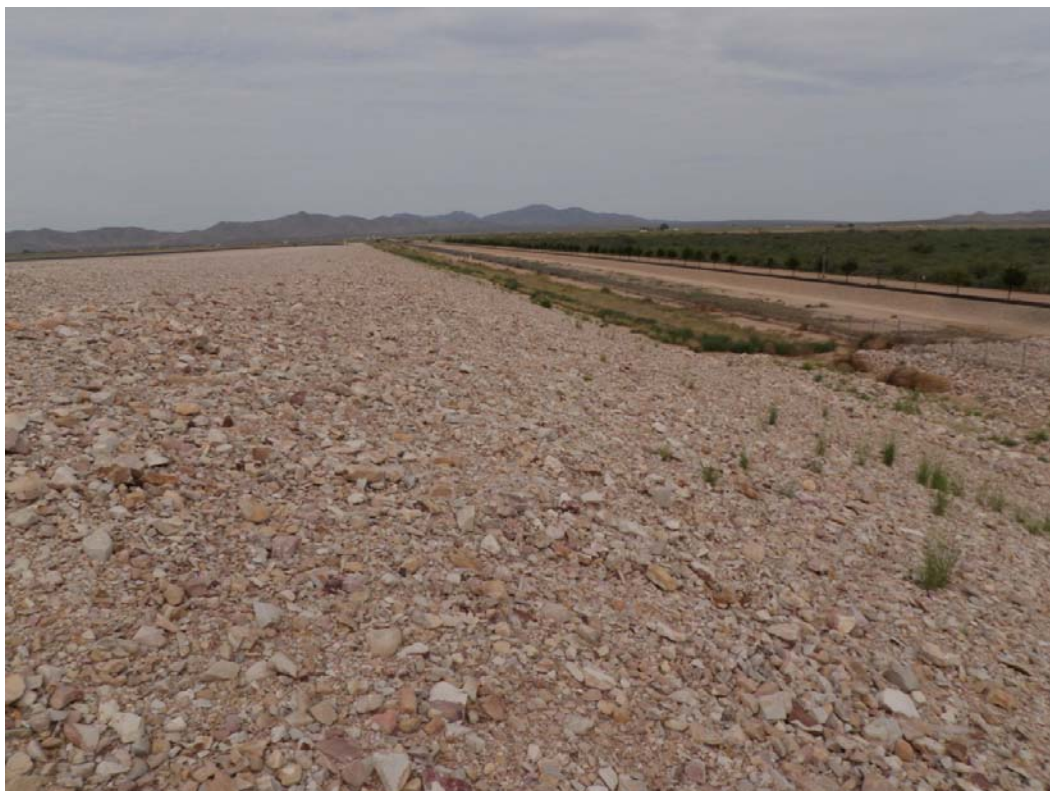
Photo 3: Downstream slope of north embankment of Ash Pond 4 facing west. Note train tracks located to north of facility.

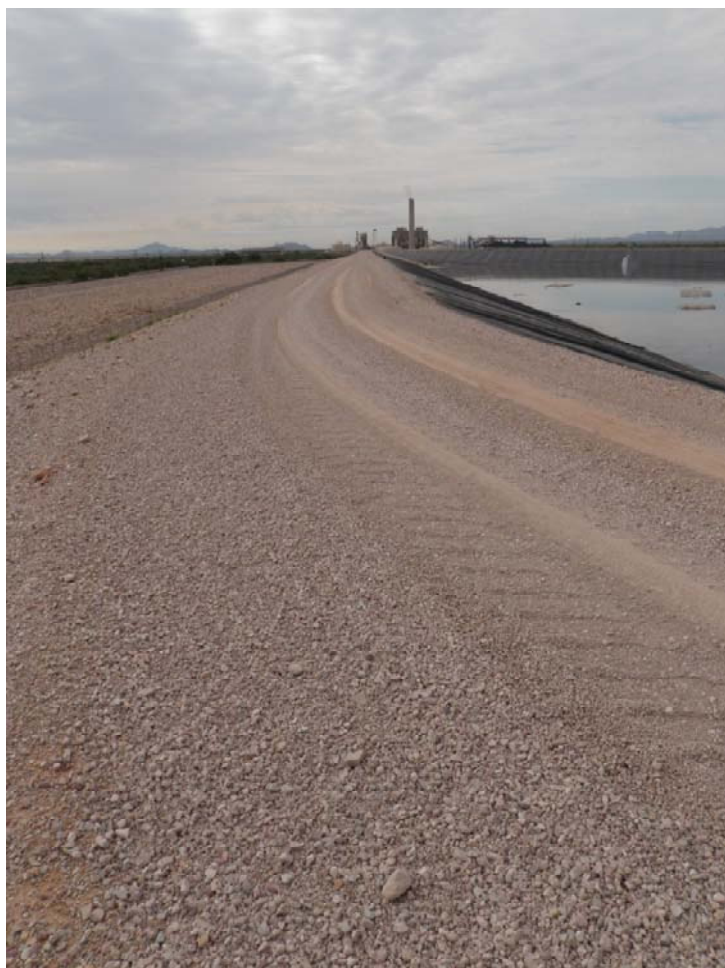
Photo 4: Crest of east embankment of Ash Pond 4 facing south.

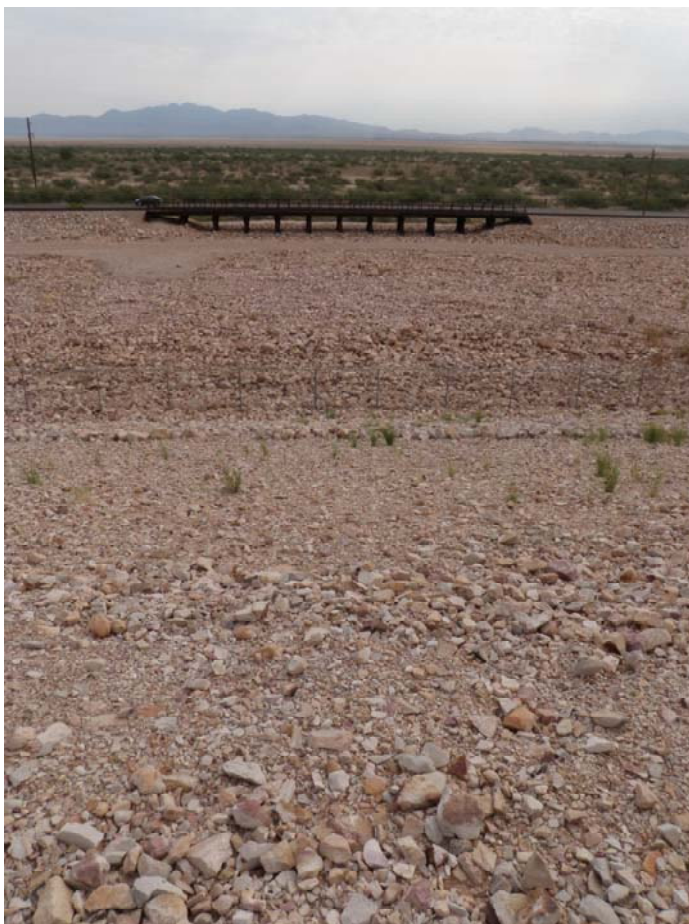
Photo 9: Looking downstream from the east embankment of Ash Pond 4 at the stormwater ditch that discharges to the east through the railroad bridge. Two residences are in the floodway between the bridge and Willcox Playa located further east.

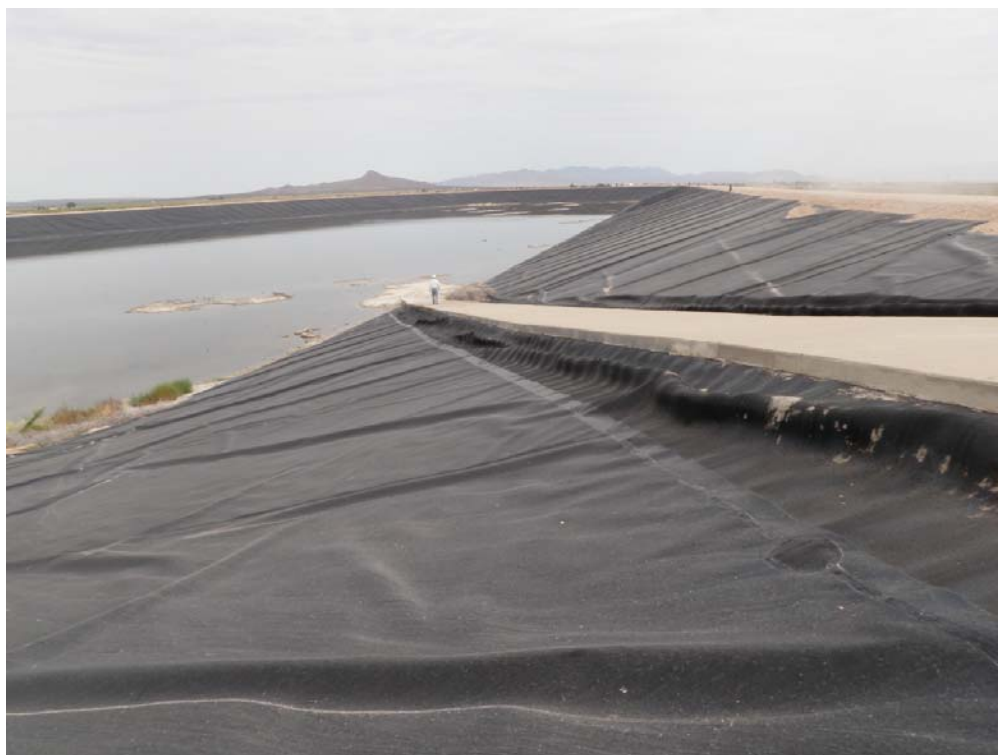
Photo 10: Upstream slope of east embankment of Ash Pond 4 facing north. Note the maintenance access concrete ramp. Pond is nearly empty.

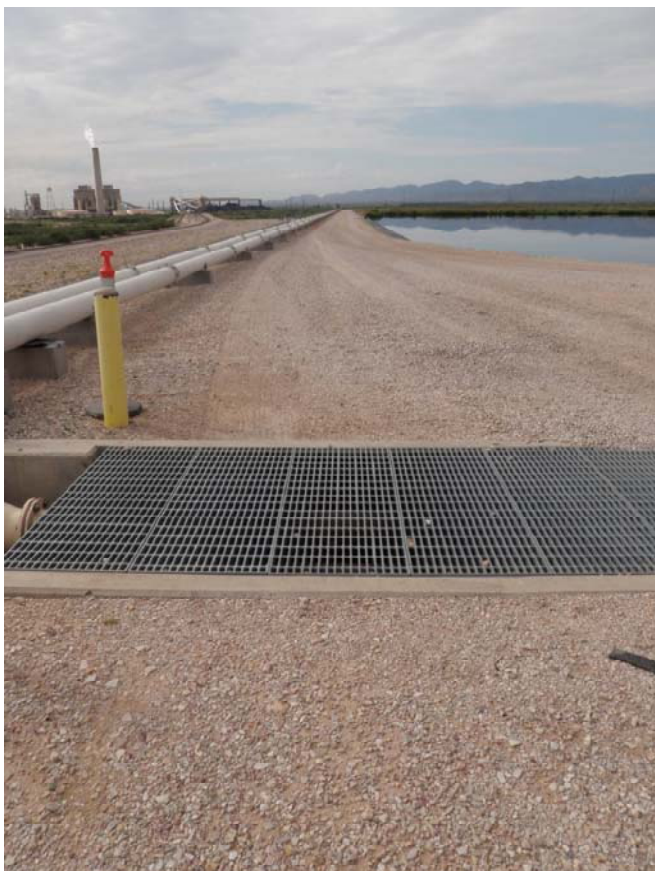
Photo 11: Crest of east embankment of Ash Pond 1 facing south. Pipelines convey slurried fly ash and residuals for disposal in the ash ponds. Note depressed pipe vault for traffic crossing.

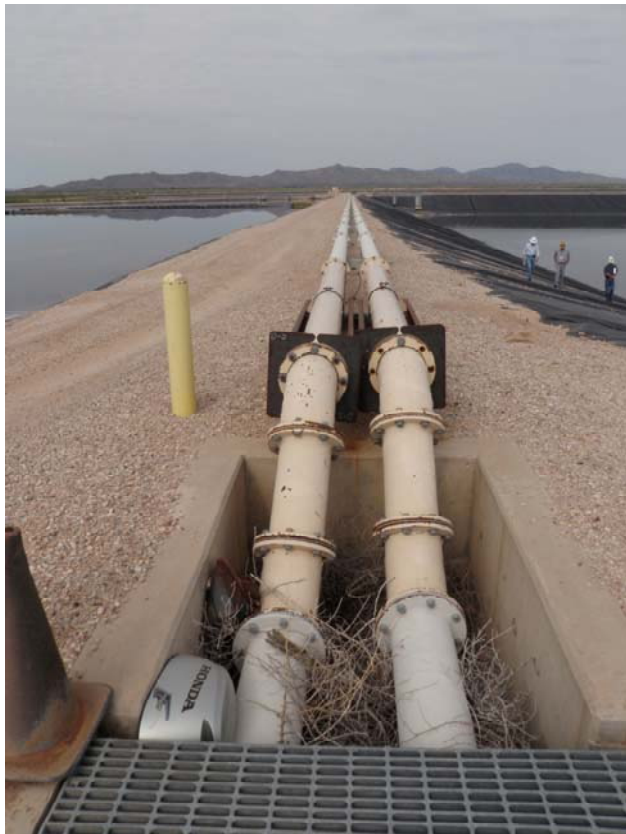
Photo 12: Crest of north embankment of Ash Pond 1 facing west. Note fly ash slurry pipelines.

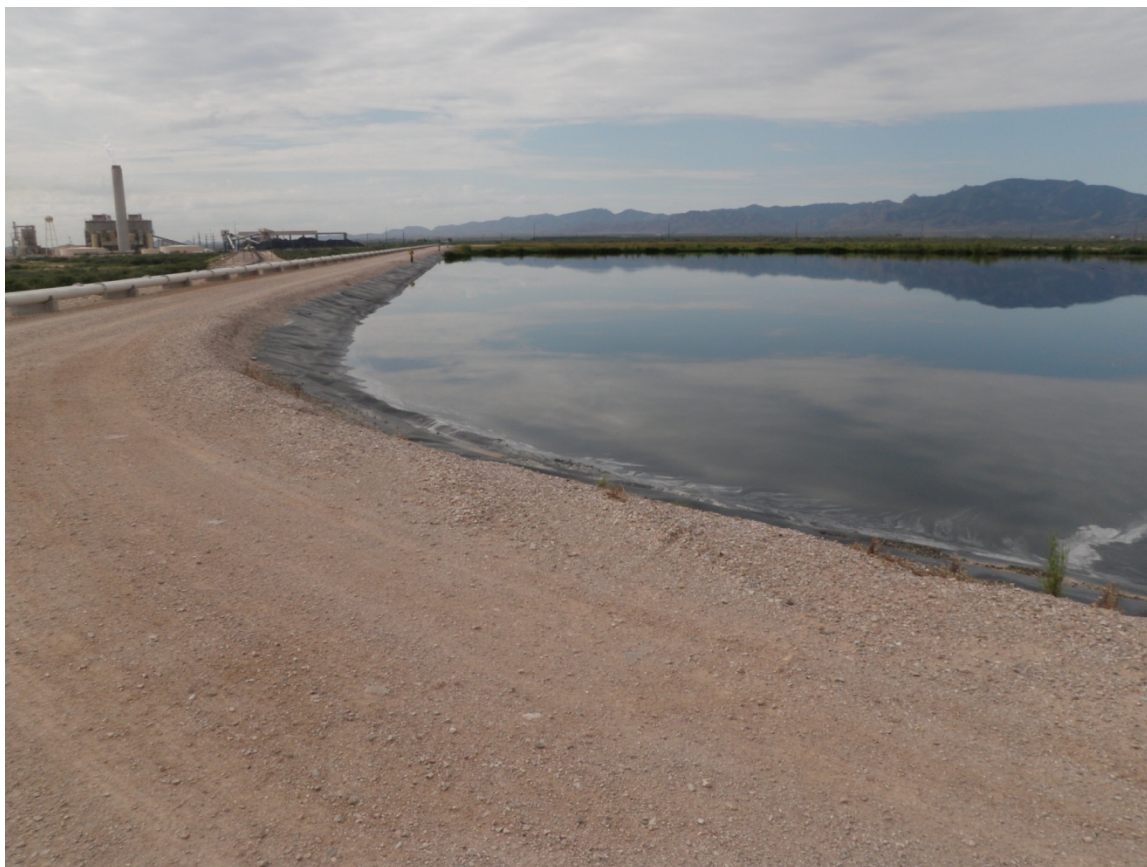
Photo 13: Upstream slope of east embankment of Ash Pond 1 facing south

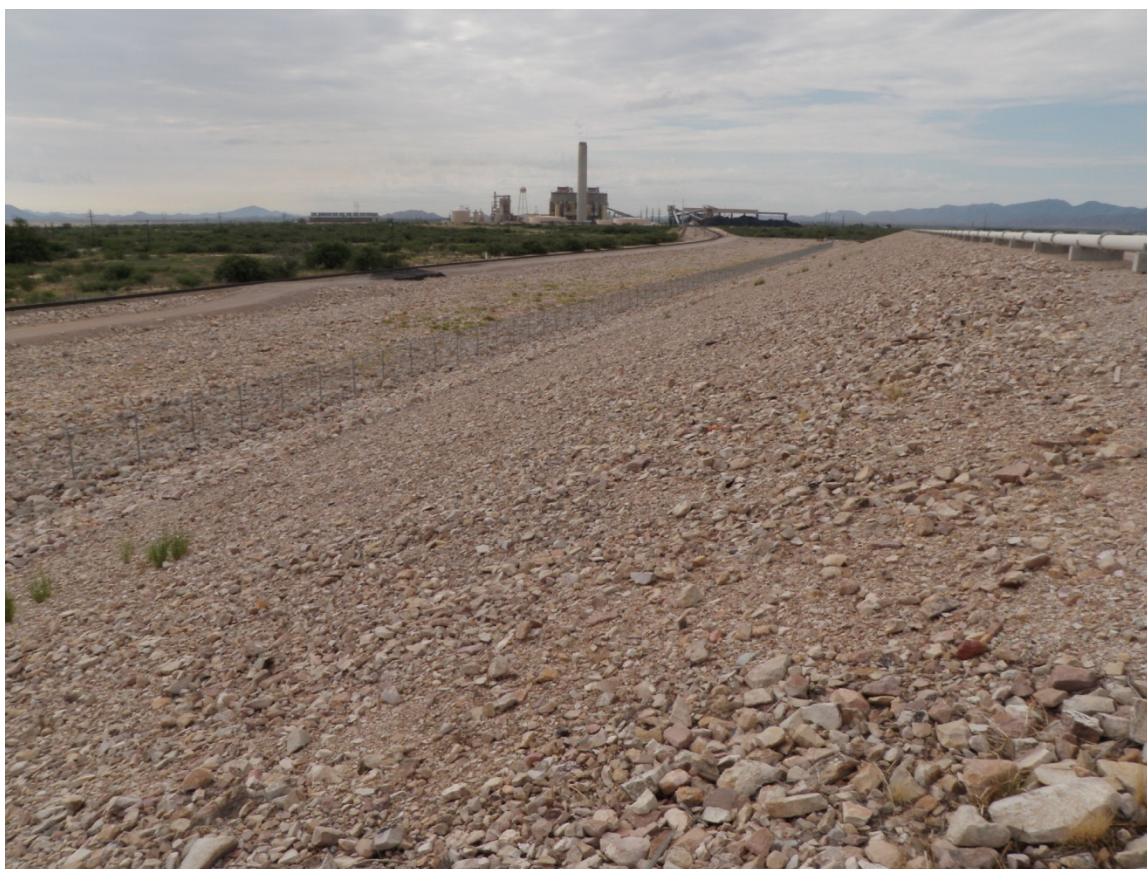
Photo 14: Downstream slope of east embankment of Ash Pond 1 facing south

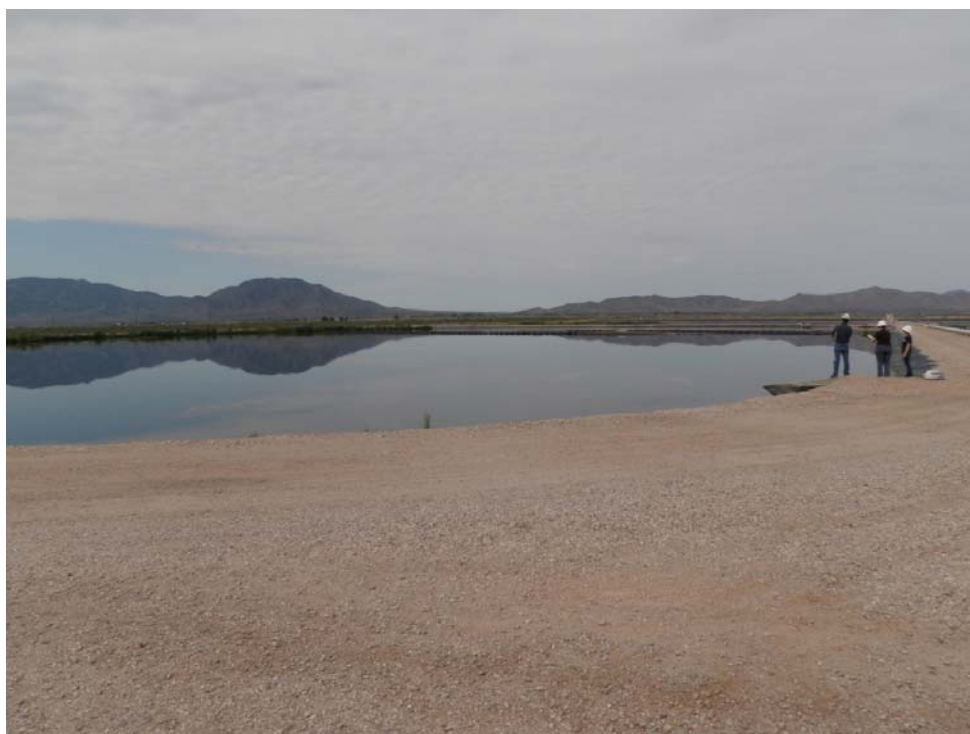
Photo 15: Panorama view of Ash Pond 1 facing southwest

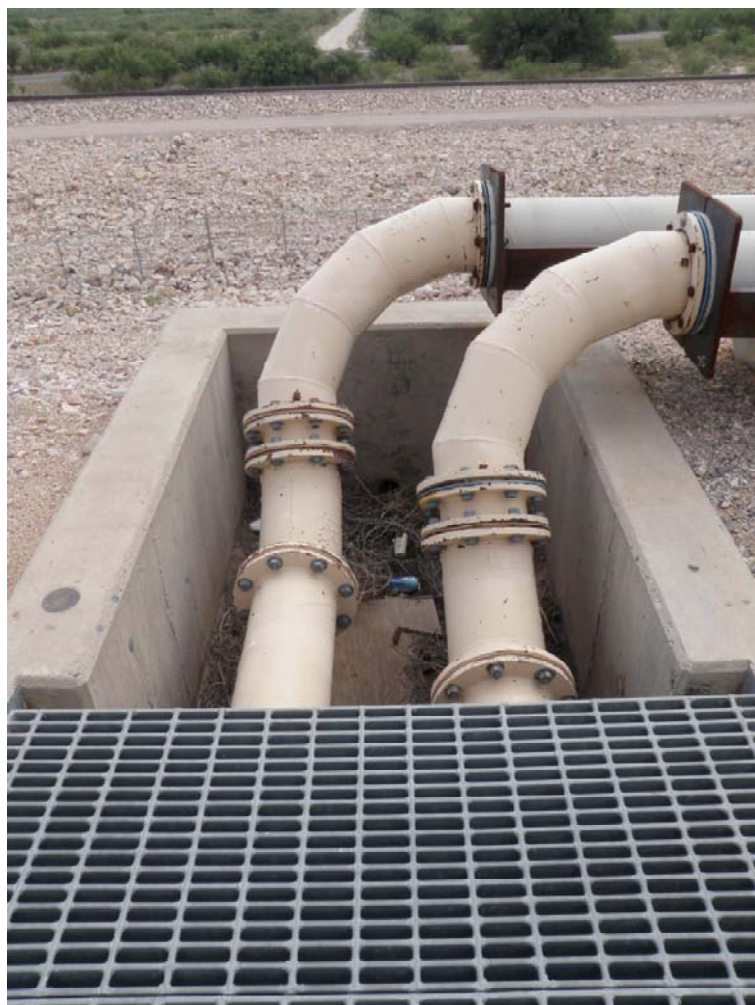
Photo 16: Looking downstream, east, at Pipe Vault

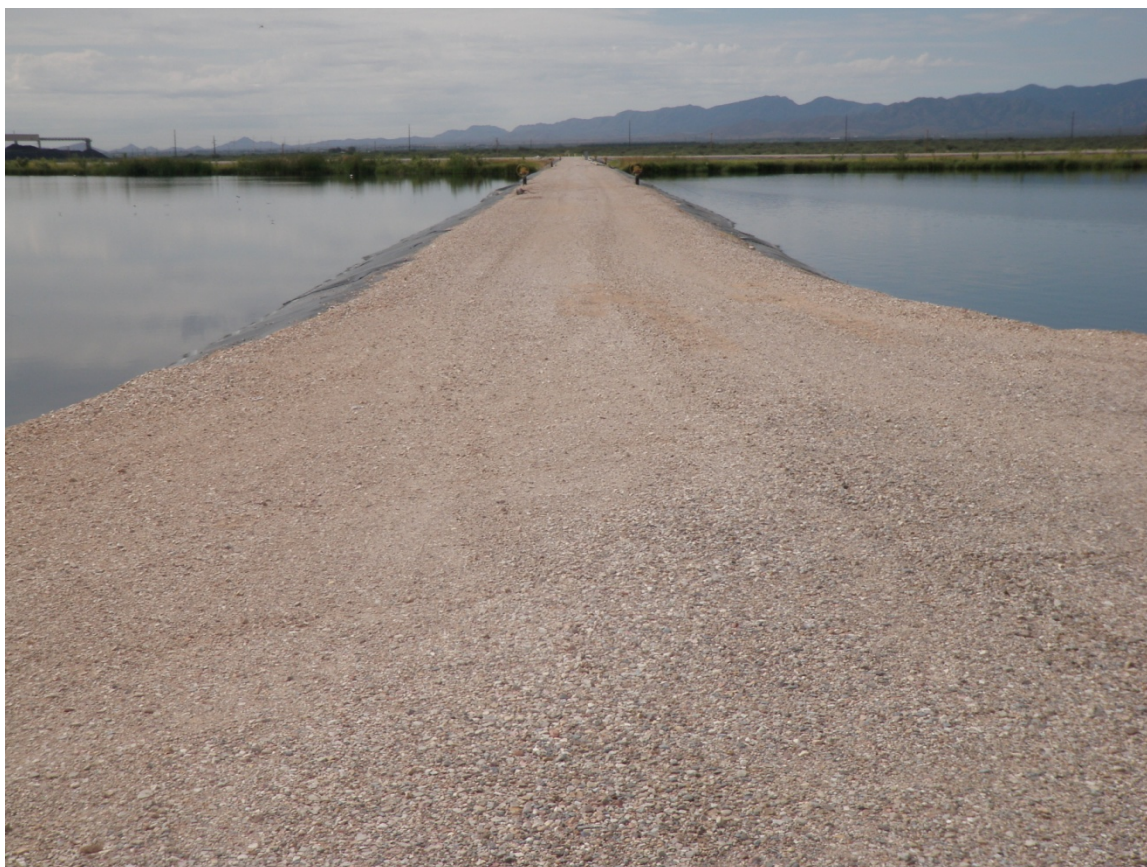
Photo 20: Crest between Ash Pond 1 and Ash Pond 2, looking south.

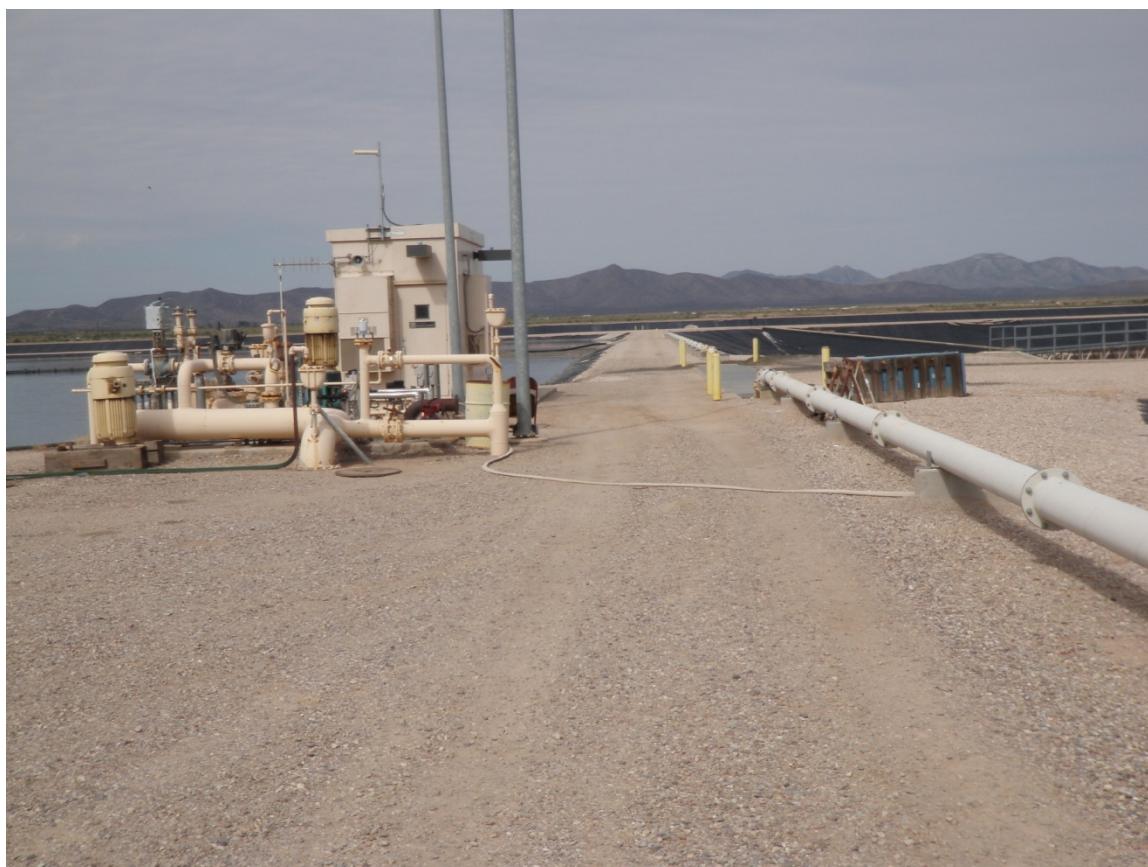
Photo 21: Crest and centralized recirculation pump station located at intersection of Ash Pond 1, 2, 3, & 4, looking west. Decant water is pumped back to the Cooling Tower Blowdown Pond.

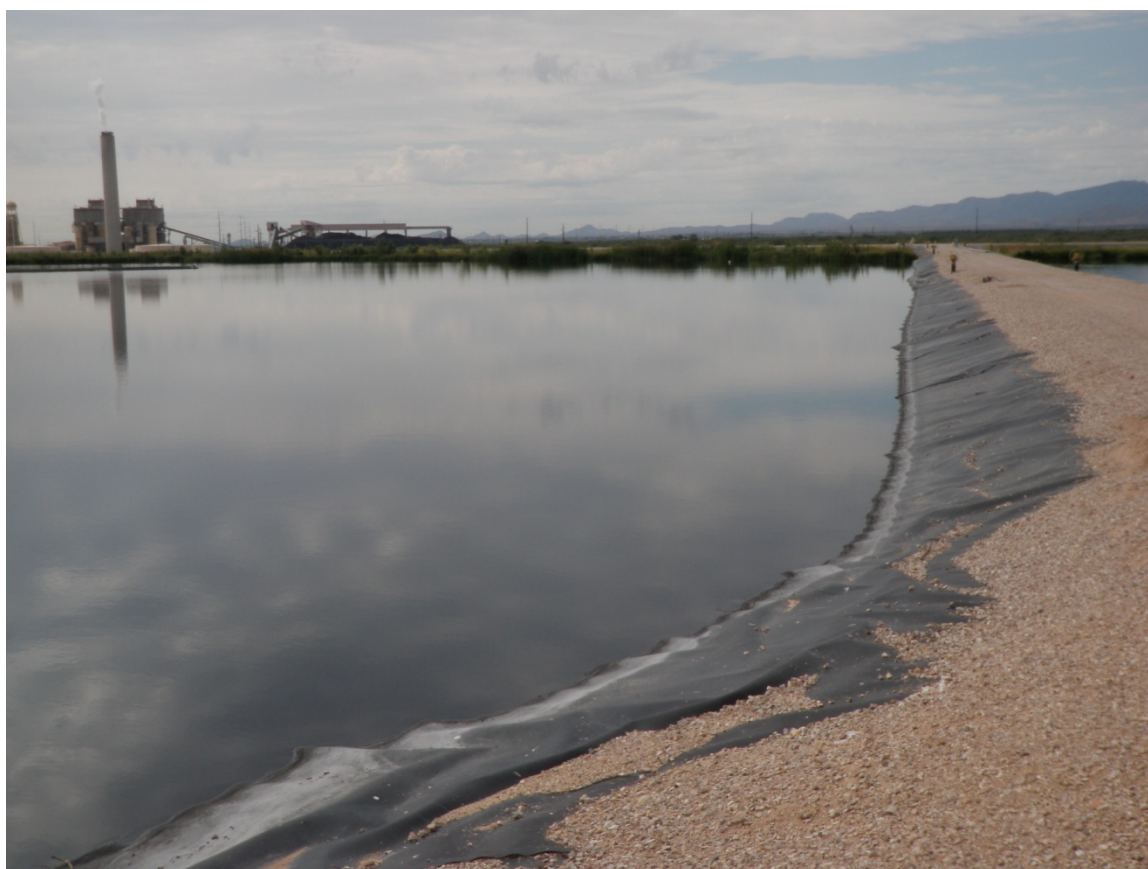
The pond is lined with an 80-mil HDPE lining on the slopes and 60-mil HDPE lining on the bottom, (see Photo 22). The upstream slope could not be observed directly because it is mostly obscured by the HDPE lining. There was no visual evidence of large bulges or depressions beneath the lining that would indicate stability issues. On this basis, the upstream slope was considered to be in acceptable condition.

Photo 22: Upstream slope of west embankment of Ash Pond 1, looking south.

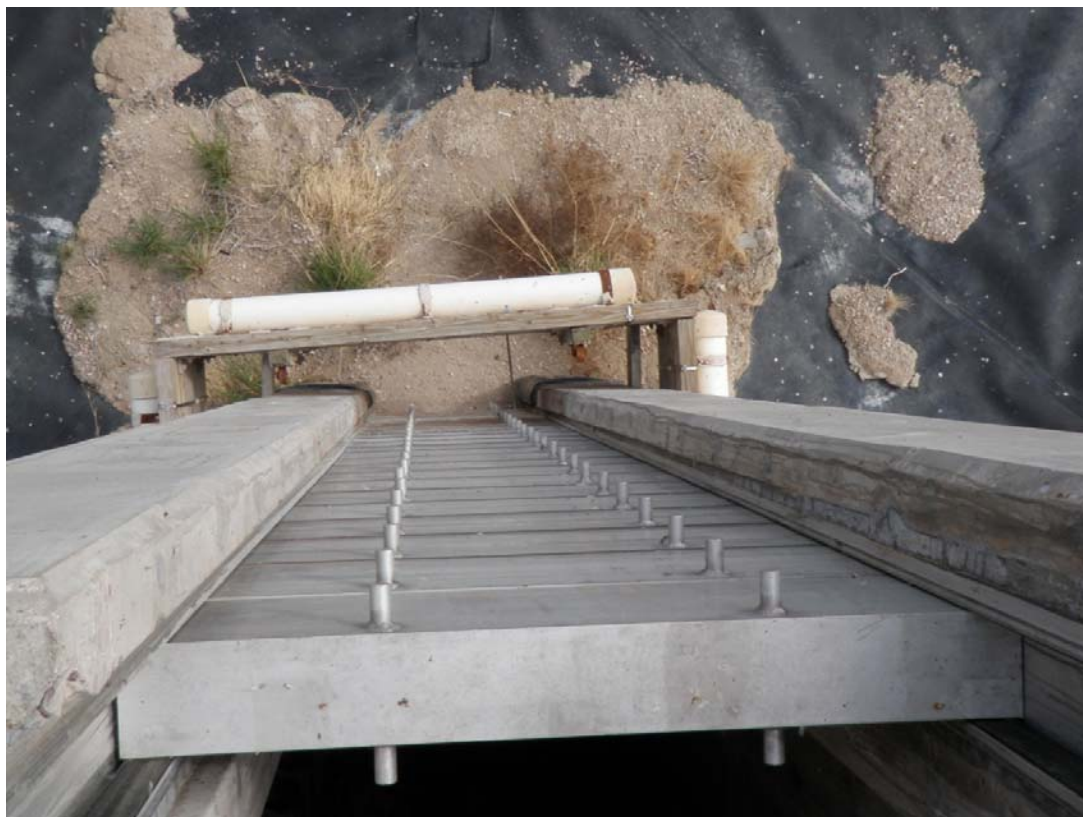
Photo 23: Exterior view of intake tower at Ash Pond 4, looking down. Note the aluminum stop logs that can be adjusted to control pond decant level.

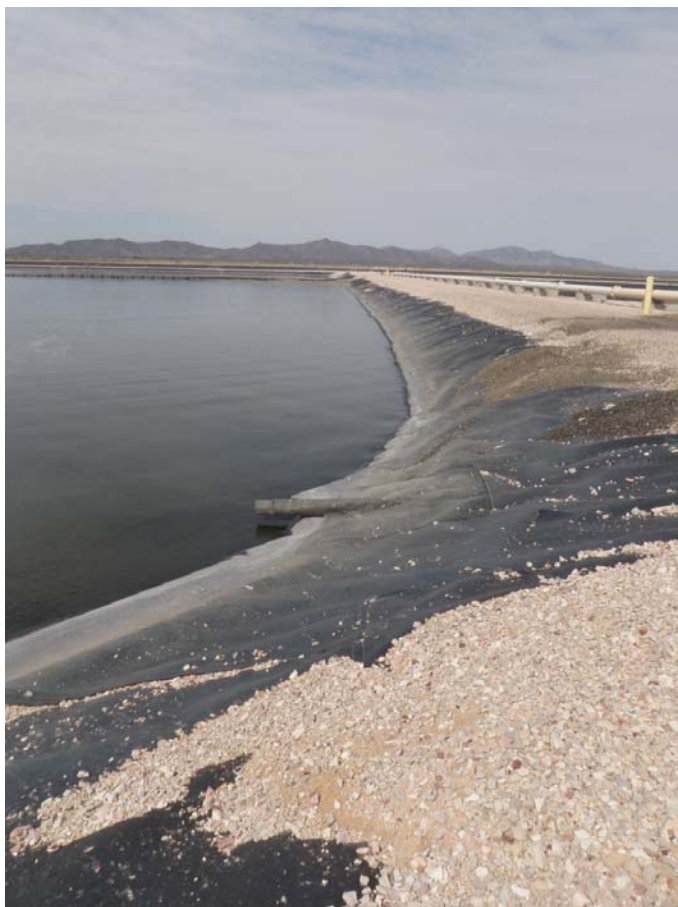
Photo 25: Upstream slope of north embankment of Ash Pond 2, looking west. Note the small pipe that drains a pipe vault.

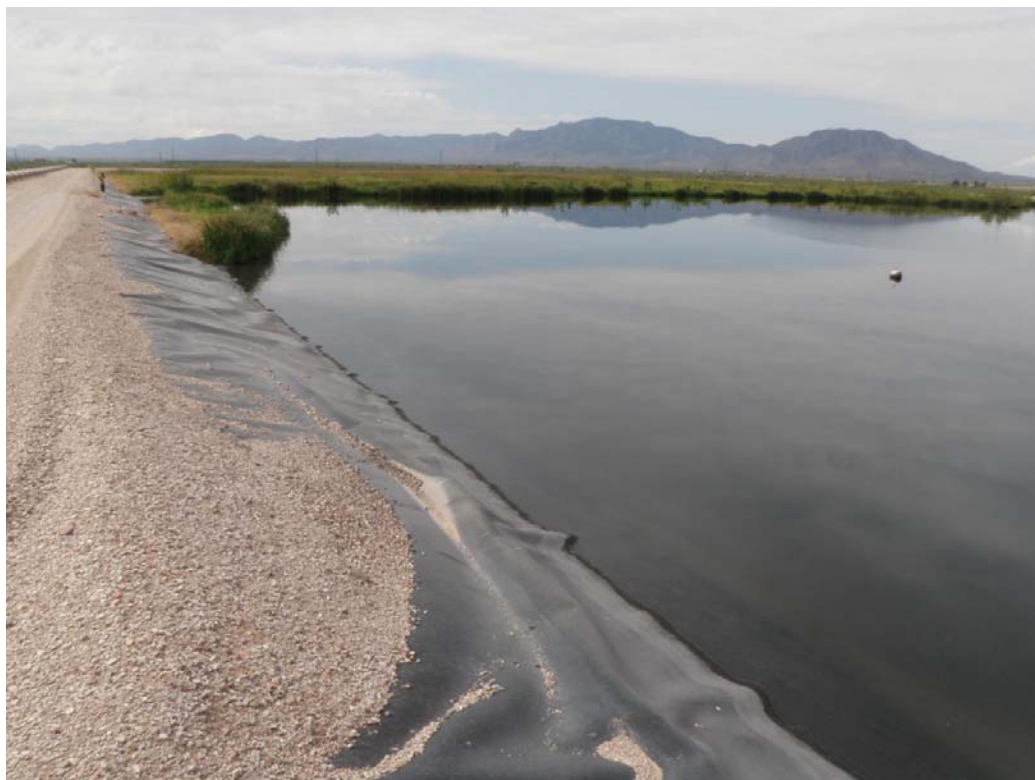
Photo 26: Upstream slope of east embankment of Ash Pond 1, looking south. Note vegetation established on the ash deposits.

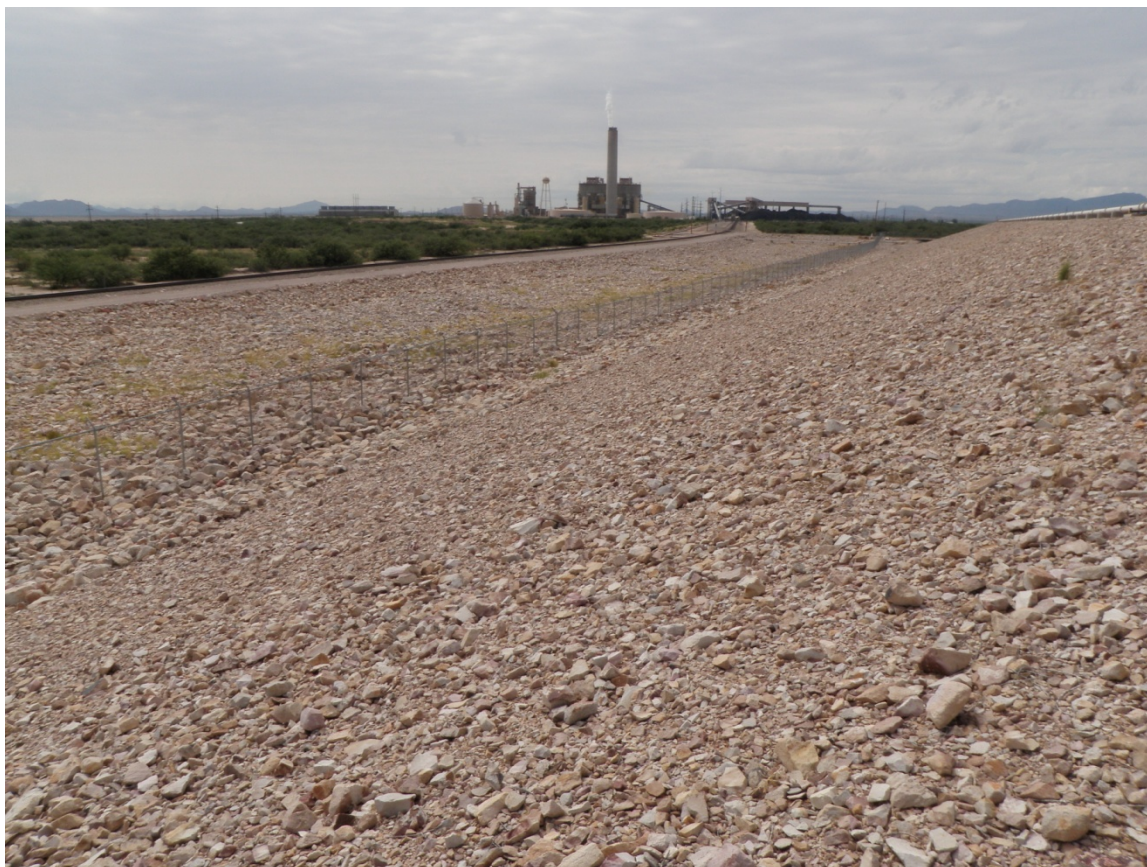
Photo 27: Downstream slope of east embankment of Ash Pond 1, looking south.

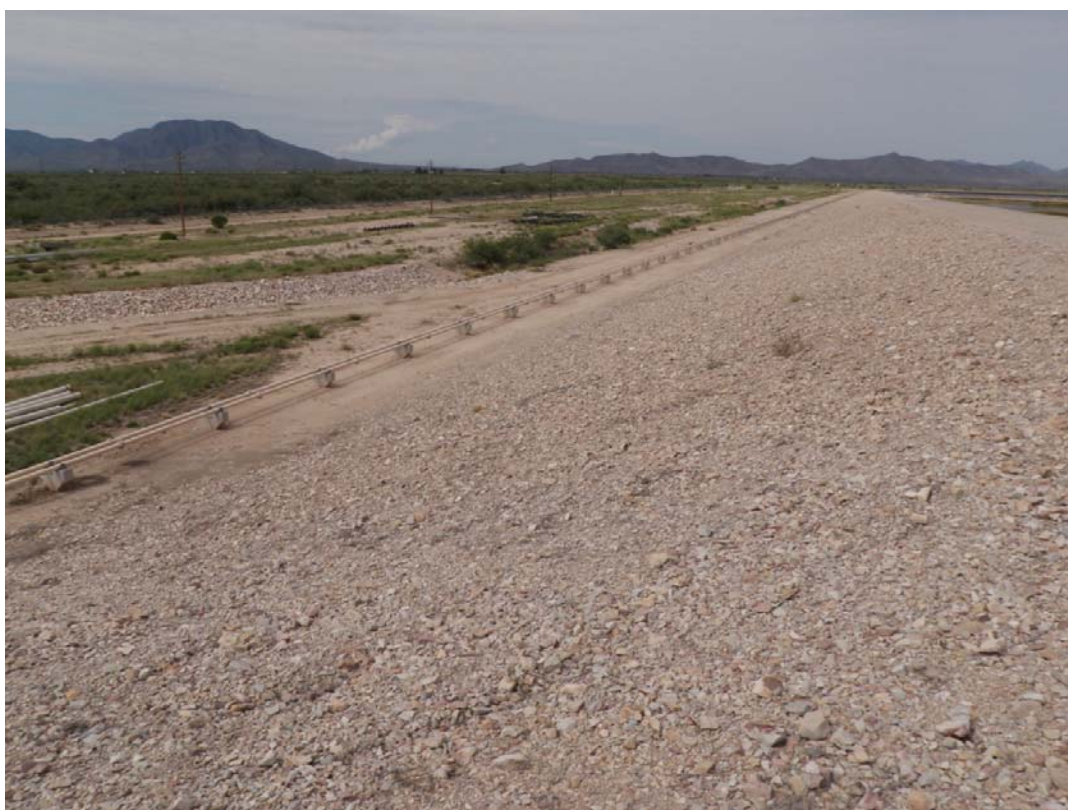
Photo 28: Downstream slope of south embankment of Ash Pond 1, looking west. Note pipes conveying slurried scrubber sludge to Scrubber Sludge Pond 1. Note riprapped stormwater channel located downstream of the embankment.

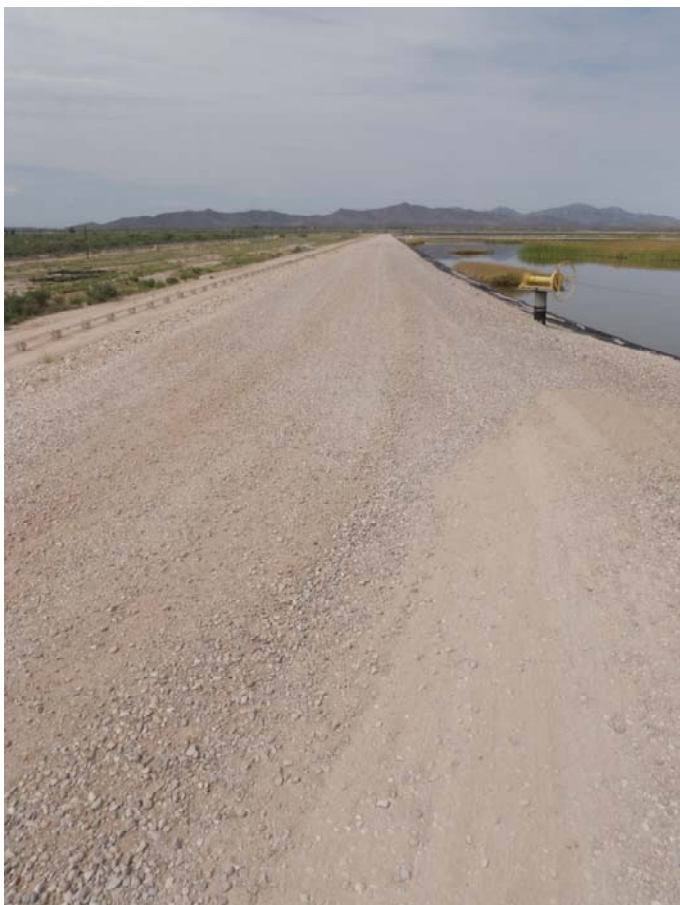
Photo 29: Ash Pond 1 Crest, looking west.

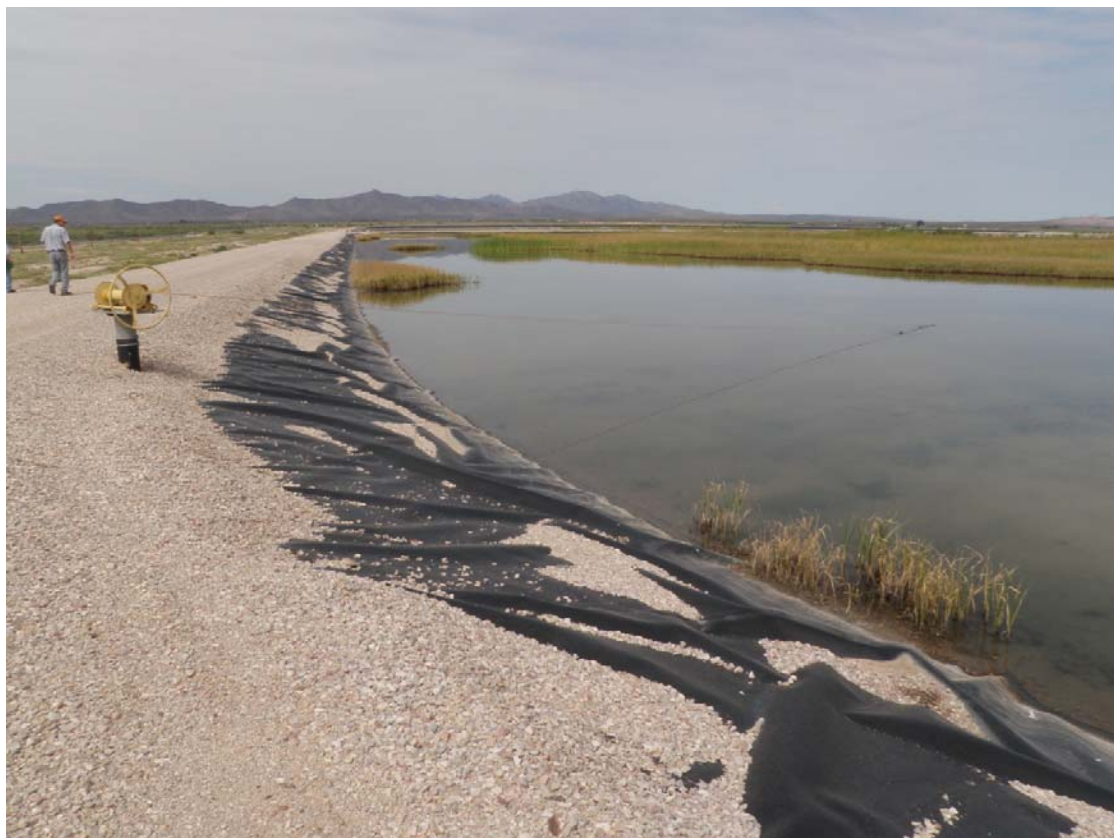
Photo 30: Upstream slope of south embankment of Ash Pond 1, looking west.

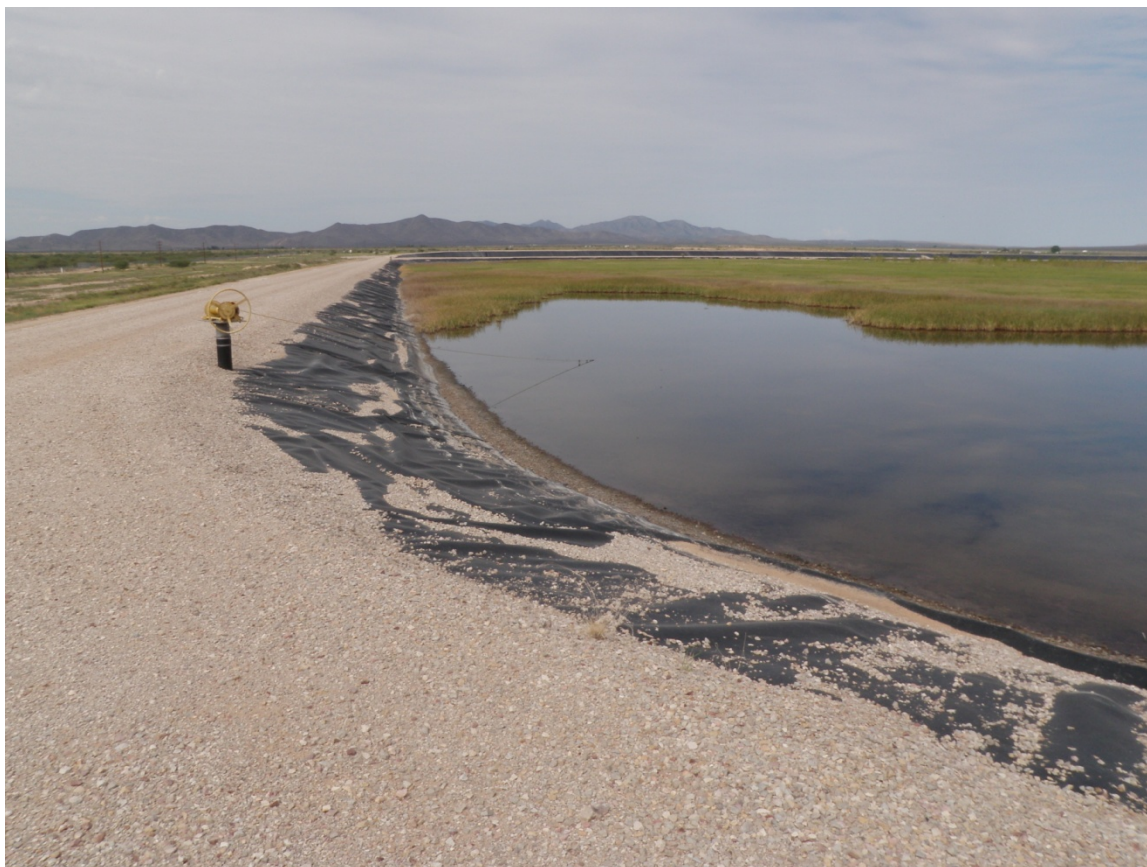
Photo 31: Ash Pond 2, upstream slope of south embankment, looking west.

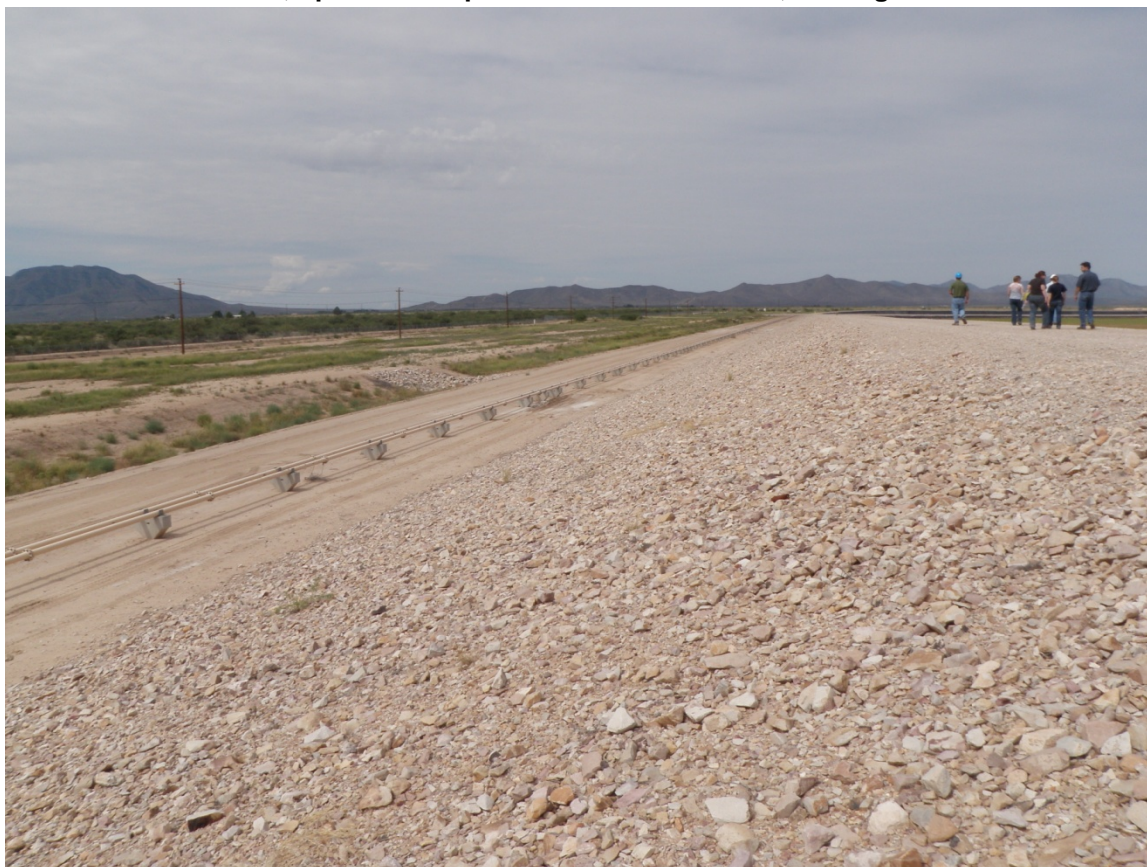
Photo 32: Ash Pond 2, downstream slope of south embankment, looking west.

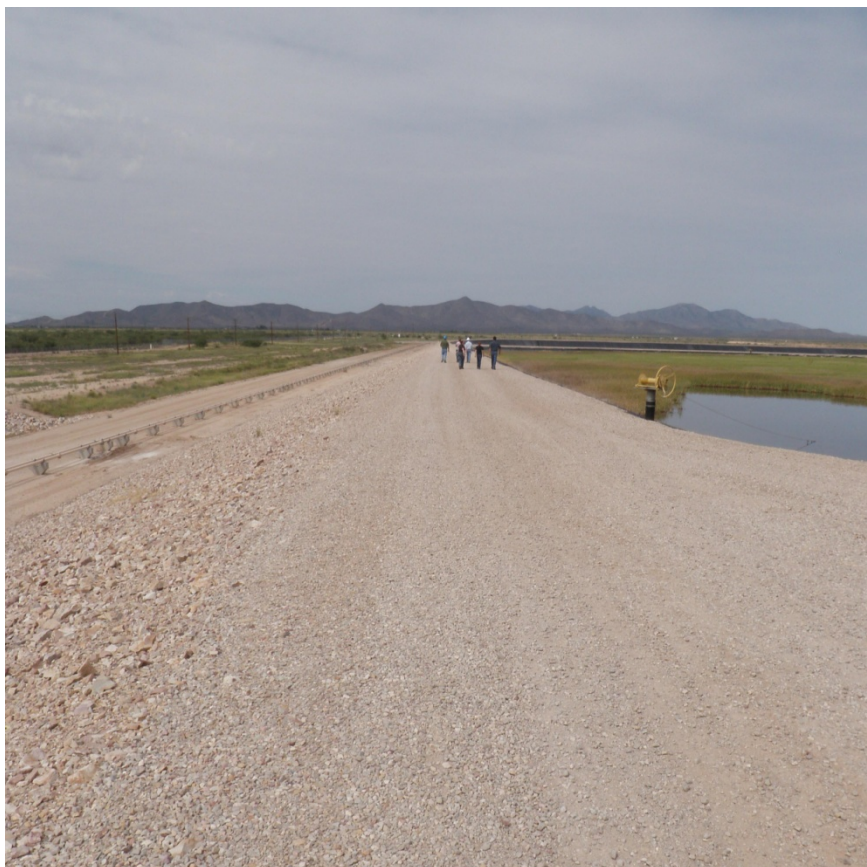
Photo 33: Ash Pond 2 Crest of south embankment, looking west.

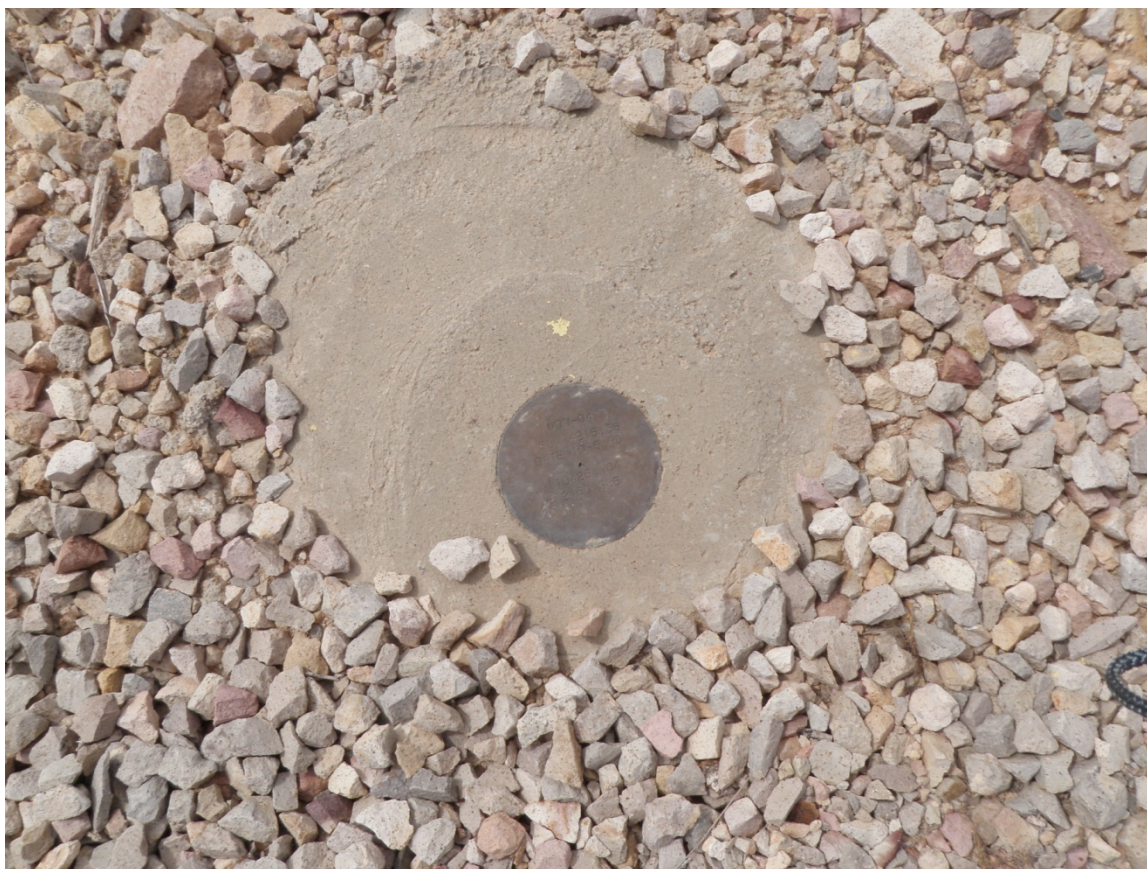
Photo 34: Survey Monument on crest of Ash Pond 2.

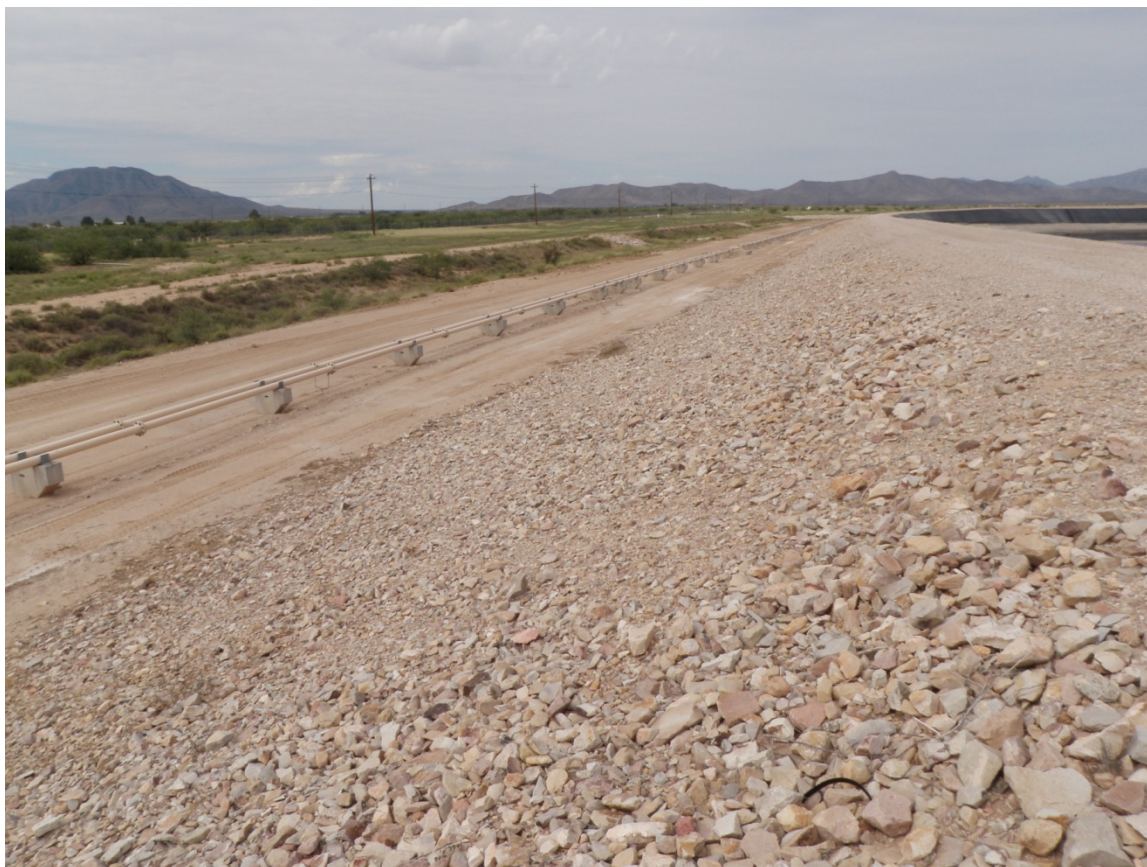
Photo 35: Evaporation Pond, downstream slope of south embankment, looking west.
