FINAL

**Specific Site Assessment for
Coal Combustion Waste
Impoundments at Arizona
Electric Power Cooperative
(AEP CO) Apache Power Plant**

Cochise, Arizona

December 2009

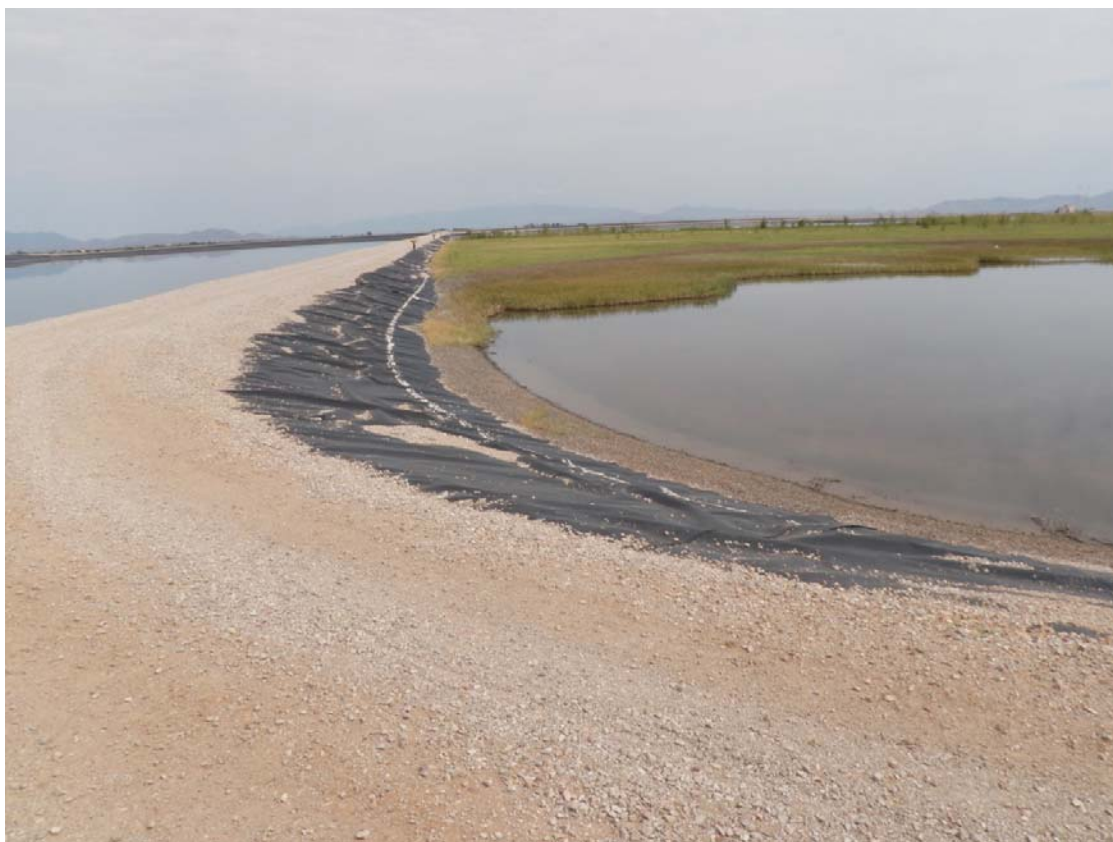
Photo 36: Ash Pond 2, upstream slope, looking north.

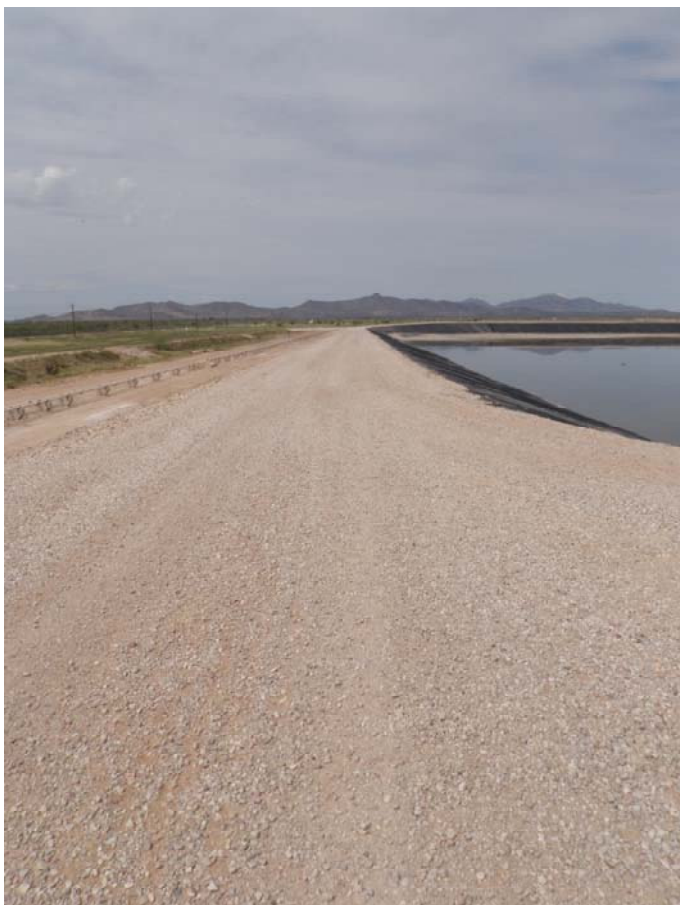
Photo 37: Crest of Evaporation Pond south embankment, looking west.

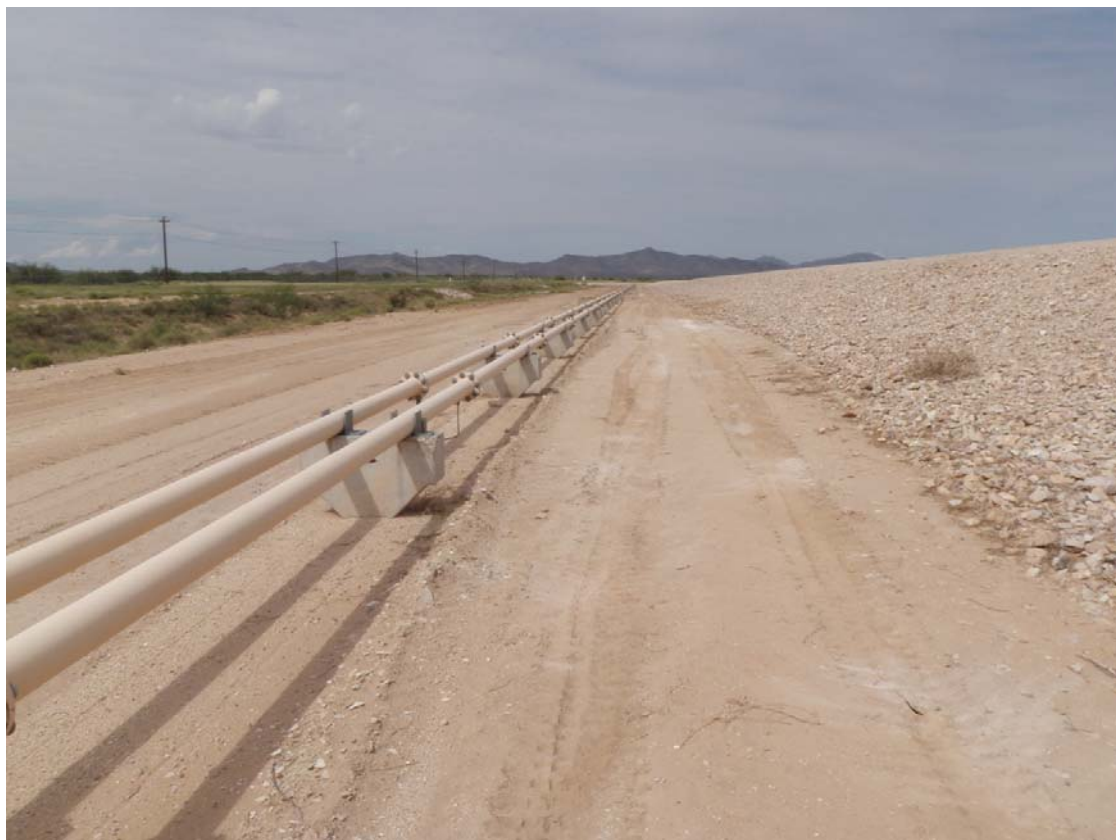
Photo 38: Downstream toe of Evaporation Pond, south embankment, looking west.

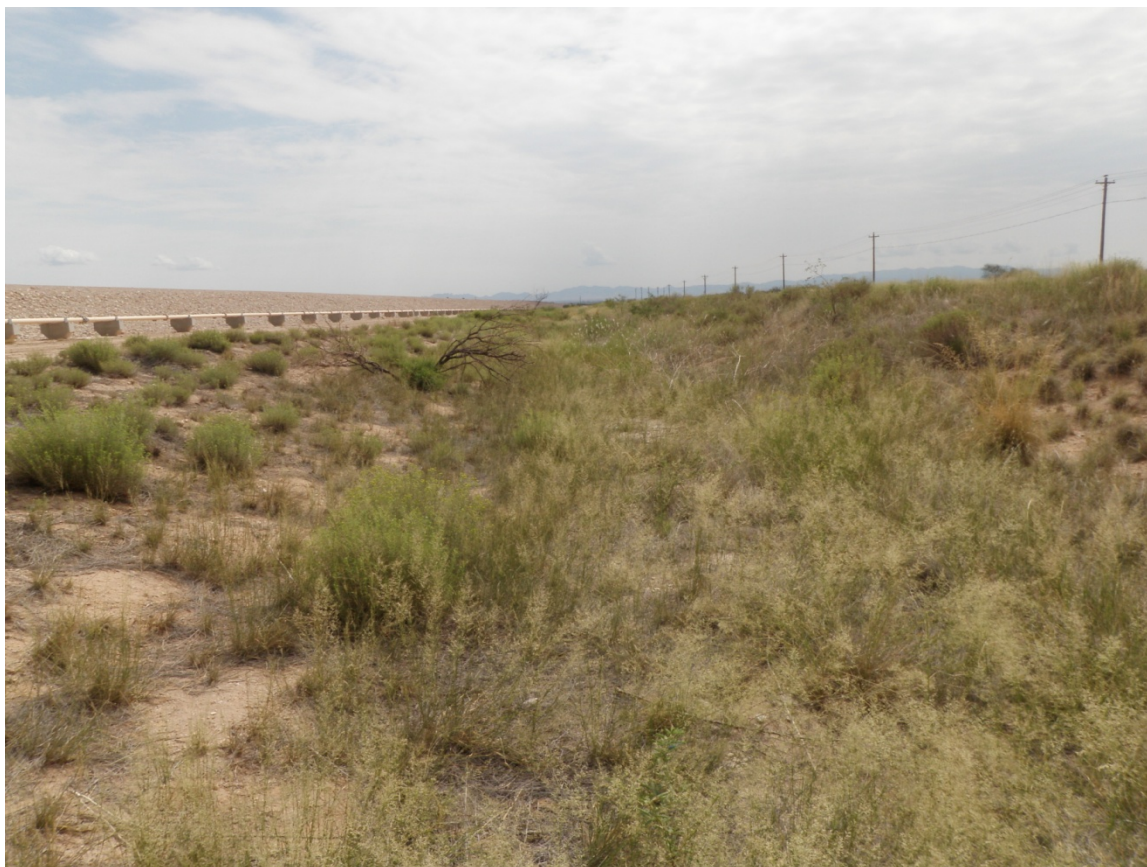
Photo 39: Stormwater ditch located south of the Evaporation Pond, looking east.

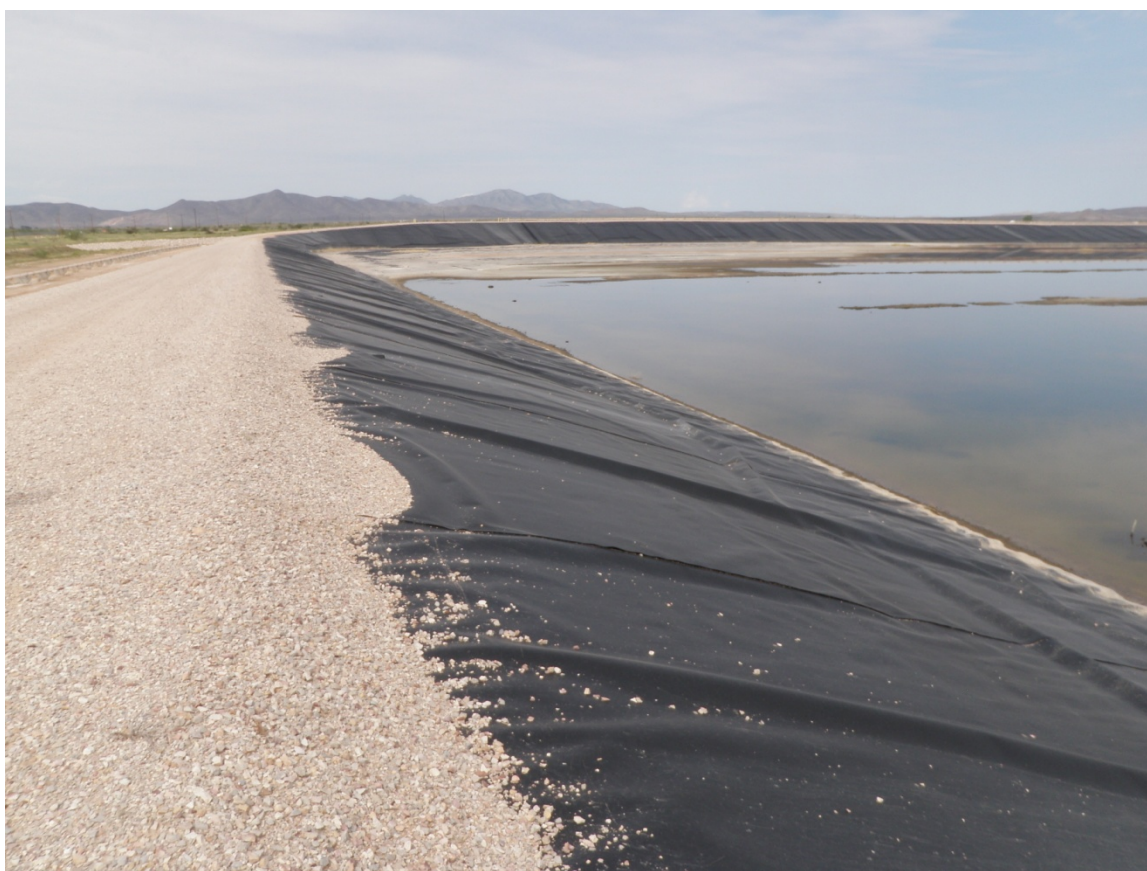
Photo 40: Evaporation Pond, upstream slope of south embankment, looking west.

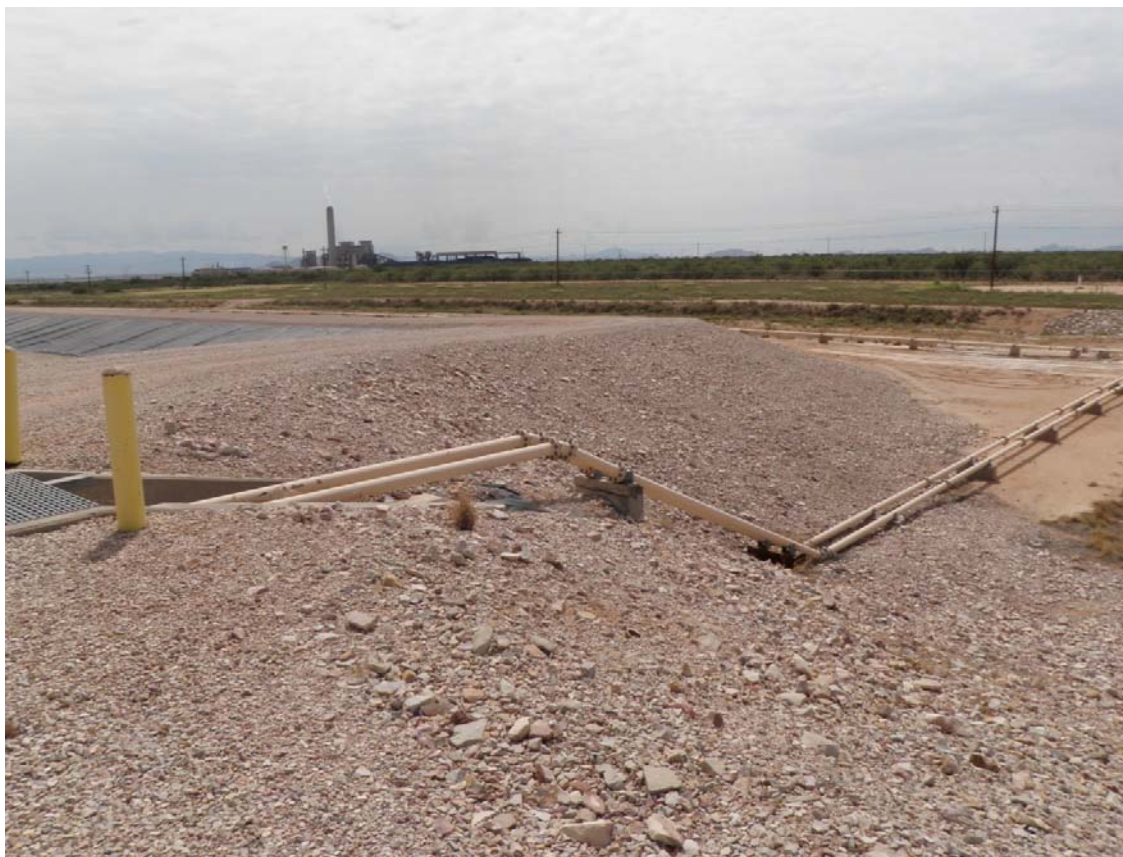
Photo 41: Pipes conveying scrubber sludge entering the facility at southwest corner of Scrubber Sludge Pond 1, looking southeast.

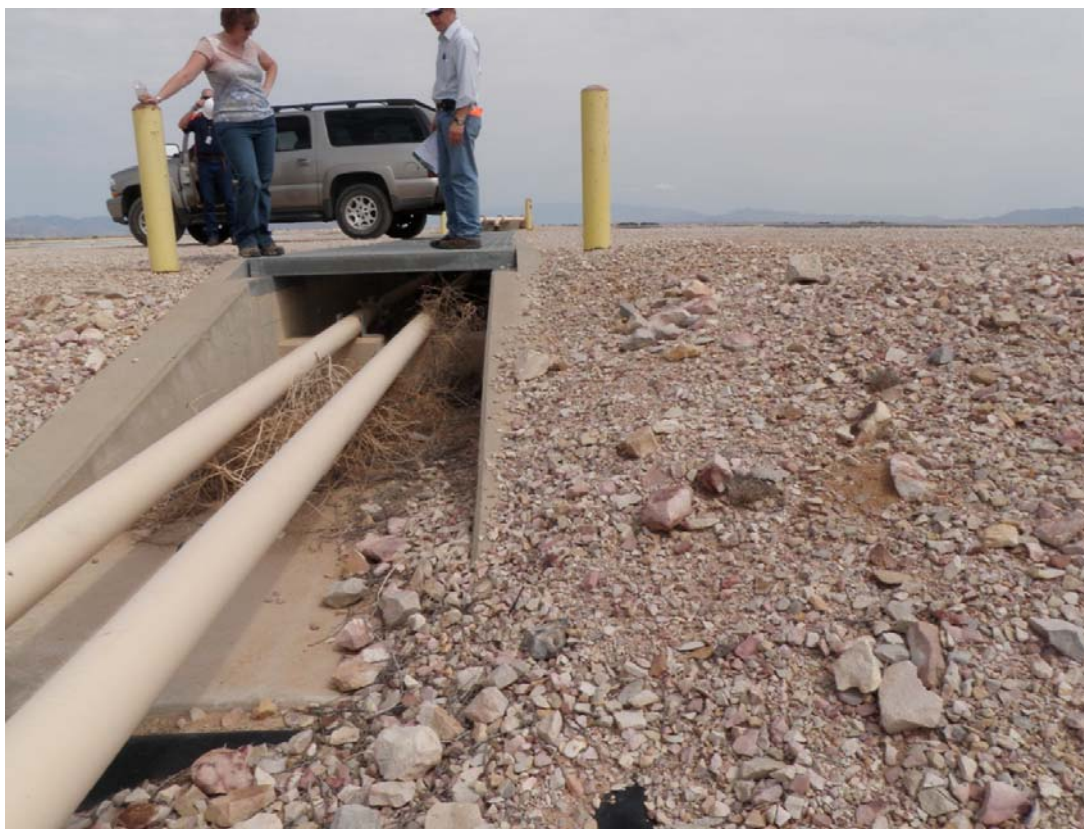
Photo 42: Pipe vault where pipes cross the crest to discharge into Scrubber Sludge Pond 1, looking north. Note the vault lacks a concrete headwall at the downstream end, which could provide a pathway to concentrate discharge of overtopping flows.

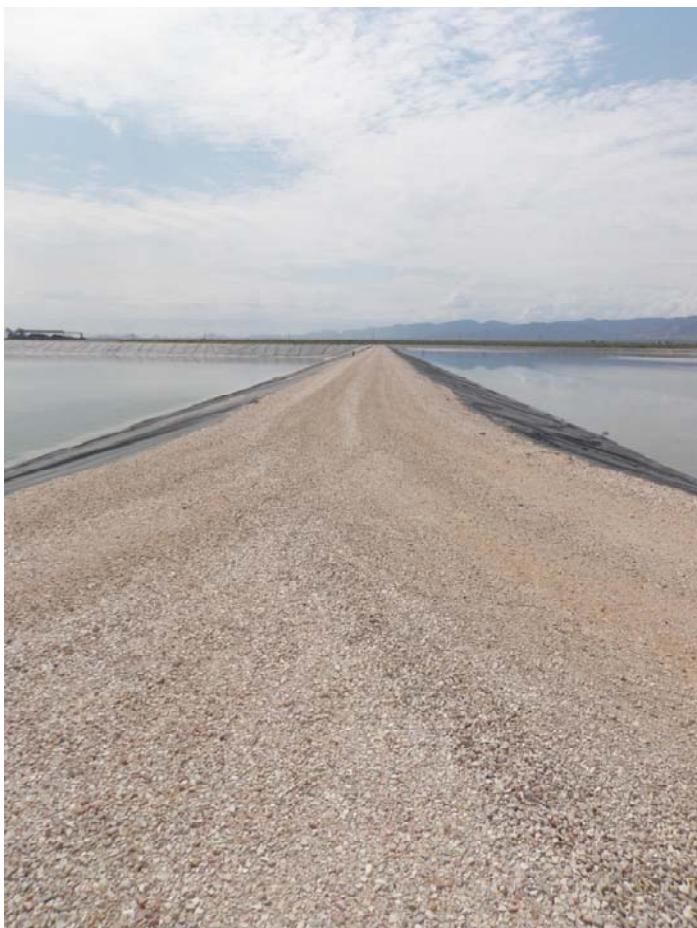
A potential outlet structure for Scrub 1 and Scrub 2 consists of three HDPE pipes that connect Scrub 1 and Scrub 2 at three different elevations (see Photo 54). The pipes are installed horizontal. At the time of the assessment, these outlet pipes were closed with blind

A potential outlet structure for Scrub 1 consists of three HDPE pipes that connect Scrub 1 and Scrub 2 at three different invert elevations (see Photo 54). The pipes are installed horizontal. At the time of the assessment, these outlet pipes were closed with blind flanges on both ends of the pipes and were not operational. These pipes can only be used to provide an outlet under specific operating conditions, such as when the water level in one pond is higher than the other pond so that a flow can be established. With the exception of these pipes, the surface sludge impoundments have no outlet. The outlet pipes appeared to be in acceptable condition and are expected to function should AEPCO choose to operate them as an outlet to discharge from Scrub 1 to Scrub 2.

Photo 54: Upstream slope of the south embankment of Scrubber Sludge Pond 2, looking west. Note 3 HDPE pipes that connect Scrubber Sludge Pond 1 and Scrubber Sludge Pond 2. The pipes were closed with blind flanges at each end.
