**DRAFT**  
**Specific Site Assessment for  
Coal Combustion Waste  
Impoundments at Basin  
Electric Laramie River Station  
Wheatland, Wyoming**

Submitted by:  
**GEI Consultants, Inc.**  
4601 DTC Boulevard, Suite 900  
Denver, CO 80237

February 2012  
Project 092886

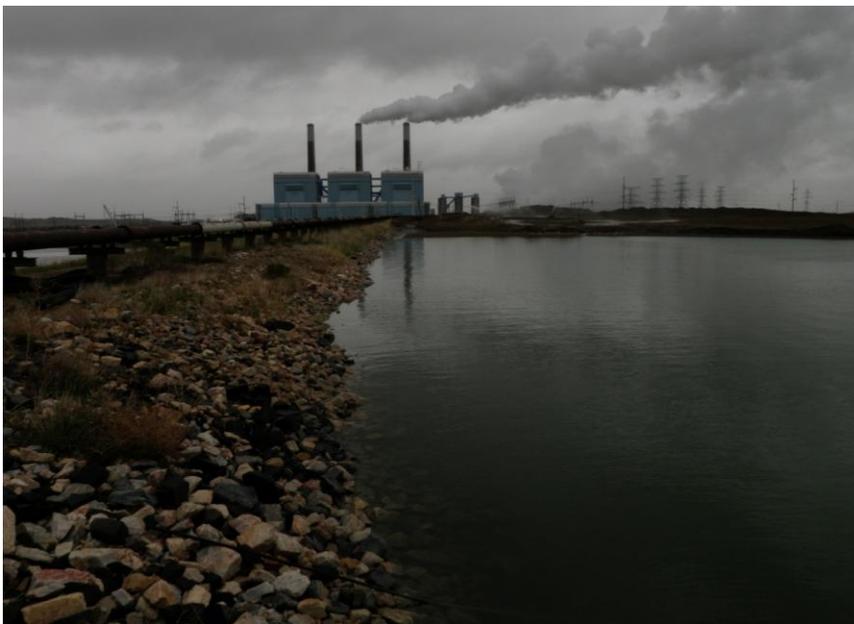
**Photo 2-2: Bottom Ash Pond 2 North Dike Upstream Slope, Looking Northeast. Note slope of landfill that is located directly north of Bottom Ash Pond 2.**

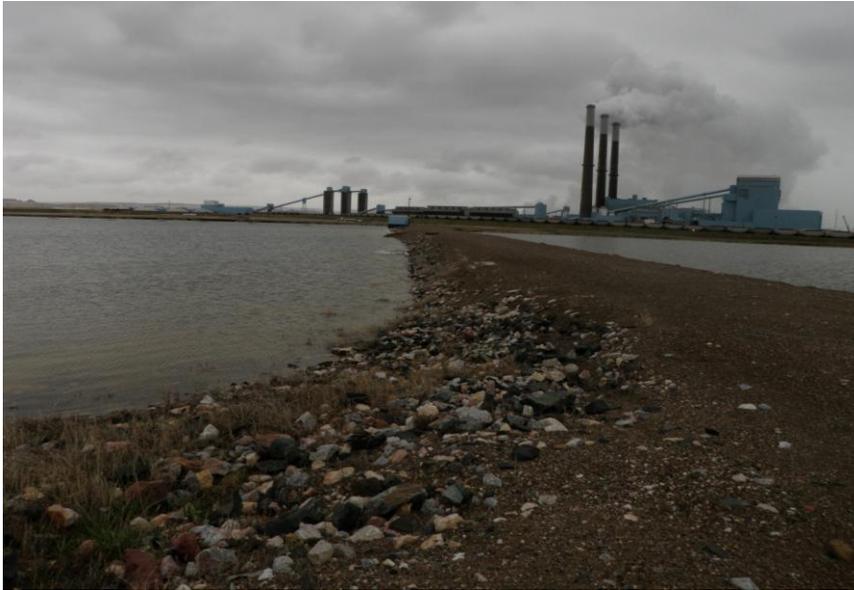
**Photo 2-4: East/West Emergency Holding Pond Divider Dike. East Emergency Holding Pond Upstream Slope, Looking South.**

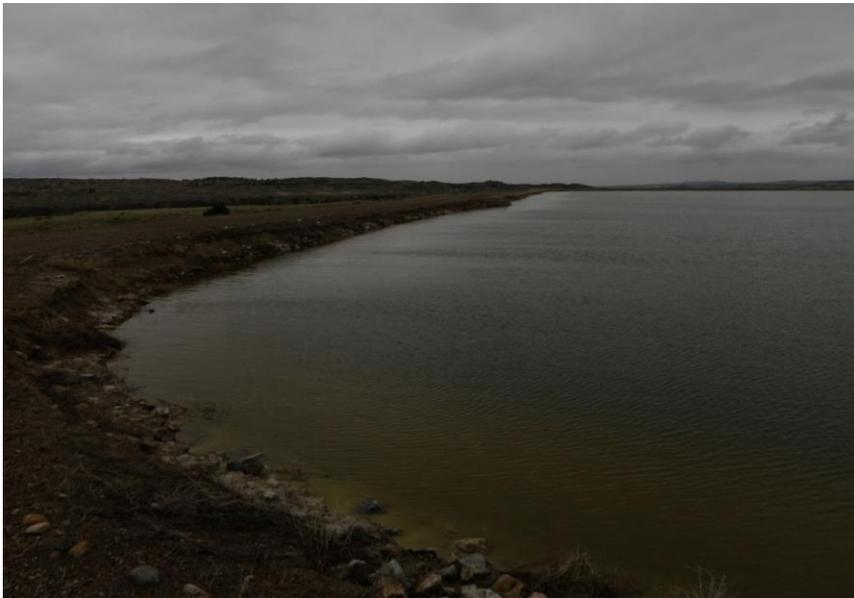
**Photo 2-5: West Emergency Holding Pond North Dike Upstream Slope, Looking Northeast.**

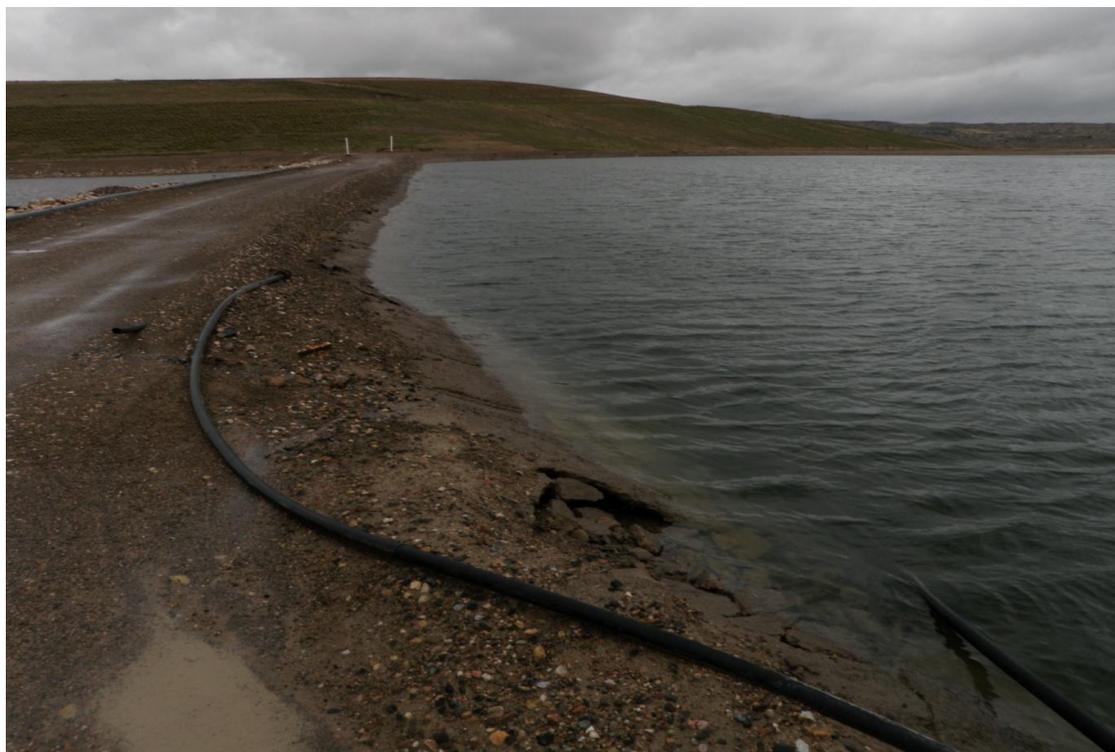
Photo 16: Bottom Ash Pond 1/Bottom Ash Pond 2. Bottom Ash Pond 1 Upstream Slope, Looking North.

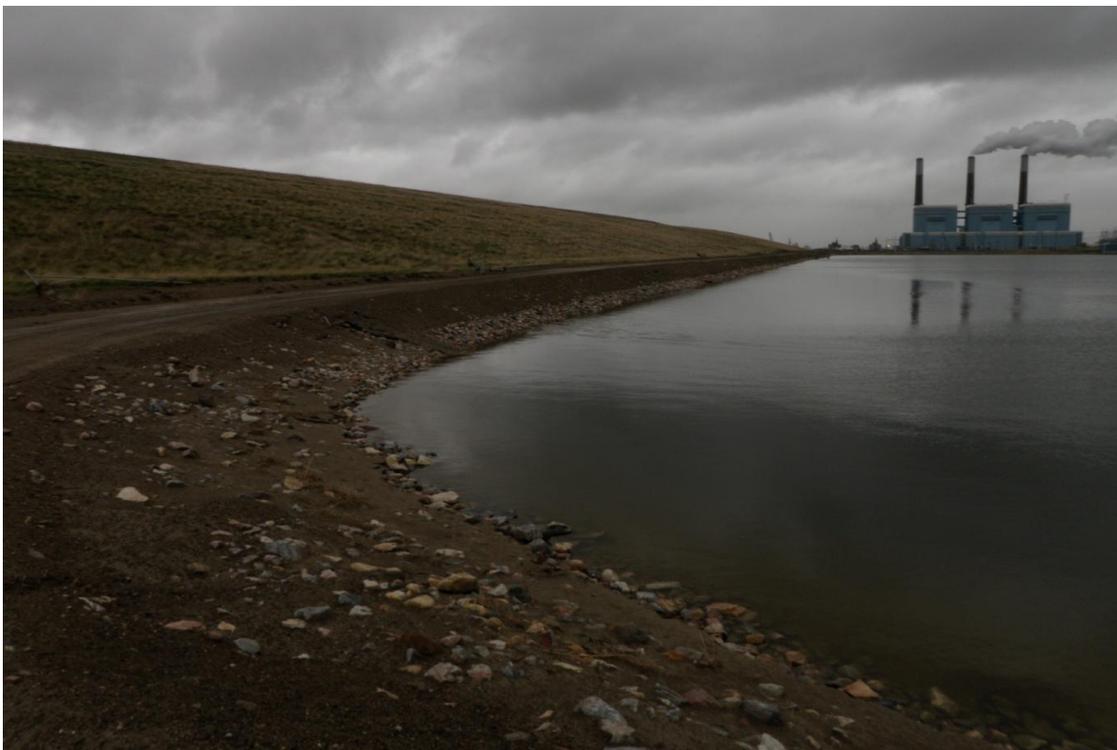
**Photo 20: Bottom Ash Pond 2 North Dike Upstream Slope, Looking Northeast.**

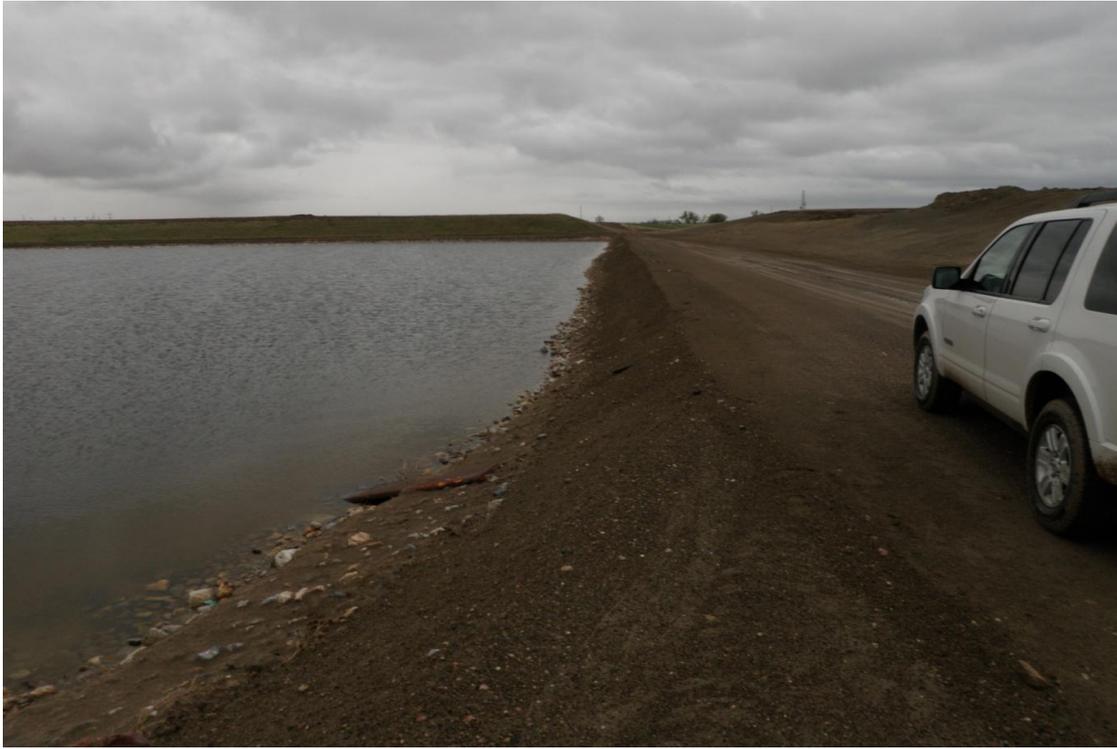
**Photo 21: Bottom Ash Pond 2 West Dike Upstream Slope, Looking South.**

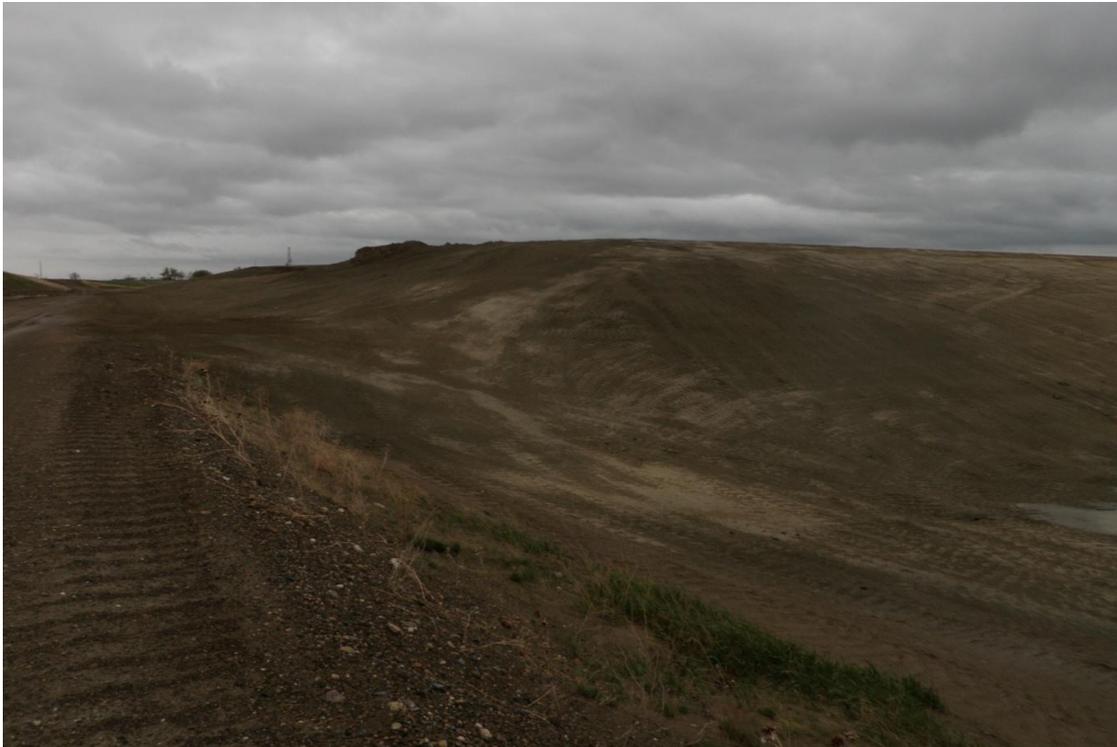
**Photo 22: Bottom Ash Pond 2 West Dike Downstream Slope/Landfill, Looking South.**

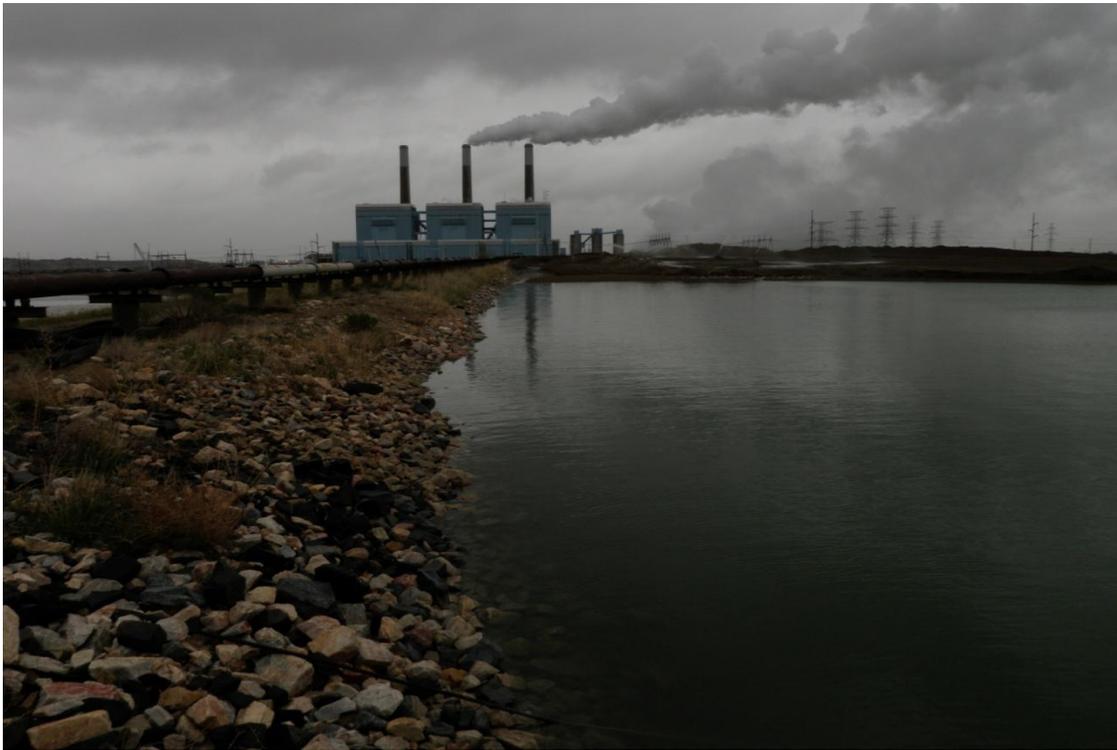
Photo 26: Bottom Ash Pond 3 North Dike Upstream Slope, Looking East.

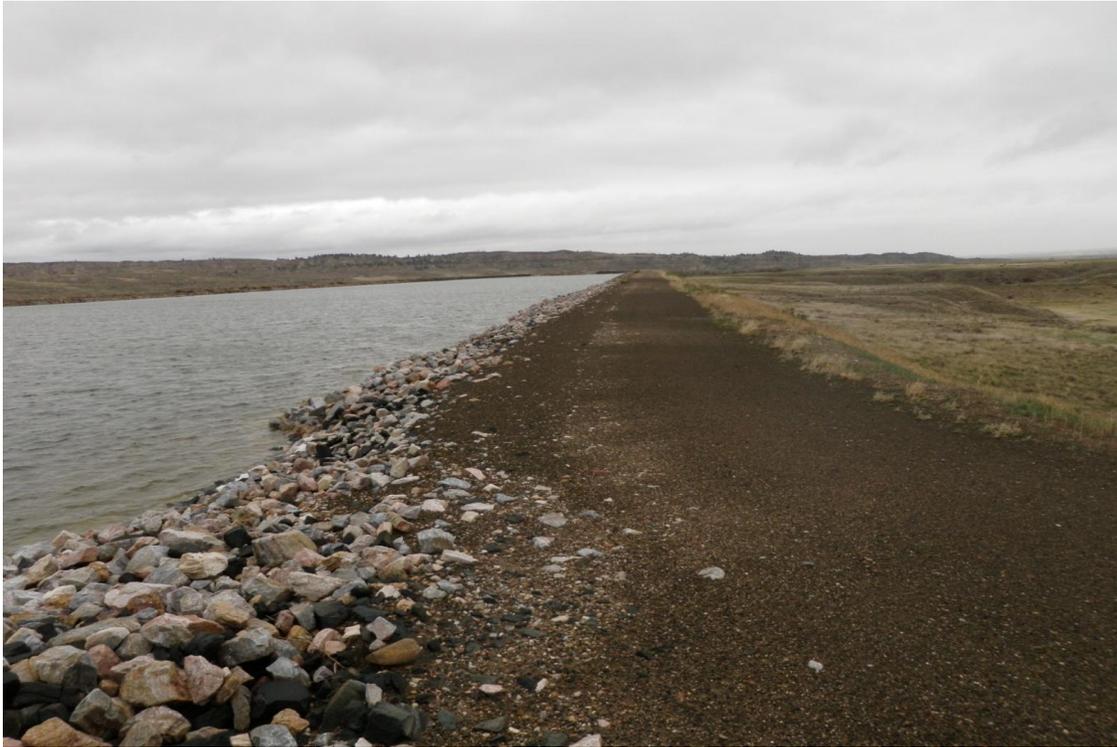
**Photo 43: East Emergency Holding Pond South Dike Upstream Slope, Looking East.**

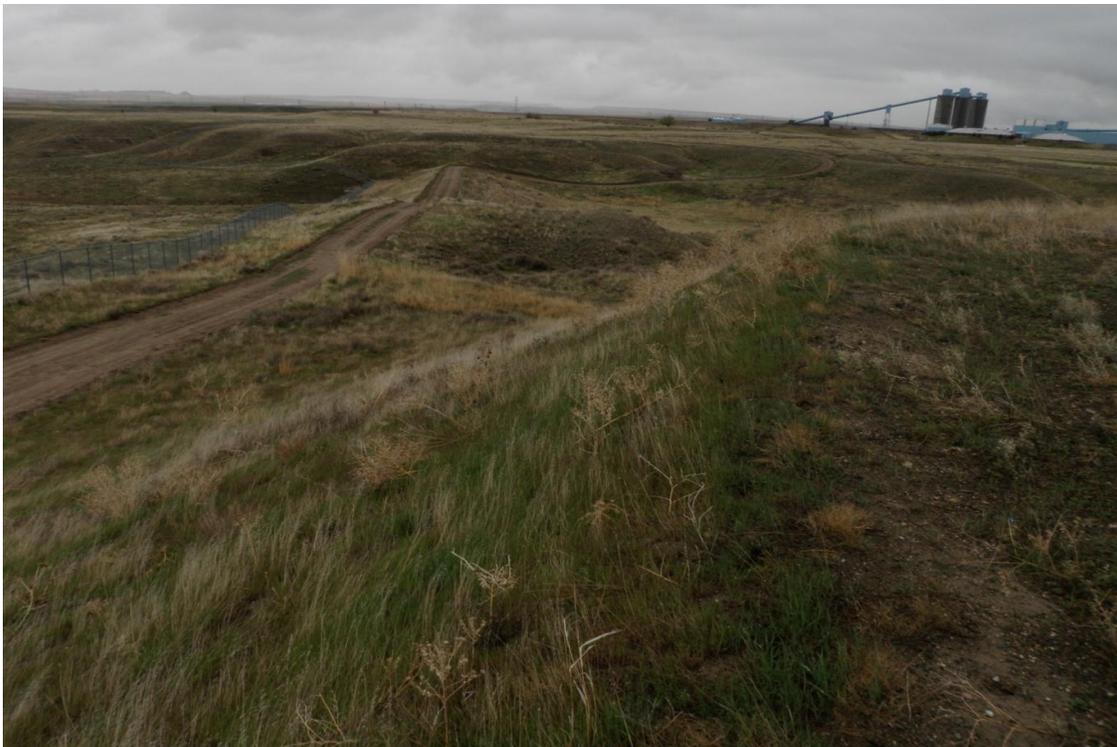
**Photo 44: East Emergency Holding Pond Southeast Corner Downstream Slope, Looking South at Stormwater Detention Basin Dam.**

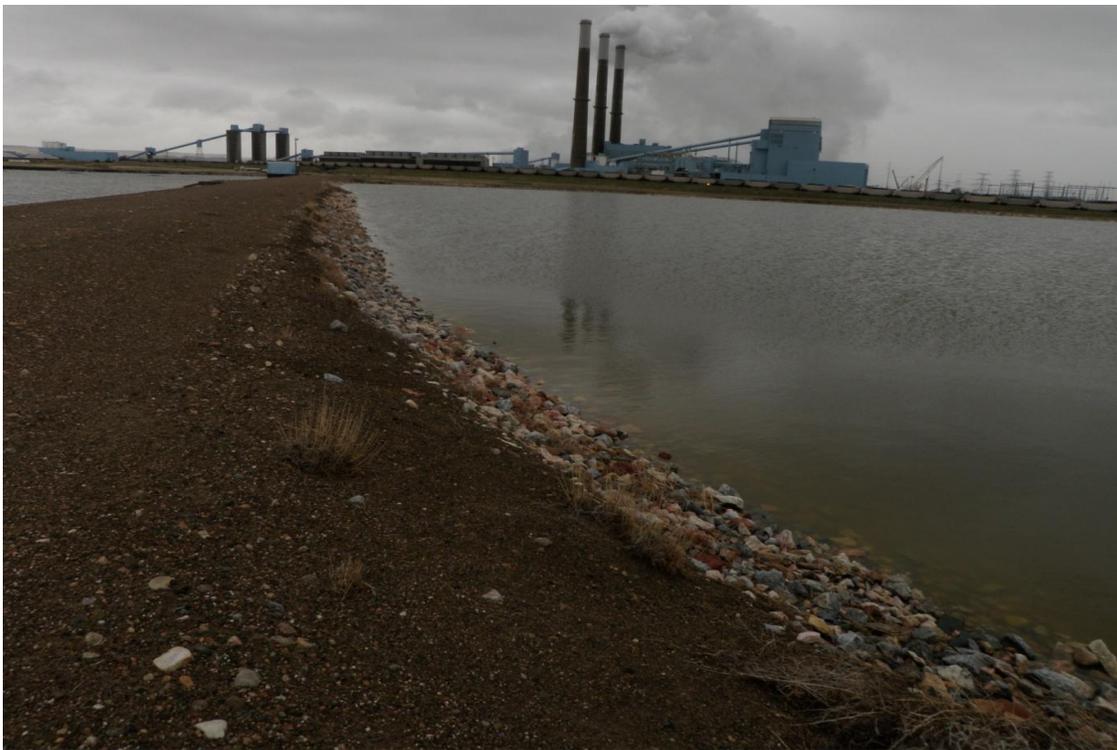
**Photo 50: East/West Emergency Holding Pond Divider Dike. West Emergency Holding Pond Upstream Slope, Looking South.**
