## Specific Site Assessment for Coal Combustion Waste Impoundments at Basin Electric Laramie River Station Wheatland, Wyoming

August 2012  
Project 092886

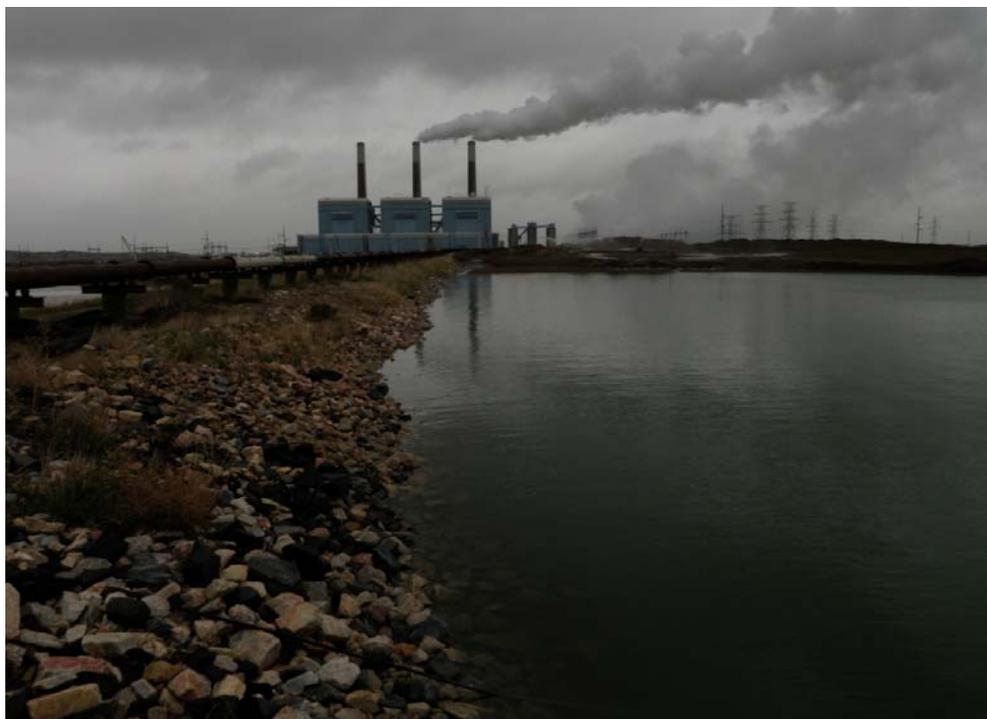
Photo 2-3: Bottom Ash Pond 3 North Dike Upstream Slope, Looking East

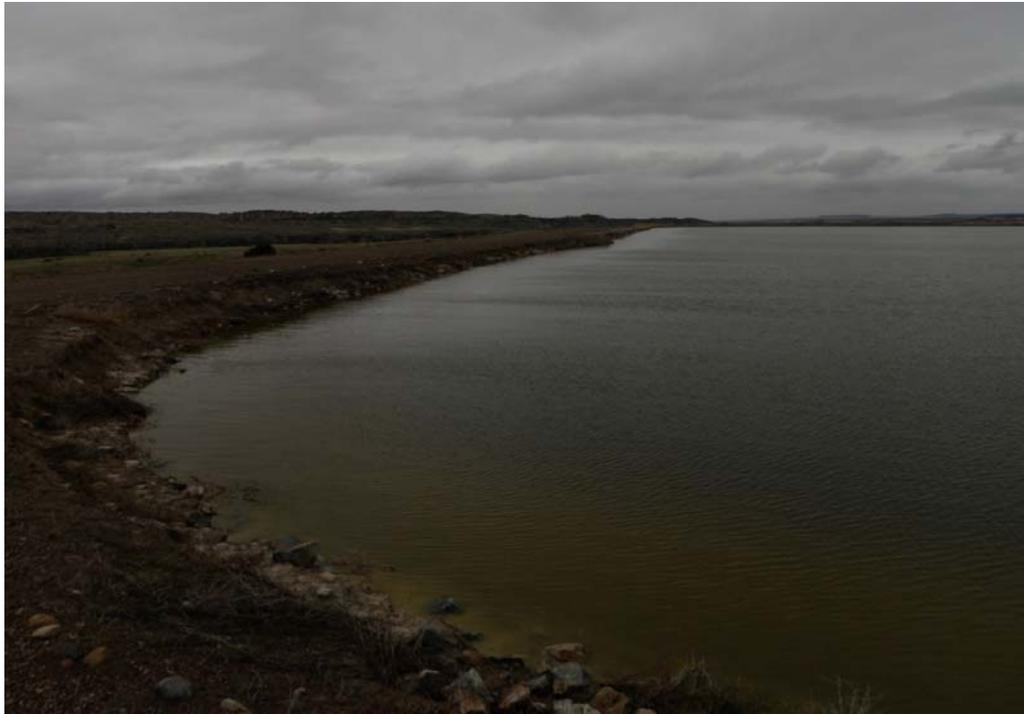
**Photo 2-5: West Emergency Holding Pond North Dike Upstream Slope, Looking Northeast**

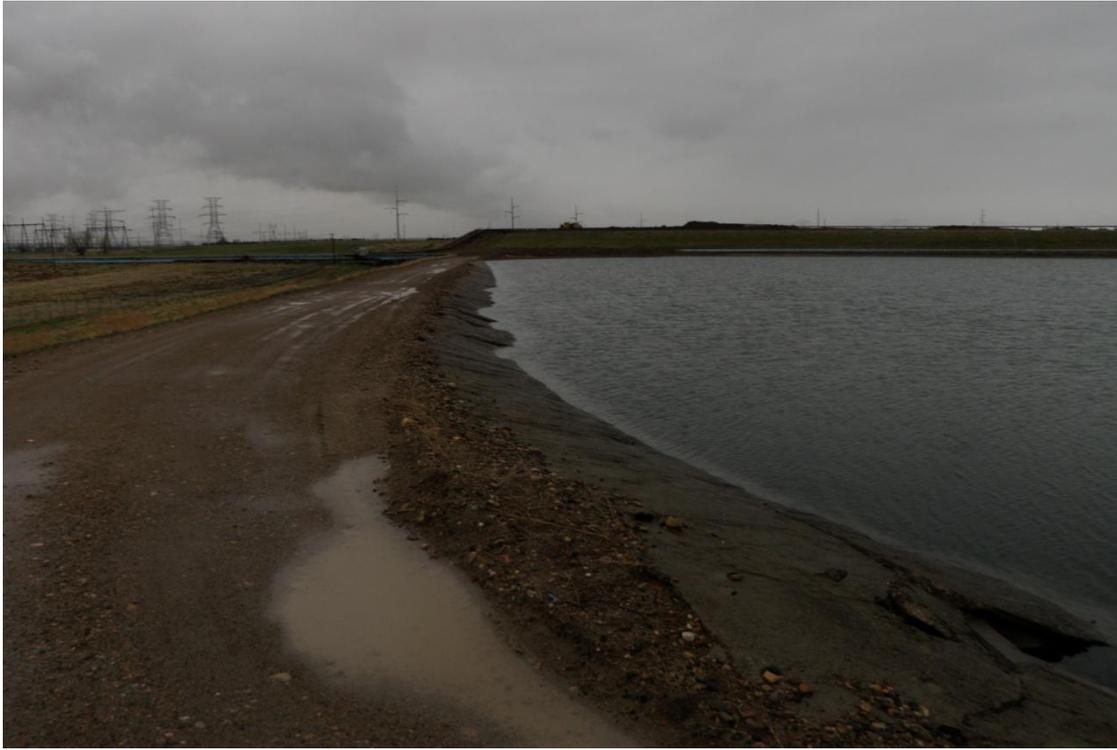
**Photo 1: Bottom Ash Pond 1 East Dike Upstream Slope, Looking South.**

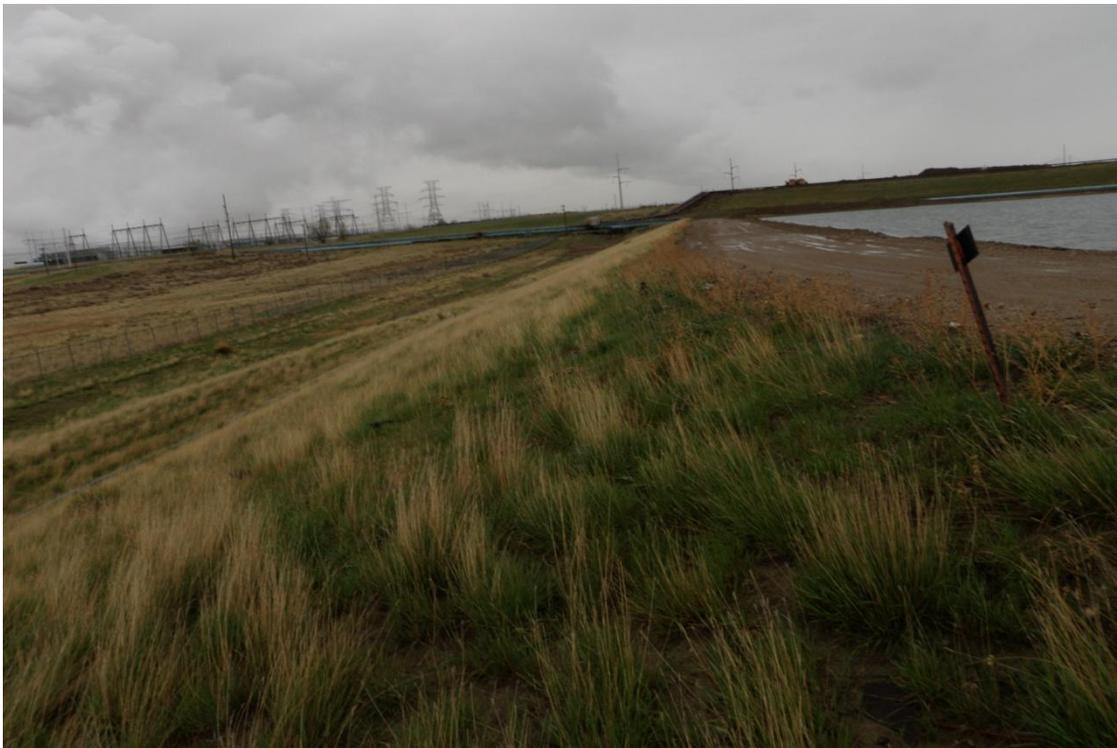
**Photo 2: Bottom Ash Pond 1 East Dike Downstream Slope, Looking South.**

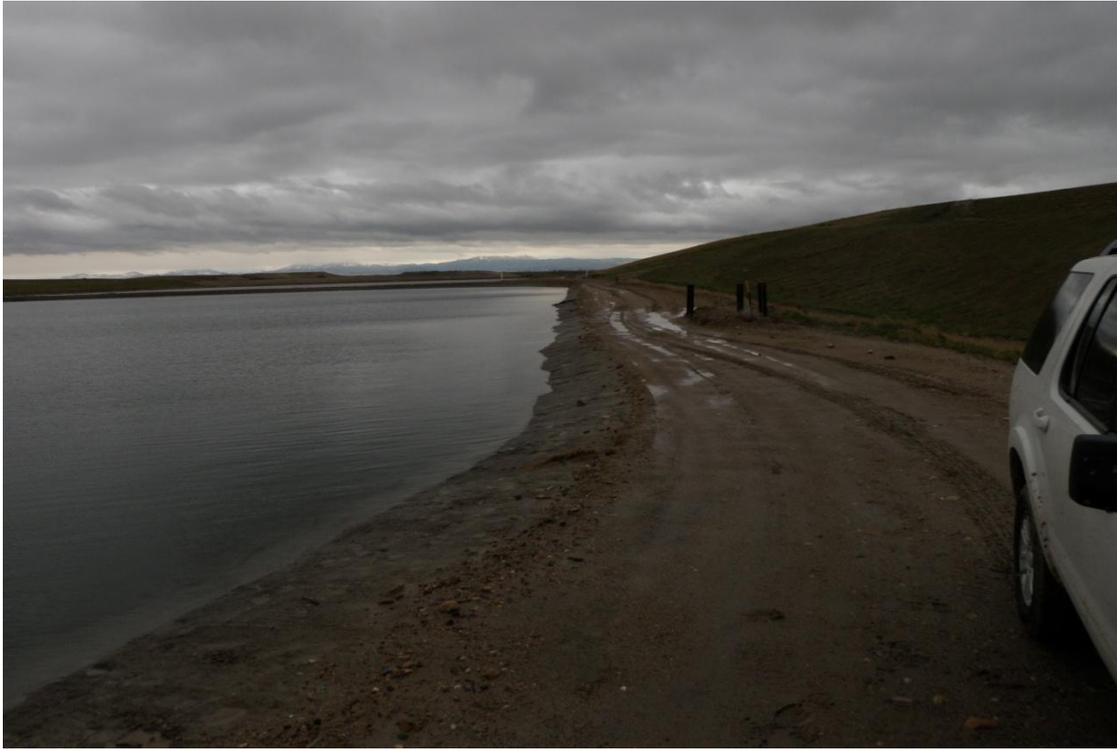
**Photo 5: Bottom Ash Pond 1 North Dike Upstream Slope, Looking West.**

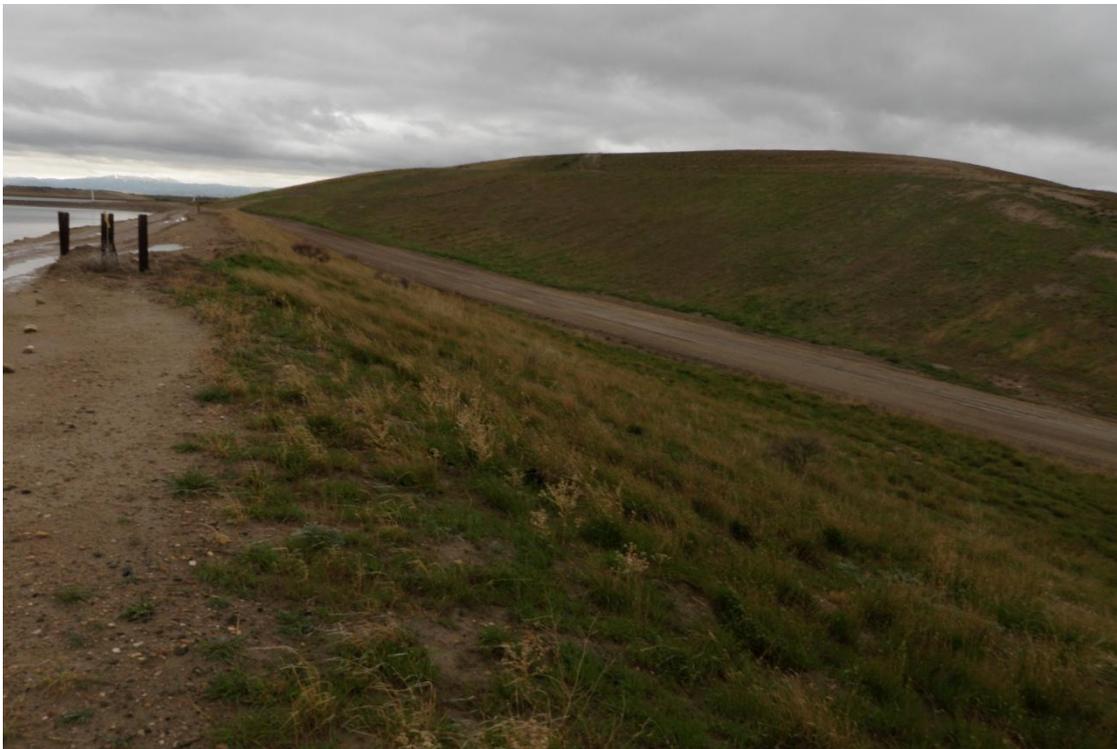
**Photo 6: Bottom Ash Pond 1 North Dike Downstream Slope, Looking West.**

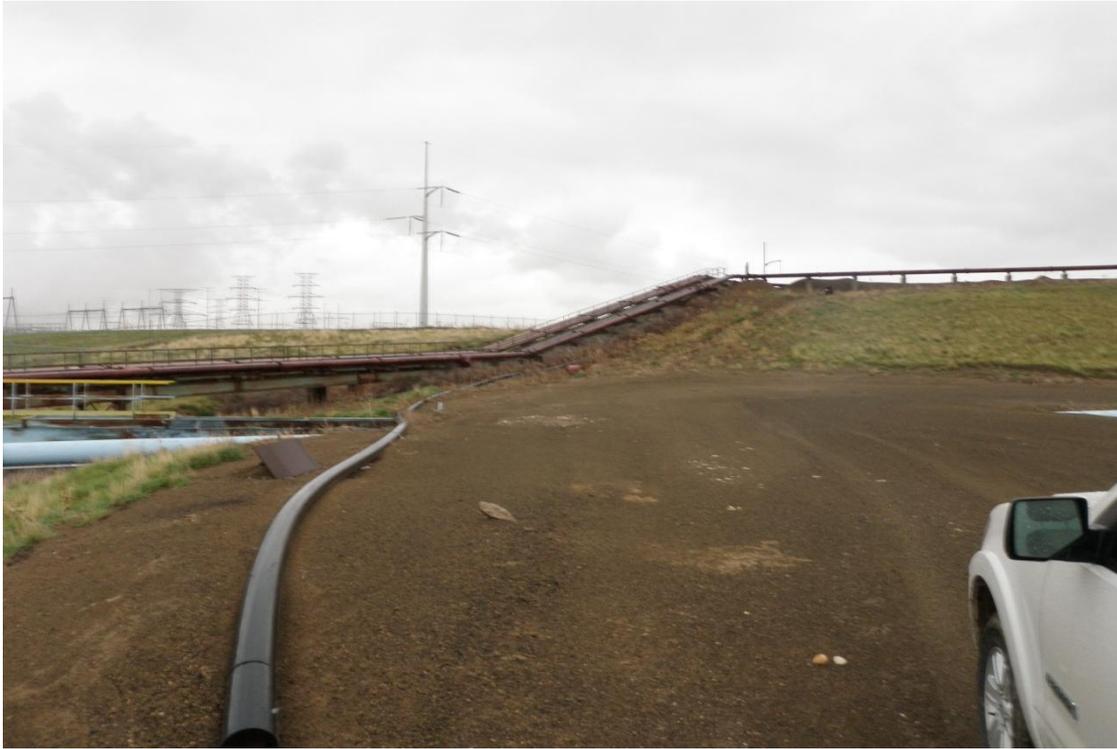
**Photo 9: Looking Southeast from Bottom Ash Pond 1 Southeast Corner at Bottom Ash Pond 3 Northeast Corner Downstream Slope.**

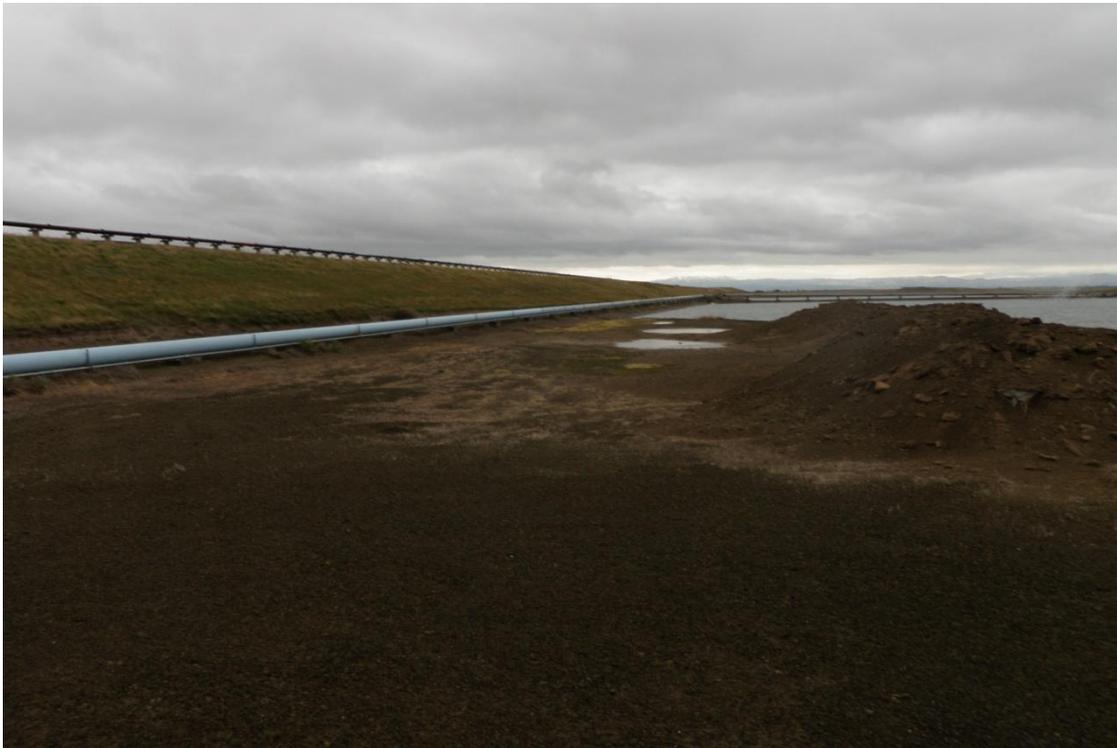
**Photo 10: Bottom Ash Pond 1 South Dike/Bottom Ash Pond 3 North Dike Downstream Slope, Looking West.**

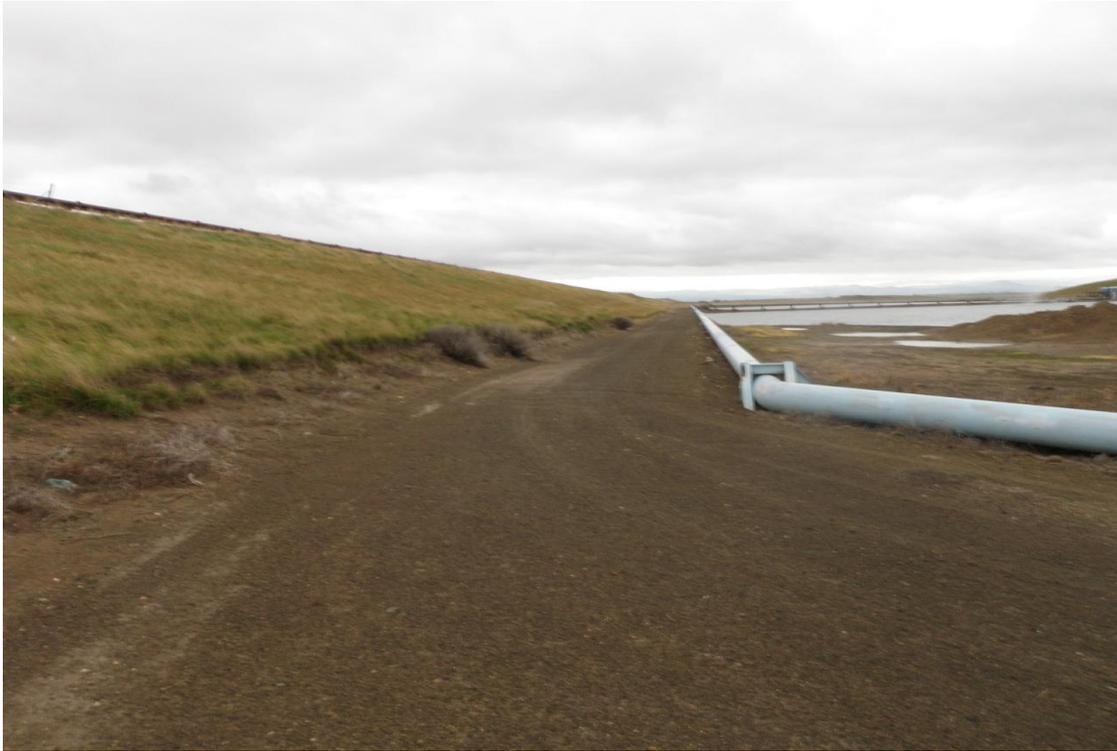
**Photo 11: Bottom Ash Pond 1 South Dike Crest/Bottom Ash Pond 3 North Dike Downstream Toe, Looking West.**

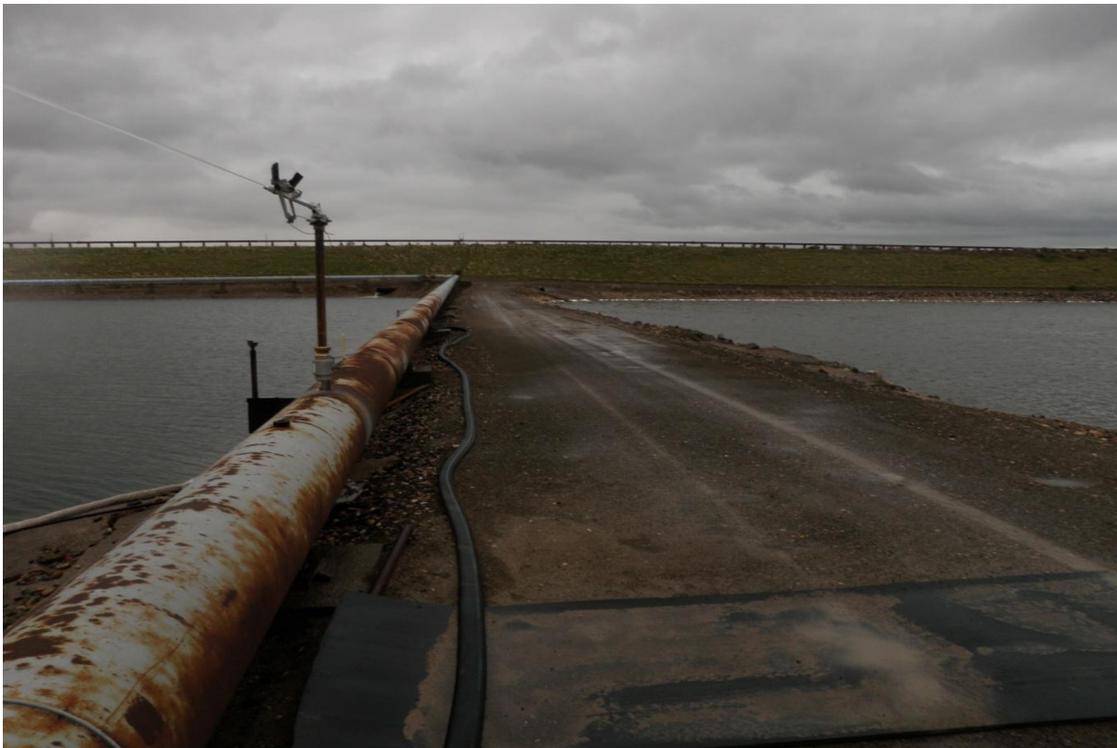
**Photo 12: Bottom Ash Pond 1/Bottom Ash Pond 2 Divider Dike, Looking South at Bottom Ash Pond 3 North Dike Downstream Slope.**

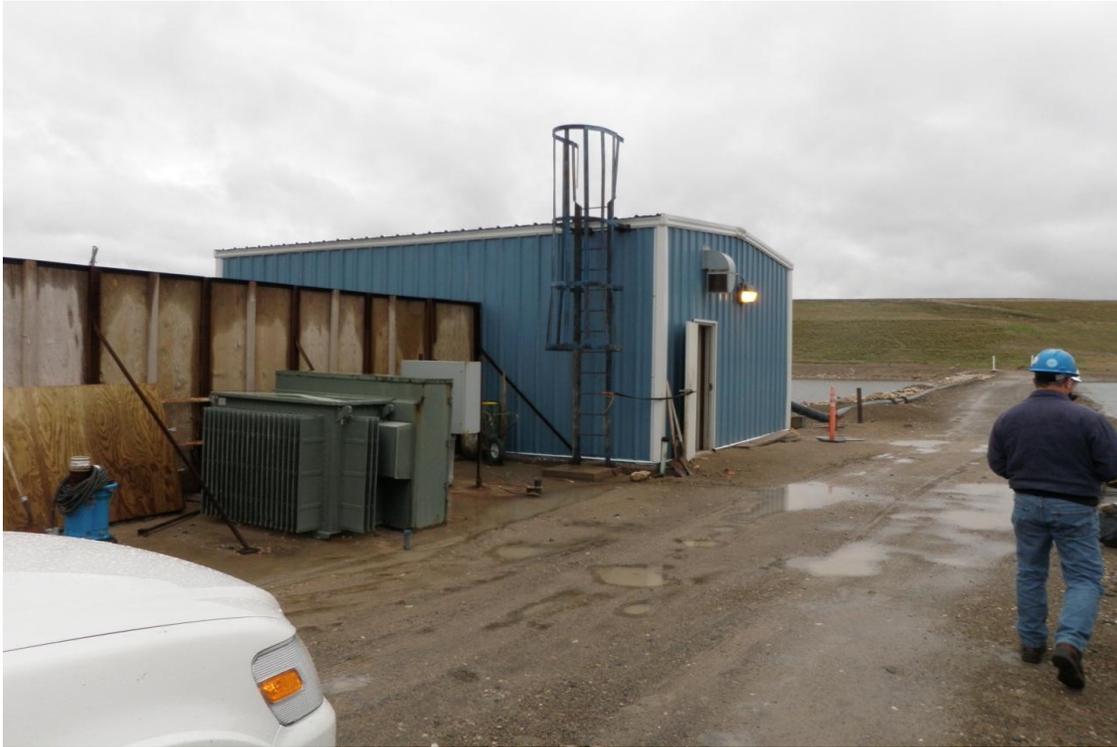
**Photo 13: Bottom Ash Pond 2 Pumphouse located on Bottom Ash Pond 1/Bottom Ash Pond 2 Divider Dike.**

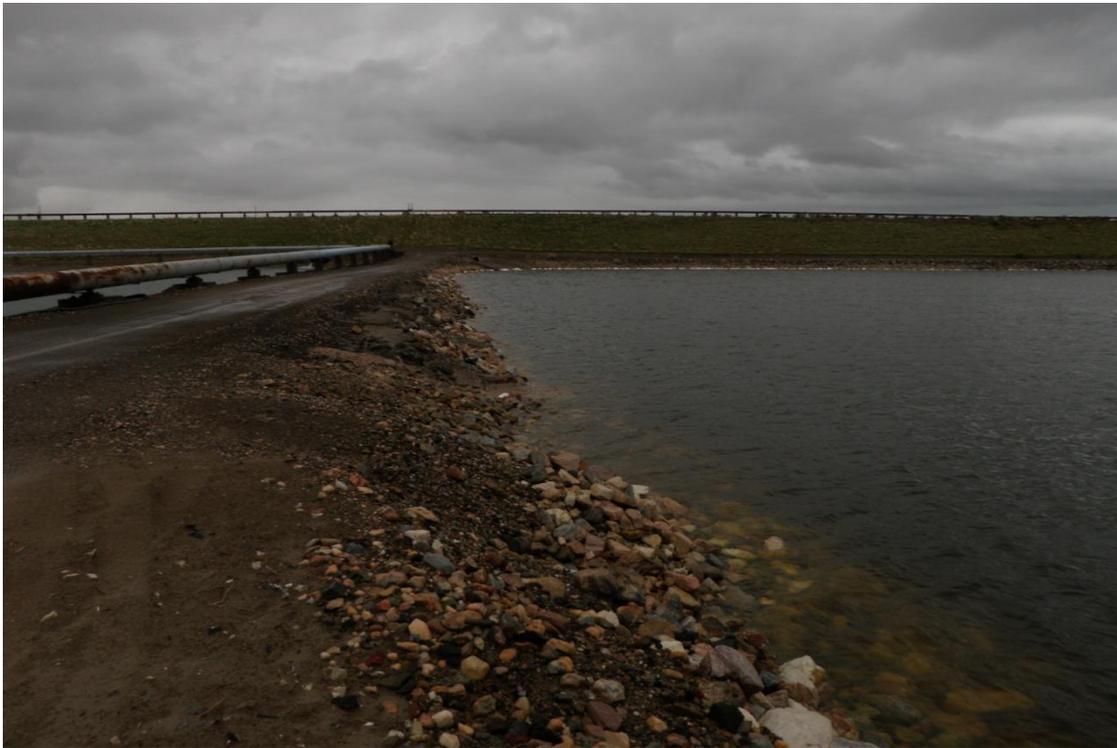
**Photo 14: Bottom Ash Pond 1/Bottom Ash Pond 2 Divider Dike. Bottom Ash Pond 2 Upstream Slope. Photo looking north.**

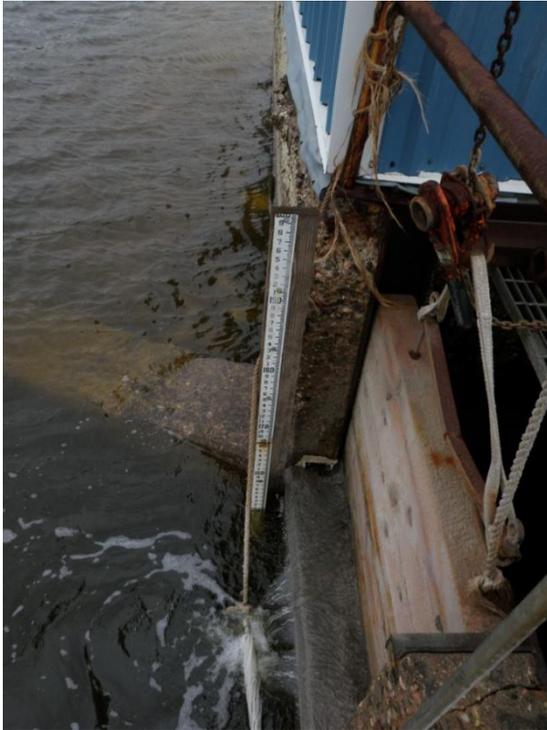
Photo 15: Bottom Ash Pond 2 Overflow Weir Staff Gauge.

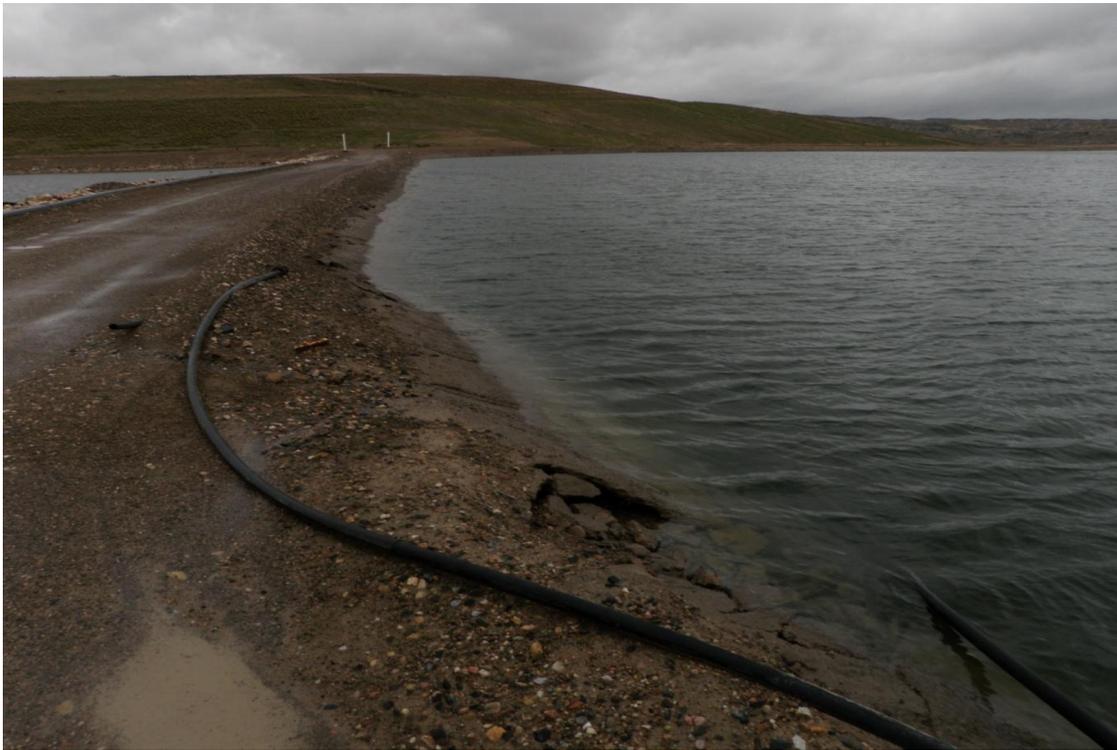
Photo 16: Bottom Ash Pond 1/Bottom Ash Pond 2. Bottom Ash Pond 1 Upstream Slope, Looking North.

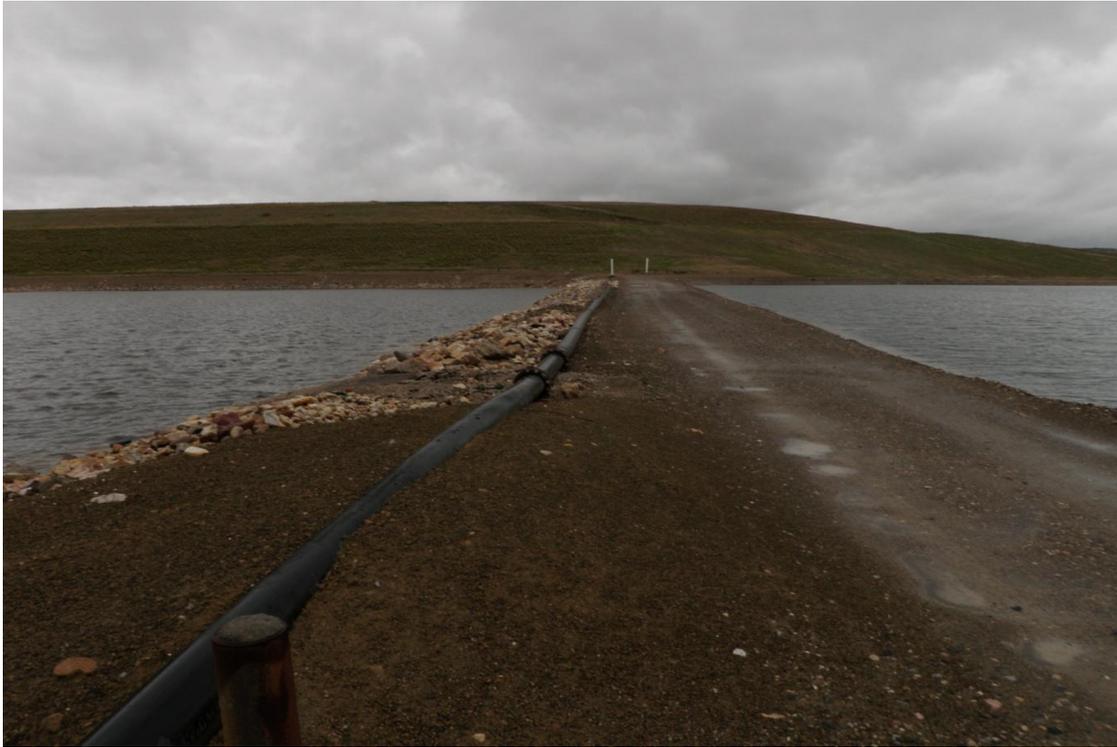
**Photo 17: Bottom Ash Pond 1/Bottom Ash Pond 2. Bottom Ash Pond 2 Upstream Slope, Looking North.**

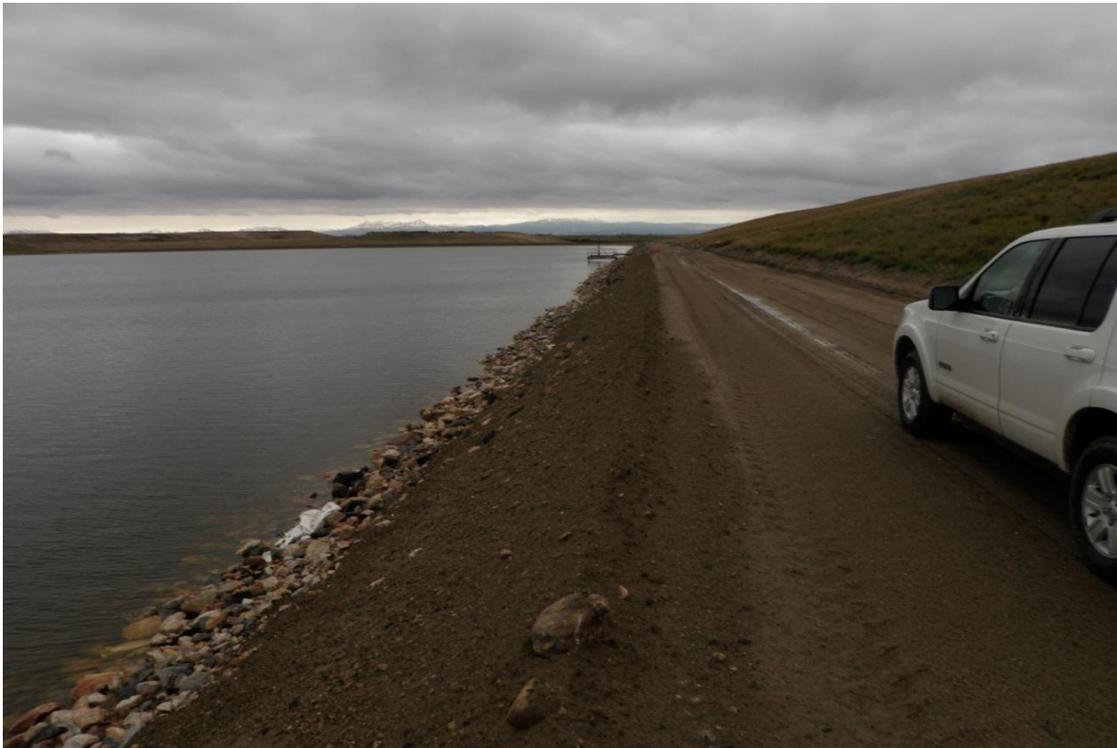
**Photo 18: Bottom Ash Pond 2 North Dike Upstream Slope, Looking West.**

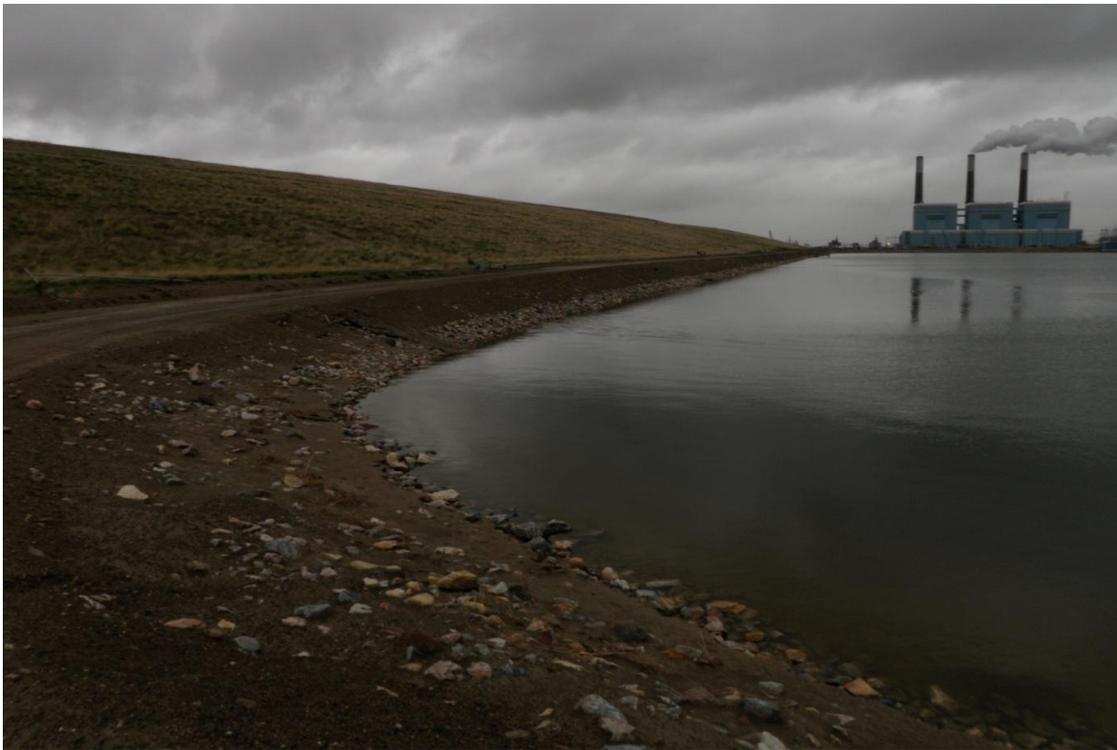
**Photo 20: Bottom Ash Pond 2 North Dike Upstream Slope, Looking Northeast.**

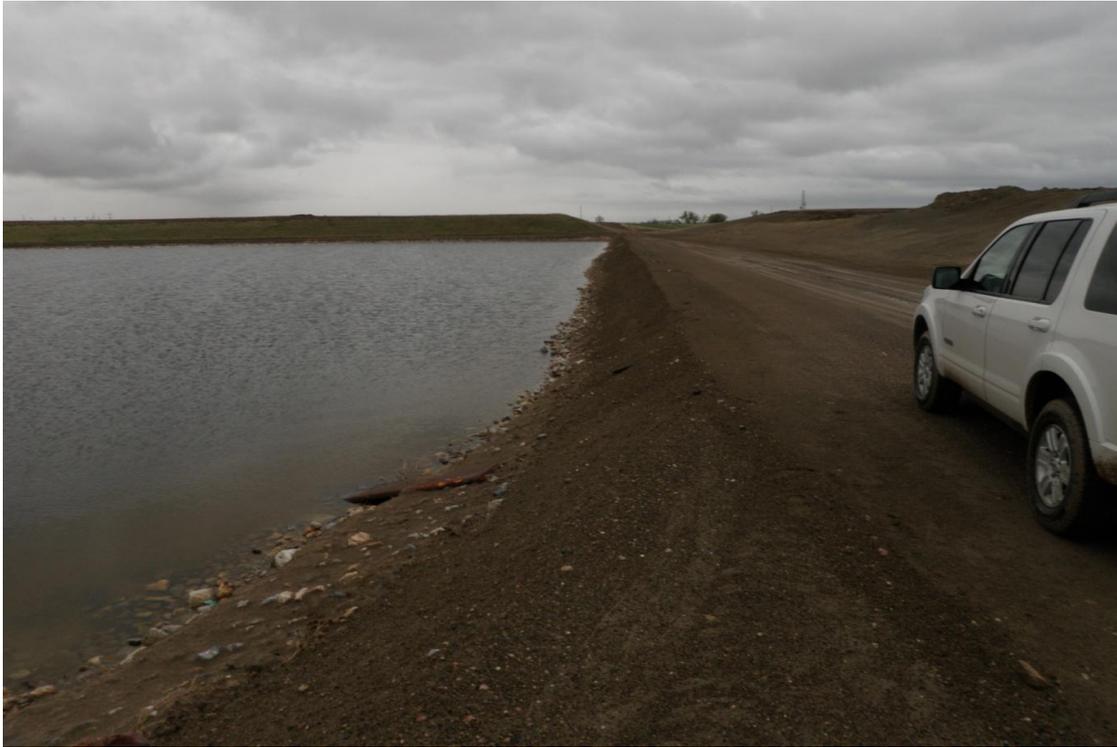
**Photo 21: Bottom Ash Pond 2 West Dike Upstream Slope, Looking South.**

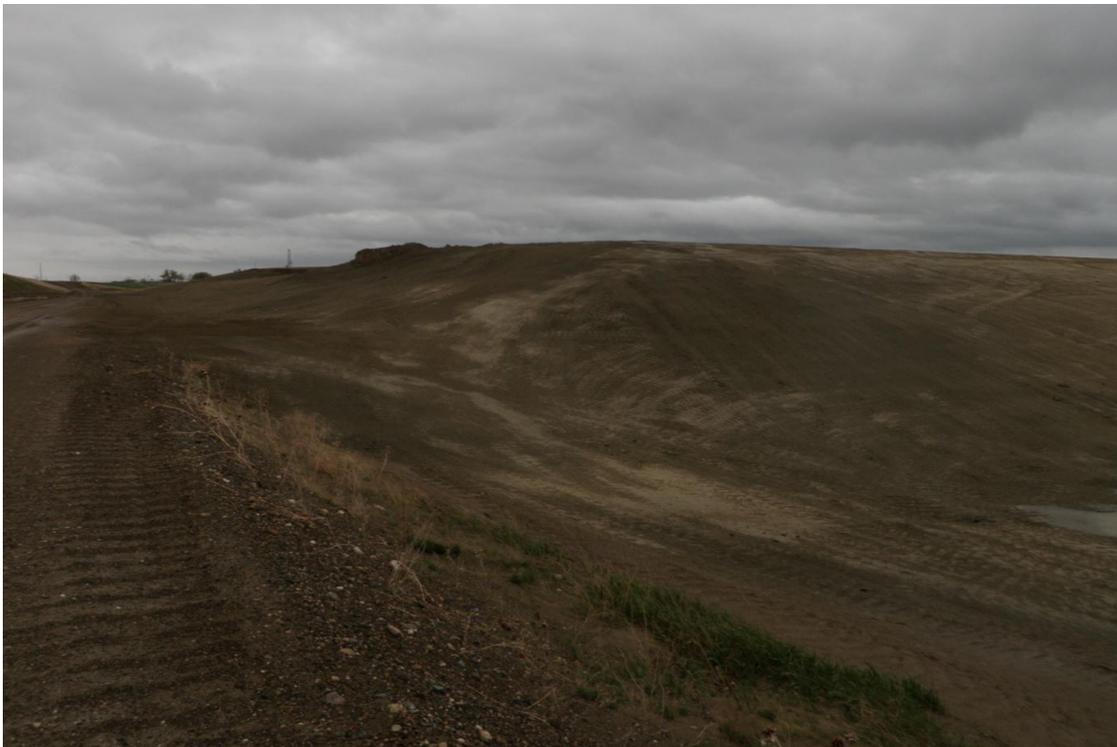
**Photo 22: Bottom Ash Pond 2 West Dike Downstream Slope/Landfill, Looking South.**

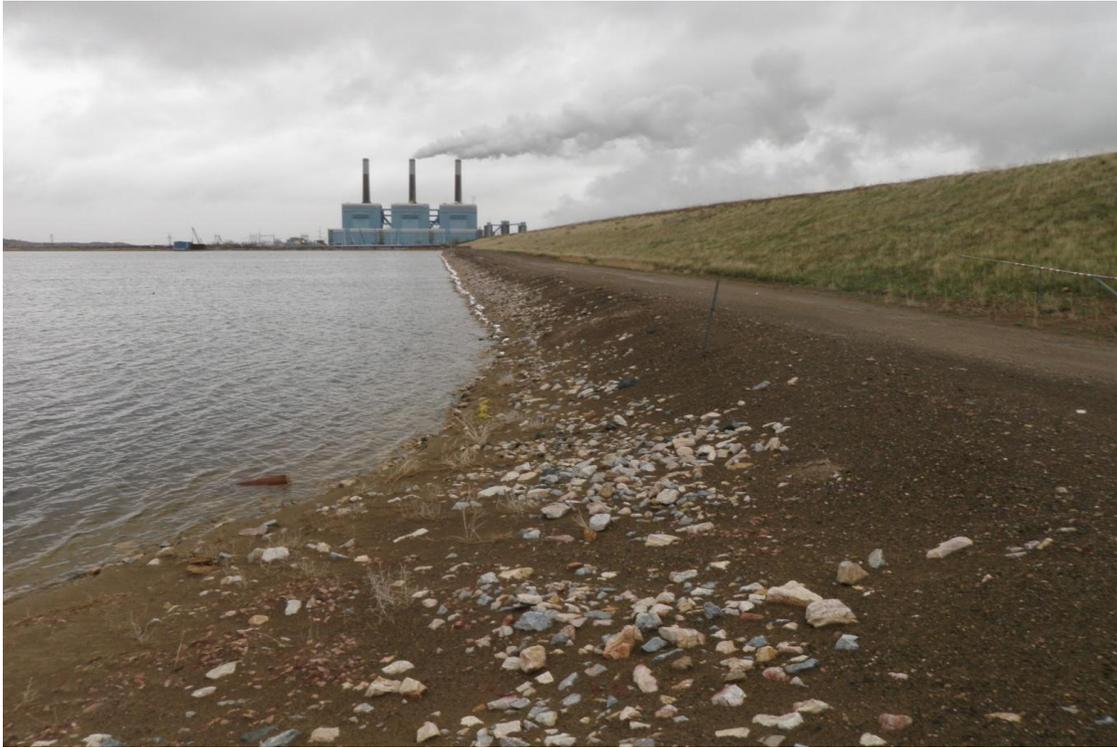
**Photo 23: Bottom Ash Pond 2 South Dike Upstream Slope, Looking East.**

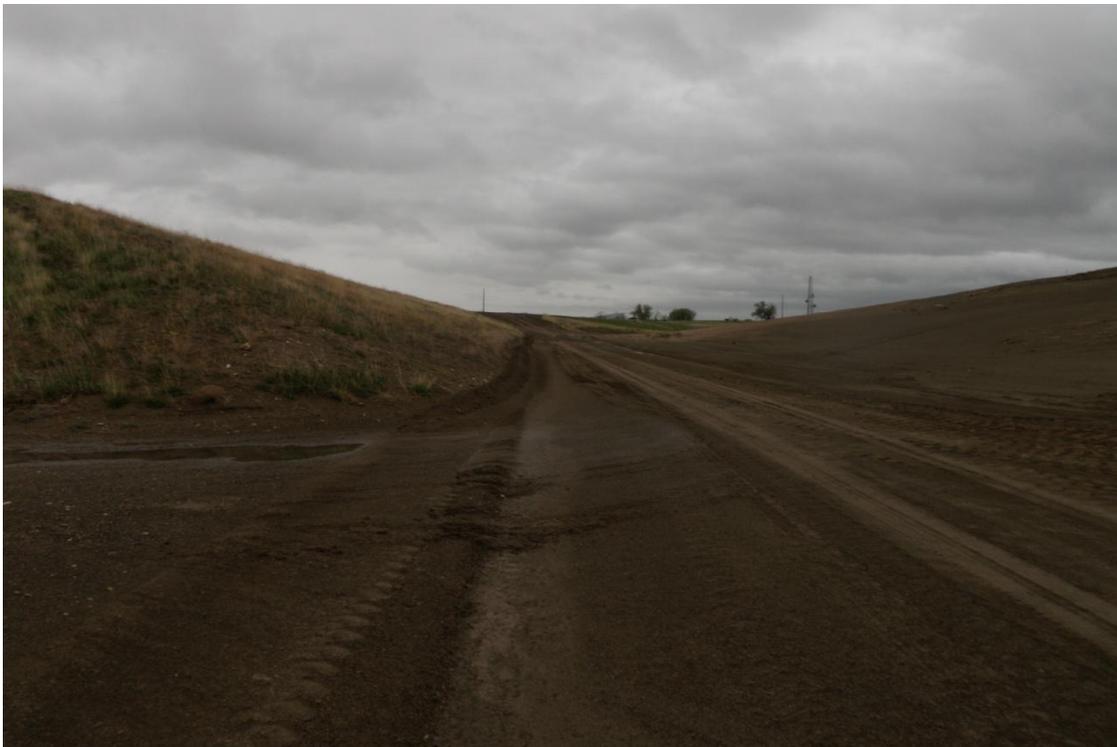
**Photo 24: Bottom Ash Pond 3 West Dike Downstream Slope, Looking South.**

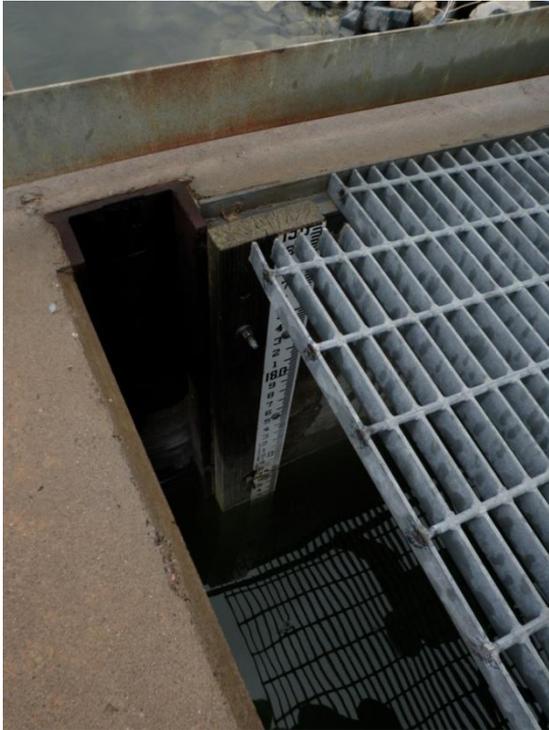
Photo 25: Bottom Ash Pond 3 Overflow Weir with Staff Gauge.

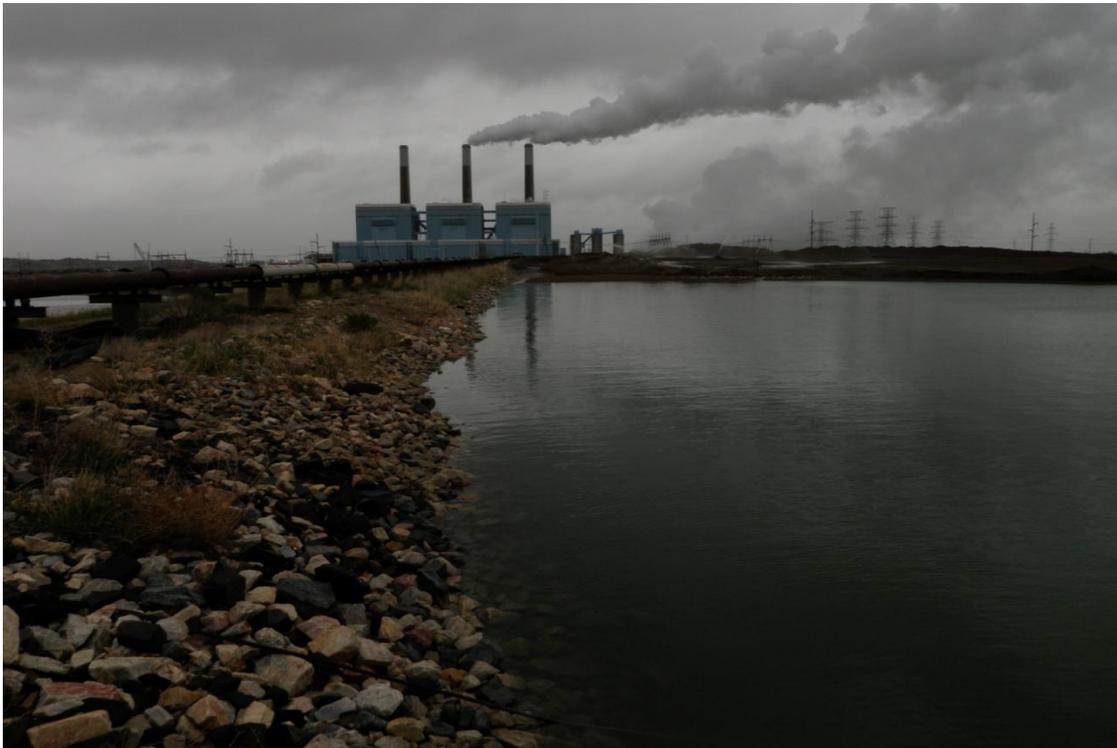
Photo 26: Bottom Ash Pond 3 North Dike Upstream Slope, Looking East.

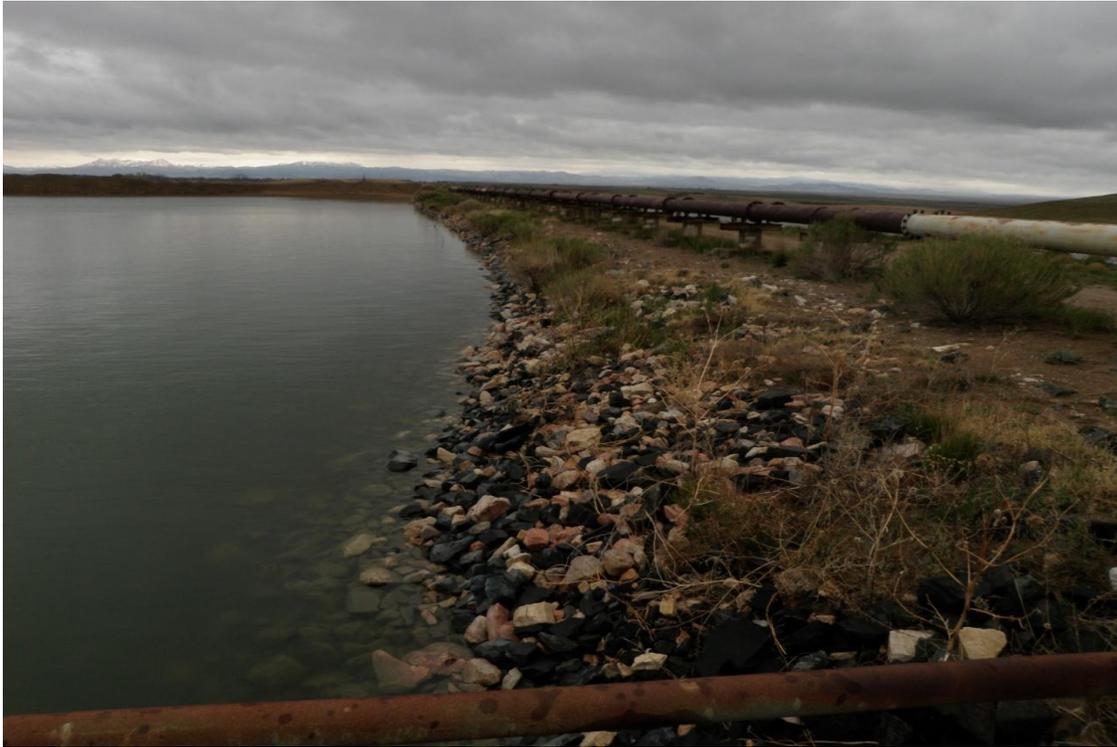
Photo 27: Bottom Ash Pond 3 North Dike Upstream Slope, Looking West.

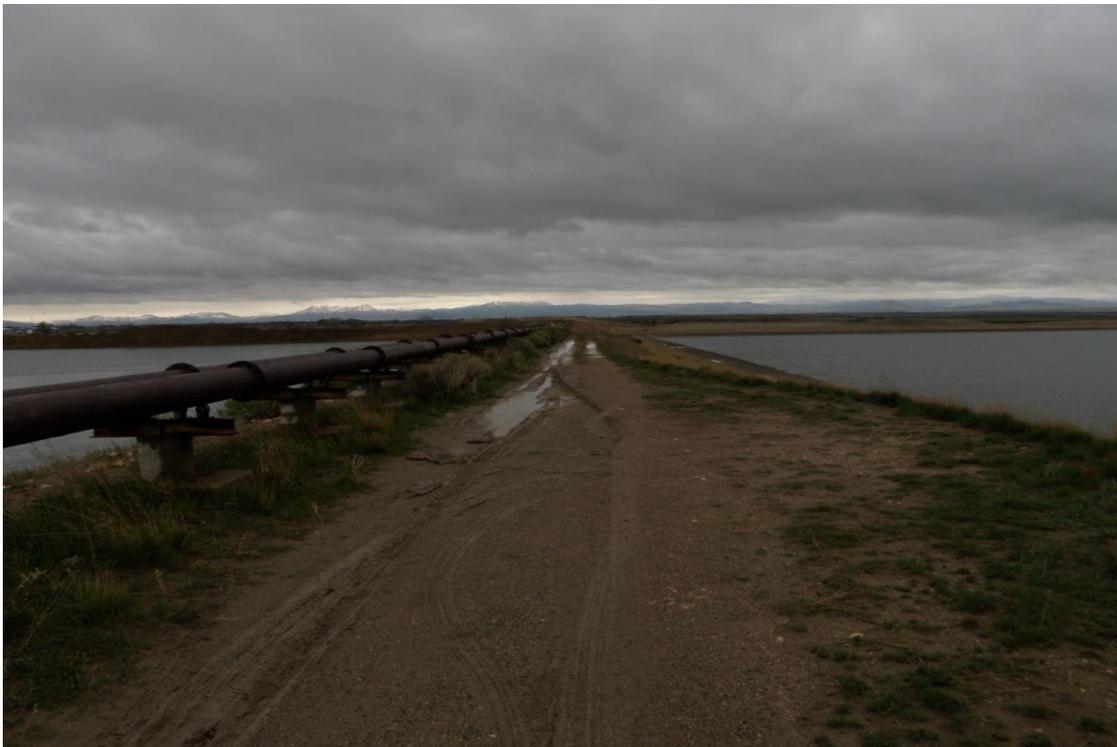
Photo 28: Bottom Ash Pond 3 North Dike Crest, Looking West.

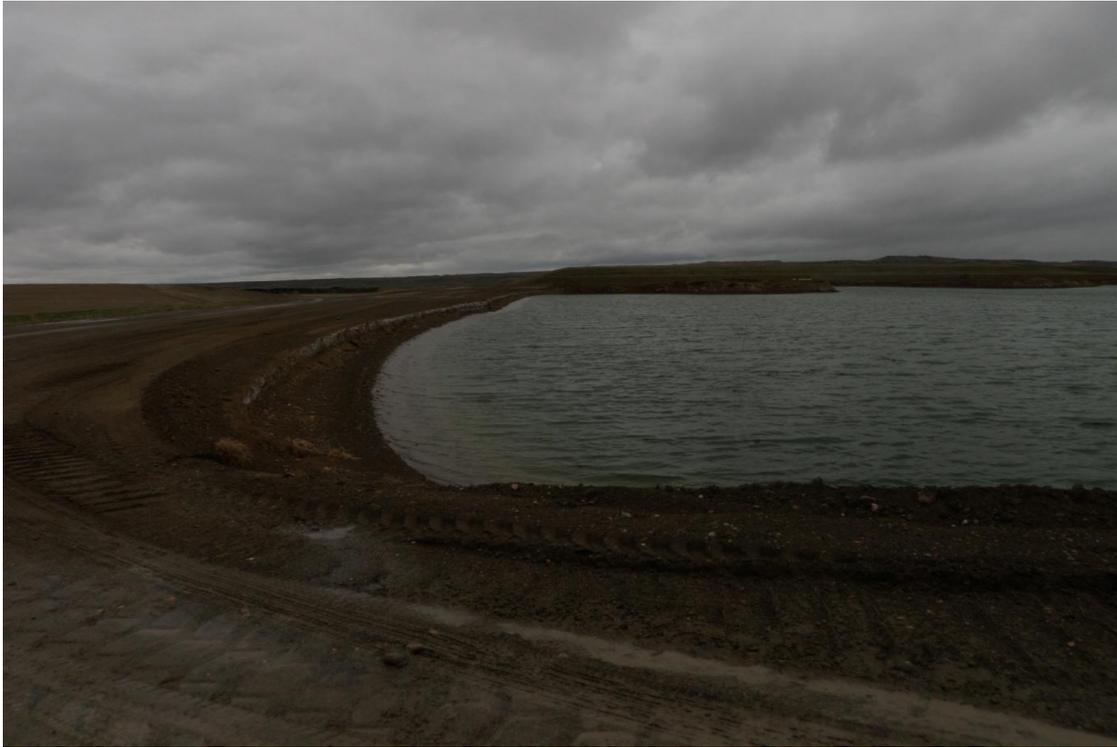
**Photo 29: Bottom Ash Pond 3 West Dike Upstream Slope, Looking North.**

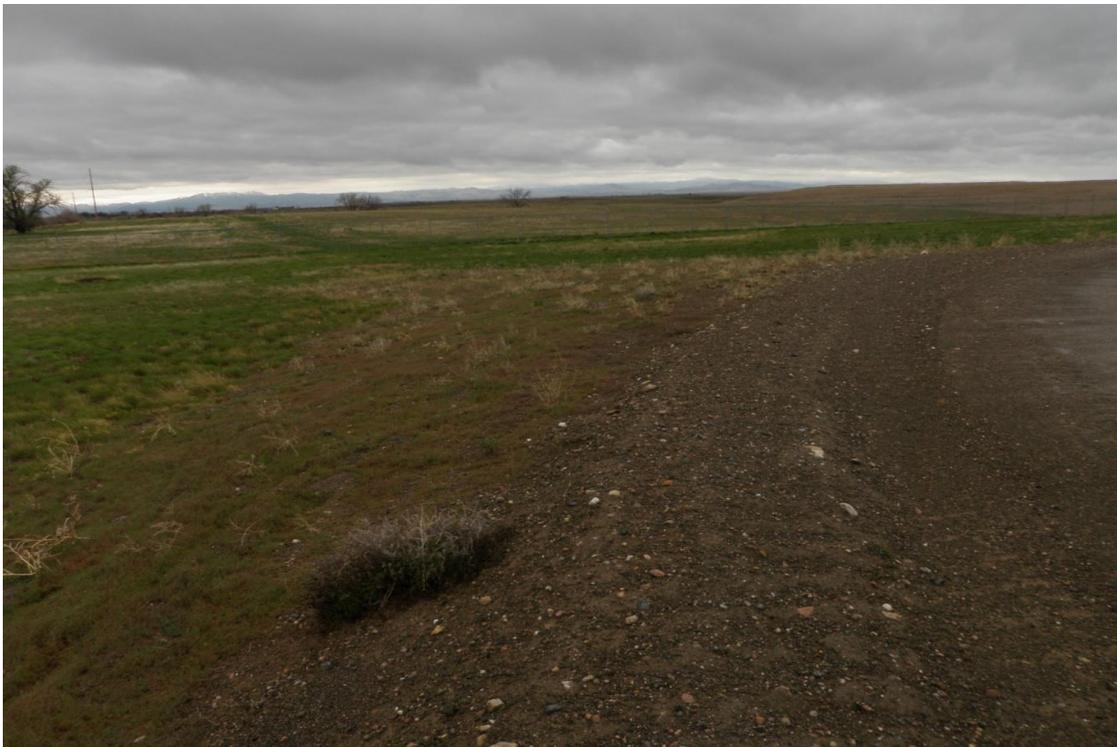
**Photo 30: Bottom Ash Pond 3 Southwest Corner Downstream Slope, Looking West.**

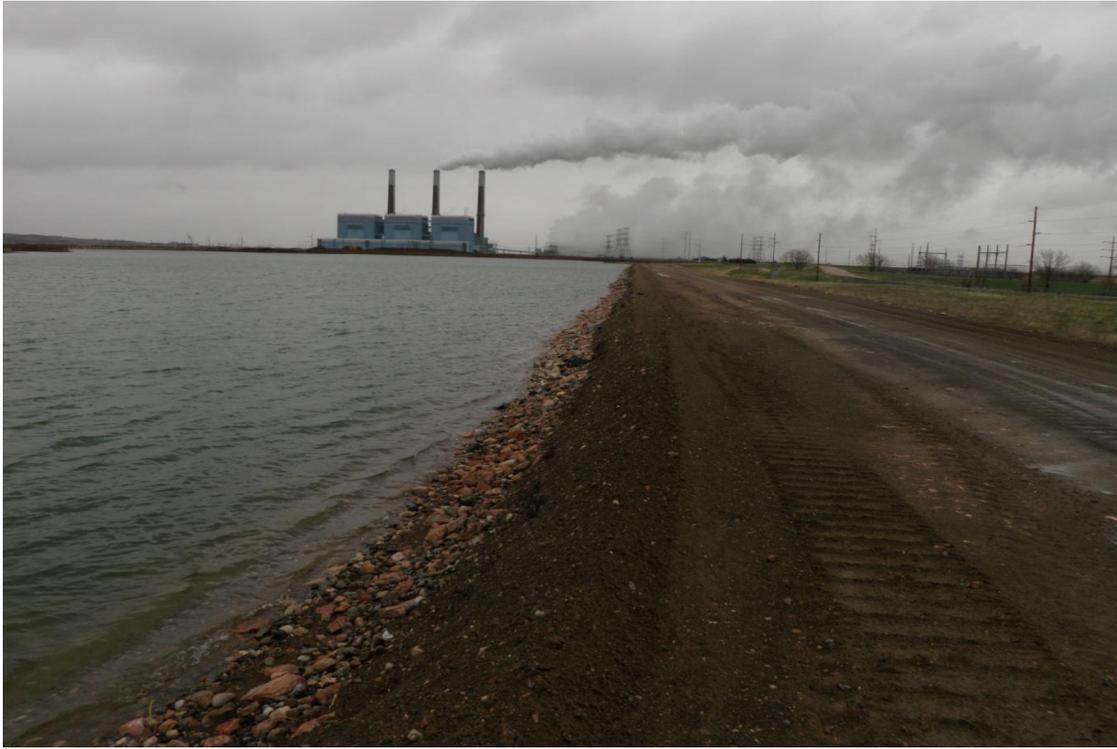
Photo 31: Bottom Ash Pond 3 South Dike Upstream Slope, Looking East.
