## Specific Site Assessment for Coal Combustion Waste Impoundments at Basin Electric Laramie River Station Wheatland, Wyoming

August 2012  
Project 092886

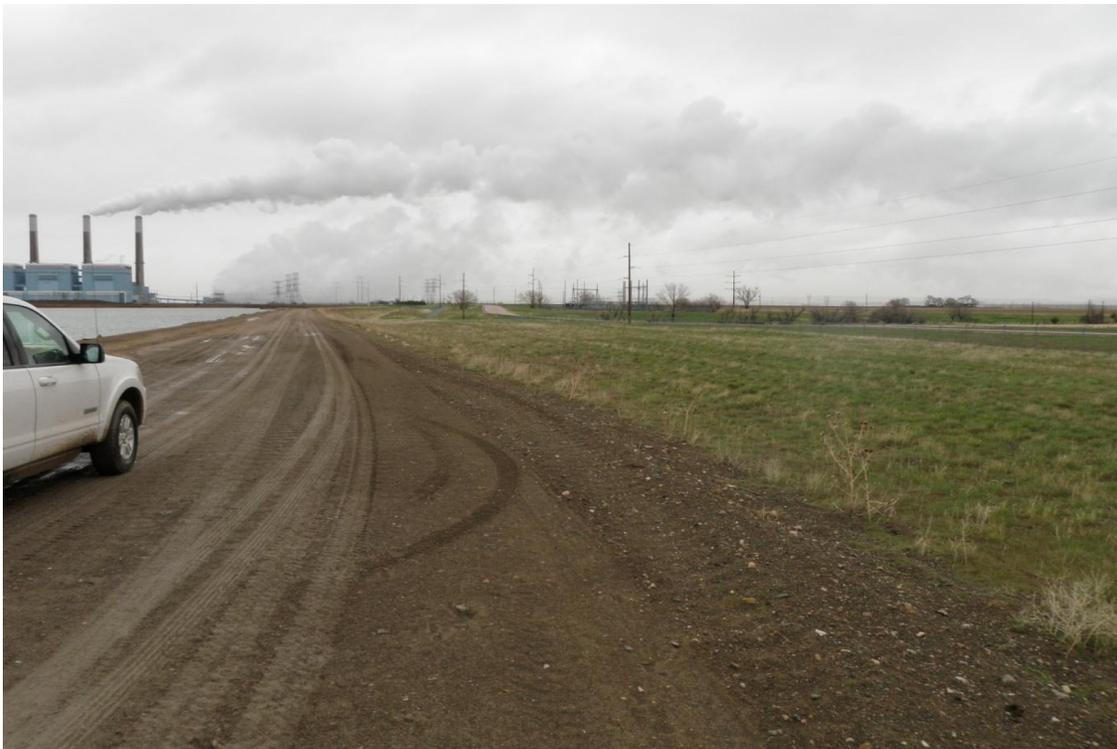
Photo 32: Bottom Ash Pond 3 South Dike Downstream Slope, Looking East.

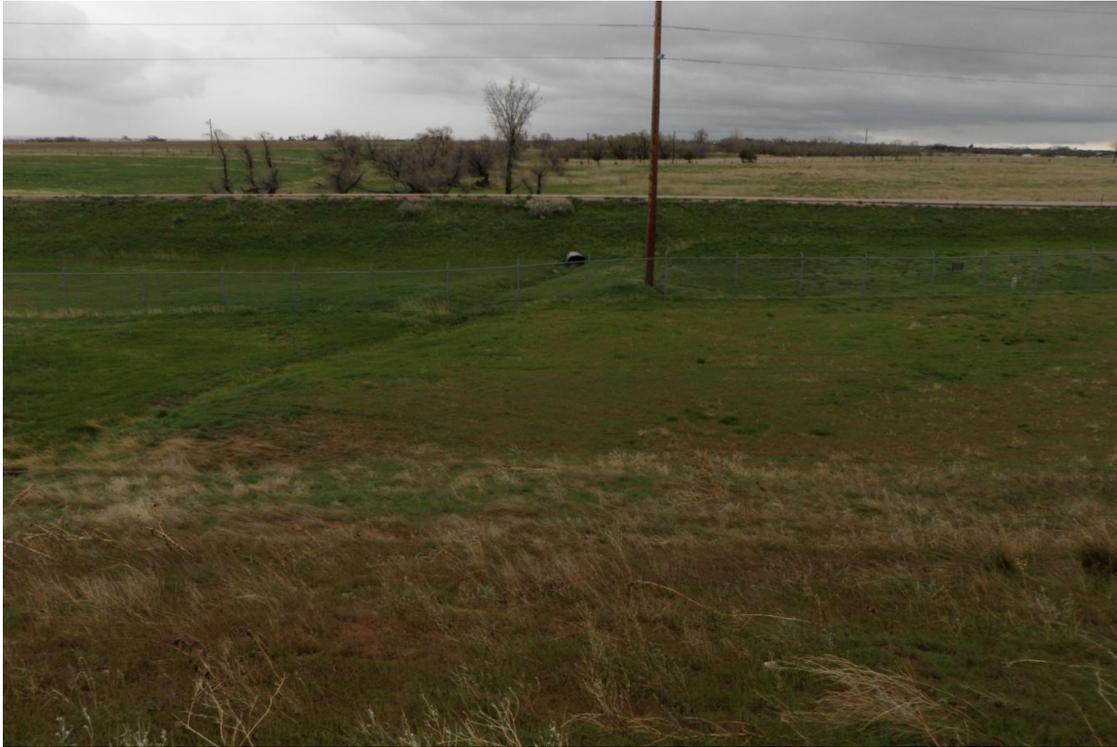
**Photo 33: Bottom Ash Pond 3 South Dike Culvert and Grayrocks Road, Looking South.**

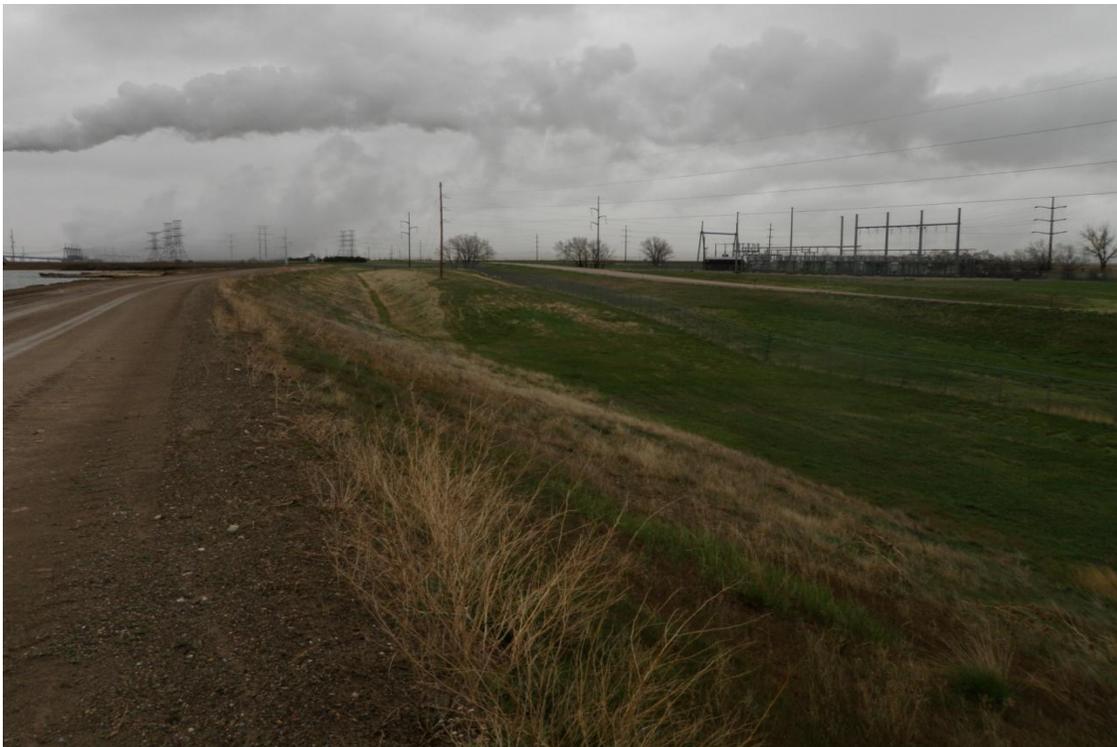
**Photo 34: Bottom Ash Pond 3 South Dike Downstream Slope, Looking East.**

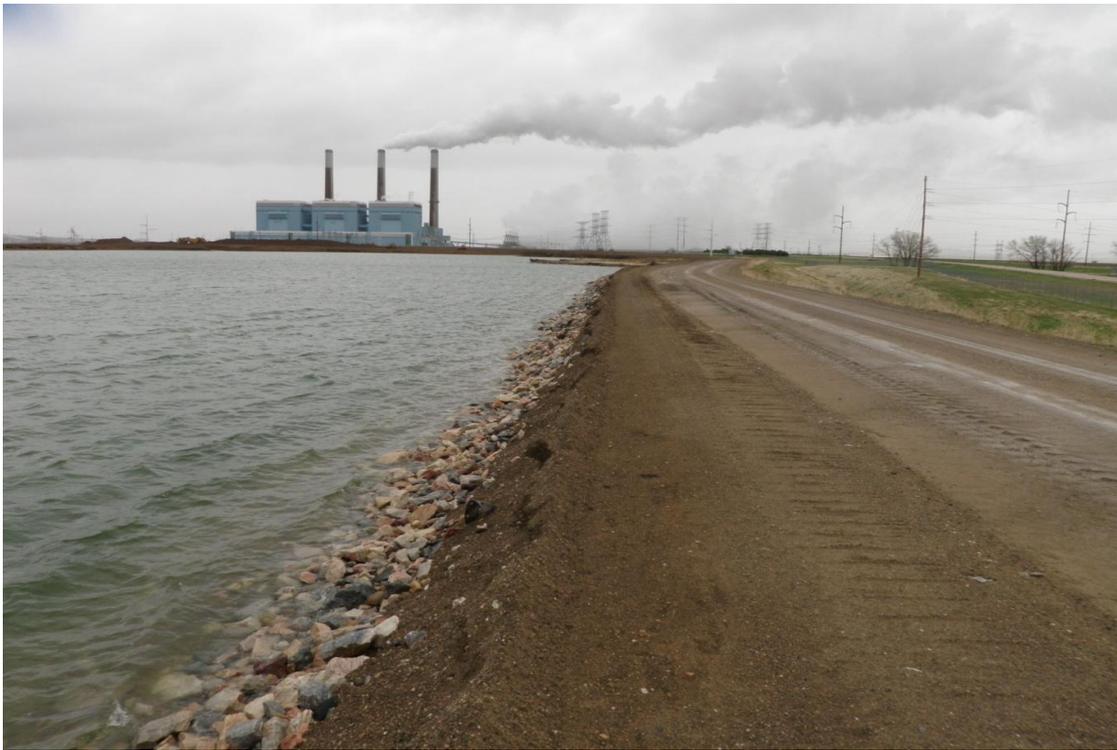
Photo 35: Bottom Ash Pond 3 South Dike Upstream Slope, Looking East.

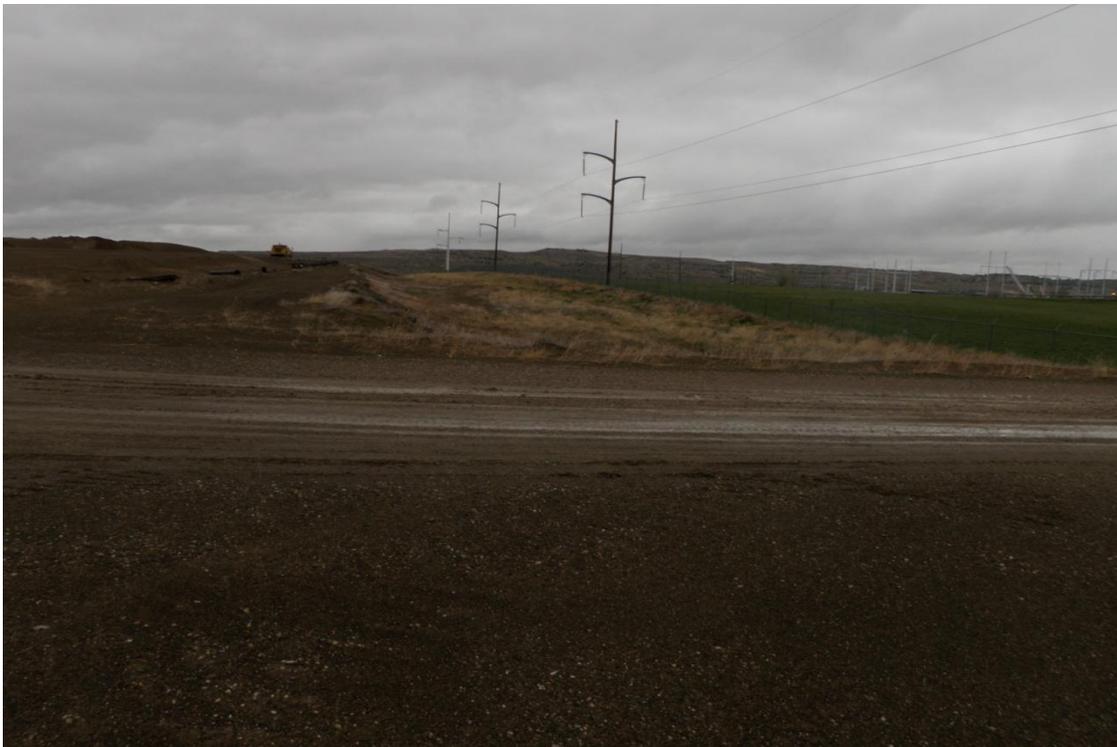
Photo 36: Bottom Ash Pond 3 East Dike Downstream Slope, Looking North

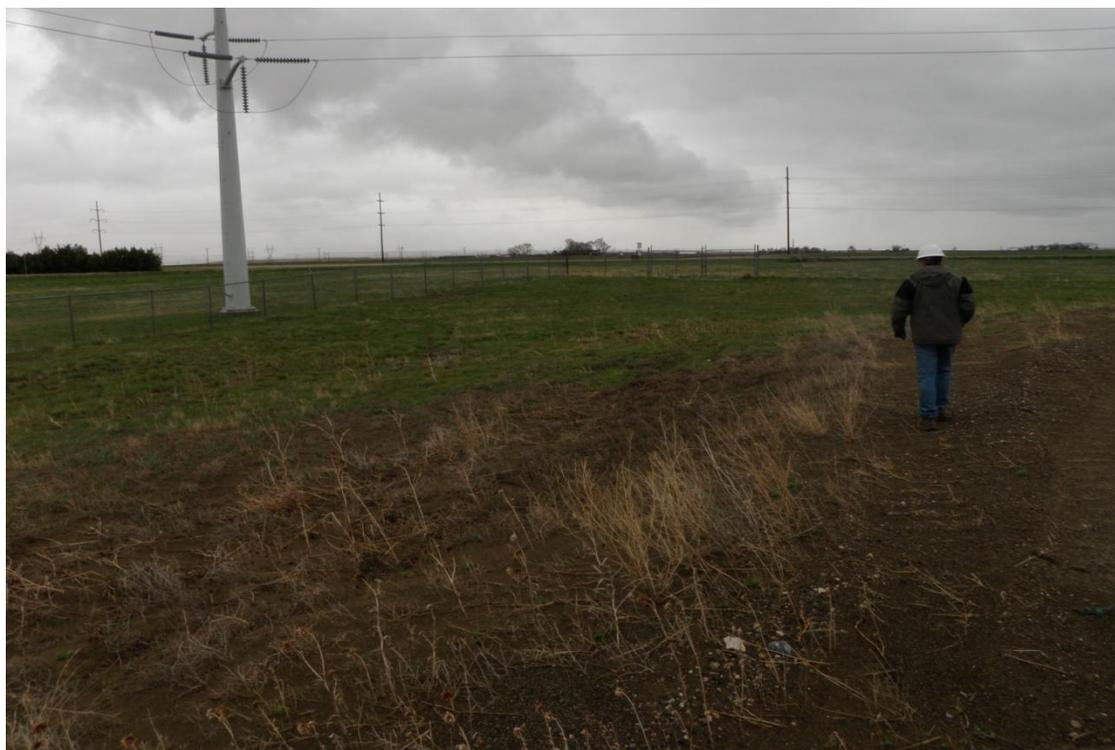
Photo 37: Bottom Ash Pond 3 Southeast Corner Downstream Slope, Looking Southeast.

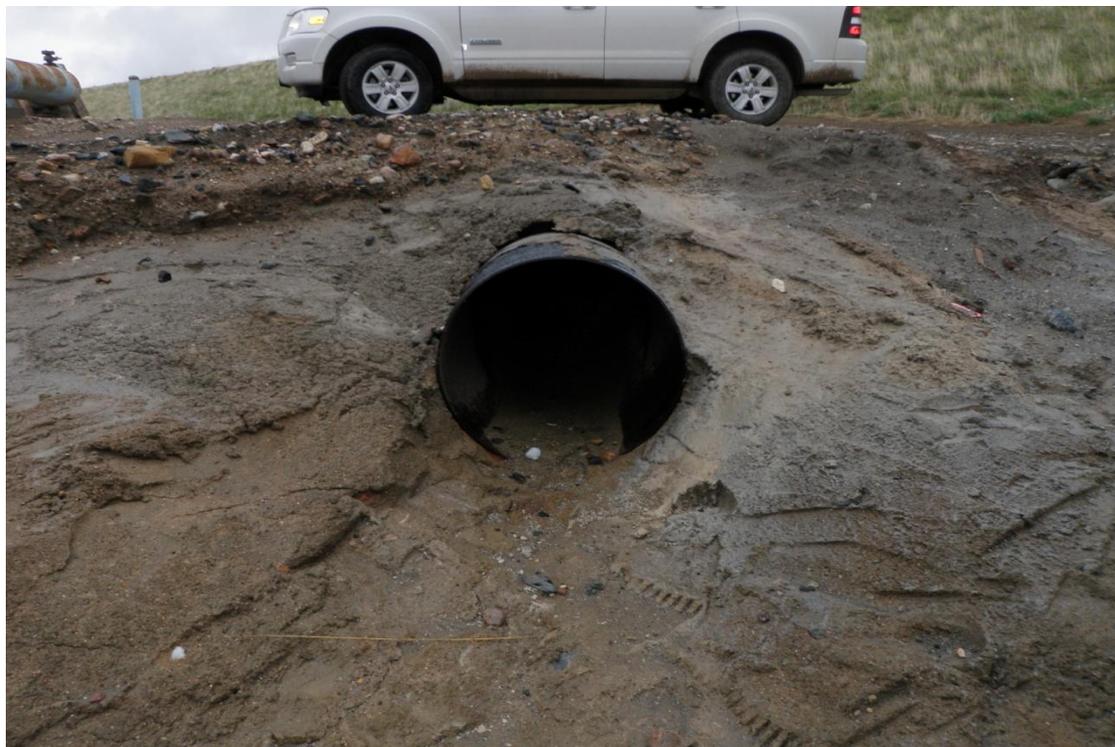
Photo 38: Bottom Ash Pond 2 30-inch-diameter Steel Inlet Pipe from Bottom Ash Pond 3.

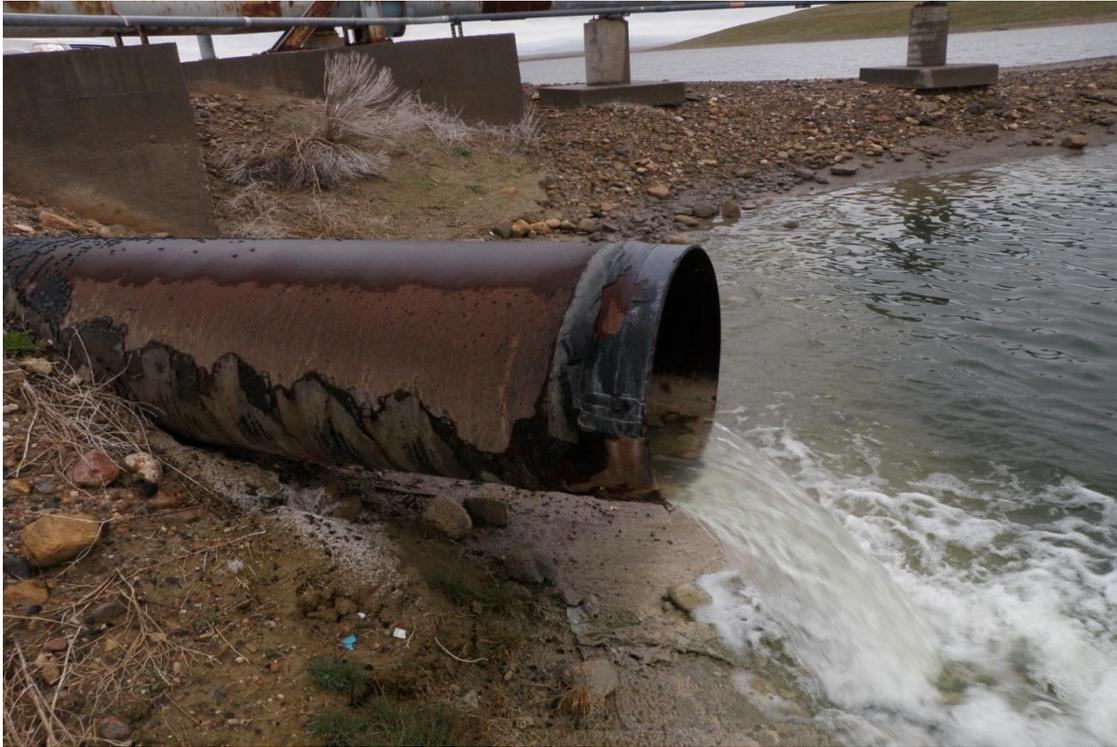
Photo 39: Bottom Ash Pond 1 30-inch-diameter Steel Inlet Pipe from Bottom Ash Pond 3.

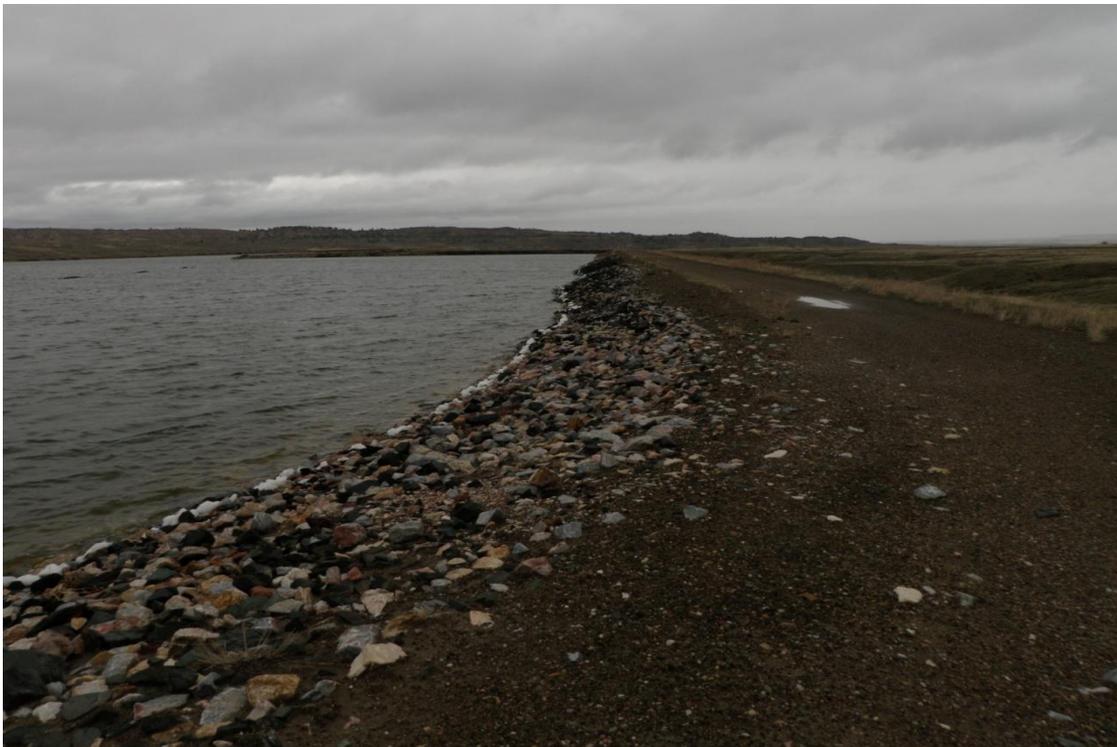
Photo 40: East Emergency Holding Pond South Dike Upstream Slope, Looking East.

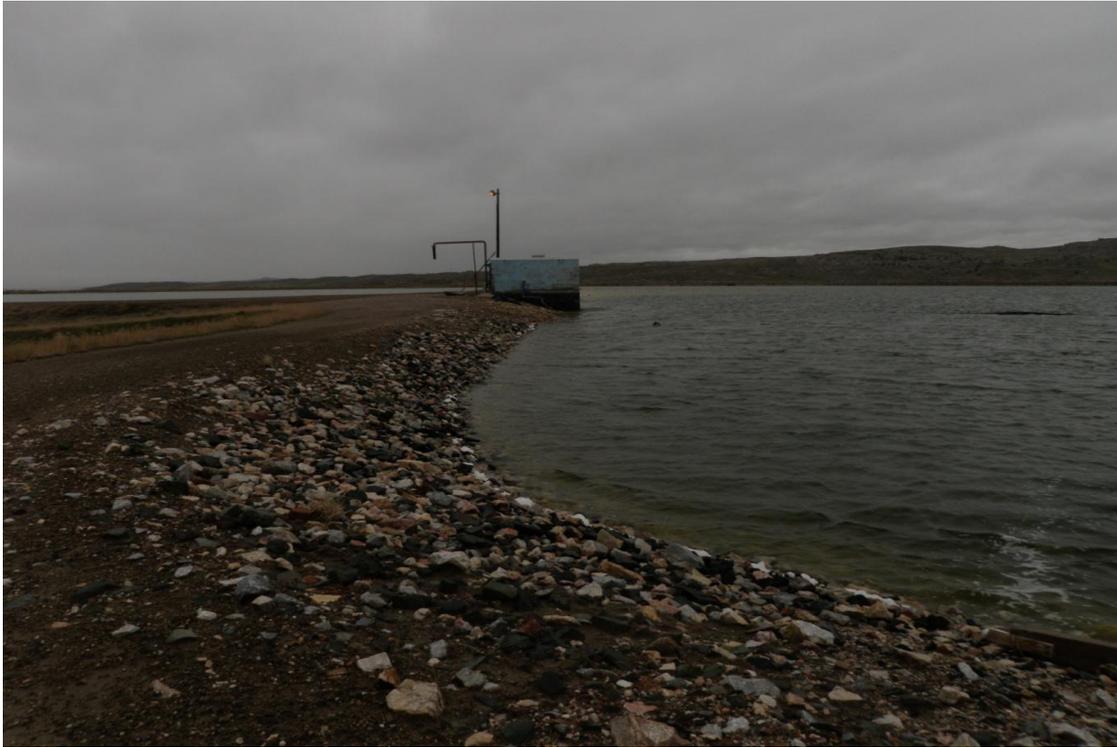
**Photo 41: East Emergency Holding Pond Southwest Corner Upstream Slope, Looking North at Divider Dike and Pump House.**

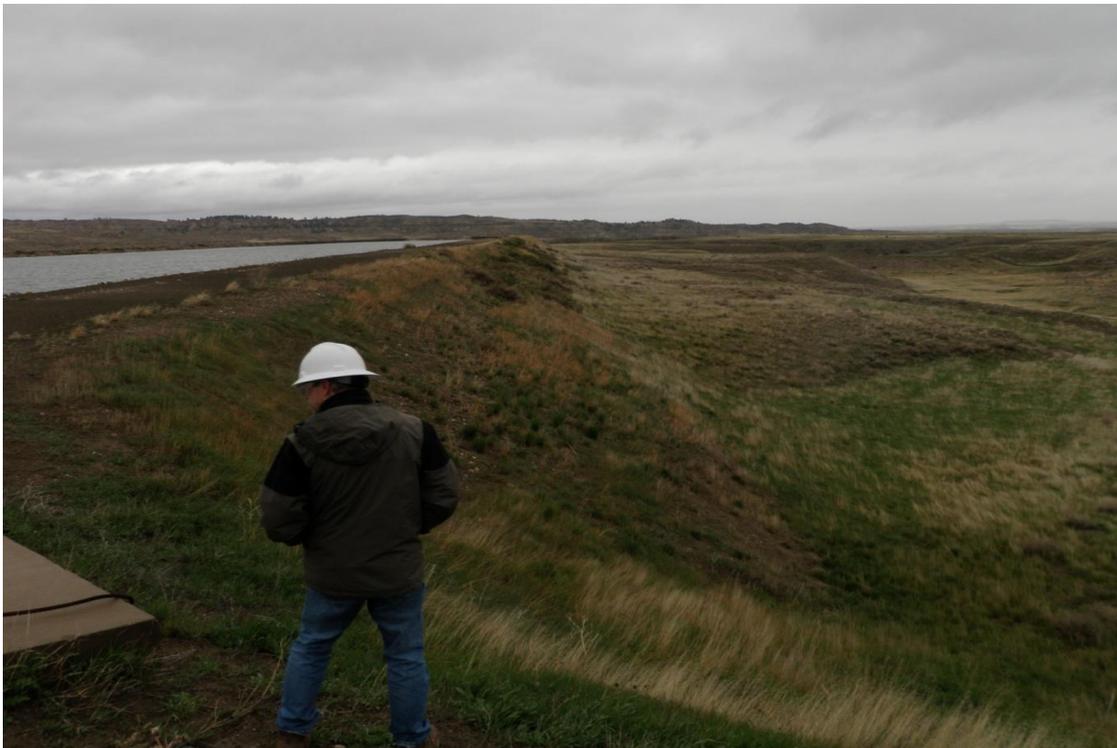
**Photo 42: East Emergency Holding Pond South Dike Downstream Slope, Looking East.**

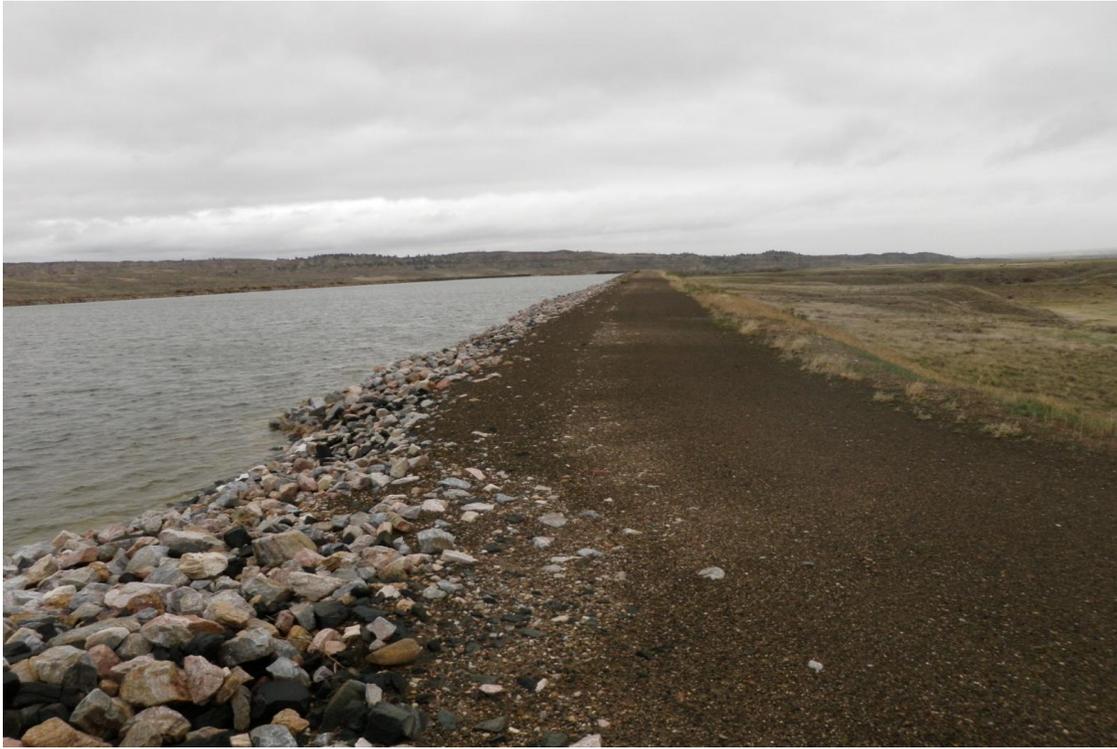
**Photo 43: East Emergency Holding Pond South Dike Upstream Slope, Looking East.**

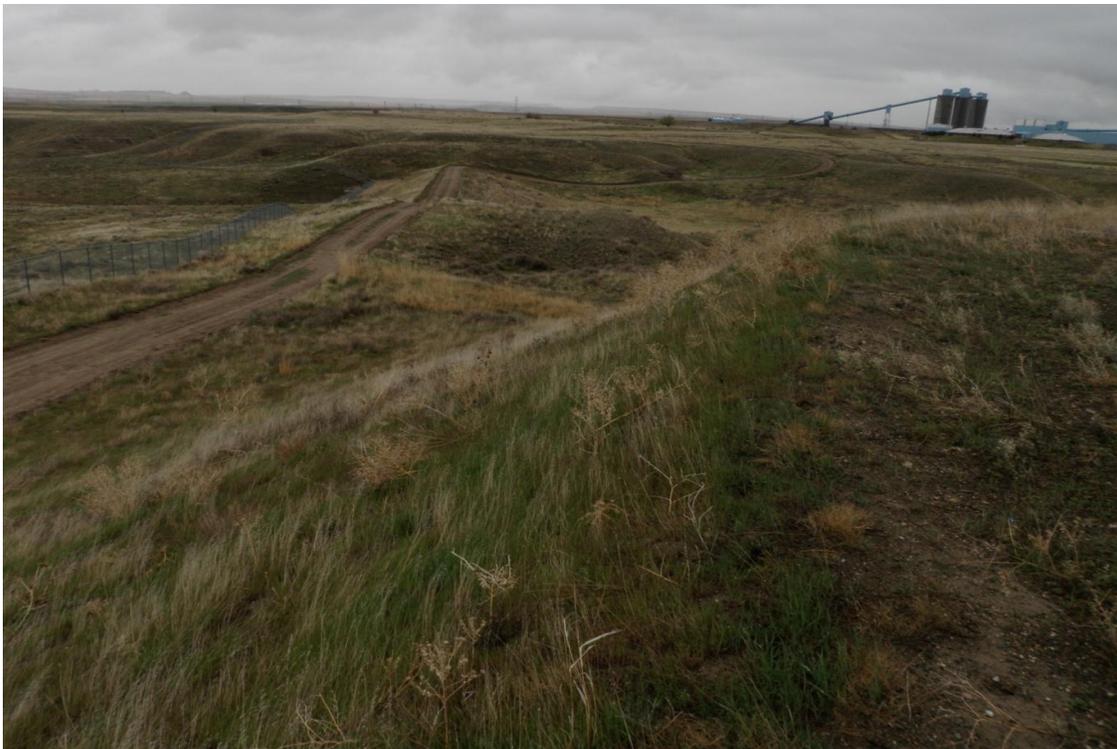
**Photo 44: East Emergency Holding Pond Southeast Corner Downstream Slope, Looking South at Stormwater Detention Basin Dam.**

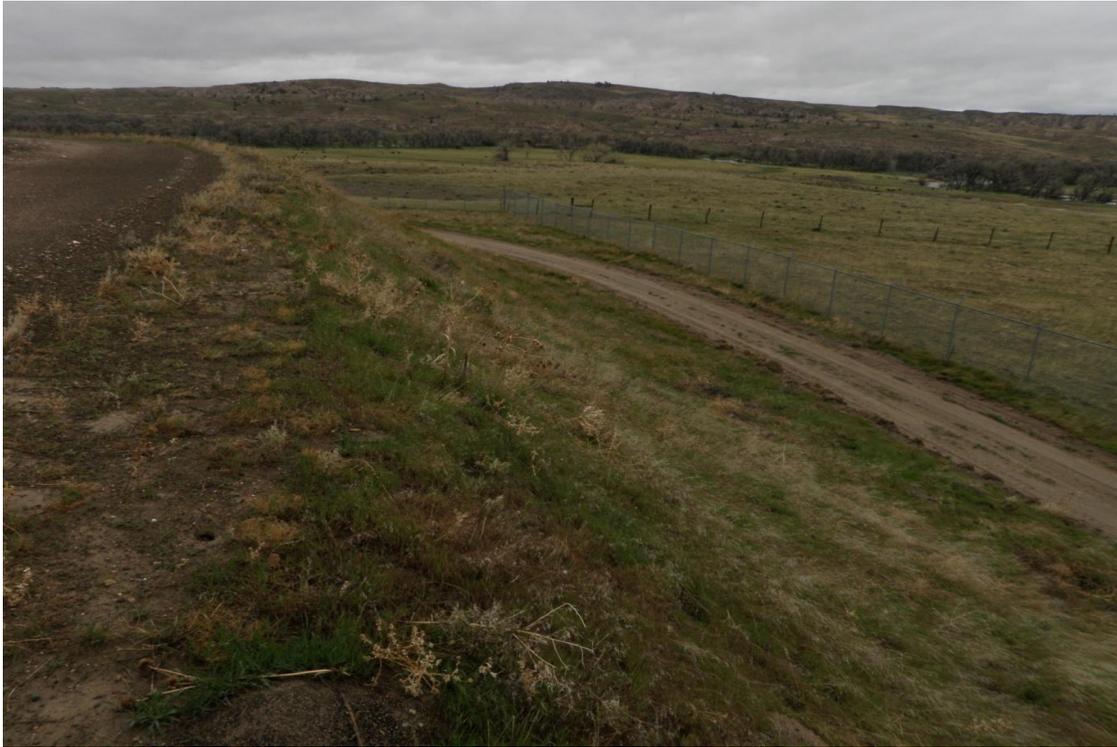
**Photo 45: East Emergency Holding Pond East Dike Downstream Slope, Looking North.**

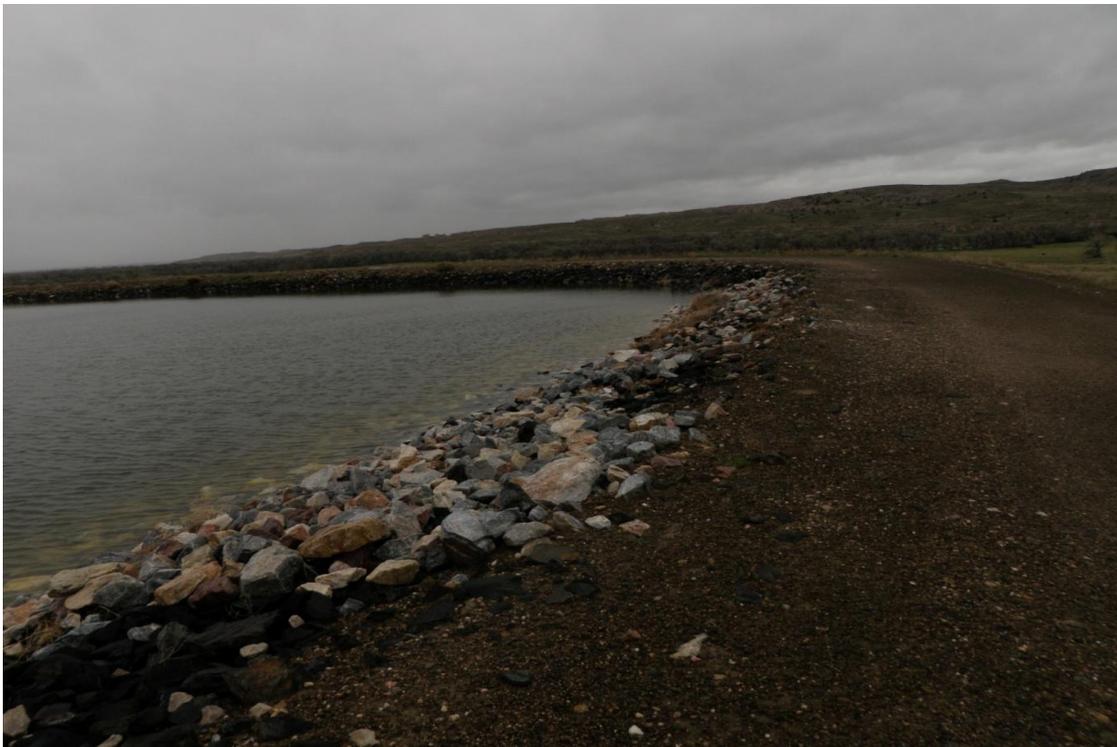
**Photo 46: East Emergency Holding Pond East Dike Upstream Slope, Looking North.**

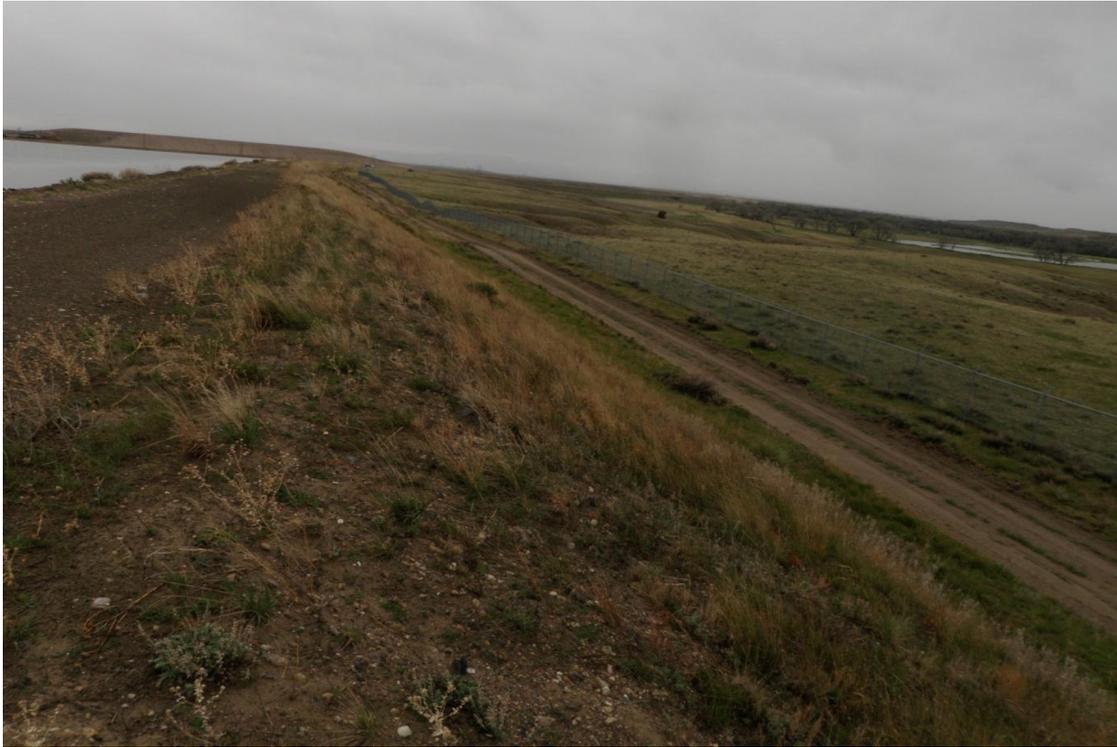
**Photo 47: East Emergency Holding Pond North Dike Downstream Slope, Looking West.**

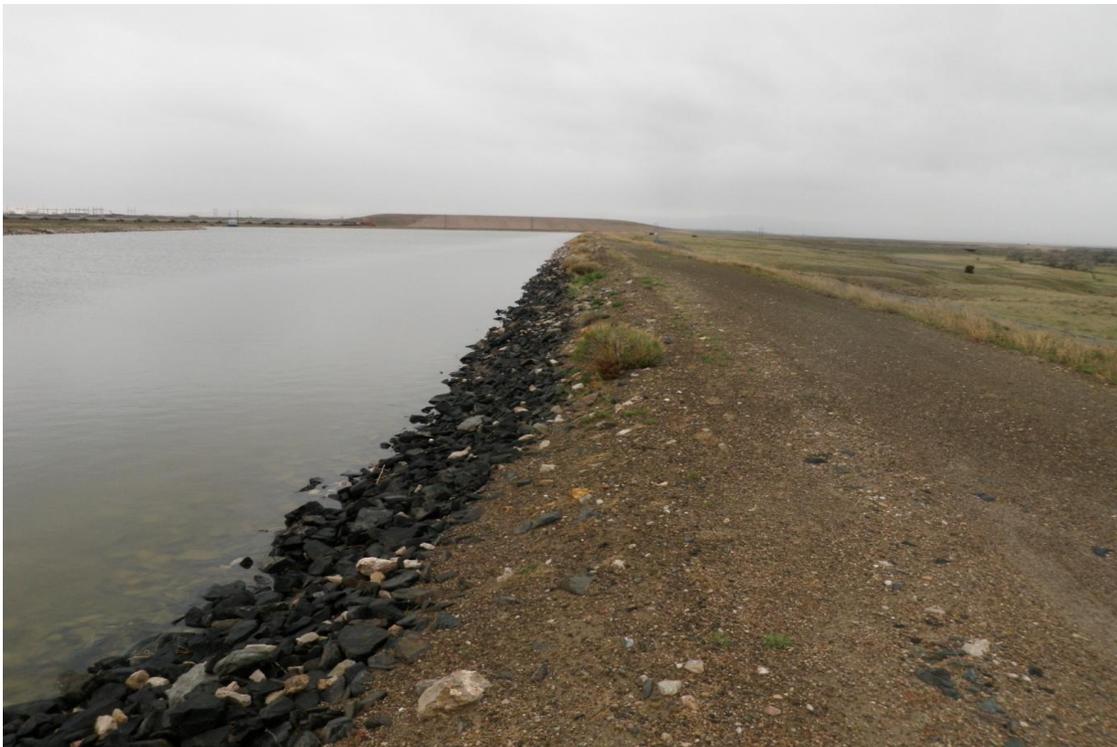
**Photo 48: East Emergency Holding Pond North Dike Upstream Slope, Looking West.**

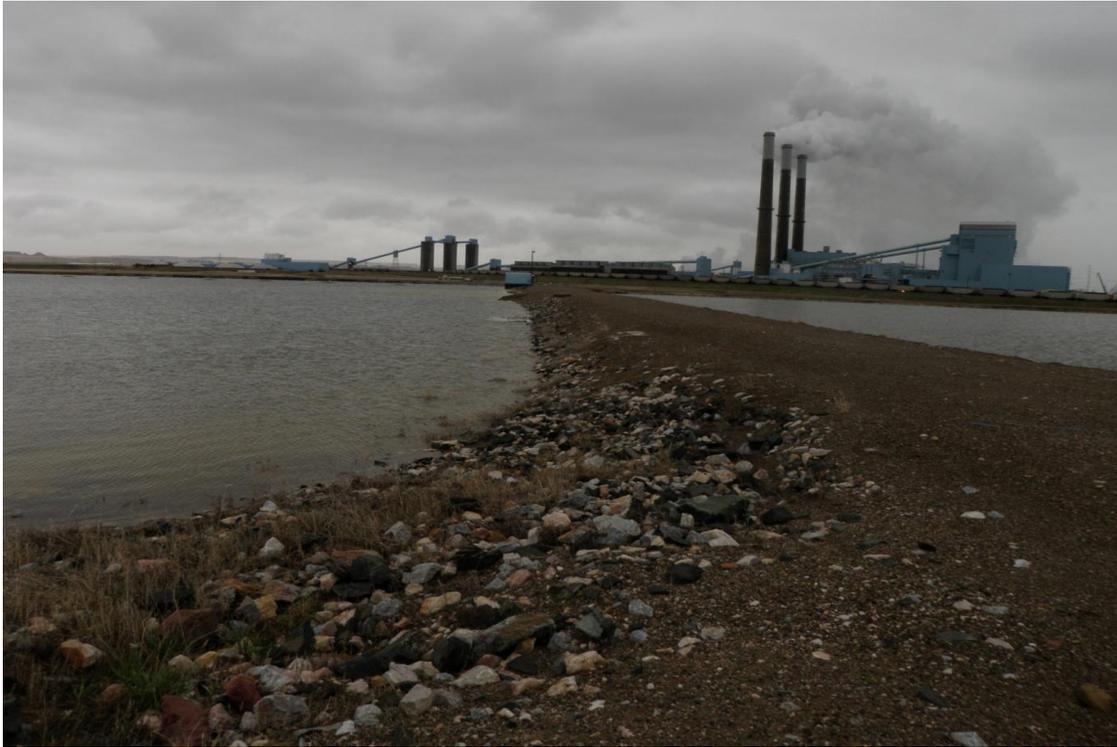
**Photo 49: East/West Emergency Holding Pond Divider Dike. East Emergency Holding Pond Upstream Slope, Looking South.**

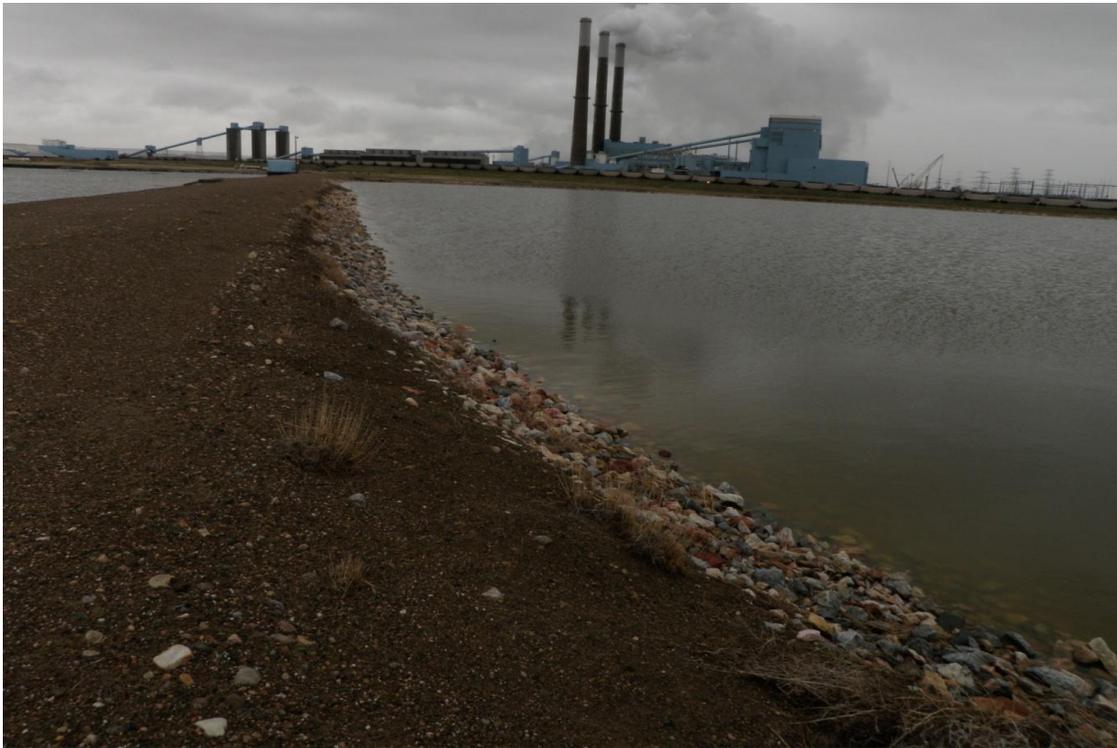
**Photo 50: East/West Emergency Holding Pond Divider Dike. West Emergency Holding Pond Upstream Slope, Looking South.**

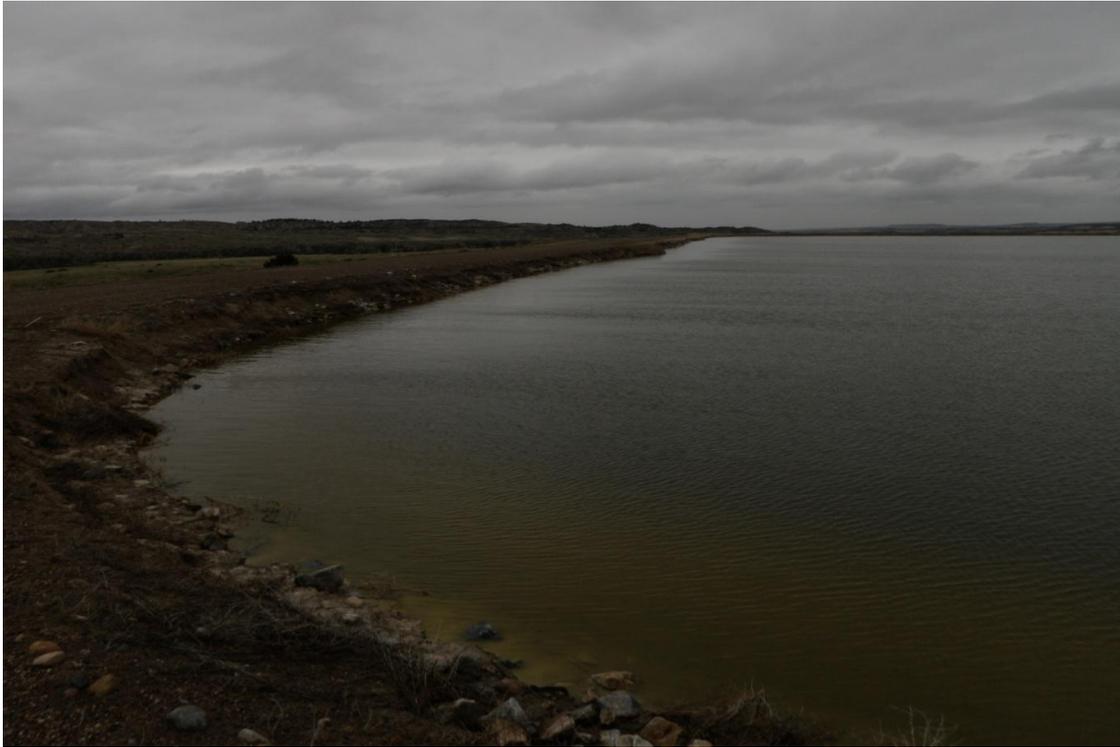
**Photo 51: West Emergency Holding Pond North Dike Upstream Slope, Looking Northeast.**

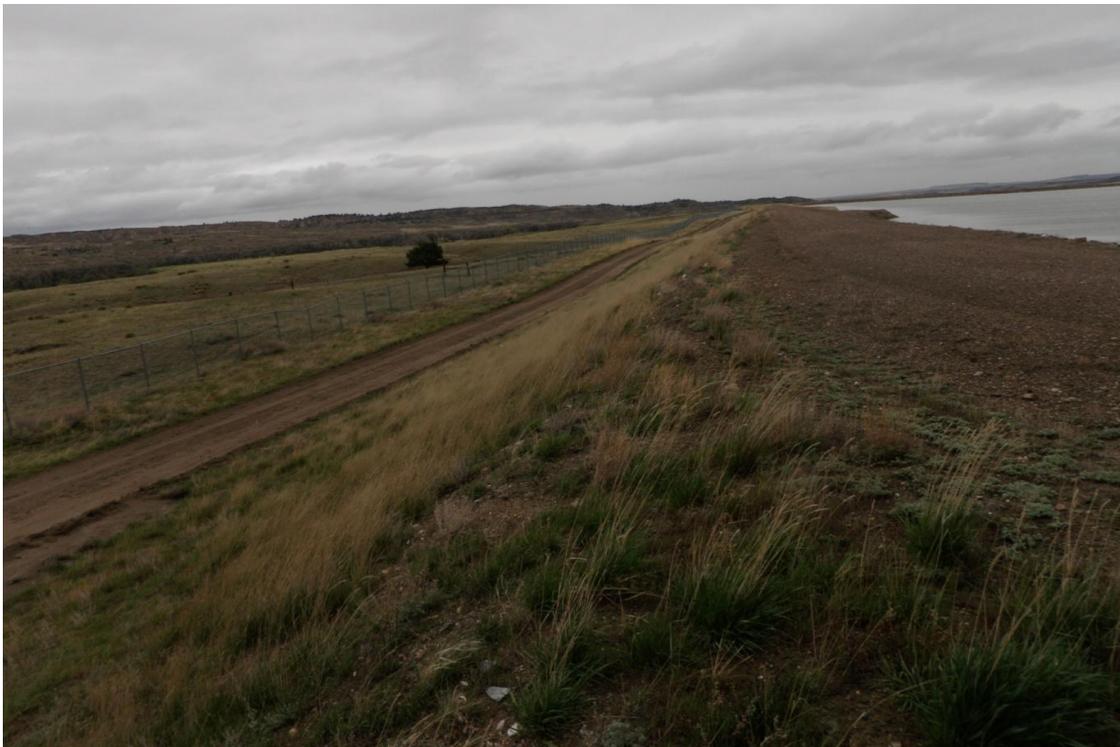
**Photo 52: West Emergency Holding Pond North Dike Downstream Slope, Looking East.**

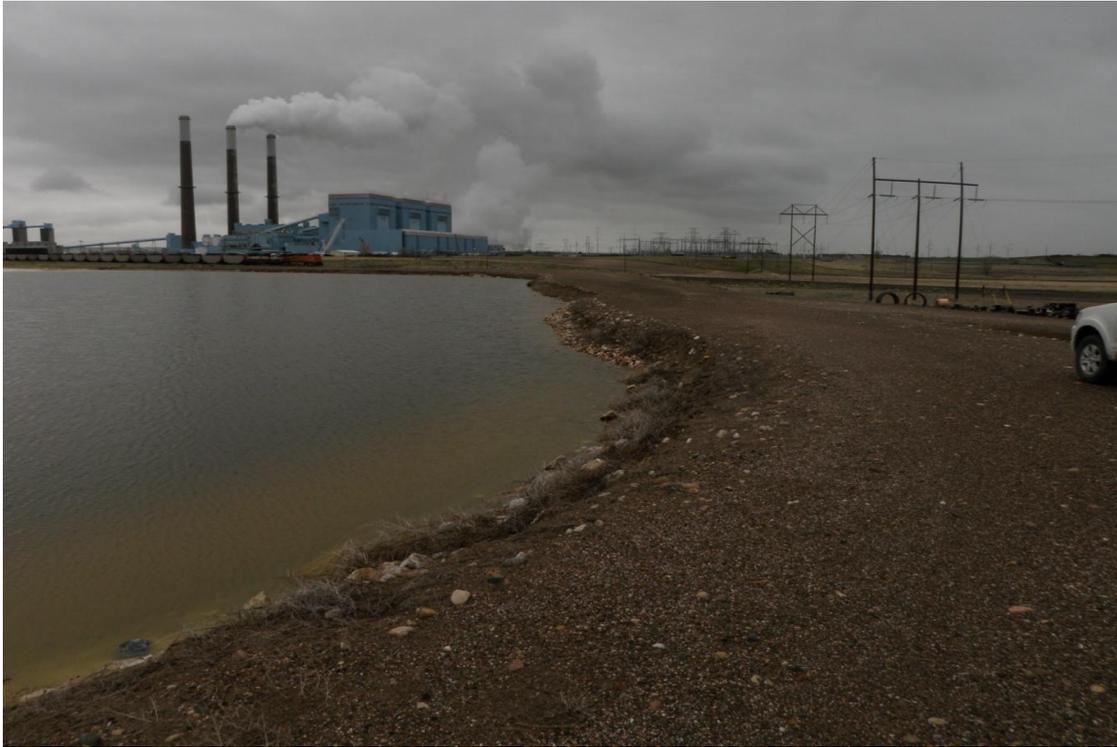
Photo 53: West Emergency Holding Pond West Dike Upstream Slope, Looking South.

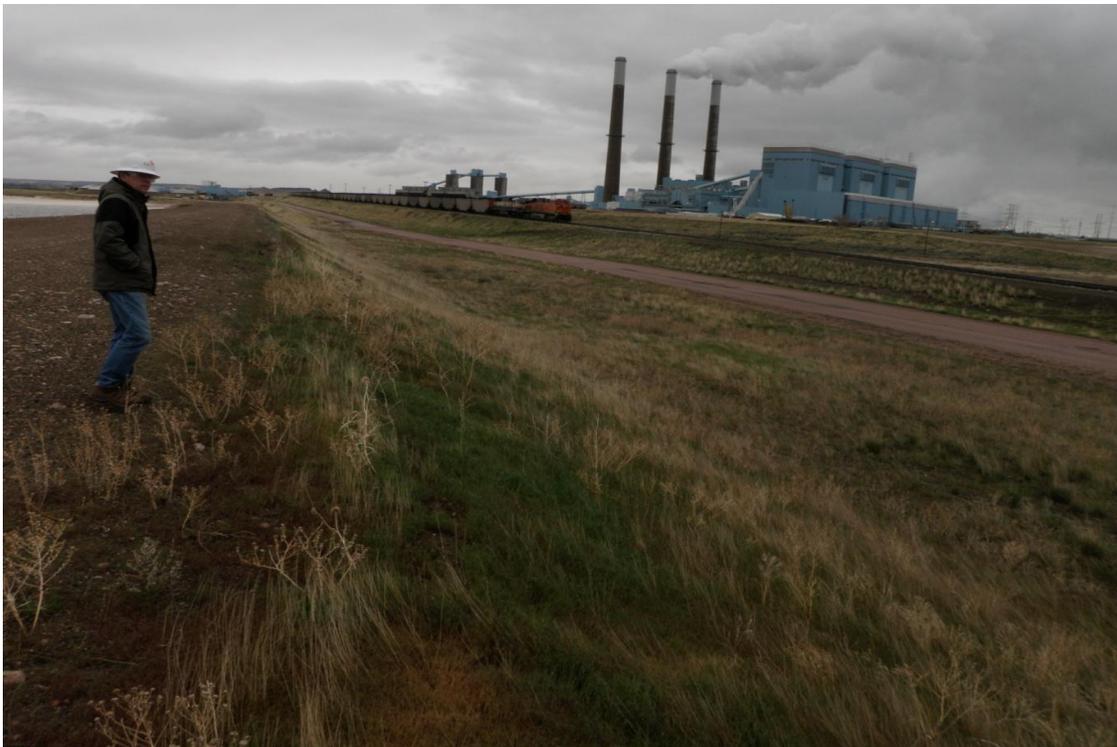
Photo 54: West Emergency Holding Pond Southwest Dike Downstream Slope, Looking Southeast.

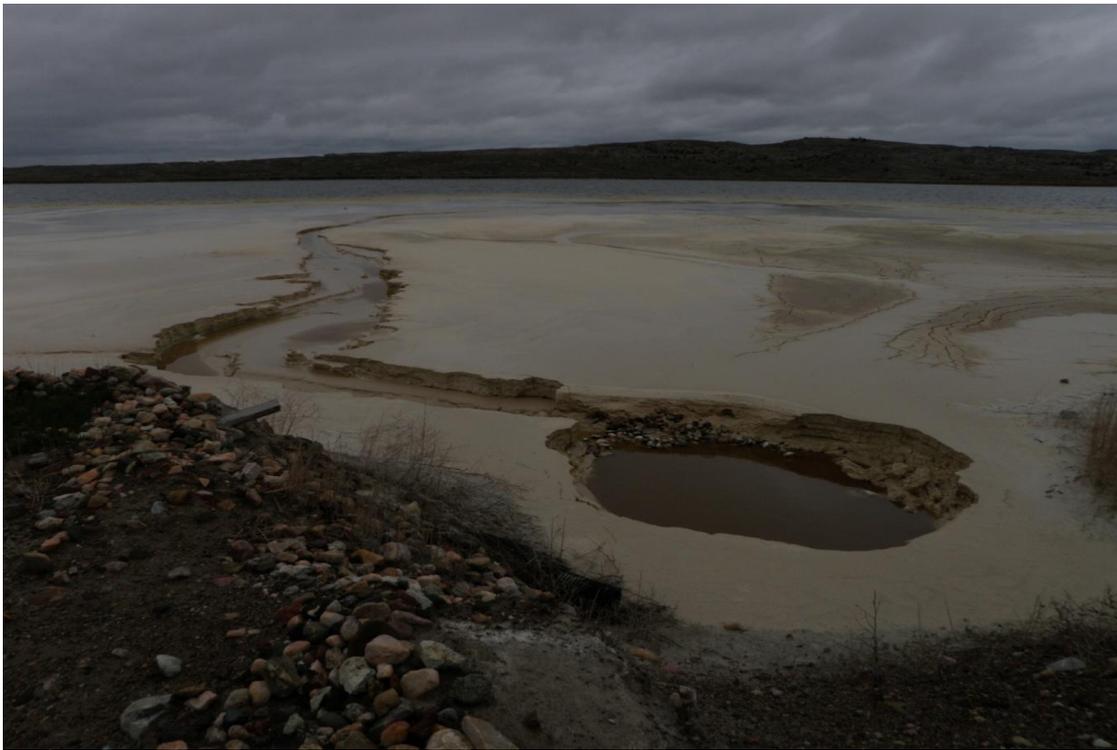
Photo 55: West Emergency Holding Pond Inlet Pipes on South Dike, Looking North.

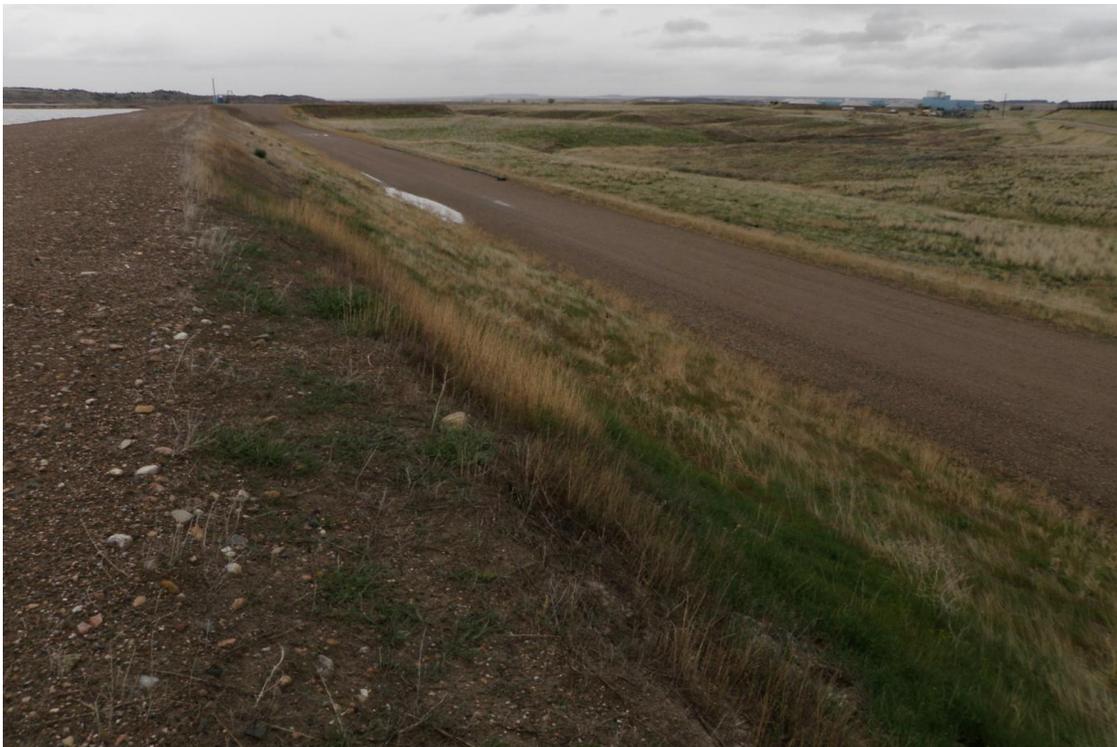
Photo 56: West Emergency Holding Pond South Dike Downstream Slope, Looking East.

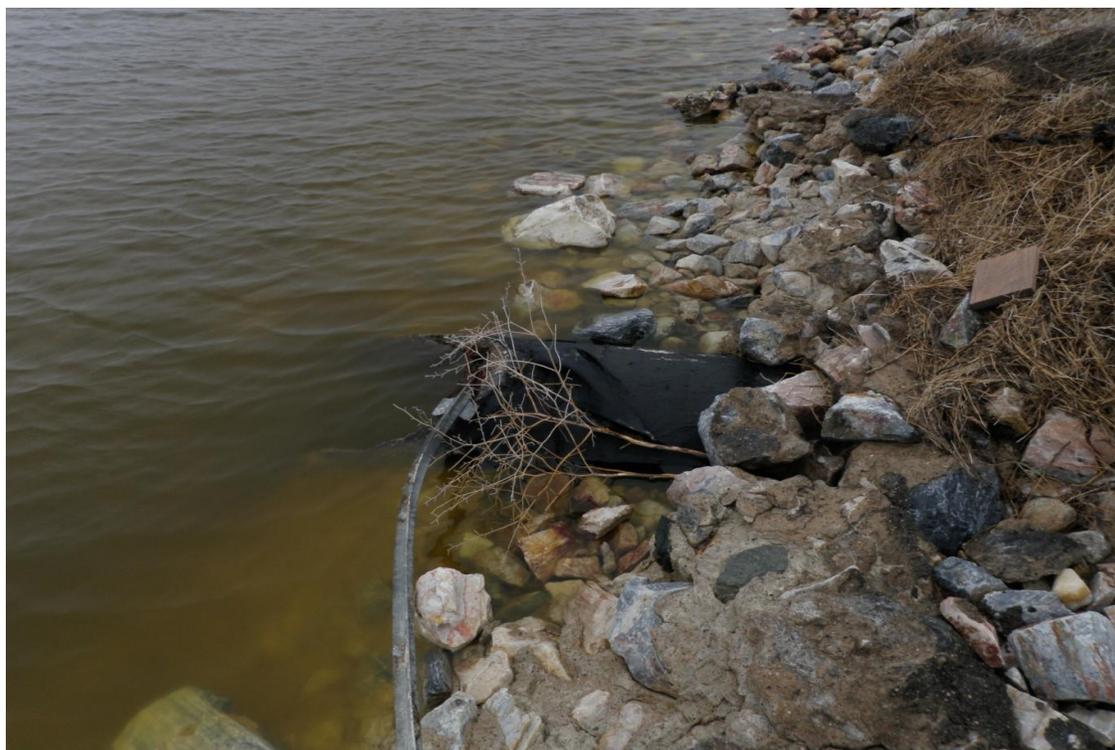
**Photo 57: 24-inch-diameter RCP Overflow Pipe from West Emergency Holding Pond to East Emergency Holding Pond.**
