**Pennsylvania Department of Environmental Protection's Comments On:  
Draft Report – Little Blue Run Dam Inspection Report  
Bruce Mansfield Power Plant  
Beaver County, Pennsylvania**

The Draft Report has been prepared for the U.S. Environmental Protection Agency, Washington, D.C., by CHA.

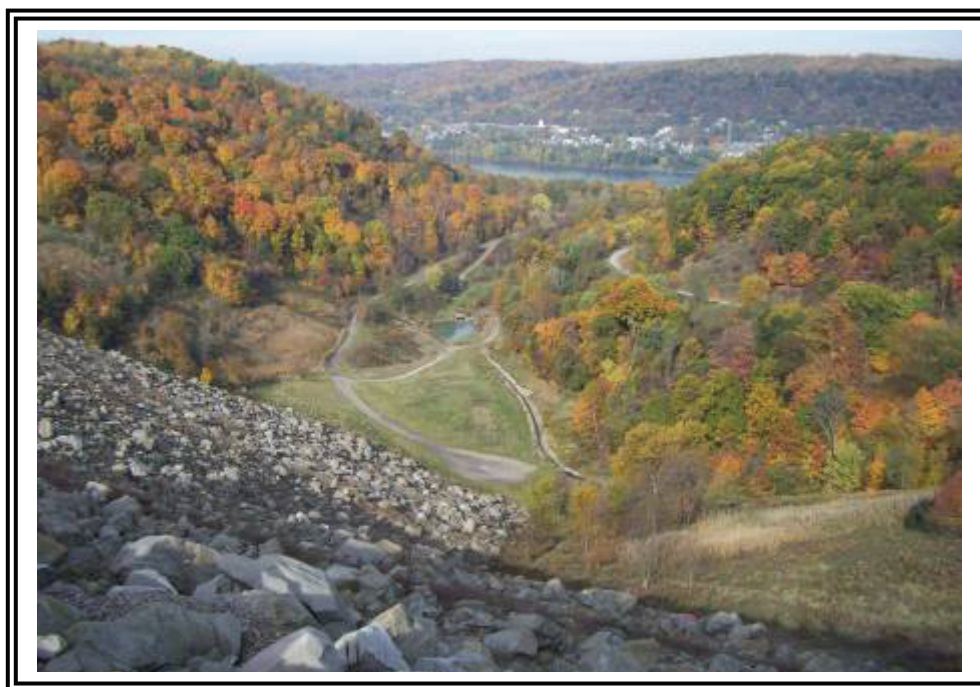
9

Downstream slope looking north at toe and stilling basin.

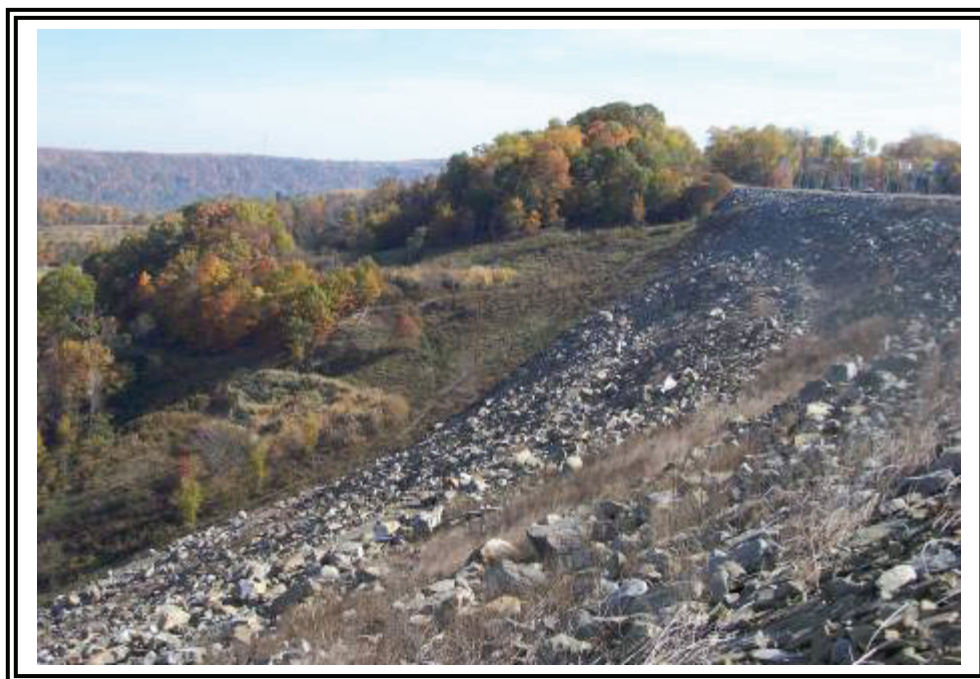
10

During the site visit, First Energy and GAI representatives pointed out areas previously repaired on the west ~~embankment-abutment contact~~ where surface sloughing and sliding of surficial soils had occurred in the location of an access road some years ago (Photos 6, 12 and 13). Seepage that is directed to weirs for monitoring was observed on the west abutment (Photos No. 27 and 33). The east abutment was also observed (Photo Nos. 1, 10, and 11).

East abutment contact with downstream slope, looking east.

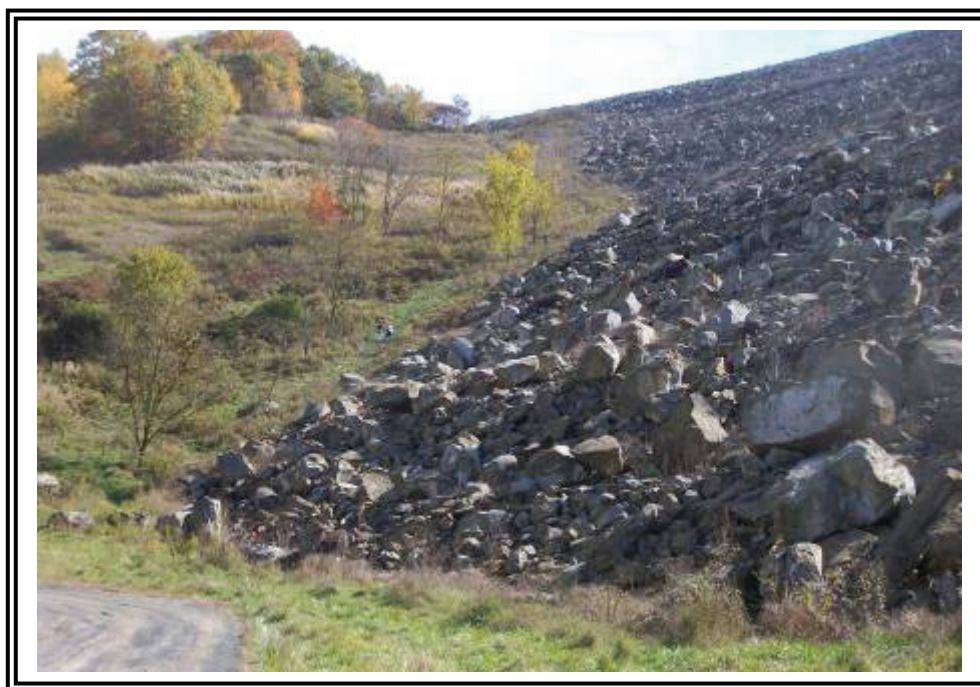
11

East abutment contact with downstream slope, looking up from the toe.

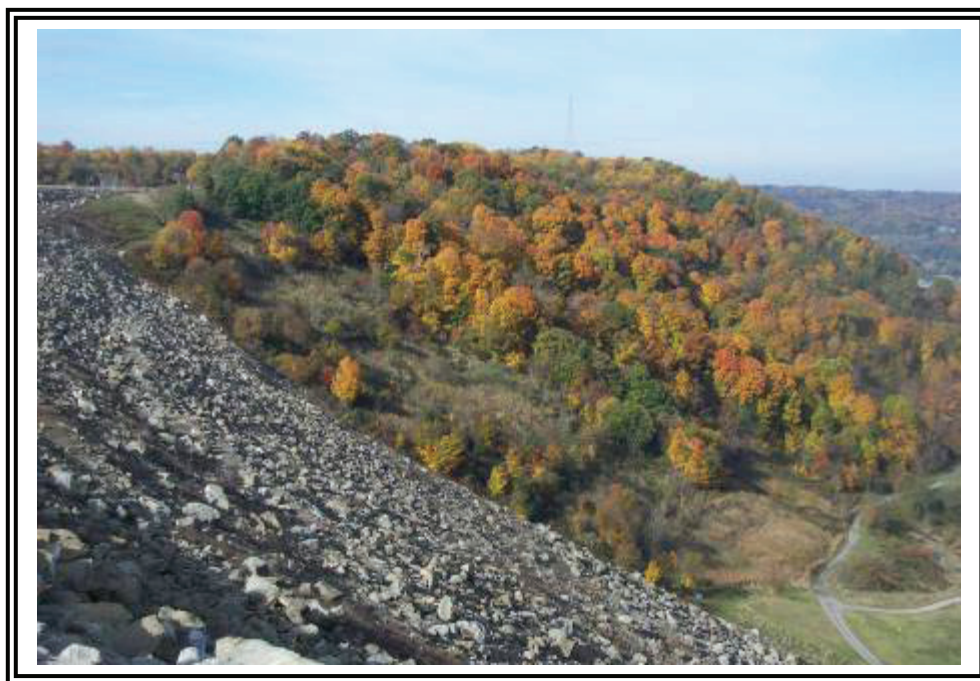
12

West abutment contact with downstream slope, looking west.

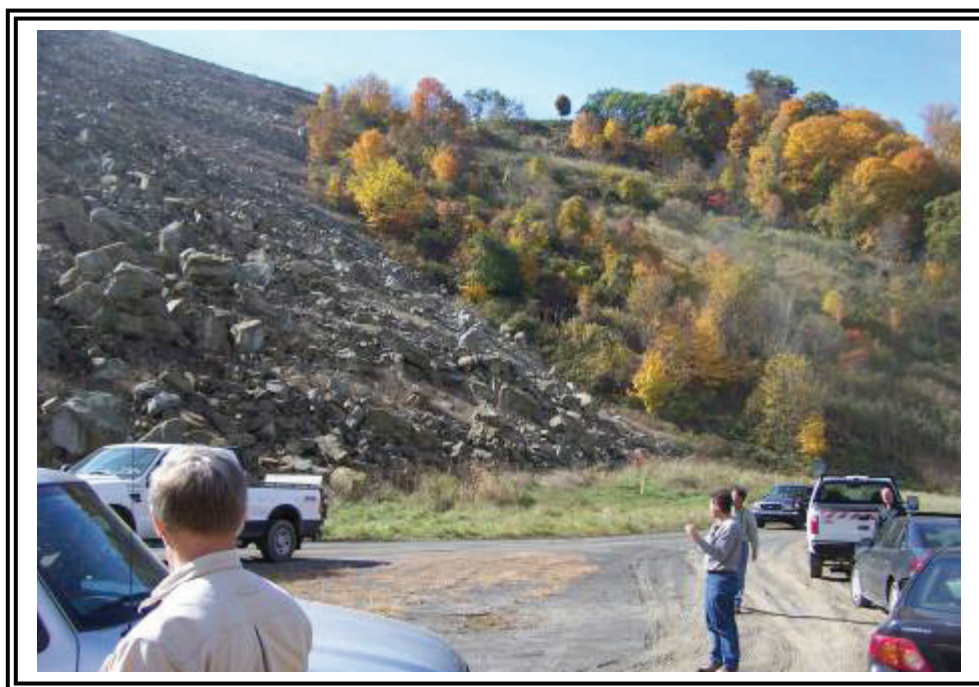
13

West abutment contact with downstream slope, looking up from the toe.

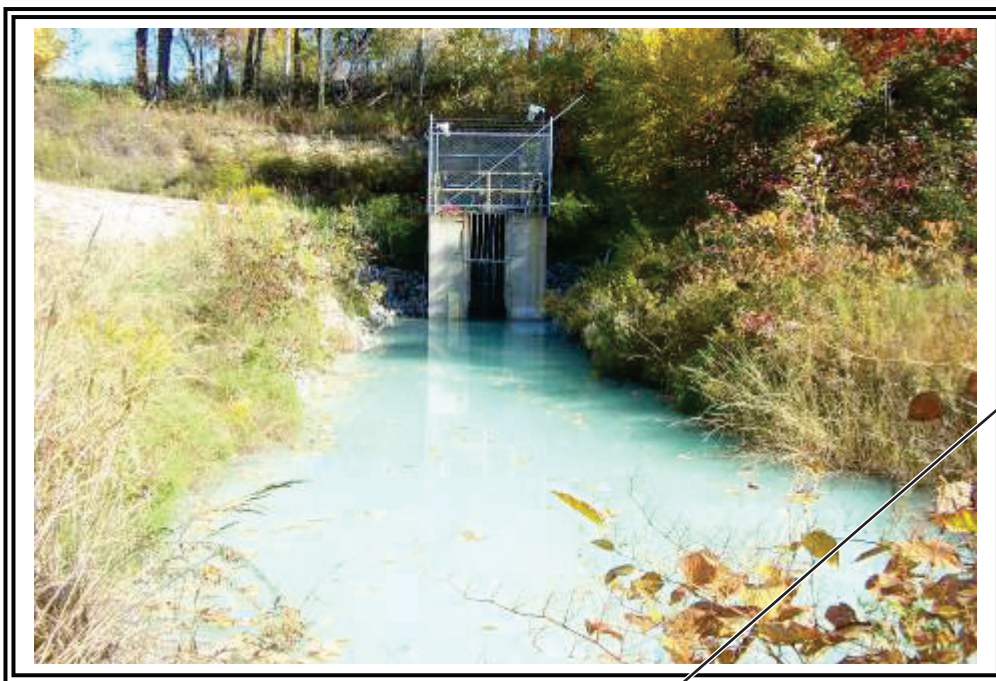
23

Secondary spillway.

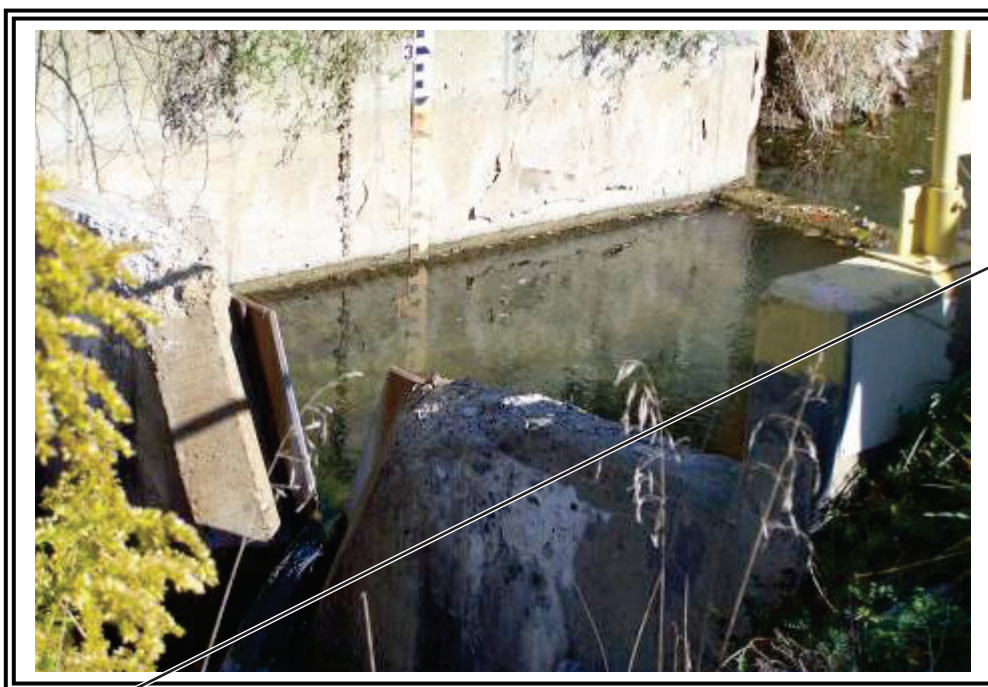
25

V-notch monitoring weir containing secondary spillway and east abutment seepage flow.

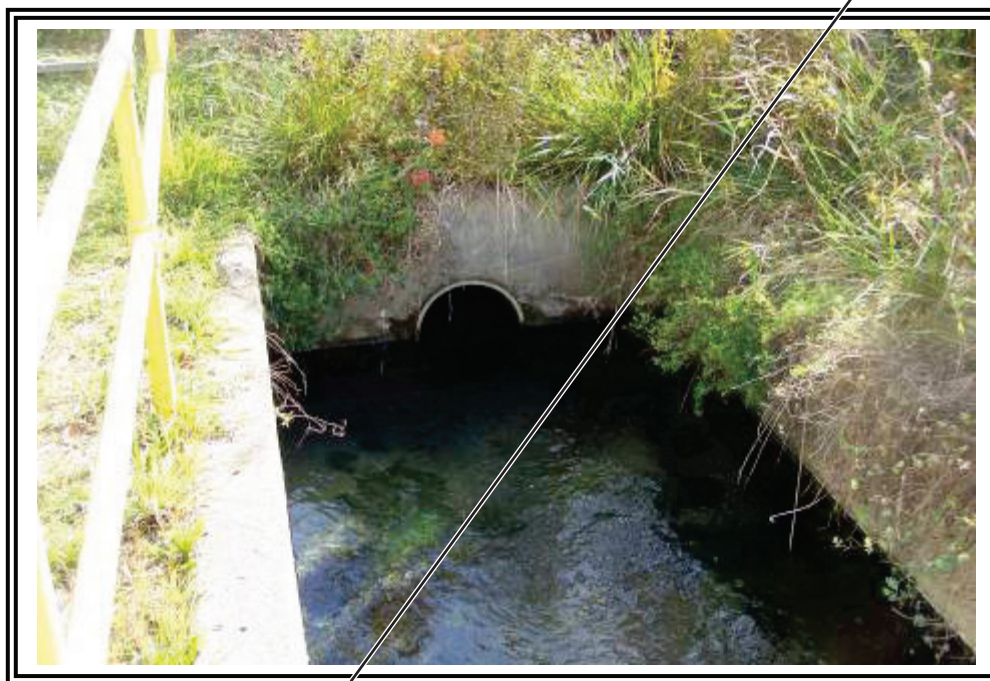
weir (ULA) was clogged causing back-flow in to the weir structure (Photo No. 30). The Parshall Flume toe drain (TD) which is a monitoring point for blanket drain seepage was also observed (Photo Nos. 28 and 29).

Toe drain collection pipe terminating in Parshall Flume.

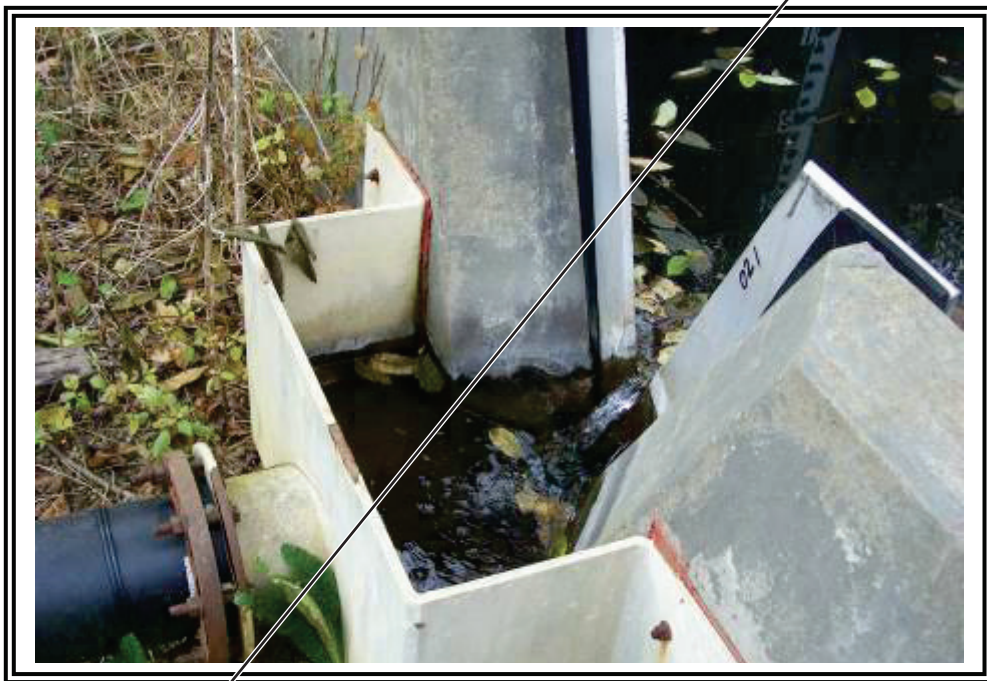
34

The weirs located on the left and right abutments to collect and monitor seepage discharges were observed. On the west abutment there are two weirs; the upper weir (ULA, Photo No. 30) and the lower weir (LLA, Photo No. 34) and on the right abutment there is one weir (RA, Photo No. 25). During the site visit it was observed that the culvert downstream of the west abutment upper

V-notch monitoring weir for lower left abutment seepage.

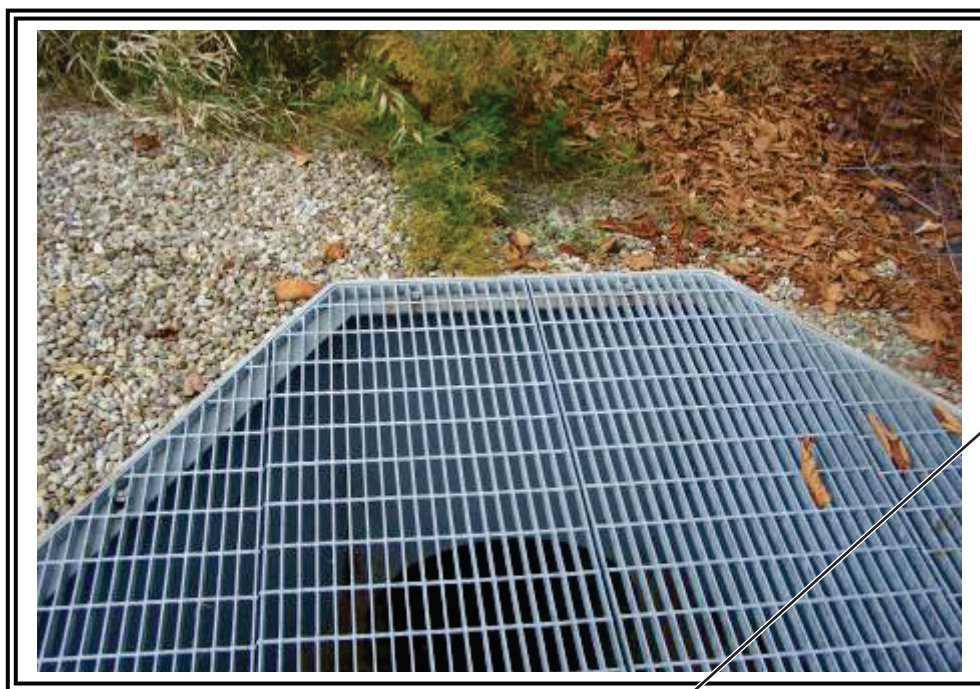
35

Outfall from stilling basin conveyed by buried pipe to the Ohio River.

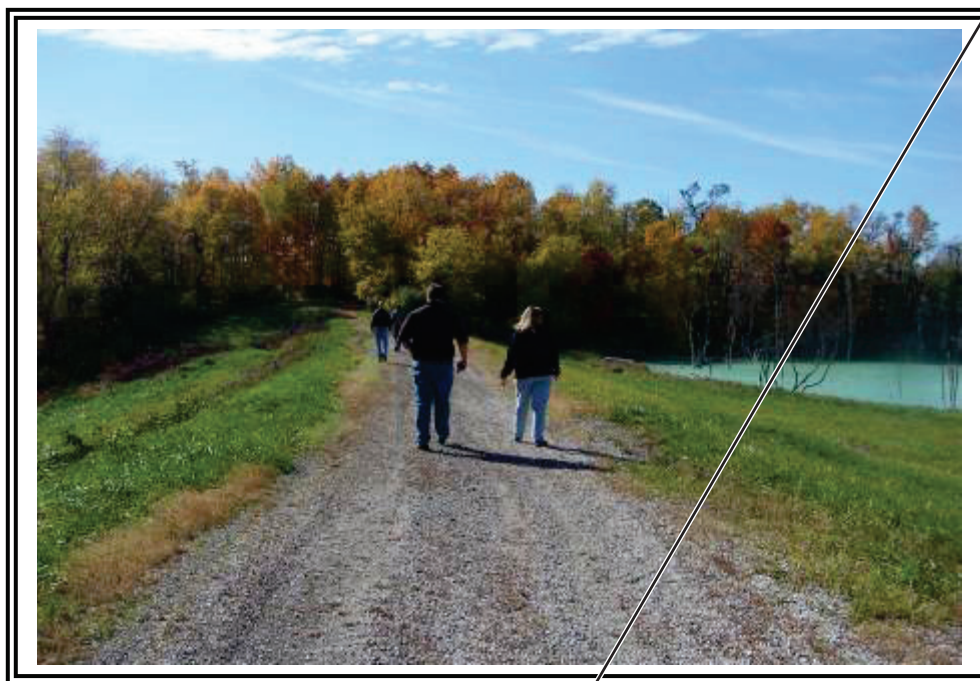
36

At the time of the site visit the Little Blue Run Dam was not impounding water. A gravel access road runs the length of the crest of the Little Blue Run Saddle Dam (Photo No. 36). The upstream and downstream embankment slopes are grass covered (Photo Nos. 37 and 39). A small rodent hole was observed on the upstream slope (Photo No. 38).

Crest of Little Blue Run Saddle ~~Like~~, looking south.

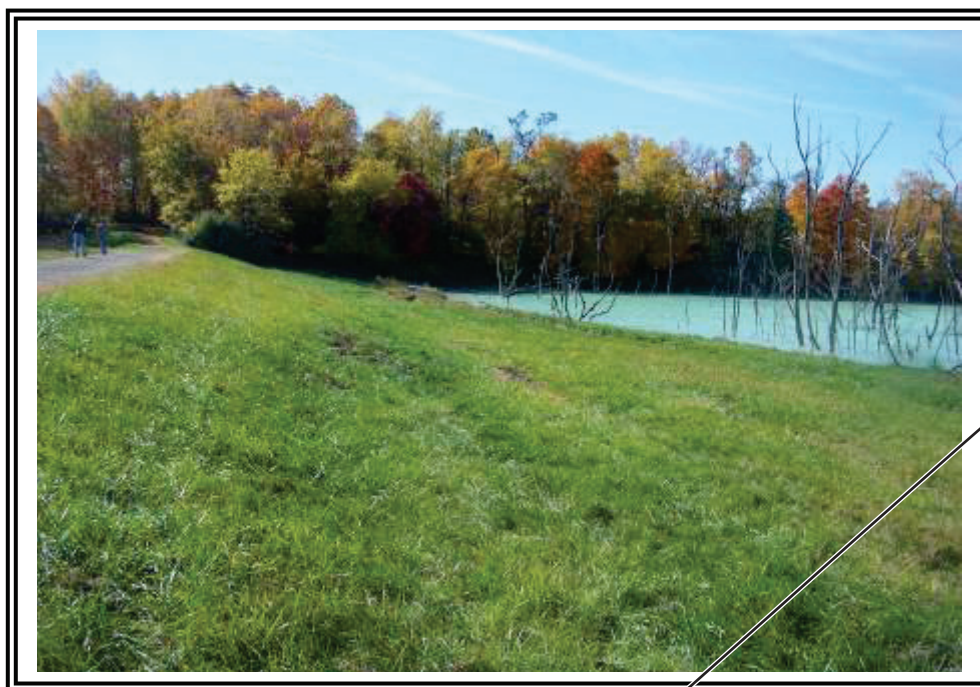
38

Upstream slope of Little Blue Run Saddle Dam, looking south.
