Report of Dam Safety Assessment of Coal  
Combustion Surface Impoundments  
Central Louisiana Electric Company (Cleco)  
American Electric Power (AEP)  
Southwest Electric Power Company (SWEPCO)  
Dolet Hills Power Station, Mansfield, LA

AMEC Project No. 3-2106-0183.0004

November 2010

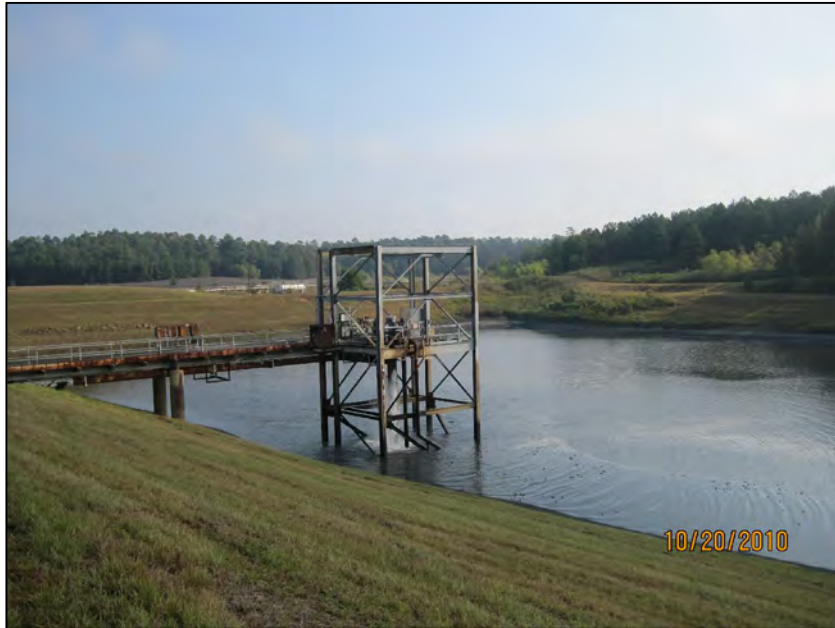
Ash Pond 1 (southern pond), Ash Pond 2 (northern pond), and the Secondary Ash Pond (central pond) abut one another and share one main embankment that runs primarily north to south along the west side of the ponds. A gravel road sits atop the embankment (Photos 3 and 6). The main embankment configuration is a combination of side-hill and cross valley. The upper downstream portions of the main embankment visually appear to have slopes greater than those described in the design documents discussed in Section 1.4.1 of this Assessment Report (3:1 H:V). Additionally, what appears to be a secondary, less steep embankment face exists below the upper, steeper portion. Internal separation embankments exist between Ash Pond 1 and the Secondary Ash Pond (Photo 2) and Ash Pond 2 and the Secondary Ash Pond (Photo 1).

**SECONDARY ASH POND-INFLUENT STRUCTURE**

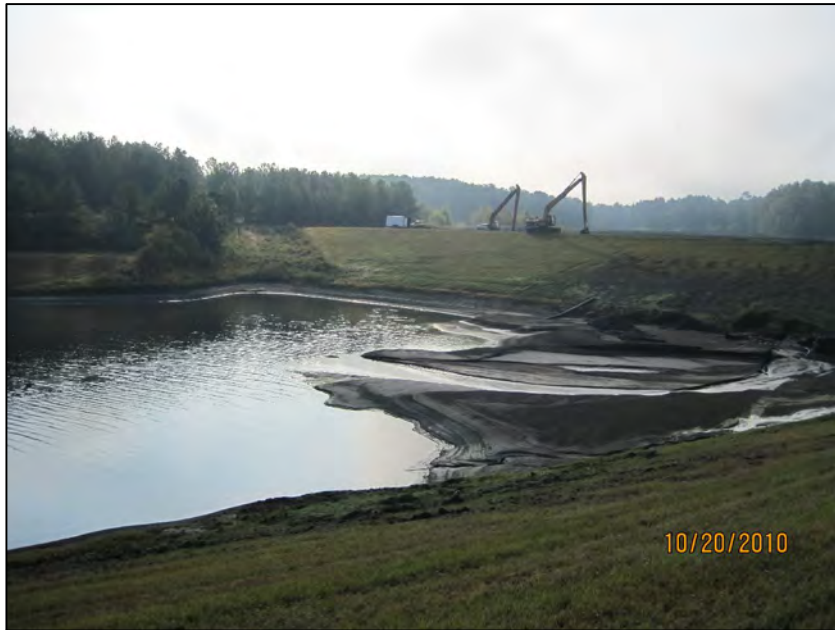
2

**SECONDARY ASH POND-LOOKING SOUTHEAST FROM CREST**

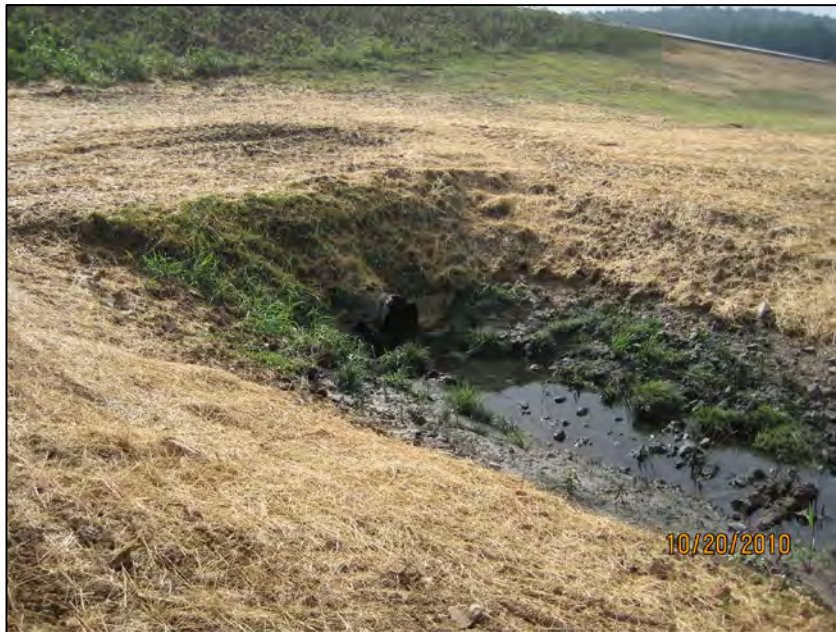
10

**SECONDARY ASH POND-LOOKING SOUTH AT LPDES OUTFALL 002 DOWNSTREAM PIPE DISCHARGE AND CHANNEL ENTRANCE**

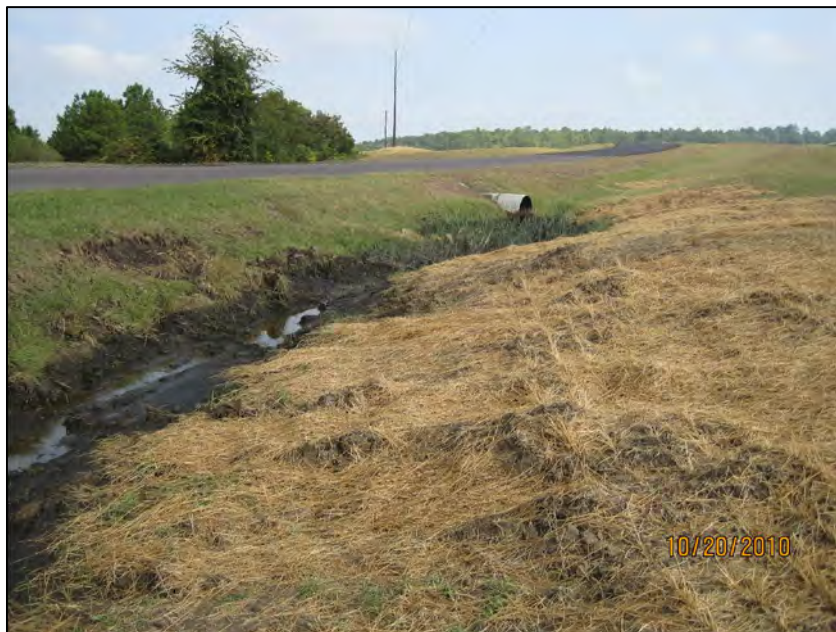
14

**SECONDARY ASH POND-LOOKING NORTH AT DRAINAGE SWALE ALONG ROAD BELOW POND EMBANKMENT**

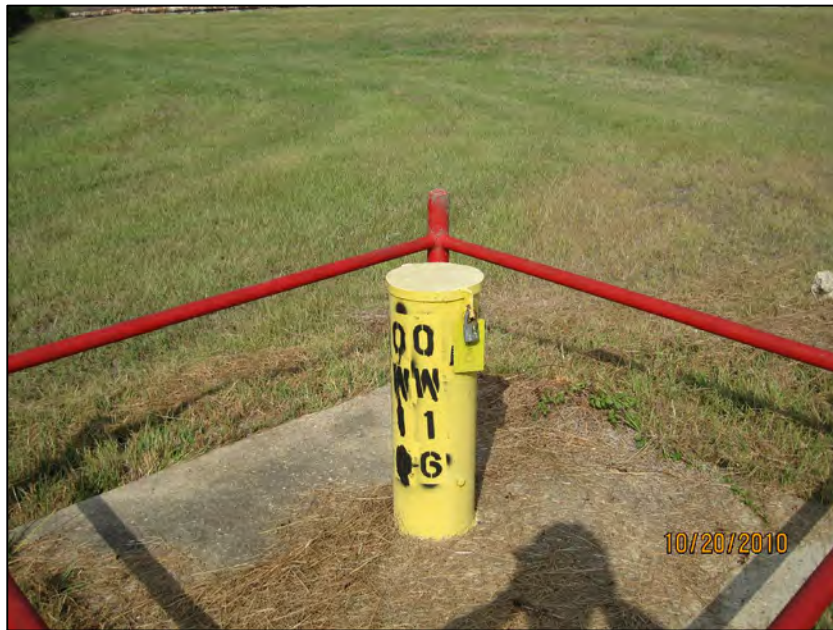
22

**ASH POND 1-MONITORING WELL 16 LOCATED ADJACENT TO ASH POND 1**

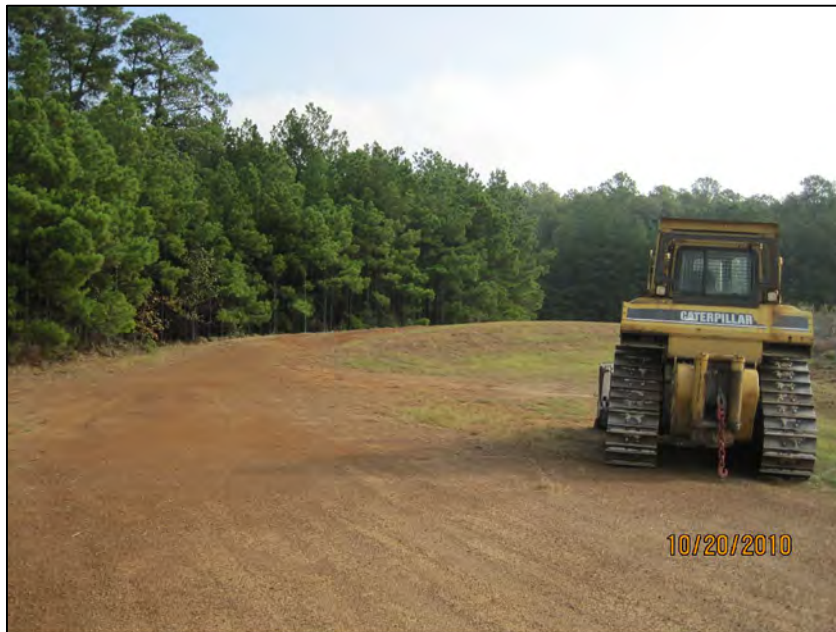
24

ASH POND 2-LOOKING NORTHEAST FROM CREST

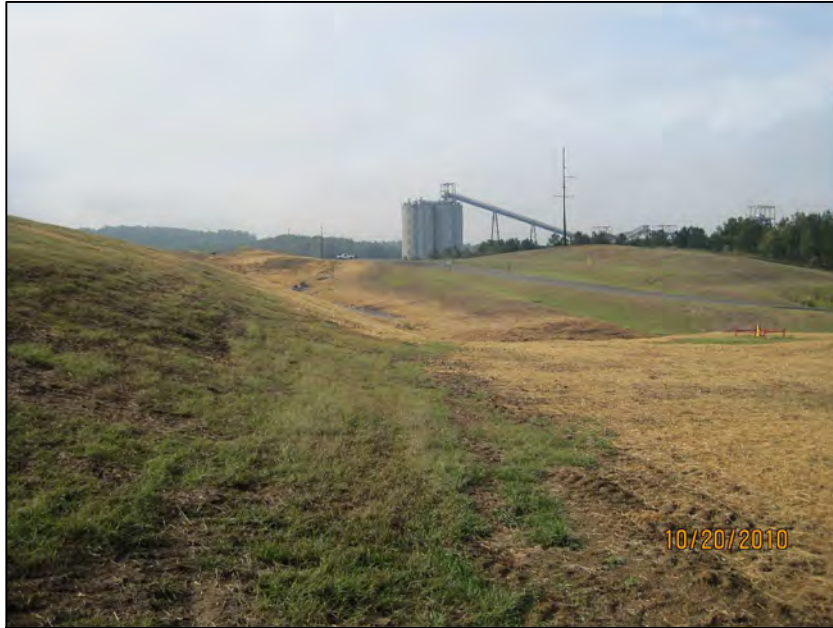
29

**ASH POND 2-LOOKING SOUTHWEST AT RESEEDING  
ALONG DOWNSTREAM EMBANKMENT FACE**

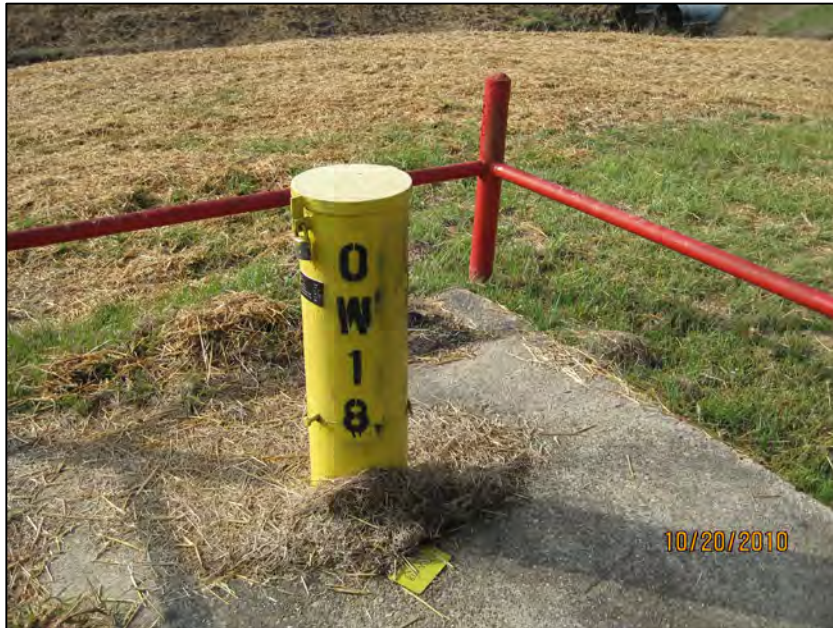
30

**ASH POND 2-OBSERVATION WELL NO. 18**

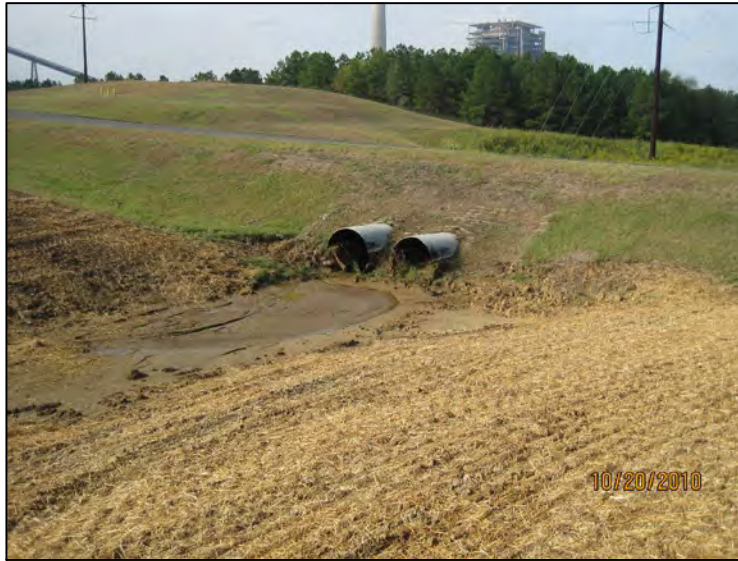
33

ASH POND 2-LOOKING WEST AT DUAL STORMWATER CULVERTS

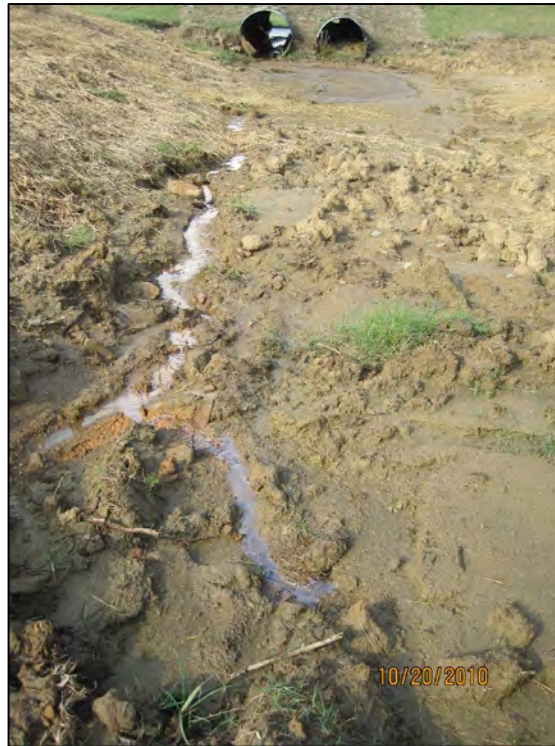
34

ASH POND 2-APPARENT SEEPAGE UPSTREAM OF STORMWATER CULVERTS, RIGHT (NORTH) CULVERT HALF FILLED WITH SEDIMENT

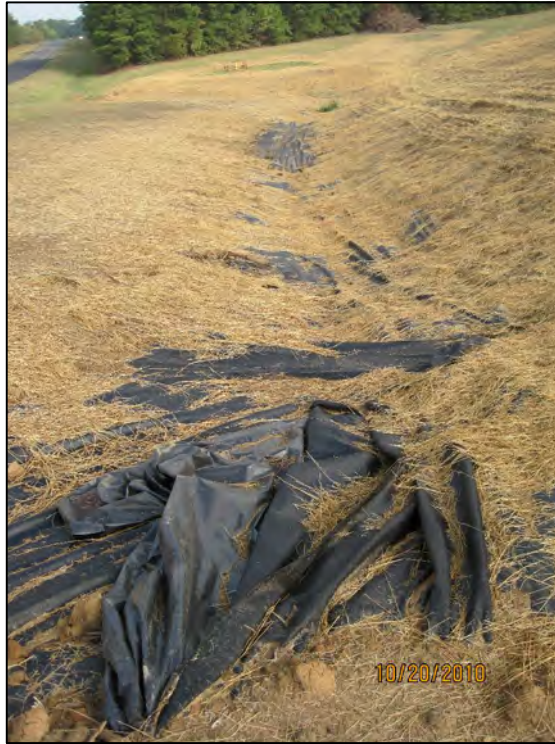
35

**ASH POND 2-LOOKING NORTH ALONG LINED DRAINAGE SWALE AT EMBANKMENT TOE**

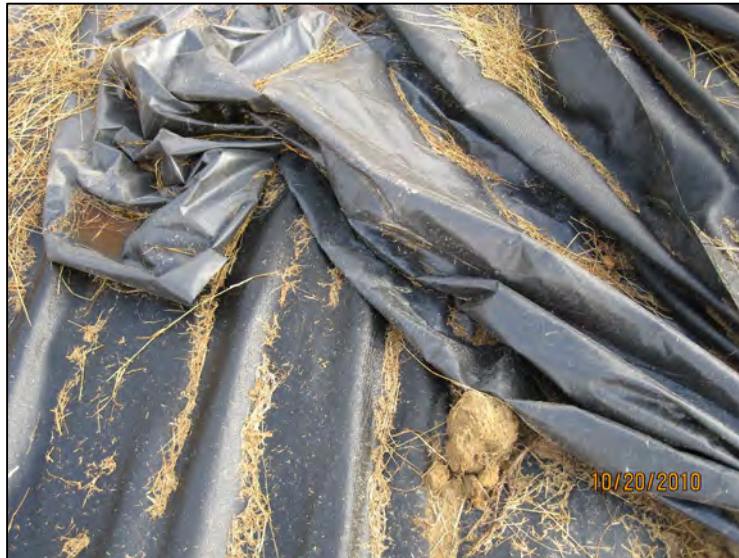
36

**ASH POND 2-WOVEN AND PLASTIC FABRIC DRAINAGE SWALE PROTECTION**

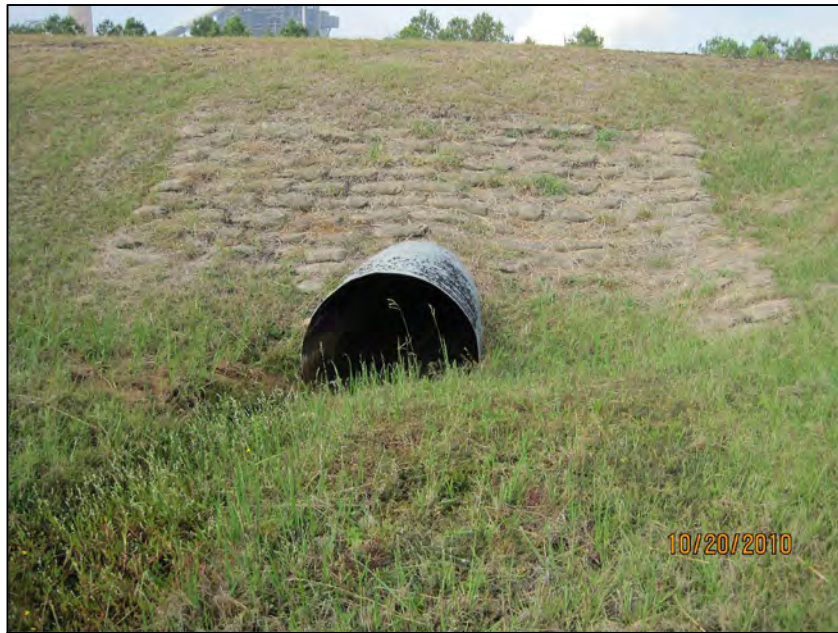
39

**ASH POND 2-LOOKING DOWNSTREAM (WEST)  
AT ROADWAY EMBANKMENT STORM DRAIN**

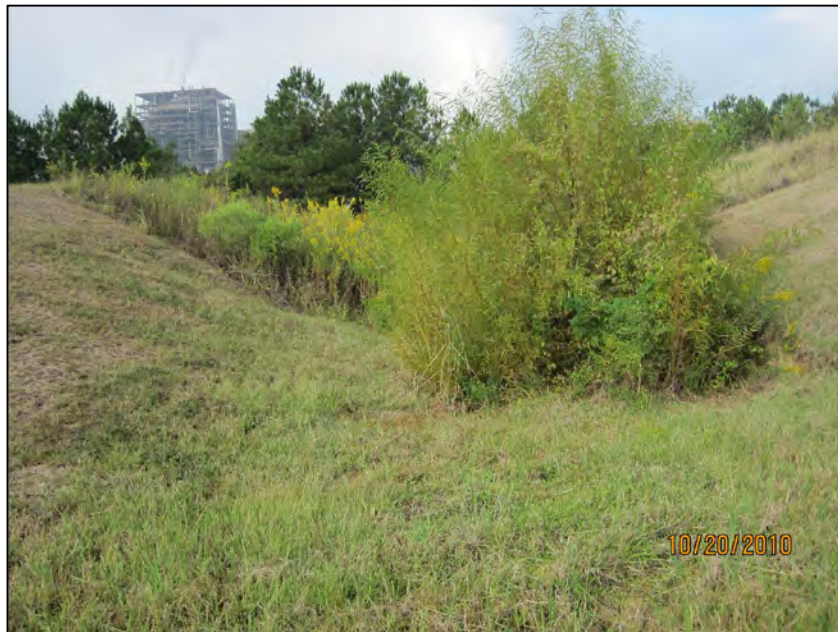
40

**ASH POND 2-LOOKING DOWNSTREAM (WEST)  
AT ROADWAY EMBANKMENT STORM DRAIN**

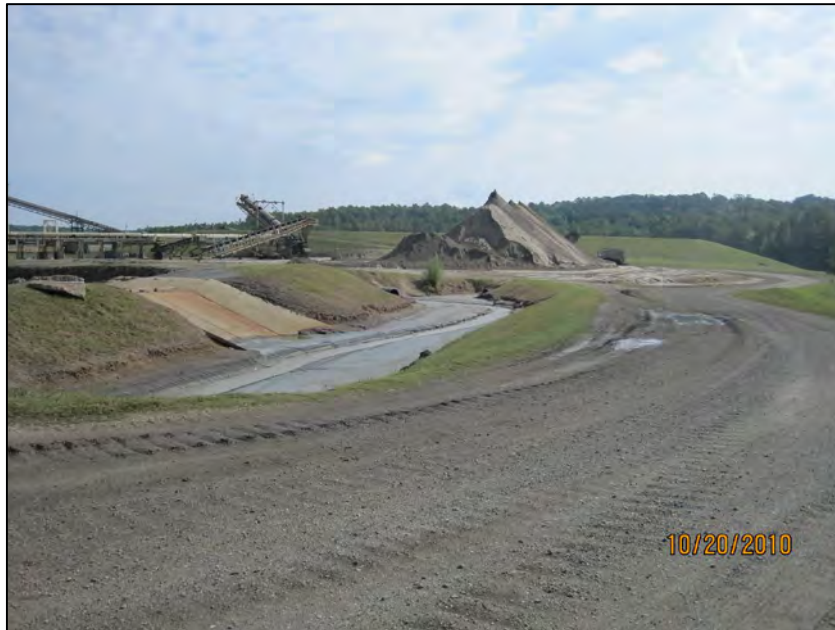
44

**AUXILIARY SURGE POND-LOOKING EAST FROM SOUTHWEST CORNER**

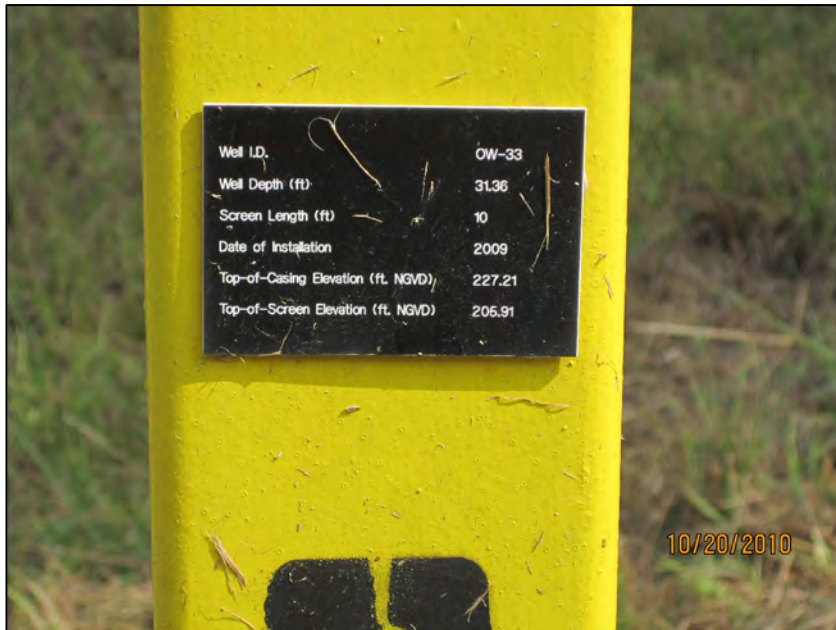
46

**MONITORING WELL 33 LOCATED SOUTHEAST OF AUXILIARY SURGE POND**

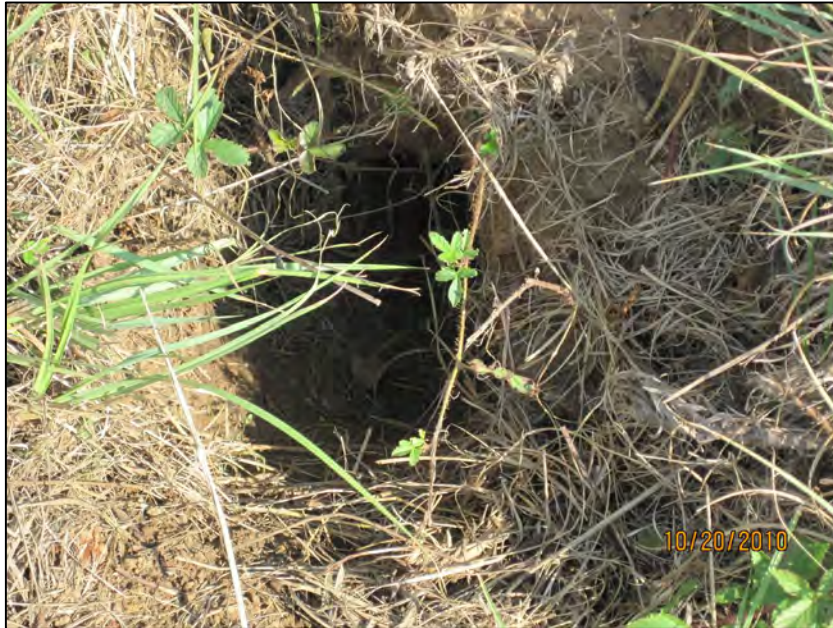
57

**SURGE POND 2-ANIMAL BURROW LOCATED BEHIND WALL SHOWN ADJACENT TO MONITORING WELL 24**

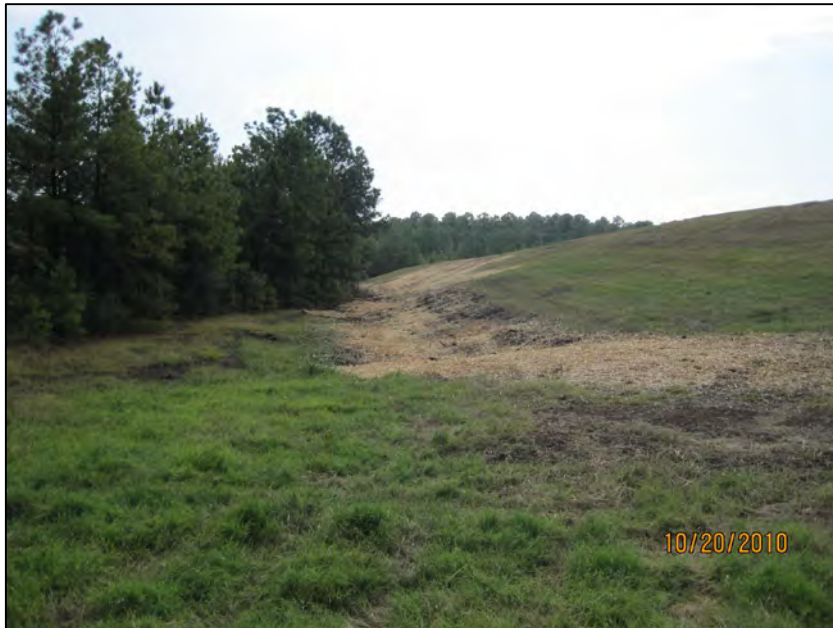
58

**SURGE POND 2-LOOKING SOUTH AT DOWNSTREAM EMBANKMENT**

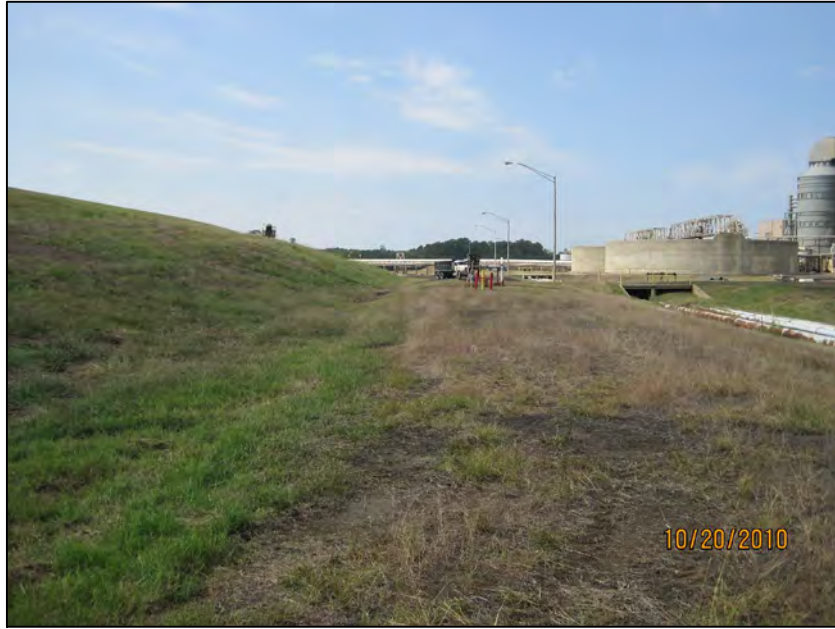
59

**SURGE POND 2-LOOKING WEST AT DOWNSTREAM EMBANKMENT**

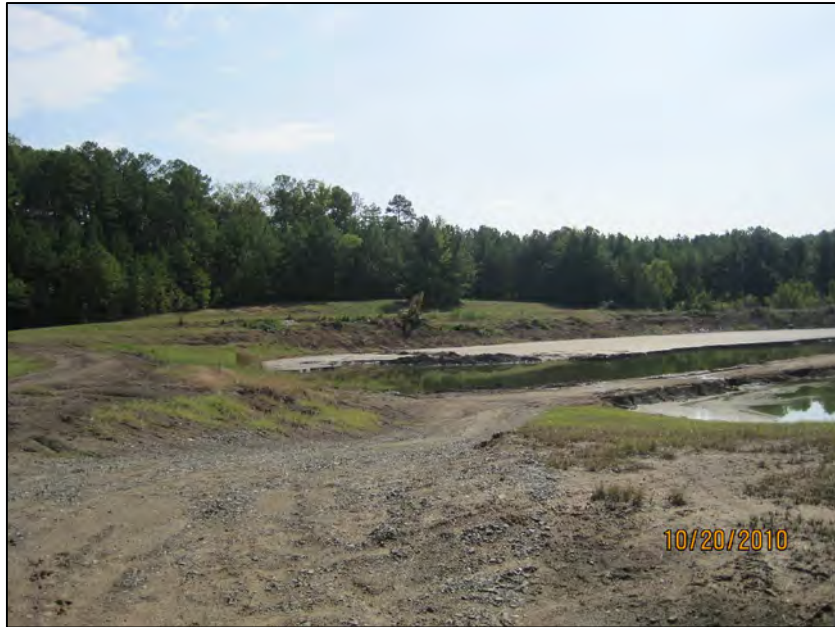
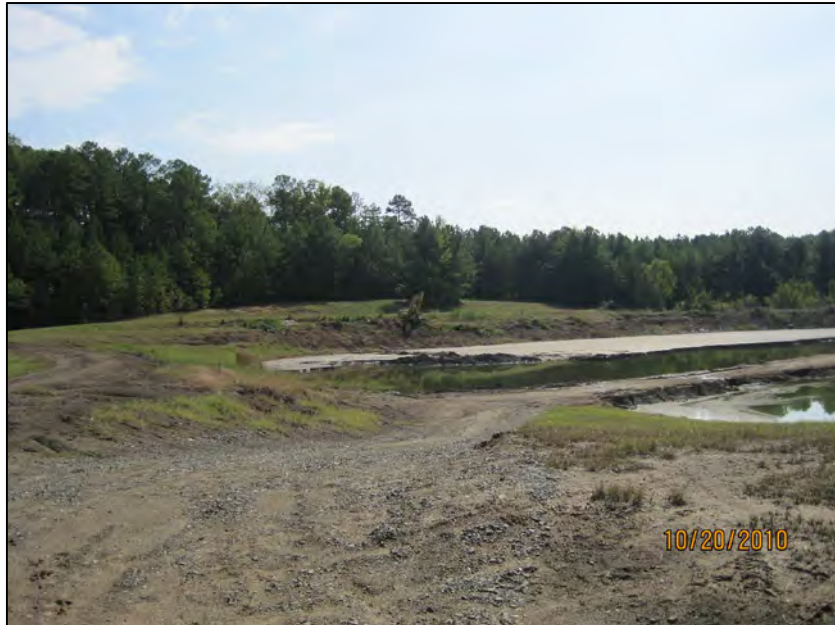
60

**LANDFILL RUNOFF POND-LOOKING EAST ACROSS NORTH END OF POND**

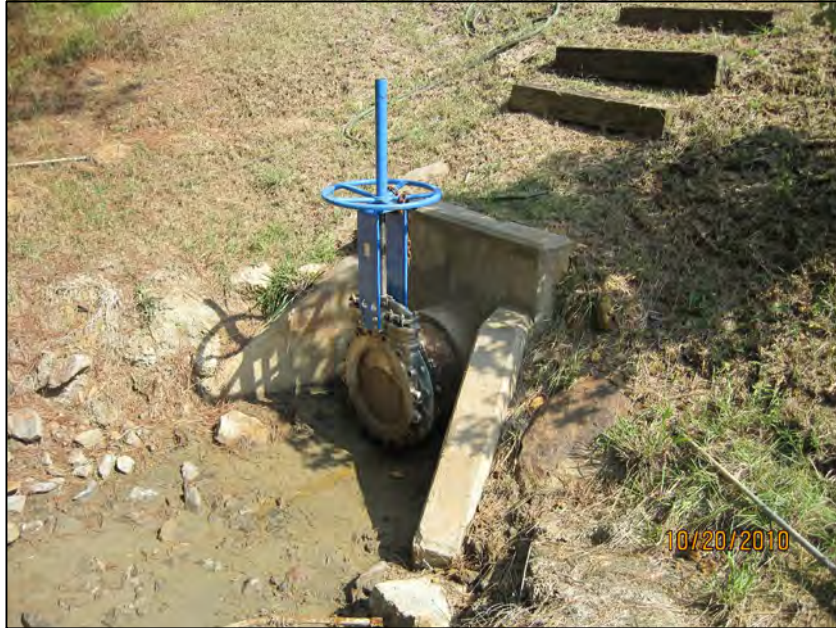
63

LANDFILL RUNOFF POND-VALVE CONTROL AT DISCHARGE

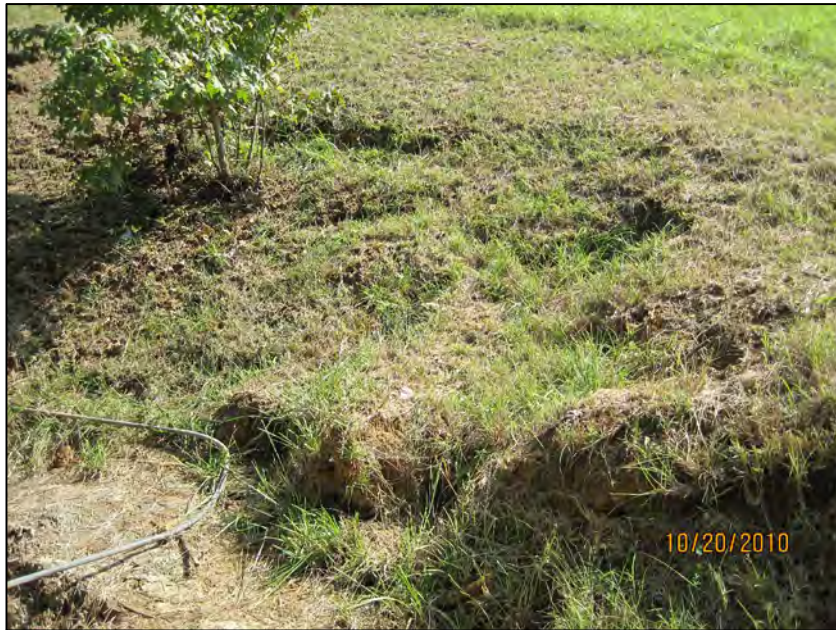
64

LANDFILL RUNOFF POND-SLUMP  
ADJACENT TO POND DISCHARGE VALVE
