Report of Dam Safety Assessment of Coal Combustion  
Surface Impoundments  
Central Louisiana Electric Company (Cleco)  
American Electric Power (AEP)  
Southwest Electric Power Company (SWEPCO)  
Dolet Hills Power Station, Mansfield, LA

AMEC Project No. 3-2106-0183.0004

May 2011

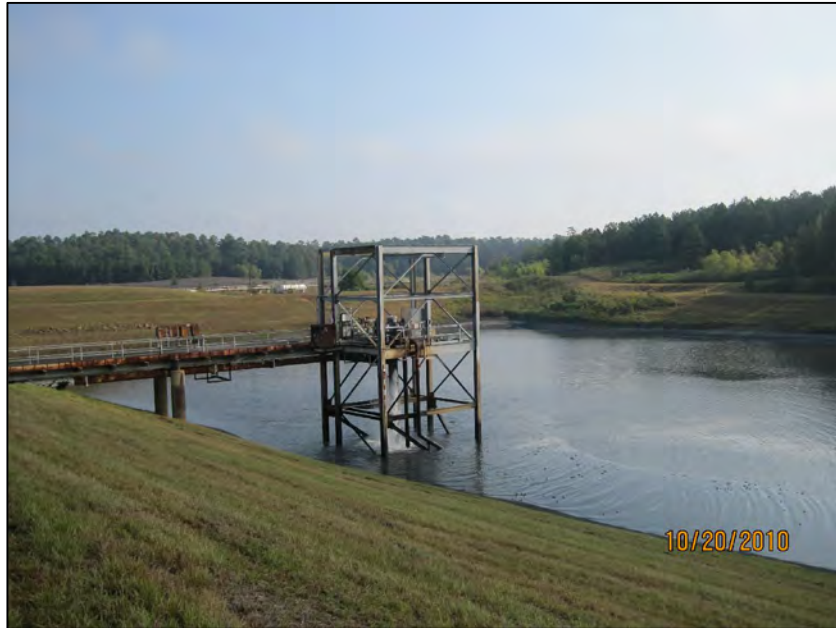
1

**SECONDARY ASH POND-INFLUENT STRUCTURE**

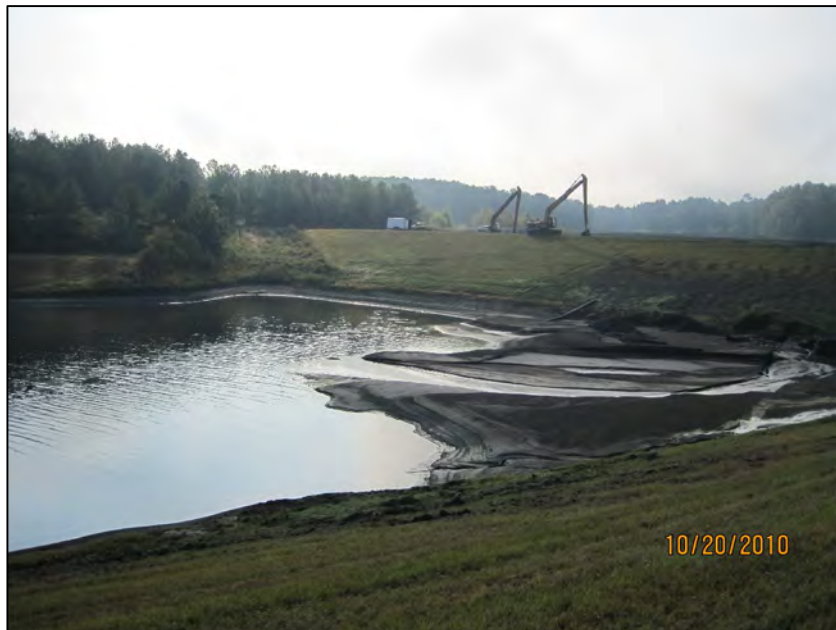
2

**SECONDARY ASH POND-LOOKING SOUTHEAST FROM CREST**

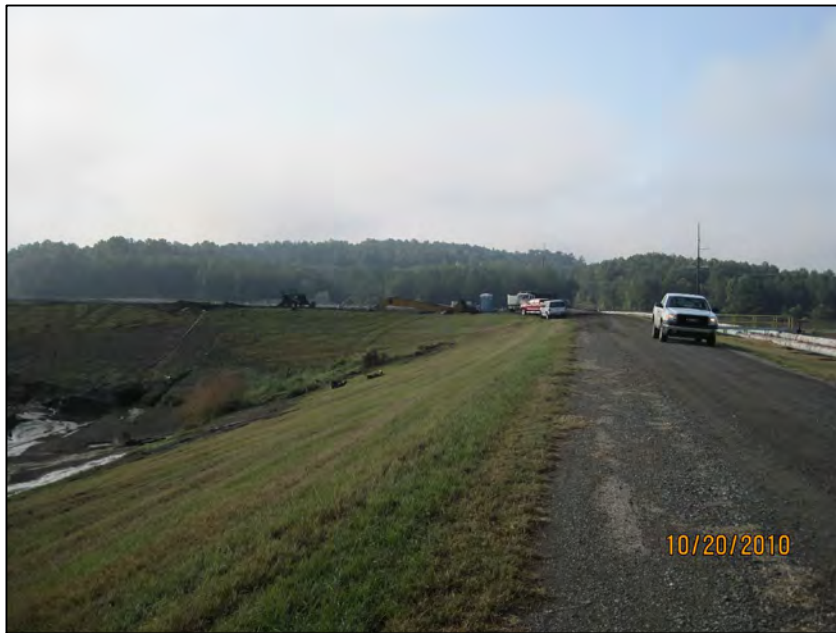
3

SECONDARY ASH POND-LOOKING SOUTH FROM CREST

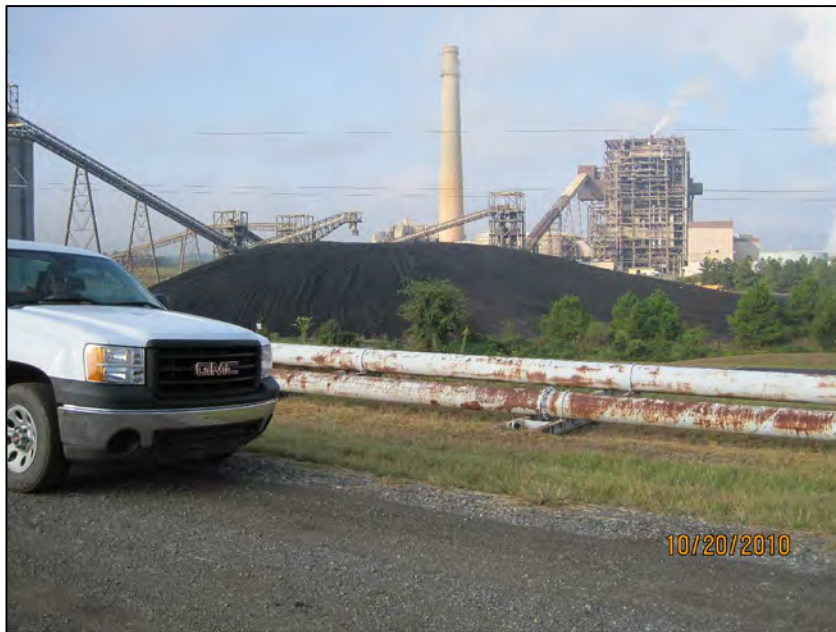
4

SECONDARY ASH POND-LOOKING SOUTHWEST FROM CREST

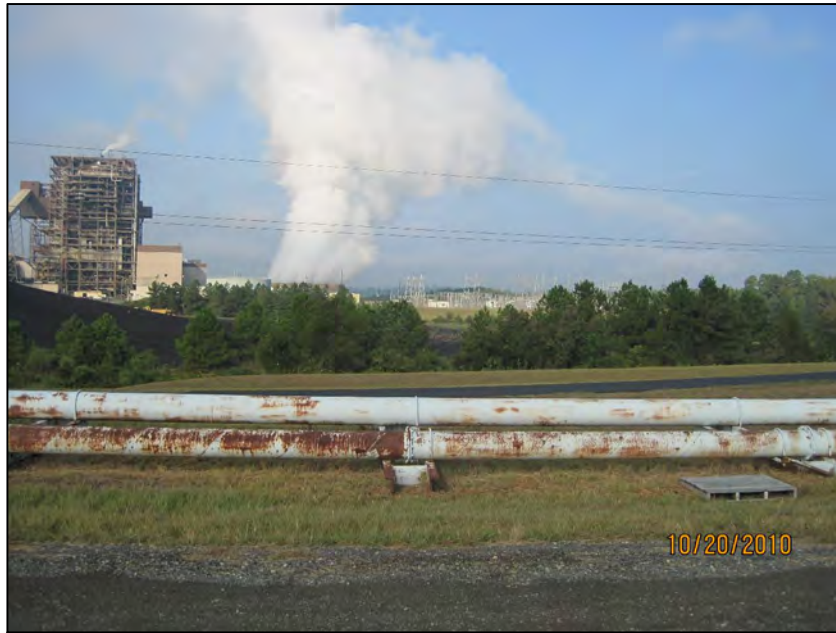
5

SECONDARY ASH POND-LOOKING WEST FROM CREST

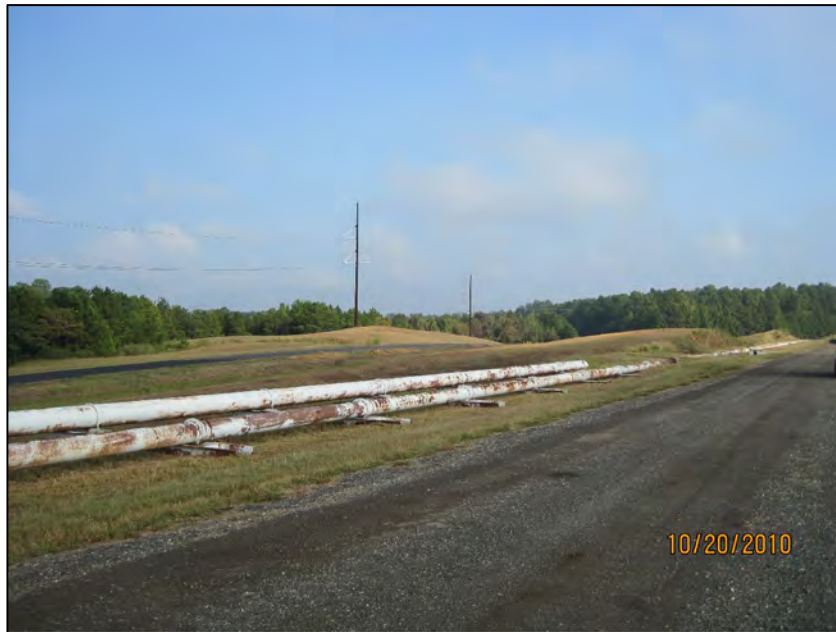
6

SECONDARY ASH POND-LOOKING NORTHWEST FROM CREST

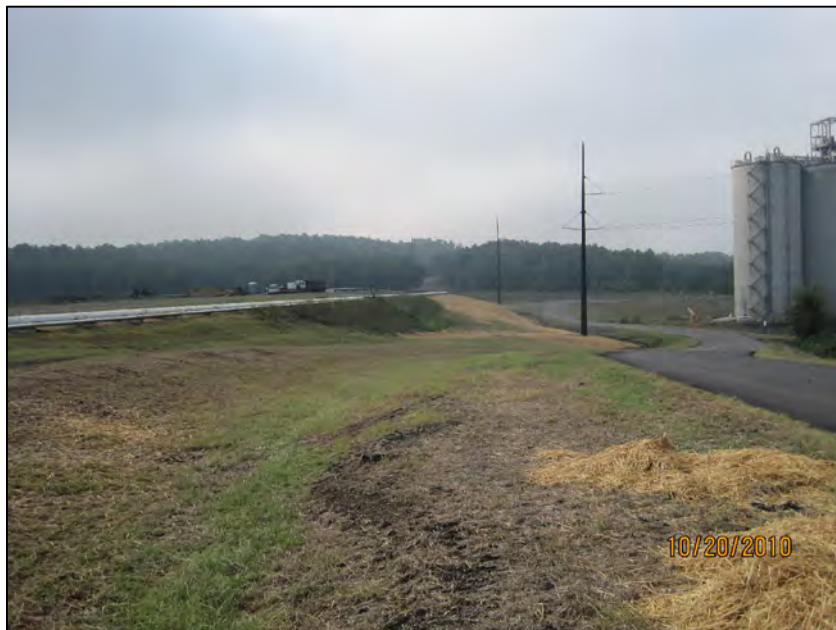
8

Large, dual stormwater culverts were located at the western downstream toe and drain to the west beneath a lower roadway (Photo 33). The northernmost culvert was noted to be half clogged with sediment; additionally, running water, possibly seepage, was noted on the ground upstream of the culverts (Photo 34). Woven and plastic liner was noted to be in place on the southwestern portions of the downstream slope repair (Photos 35 and 36). Facility personnel indicated that plans were to install rip rap in locations where the liner material is currently places once a grass cover begins to grow. An area of erosion was noted on a drainage swale that was outside (west) of the downstream embankment toe of Ash Pond 2 (Photo 37). Additional stormwater culverts were located directly west of the internal embankment shared by Ash Pond 2 and the Secondary Ash Pond, and are aligned to carry runoff from the toe of the main embankment to the west under the lower roadway (Photos 38, 39, and 40). Additional repair and seeding work was evident along the lower roadway located west of the Secondary Ash Pond portion of the main embankment (Photos 7 and 8).

**SECONDARY ASH POND-LOOKING SOUTH ALONG  
ROADWAY WEST OF ASH POND EMBANKMENTS**

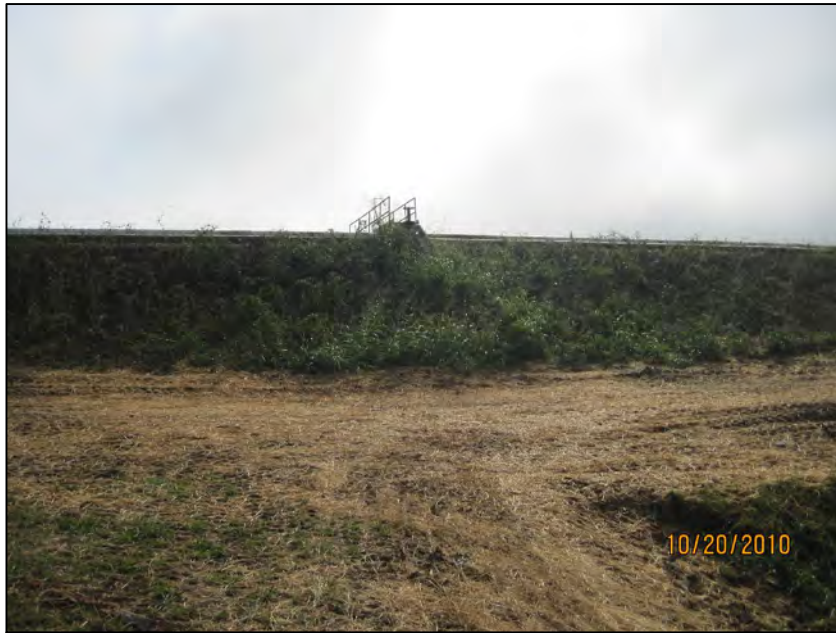
9

**SECONDARY ASH POND-LOOKING EAST AT SECONDARY ASH POND DISCHARGE PIPE AND VALVE OPERATOR (LPDES OUTFALL 002)**

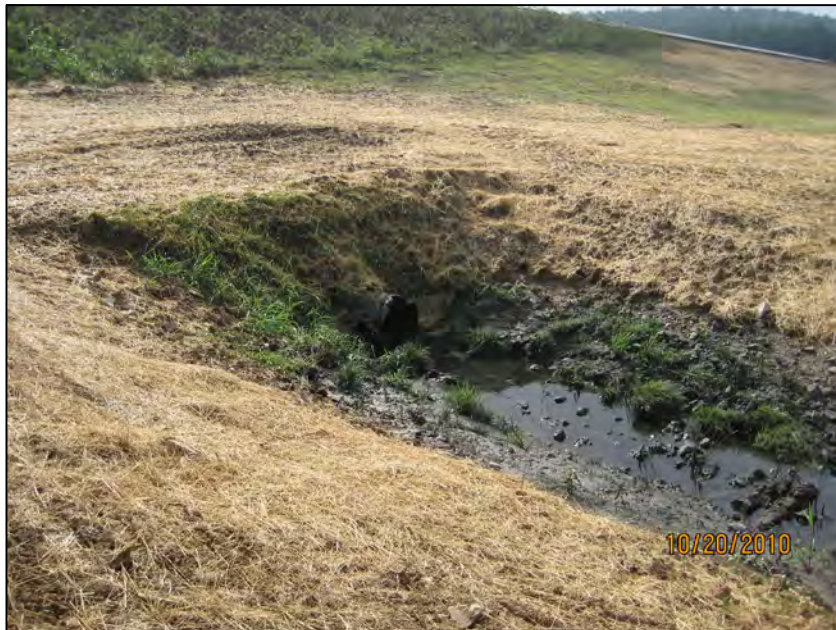
10

**SECONDARY ASH POND-LOOKING SOUTH AT LPDES OUTFALL 002 DOWNSTREAM PIPE DISCHARGE AND CHANNEL ENTRANCE**

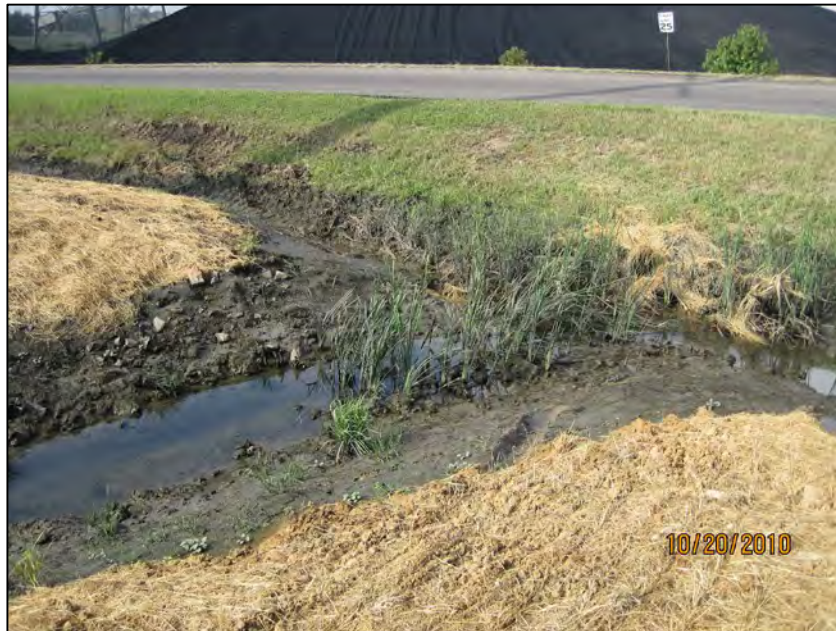
11

**SECONDARY ASH POND-LOOKING SOUTHWEST  
AT LPDES OUTFALL 002 CHANNEL**

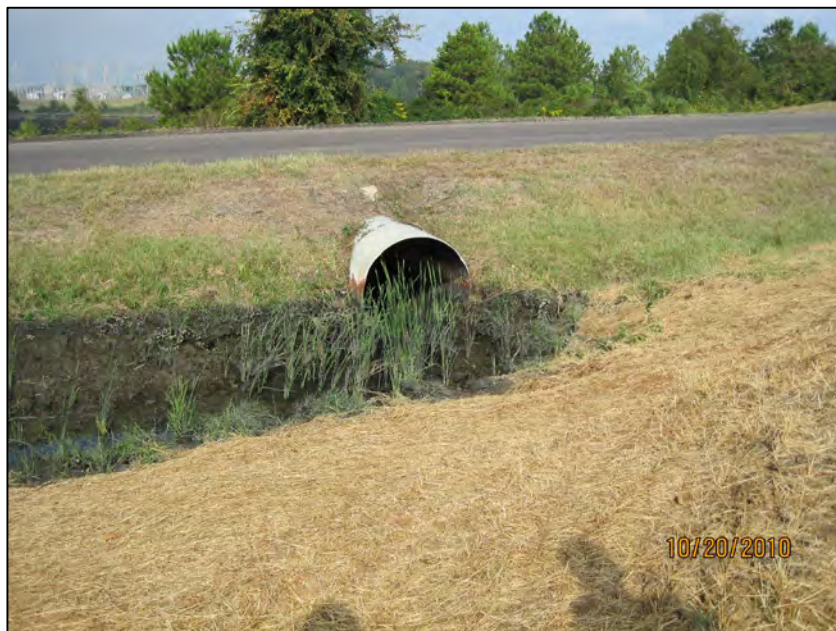
12

**SECONDARY ASH POND-LOOKING WEST AT LPDES  
OUTFALL 002 CHANNEL AND PIPE CULVERT UNDER ROADWAY**

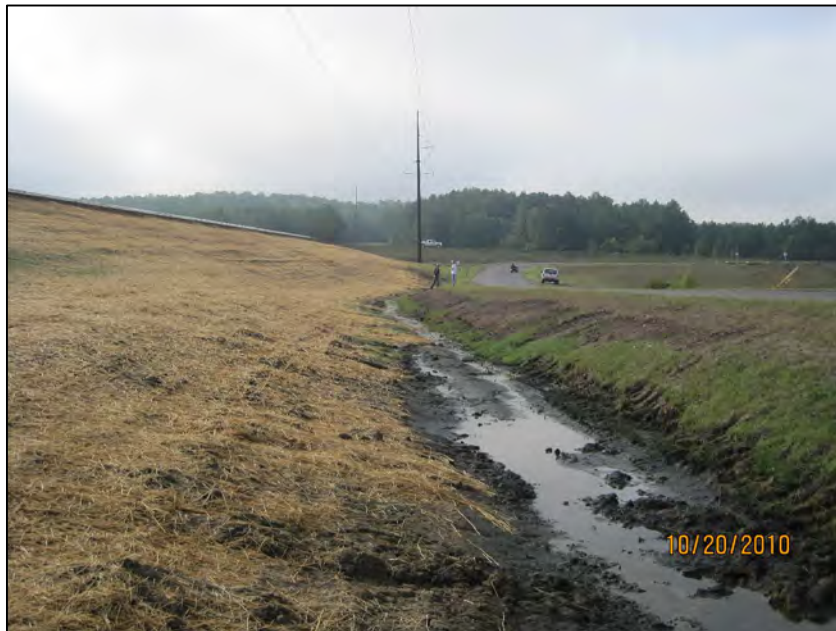
13

**SECONDARY ASH POND-LOOKING SOUTH AT DRAINAGE  
SWALE ALONG ROAD BELOW POND EMBANKMENT**

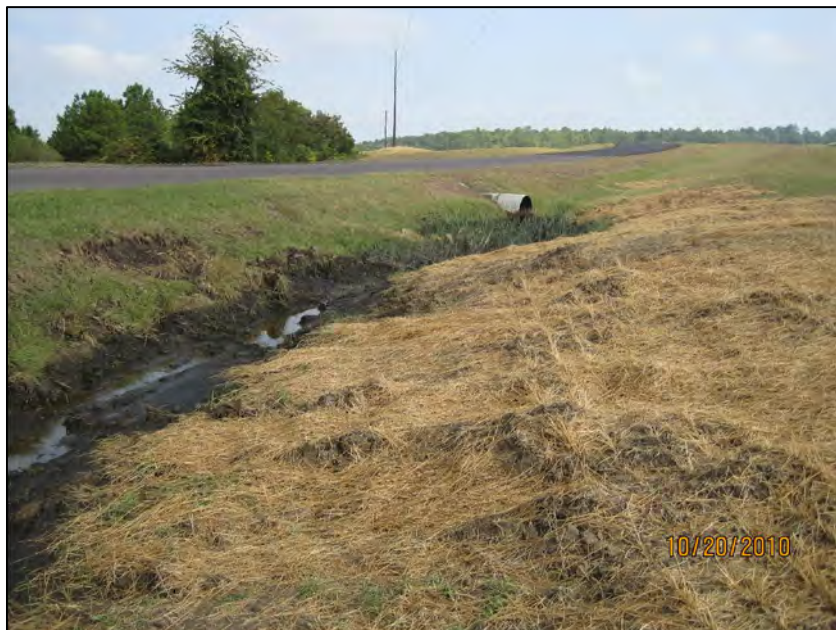
14

**SECONDARY ASH POND-LOOKING NORTH AT  
DRAINAGE SWALE ALONG ROAD BELOW POND EMBANKMENT**

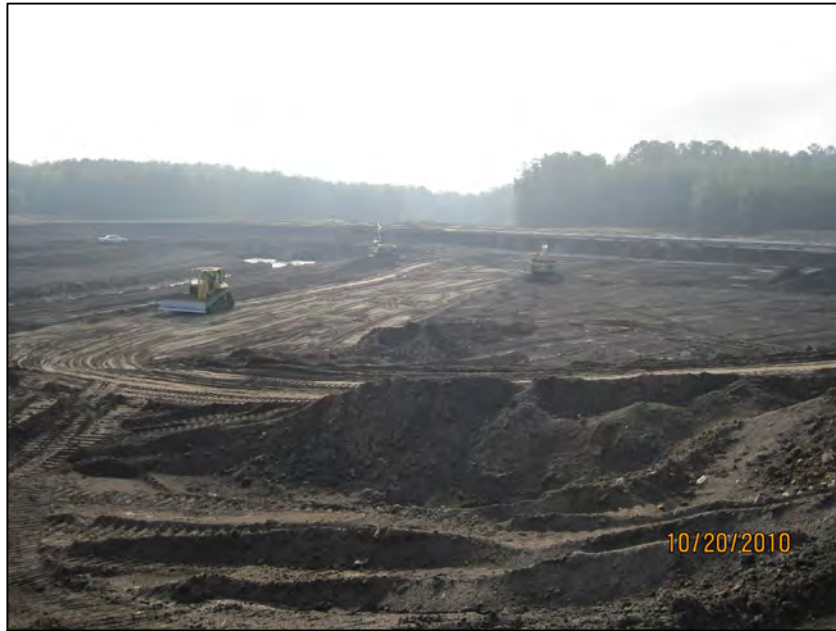
17

ASH POND 1-LOOKING SOUTHEAST ACROSS POND

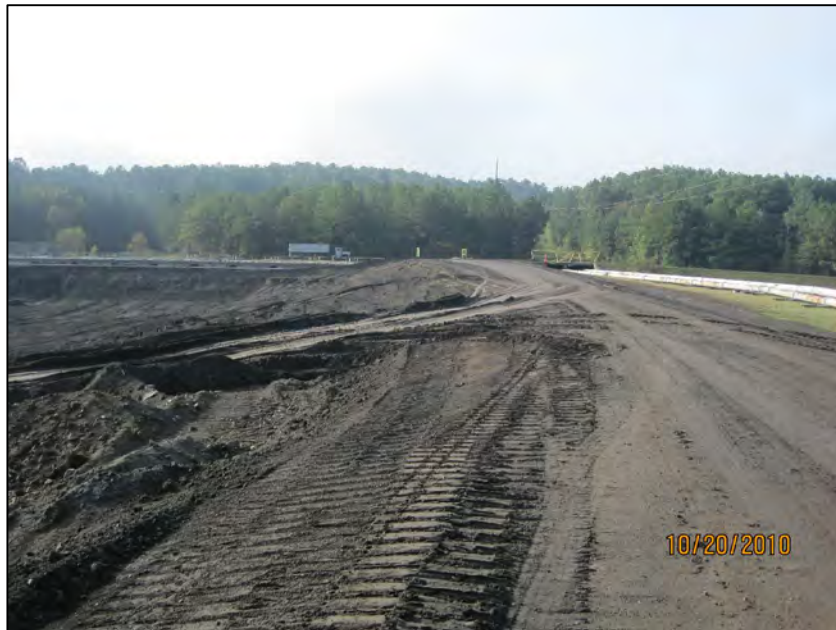
18

ASH POND 1-LOOKING SOUTH ALONG CREST

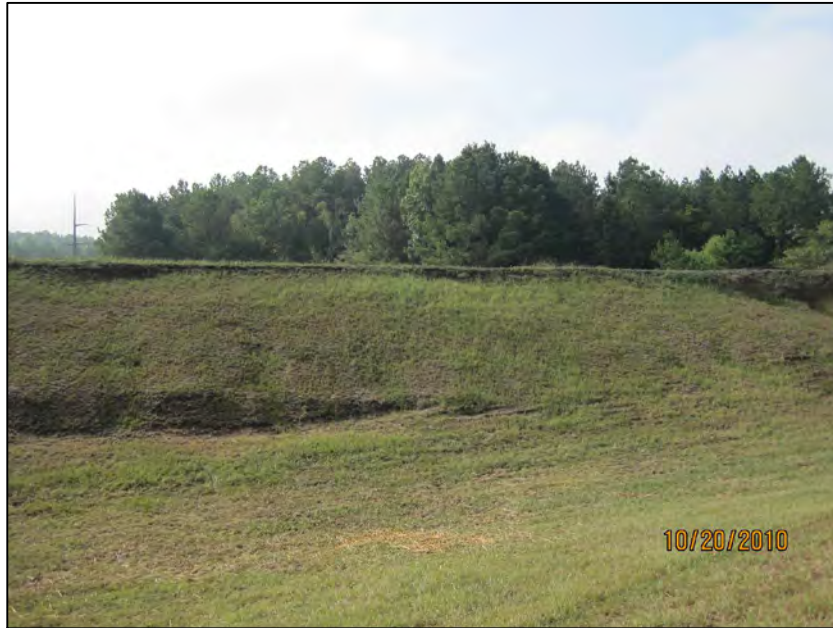
21

**ASH POND 1-LOOKING SOUTHWEST AT EROSION ON SIDE OF  
ROADWAY LEADING TO ASH POND 1 EMBANKMENT CREST**

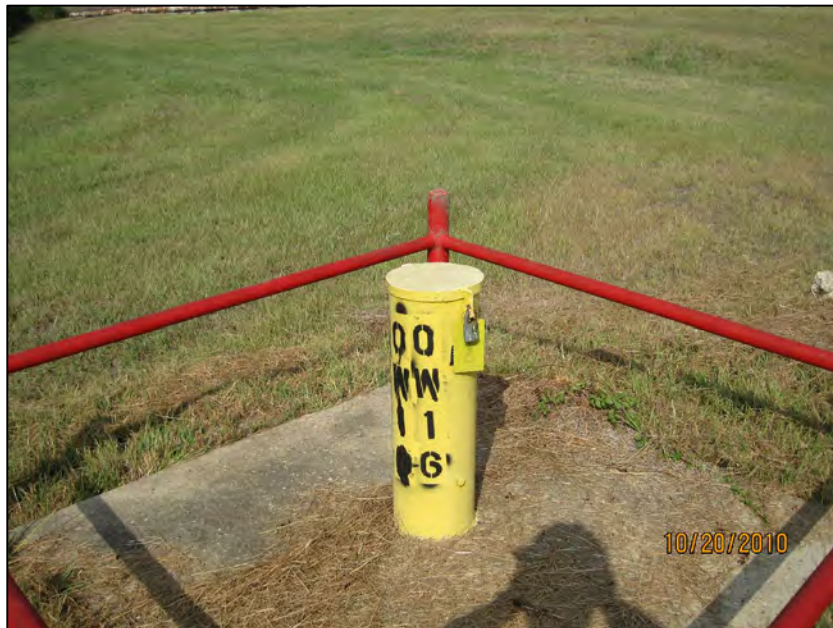
22

**ASH POND 1-MONITORING WELL 16  
LOCATED ADJACENT TO ASH POND 1**

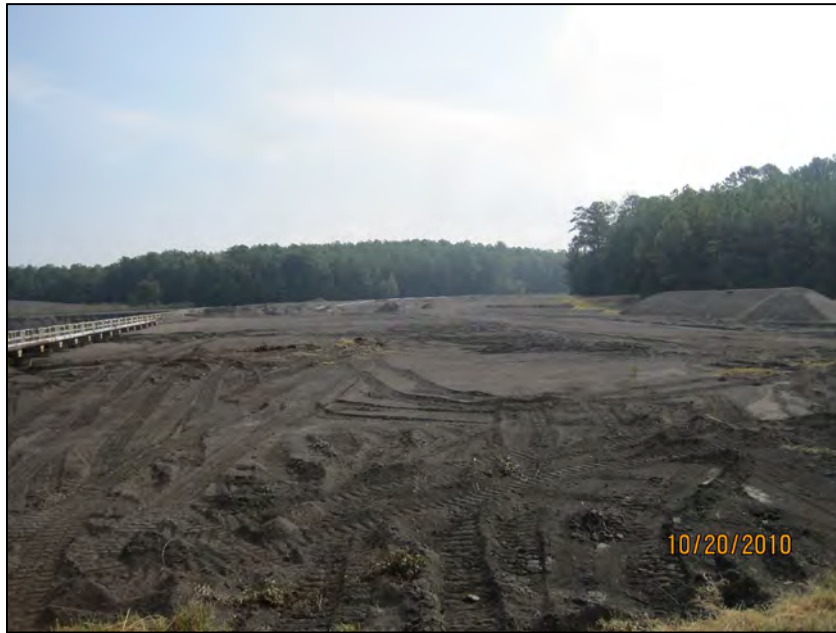
23

ASH POND 1-VIEW FROM SOUTH END OF EMBANKMENT LOOKING EAST

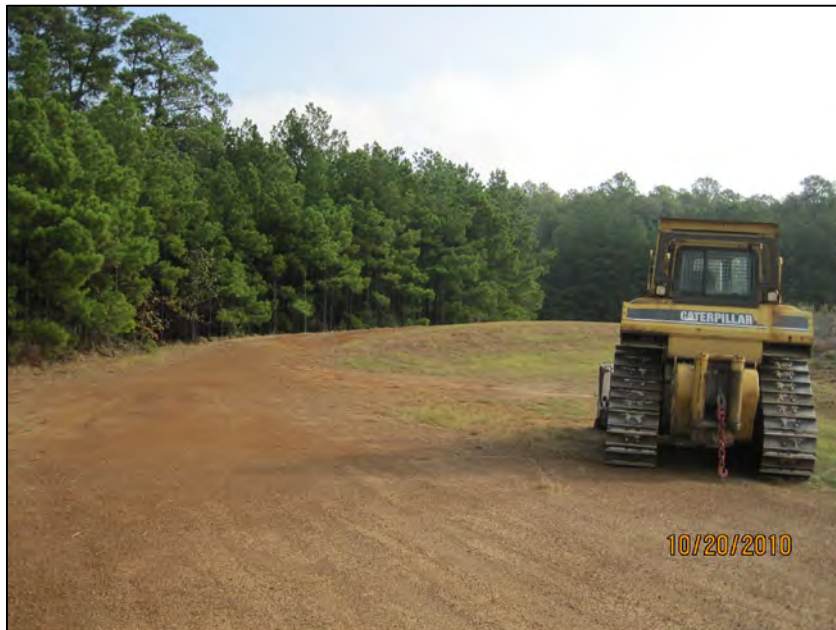
24

The main embankment wraps around the north end of Ash Pond 2 (Photo 24). Ash was noted stacked just inside the embankment on much of the upper portions of Ash Pond 2 (Photos 25 and 26). The ground along the downstream embankment toe adjacent to Ash Pond 2 is sloped quite heavily from the north to the west of the ash pond as well as from the southwestern toe to the west (Photos 28, 29, 32, and 35). Much of the area had been recently repaired and seeded.

ASH POND 2-LOOKING NORTHEAST FROM CREST

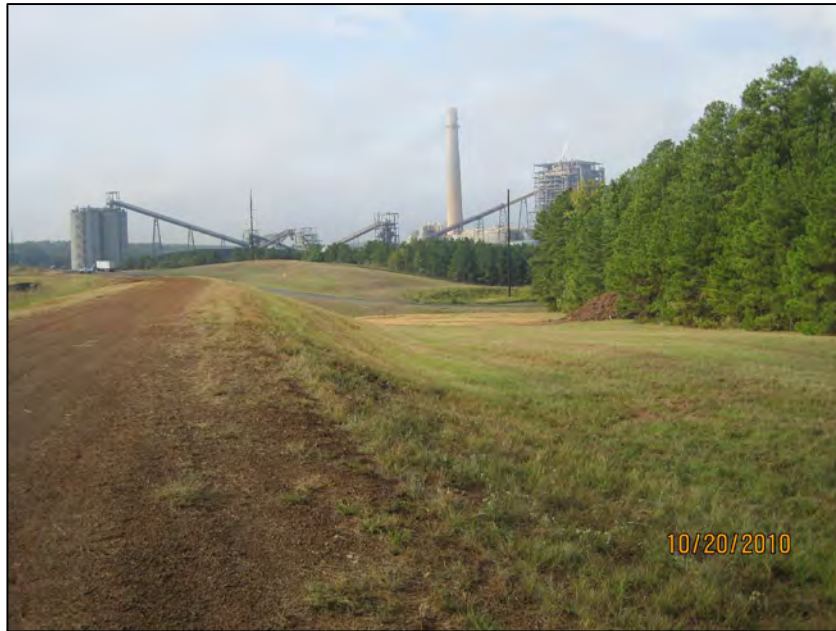
**27**  
**ASH POND 2-LOOKING SOUTHWEST  
TOWARD PLANT FROM EMBANKMENT**

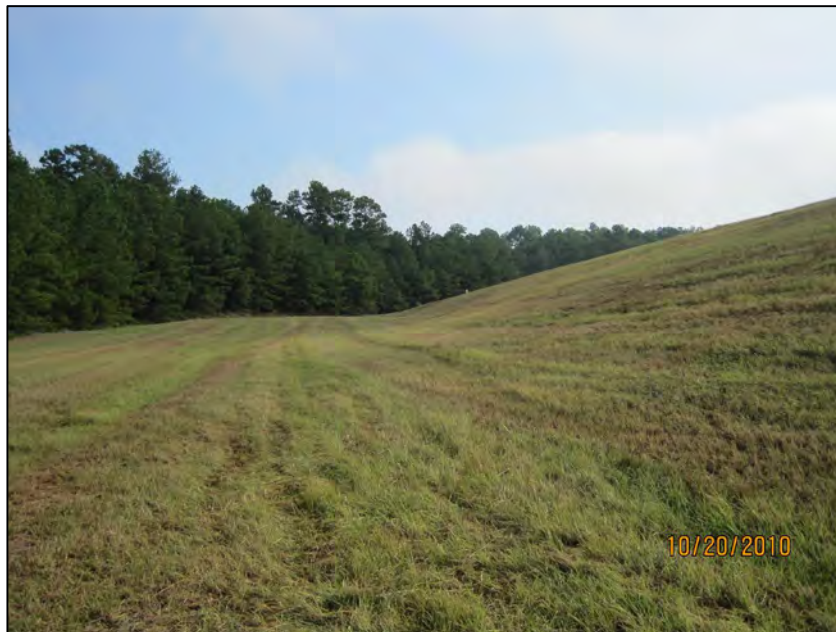
**28**  
**ASH POND 2-LOOKING NORTHEAST  
ALONG DOWNSTREAM EMBANKMENT FACE**

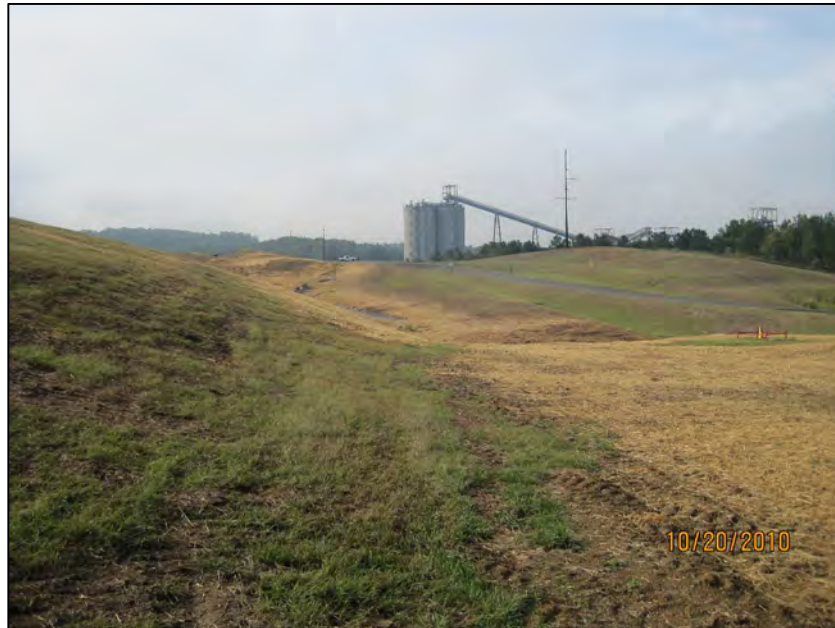
29

**ASH POND 2-LOOKING SOUTHWEST AT RESEEDING  
ALONG DOWNSTREAM EMBANKMENT FACE**

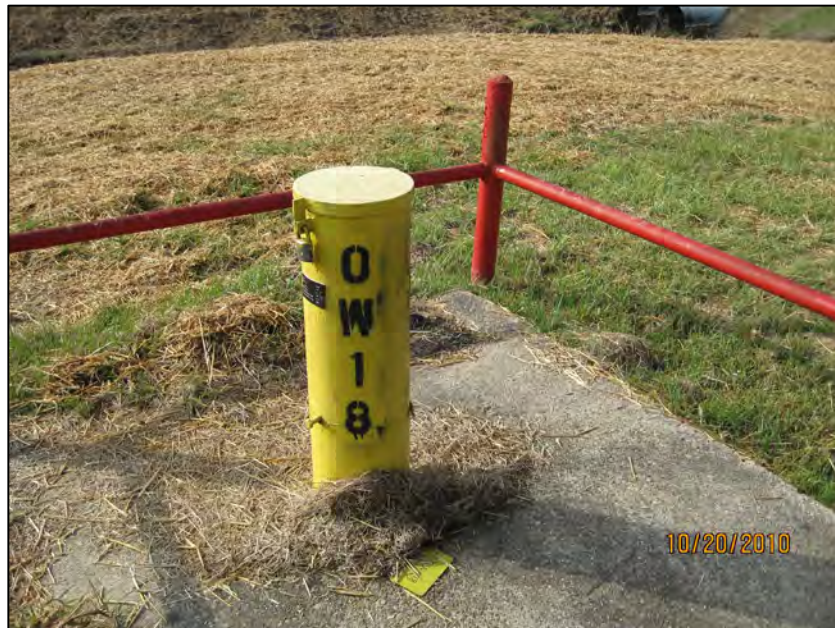
30

**ASH POND 2-OBSERVATION WELL NO. 18**

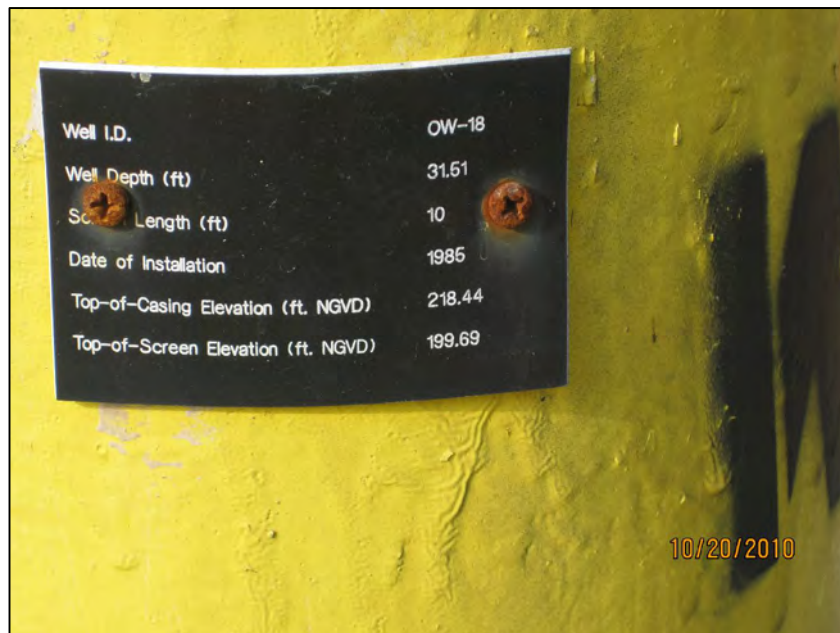
31

### ASH POND 2-EXAMPLE OF OBSERVATION WELL IDENTIFICATION PLATE

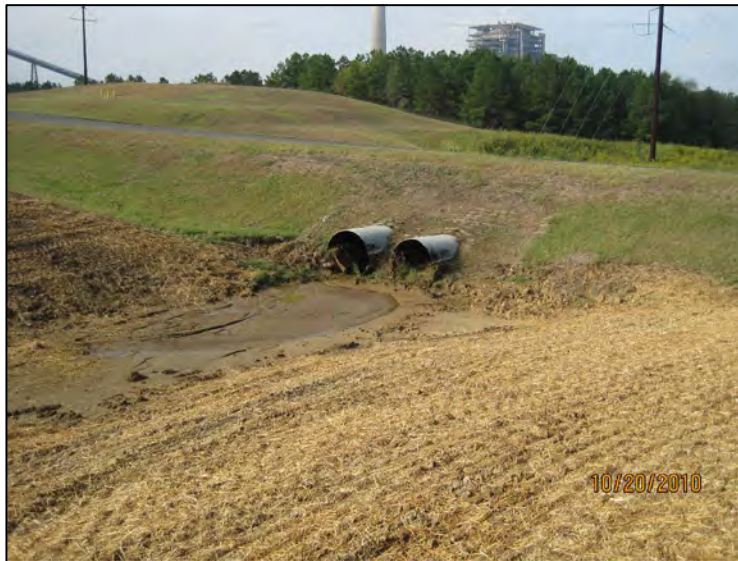
33

ASH POND 2-LOOKING WEST AT DUAL STORMWATER CULVERTS

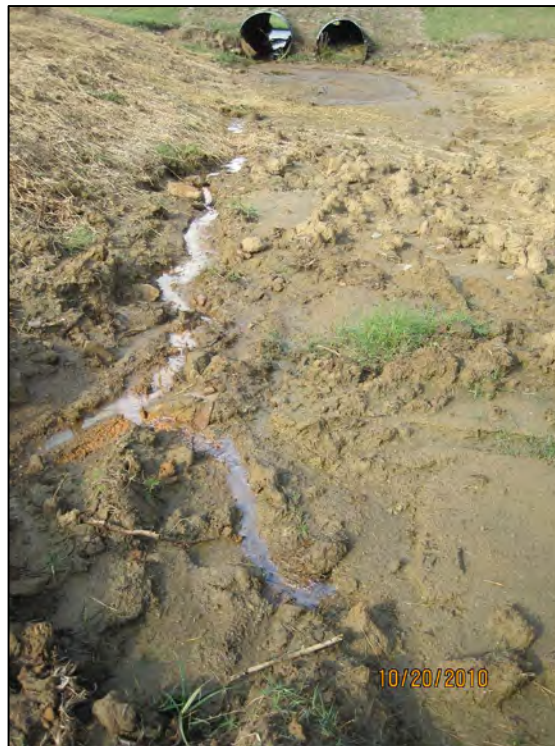
34

ASH POND 2-APPARENT SEEPAGE UPSTREAM OF STORMWATER CULVERTS, RIGHT (NORTH) CULVERT HALF FILLED WITH SEDIMENT

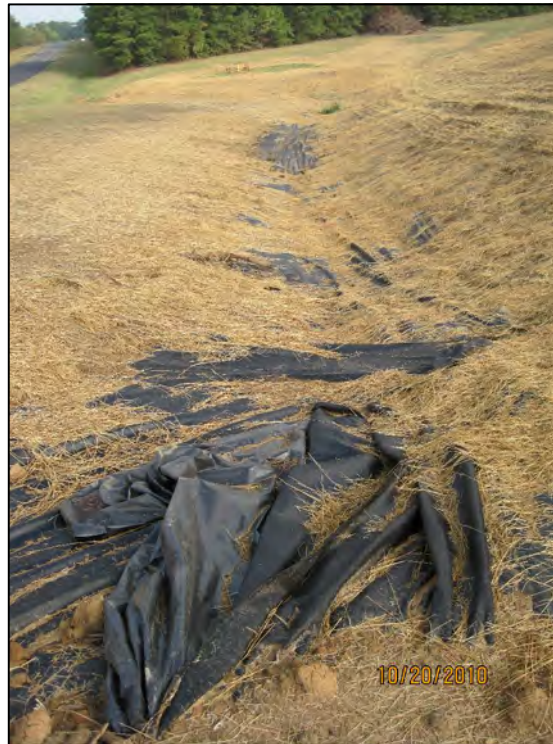
35

**ASH POND 2-LOOKING NORTH ALONG LINED  
DRAINAGE SWALE AT EMBANKMENT TOE**

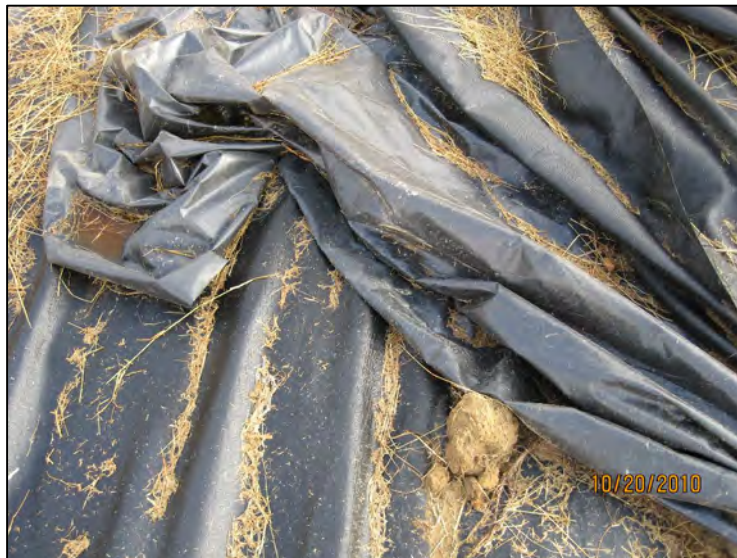
36

**ASH POND 2-WOVEN AND PLASTIC FABRIC  
DRAINAGE SWALE PROTECTION**

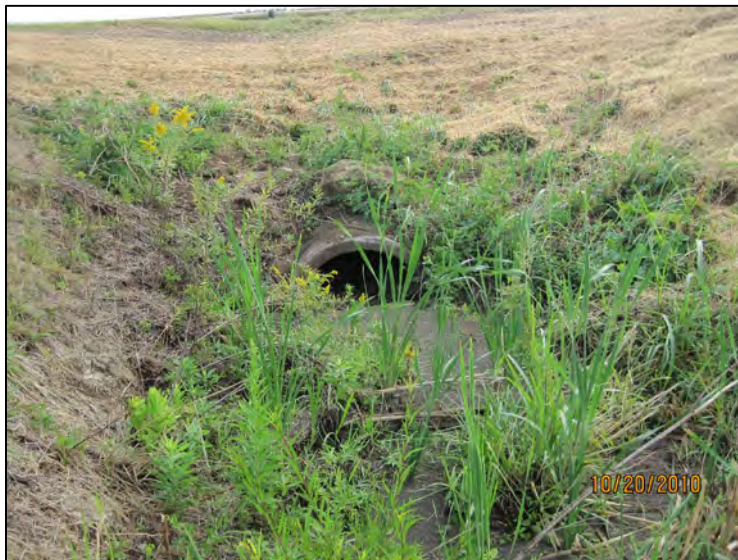
38

**ASH POND 2-LOOKING UPSTREAM (EAST) AT  
ROADWAY EMBANKMENT STORM DRAIN**

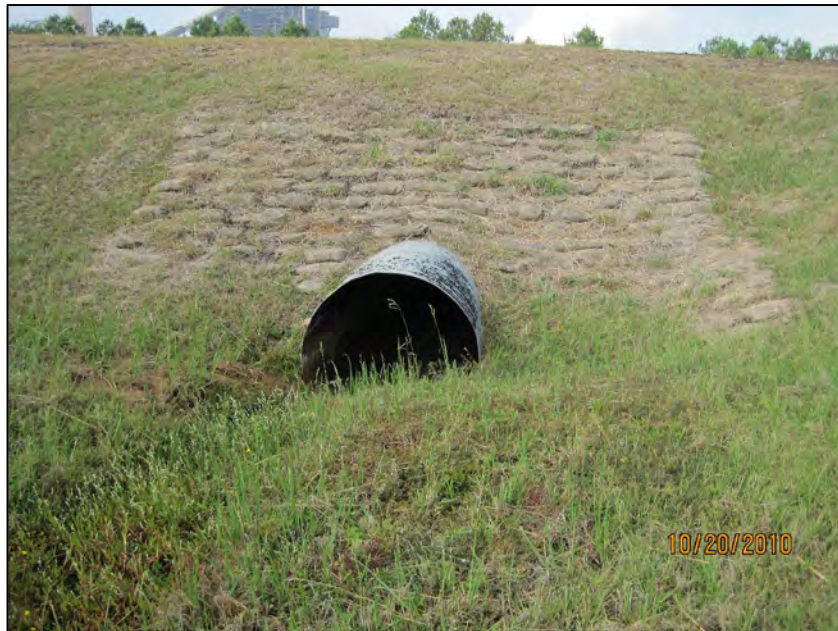
39

**ASH POND 2-LOOKING DOWNSTREAM (WEST)  
AT ROADWAY EMBANKMENT STORM DRAIN**

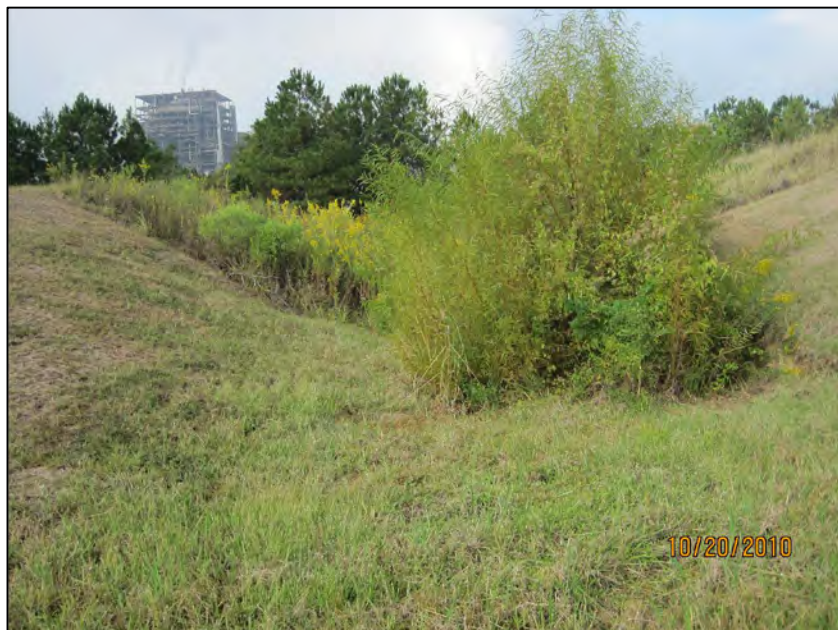
40

**ASH POND 2-LOOKING DOWNSTREAM (WEST)  
AT ROADWAY EMBANKMENT STORM DRAIN**

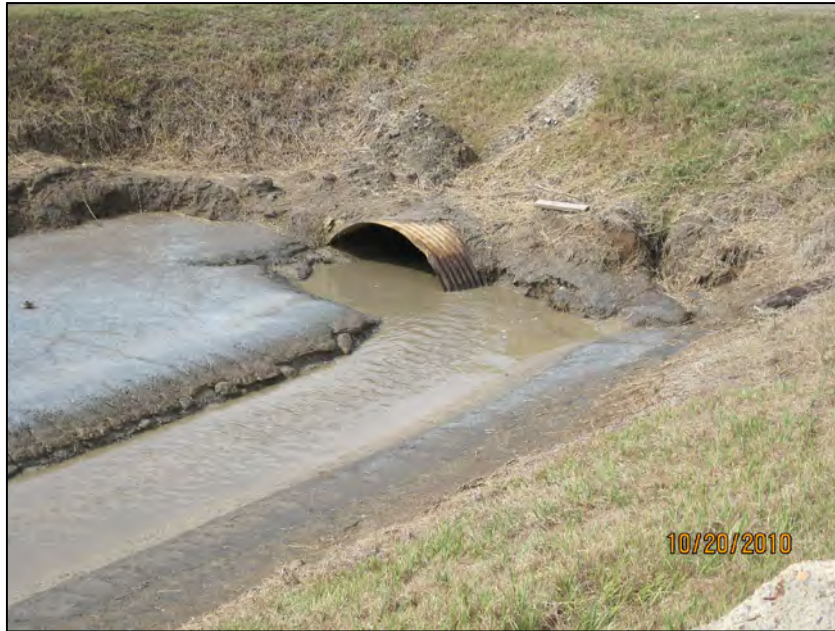
43

**AUXILIARY SURGE POND-DISCHARGE RECEIVING CHANNEL**

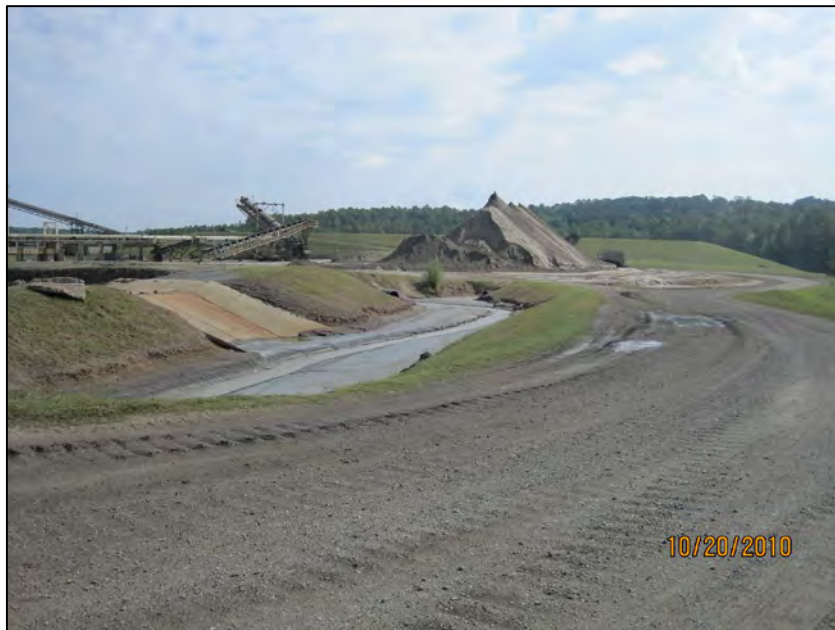
44

**AUXILIARY SURGE POND-LOOKING  
EAST FROM SOUTHWEST CORNER**

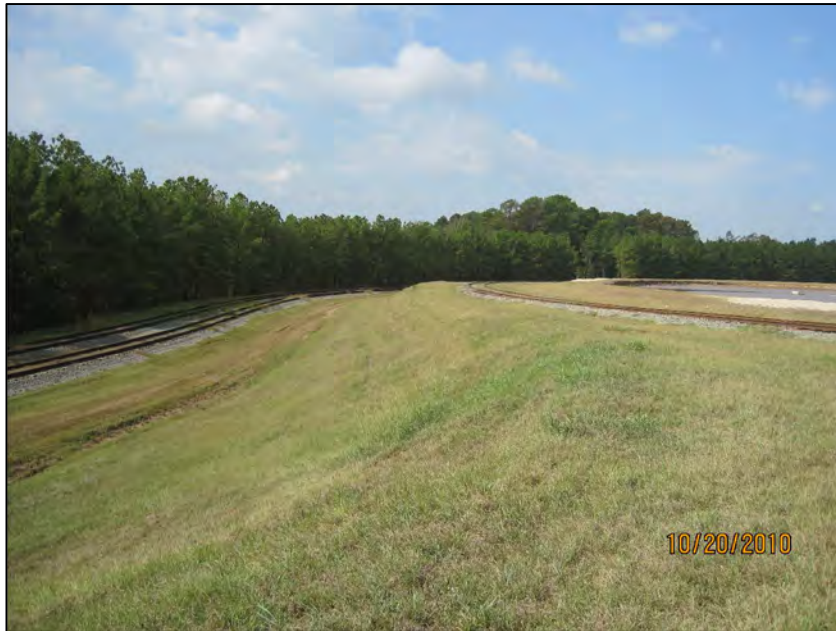
45

**AUXILIARY SURGE POND-LOOKING WEST FROM  
SOUTHWEST CORNER ALONG SURGE POND 1 EMBANKMENT**

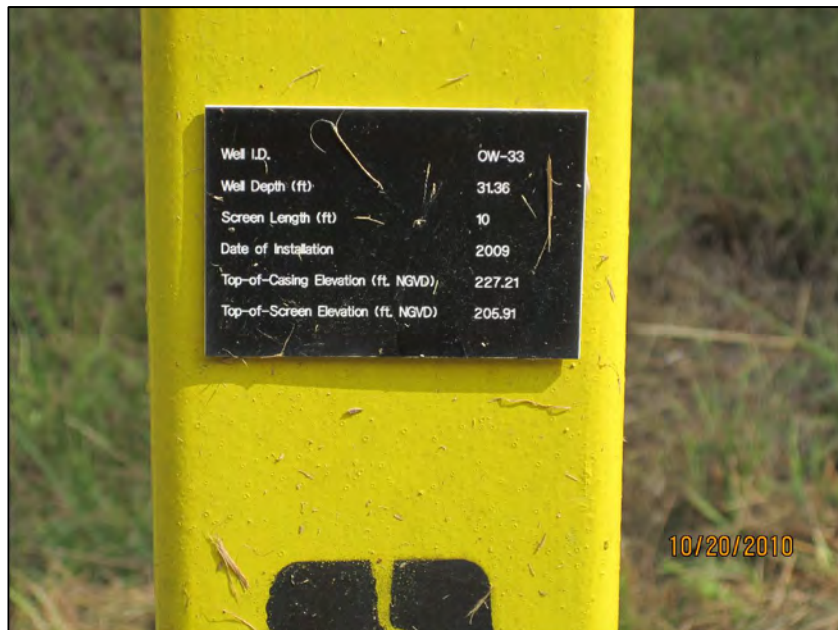
46

**MONITORING WELL 33 LOCATED SOUTHEAST OF AUXILIARY SURGE POND**

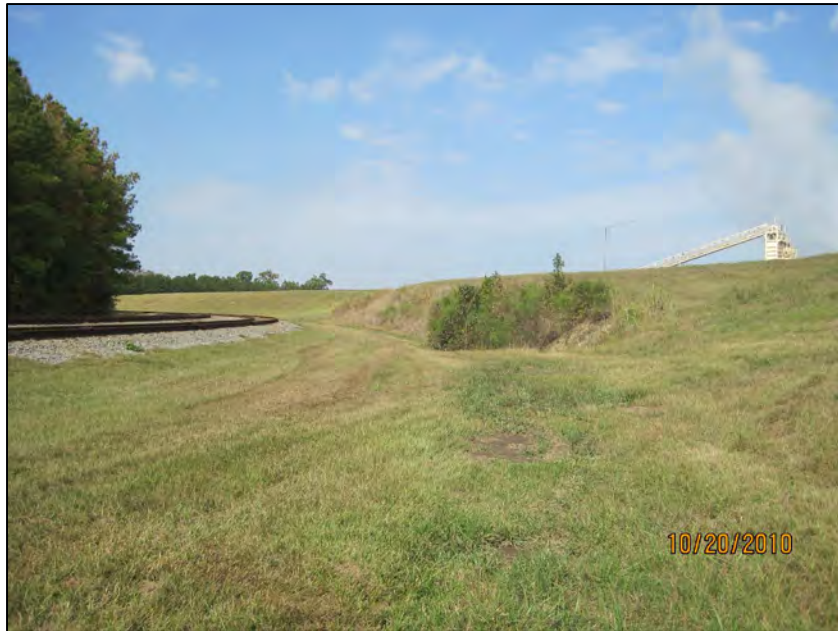
47

LOOKING NORTHWEST ALONG BOTTOM OF EMBANKMENT ADJACENT TO  
AUXILIARY SURGE POND-SEE SURGE POND 1 EMBANKMENT IN DISTANCE

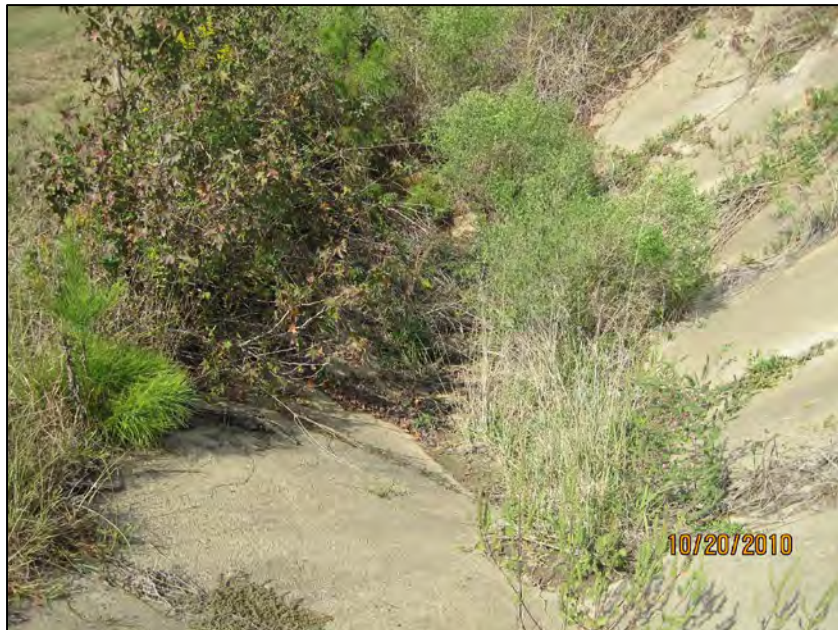
48

CONCRETE WELL BELOW AUXILIARY SURGE  
POND EMBANKMENT WITH 18-INCH CMP EXITING TO LEFT (WEST)

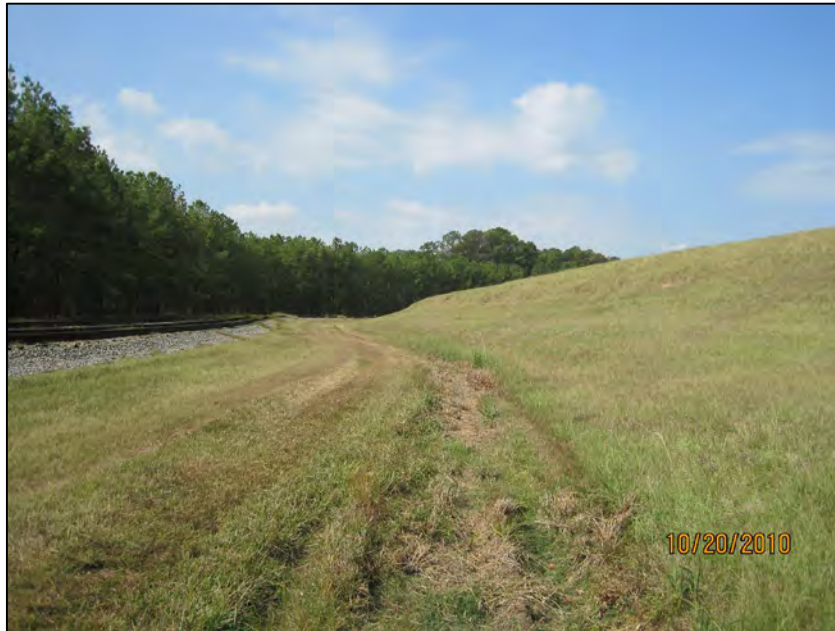
49

**BELOW AUXILIARY SURGE POND EMBANKMENT-LOOKING  
WEST ALONG SURGE POND 1 EMBANKMENT**

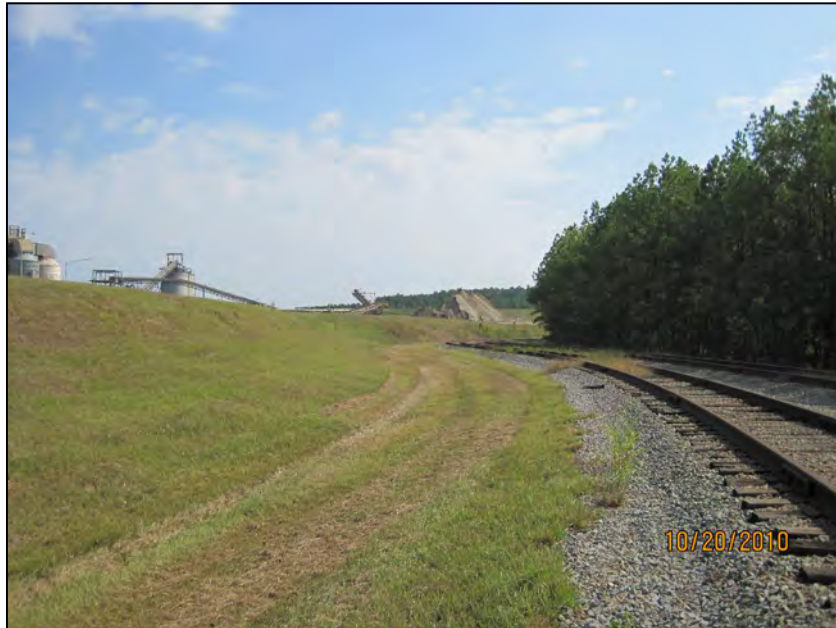
51

**SURGE POND 1-LOOKING EAST ALONG SOUTHERN EMBANKMENT**

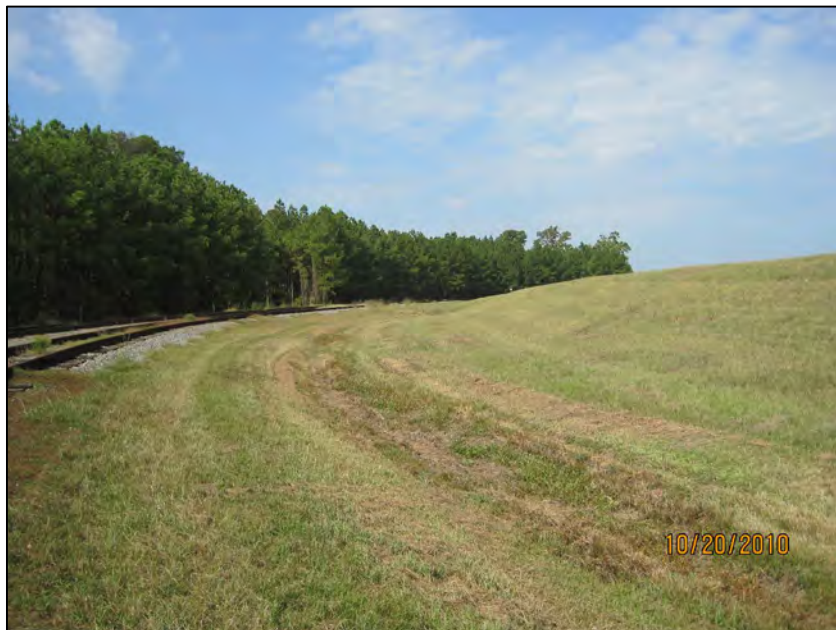
52

**SURGE POND 1-LOOKING WEST ALONG SOUTHERN EMBANKMENT**

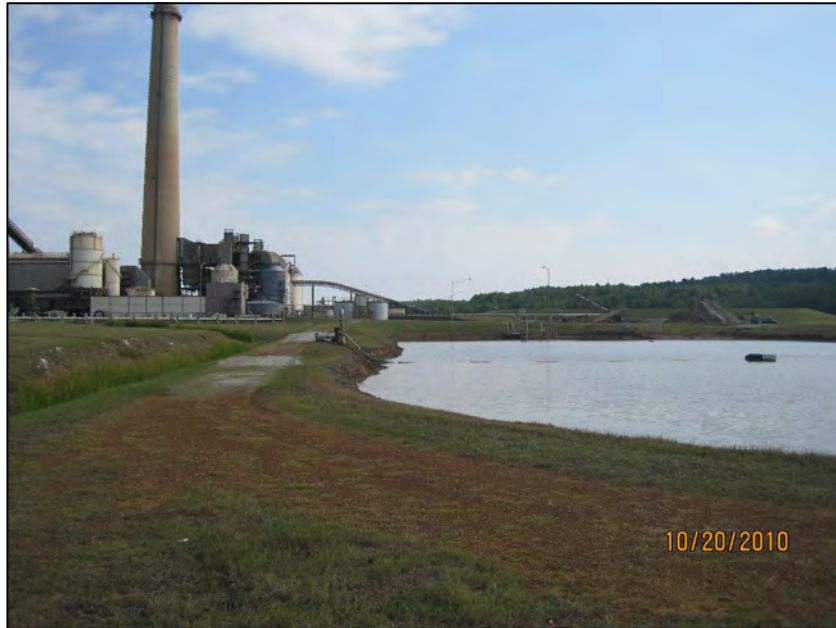
53

**SURGE POND 1-LOOKING EAST ACROSS NORTHERN CREST**

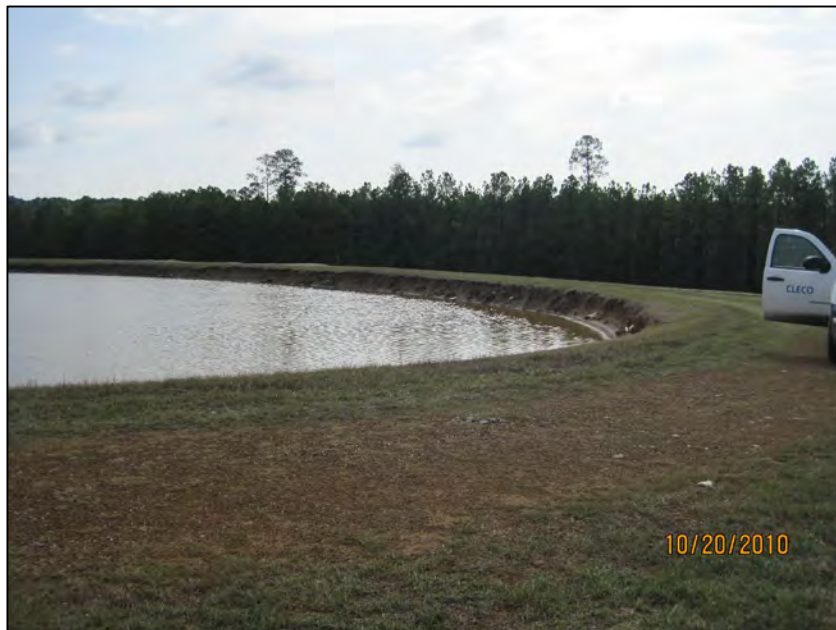
54

**SURGE POND 1-LOOKING SOUTHEAST ACROSS WEST END**
