Report of Dam Safety Assessment of Coal Combustion  
Surface Impoundments  
Central Louisiana Electric Company (Cleco)  
American Electric Power (AEP)  
Southwest Electric Power Company (SWEPCO)  
Dolet Hills Power Station, Mansfield, LA

AMEC Project No. 3-2106-0183.0004

May 2011

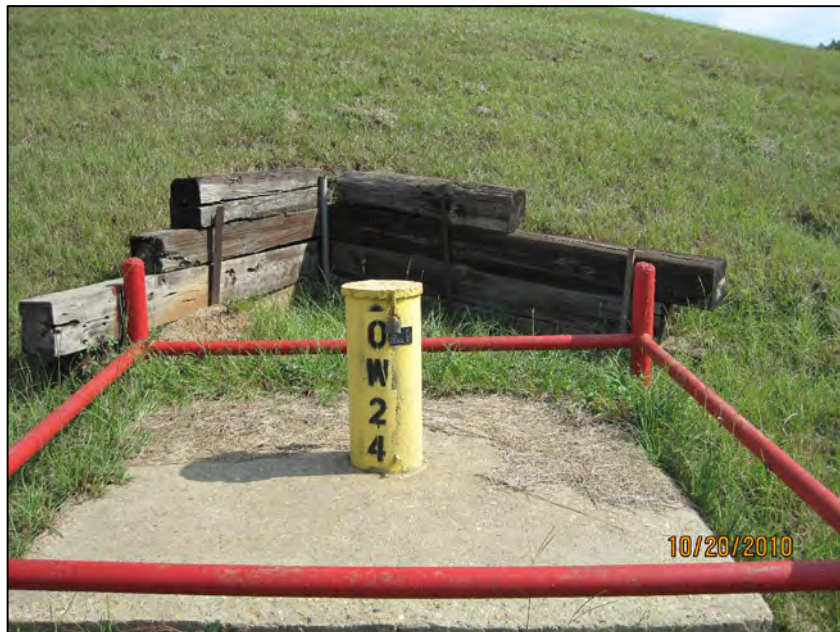
56

**SURGE POND 2-MONITORING WELL 24 LOCATED AT SOUTHWEST CORNER**

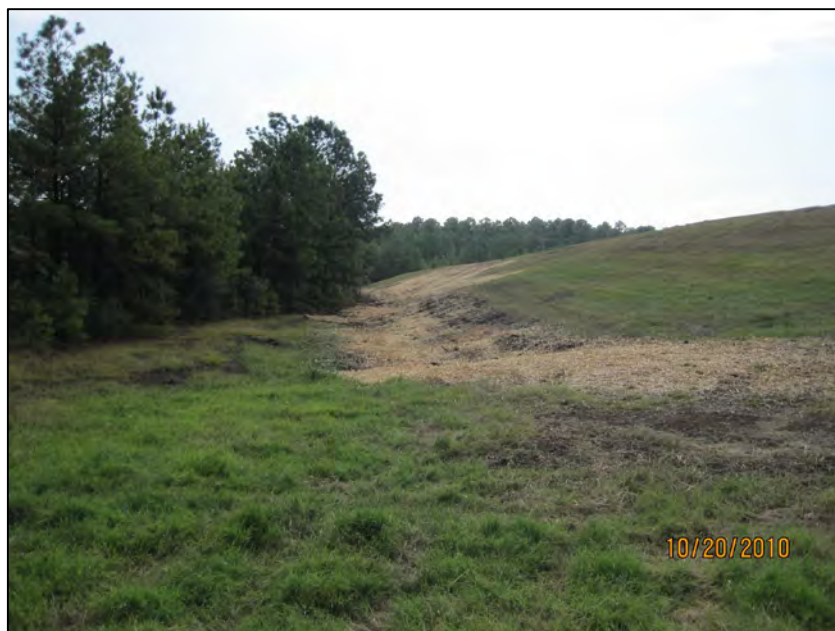
58

**SURGE POND 2-LOOKING SOUTH AT DOWNSTREAM EMBANKMENT**

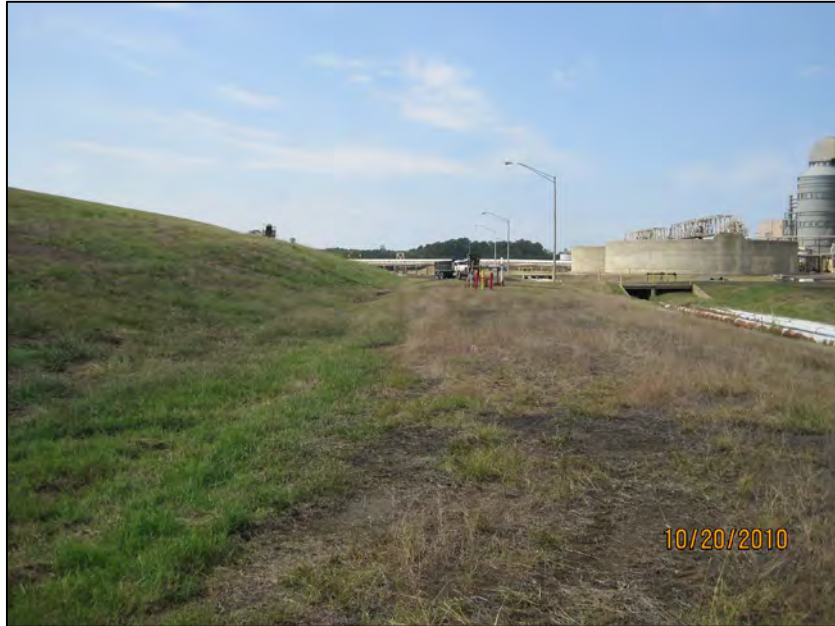
59

**SURGE POND 2-LOOKING WEST AT DOWNSTREAM EMBANKMENT**

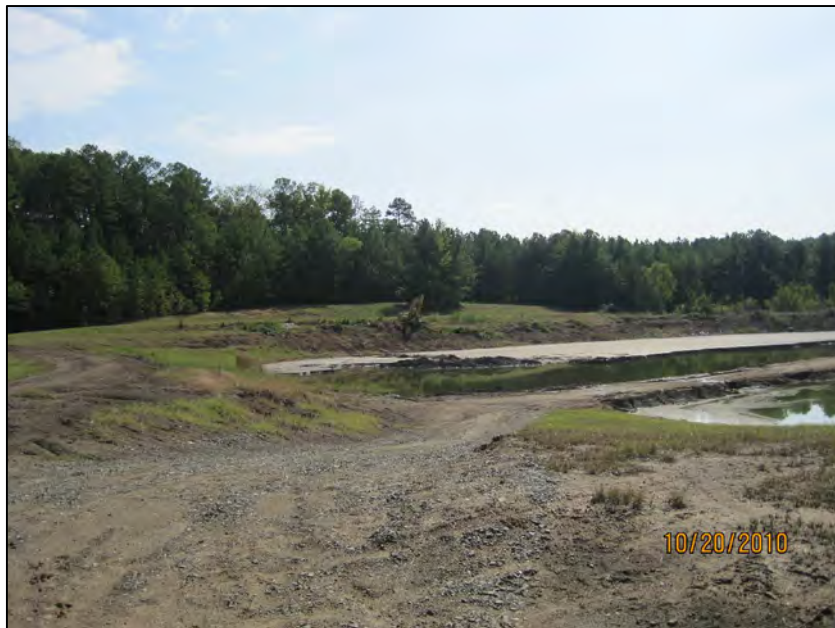
60

**LANDFILL RUNOFF POND-LOOKING  
EAST ACROSS NORTH END OF POND**

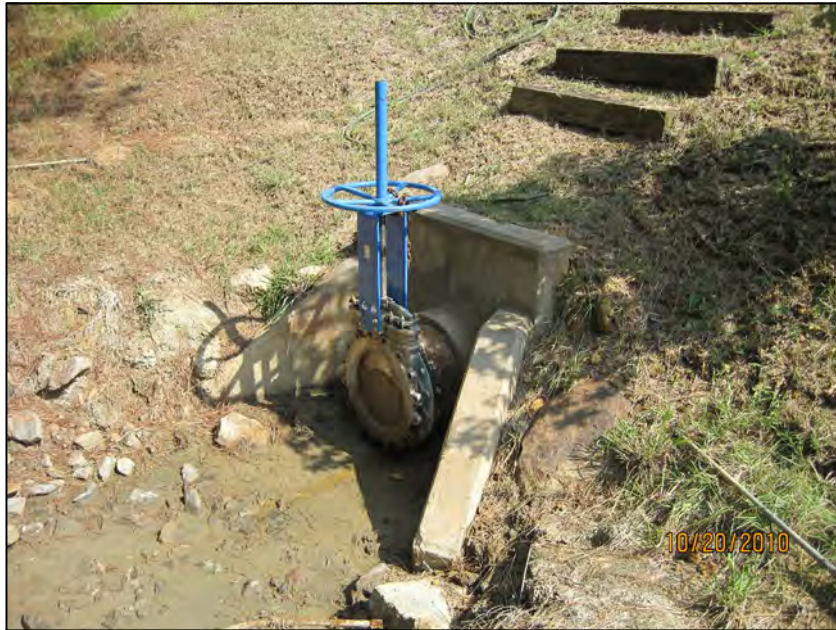
63

LANDFILL RUNOFF POND-VALVE CONTROL AT DISCHARGE

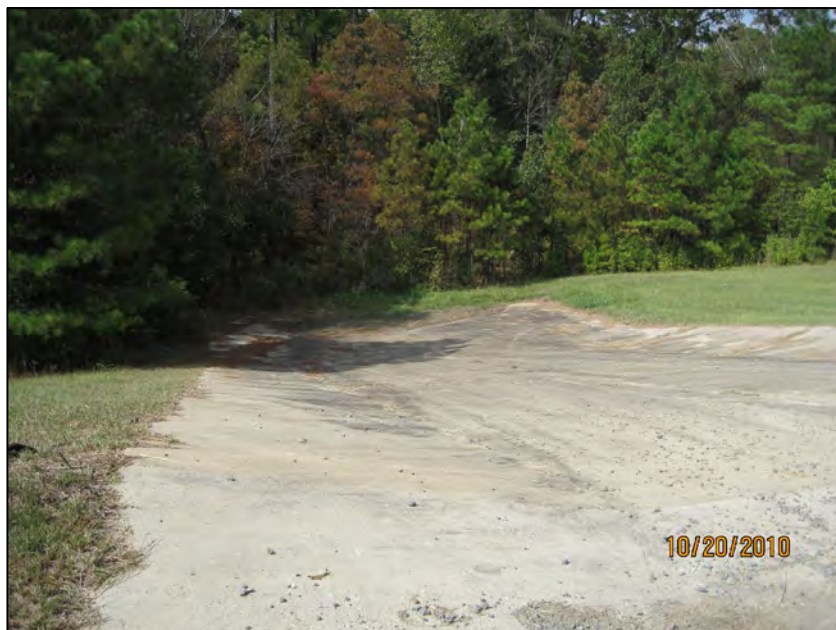
**68**  
**LANDFILL RUNOFF POND-DOWNSTREAM**  
**PORTION OF EMERGENCY SPILLWAY**
