ASSESSMENT OF DAM SAFETY OF COAL COMBUSTION SURFACE IMPOUNDMENTS – DRAFT REPORT

**CPS Energy
J.T. Deely Power Plant
San Antonio, Texas**

Prepared for
*U.S. Environmental
Protection Agency
Washington, D.C.*

December 2012
Revision 1, December 2013

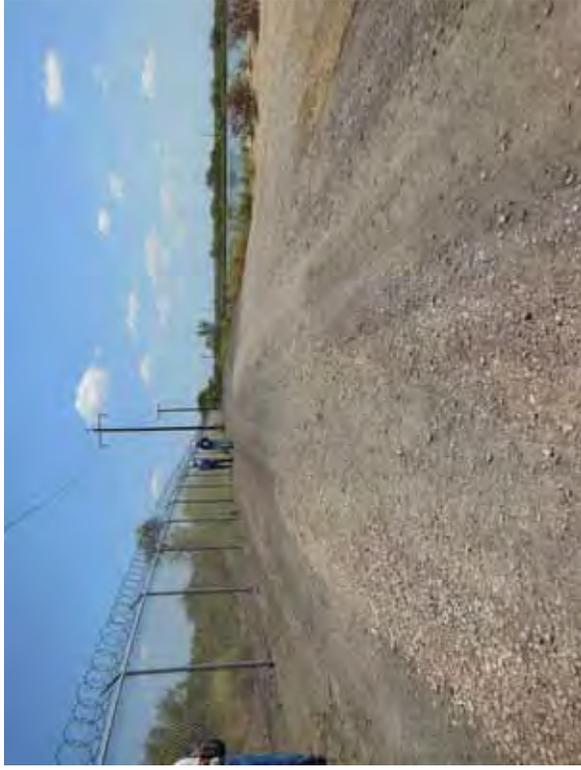
The crest of the North Bottom Ash Pond appeared to be in satisfactory condition (Photographs 1, 10, 29, and 42). The crest was approximately 15 feet wide at all embankments except the north embankment where the crest measured approximately 30 feet wide. The crest of the embankments consists of compacted granular soils and gravel and is exposed to minimal vehicle traffic. An area of erosion near a fence post was observed at the north embankment crest (Photographs 5 and 52). Wood support poles for overhead powerlines are located in the crest of the north embankment (Photograph 1). No depressions or evidence of settlement were observed on the crest.

Photo 1: NP - North Embankment crest, looking east.

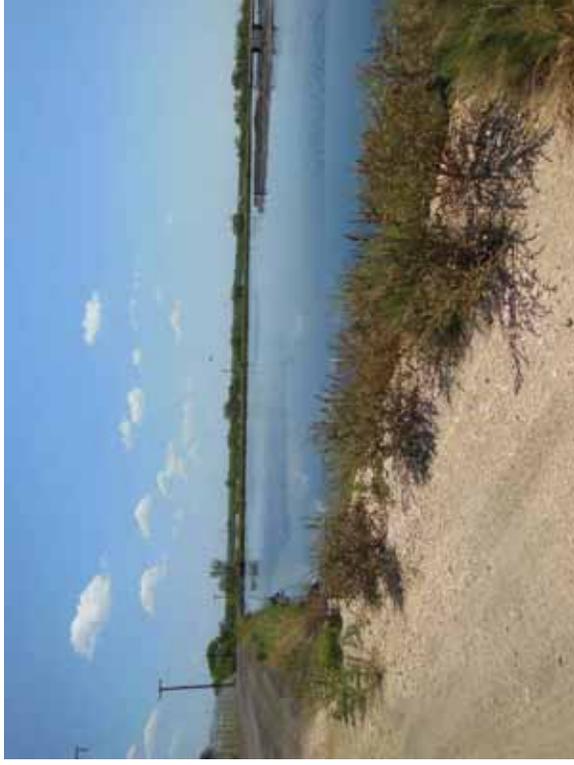
Photo 2: NP - North embankment interior slope, looking east.

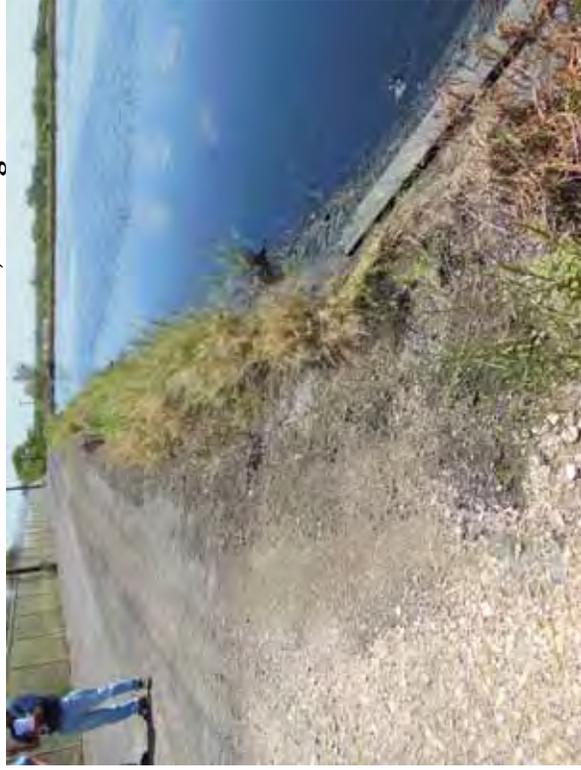
Due to the water level in the North Bottom Ash Pond during the assessment, only the upper 2 feet of the interior slopes were visible (Photographs 3, 12, 27, and 40). Based on construction drawings, the interior slopes were constructed at 2H:1V. The interior slopes were measured at approximately 3H:1V near the top of the embankment and included a layer of ash material (Photograph 28). Small areas of erosion into ash were observed on the interior slope at the east, south, and west embankments (Photographs 17, 23, 38, and 43) and an area of loose ash was observed on the east embankment interior slope (Photograph 14). Vegetation covered some portions of the interior slopes that were visible (Photographs 6, 12, 32, and 35). Visible portions of interior slopes did not include riprap or other armoring.

Photo 3: NP - North embankment interior slope, looking east.

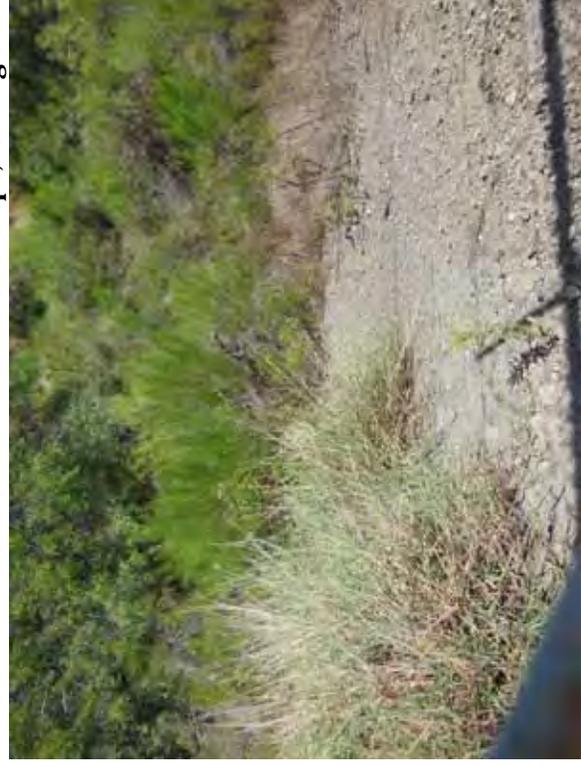
Photo 4: NP - North embankment exterior slope, looking north.

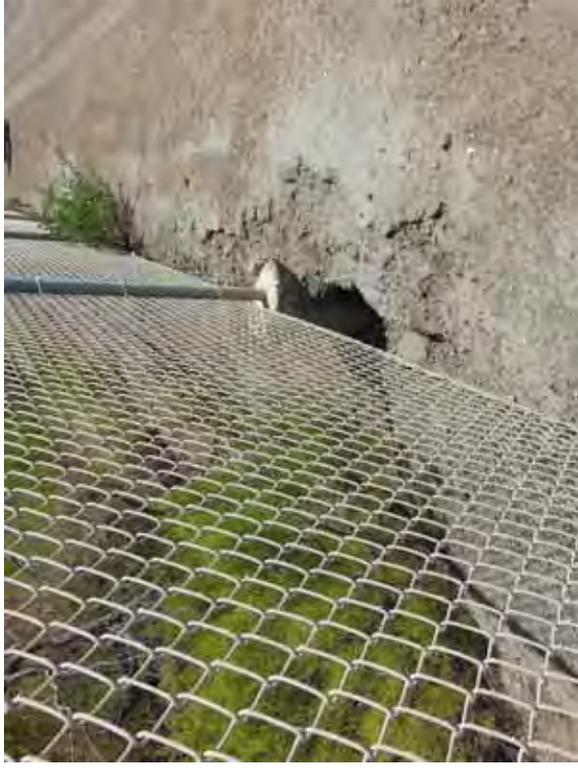
**Photo 5: NP - North embankment exterior slope, looking northeast.
Note erosion near fence post.**

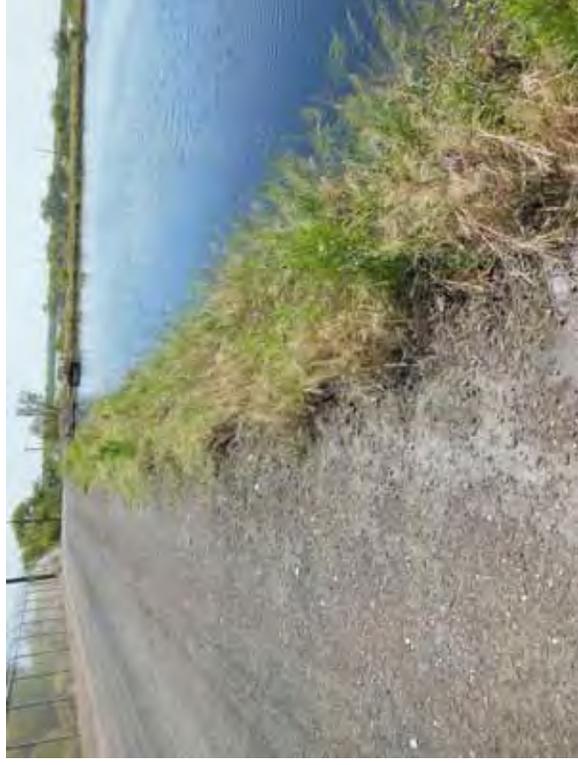
Photo 6: NP - North embankment interior slope, looking east.

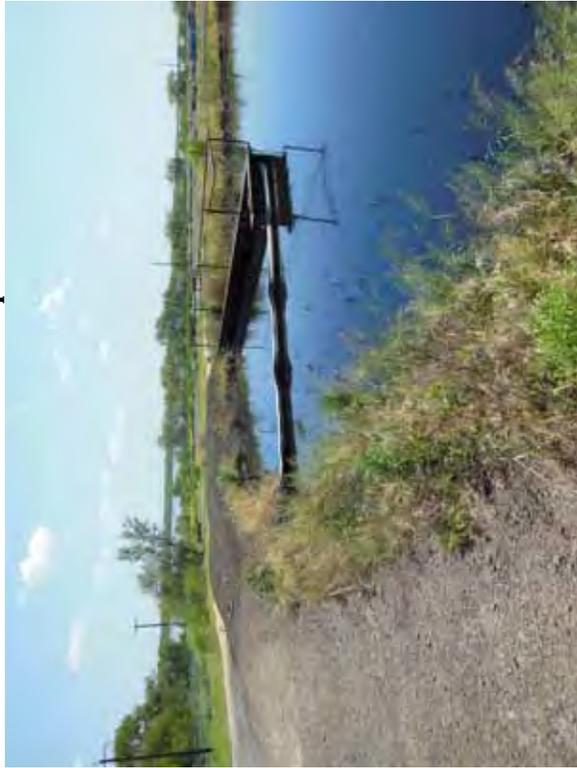
Photo 7: NP - Outlet structure at northeast corner, looking east.

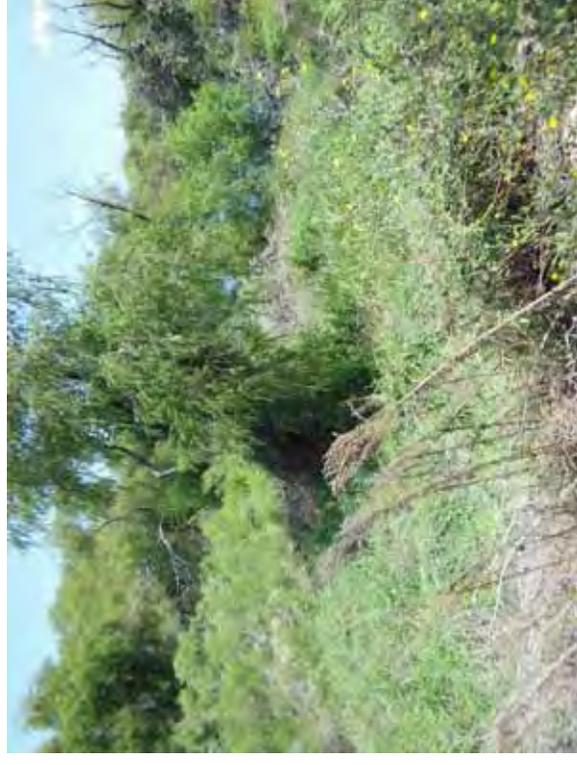
**Photo 8: NP - North embankment exterior slope, looking north. Calaveras
Lake in distance.**

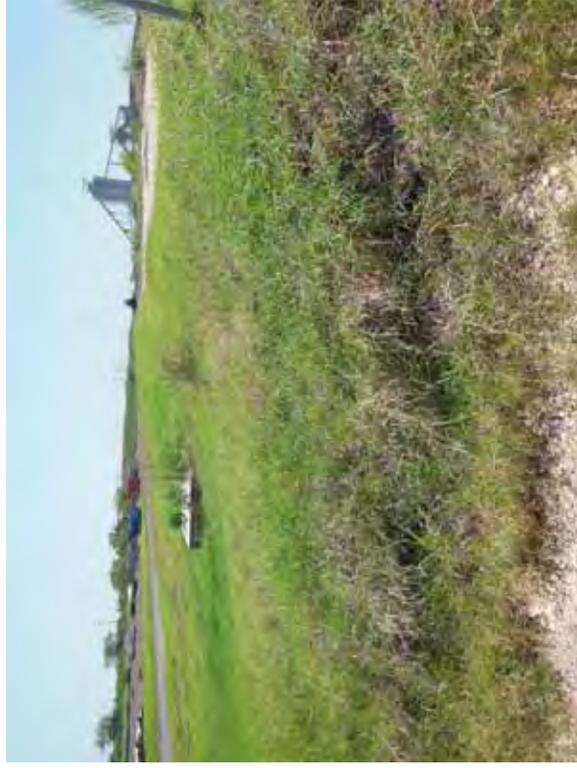
Photo 9: NP - East embankment exterior slope, looking south.

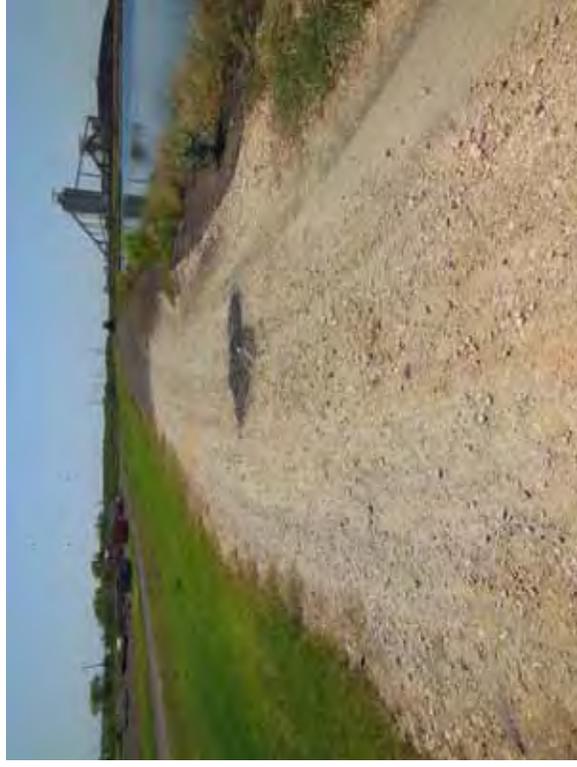
Photo 10: NP - East embankment crest, looking south.

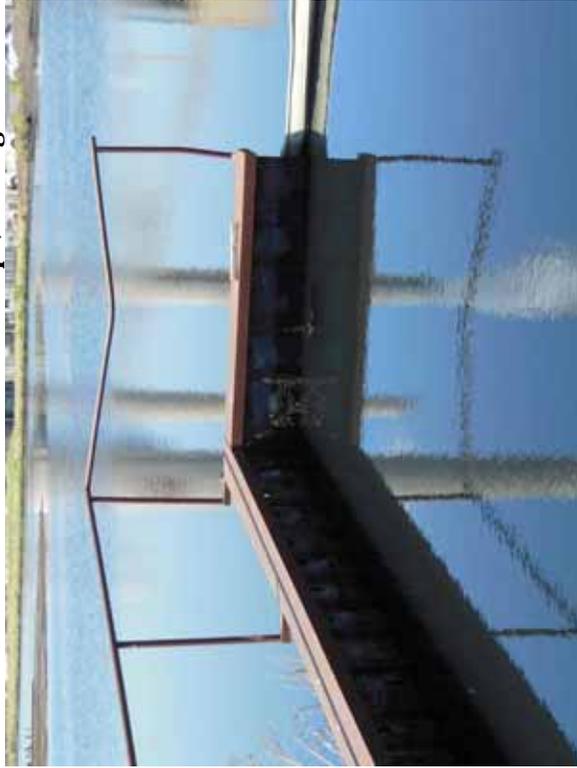
**Photo 11: NP - Outlet structure at northeast corner, looking west.
Outlet riser pipe.**

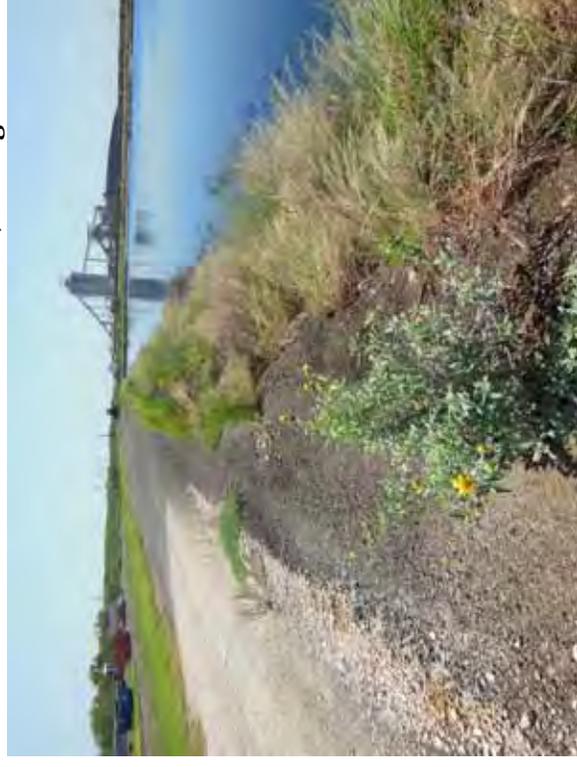
Photo 12: NP - East interior slope, looking south.

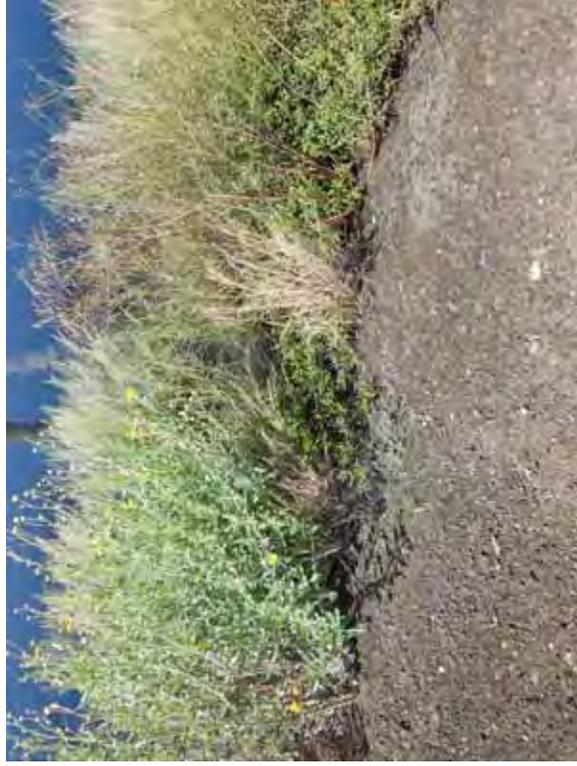
Photo 13: NP - East embankment interior slope, looking west. Note vegetation on slope.

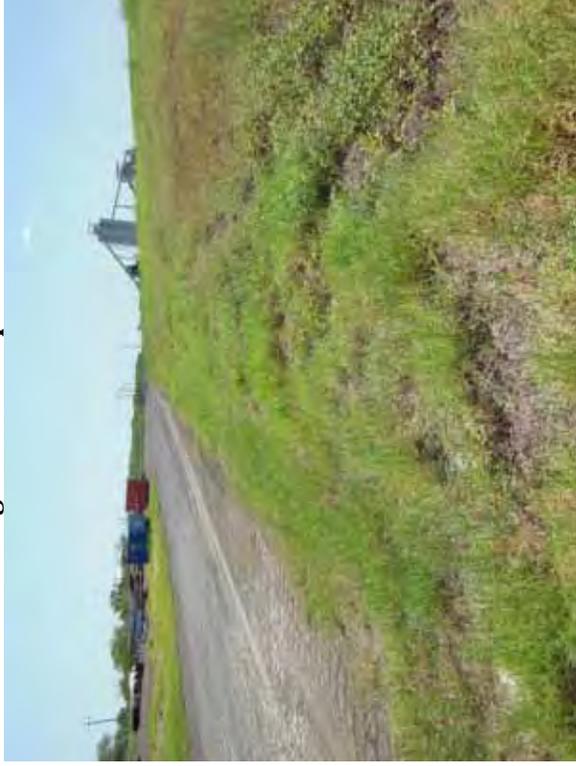
Exterior slopes of the North Bottom Ash Pond appear to be in fair condition (Photographs 15, 30, 39, and 49). Due to the terrain and vegetation on the exterior slope of the north embankment, the slope was only visible from the embankment crest (Photograph 50). A few small trees and brush less than 8 inches in diameter were observed on the exterior slope of the north embankment (Photographs 47 and 48). The exterior slopes of the west and east embankments are approximately 3H:1V and covered in grassy vegetation approximately 3 inches tall (Photographs 16 and 39). The south embankment is shared with the South Bottom Ash Pond and is covered in ash material with sparse vegetation consisting primarily of grass and brush, approximately 2 feet high. Some areas of minor erosion into the ash material (Photographs 24, 25, and 26) were observed. The #1 Stormwater Runoff Pond is located at the west embankment exterior toe and the SRH Pond is located at the exterior toe of the southwest corner (Photograph 37).

Photo 15: NP - East embankment exterior slope, looking south.

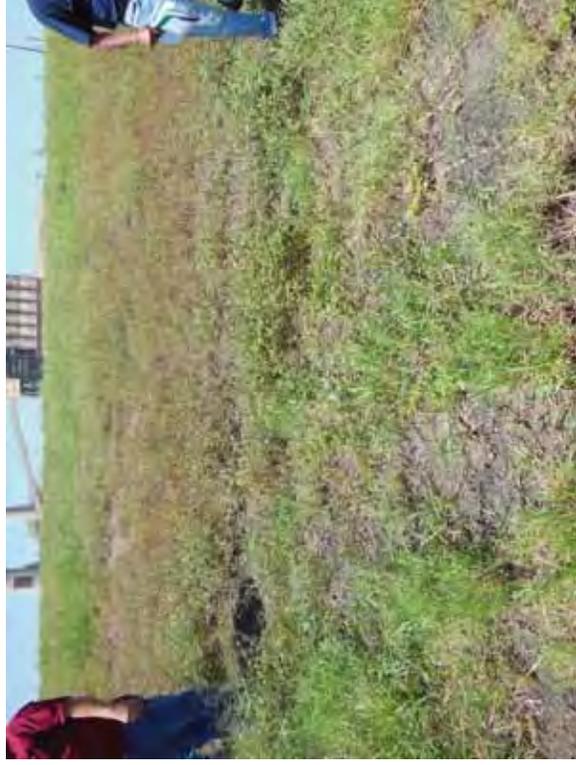
Photo 16: NP - East embankment exterior slope, looking west.

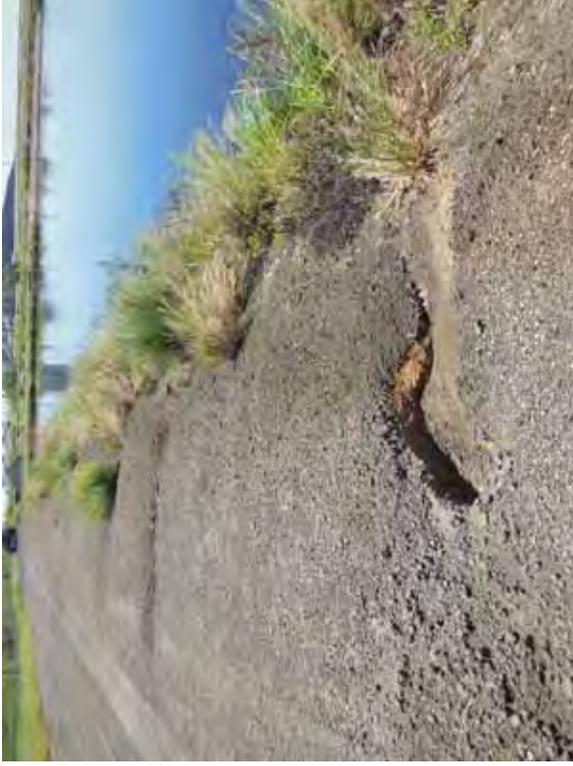
Photo 17: NP - East embankment interior slope, looking south. Note erosion rills in ash material.

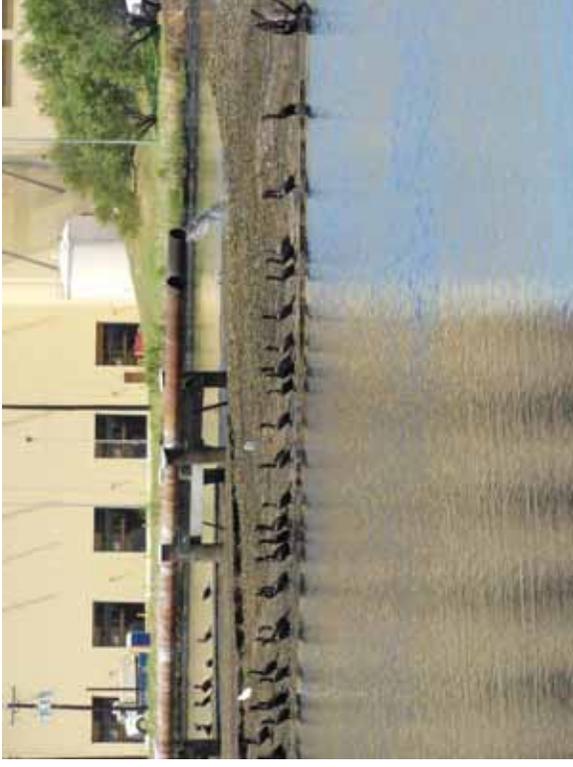
Three inlet pipes discharge liquids near the center of the North Bottom Ash Pond; two 12-inch-diameter welded steel and one 8-inch-diameter welded steel pipe (Photographs 18 and 33).

Photo 18: NP - Inlet piping, looking northwest. Piping includes one 8-inch diameter and two 12-inch-diameter pipes.

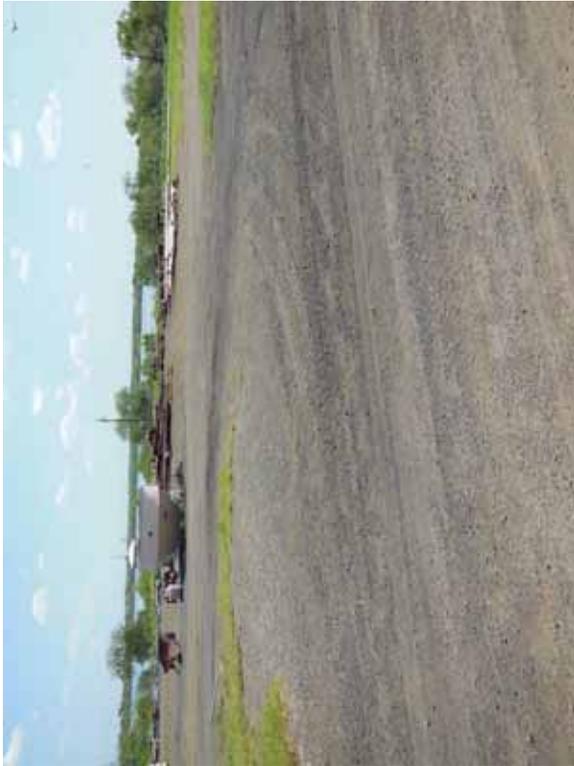
Photo 19: NP - Exterior slope at southeast corner, looking east.

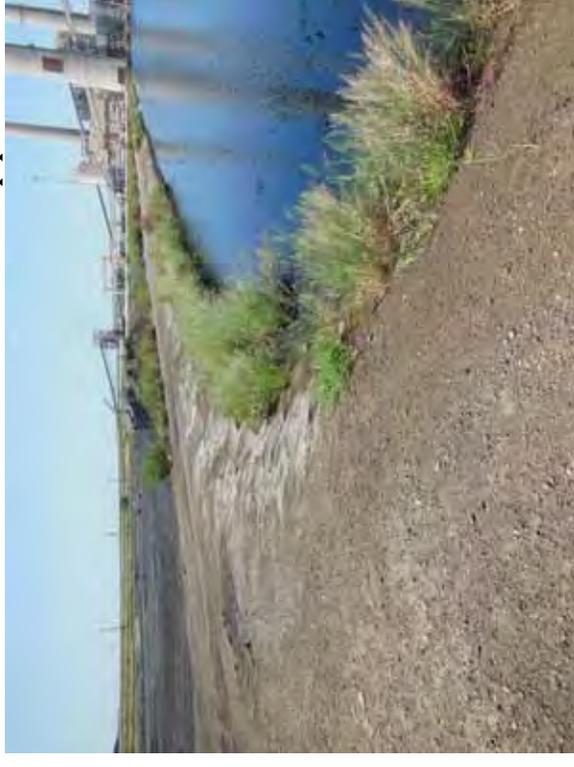
Photo 20: NP - Interior slope at southeast corner, looking west.

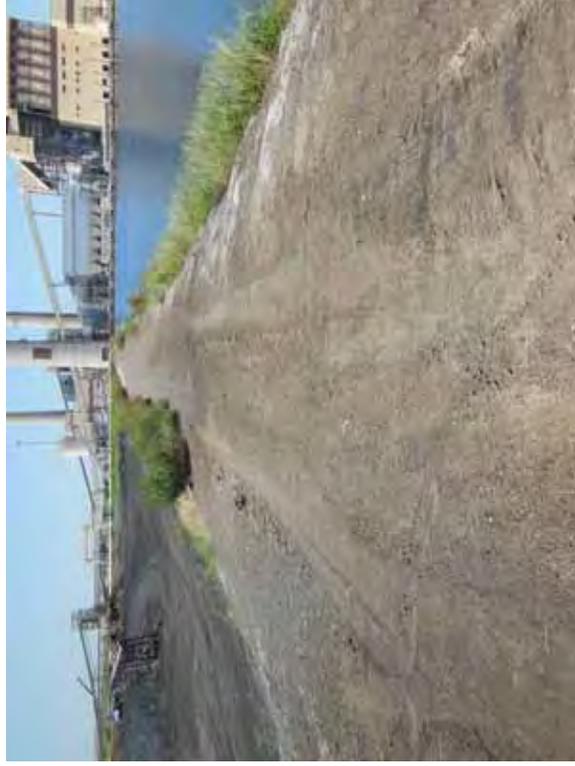
Photo 21: NP/SP - Common embankment crest, looking west.

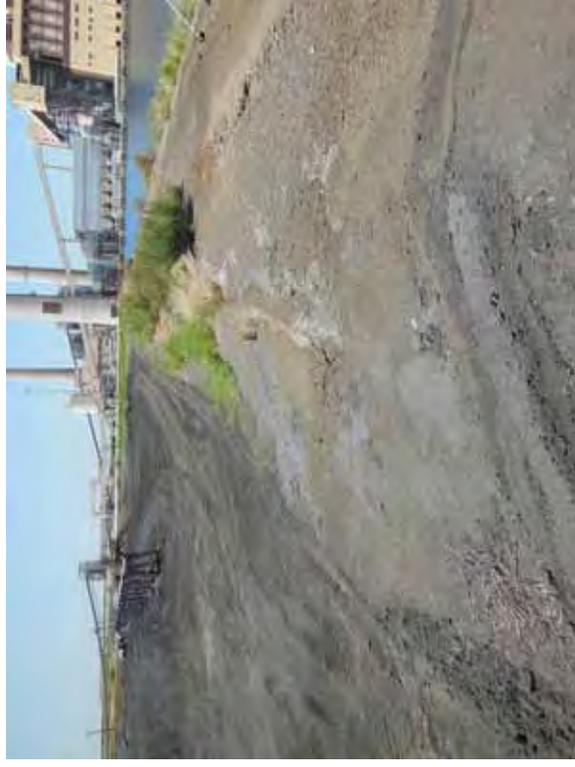
Interior slopes appeared to be in fair condition (Photographs 30, 59, 66, and 70). Based on construction drawings, the interior slopes were constructed at 2H:1V. The north embankment is shared with the North Bottom Ash Pond and is covered in ash material (Photograph 22). Vegetation is sparse, consisting primarily of grass and brush, approximately 2 feet high (Photographs 24, 25, 26, 59, 64, 70, and 84). Some areas of minor erosion into the ash material (Photographs 24, 25, and 26) were observed. A stockpile of CCW was observed on the east embankment interior slope (Photograph 57). Visible portions of interior slopes were not protected by riprap or other armoring.

Photo 22: NP/SP - Common embankment south slope, looking west.

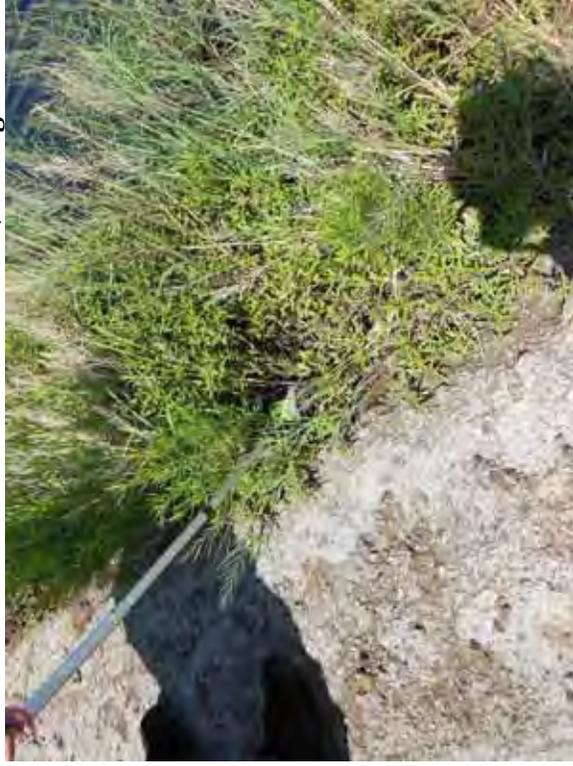
Photo 23: NP/SP - Erosion of ash material on common embankment north slope.

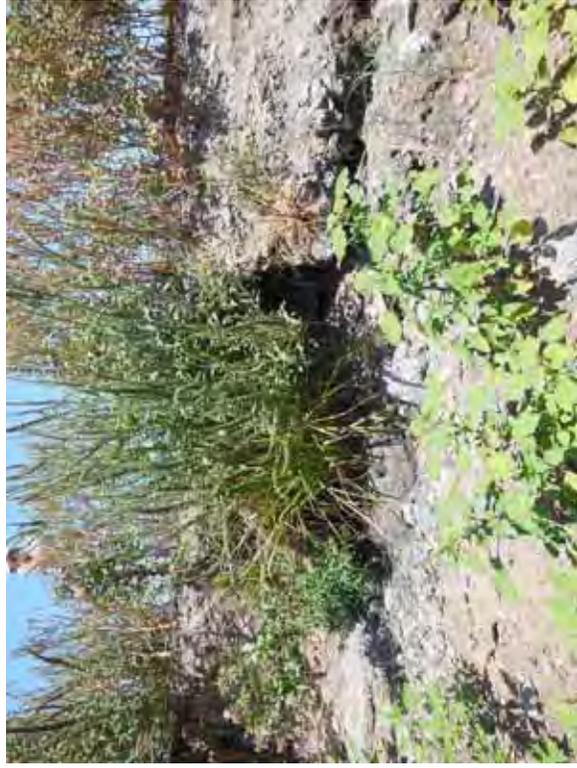
Photo 25: NP/SP - Vegetation and ash material on common embankment south slope.

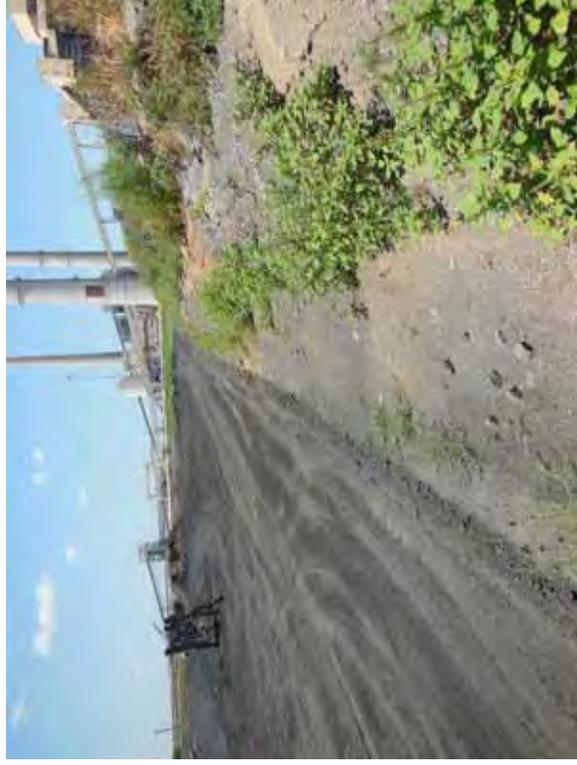
Photo 26: NP/SP - Erosion of ash material on common embankment south slope, looking west.

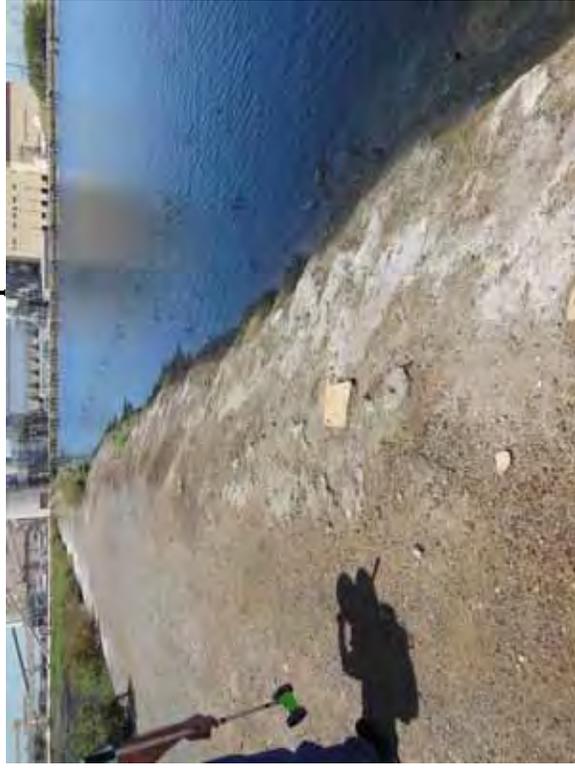
Exterior slopes of the South Bottom Ash Pond appear to be in fair condition (Photographs 27, 58, 62, and 74). The exterior slopes of the east and south embankments are approximately 3H:1V and covered in grassy vegetation approximately 3 inches tall (Photograph 63). The north embankment exterior slope is shared with the North Bottom Ash Pond and is covered in ash material with sparse vegetation consisting of grass and brush, approximately 2 feet high. Some areas of minor erosion were observed on the exterior slope, in the ash material (Photograph 23). The SRH Pond is located at the west embankment exterior slope and is covered with ash and other granular material (Photographs 74, 81, and 82). A drainage ditch is located at the south embankment exterior toe (Photograph 67).

Photo 27: NP/SP - Common embankment north slope, looking west.

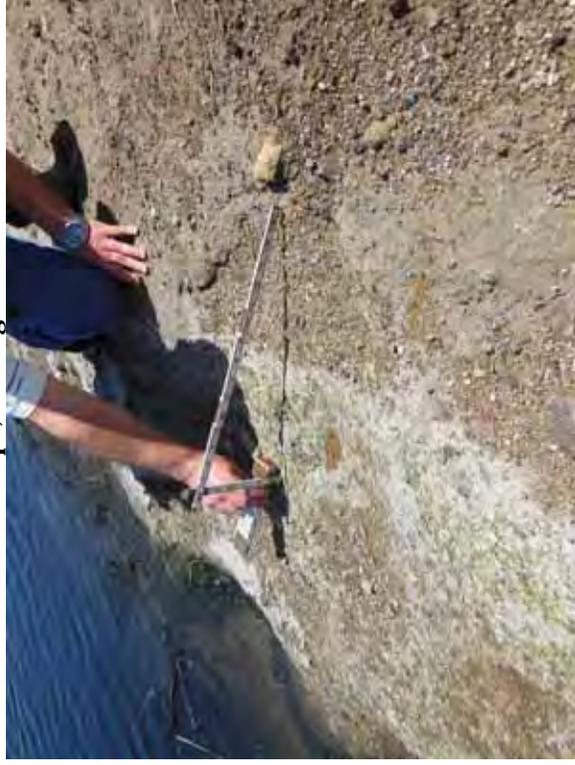
Photo 28: NP/SP - Common embankment north slope, looking east. Slope measured approximately 3H:1V.

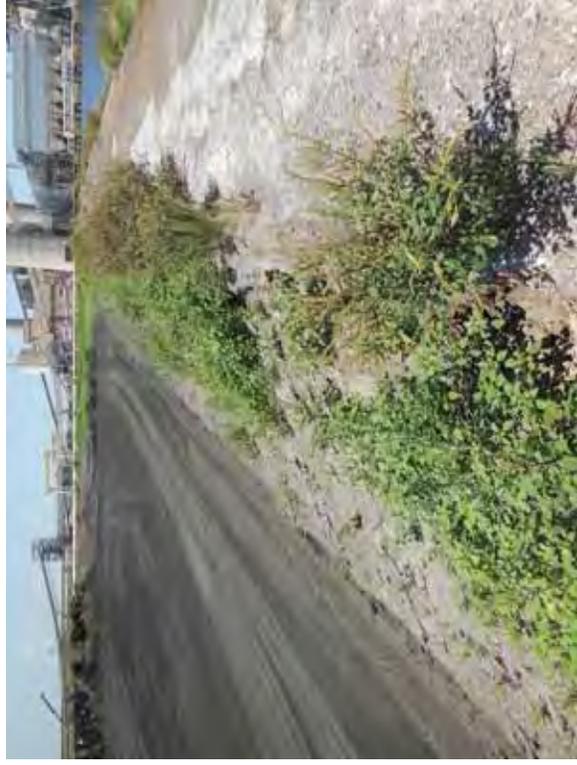
Photo 30: NP/SP - Common embankment south slope, looking west.

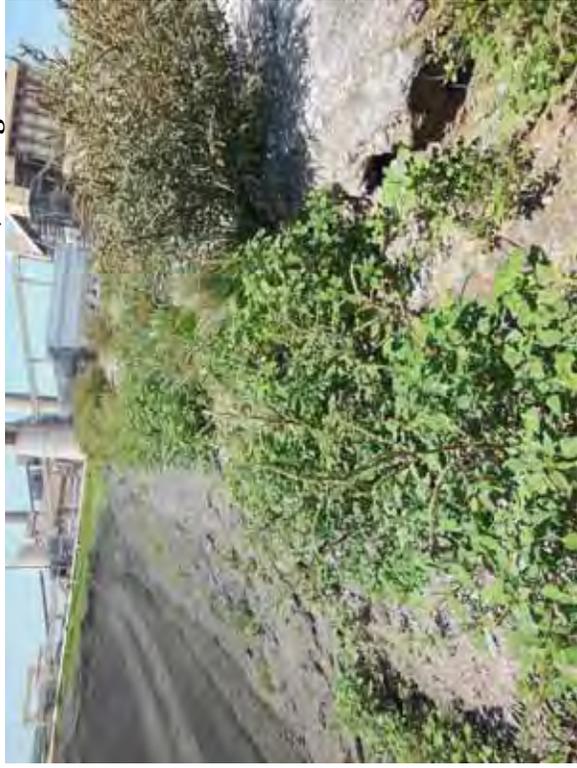
Photo 31: NP/SP - Common embankment south slope, looking west.

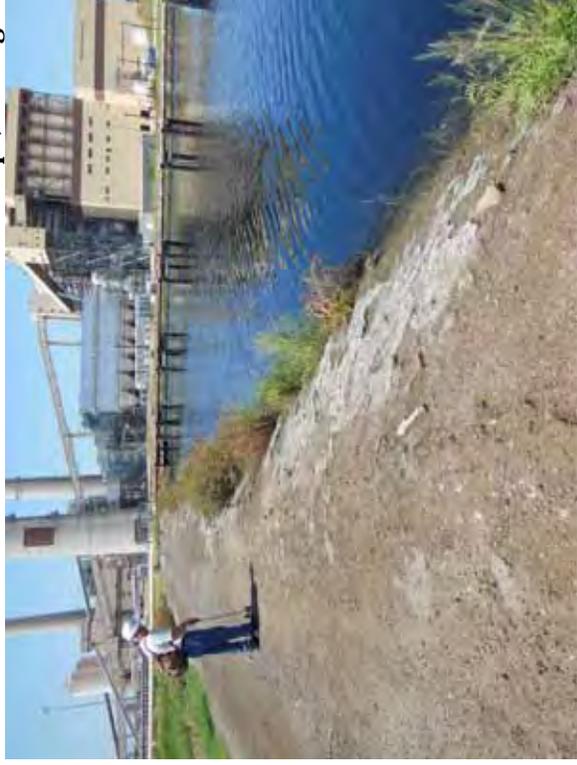
Photo 32: NP/SP - Common embankment north slope, looking west.

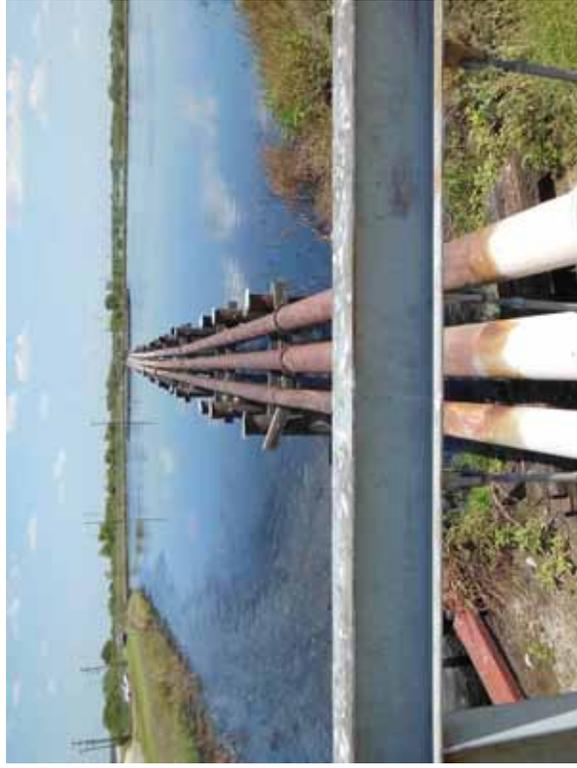
Photo 33: NP - Inlet pipes at southwest corner. Piping includes one 8-inch diameter and two 12-inch-diameter pipes.

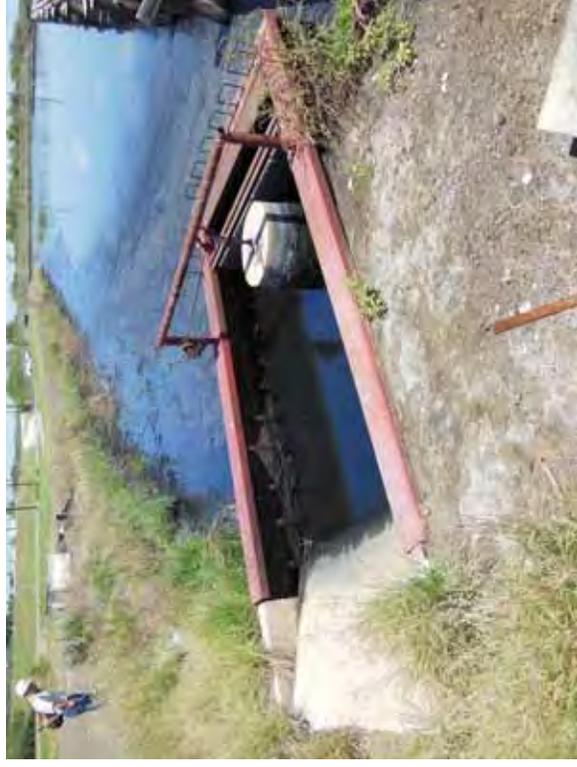
The outlet structure located near the interior slope of the northeast corner consists of a 12-inch-diameter welded steel vertical outlet pipe and a 12-inch-diameter welded steel drain pipe. The outlet pipes are partially surrounded by a steel sheet pile wall containing an opening, with a floating sorbent boom (Photographs 7 and 11). The outlet pipes discharge liquids from the North Bottom Ash Pond to outfalls at the Plant intake canal (Photographs 85, 86, 87, and 88). A 24-inch-diameter welded steel outlet pipe at the interior slope near the southwest corner returns liquids from the pond to the Plant (Photograph 34).

Photo 34: NP - 24-inch-diameter Plant return outlet, looking north.

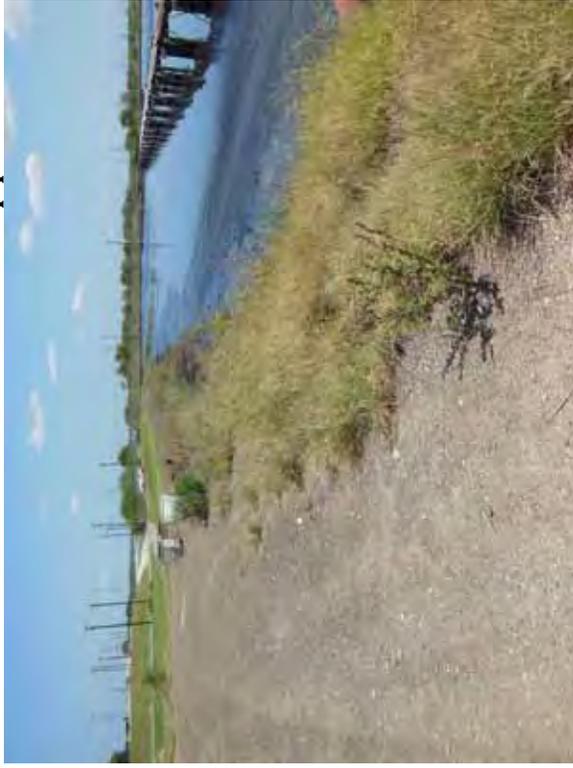
Photo 35: NP - West embankment interior slope, looking northeast.

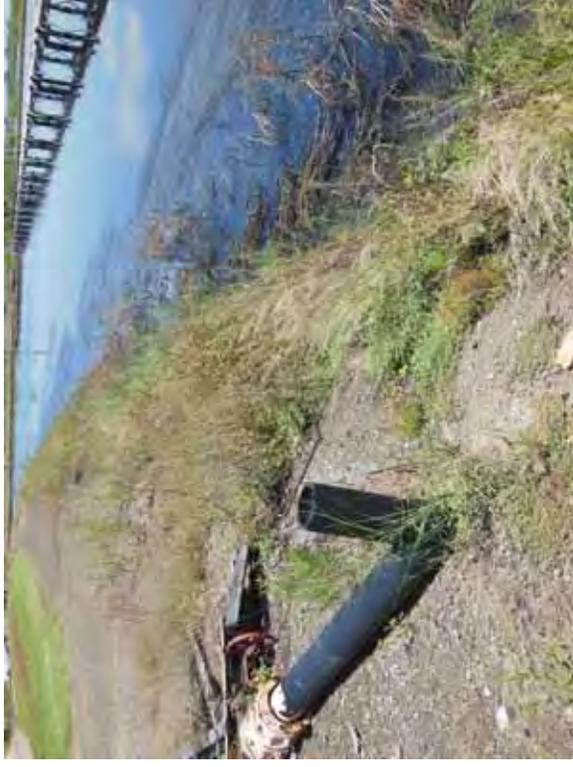
Photo 36: NP - North embankment interior slope, looking northeast.

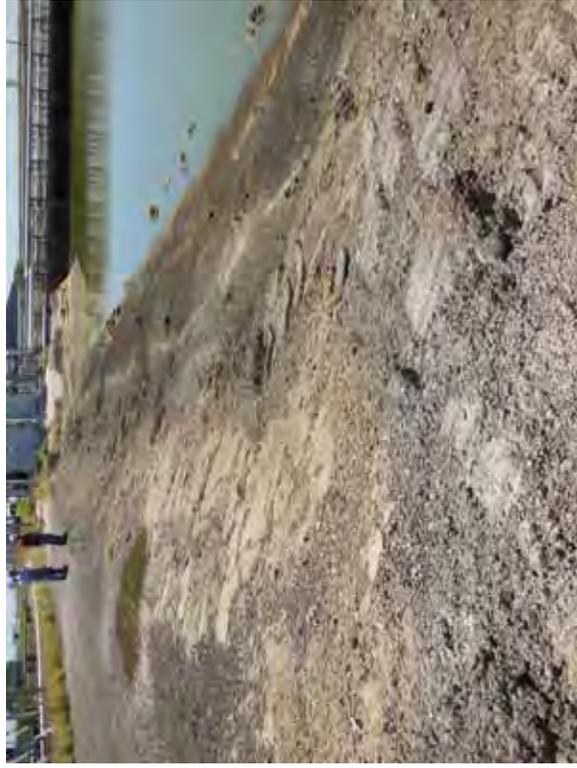
Photo 37: NP - West embankment exterior slope, looking south.

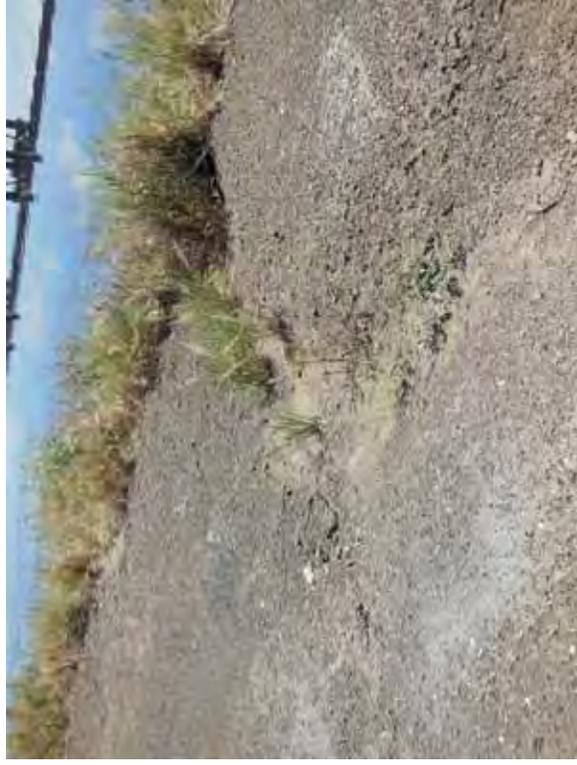
Photo 38: NP - Erosion rill in ash material at west embankment interior slope.

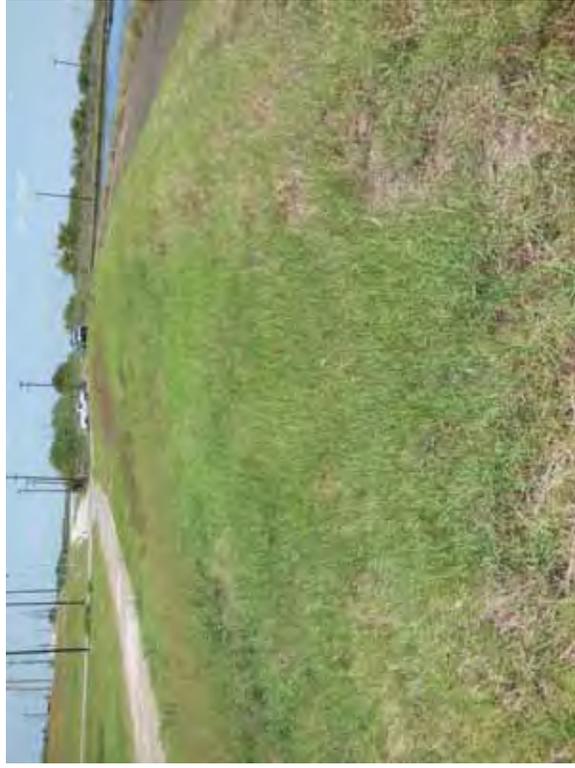
Photo 39: NP - West embankment exterior slope, looking northeast.

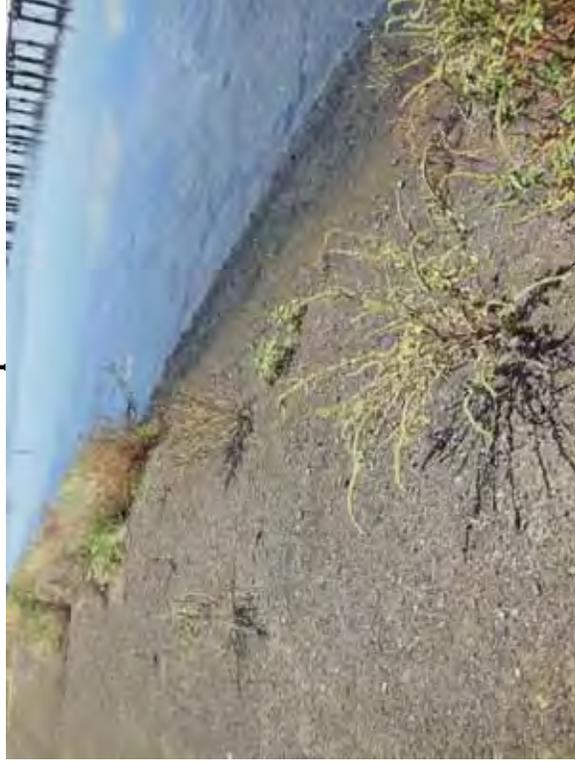
Photo 40: NP - West embankment interior slope, looking northeast.

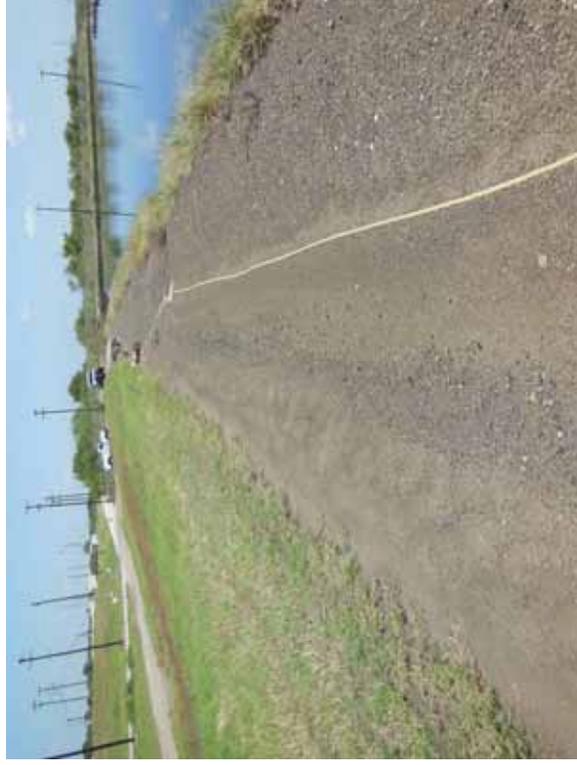
Photo 42: NP - West embankment crest, looking northeast.

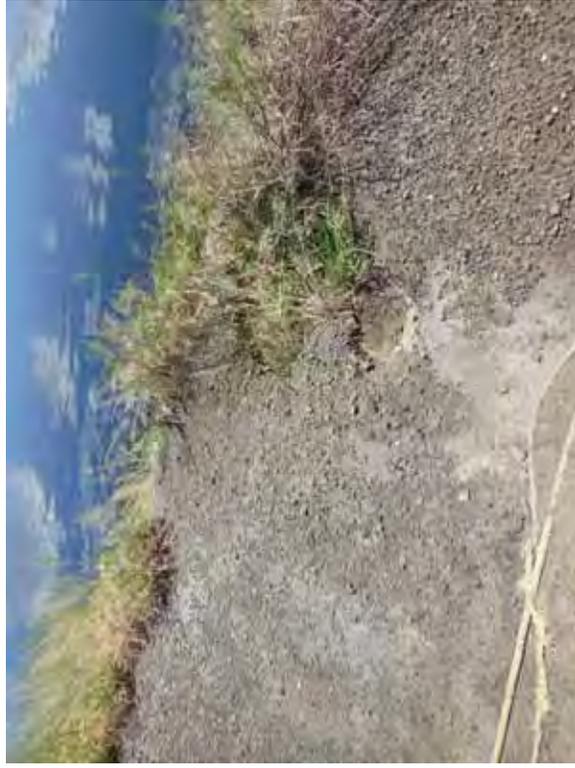
Photo 43: NP - Erosion of ash material at west embankment interior slope.

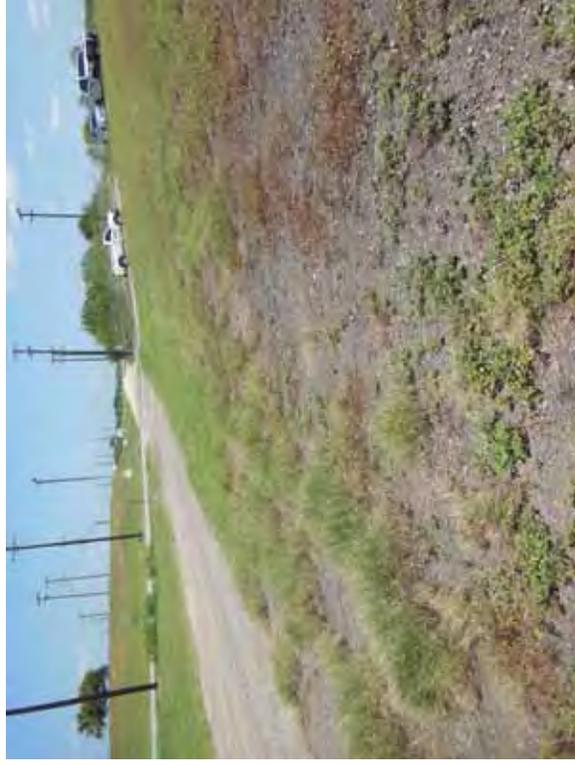
Photo 44: NP - West embankment exterior slope, looking north.

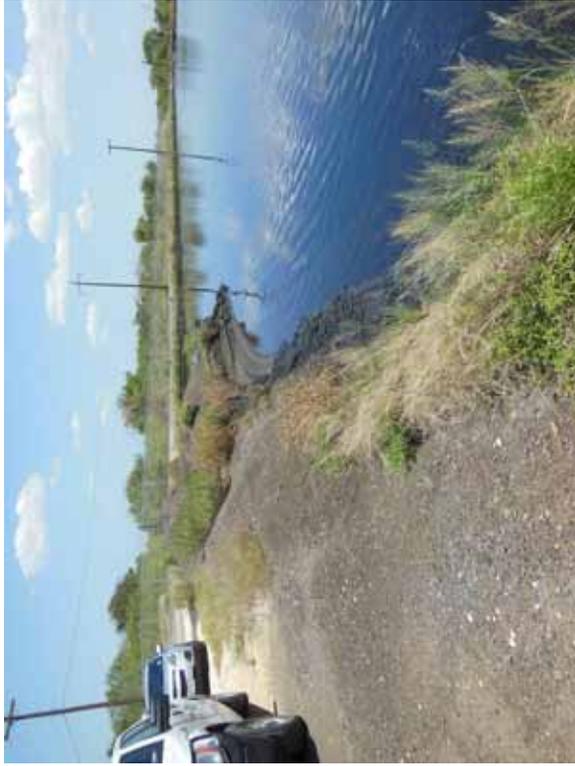
Photo 45: NP - West embankment interior slope, looking northeast. Note area of ash material on slope near northwest corner.

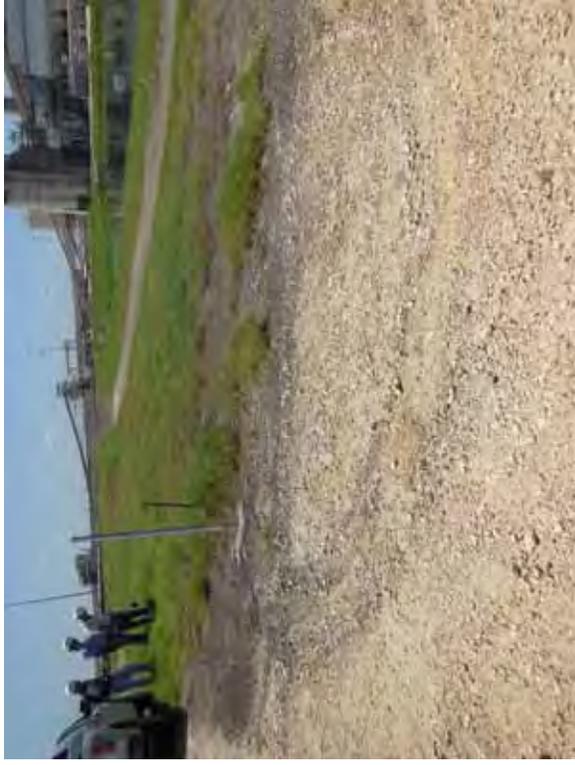
Photo 46: NP - Northwest corner exterior slope, looking south.

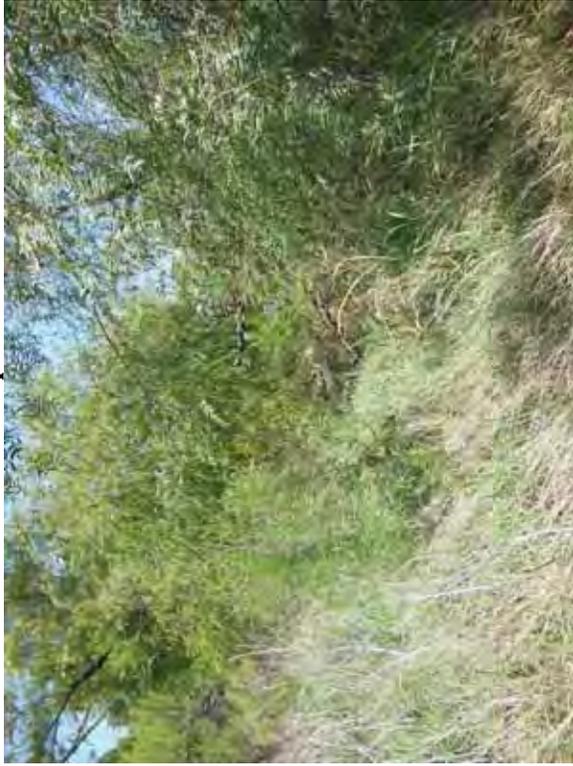
Photo 47: NP - Vegetation on north embankment exterior slope, looking north.

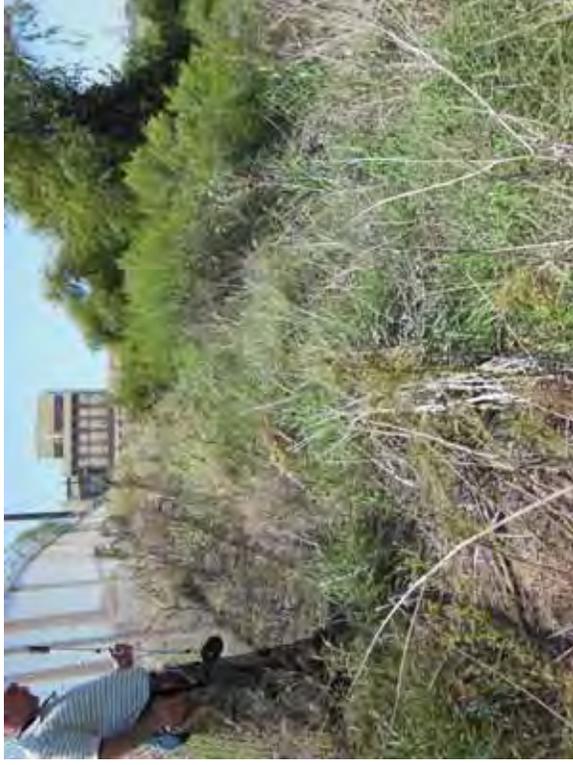
Photo 48: NP - North embankment exterior slope, looking west.

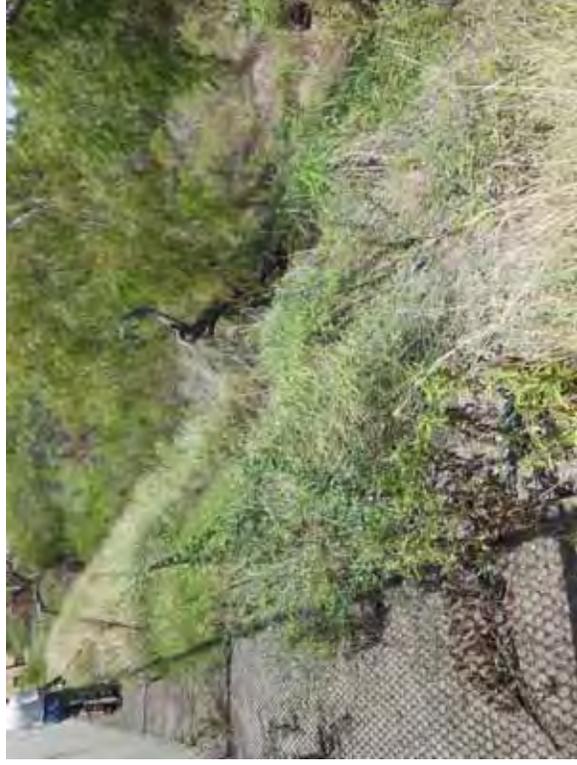
Photo 50: NP - North embankment exterior slope, looking west.

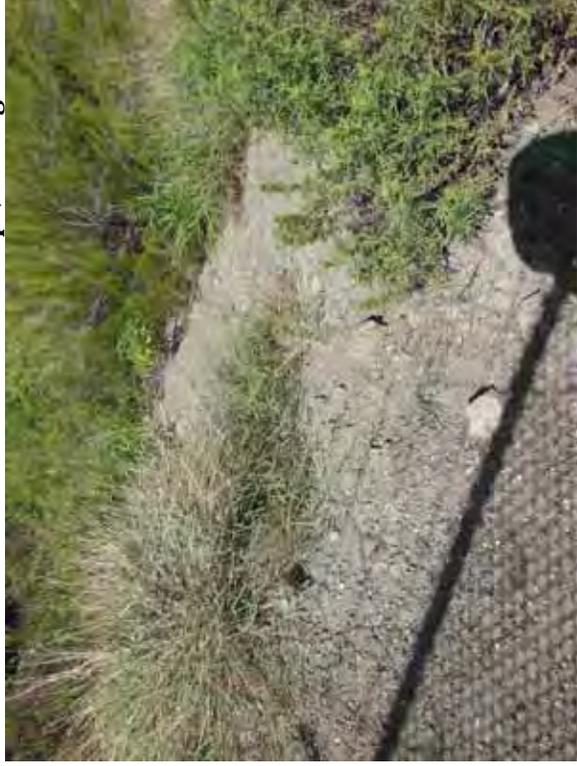
Photo 51: NP - Erosion on north embankment exterior slope, looking north.

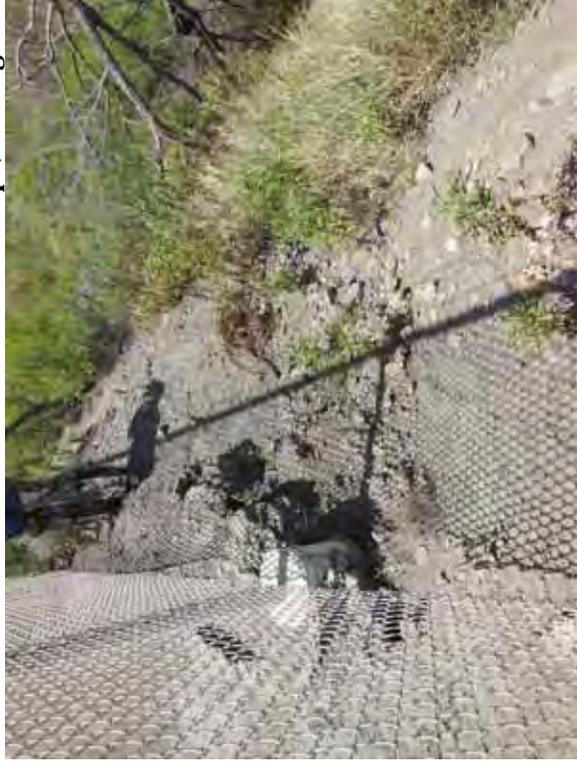
Photo 52: NP - Erosion at fence post on north embankment exterior slope.
