ASSESSMENT OF DAM SAFETY OF COAL COMBUSTION SURFACE IMPOUNDMENTS – DRAFT REPORT

**CPS Energy
J.T. Deely Power Plant
San Antonio, Texas**

Prepared for
*U.S. Environmental
Protection Agency
Washington, D.C.*

December 2012
Revision 1, December 2013

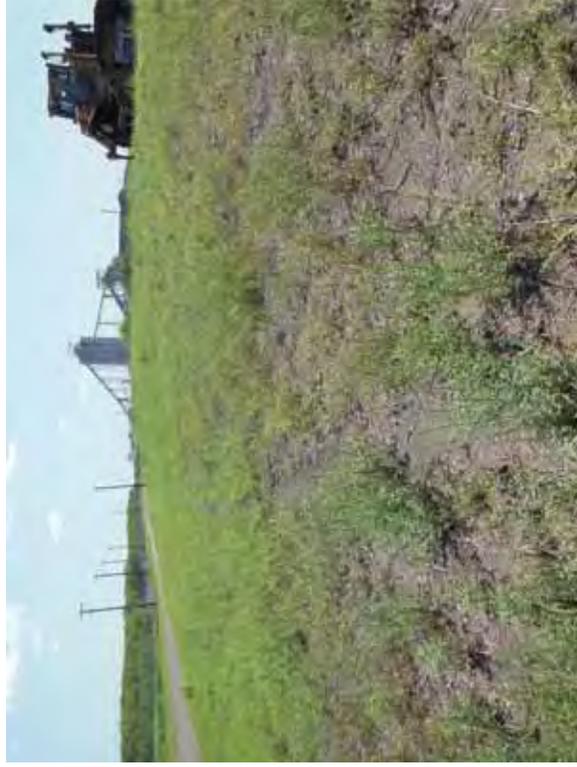
Photo 53: SP - East embankment exterior slope, looking south.

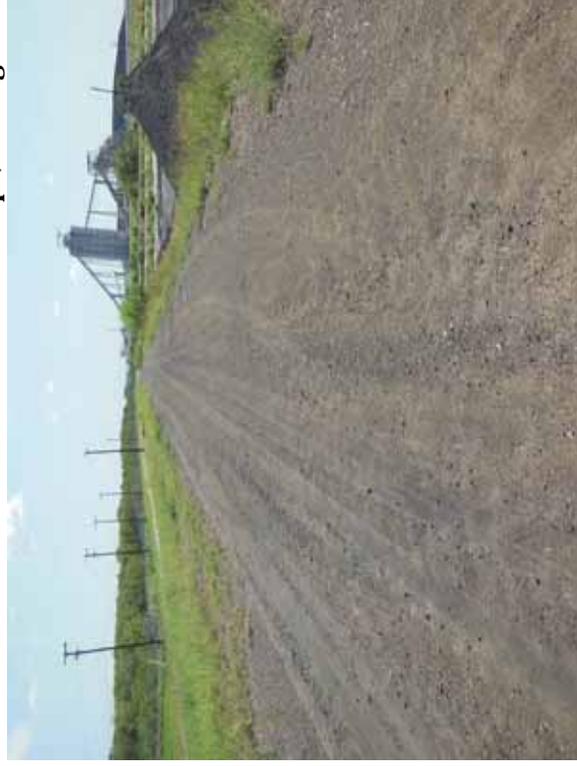
The crest of the South Bottom Ash Pond appeared to be in satisfactory condition (Photographs 29, 56, 65, and 73). All embankment crests were approximately 15 feet wide and consists of compacted granular soils and gravel and is exposed to minimal vehicle traffic. A clarifier structure associated with the adjacent SRH Pond was located on the west embankment crest (Photograph 78). The west embankment crest included two spillways connecting the SRH and South Bottom Ash Ponds (Photographs 75, 76, 77, 79, 80, and 81). No depressions or evidence of settlement were observed on the crest.

Photo 56: SP - East embankment crest, looking south.

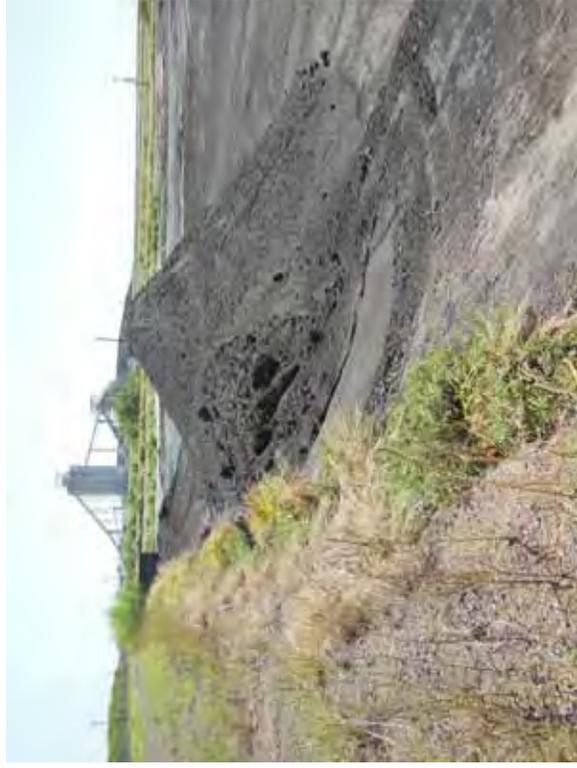
Interior slopes appeared to be in fair condition (Photographs 30, 59, 66, and 70). Based on construction drawings, the interior slopes were constructed at 2H:1V. The north embankment is shared with the North Bottom Ash Pond and is covered in ash material (Photograph 22). Vegetation is sparse, consisting primarily of grass and brush, approximately 2 feet high (Photographs 24, 25, 26, 59, 64, 70, and 84). Some areas of minor erosion into the ash material (Photographs 24, 25, and 26) were observed. A stockpile of CCW was observed on the east embankment interior slope (Photograph 57). Visible portions of interior slopes were not protected by riprap or other armoring.

Photo 57: SP - Ash/soil pile on east embankment interior slope, looking south.

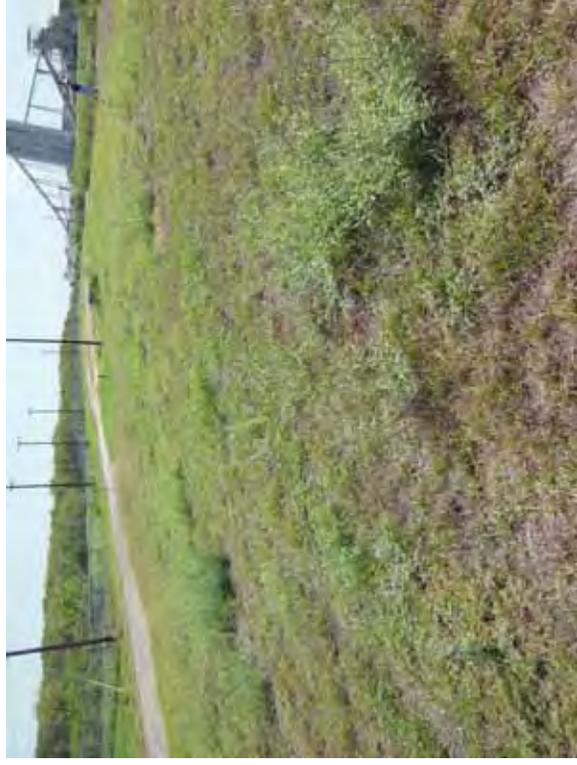
Exterior slopes of the South Bottom Ash Pond appear to be in fair condition (Photographs 27, 58, 62, and 74). The exterior slopes of the east and south embankments are approximately 3H:1V and covered in grassy vegetation approximately 3 inches tall (Photograph 63). The north embankment exterior slope is shared with the North Bottom Ash Pond and is covered in ash material with sparse vegetation consisting of grass and brush, approximately 2 feet high. Some areas of minor erosion were observed on the exterior slope, in the ash material (Photograph 23). The SRH Pond is located at the west embankment exterior slope and is covered with ash and other granular material (Photographs 74, 81, and 82). A drainage ditch is located at the south embankment exterior toe (Photograph 67).

Photo 58: SP - East embankment exterior slope, looking south.

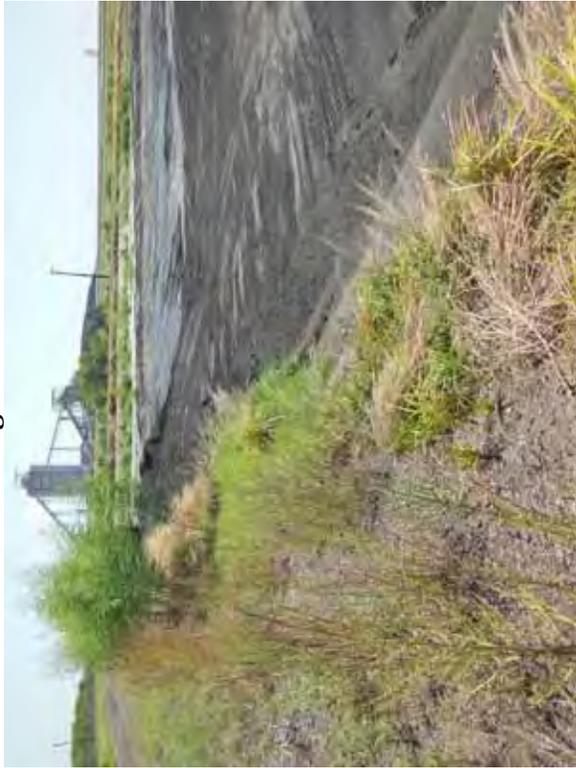
Photo 59: SP - East embankment interior slope, looking south.

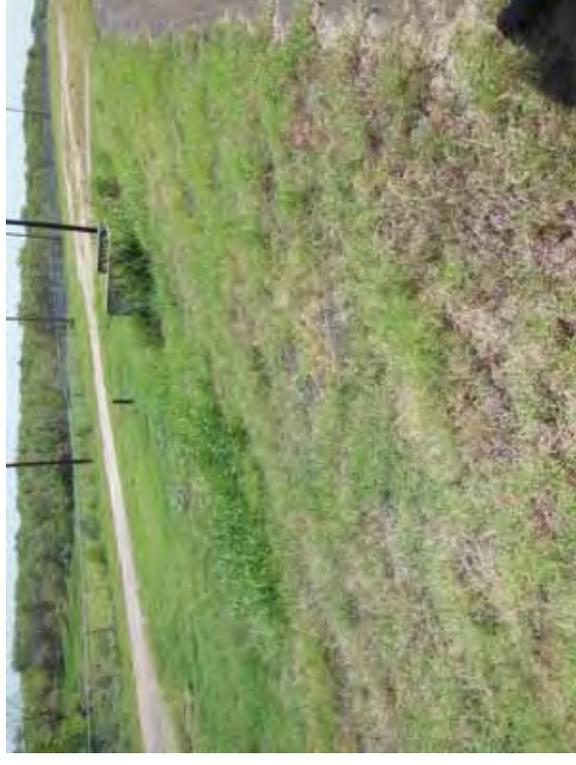
Photo 60: SP - Exterior slope at southeast corner, looking south.

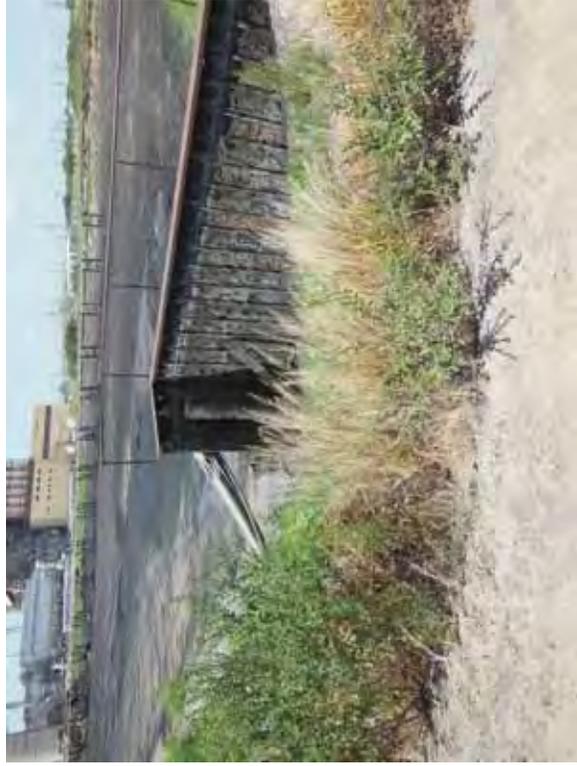
The outlet structure near the interior slope of at the southeast corner consists of a 12-inch-diameter welded steel vertical outlet pipe and a 12-inch-diameter steel drain pipe. The outlet pipes are partially surrounded by a steel sheet pile wall containing an opening, with a floating sorbent boom, for flow to the outlet pipes (Photograph 61). The outlet pipes discharge liquids from the South Bottom Ash Pond to outfalls at the Plant intake canal (Photographs 85, 86, 87, and 89). A 24-inch-diameter welded steel outlet pipe at the interior slope near the northwest corner returns liquids from the pond to the Plant (Photograph 83).

Photo 61: SP - Outlet structure at southeast corner interior slope, looking northwest.

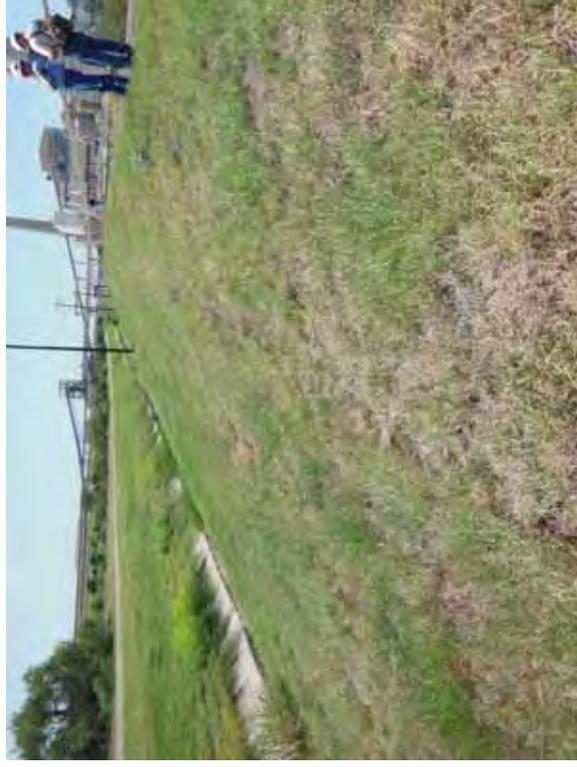
Photo 62: SP - South embankment exterior slope, looking west.

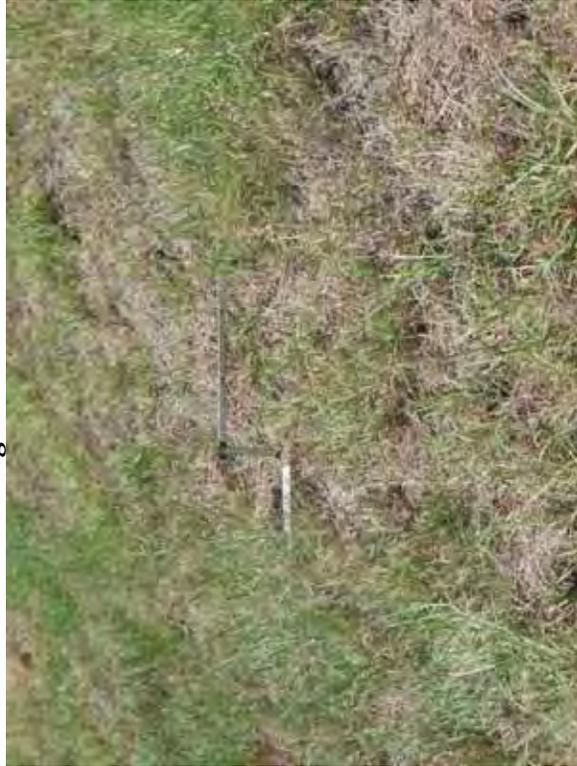
Photo 63: SP - Approximately 3H:1V side slope at south embankment exterior slope.

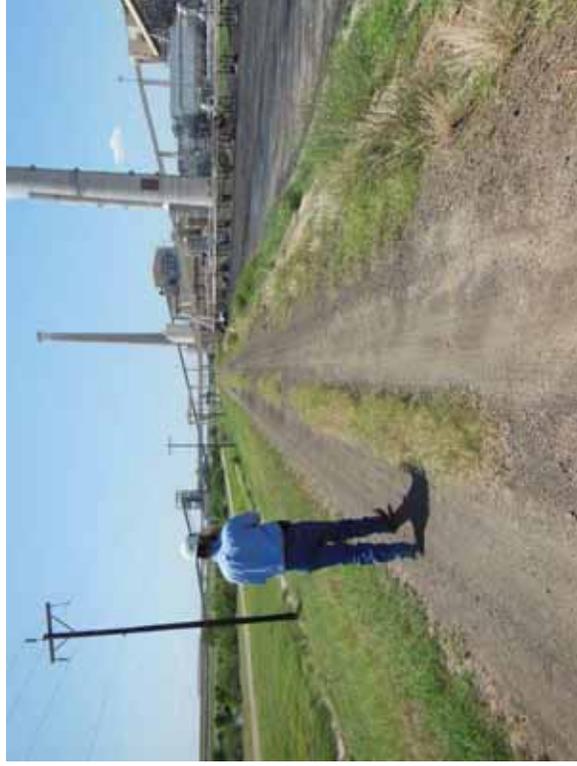
Photo 65: SP - South embankment crest, looking west.

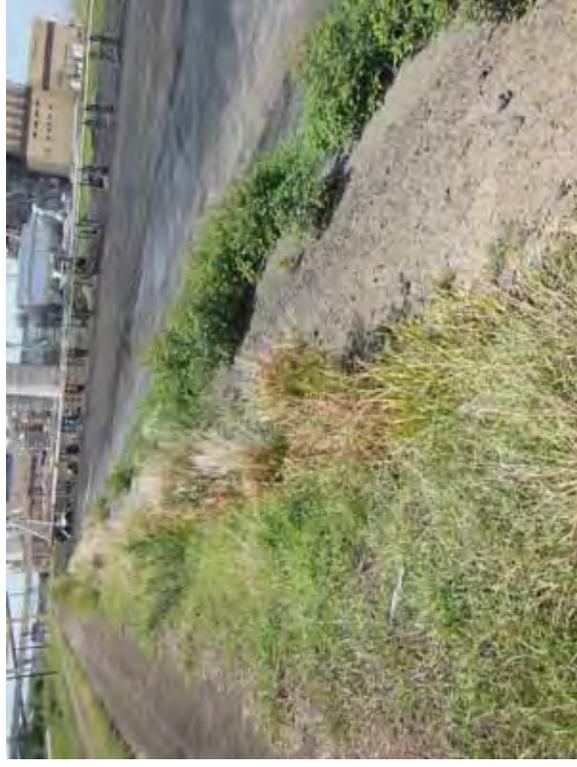
Photo 66: SP - South embankment interior slope, looking west.

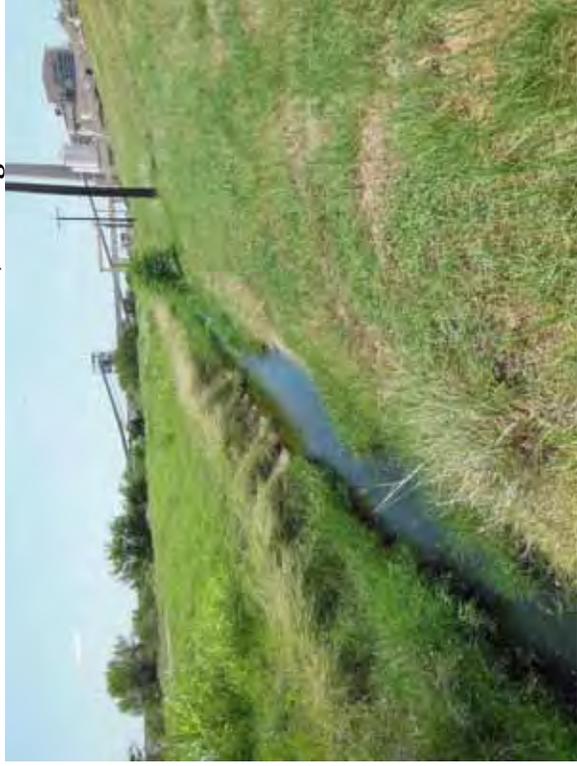
Photo 67: SP - Drainage ditch at south embankment exterior toe, looking west.

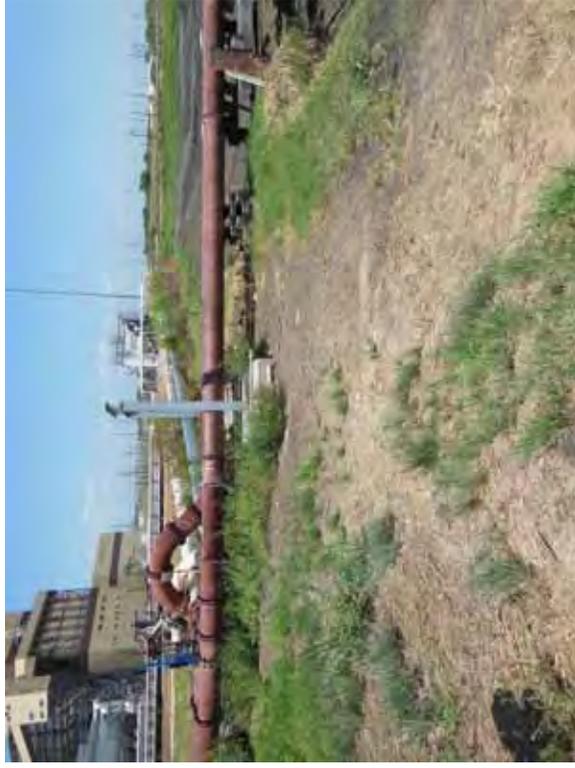
Photo 69: SP - Inlet piping at southwest corner interior slope, looking north.

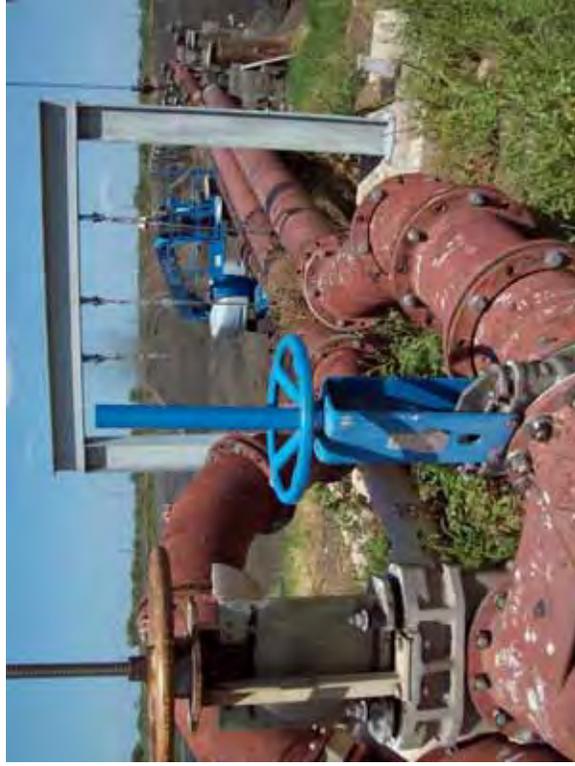
Three inlet pipes discharge liquids near the center of the South Bottom Ash Pond; two 12-inch-diameter welded steel and one 8-inch-diameter welded steel pipe (Photograph 71). The piping was being replaced during the site assessment (Photograph 68).

Photo 71: SP - Inlet piping at southwest corner interior slope, looking northeast.

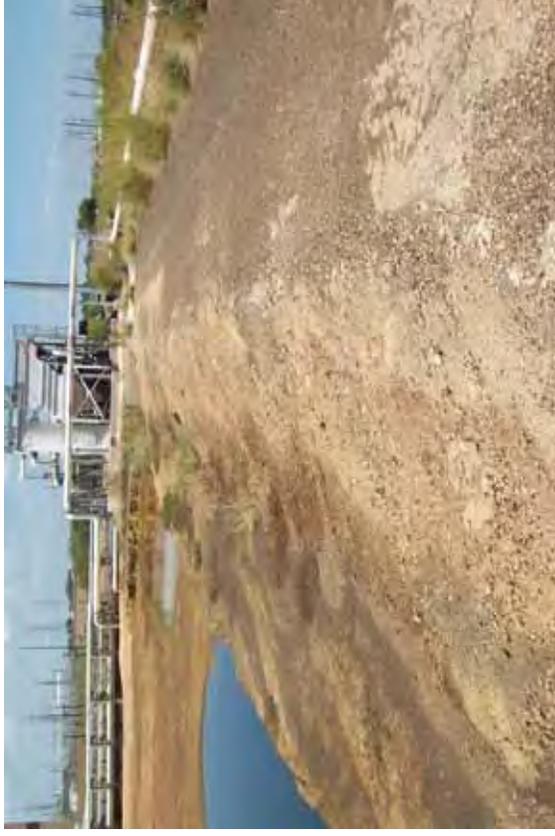
Photo 74: SP - West embankment exterior slope, looking north.

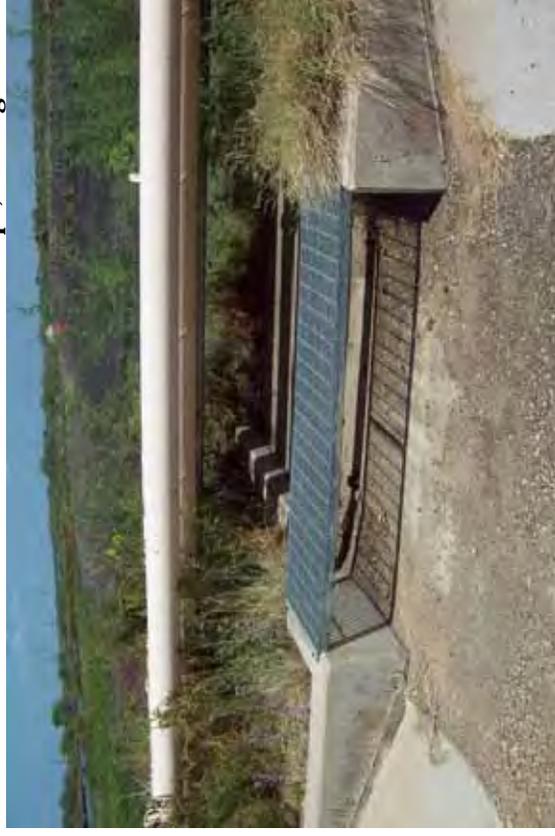
Photo 76: SP - Spillway between SRH Pond and South Bottom Ash Pond at west embankment interior slope, looking east.

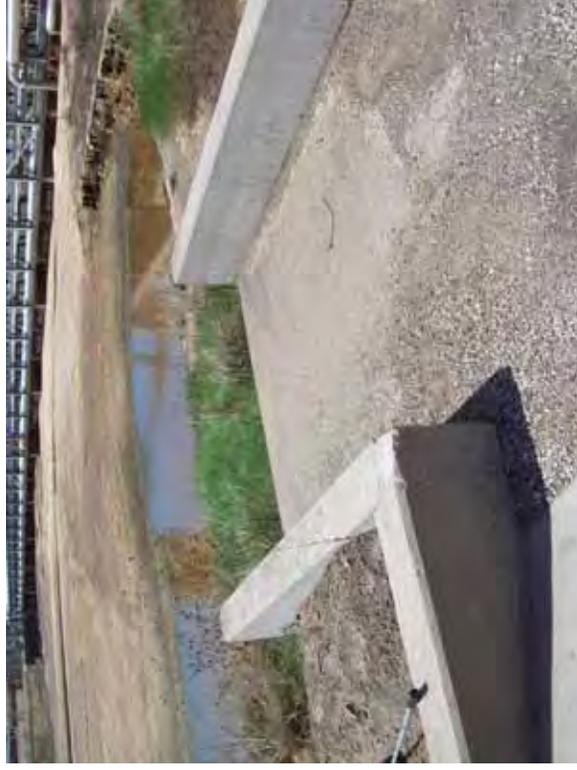
Photo 77: SP - Spillway between SRH Pond and South Bottom Ash Pond at west embankment exterior slope, looking west.

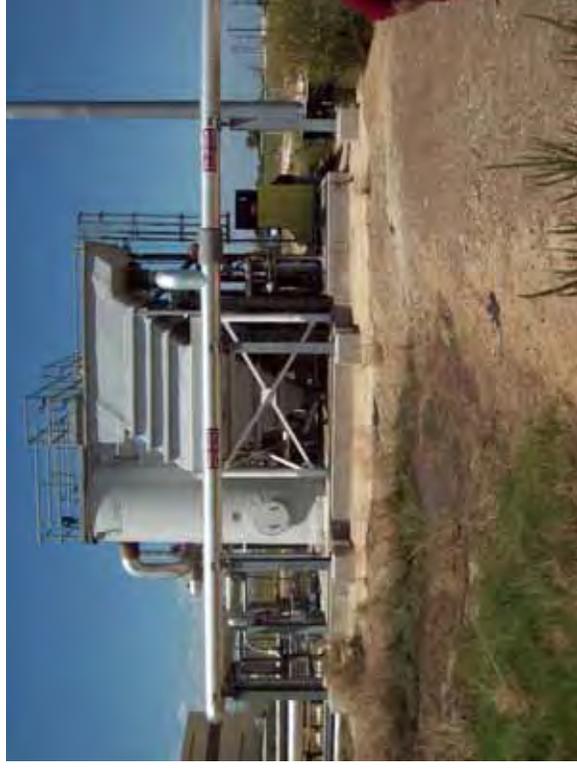
Photo 78: SP - SRH Pond clarifier structure at west embankment crest, looking north.

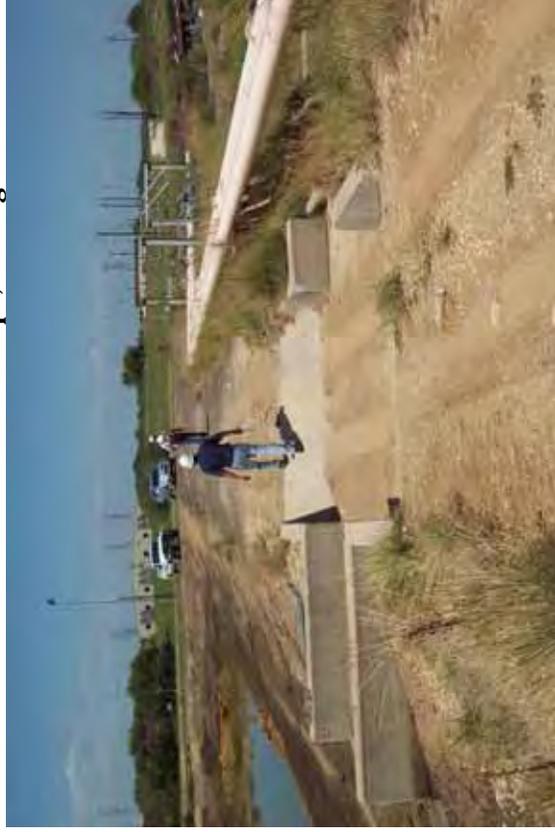
Photo 79: SP - Spillway between SRH Pond and South Bottom Ash Pond at west embankment crest, looking north.

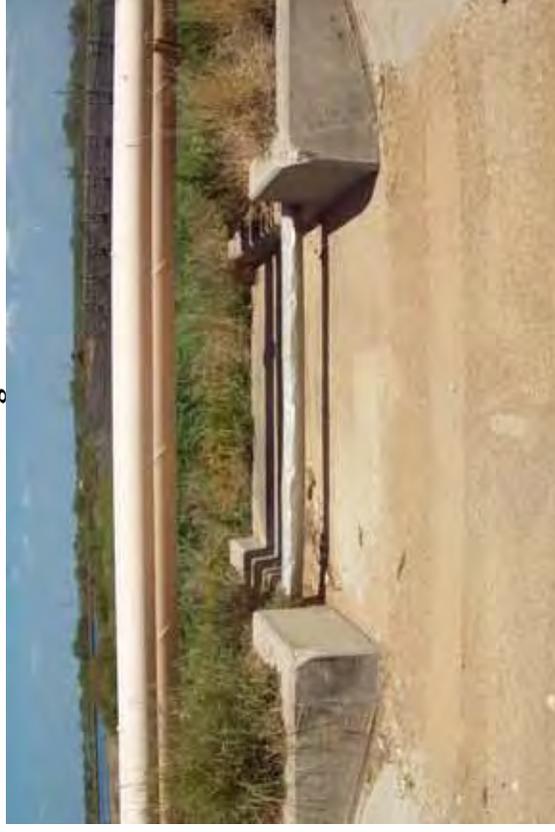
Photo 80: SP - Spillway between SRH Pond and South Bottom Ash Pond at west embankment interior slope, looking east.

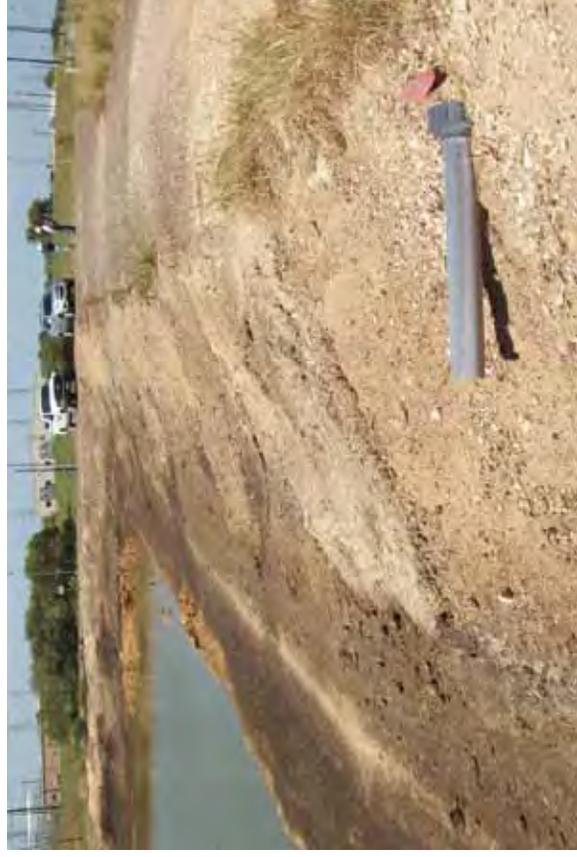
Photo 82: SP - West embankment exterior slope, looking north.

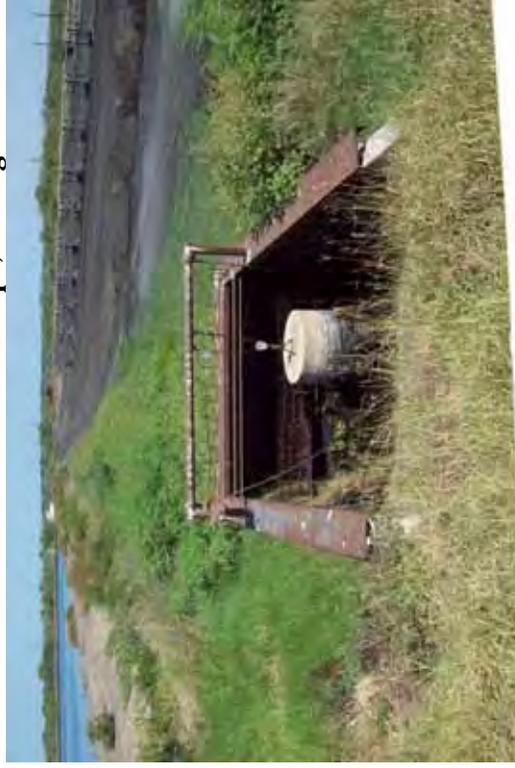
Photo 83: SP - 24-inch-diameter Plant return outlet, looking east.

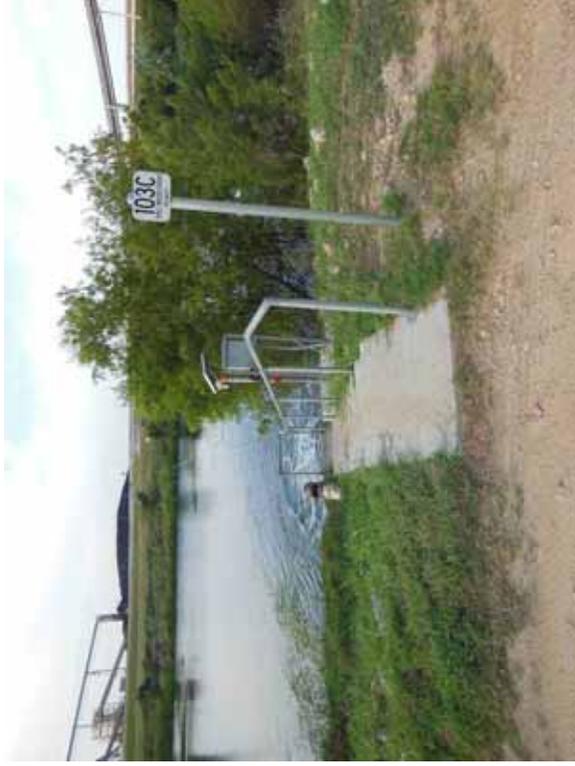
Photo 85: NP/SP - Discharge outfall 103C into Plant intake canal.

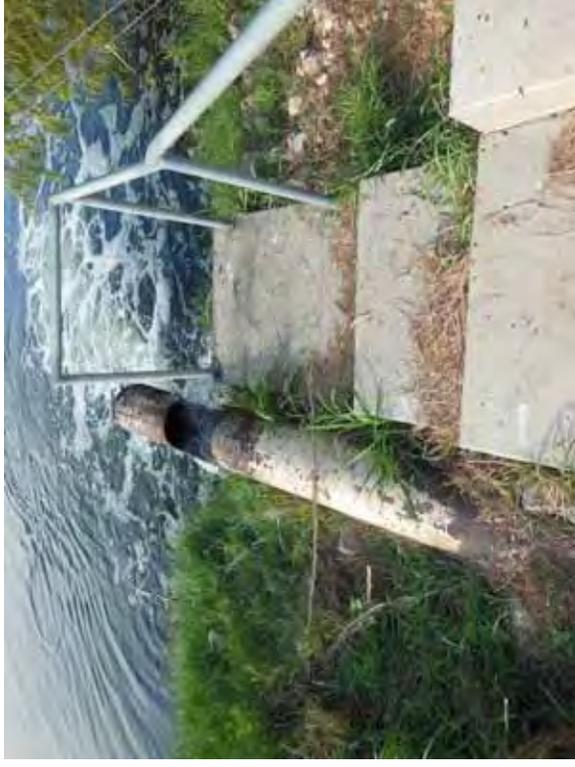
Photo 86: NP/SP - 12-inch-diameter piping at outfall 103C.

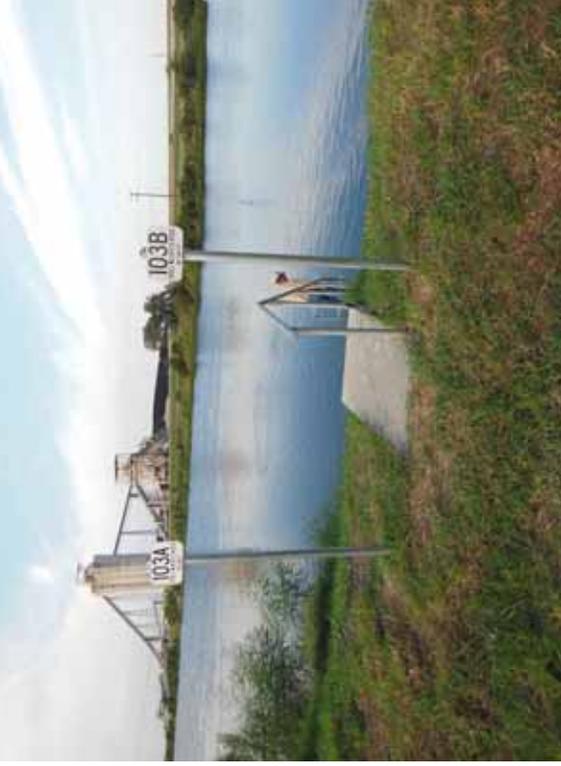
Photo 87: NP/SP - Discharge outfalls 103A and 103B into Plant intake canal.

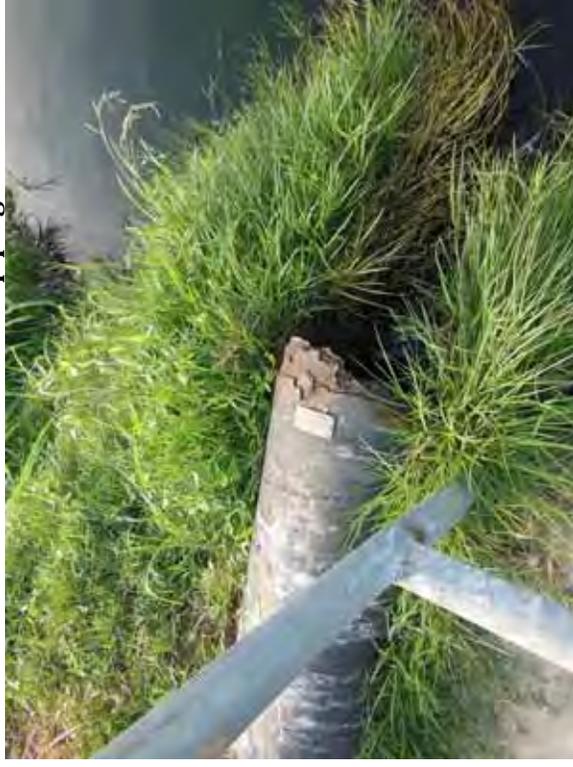
Photo 88: NP - 12-inch-diameter piping at outfall 103A.

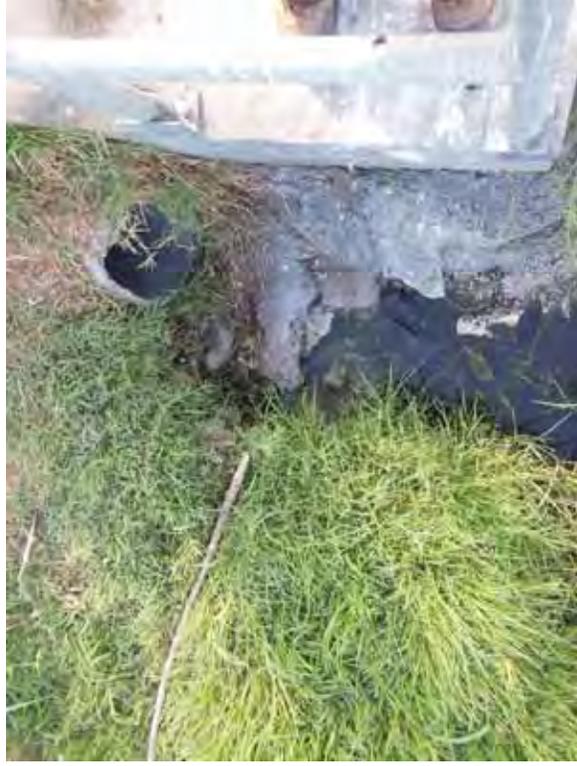
Photo 89: SP – 12-inch-diameter piping at outfall 103B.

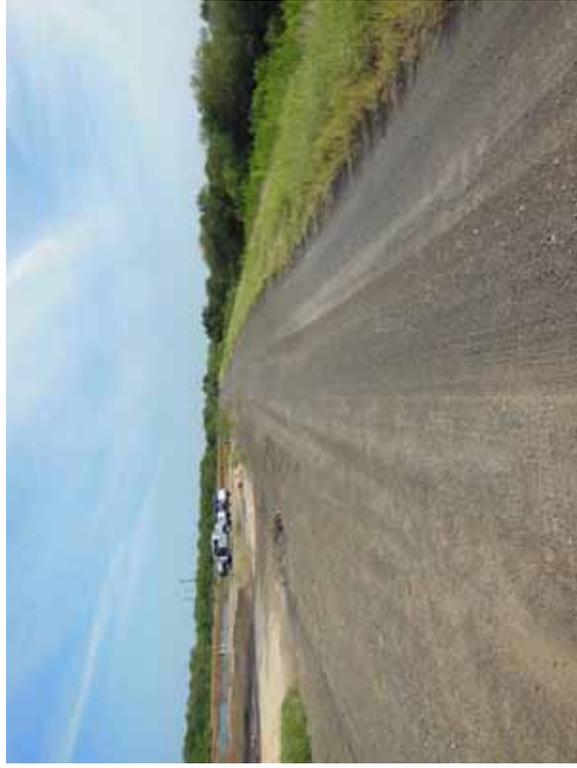
The embankment crest of the Evaporation Pond appeared to be in satisfactory condition (Photographs 90, 100, 108, and 114). The crest was approximately 15 feet wide at all embankments except the north embankment where the crest measured approximately 50 feet wide. The crest of the embankment consists of a compacted gravel drive and grass. The surface is exposed to minimal vehicle traffic. No depressions or evidence of settlement were observed on the crest.

Photo 90: East Embankment crest, looking north.

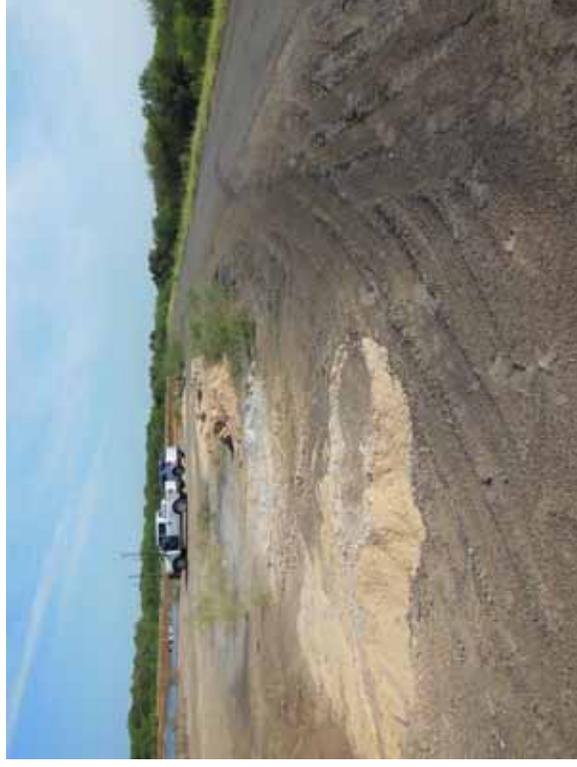
Due to the level of solids and water in the Evaporation Pond during the assessment, only the upper 0.5 to 2 feet of the interior slopes were visible (Photographs 91, 101, 102, 106, and 115). Vegetation covered some portions of the west and south embankment interior slopes (Photographs 111, 115, and 120). Ash and other solid material extend up to the crest near the southeast corner interior slope and on the east embankment interior slope (Photographs 91 and 122). Visible portions of interior slopes did not include riprap or other armoring.

Photo 91: East embankment interior slope, looking north.

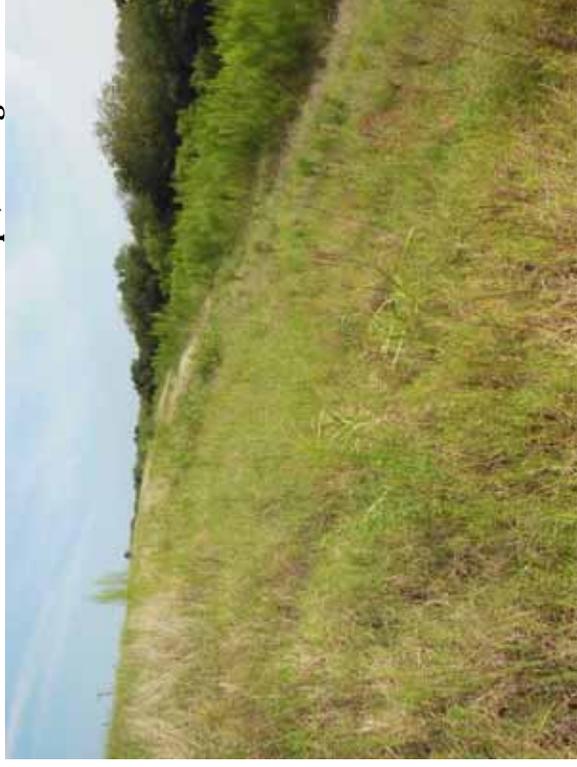
The exterior slopes appear to be in satisfactory condition and are covered in grassy vegetation approximately 2 feet high and a few small trees and bushes with diameters less than 6 inches in diameter (Photographs 93, 98, 109, and 119). Areas of loose soil were observed at the east embankment exterior slope (Photographs 92, 94, and 96) and an animal burrow was observed in the west embankment exterior slope (Photograph 110). An area of exposed soil was observed at the south embankment exterior slope (Photograph 117). Based on construction drawings, the exterior slopes are 3H:1V at all embankments, though slopes measured in the field ranged from 3H:1V to 4H:1V (Photographs 97 and 118). Trees up to 12 inches in diameter were located at the toe of all embankments (Photographs 95, 105, 112, and 119).

Photo 93: East embankment exterior slope, looking north.

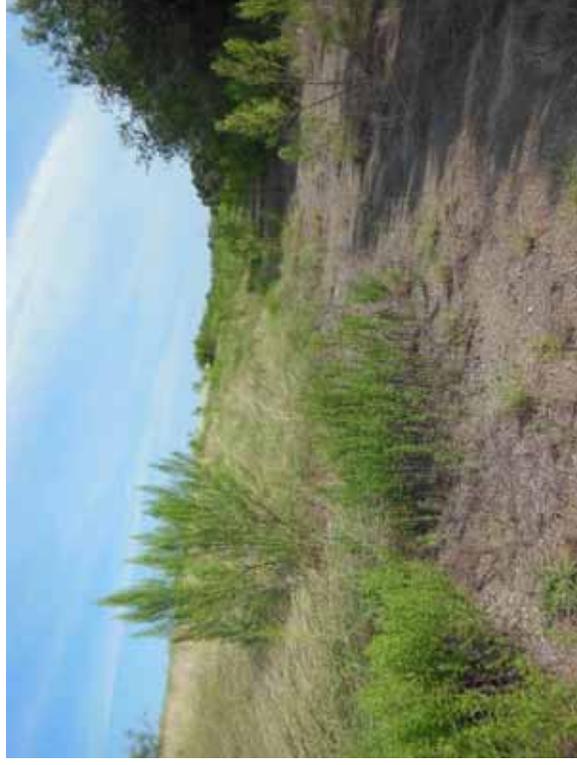
Photo 95: East embankment exterior toe, looking north.

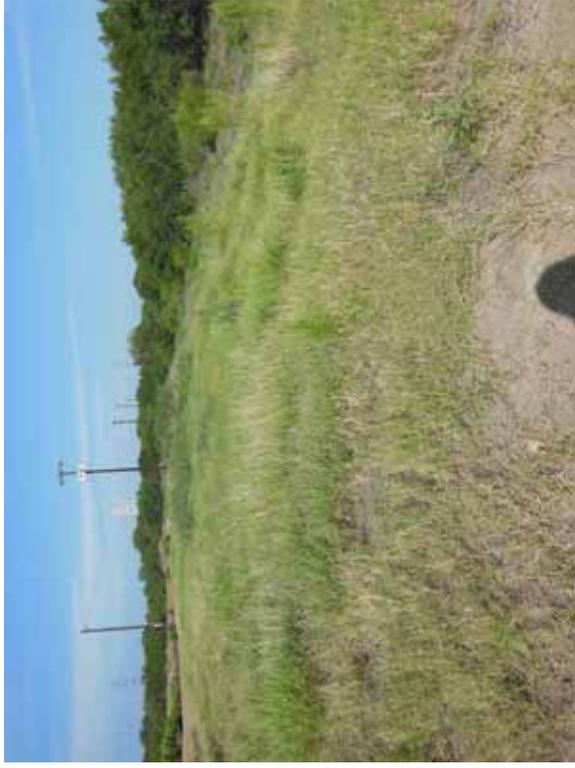
Photo 98: North embankment exterior slope, looking west.

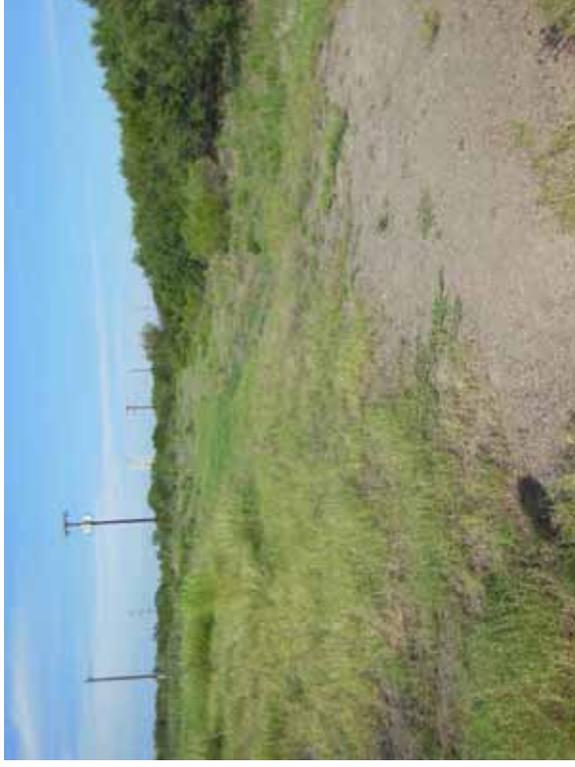
Photo 99: North embankment exterior slope, looking west.

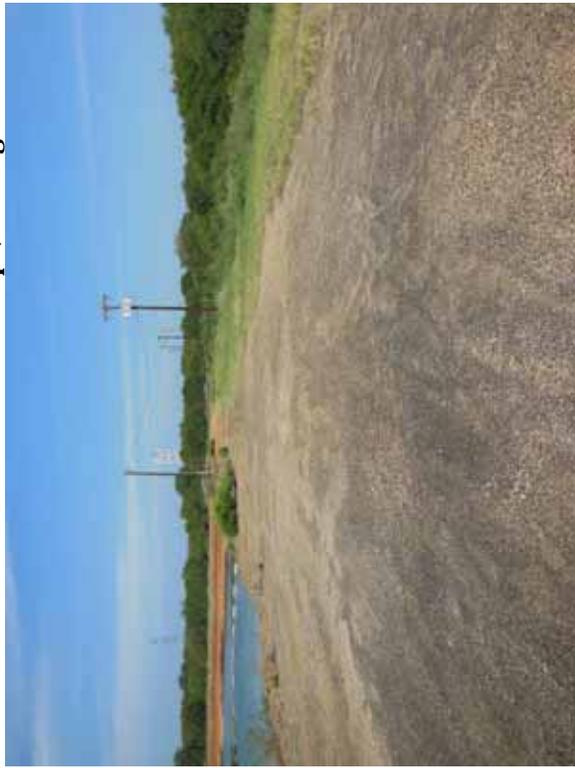
Photo 100: North embankment crest, looking west.

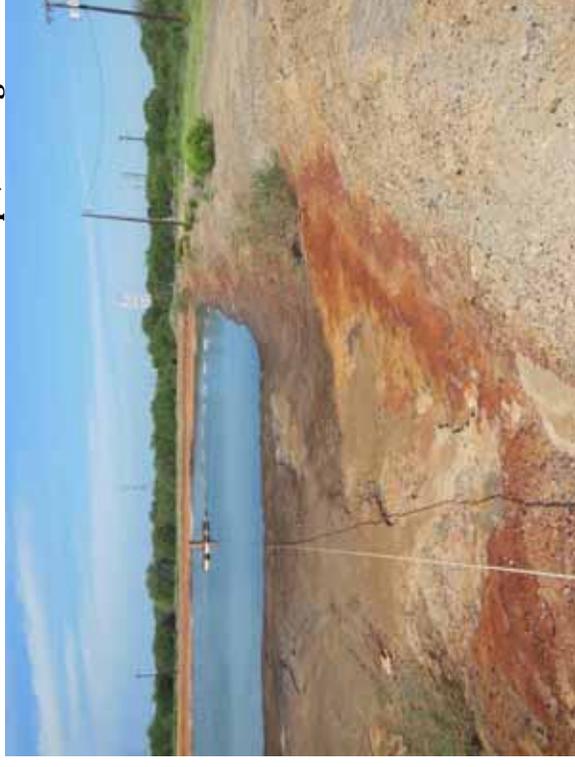
Photo 101: North embankment interior slope, looking west.

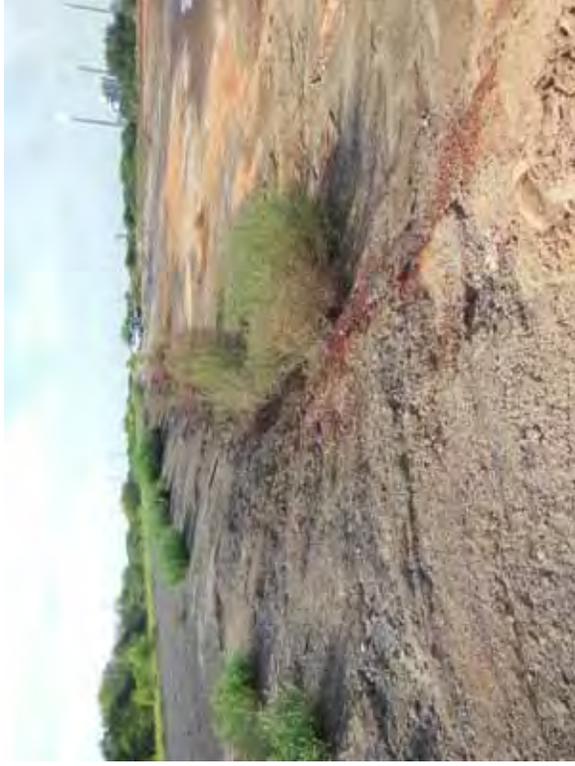
Photo 102: East embankment interior slope, looking south.

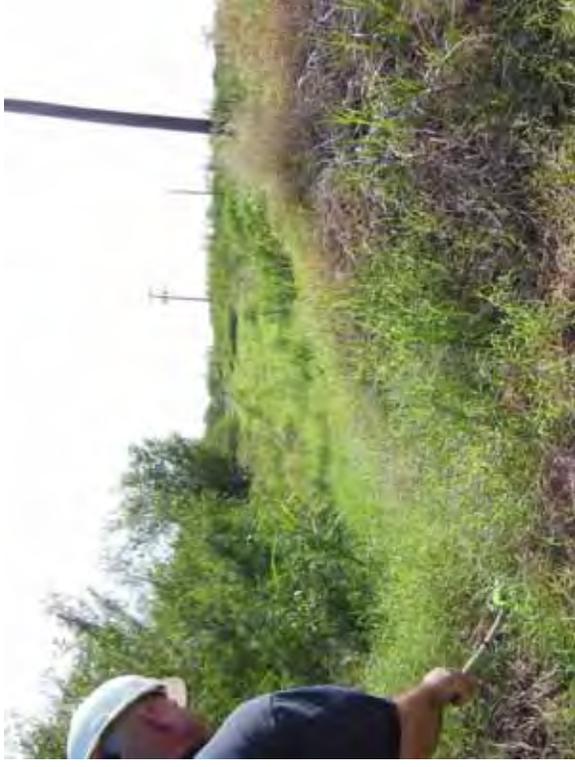
Photo 103: North embankment exterior slope, looking east.

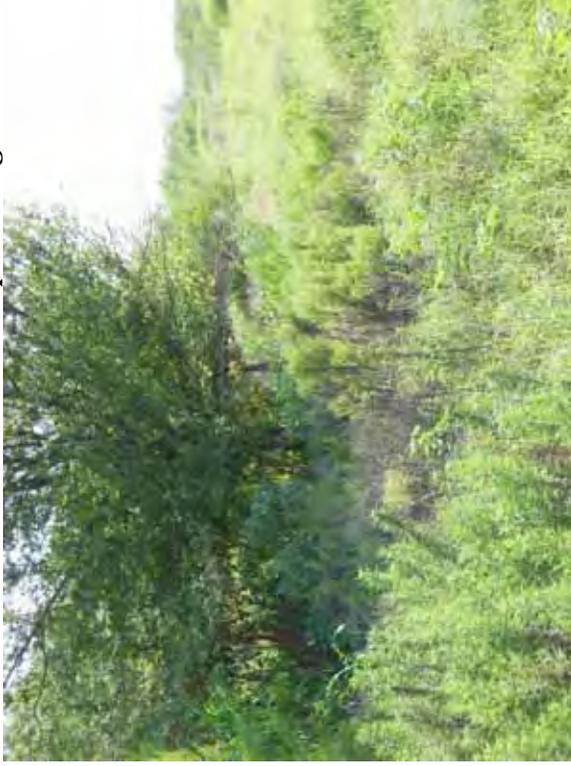
Photo 104: North embankment exterior slope, looking east. Note trees near exterior toe.

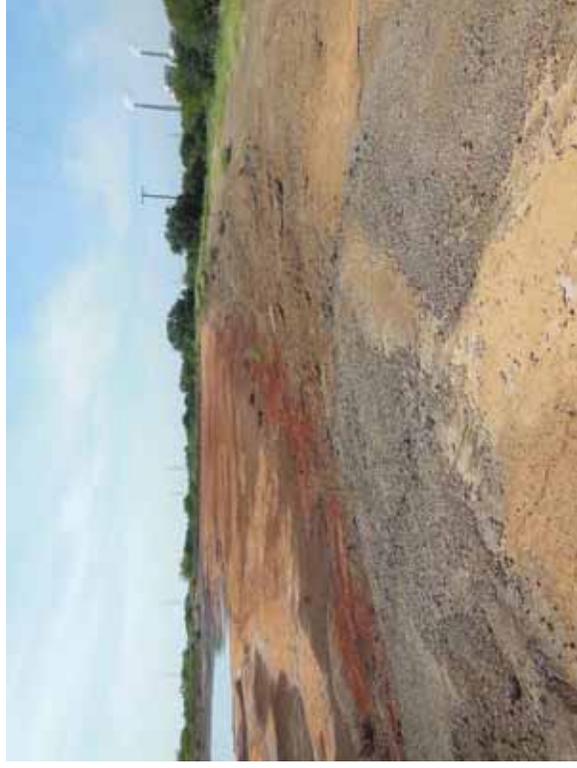
Photo 106: West embankment interior slope, looking south.

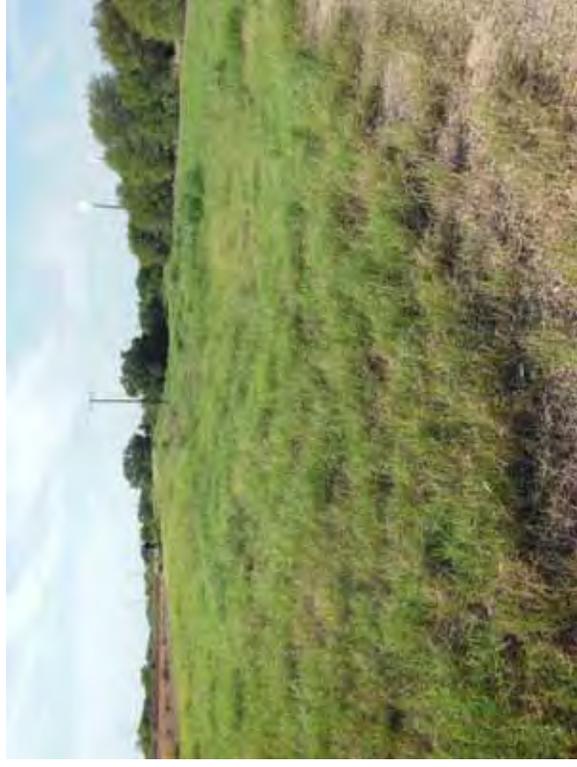
Photo 107: West embankment exterior slope, looking south.

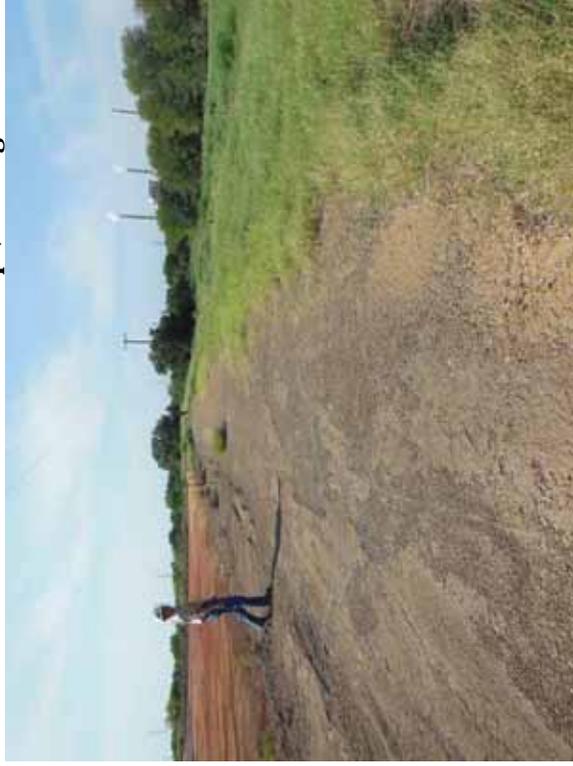
Photo 108: West embankment crest, looking south.

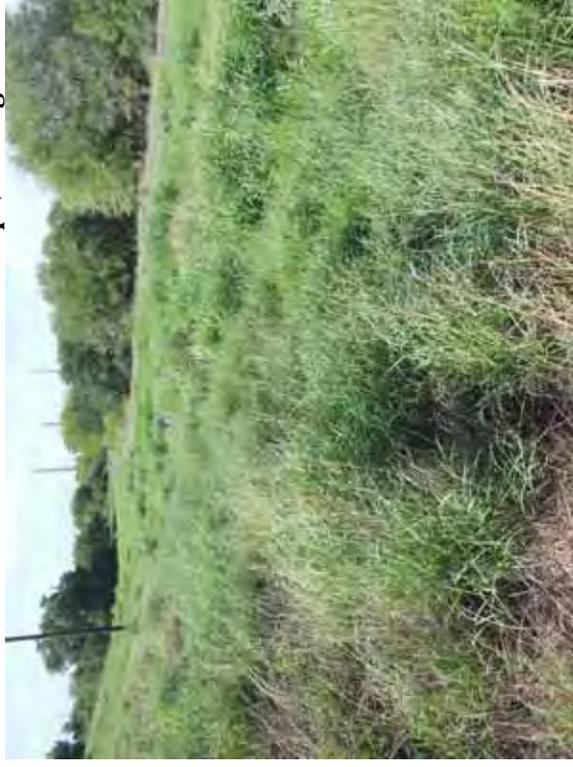
Photo 109: West embankment exterior slope, looking southwest.

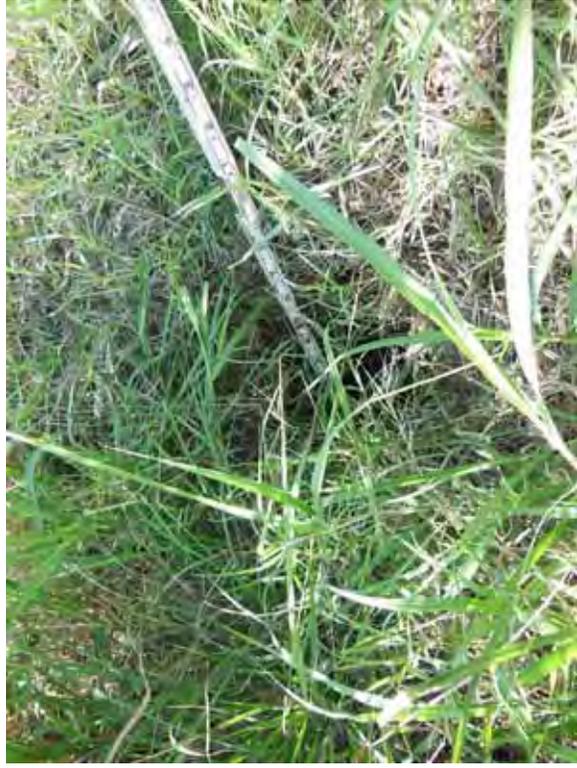
Photo 110: Approximately 18-inch-deep animal burrow at west embankment exterior slope.

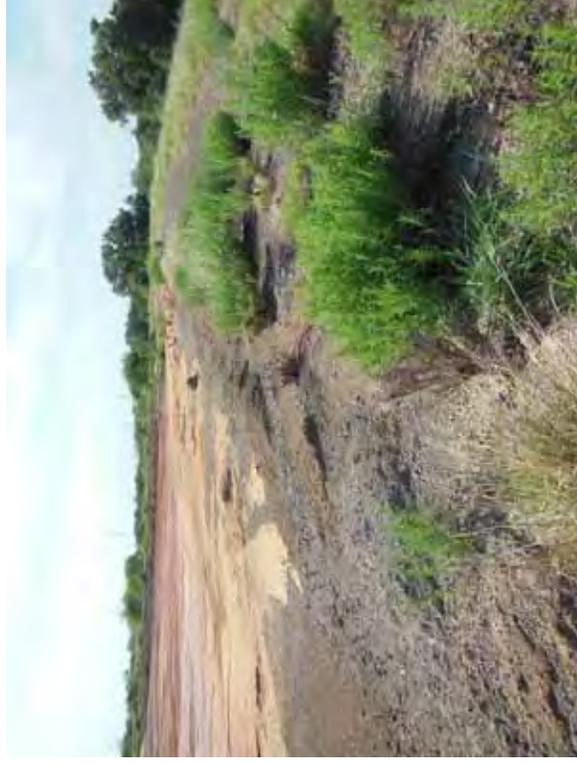
Photo 111: West embankment interior slope, looking south.

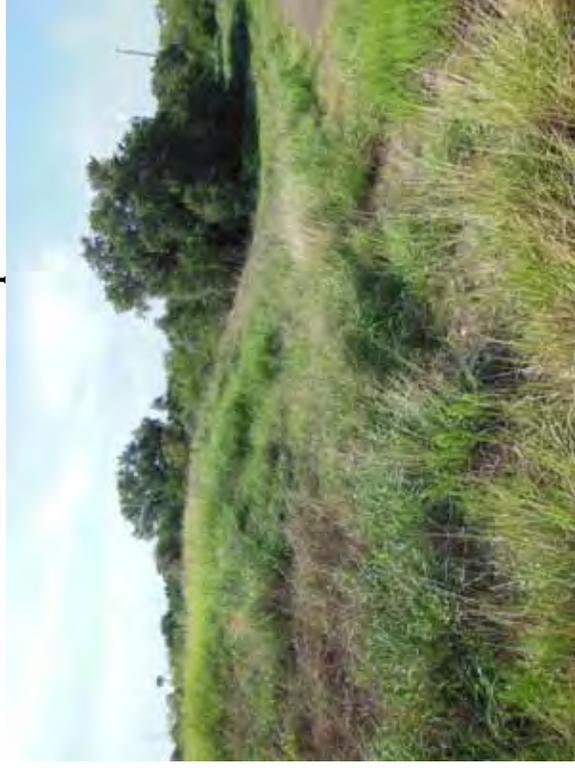
Photo 112: West embankment exterior slope, looking south.

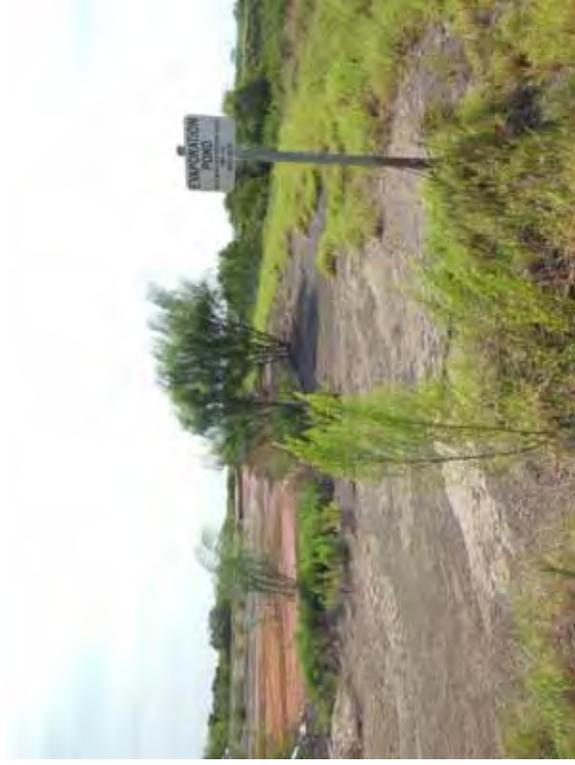
Photo 113: Pond signage near southwest corner.

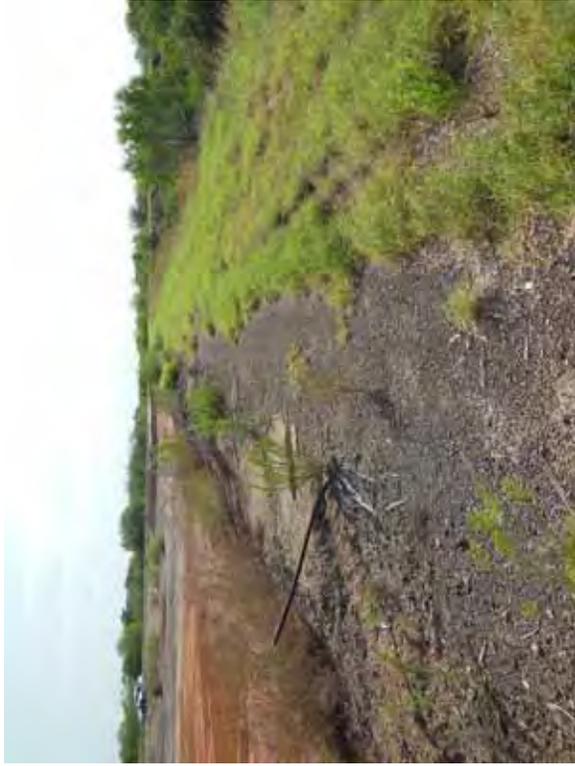
Photo 114: South embankment crest, looking east.
