ASSESSMENT OF DAM SAFETY OF COAL COMBUSTION SURFACE IMPOUNDMENTS – DRAFT REPORT

**CPS Energy
J.T. Deely Power Plant
San Antonio, Texas**

Prepared for
*U.S. Environmental
Protection Agency
Washington, D.C.*

December 2012
Revision 1, December 2013

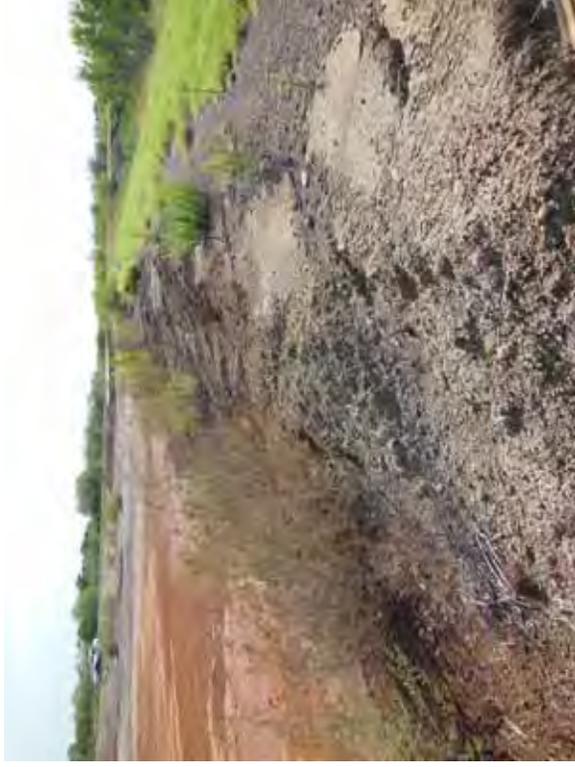
Due to the level of solids and water in the Evaporation Pond during the assessment, only the upper 0.5 to 2 feet of the interior slopes were visible (Photographs 91, 101, 102, 106, and 115). Vegetation covered some portions of the west and south embankment interior slopes (Photographs 111, 115, and 120). Ash and other solid material extend up to the crest near the southeast corner interior slope and on the east embankment interior slope (Photographs 91 and 122). Visible portions of interior slopes did not include riprap or other armoring.

Photo 115: South embankment interior slope, looking east.

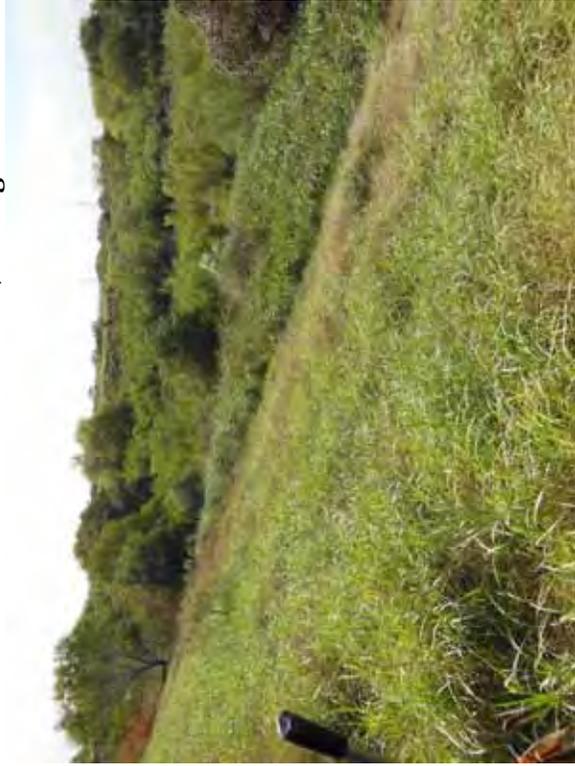
Photo 116: South embankment exterior slope, looking southeast.

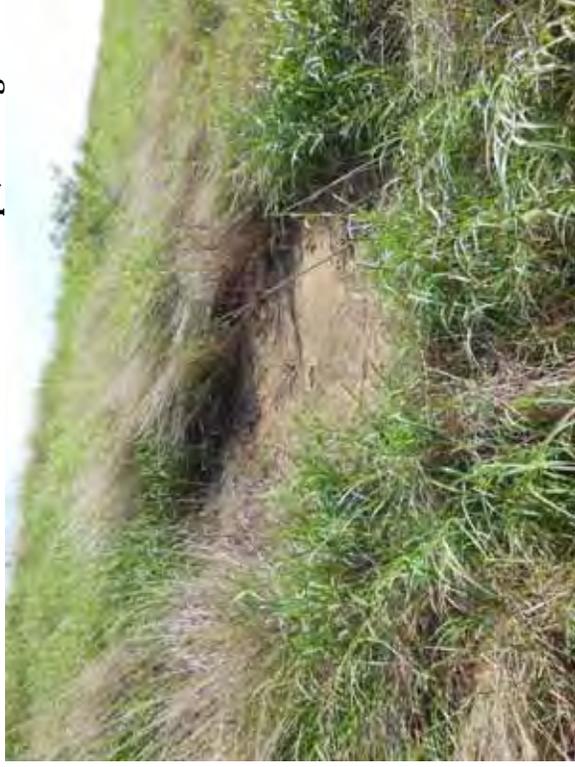
Photo 117: Exposed soil at south embankment exterior slope, looking north.

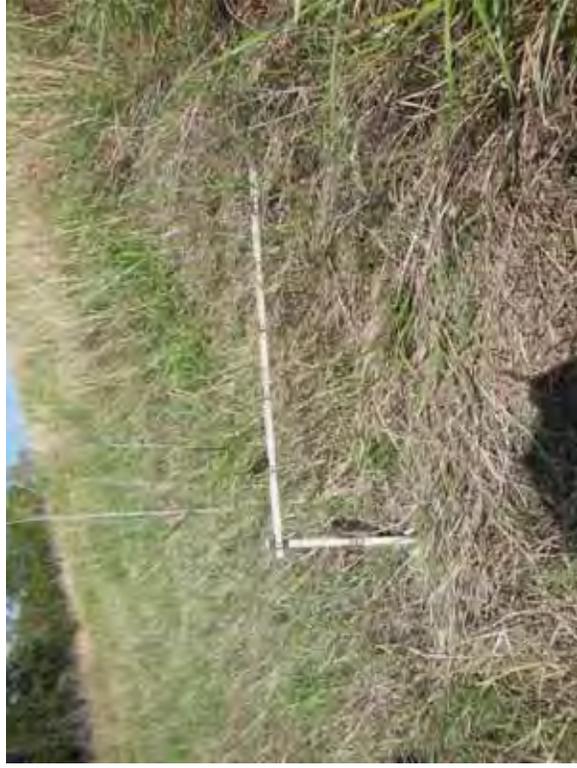
Photo 118: South embankment exterior slope measured approximately 3H:1V.

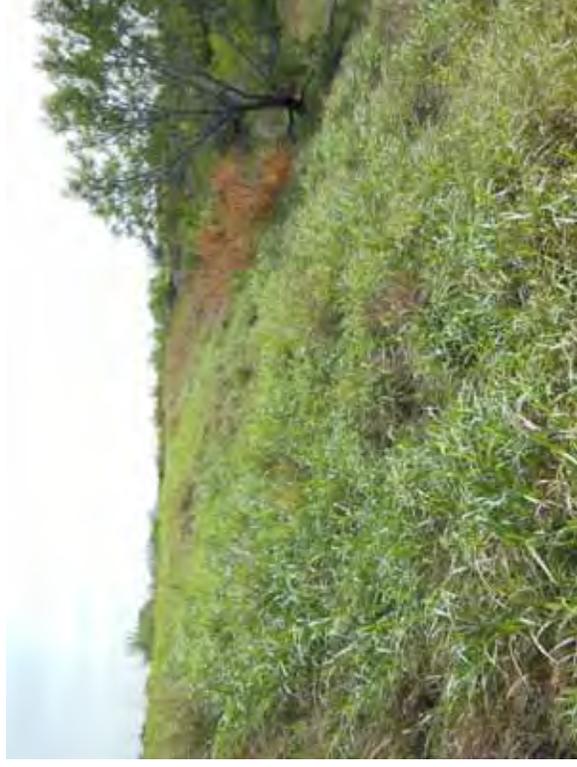
The exterior slopes appear to be in satisfactory condition and are covered in grassy vegetation approximately 2 feet high and a few small trees and bushes with diameters less than 6 inches in diameter (Photographs 93, 98, 109, and 119). Areas of loose soil were observed at the east embankment exterior slope (Photographs 92, 94, and 96) and an animal burrow was observed in the west embankment exterior slope (Photograph 110). An area of exposed soil was observed at the south embankment exterior slope (Photograph 117). Based on construction drawings, the exterior slopes are 3H:1V at all embankments, though slopes measured in the field ranged from 3H:1V to 4H:1V (Photographs 97 and 118). Trees up to 12 inches in diameter were located at the toe of all embankments (Photographs 95, 105, 112, and 119).

Photo 119: South embankment exterior slope, looking east.

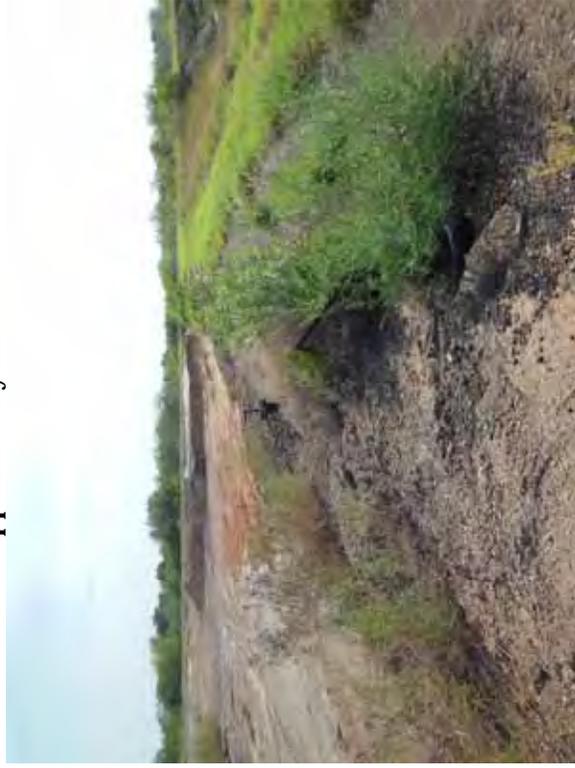
Photo 120: South embankment interior slope, looking east.

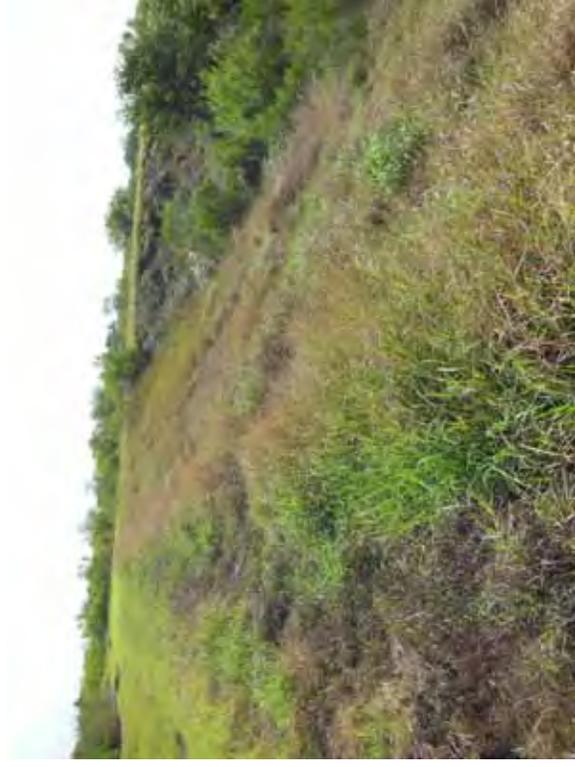
Photo 121: South embankment exterior slope, looking east.

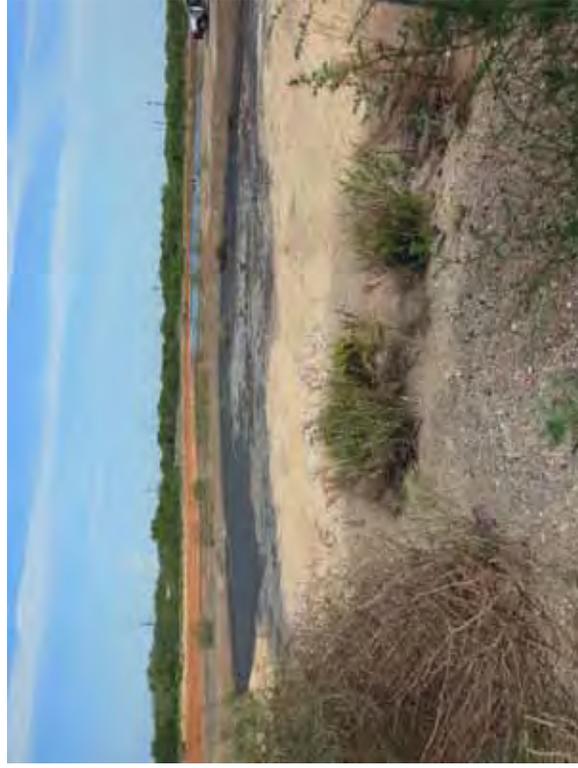
Photo 122: Interior slope at southeast corner, looking northwest.
