# ASSESSMENT OF DAM SAFETY OF COAL COMBUSTION SURFACE IMPOUNDMENTS FINAL REPORT

**CPS Energy  
J.T. Deely Power Plant  
San Antonio, Texas**

Prepared for  
*U.S. Environmental  
Protection Agency  
Washington, D.C.*

February 2014  
Revised May 2014  
Revised June 2014

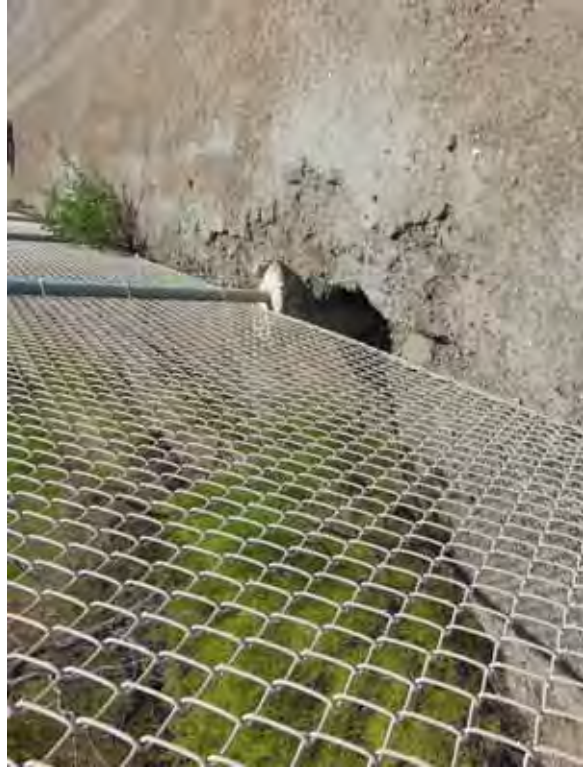
**Photo 5: NP - North embankment exterior slope, looking northeast.  
Note erosion near fence post.**

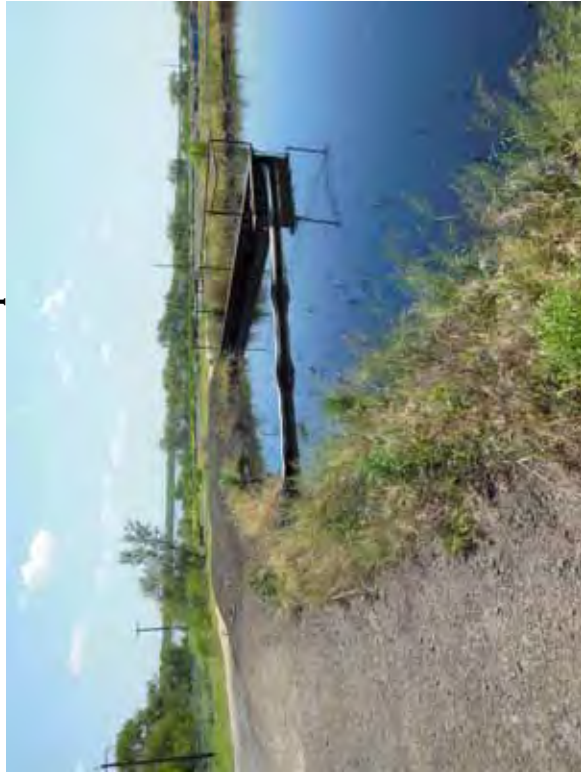
**Photo 7: NP - Outlet structure at northeast corner, looking east.**

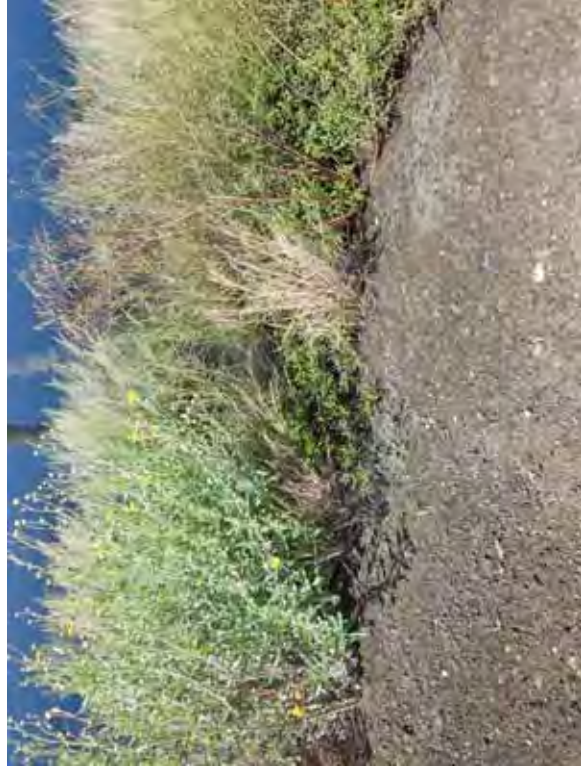
**Photo 13: NP - East embankment interior slope, looking west. Note vegetation on slope.**

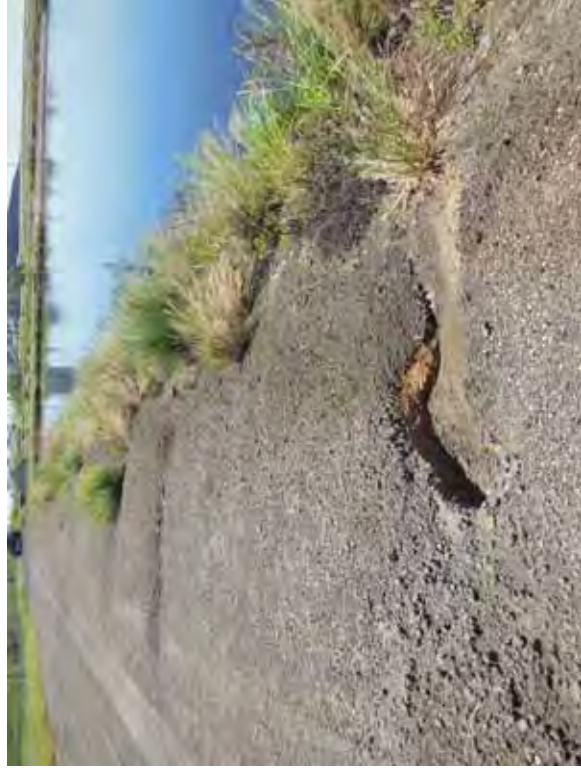
**Photo 17: NP - East embankment interior slope, looking south. Note erosion rills in ash material.**

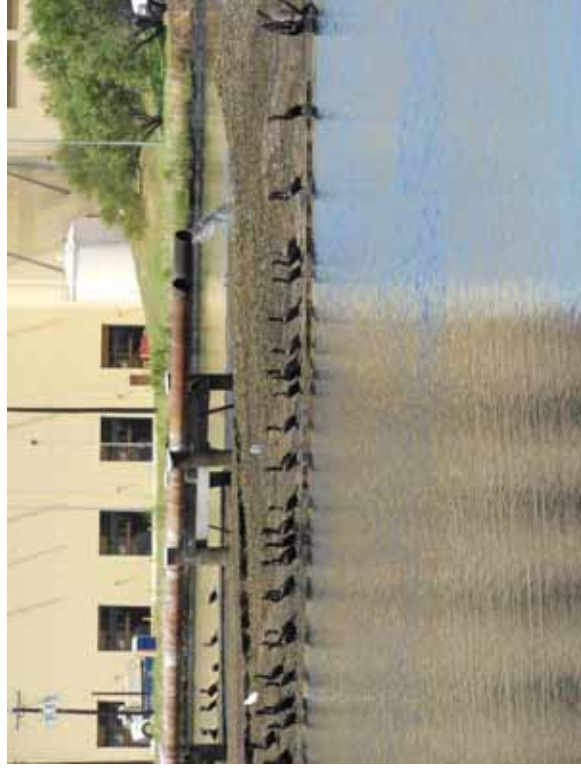
Three inlet pipes discharge liquids near the center of the North Bottom Ash Pond; two 12-inch-diameter welded steel and one 8-inch-diameter welded steel pipe (Photographs 18 and 33).

**Photo 18: NP - Inlet piping, looking northwest. Piping includes one 8-inch diameter and two 12-inch-diameter pipes.**

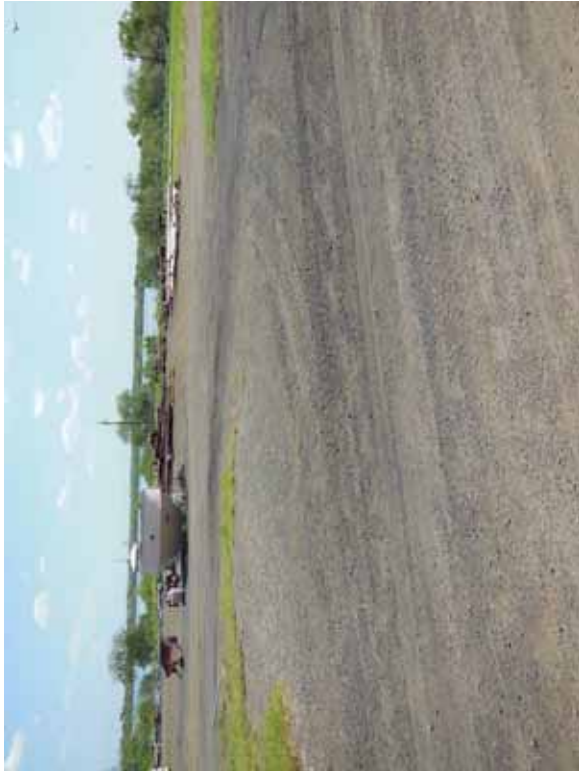
**Photo 19: NP - Exterior slope at southeast corner, looking east.**

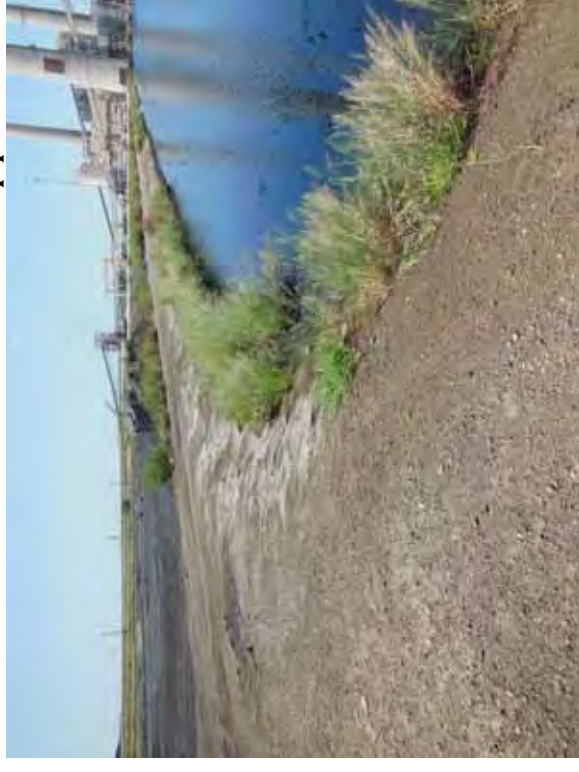
**Photo 20: NP - Interior slope at southeast corner, looking west.**

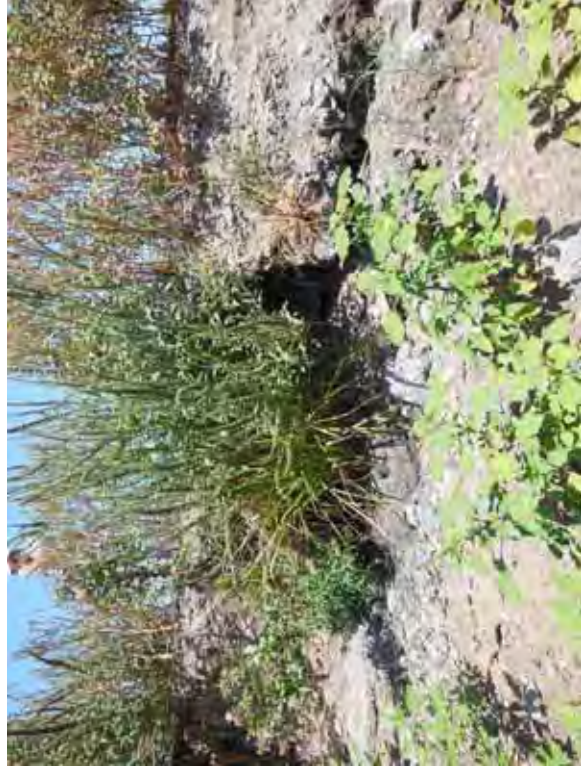
**Photo 25: NP/SP - Vegetation and ash material on common embankment south slope.**

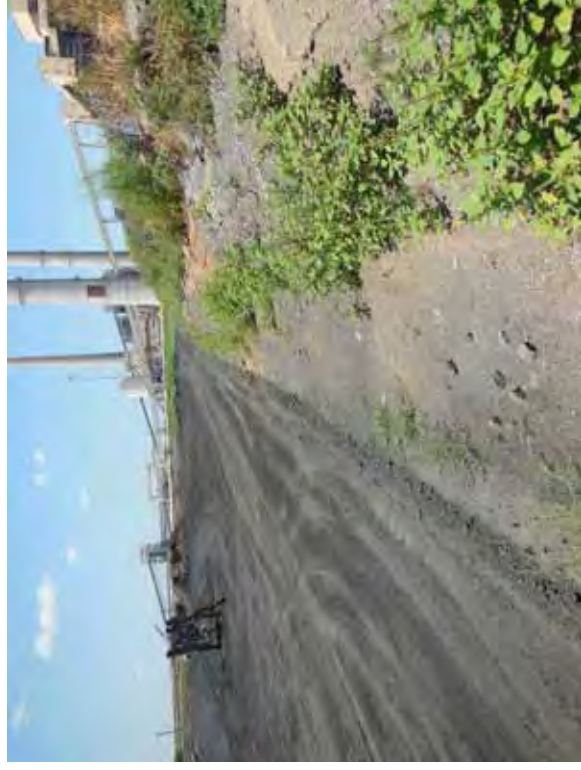
**Photo 26: NP/SP - Erosion of ash material on common embankment south slope, looking west.**

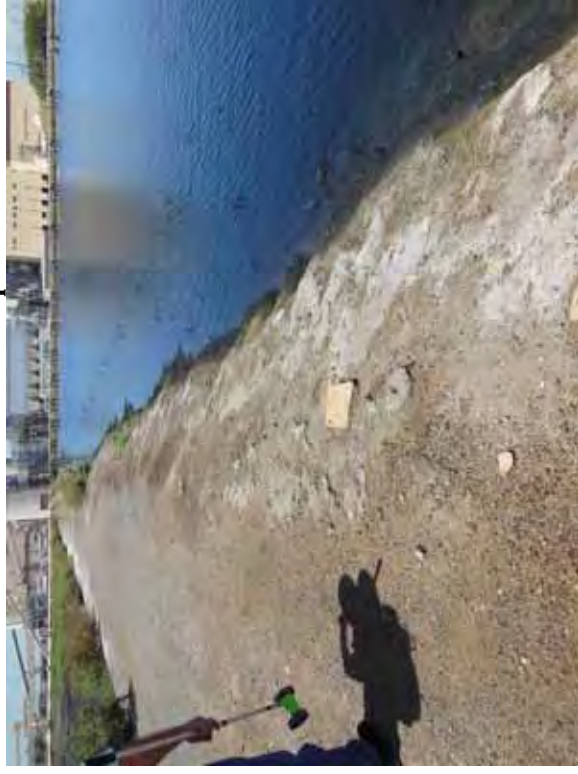
Due to the water level in the North Bottom Ash Pond during the assessment, only the upper 2 feet of the interior slopes were visible (Photographs 3, 12, 27, and 40). Based on construction drawings, the interior slopes were constructed at 2H:1V. The interior slopes were measured at approximately 3H:1V near the top of the embankment and included a layer of ash material (Photograph 28). Small areas of erosion into ash were observed on the interior slope at the east, south, and west embankments (Photographs 17, 23, 38, and 43) and an area of loose ash was observed on the east embankment interior slope (Photograph 14). Vegetation covered some portions of the interior slopes that were visible (Photographs 6, 12, 32, and 35). Visible portions of interior slopes did not include riprap or other armoring.

Exterior slopes of the South Bottom Ash Pond appear to be in fair condition (Photographs 27, 58, 62, and 74). The exterior slopes of the east and south embankments are approximately 3H:1V and covered in grassy vegetation approximately 3 inches tall (Photograph 63). The north embankment exterior slope is shared with the North Bottom Ash Pond and is covered in ash material with sparse vegetation consisting of grass and brush, approximately 2 feet high. Some areas of minor erosion were observed on the exterior slope, in the ash material (Photograph 23). The SRH Pond is located at the west embankment exterior slope and is covered with ash and other granular material (Photographs 74, 81, and 82). A drainage ditch is located at the south embankment exterior toe (Photograph 67).

**Photo 27: NP/SP - Common embankment north slope, looking west.**

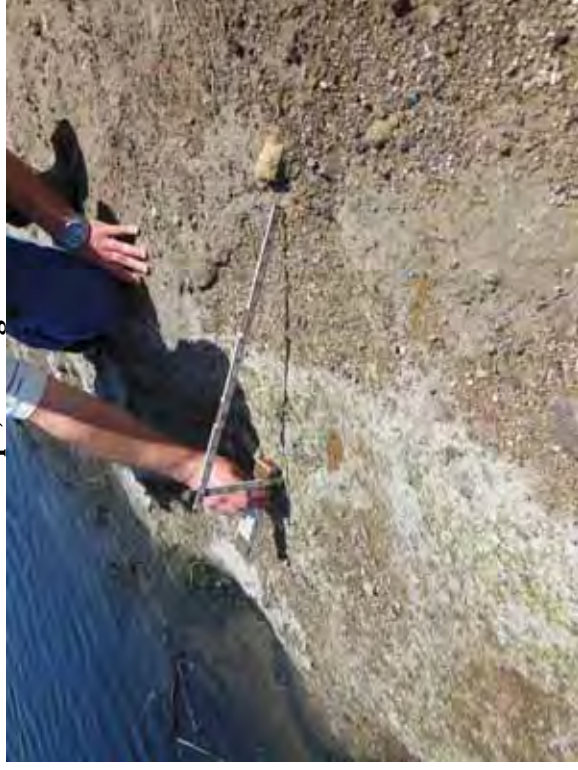
**Photo 28: NP/SP - Common embankment north slope, looking east. Slope measured approximately 3H:1V.**

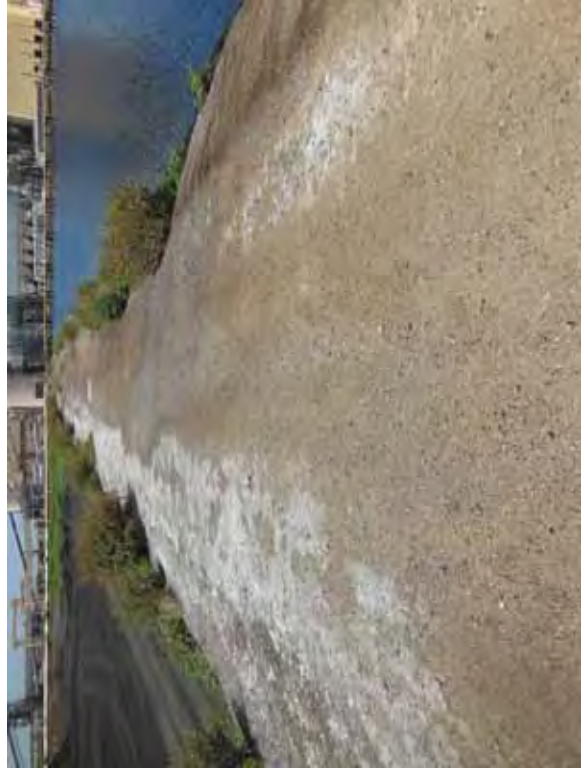
The crest of the North Bottom Ash Pond appeared to be in satisfactory condition (Photographs 1, 10, 29, and 42). The crest was approximately 15 feet wide at all embankments except the north embankment where the crest measured approximately 30 feet wide. The crest of the embankments consists of compacted granular soils and gravel and is exposed to minimal vehicle traffic. An area of erosion near a fence post was observed at the north embankment crest (Photographs 5 and 52). Wood support poles for overhead powerlines are located in the crest of the north embankment (Photograph 1). No depressions or evidence of settlement were observed on the crest.

The crest of the South Bottom Ash Pond appeared to be in satisfactory condition (Photographs 29, 56, 65, and 73). All embankment crests were approximately 15 feet wide and consists of compacted granular soils and gravel and is exposed to minimal vehicle traffic. A clarifier structure associated with the adjacent SRH Pond was located on the west embankment crest (Photograph 78). The west embankment crest included two spillways connecting the SRH and South Bottom Ash Ponds (Photographs 75, 76, 77, 79, 80, and 81). No depressions or evidence of settlement were observed on the crest.

**Photo 29: NP/SP - Common embankment crest, looking west.**

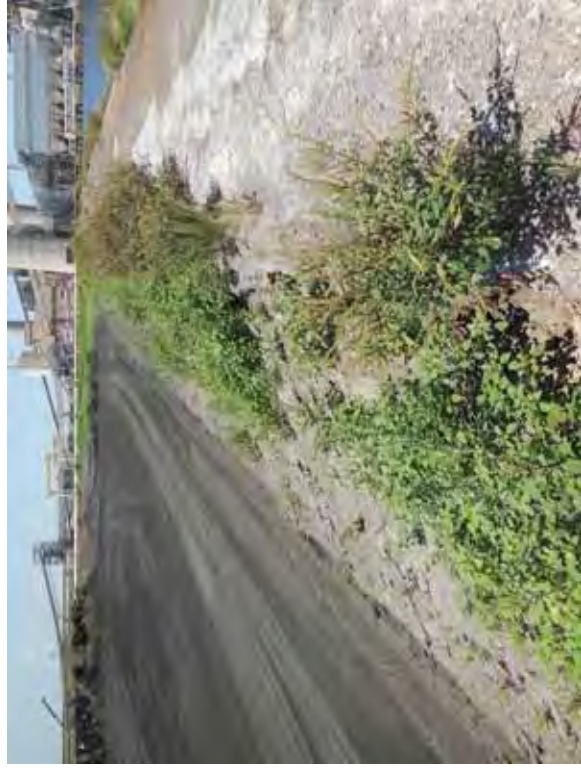
Exterior slopes of the North Bottom Ash Pond appear to be in fair condition (Photographs 15, 30, 39, and 49). Due to the terrain and vegetation on the exterior slope of the north embankment, the slope was only visible from the embankment crest (Photograph 50). A few small trees and brush less than 8 inches in diameter were observed on the exterior slope of the north embankment (Photographs 47 and 48). The exterior slopes of the west and east embankments are approximately 3H:1V and covered in grassy vegetation approximately 3 inches tall (Photographs 16 and 39). The south embankment is shared with the South Bottom Ash Pond and is covered in ash material with sparse vegetation consisting primarily of grass and brush, approximately 2 feet high. Some areas of minor erosion into the ash material (Photographs 24, 25, and 26) were observed. The #1 Stormwater Runoff Pond is located at the west embankment exterior toe and the SRH Pond is located at the exterior toe of the southwest corner (Photograph 37).

Interior slopes appeared to be in fair condition (Photographs 30, 59, 66, and 70). Based on construction drawings, the interior slopes were constructed at 2H:1V. The north embankment is shared with the North Bottom Ash Pond and is covered in ash material (Photograph 22). Vegetation is sparse, consisting primarily of grass and brush, approximately 2 feet high (Photographs 24, 25, 26, 59, 64, 70, and 84). Some areas of minor erosion into the ash material (Photographs 24, 25, and 26) were observed. A stockpile of CCW was observed on the east embankment interior slope (Photograph 57). Visible portions of interior slopes were not protected by riprap or other armoring.

**Photo 30: NP/SP - Common embankment south slope, looking west.**

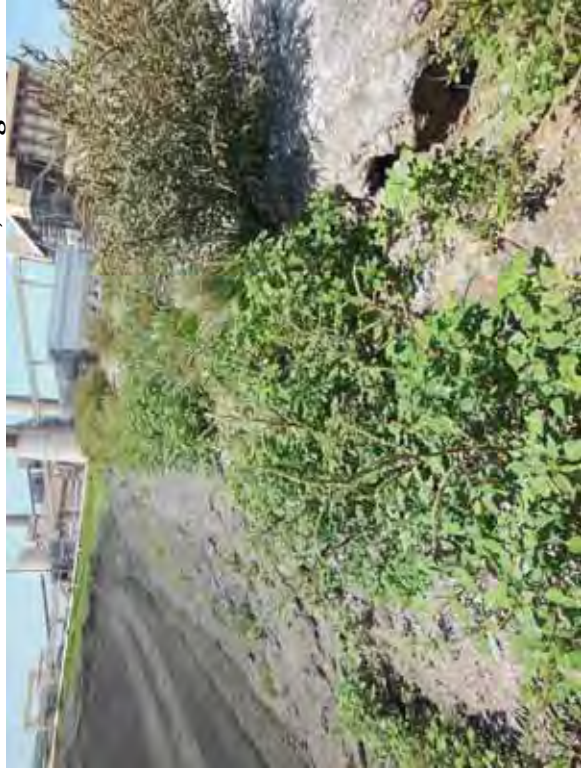
**Photo 31: NP/SP - Common embankment south slope, looking west.**

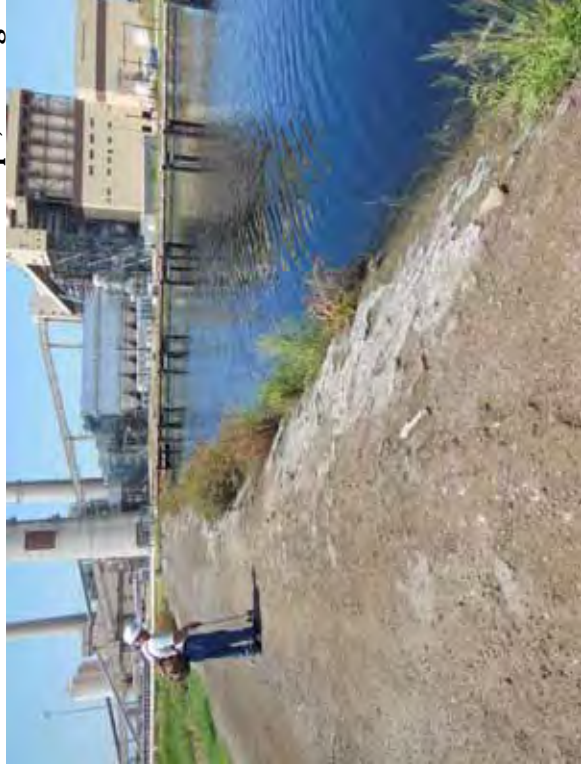
**Photo 32: NP/SP - Common embankment north slope, looking west.**

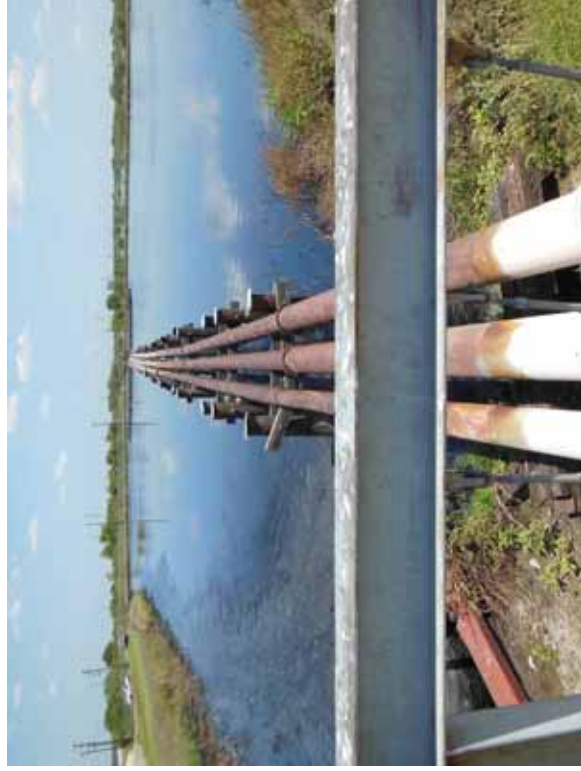
**Photo 33: NP - Inlet pipes at southwest corner. Piping includes one 8-inch diameter and two 12-inch-diameter pipes.**

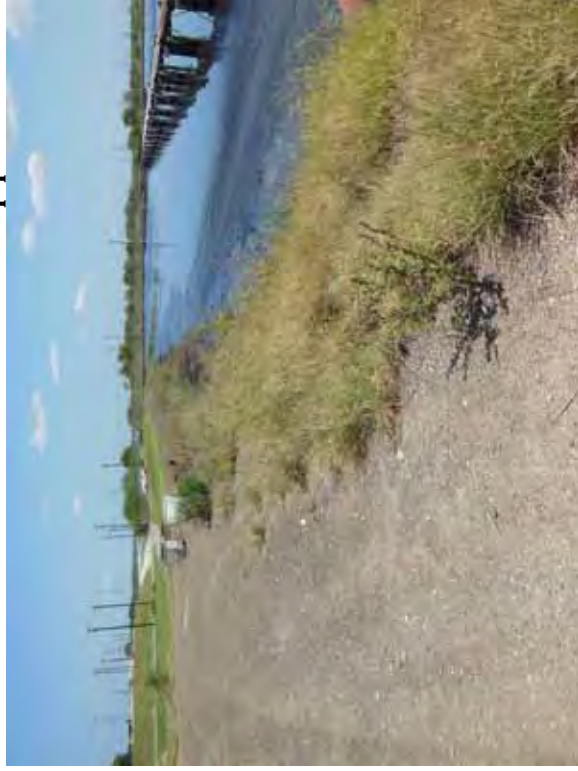
**Photo 35: NP - West embankment interior slope, looking northeast.**

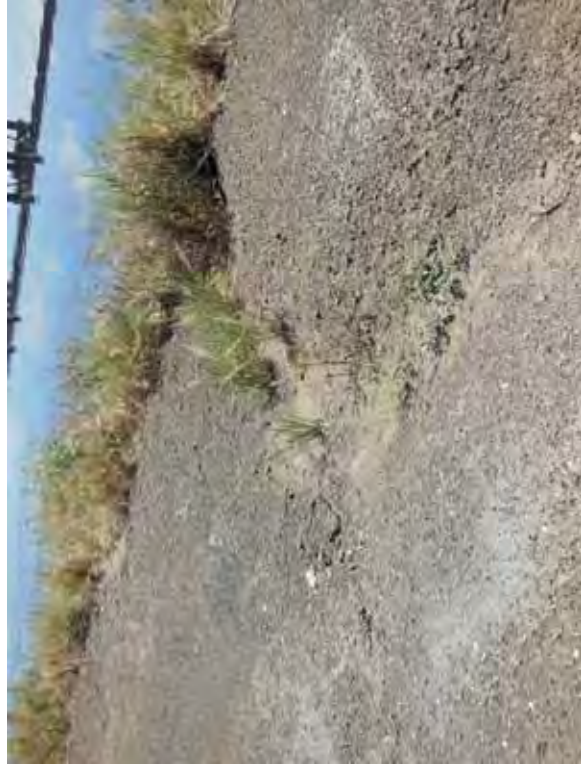
**Photo 38: NP - Erosion rill in ash material at west embankment interior slope.**

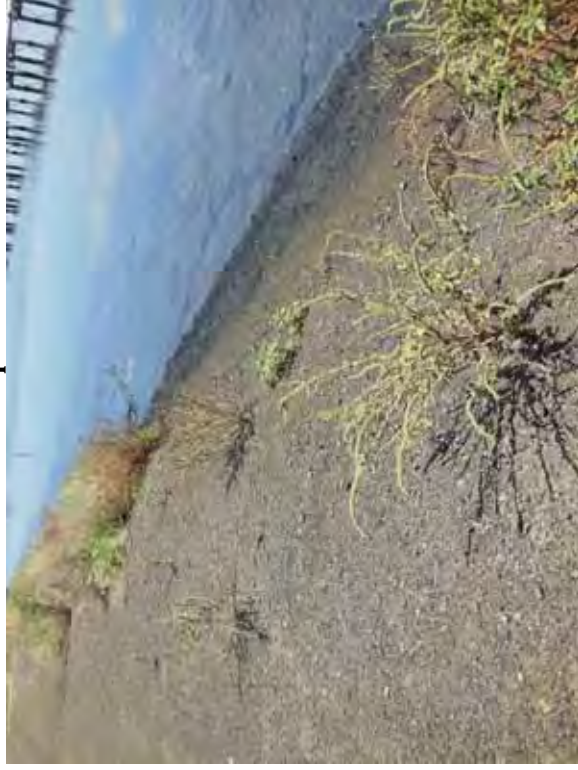
**Photo 40: NP - West embankment interior slope, looking northeast.**

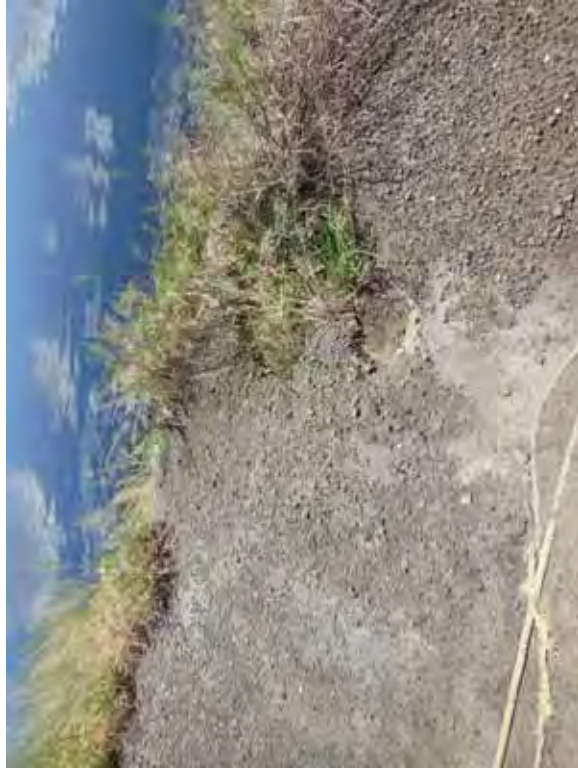
**Photo 43: NP - Erosion of ash material at west embankment interior slope.**

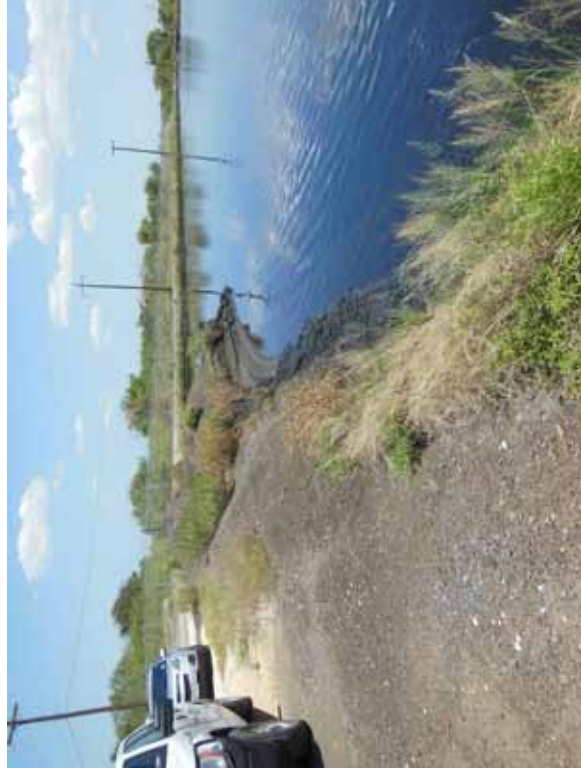
**Photo 45: NP - West embankment interior slope, looking northeast.  
Note area of ash material on slope near northwest corner.**

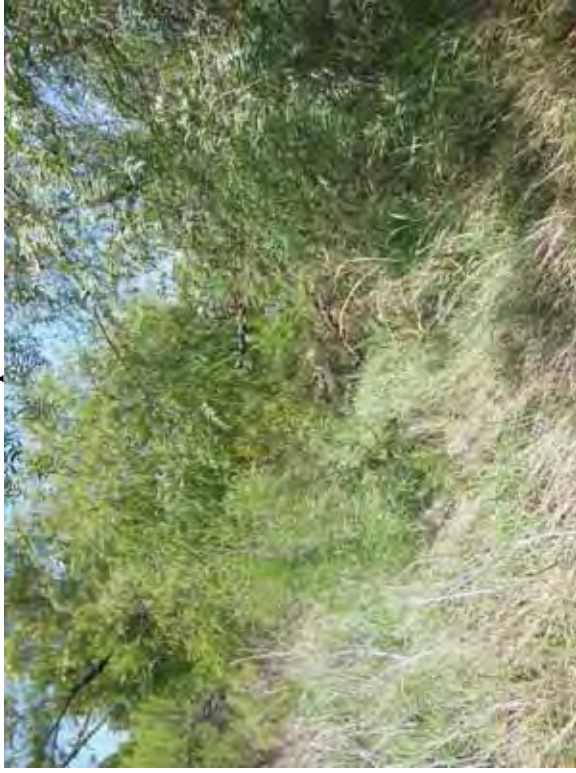
**Photo 47: NP - Vegetation on north embankment exterior slope,  
looking north.**

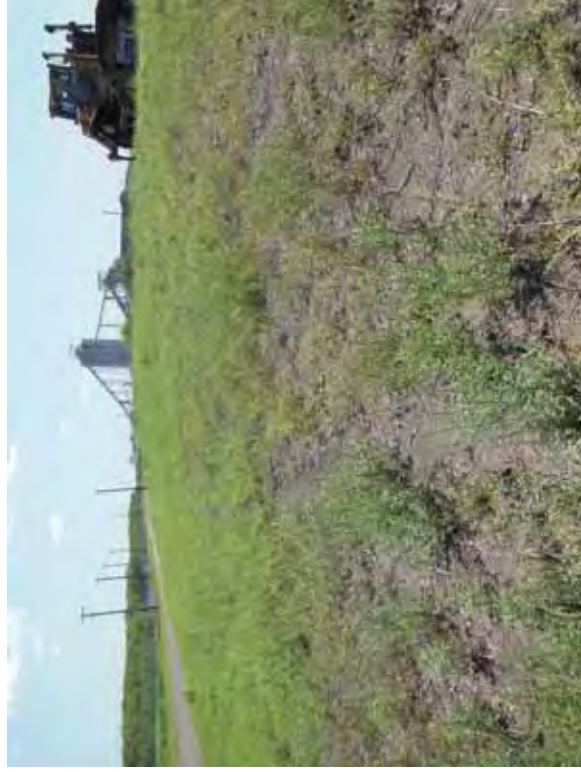
**Photo 53: SP - East embankment exterior slope, looking south.**

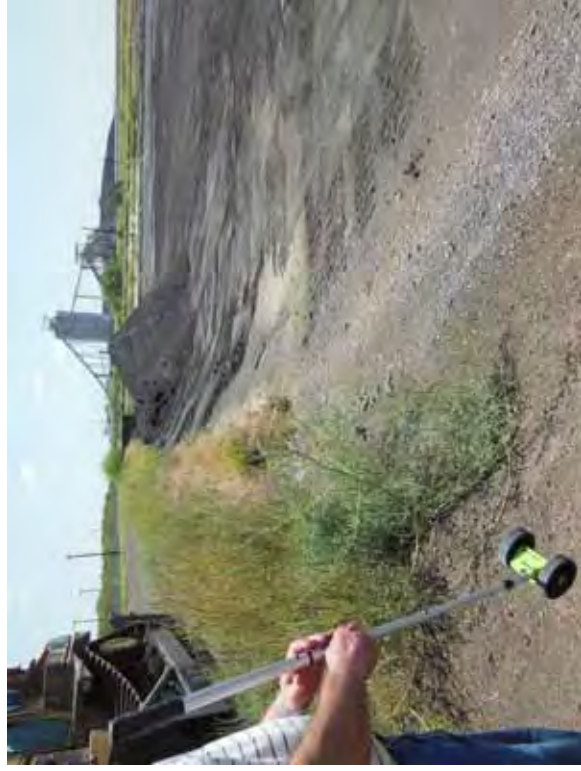
**Photo 54: SP - East embankment interior slope, looking south.**

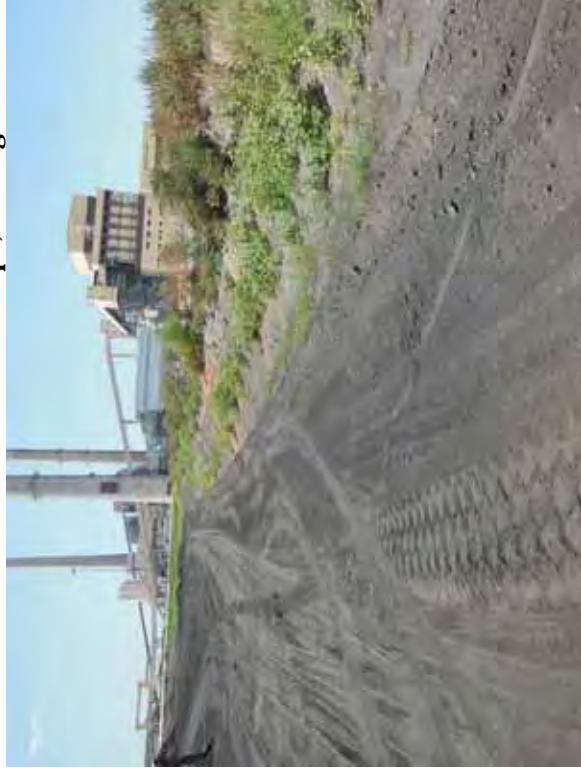
**Photo 55: NP/SP - Common embankment south slope, looking west.**

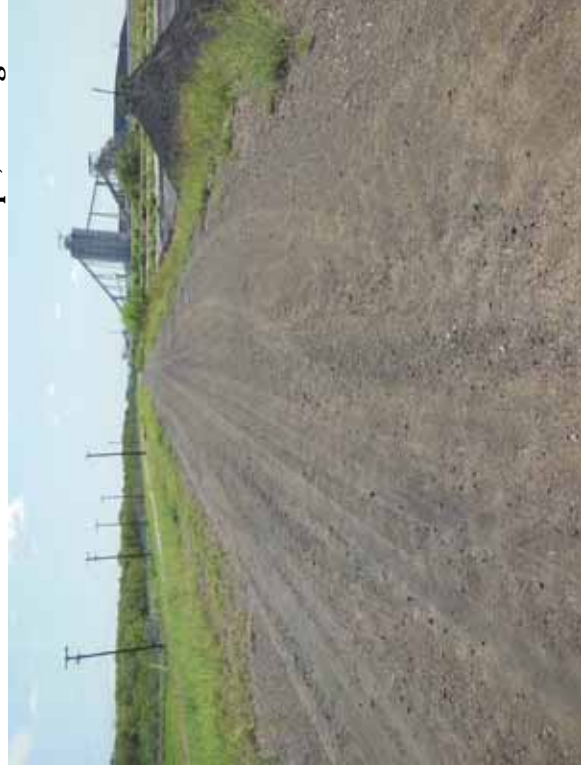
**Photo 56: SP - East embankment crest, looking south.**

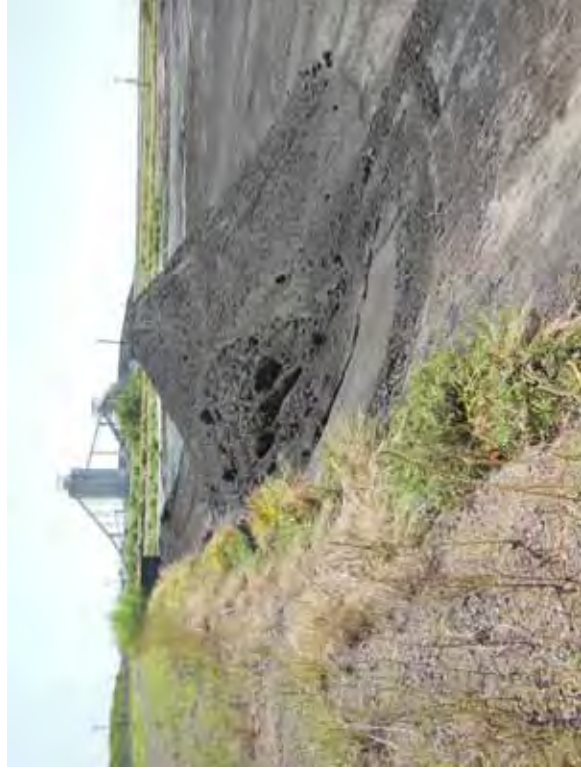
**Photo 57: SP - Ash/soil pile on east embankment interior slope, looking south.**

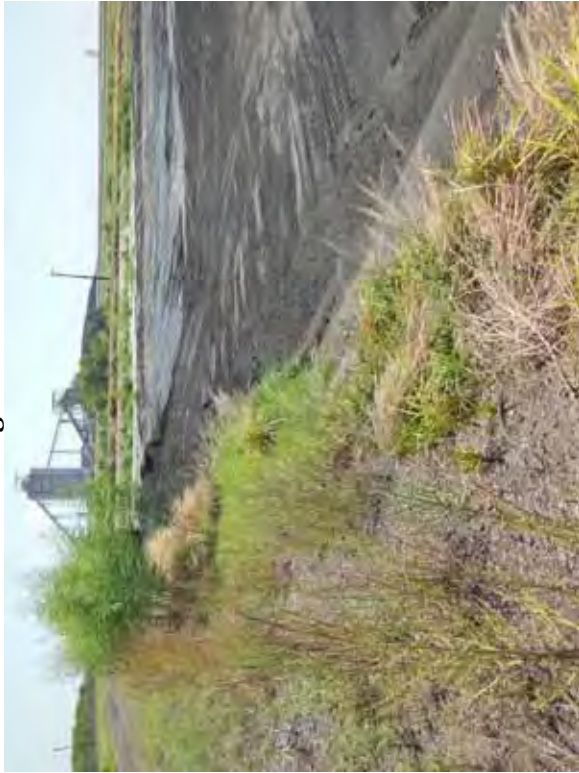
**Photo 59: SP - East embankment interior slope, looking south.**

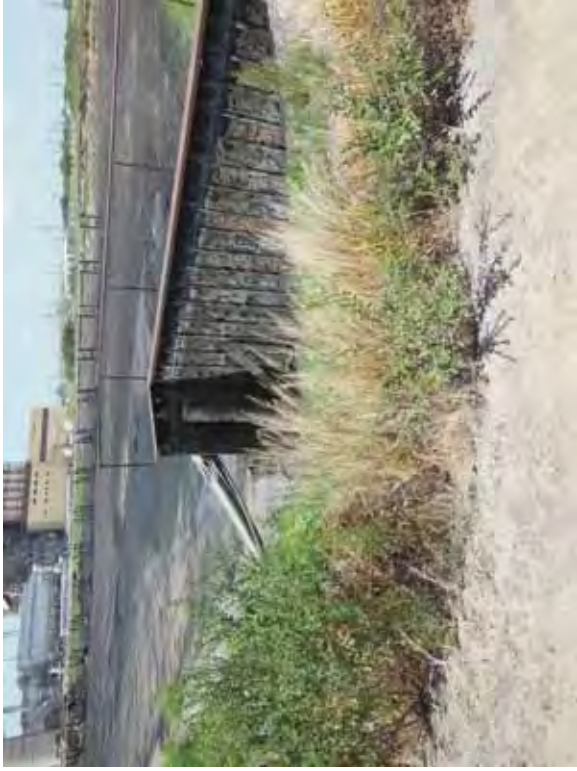
**Photo 61: SP - Outlet structure at southeast corner interior slope, looking northwest.**

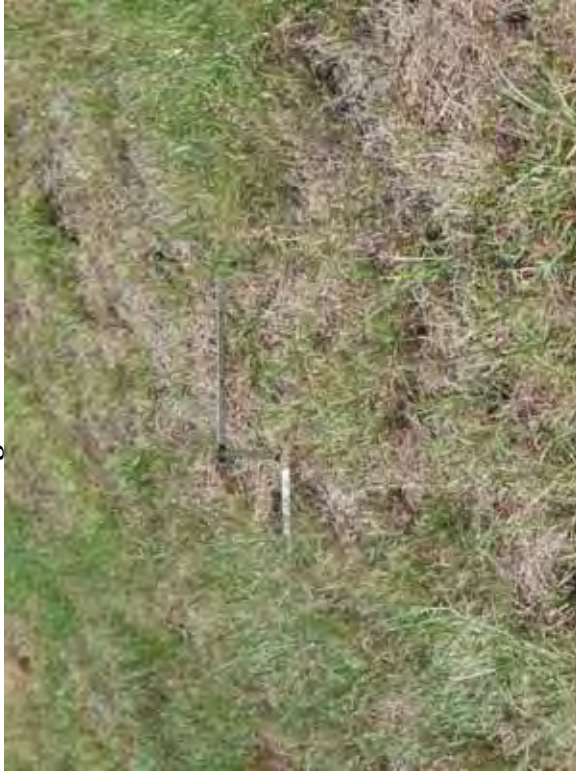
**Photo 63: SP - Approximately 3H:1V side slope at south embankment exterior slope.**

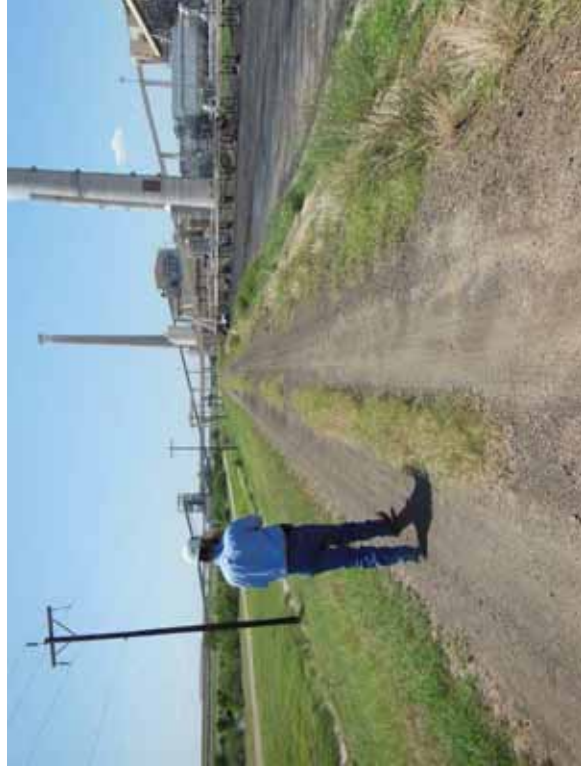
**Photo 65: SP - South embankment crest, looking west.**

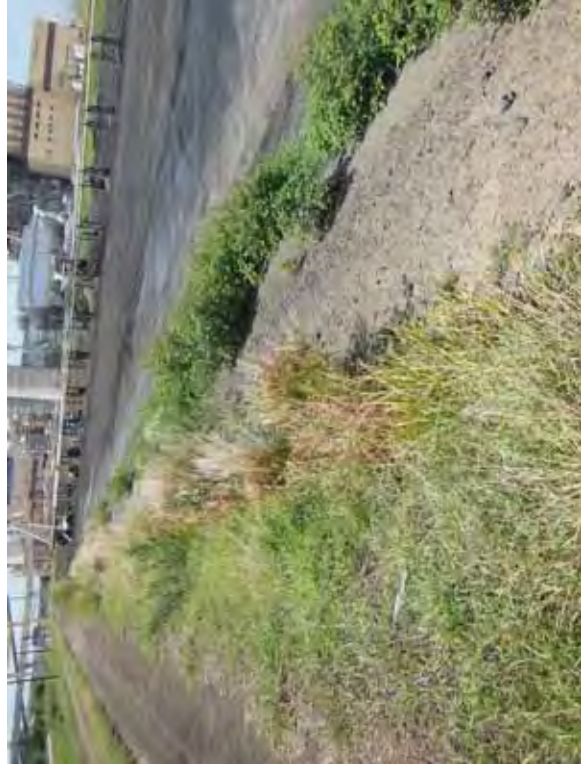
**Photo 66: SP - South embankment interior slope, looking west.**

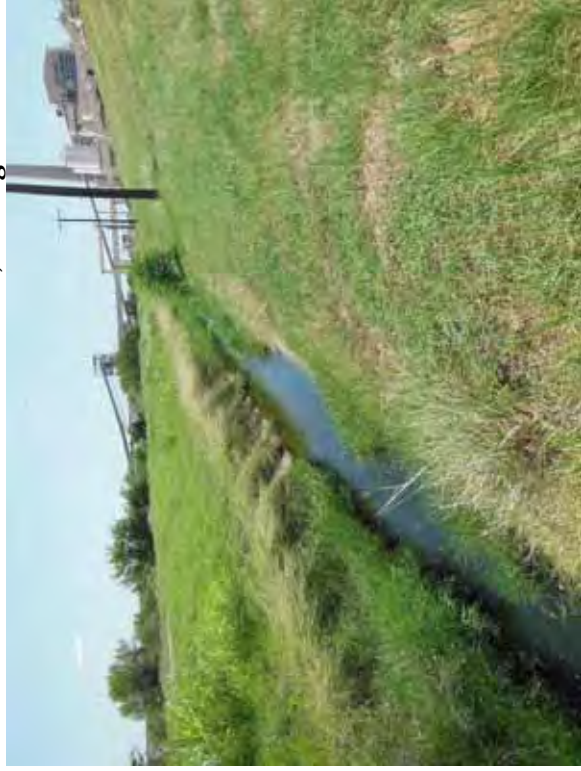
**Photo 67: SP - Drainage ditch at south embankment exterior toe, looking west.**

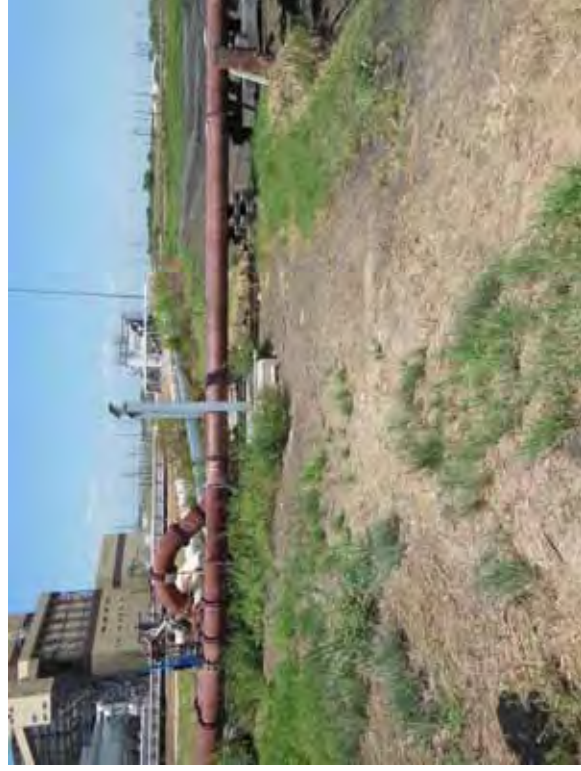
**Photo 69: SP - Inlet piping at southwest corner interior slope, looking north.**

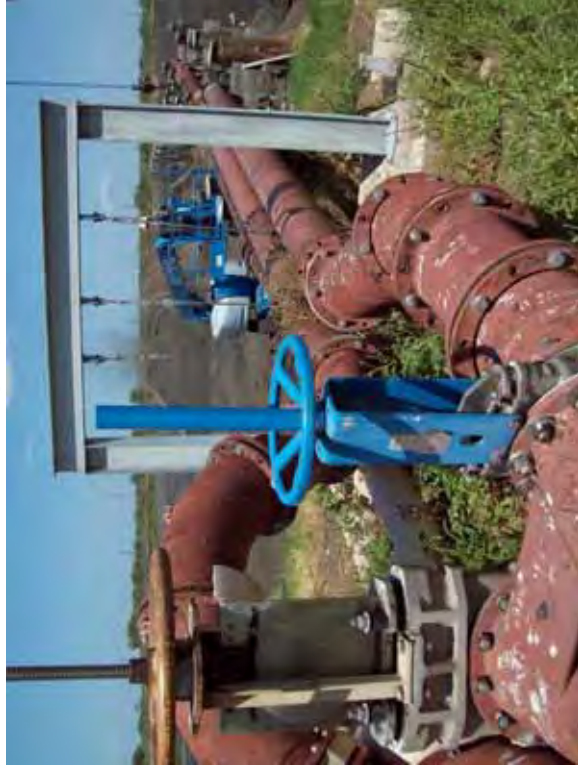
Three inlet pipes discharge liquids near the center of the South Bottom Ash Pond; two 12-inch-diameter welded steel and one 8-inch-diameter welded steel pipe (Photograph 71). The piping was being replaced during the site assessment (Photograph 68).

**Photo 71: SP - Inlet piping at southwest corner interior slope, looking northeast.**

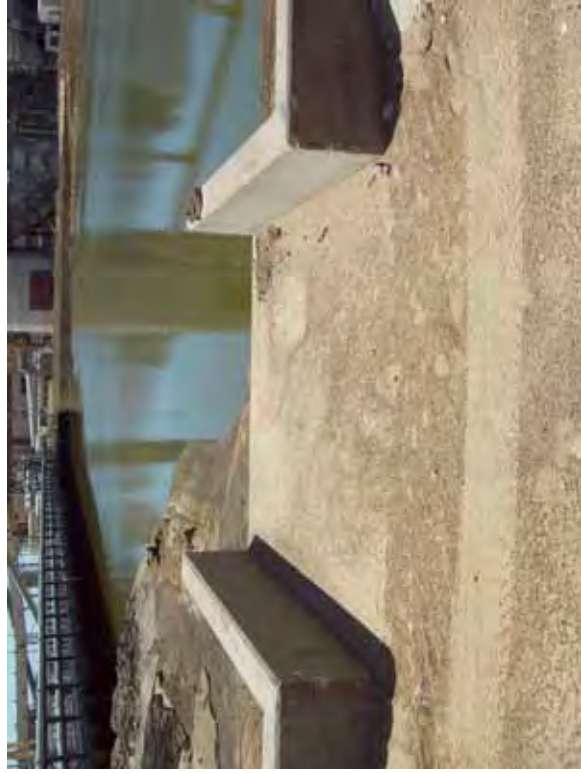
**Photo 81: SP - Spillway between SRH Pond and South Bottom Ash Pond at west embankment exterior slope, looking west.**

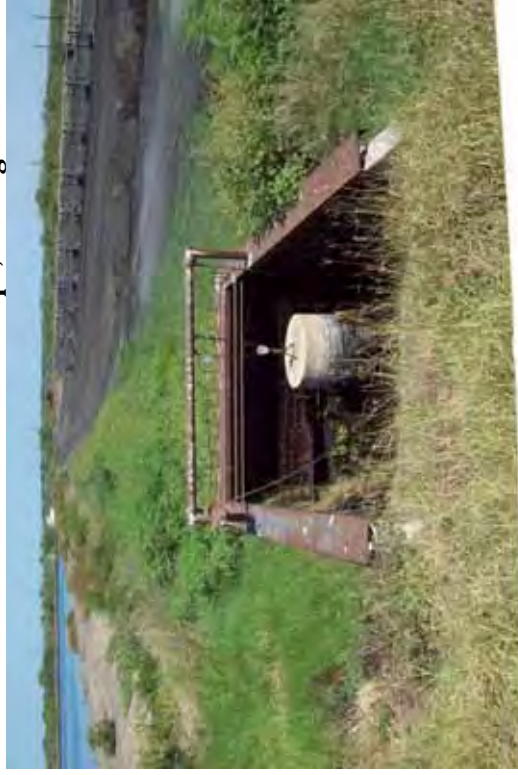
The outlet structure near the interior slope of at the southeast corner consists of a 12-inch-diameter welded steel vertical outlet pipe and a 12-inch-diameter steel drain pipe. The outlet pipes are partially surrounded by a steel sheet pile wall containing an opening, with a floating sorbent boom, for flow to the outlet pipes (Photograph 61). The outlet pipes discharge liquids from the South Bottom Ash Pond to outfalls at the Plant intake canal (Photographs 85, 86, 87, and 89). A 24-inch-diameter welded steel outlet pipe at the interior slope near the northwest corner returns liquids from the pond to the Plant (Photograph 83).

**Photo 83: SP - 24-inch-diameter Plant return outlet, looking east.**

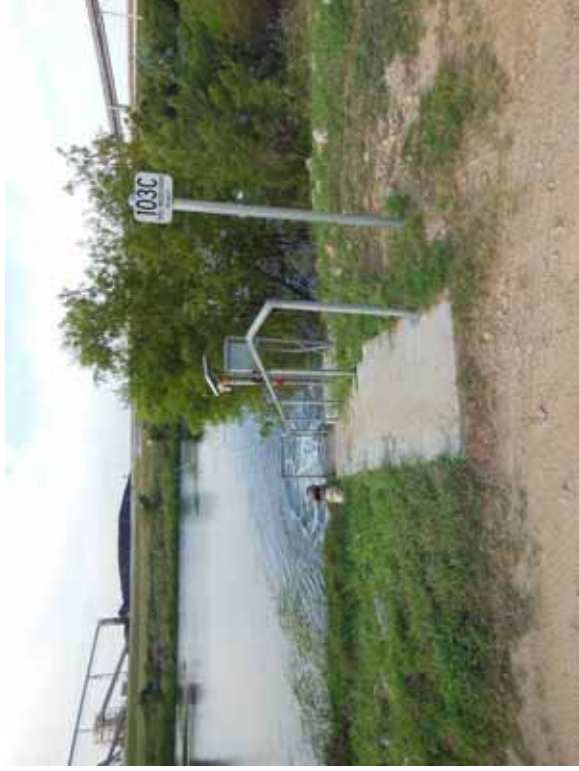
**Photo 85: NP/SP - Discharge outfall 103C into Plant intake canal.**

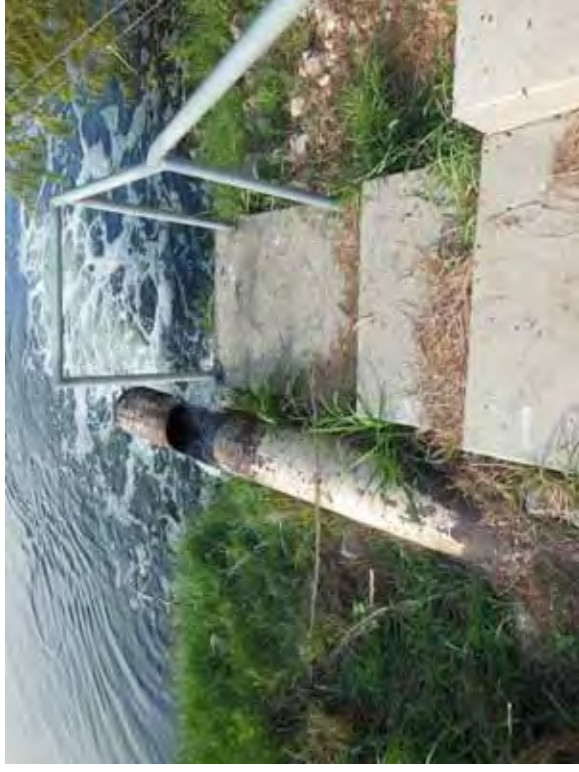
**Photo 86: NP/SP - 12-inch-diameter piping at outfall 103C.**

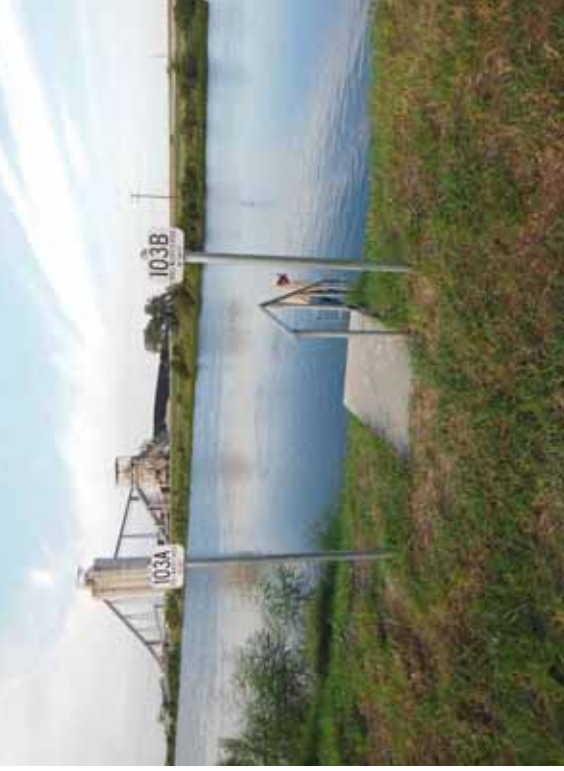
**Photo 87: NP/SP - Discharge outfalls 103A and 103B into Plant intake canal.**

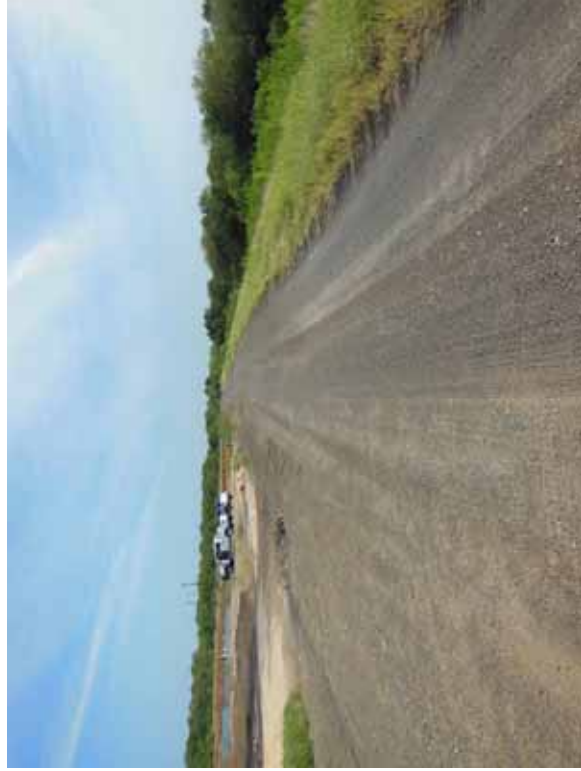
The embankment crest of the Evaporation Pond appeared to be in satisfactory condition (Photographs 90, 100, 108, and 114). The crest was approximately 15 feet wide at all embankments except the north embankment where the crest measured approximately 50 feet wide. The crest of the embankment consists of a compacted gravel drive and grass. The surface is exposed to minimal vehicle traffic. No depressions or evidence of settlement were observed on the crest.

**Photo 90: East Embankment crest, looking north.**

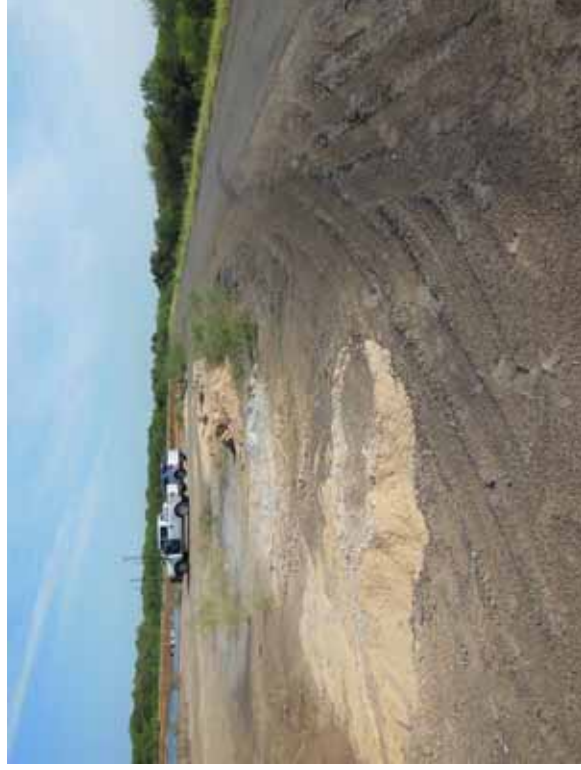
Due to the level of solids and water in the Evaporation Pond during the assessment, only the upper 0.5 to 2 feet of the interior slopes were visible (Photographs 91, 101, 102, 106, and 115). Vegetation covered some portions of the west and south embankment interior slopes (Photographs 111, 115, and 120). Ash and other solid material extend up to the crest near the southeast corner interior slope and on the east embankment interior slope (Photographs 91 and 122). Visible portions of interior slopes did not include riprap or other armoring.

**Photo 91: East embankment interior slope, looking north.**

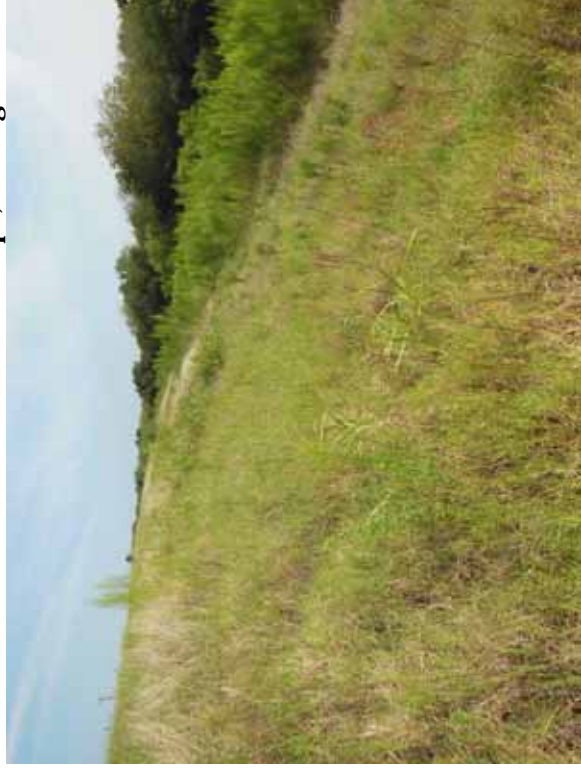
The exterior slopes appear to be in satisfactory condition and are covered in grassy vegetation approximately 2 feet high and a few small trees and bushes with diameters less than 6 inches in diameter (Photographs 93, 98, 109, and 119). Areas of loose soil were observed at the east embankment exterior slope (Photographs 92, 94, and 96) and an animal burrow was observed in the west embankment exterior slope (Photograph 110). An area of exposed soil was observed at the south embankment exterior slope (Photograph 117). Based on construction drawings, the exterior slopes are 3H:1V at all embankments, though slopes measured in the field ranged from 3H:1V to 4H:1V (Photographs 97 and 118). Trees up to 12 inches in diameter were located at the toe of all embankments (Photographs 95, 105, 112, and 119).

**Photo 93: East embankment exterior slope, looking north.**

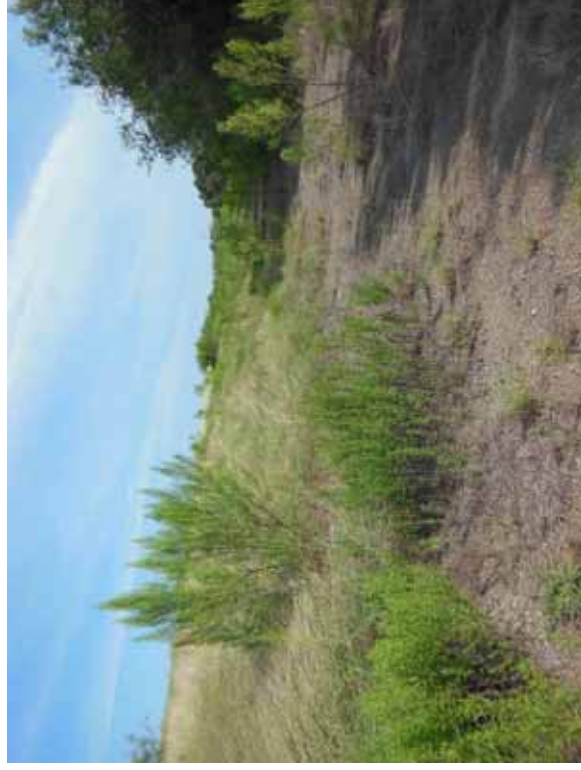
**Photo 95: East embankment exterior toe, looking north.**
