# ASSESSMENT OF DAM SAFETY OF COAL COMBUSTION SURFACE IMPOUNDMENTS FINAL REPORT

**CPS Energy  
J.T. Deely Power Plant  
San Antonio, Texas**

Prepared for  
*U.S. Environmental  
Protection Agency  
Washington, D.C.*

February 2014  
Revised May 2014  
Revised June 2014

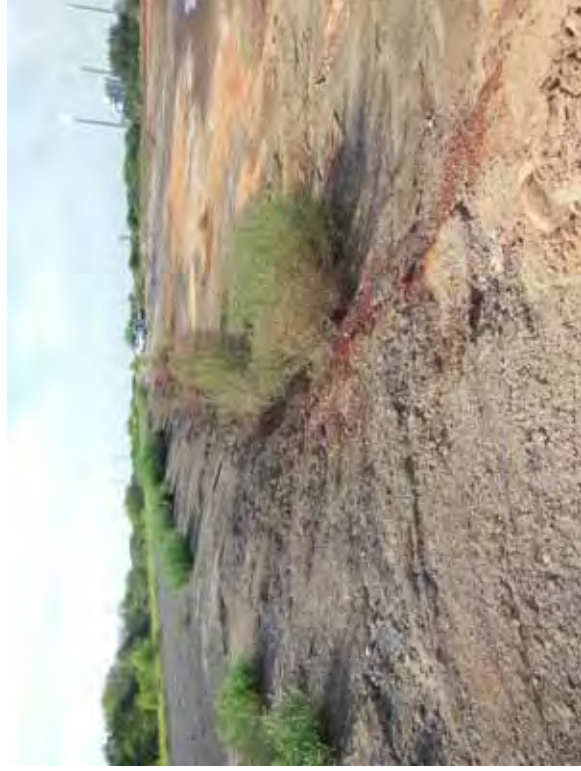
Due to the level of solids and water in the Evaporation Pond during the assessment, only the upper 0.5 to 2 feet of the interior slopes were visible (Photographs 91, 101, 102, 106, and 115). Vegetation covered some portions of the west and south embankment interior slopes (Photographs 111, 115, and 120). Ash and other solid material extend up to the crest near the southeast corner interior slope and on the east embankment interior slope (Photographs 91 and 122). Visible portions of interior slopes did not include riprap or other armoring.

**Photo 102: East embankment interior slope, looking south.**

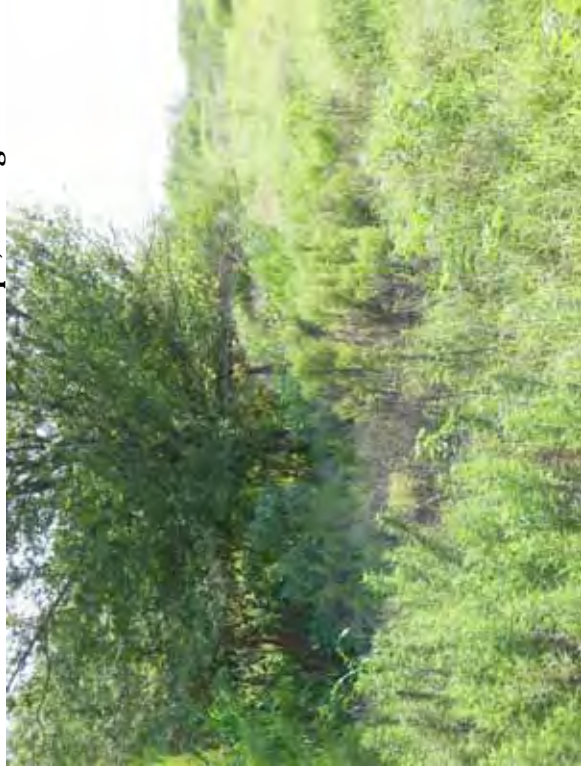
**Photo 104: North embankment exterior slope, looking east. Note trees near exterior toe.**

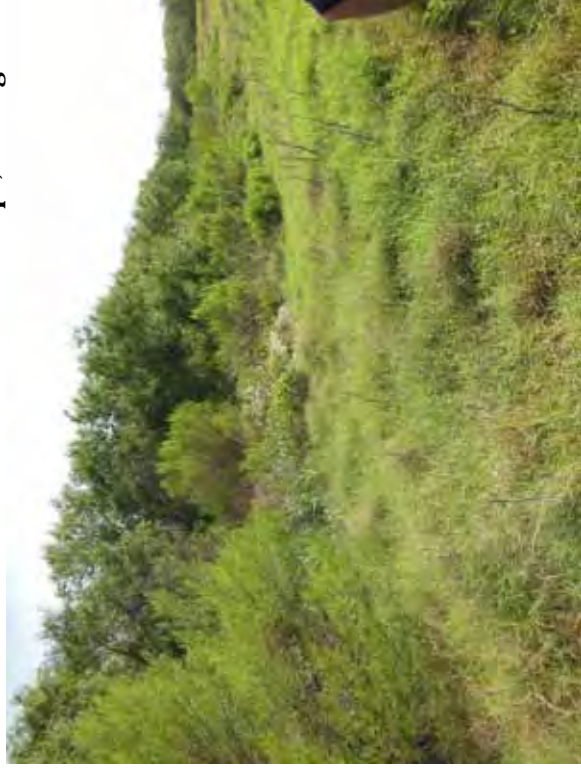
The exterior slopes appear to be in satisfactory condition and are covered in grassy vegetation approximately 2 feet high and a few small trees and bushes with diameters less than 6 inches in diameter (Photographs 93, 98, 109, and 119). Areas of loose soil were observed at the east embankment exterior slope (Photographs 92, 94, and 96) and an animal burrow was observed in the west embankment exterior slope (Photograph 110). An area of exposed soil was observed at the south embankment exterior slope (Photograph 117). Based on construction drawings, the exterior slopes are 3H:1V at all embankments, though slopes measured in the field ranged from 3H:1V to 4H:1V (Photographs 97 and 118). Trees up to 12 inches in diameter were located at the toe of all embankments (Photographs 95, 105, 112, and 119).

**Photo 105: Trees at north embankment exterior toe, looking east.**

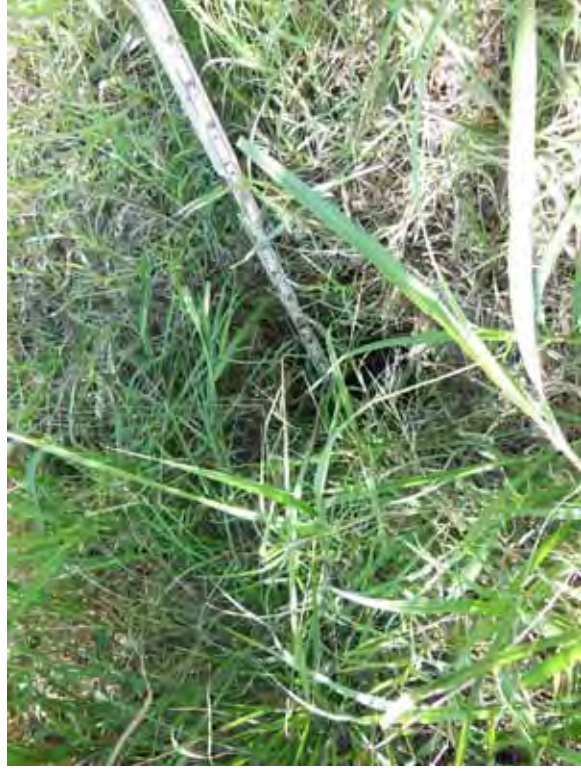
**Photo 110: Approximately 18-inch-deep animal burrow at west embankment exterior slope.**

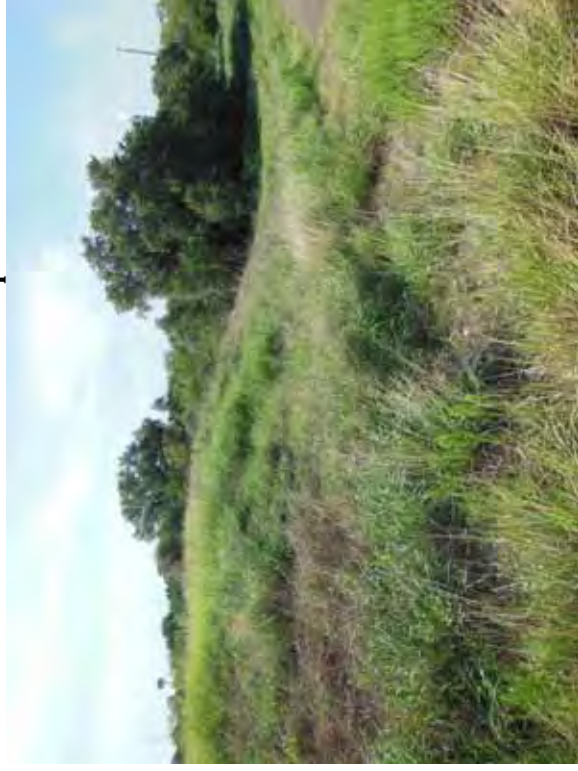
**Photo 112: West embankment exterior slope, looking south.**
