ASSESSMENT OF DAM SAFETY OF COAL COMBUSTION SURFACE IMPOUNDMENTS – FINAL REPORT

**Crisp County Power
Commission
Plant Crisp
Warwick, Georgia**

Prepared for
*U.S. Environmental
Protection Agency
Washington, D.C.*

December 2013
Revision 1, February 2014

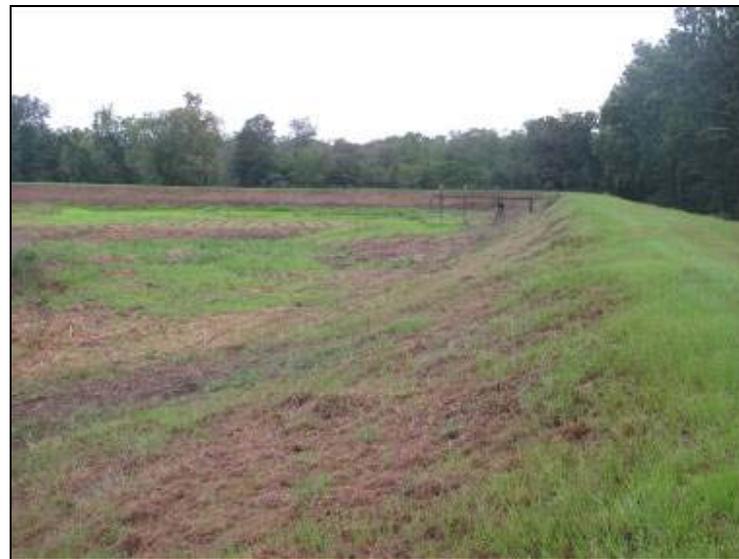
Photo 2: Ash Pond – North embankment interior slope, looking west.

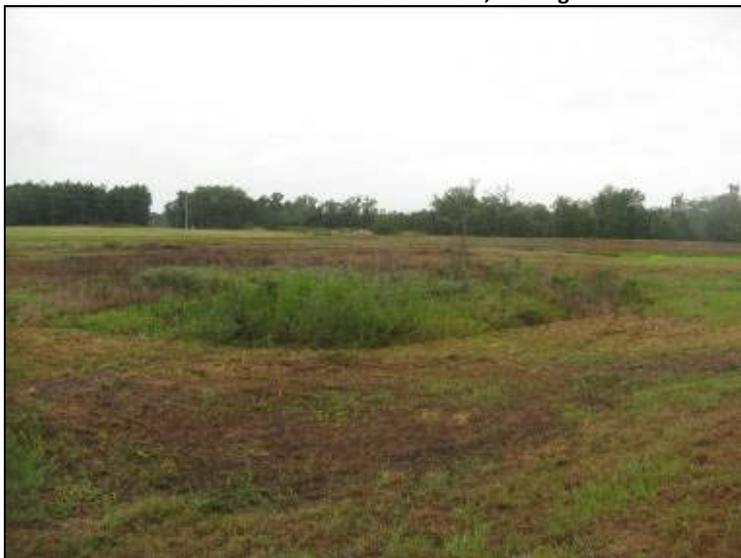
Photo 3: Ash Pond – North embankment interior slope, general view of pond surface area looking southwest.

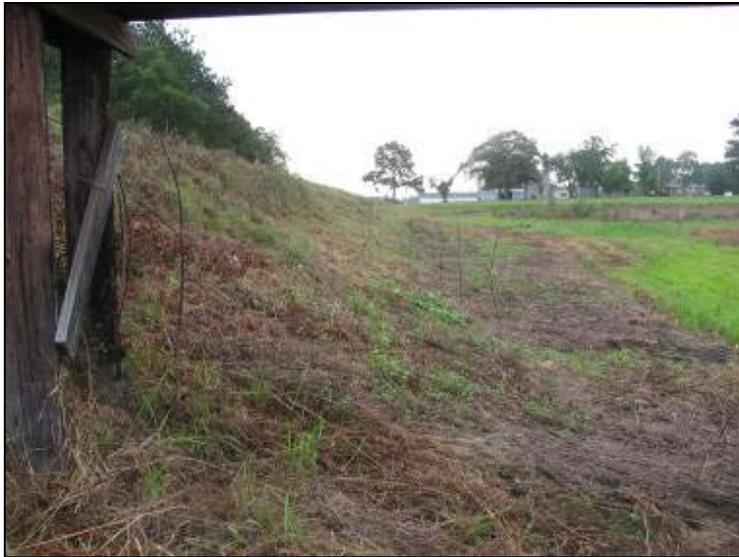
Photo 9: Ash Pond – North embankment interior slope, looking east.

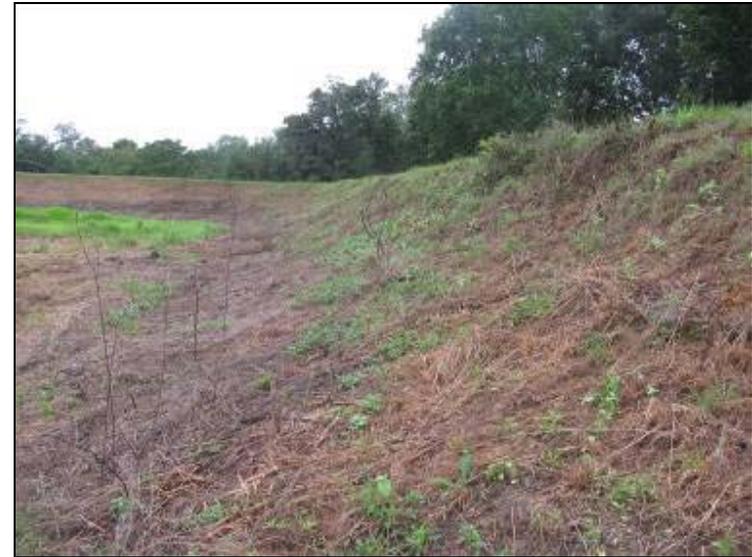
Photo 10: Ash Pond – North embankment interior slope, looking west.

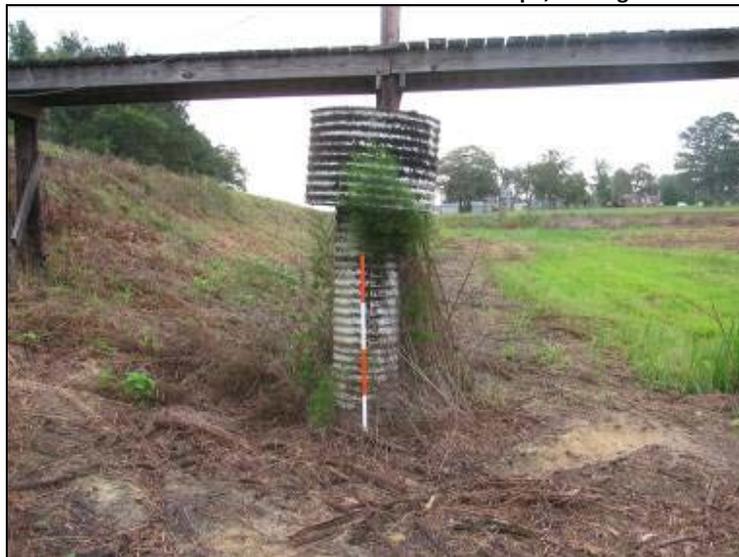
The outlet structure consists of an 18-inch-diameter corrugated metal riser pipe (CMP), with an approximate 2-foot-high by 36-inch-wide CMP trash-rack at the neck of the outlet pipe. This outlet is located near the central portion of the north embankment (Photographs 11, 12 and 64). Based on the drawings provided by the Crisp County Power Commission (Appendix A), we understand that this riser pipe connects into a 12-inch-diameter CMP and discharges near the toe of slope of the north embankment. CDM Smith was not able to locate the exit pipe due to the high vegetation at the apparent outfall/discharge location.

Photo 11: Ash Pond – North embankment interior slope, 18-inch outlet riser pipe, looking east.

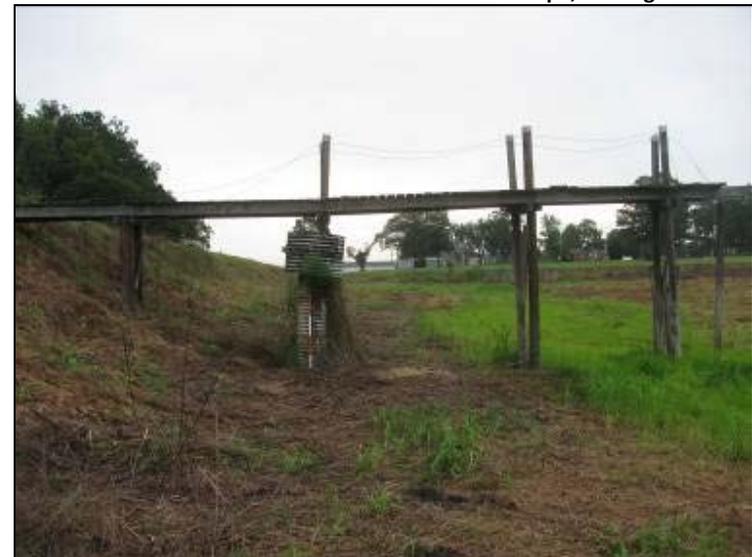
Photo 12: Ash Pond – North embankment interior slope, boardwalk and 18-inch outlet riser pipe looking east.

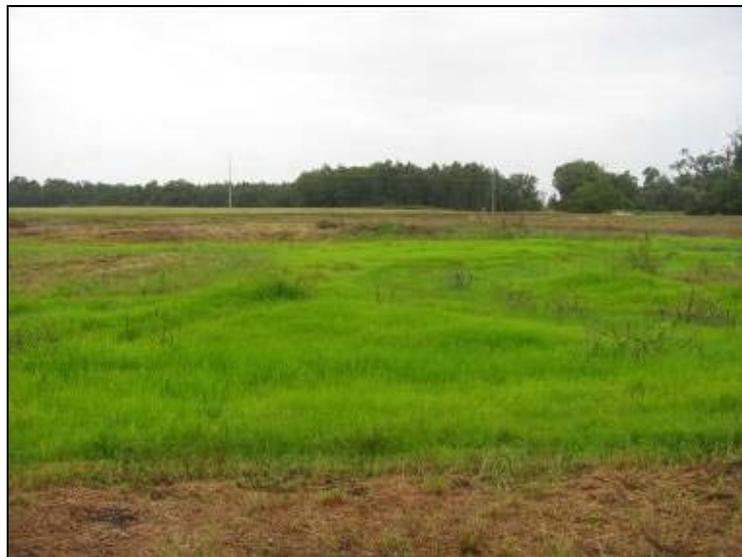
Photo 13: Ash Pond – General view of pond bottom surface, looking south.

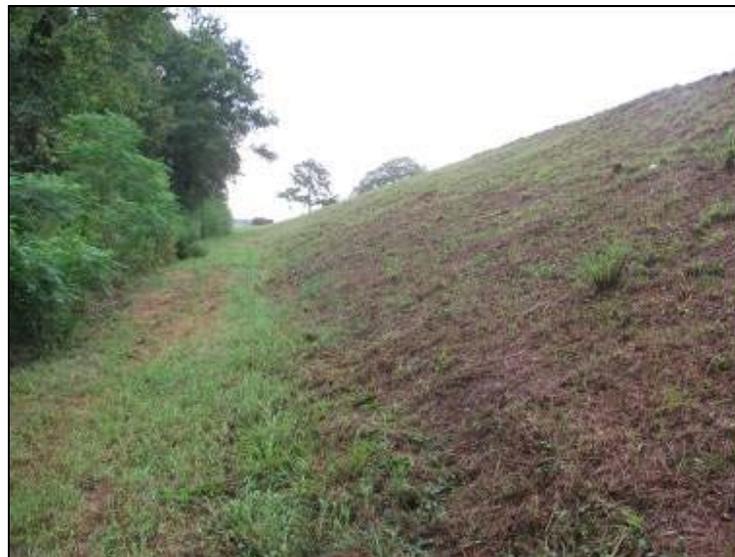
Photo 14: Ash Pond – North embankment exterior slope, looking east.

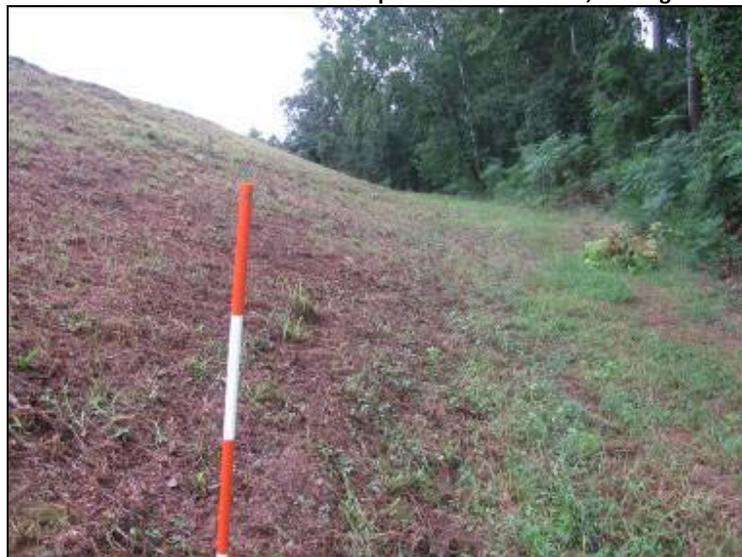
Photo 15: Ash Pond – North embankment exterior slope, looking west.

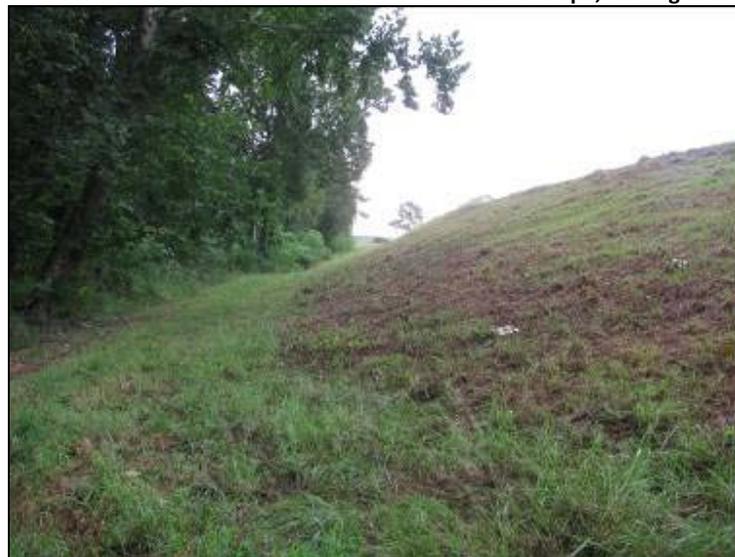
Photo 16: Ash Pond – North embankment exterior slope near northwest corner, looking east.

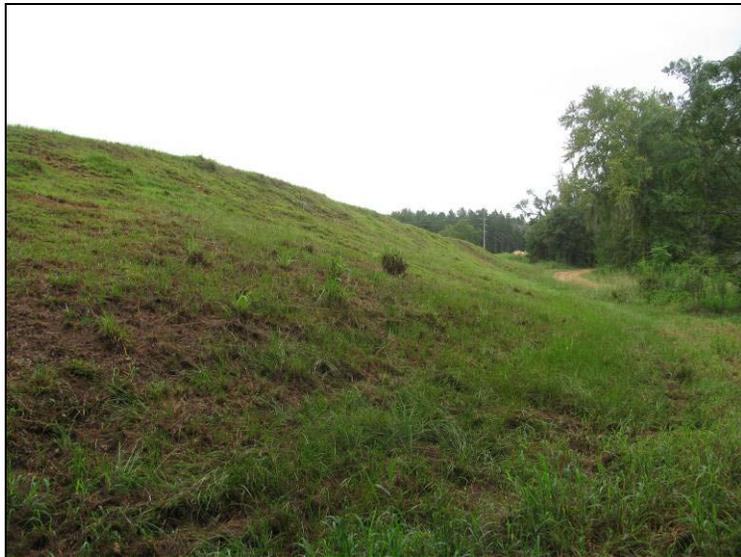
Photo 17: Ash Pond – West embankment exterior slope near northwest corner, looking west.

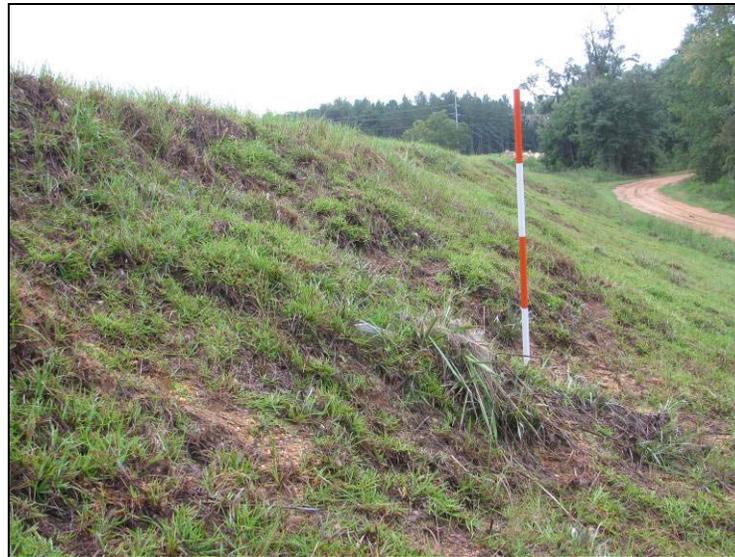
The exterior slopes appear to be in **FAIR** condition. The exterior slopes of the embankments are about 2H:1V at the north and west embankments, 5H:1V at the south embankment, and 4H:1V at the southeast embankment. The east portion of the north embankment has an approximate slope of 3H:1V with a slope break near the outlet structure to 2H:1V (Photograph 6). Slopes shown on the drawings provided are 3H:1V. The exterior slopes are covered with grass that was approximately 4 to 6 inches high at the time of the visual assessment (Photographs 14 to 17, 31, 32, 38, 39, 44 and 45). Surficial erosion rills and scarps were observed at the north embankment (Photographs 5, 7 and 8). An apparent 16-foot-long semicircular surficial slough (Photographs 21 to 23) and several minor sloughs and scarps near the crest (Photograph 18, 19, 20, and 24 to 27) were observed on the west embankment.

Photo 18: Ash Pond – West embankment exterior slope sloughing, looking South.

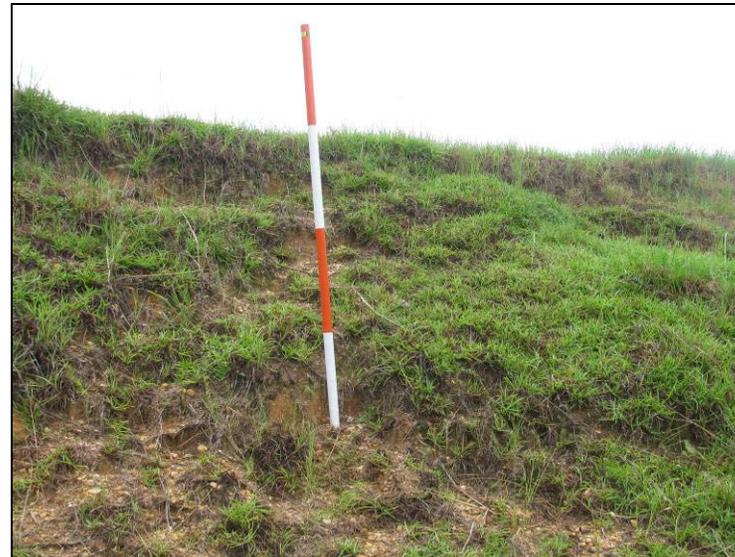
Photo 20: Ash Pond – West embankment exterior slope sloughing, looking southeast.

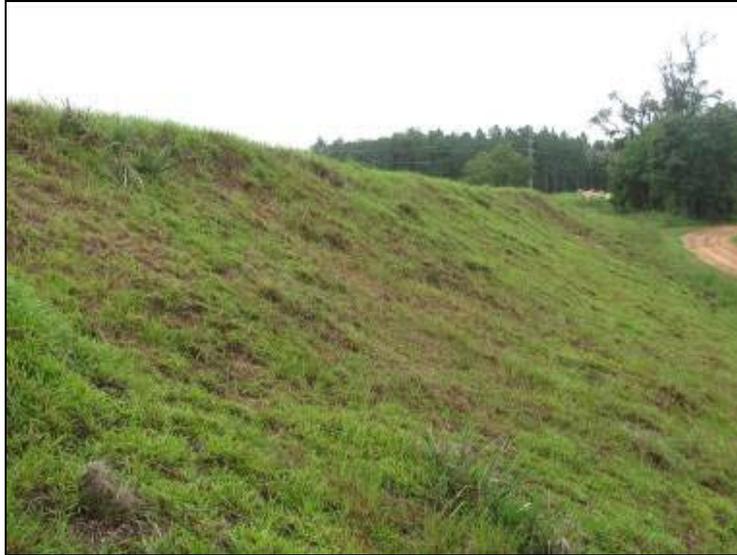
Photo 21: Ash Pond – West embankment exterior slope, apparent 16-foot long semi-circular sloughing, looking southeast.

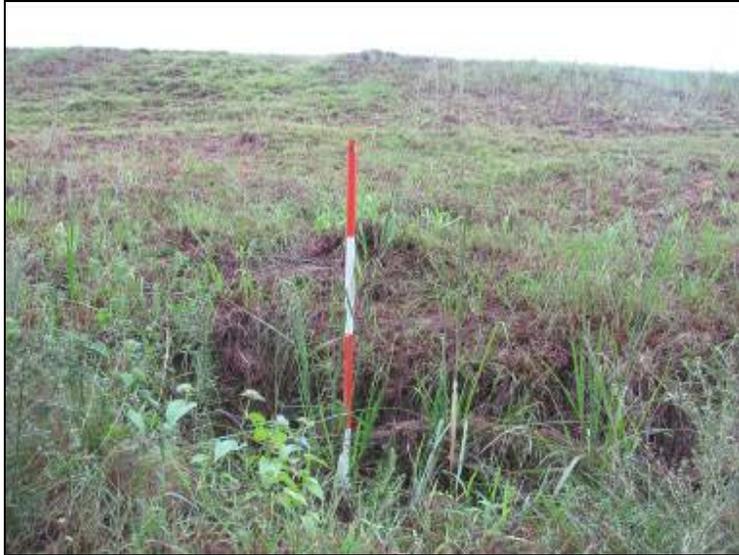
A runoff swale was cut into the toe of the slope of the west embankment (Photographs 29 to 31). It was reported by the Crisp County Power Commission representatives that the toe of slope of the west embankment extends beyond the plant property line.

Photo 29: Ash Pond – West embankment exterior slope, swale cut at toe of slope, looking east.

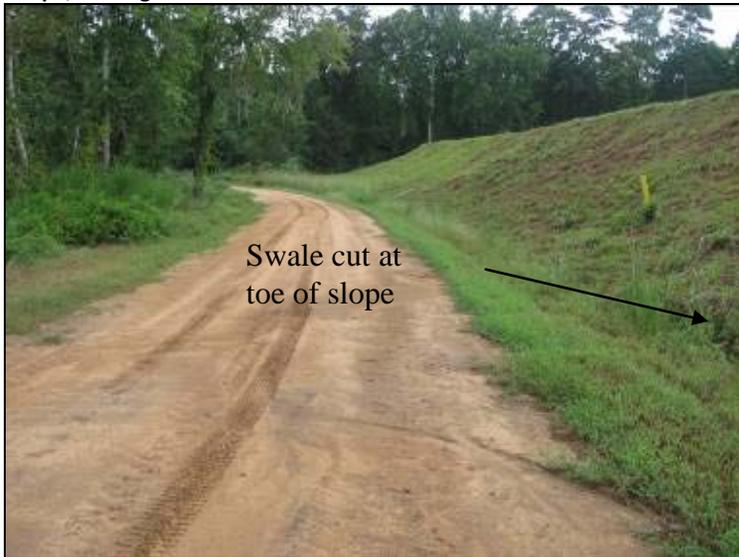
Photo 31: Ash Pond – West embankment exterior slope, toe of slope and road looking north.

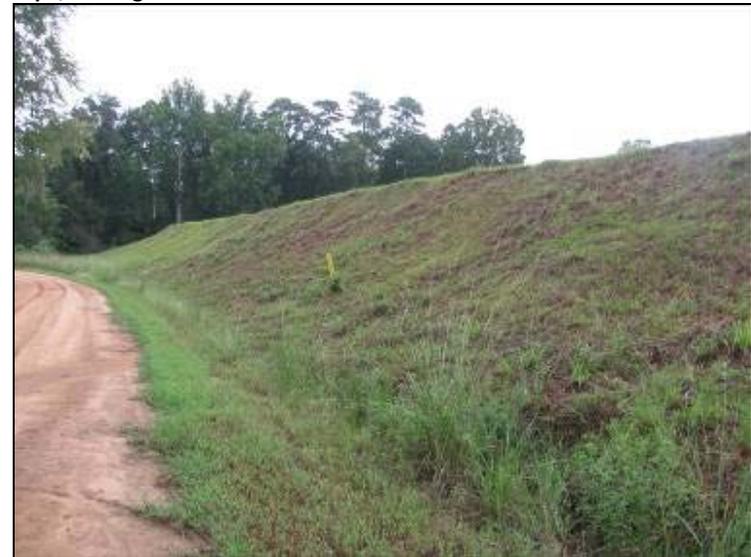
Photo 32: Ash Pond – West embankment exterior slope near southwest corner, looking north.

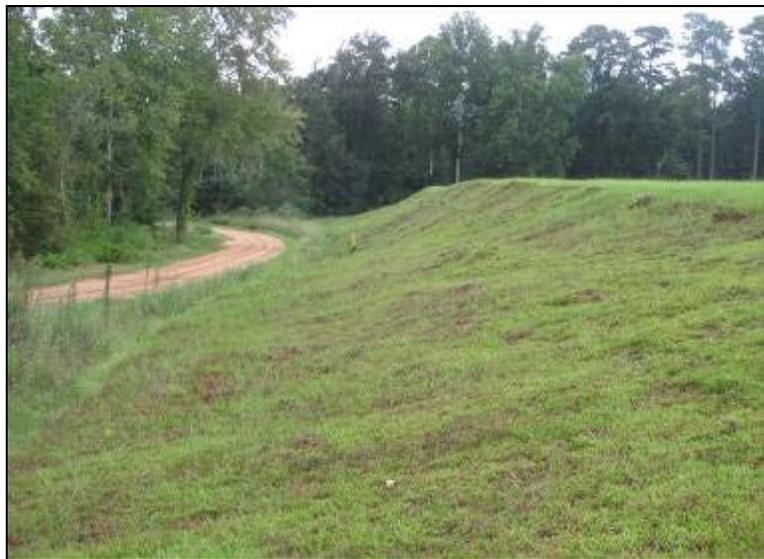
Photo 33: Ash Pond – West embankment exterior slope near southwest corner, looking north.

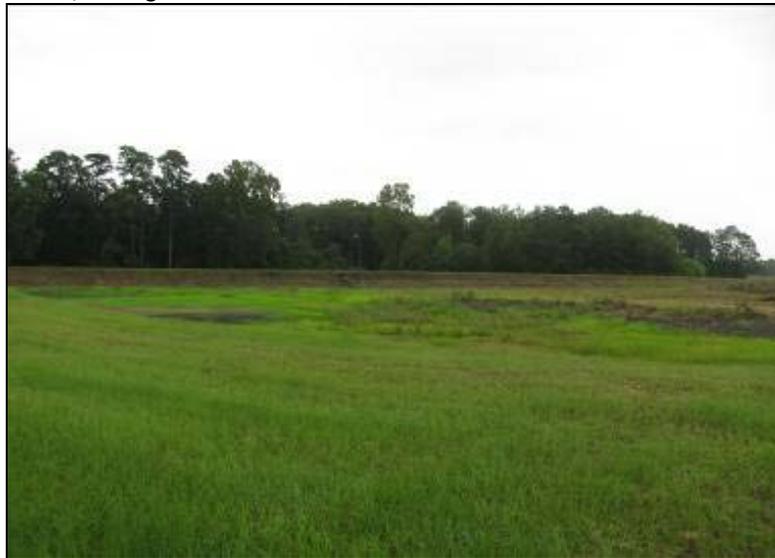
Photo 35: Ash Pond – General view of pond surface area looking northeast.

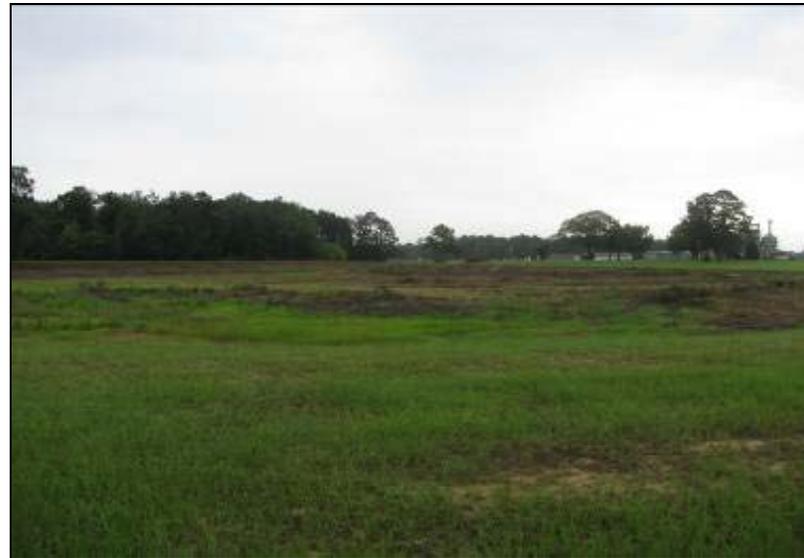
Photo 36: Ash Pond – General view of pond surface area looking northeast.

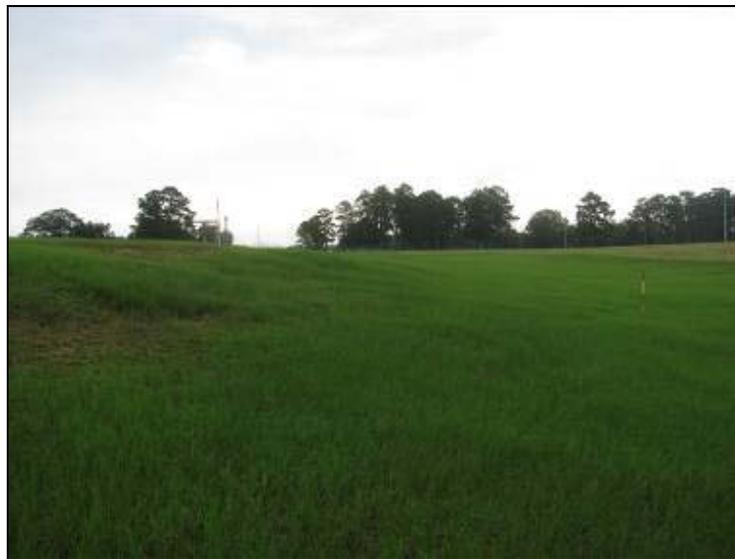
Photo 38: Ash Pond – South embankment exterior slope, looking east.

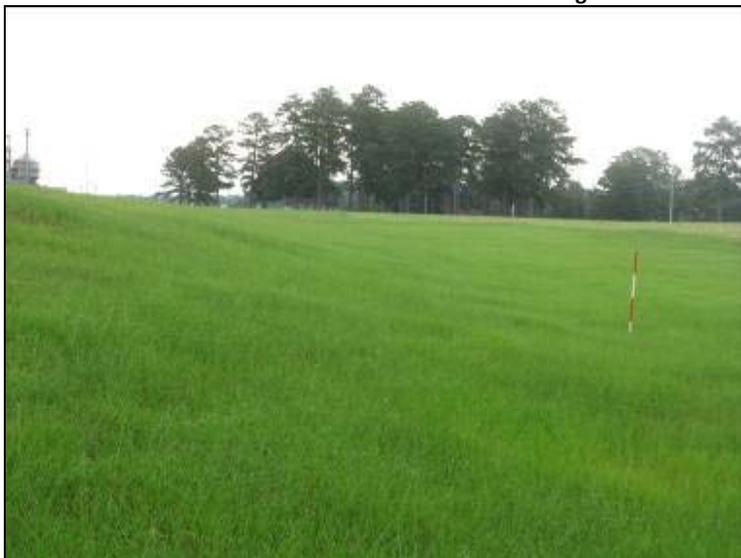
Photo 39: Ash Pond – South embankment exterior slope, looking east.

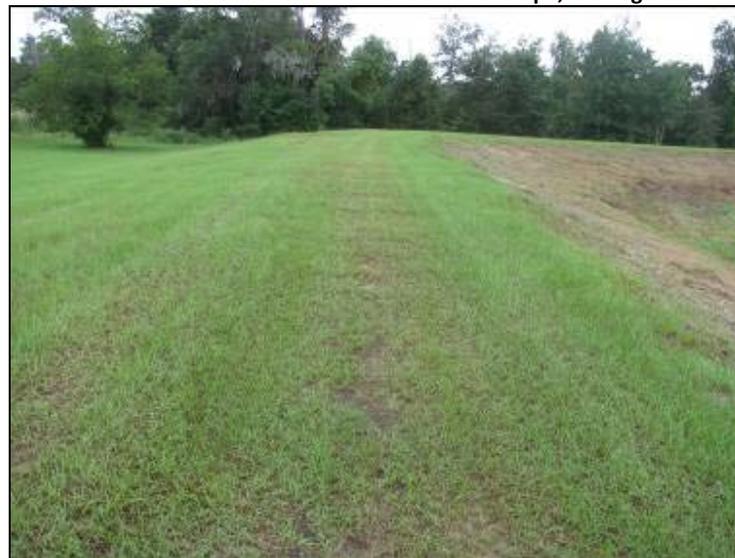
The crest of the perimeter embankment appeared to be in **SATISFACTORY** condition (Photographs 1, 34, 37, 40, 41, 46, 48 and 58). The crest width varies from about 15 and 20 feet. The crest of the embankments has a grass cover that was about 4 to 6 inches high. Reportedly, the crest is exposed to very limited vehicle traffic, only during maintenance operations. No signs of cracks, erosion, scarps, depressions, or settlement were observed on the crest of any of the embankments.

Photo 40: Ash Pond – Crest of south embankment looking west.

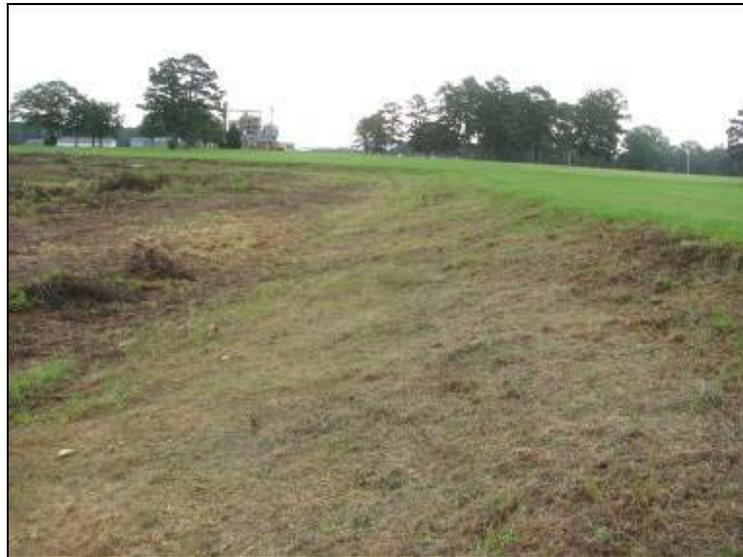
Photo 42: Ash Pond – South embankment interior slope, looking east.

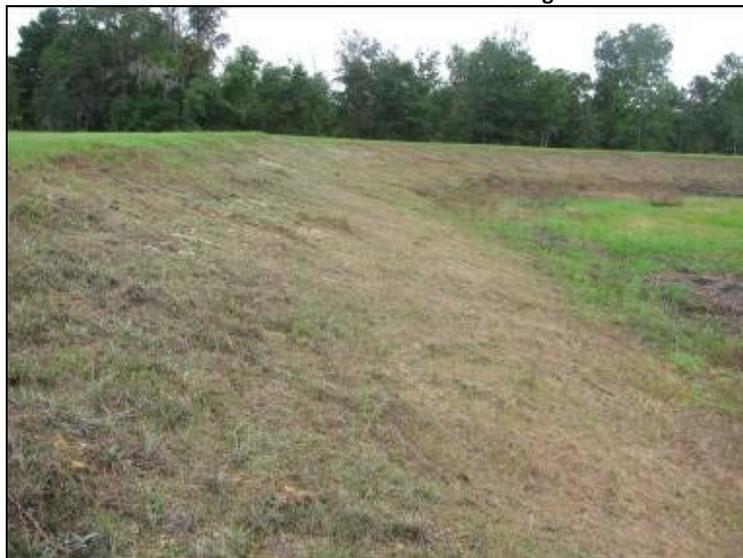
Photo 43: Ash Pond – South embankment interior slope, looking west.

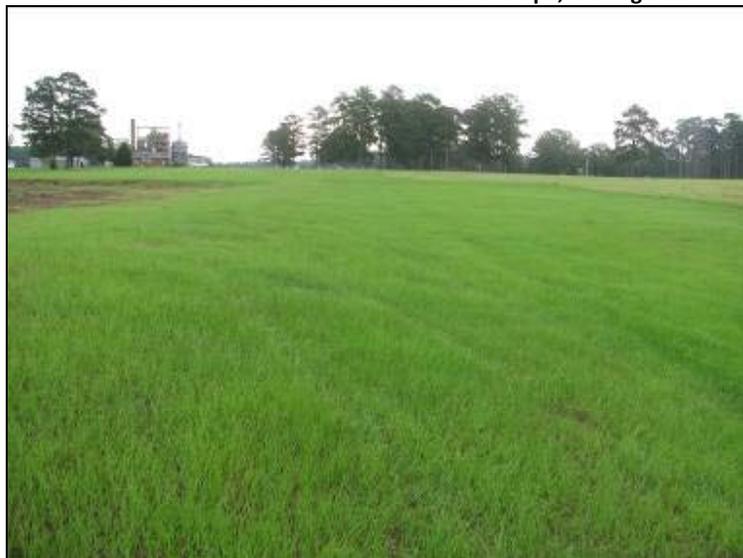
Photo 44: Ash Pond – South embankment exterior slope, looking east.

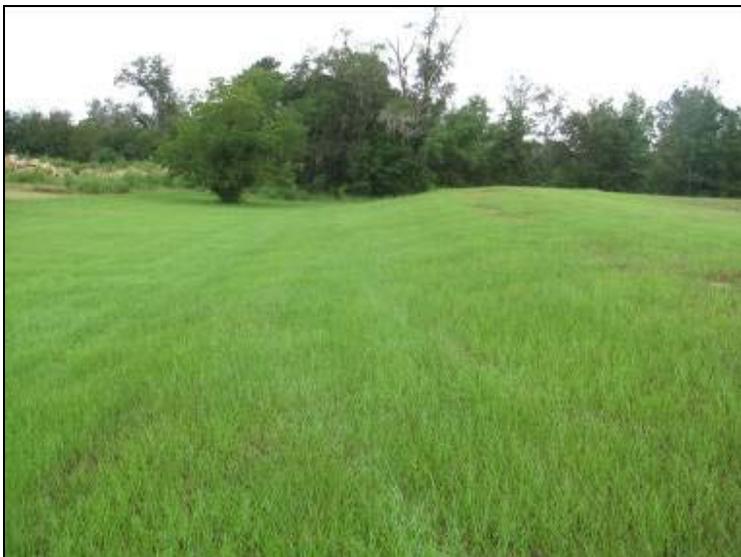
Photo 45: Ash Pond – South embankment exterior slope, looking west.

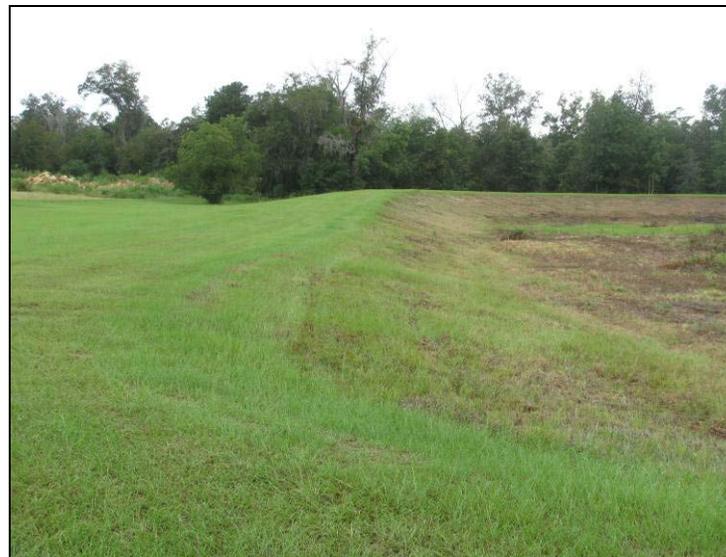
Photo 46: Ash Pond –Crest of South embankment near southeast corner looking west.

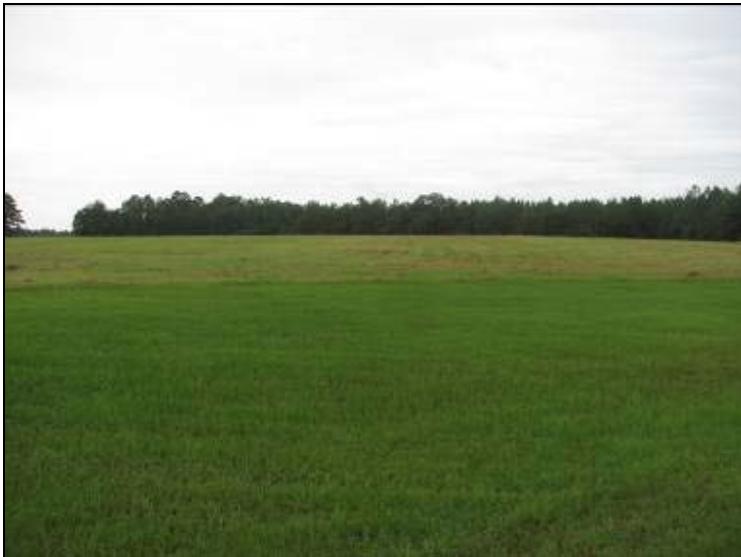
Photo 47: Ash Pond – General view of floodplain area south of Ash Pond, looking southeast.

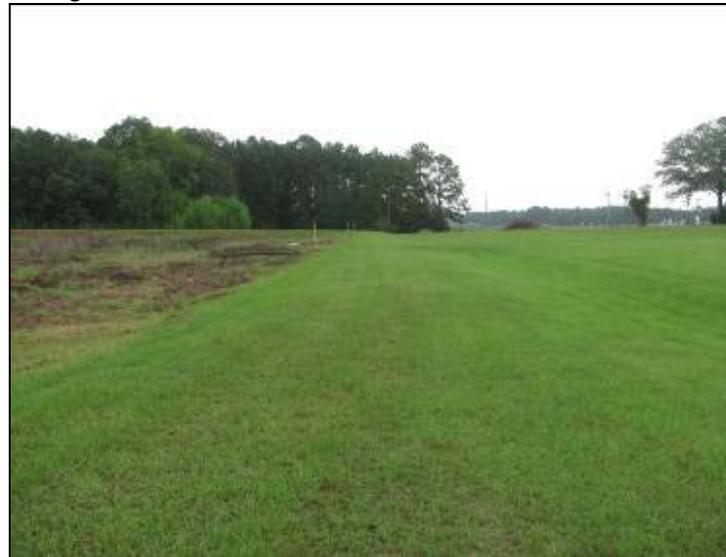
Photo 48: Ash Pond – Crest of southeast embankment near southeast corner, looking northeast.

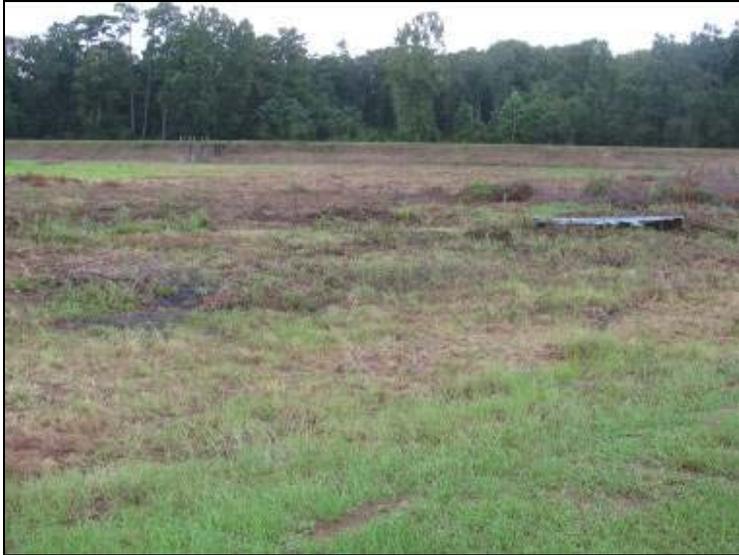
Photo 49: Ash Pond – General view of pond surface area near southeast corner, looking northwest.

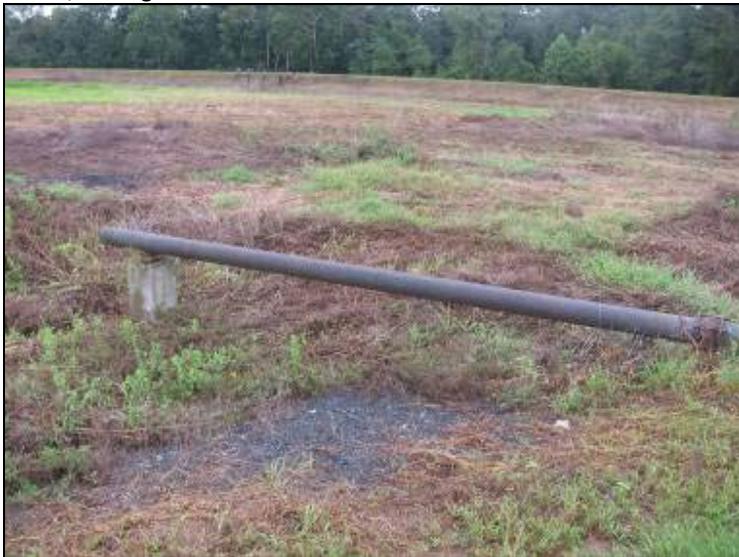
The Ash Pond has two inlet pipes located on the southeast embankment (Photographs 4, 51, and 55); one 8-inch-diameter polyvinyl chloride (PVC) pipe and one 7-inch-diameter ductile iron pipe (DIP). During the visual assessment, water from the plant was discharging through the PVC pipe (Photograph 63).

Photo 51: Ash Pond – Southeast embankment interior slope, 7-inch I.D. Ductile iron pipe looking northwest.

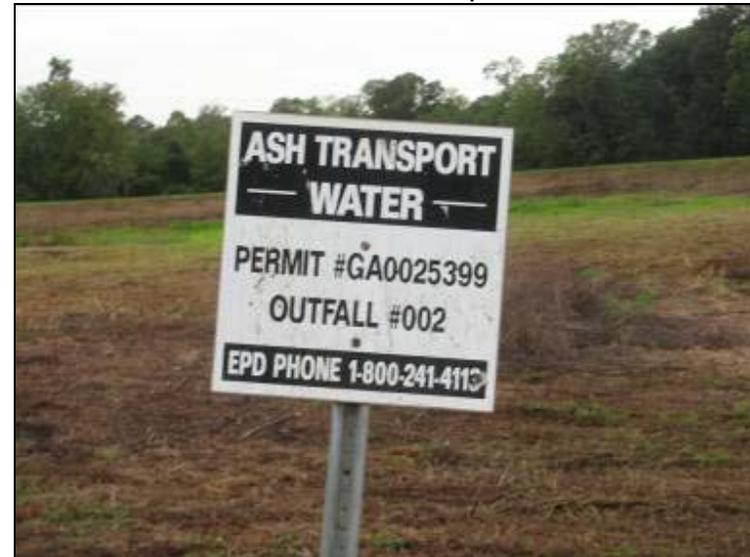
Photo 52: Ash Pond – Permit sign on southeast embankment, looking west.

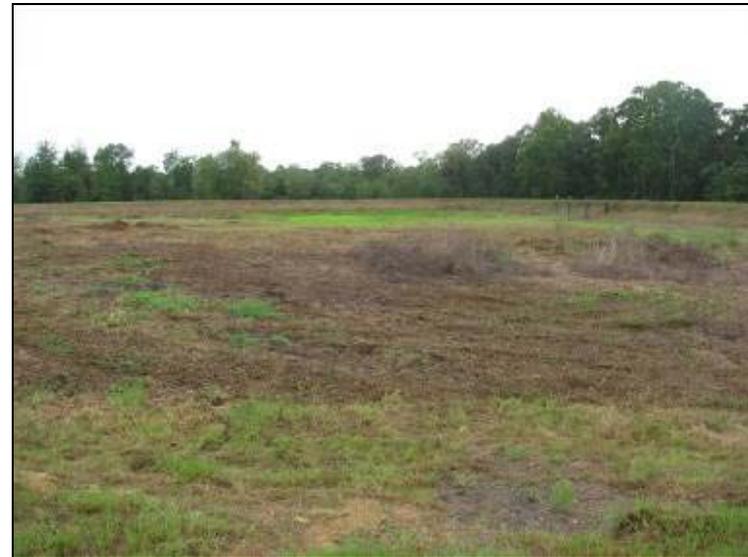
Photo 54: Ash Pond – General view of pond surface, looking west.

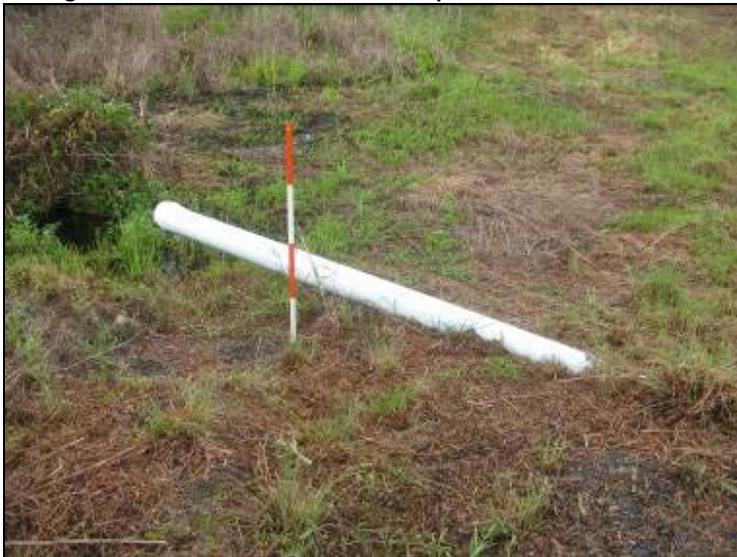
Photo 55: Ash Pond – Southeast embankment interior slope, 8-inch PVC inlet pipe, looking northwest.

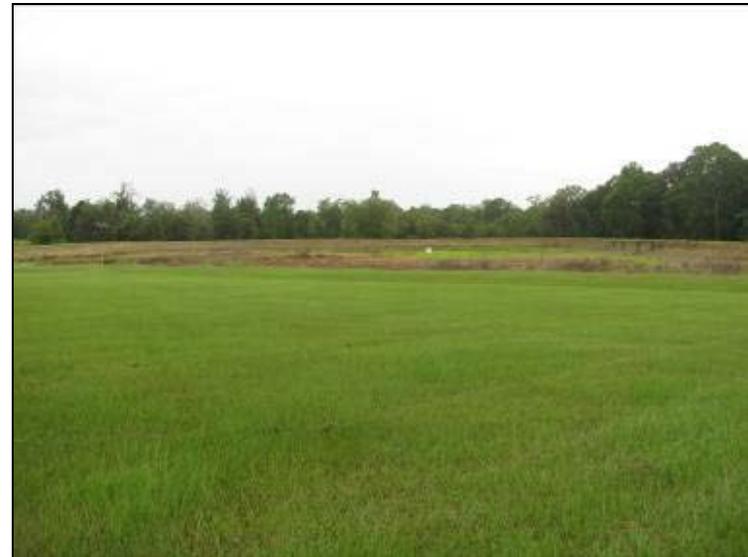
Photo 56: Ash Pond – General view of Ash pond, looking west.

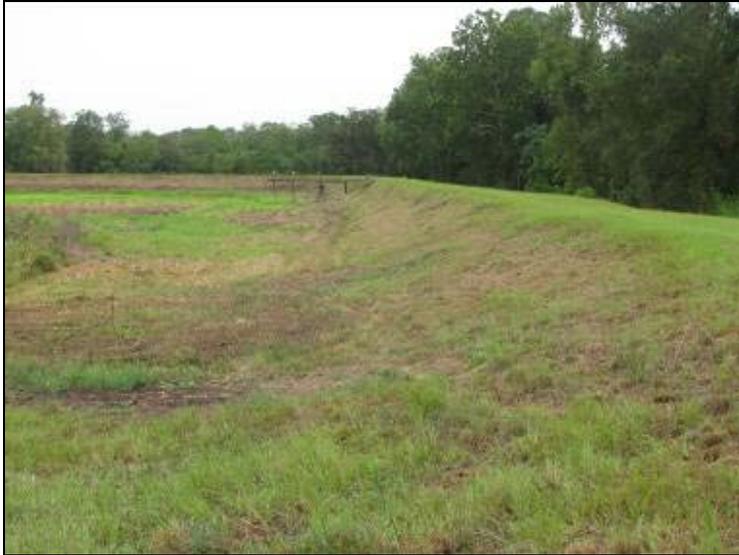
Photo 57: Ash Pond –North embankment interior slope near northeast corner, looking west.

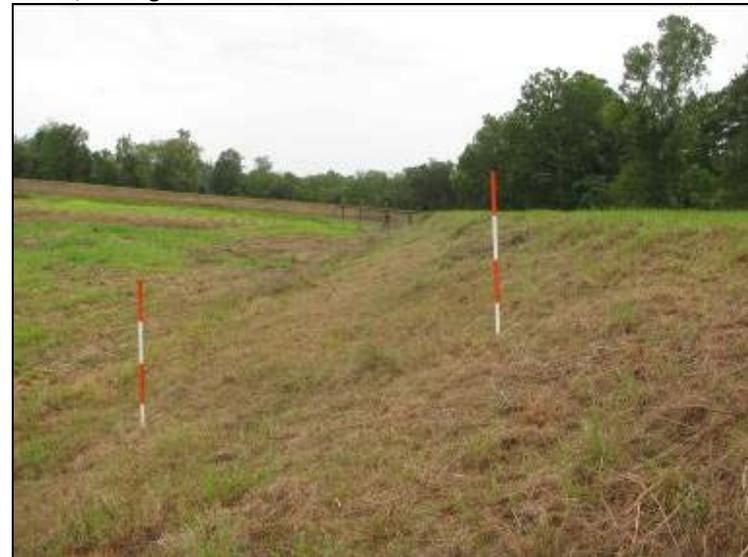
Photo 60: Ash Pond – North embankment interior slope, looking west.

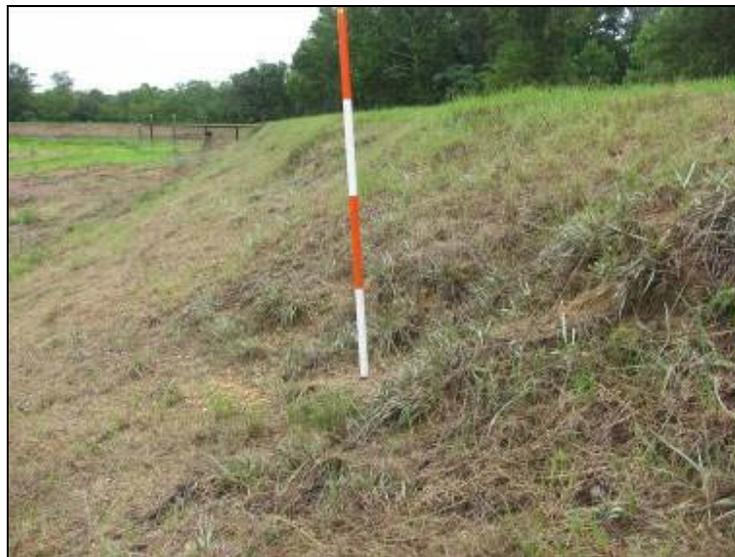
Photo 62: Ash Pond – North embankment interior slope surficial erosion, looking west.

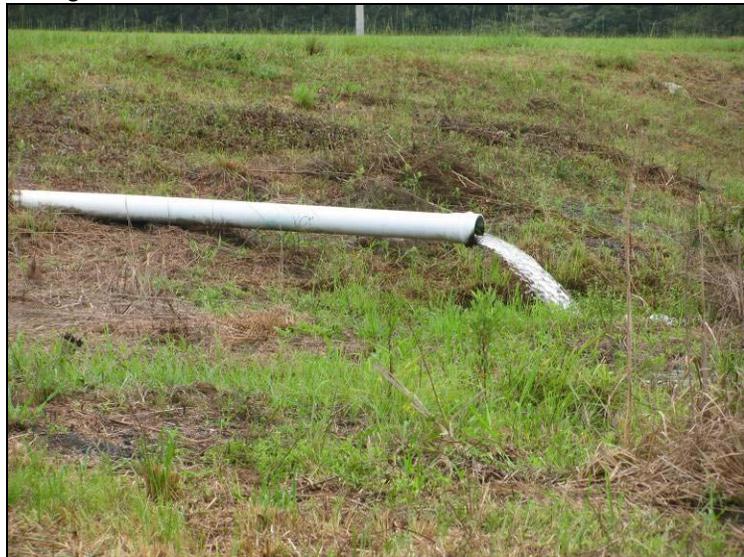
Photo 63: Ash Pond – 8-inch PVC inlet pipe on southeast embankment, looking south. Note: water flowing.

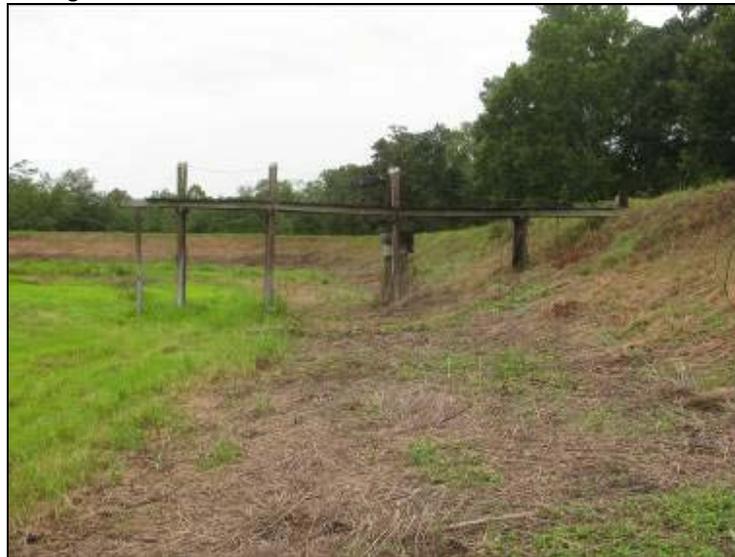
Photo 64: Ash Pond – North embankment interior slope, boardwalk and outlet 18-inch CMP riser pipe looking west.

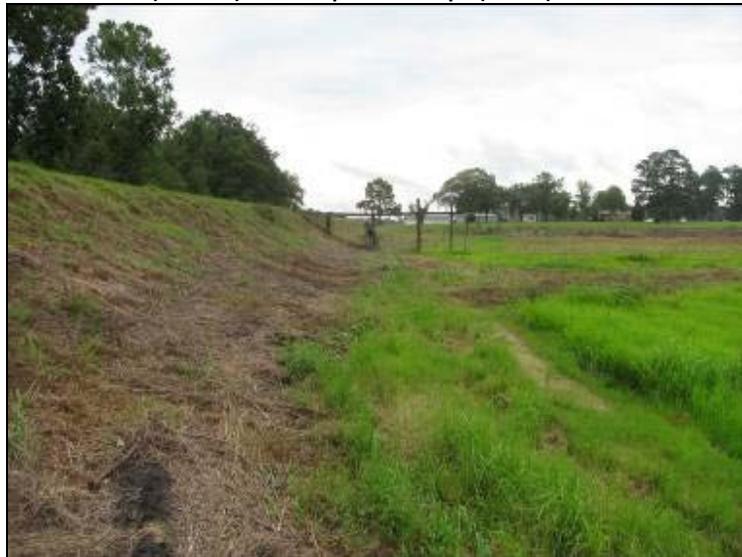
Photo 67: Ash Pond – North embankment interior slope, looking east.

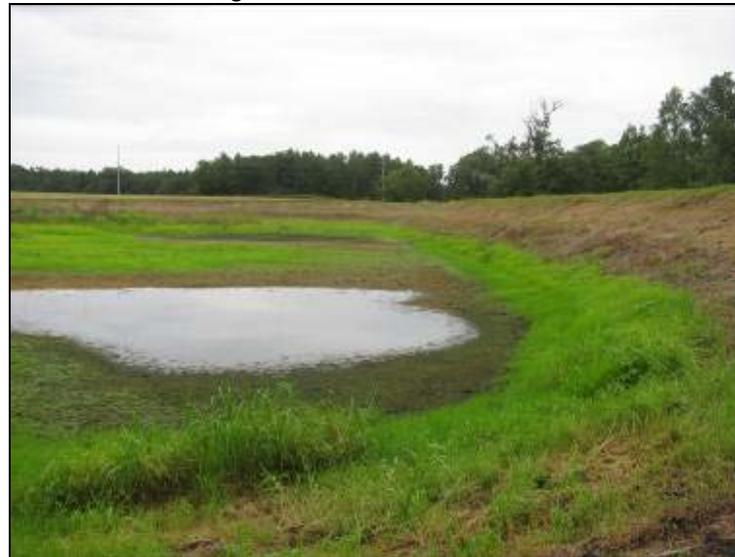
At the time of the assessment, the Ash Pond contained residual ash and a limited amount of ponded water near the northwest corner of the impoundment (Photograph 68). The volume of ponded water did not adversely impact storage capacity of the Ash Pond. The bottom of the pond was covered with well-maintained vegetative cover. It was indicated by the Crisp County Power Commission staff that the Ash Pond has never been dredged to remove accumulated ash. Approximately 8 feet of freeboard was available near the northwest corner of the pond, where the ponded water was observed. The Ash Pond is of a side-hill configuration, with the north and west embankments constructed to a height of about 23 feet.

Photo 68: Ash Pond – West embankment interior slope, looking south.
 Note: ponded water near northwest corner of pond.

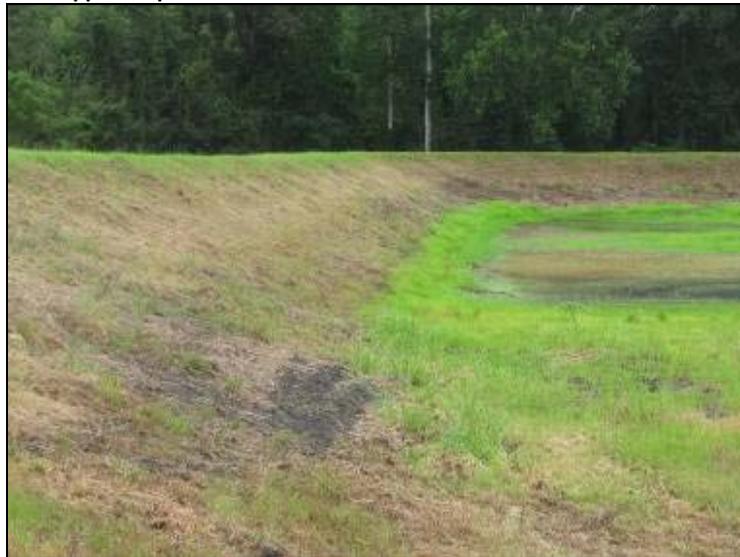
Photo 71: Ash Pond – West embankment interior slope, looking north.

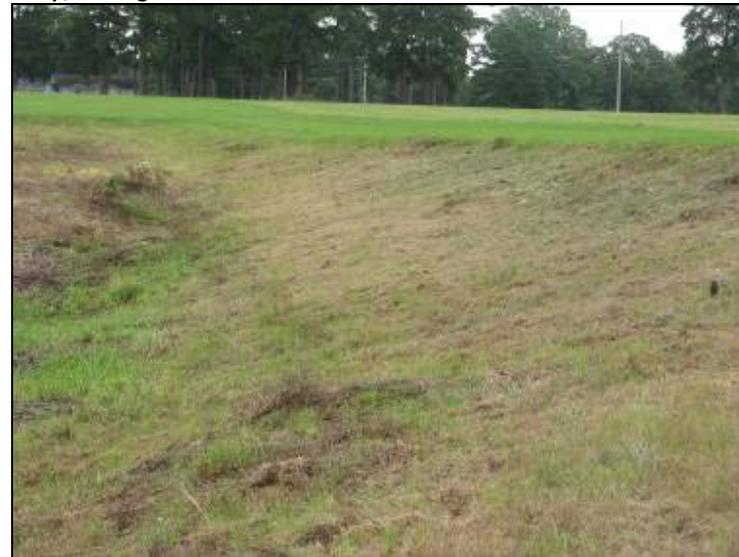
Photo 72: Ash Pond – South embankment interior slope, looking east.

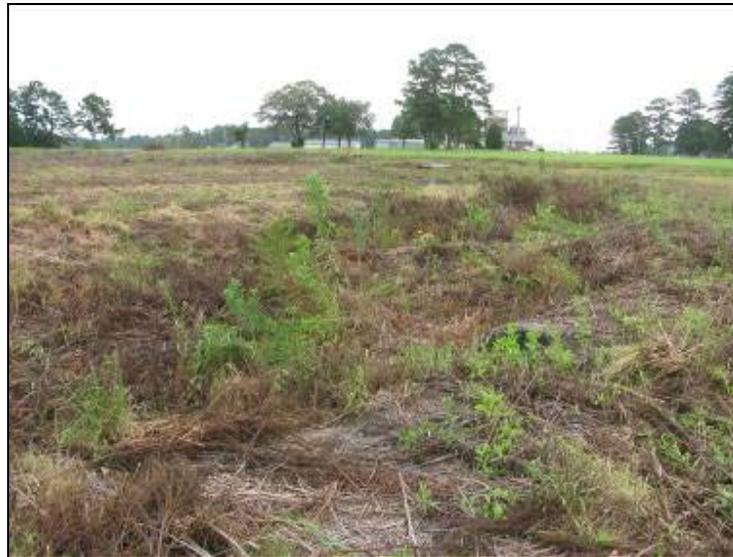
Photo 74: Ash Pond – Incised channel in the Ash deposited at bottom of pond, looking east.
