# ASSESSMENT OF DAM SAFETY OF COAL COMBUSTION SURFACE IMPOUNDMENTS

**Gainesville Regional  
Utilities  
Deerhaven Plant  
Gainesville, Florida**

Prepared for  
*U.S. Environmental  
Protection Agency  
Washington, D.C.*

October, 2012  
Revision 1, September 2013

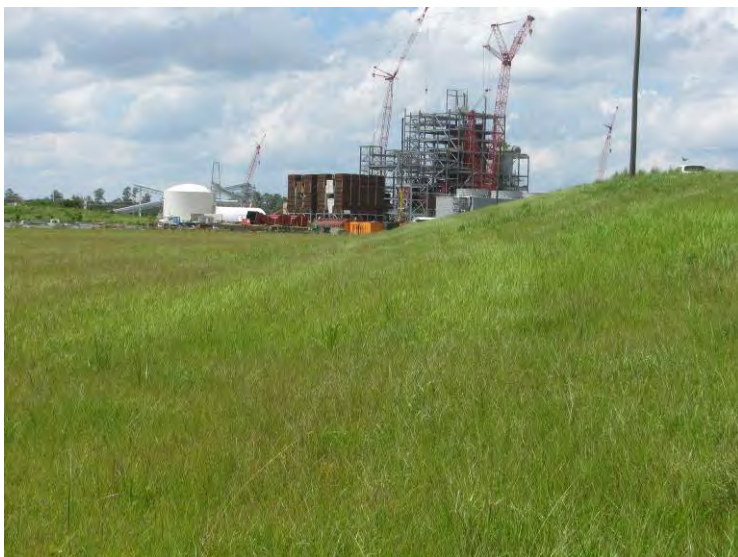
The exterior slopes appear to be in **SATISFACTORY** condition. The exterior slopes of the embankments are approximately 4H:1V. They have a grass cover that was approximately 6 to 8 inches high at the time of the visual assessment (Photographs 1, 3, 7, 76, 77, and 79). At some areas on the northwest embankment, the grass cover was somewhat higher (Photographs 83, 84 and 86). Some saturated areas were observed along the toe of the slope of the southwest embankment (Photograph 2 and 78) and the northwest embankment (Photographs 82 and 85). A runoff swale is located at the toe of slope of the southeast embankment of Pump Back Cells #1 and #2 (Photographs 3, 10 and 11). It was difficult to determine if these wet areas were caused by seepage or the relatively heavy rainfall prior to our assessments. Based on the embankment height, embankment geometry and surface water elevation, these areas could potentially be due to seepage. Based on review of drawings the perimeter embankments were constructed with a cutoff slurry wall, keyed into the existing natural clay layer (as discussed in Section 4). It is noted however that the top of slurry wall was shown to be at elevation 184 and the observed water level in Ash Cell #1 was about elevation 194 during the condition assessment.

Photo 1: Pump Back Cell No. 1 – Southwest embankment exterior slope, looking northwest.

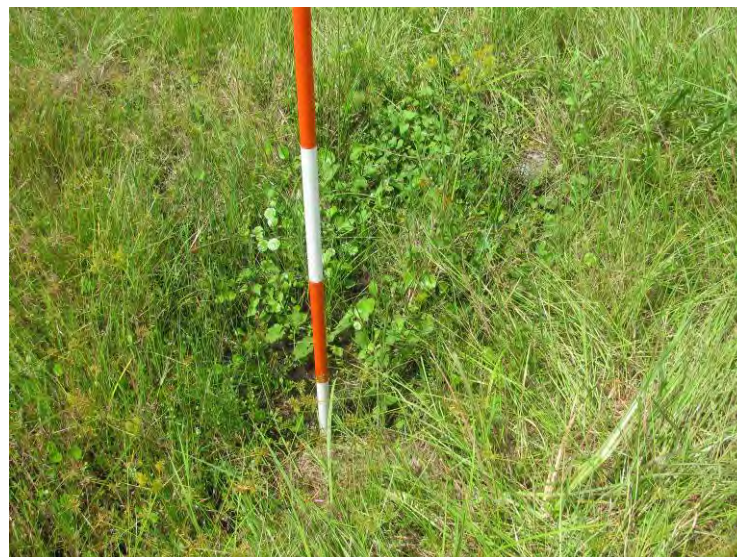
Photo 2: Pump Back Cell No. 1 – Southwest embankment exterior slope, runoff swale culvert pipe under road, looking northeast.

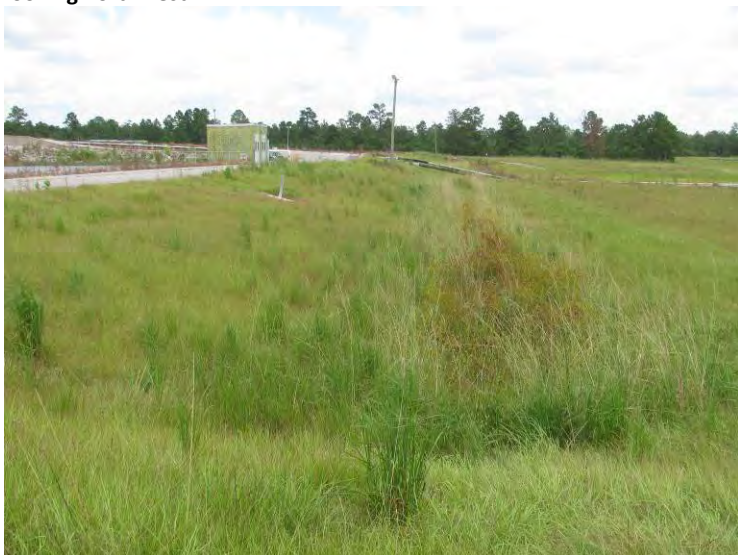
Photo 3: Pump Back Cell No. 1 – Southeast embankment exterior slope, runoff swale looking northeast.

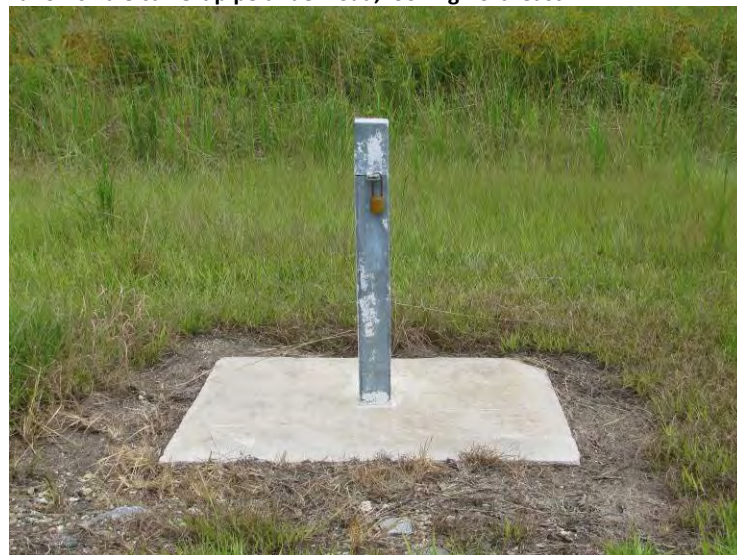
Photo 4: Pump Back Cell No. 1 - Southeast embankment exterior slope, monitoring well, looking southeast.

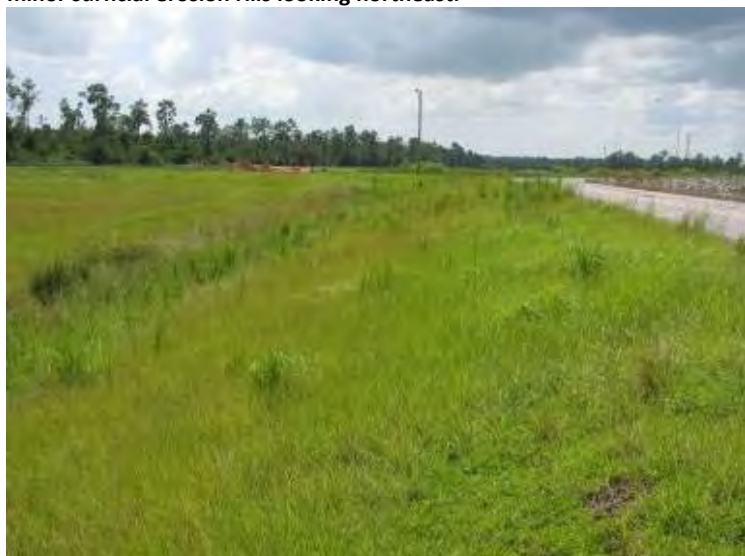
Photo 7: Pump Back Cell No. 1 – Southeast embankment exterior slope, general view looking southwest.

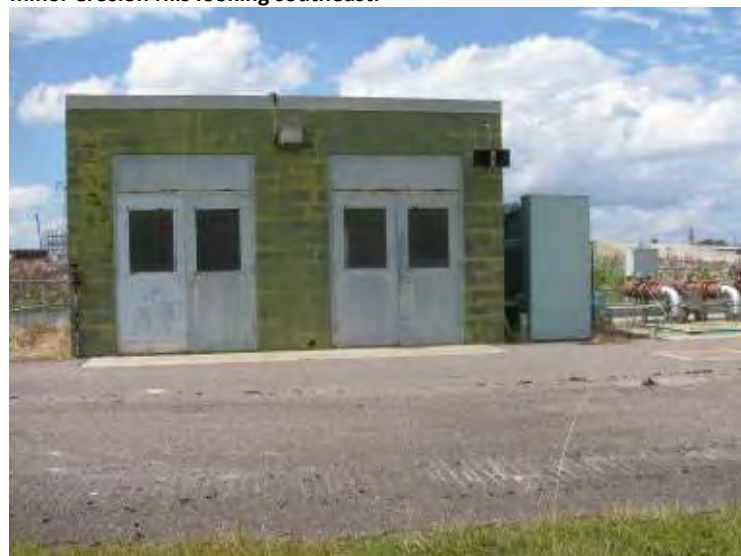
Photo 8: Pump Back Cell No. 1 – Crest of southeast embankment, general view of pump house, looking northwest.

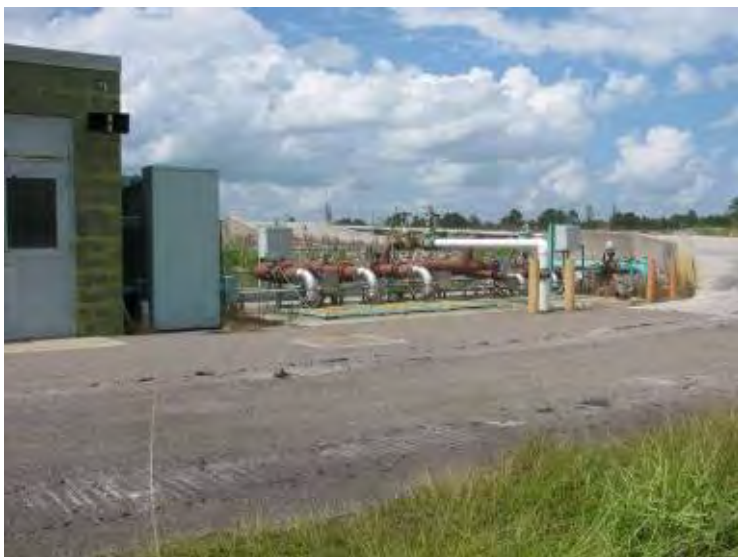
Photo 9: Pump Back Cell No. 1 – Crest of southeast embankment, general view of pump house looking north.

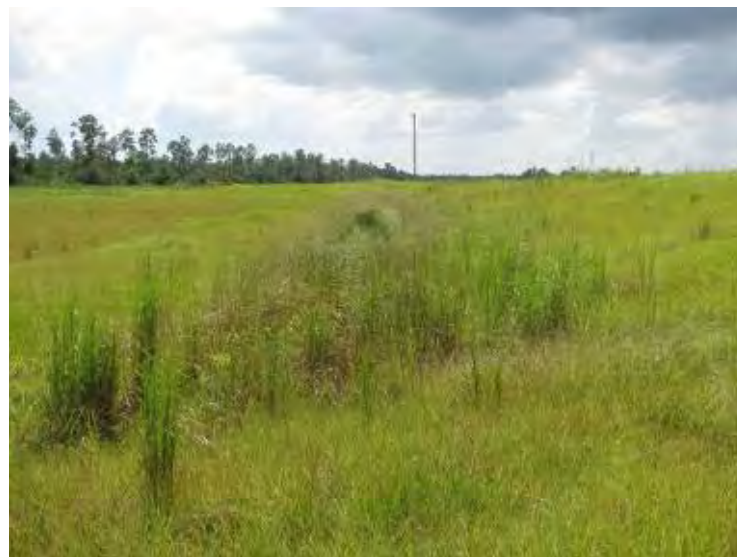
Photo 10: Pump Back Cell No. 1 – Southeast embankment exterior slope, runoff swale looking south.

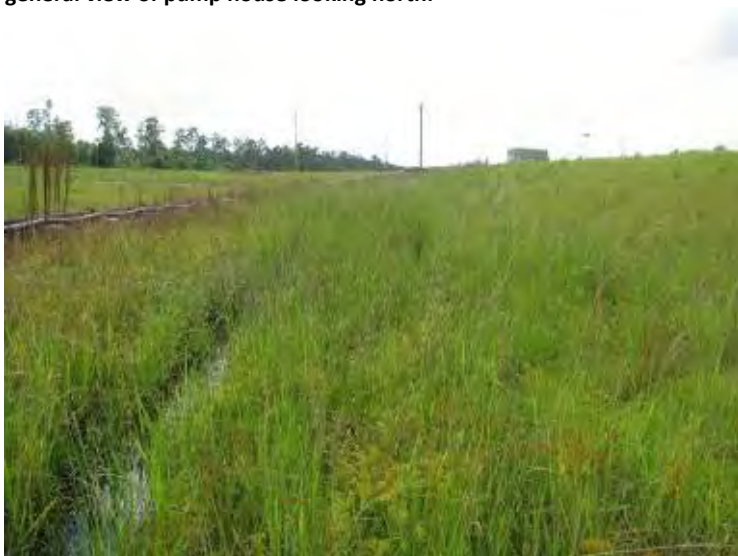
Photo 11: Pump Back Cell No. 2 – Southeast embankment exterior slope, runoff swale located along toe of slope, looking southwest.

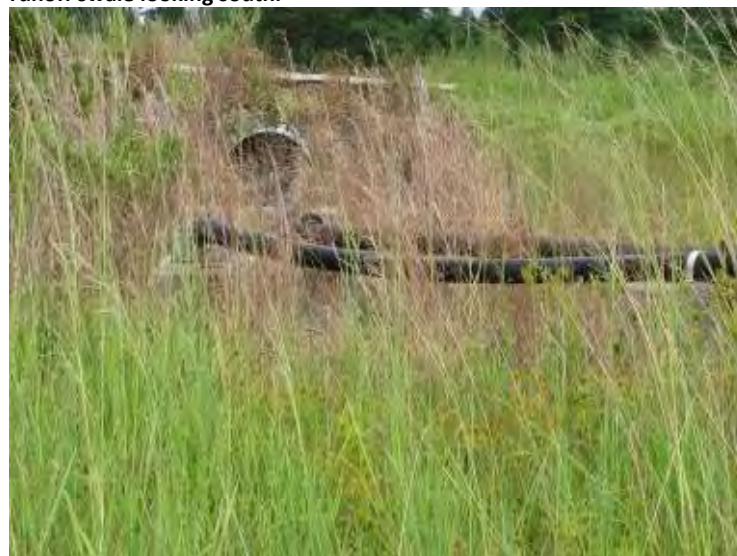
Photo 12: Pump Back Cell No. 2 – Southeast embankment exterior slope, 24-inch dia. corrugated culvert pipe below access road between Pump Back Cell No. 2 and Lime Sludge Cell No. 2, looking northeast. Note lime sludge pipes.

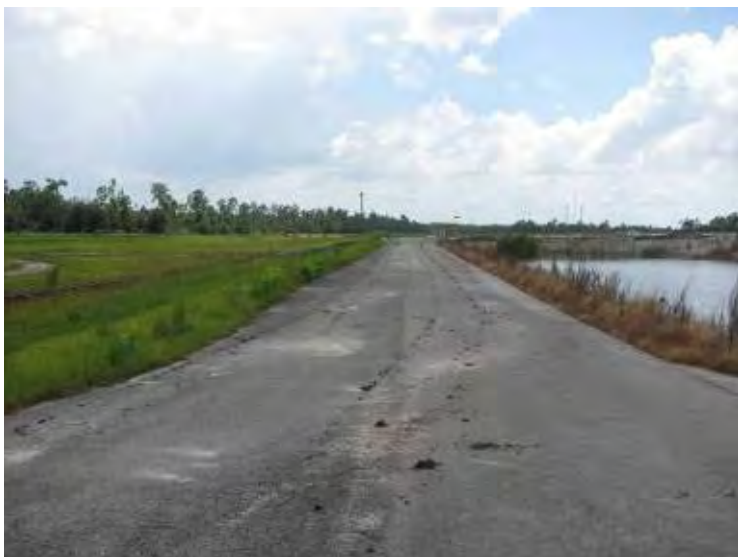
Photo 13: Pump Back Cell No. 2 – Paved crest of southeast embankment, looking southwest.

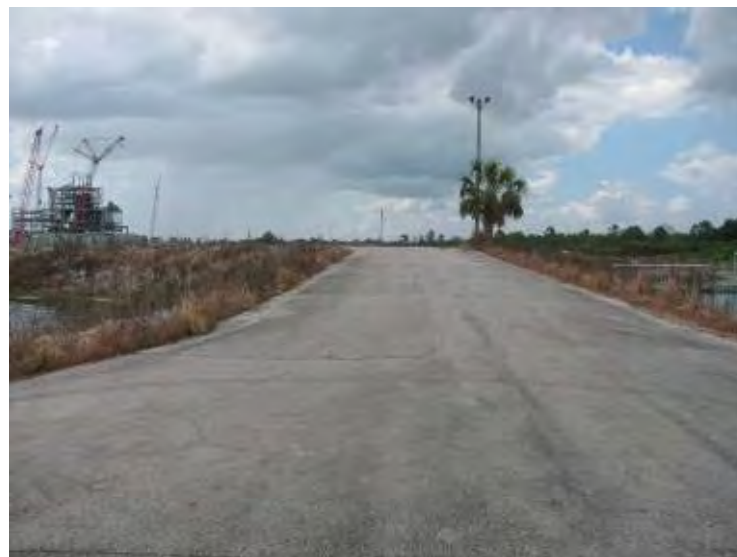
The crest of the Lime Sludge Ponds appears to be in fair condition. The typically crest width is approximately 25 feet (Photographs 14, 17, 19, 92 and 93). No evidence of settlement or major cracks was observed on the crests. The interior slopes appear to be in fair condition and they appear to be approximately 3H:1V. These slopes are riprap armored with sparse vegetation cover (Photograph 18 and 93). A concrete valve box for the inlet pipes was observed at the northwest embankment at each Sludge Cell (Photograph 20). Dry lime sludge piles near the east corner of Sludge Cell #1 (Photograph 94) were observed. The exterior slopes appear to be in satisfactory condition and they are approximately 4H:1V. They are covered with grass that was approximately 6 to 8 inches high at the time of the visual assessment (Photographs 87 to 91). Lime sludge pipes are located at the toe of slope of the northeast embankment exterior slope of Sludge Cell #2 (Photographs 96 and 97). An animal burrow was observed on the southeast embankment exterior slope of Sludge Cell #2 (Photograph 16).

Photo 14: Paved crest of divider embankment between Pump Back Cell No. 2 and Lime Sludge Cell No.2, looking northwest.

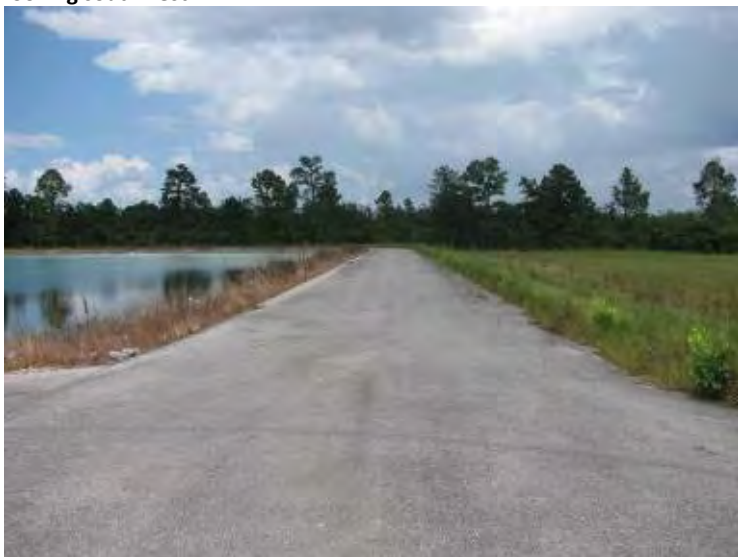
Photo 15: Lime Sludge Cell No. 2 – Paved crest of southeast embankment, looking northeast.

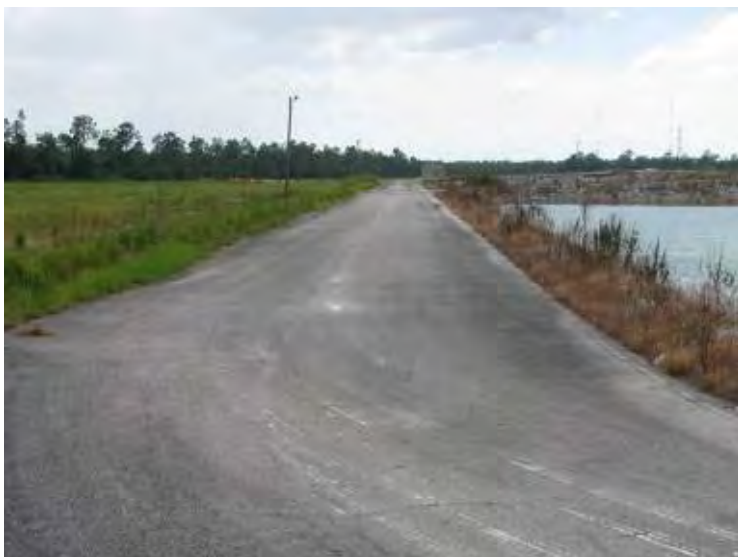
Photo 17: Lime Sludge Cell No. 2 – Paved crest of southeast embankment Near east corner, looking southwest.

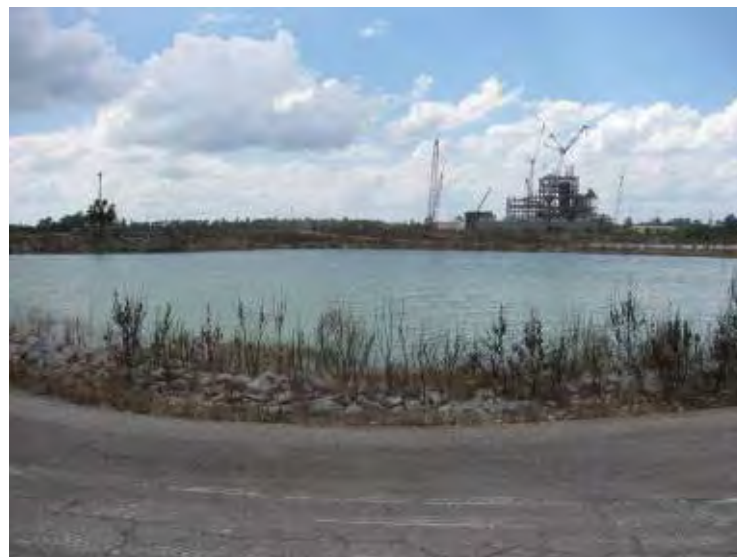
Photo 18: Lime Sludge Cell No. 2 – Southeast embankment east corner, view of pond surface looking west.

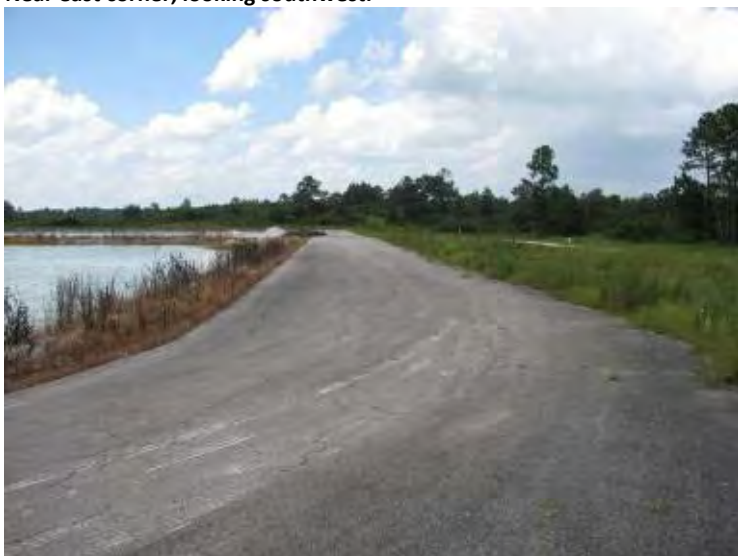
Photo 19: Lime Sludge Cell No. 2 – Paved crest of northeast embankment near east corner, looking northwest.

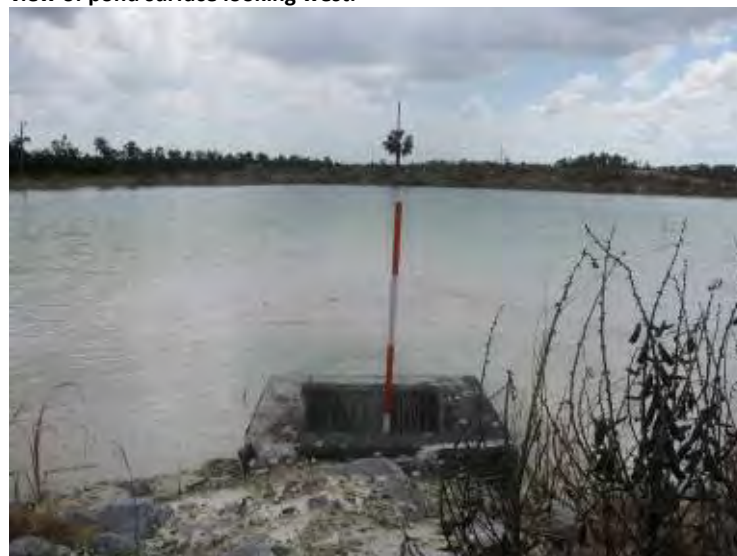
Photo 20: Lime Sludge Cell No. 2 – Northeast embankment interior slope, Concrete box for inlet pipe and view of pond surface, looking southwest.

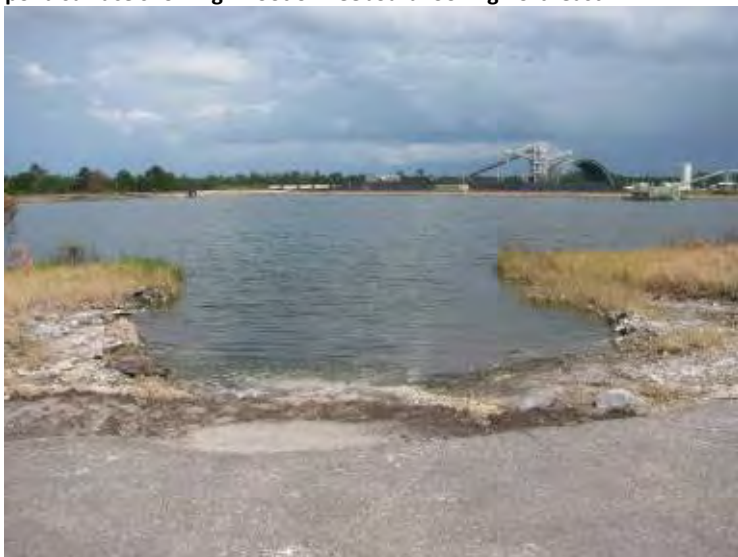
Photo 23: Ash Cell No. 1 – Southwest embankment west corner, view of pond surface looking east. Note access for dredging.

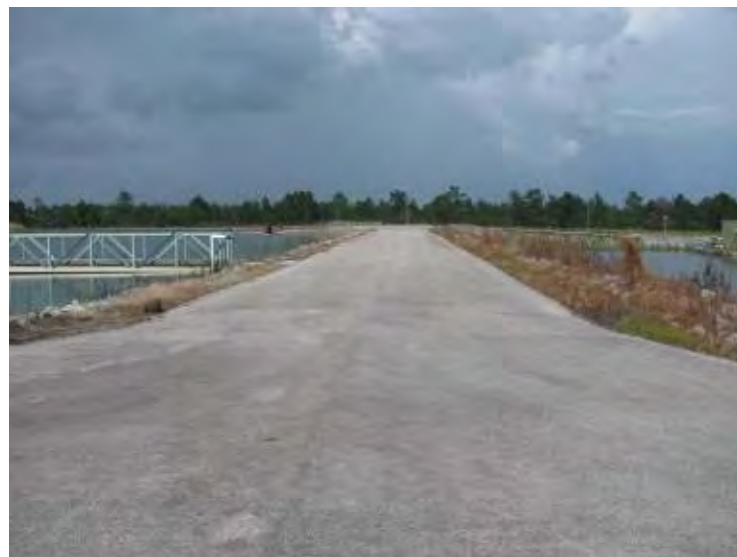
Photo 22: Paved crest of divider embankment between Ash Cell No. 1 and Pump Back Cell No. 1, looking northeast.

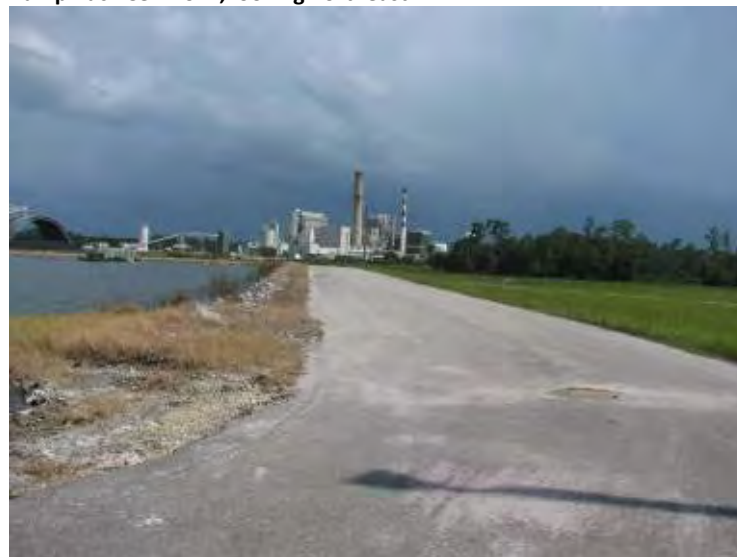
Photo 24: Ash Cell No. 1 – Paved crest of southwest embankment interior slope, looking southeast.

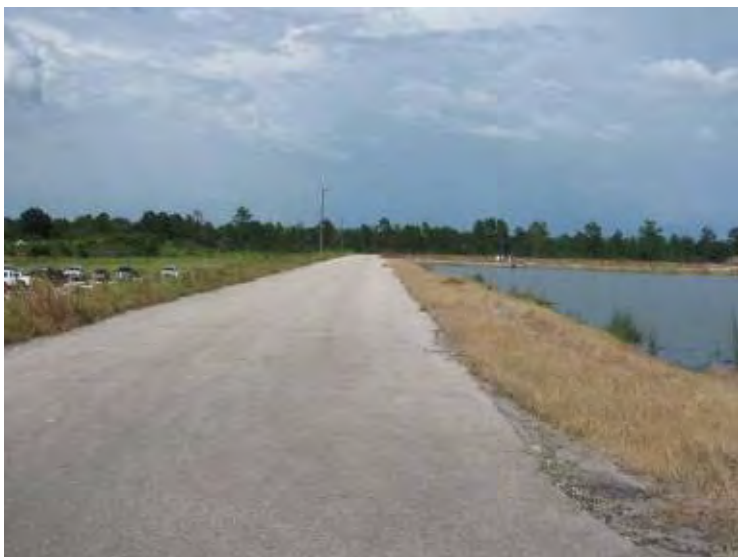
Photo 25: Ash Cell No. 1 – Paved crest of northwest embankment interior slope, looking northeast.

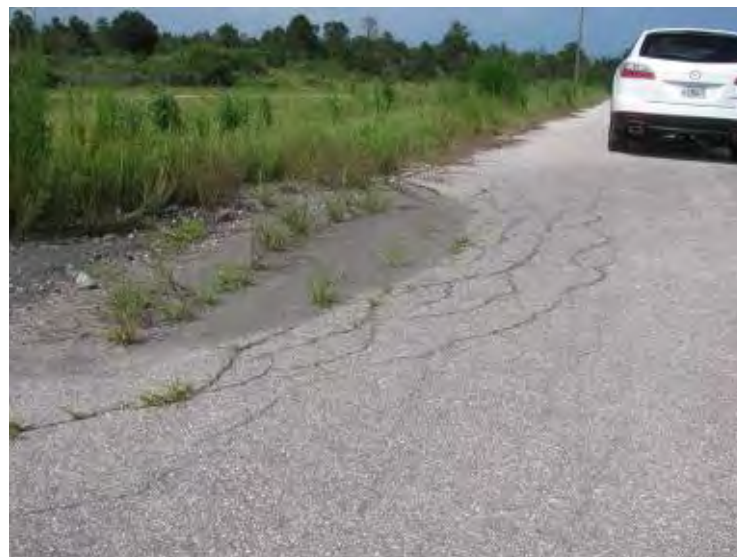
The crest of the perimeter embankments and divider embankments appeared to be in **FAIR** condition (Photographs 13-15, 22-25 and 38). Signs of previously repaired scarps and erosion areas were observed at the crest of the northwest embankment of the Ash Cell #2. The crest widths were typically 25 feet wide. The crest of the embankments has paved surfaces with exposure to limited vehicle traffic during normal operations. In general, no major cracks or evidence of settlement were observed on the crests of any of the embankments. Minor depression and areas of erosion were observed near Ash Cell #2 on the northwest embankment (Photographs 26 and 27).

Photo 26: Ash Cell No. 2 – Northwest embankment exterior slope, erosion along top of slope, looking north. Note pavement distress.

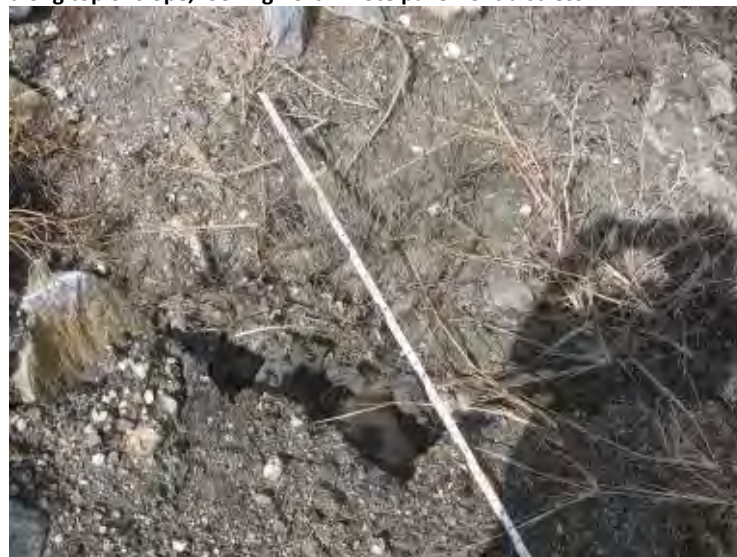
The interior slopes of the cells appear to be in **FAIR** condition with riprap armoring (Photographs 38, 42, 46 and 47) and sparse vegetative cover. The interior slopes appeared to have a slope of approximately 3H: 1V. Discontinuities and eroded areas (Photographs 28, 29, and 31) were observed along the interior slopes of the northwest embankment at Ash Cell #2.

Photo 28: Ash Cell No. 2 – Northwest embankment interior slope, erosion rill looking southeast. (typical of several)

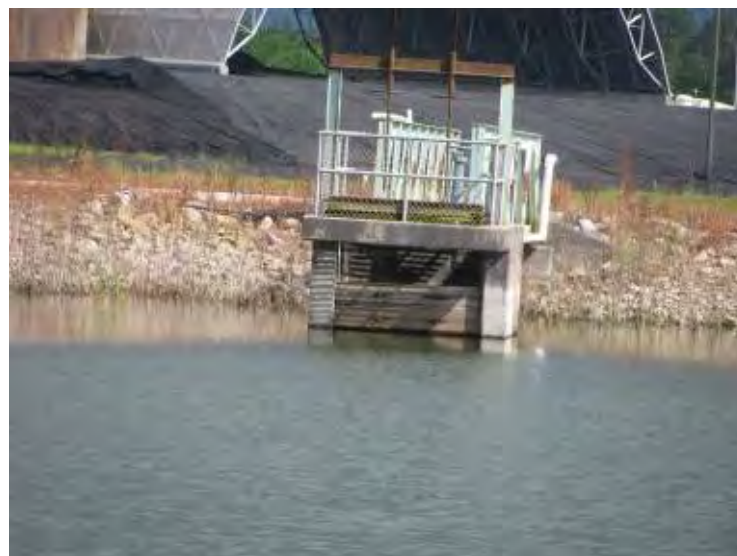
The outlet structures for the Ash Cells #1 and #2 consist of a concrete drop structure with stop logs (Photographs 30, 32 and 33). We understand that these cells are hydraulically connected to Pump Back Cells #1 and #2 and then the decant water is pumped back into the plant for reuse. Other details about the outlet structures are not known. The Process Water Ponds are a zero-discharge facility; therefore, there is not a general outlet/discharge structure.

Photo 30: Ash Cell No. 2 – Northwest embankment, outlet structure with stop logs southeast divider embankment interior slope, looking southeast.

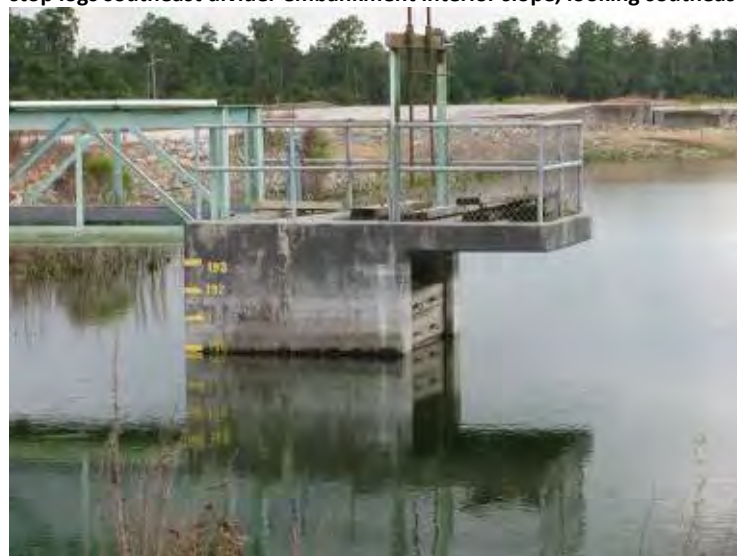
Photo 32: Ash Cell No. 2 – Outlet structure/stop logs and staff gage, looking southwest.

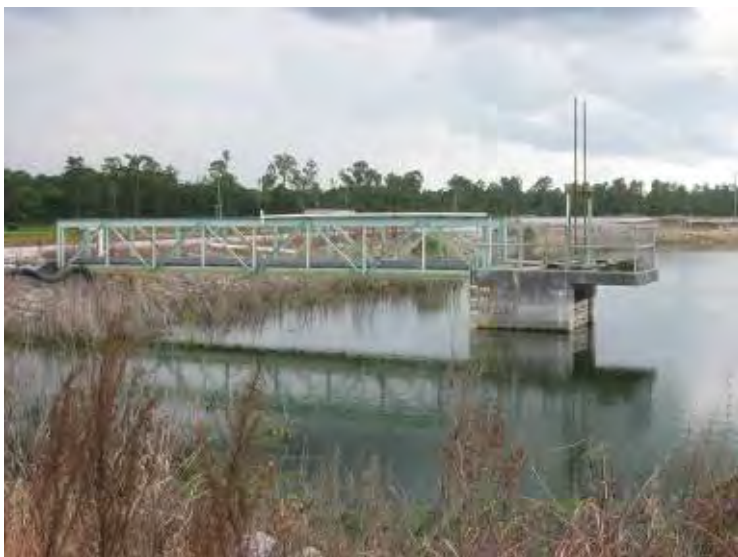
Photo 33: Ash Cell No. 2 – Outlet structure/stop logs looking southwest.

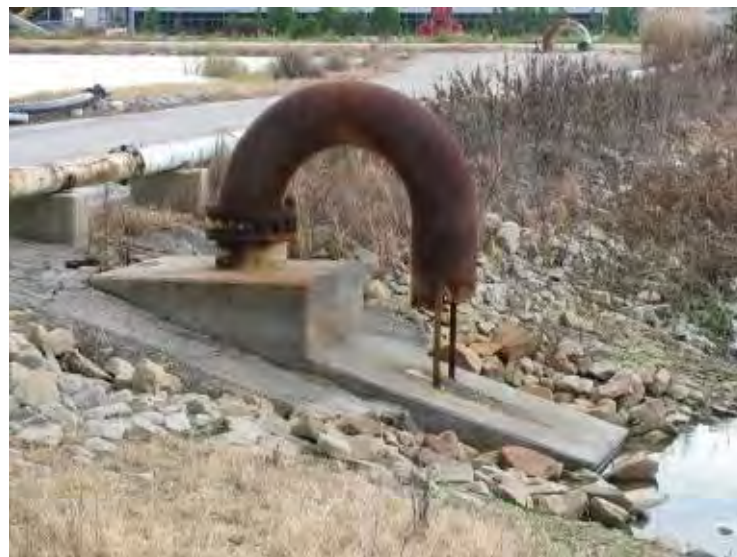
Photo 34: Ash Cell No. 2 – Southwest divider embankment interior slope, metal inlet pipe (15-inch diameter) and splash pad, looking northwest.

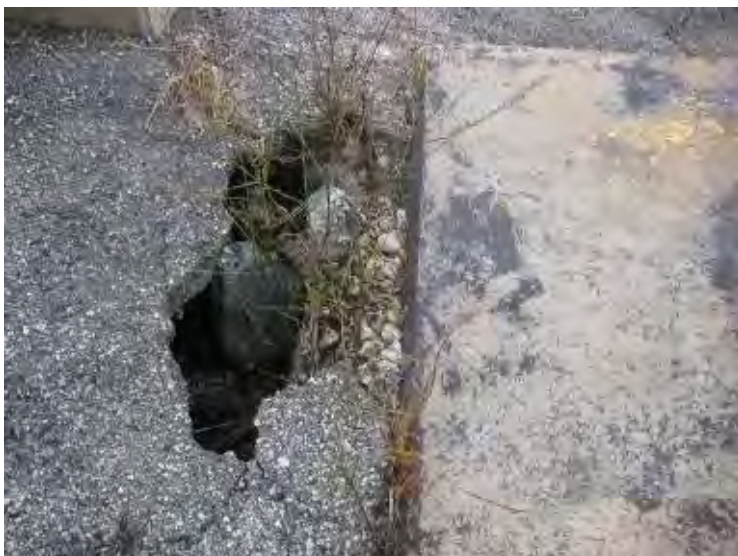
A concrete u-shape channel structure and metal grates located on the northeast side of the divider embankment between Ash Cell #1 and Ash Cell #2 protect the inlet pipes that extend from the plant (Photographs 41 and 42). A small cave-in of the pavement behind Ash Cell #2 inlet pipe concrete structure (Photographs 34 and 35) was observed. A pump house and pump system is located near the east corner of the southeast embankment of Pump Back Cell #1 (Photographs 8 and 9). Inlet pipes are located at the divider embankment between Ash Cells #1 and #2 (Photographs 40 and 43).

Photo 35: Ash Cell No. 2 – Erosion of slope pavement behind inlet pipe shown in previous photo.

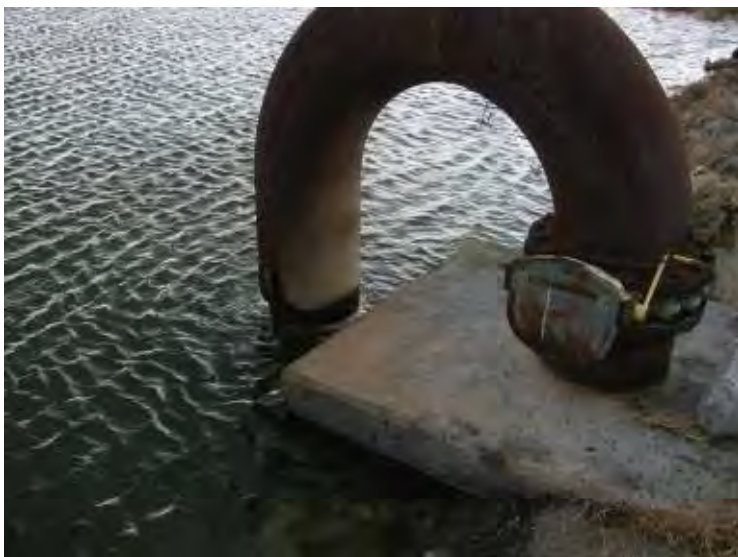
Photo 37: Ash Cell No. 1 – Metal inlet pipe (15-inch diameter) & submerged Splash pad, looking west.

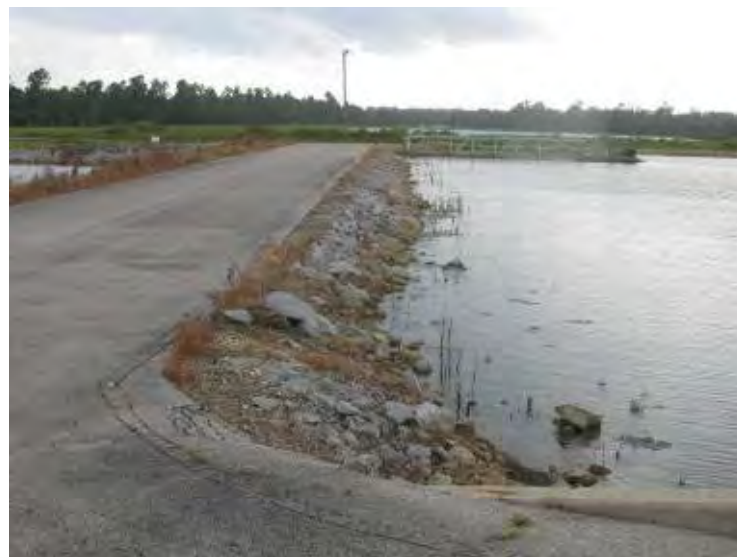
Photo 38: Ash Cell No. 1 – Paved crest of southeast divider embankment interior slope between Ash Cell No. 1 and Pump Back Cell No. 1, looking southwest.

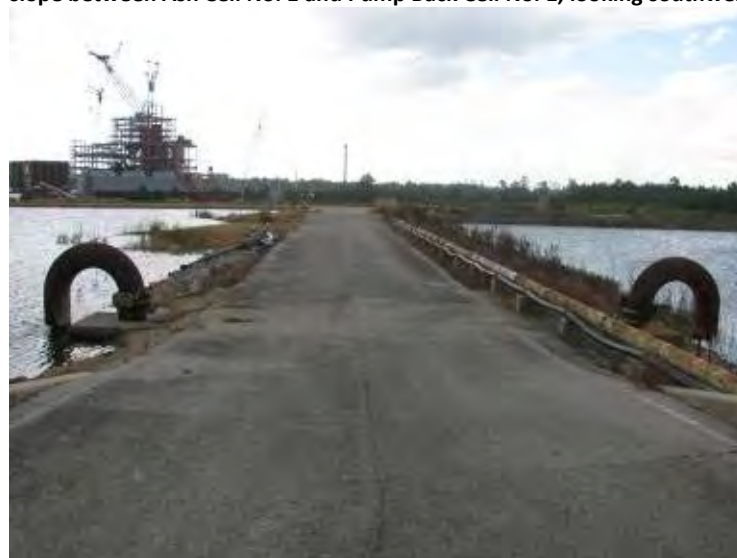
Photo 40: Ash Cell No. 1 – Crest of divider embankment between Ash Cell No. 1 and Ash Cell No. 2, looking northwest.

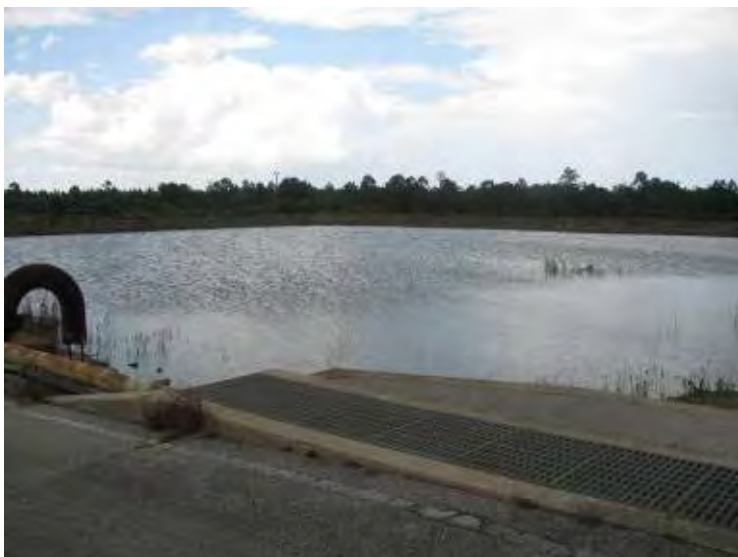
Photo 41: Ash Cell No. 2 – General view of pond looking north. Note concrete U-shaped channel and metal grate to protect sluice ash pipelines.

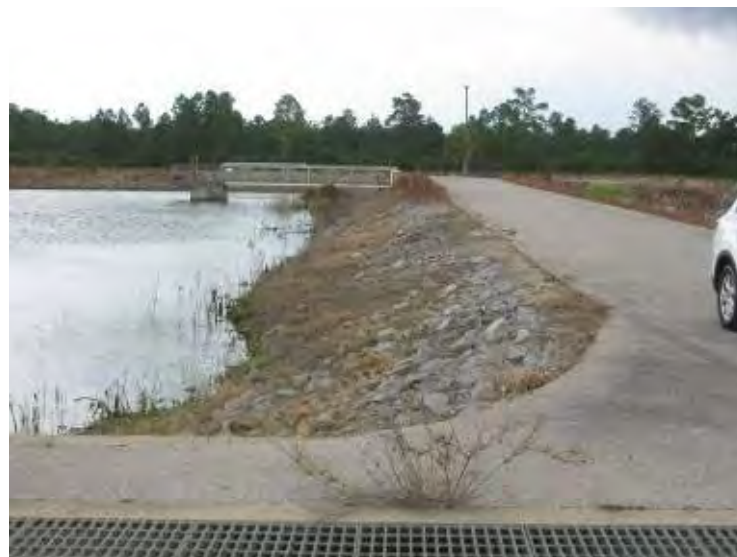
Photo 42: Ash Cell No. 2 - Paved crest and interior slope of southeast divider embankment, between Ash Cell No. 2 and Pump Back Cell No. 2, looking northeast.

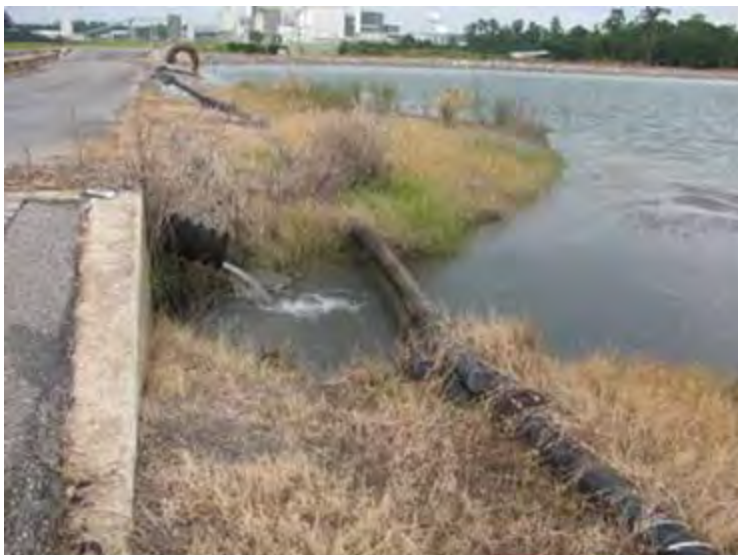
Photo 43: Ash Cell No. 1 – Inlet pipe and northeast divider embankment Interior slope, looking southeast. Note abandoned HDPE pipe.

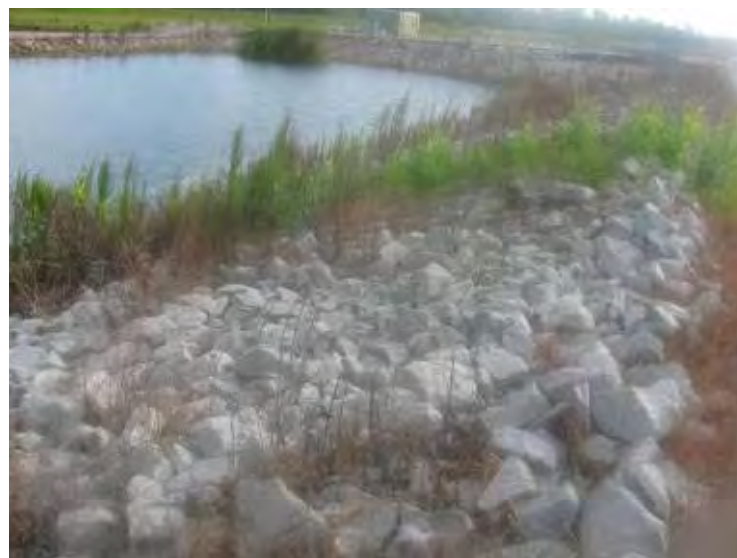
Photo 46: Pump Back Cell No. 2 – Northwest divider embankment interior slope, riprap armoring looking southwest.

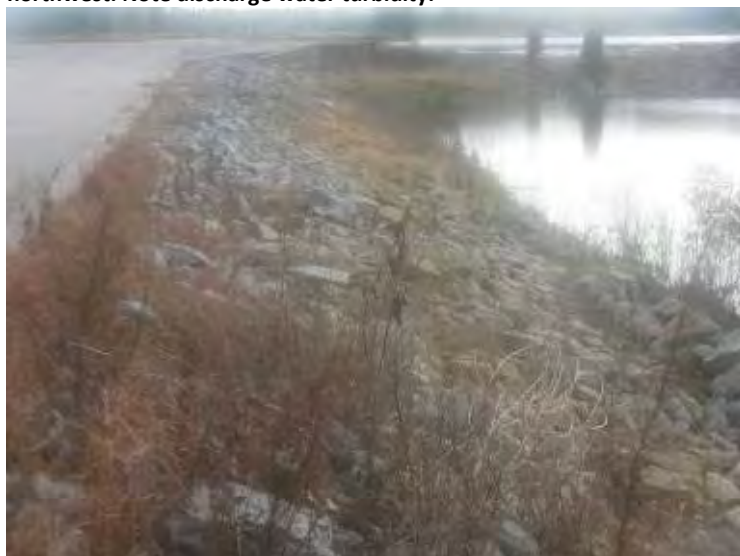
Photo 47: Ash Cell No. 2 – Northwest divider embankment interior slope, rip-rap slope treatment looking southwest.

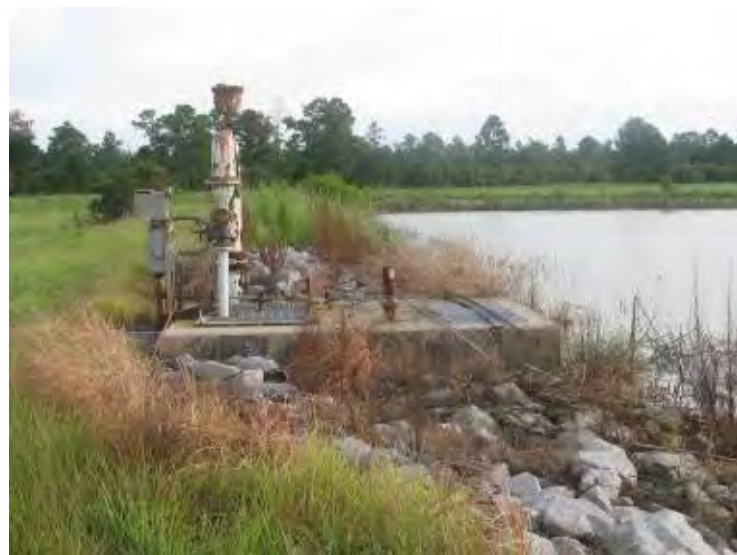
The interior slopes are riprap armored and appear to have 3H:1V slopes (Photograph 51 and 52). A pump station is located near the southwest corner of the impoundment (Photograph 58).

Photo 58: Coal Stockpile Runoff Collection Pond – West embankment interior slope, pump station located at southwest corner looking north.

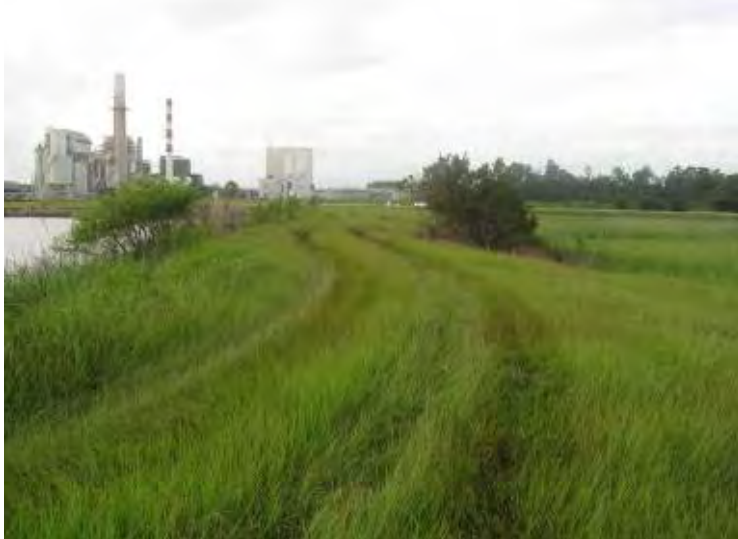
The coal stockpile runoff collection pond receives all runoff collected in a swale located north of the coal stockpile and from ditches that extend along the east, south and west sides of the coal stockpile (Photographs 50, 53 and 55). The crest of the perimeter embankments appears to be in fair condition, and they are grass covered with some tire ruts (Photographs 49, 56, 57, 63 and 64).

Photo 63: Coal Stockpile Runoff Collection Pond – Crest of west embankment, looking south.

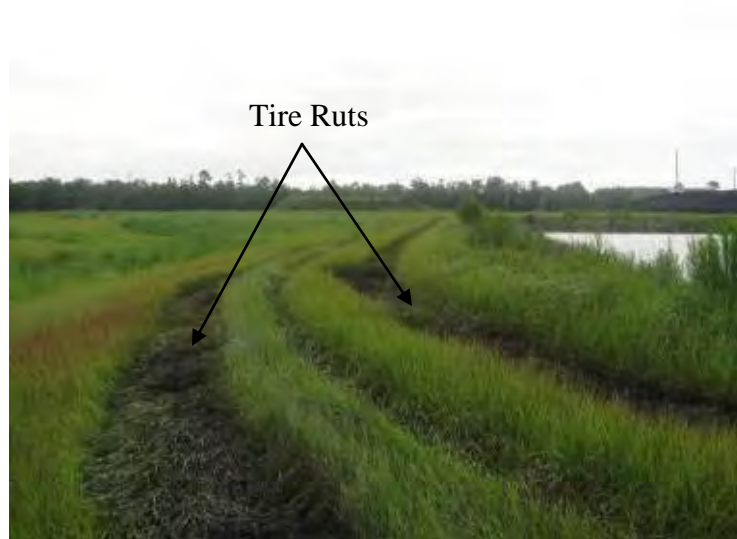
Photo 64: Coal Stockpile Runoff Collection Pond – Crest of north embankment, looking east. Note tire ruts.

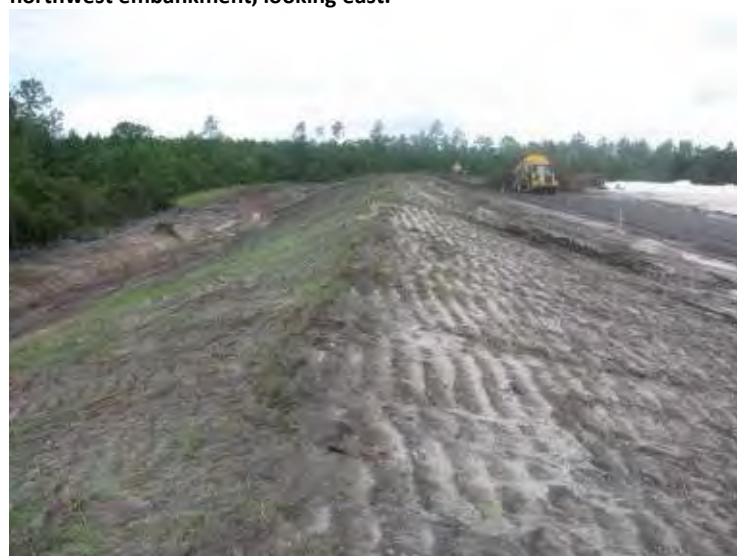
The Ash Dry Stack Landfill Area, located west of the Process Water Ponds, receives the ash produced by the Deerhaven Plant operations. At the time of the assessment the Ash Dry Stack Landfill Area was under construction. Based on visual observations the landfill area appears to be in fair condition. The south embankment of the landfill appears to have a 4H:1V slope (Photograph 72). Small ash stockpiles were observed within the landfill area (Photographs 73 to 74).

Photo 72: Ash Dry Stack Landfill Area – Crest of south embankment showing landfill area currently under construction, looking west.

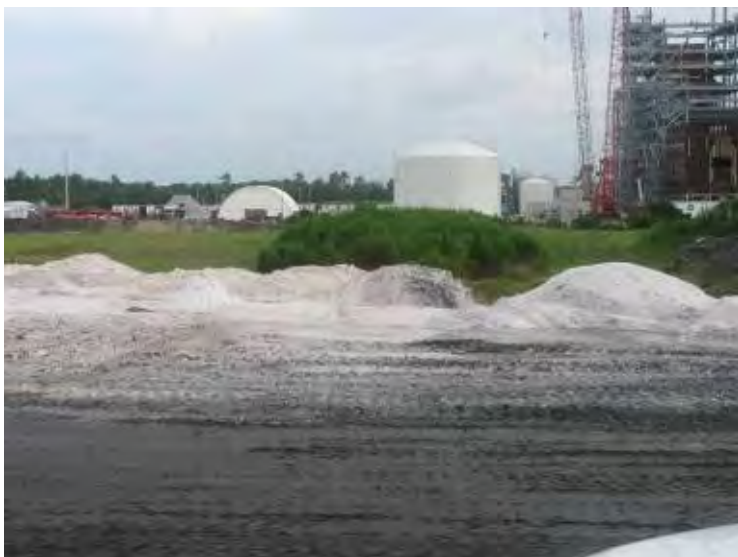
Photo 73: Ash Dry Stack Landfill Area – General view of landfill area currently under construction, looking north.

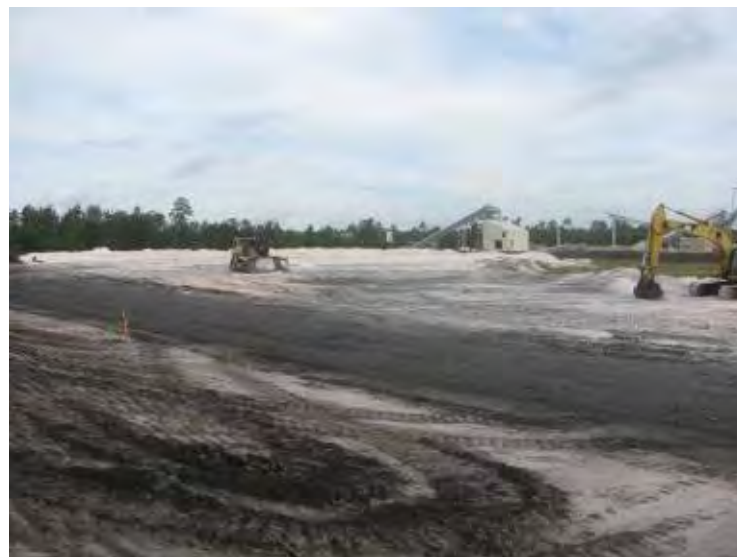
Photo 74: Ash Dry Stack Landfill Area – General view of landfill area currently under construction, looking northwest.

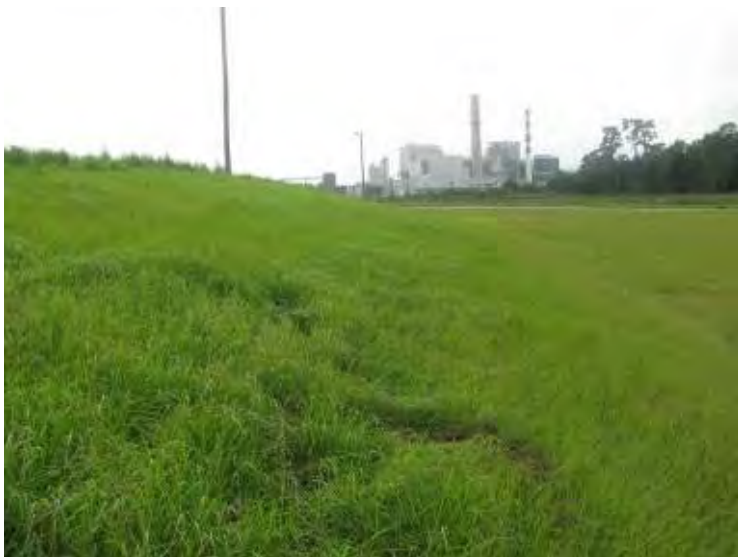
Photo 77: Ash Cell No. 1 – Southwest embankment exterior slope, looking southeast.

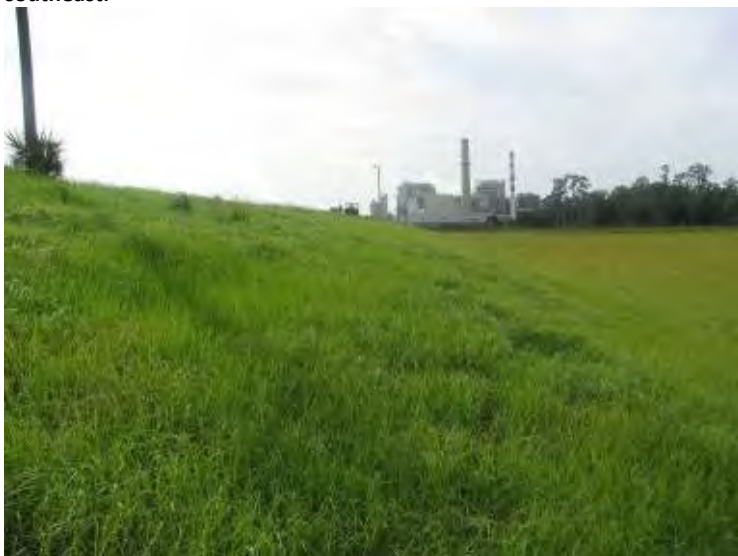
Photo 79: Ash Cell No. 1 – Southwest embankment exterior slope, looking southeast.

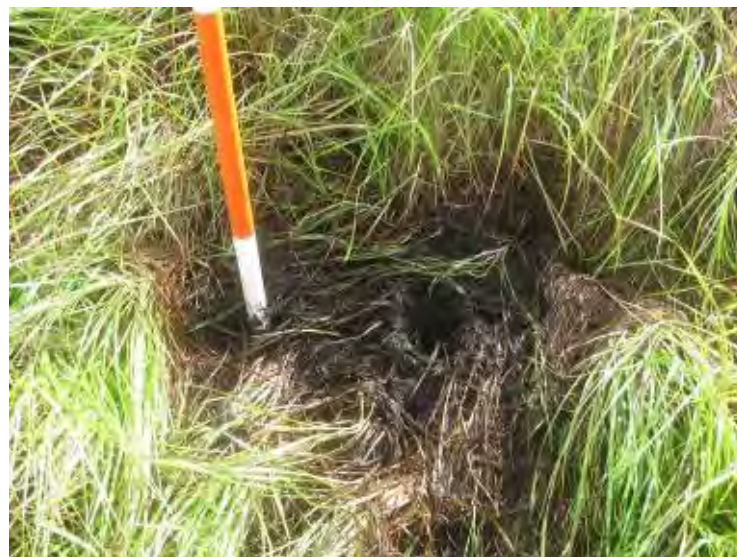
Photo 78: Ash Cell No. 1 – Southwest embankment exterior slope, saturated area along exterior toe of slope (typical), looking northeast.

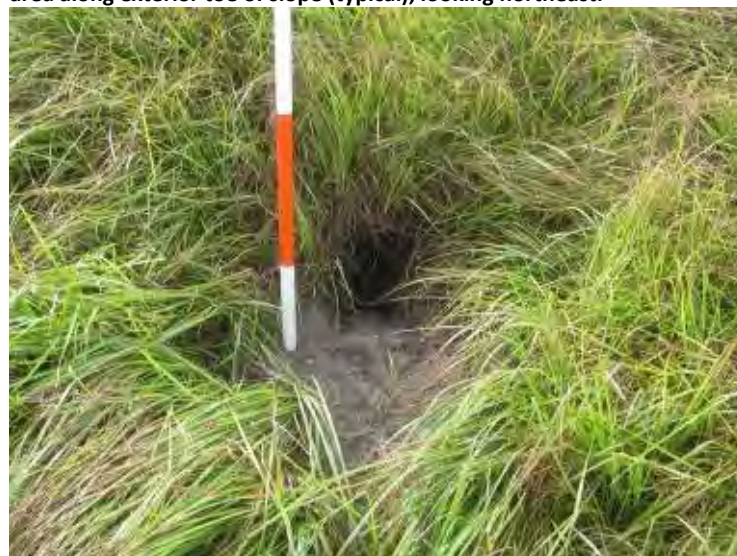
Minor erosion rills were observed on the exterior slope of the southeast embankment of Pump Back Cell #1 (Photographs 5 and 6). An animal burrow was observed on the northwest embankment of Ash Cell #1 (Photograph 80).

Photo 80: Ash Cell No. 1 – Animal burrow, northwest embankment exterior slope, looking southeast.

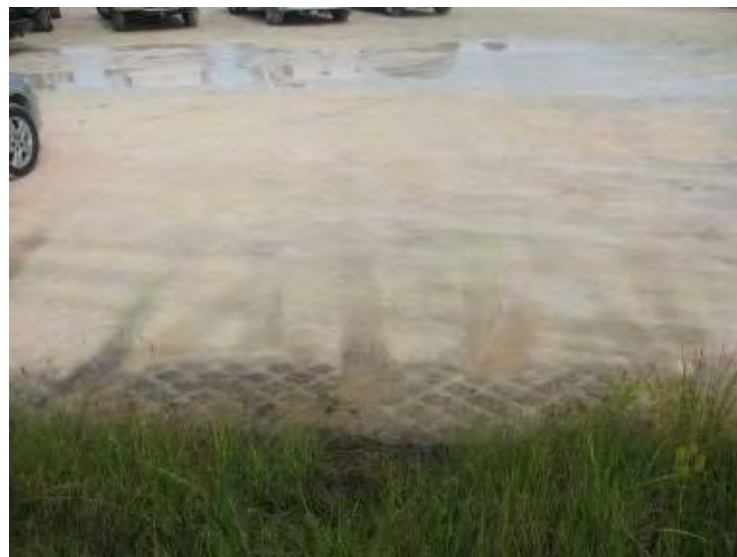
Photo 82: Ash Cell No. 1 – Northwest embankment exterior slope, ponded water and saturation along toe of slope, looking northwest.

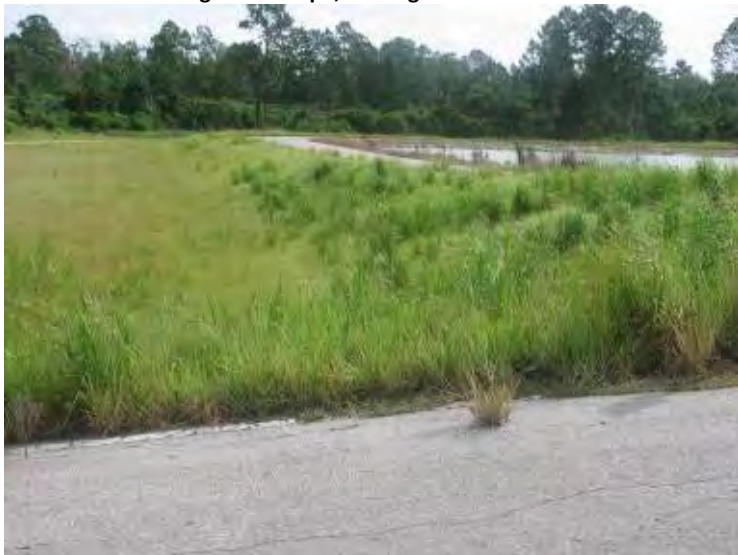
Photo 85: Ash Cell No. 2 – Northwest embankment exterior slope, saturated area along toe of slope, looking southeast.
