# ASSESSMENT OF DAM SAFETY OF COAL COMBUSTION SURFACE IMPOUNDMENTS

**Gainesville Regional  
Utilities  
Deerhaven Plant  
Gainesville, Florida**

Prepared for  
*U.S. Environmental  
Protection Agency  
Washington, D.C.*

October, 2012  
Revision 1, September 2013

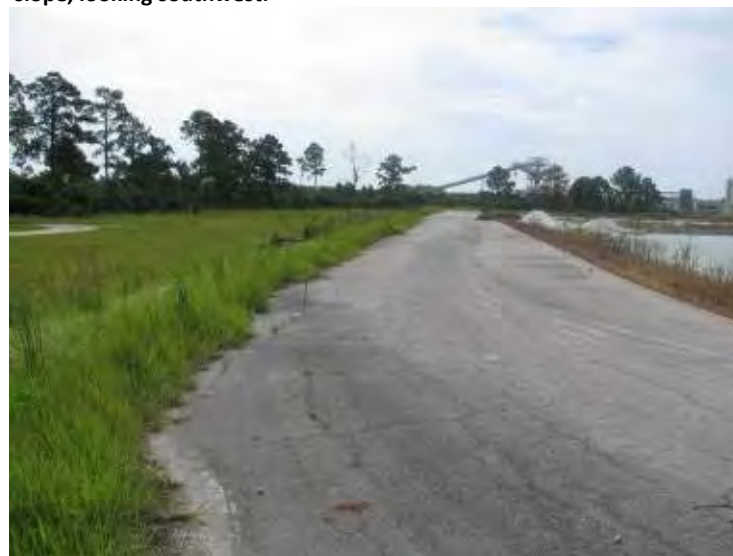
The crest of the Lime Sludge Ponds appears to be in fair condition. The typically crest width is approximately 25 feet (Photographs 14, 17, 19, 92 and 93). No evidence of settlement or major cracks was observed on the crests. The interior slopes appear to be in fair condition and they appear to be approximately 3H:1V. These slopes are riprap armored with sparse vegetation cover (Photograph 18 and 93). A concrete valve box for the inlet pipes was observed at the northwest embankment at each Sludge Cell (Photograph 20). Dry lime sludge piles near the east corner of Sludge Cell #1 (Photograph 94) were observed. The exterior slopes appear to be in satisfactory condition and they are approximately 4H:1V. They are covered with grass that was approximately 6 to 8 inches high at the time of the visual assessment (Photographs 87 to 91). Lime sludge pipes are located at the toe of slope of the northeast embankment exterior slope of Sludge Cell #2 (Photographs 96 and 97). An animal burrow was observed on the southeast embankment exterior slope of Sludge Cell #2 (Photograph 16).

Photo 92: Lime Sludge Pond No. 1 – Paved crest of northeast embankment, looking southeast.

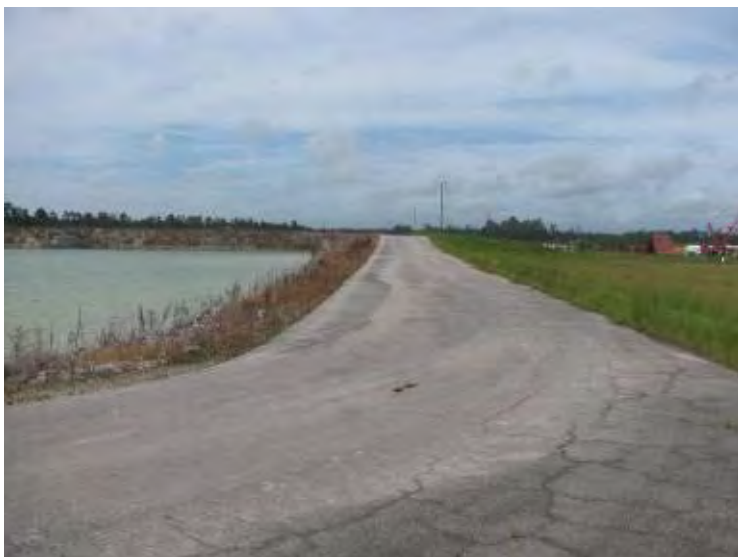
Photo 93: Lime Sludge Cell No. 1 – Paved crest of northwest embankment, looking southwest.

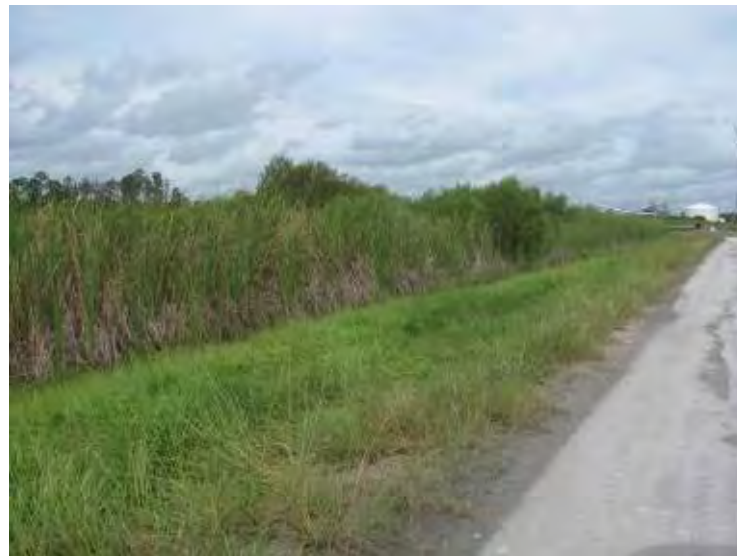
Photo 98: Stormwater Pond – Northeast embankment interior slope, looking west. Note areas of dense vegetation (i.e. – cattails).
