ASSESSMENT OF DAM SAFETY OF COAL COMBUSTION SURFACE IMPOUNDMENTS FINAL REPORT

Gainesville Regional Utilities Deerhaven Plant Gainesville, Florida

Prepared for
*U.S. Environmental
Protection Agency
Washington, D.C.*

May, 2014

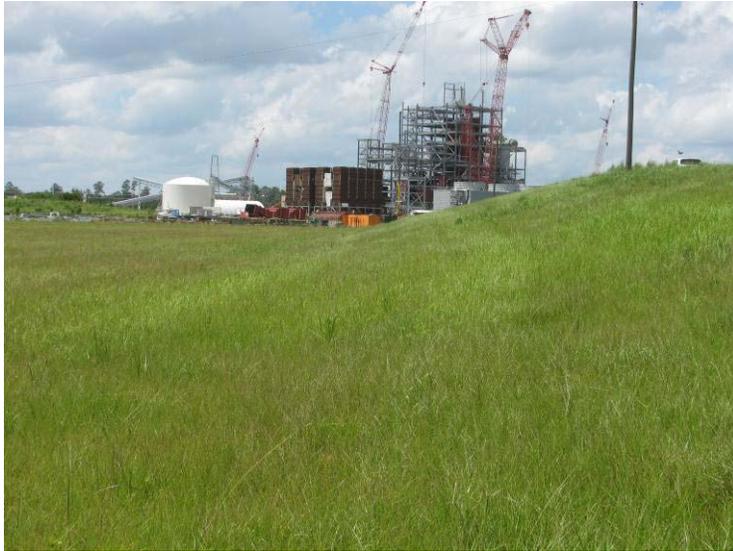
The exterior slopes appear to be in satisfactory condition. The exterior slopes of the embankments are approximately 4H:1V. They have a grass cover that was approximately 6 to 8 inches high at the time of the visual assessment (Photographs 1, 3, 7, 76, 77, and 79). At some areas on the northwest embankment, the grass cover was somewhat higher (Photographs 83, 84 and 86). Some saturated areas were observed along the toe of the slope of the southwest embankment (Photograph 2 and 78) and the northwest embankment (Photographs 82 and 85). A runoff swale is located at the toe of slope of the southeast embankment of Pump Back Cells #1 and #2 (Photographs 3, 10 and 11). It was difficult to determine if these wet areas were caused by seepage or the relatively heavy rainfall prior to our assessments as described in Section 5.1. Based on the embankment height, embankment geometry and surface water elevation, these areas could potentially be due to seepage. Based on review of drawings the perimeter embankments were constructed with a cutoff slurry wall, keyed into the existing natural clay layer (as discussed in Section 4). It is noted however that the top of slurry wall was shown to be at elevation 184 and the observed water level in Ash Cell #1 was about elevation 194 during the condition assessment.

Photo 1: Pump Back Cell No. 1 – Southwest embankment exterior slope, looking northwest.

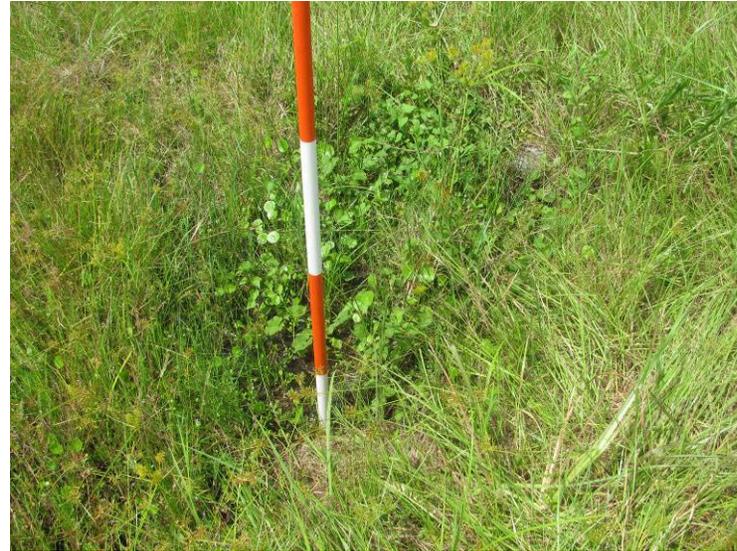
Photo 2: Pump Back Cell No. 1 – Southwest embankment exterior slope, runoff swale culvert pipe under road, looking northeast.

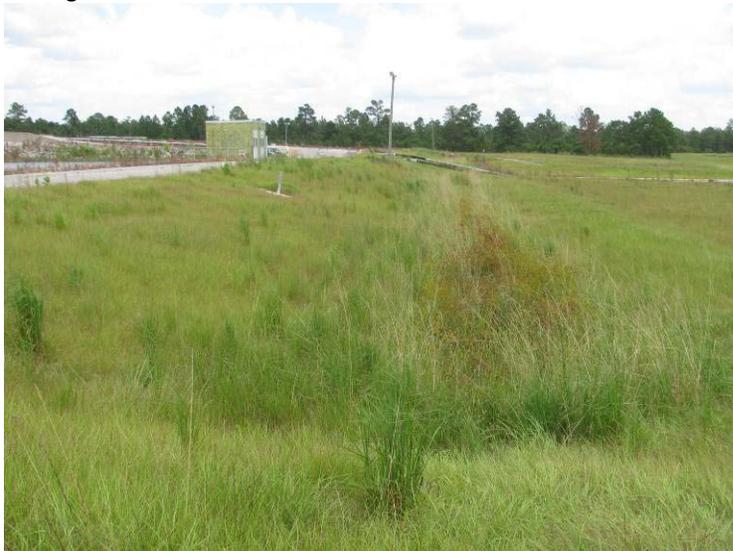
Photo 3: Pump Back Cell No. 1 – Southeast embankment exterior slope, runoff swale looking northeast.

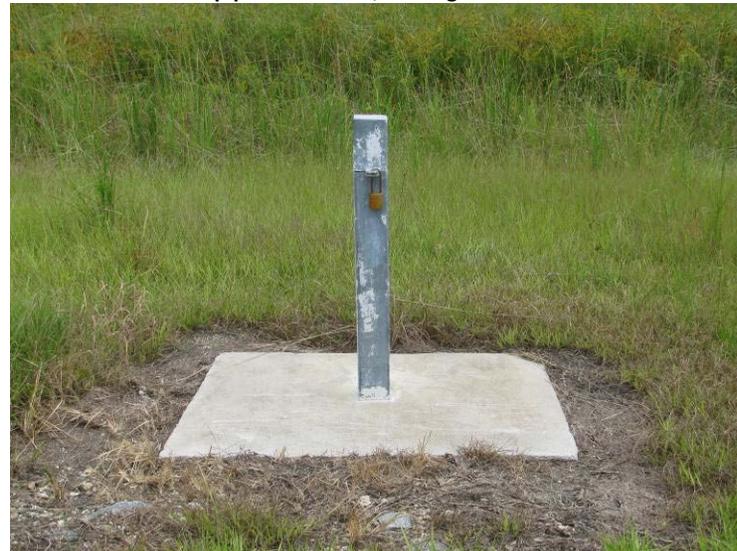
Photo 4: Pump Back Cell No. 1 - Southeast embankment exterior slope, monitoring well, looking southeast.

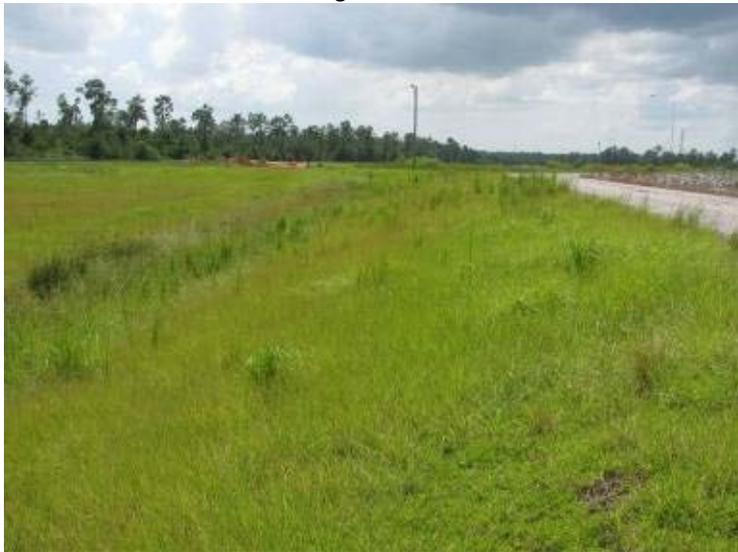
Photo 7: Pump Back Cell No. 1 – Southeast embankment exterior slope, general view looking southwest.

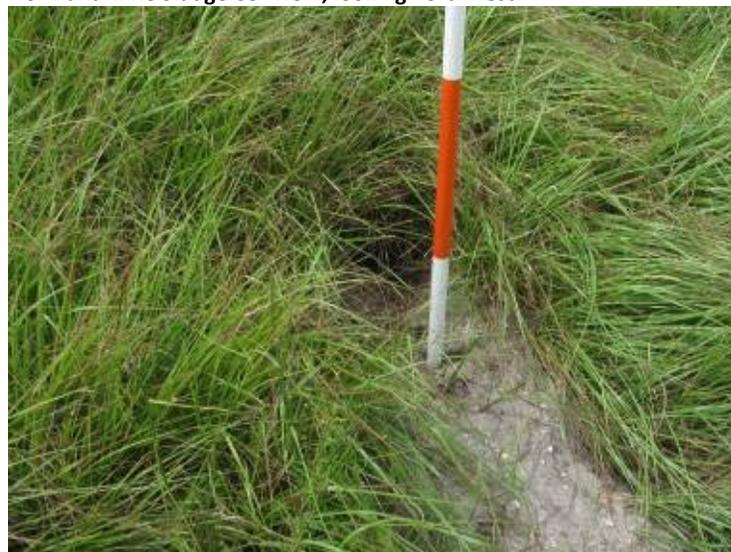
Photo 16: Lime Sludge Cell No. 2 – Animal burrow, southeast embankment exterior slope, looking northwest.

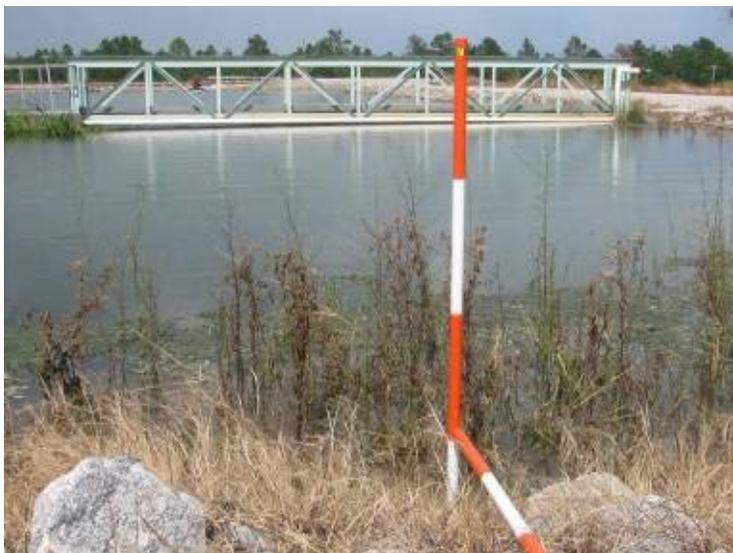
Photo 21: Ash Cell No. 1 – Southwest embankment interior slope, view of pond surface showing 1-foot of freeboard looking northeast.

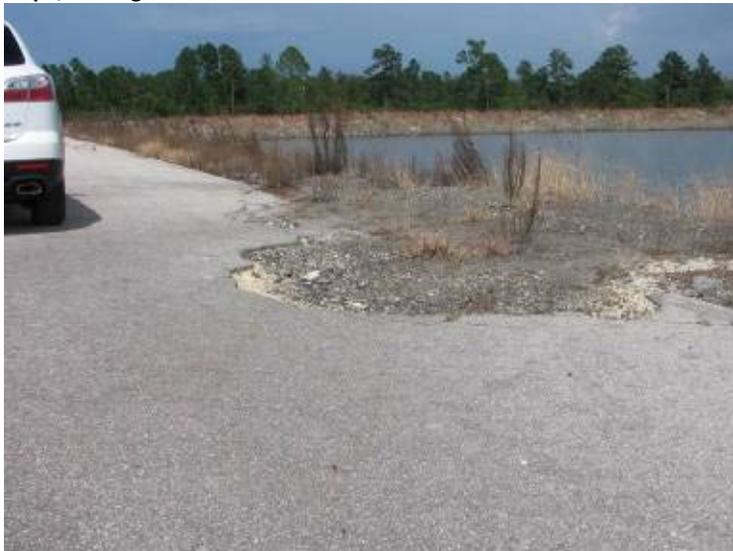
Photo 27: Ash Cell No. 2 – Northwest embankment interior slope, erosion along top of slope looking southeast. Note pavement distress.

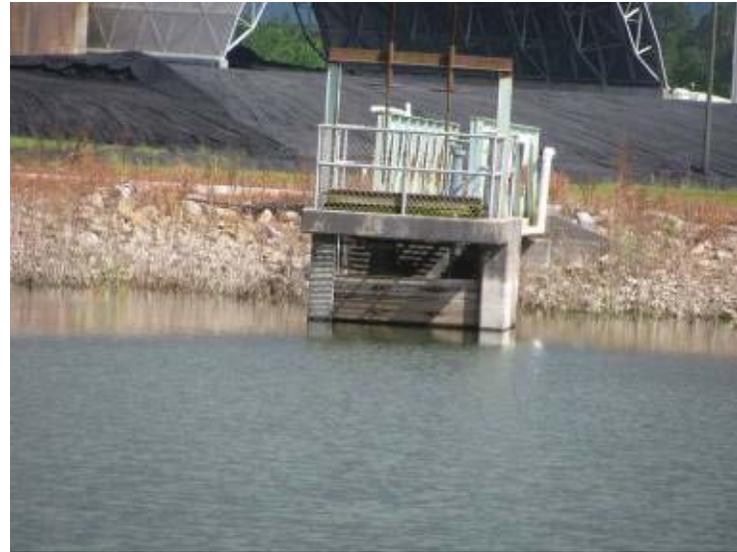
The outlet structures for the Ash Cells #1 and #2 consist of concrete drop structures with stop logs (Photographs 30, 32 and 33). We understand that these cells are hydraulically connected to Pump Back Cells #1 and #2 and the decant water is pumped back to the plant for reuse. Other details about the outlet structures are not known. The Process Water Ponds are part of a zero-discharge facility; therefore, there is not a general outlet/discharge structure.

Photo 30: Ash Cell No. 2 – Northwest embankment, outlet structure with stop logs southeast divider embankment interior slope, looking southeast.

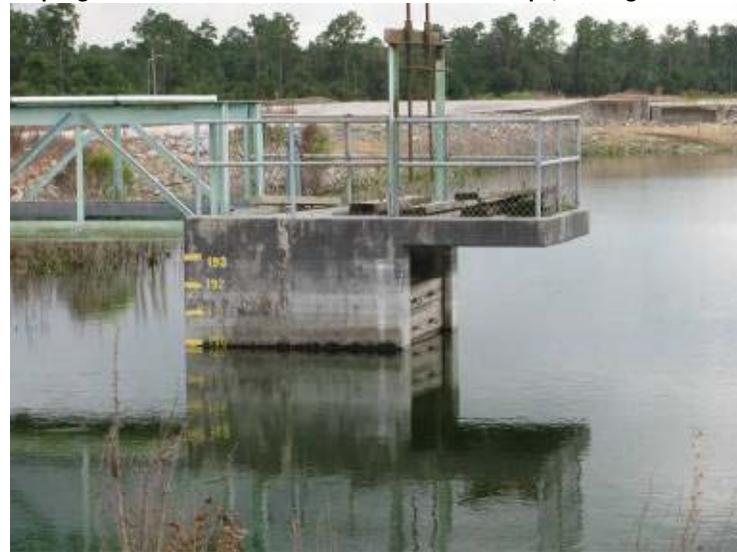
Photo 32: Ash Cell No. 2 – Outlet structure/stop logs and staff gage, looking southwest.

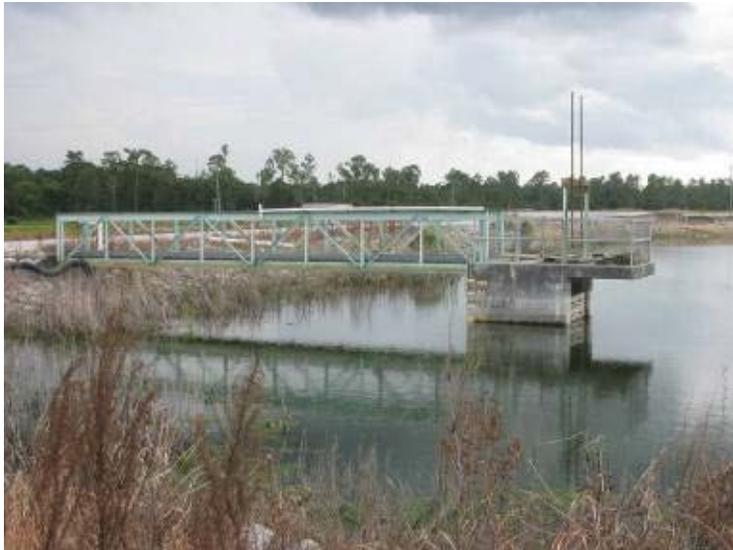
Photo 33: Ash Cell No. 2 – Outlet structure/stop logs looking southwest.

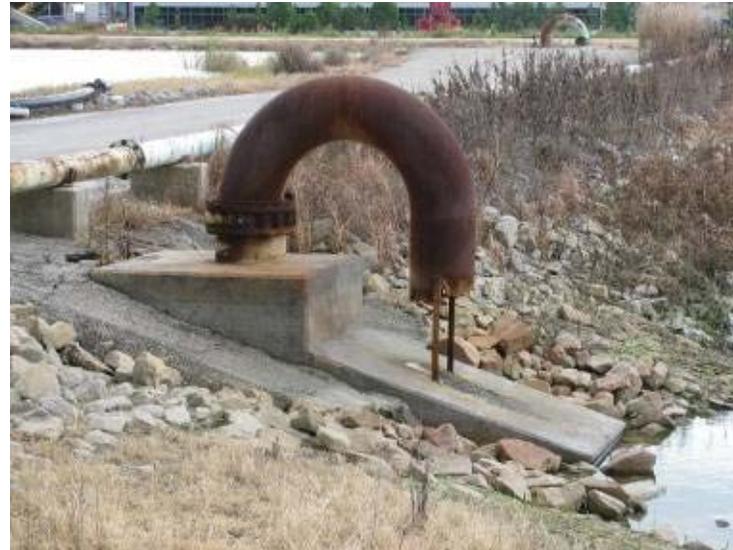
Photo 34: Ash Cell No. 2 – Southwest divider embankment interior slope, metal inlet pipe (15-inch diameter) and splash pad, looking northwest.

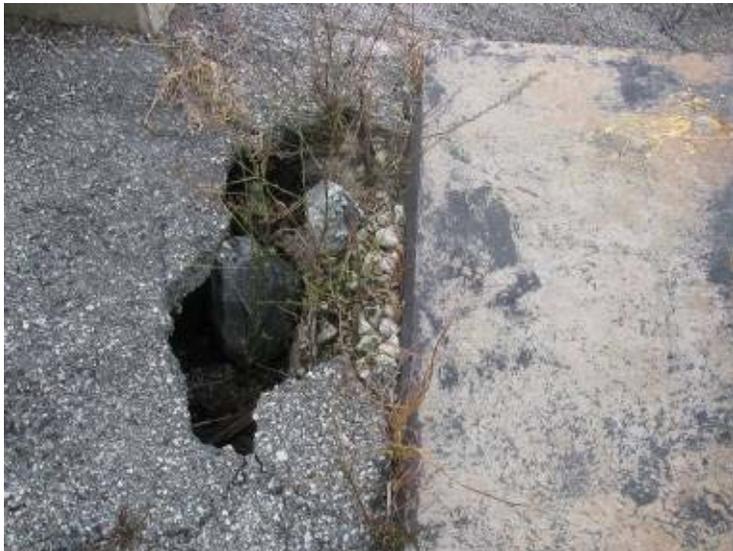
Photo 35: Ash Cell No. 2 – Erosion of slope pavement behind inlet pipe shown in previous photo.

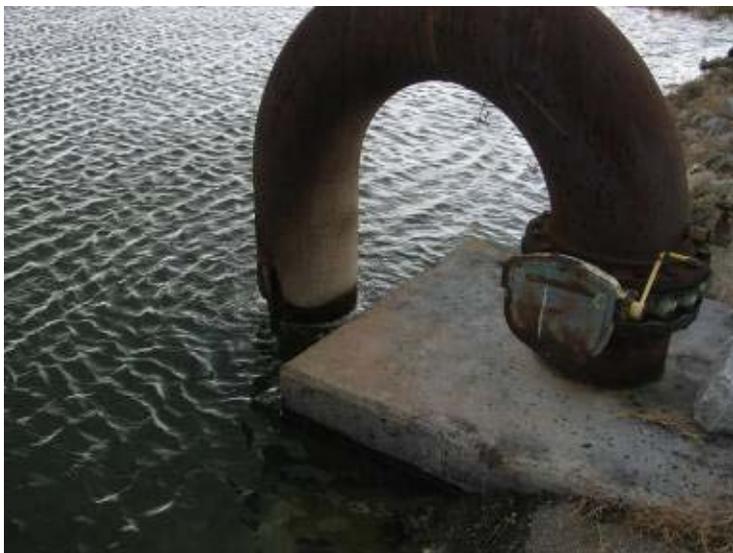
Photo 37: Ash Cell No. 1 – Metal inlet pipe (15-inch diameter) & submerged Splash pad, looking west.

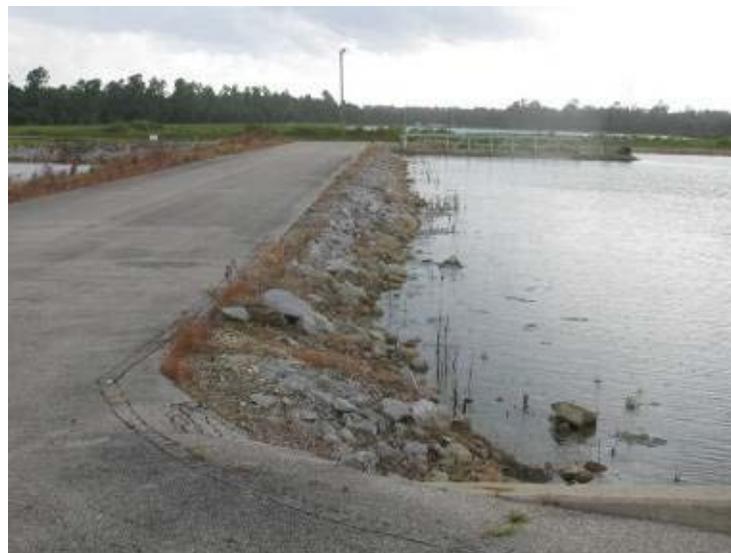
The interior slopes of the cells appear to be in fair condition with riprap armoring (Photographs 38, 42, 46 and 47) and sparse vegetative cover. The interior slopes appeared to have a slope of approximately 3H: 1V. Discontinuities and eroded areas (Photographs 28, 29, and 31) were observed along the interior slopes of the northwest embankment at Ash Cell #2.

Photo 38: Ash Cell No. 1 – Paved crest of southeast divider embankment interior slope between Ash Cell No. 1 and Pump Back Cell No. 1, looking southwest.

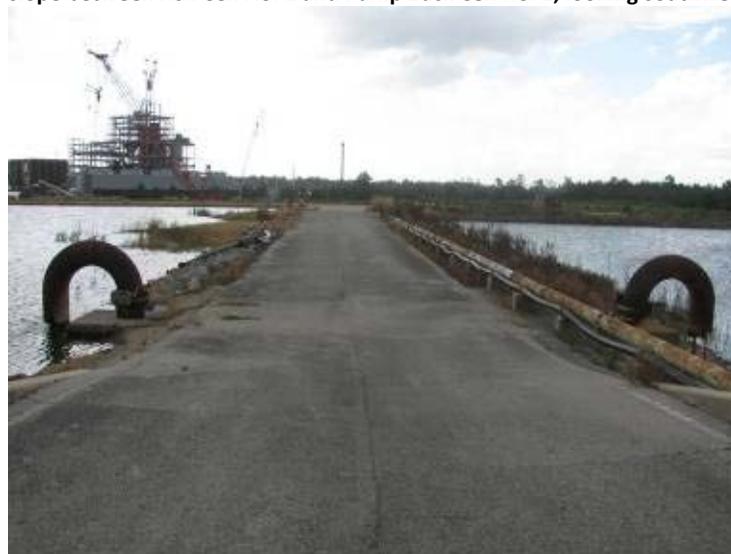
A concrete u-shaped channel structure and metal grates located on the northeast side of the divider embankment between Ash Cell #1 and Ash Cell #2 protect the inlet pipes that extend from the plant (Photographs 41 and 42). A small cave-in of the pavement behind Ash Cell #2 inlet pipe concrete structure (Photographs 34 and 35) was observed. A pump house and pump system is located near the east corner of the southeast embankment of Pump Back Cell #1 (Photographs 8 and 9). Inlet pipes are located at the divider embankment between Ash Cells #1 and #2 (Photographs 40 and 43).

Photo 40: Ash Cell No. 1 – Crest of divider embankment between Ash Cell No. 1 and Ash Cell No. 2, looking northwest.

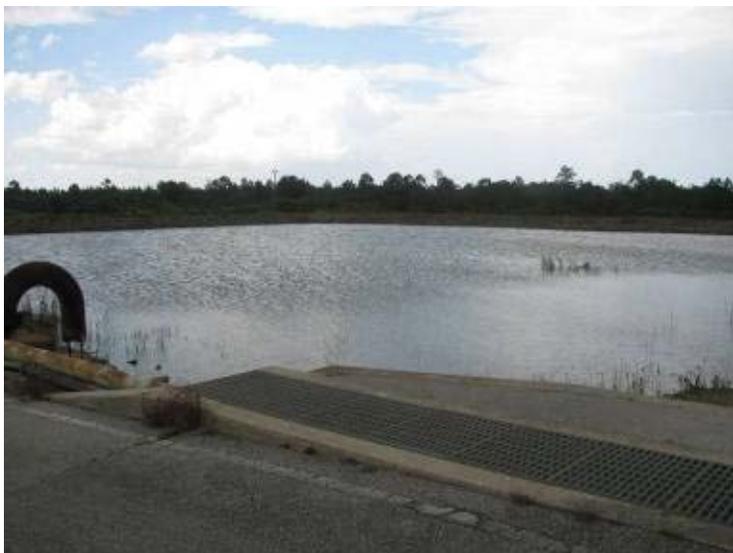
Photo 41: Ash Cell No. 2 – General view of pond looking north. Note concrete U-shaped channel and metal grate to protect sluice ash pipelines.

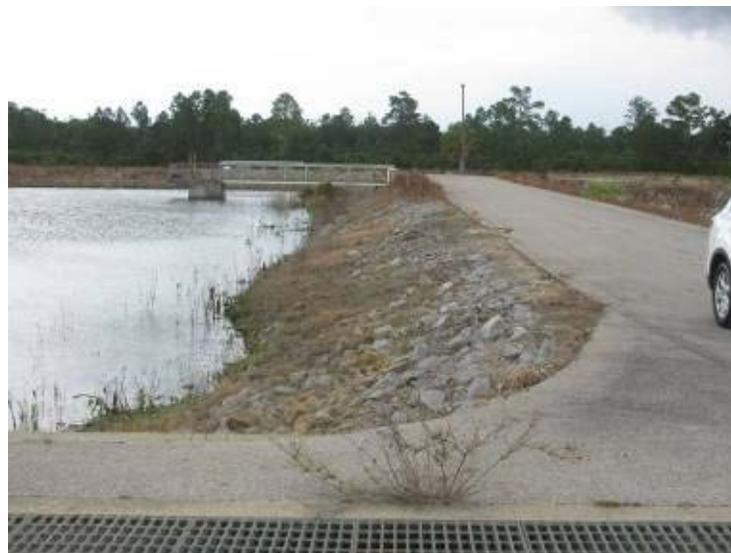
Photo 42: Ash Cell No. 2 - Paved crest and interior slope of southeast divider embankment, between Ash Cell No. 2 and Pump Back Cell No. 2, looking northeast.

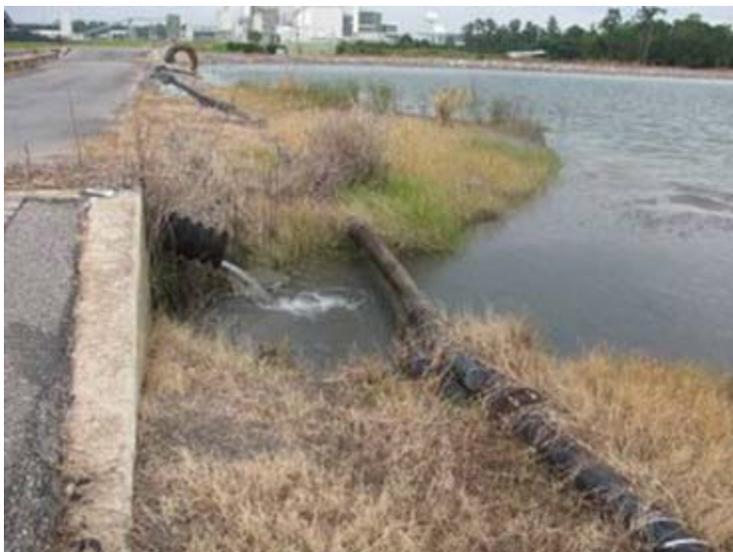
Photo 43: Ash Cell No. 1 – Inlet pipe and northeast divider embankment Interior slope, looking southeast. Note abandoned HDPE pipe.

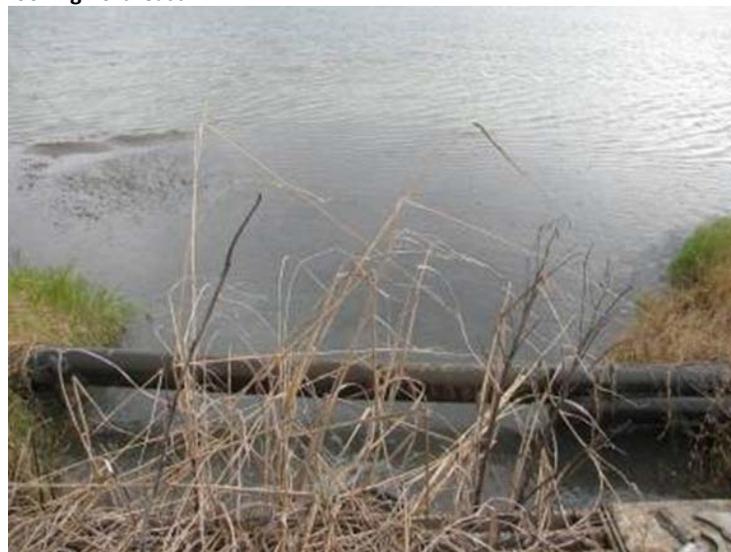
Photo 44: Ash Cell No. 1 – Ash delta, northeast divider embankment interior slope, looking southwest.

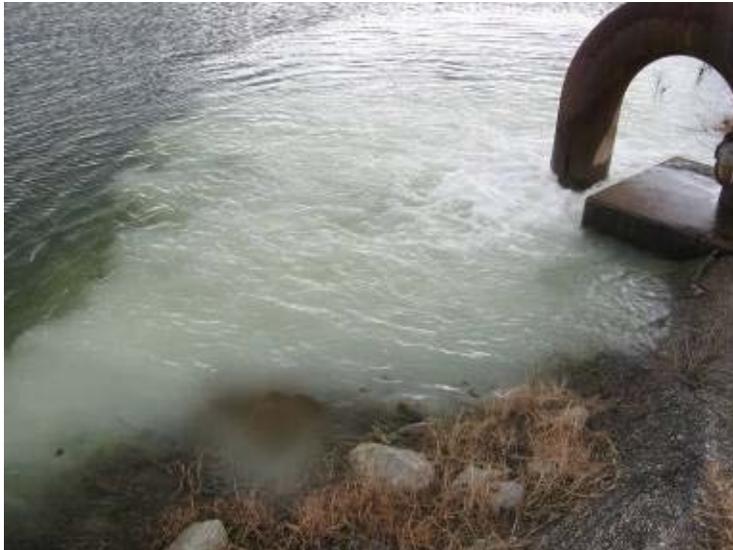
Photo 45: Ash Cell No. 1 – Inlet metal pipe (15-inch diameter), looking northwest. Note discharge water turbidity.

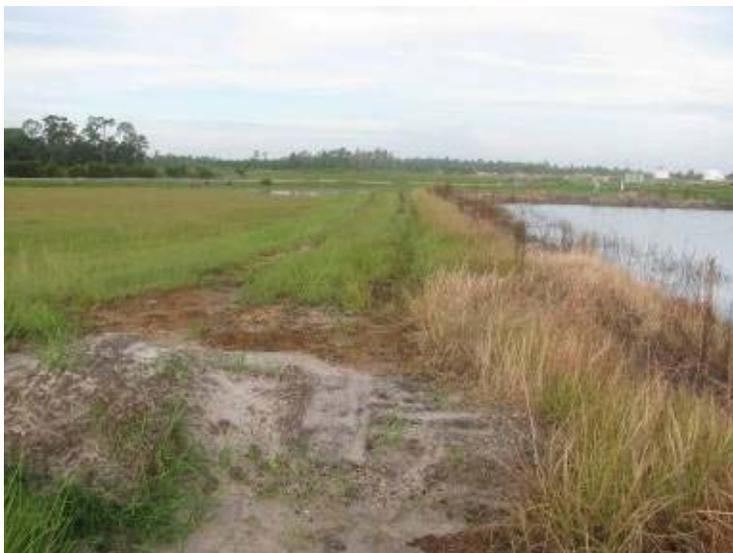
The Coal Stockpile Runoff Collection Pond receives all runoff collected in a swale located north of the coal stockpile and from ditches that extend along the east, south and west sides of the coal stockpile (Photographs 50, 53 and 55). The crest of the perimeter embankments appears to be in fair condition, and they are grass covered with some tire ruts (Photographs 49, 56, 57, 63 and 64).

Photo 49: Coal Stockpile Runoff Collection Pond – Crest of south embankment, looking west.

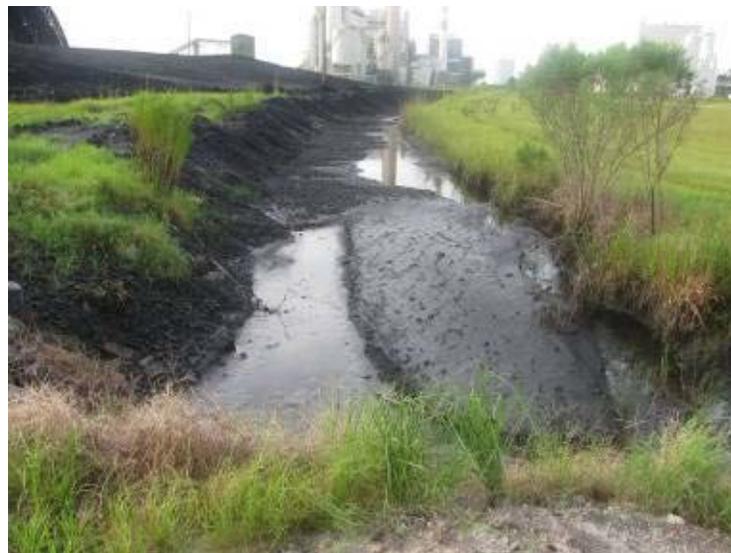
Photo 50: Coal Stockpile Runoff Collection Pond – Runoff ditch west of coal stockpile near southeast corner of pond, looking south.

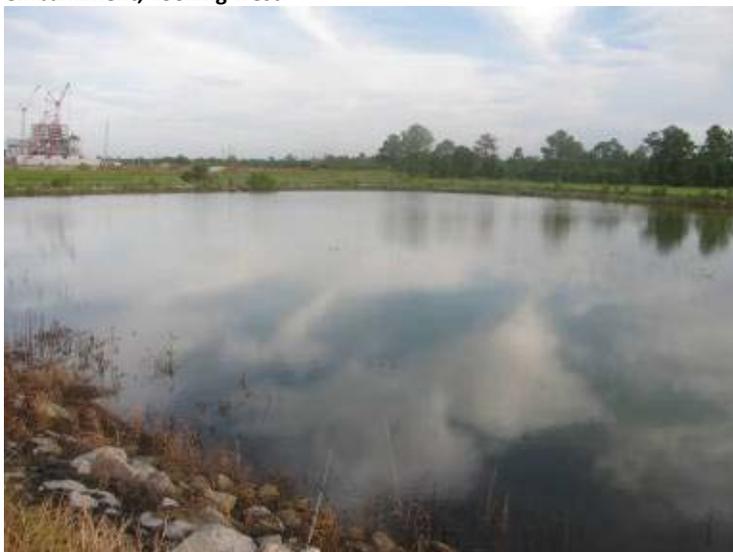
The interior slopes are riprap armored and appear to have 3H:1V slopes (Photograph 51 and 52). A pump station is located near the southwest corner of the impoundment (Photograph 58).

Photo 51: Coal Stockpile Runoff Collection Pond – General view of surface looking northwest.

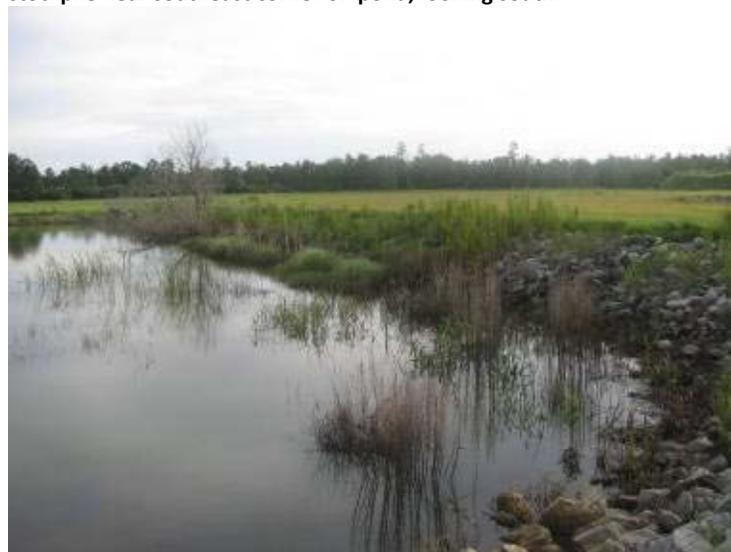
Photo 52: Coal Stockpile Runoff Collection Pond – East embankment interior slope, looking northeast.

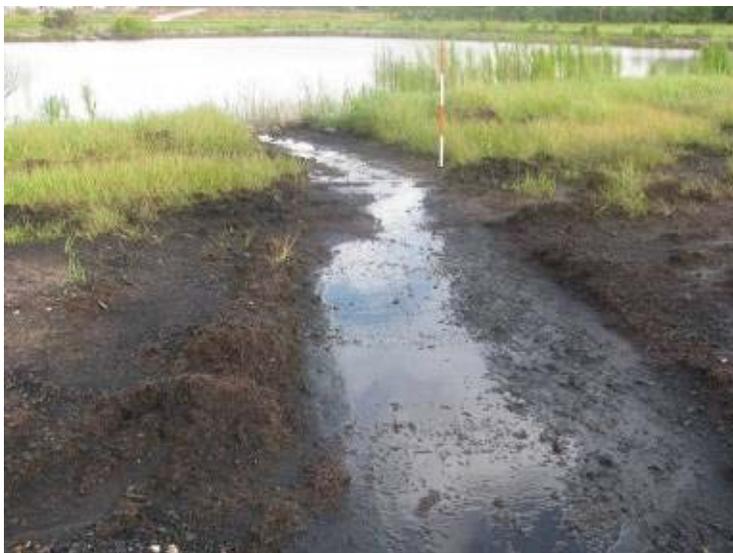
Photo 53: Coal Stockpile Runoff Collection Pond – East embankment runoff swale, looking west.

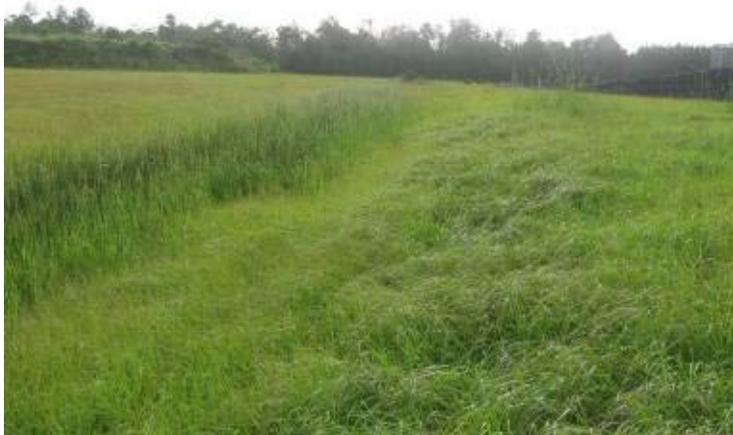
Photo 55: Coal Stockpile Collection Pond – Runoff swale north of coal stockpile, looking east.

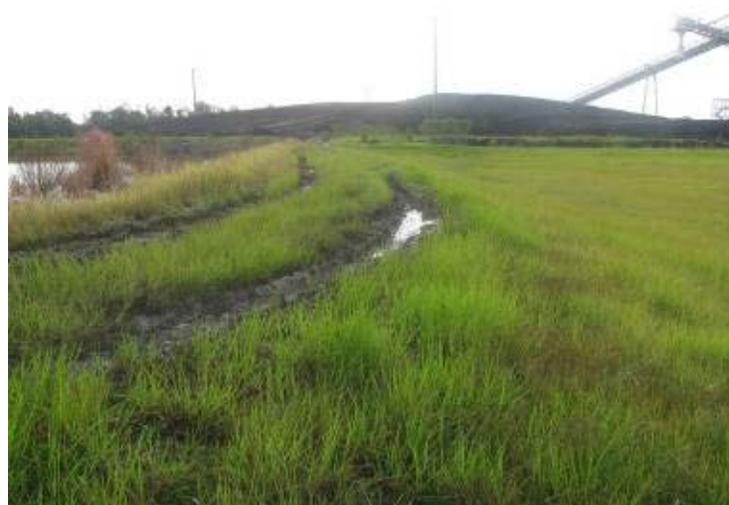
Photo 56: Coal Stockpile Runoff Collection Pond – Crest and exterior slope of south embankment, looking east.

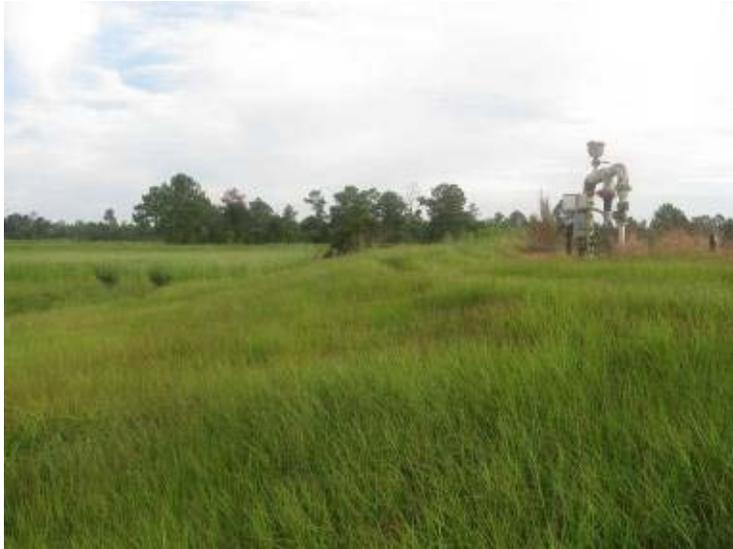
Photo 57: Coal Stockpile Runoff Collection Pond – Crest and exterior slope of west embankment, looking north.

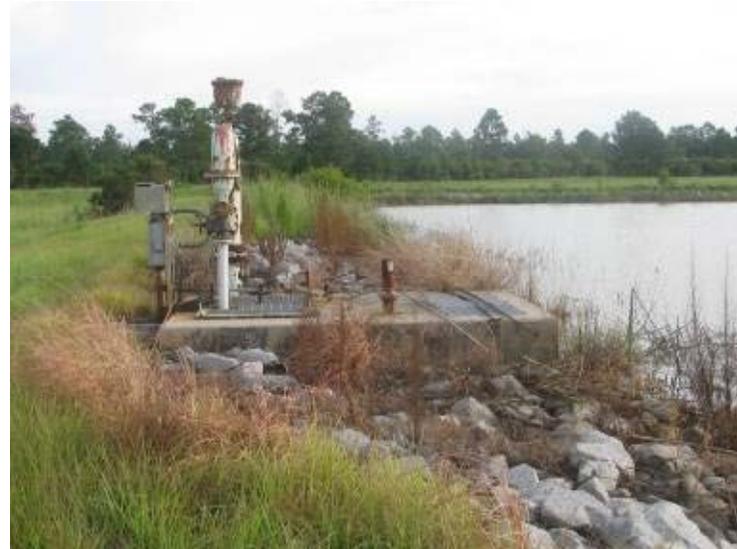
Photo 58: Coal Stockpile Runoff Collection Pond – West embankment interior slope, pump station located at southwest corner looking north.

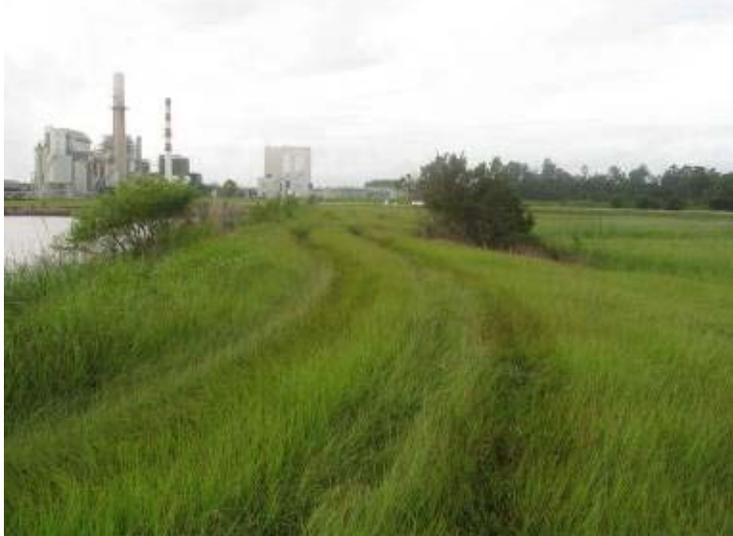
Photo 63: Coal Stockpile Runoff Collection Pond – Crest of west embankment, looking south.

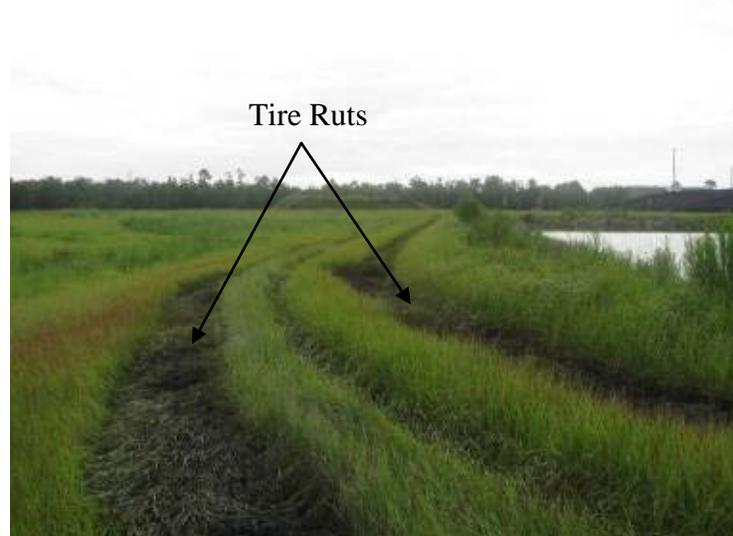
Photo 64: Coal Stockpile Runoff Collection Pond – Crest of north embankment, looking east. Note tire ruts.

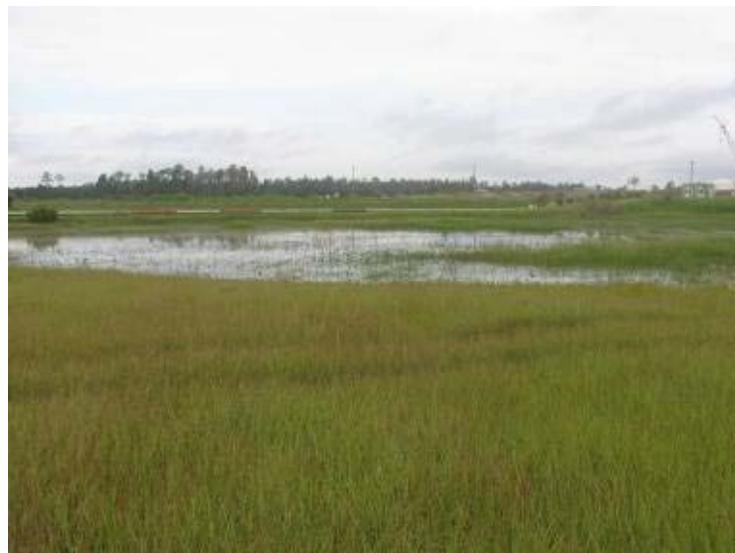
Surrounding areas to the west and southwest of the Coal Stockpile Runoff Collection Pond had relatively low and standing water (Photograph 66).

Photo 66: Coal Stockpile Runoff Collection Pond – General view of standing water in surrounding low areas to the west and southwest of pond, looking west.

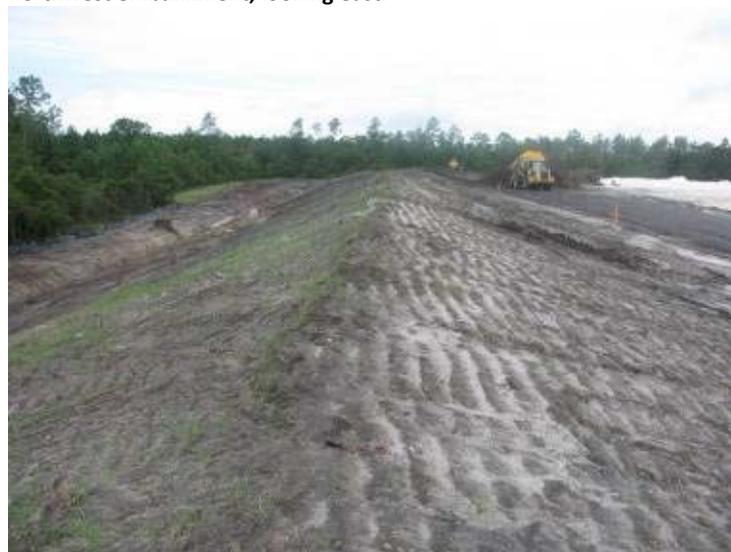
The Ash Dry Stack Landfill Area, located west of the Process Water Ponds, receives the ash produced by the Deerhaven Plant operations. At the time of the assessment the Ash Dry Stack Landfill Area was undergoing improvements. Based on visual observations, the landfill area appears to be in fair condition. The south embankment of the landfill appears to have a 4H:1V slope (Photograph 72). Small ash stockpiles were observed within the landfill area (Photographs 73 to 74).

Photo 72: Ash Dry Stack Landfill Area – Crest of south embankment showing landfill area currently under construction, looking west.

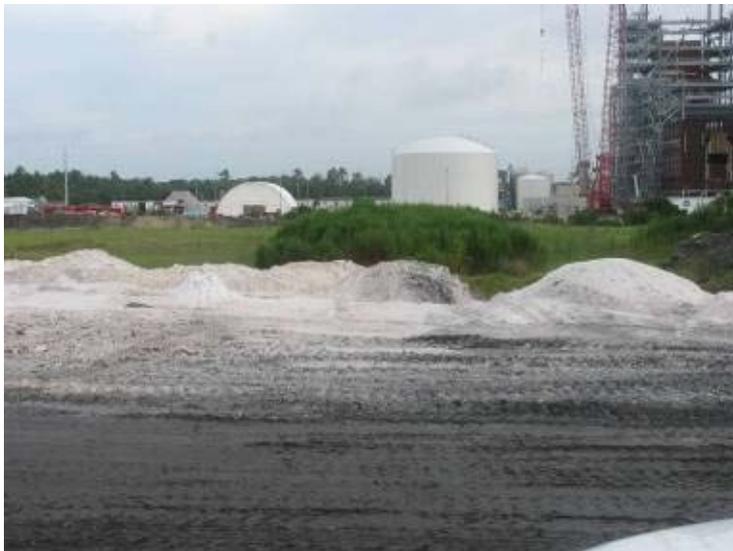
Photo 73: Ash Dry Stack Landfill Area – General view of landfill area currently under construction, looking north.

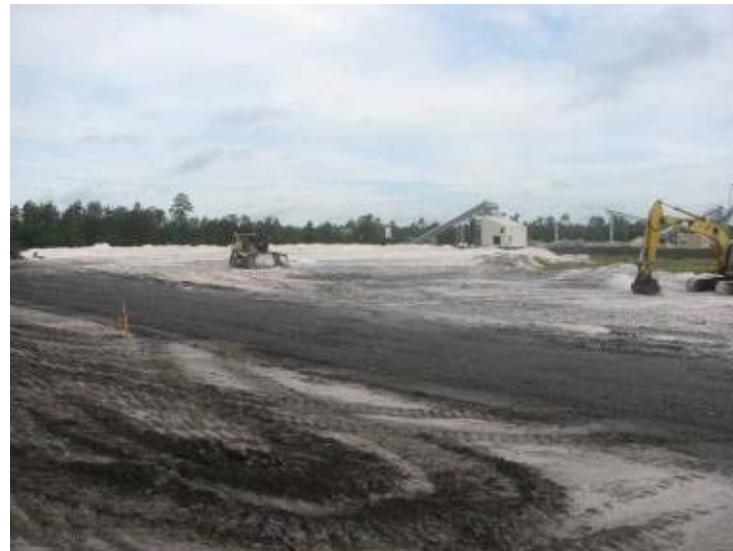
Photo 74: Ash Dry Stack Landfill Area – General view of landfill area currently under construction, looking northwest.

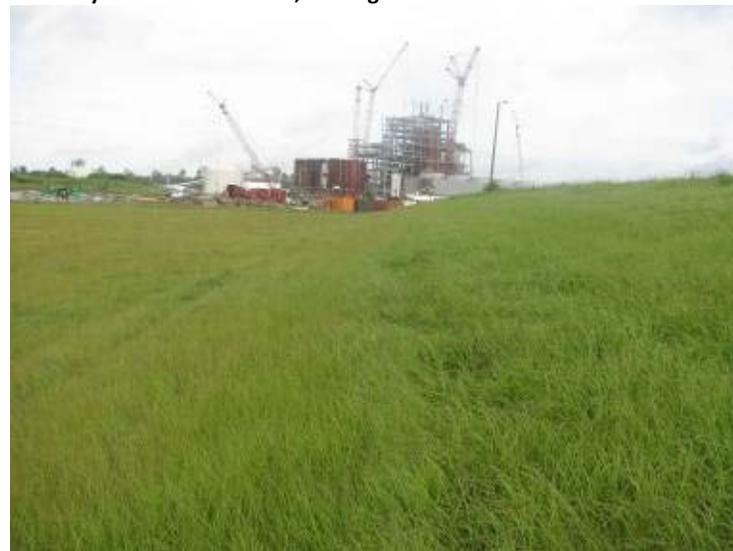
Photo 76: Ash Cell No. 1 – Southwest embankment exterior slope, looking northwest.

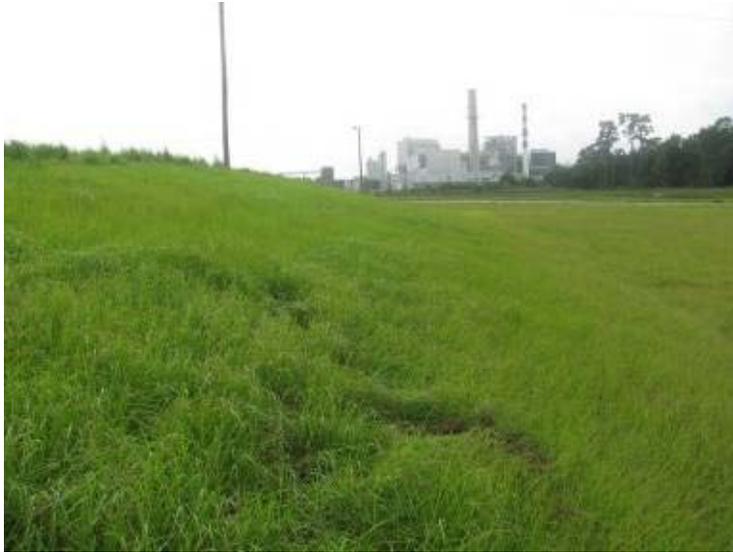
Photo 77: Ash Cell No. 1 – Southwest embankment exterior slope, looking southeast.

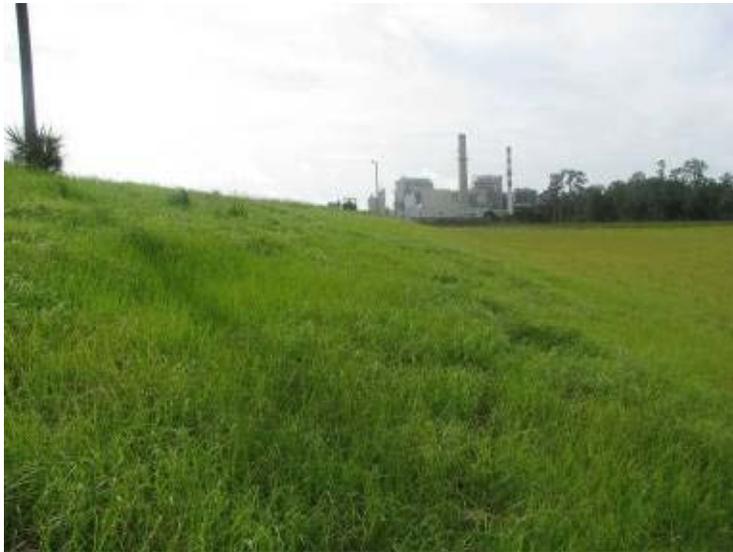
Photo 79: Ash Cell No. 1 – Southwest embankment exterior slope, looking southeast.

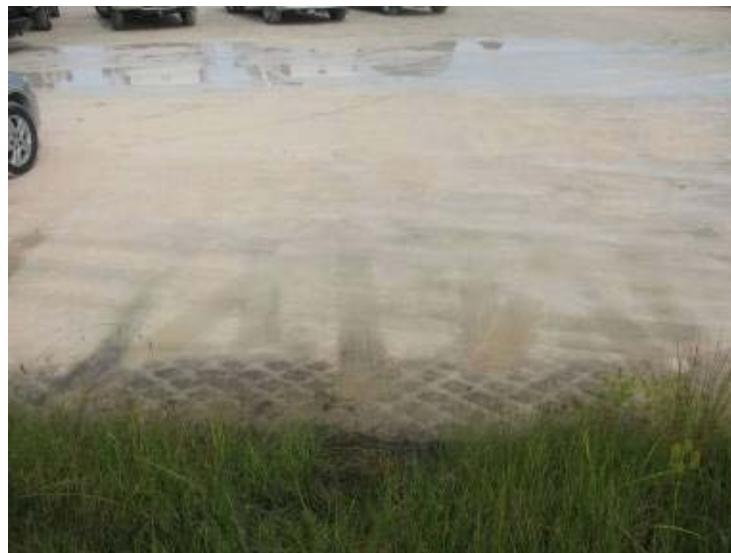
Photo 82: Ash Cell No. 1 – Northwest embankment exterior slope, ponded water and saturation along toe of slope, looking northwest.

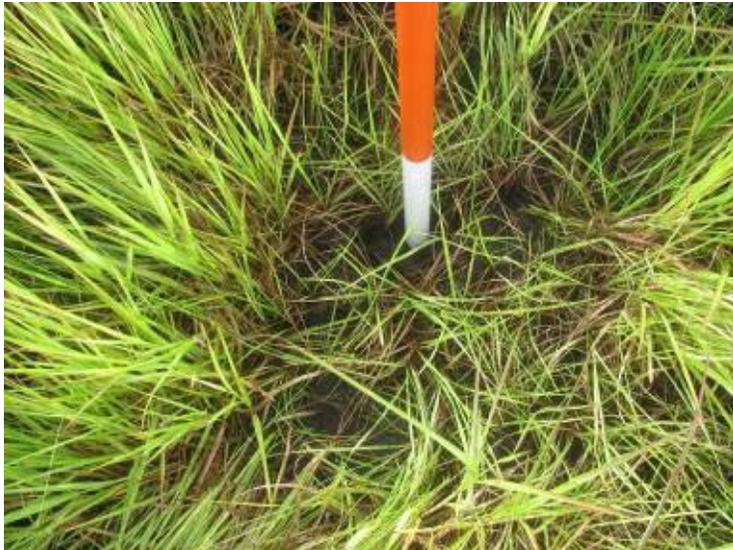
Photo 85: Ash Cell No. 2 – Northwest embankment exterior slope, saturated area along toe of slope, looking southeast.

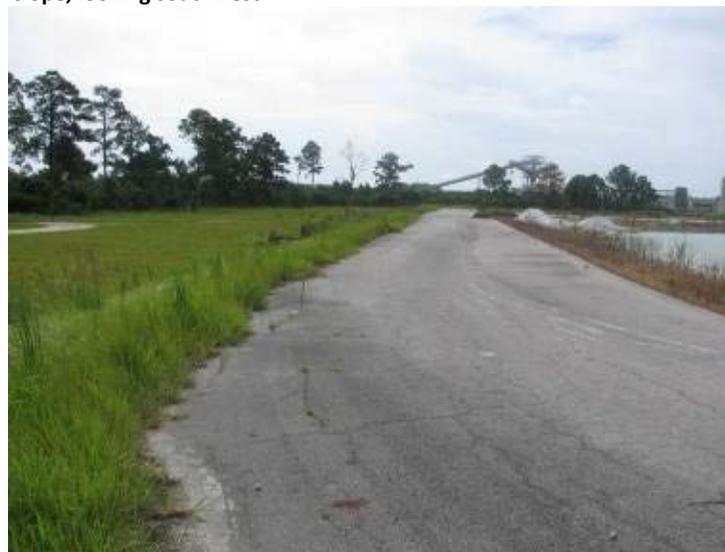
Photo 92: Lime Sludge Pond No. 1 – Paved crest of northeast embankment, looking southeast.

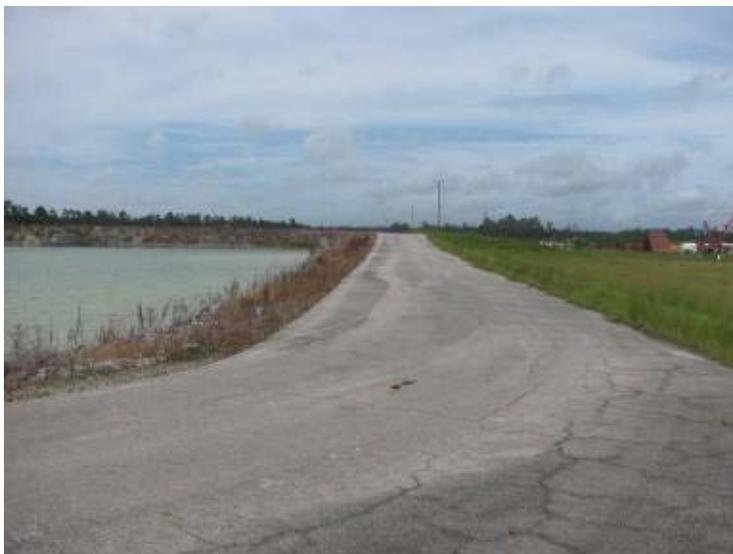
Photo 93: Lime Sludge Cell No. 1 – Paved crest of northwest embankment, looking southwest.

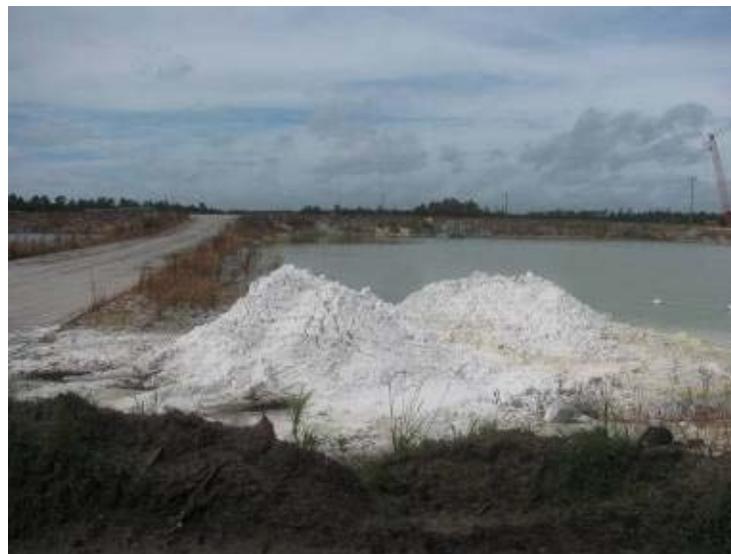
Photo 94: Lime Sludge Pond No. 1 – Southeast divider embankment interior slope, view of dry lime sludge piles and pond surface, looking southwest.

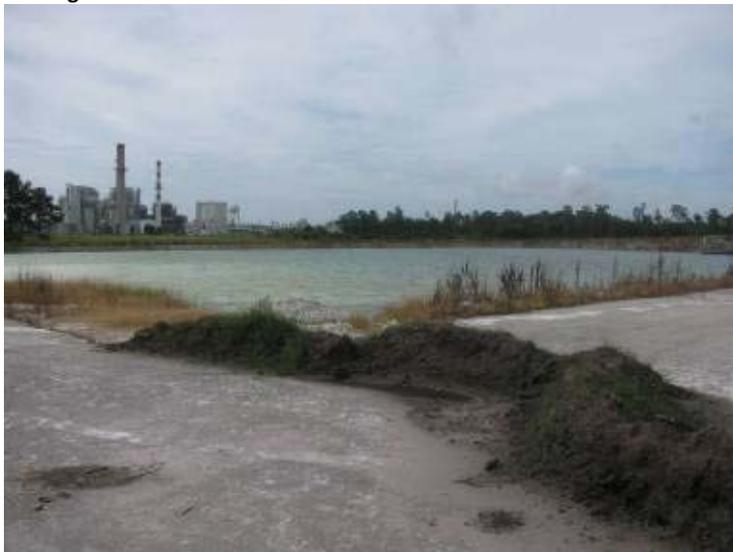
Photo 95: Lime Sludge Pond No. 2 – General view of pond, looking south.

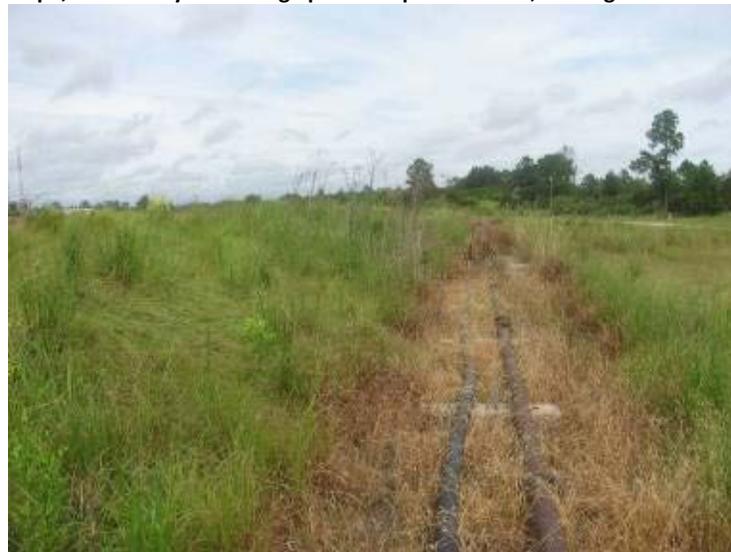
Photo 96: Lime Sludge Pond No. 2 – Northeast embankment exterior slope, looking northwest. Note lime sludge pipes on ground.

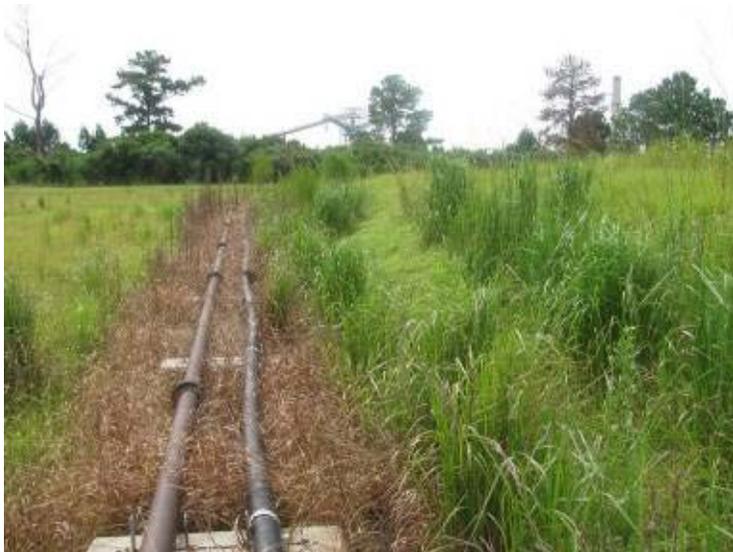
Photo 97: Lime Sludge Pond No. 2 – Northeast embankment exterior slope, looking southeast. Note lime sludge pipes.

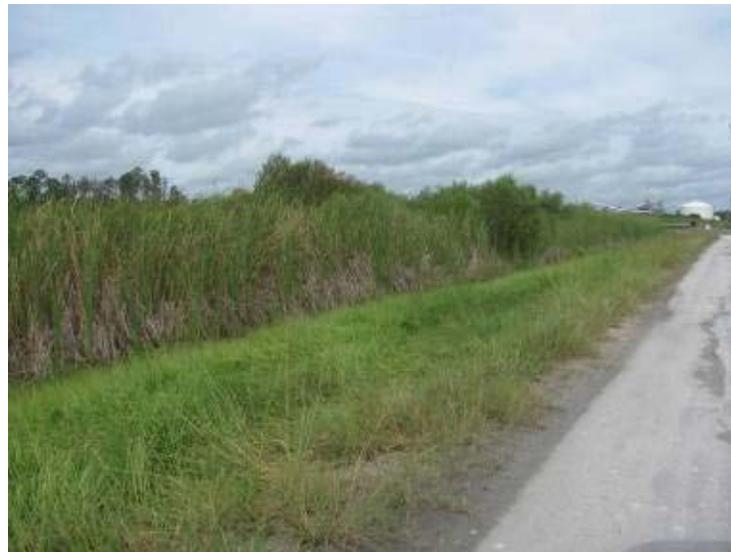
Photo 98: Stormwater Pond – Northeast embankment interior slope, looking west. Note areas of dense vegetation (i.e. – cattails).
