# Assessment of Dam Safety

## Coal Combustion Surface Impoundments (Task 3)

Dayton Power &  
Light Company

JM Stuart Station

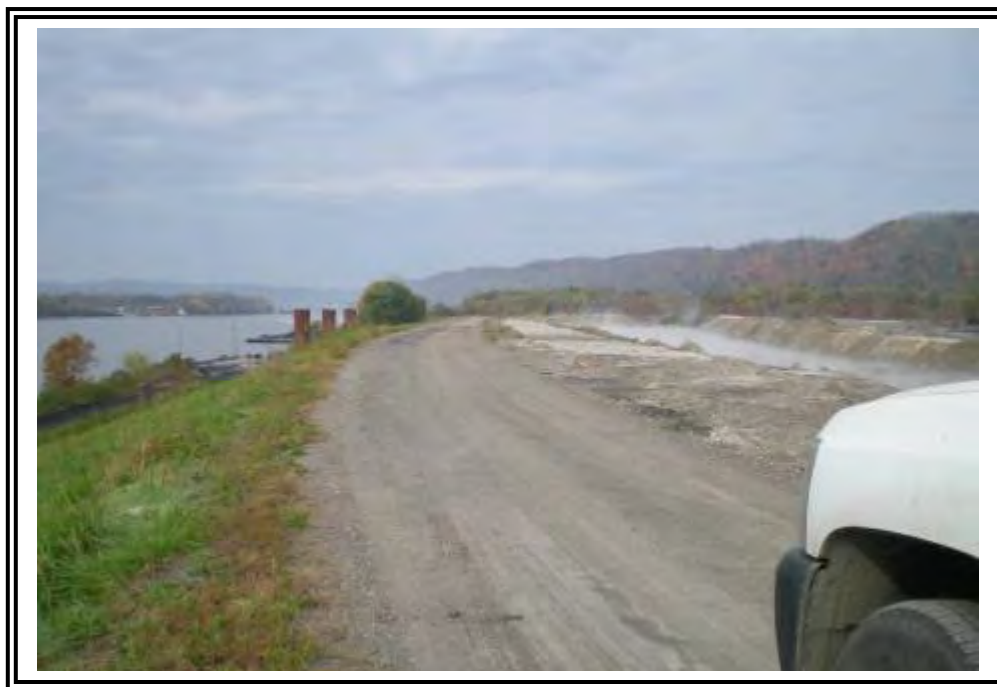
1

Looking west along the south dike of pond 5. The Ohio river can be seen on left of photo.

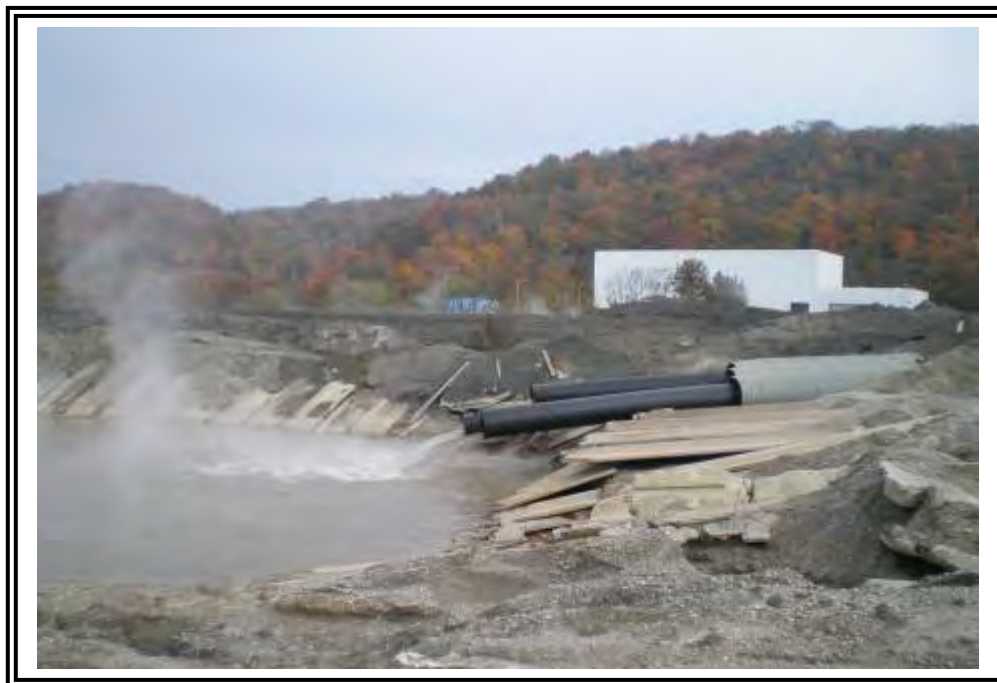
Sluice lines enter the pond at the east end which is mostly filled with bottom ash and the water runs through ditches cut into the bottom ash into the west end of the pond. Photo 2 shows boards that have been placed on the upstream side of the dike at the sluice lines to assist with erosion control. The average observed height from the embankment crest to the water level in the pond (the freeboard) was visually estimated to be approximately 4 to 6 feet. The upstream slopes of the west end are covered with vegetation on the south side and are partially armored with riprap on the north side (Photos 7, 8, 9, 17, 23 and 24). In general, the dikes do not show signs of changes in their horizontal alignments from the proposed alignments. The crest width of the north and south dikes of the Pond 5 embankment were measured to be approximately 23 and 12 feet, respectively.

Looking north at the sluice lines coming into the pond.

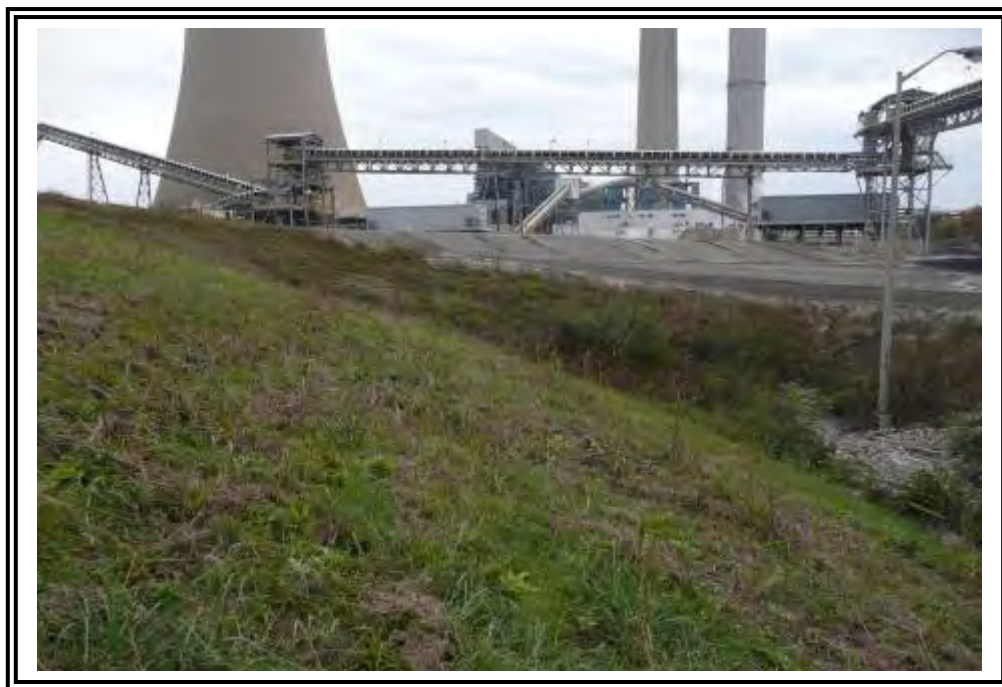
3

Looking east at the start of the south dike with the plant in the background.

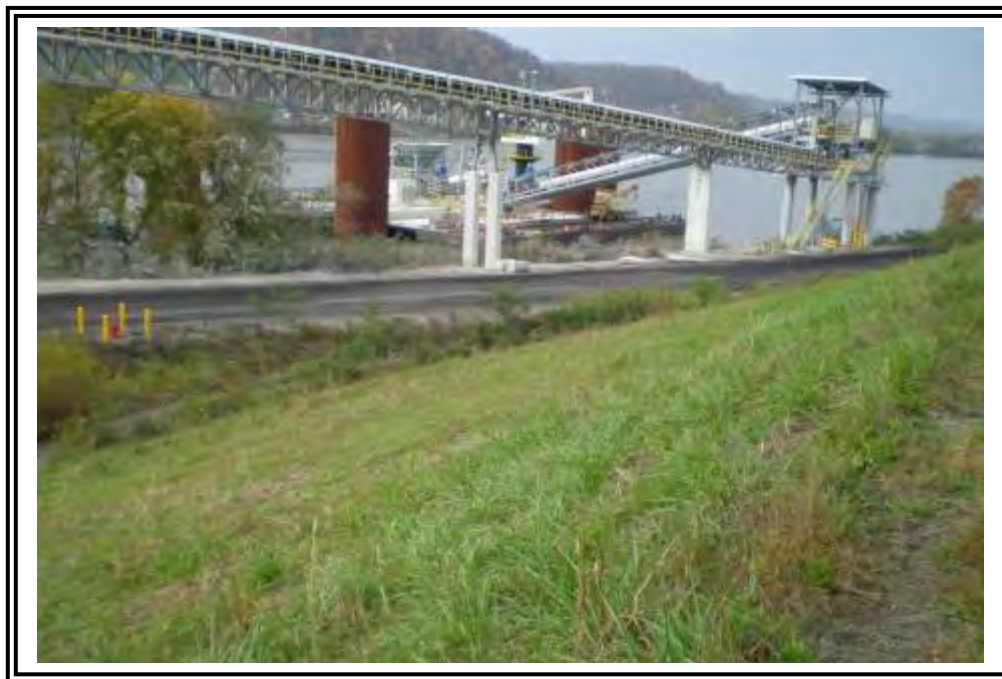
4

Looking southwest at the downstream slope with the Ohio river and off loading area in the background.

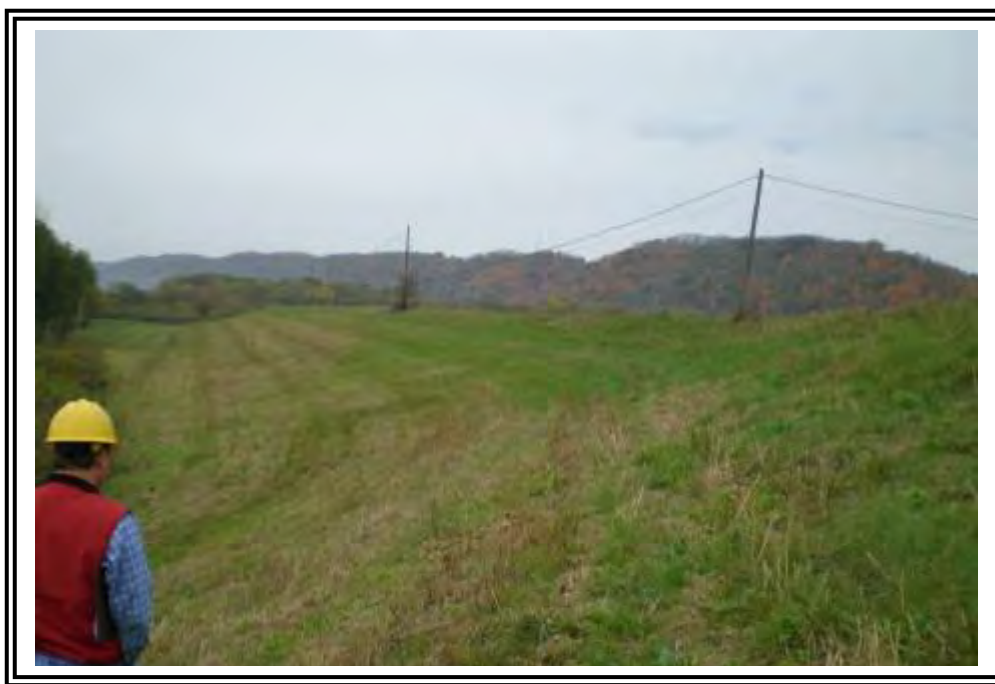
In general, the south dike (Photo 6) and the north dike (Photos 20 and 21) appeared to be maintained and mowed. However, seepage initiated slope softening and subsequent mowing induced rutting and slope deformation was observed on the downstream slopes of the dikes in at least four locations. One such area measured approximately 326 feet long approximately 52 feet from the toe with 6 to 12 inches of standing water (Photos 15 and 16). These areas often had heavier vegetation, scrub brush, and small trees established where routine tractor mounted mowing had not occurred for a fairly long period of time as a consequence of the softened slope conditions (Photos 11 and 12). In most cases however, these areas were generally covered with heavier grass and other weedy vegetation (Photos 10, 19 and 22)

Looking west along the downstream slope of the south dike.

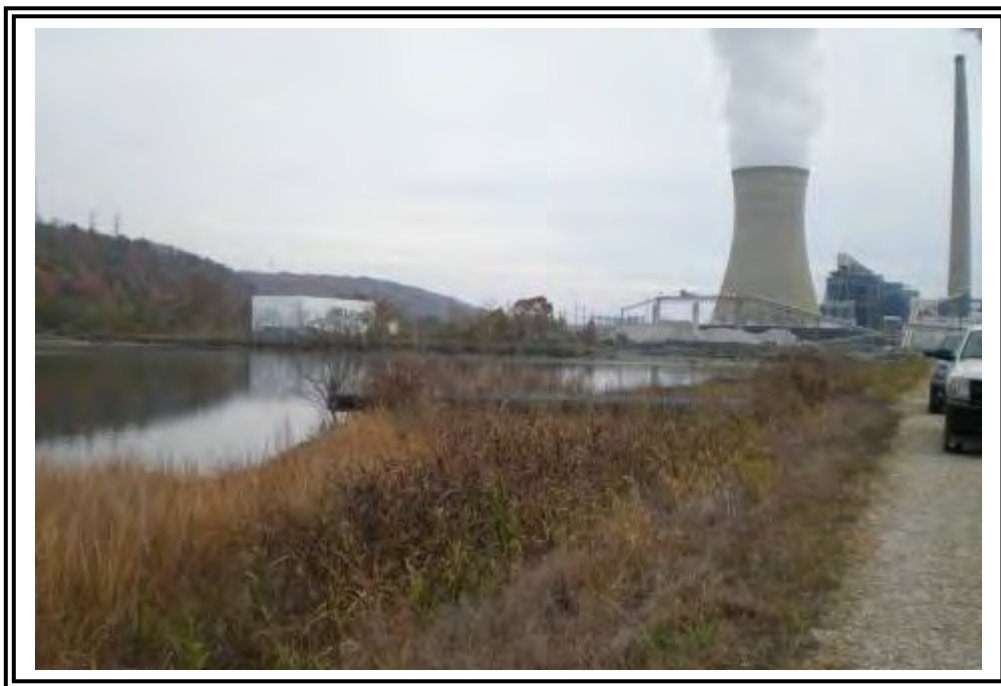
7

Looking east along upstream side of the south dike.

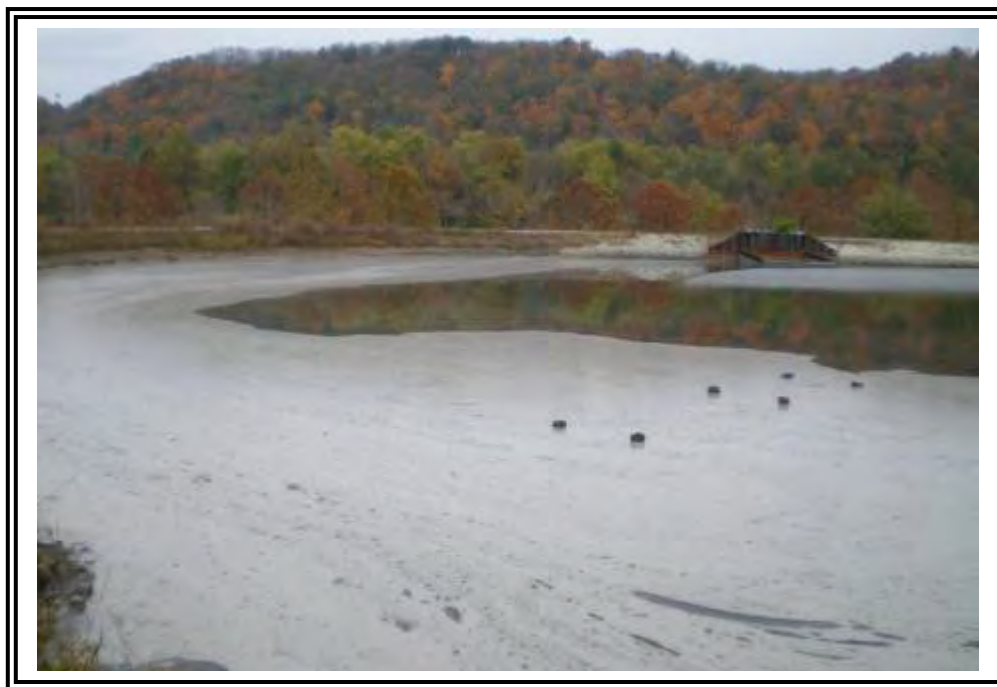
9

Near the west end of the pond an outlet structure was observed (Photos 8 and 9). It appeared to be a concrete drop inlet intake structure with metal sheeting and a skimmer to keep debris from fouling the structure. The outlet structure appeared to be operating properly. The observed location of the outlet structure differs from the location shown on the 1968 drawing.

Looking north across the west end of pond 5.

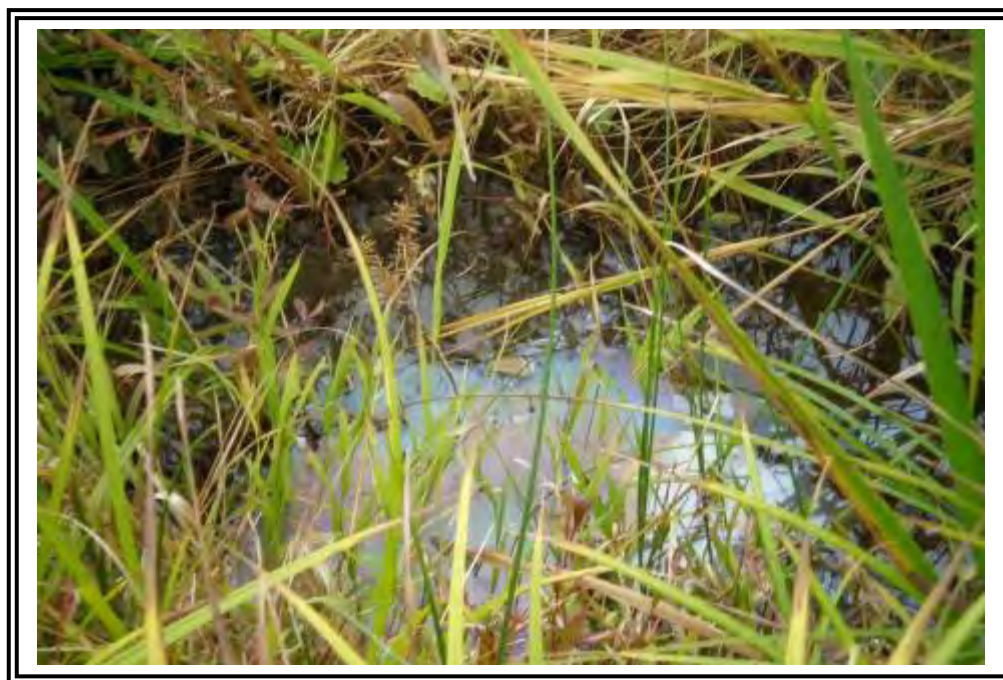
16

A close up of a larger seep with a sheen on the surface.

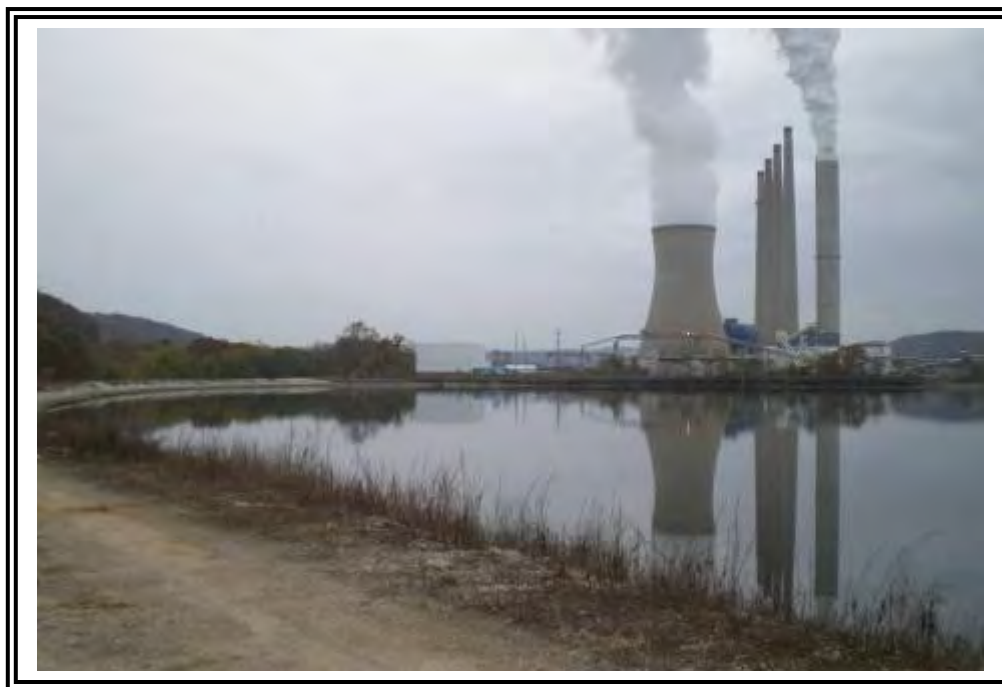
17

Looking east across the pond at part of the crest and upstream slope which is lined with riprap.

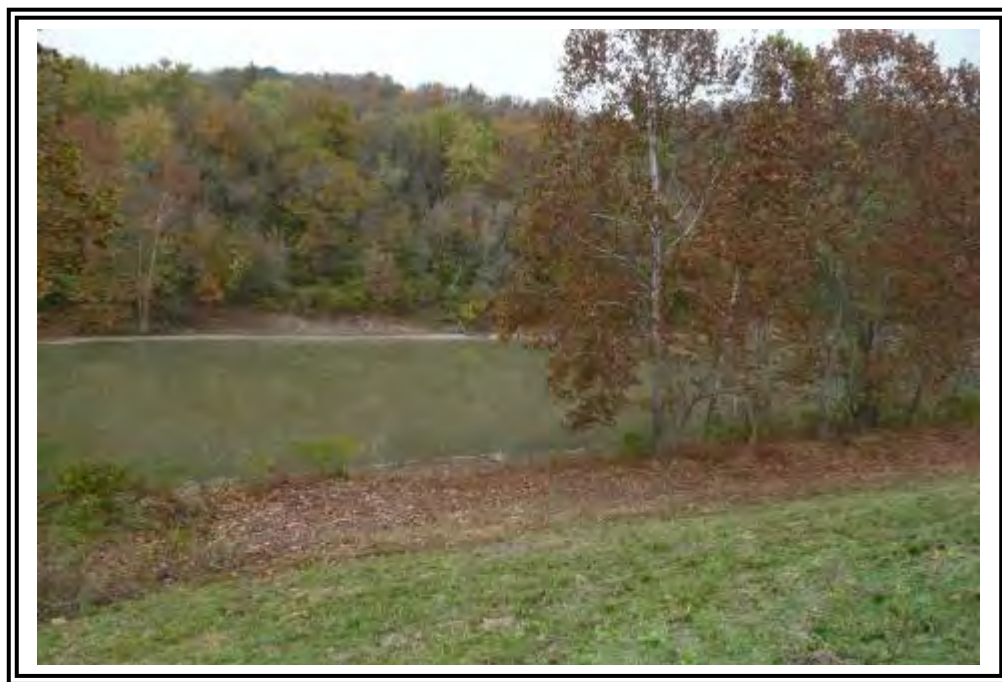
18

Looking north at toe of the northern dike with the creek in the background .

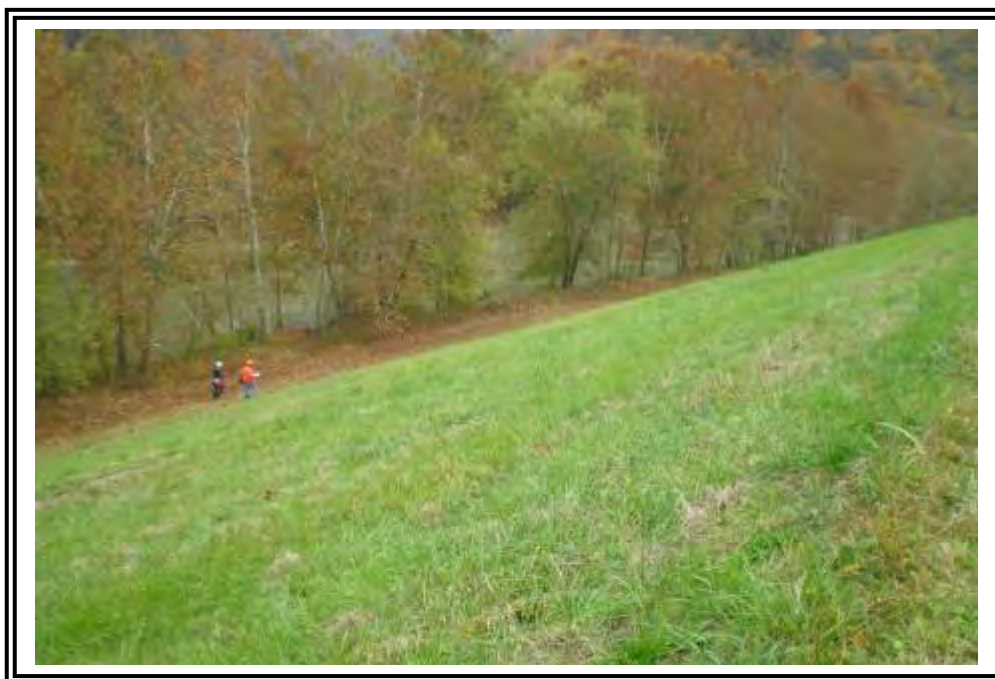
20

Looking northeast along the downstream slope of the northern dike.

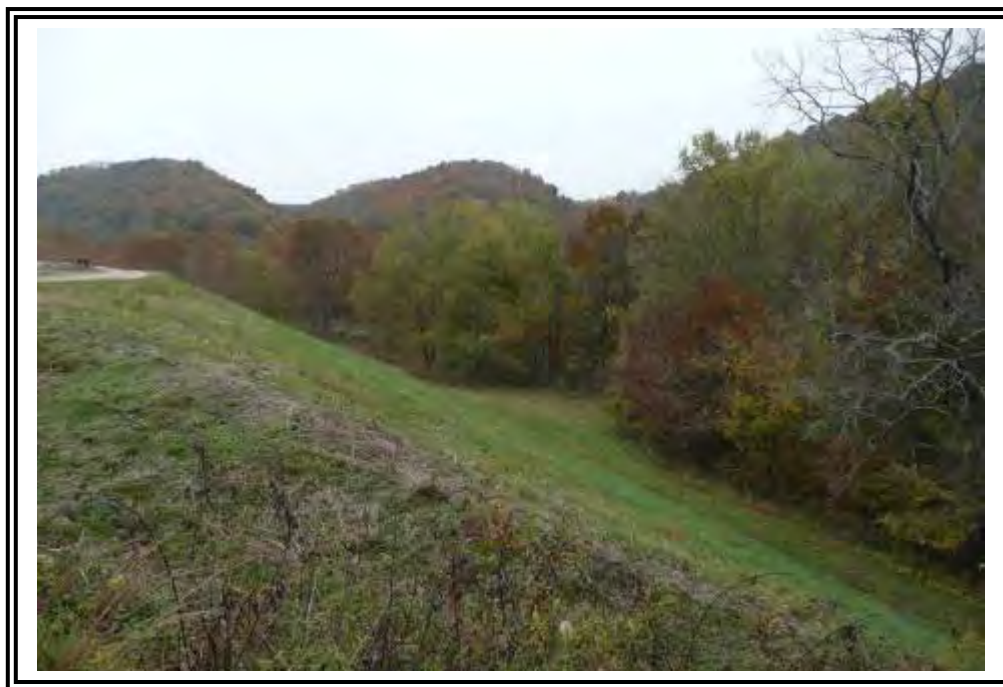
21

Looking west along downstream slope of the northern dike back toward the west end of the pond.

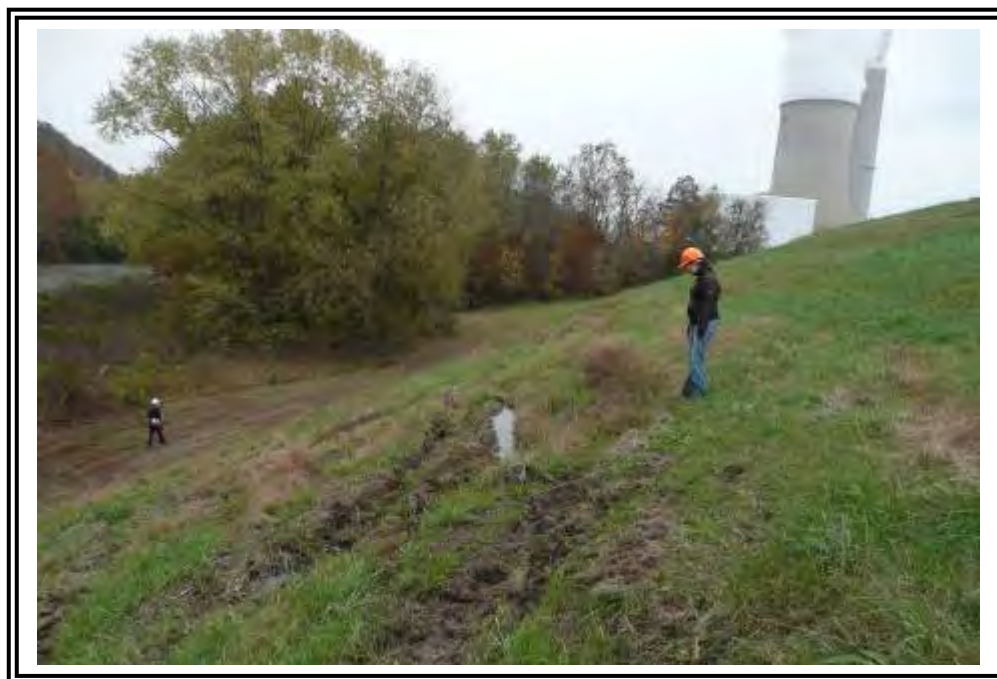
22

Looking east at the downstream slope of the northern dike near the middle of the pond where some seepage, subsequent softening, and slope deformation due to rutting has occurred.

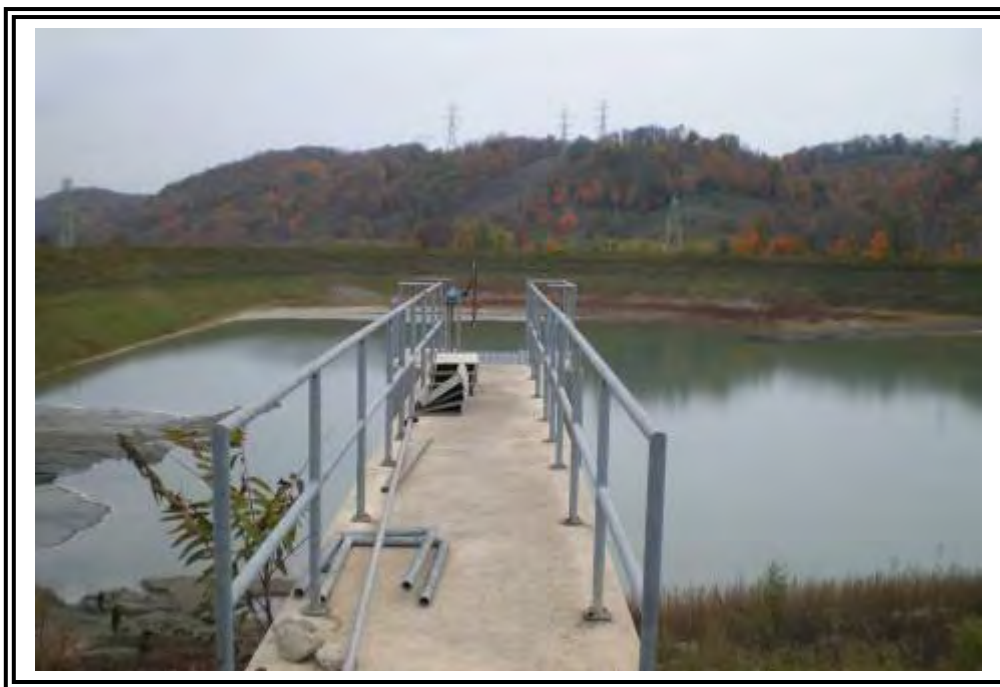
25

Looking northwest from the top of the outfall structure across the west end of pond 10.

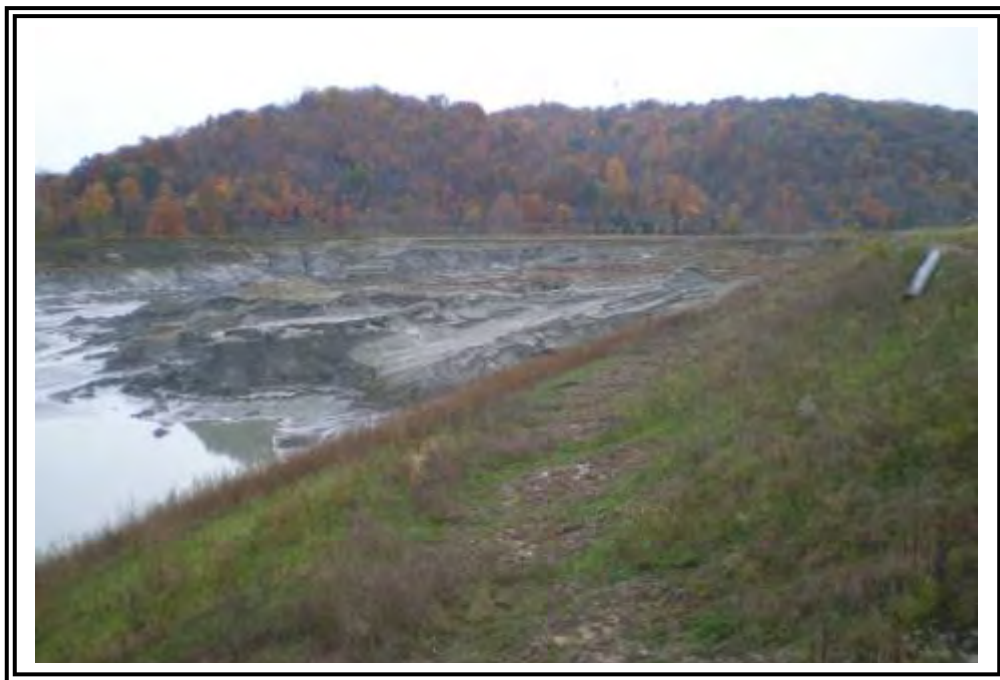
26

Looking northwest across the northern end of the pond and along the upstream slope of the eastern dike.

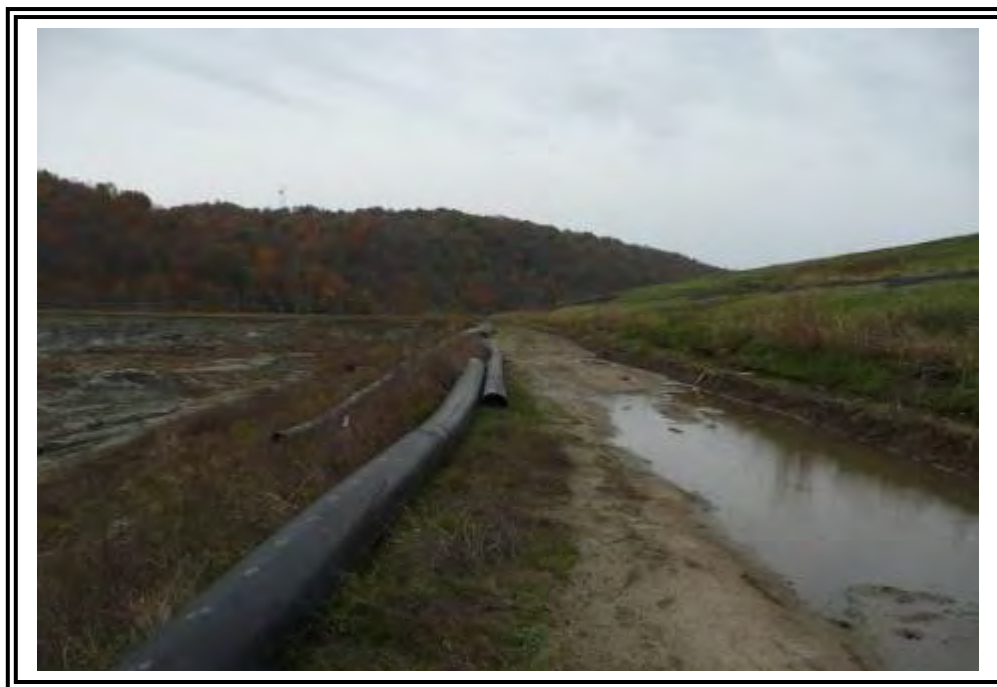
27

Looking northeast along the crest of the eastern dike. Landfill #11 is off the right of the photo

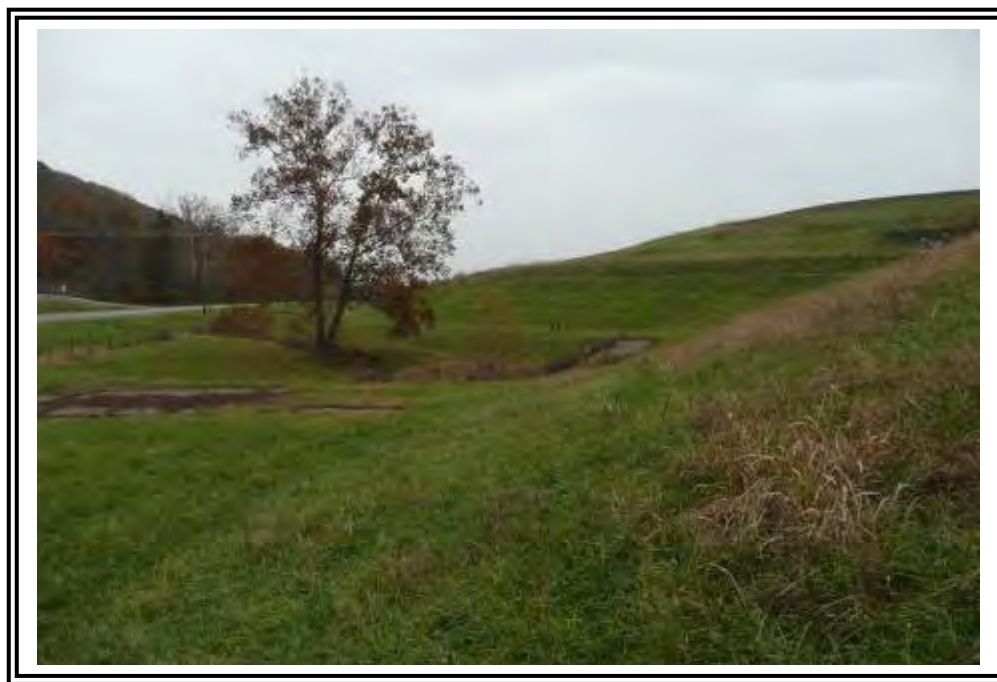
28

Looking east at the toe of the northern tip of pond ten with landfill 11 in the background.

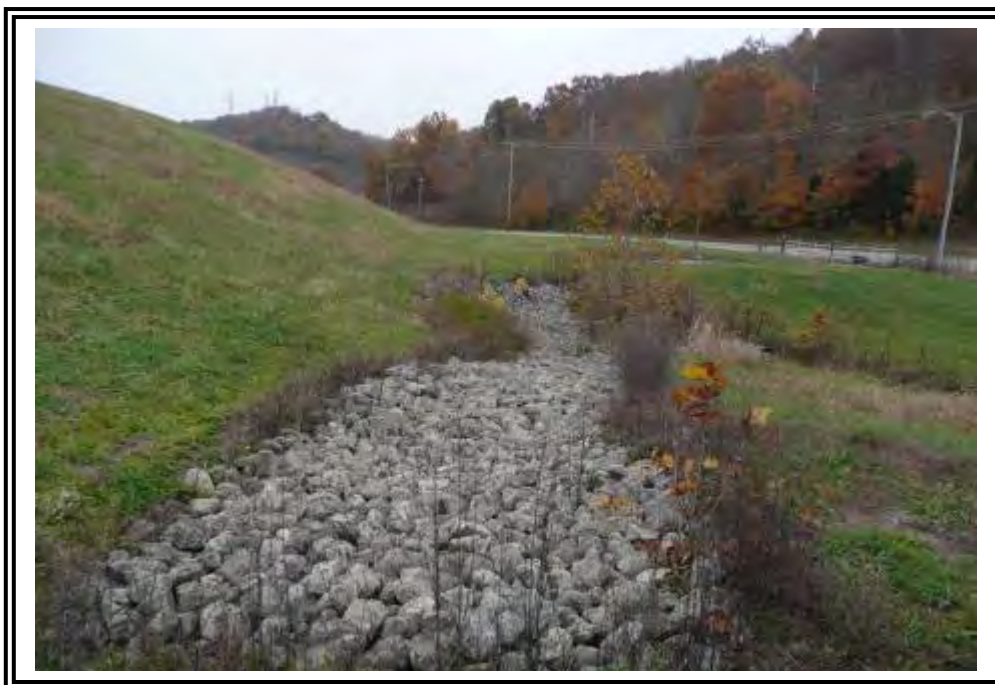
29

Looking northwest along the riprap drainage swale at the north tip of the pond

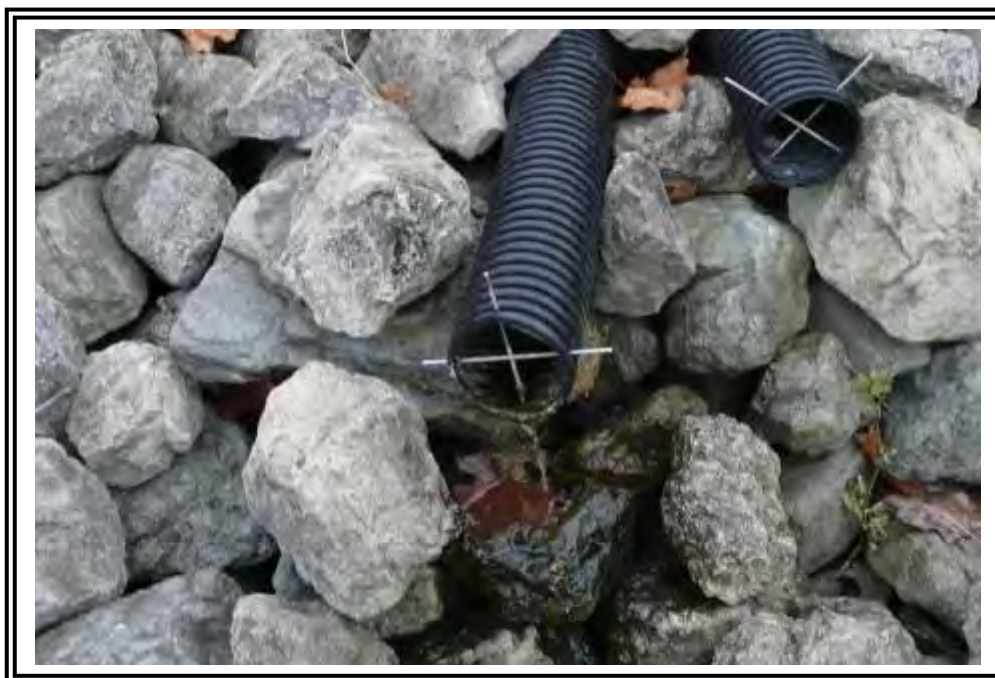
30

Close up of the drainage pipes that empty into the riprap drainage swale.

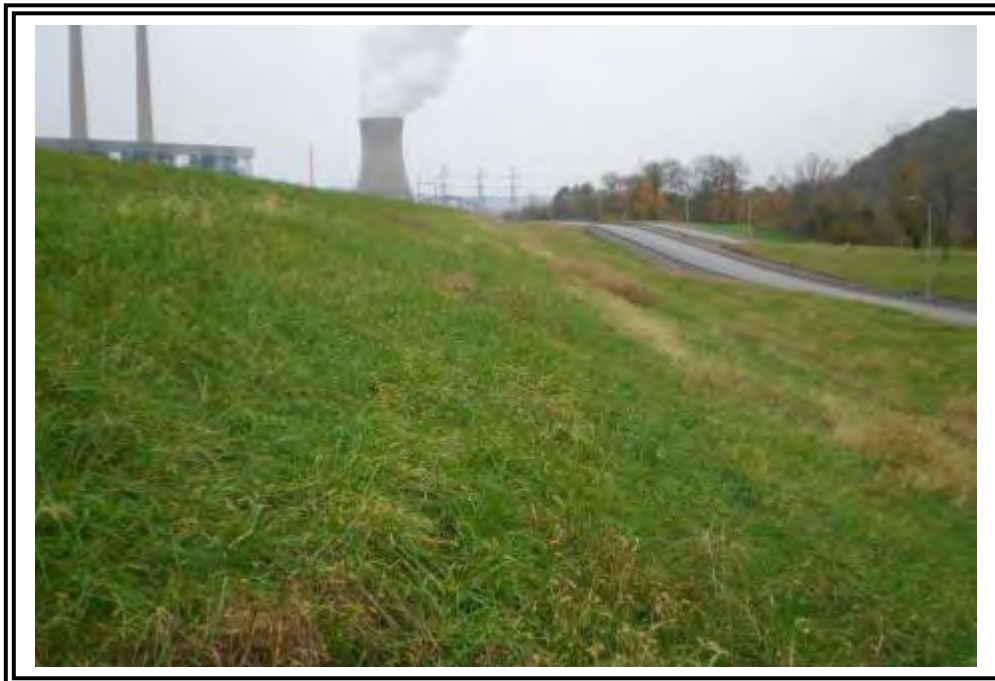
31

Looking southwest along the downstream slope of the northern dike.

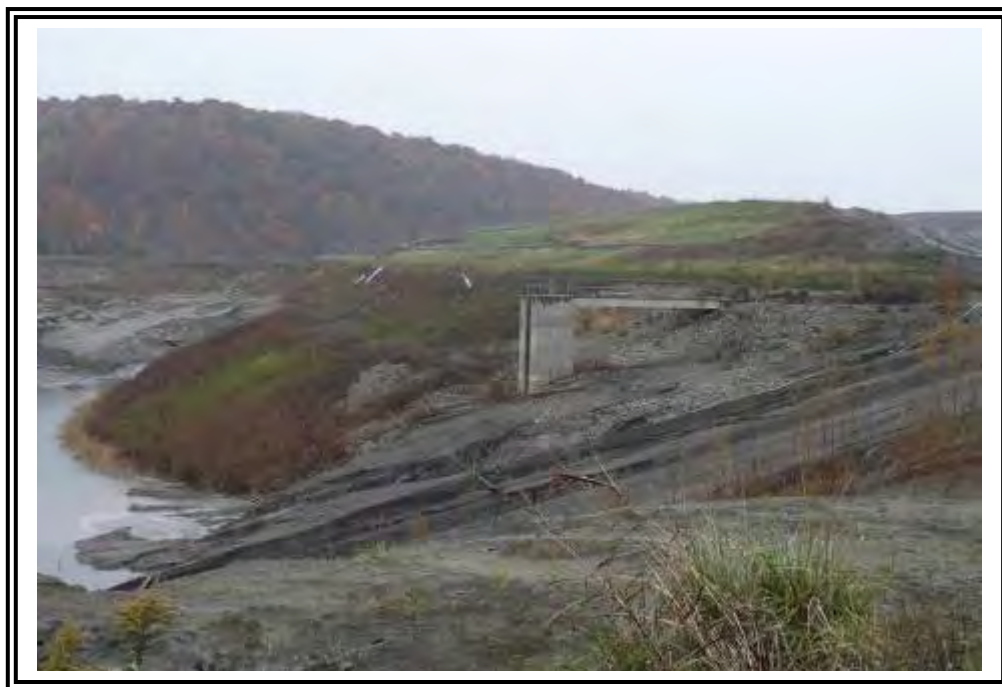
33

Looking north across pond back toward the outfall structure and truck ramp.

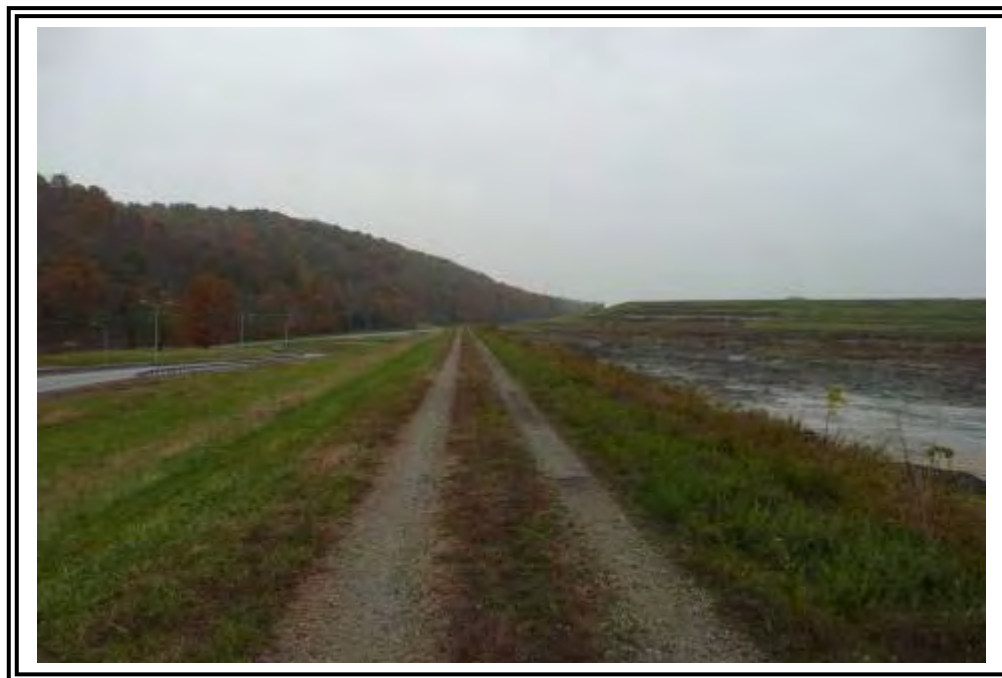
34

Looking northeast along the crest of the northern dike.

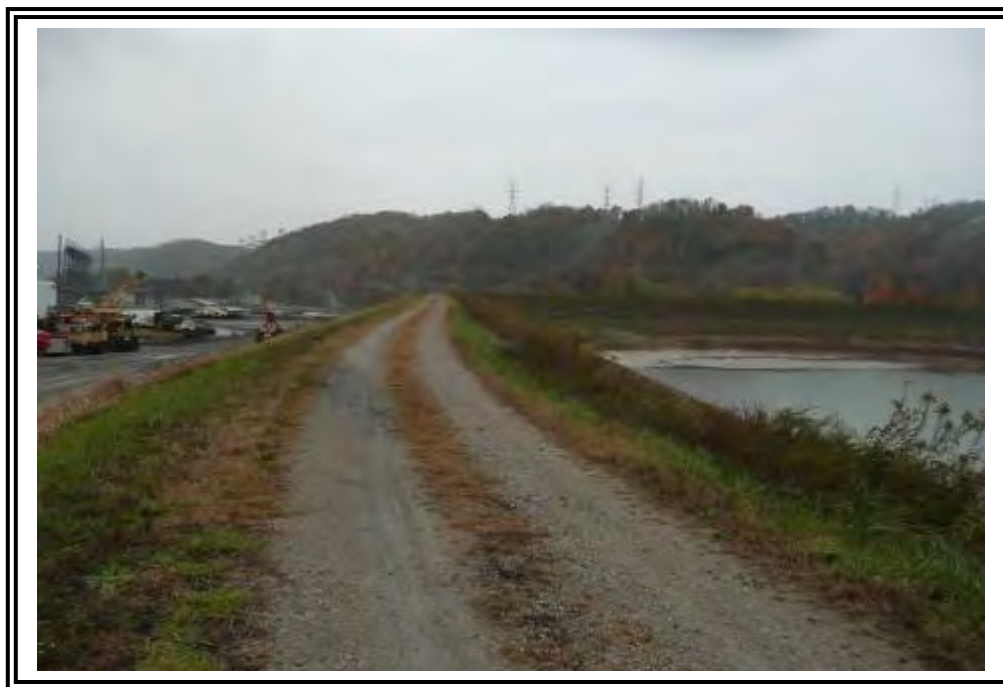
35

Looking northwest along the crest of the southwest dike.

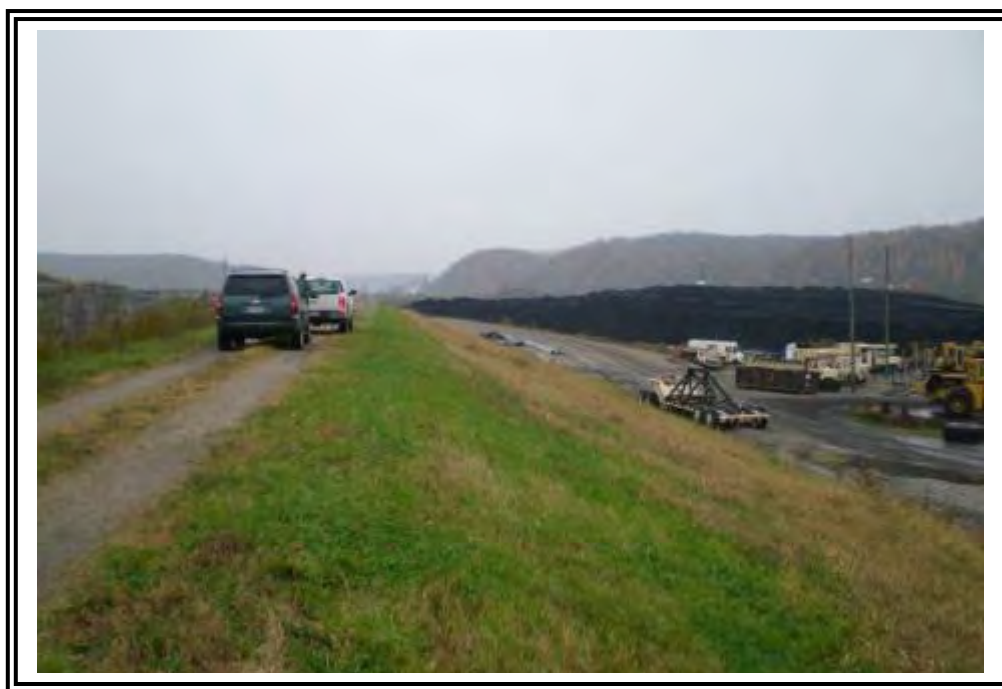
37

Looking southeast along downstream slope and crest of southwestern dike.

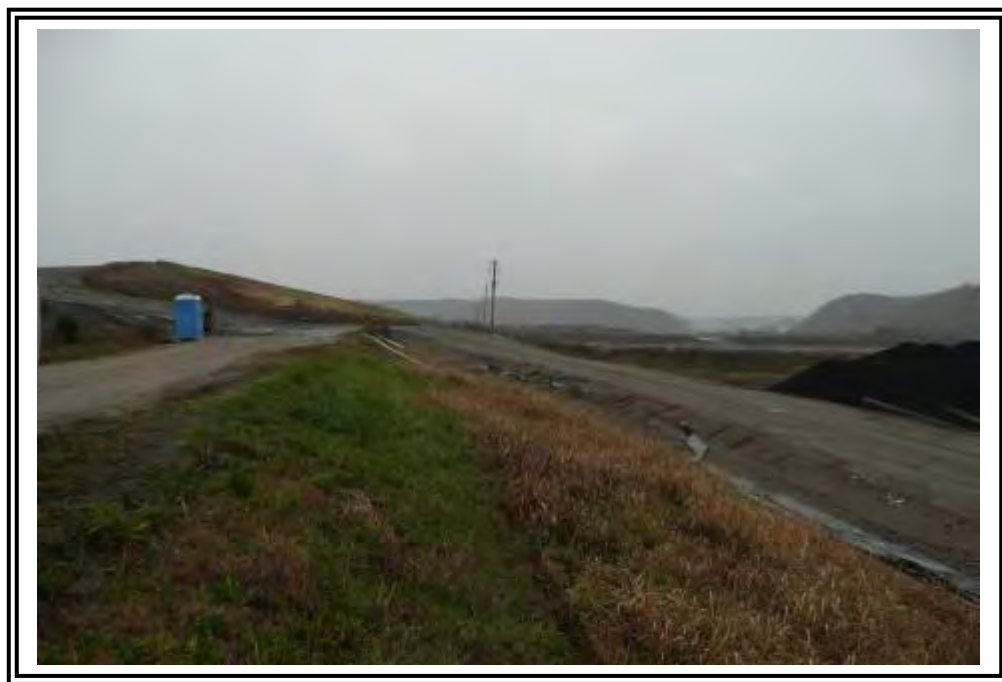
38

Looking southeast at downstream slope and crest of southwestern dike at the southeast corner.

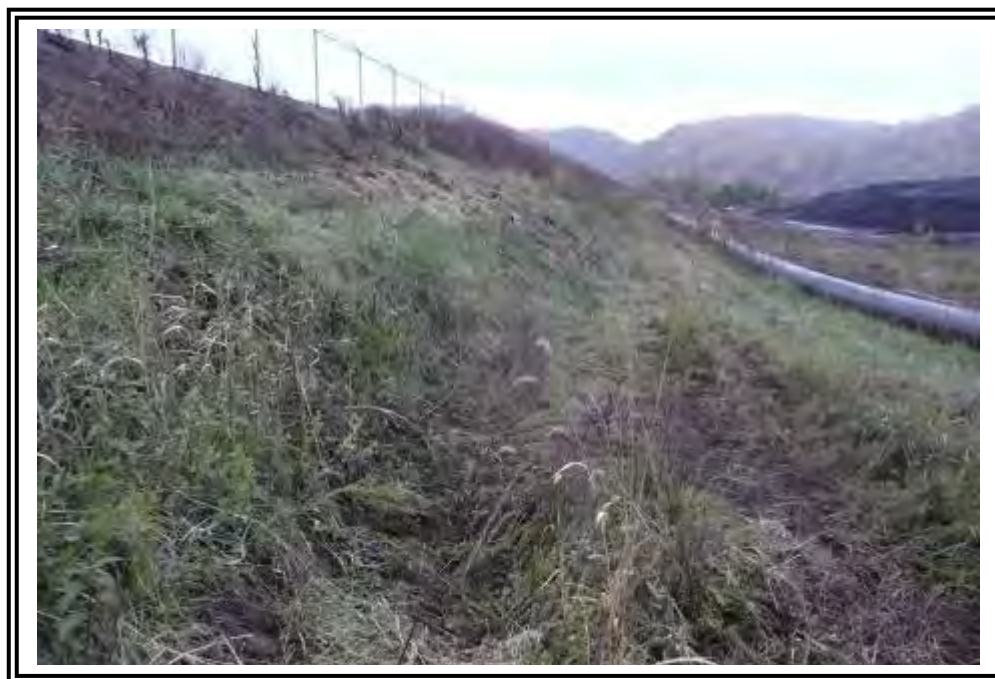
40

Looking south along the downstream slope at over-steepened area of the west dike of pond.  
Note sluice pipe near dike toe.

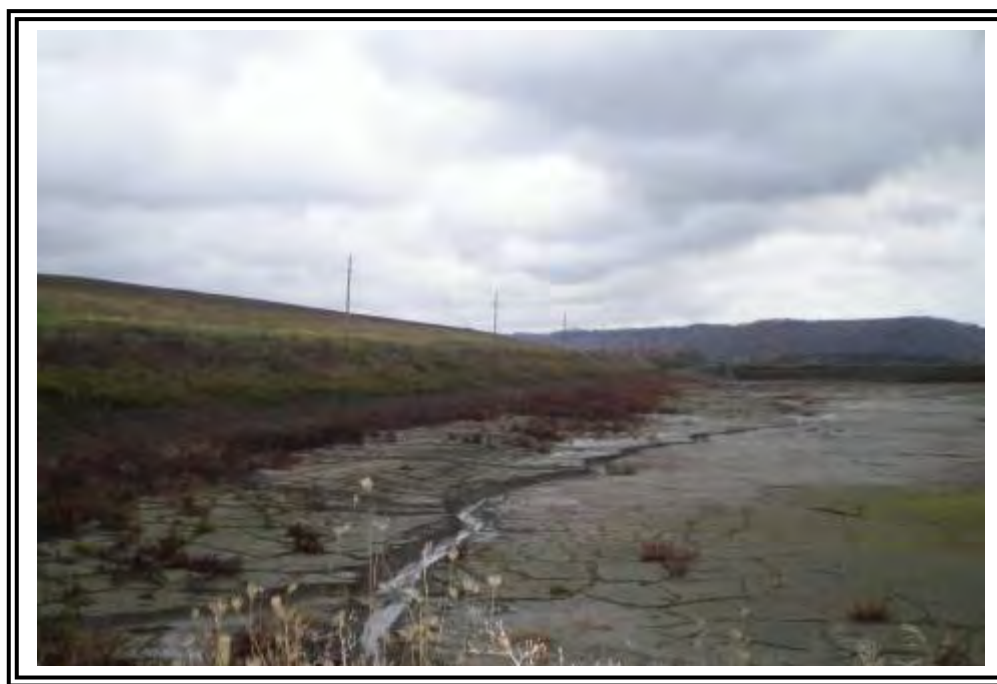
42

Looking east at upstream slope of the north dike of the pond.  
There is some beaching just above the ash line on the upstream slope.

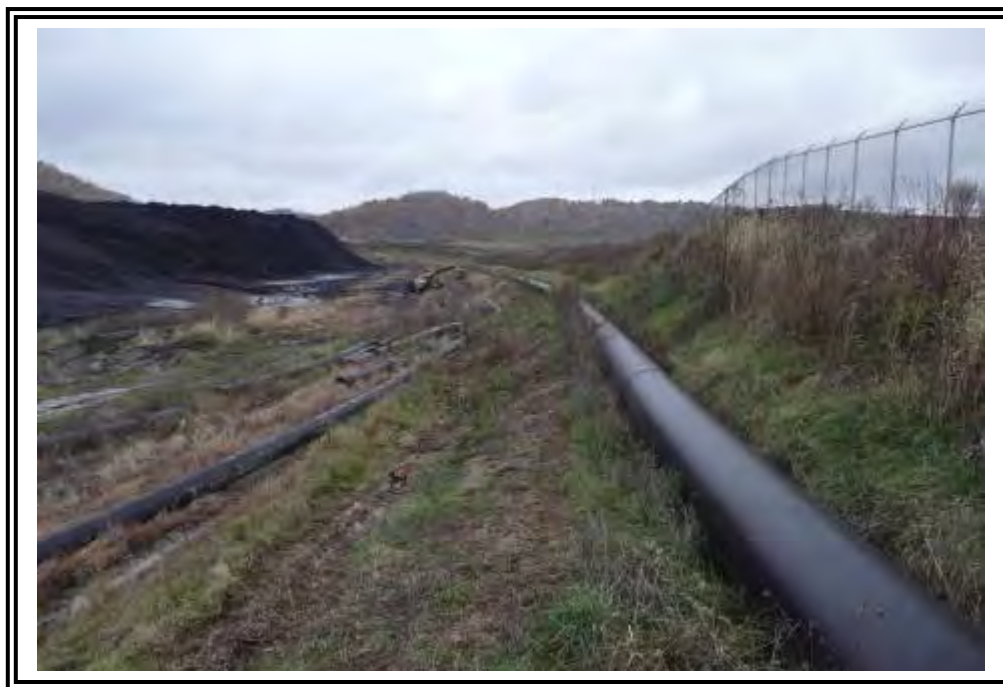
43

Looking north along the downstream slope of the west dike from the south end. Note sluice pipe on slope.

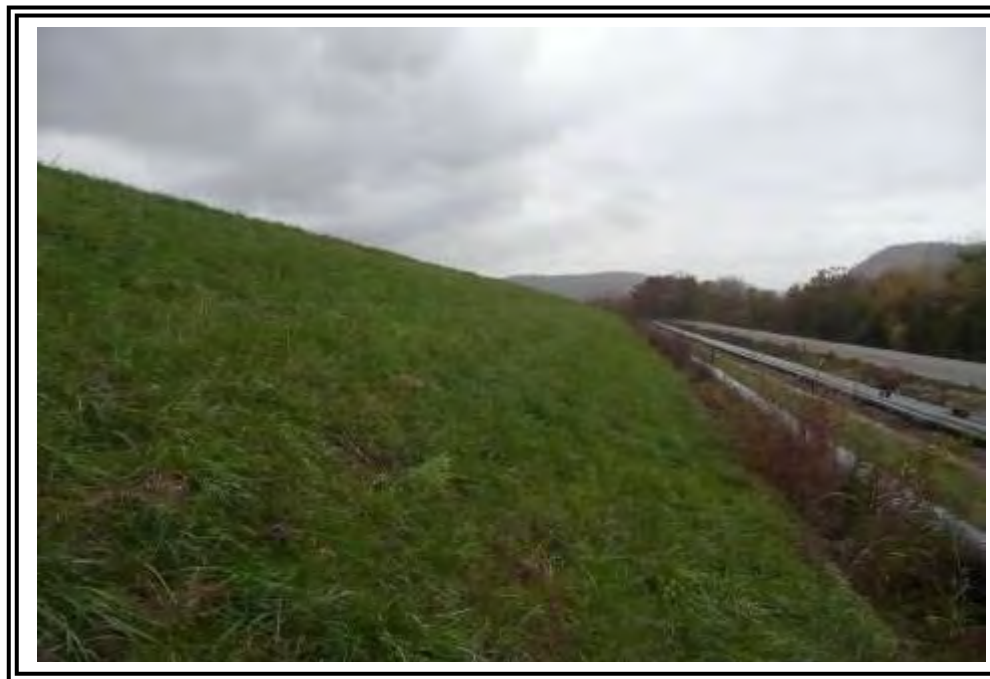
44

Looking east along the downstream slope of the south dike. Inactive sluice pipe in bench is visible at dike toe.

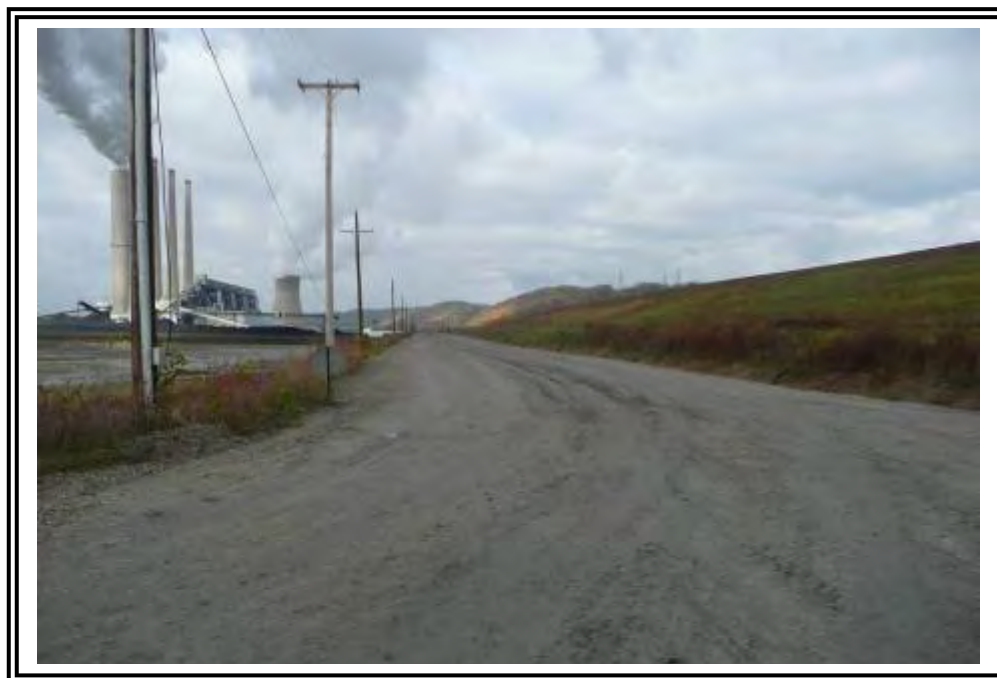
48

Looking west along the road on the north dike. Landfill 11 is shown on the right side of the photo.

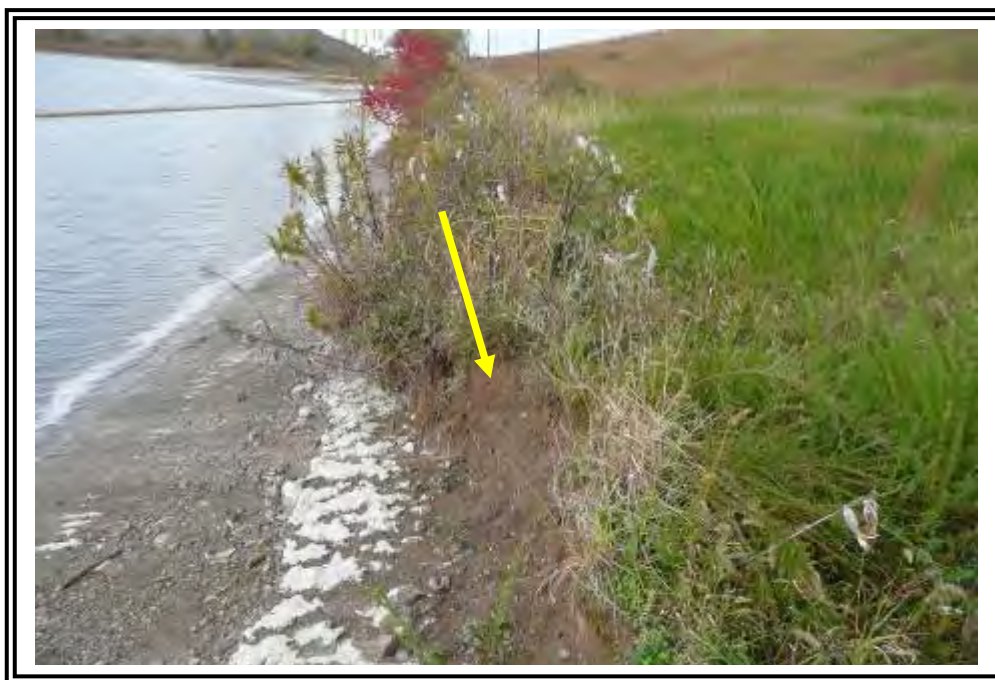
58

Looking west at beaching erosion (arrow) on north wall of Pond 6. Recent high water level is evident from deposited ash in picture.
