# Assessment of Dam Safety

## Coal Combustion Surface Impoundments (Task 3)

Dayton Power &  
Light Company

JM Stuart Station

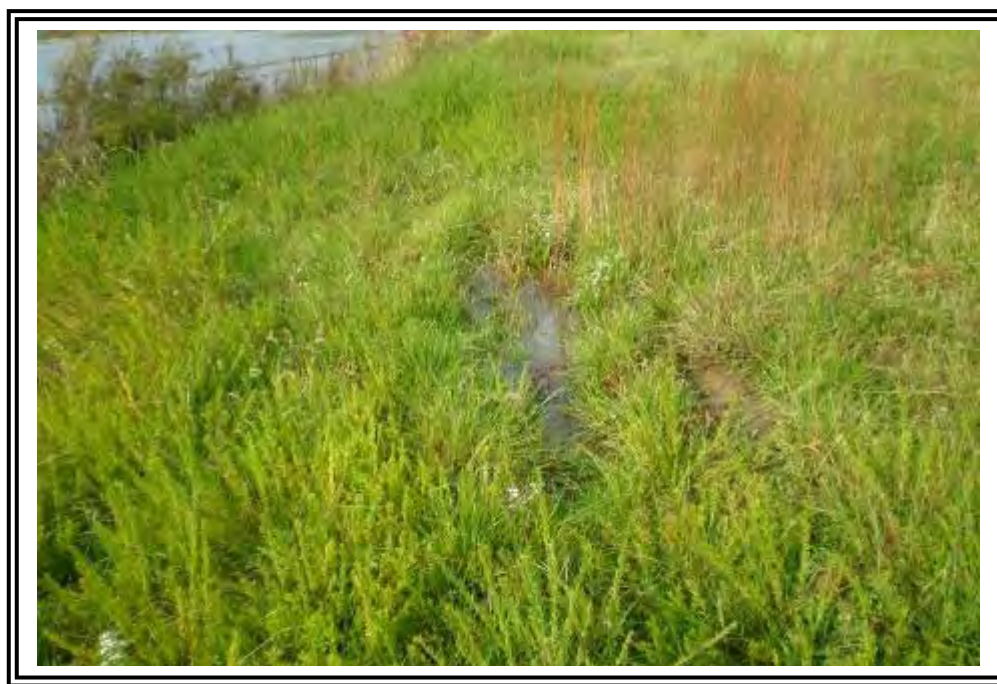
60

The north wall of the pond appears to be at the approximate foundation level for Landfill 11 (formerly Pond 8) as seen in Photo 61. This area is moderately to heavily vegetated with weeds, grasses, brush, and smaller trees (Photos 56, 57, 59, and 62). The pond level was down slightly during the site visit, and some beaching erosion was visible as noted in Photos 58 and 59. Standing water was also encountered intermittently in this area (Photo 60), but this was likely due to the recent rains, sheetflow runoff from the landfill, and the fairly flat topography in the area between Pond 6 and Landfill 11.

Standing water in grass and weeds adjacent to north wall of Pond 6.

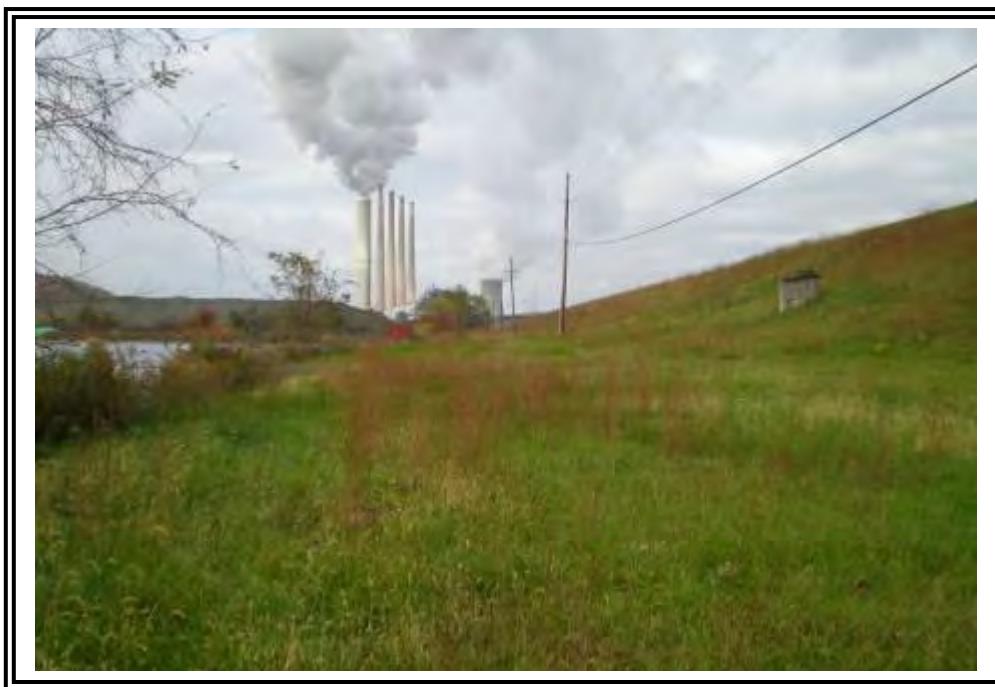
61

Looking west along the northern side of Pond 6. Landfill 11 is off the right side of photo.

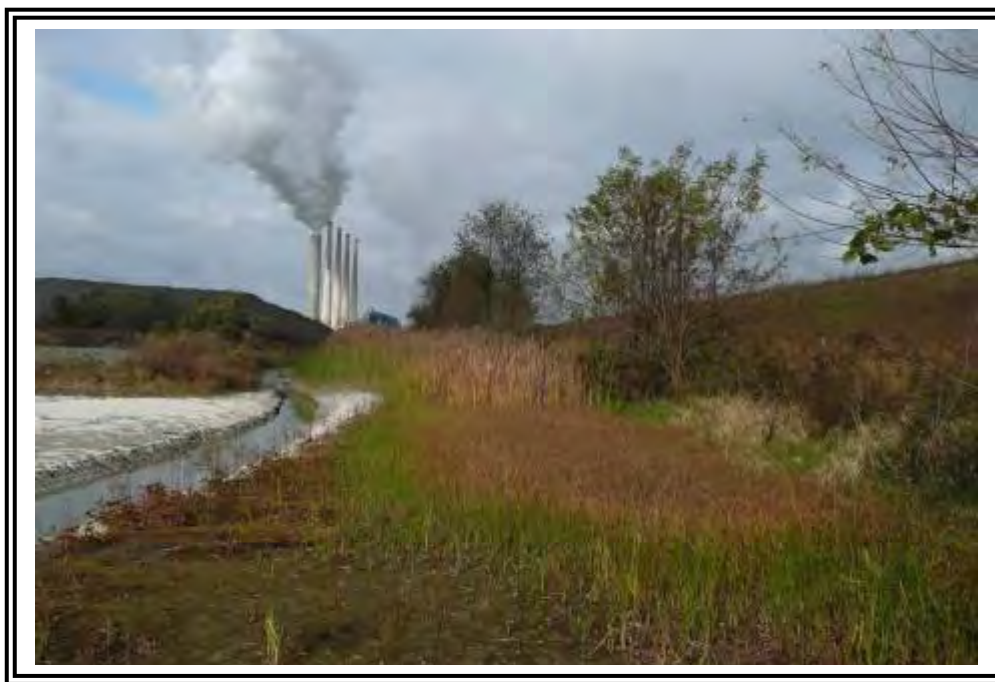
62

Looking west along the northern side of Pond 6 from a point farther west than shown in Photo 61.

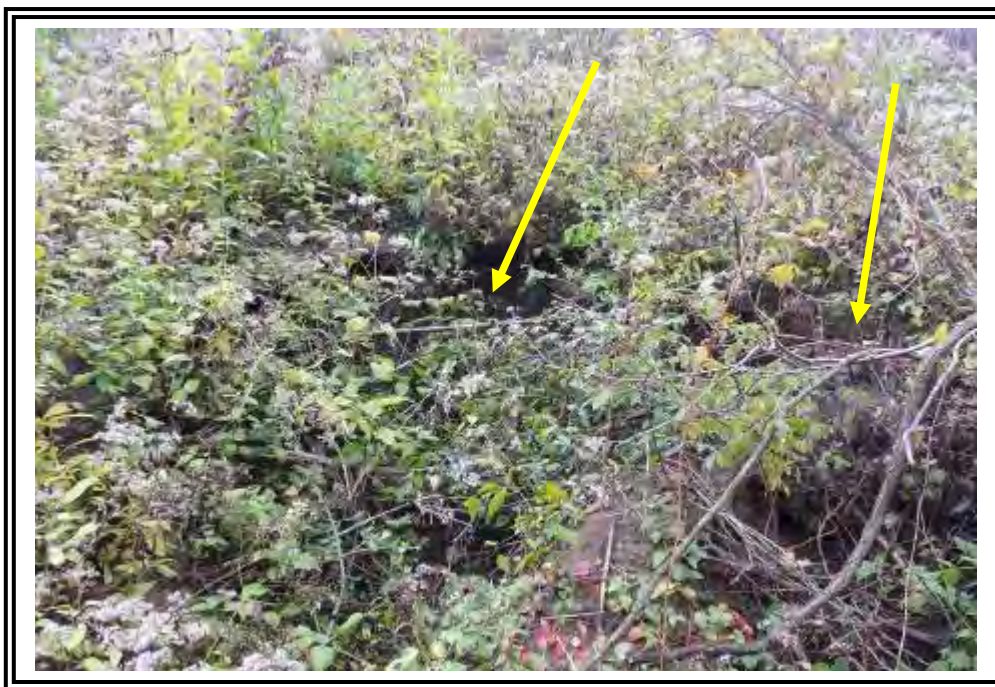
65

Deep, heavily vegetated erosion gullies on downstream east dike slope of Pond 6.  
These were 3.5 to 4 feet deep located near the north end of the dike.

Erosion rills and subsequent loss of grass cover were observed on multiple embankment slopes of the Ash Ponds as discussed in Sections 2.2.1 and 2.3.1. Thinning and loss of grass cover due to concentrated flow was noted on the embankment slopes. CHA recommends repairing these area by filling all rills with compacted material and re-seeding to establish grass where applicable (i.e. exterior embankment slopes).

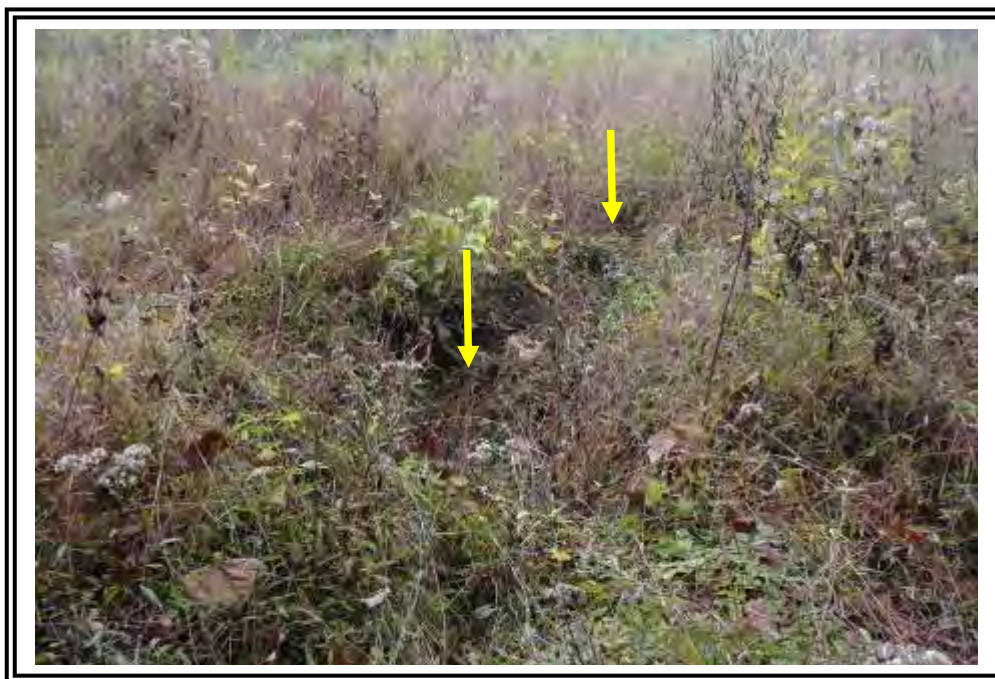
66

Vegetated erosion rill toward the center of the east dike of Pond 6  
approximately 1.0 to 2.0 feet deep.

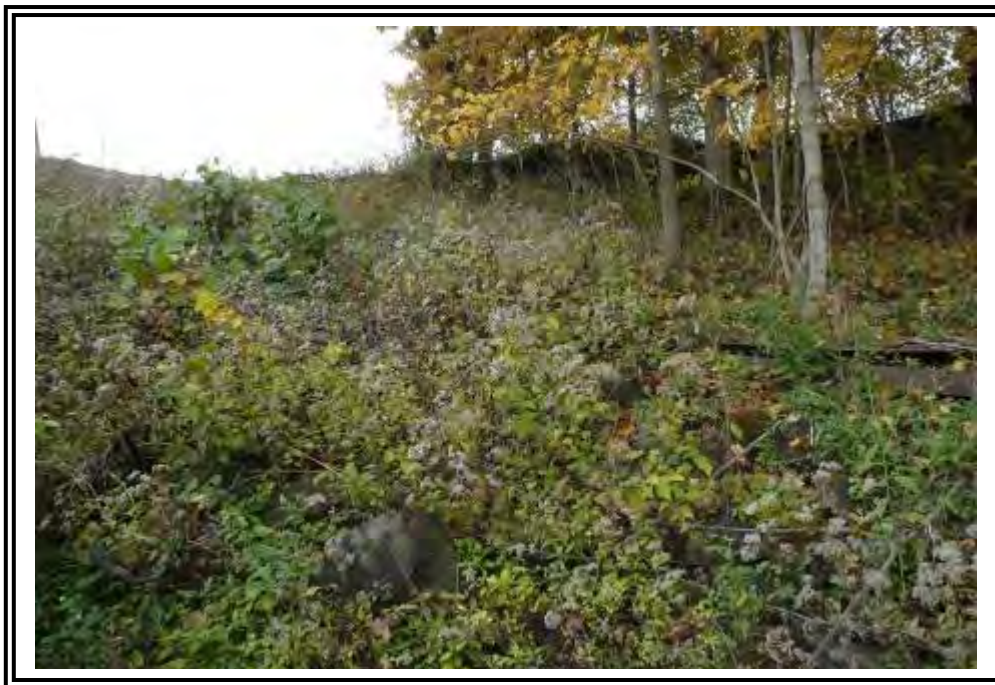
67

Looking up slope at the start of the eastern dike at Pond 6.  
Vegetation obscures rock groin in this area.

Trees and brush should be cleared from all of the interior and exterior slopes of all the Ash Pond dikes. Heavy brush cover precludes observation of erosion, sloughing, rodent activity, or other causes of embankment deterioration.

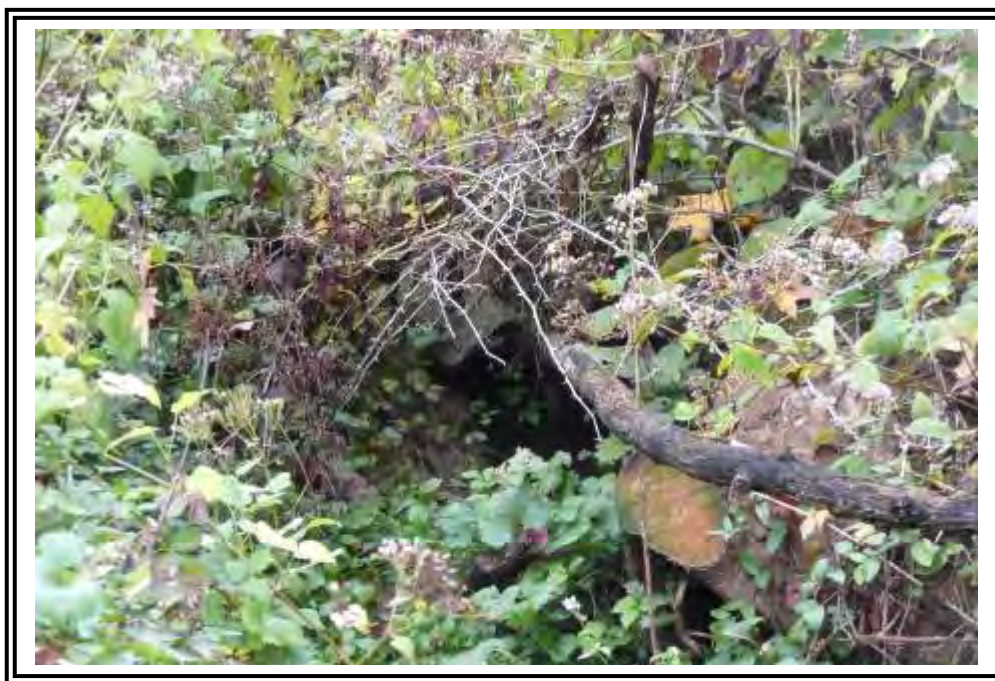
68

Close up of a possible rodent burrow or animal cave in the dense vegetation on the  
downstream slope of Pond 6 east dike.

Evidence of animal burrows was observed on the downstream side of the several of the dikes. Thick vegetation cover may have obscured borrow at locations not identified herein. CHA recommends vigilance by DP&L personnel to make note of areas disturbed by animal activity, trap the animals, and make repairs to areas to protect the integrity of the dikes.

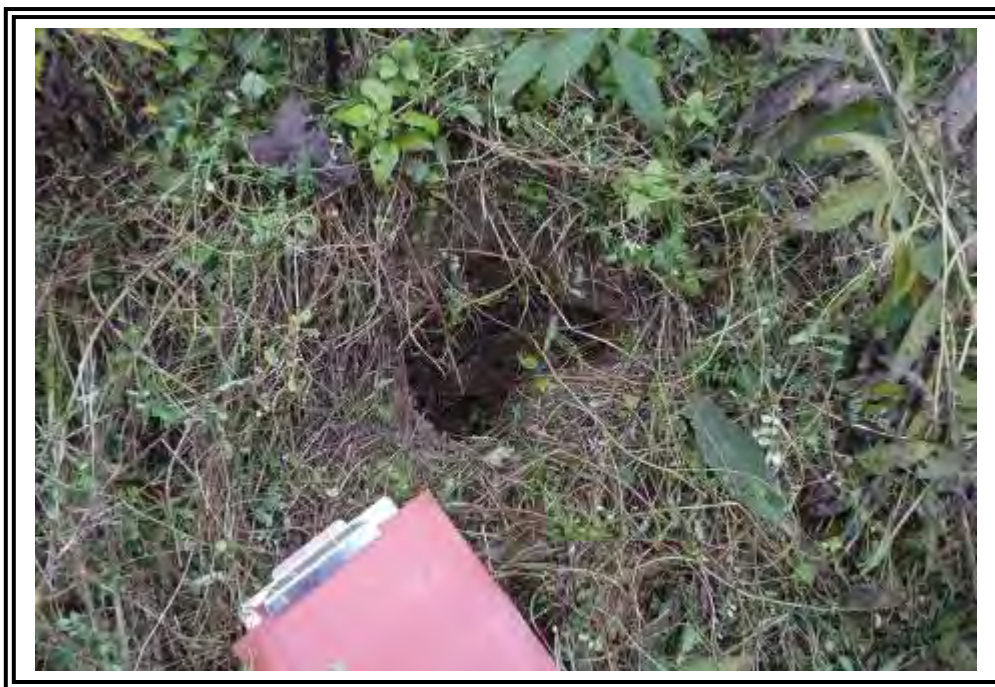
73

Close up of a potentially abandoned rodent hole in the downstream slope of Pond 7/7A east dike.

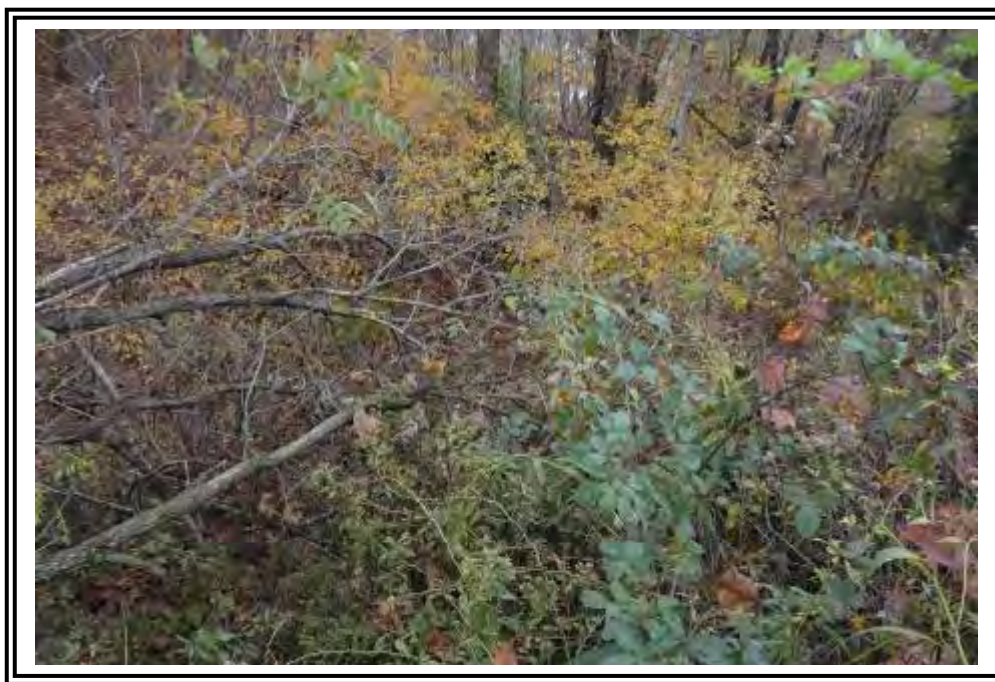
74

Dense to very dense vegetation on the downstream slope of Pond 7/7A east dike.

CHA recommends that vegetation be cut on a regular basis ensure that adequate visual observations are being made by during routine inspections.

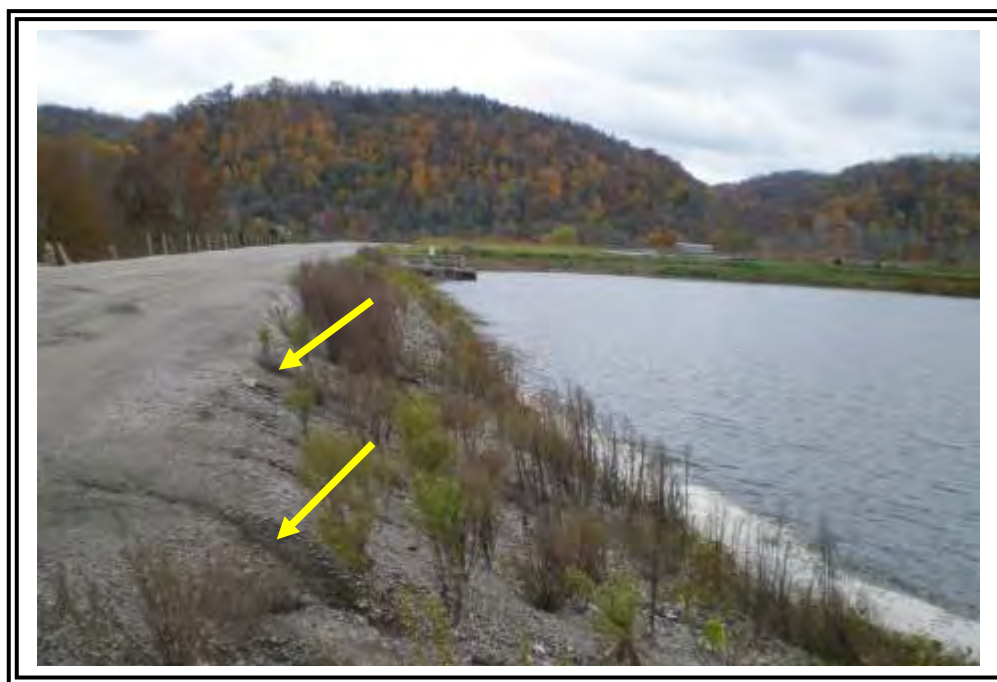
76

Looking south along the crest and upstream slope of the Pond 7A east dike.  
Note the erosion rills at the crest (arrows).

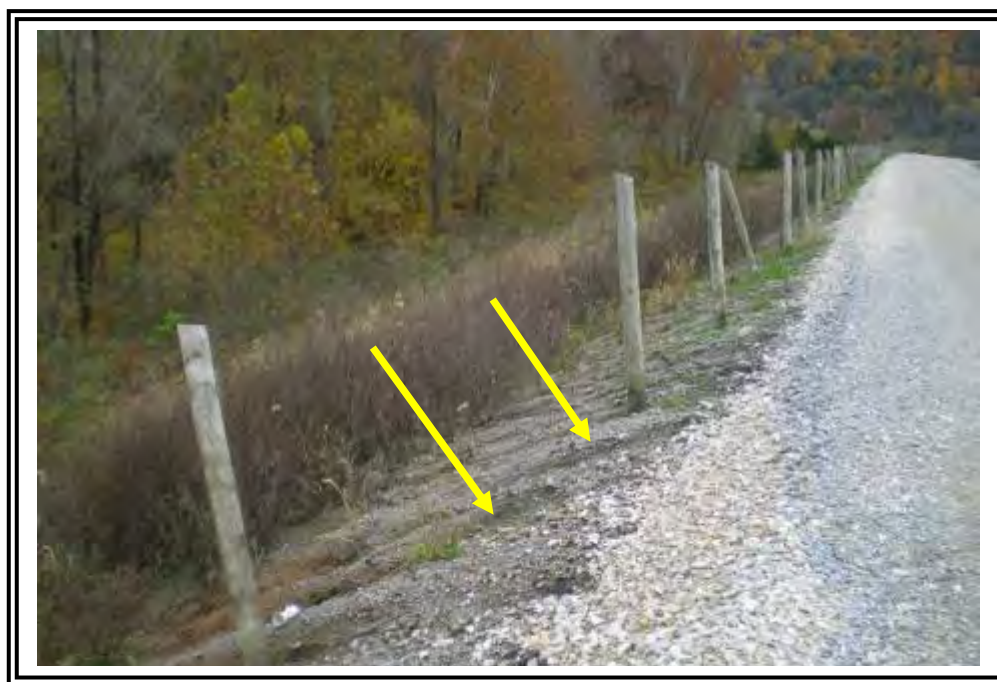
80

Looking south along the crest and downstream slope of the east dike. Note erosion rills near crest (arrow).

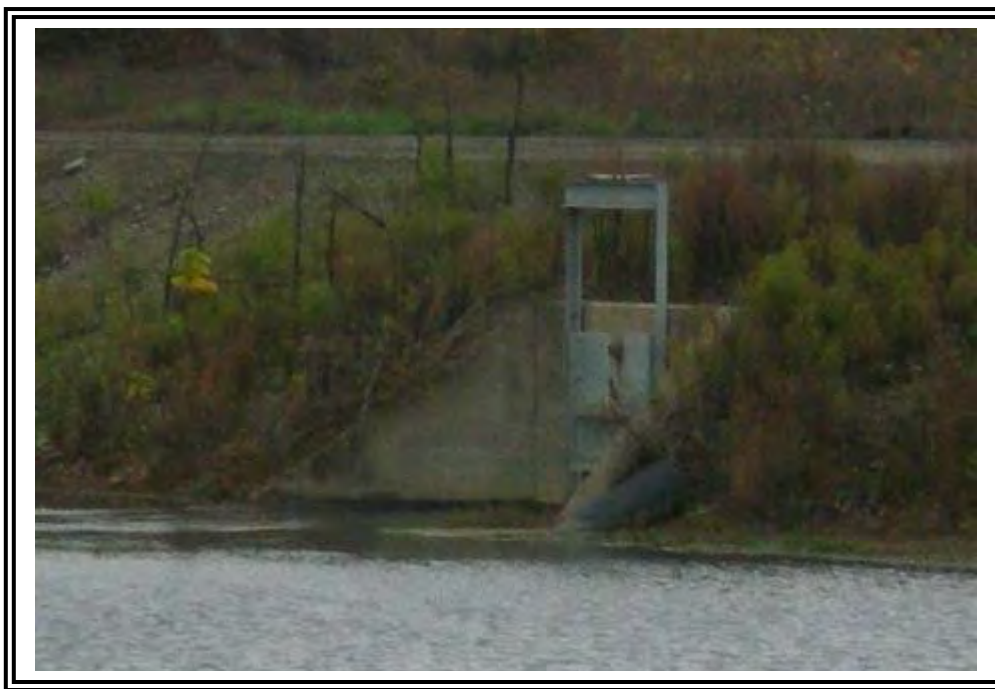
81

Looking northerly toward the influent gate in Pond 7A from the treatment station and outfall on Pond 6.

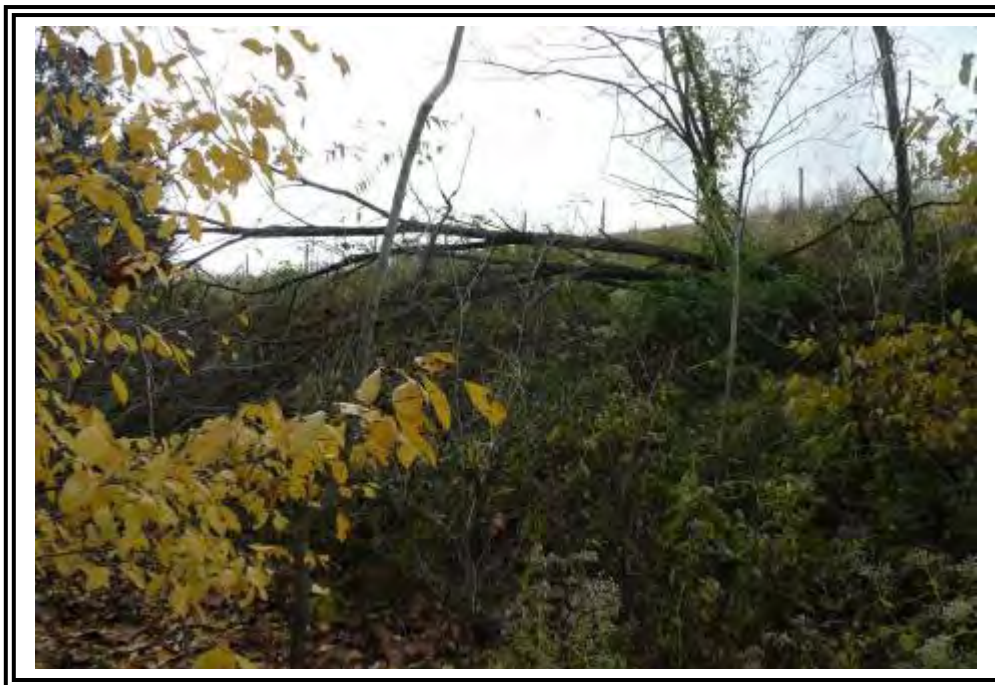
83

Looking up the slope of the Pond 7 south dike along the Ohio River near the location of the outfall into the river.

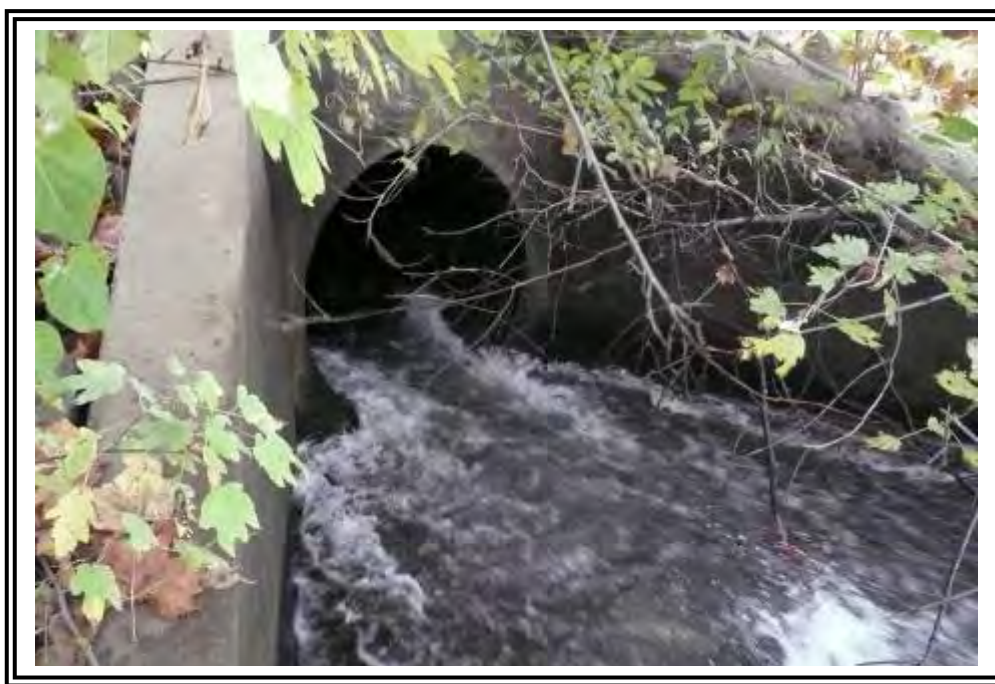
84

A close up of the outfall to the river from Pond 7A.

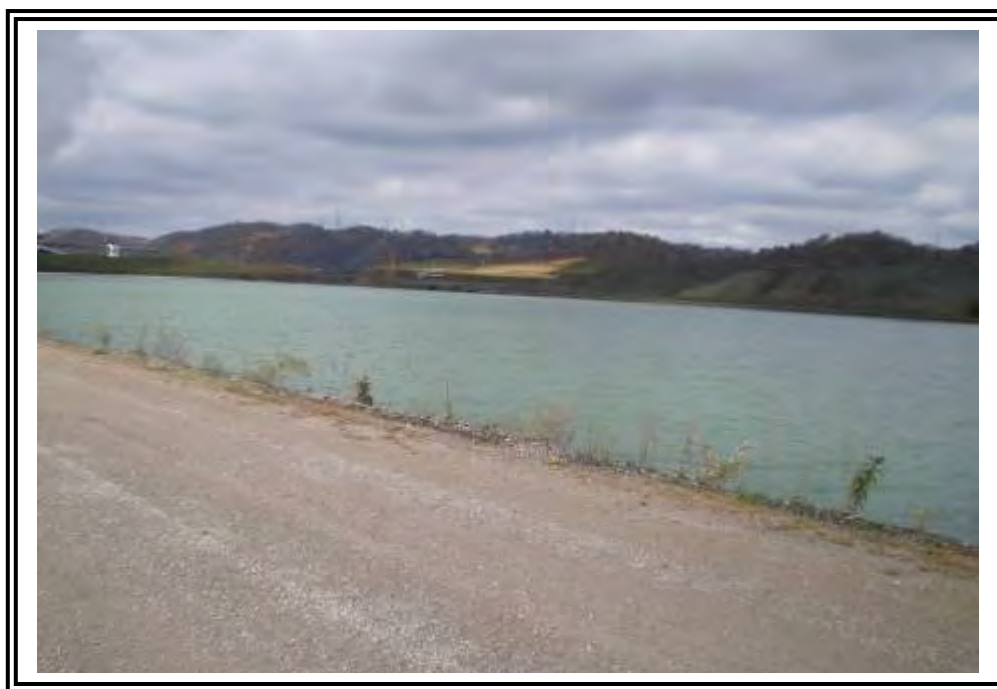
85

Looking northwest across Pond 7.

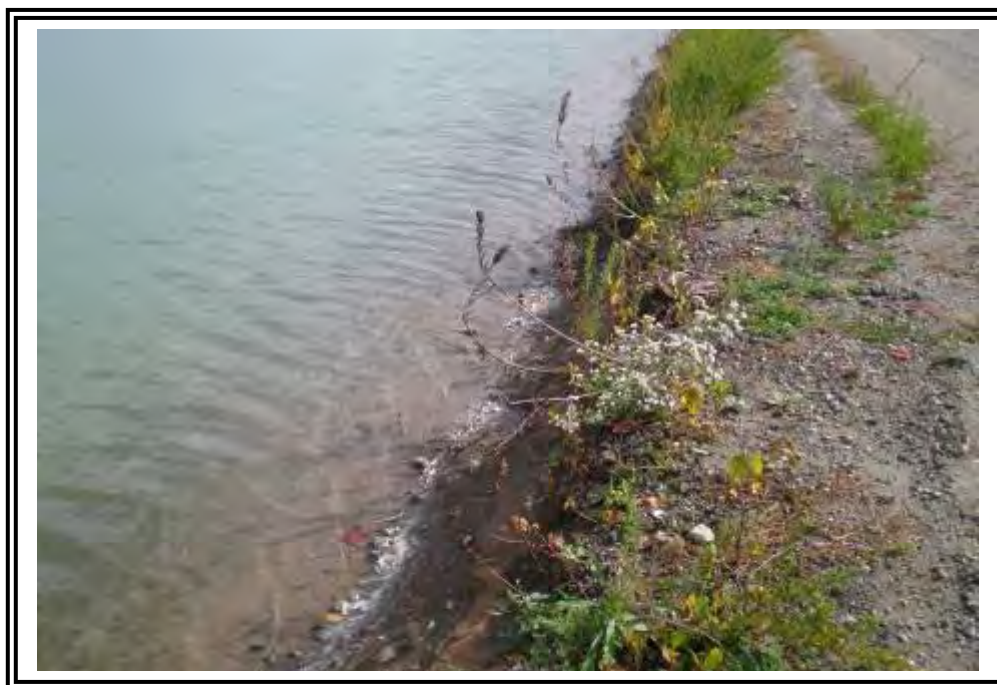
86

Close up of upstream slope of Pond 7 south dike.

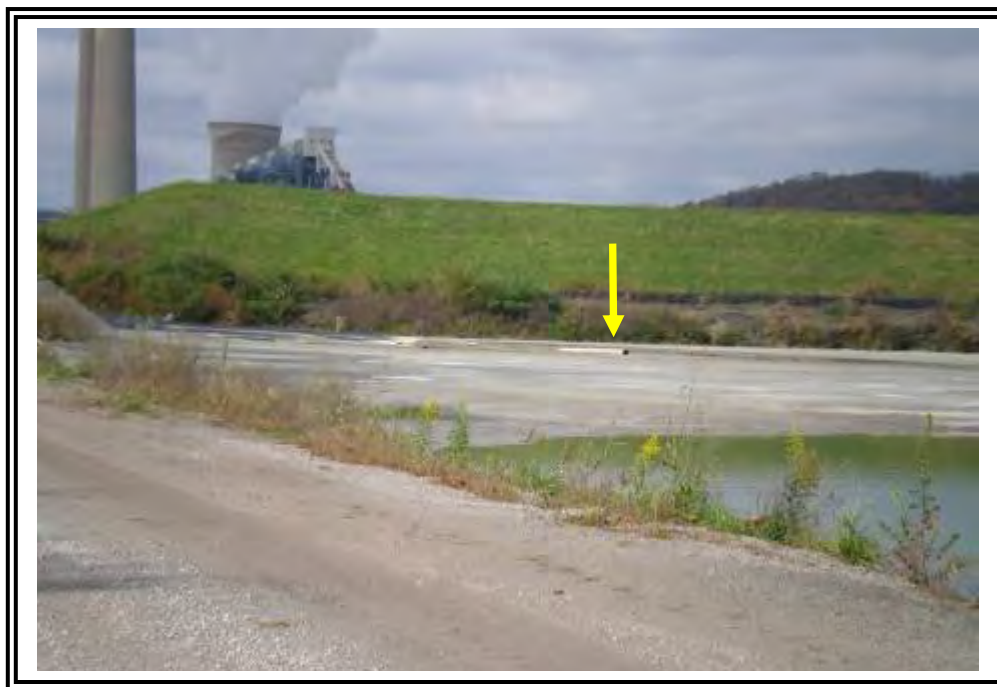
87

Looking at the northwest corner of Pond 7 showing ash delta and sluice lines (arrow).  
Pond 3A's east dike is in the background.

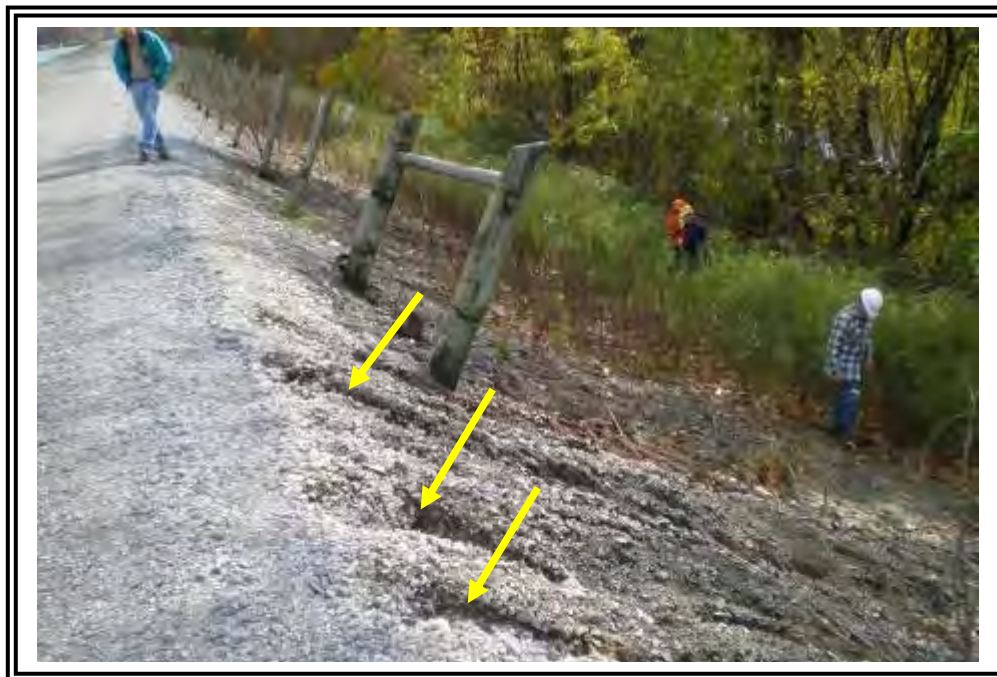
88

Looking east along the crest and downstream slope of Pond 7 south dike. Note erosion rills in slope (arrows)

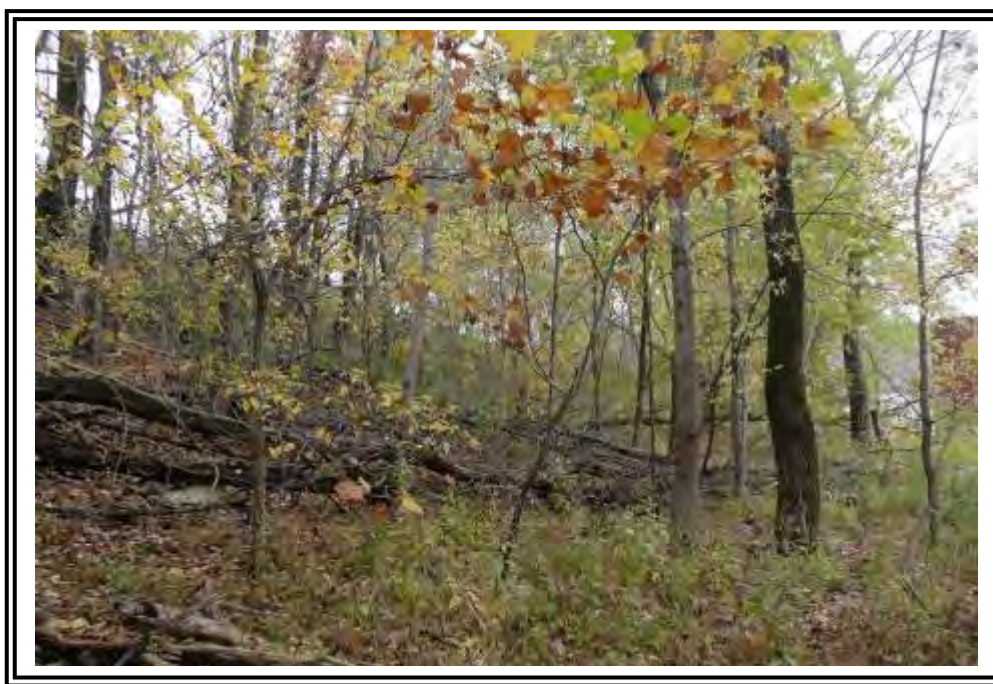
90

Looking east along the toe of the Pond 7 south dike near the Ohio River bank.

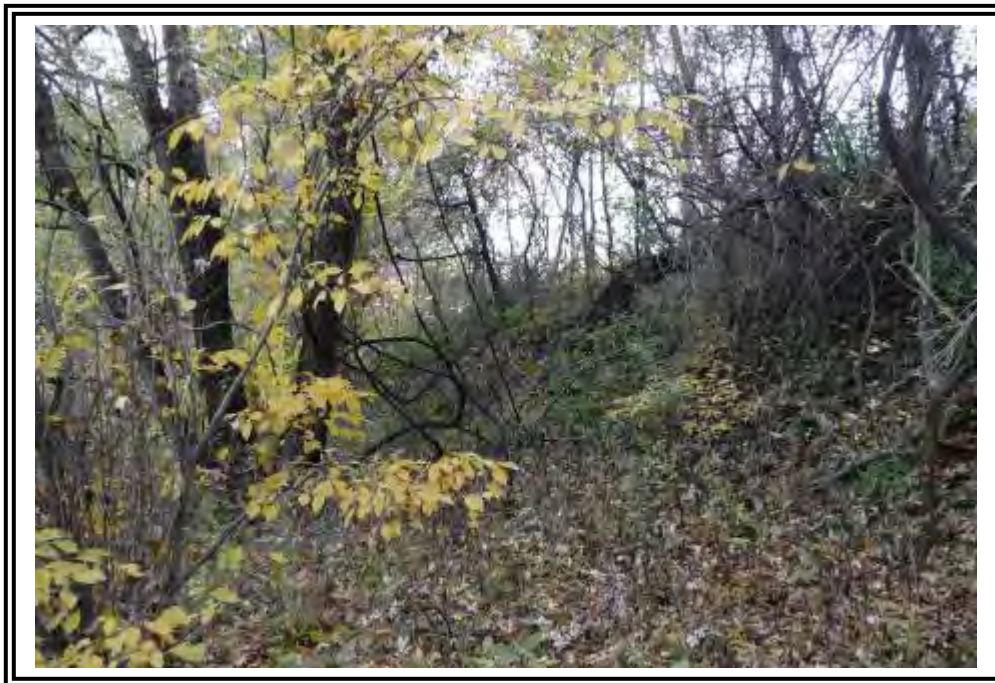
91

Another view of larger trees at the toe of the downstream slope of Pond 7 near the Ohio River bank.

Tree roots can allow for seepage of the retained water through the dikes, which could lead to internal erosion. Internal erosion could weaken the dikes and cause slope failures. Additionally, the uprooting of trees during storms can create large voids in the embankments that are then susceptible to erosion. Considering the progressive erosion that could occur during a storm which blows the tree over during heavy rains (i.e., hurricane type storm systems) progressive erosion could potentially result in enough loss of soil from the dike to create an unstable situation, which if failure occurs could result in a release of ash.

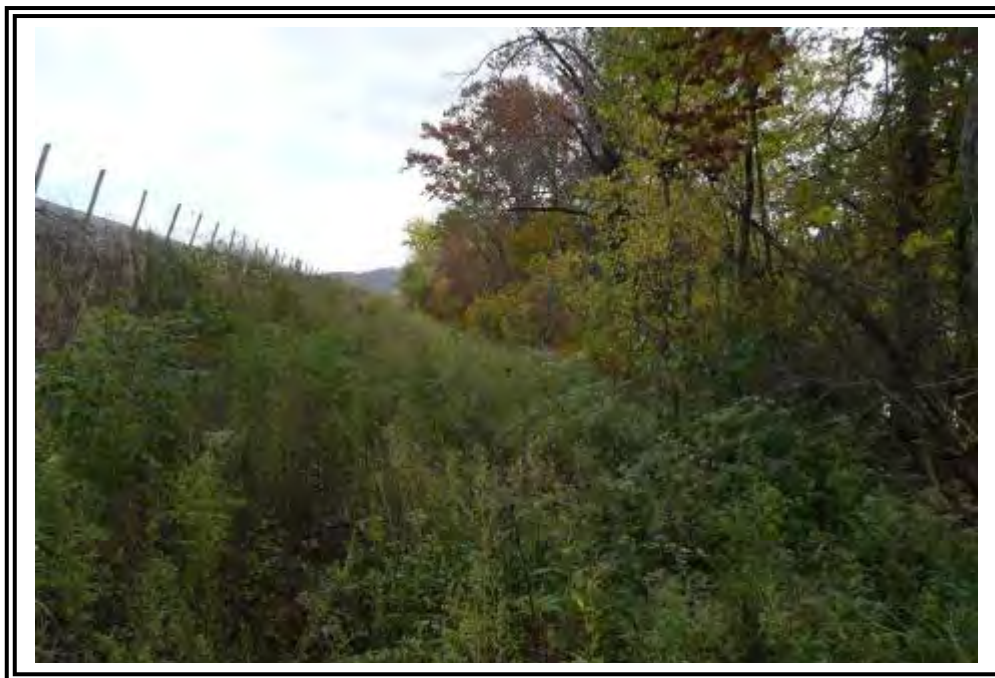
92

Looking east along the downstream slope of the Pond 7 south dike near the Ohio River bank. Note heavier woody vegetation and trees encroaching on dike toe.

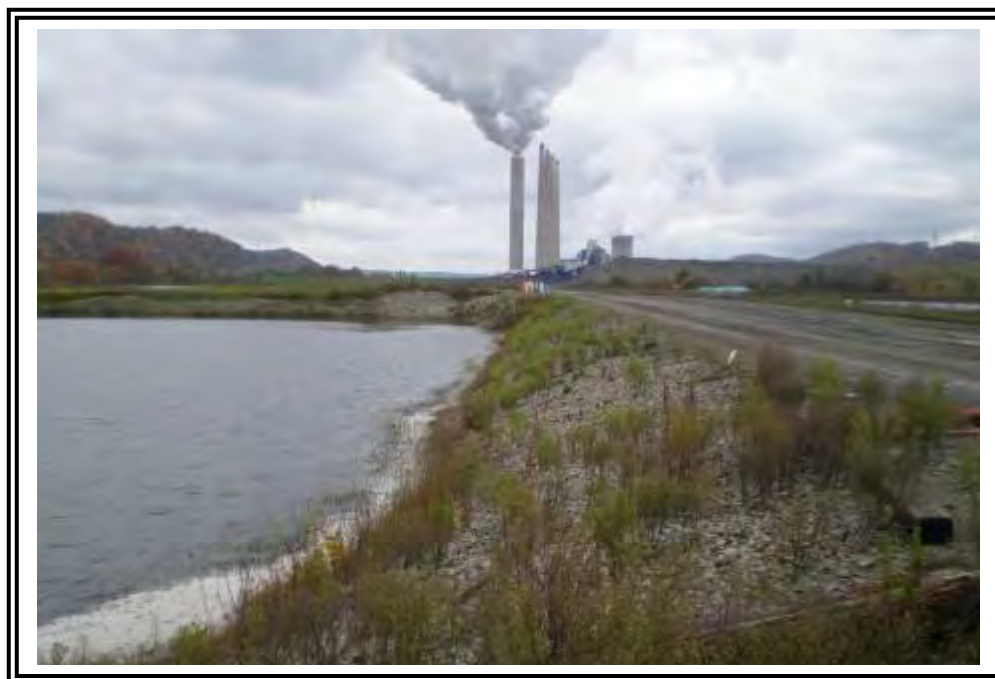
96

Looking west along the Pond 7/7A north dike upstream slope impounding Pond 7A.  
Note gravel slope surface and freeboard at this location of the dike.

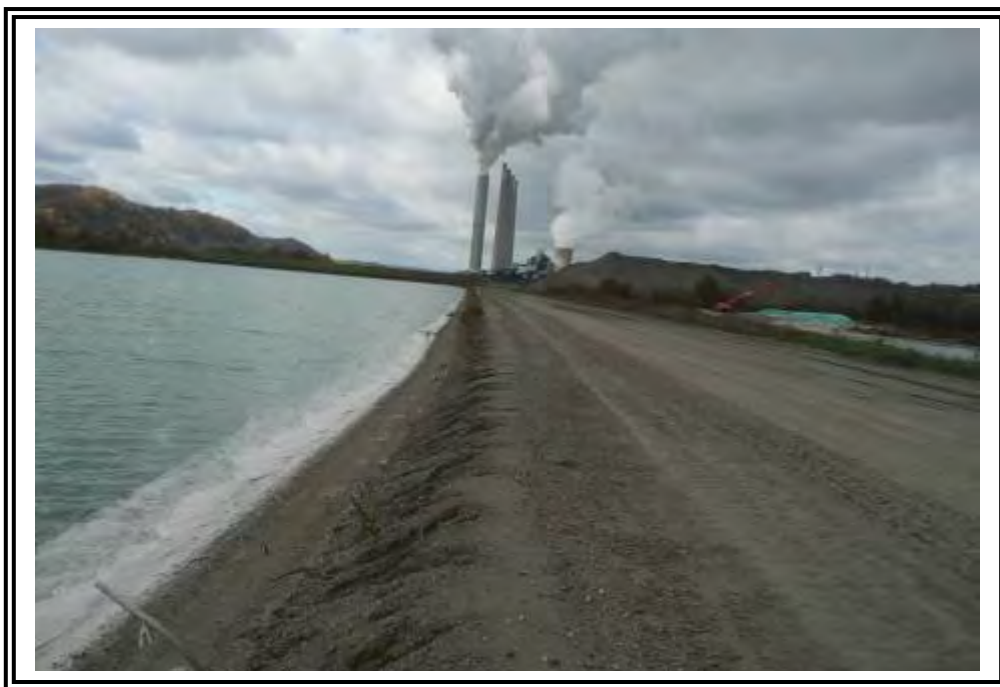
97

Looking west along the separator dike between Pond 7 (left) and Pond 6 (right).
