Assessment of Dam Safety Coal Combustion Surface Impoundments (Task 3) Final Report

Duke Energy
Riverbend Steam Station
Mt. Holly, North Carolina

September 14, 2009

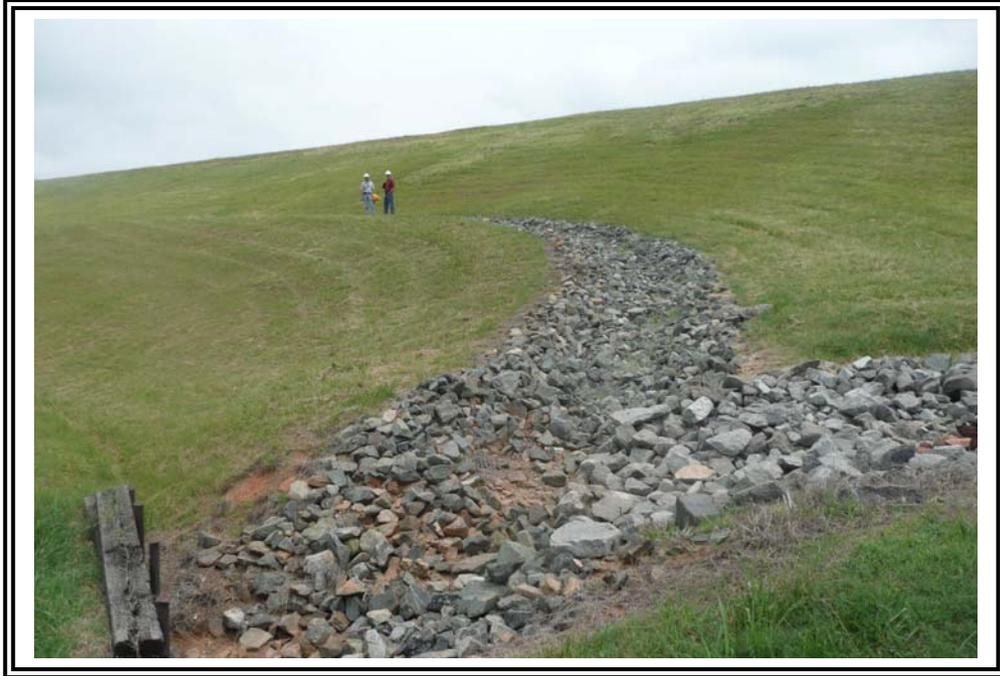
9

Primary dike downstream slope at left (south) groin drainage swale/upper bench drainage swale intersection.

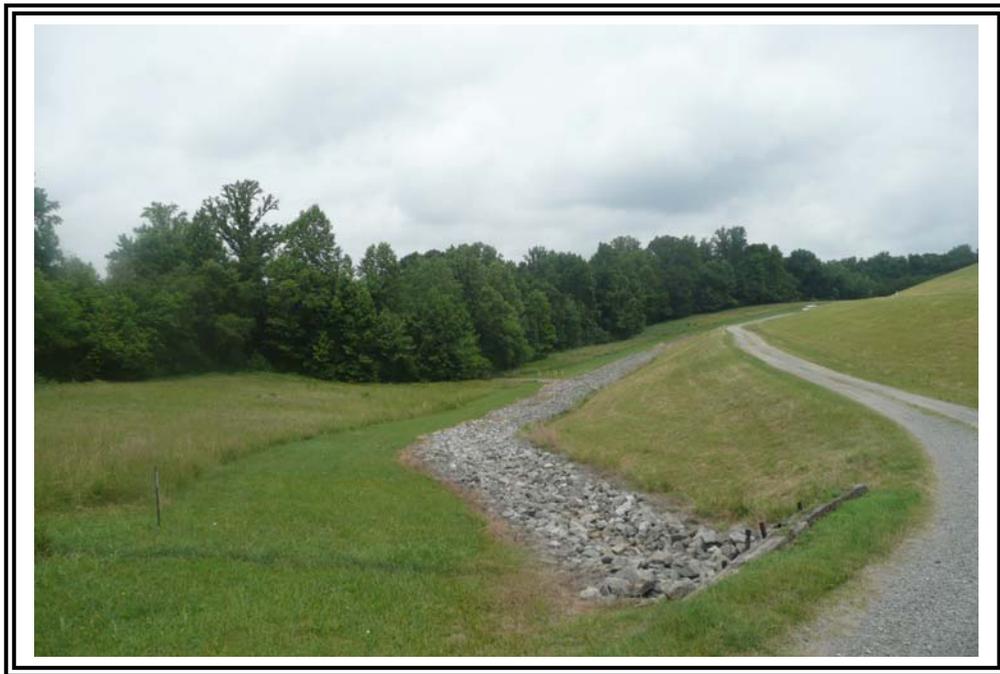
10

Primary dike downstream slope, drainage swale at toe. Access road runs across bottom bench.

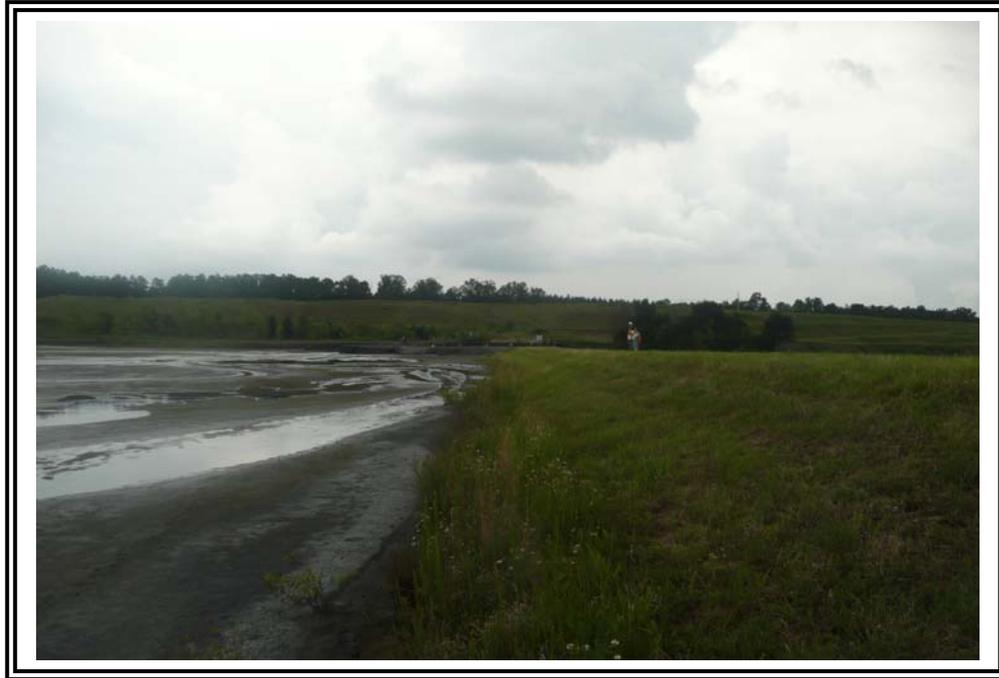
Photo 16 shows an area downstream of the toe at the north end of the primary dike where soil is exposed. Duke Energy personnel indicated this area had remained unchanged in many years, and CHA observed signs in this exposed soil that it was natural ground and not part of the embankment. The upstream embankment is shown in Photos 17 through 19.

Primary dike upstream slope, looking south.

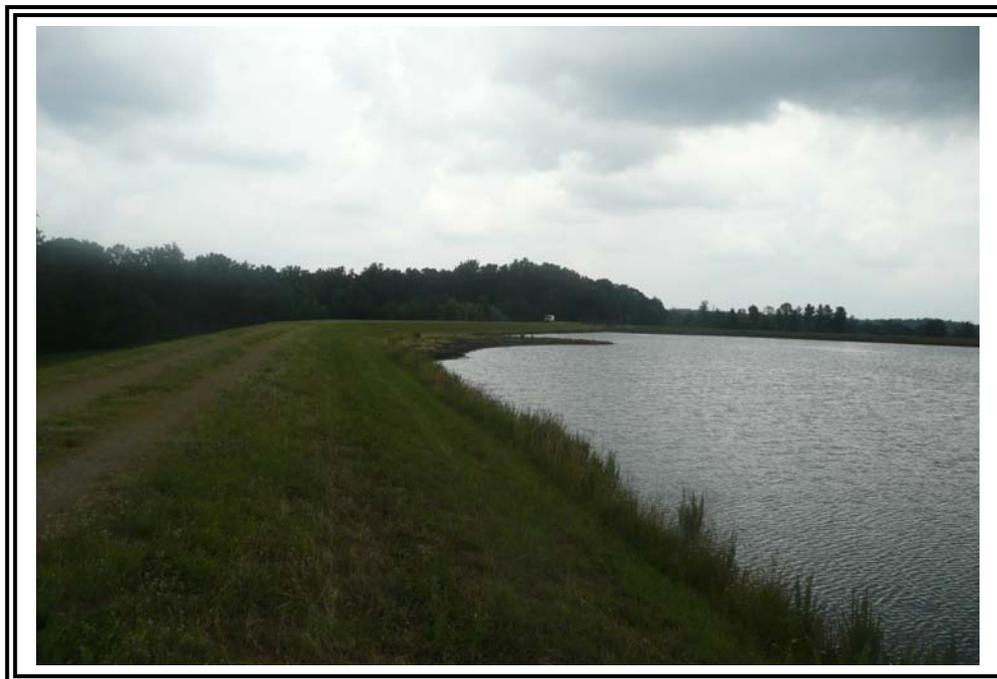
19

Right end (north) upstream slope of primary dike at intermediate dike.

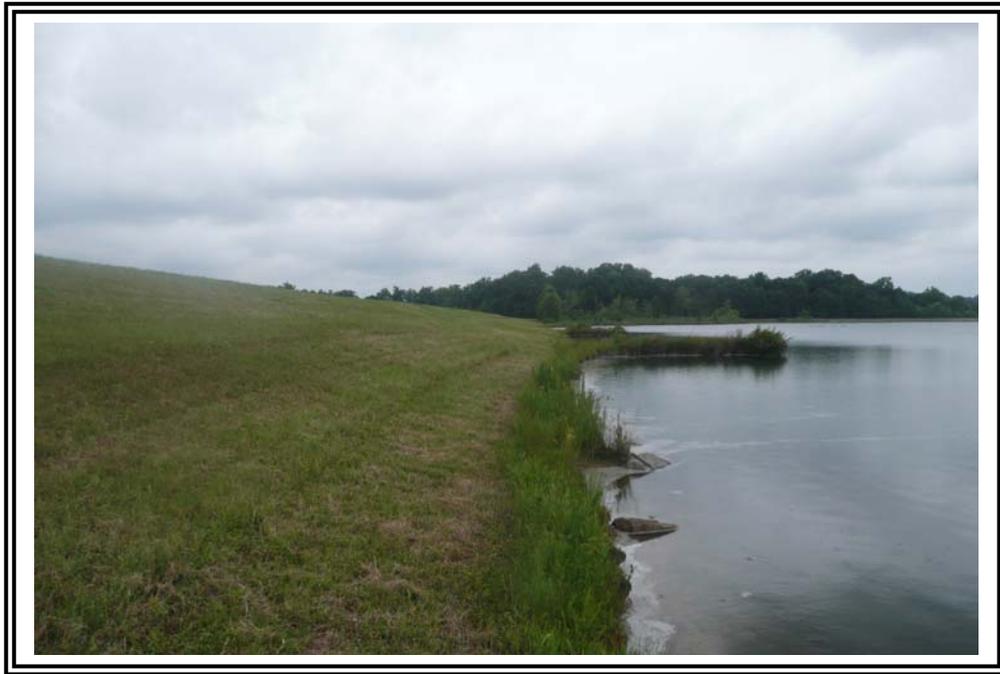
Design drawings of the intermediate dike indicate a 10-foot wide bench was to be constructed on the downstream slope. This bench was not observed in the field although it is possible it was submerged under the secondary pond water level at the time of our visit. Additional features on the downstream slope are four peninsulas that extend 20 to 30 feet into the secondary pond. These are located at approximately even spacing, and are not shown on the plans provided to CHA, although they are referred to in previous inspection reports as landmarks. Photos 34 and 35 show two of these peninsulas.

Downstream slope intermediate dike, looking west.

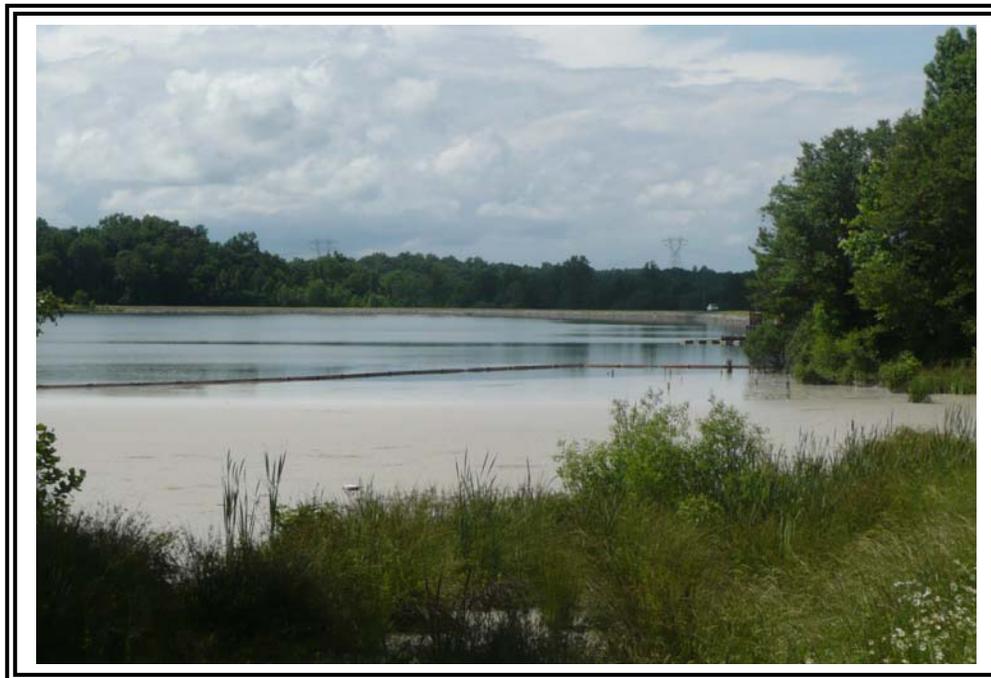
37

Secondary pond from east abutment, looking west. Booms are in place to contain floating cenospheres in forefront of pond.

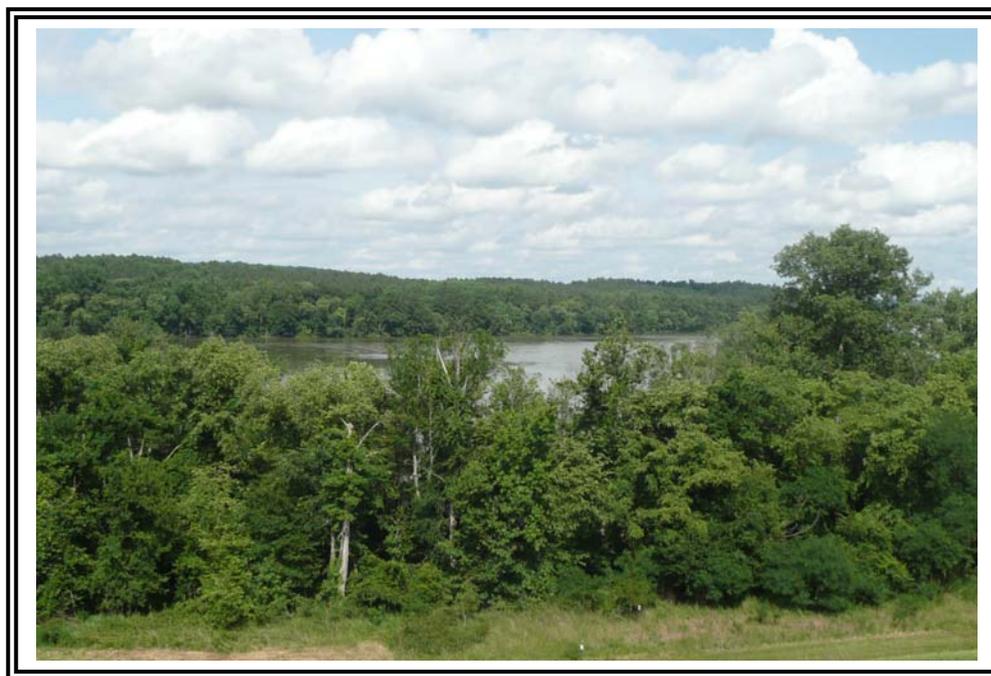
38

Catawba River from secondary dike.

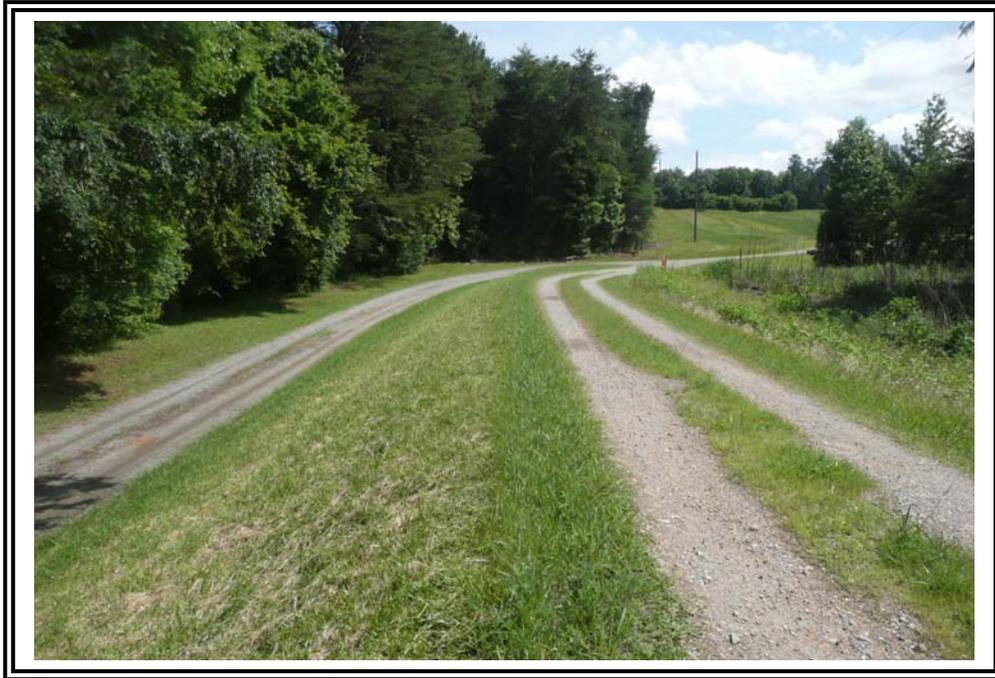
39

East abutment of secondary dike, looking south.

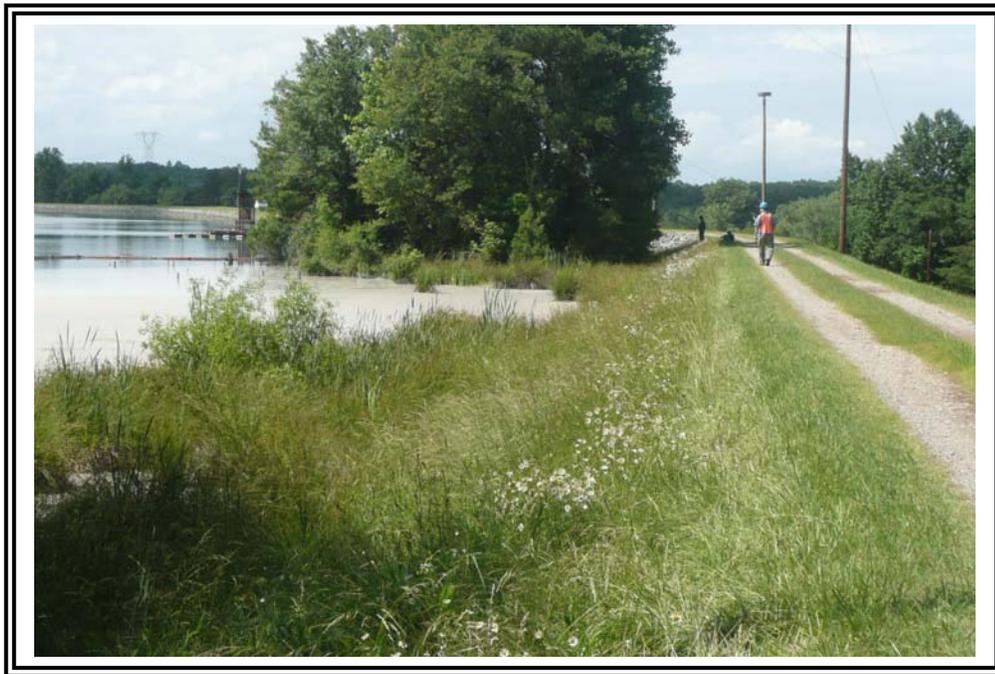
40

East end of upstream slope and crest of secondary dike, looking northwest.

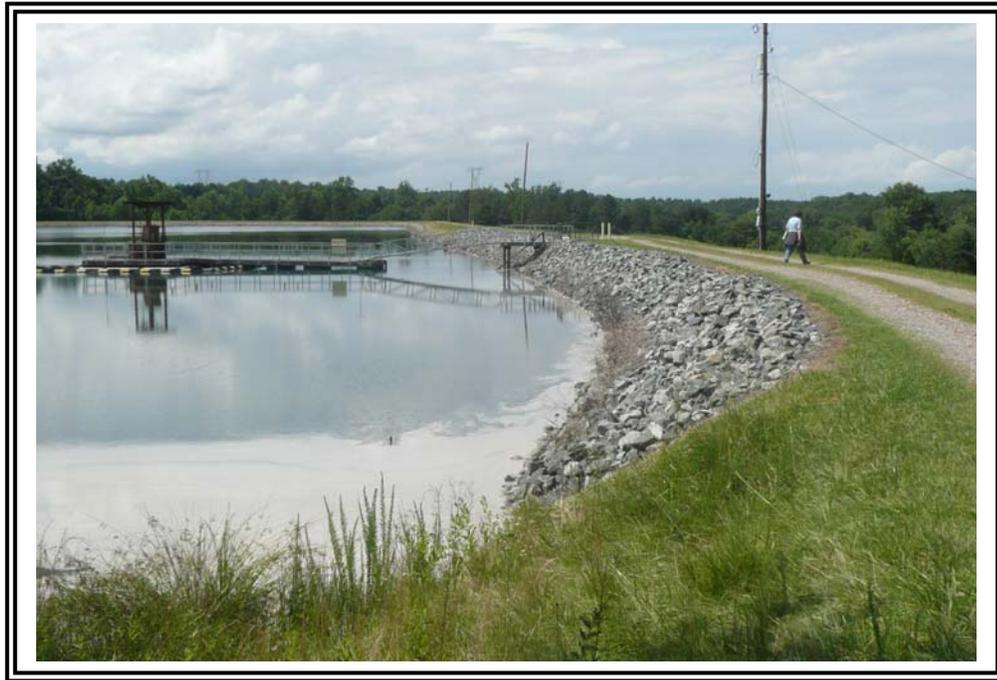
41

Upstream slope and intake tower at secondary dike, looking northwest.

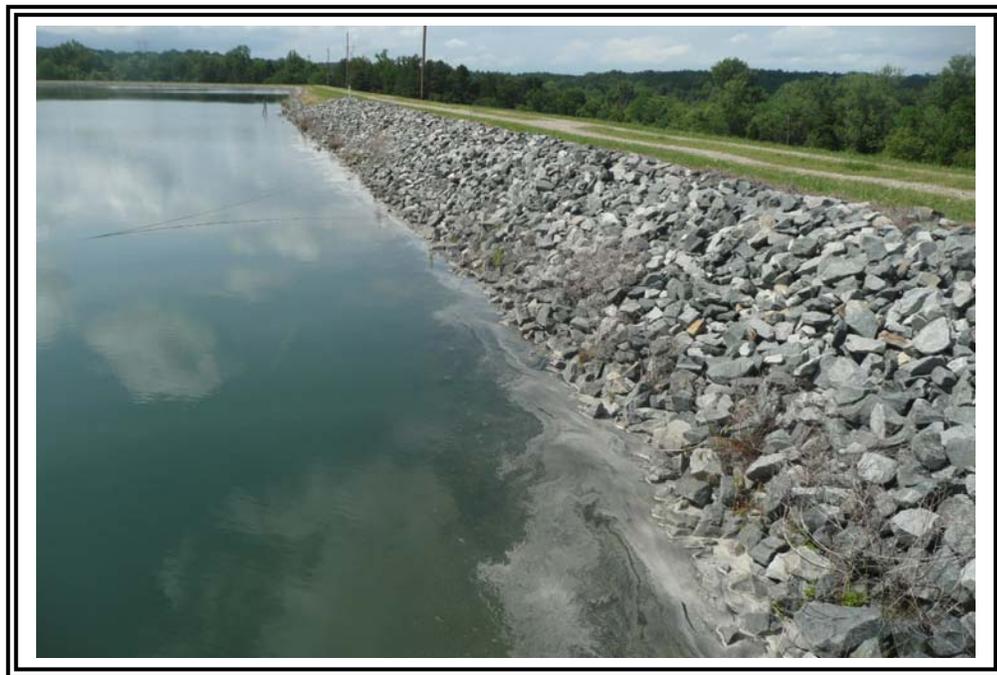
42

Upstream slope of secondary dike taken from the intake tower, looking west.

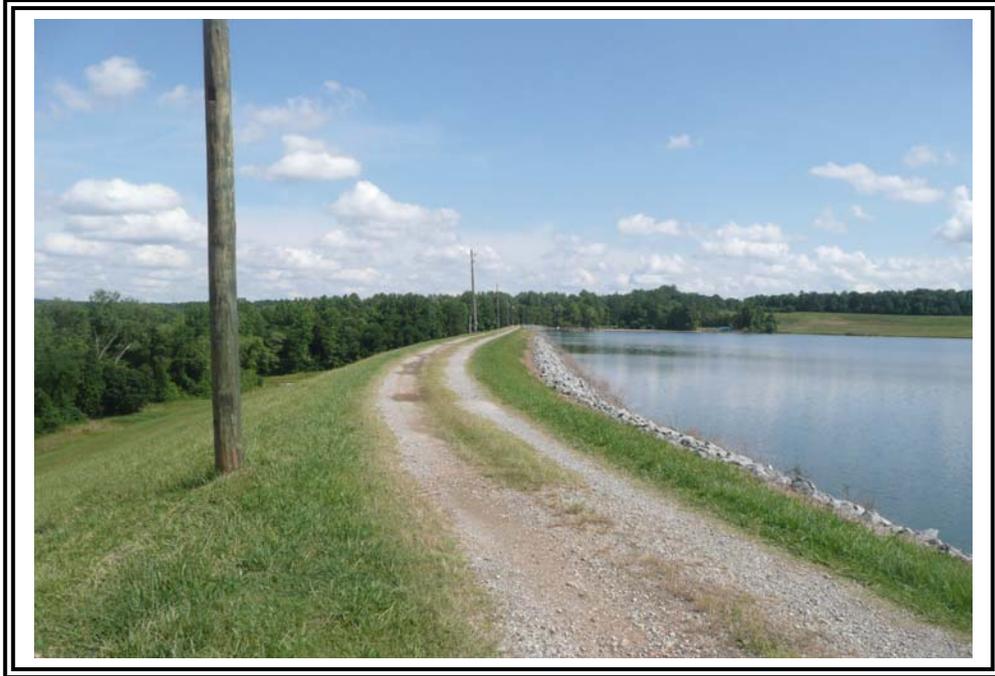
43

West end of secondary dike crest, looking southeast.

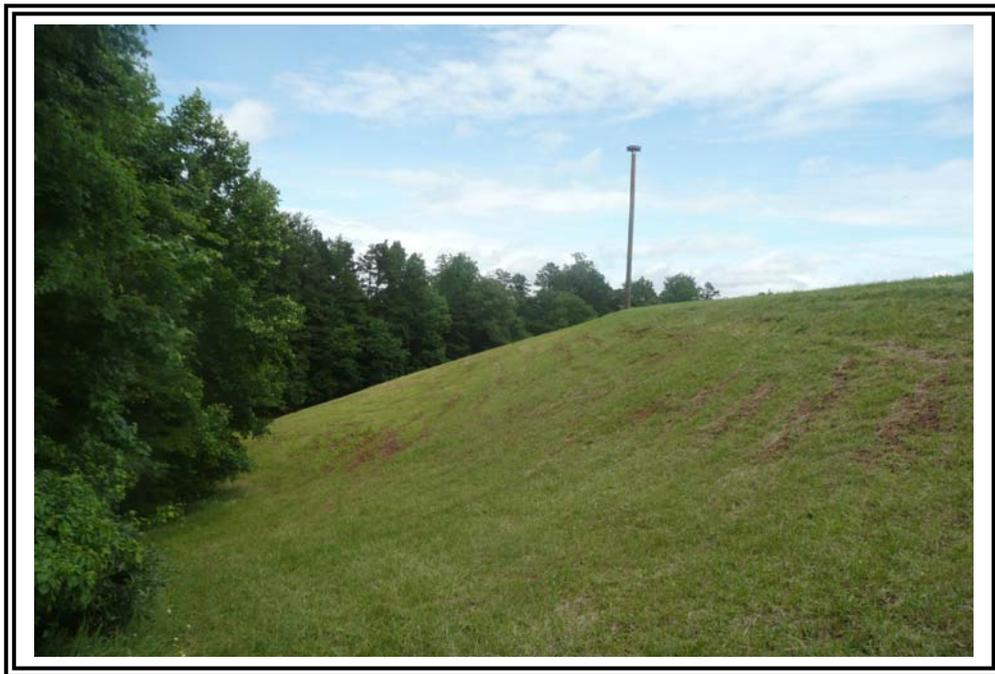
44

West end of secondary dike downstream slope, looking east.

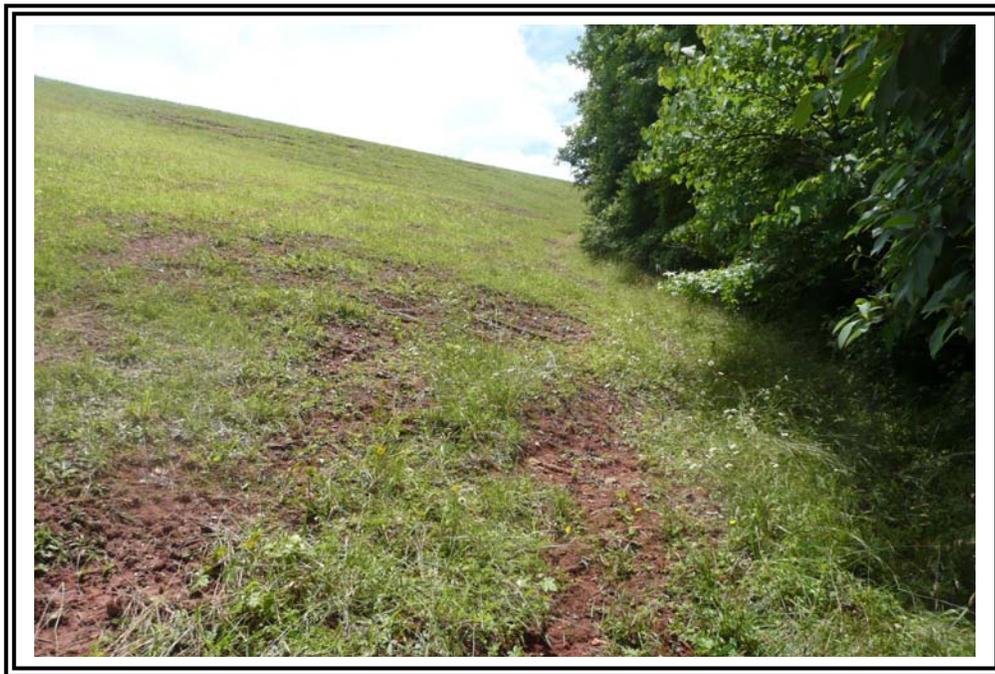
46

Root growth from trees beyond toe. West end of secondary dike.

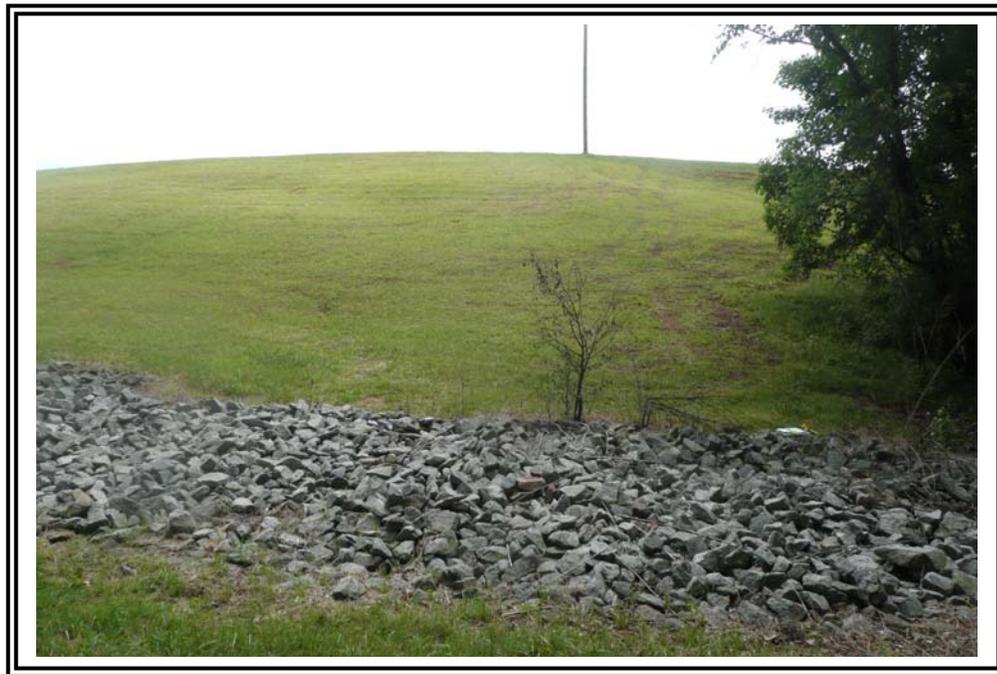
48

Downstream slope of secondary dike at northern point, looking south.

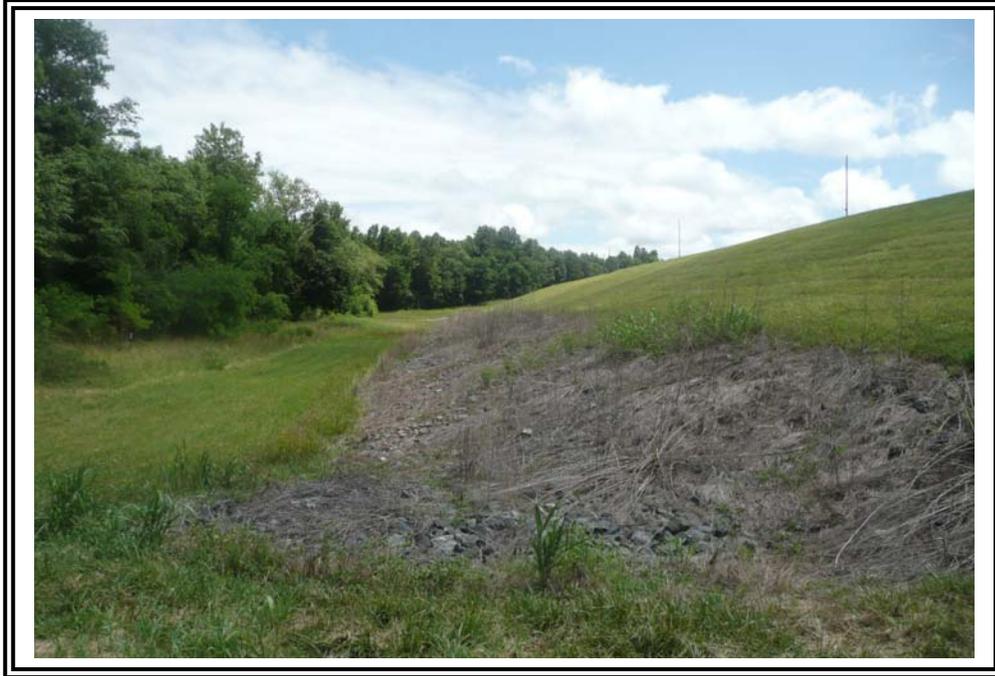
49

Downstream slope and toe drain of secondary dike, looking east.

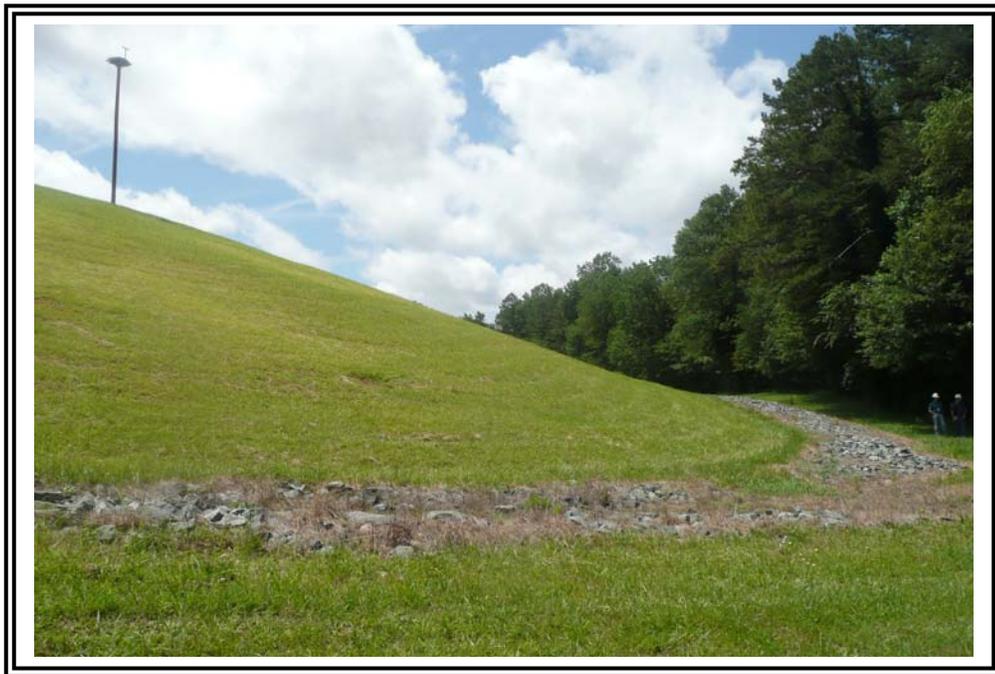
50

Downstream slope of secondary dike, looking west.

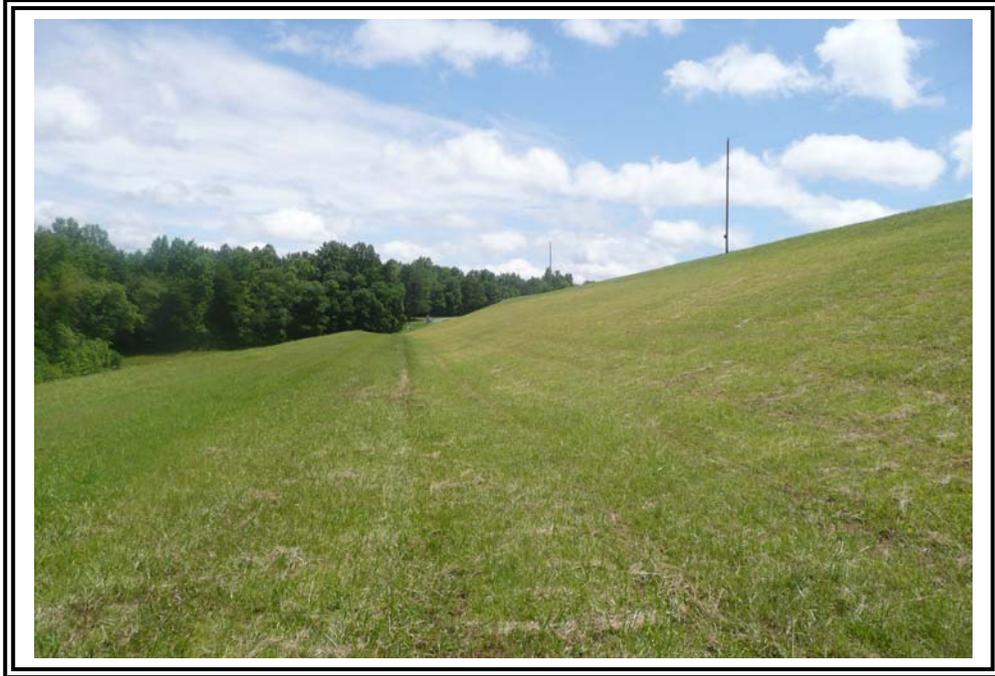
51

Downstream slope of secondary dike at mid-slope bench, looking east.

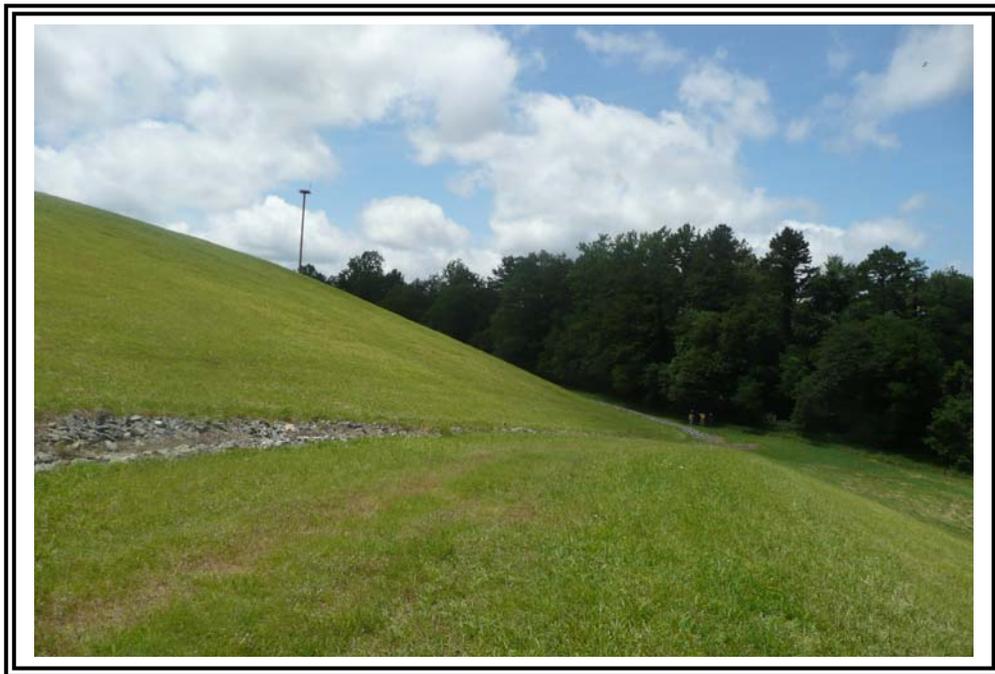
52

Downstream slope of secondary dike drainage swale on bench ties into drainage swale at toe of dike, looking west.

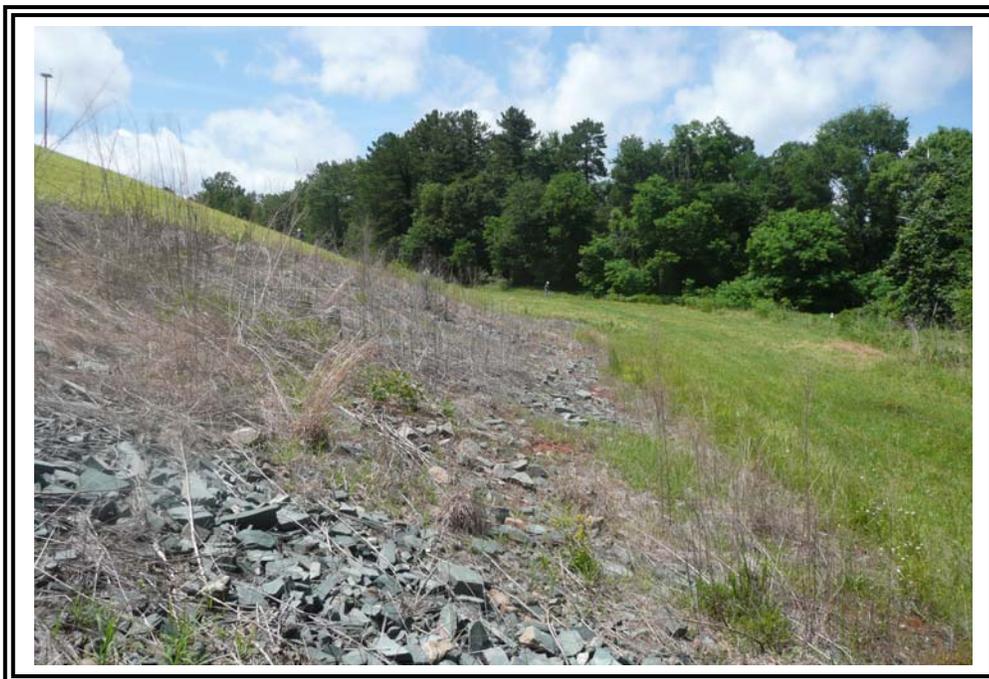
53

Toe drain of secondary dike. Duke Power controls vegetation growth in the rip rap with herbicides.

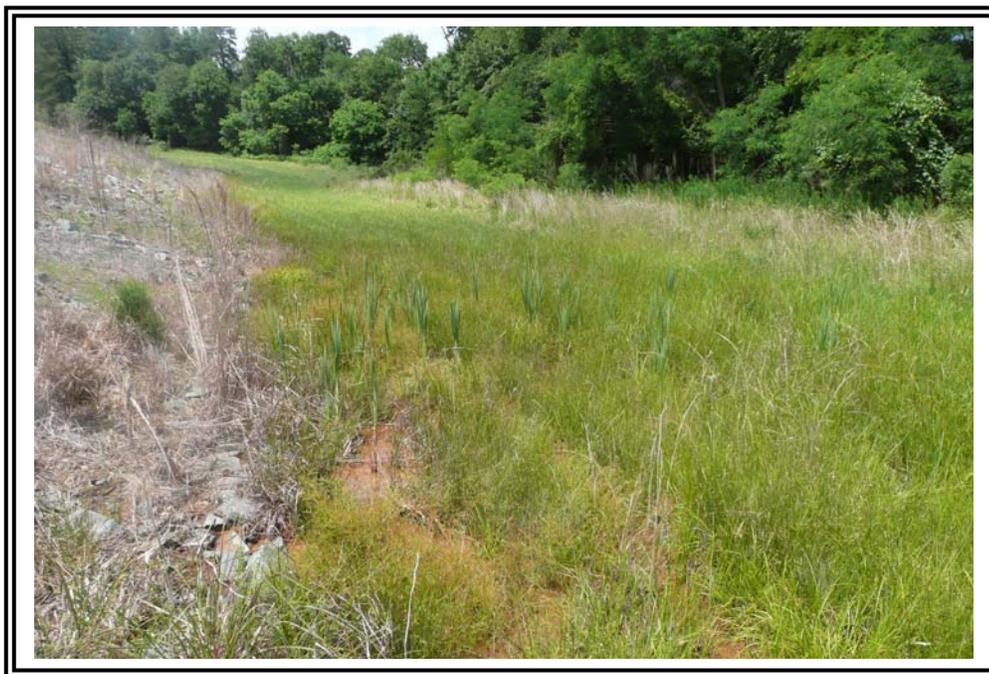
54

Reeds growing in area of seepage at the toe of secondary dike.

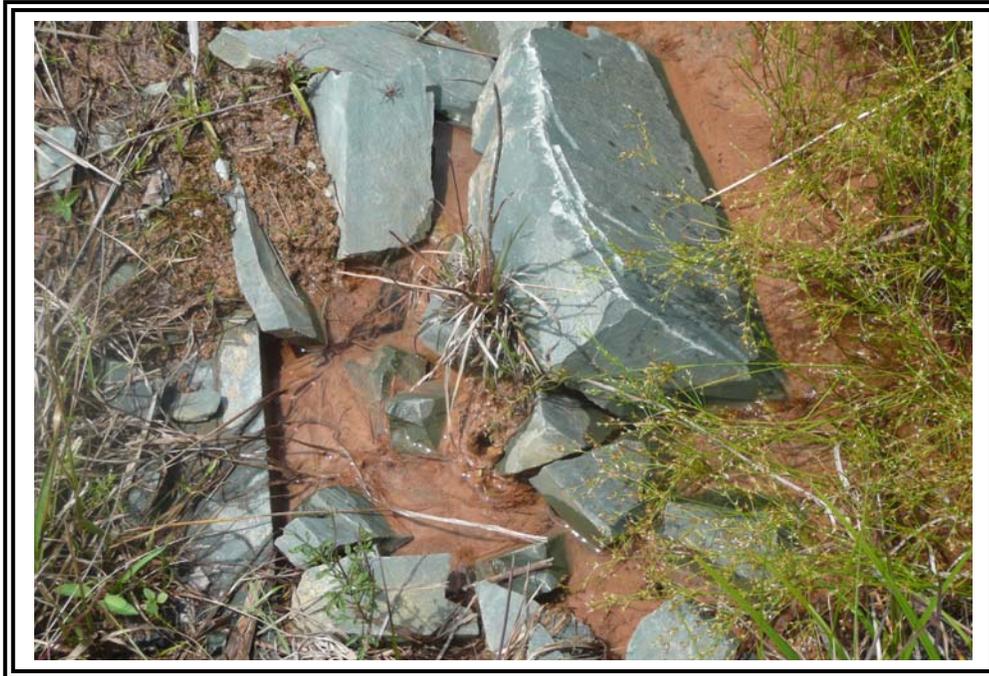
55

Seepage at the toe of the secondary dike about 300 feet from piezometer row. Water is clear.

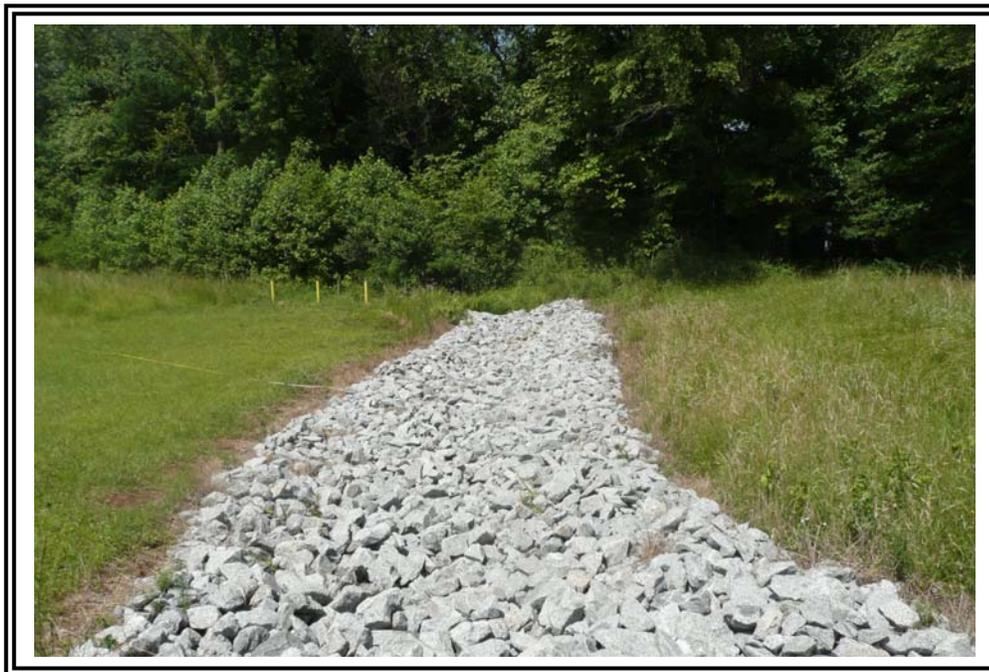
56

Rip rap placed in a wet area at the toe of the secondary dike. Based on field observations it appears the wet area was the result of surface drainage from the bench swale discharge and shallow groundwater levels in this area.

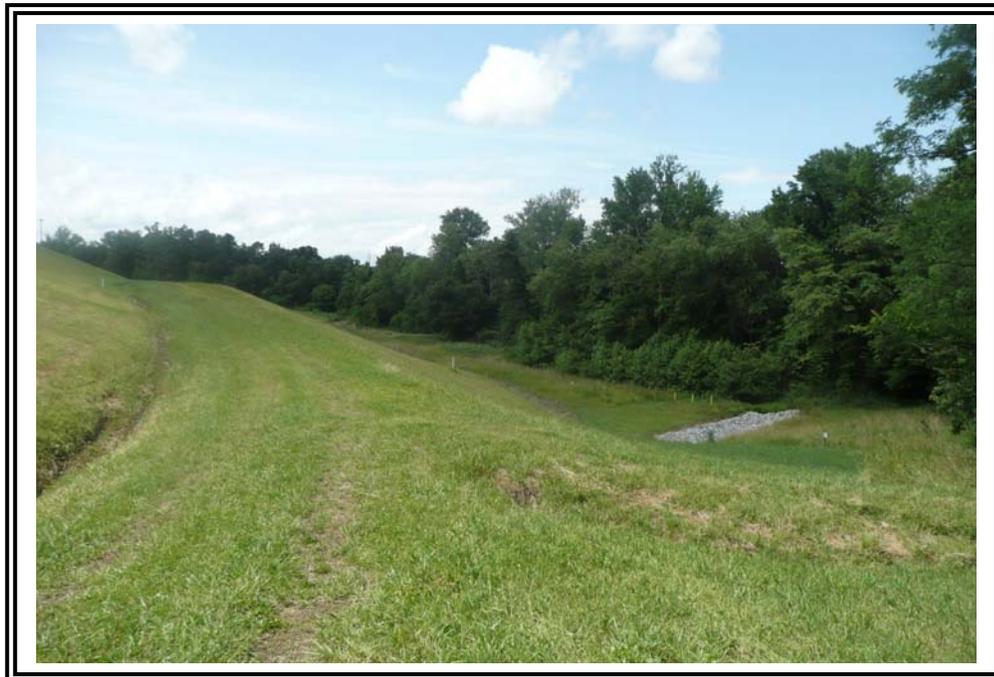
57

Bench and toe area of secondary dike, looking northwest.

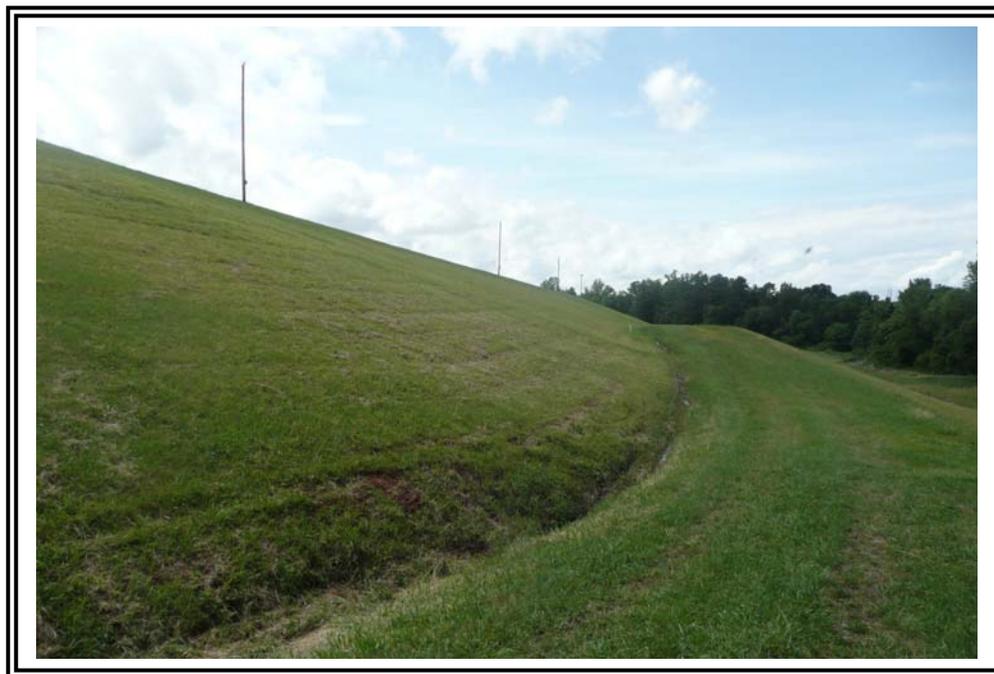
58

Downstream slope and bench of secondary dike, looking west. Note steeper area of drainage swale to left of bench in photo is the location of a culvert draining to the downstream area of the dike.

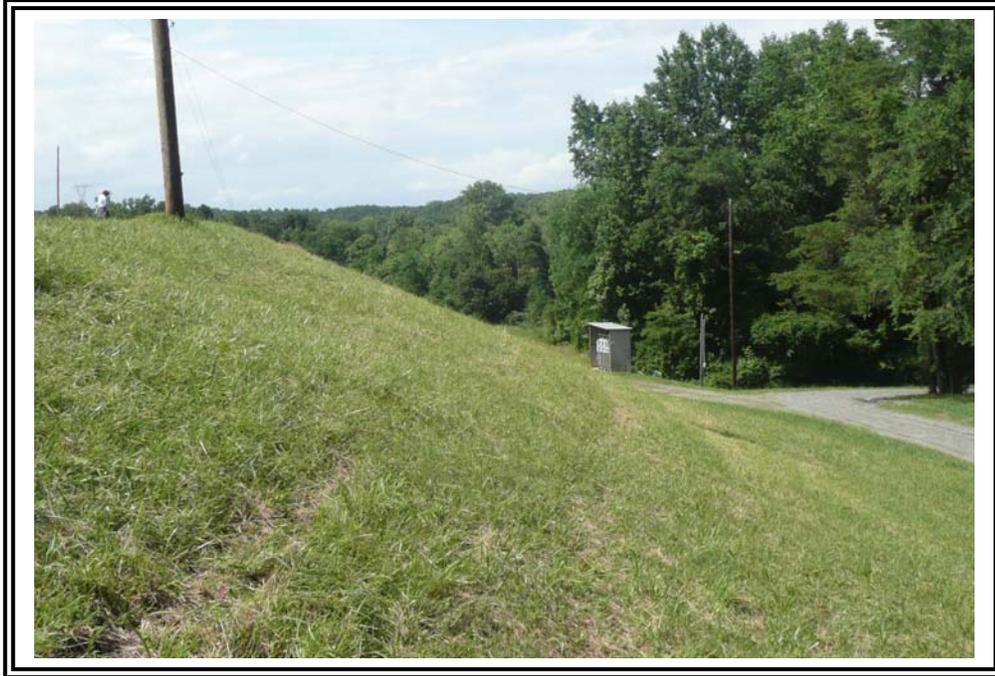
59

Downstream slope near east end of secondary dike, looking northwest.

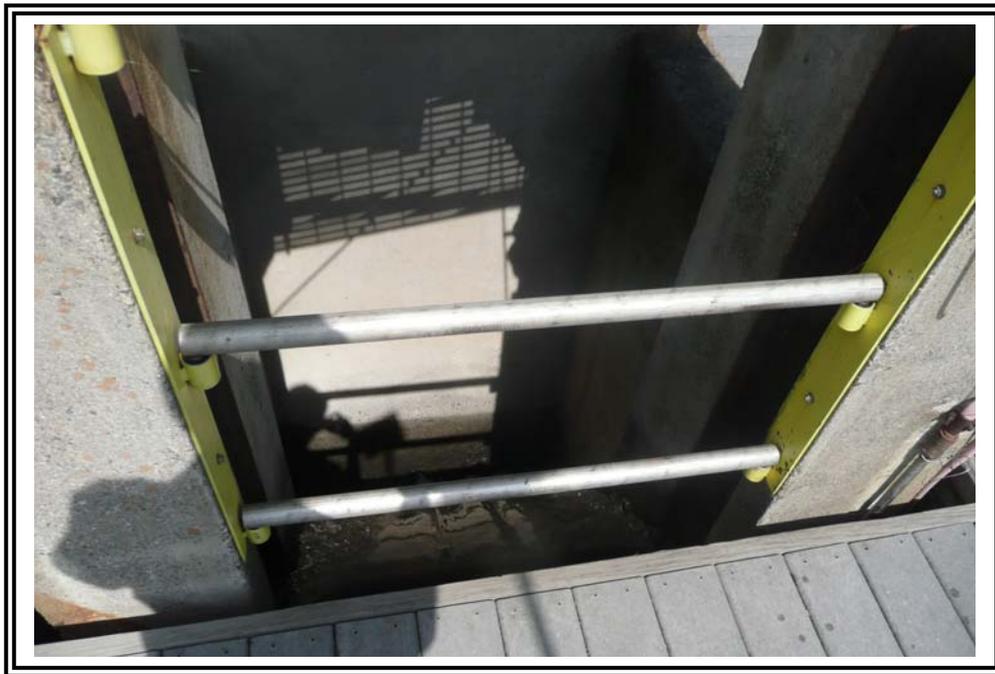
60

Intake tower in secondary pond.

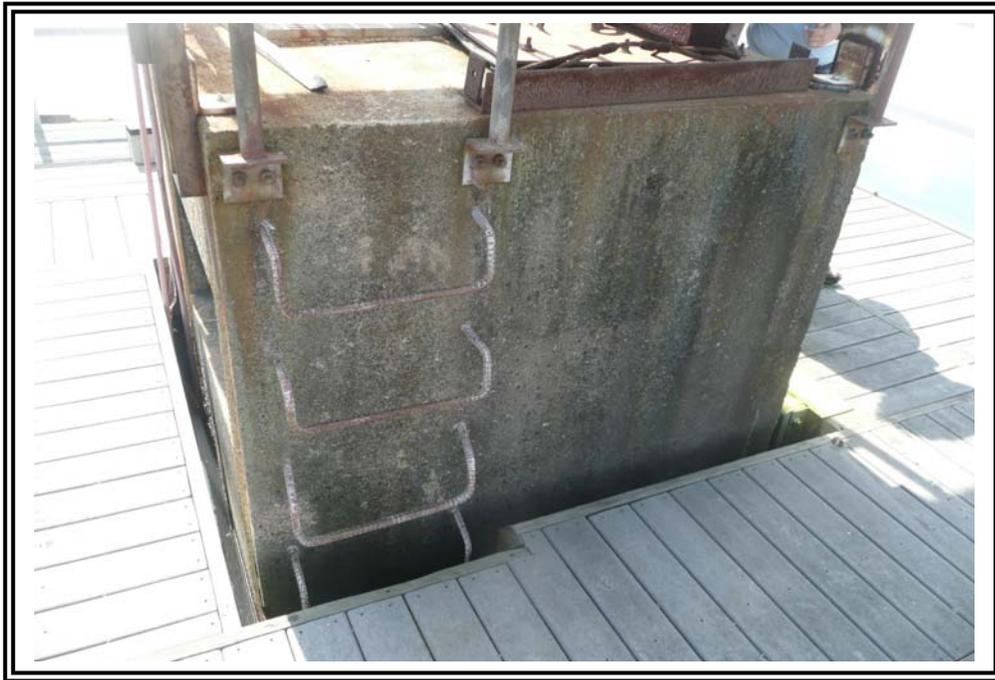
61

Intake tower in secondary pond.

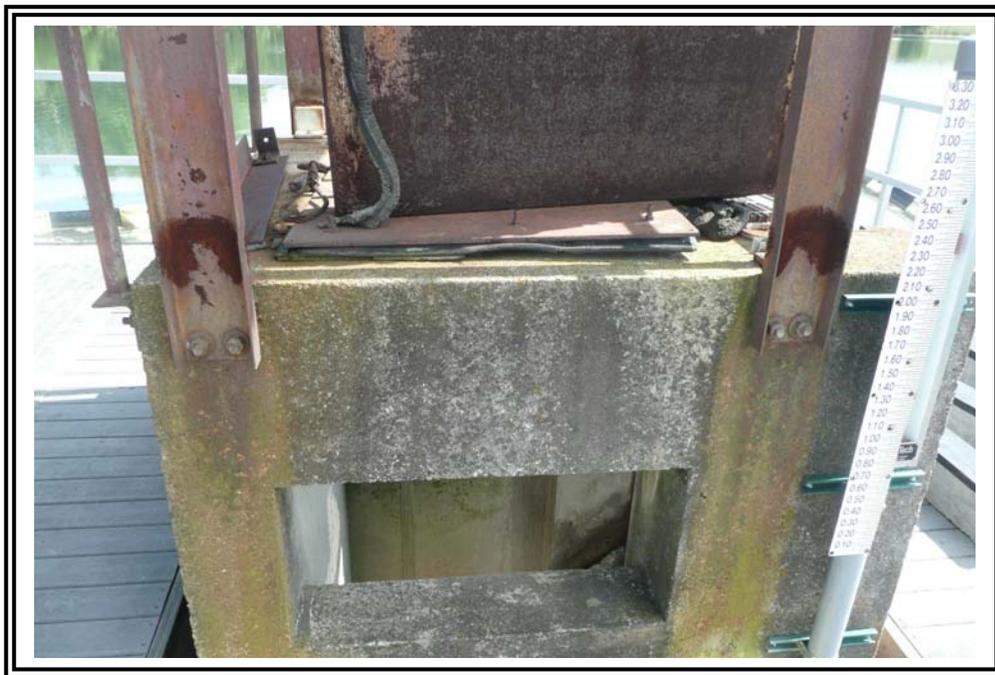
62

Intake tower in secondary pond.

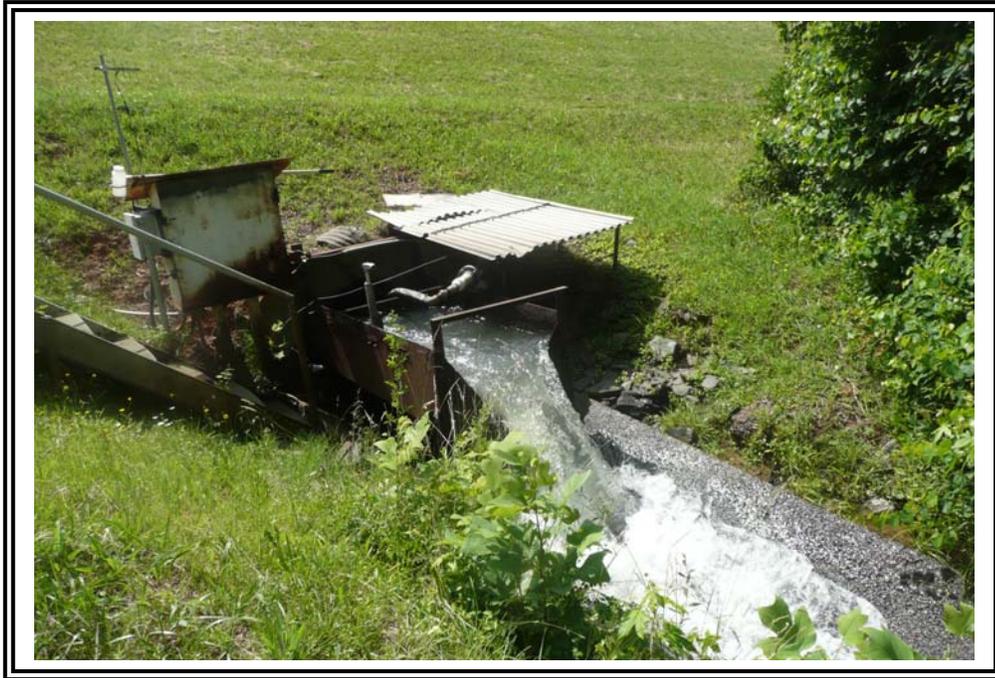
63

Outlet structure at toe of secondary dike, looking upstream to the south-southwest (towards secondary cell).

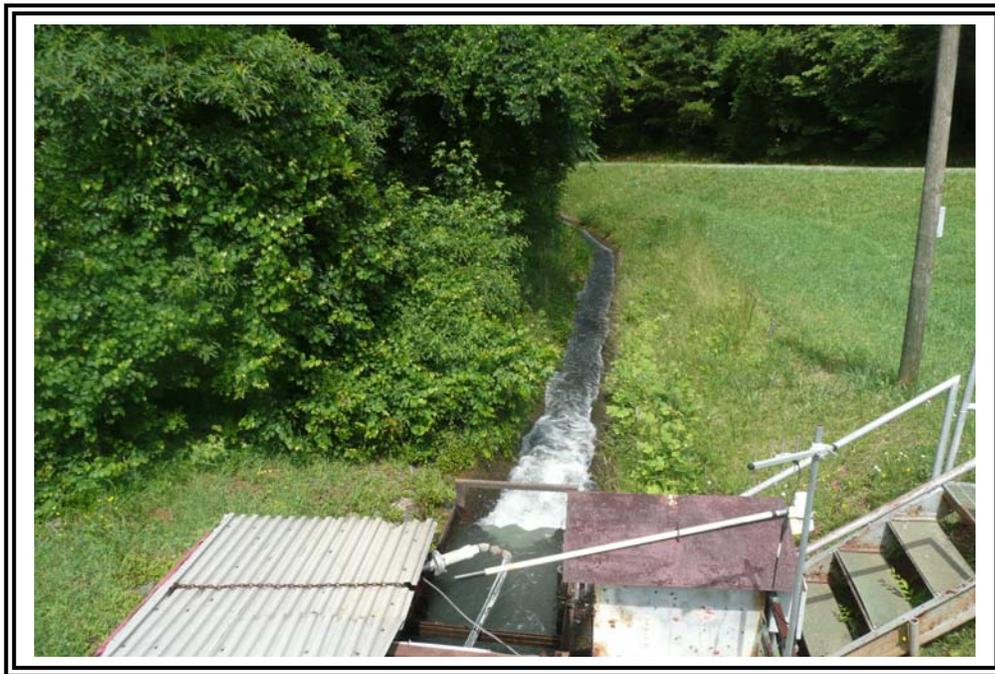
64

Outlet channel of secondary dike, looking downstream to the north-northeast (towards the Catawba River).
