Re: Task 3 Dam Assessment Report
Project #0-381
Allen Steam Station Coal Ash Retention Dam
Belmont, North Carolina

EXECUTIVE SUMMARY

This Phase I Inspection/Evaluation Report details the results of a visual dam inspection of the Allen Steam Station Coal Active Ash Basin North and East Dikes located off State Highway 273 in Belmont, North Carolina. The inspection was performed on June 12, 2009 by GZA GeoEnvironmental, Inc (GZA).

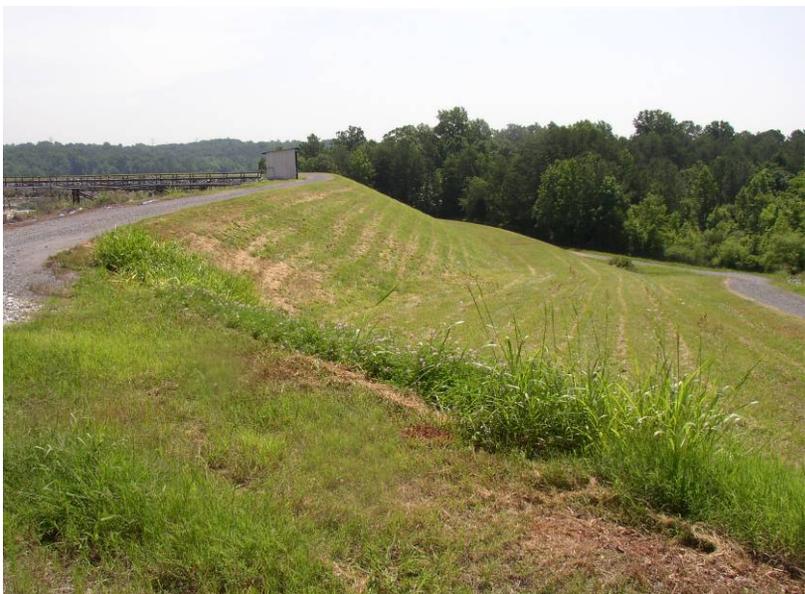
1 Southern Crest & Downstream Slope of East Dike – Local Reseeded Area

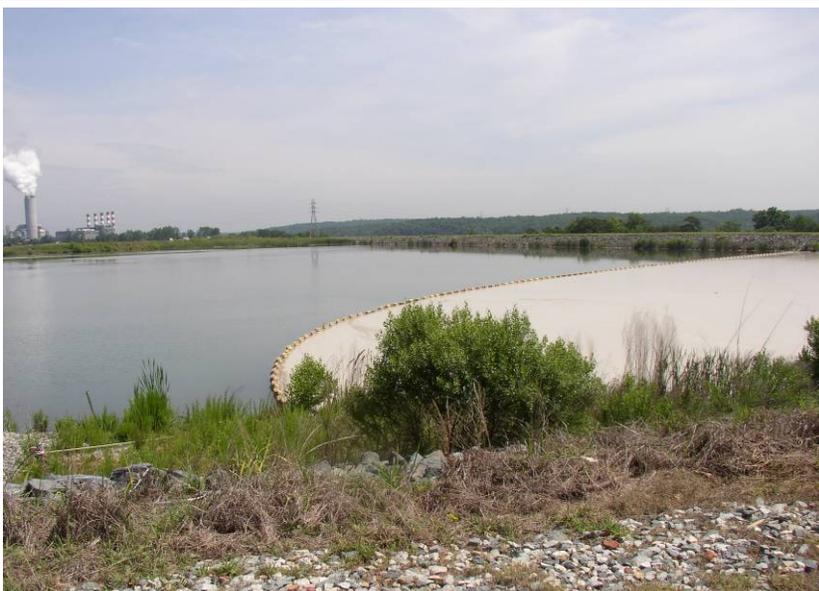
#2 Overview of Polishing Cell

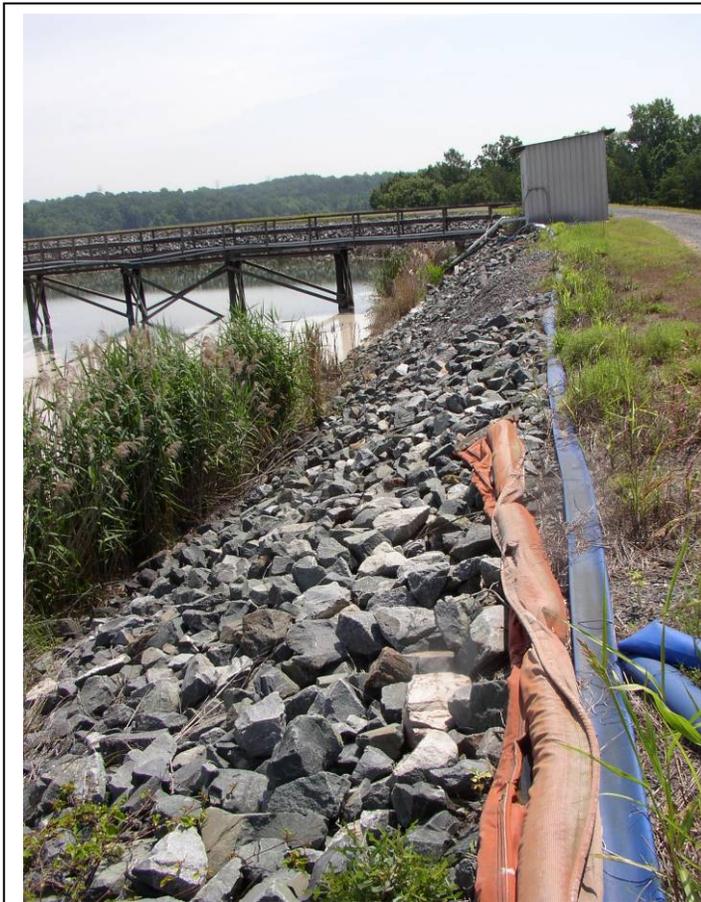
#3 Upstream Slope & Bridge to Drop Inlet Structure

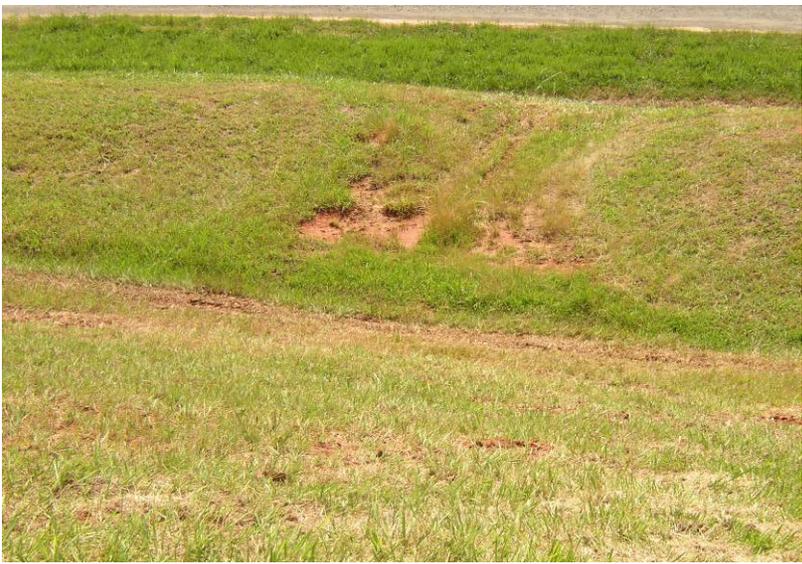
#4 Local Erosion on Top of Downstream Stability Berm – Southern Portion of East Dike

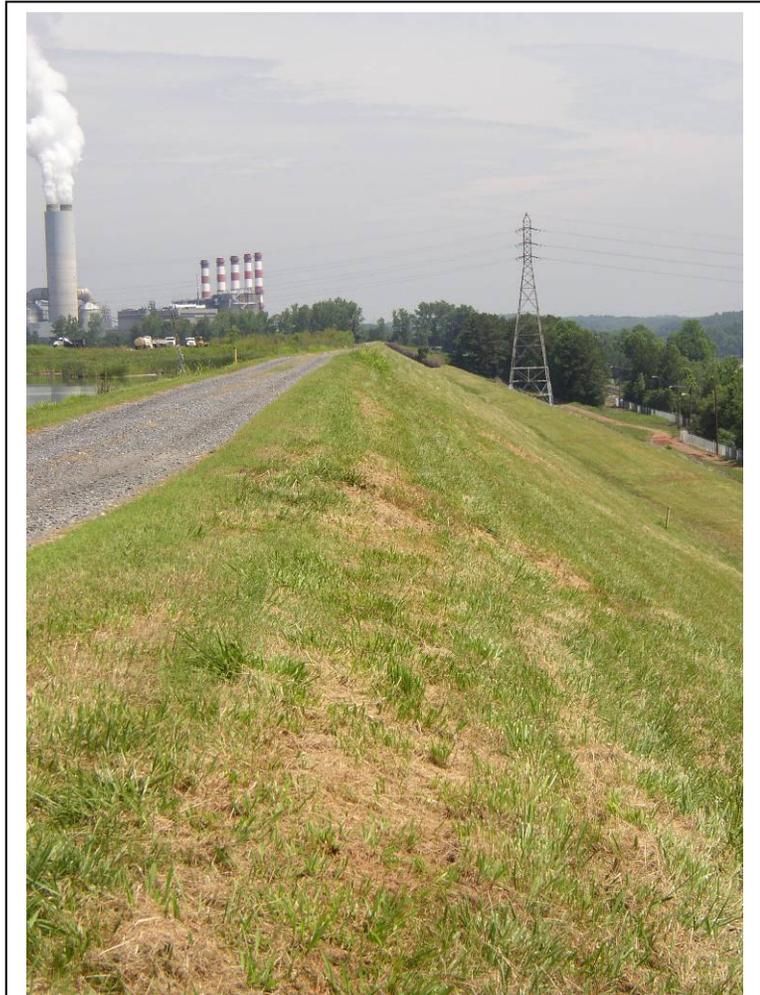
#6 Crest & Downstream Slope of East Dike

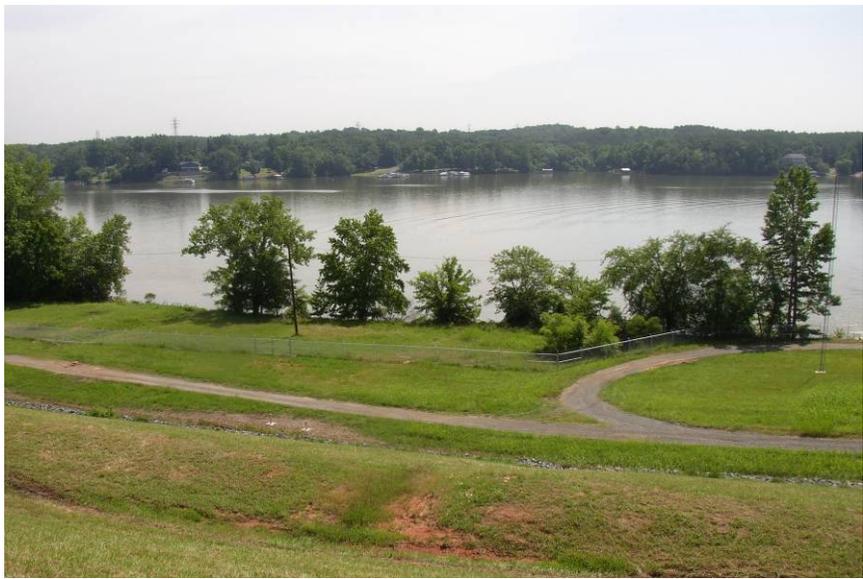
#7 Downstream Berm & Toe Area of East Dike – Southern Portion
Lake Wylie at Downstream Toe

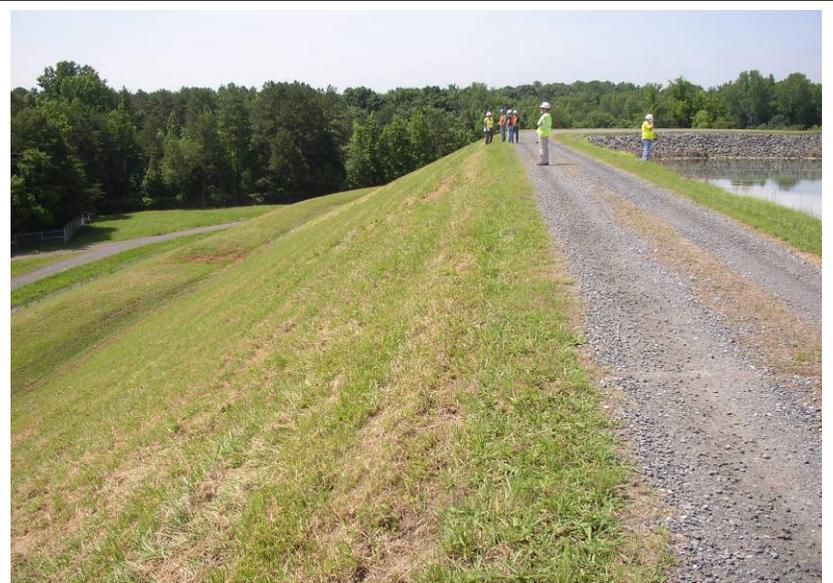
#9 Southern Portion of Crest & Downstream Slope of East Dike –
Note Pondered Water on Berm

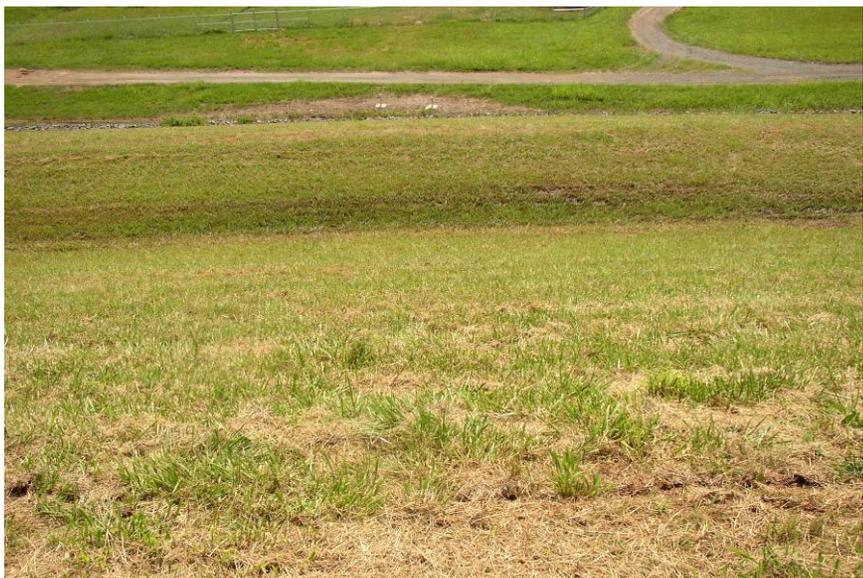
#8 Pondered Water on Bench of Downstream Stability Berm of East Dike

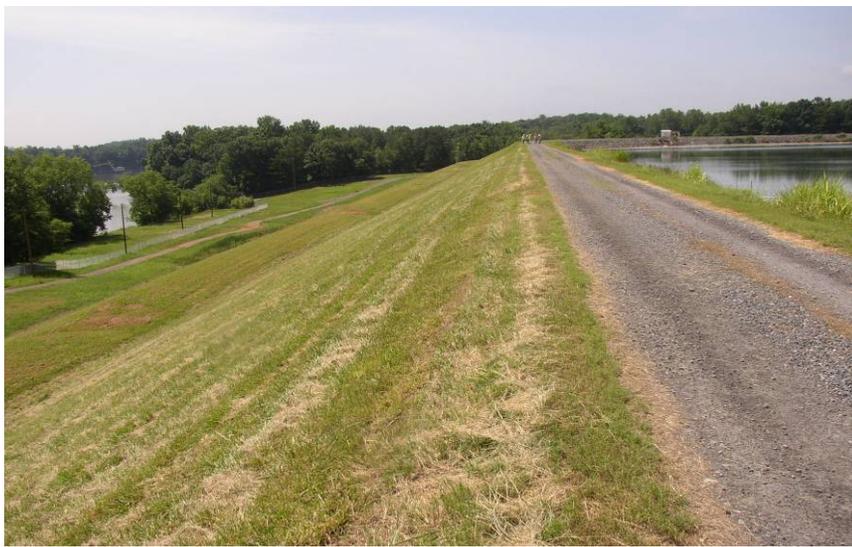
**#11 Maximum Section Portion of East Dike –
Note Wet Area at Toe and Local Berm Erosion**

4. Observations of the upper downstream toe of the East Dike should be made during periods of low rainfall to determine whether the standing water observed at the toe was due to surface water runoff or internal seepage. Seepage conditions should be monitored regularly

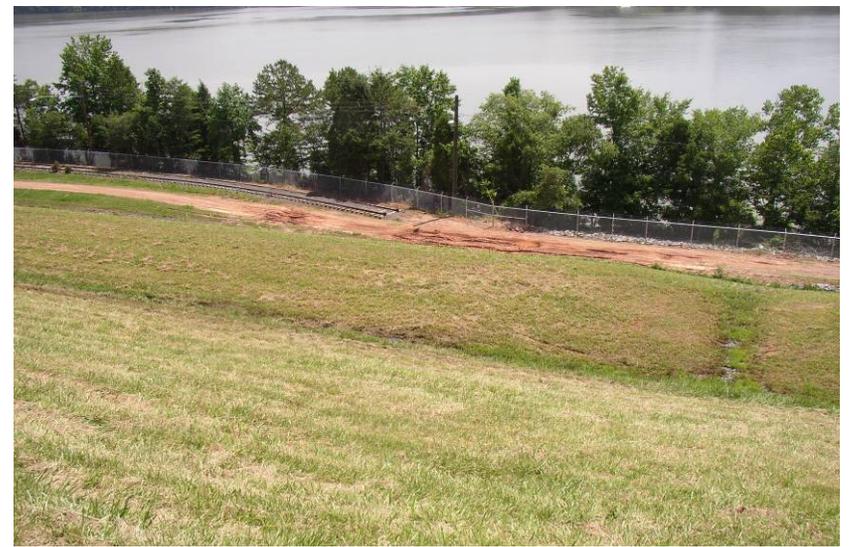
**#13 Eroded Area of Downstream Toe Road from Operations due to
Installation of Chain Link Fencing and Mowing**

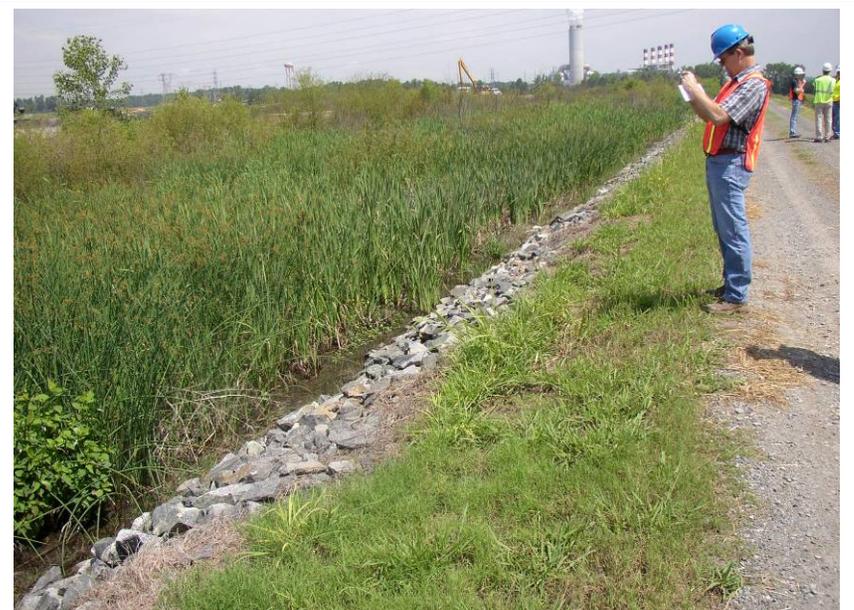
#14 Northern Ash Retention Cell 3

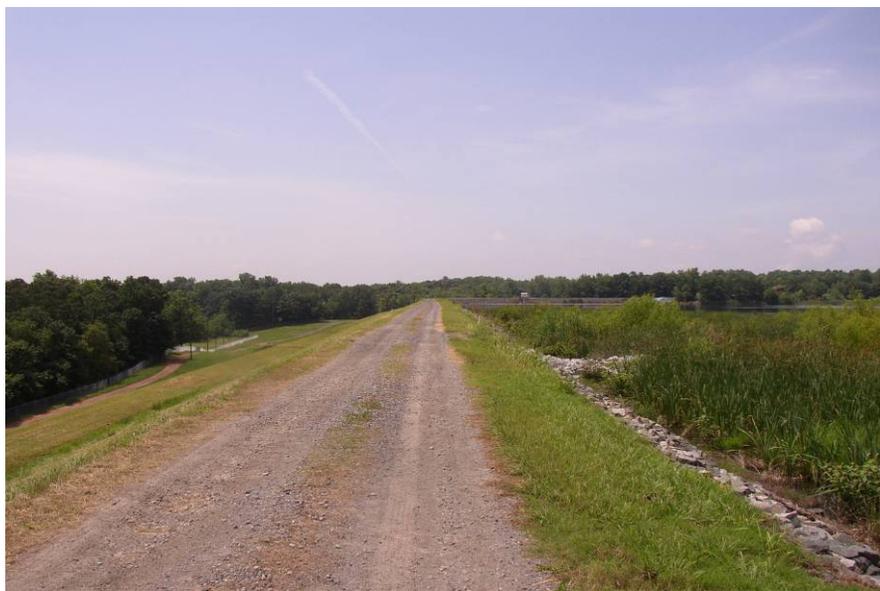
#15 Crest of East Dike Looking South - Satisfactory Alignment

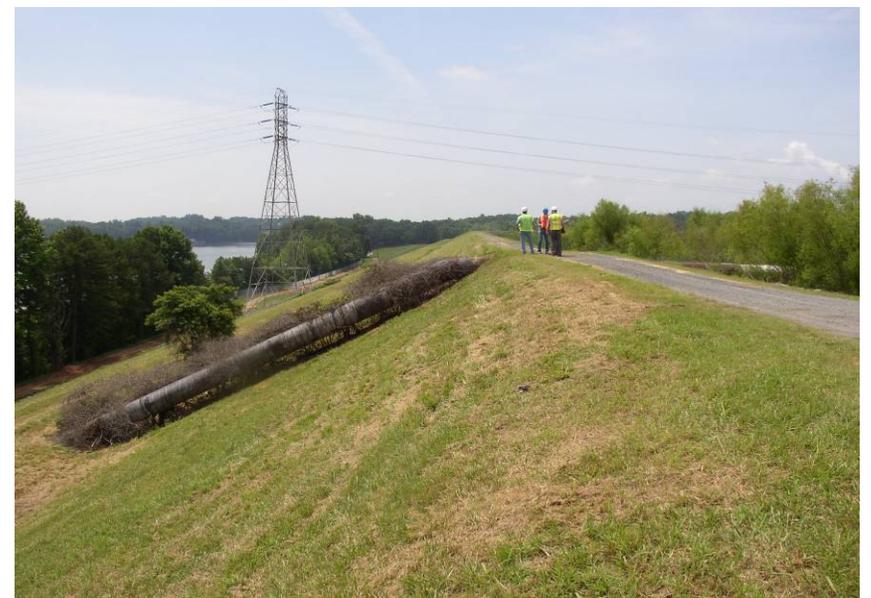
#17 Northern Portion of Downstream Slope of East Dike

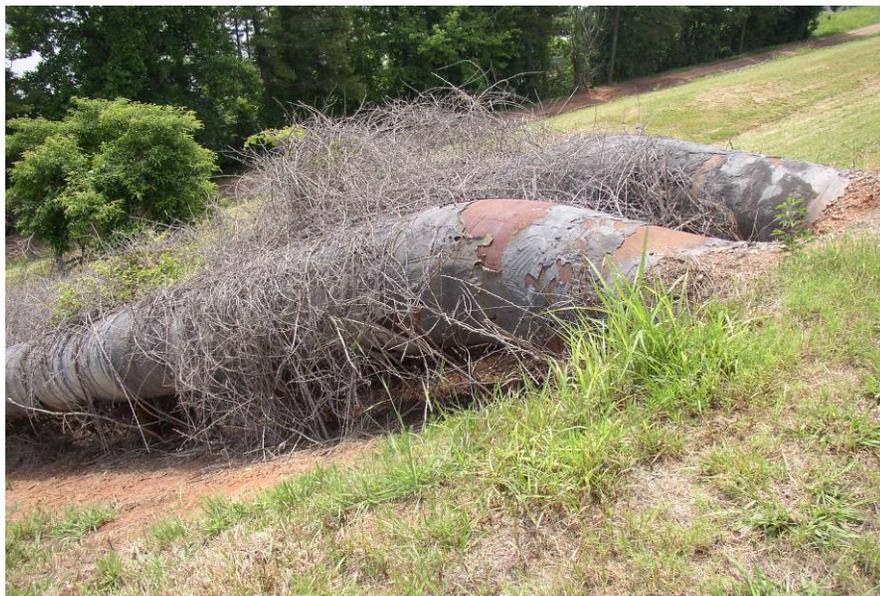
#16 Wastewater Sump Discharge Pipes @ Cell 3

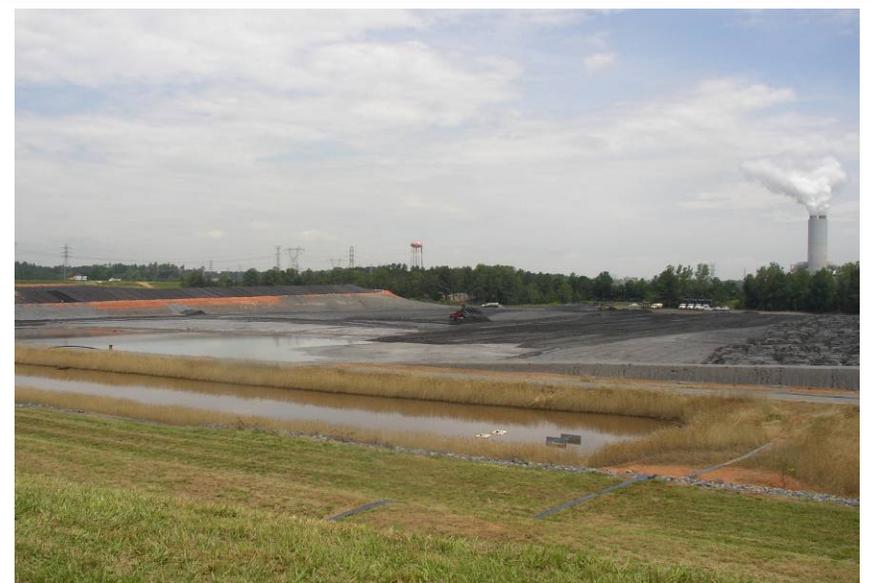
#18 New Ash Landfill Construction

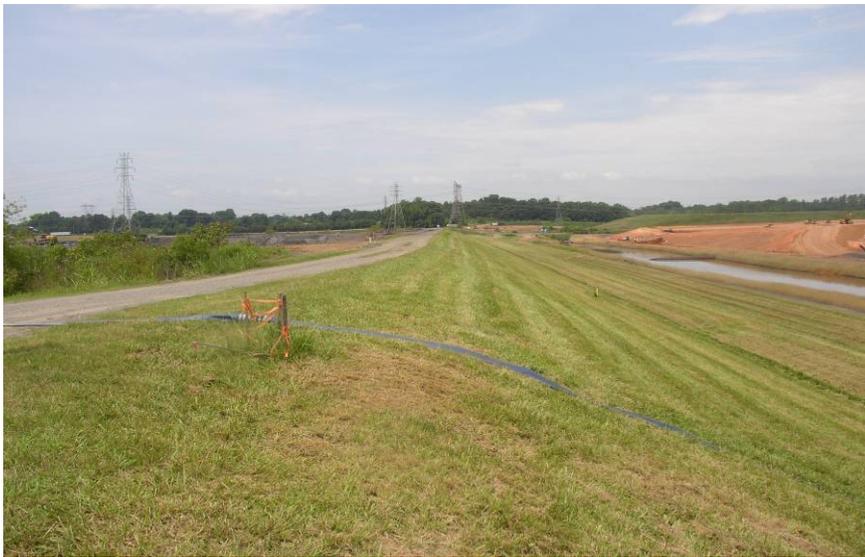
#19 Overview of Crest & Downstream Slope of North Dike

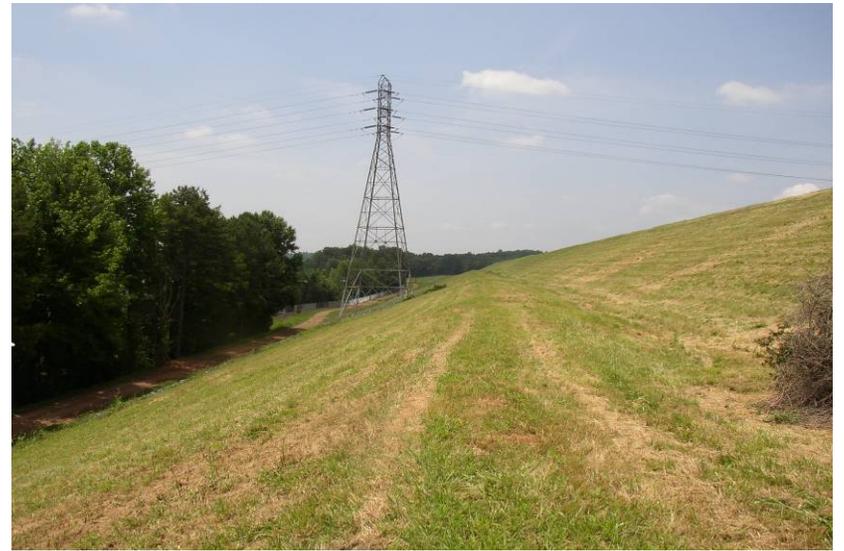
#21 Stability Berm at North End of East Dike

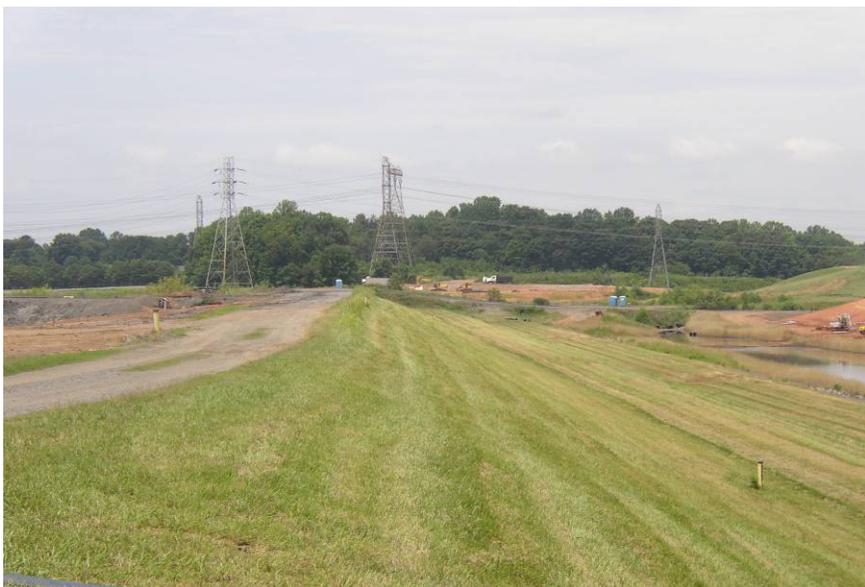
#20 Overview of Central Portion of North Dike

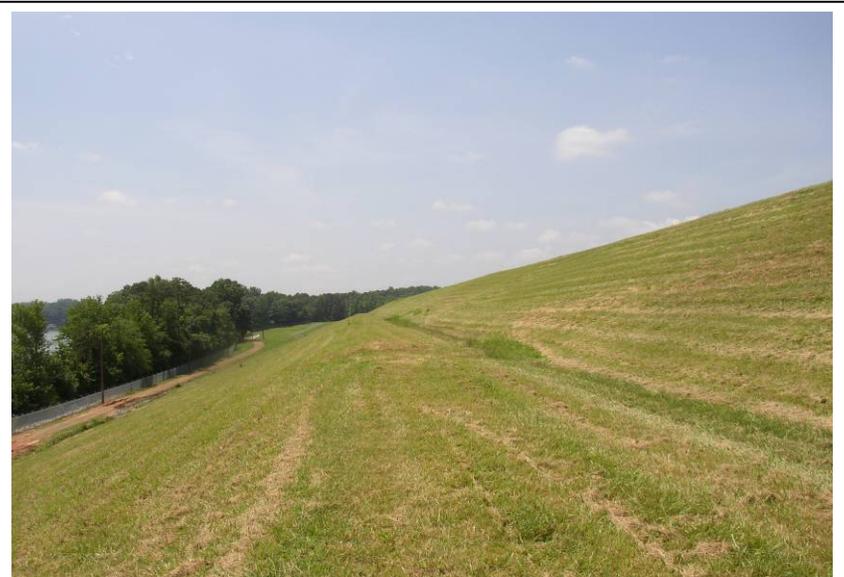
#22 Stability Berm and Downstream Slope of East Dike

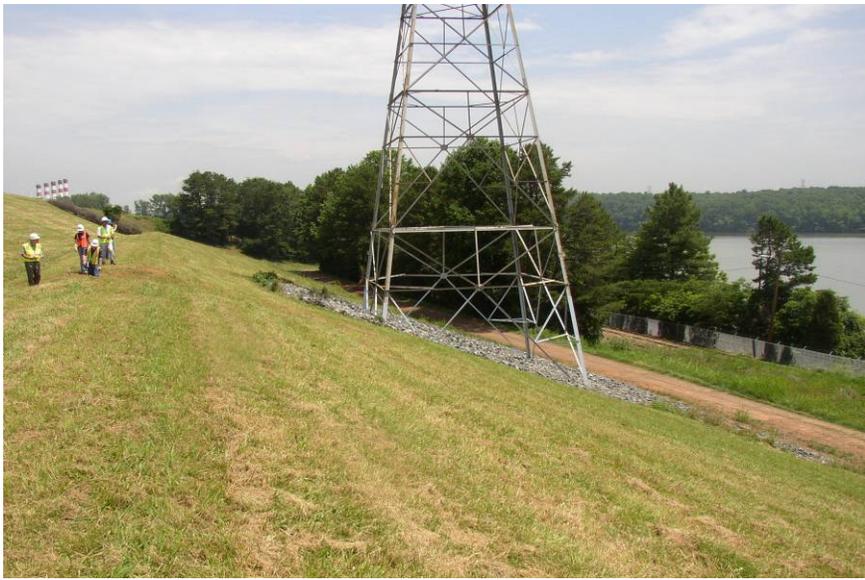
#23 Northern End of East Dike - Note Stability Berm Extends Over Transmission Tower

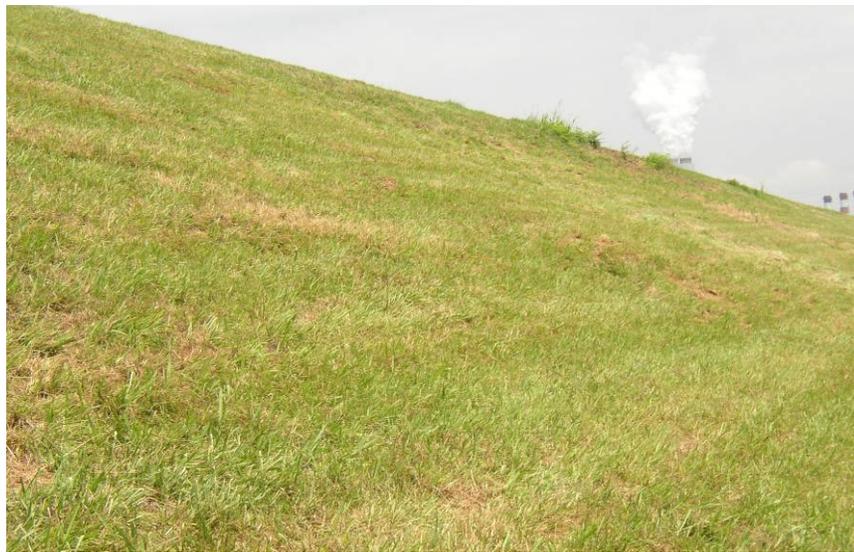
#27 Note Minor Bulging of Lower Portions – Upper Slope Above Stability Berm of East Dike

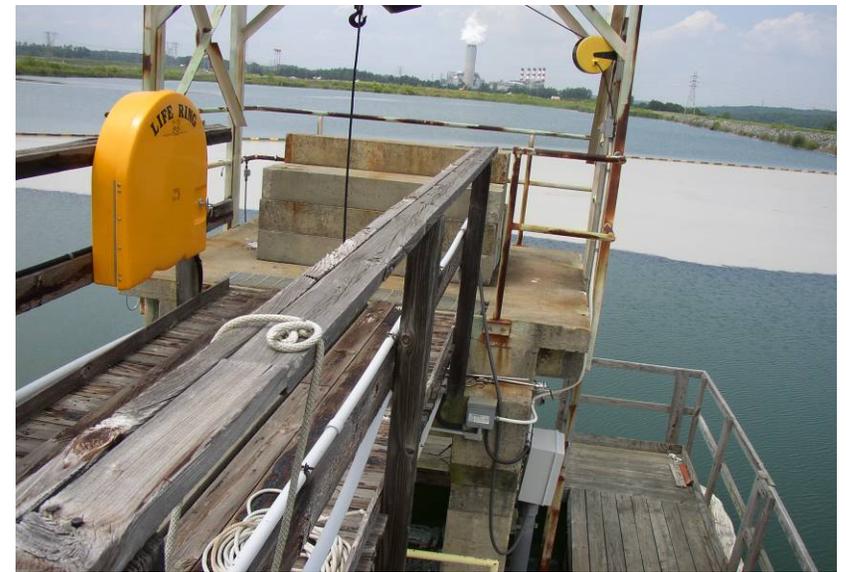
#29 Drop Inlet Structure - Note Concrete Stop Logs and Crane

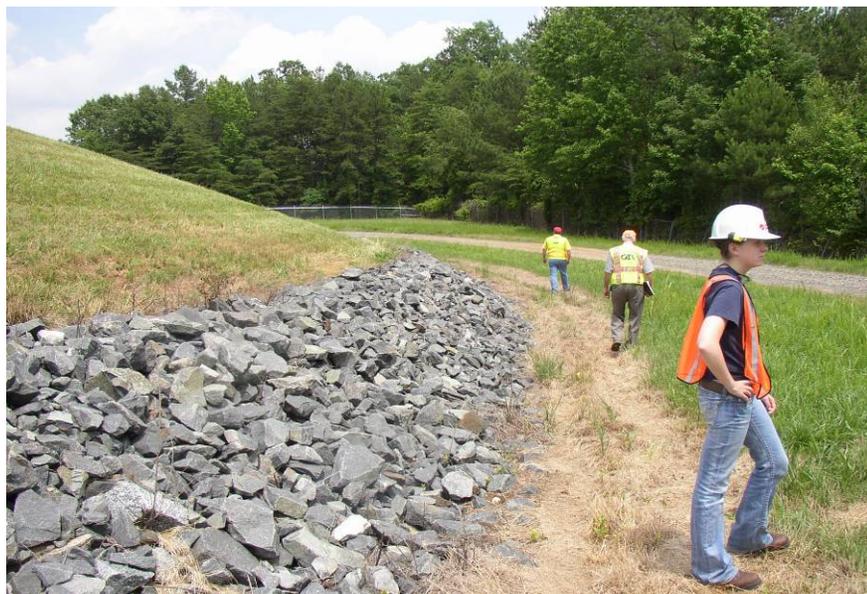
#28 Riprap at Downstream Toe of East Dike - Southern Portion

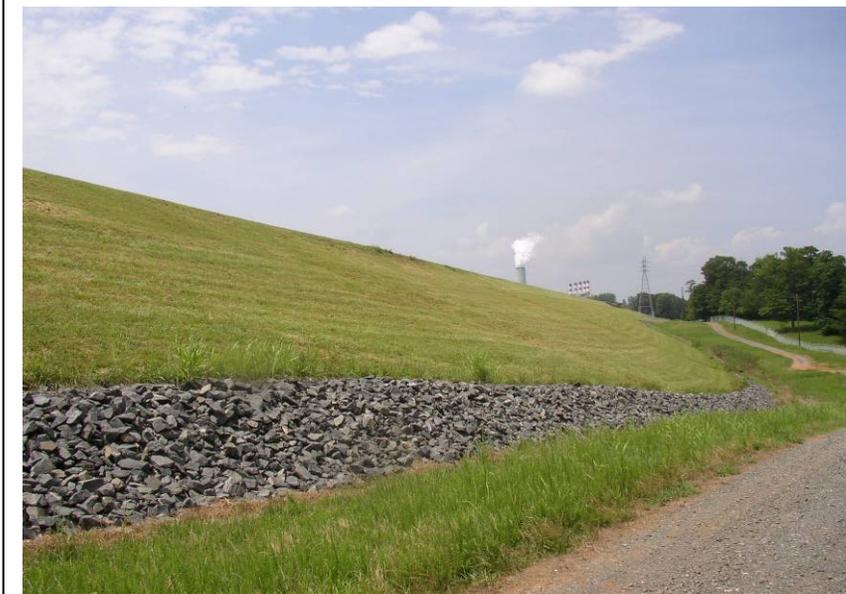
#30 Overview of Downstream Toe of East Dike Near Maximum Section

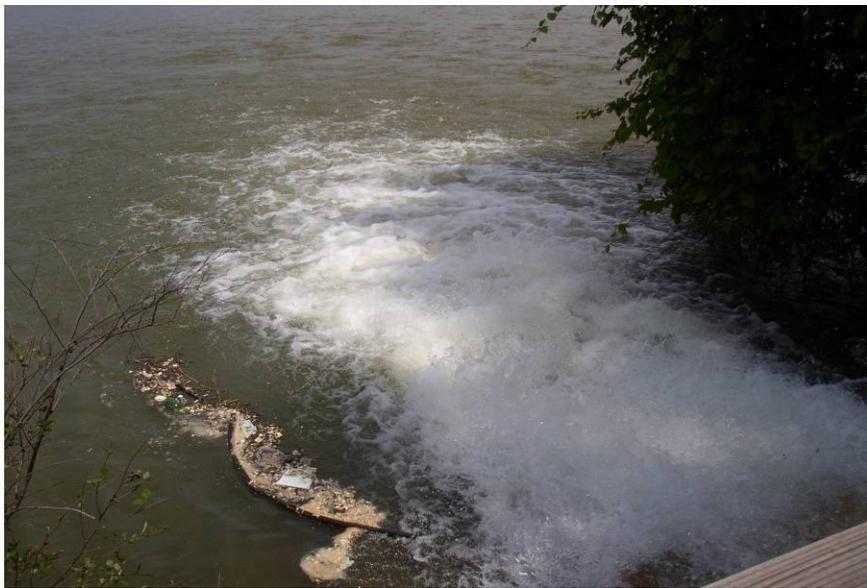
#31 Discharge at Outlet Pipe

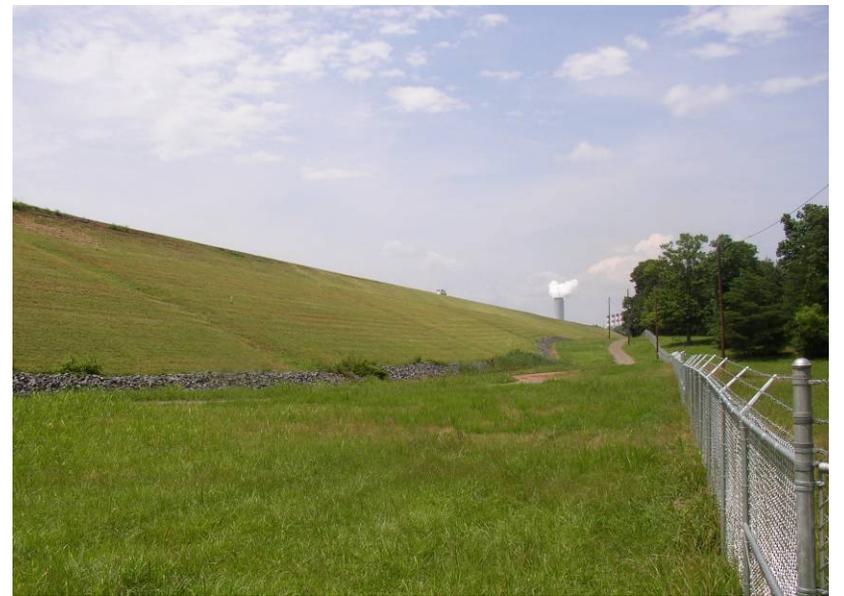
#33 Overview of Downstream Slope of East Dike – Maximum Section

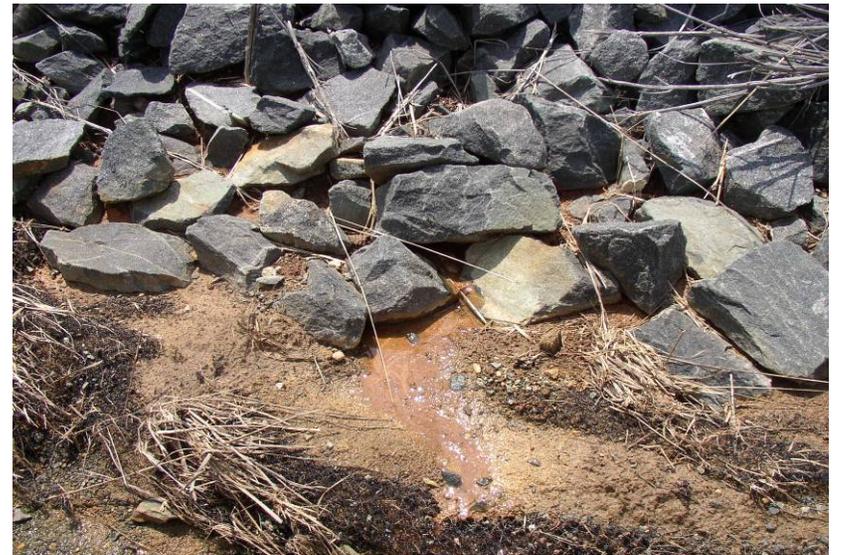
#34 Minor Local Clear Seepage Discharges from Downstream Rock Toe at South End of East Dike

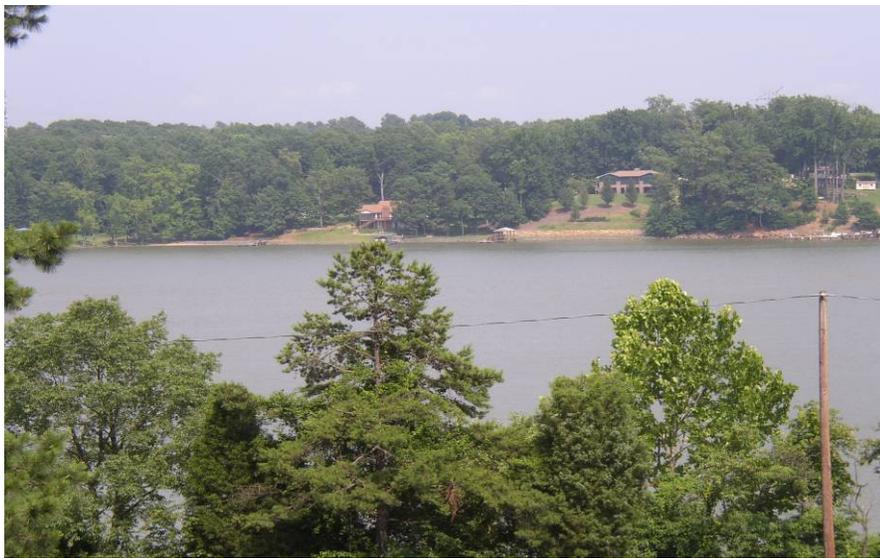
#41 Shoreline on Opposite Bank of Tailwater Impoundment – Lake Wylie –
Note Development

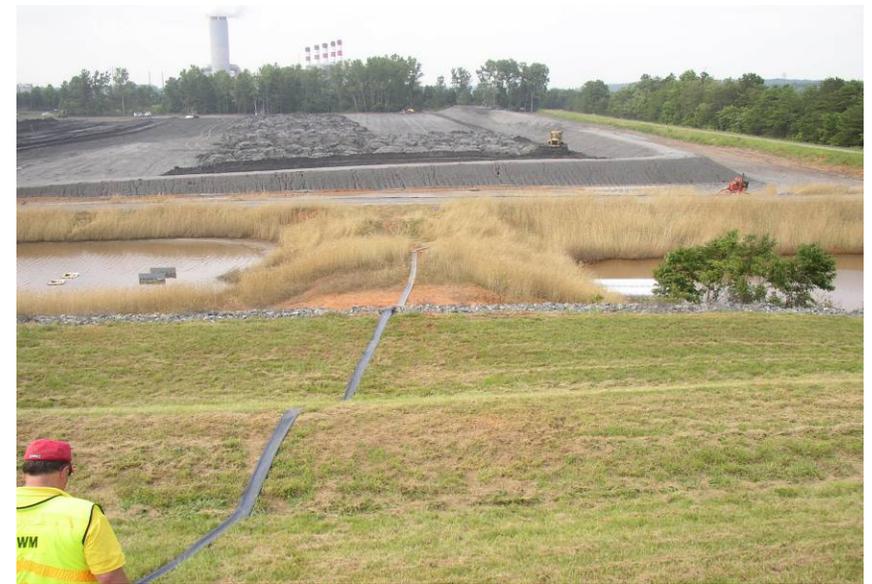
#43 Stabilizing Berm from Crest

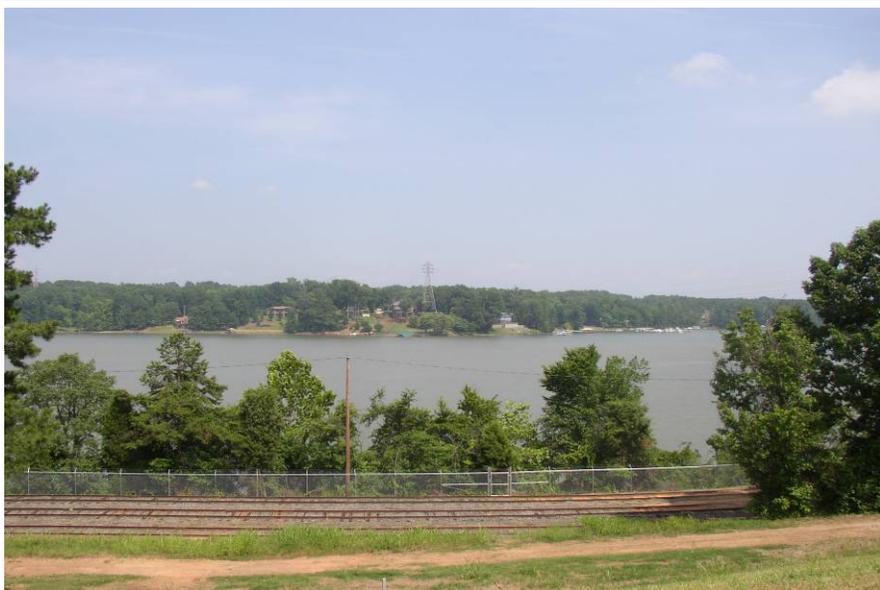
#42 Shoreline on Opposite Bank of Tailwater Impoundment – Lake Wylie

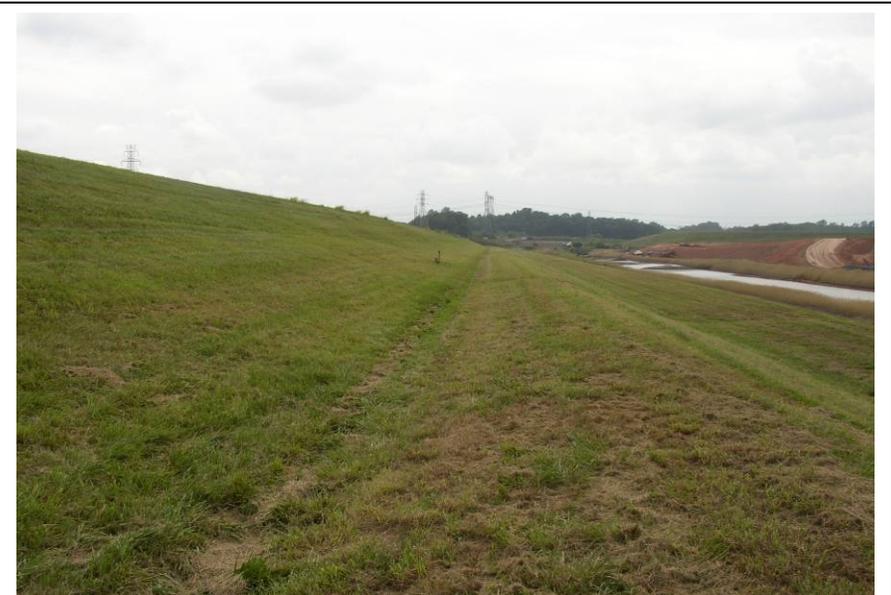
#44 Upper Berm of North Dike - 15 Feet Wide @ Elev. 630

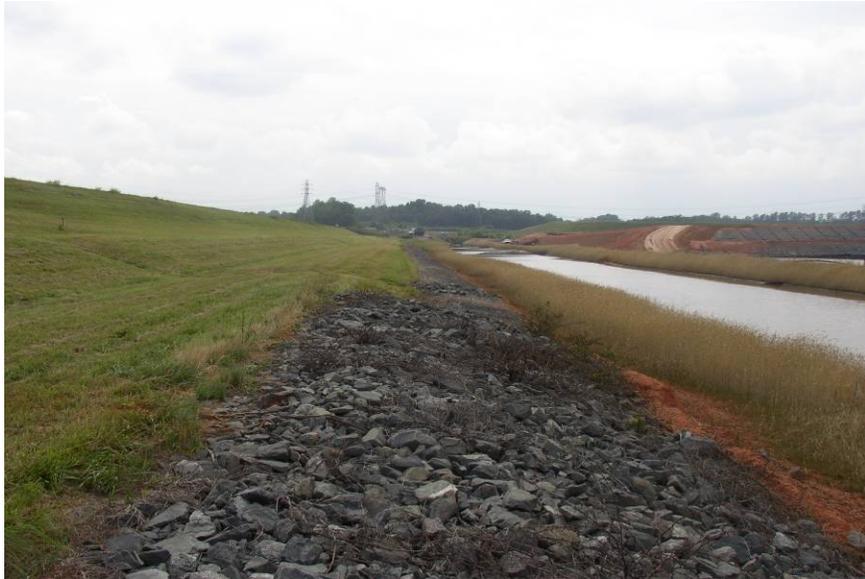
#45 Downstream Toe of North Dike

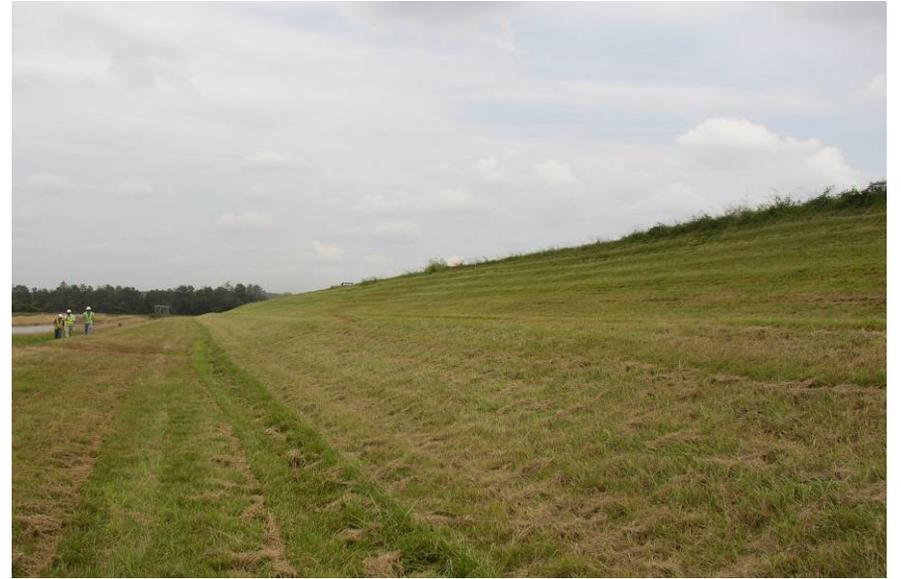
#47 Lower Berm of North Dike – 25-Foot-Wide Berm @ Elev. 625

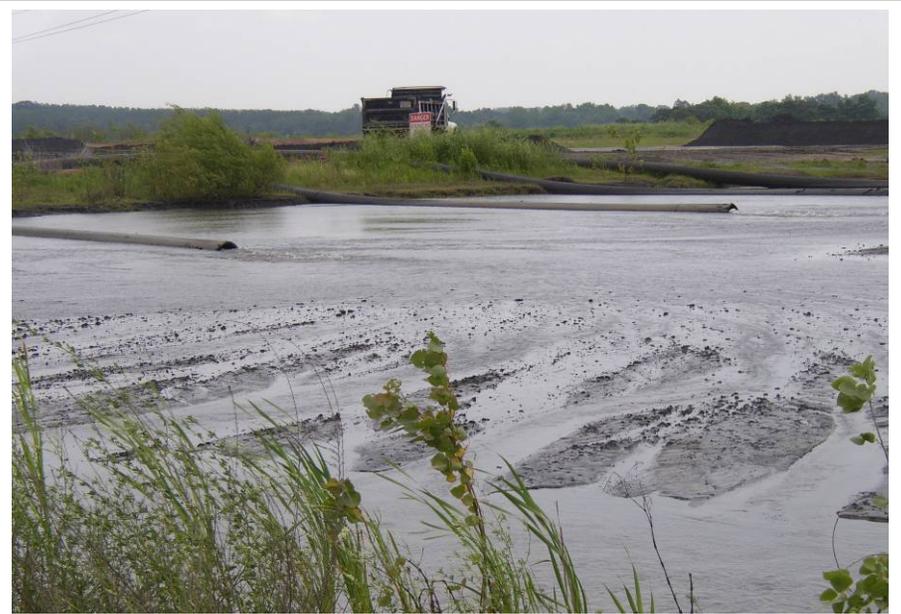
#48 Inlets of Sluice Pipes - Pool Elev. 635 +/- in Cell 2

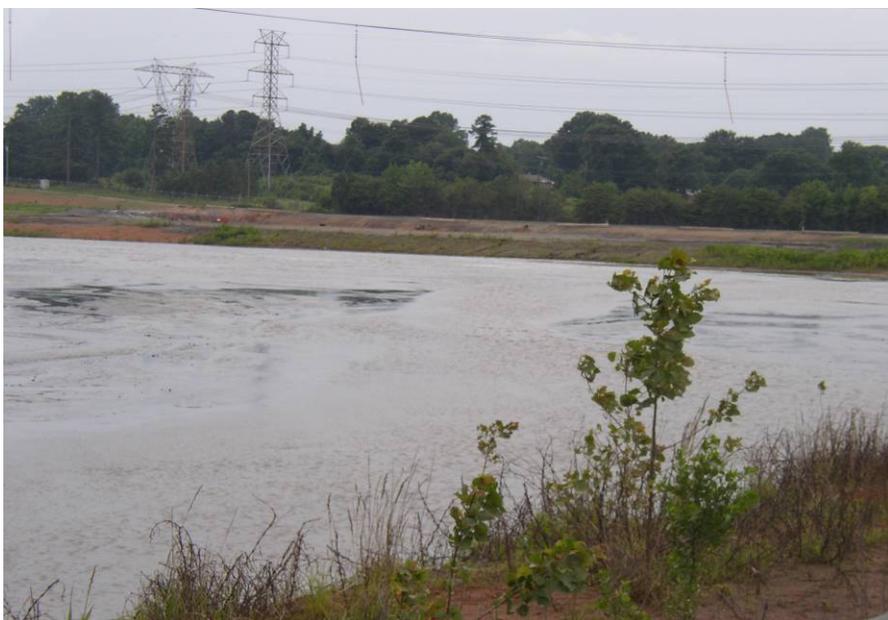
#49 Pool at Elev. 635 in Cell 2

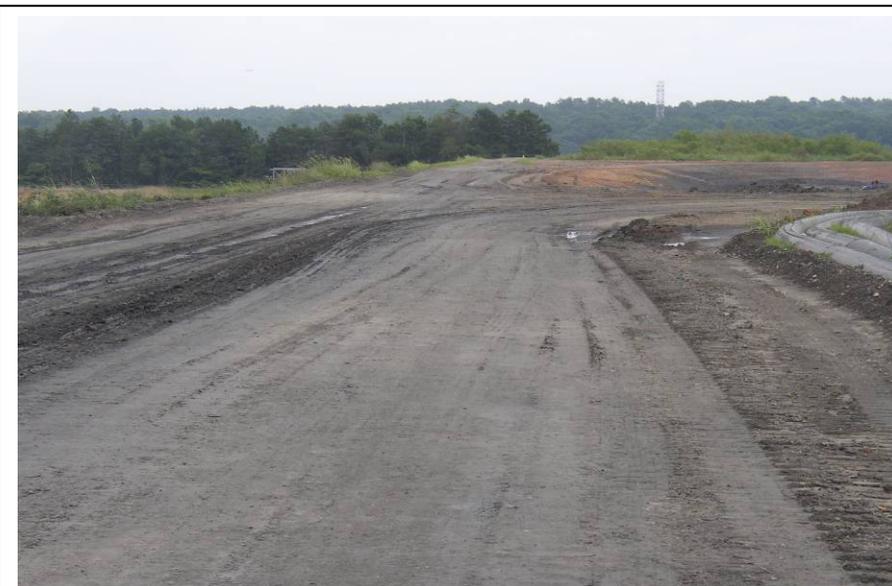
#51 Widened Crest in Cell 3 to Create Haul Road.
Width Increased from 15 to about 45 Feet.

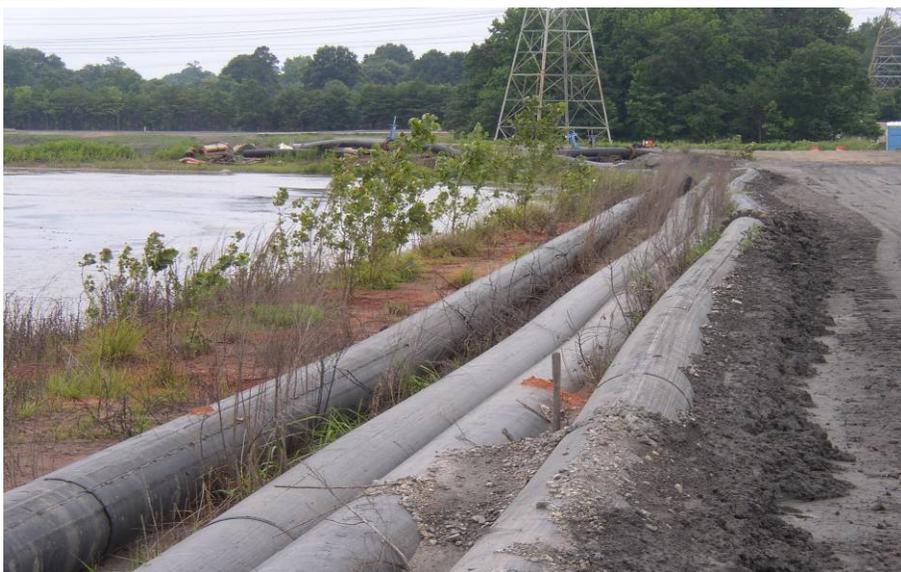
#50 Pipes Used for Sluicing

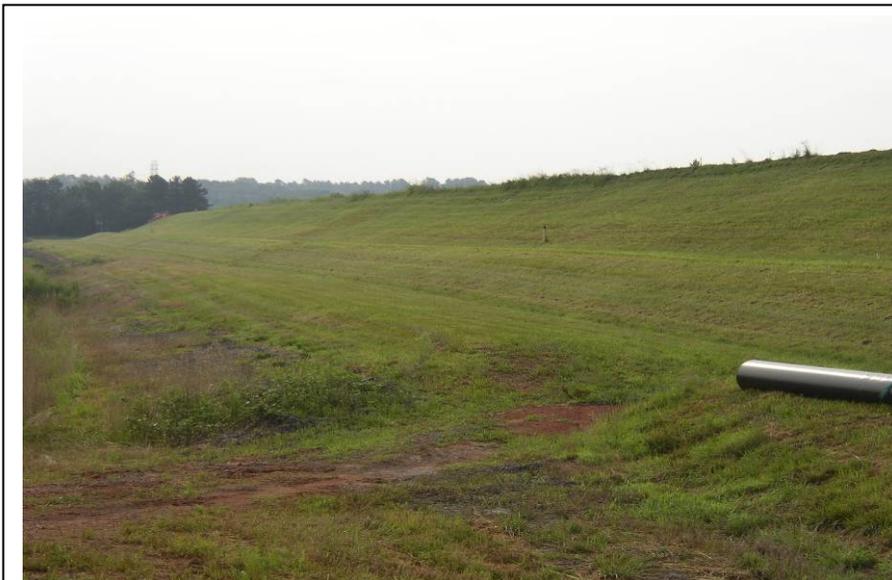
#52 Overview of Downstream Slope from a Point Near Construction Ramp

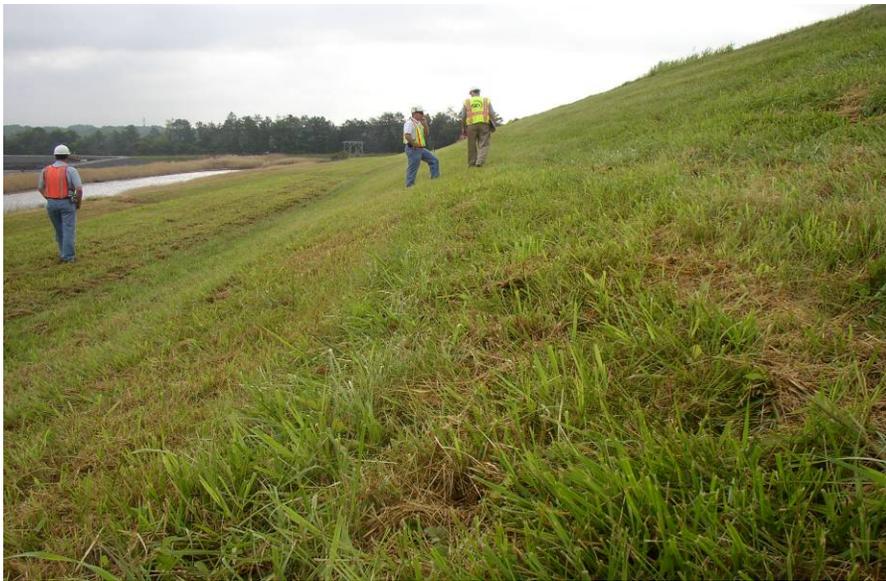
#53 Downstream Slope of North Dike (Central Area)

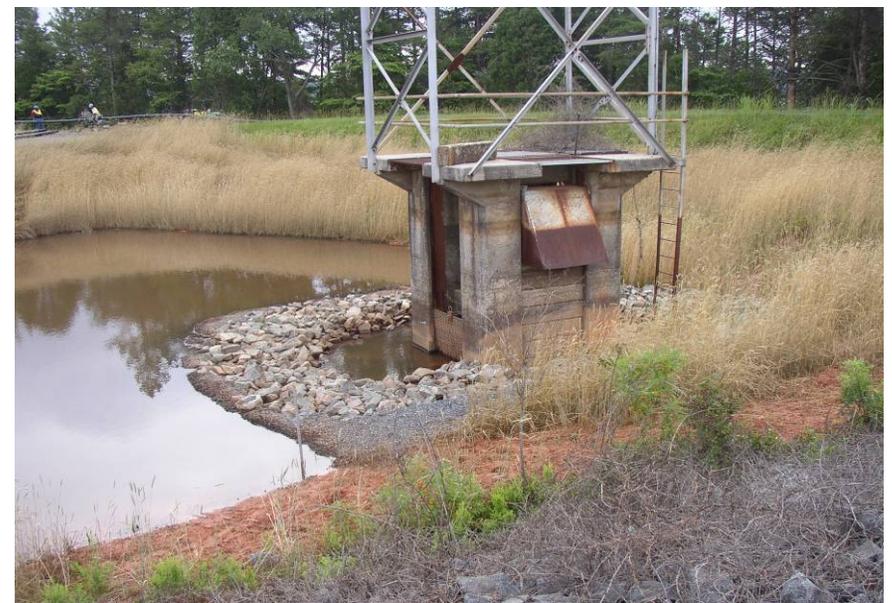
#55 Drop Inlet for Retained Ash Basin

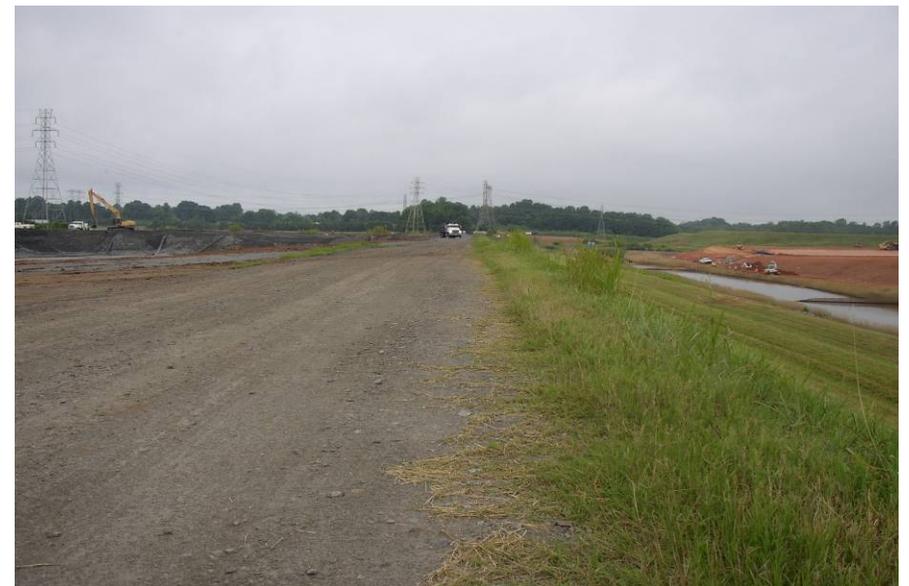
#56 Widened Upstream Crest (to 45 Feet) to Create Haul Road

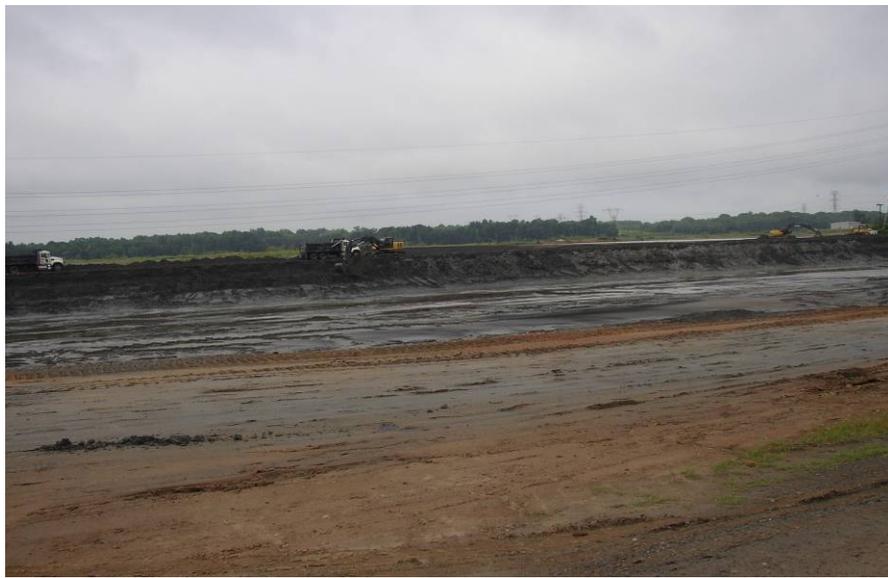
#57 Cell 3 Excavated to About 20-Foot Depth. No Water Impounded Due to Dewatering by Pumping.

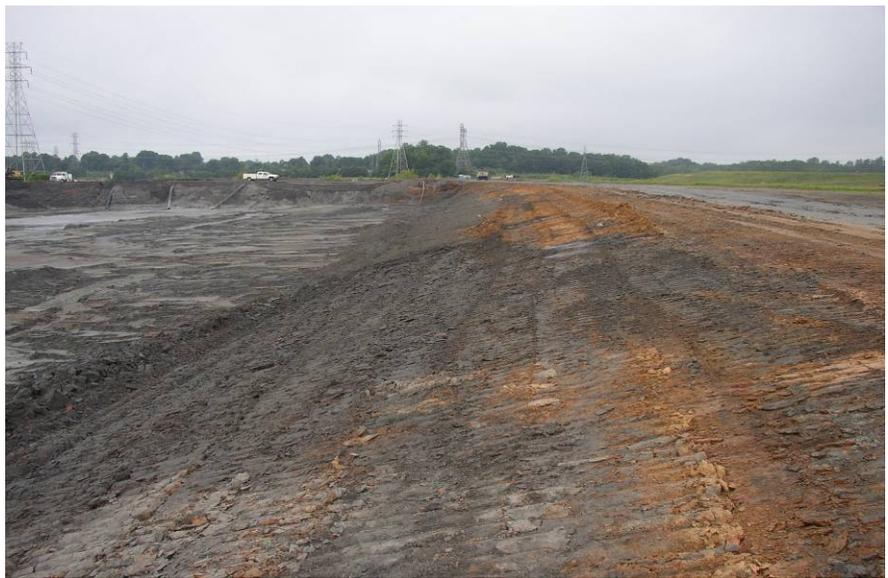
#58 Upstream Slope of Cell 3. Ash Excavated to Depth of About 20 Feet. No Water Impoundment
