Re: Task 3 Dam Assessment Report
Project #0-381
Allen Steam Station Coal Ash Retention Dam
Belmont, North Carolina

EXECUTIVE SUMMARY

This Phase I Inspection/Evaluation Report details the results of a visual dam inspection of the Allen Steam Station Coal Active Ash Basin North and East Dikes located off State Highway 273 in Belmont, North Carolina. The inspection was performed on June 12, 2009 by GZA GeoEnvironmental, Inc (GZA).

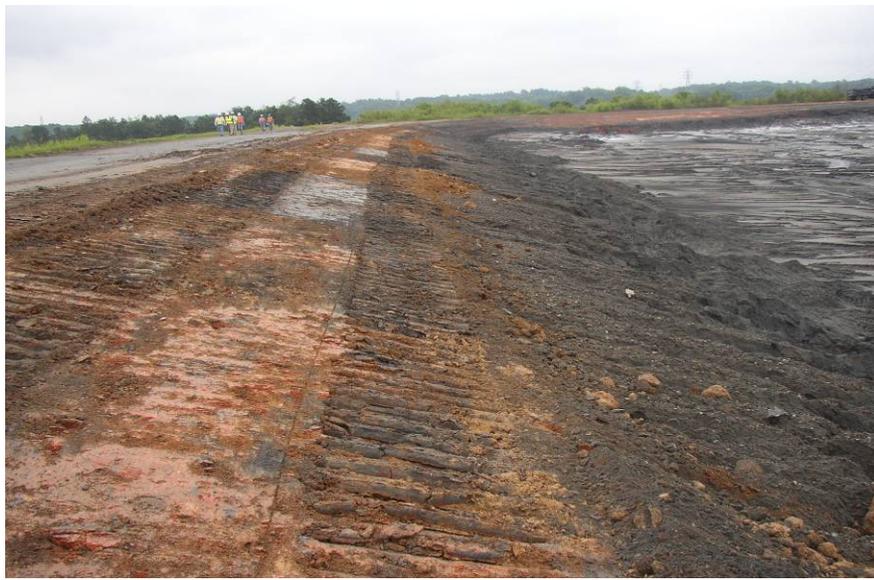
#60 Dewatered Cell 3, Ash Excavated to up to 20-Foot Depth

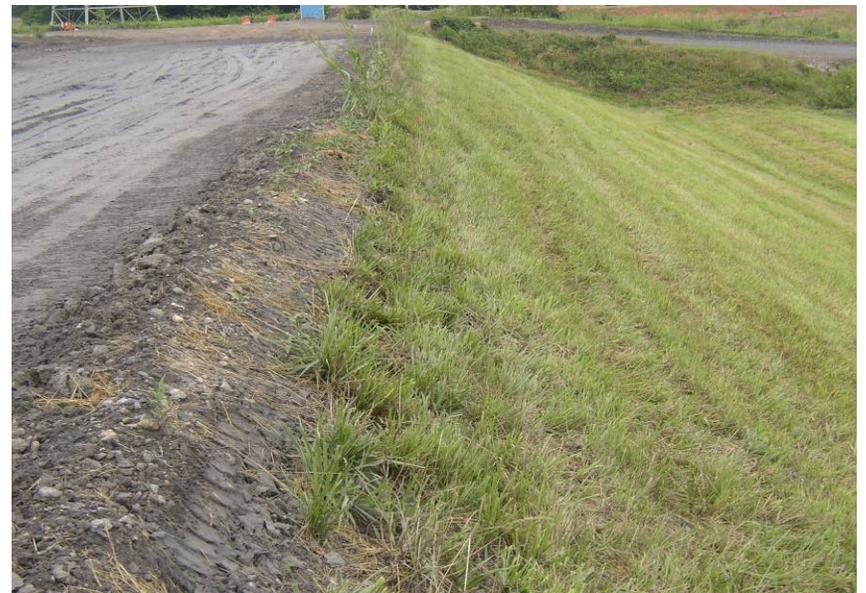
#62 Crest of Western Portion of North Dike

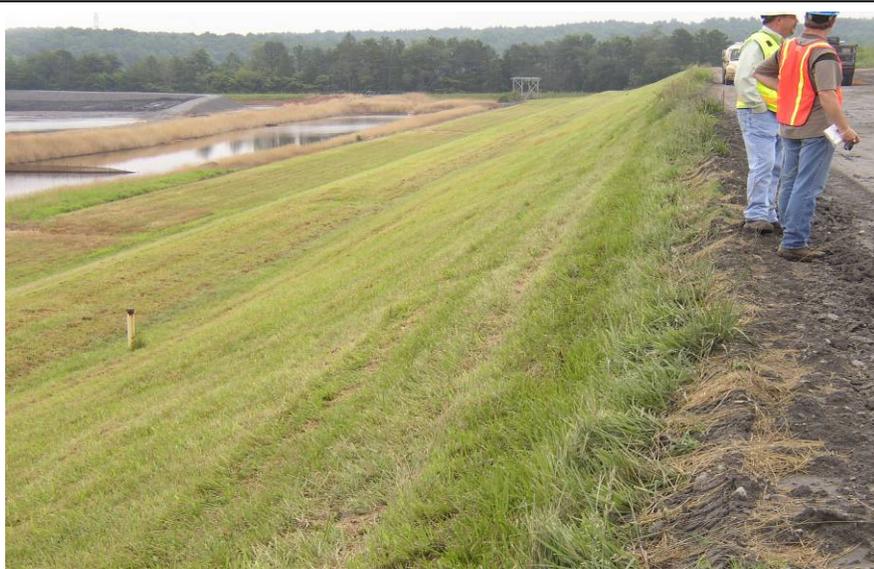
#61 Overview of Central Portion of North Dike

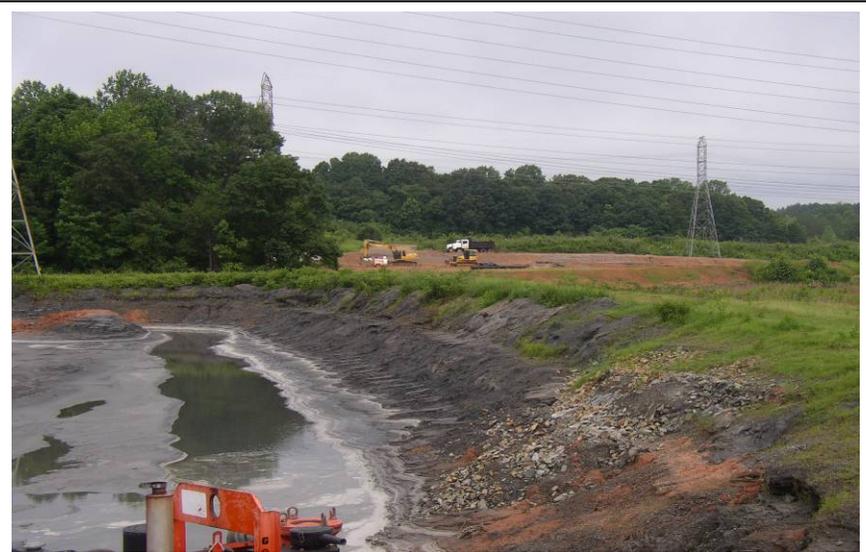
#63 Western Bend in North Dike at Cell 1 - Note Erosion in Upstream Slope of Ashfill

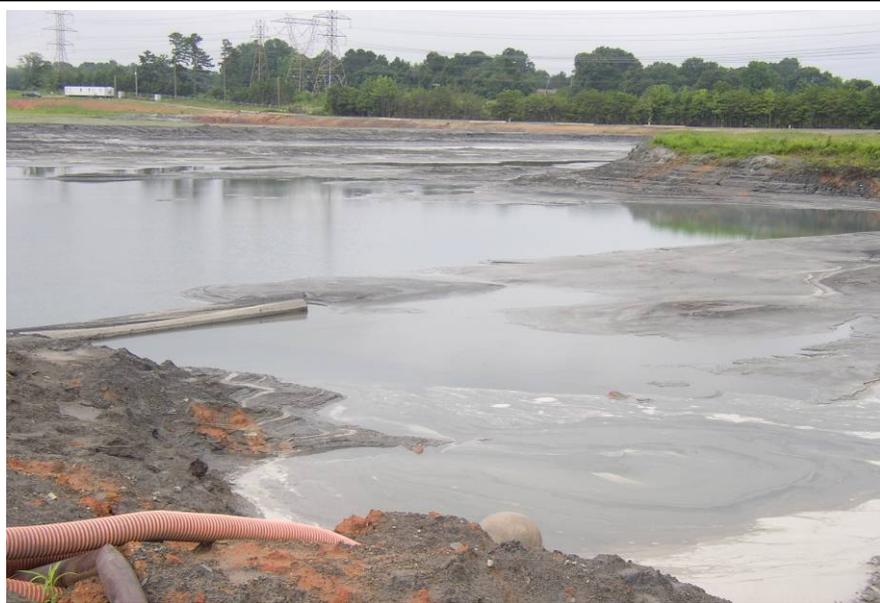
#64 Cell 1 Dewatering

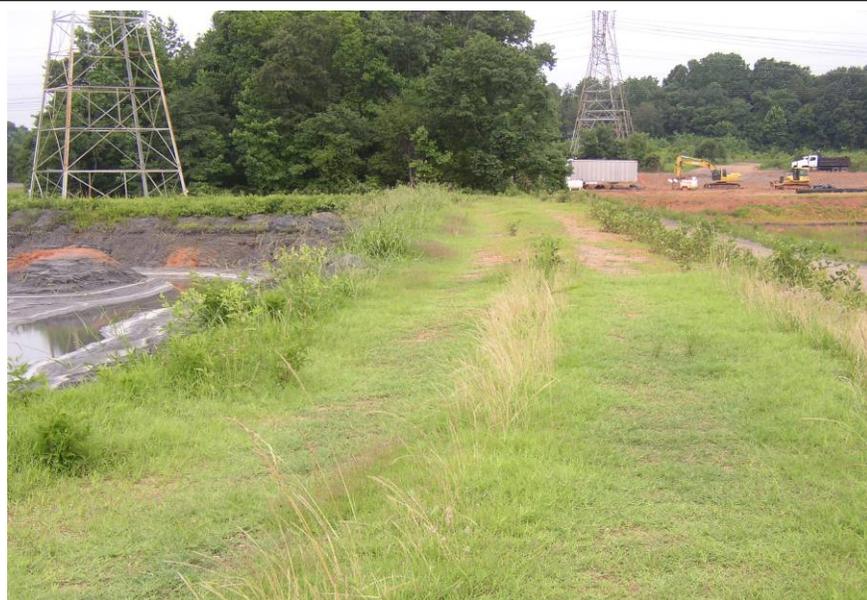
#65 Overview Crest of North Dike at West End

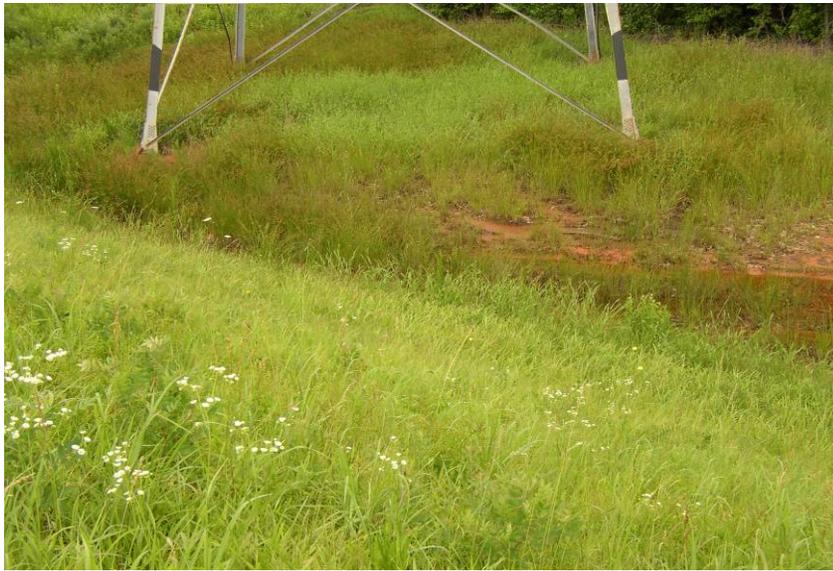
#68 Ponded Water Near Downstream Toe of North Dike

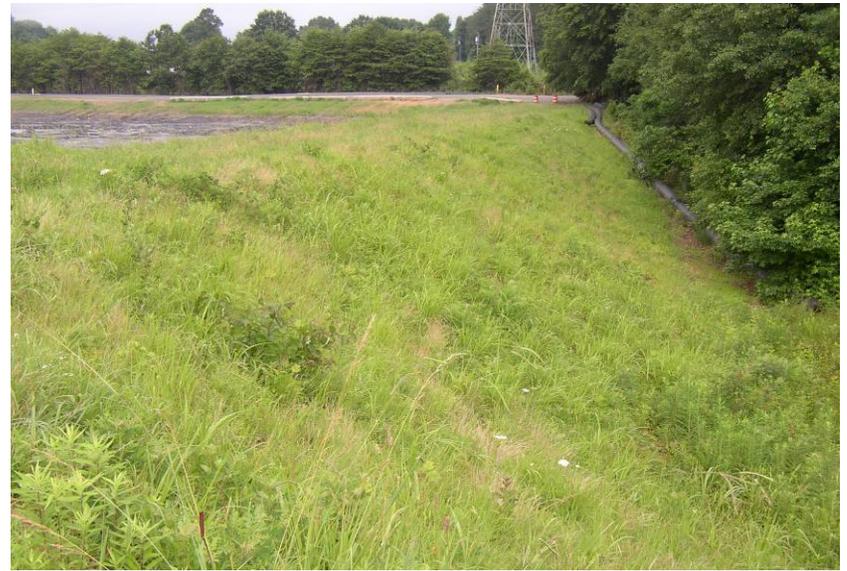
#70 Downstream Slope Near Western Limit of North Dike

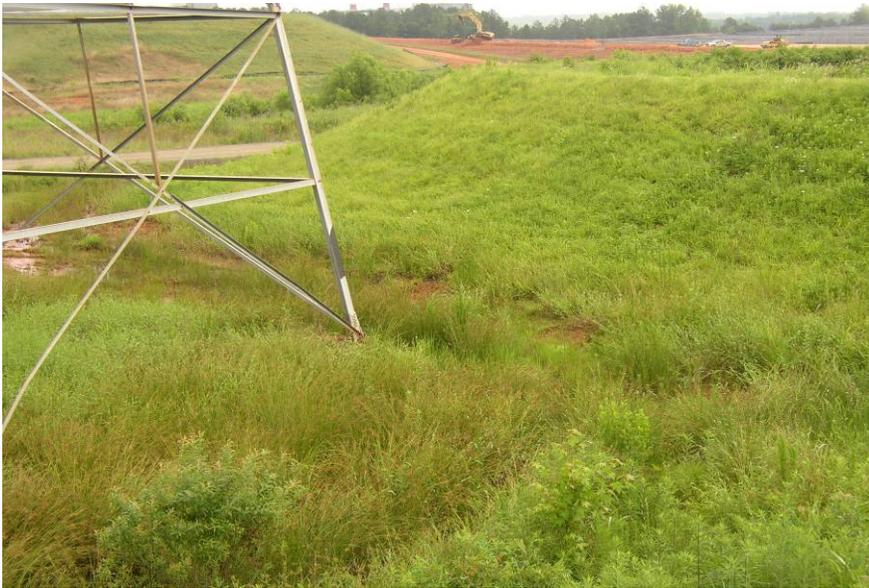
#72 Area to Improve Drainage at West End of North Dike

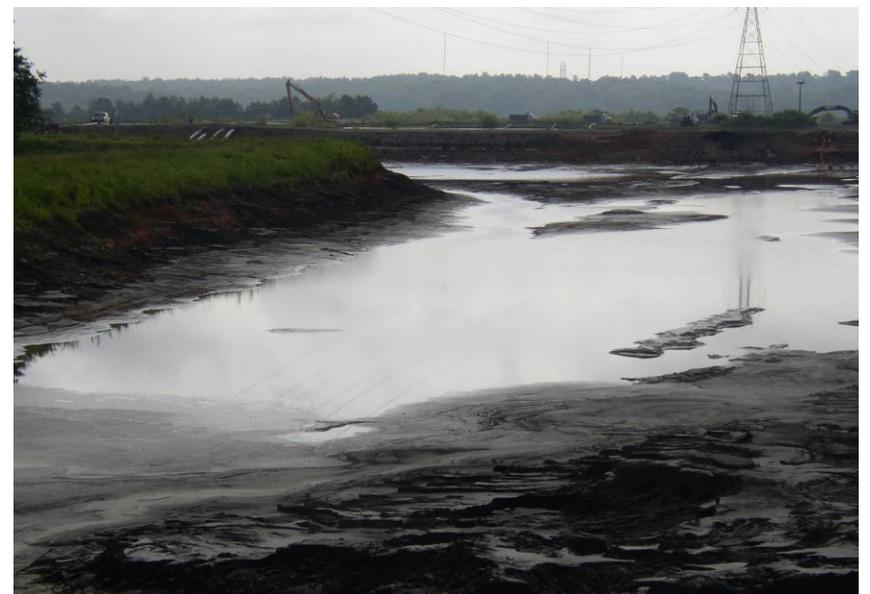
#74 Excavated Ash & Pool Elev. 635 in Cell 1

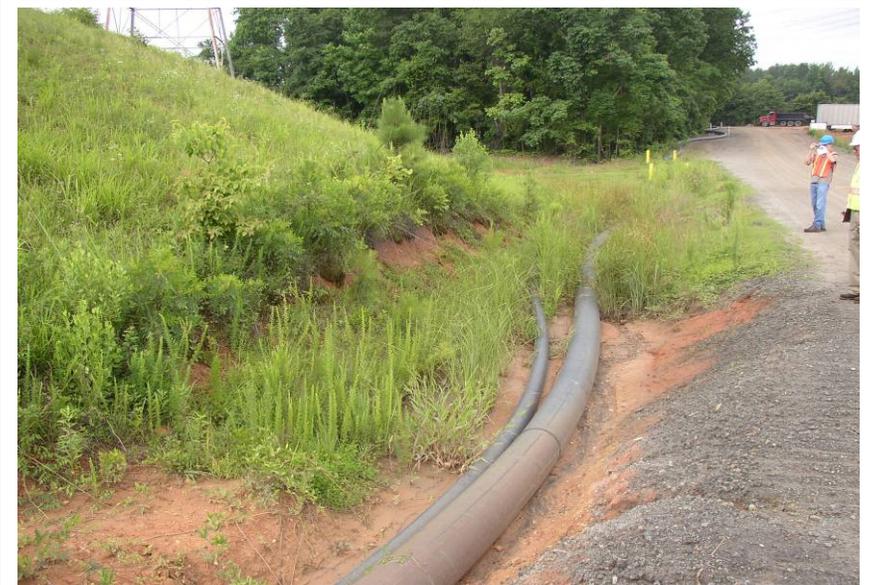
#75 Cut Into Downstream Toe of North Dike For Pipe Installation
