Re: Task 3 Dam Assessment Report  
Project #0-381  
Allen Steam Station Coal Ash Retention Dam  
Belmont, North Carolina

**FINAL REPORT**

This Phase I Inspection/Evaluation Report presents the results of a visual dam inspection of the Allen Steam Station Coal Active Ash Basin North and East Dikes located off State Highway 273 in Belmont, North Carolina. The inspection was performed on June 11 and June 12, 2009 by representatives of GZA GeoEnvironmental, Inc (GZA).

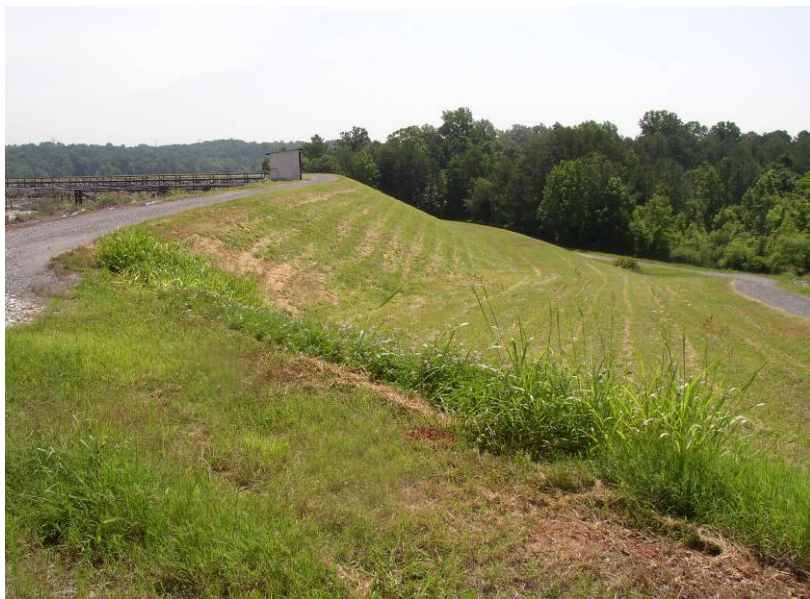
# 1 Southern Crest & Downstream Slope of East Dike – Local Reseeded Area

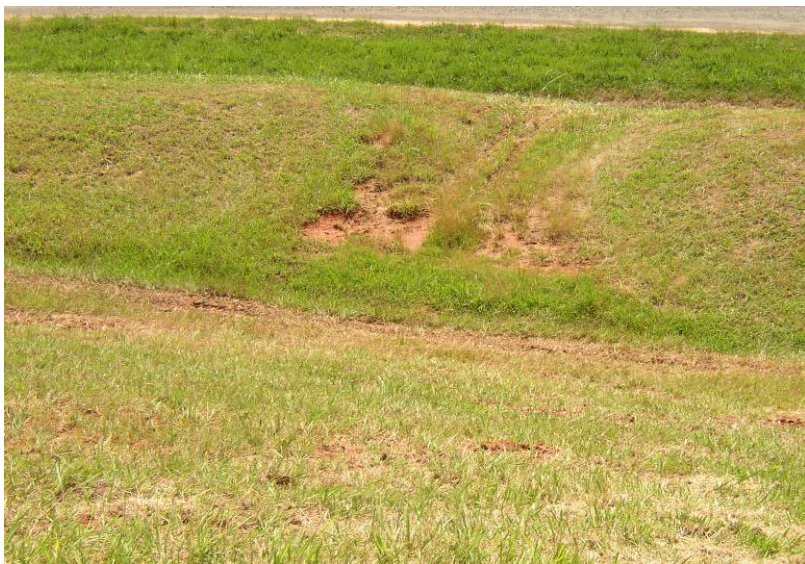
**#4 Local Erosion on Top of Downstream Stability Berm – Southern Portion of East Dike**

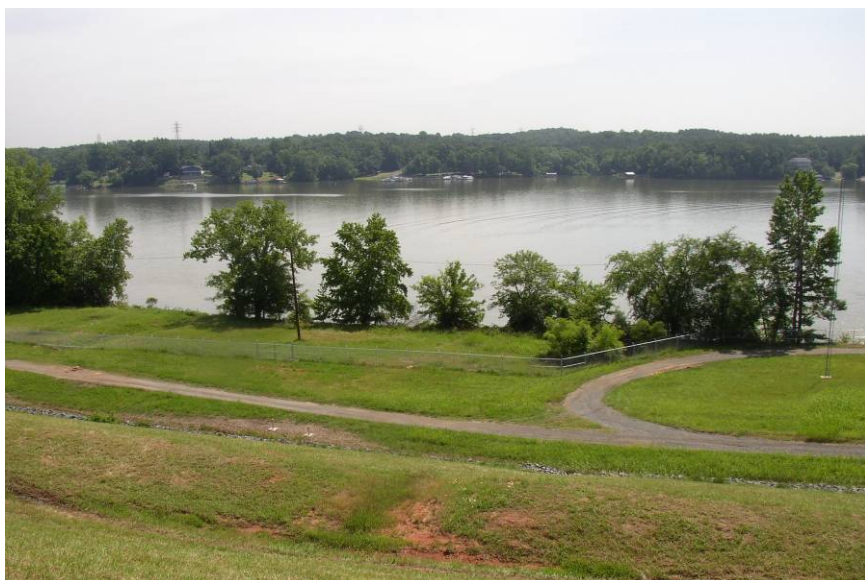
**#7 Downstream Berm & Toe Area of East Dike – Southern Portion  
Lake Wylie at Downstream Toe**

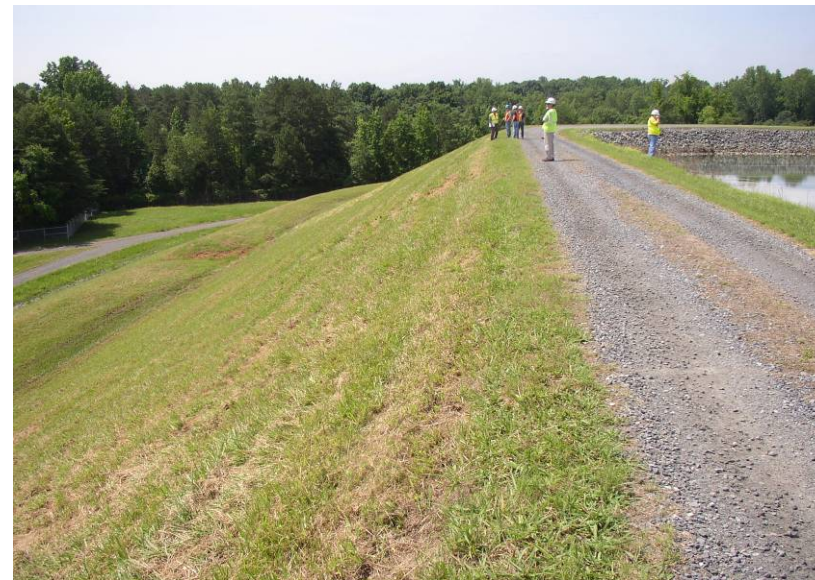
**#9 Southern Portion of Crest & Downstream Slope of East Dike –  
Note Pooled Water on Berm**

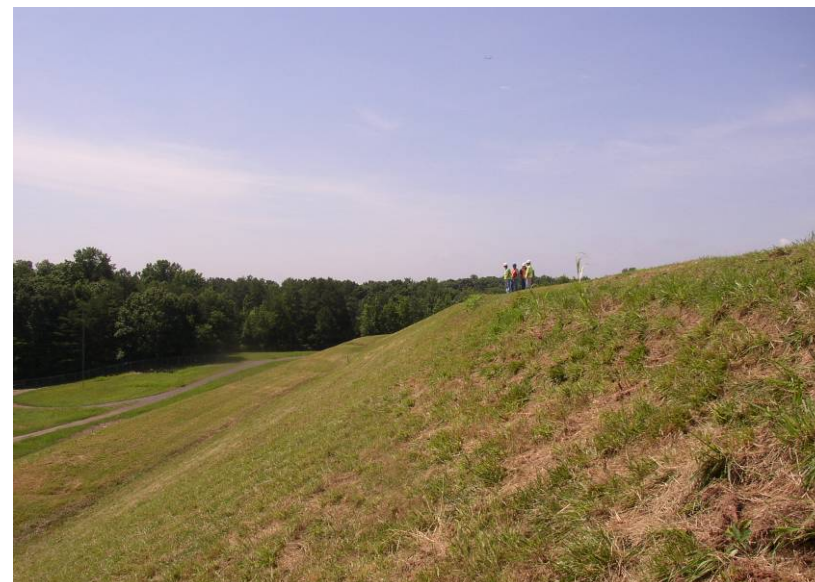
Minor scarps have occurred on the upper part of the downstream slope. These scarps are located several feet below the crest and are attributed to shallow slip failures within the upper layers of soil. The scarps remain on the embankment, and appear to have caused minor bulging in the lower section of the 2H:1V slope (above the stability berm). They are reportedly periodically addressed as maintenance items.

**#10 Southern Downstream Slope of East Dike - Note Local Scarps in Upper Slope**

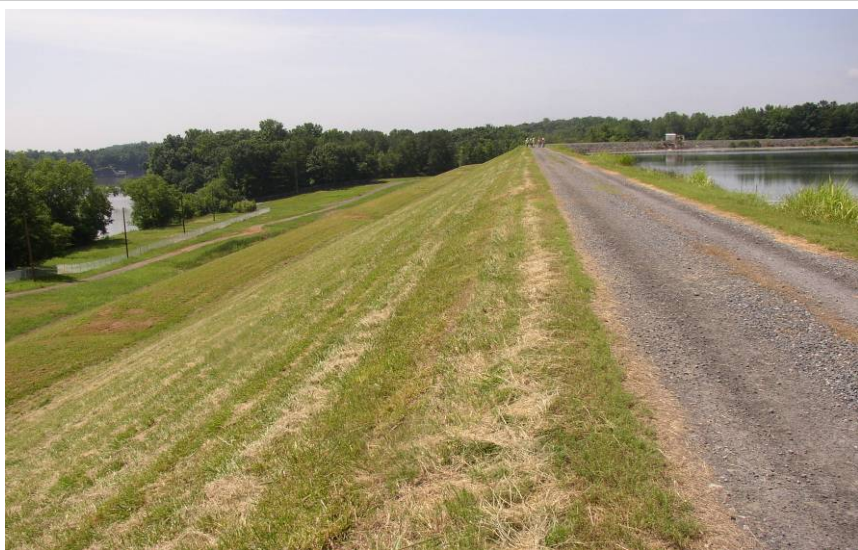
**#11 Maximum Section Portion of East Dike –  
Note Wet Area at Toe and Local Berm Erosion**

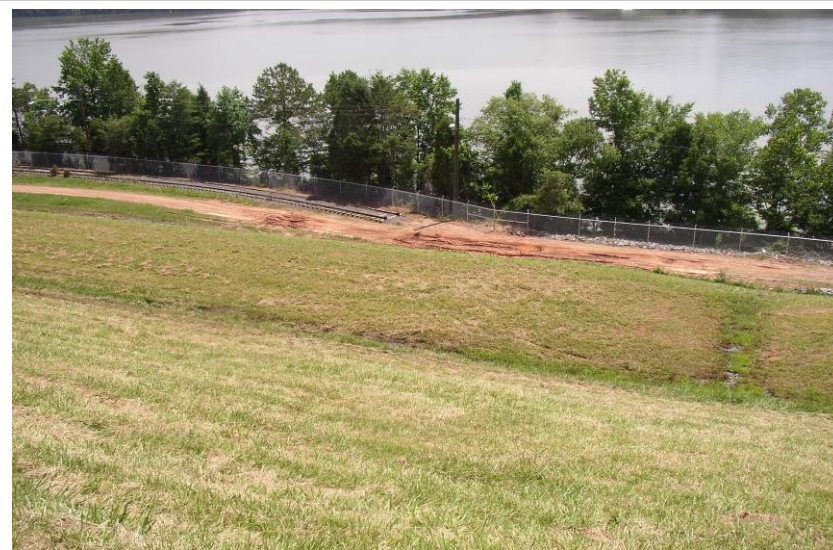
**#13 Eroded Area of Downstream Toe Road from Operations due to  
Installation of Chain Link Fencing and Mowing**

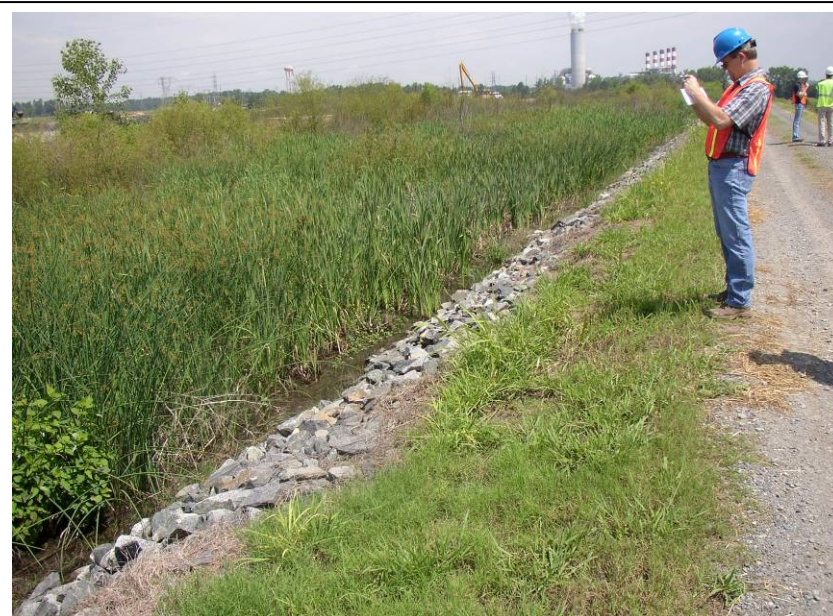
**#14 Northern Ash Retention Cell 3**

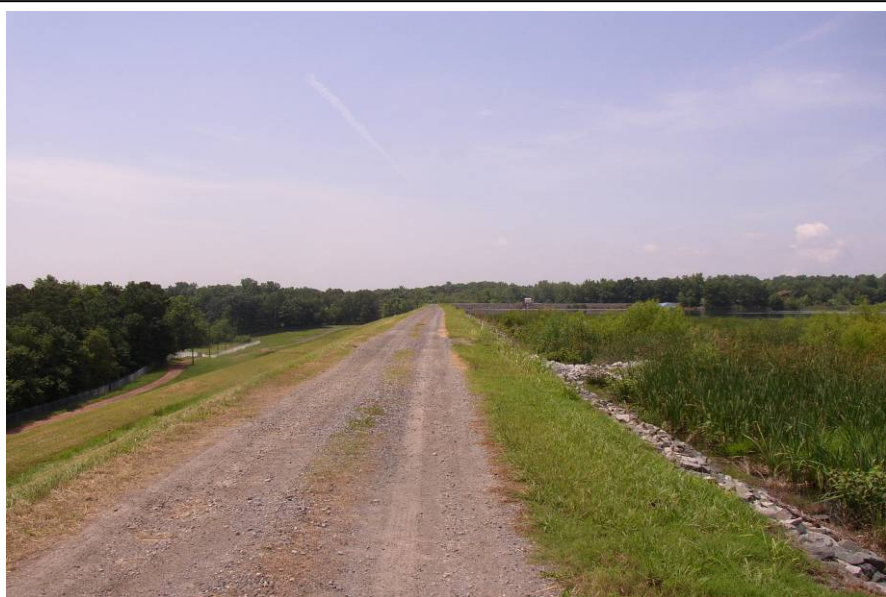
#15 Crest of East Dike Looking South - Satisfactory Alignment

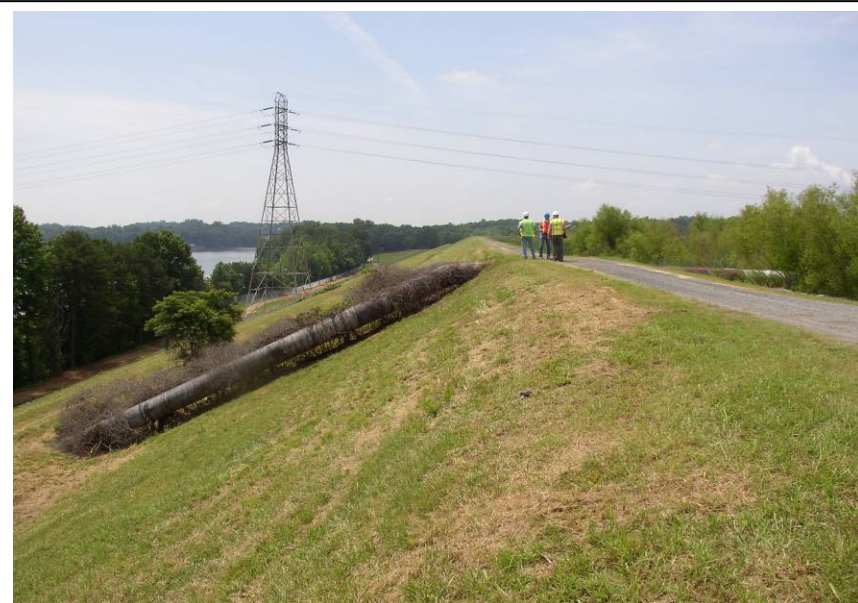
#17 Northern Portion of Downstream Slope of East Dike

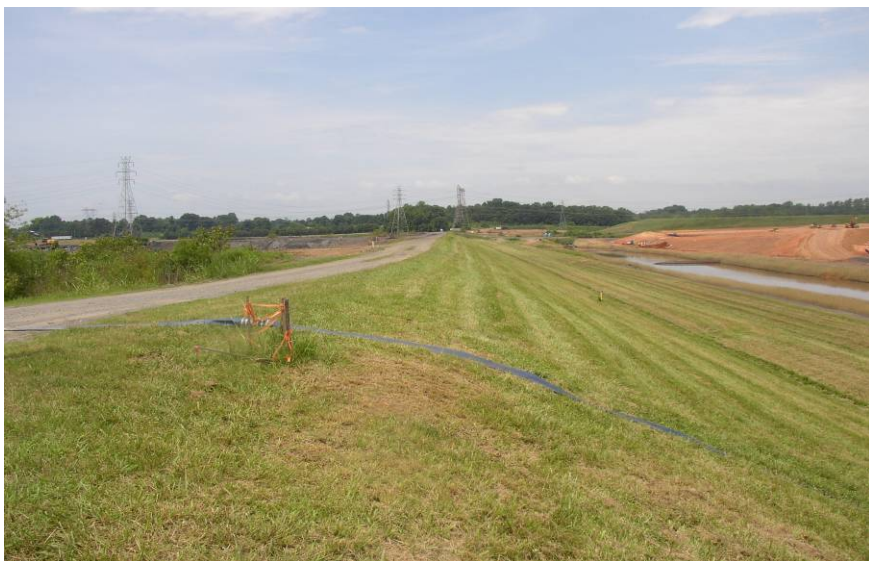
**#19 Overview of Crest & Downstream Slope of North Dike**

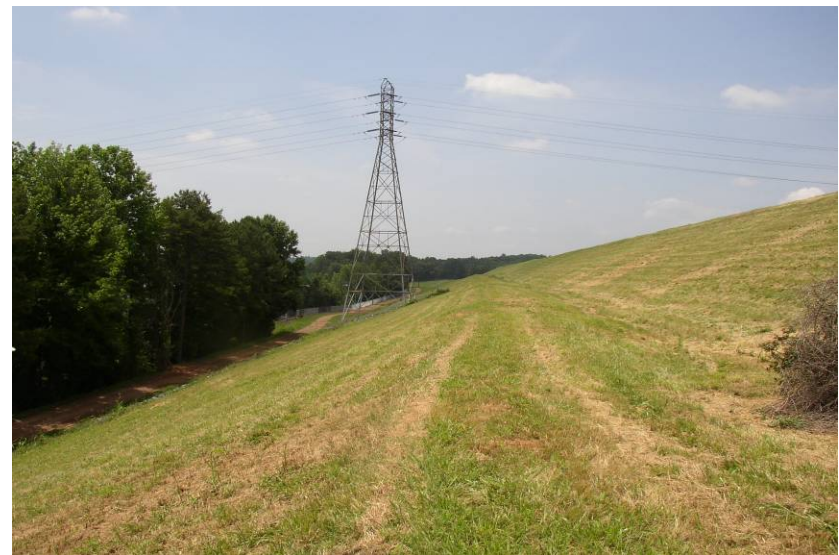
**#21 Stability Berm at North End of East Dike**

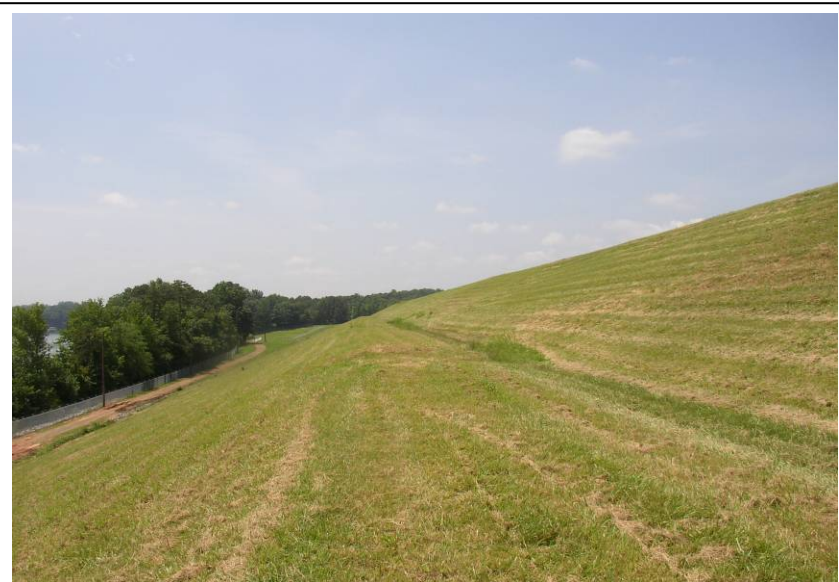
**#22 Stability Berm and Downstream Slope of East Dike**

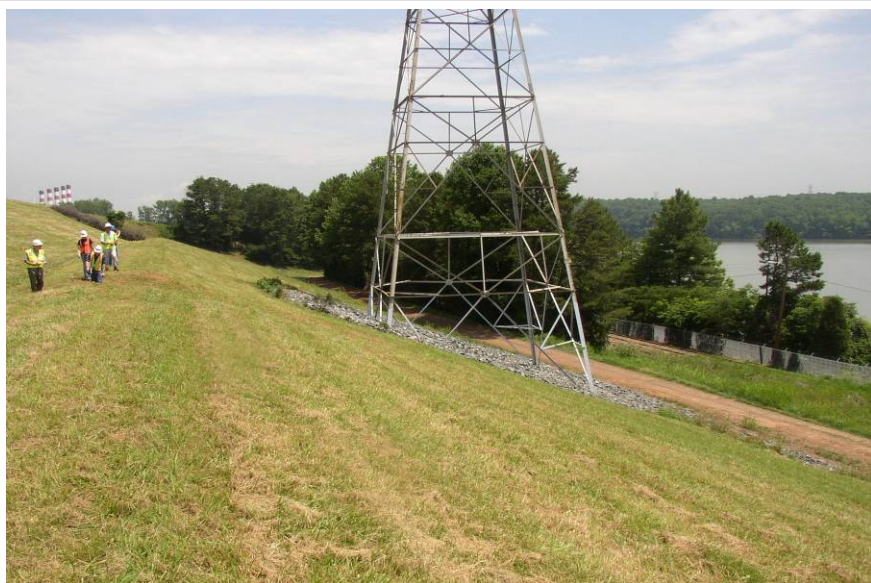
#23 Northern End of East Dike - Note Stability Berm Extends Over Transmission Tower

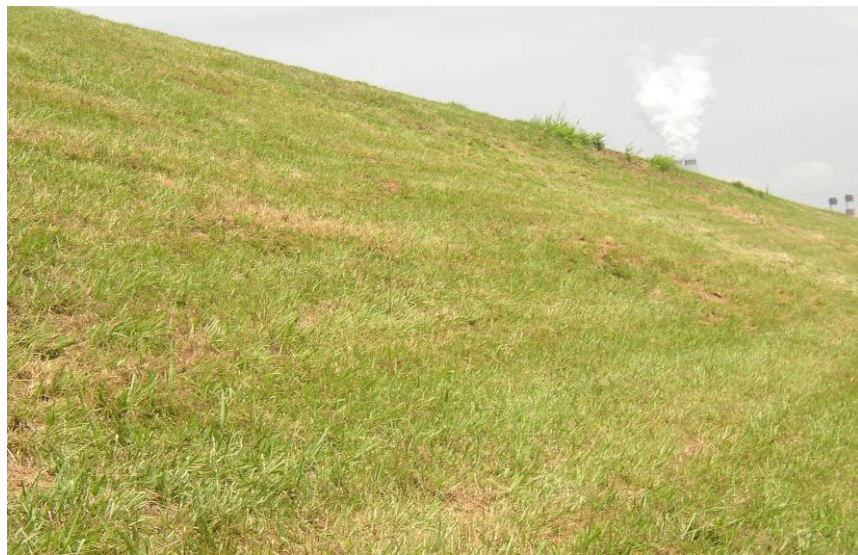
#27 Note Minor Bulging of Lower Portions – Upper Slope Above Stability Berm of East Dike

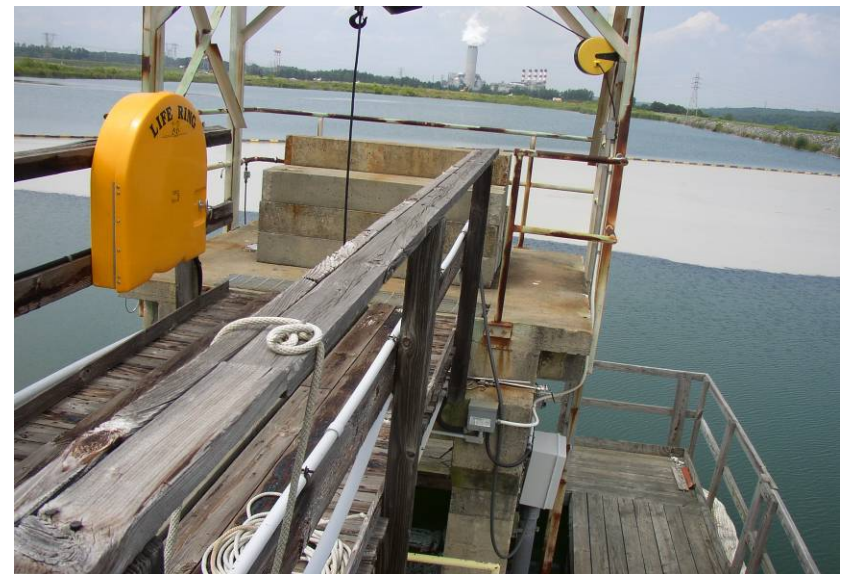
#29 Drop Inlet Structure - Note Concrete Stop Logs and Crane

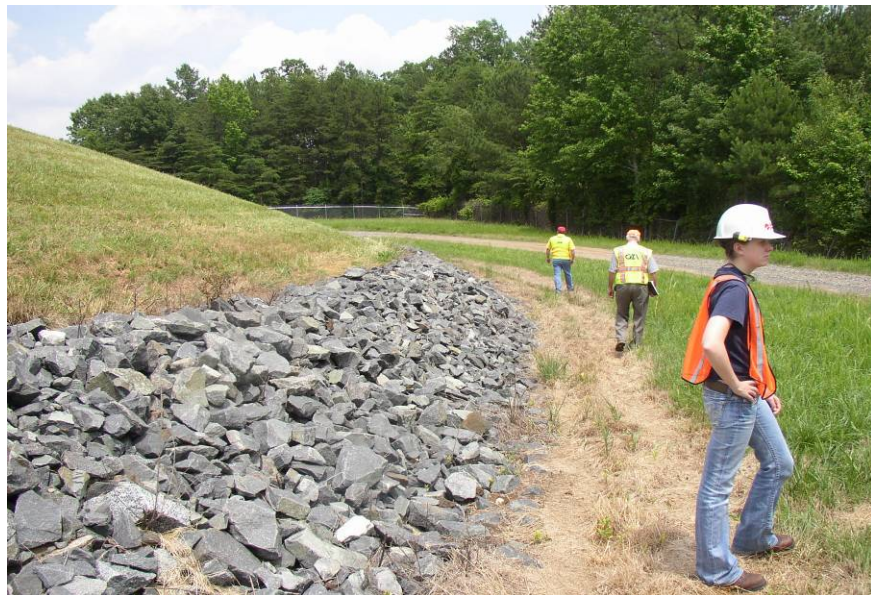
#28 Riprap at Downstream Toe of East Dike - Southern Portion

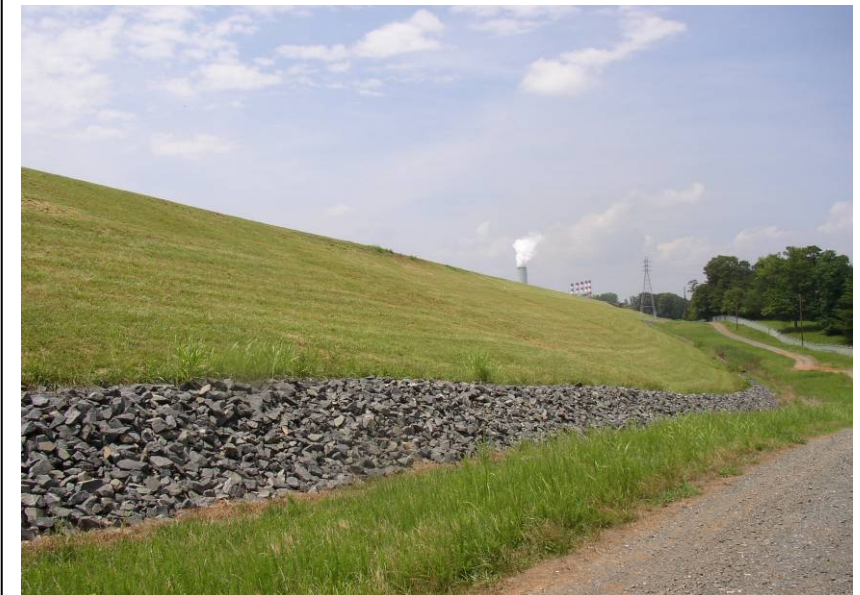
#30 Overview of Downstream Toe of East Dike Near Maximum Section

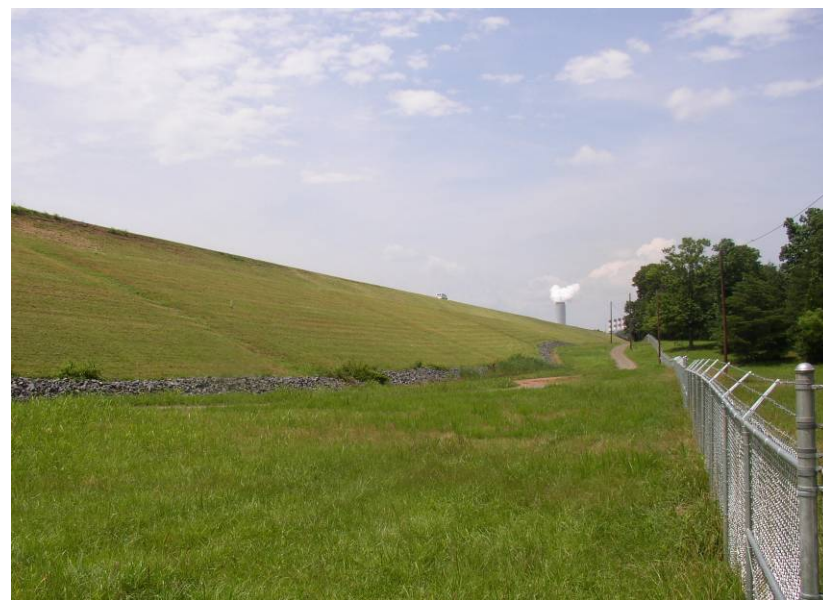
#33 Overview of Downstream Slope of East Dike – Maximum Section

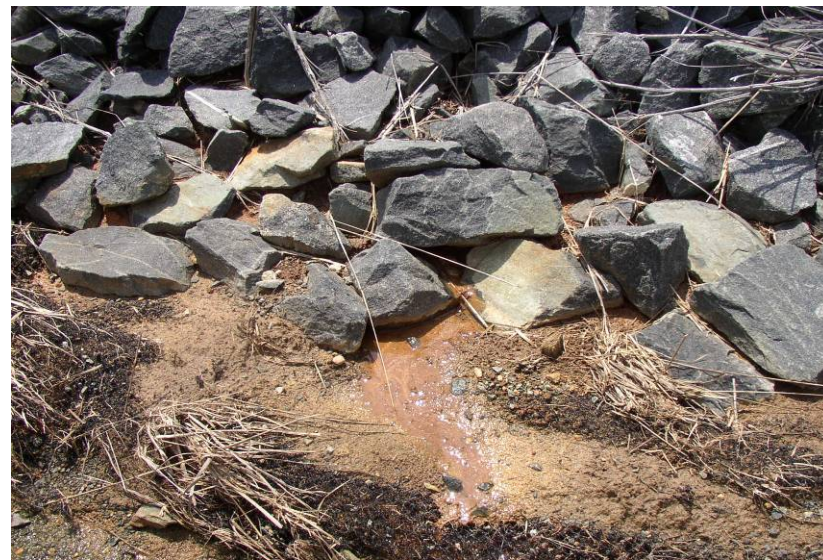
#34 Minor Local Clear Seepage Discharges from Downstream Rock Toe at South End of East Dike

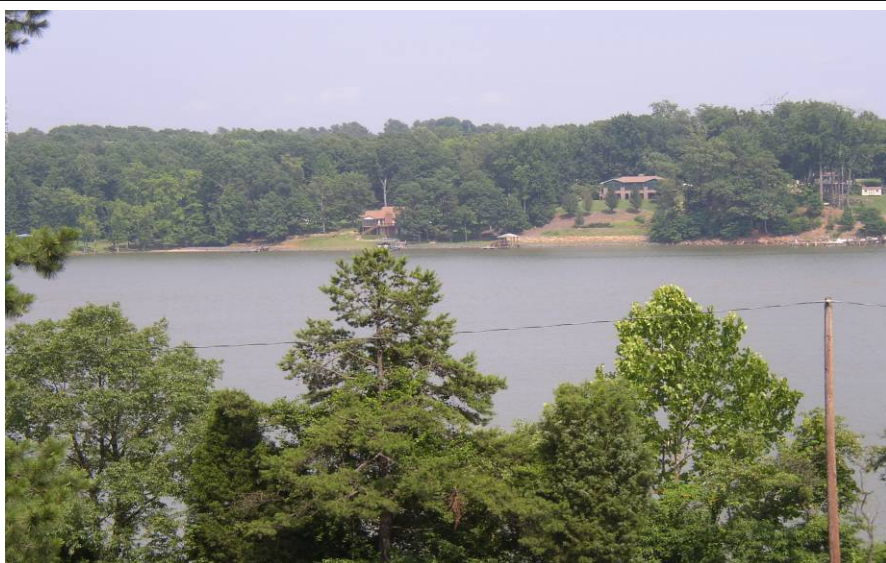
**#41 Shoreline on Opposite Bank of Tailwater Impoundment – Lake Wylie –  
Note Development**

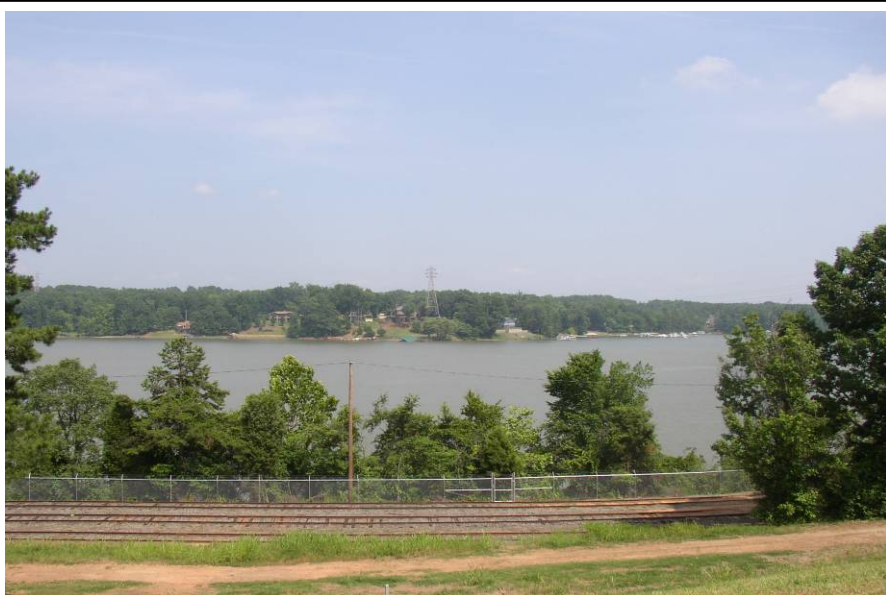
**#42 Shoreline on Opposite Bank of Tailwater Impoundment – Lake Wylie**

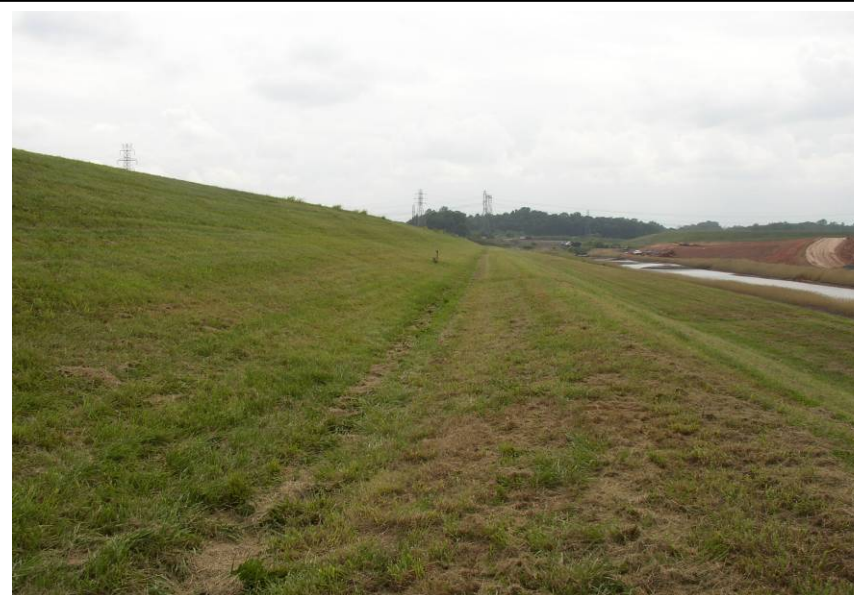
**#44 Upper Berm of North Dike - 15 Feet Wide @ Elev. 630**

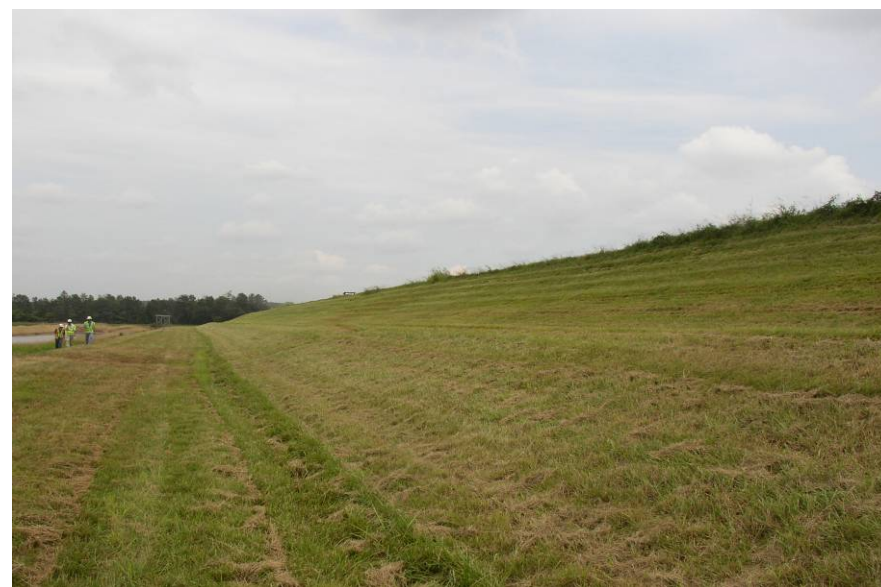
#47 Lower Berm of North Dike – 25-Foot-Wide Berm @ Elev. 625

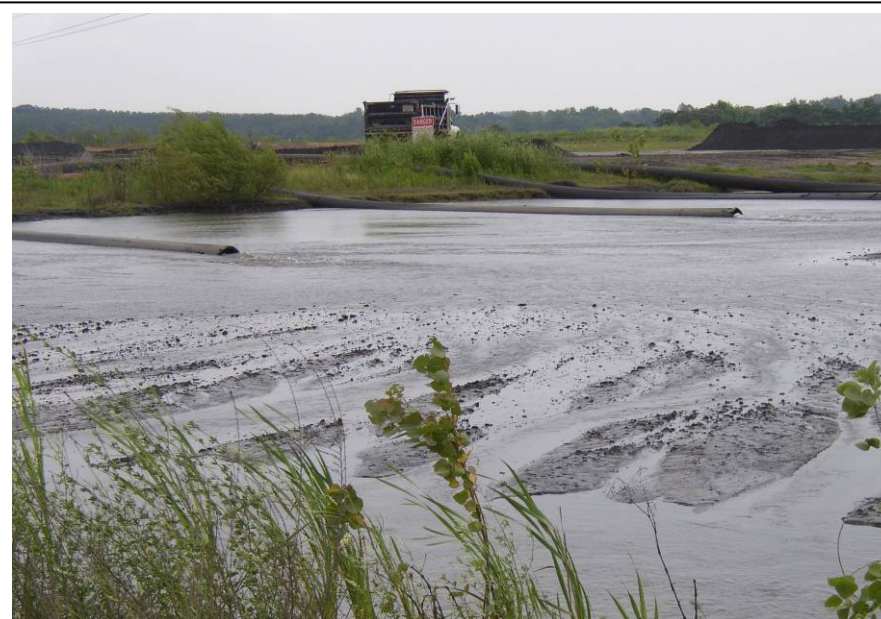
#48 Inlets of Sluice Pipes - Pool Elev. 635 +/- in Cell 2

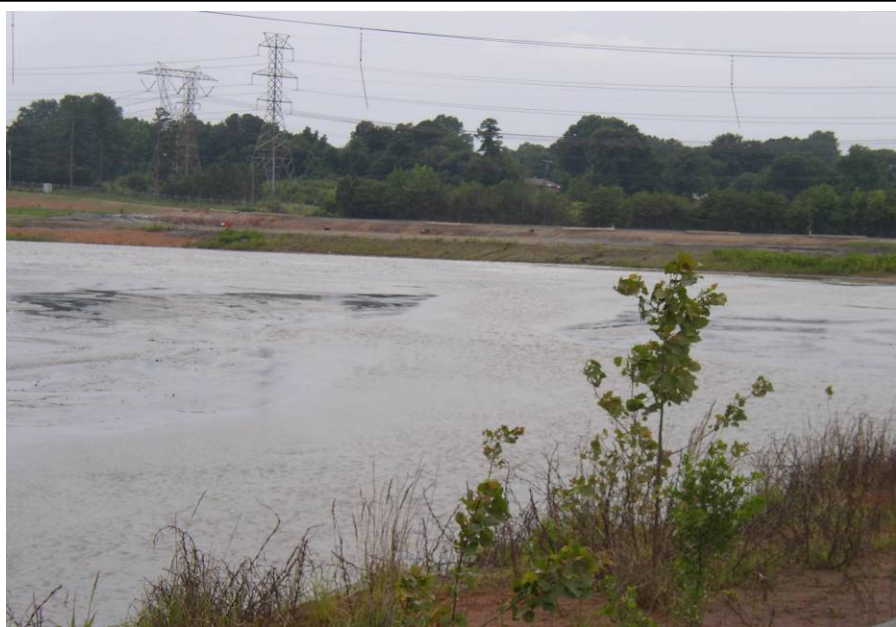
**#49 Pool at Elev. 635 in Cell 2**

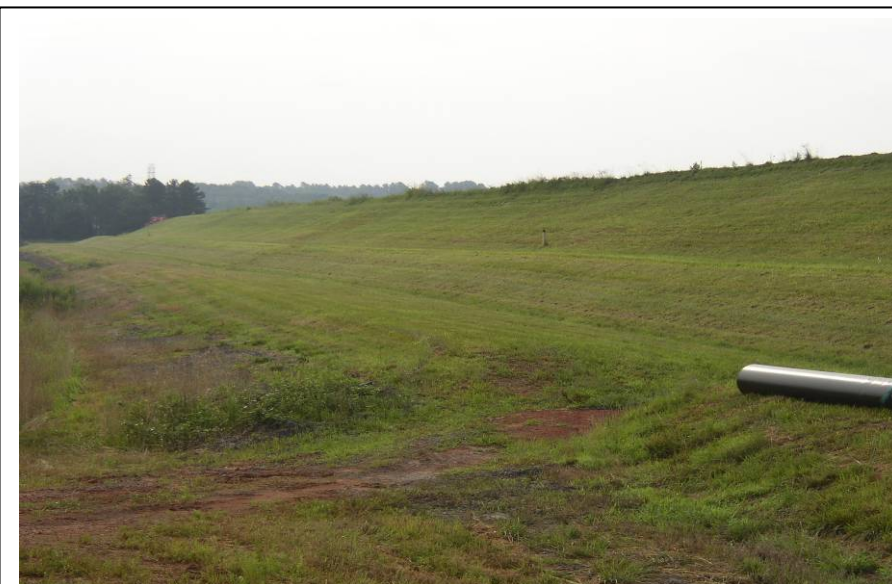
**#52 Overview of Downstream Slope from a Point Near Construction Ramp**

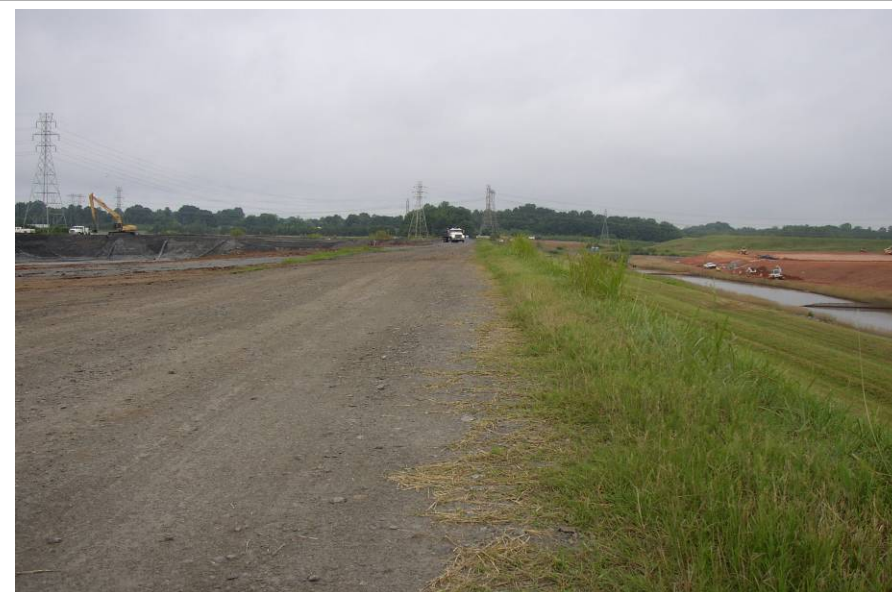
#56 Widened Upstream Crest (to 45 Feet) to Create Haul Road

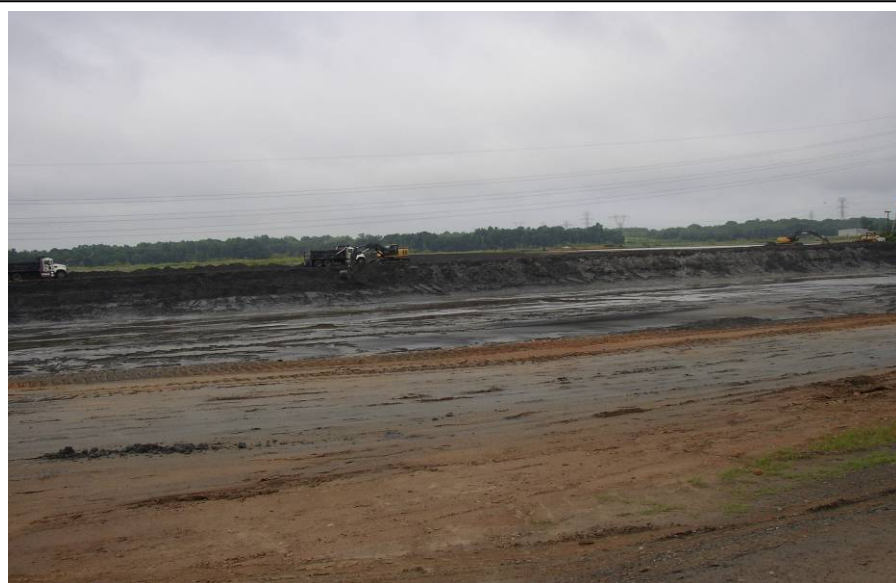
**#57 Cell 3 Excavated to About 20-Foot Depth. No Water Impounded Due to Dewatering by Pumping.**

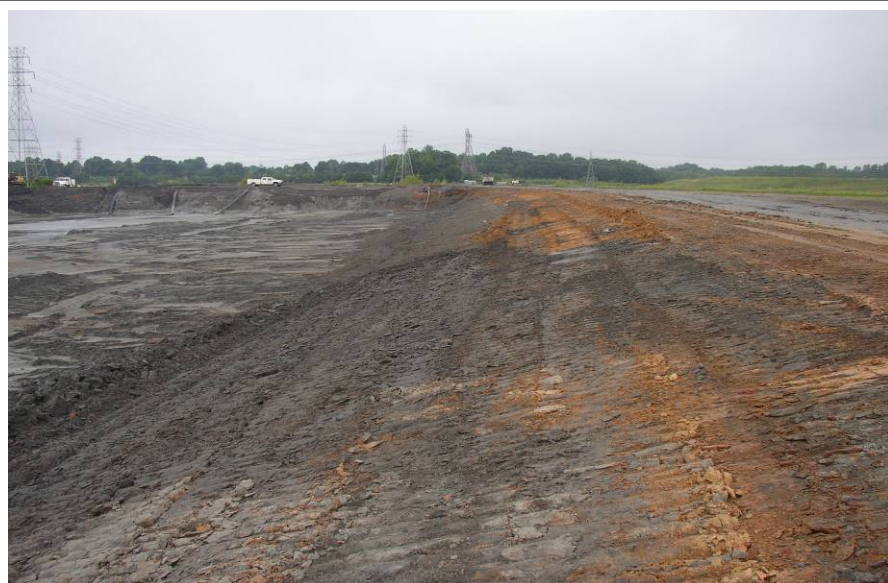
**#58 Upstream Slope of Cell 3. Ash Excavated to Depth of About 20 Feet. No Water Impoundment**

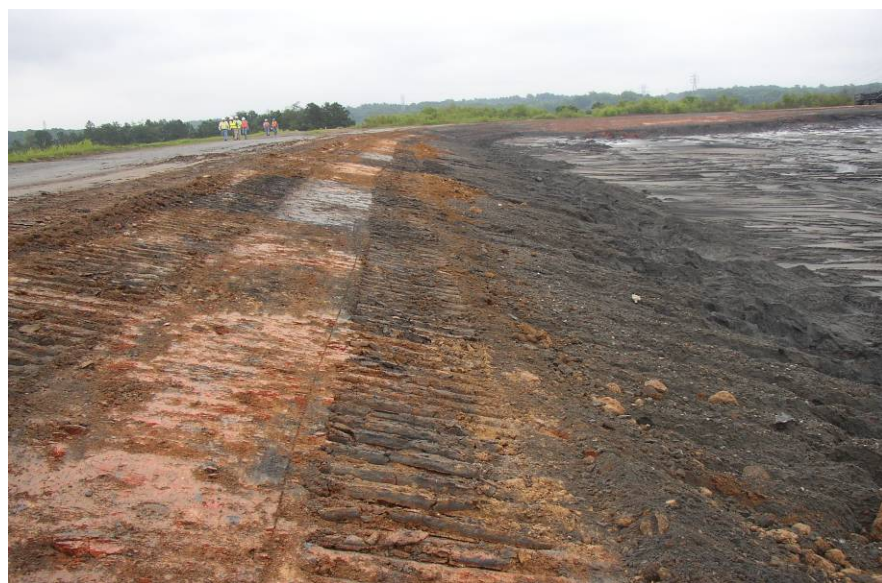
#60 Dewatered Cell 3, Ash Excavated to up to 20-Foot Depth

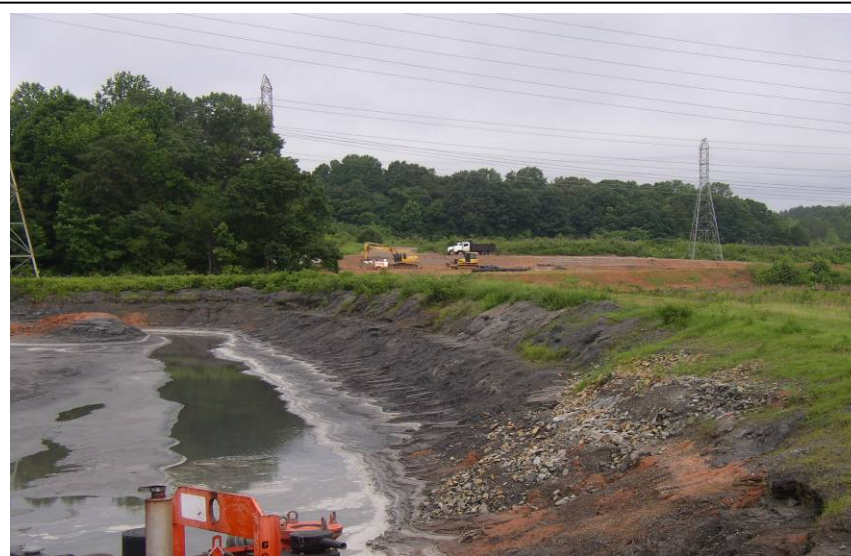
#63 Western Bend in North Dike at Cell 1 - Note Erosion in Upstream Slope of Ashfill

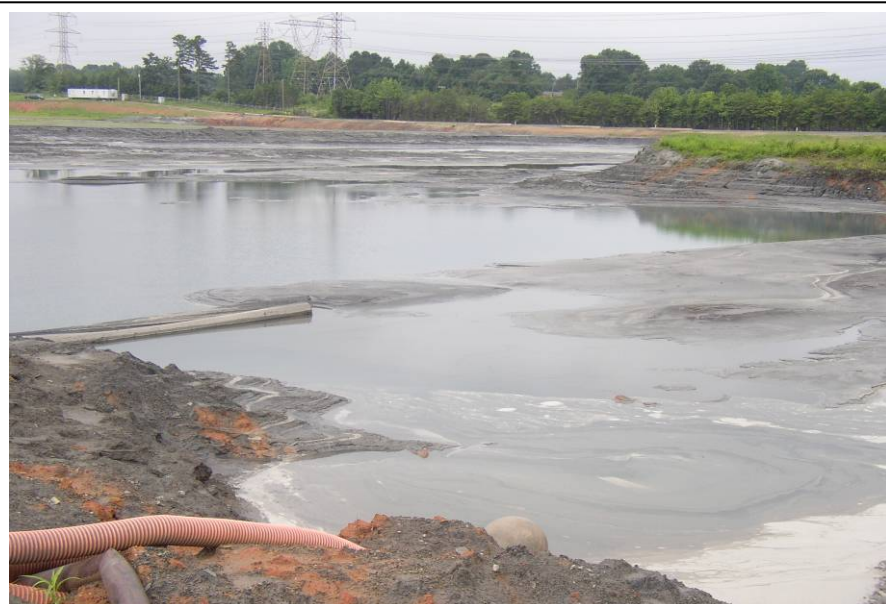
#64 Cell 1 Dewatering

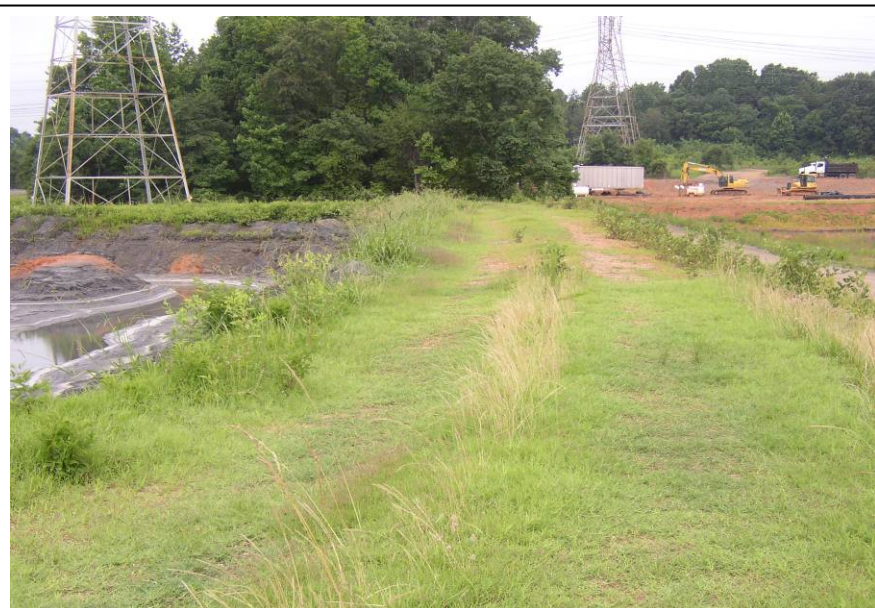
#65 Overview Crest of North Dike at West End

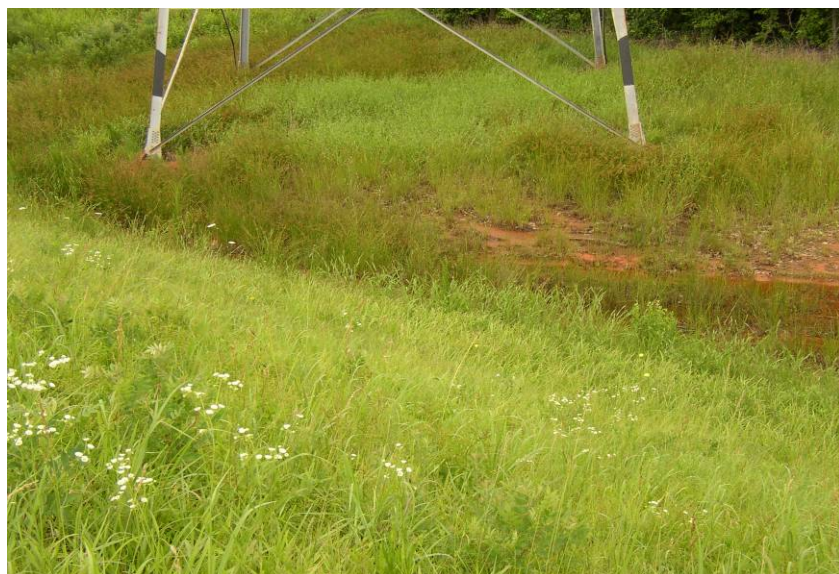
**#68 Ponded Water Near Downstream Toe of North Dike**

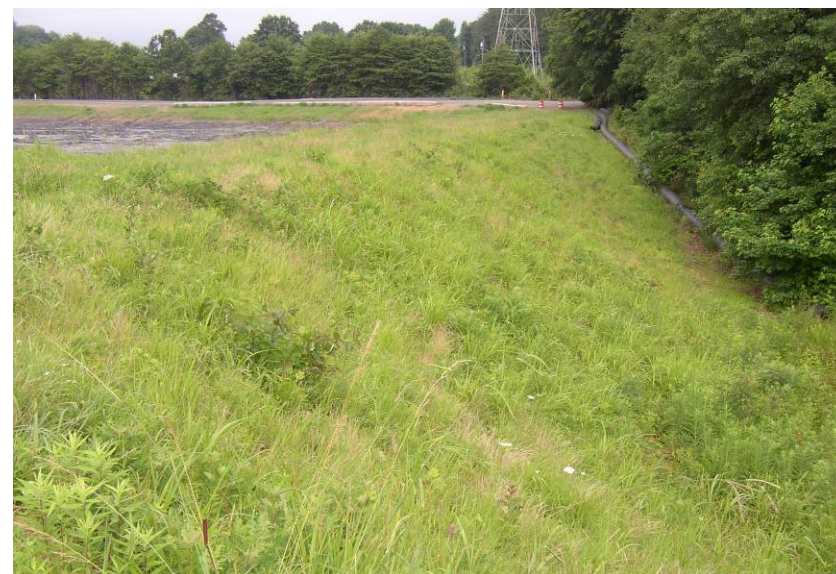
**#70 Downstream Slope Near Western Limit of North Dike**

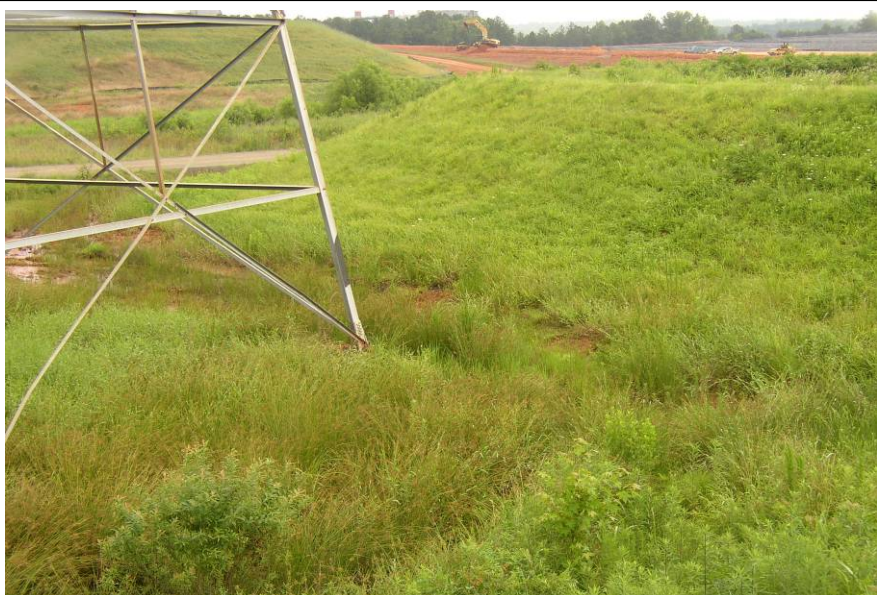
#72 Area to Improve Drainage at West End of North Dike
