Assessment of Dam Safety Coal Combustion Surface Impoundments (Task 3) Draft Report

Duke Energy

W.C. Beckjord Station
New Richmond, Ohio

December 7, 2009

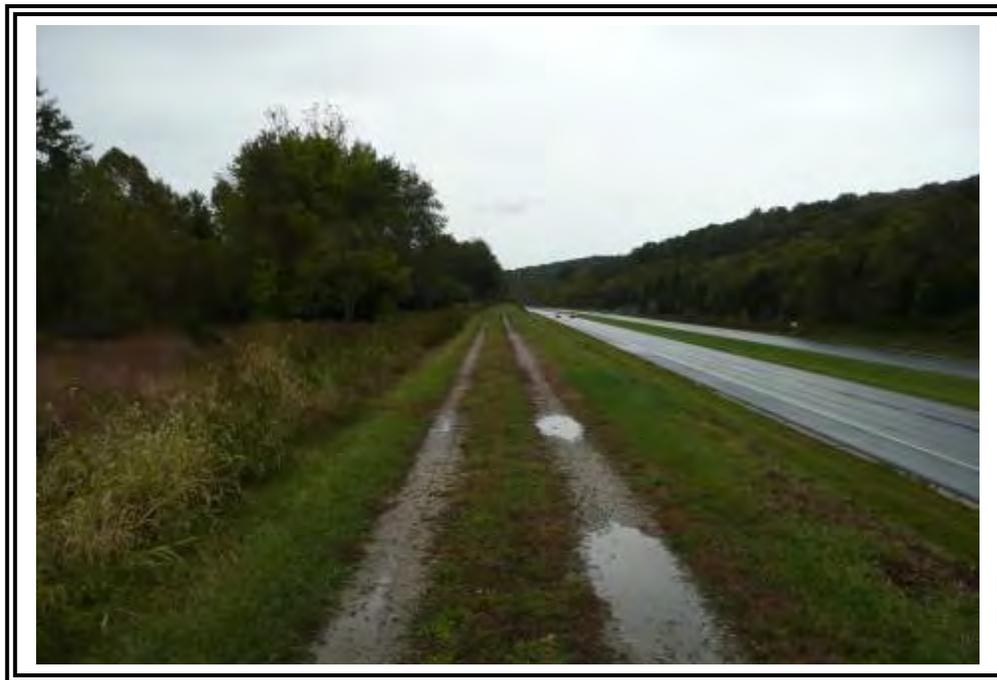
1

East dike crest and interior slope face, looking north.
Note small isolated “birdbaths” in access drive as a result of recent rainfall.

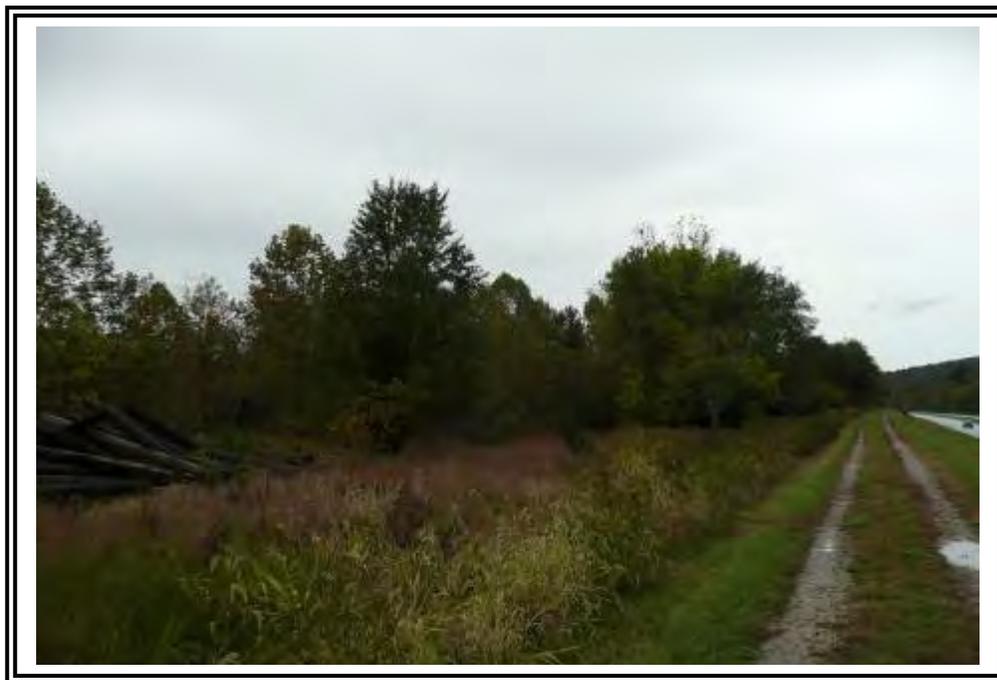
2

Looking across Ash Pond A from east dike, facing north. Note vegetation and large trees in ash/slag surface.

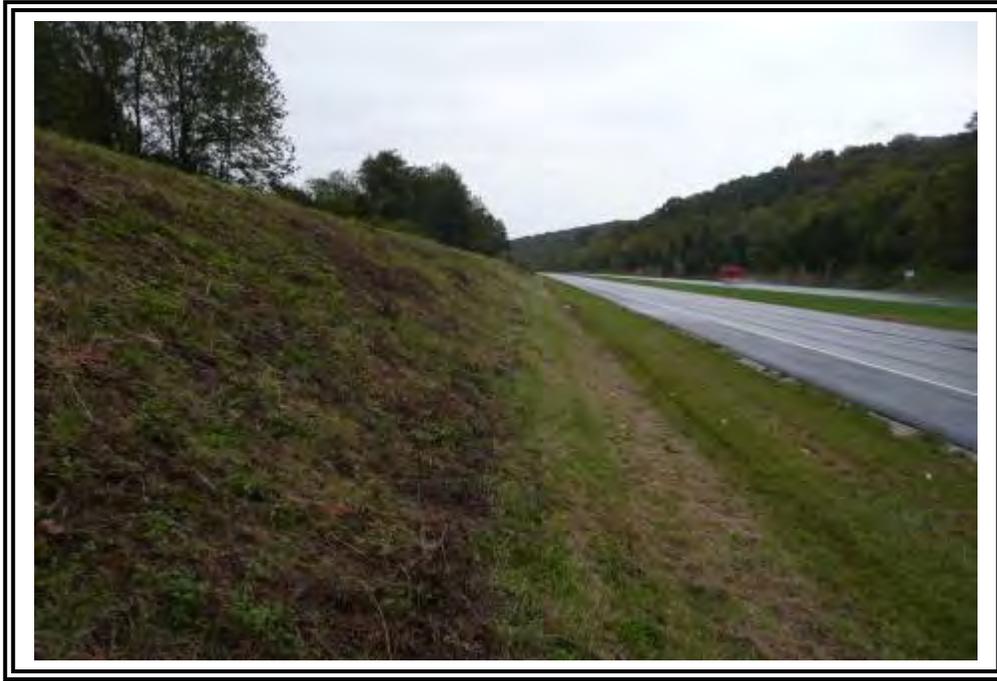
3

Exterior slope of east dike, looking north. Note proximity of U.S. Route 52 southbound lanes and ditch at toe.

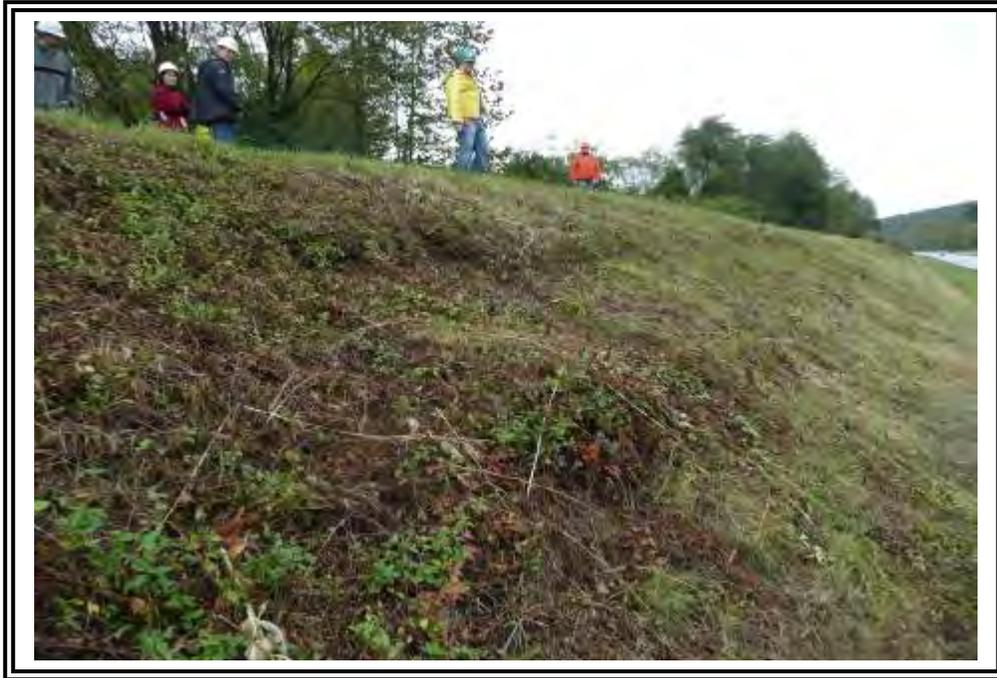
5

Surficial scarps/sloughs were observed on the exterior slope of the east dike. One scarp/slough was measured to be approximately 15 to 20 foot long. The scarps/sloughs appeared to be the

result of an over steepened slope. The areas were generally covered with grass (Photo 5). Water was observed in the US Route 52 drainage swale at the toe of the east dike (Photo 6).

Faint vegetated creep in east dike exterior slope, looking north.

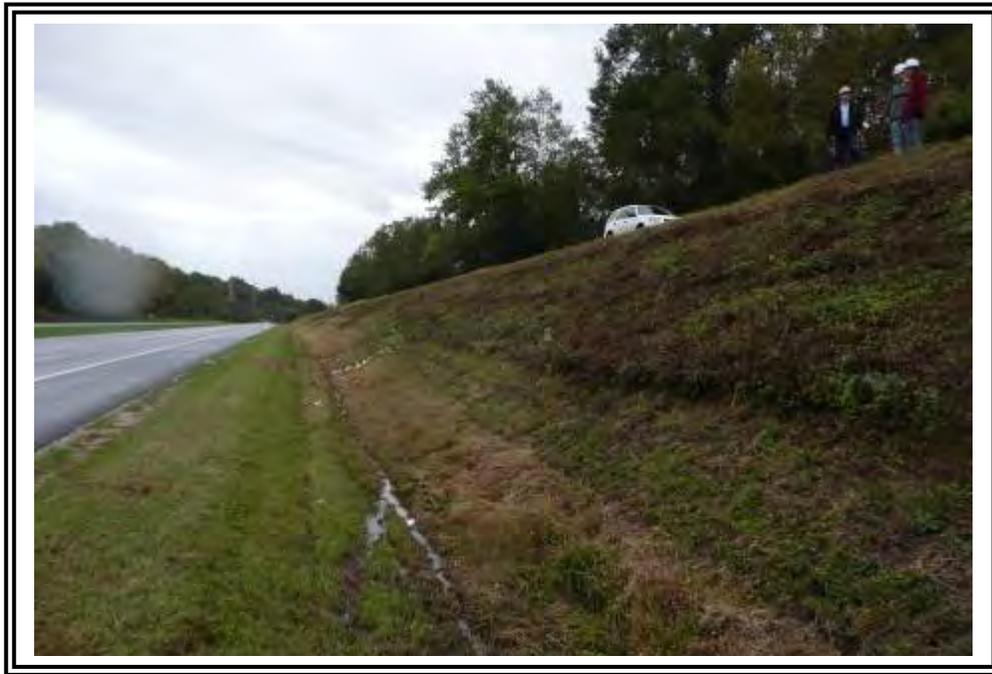
6

East dike exterior slope, looking south. Runoff is collected in the highway ditch line.

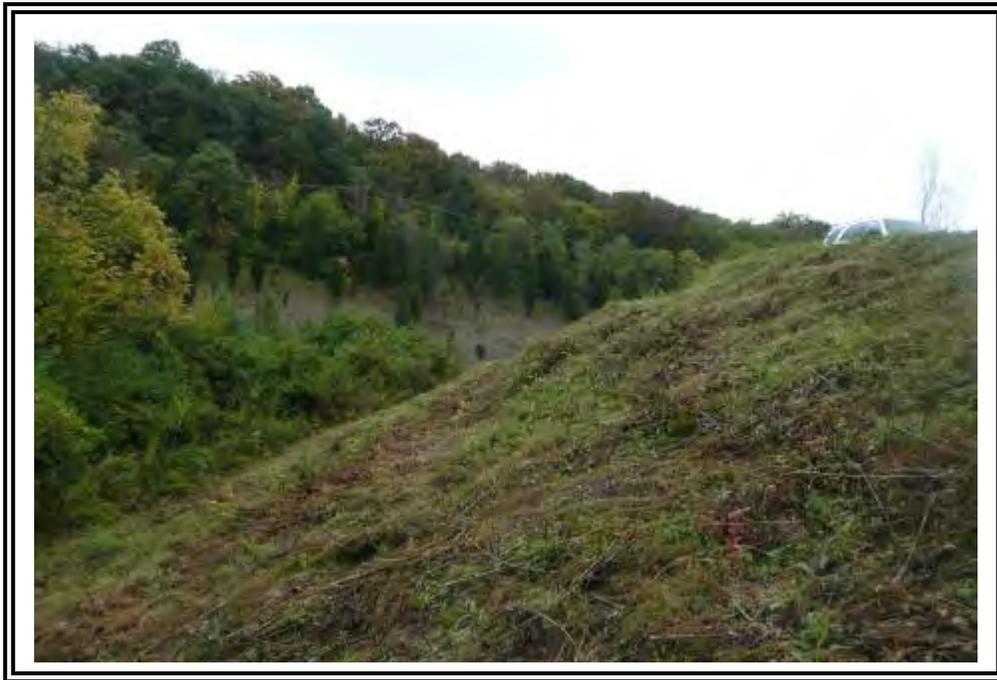
7

Surface undulations on exterior slope at corner of east and north dikes, looking east.

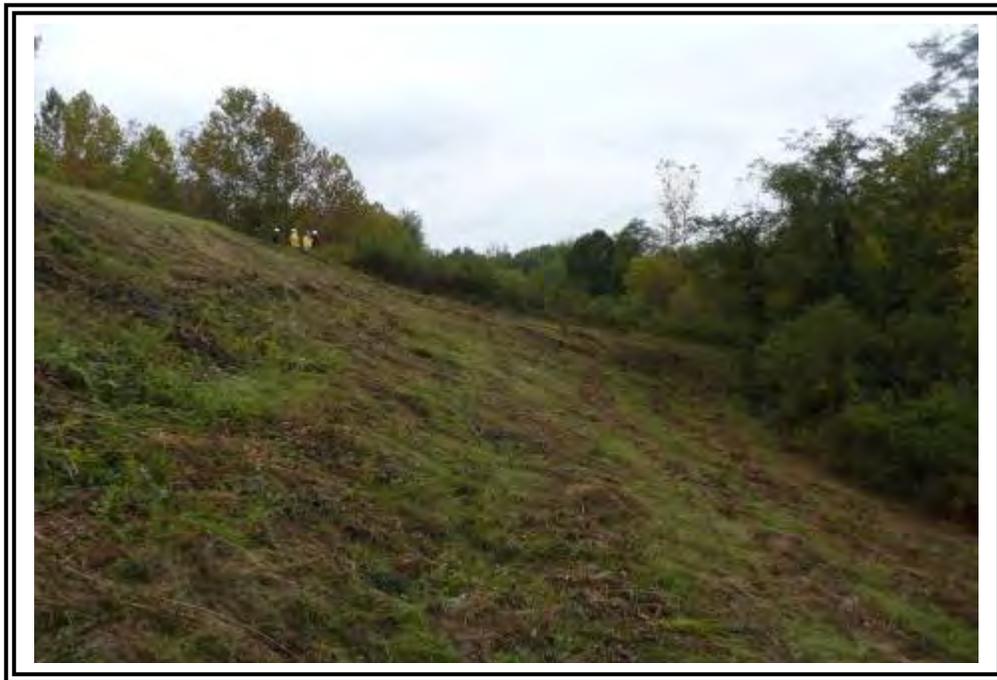
8

North dike, exterior slope, looking west. Note that slope gets flatter here and vegetation is not maintained where cell tower access road crosses drainage swale/creek at toe of dike.

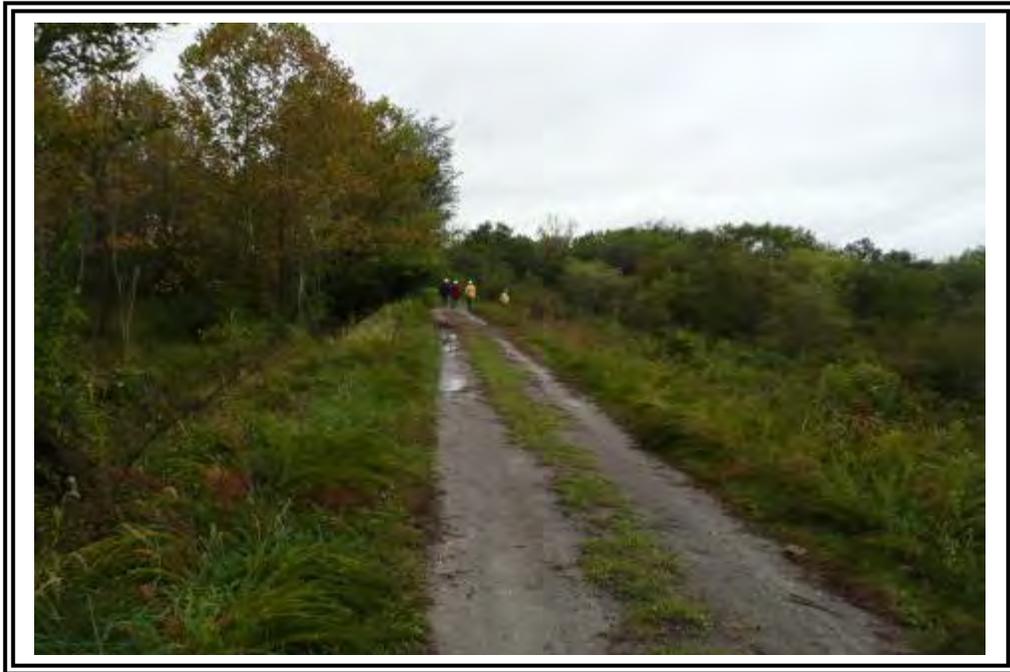
10

North dike crest and interior slope, looking west.

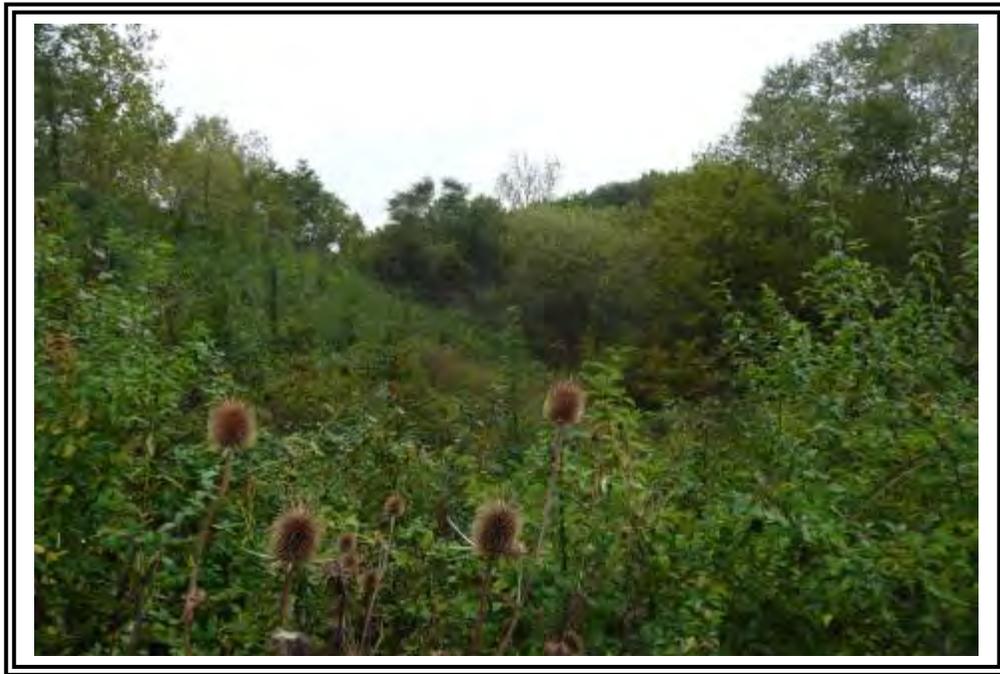
12

Heavy vegetation on the north dike exterior slope, looking west.

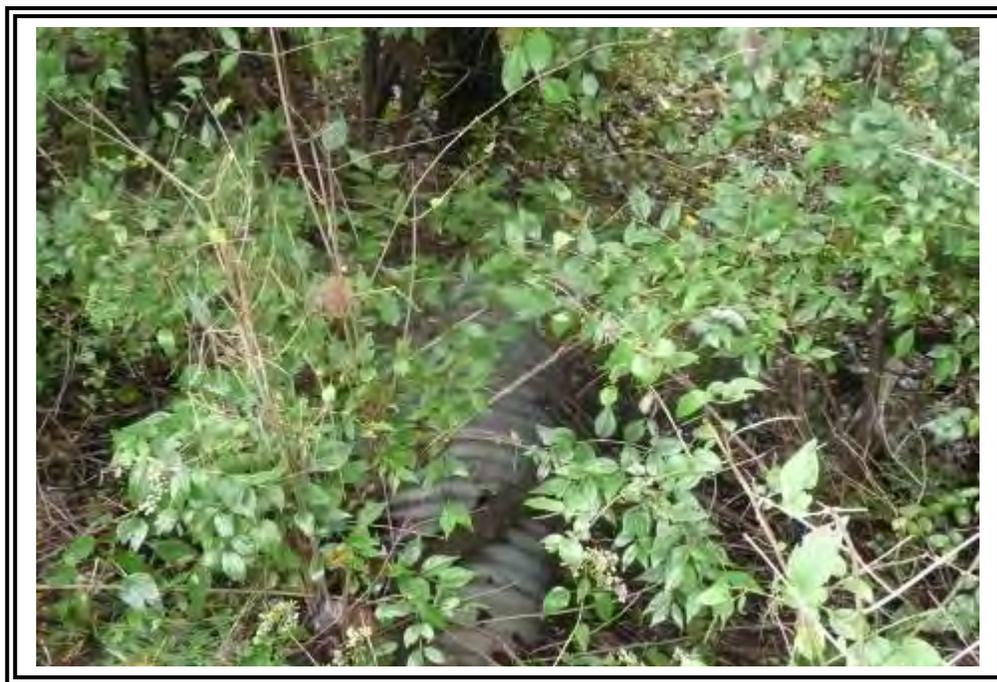
13

Culvert for creek/drainage swale at toe of north dike carrying flow beneath cell site access drive.

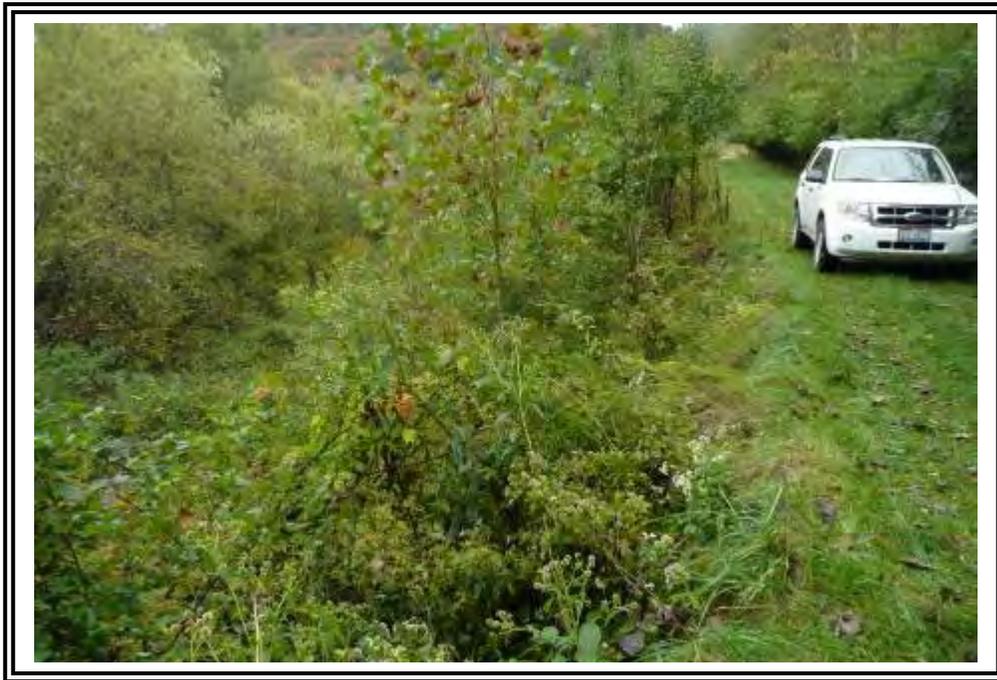
15

Heavy vegetation on the exterior slope of the north dike, looking east from the north dike crest.

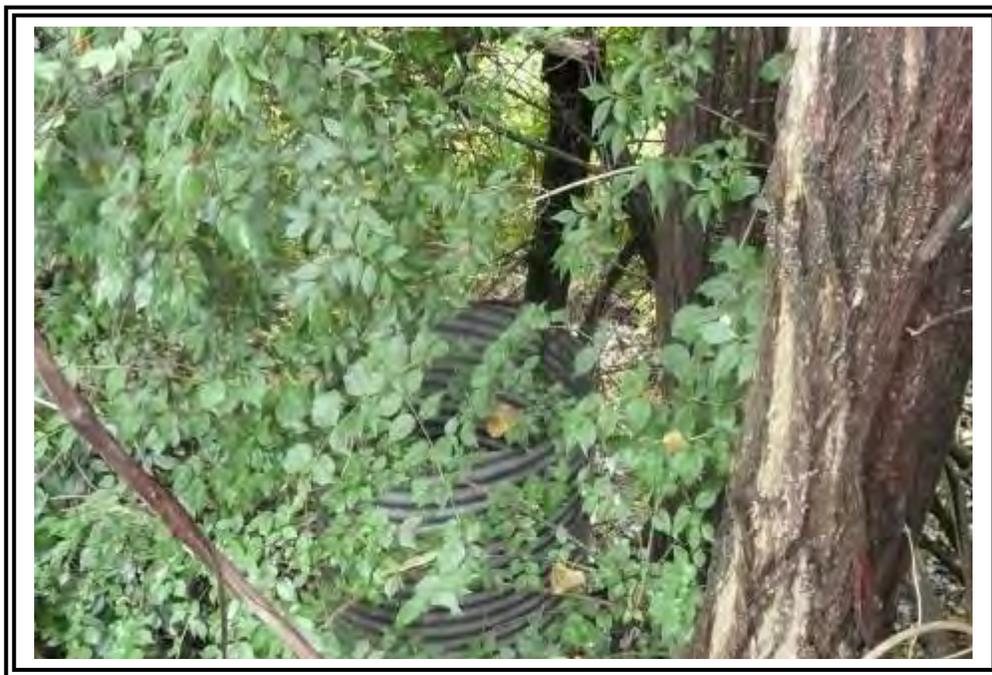
16

Inactive corrugated metal outlet riser/decanting structure in trees and vegetation.

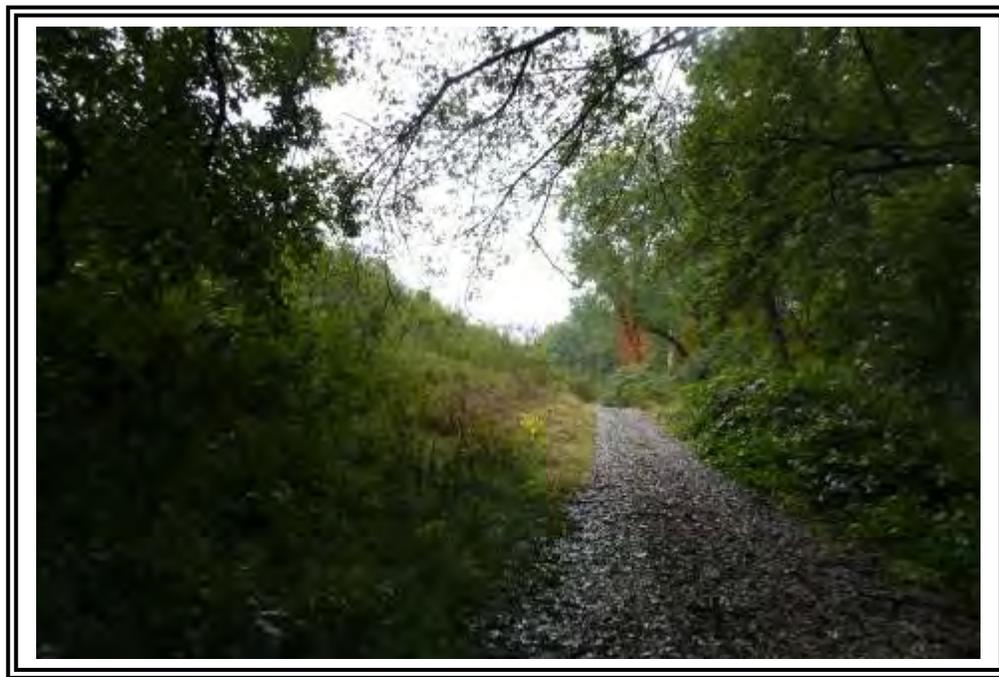
18

West dike exterior slope along access drive at toe, looking south from northern end.

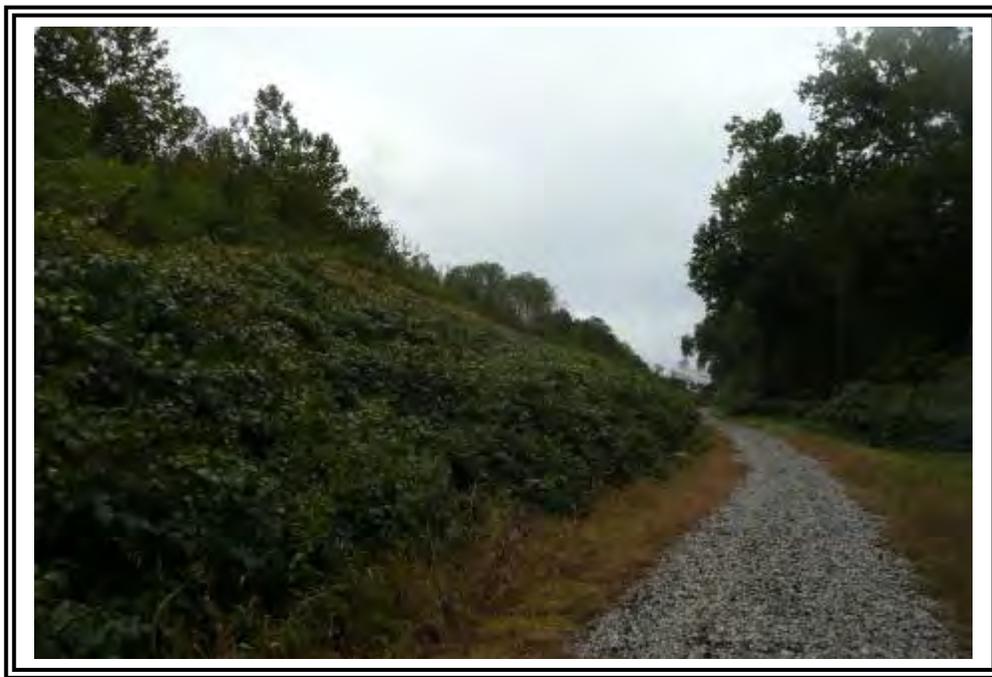
20

West dike exterior slope, looking south. Note heavy, broad, leafy, bush-like vegetation.

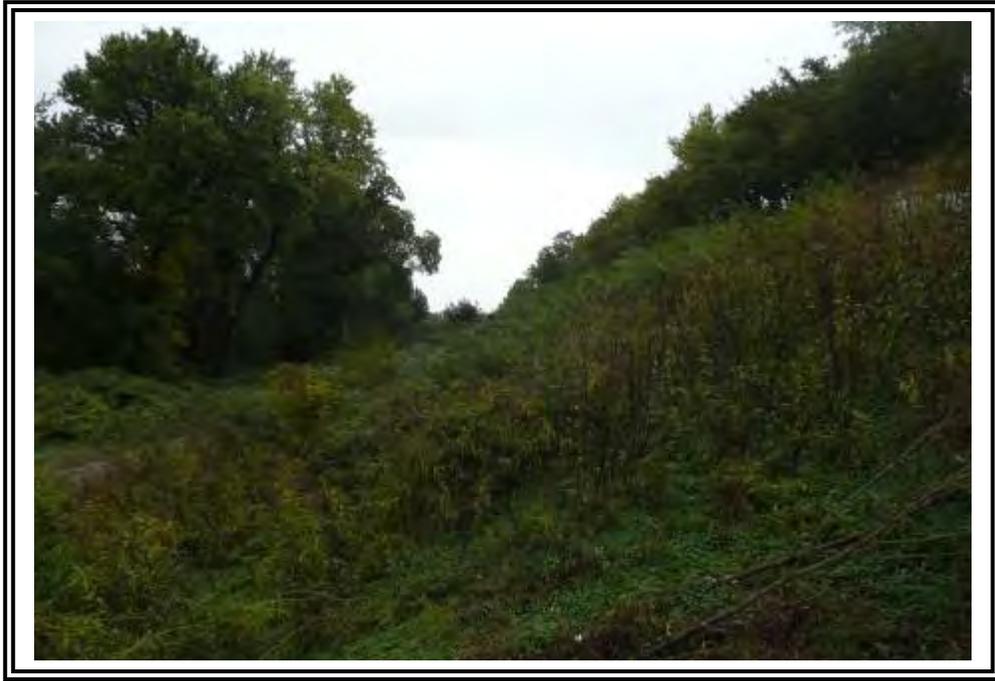
21

Exterior slope of west dike, looking north. Heavy vegetation prevalent with tree growth in basin above slope.

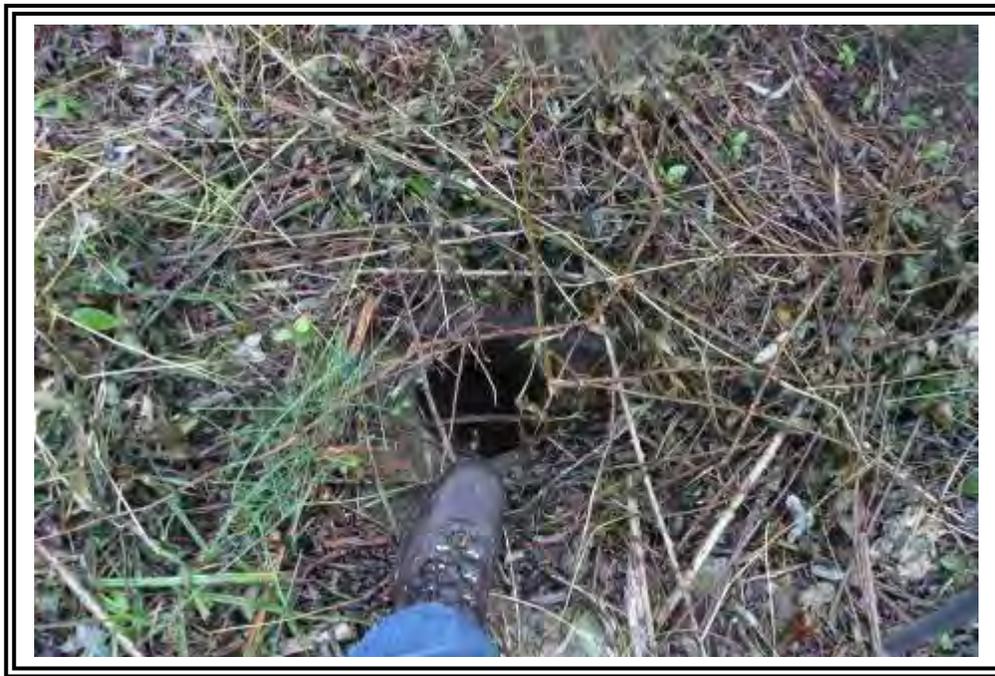
22

Possible rodent burrow at western terminus of south dike.

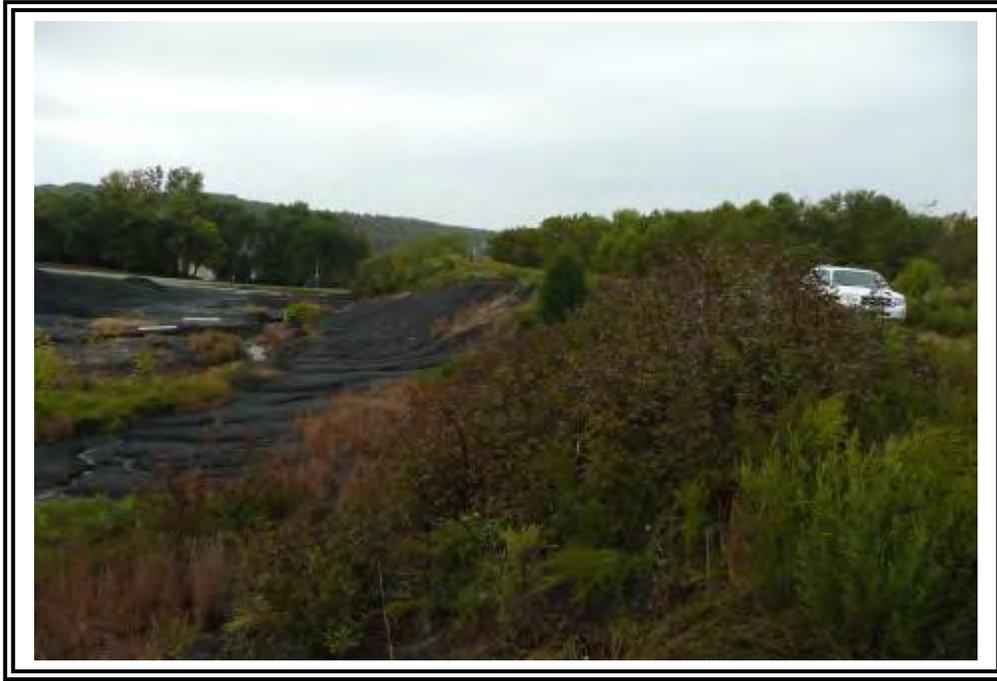
23

Exterior slope of south dike, looking west. Note erosion rills in coal material pushed against dike and areas of moderate to heavy vegetation. Dike in this area abuts the coal pile operations.

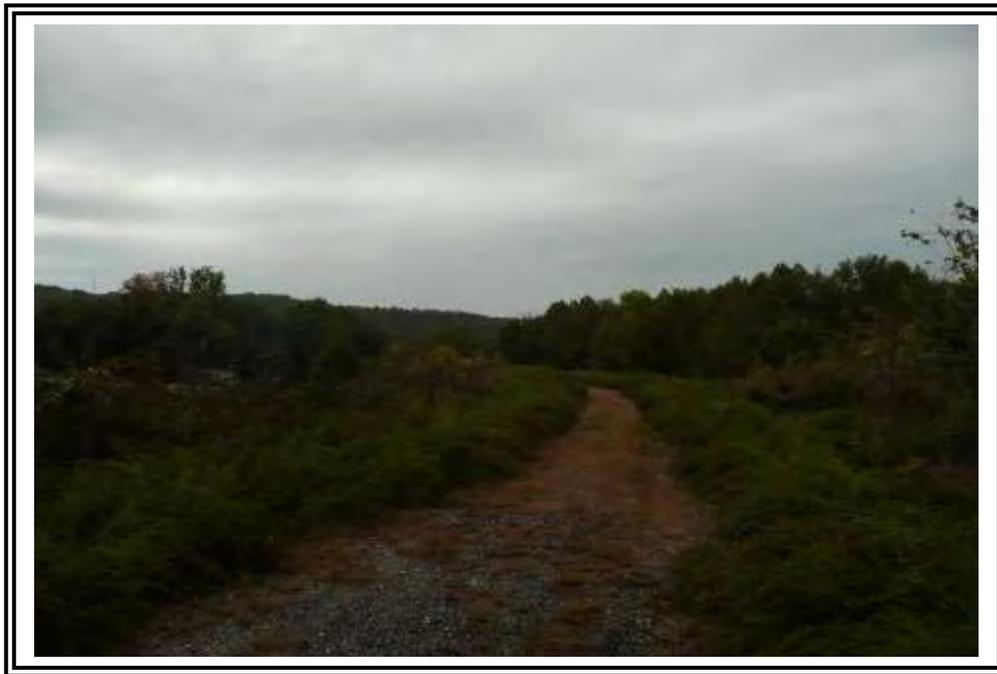
24

South dike crest near where it abuts the north end of the Ash Pond B west dike, looking west.

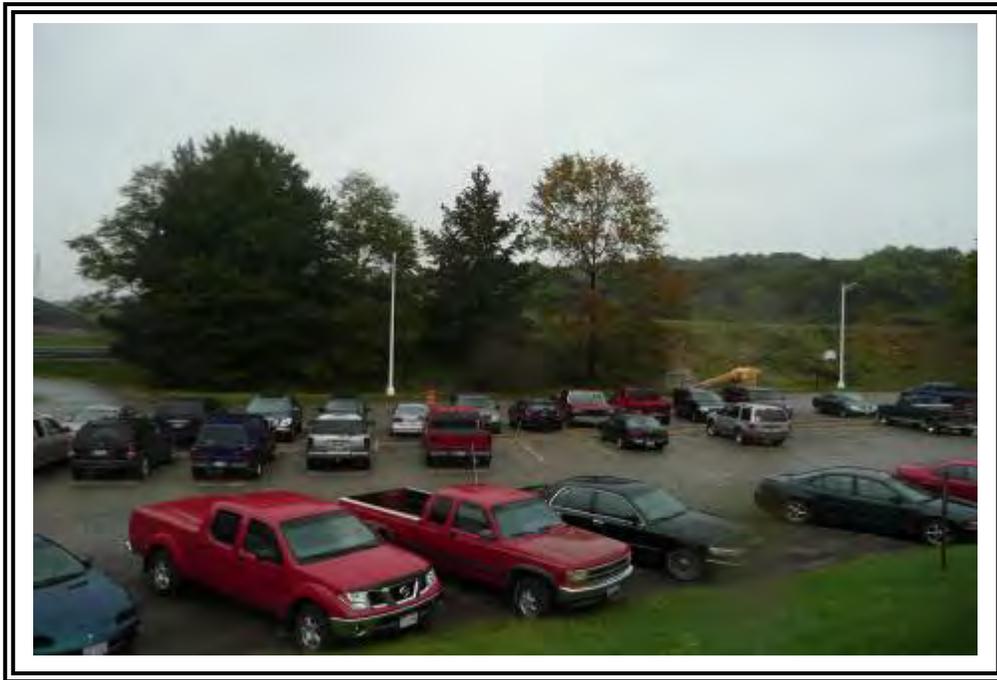
25

Exterior slope of the south dike, looking north. Note large, mature trees at the southwest corner (left) of the dike.

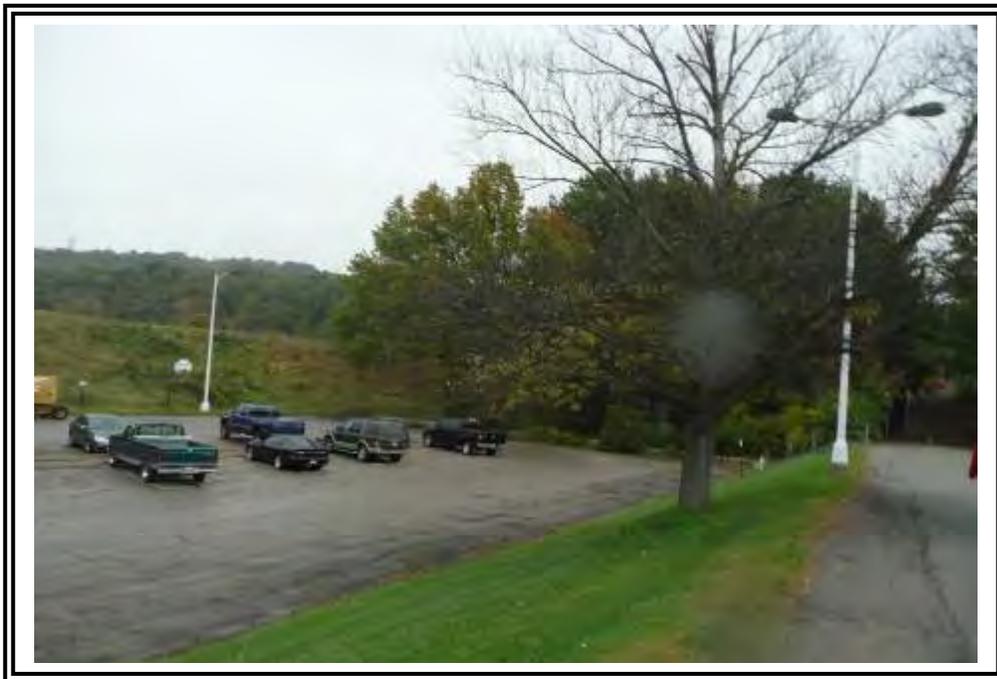
26

Exterior slope of the south dike, looking northeast toward central portion of the dike. Large trees on dike slope, as well as parking lot embankment, abut the dike.

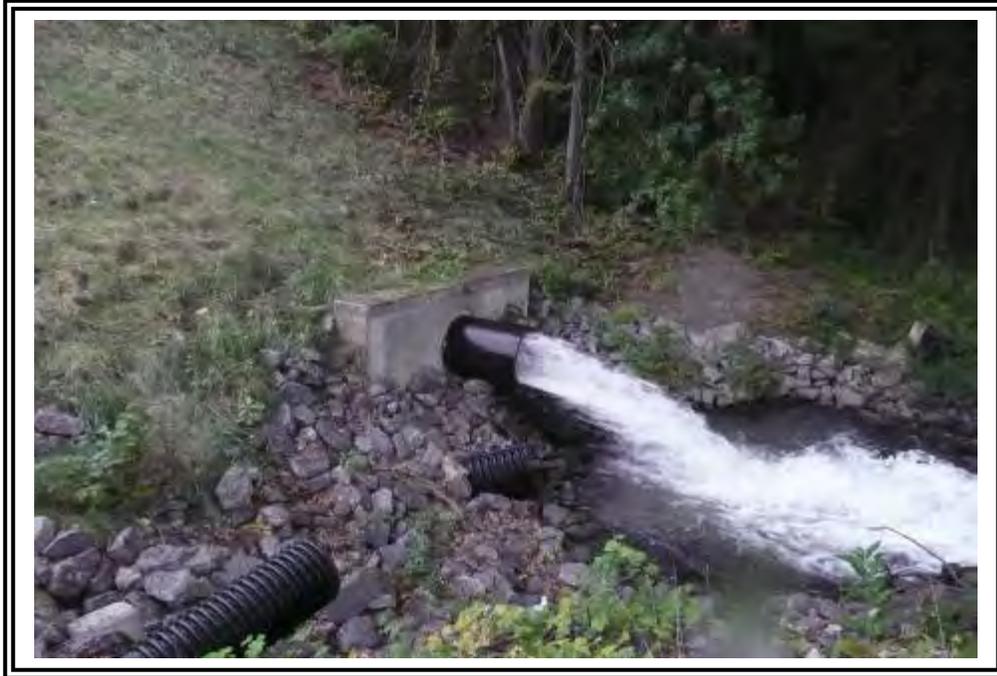
27

Ash Pond B outlet headwall, rock lined outlet channel and site drainage/seepage pipes.

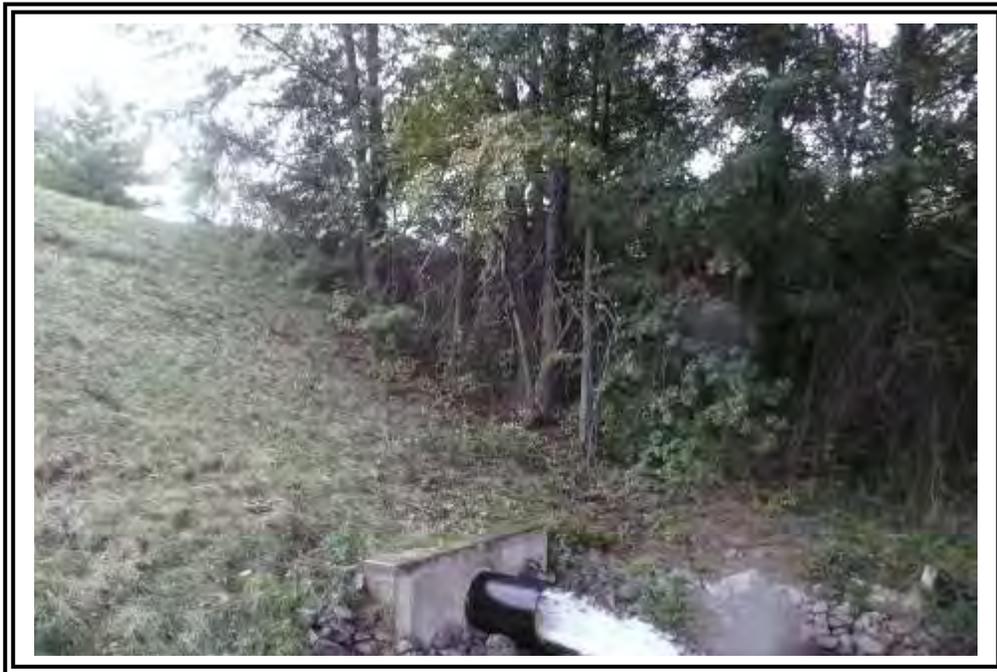
28

Ash Pond B outlet and vegetation and trees on slope face.

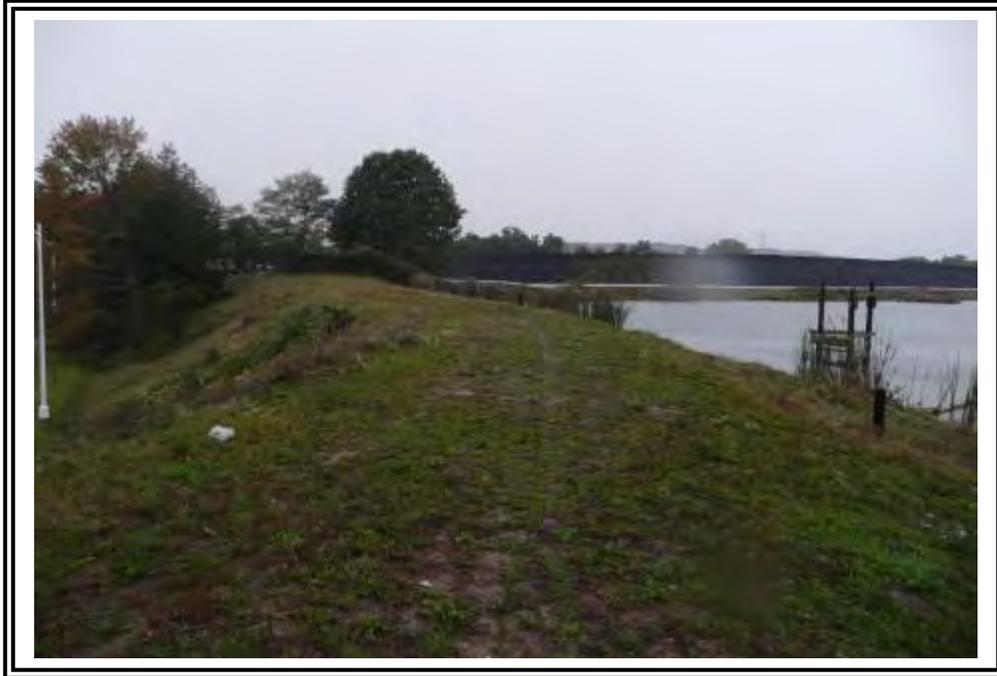
29

South dike crest and exterior slope, looking west.

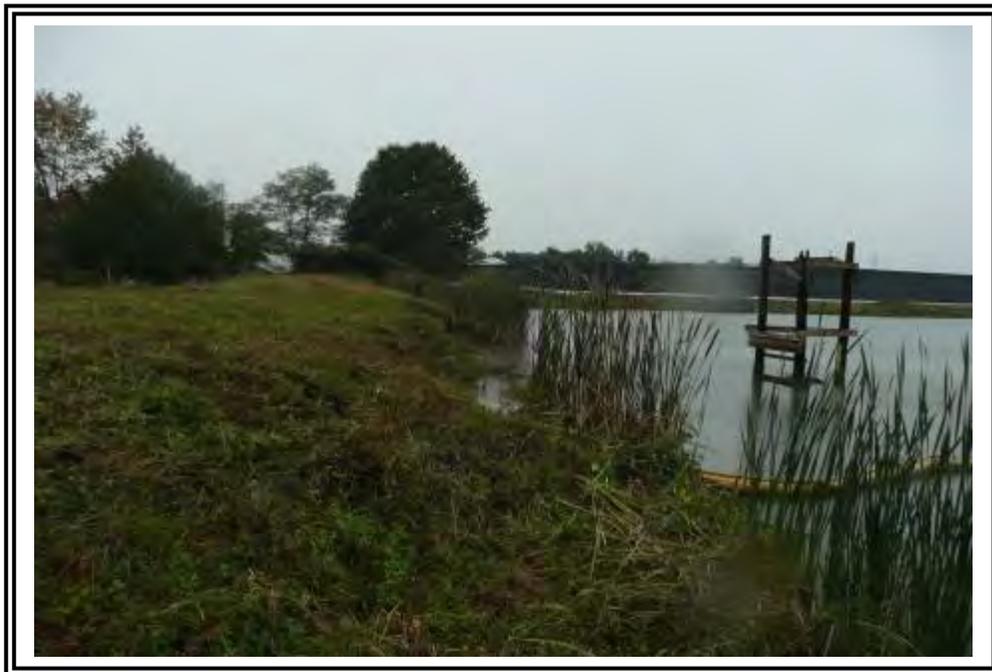
30

South dike interior slope and pond elevation, looking west.

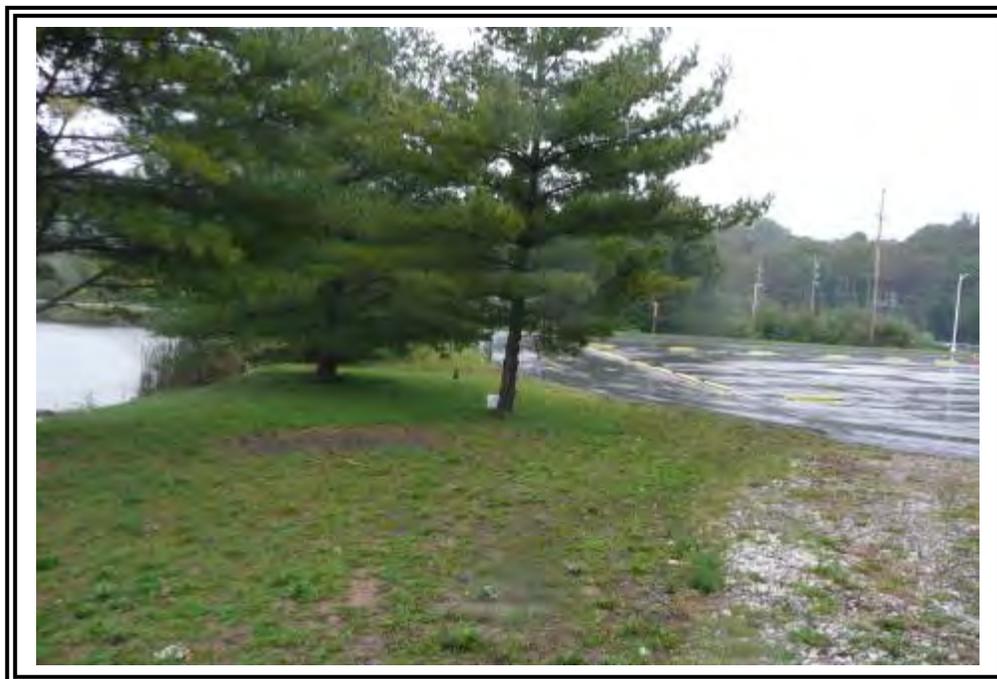
31

South dike crest area where parking lot embankment abuts the pond, looking east.

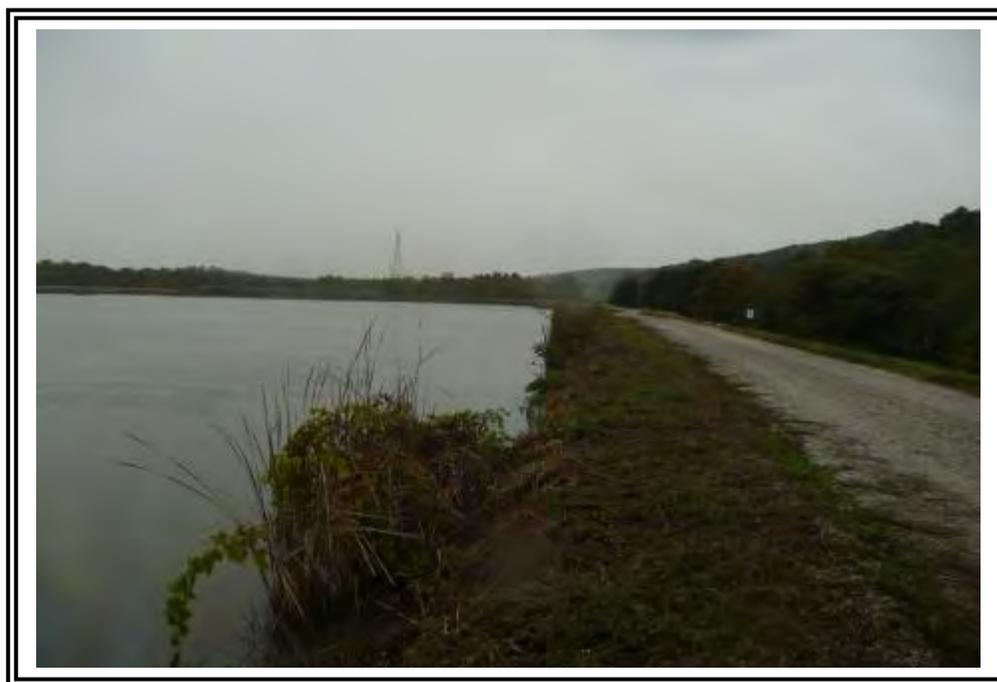
32

East dike, crest and interior slope, looking north.

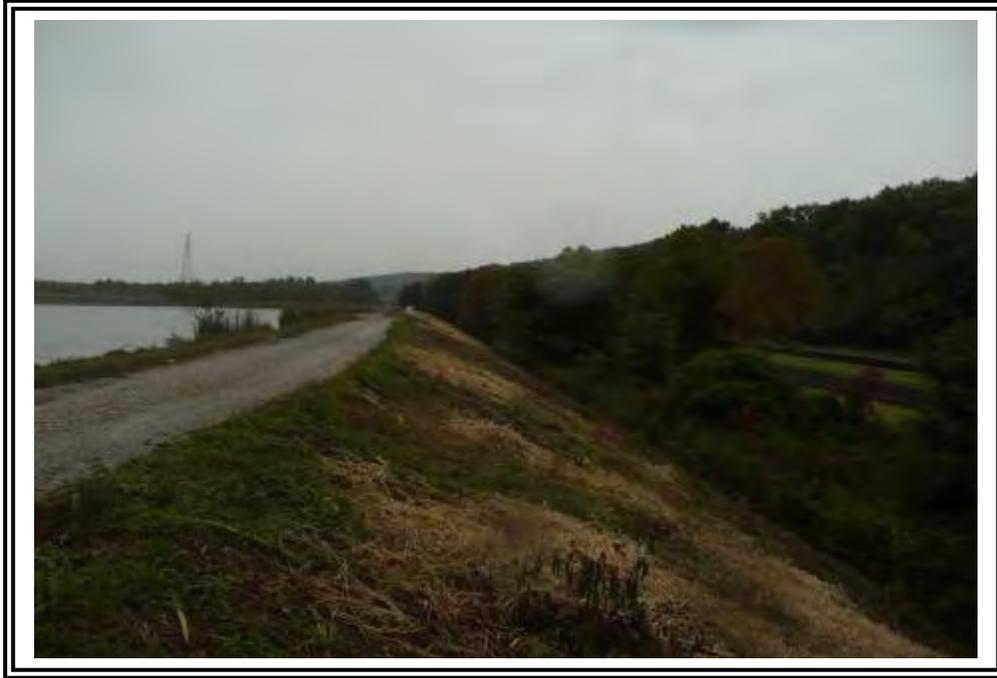
33

East dike exterior slope, looking north.

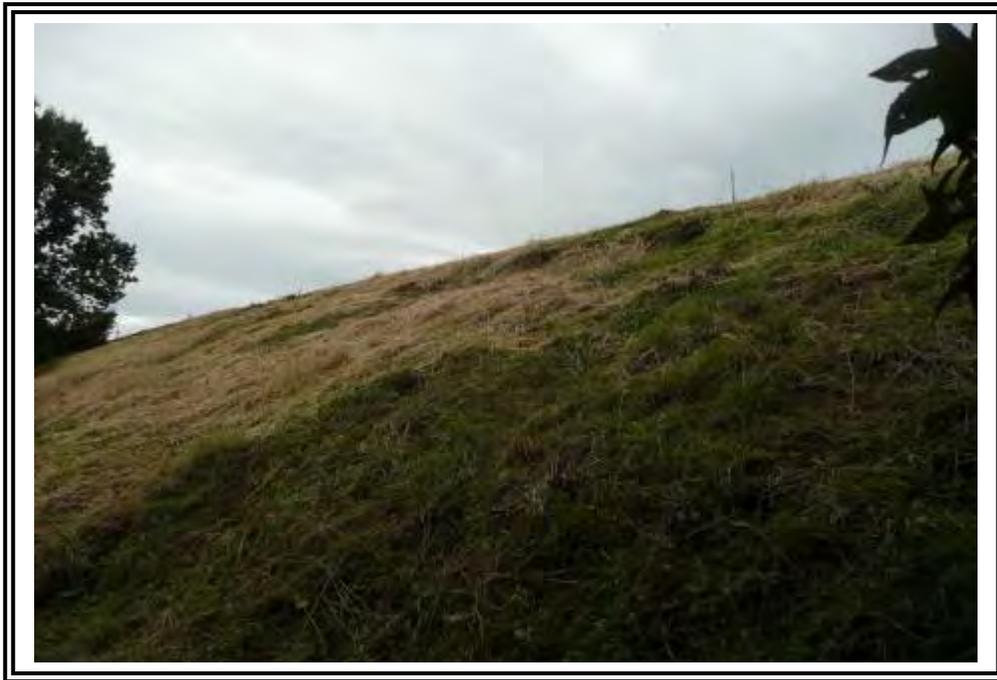
35

Active surface scarp and slough on east dike (different feature from Photo No. 10).

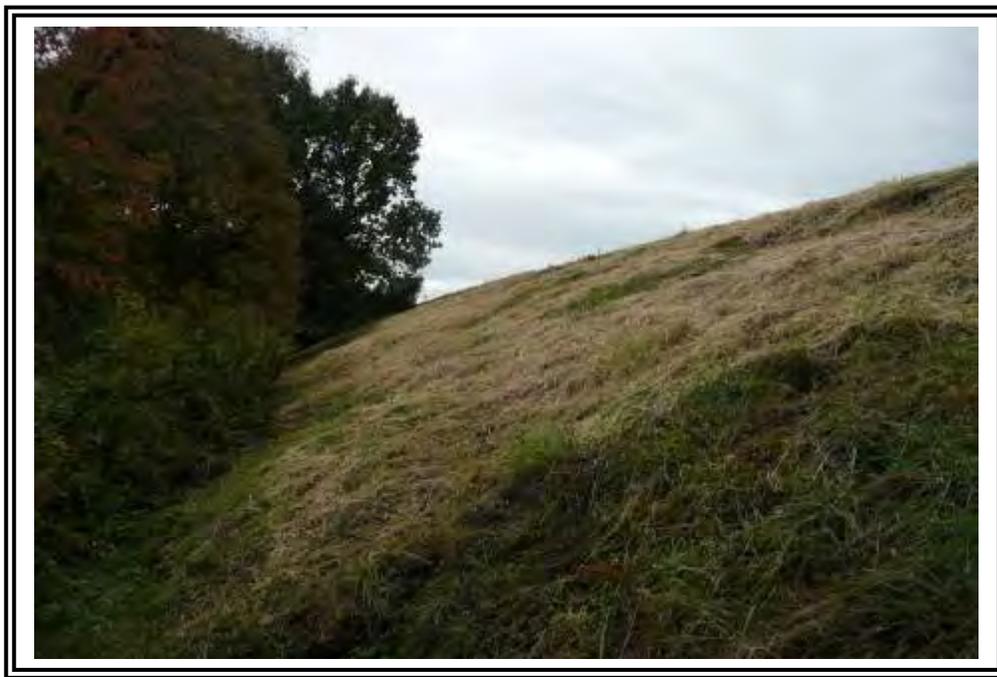
36

Toe bulge expression from active surface scarp and slough in Photo No. 11, looking south.

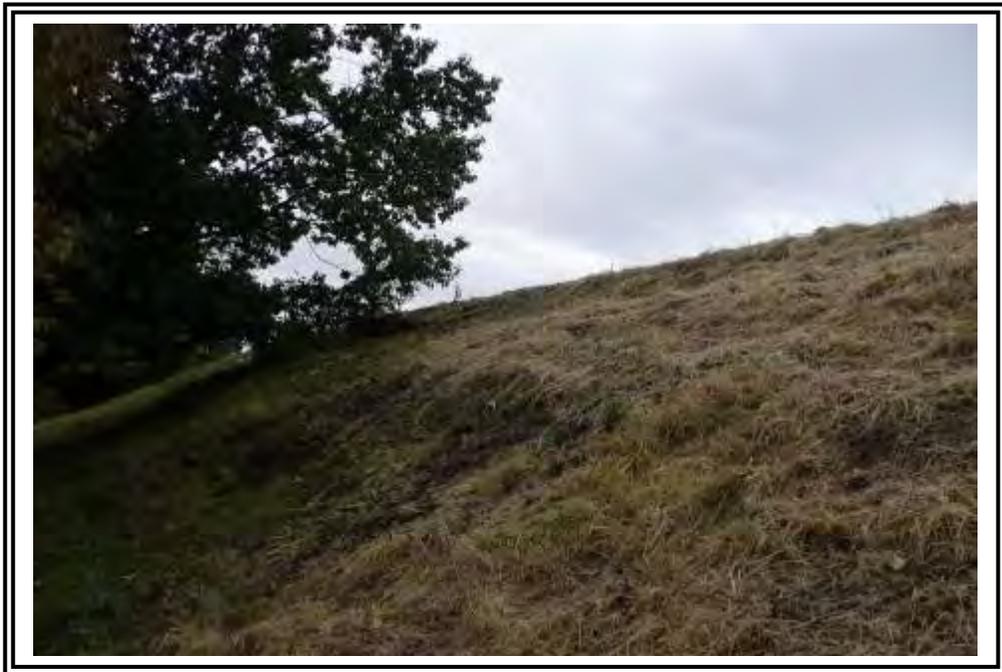
38

Slough on east dike exterior slope adjacent to mature tree at slope toe.

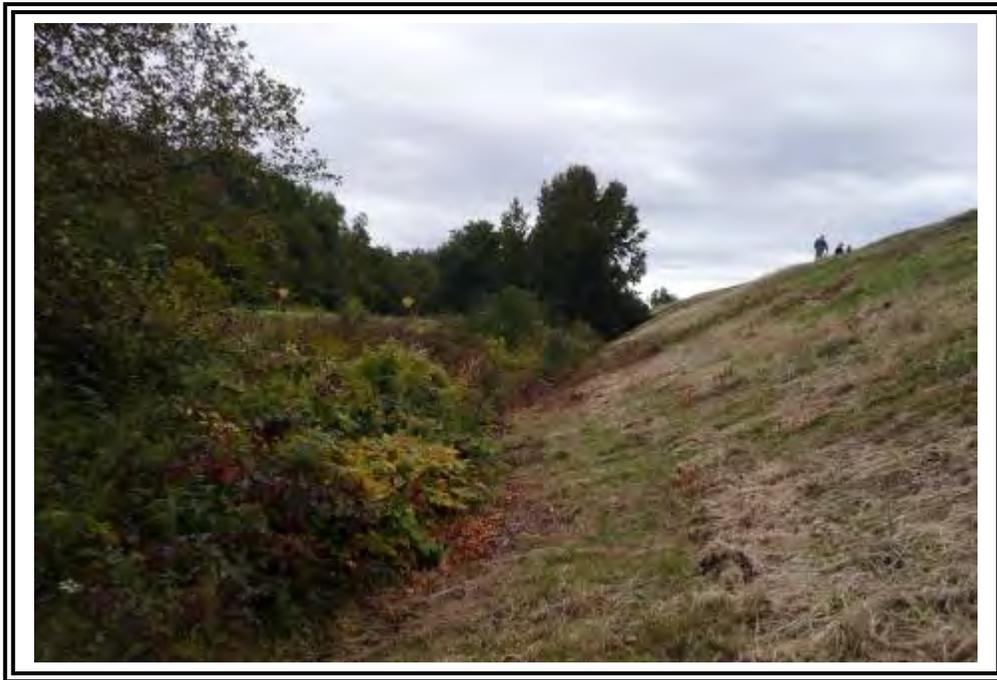
38

General view of east dike exterior slope, looking south from northern terminus. Note vegetation at dike toe. A ditch/drainage swale is located at base of dike toe.

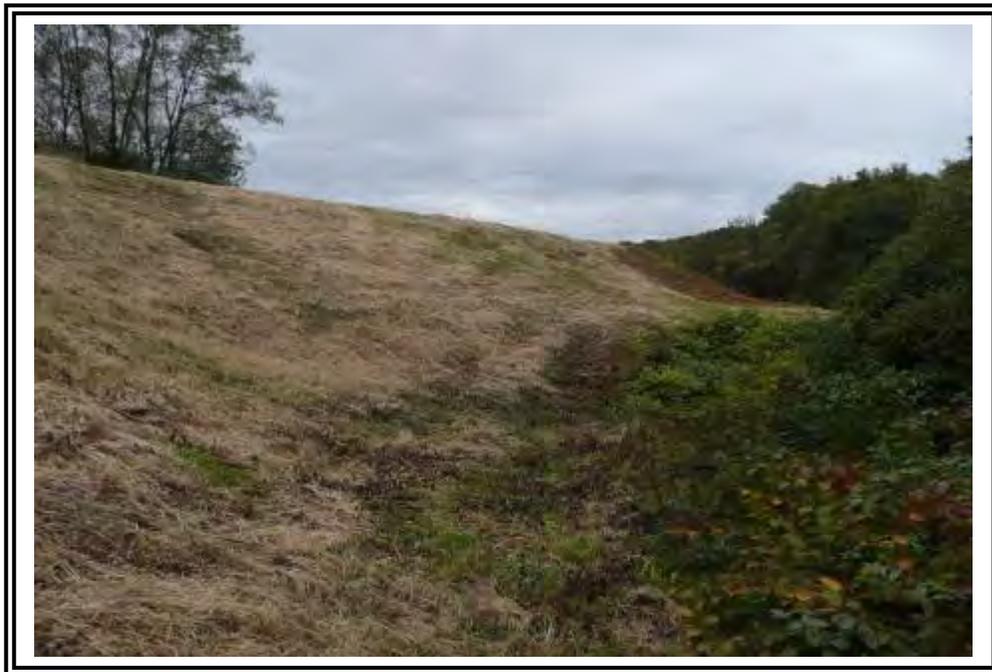
40

Exterior slope of east dike at contact with south dike of Ash Pond A, looking north.

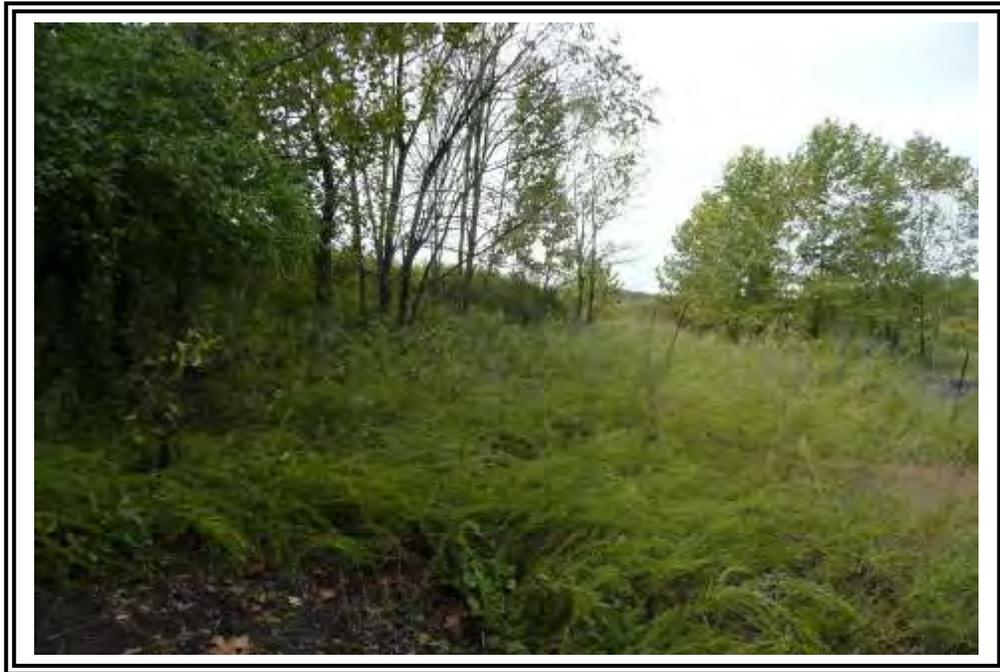
42

North dike exterior slope, looking west. Note bottom ash/slag exposed in Ash Pond A surface.
