Assessment of Dam Safety Coal Combustion Surface Impoundments (Task 3) Draft Report

Duke Energy

W.C. Beckjord Station
New Richmond, Ohio

December 7, 2009

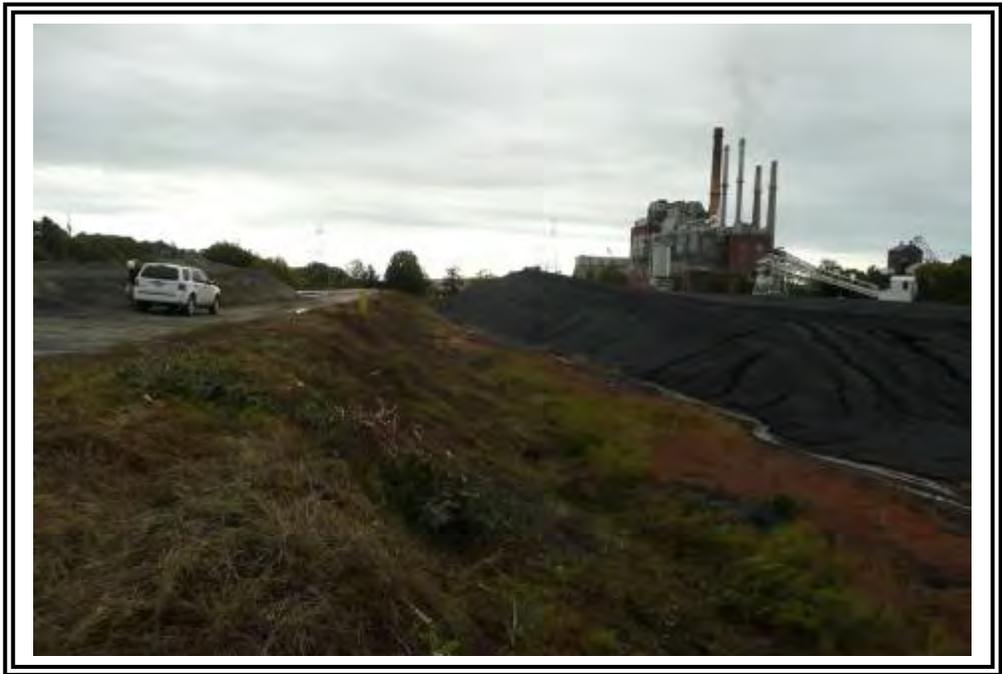
44

Exterior slope and part of west dike crest, looking south.

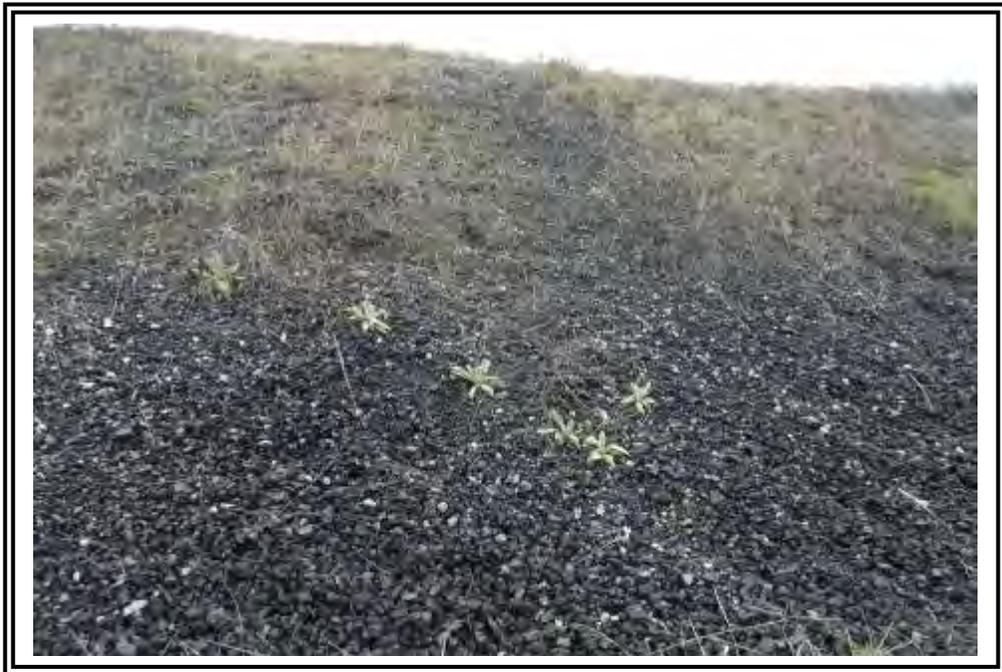
48

Slag surface prevalent in this portion of the west dike where grass/weed cover is sparse.

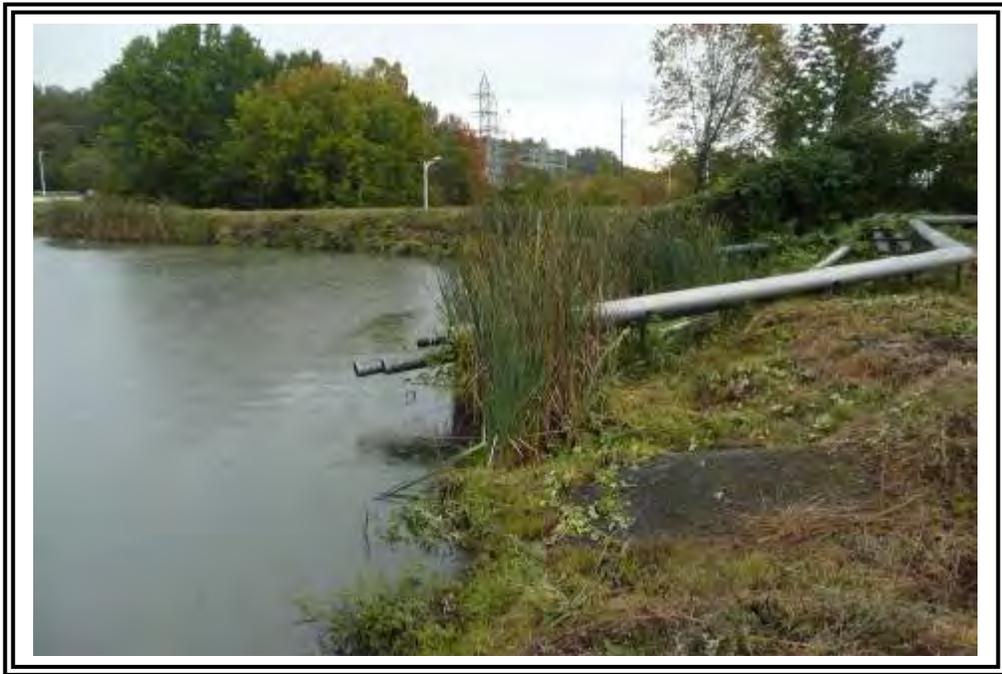
50

Interior slope of the west dike at the southwest corner of the pond, looking south.
Interior slope of south dike visible in background.

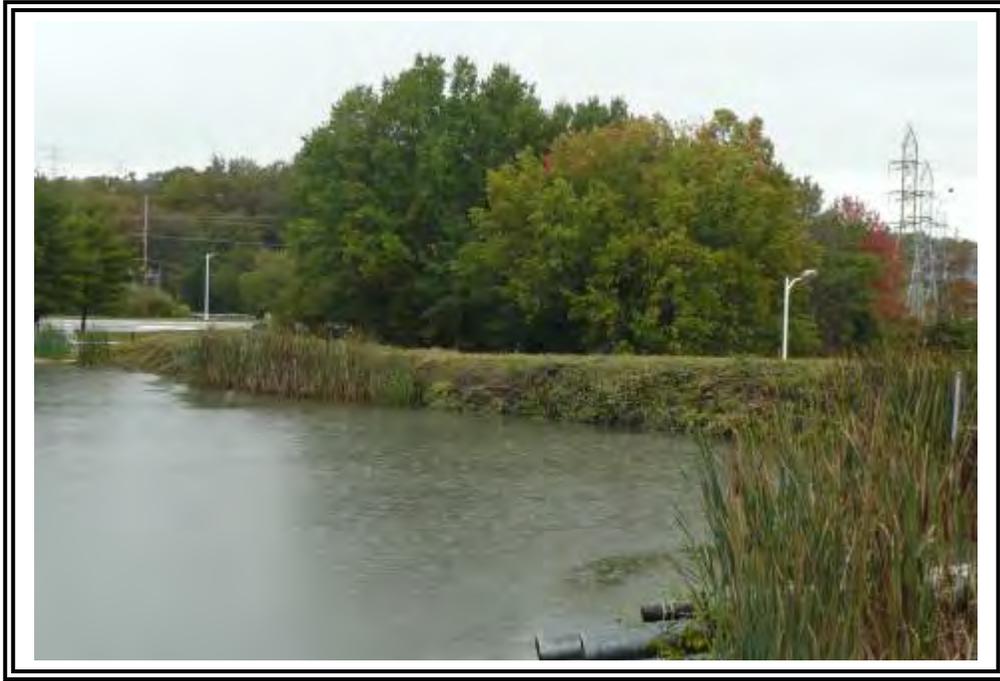
51

South dike and interior slope, looking south.

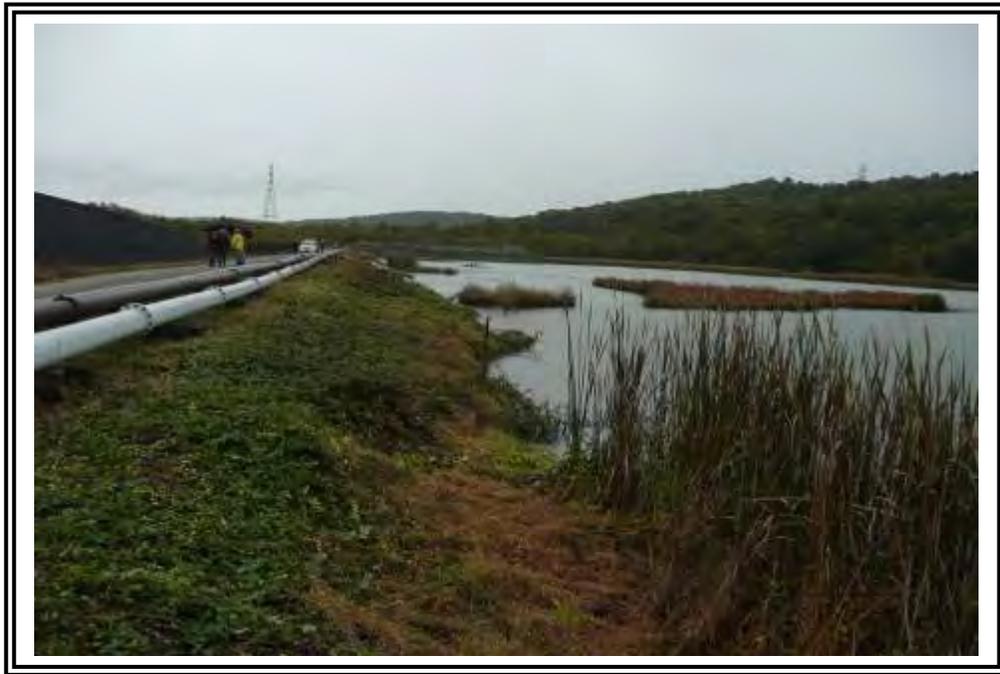
52

Crest and interior slope of west dike, looking north from southwest corner of pond.

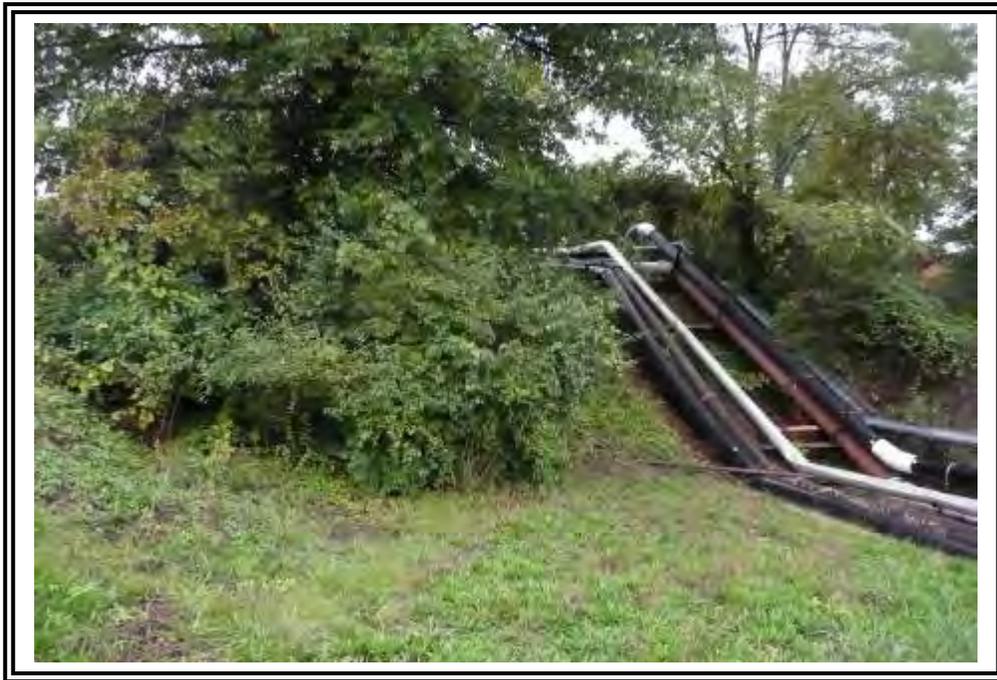
53

Exterior slope where the west dike meets the south dike, looking northeast.
Note heavy vegetation and tree growth.

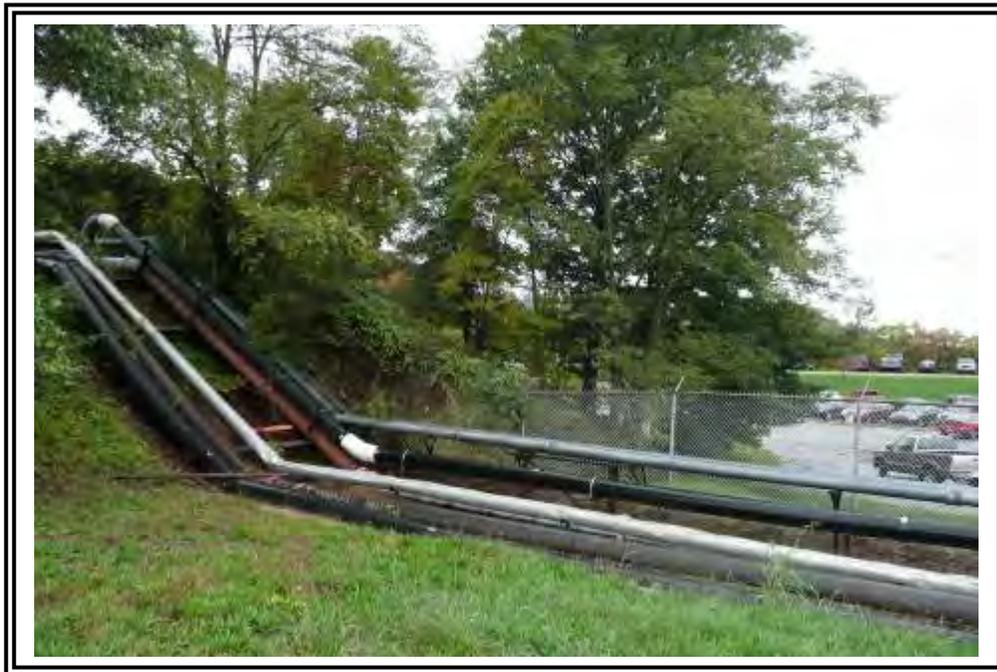
54

South dike, exterior slope looking west, showing trees and vegetation.

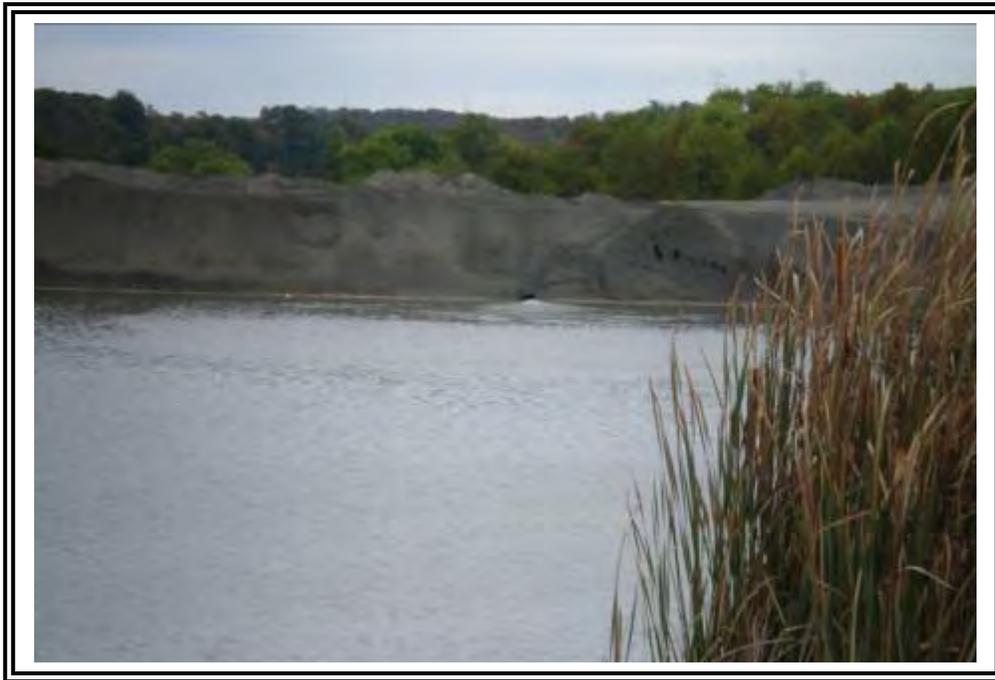
55

Looking northwest at pipe from under ash pile.

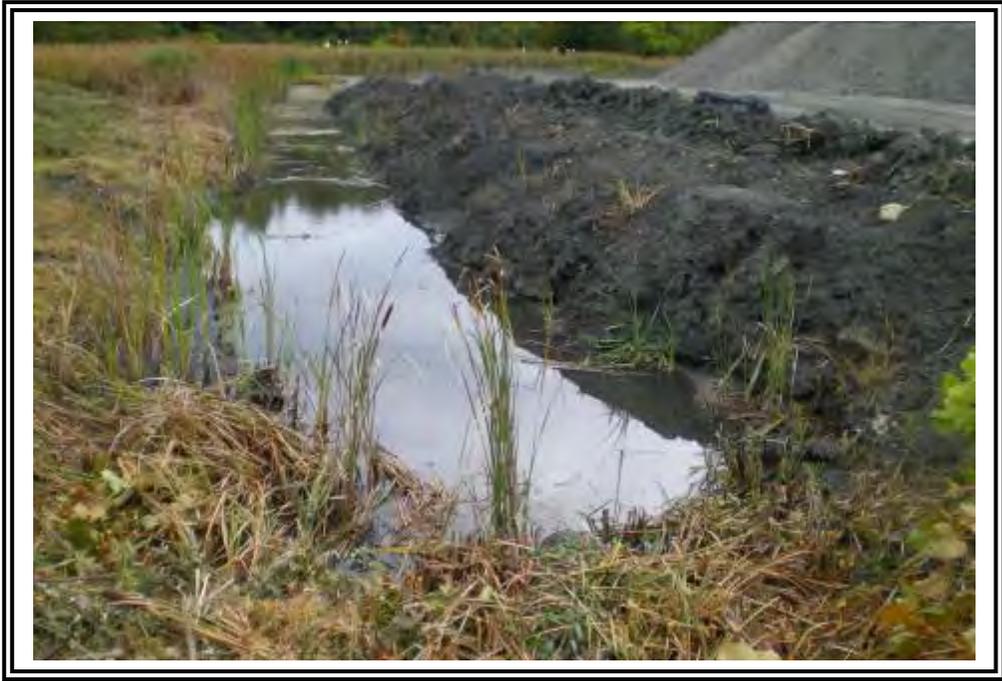
57

Looking west at settling ditch at north end of pond.

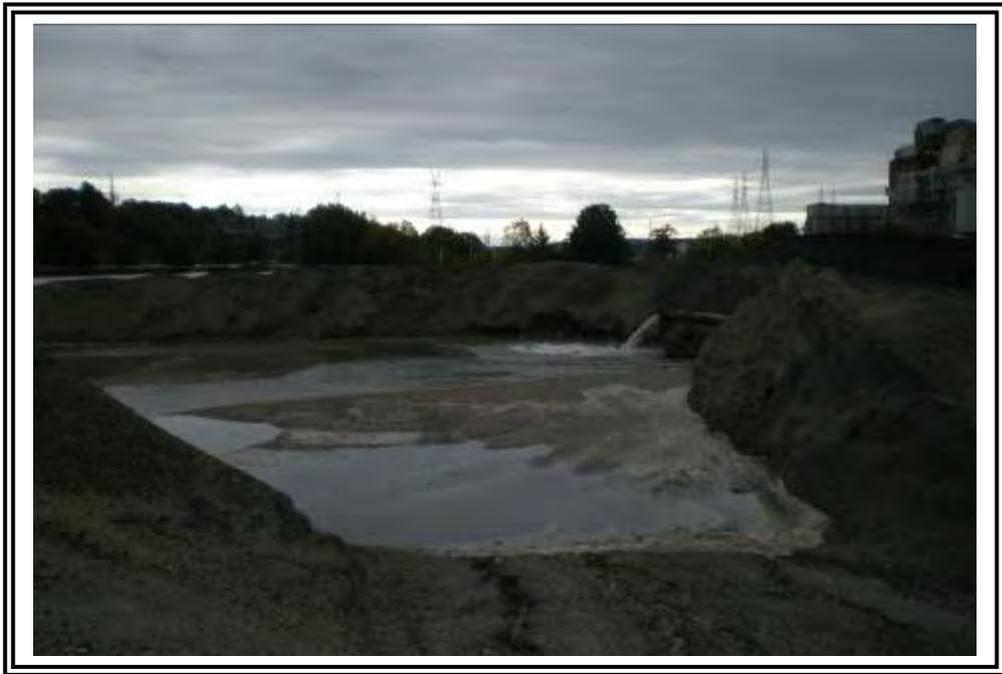
58

Looking south at inflow pipes.

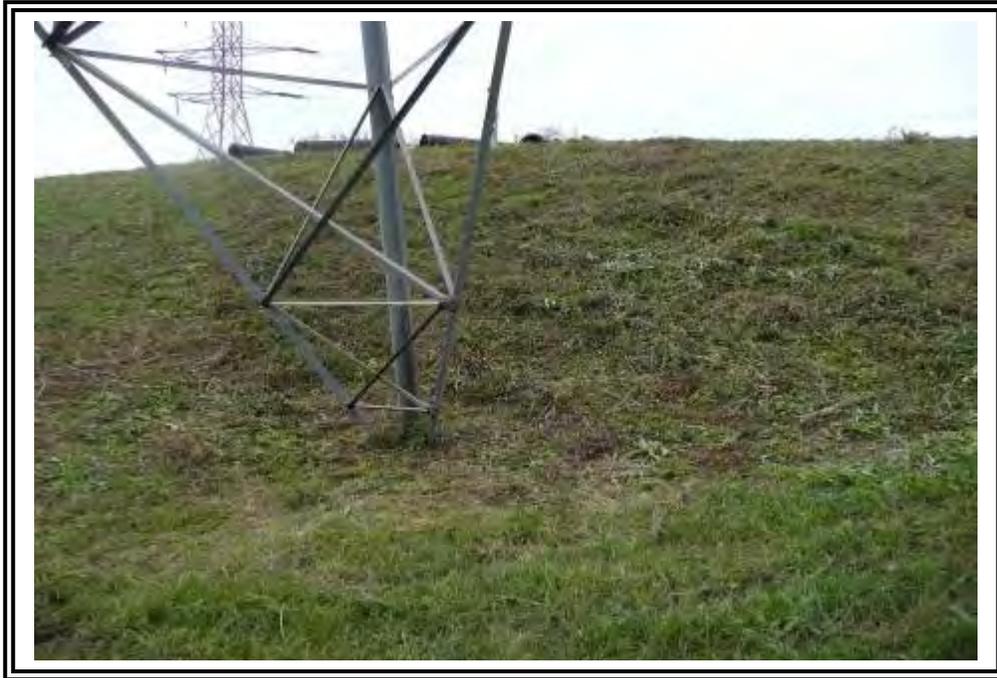
59

Grass cover on exterior slope of northeast corner of east dike at driveway embankment contact, facing west.

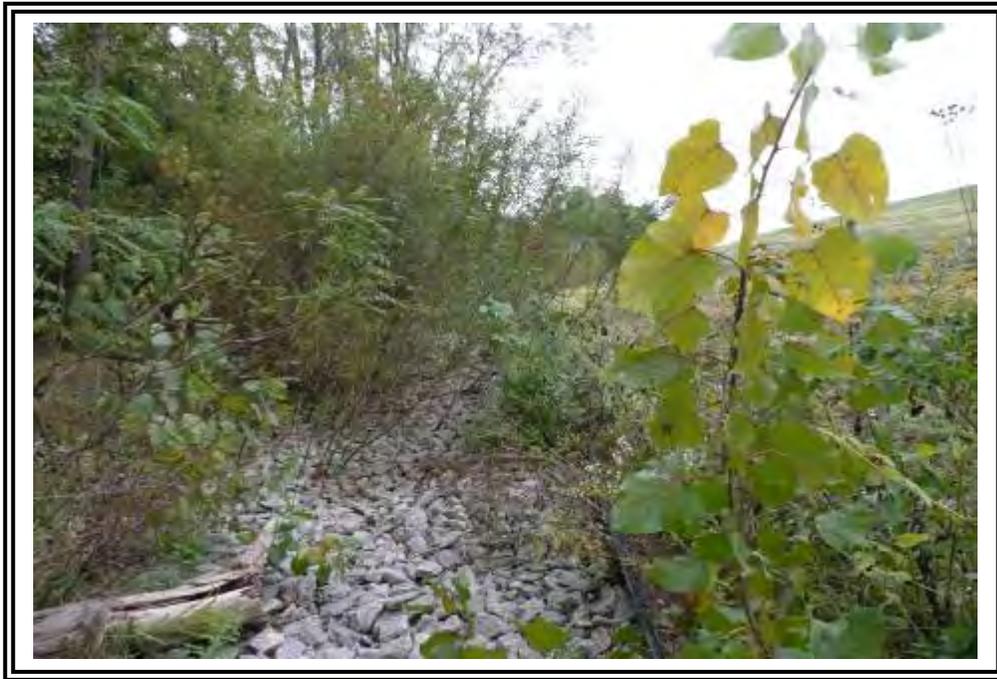
60

Vegetated rock toe drain/ditch area at northeast corner of east dike, looking south.

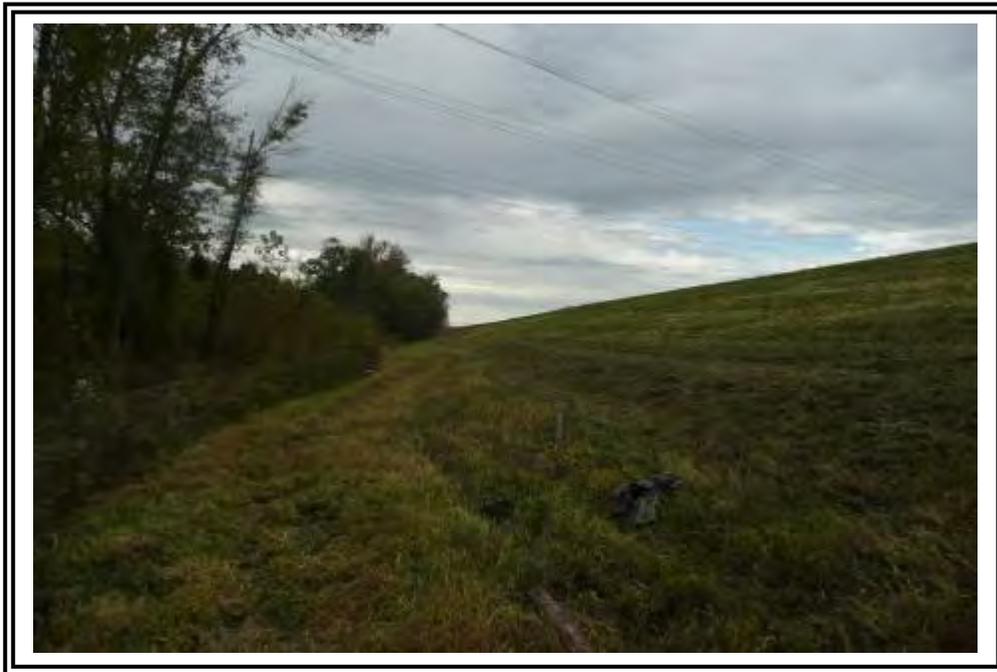
62

Exterior slope of east dike where the toe was extended out as a part of the 2003 slide repair, looking south.

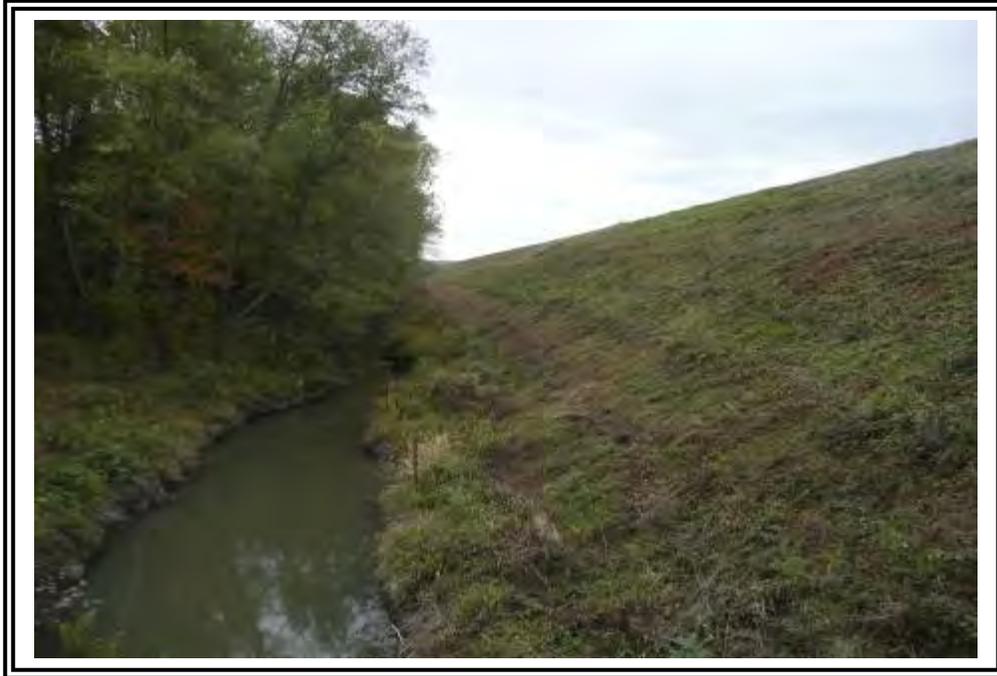
65

Looking south beyond 2003 slide repair area. Water in ditch is predominantly effluent from Ash Pond B.

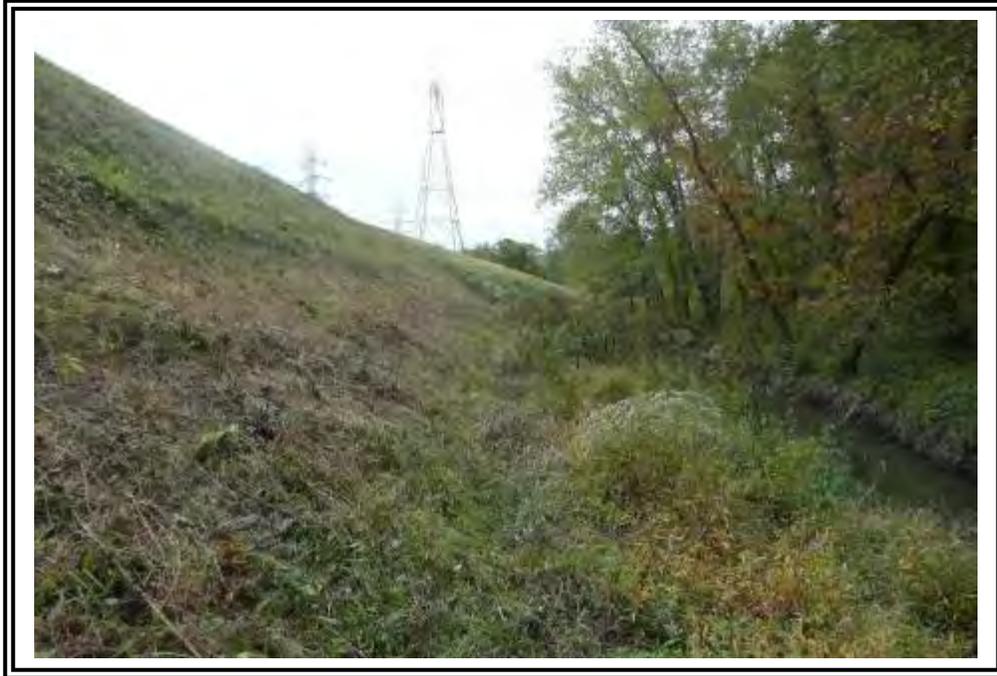
67

East dike exterior slope, looking north.

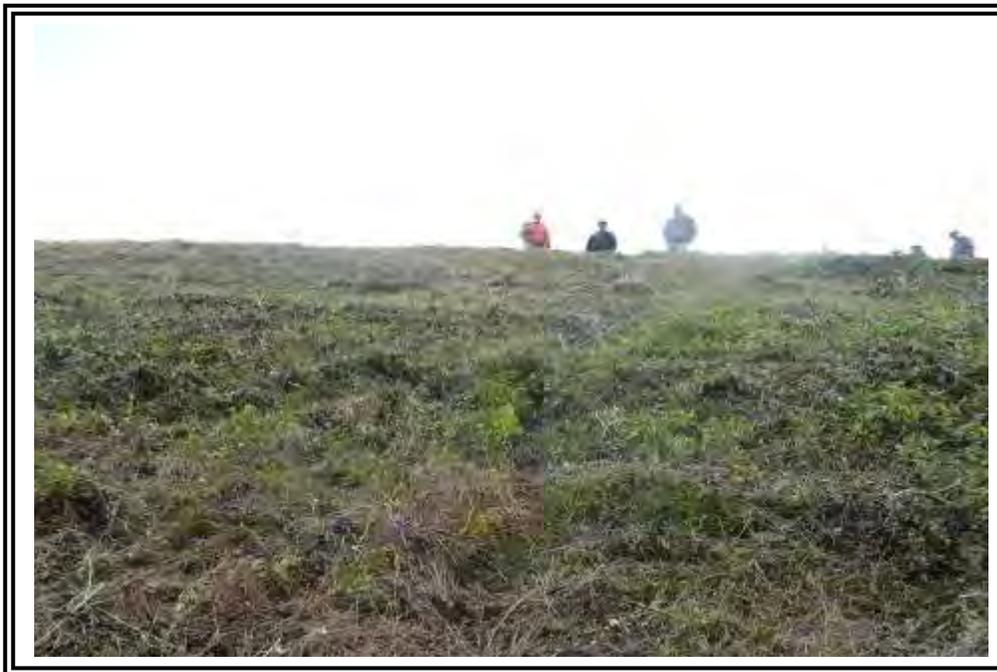
68

Erosion rill or possible animal trail.

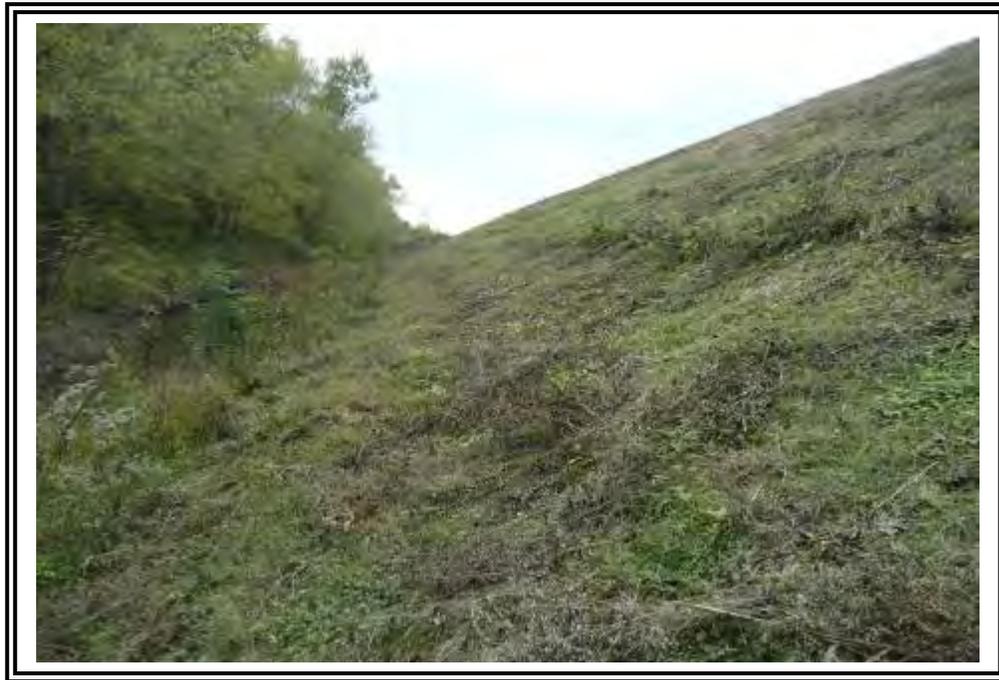
69

Exterior slope at toe of east dike, looking south. Training wall at creek entrance is in background.

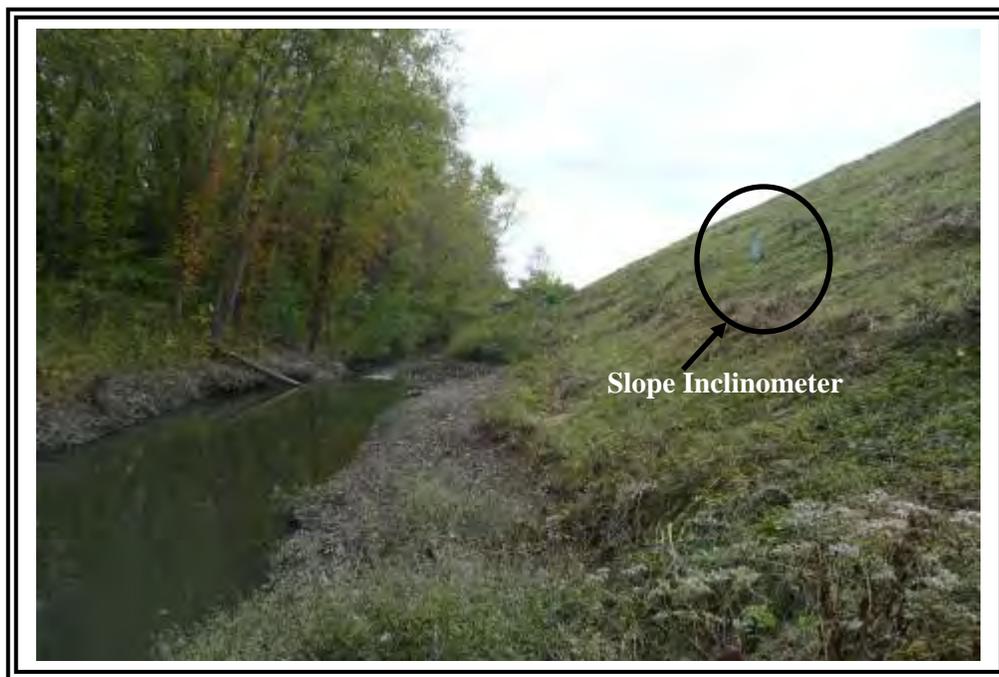
70

Toe of east dike, looking south. Slope inclinometer (blue) can be seen in right of photo.

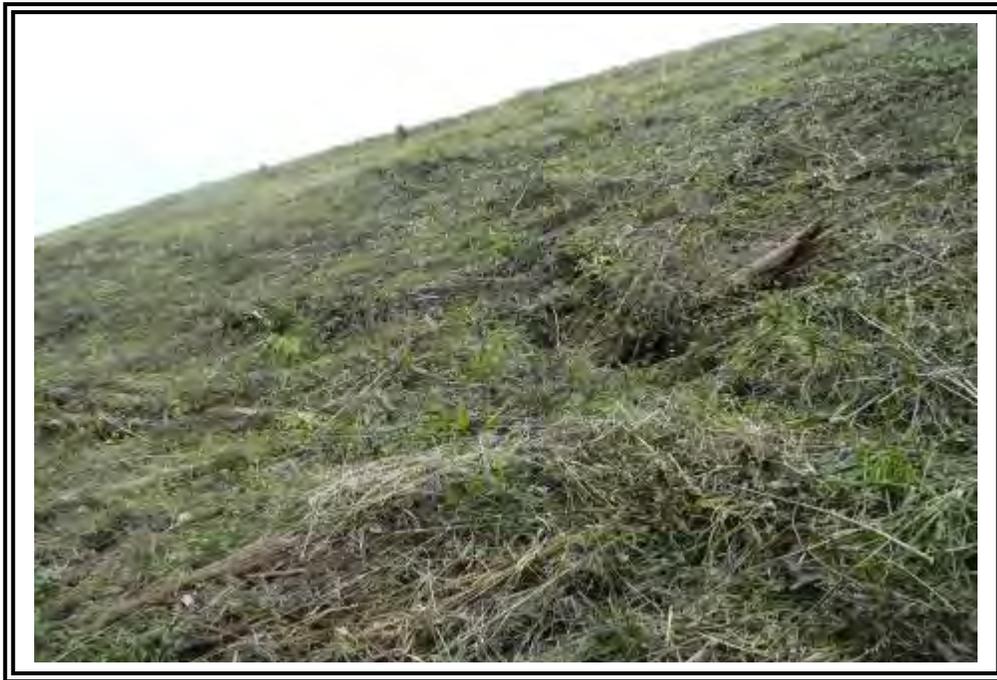
71

Vegetated surface scarp/creep on east dike slope.

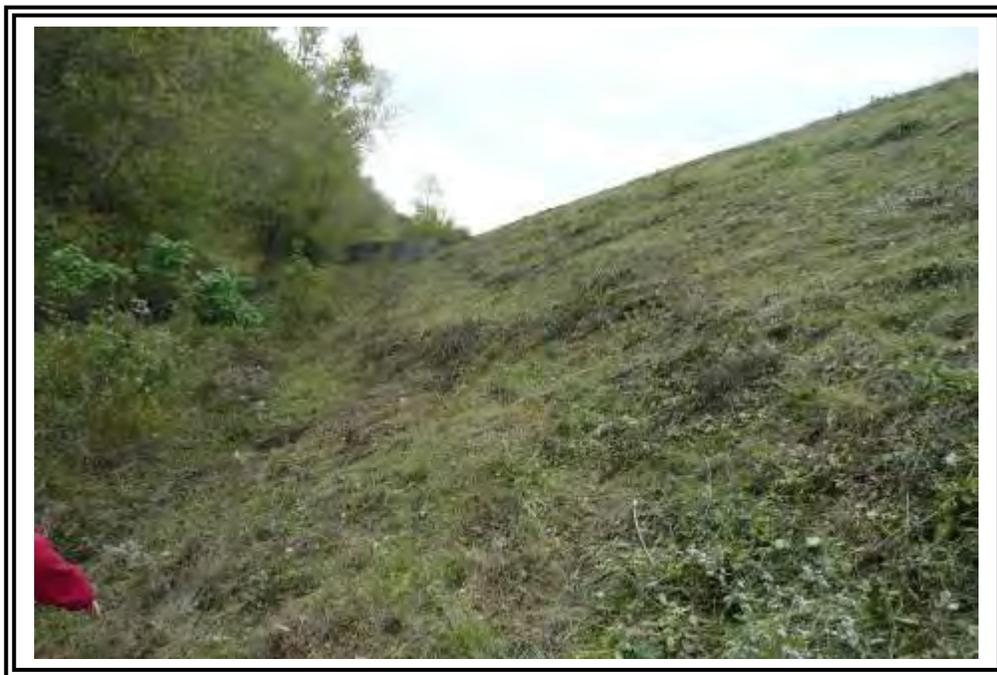
72

Vegetated toe bulge and surface slough on east dike slope, looking south.
Concrete training wall at creek entrance in background.

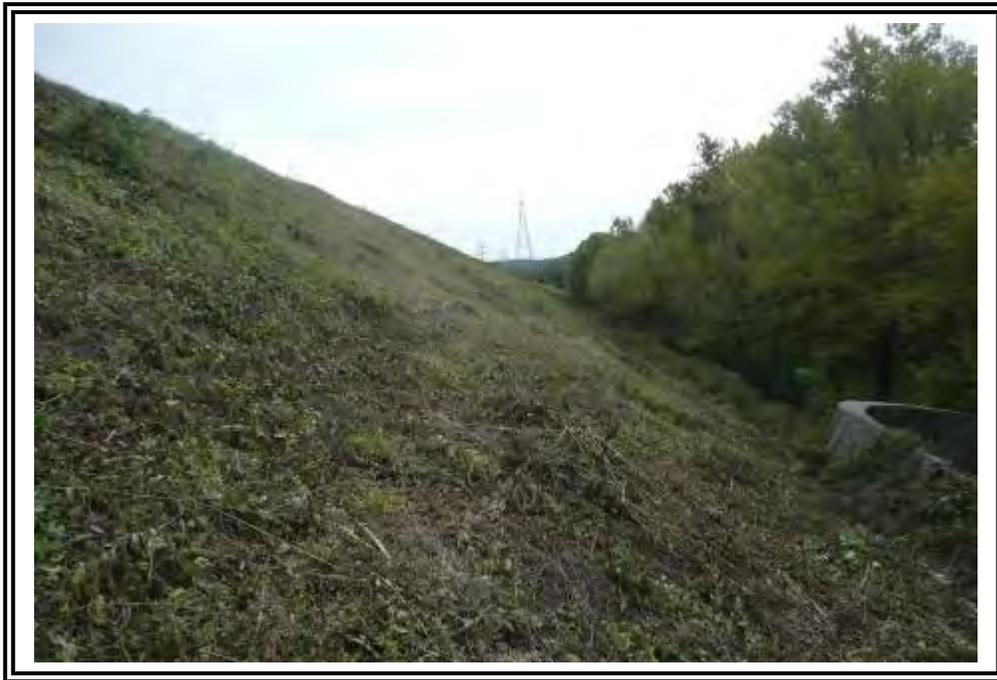
73

Vegetated undulations on east dike exterior slope above concrete training wall, looking north.

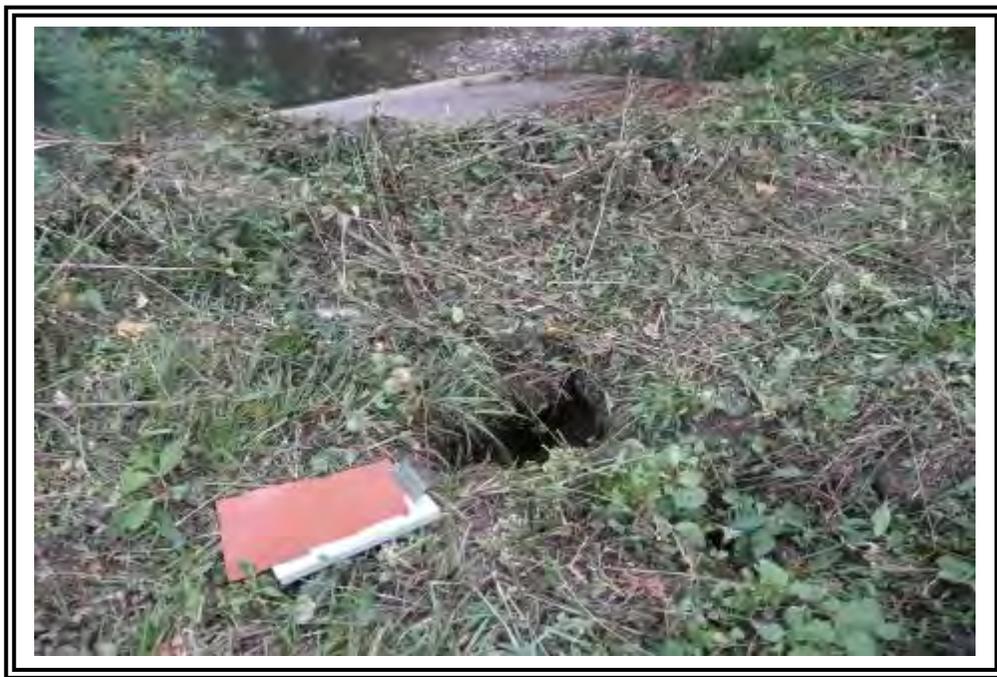
74

Rodent burrow on east dike above concrete training wall.

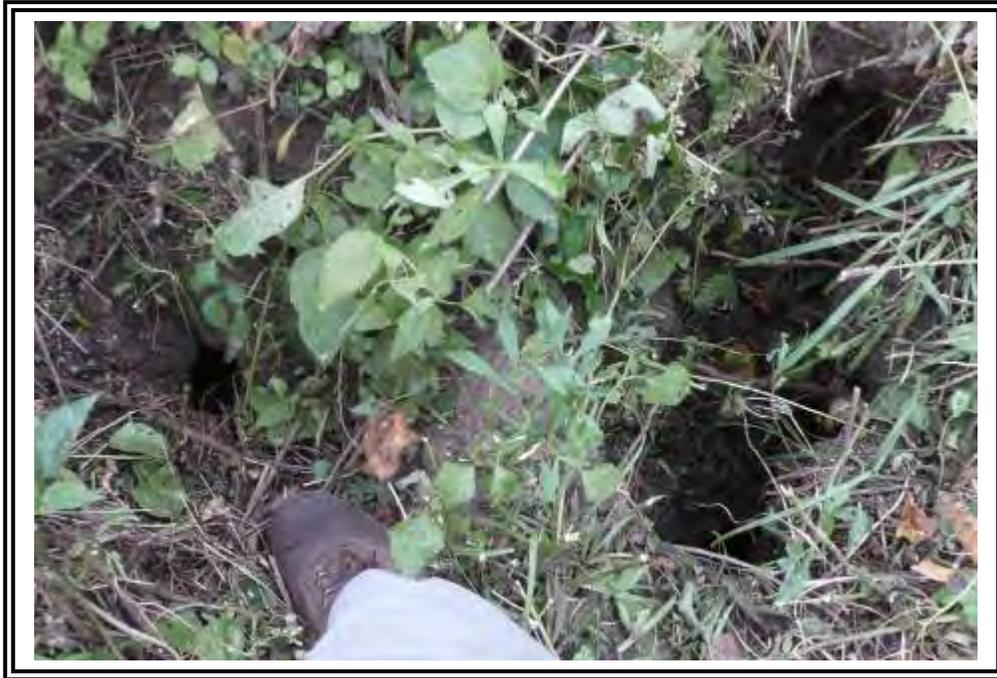
75

Rodent burrow (to left) and possible erosion feature (to right) adjacent to and above concrete training wall.

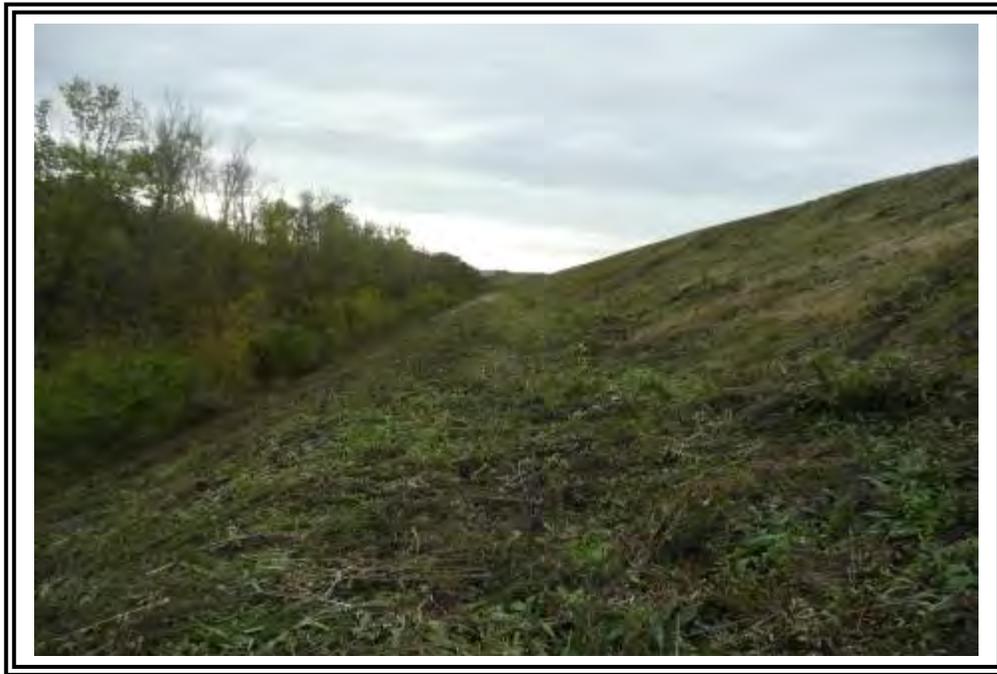
76

East dike exterior slope in area of 1991-1992 slope repair, looking south. Note bench and broad leafy vegetation.

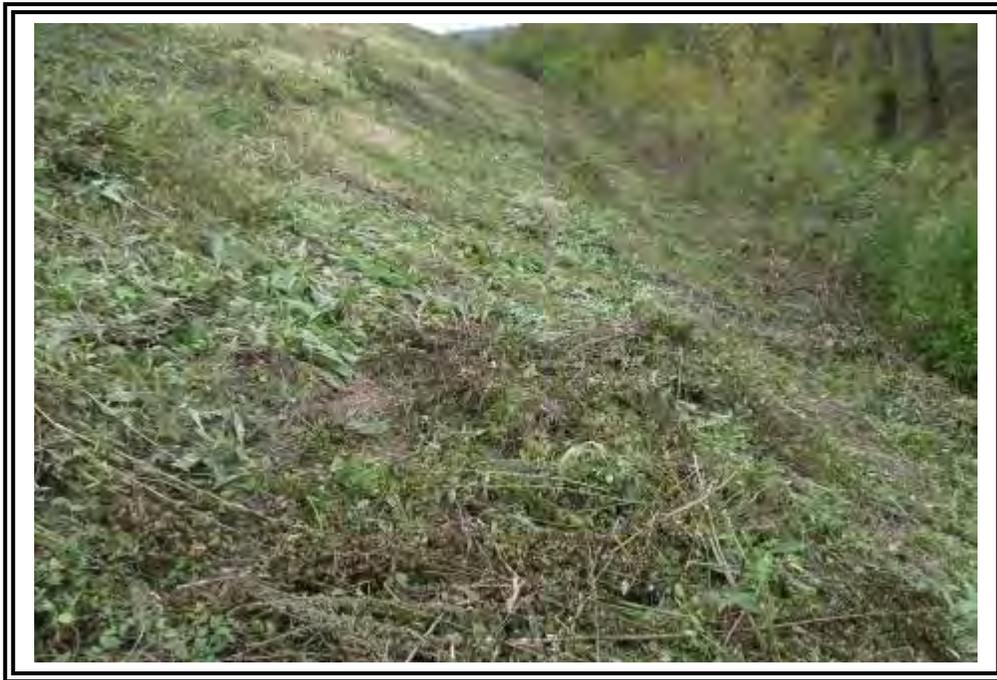
77

Broad leafy vegetation more prevalent in this area of the east dike, looking north.

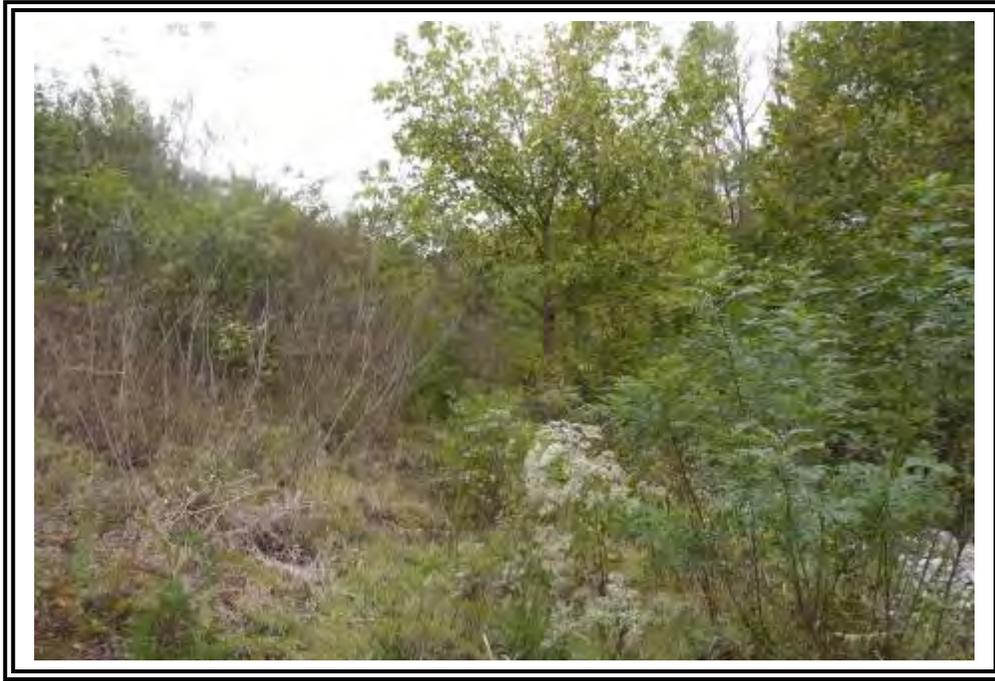
79

Exterior slope toe of east dike at the southeast corner, looking north. Note heavy vegetation and young trees.

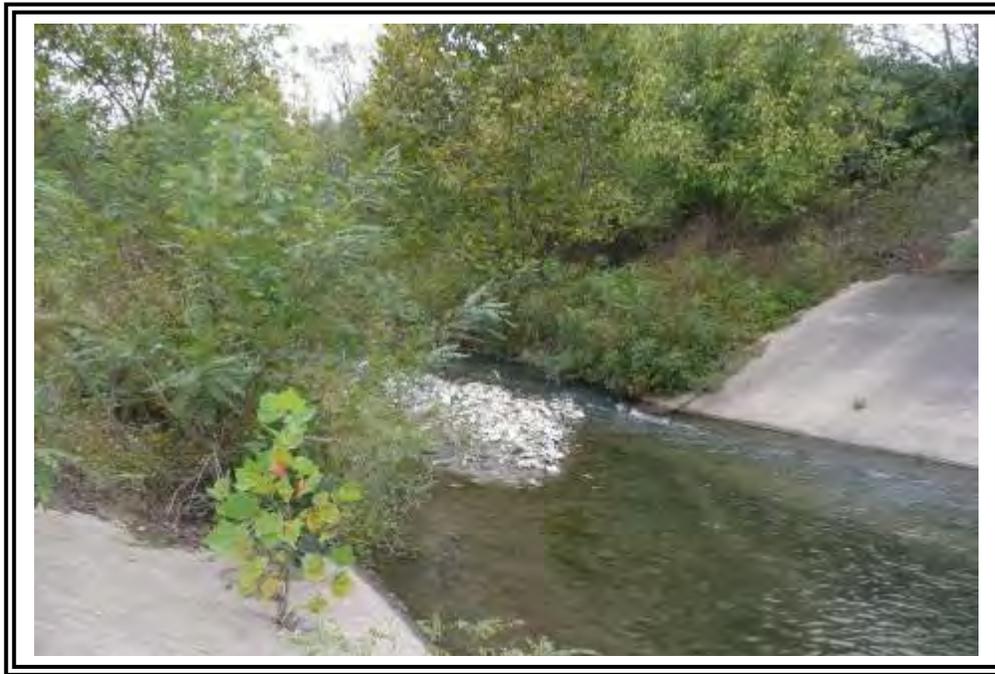
80

Channelized creek adjacent to east dike toe where the creek starts to turn to the west between Ash Pond C and Ash Pond C Extension.

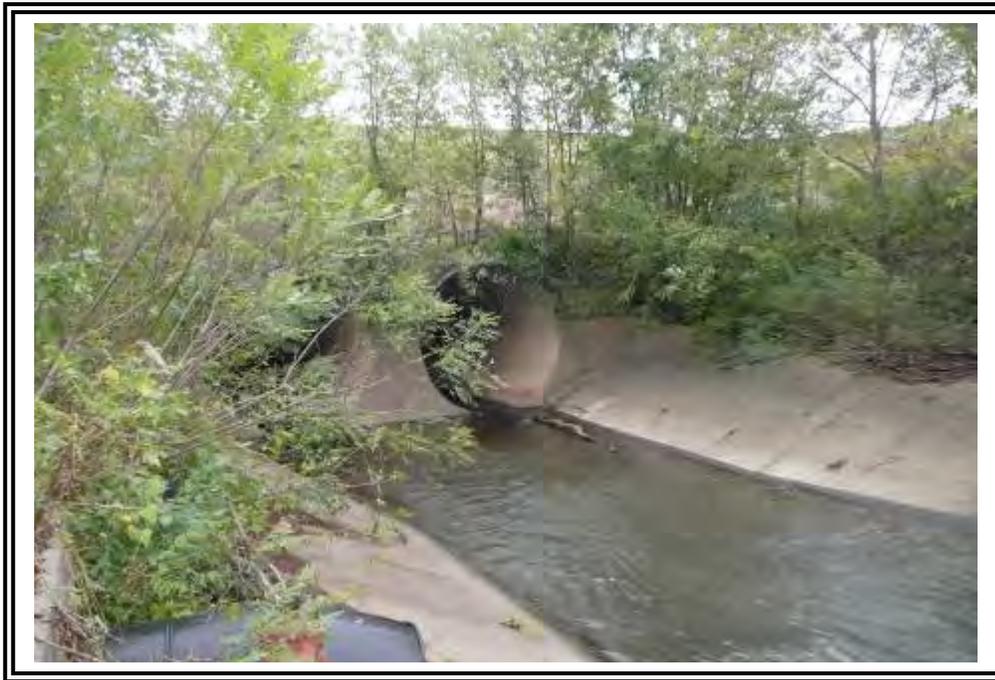
81

Channelized creek between Pond C and Pond C Extension at the Pond C outlet, looking east. Creek traverses beneath a haul road embankment through large diameter culverts.

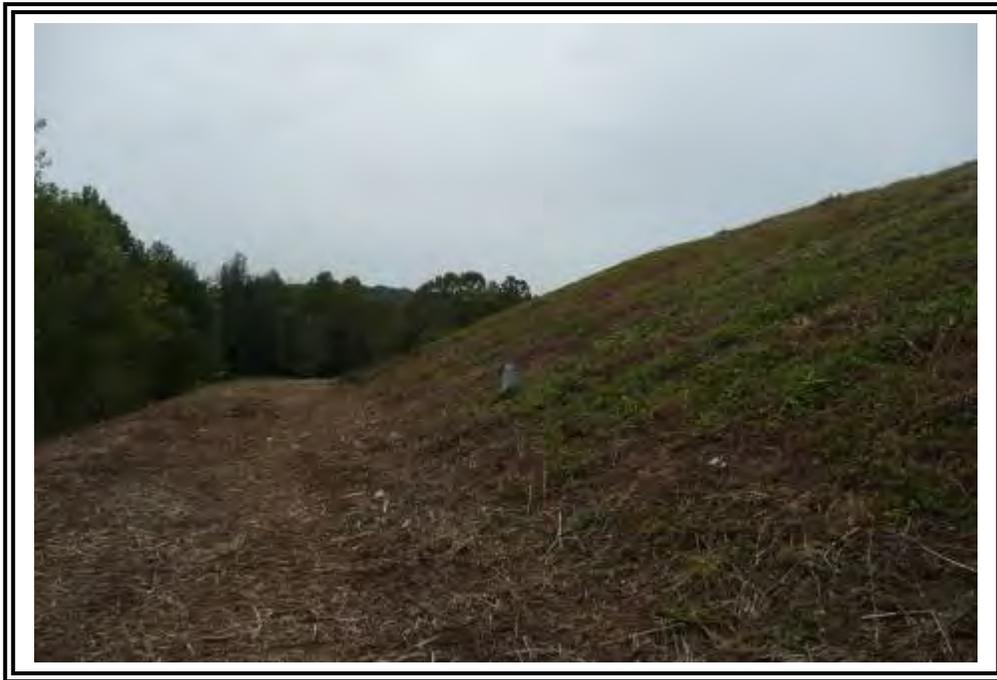
83

Exterior slope of the south dike, looking west. Note slope instrumentation.

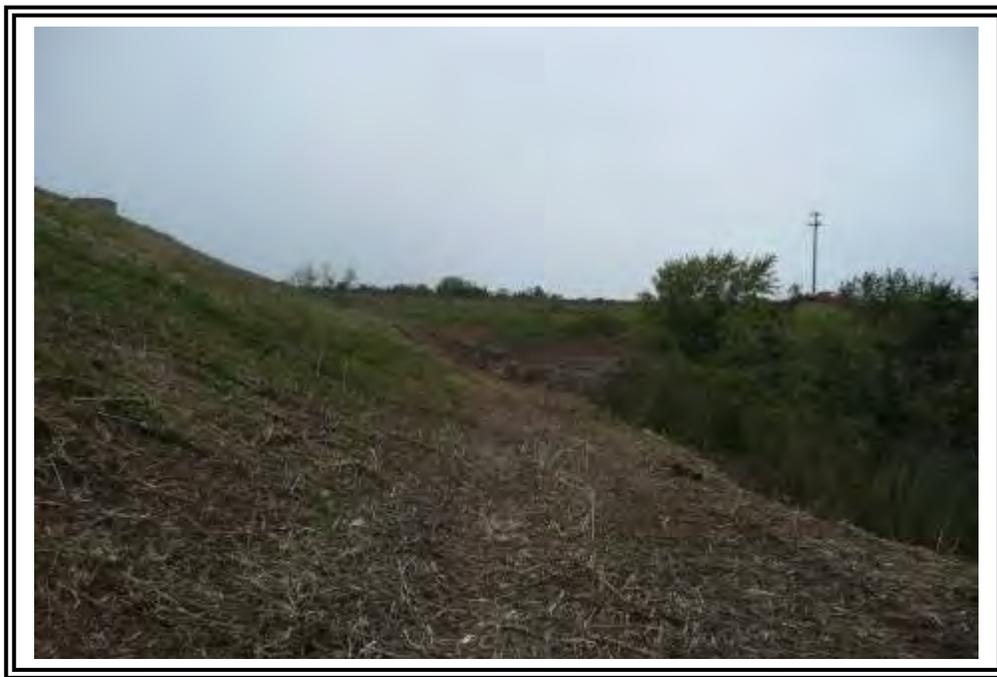
84

Exterior slope of the south dike, looking east.

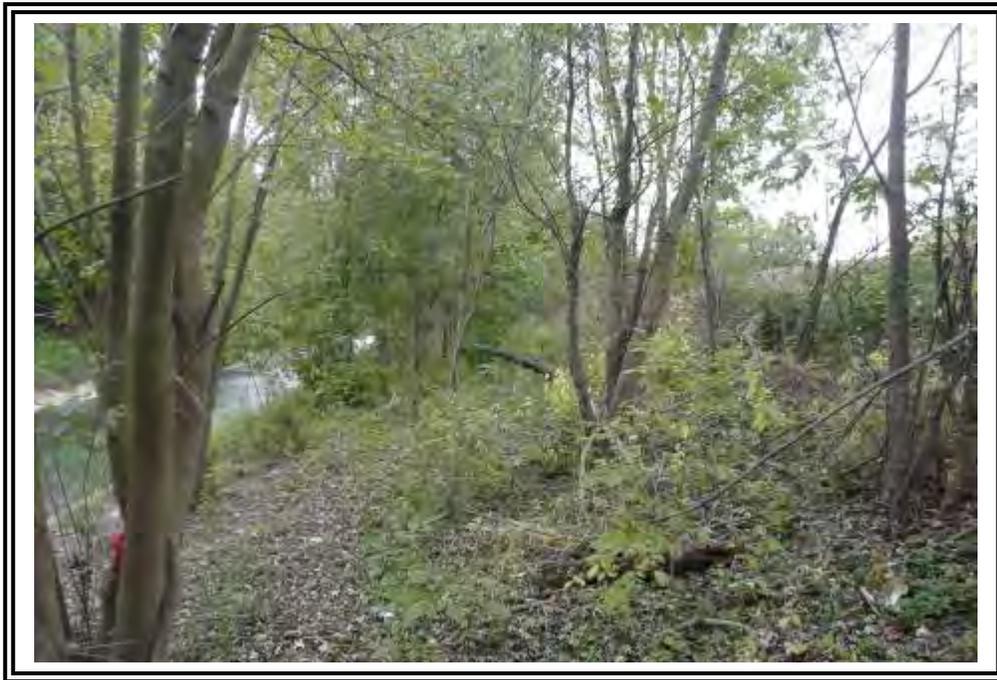
85

Vegetation adjacent to channelized creek, looking west.
This area is below the bench at the south dike and is believed to be on the creek bank.

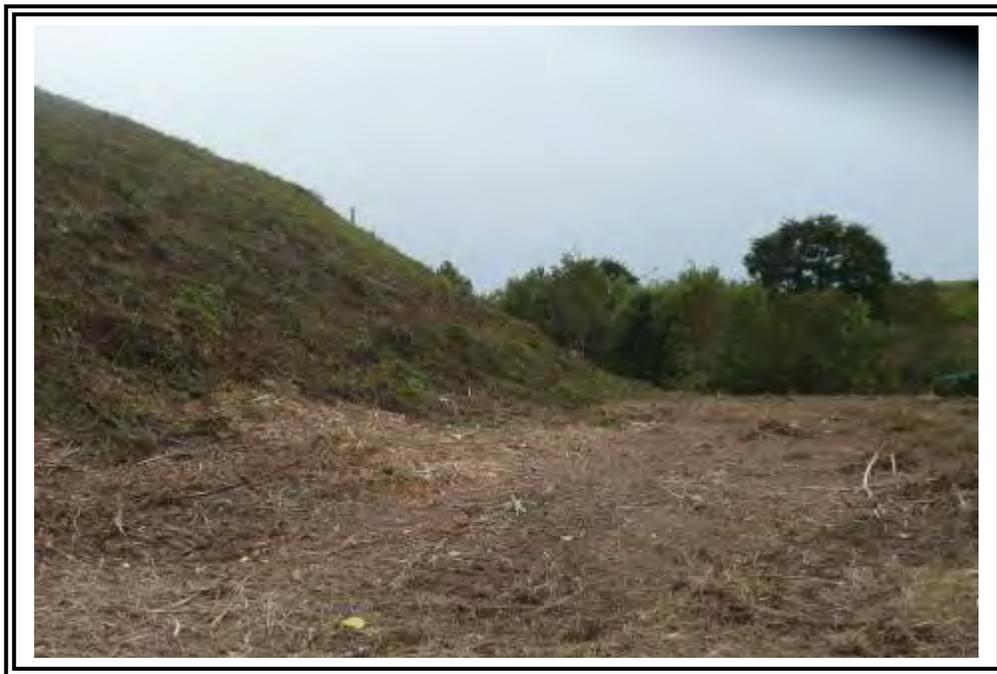
86

Exterior slope at the southwest corner of west dike, looking south. Instrumentation visible near slope crest.

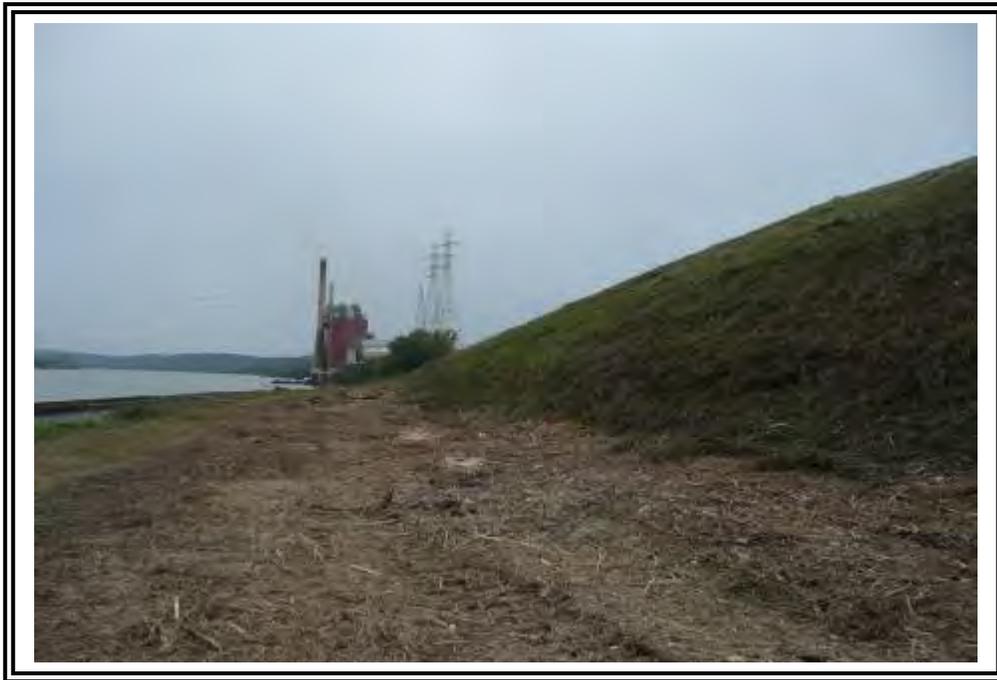
87

West dike exterior slope adjacent to the Ohio River, looking north.
