Assessment of Dam Safety Coal Combustion Surface Impoundments (Task 3) Draft Report

Duke Energy

W.C. Beckjord Station
New Richmond, Ohio

December 7, 2009

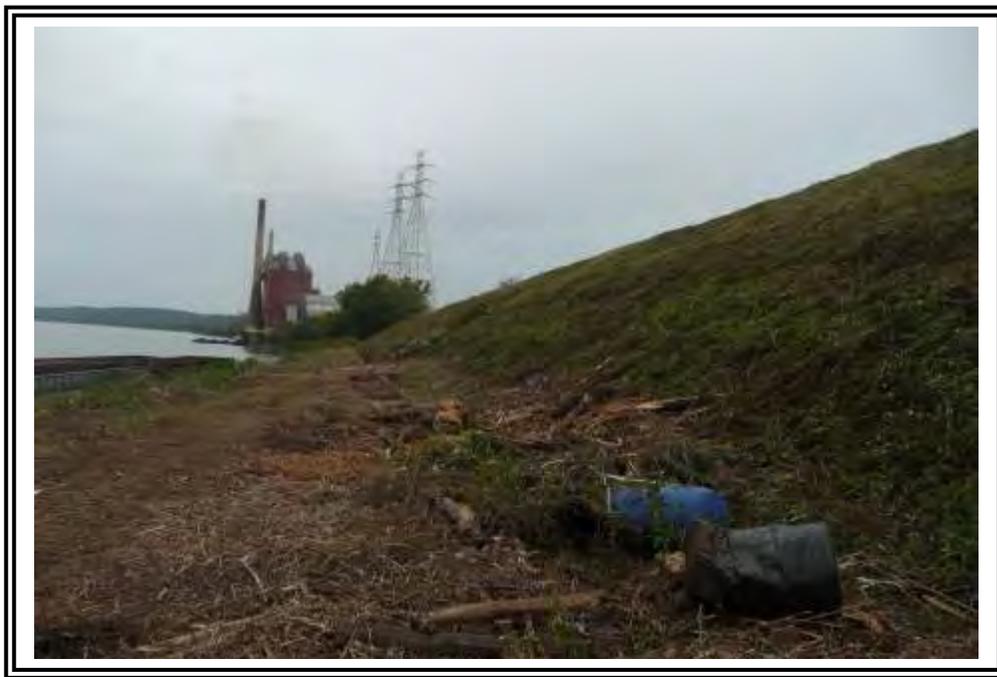
88

West dike exterior slope adjacent to the Ohio River, looking north, showing flood deposited debris on river terrace and beginning of 1998 rip-rap buttress slope repair in background.

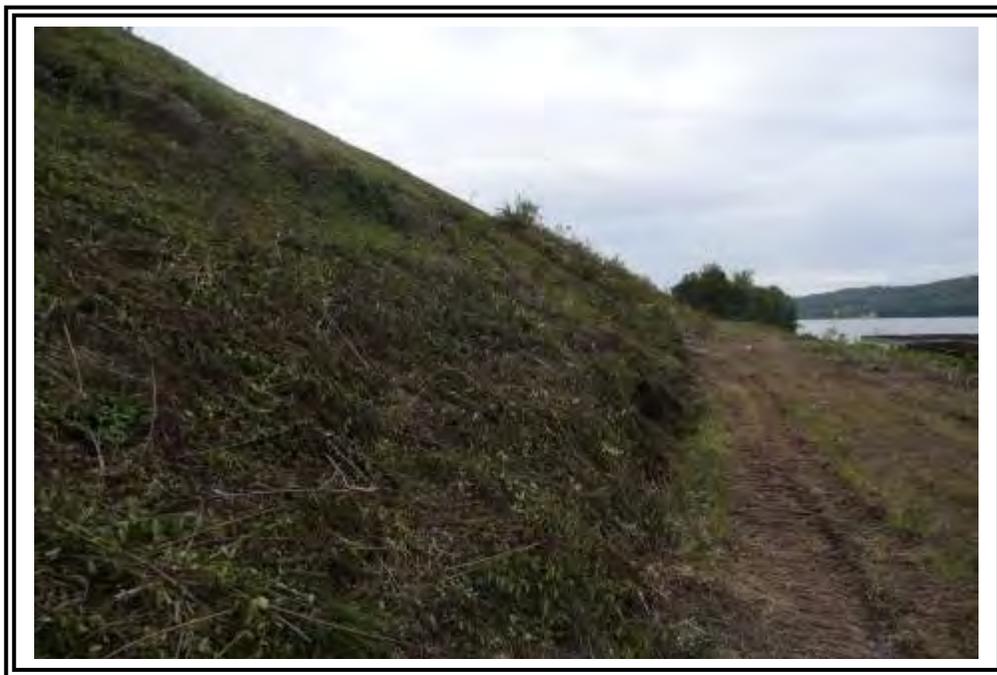
90

West dike showing the northern extent of rip-rap slope repair, looking south.

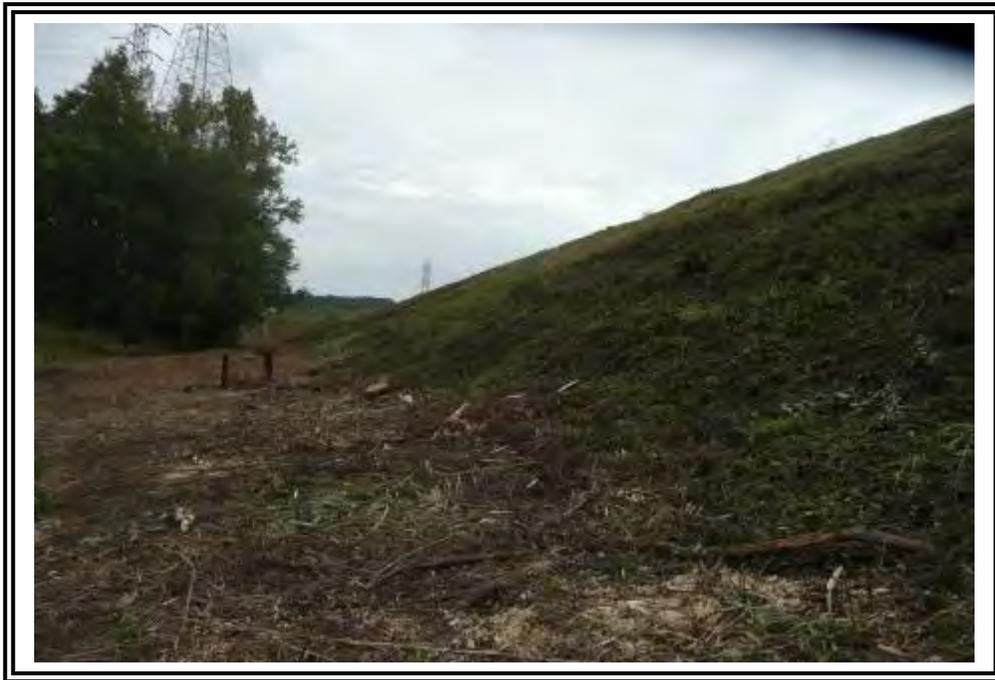
91

West dike slope, looking north. Note groundwater monitoring well at slope toe.

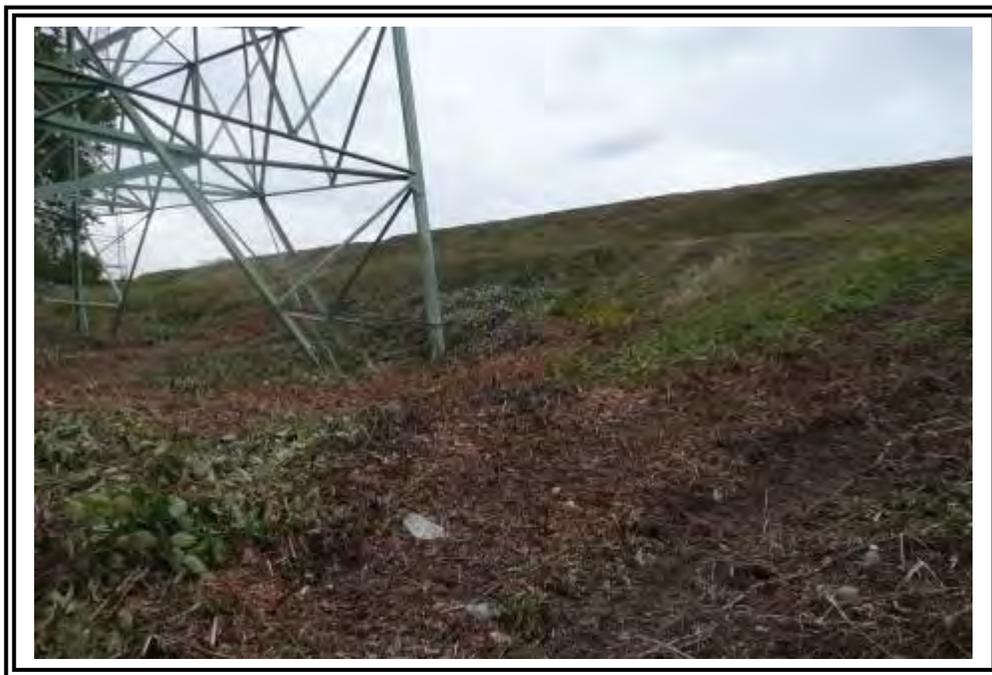
92

West dike slope in area of 2002 slope repair where soil buttress and toe was constructed, looking northeast. Bench can be seen near middle of slope.

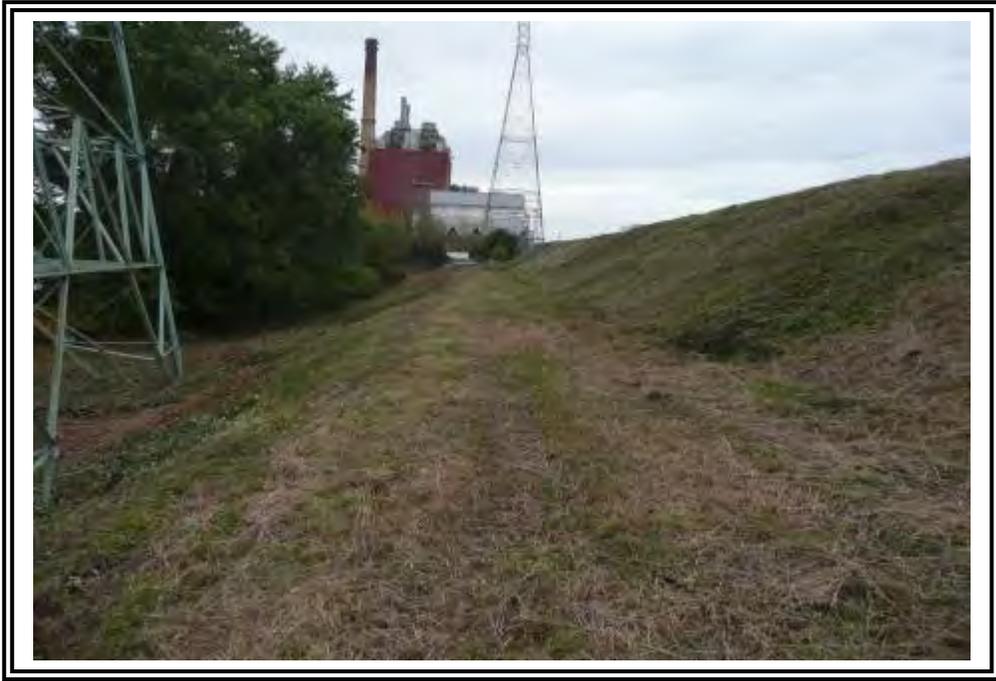
93

West dike exterior slope in area of 2002 slope repair, looking south.

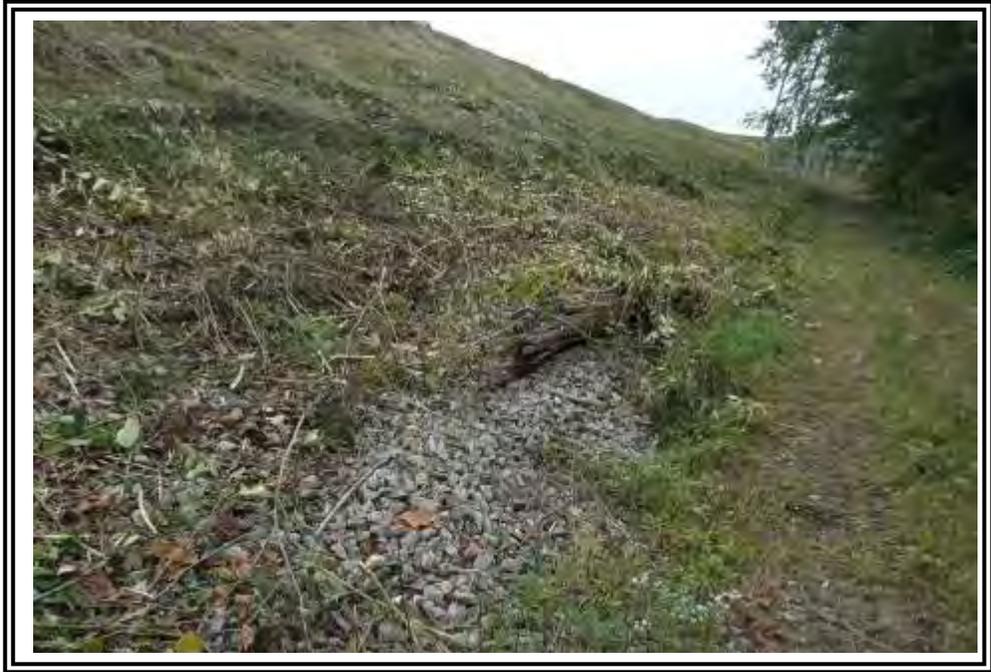
96

Rock toe drain on west dike exterior slope, looking south.

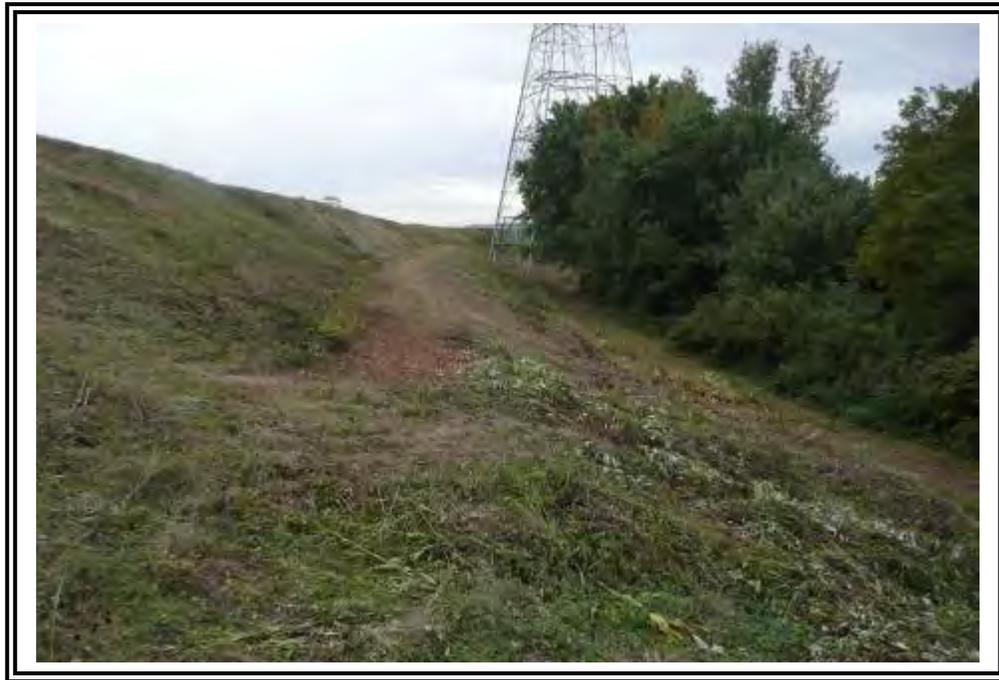
97

Exterior slope of west dike on bench near northwest corner, looking south from mid slope.

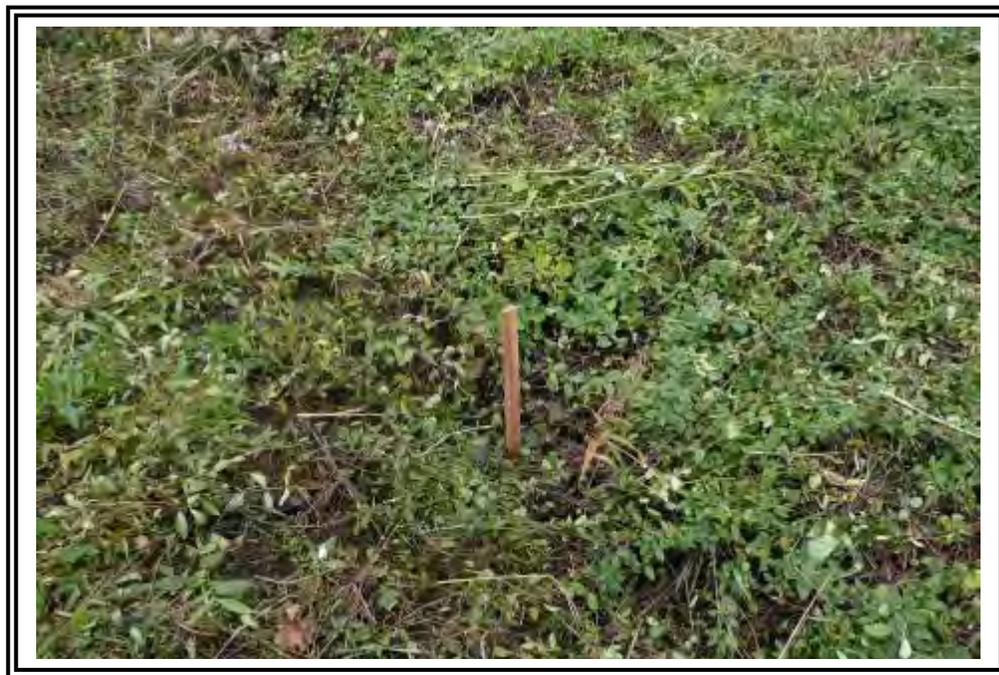
98

Water collecting near toe of west dike from surface runoff. Maintenance spoil placed there has restricted drainage.

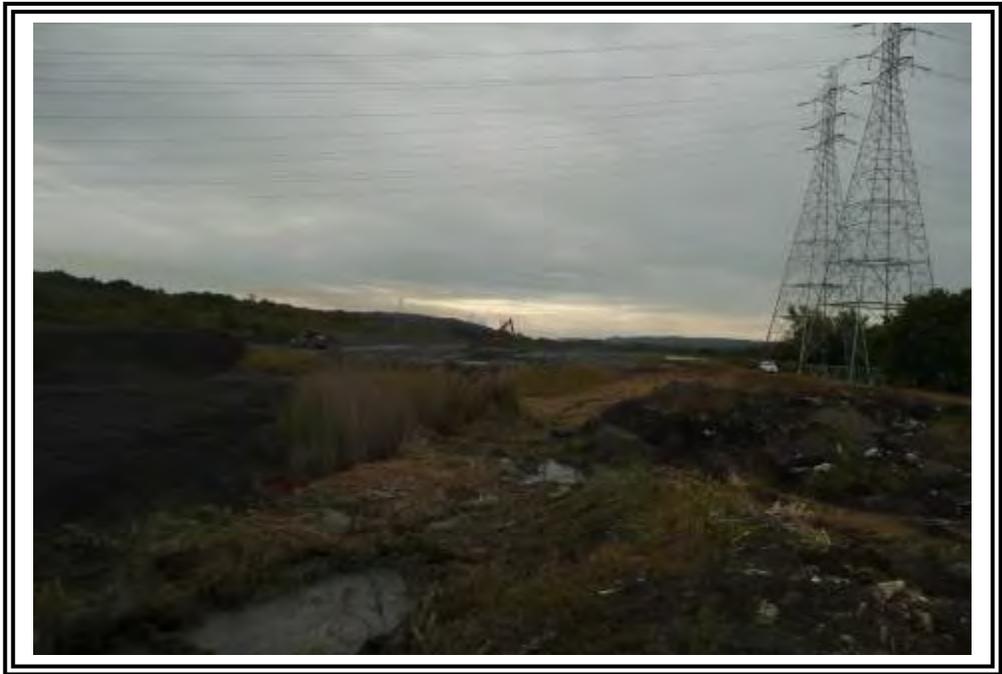
100

Looking south from northwest corner of west dike across pond area. Note there is no open water in this area.

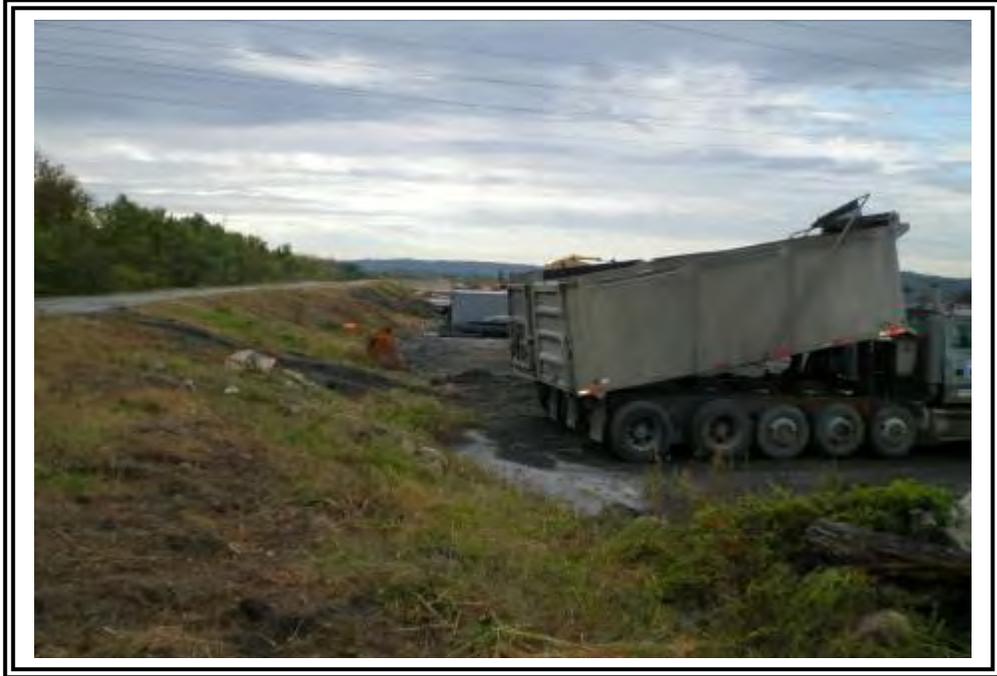
101

East dike interior slope, looking south.

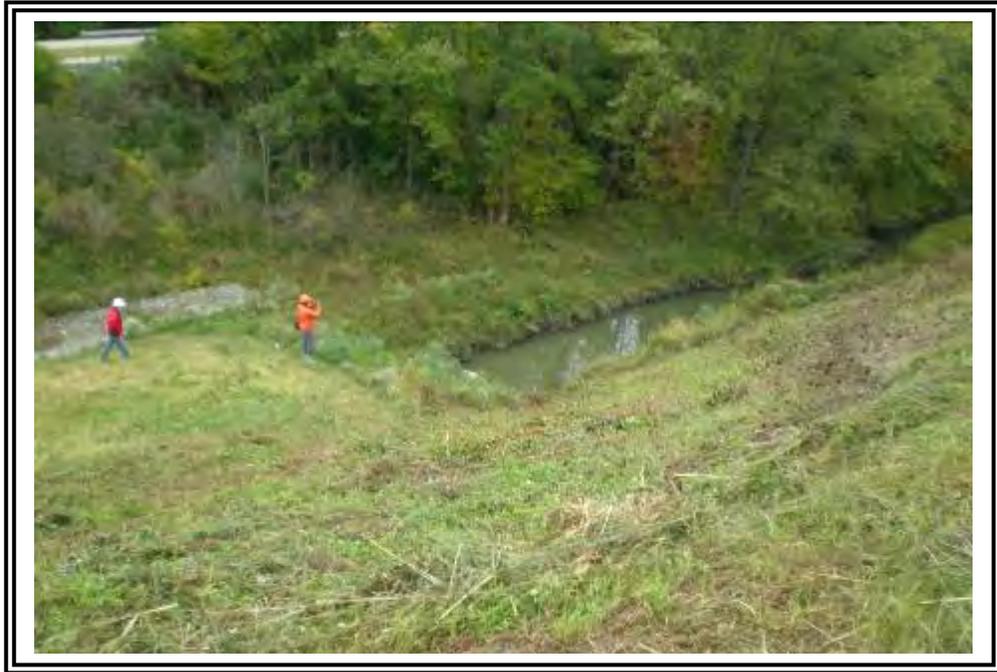
102

Change in slope, becomes much steeper, end of rock lined ditch, start of creek, looking southeast.

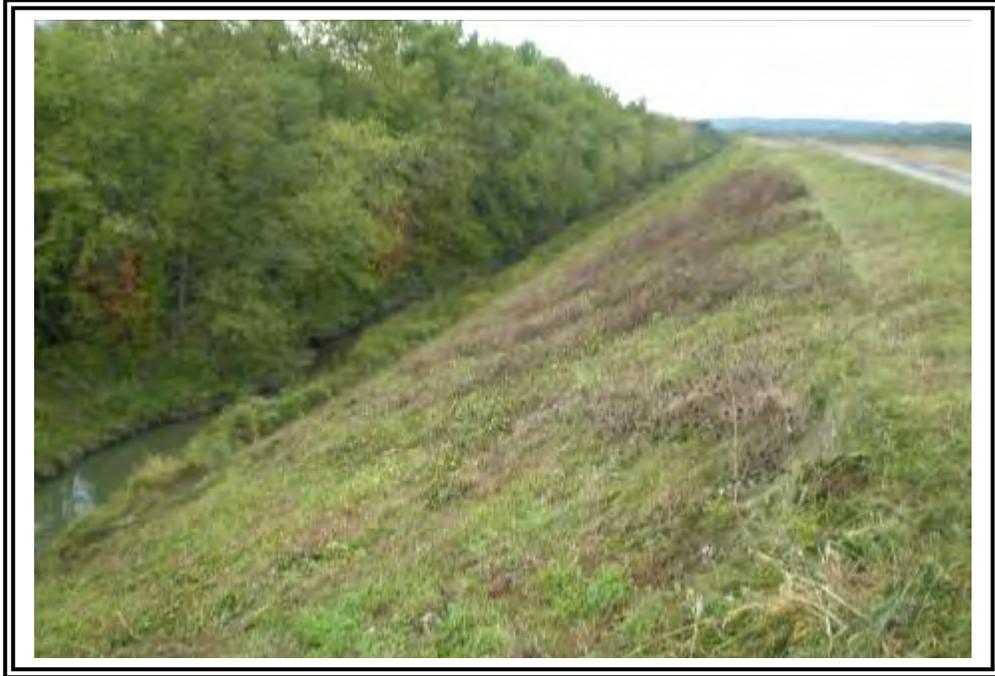
103

Steeper portion of east exterior slope, looking south.

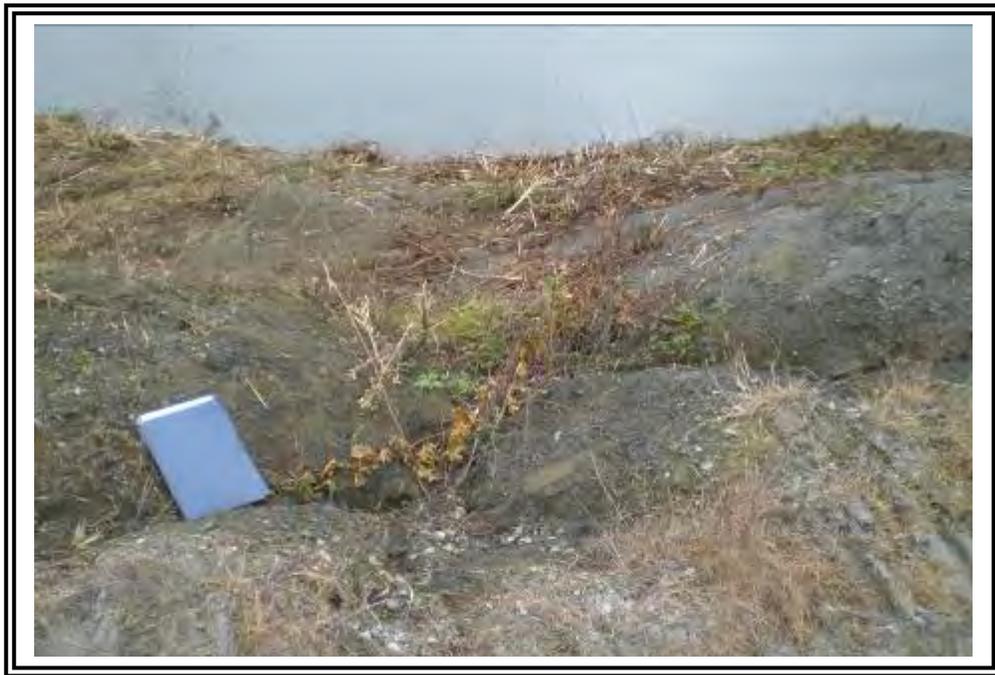
104

Erosion on upstream slope, looking west.

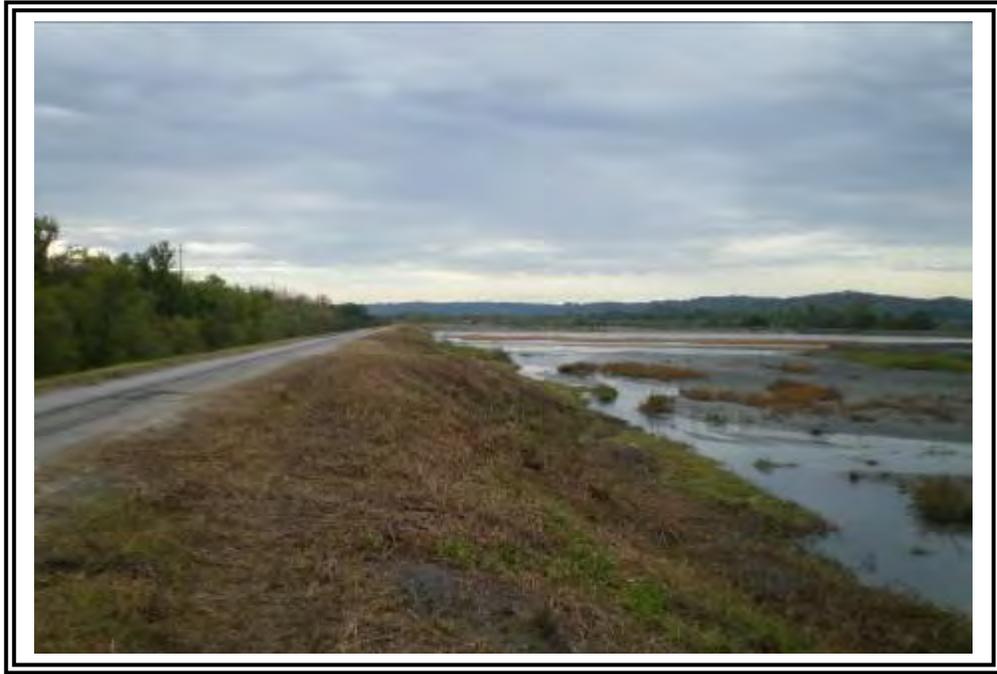
106

Crest and interior slope of west dike, looking south.

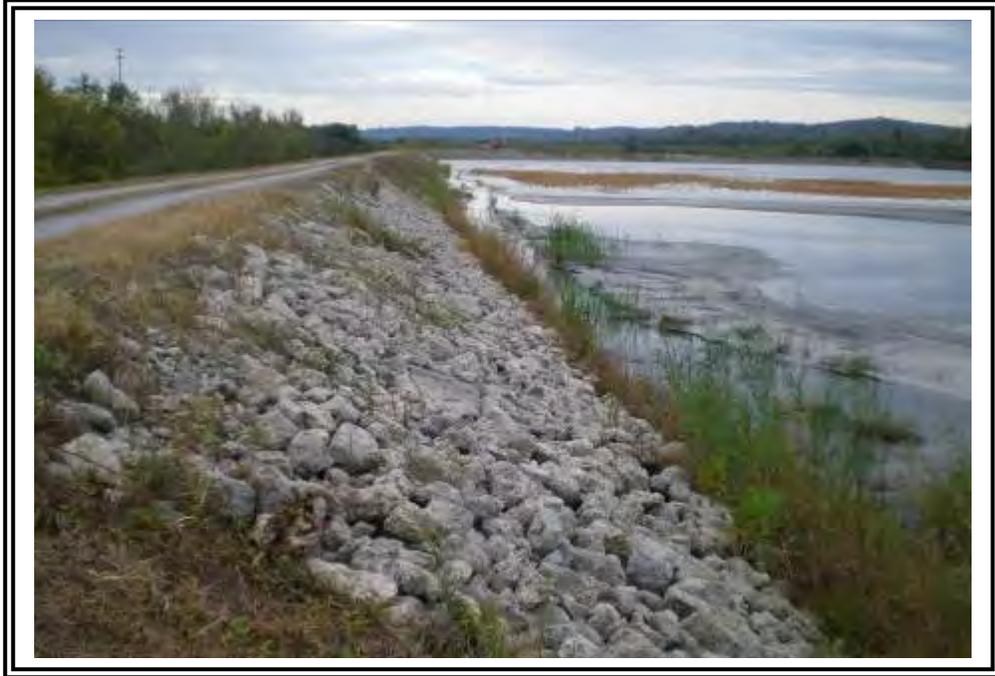
107

Crest and interior slope at start of rip rap, looking south.

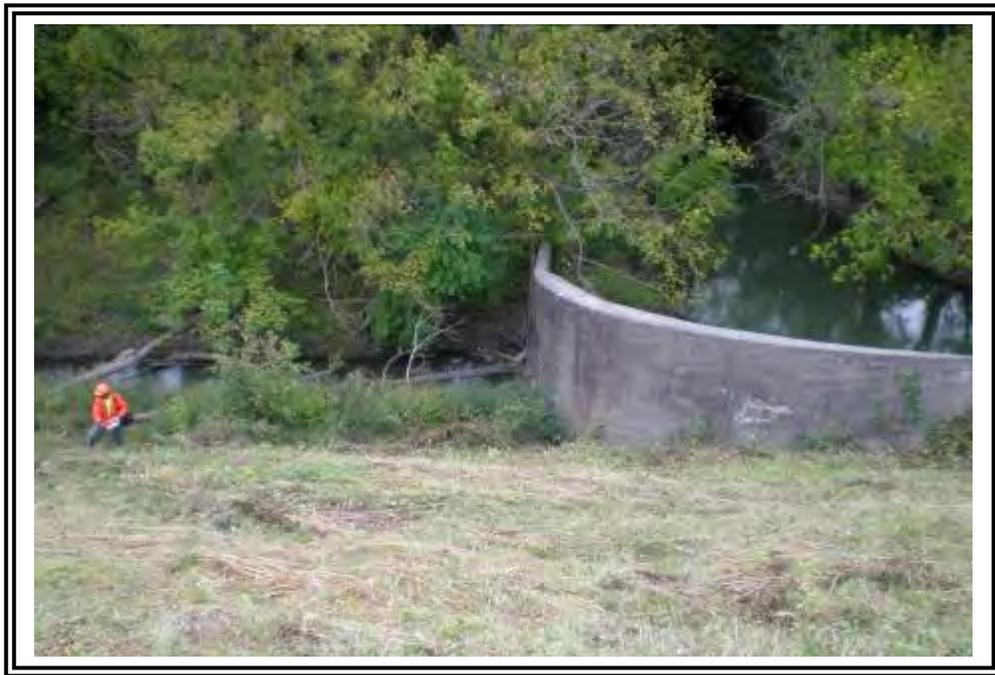
108

Exterior slope at concrete wall where creeks meet, looking east.

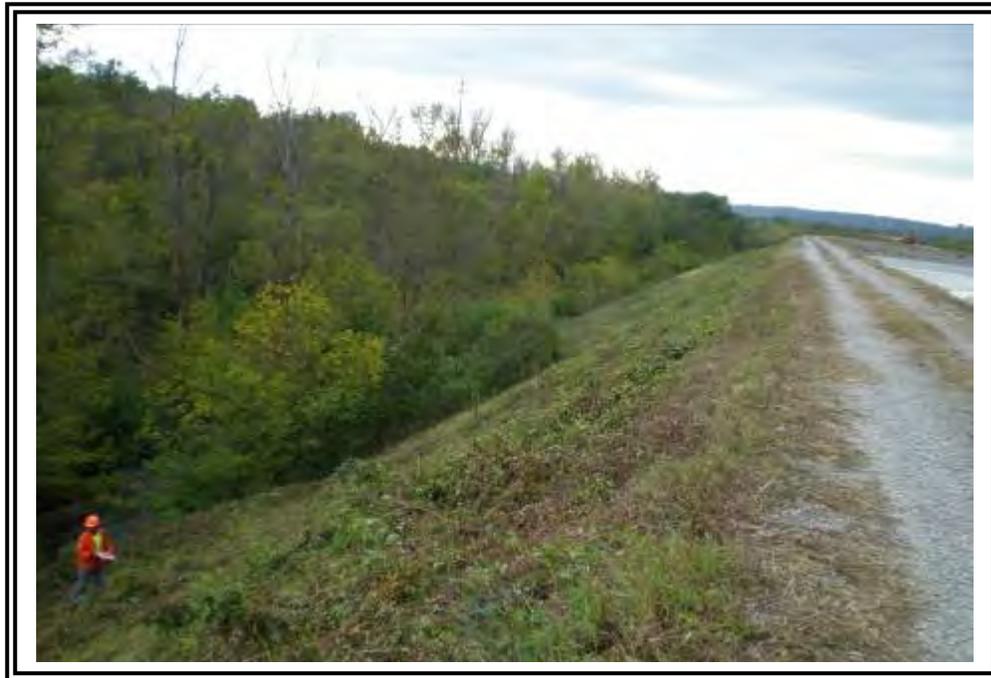
109

Exterior slope and crest after wall, looking south-southwest.

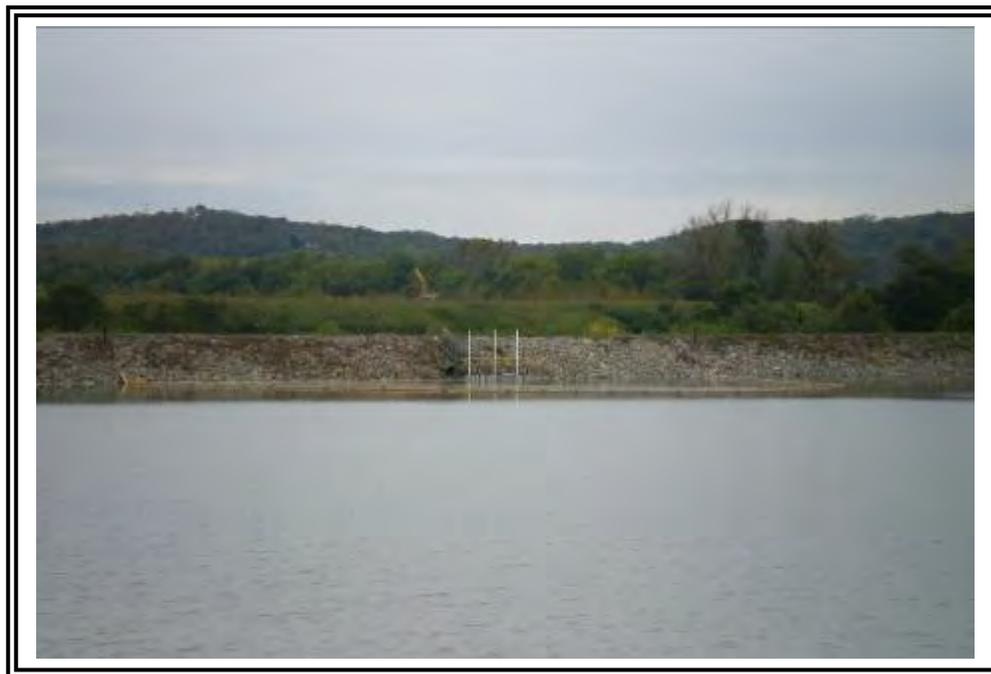
110

Outflow structure, looking south.

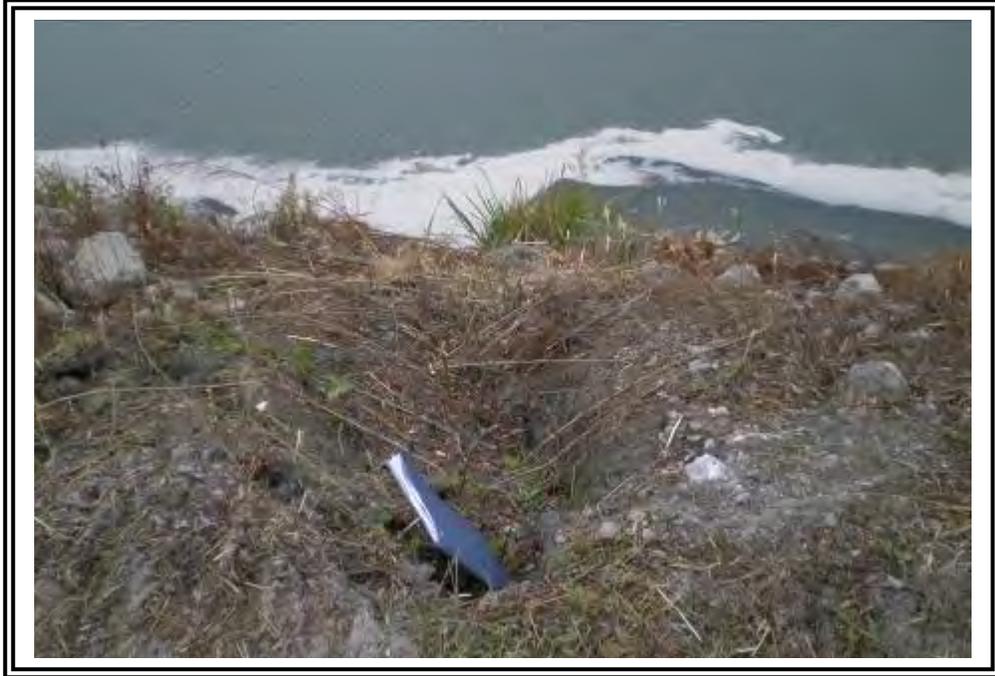
111

Deep rill on interior slope and gap in rip rap, looking west.

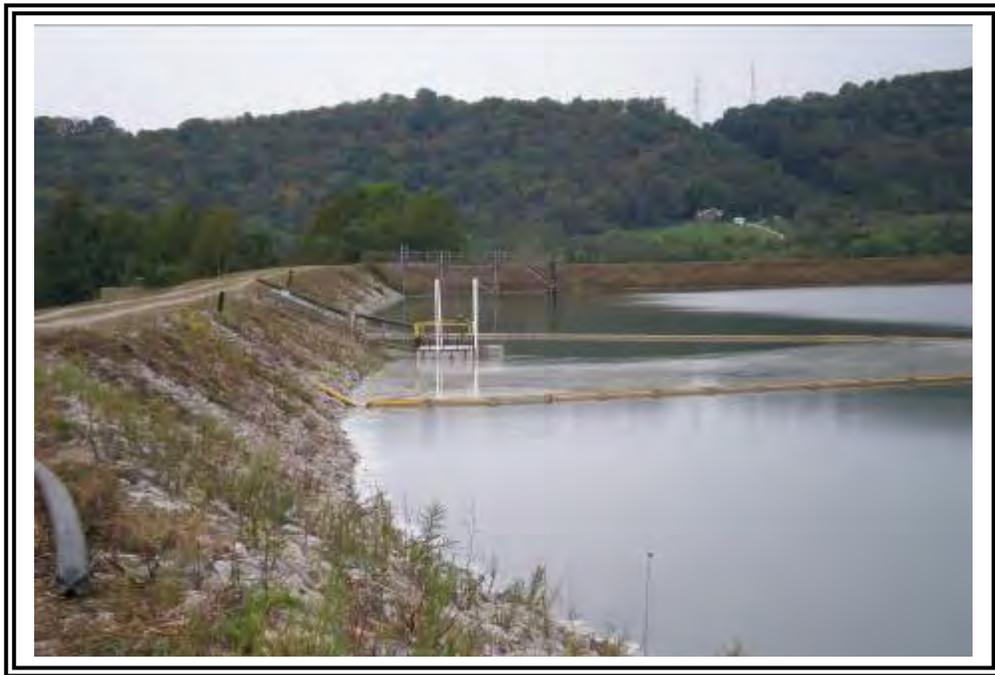
112

South dike interior slope and outfall structures, looking west.

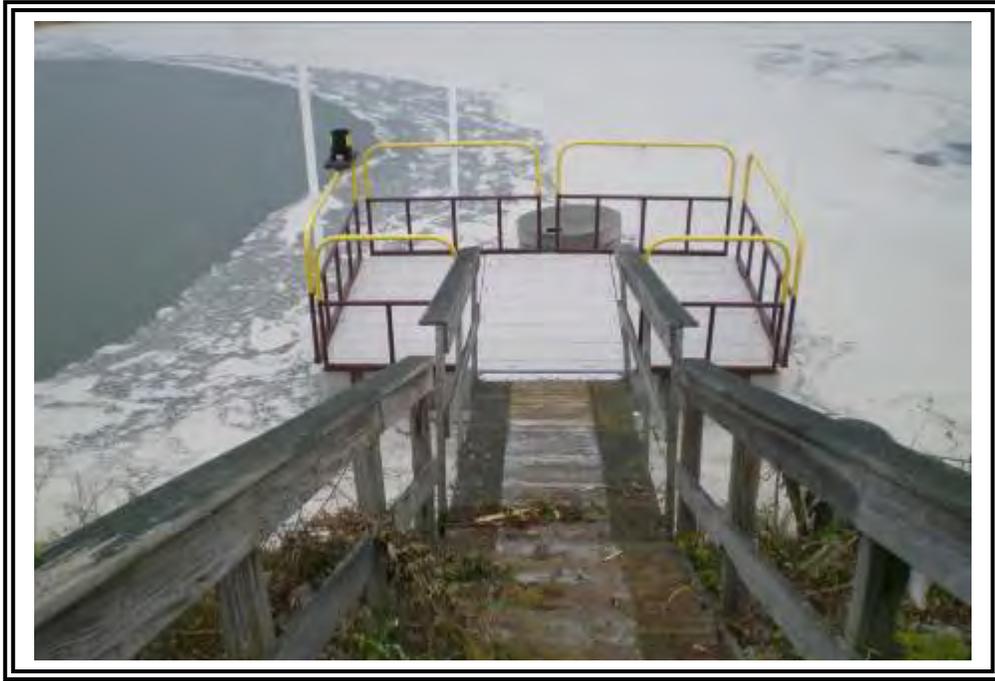
113

Outfall, looking north.

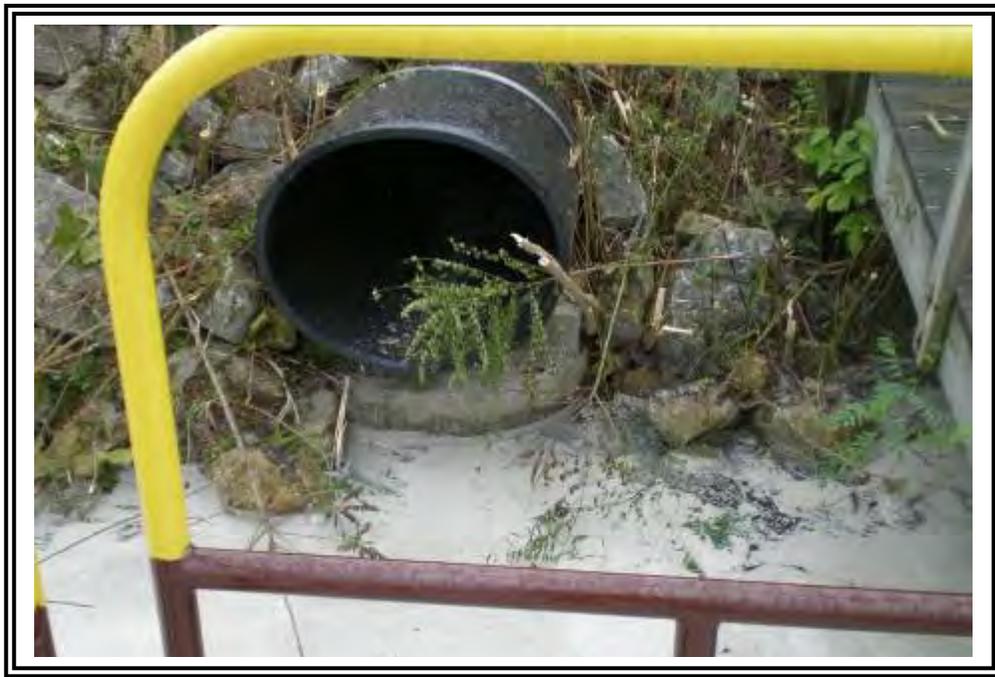
114

Pipe coming in pond next to outfall.

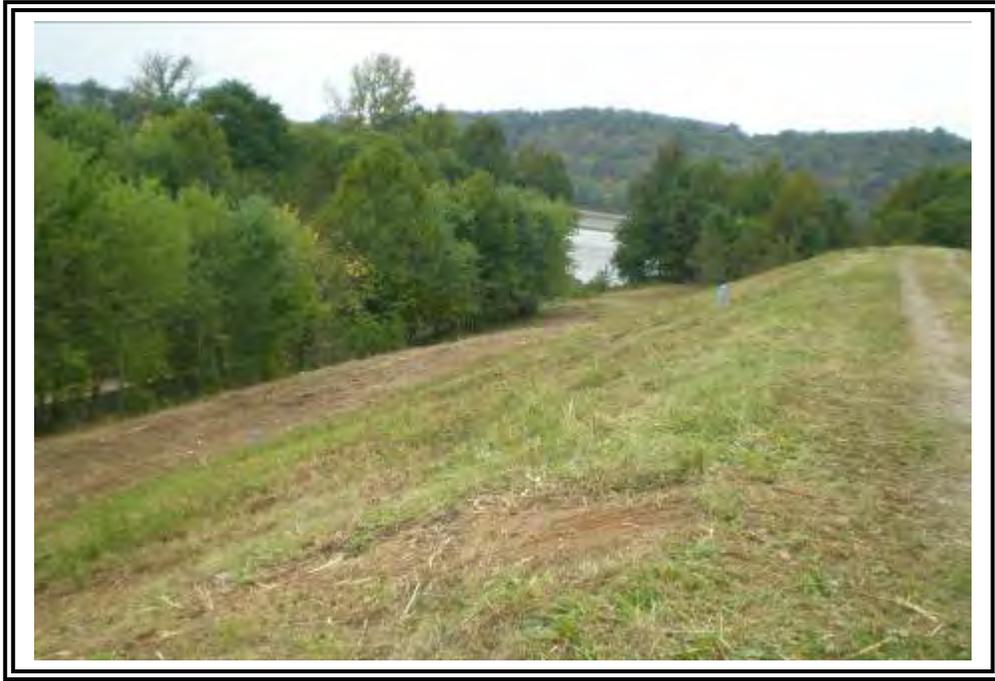
115

South dike crest and exterior slope, looking west.

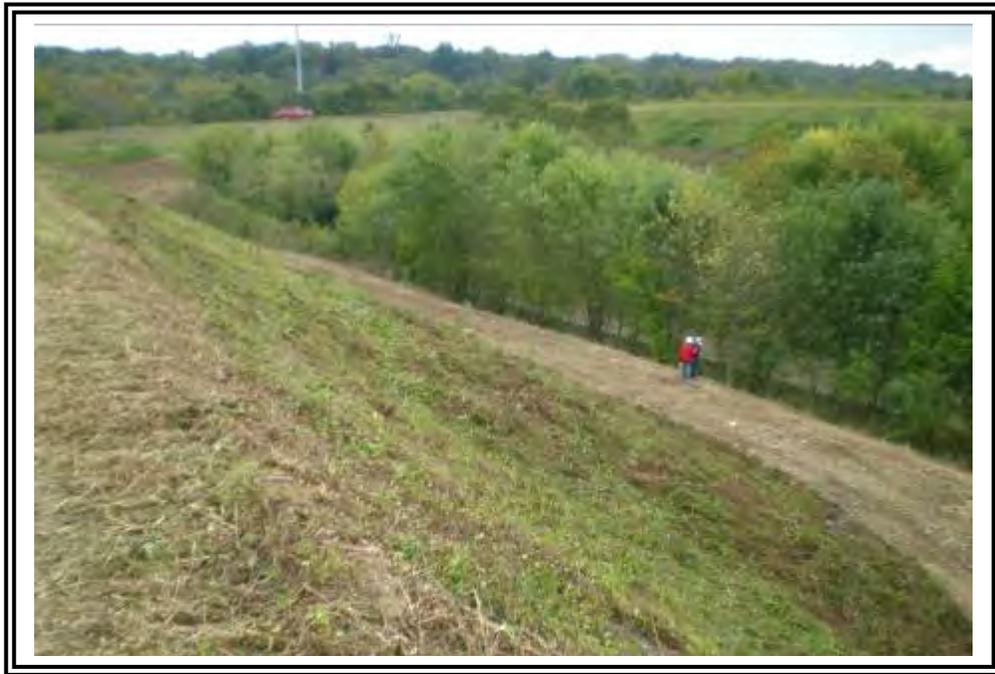
116

Exterior slope of south dike, looking southeast.

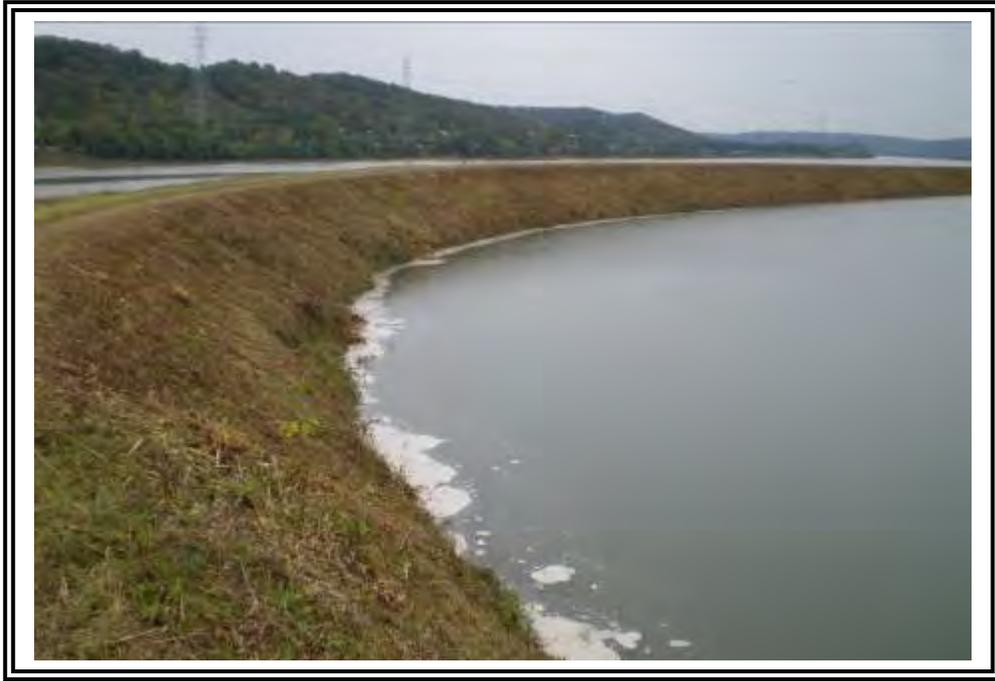
117

West dike interior slope corner, looking west-northwest.

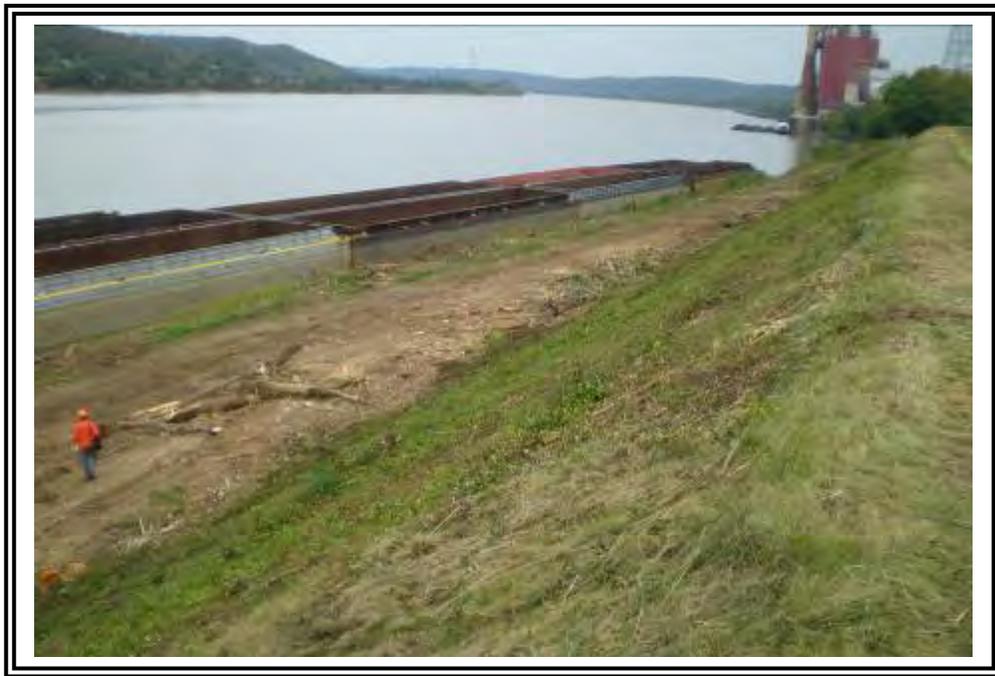
118

Exterior slope of west dike, looking north.

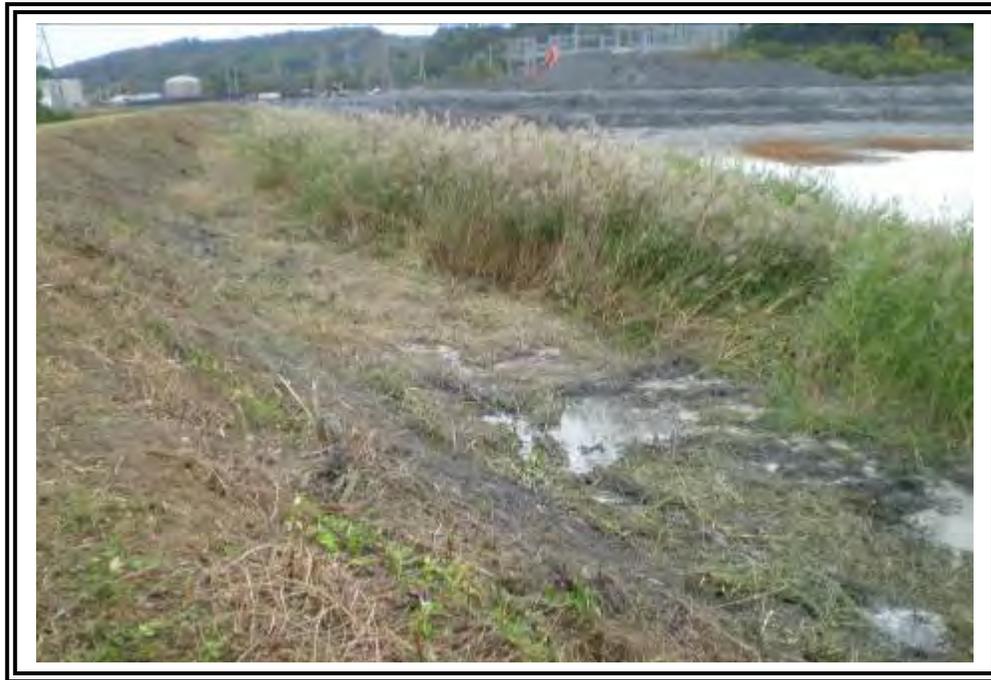
119

West dike interior slope, looking north.

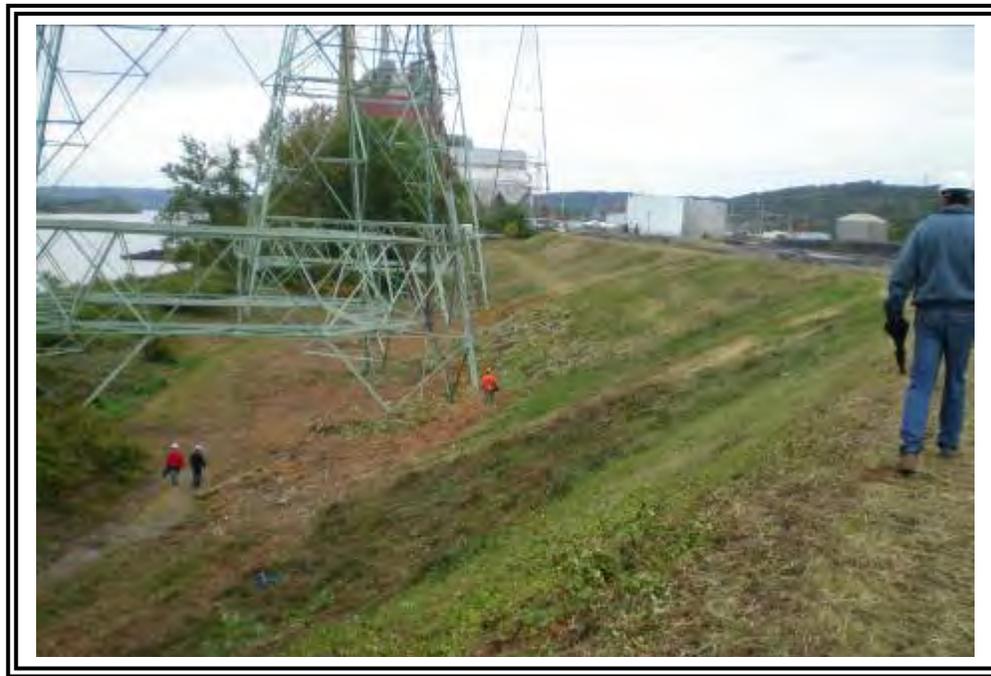
120

West dike exterior slope, note change in slope, looking north.

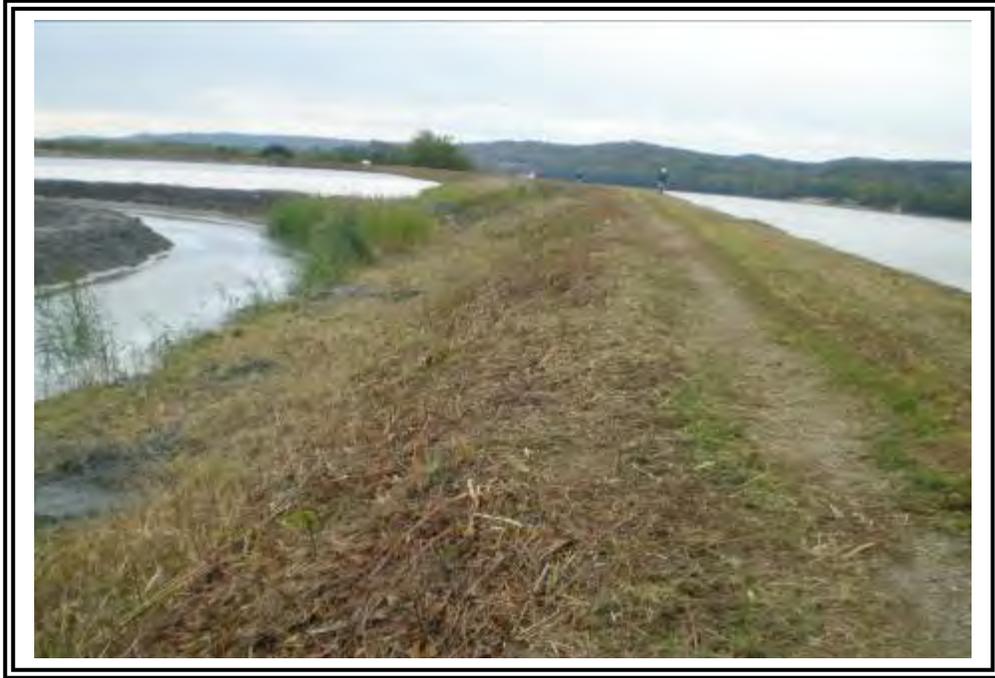
121

West dike crest and interior slope, looking south.

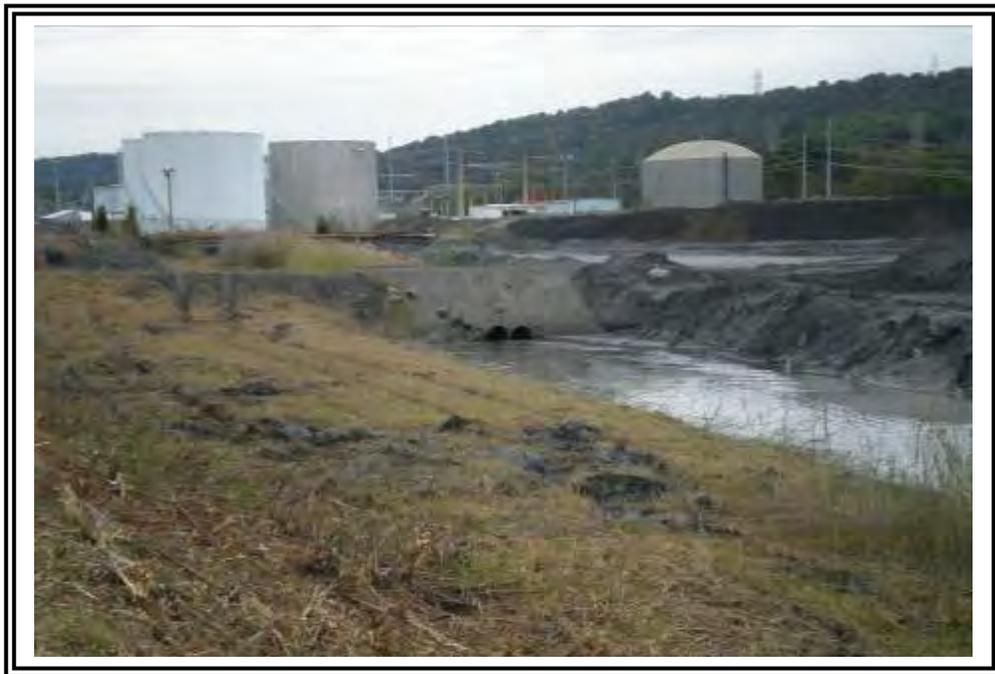
122

Culvert pipes under truck entrance, looking north.

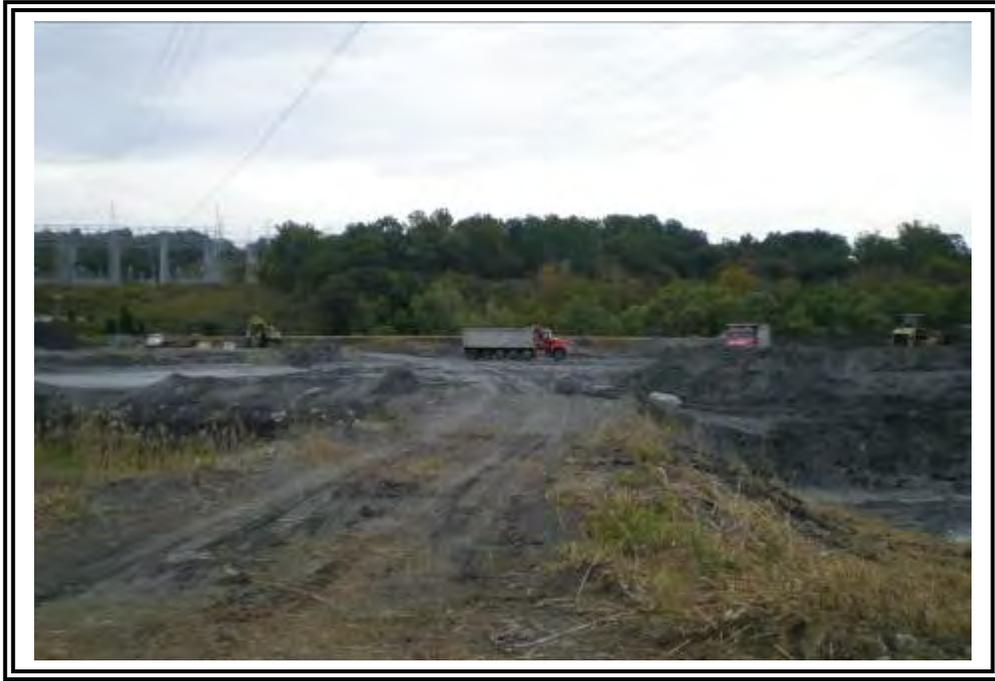
123

Looking east across pond at truck entrance for piling and moving ash.

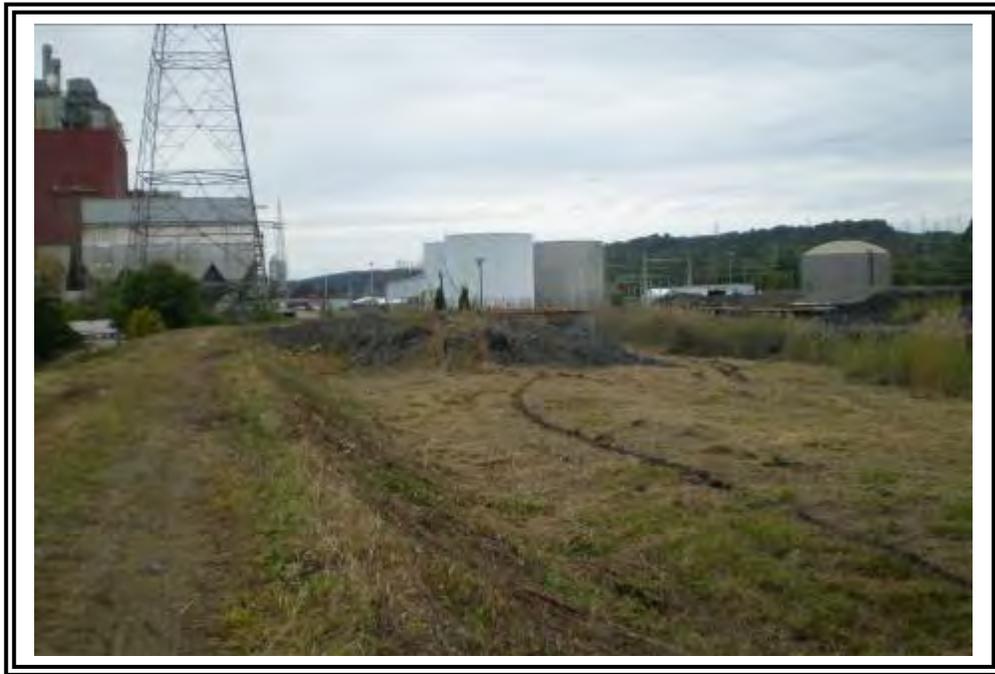
124

West dike crest and interior, looking north.

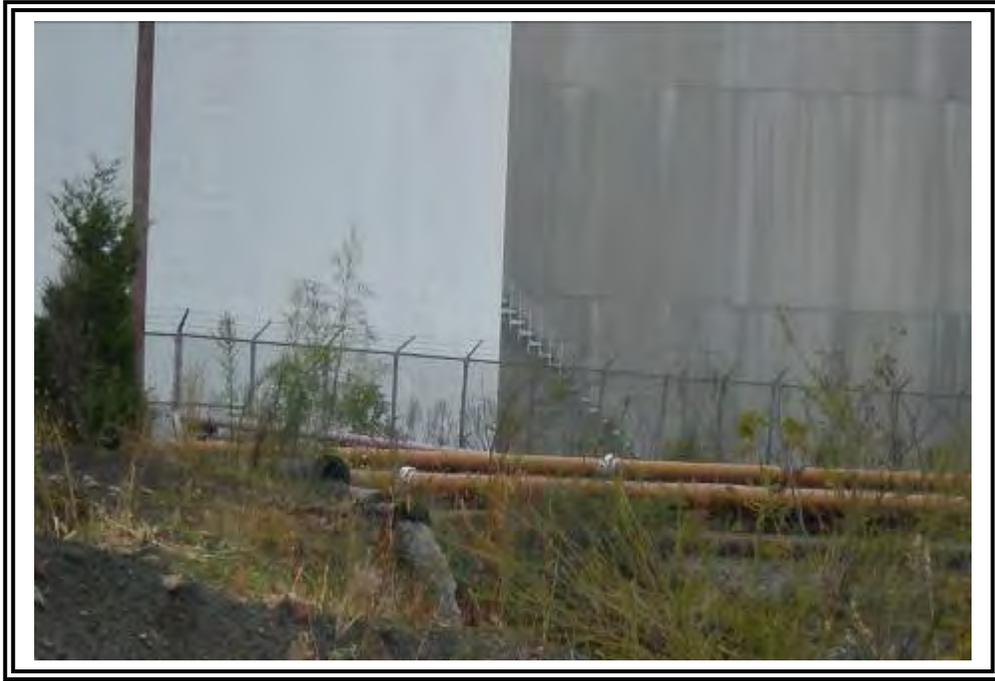
125

Inflow pipes.
