Assessment of Dam Safety Coal Combustion Surface Impoundments (Task 3) Draft Report

Duke Energy

W.C. Beckjord Station
New Richmond, Ohio

December 7, 2009

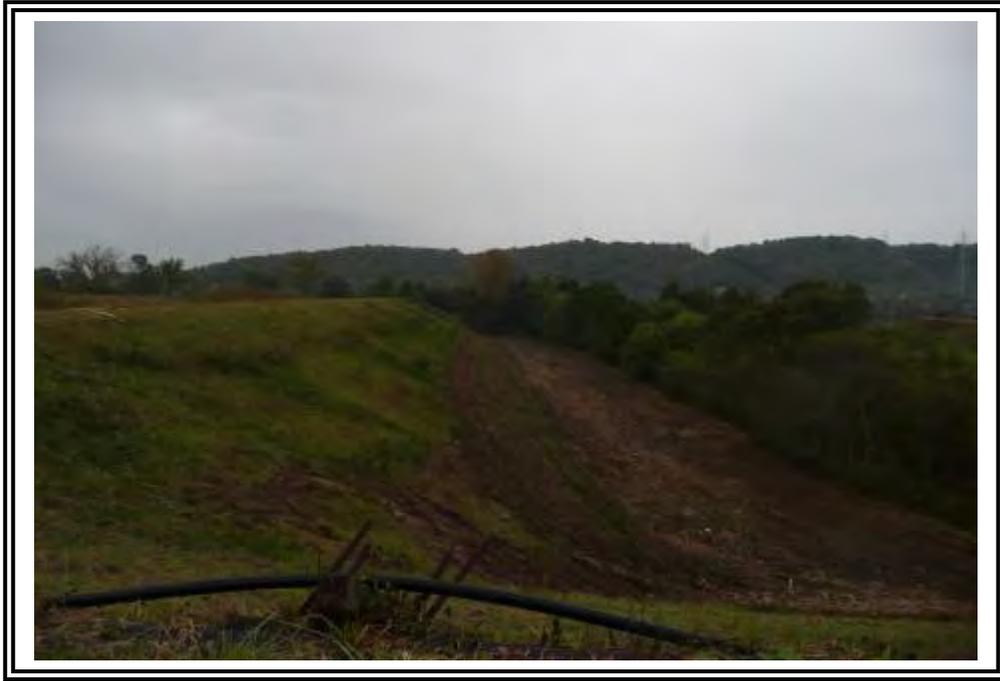
126

Exterior slope of north dike, looking west.

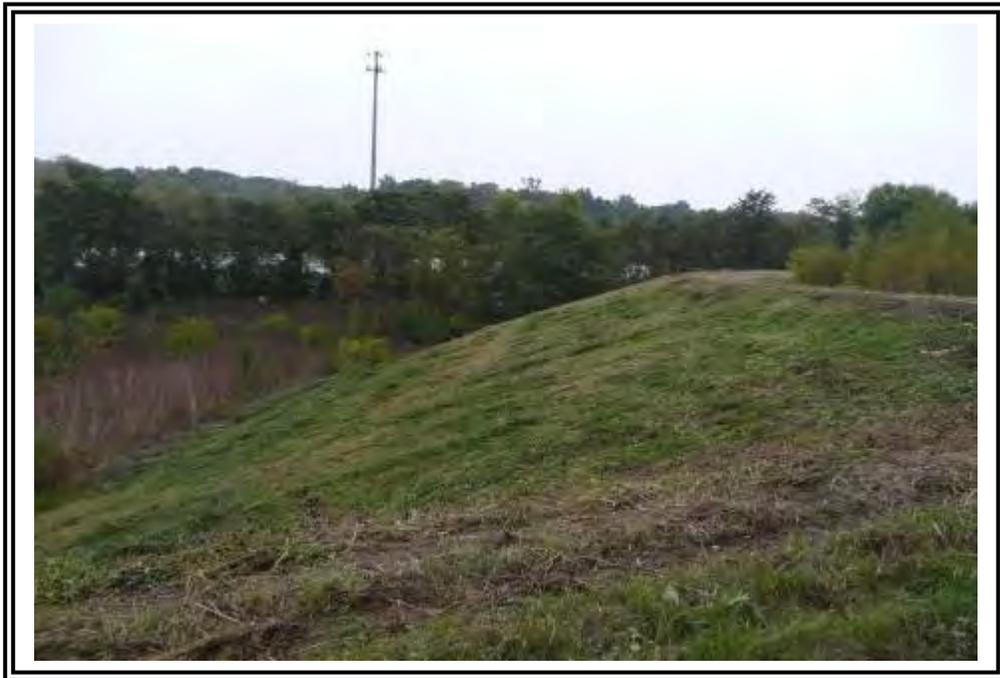
127

Exterior slope of north dike, looking east. Vegetation and rock toe drain is visible at base of slope.

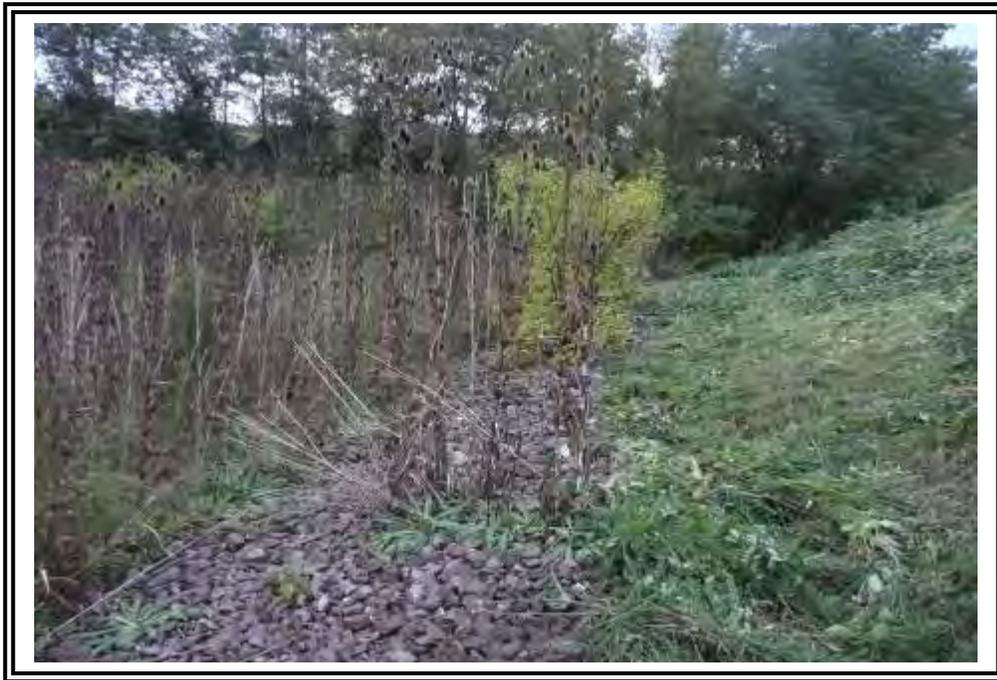
127

Rock toe drain and vegetation beginning to establish itself.

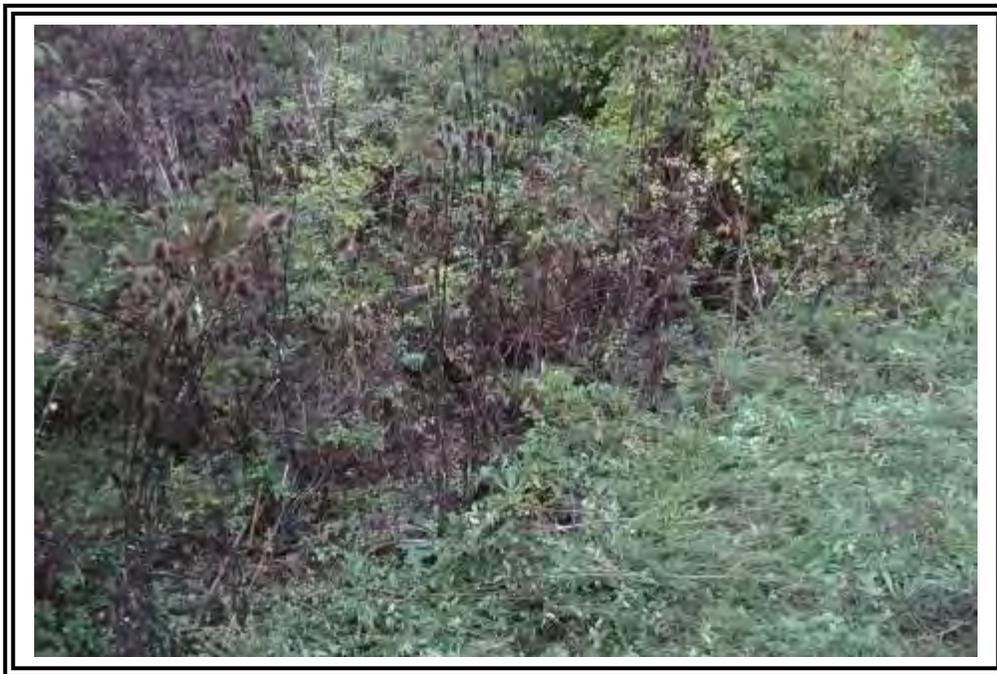
129

Rock toe drain overgrown with vegetation.

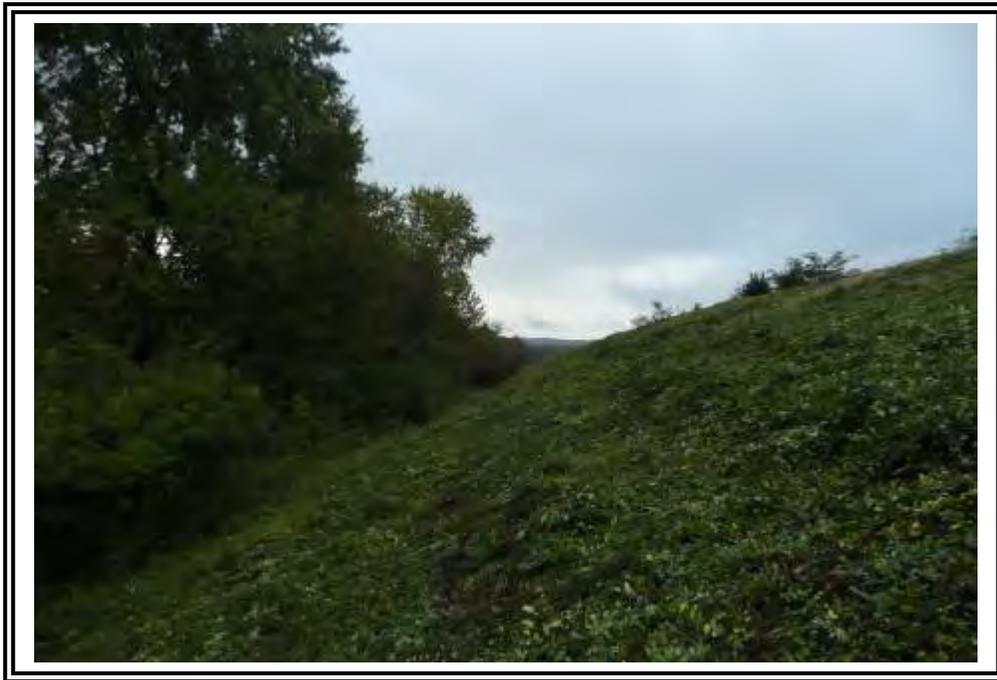
130

Exterior slope of east dike, looking south. Trees and heavy vegetation established adjacent to and on slope toe.

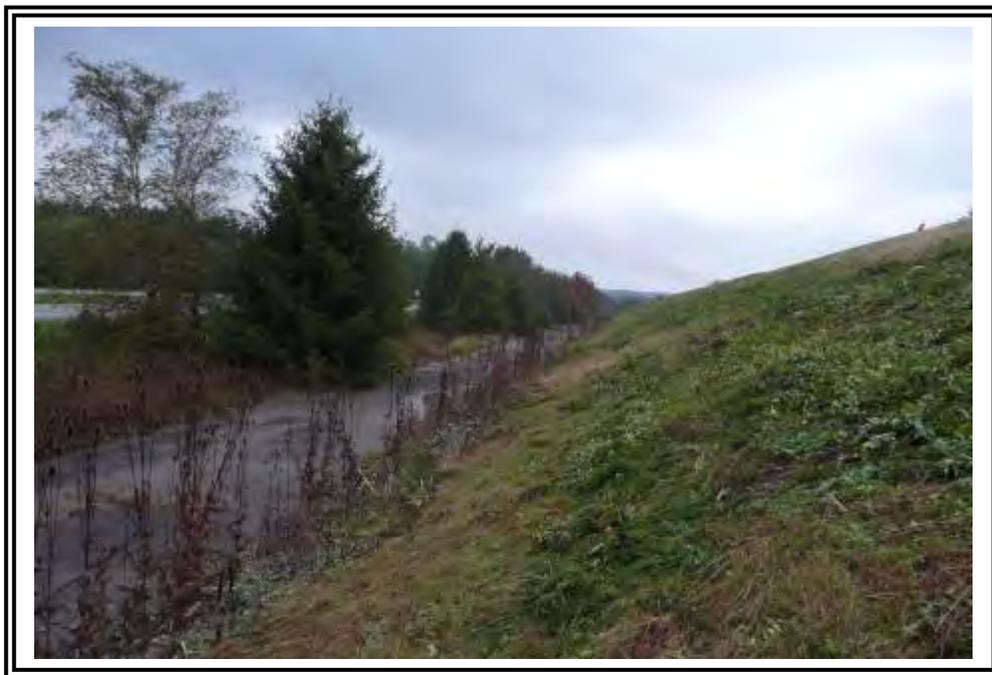
131

Exterior slope of east dike in area where old access road is located at base of slope.
Note dying vegetation in rock toe drain.

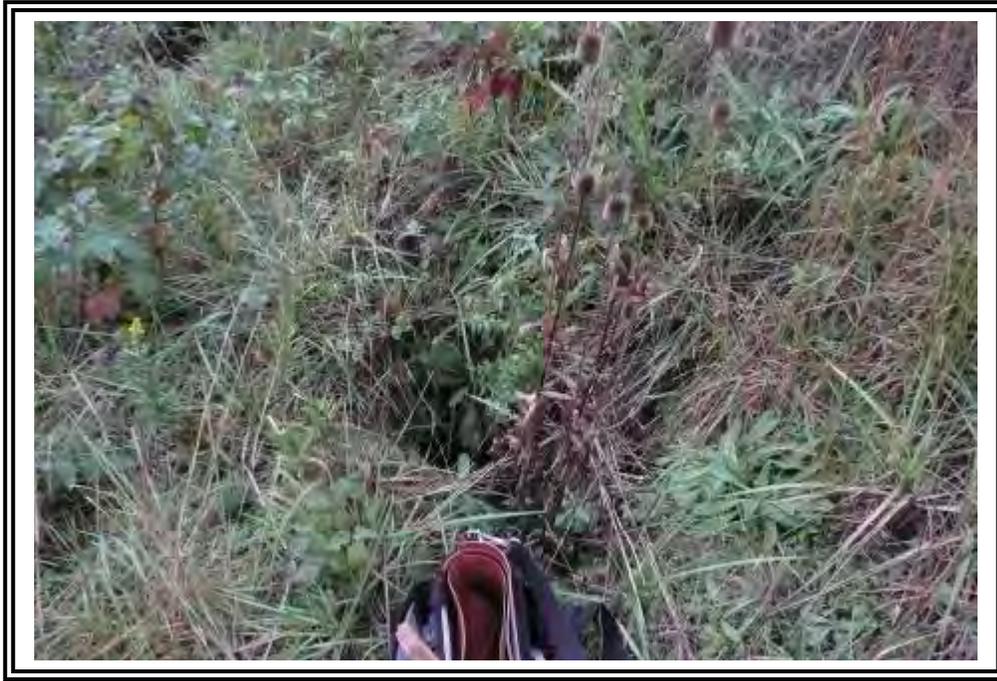
134

Grassy surface hole/depression likely the result of shallow creep/sloughing that became prevalent below mid-slope along the southern 240 feet of the east dike. These were typically obscured by vegetation.

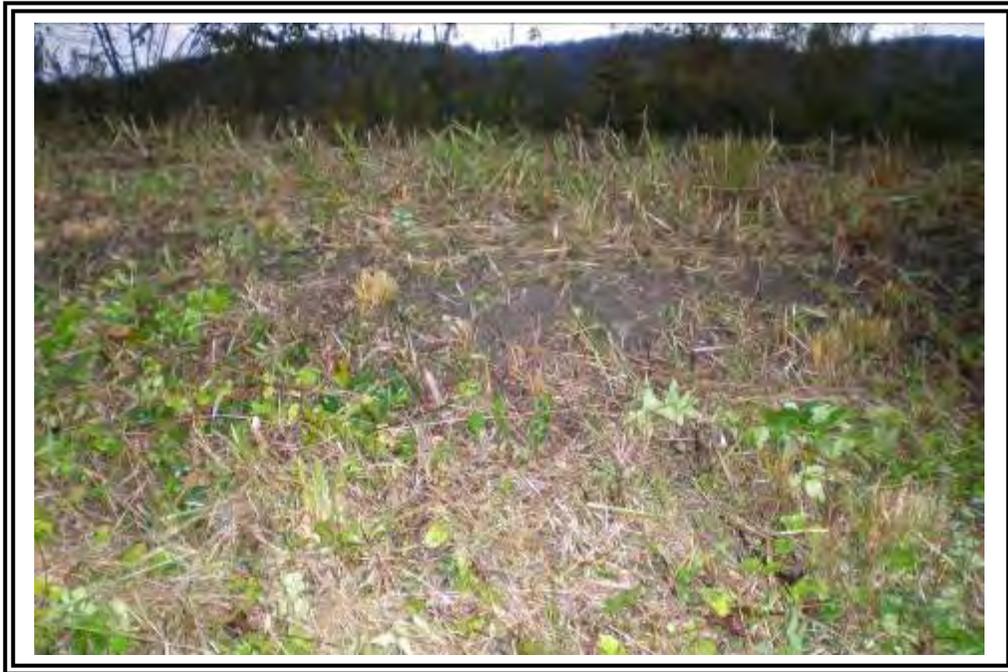
137

Looking west at erosion rill at crest on downstream side of east dike.

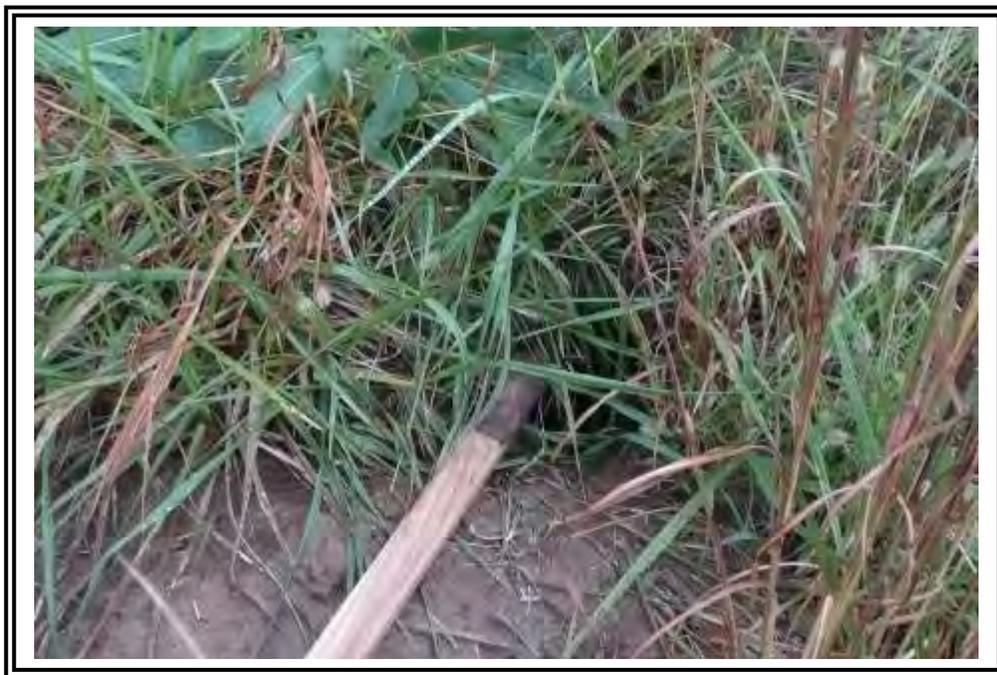
143

Small rodent burrow on south dike.

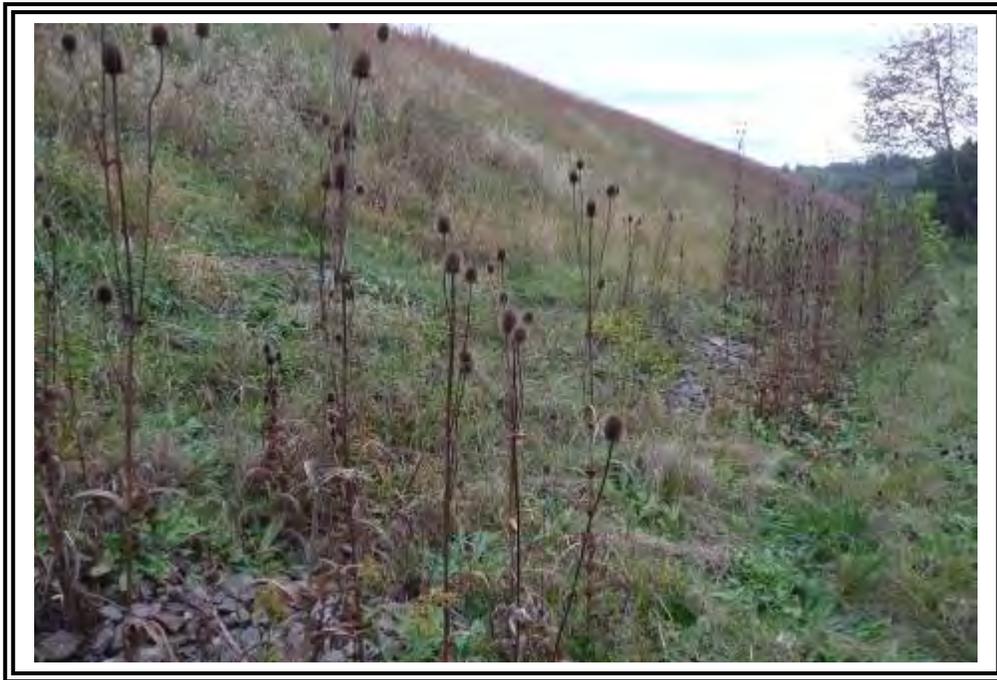
144

Small vegetated slough and erosion transporting soil over the rock toe drain on south dike.

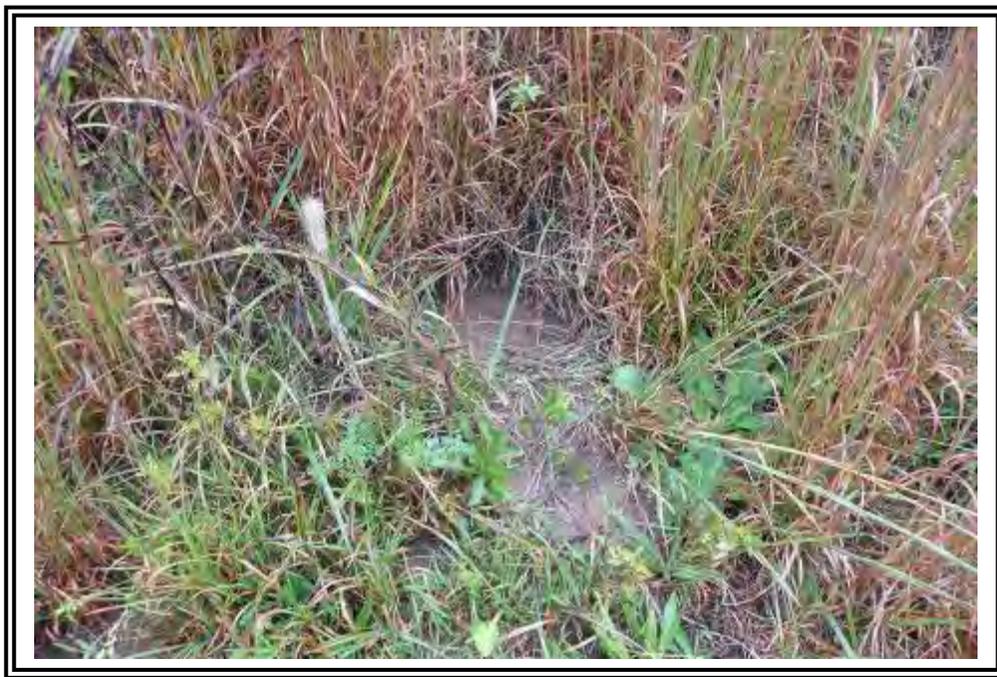
145

Depression//hole on south dike exterior slope holding standing water from recent rainfall.

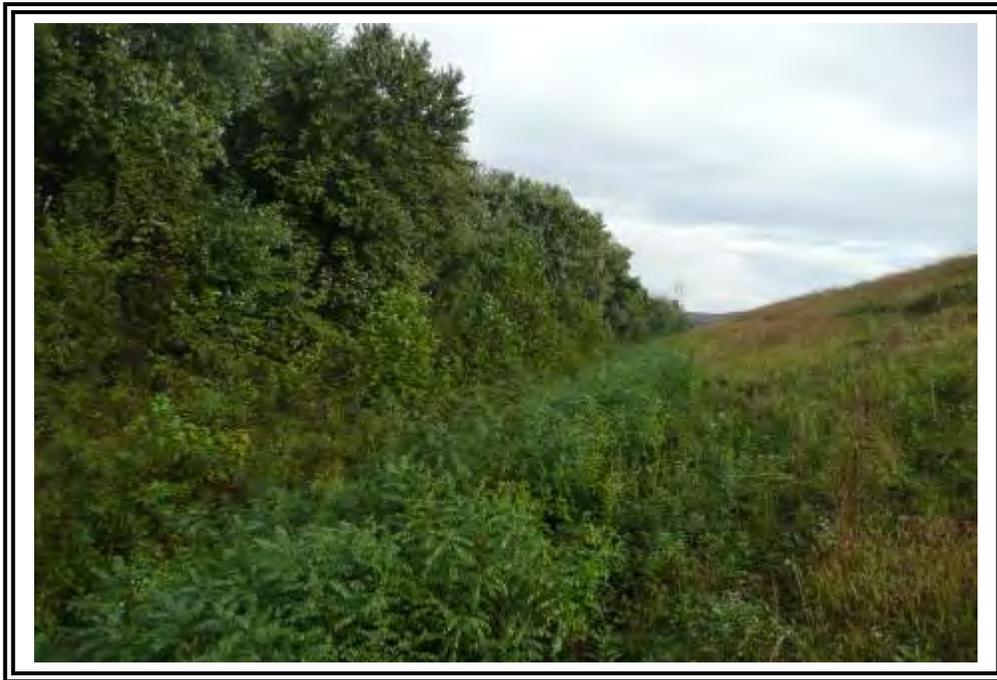
148

West dike, exterior slope, looking north. Note very heavy vegetation on bottom 1/3 of slope near dike toe.

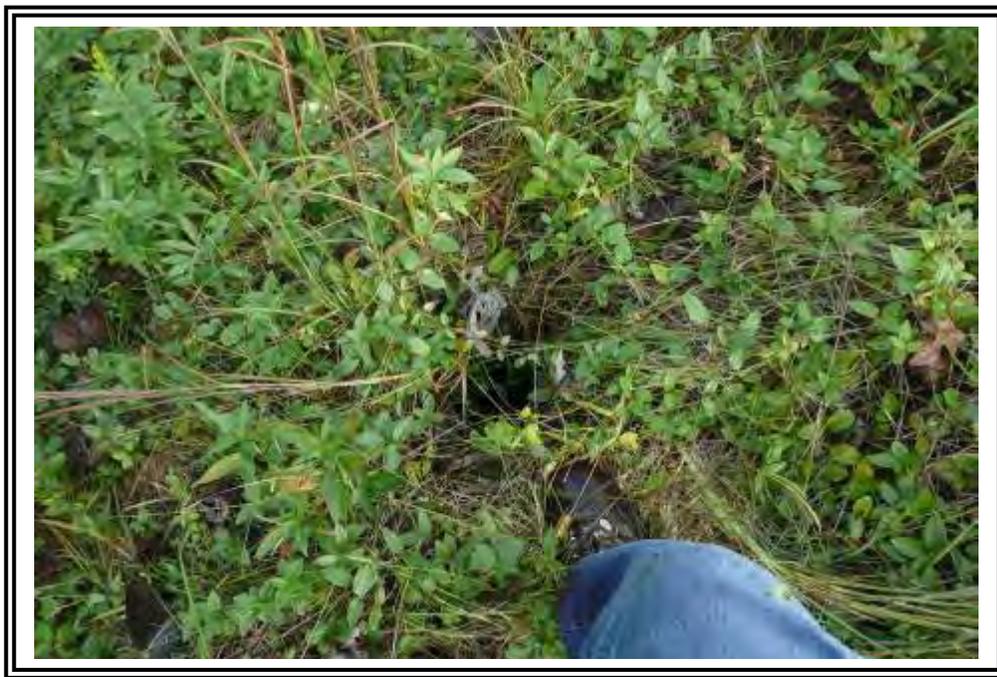
149

Old rodent burrow obscured in vegetation on west dike.

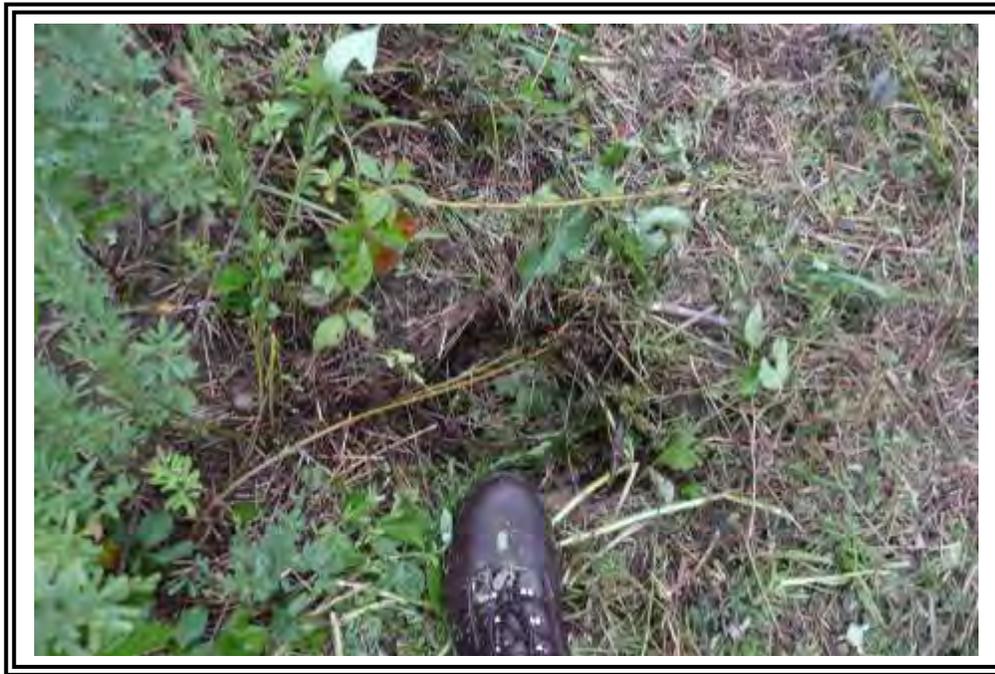
153

Grassed pocket/depression on exterior slope of west dike. Likely the result of shallow creep/sloughing.

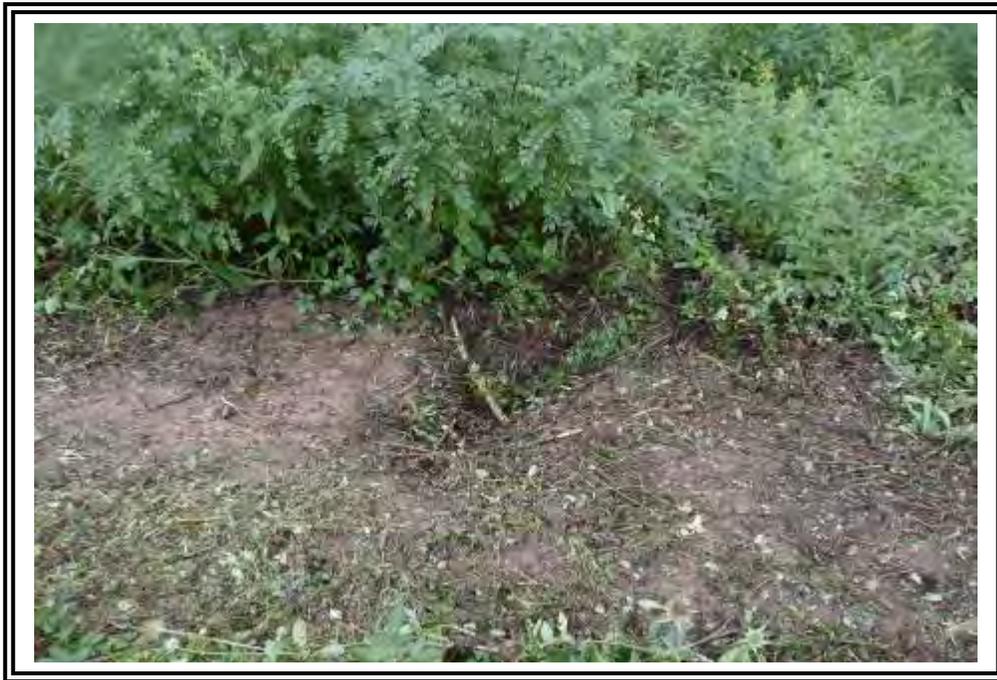
154

Looking down slope at erosion rill mowing exposed above bottom 1/4 to 1/3 of exterior slope of the west dike where the slope steepens in area of heavy vegetation.

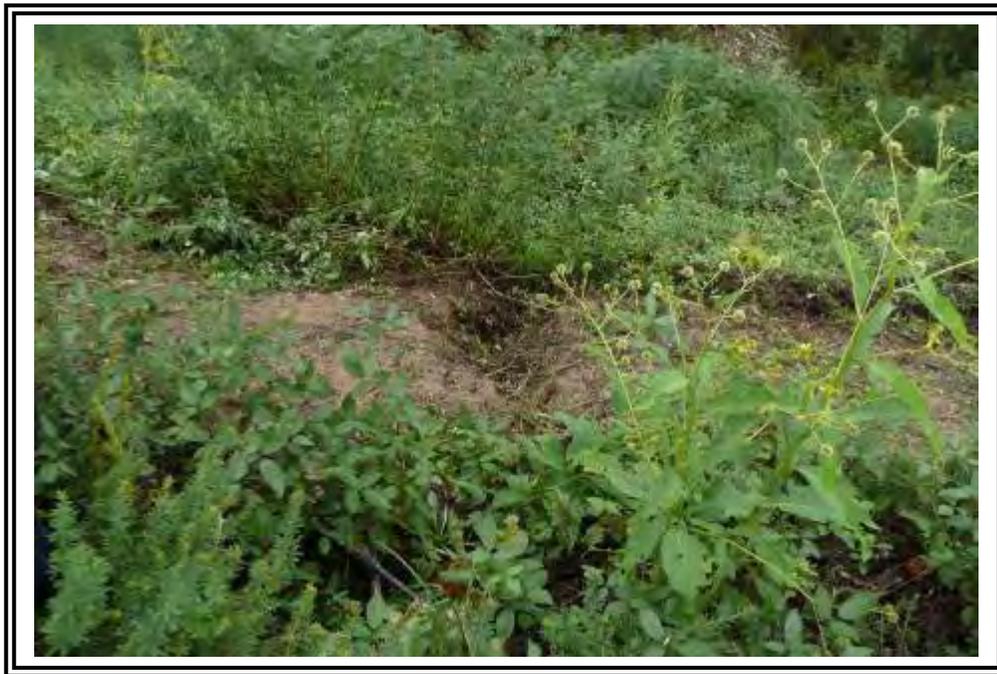
155

Another grassed erosion rill mowing has exposed on exterior slope of west dike.

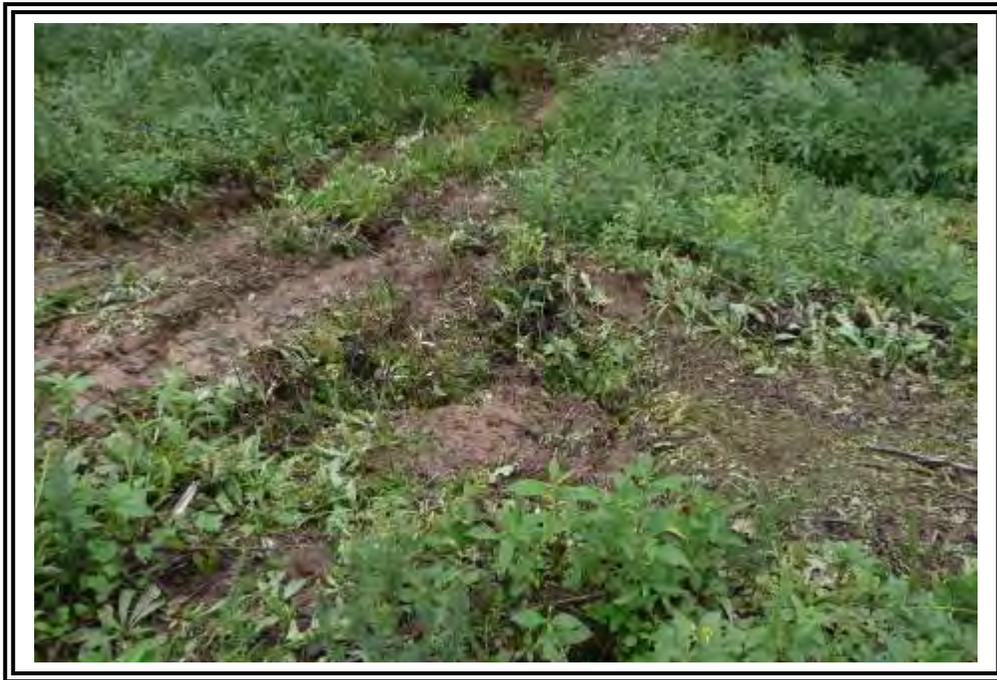
156

Example of an erosion rill on the west dike face normally obscured by vegetation.

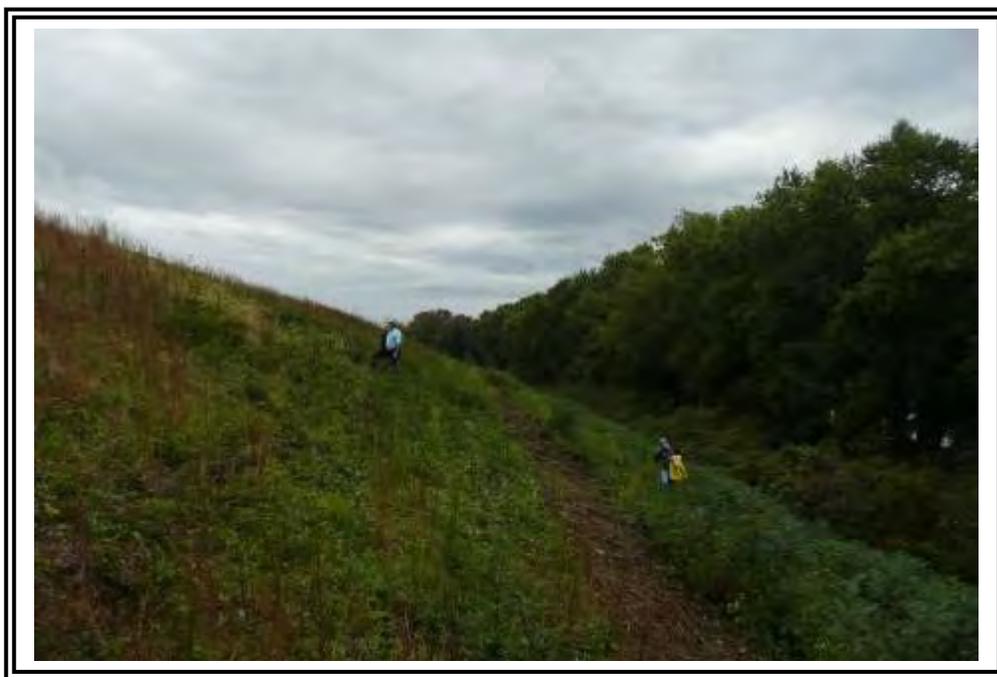
157

Exterior slope of the south dike, facing south.
Note heavy brush vegetation at toe of slope where rock toe drain is located.

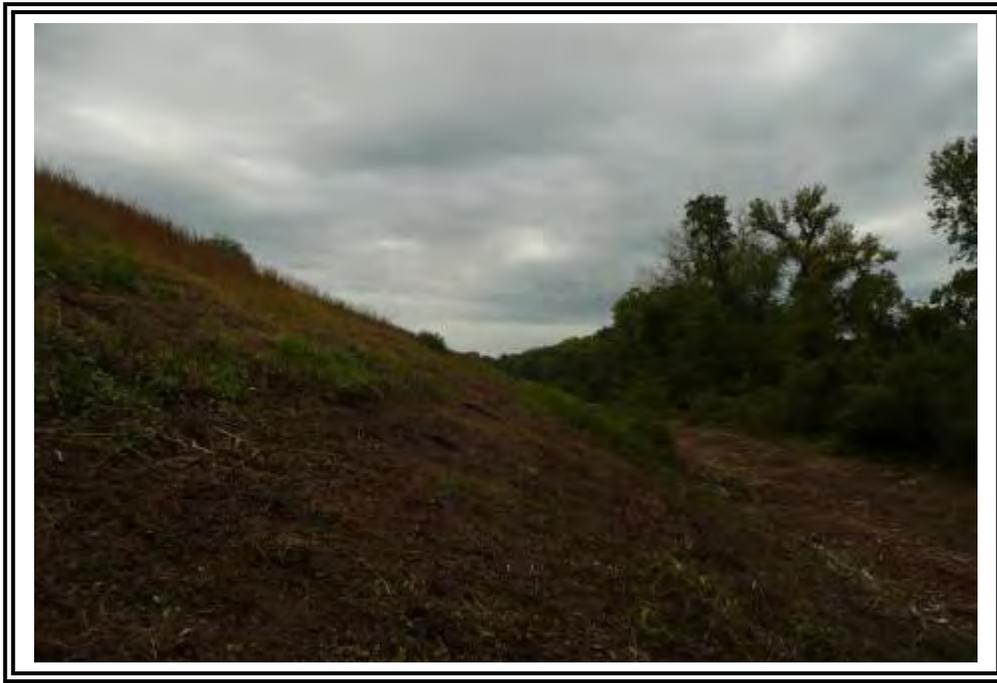
158

Looking south along the exterior slope of west dike. Heavy vegetation was recently mowed.

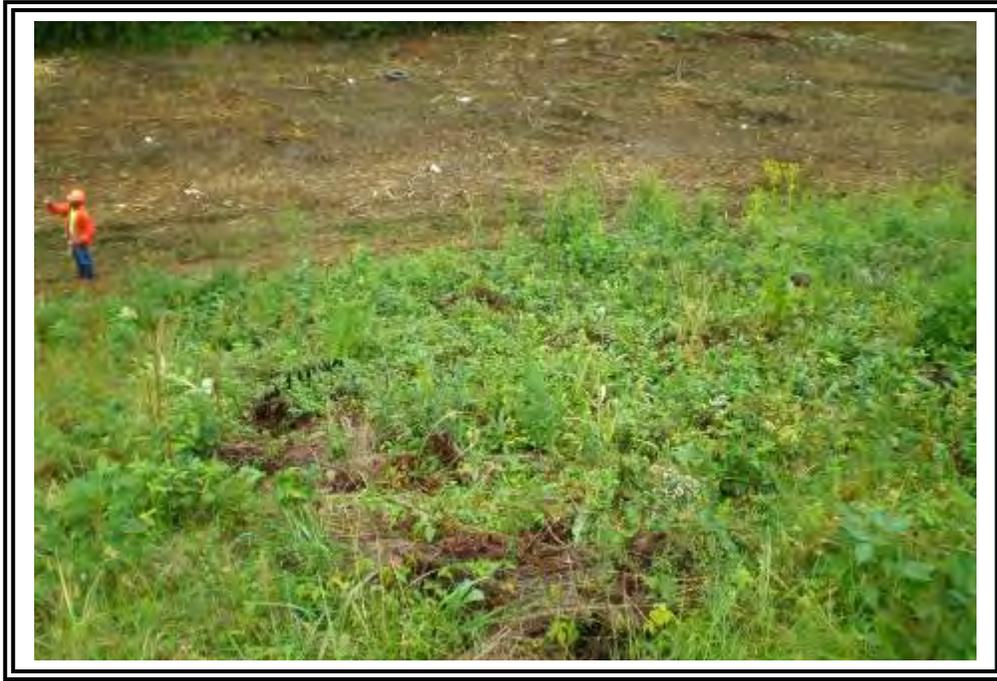
164

Erosion rill on exterior slope of west dike, looking west.

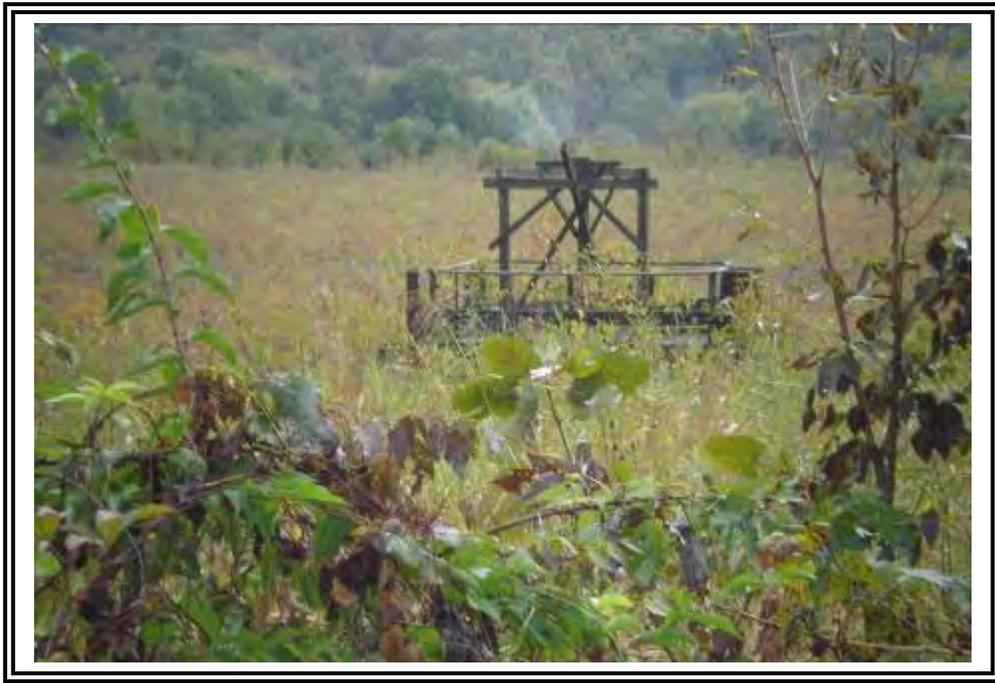
166

Abandoned overflow pipe structure, looking northeast/east.

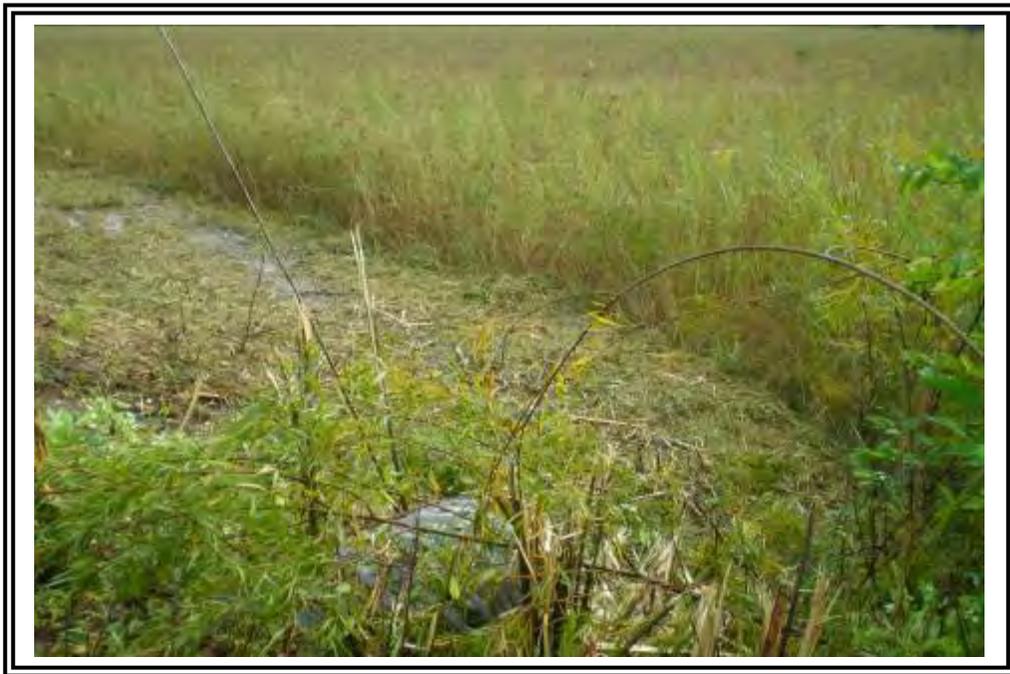
167

Abandoned 24-inch diameter emergency overflow pipe.
