Assessment of Dam Safety Coal Combustion Surface Impoundments Draft Report

Duke Energy
Buck Steam Station
Spencer, North Carolina

July 13, 2009

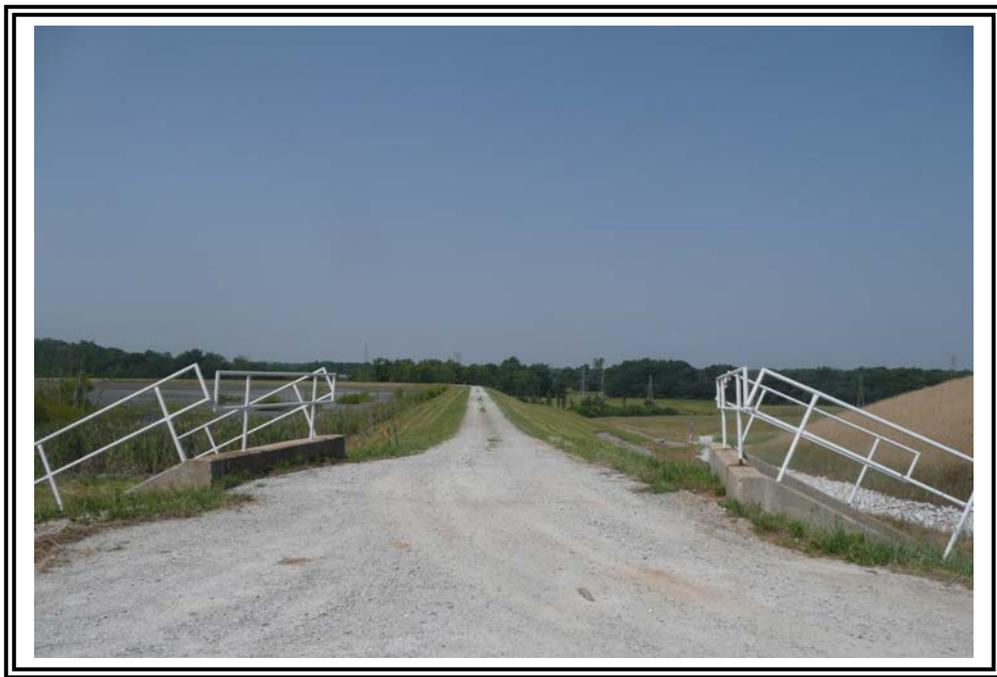
In general, the alignment of the new dike crest does not show signs of change in its horizontal alignment. Photos 2 and 23 show the north and west portions of the new dike crest alignment, respectively.

New Dike crest looking south west (from north abutment).

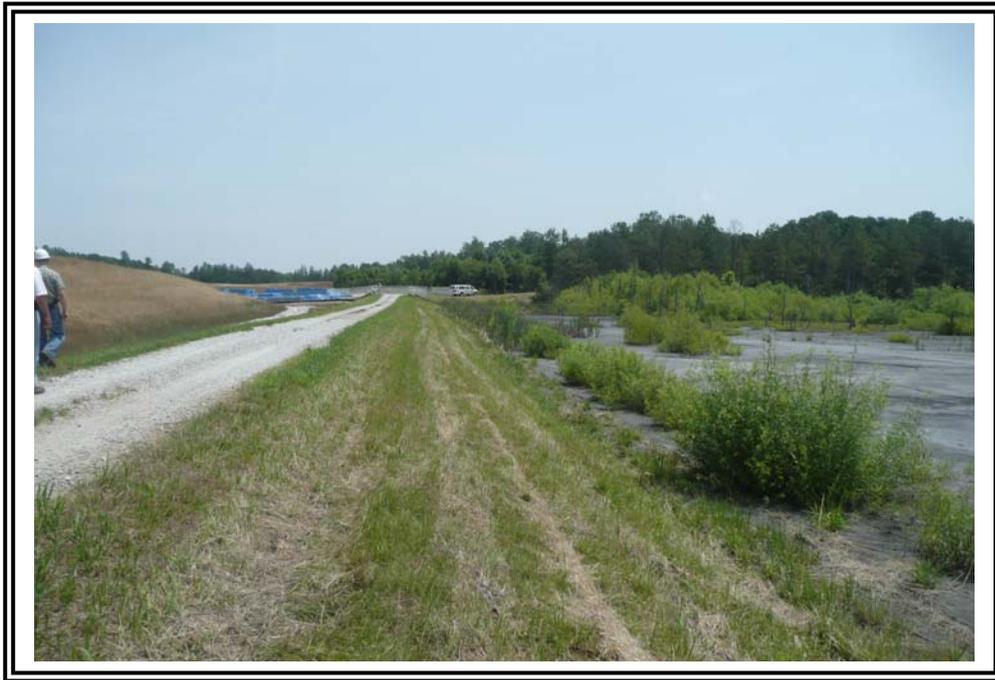
The upstream slope was covered with appropriate grass vegetation. Sluiced ash deposited higher than the current water level is adjacent to the upstream slope of the new dike. There are taller weeds growing on the ash adjacent to the dike slope. Photos 3 and 4 show the upstream slope along the north portion of the new dike.

New Dike crest and upstream slope looking northeast towards North Abutment (note van is on abutment).

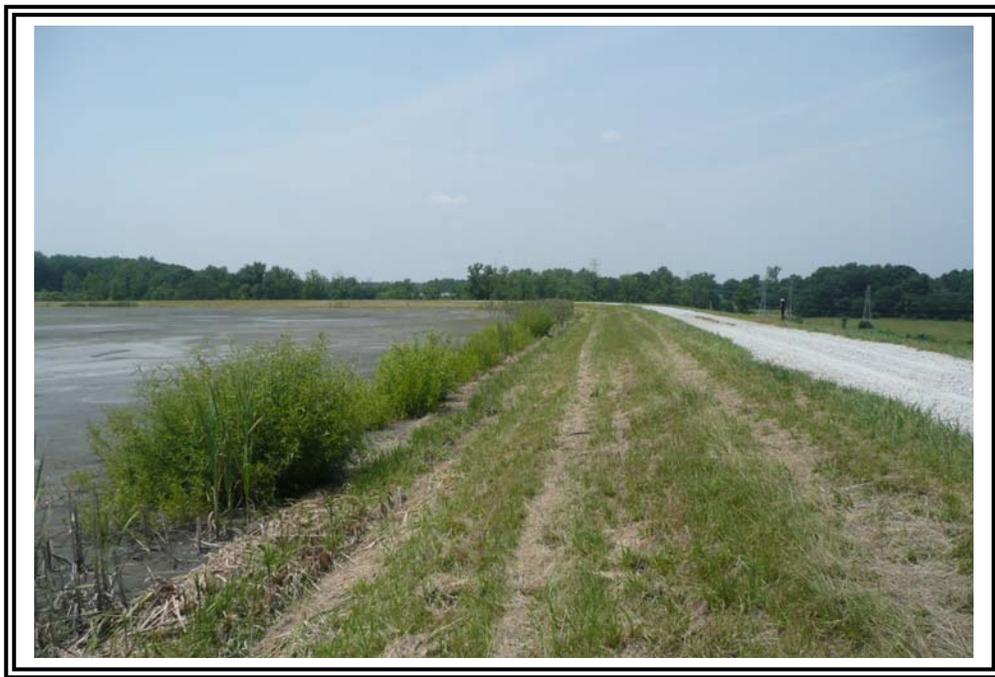
4

New Dike crest and upstream slope looking southwest.

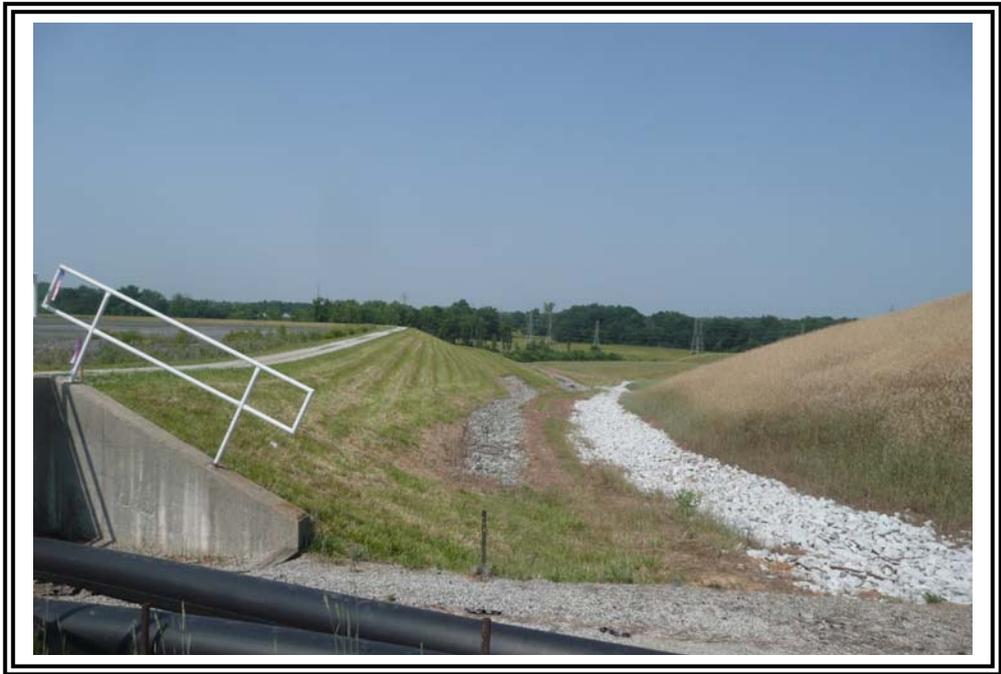
6

Downstream Slope looking southwest from north Abutment. Note “gray” rip rap swale is groin drainage swale associated with the New Dike, the “white” rip rap to the right is a surface drainage swale associated with the combined cycle plant currently under construction. Hill in near right of photo is a stockpile of excavated material from the combined cycle plant construction.

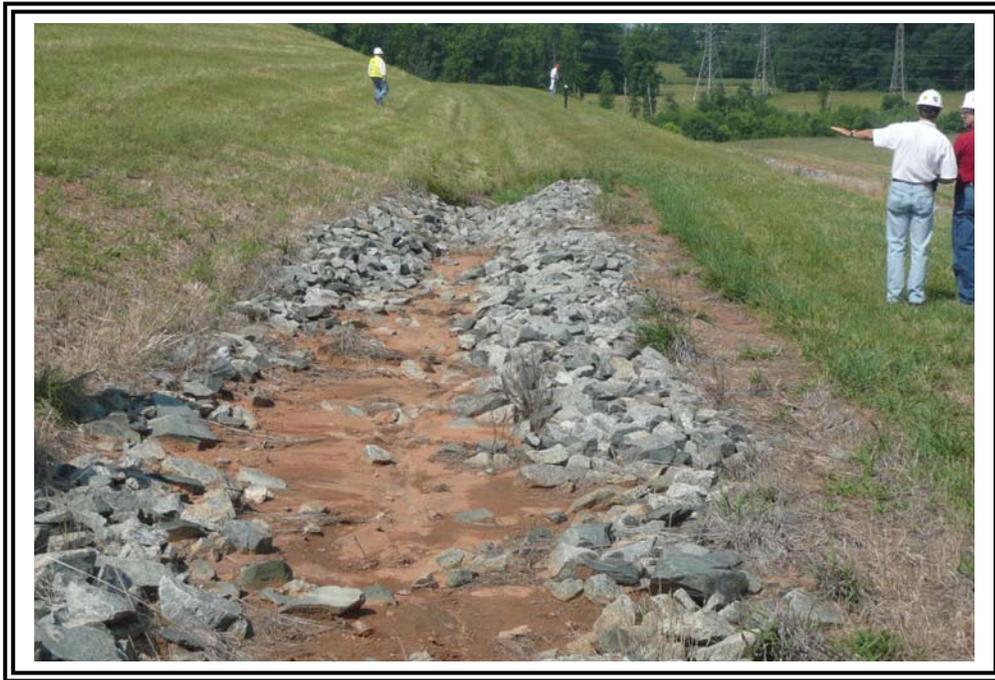
7

The downstream slope of the new dike was constructed with two benches at elevations 690 and 670 (as compared to the dike crest at elevation 710). Each bench has a drainage swale, which in some areas is rip rapped and in some areas is grass lined, and culverts at low points along the bench swale discharge the collected surface runoff to the bench or toe drainage swale below. Photos 8, 12, 20, and 21 show examples of these drainage culverts. As can be seen in Photo 7, the drainage swales have areas where surface runoff has deposited sediment, clogging the rip rap. Although each swale has silted in to varying degrees, this is a common feature at the new dike.

Drainage swale at north end of upper bench clogged with silt.

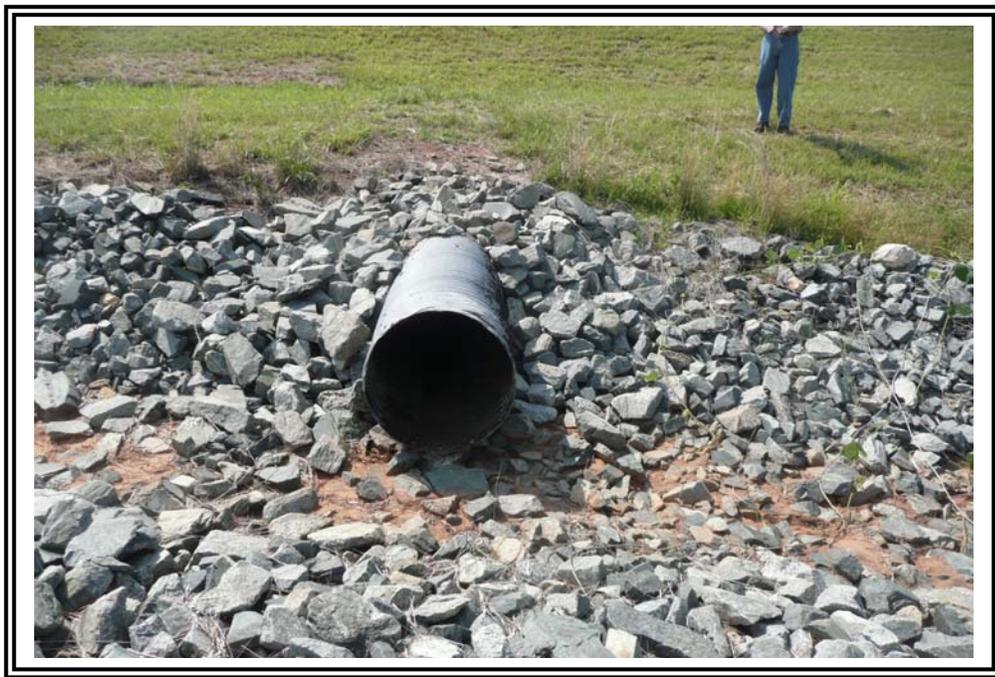
8

Upper bench drainage swale culvert discharging into toe swale.

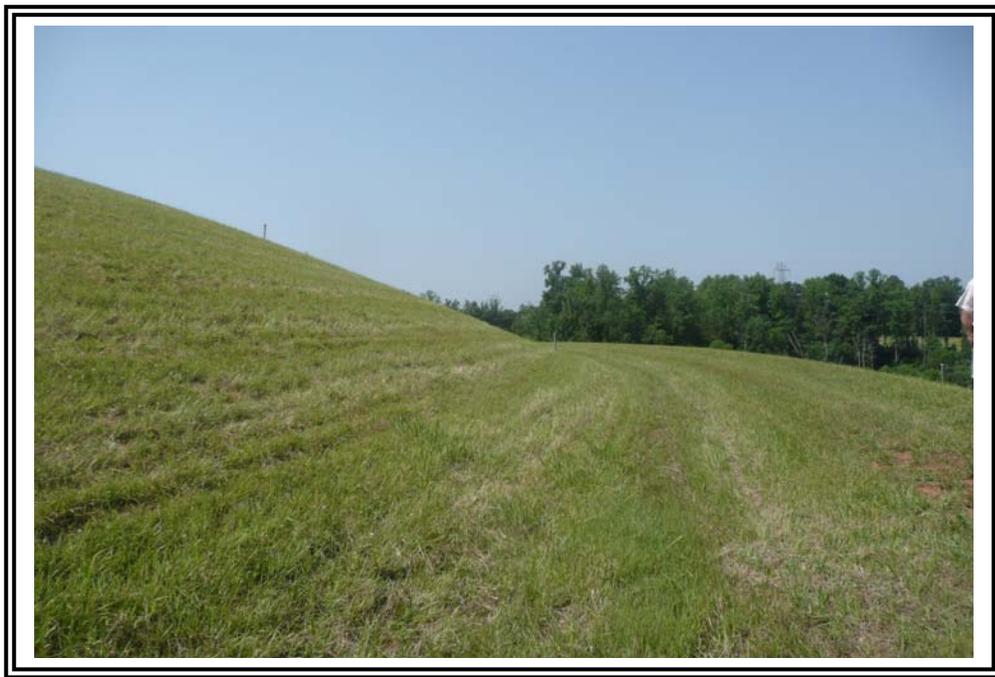
10

Downstream Slope at Upper Bench of New Dike looking southwest. Note occasional sparse grass cover.

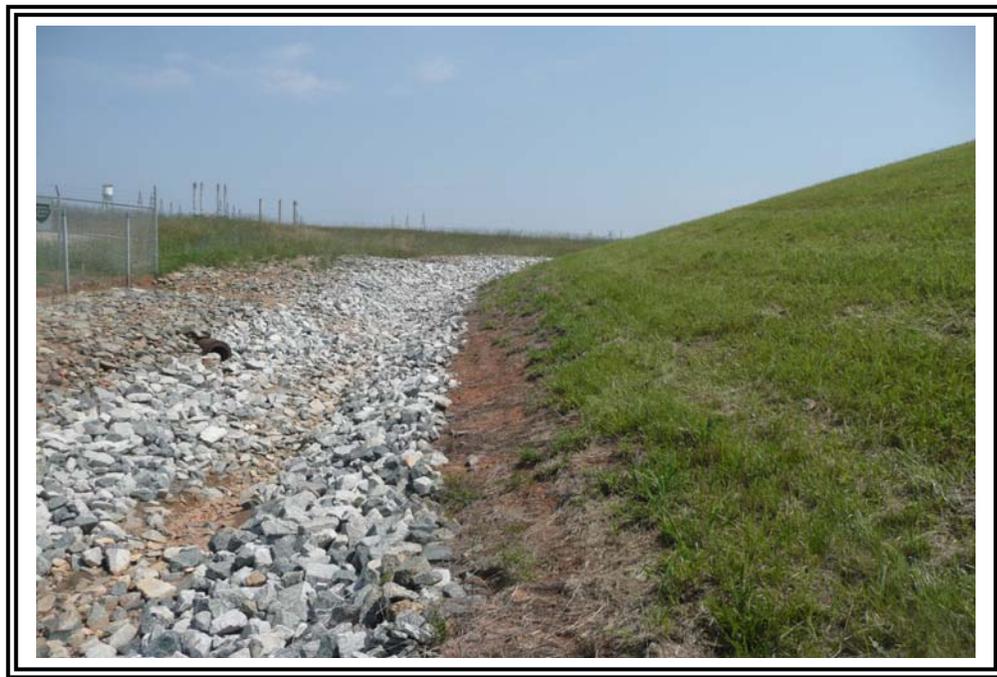
16

Toe swale of New Dike looking north. Note drainage pipe entering drainage swale from across access road to new combined cycle plant site. Sparse vegetation along rip rap edge likely from herbicide use to control weeds in the rip rap.

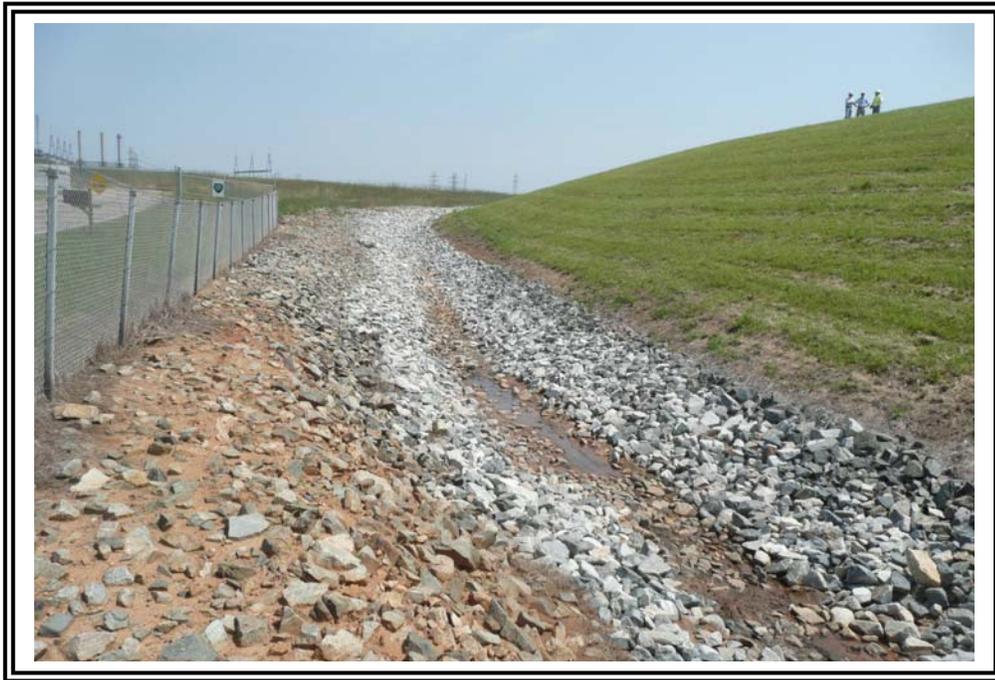
17

Toe swale of New Dike looking north. Area of toe drain seepage. Area starts about 100 feet north of discharge culvert under Dukeville Road.

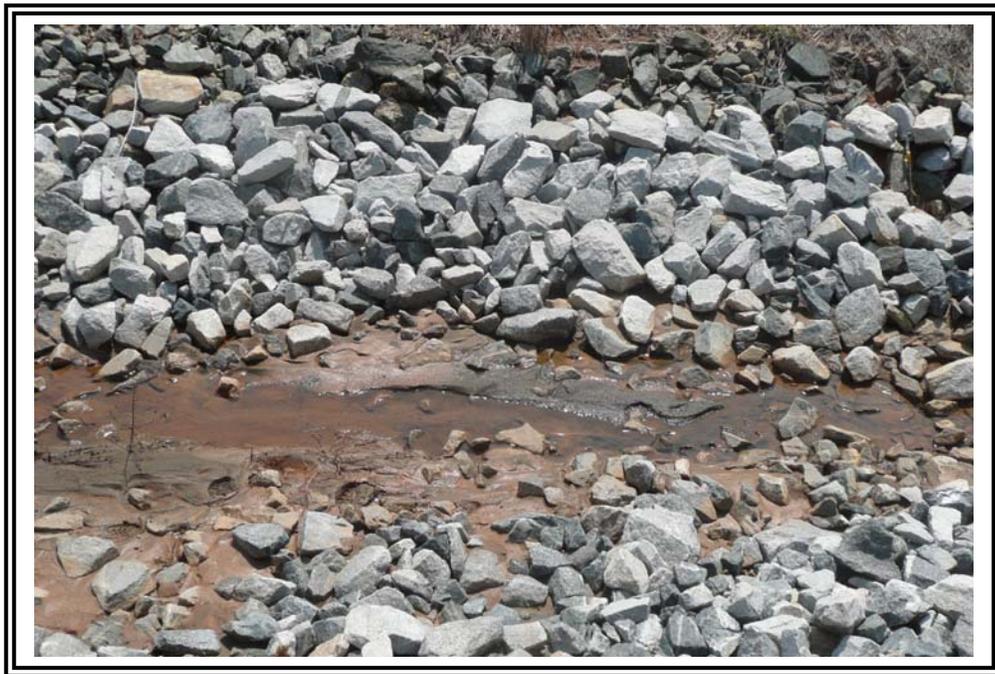
18

Closeup of toe drain seepage at New Dike. Water was flowing clear. Reportedly Duke Energy is in the process of discussing installation of a seepage monitoring system with an outside consultant.

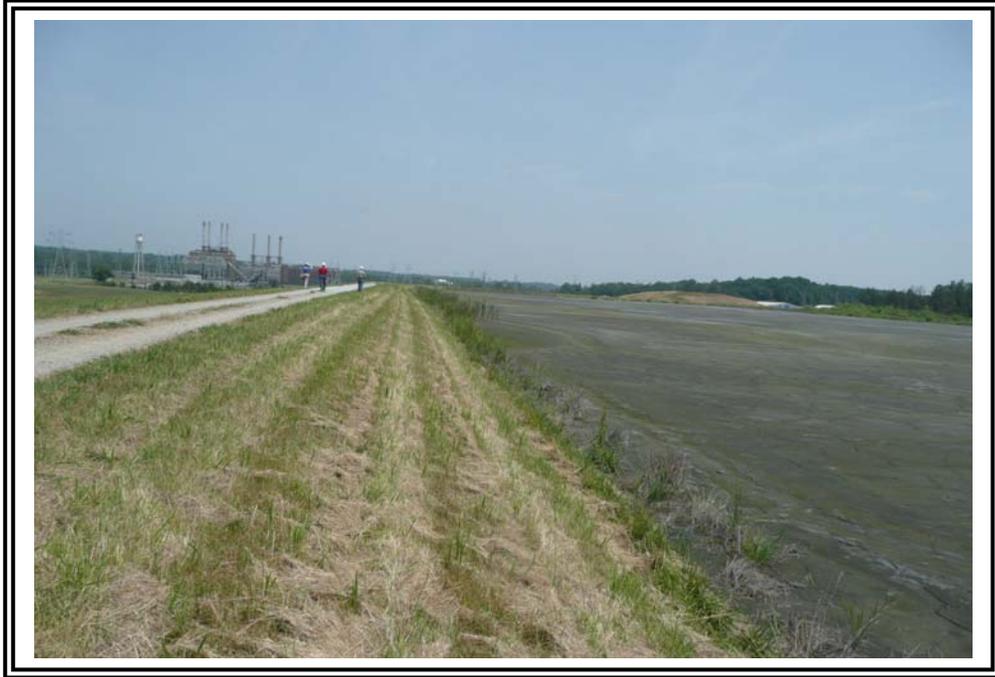
23

Upstream slope and crest alignment of west portion of New Dike, looking north.

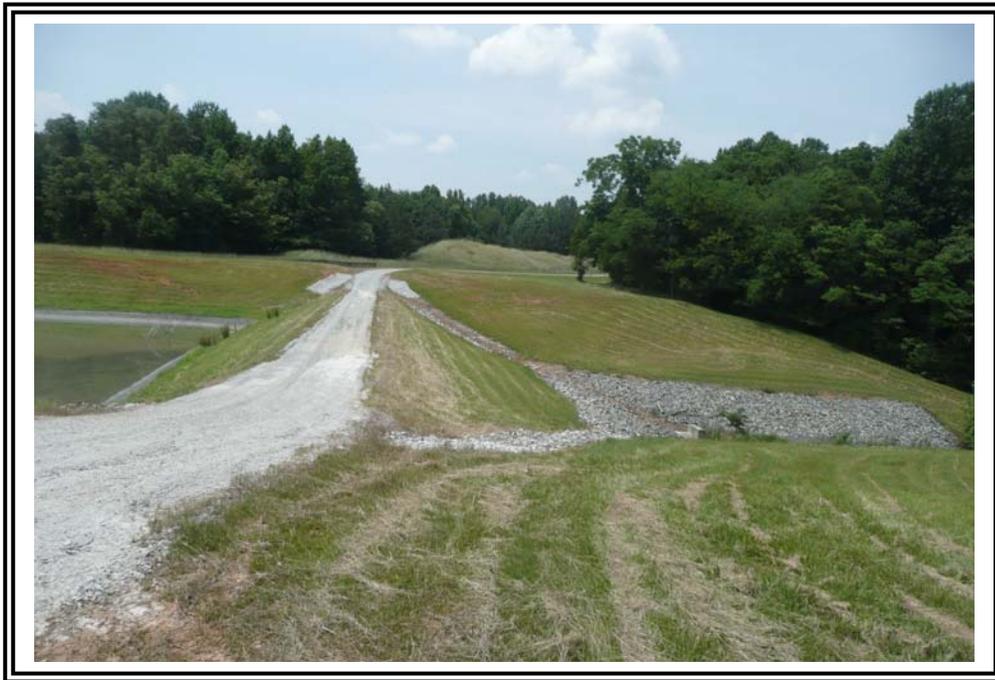
The Basin 1 to Basin 2 Outlet Dam is about 260 feet long. The crest is at El. 710 per design drawings; the same as the new dike. Photos 24 and 25 show this structure. No major issues were noted with this dam. Failure of this structure would not release impounded fluid or materials outside of the basin system although this is discussed further in Section 3.4.

Outlet dam from Basin 1 to Basin 2 looking north. This dam is in a cut channel created to drain Basin 1 into Basin2 through a high point in the natural topography.

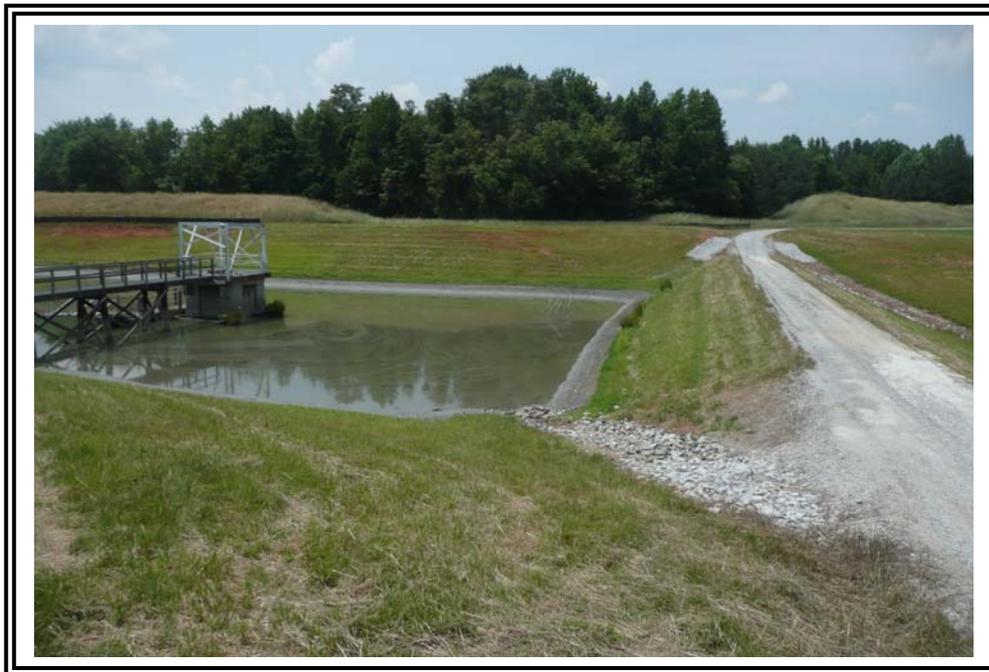
25

Basin 1 Outlet Tower.

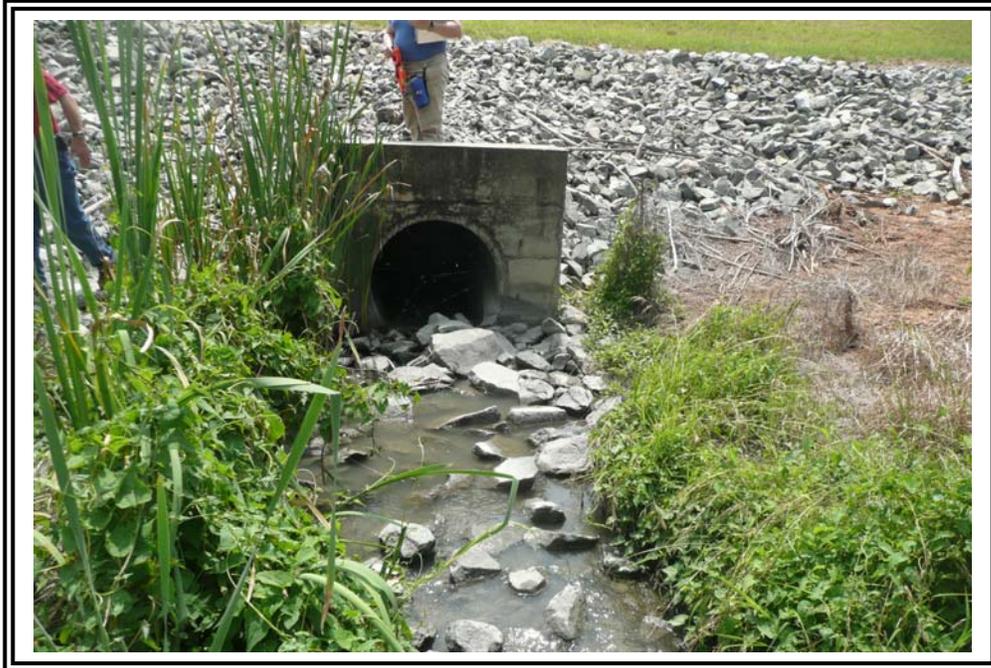
27

Downstream end of Basin 1 outlet pipe.

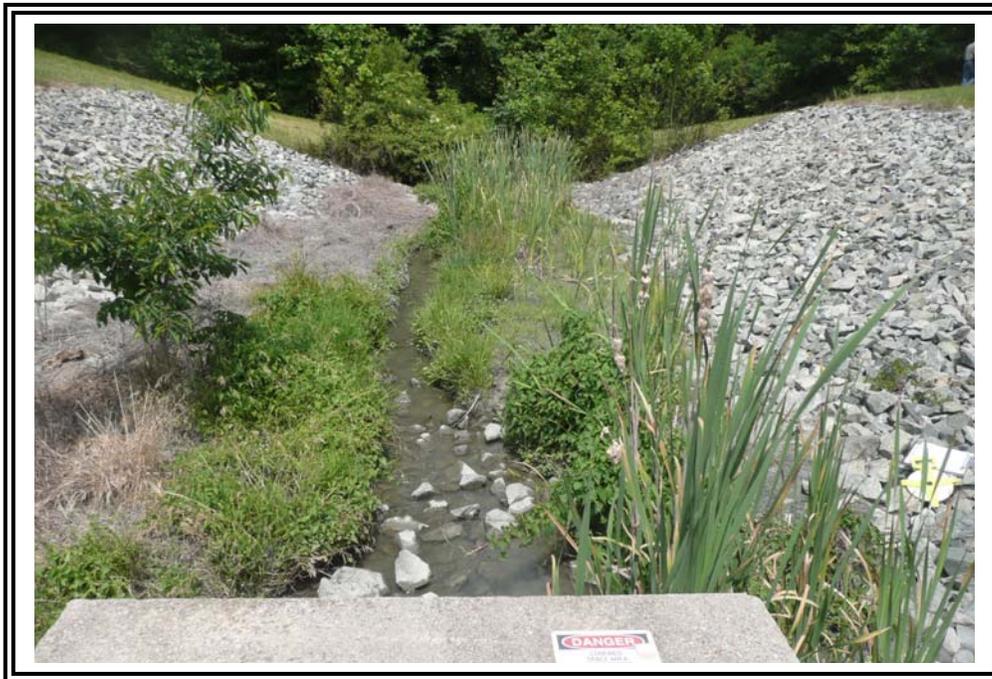
28

Basin 1 to Basin 2 outlet channel looking toward Basin 2.

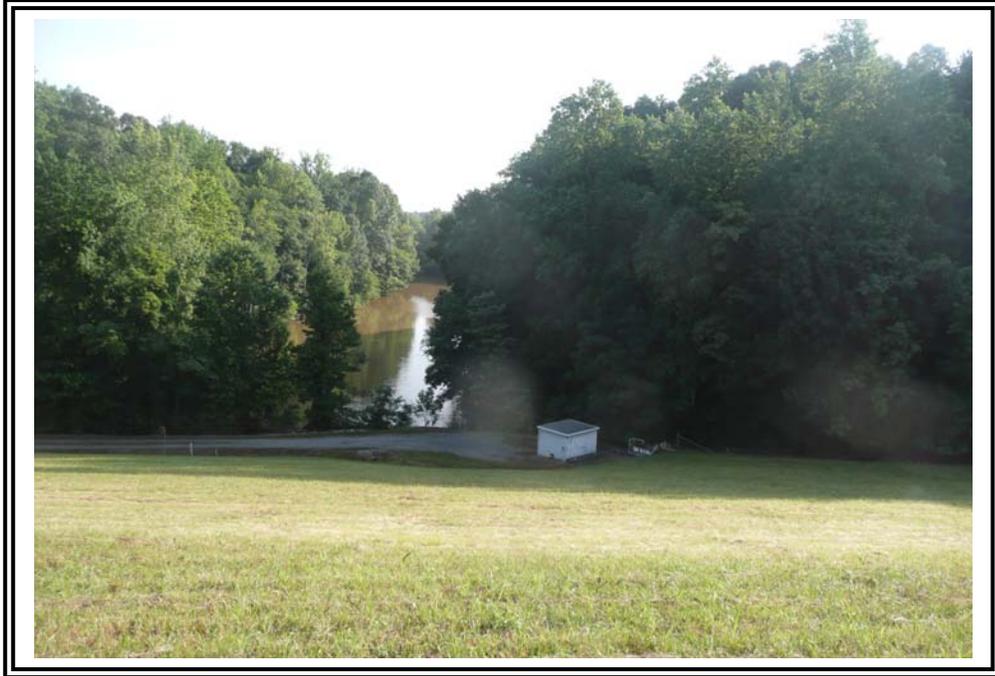
30

Yadkin River back water from crest of Main Dike, looking northeast.

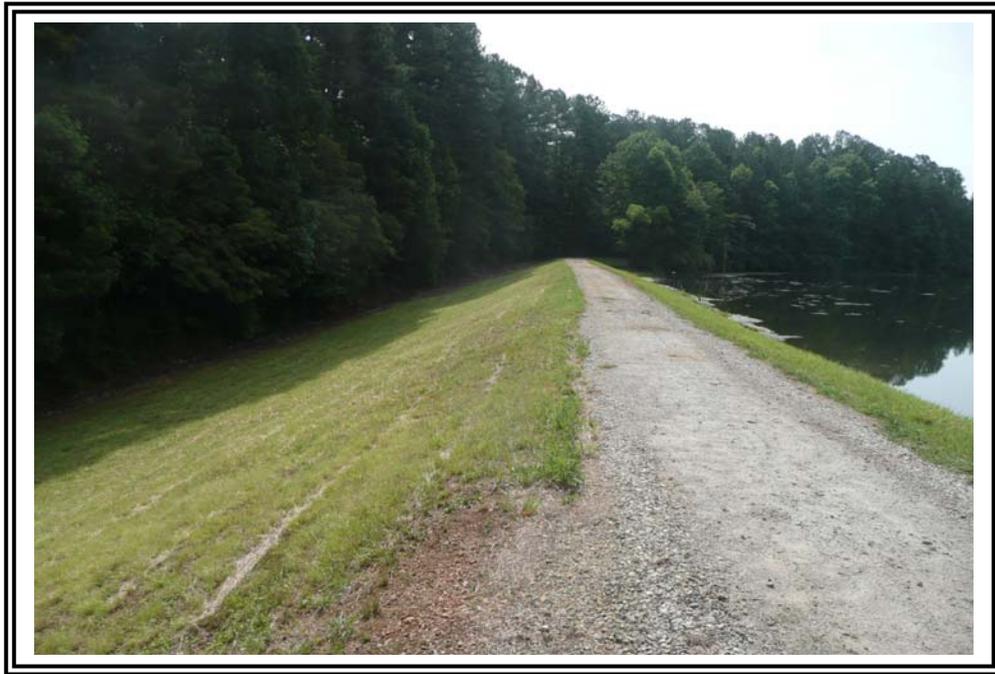
31

East portion of Main Dike crest adjacent to Basin 3, looking east.

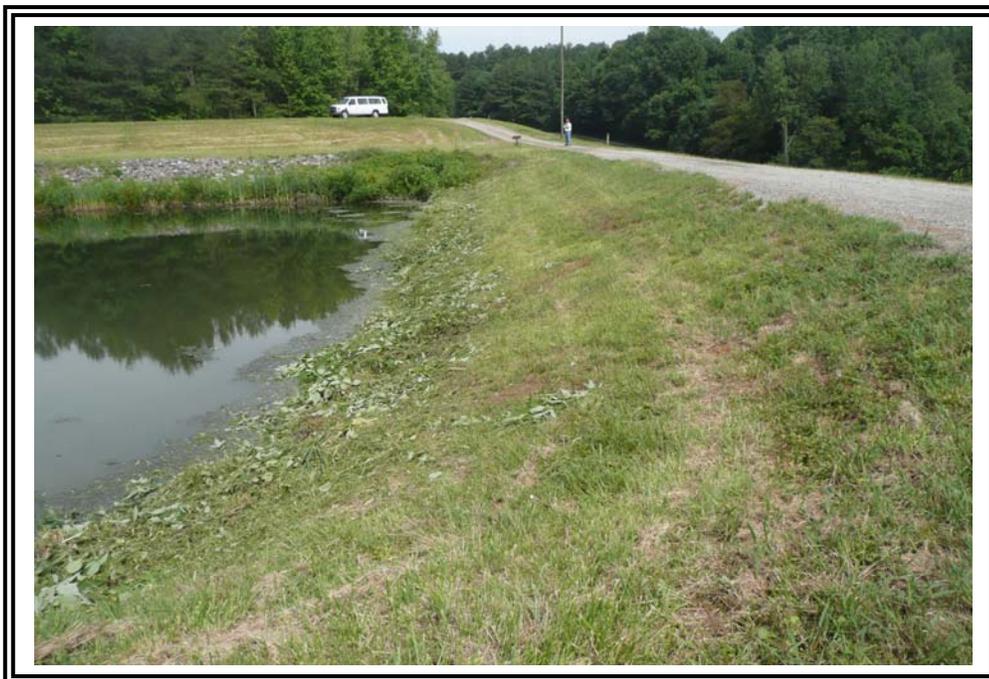
32

Middle portion of Main Dike crest and upstream slope adjacent to Basin 3, looking west. Van is parked on the diverter dike.

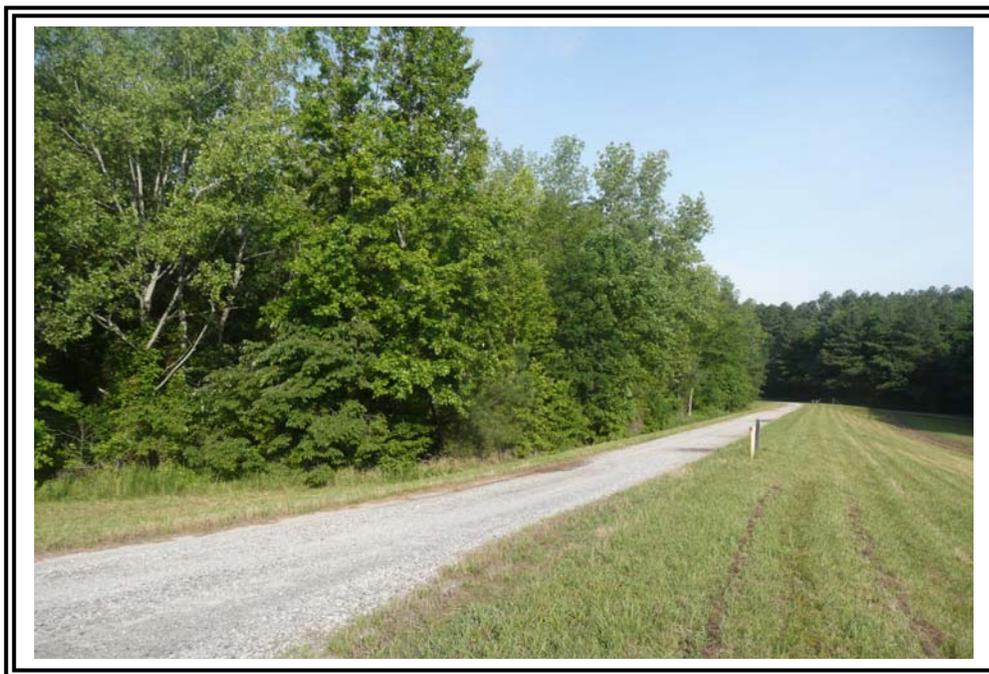
33

West portion of Main Dike crest adjacent to Basin 2, looking west.

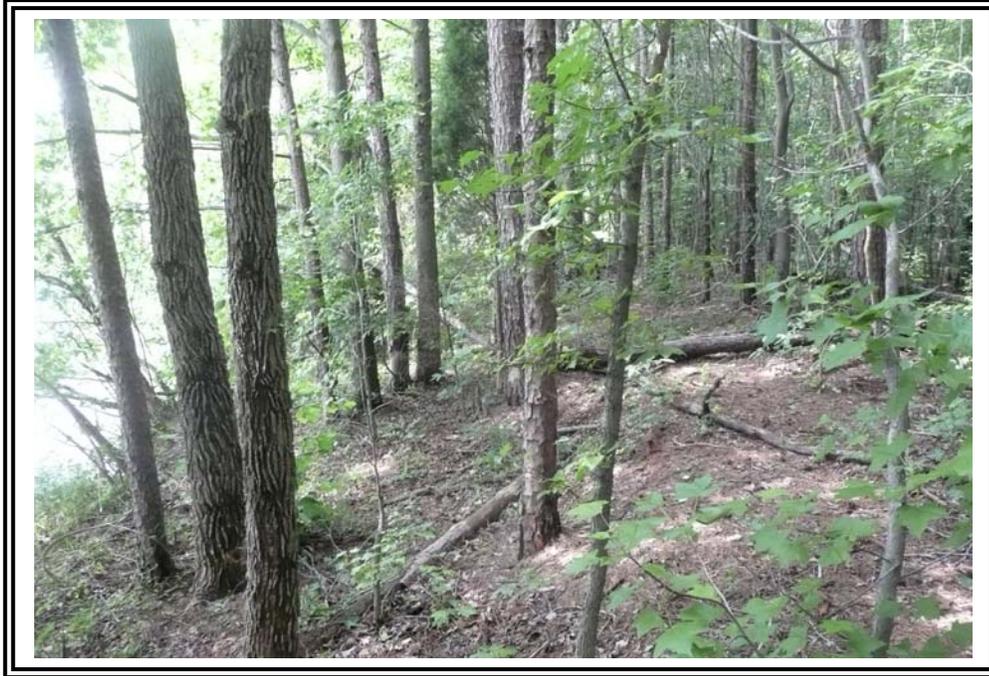
34

Main Dike extended all the way to the emergency spillway. Overgrown portion not impounding water during normal pool operations.

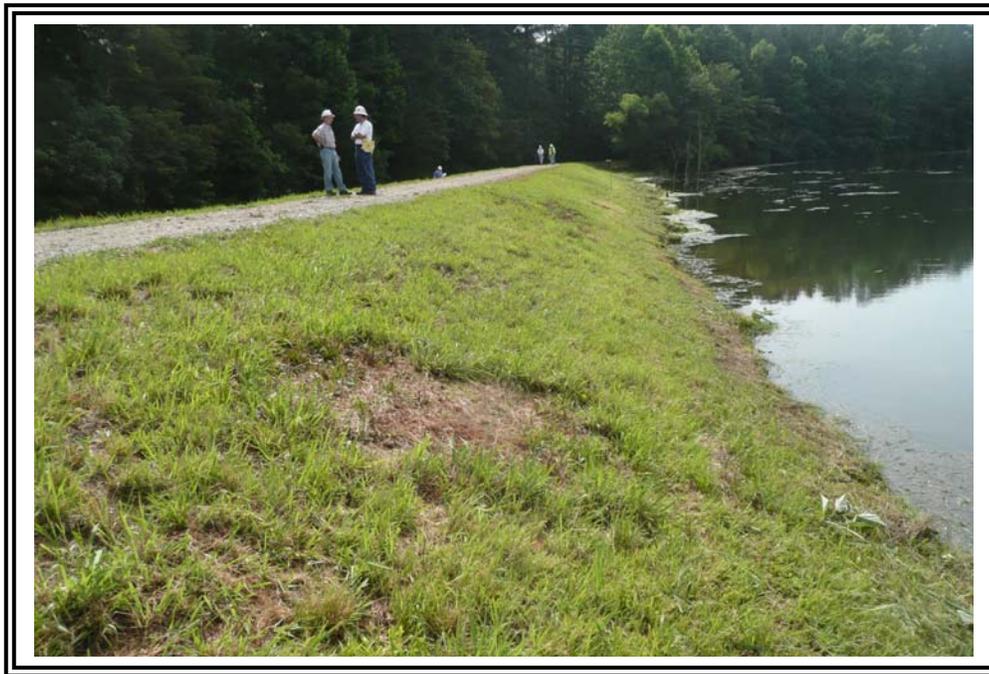
35

Upstream slope of Main Dike adjacent to Basin 3, looking east.

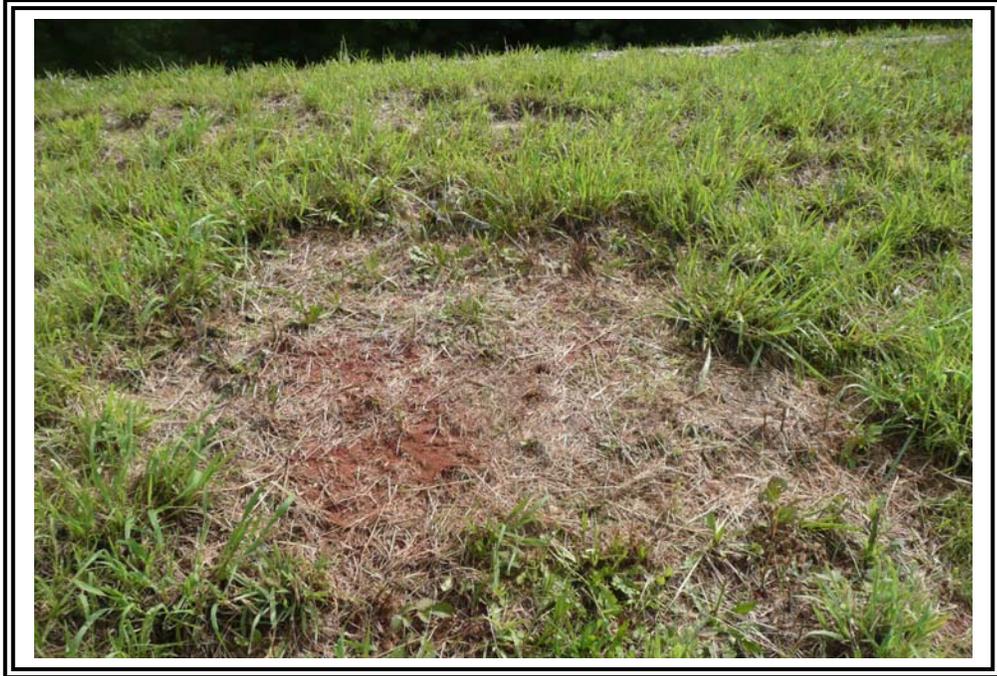
36

Close up of poor vegetation cover area.

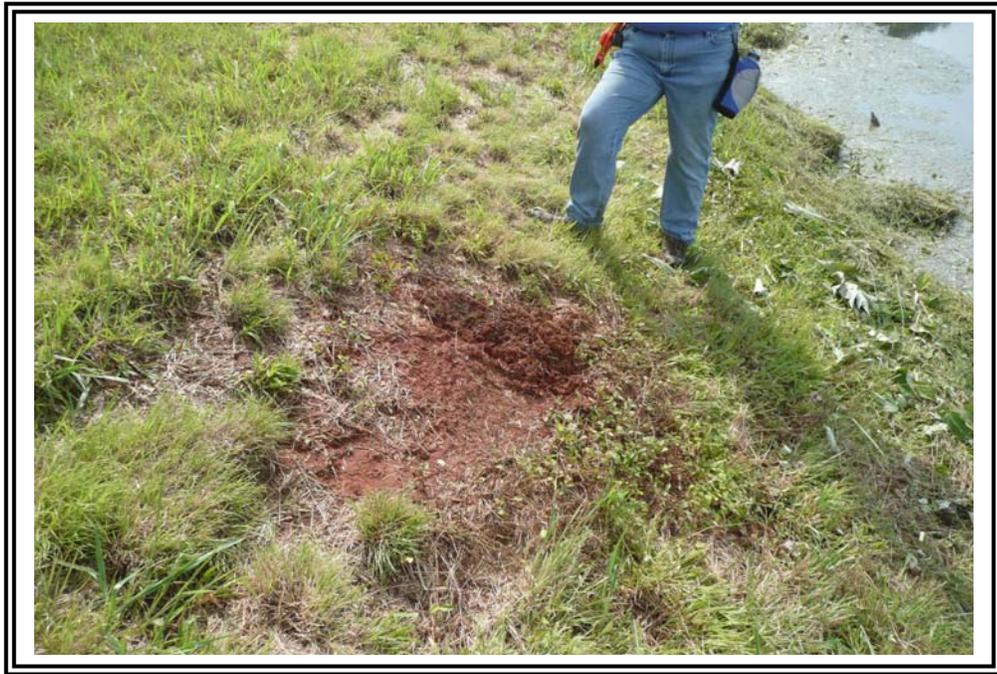
37

Close up of animal disturbance (possibly turtle nest).

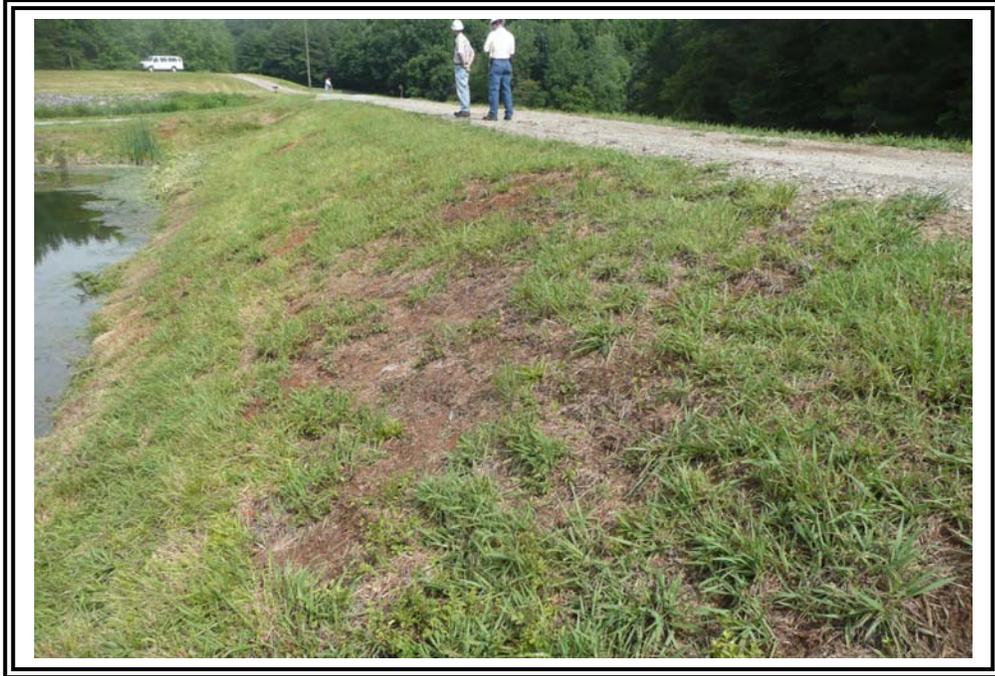
38

Close up of poor vegetation cover area.

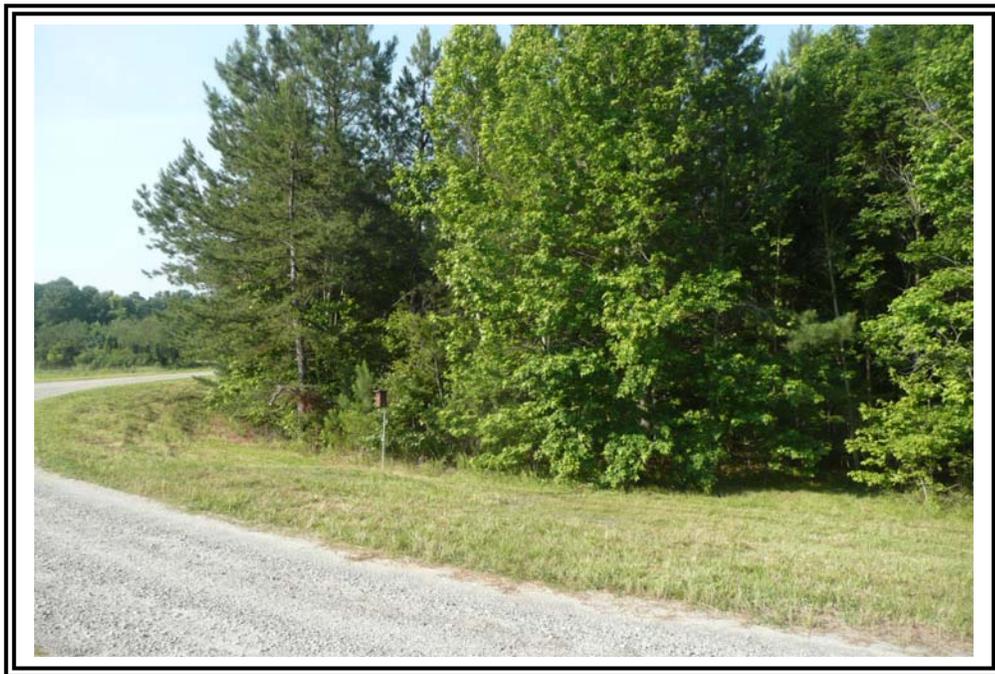
39

Upstream slope of Main Dike adjacent to Basin 2 and Diverter Dike, looking south.

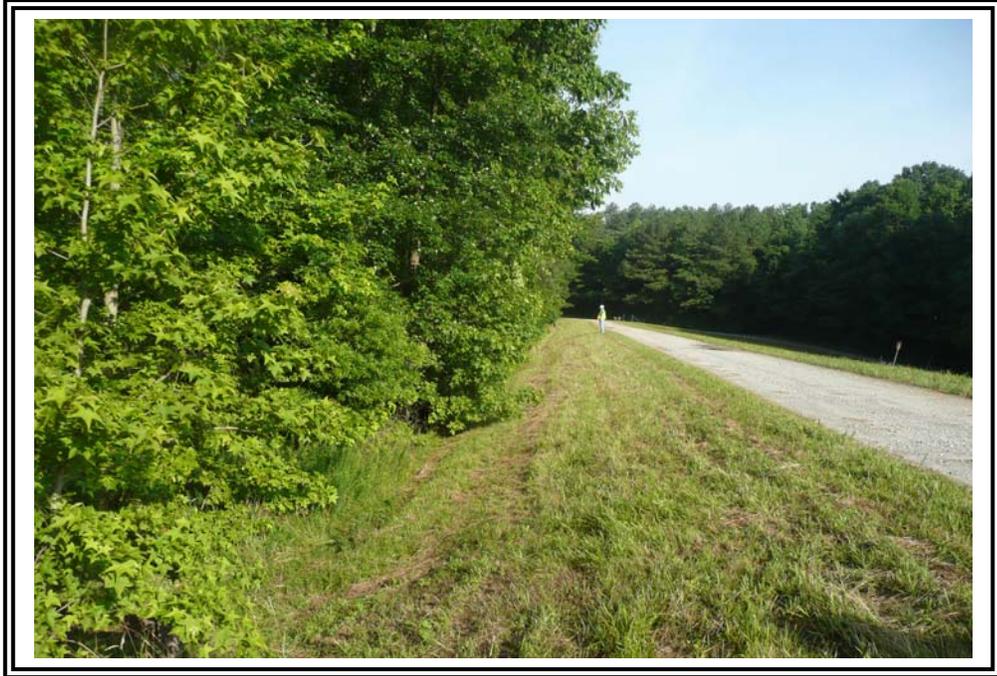
40

Upstream slope of Main Dike, adjacent to Basin 2, looking west.

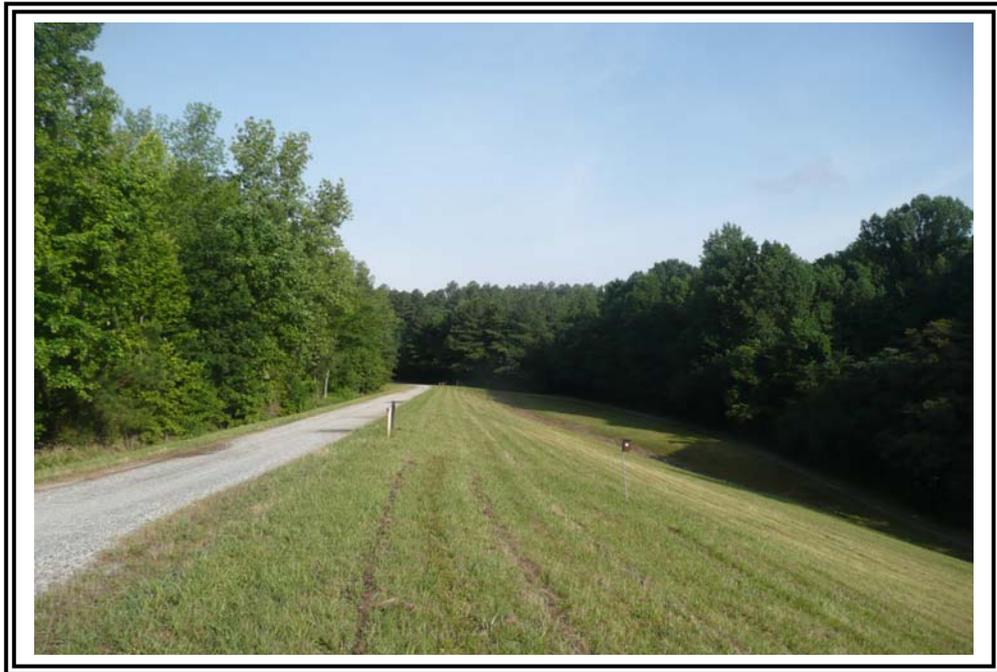
41

Downstream slope of Main Dike adjacent to Basin 2, looking west.

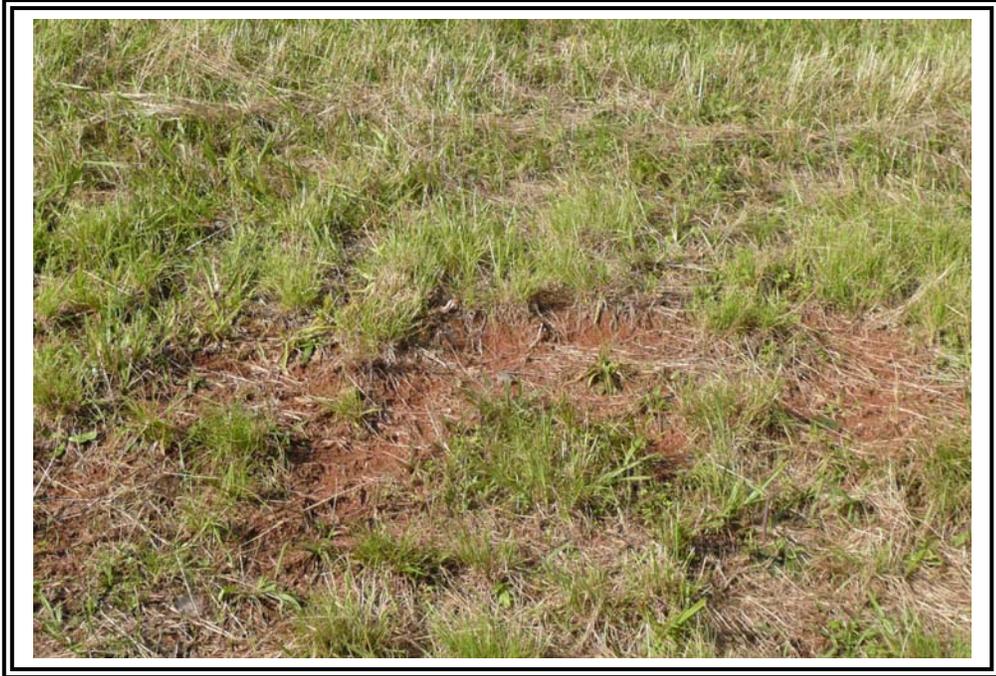
42

Close up of poor vegetation cover on downstream slope of Main Dike.

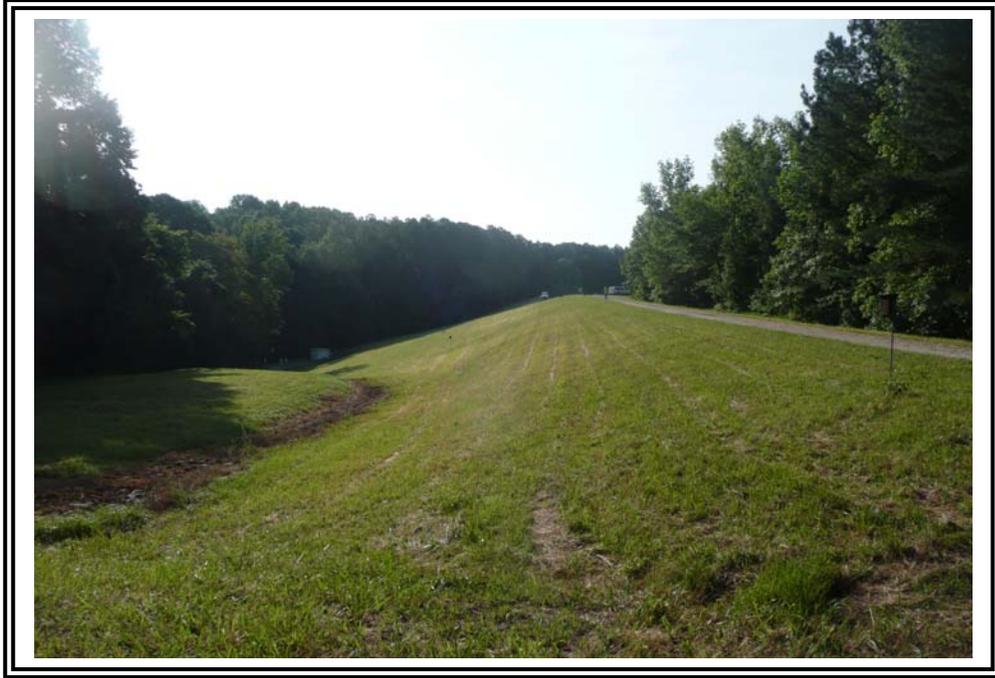
44

Downstream slope of Main Dike from West Abutment, looking east.

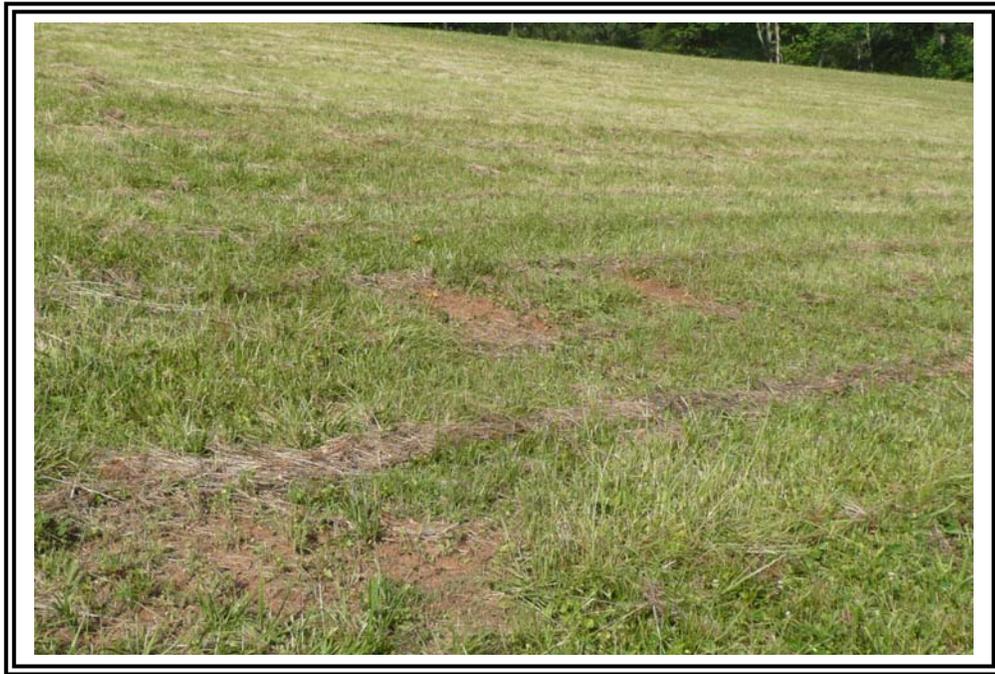
45

Close-up of sparse vegetation cover.

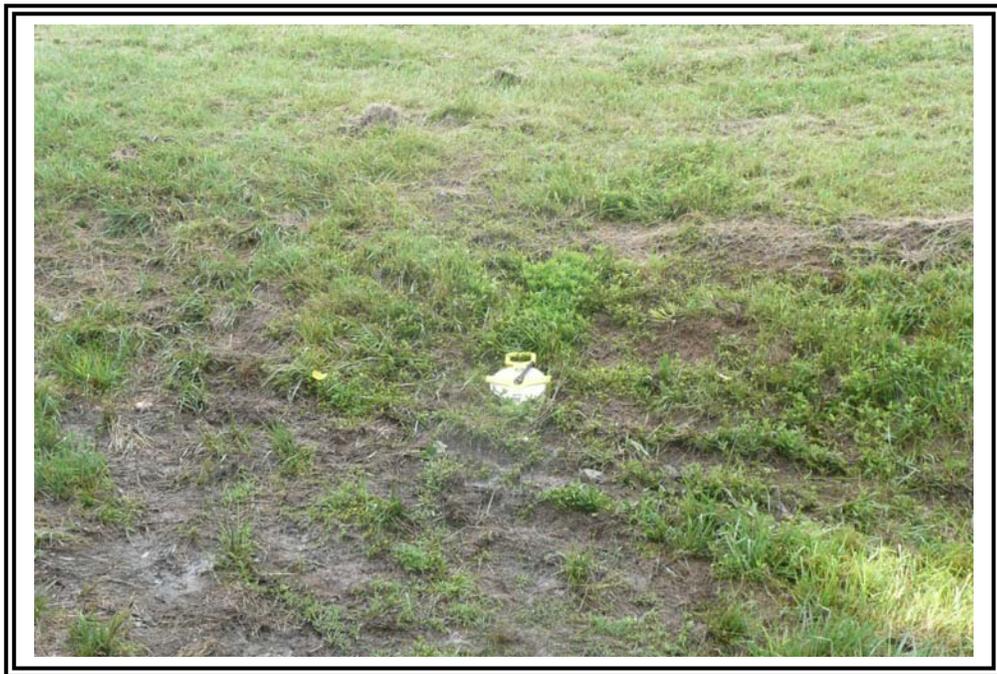
47

Sparse vegetation at toe of Main Dike near the outlet structure.

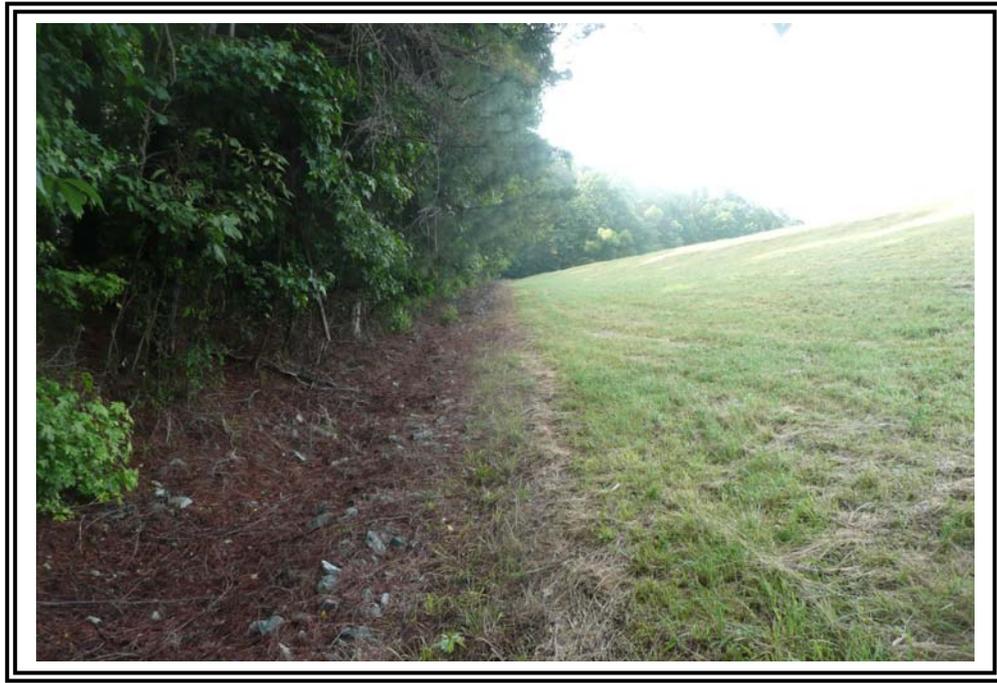
48

Downstream slope east of the outlet structure, looking east.
Note: Rip rap is groin drainage swale. Duke Energy uses herbicide to control vegetation in rip rap.
