Assessment of Dam Safety Coal Combustion Surface Impoundments Draft Report

Duke Energy
Buck Steam Station
Spencer, North Carolina

July 13, 2009

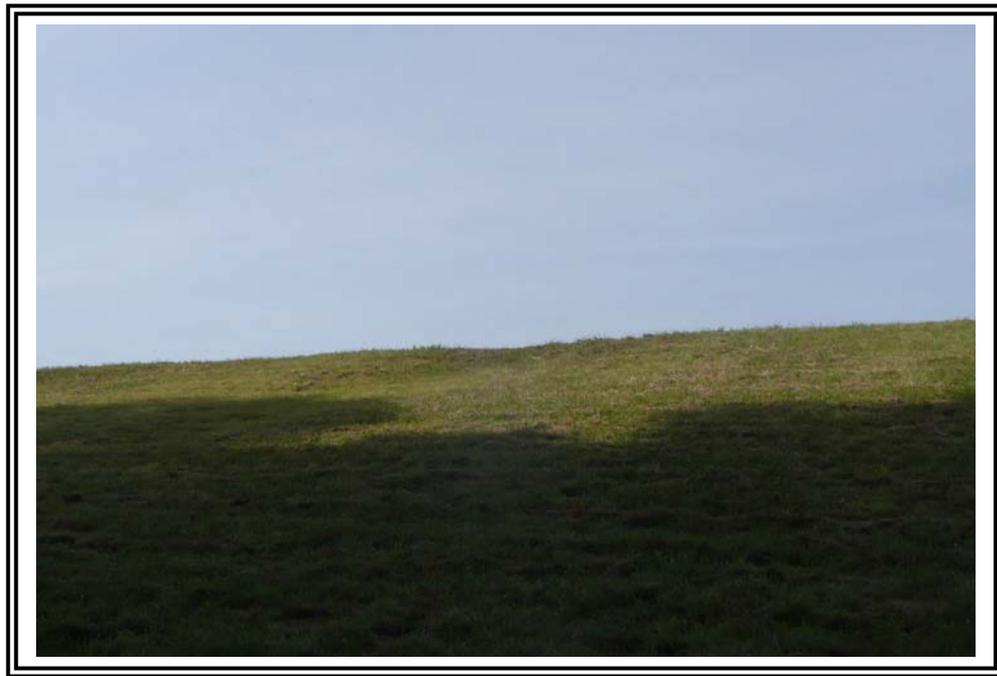
49

Low spot at crest, as seen from toe of Main Dike, location is adjacent to Basin 3.

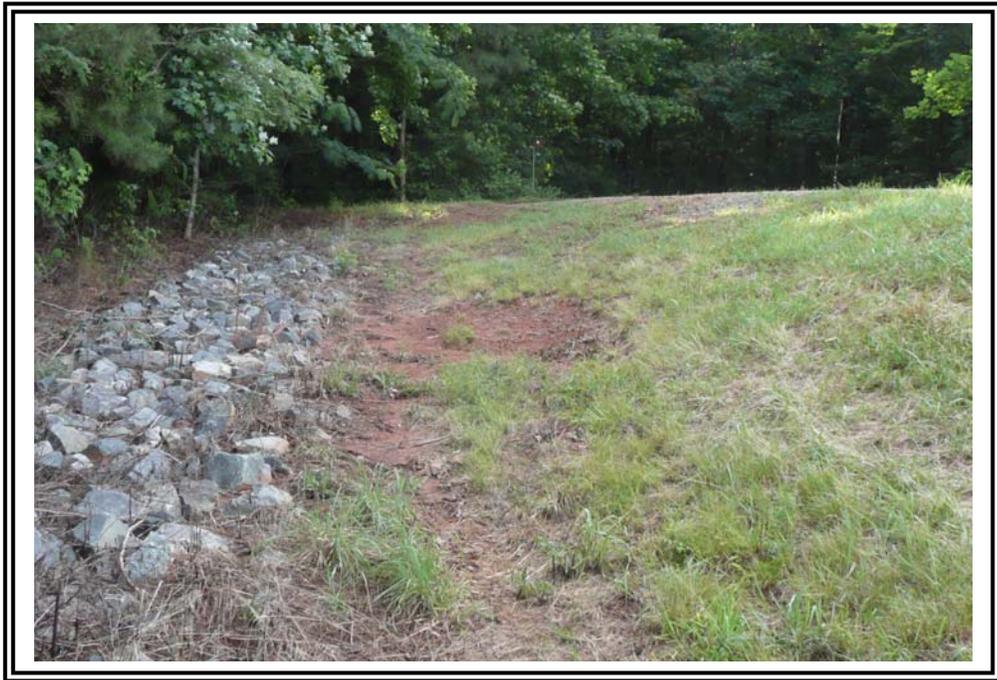
50

Sparse vegetation on downstream slope at east end of maintained Main Dike, looking east.

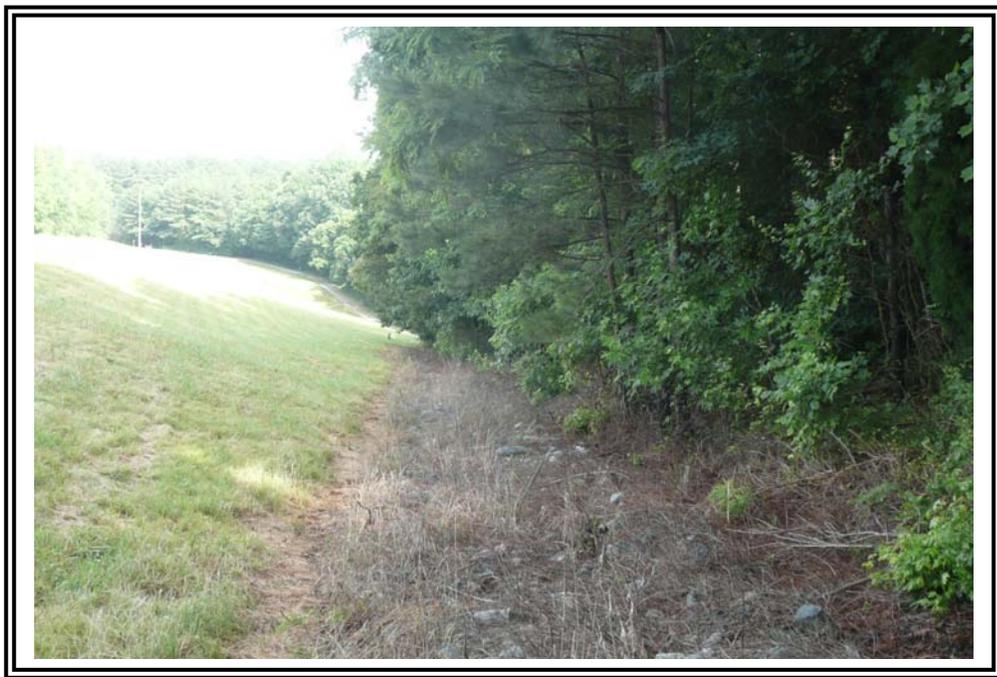
51

Herbicide treated vegetation in groin swale at the east end of Main Dike.

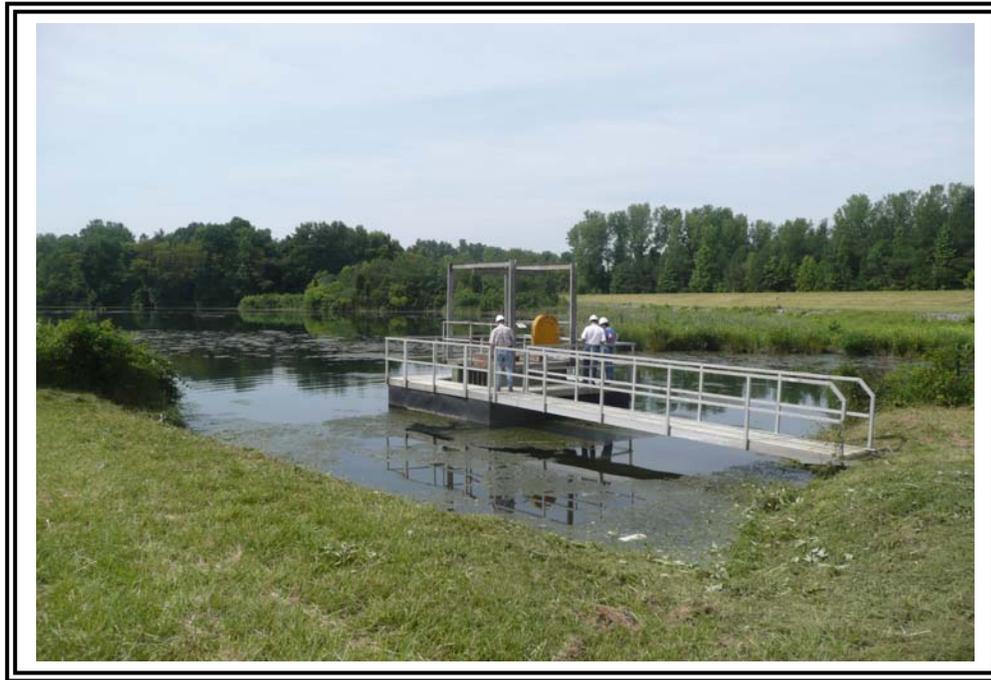
52

Outlet control structure in Basin 3. Structure is surrounded in Y-shaped berm system, not part of the Main Dike.

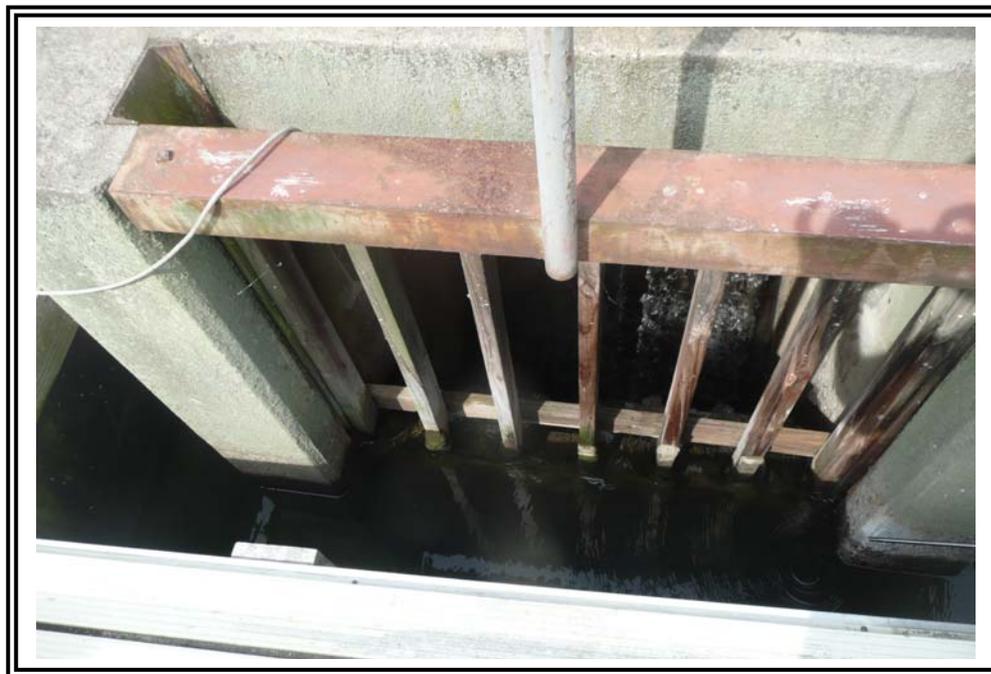
53

Timber trash rack sits on stop logs in Basin 3 outlet structure and can be easily removed if adjustment of stop log elevation is required.

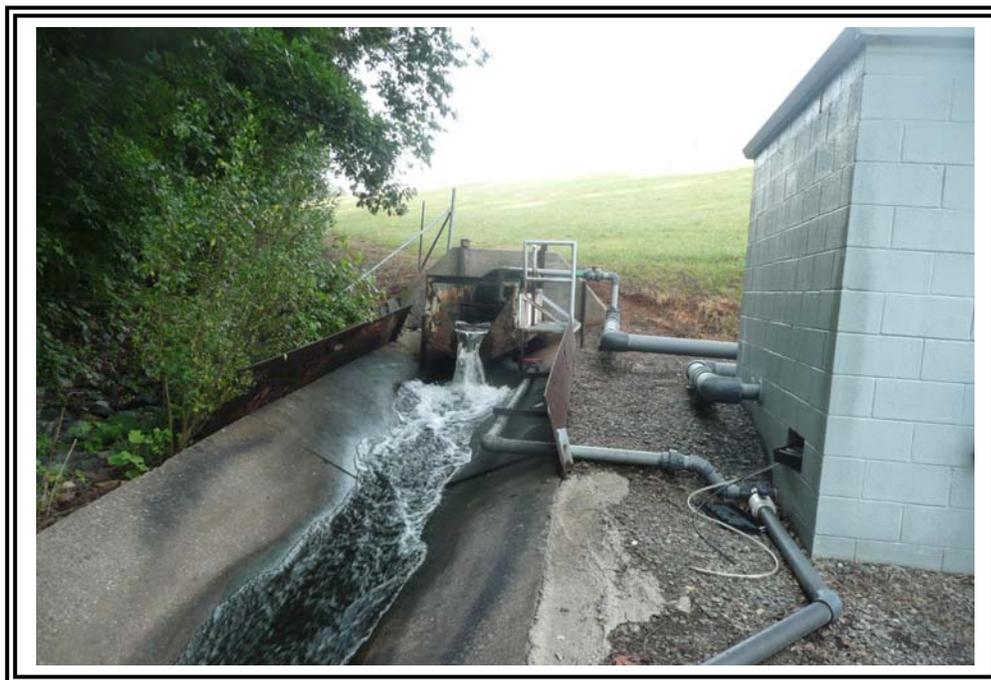
54

Discharge end of Basin 3 outlet.

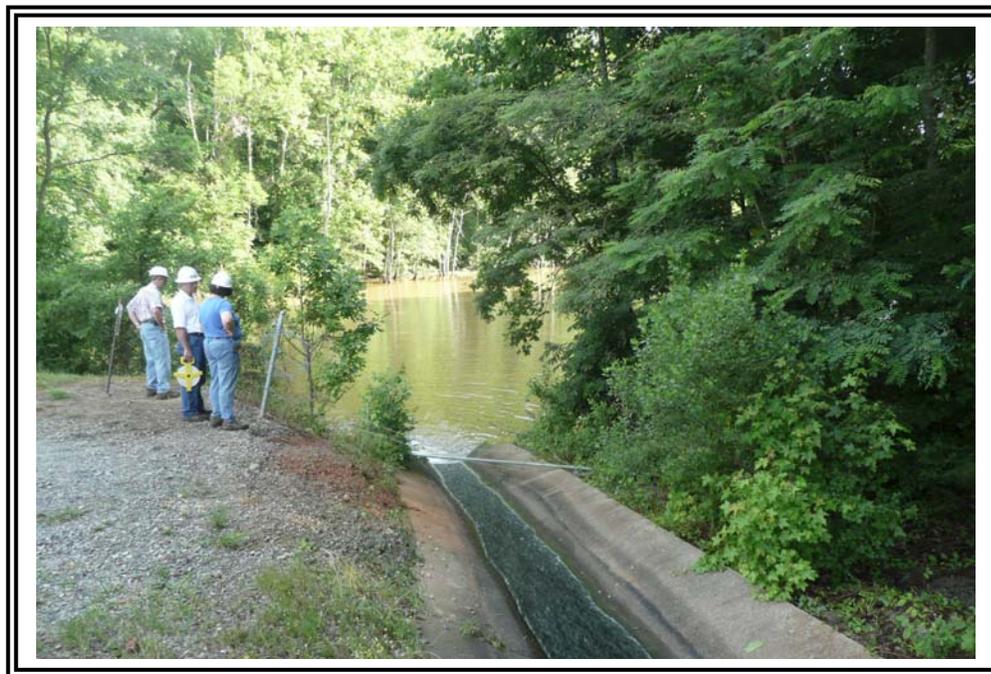
55

Discharge from Basin 3 in concrete lined channel discharges into Yadkin River backwater.

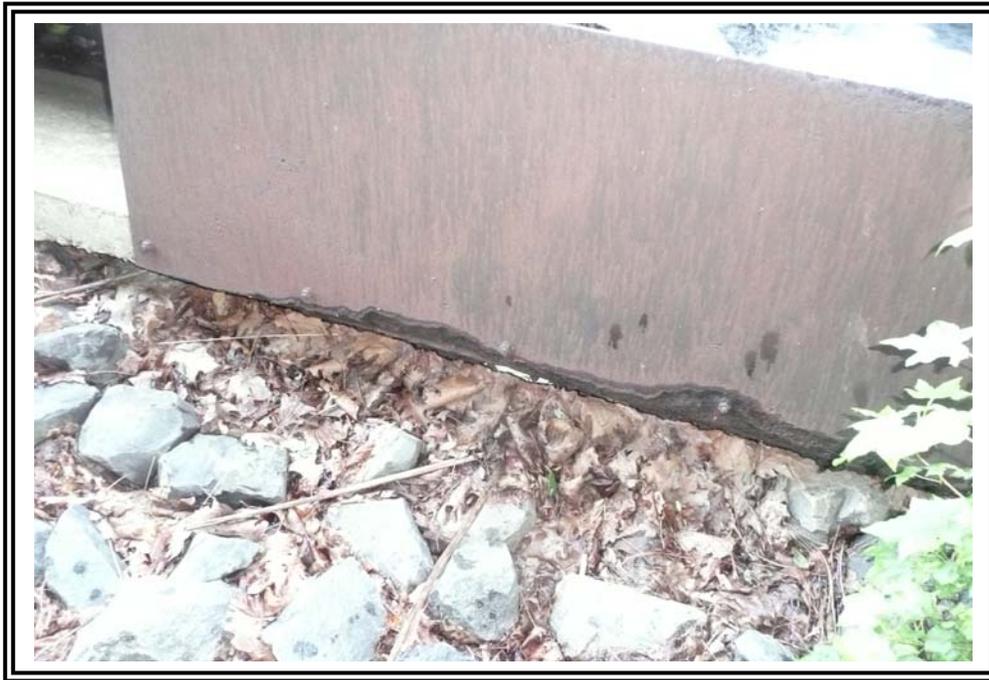
58

Slight undermining of concrete discharge channel at outlet structure.
Baffles in place to control splash out of channel during high flows.

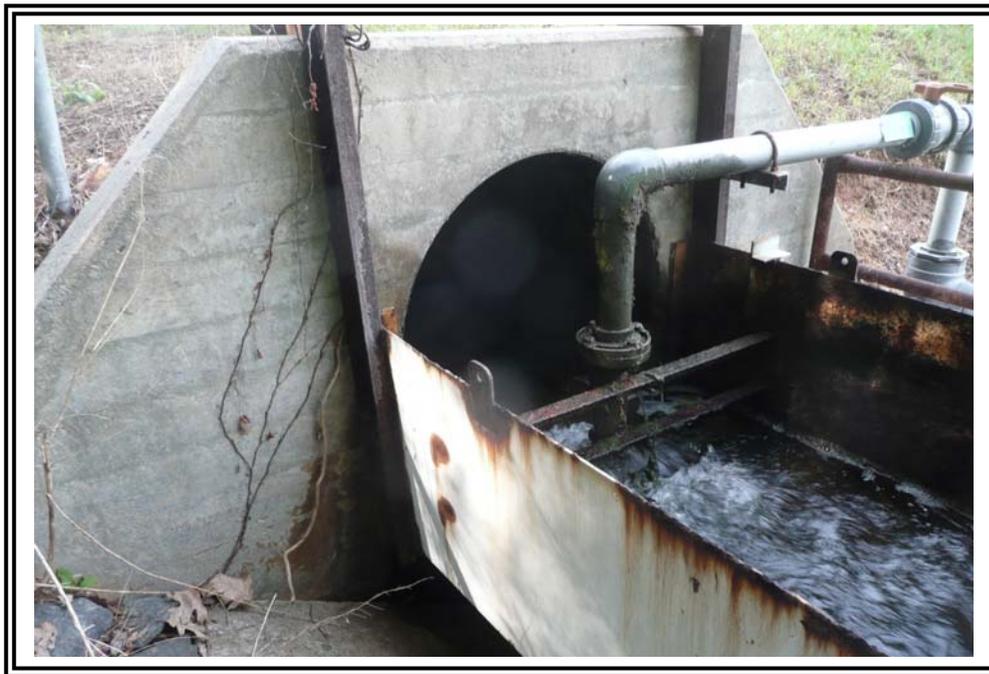
59

Main Dike outlet pipe headwall and ph treatment.

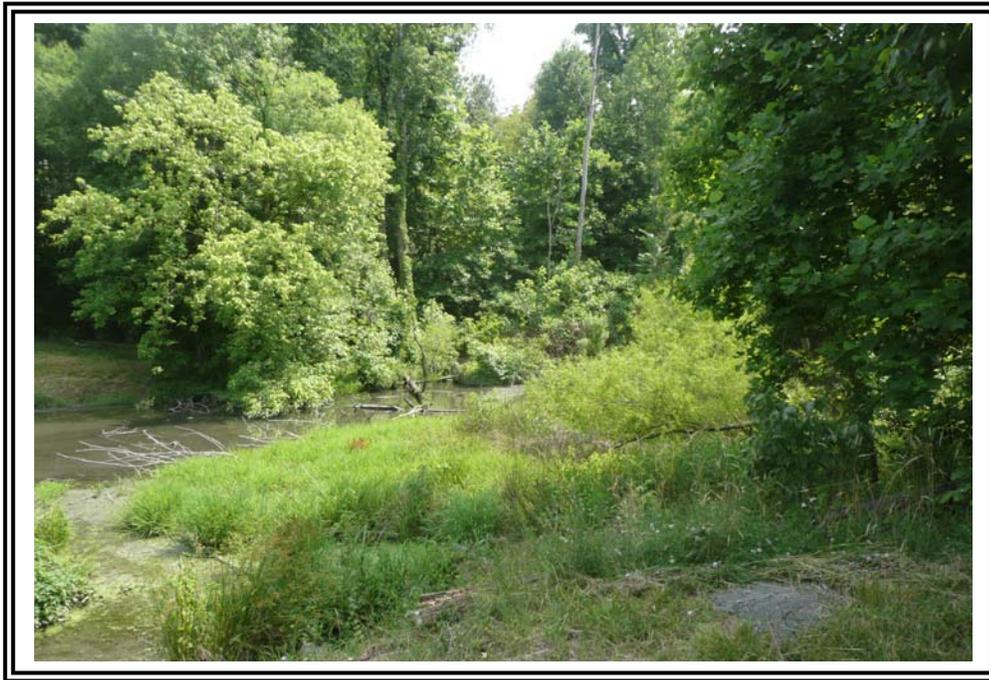
60

Channel from Basin 2 approaching outlet control structure.

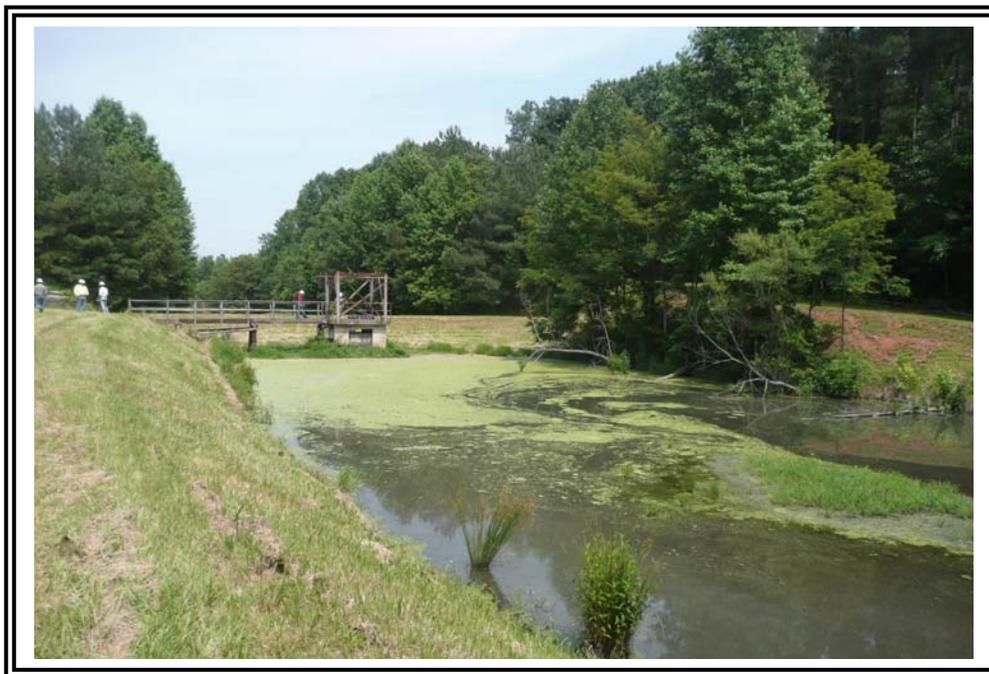
61

Basin 2 outlet control structure.
Note: Photographer at rim of channel excavated into natural ground.

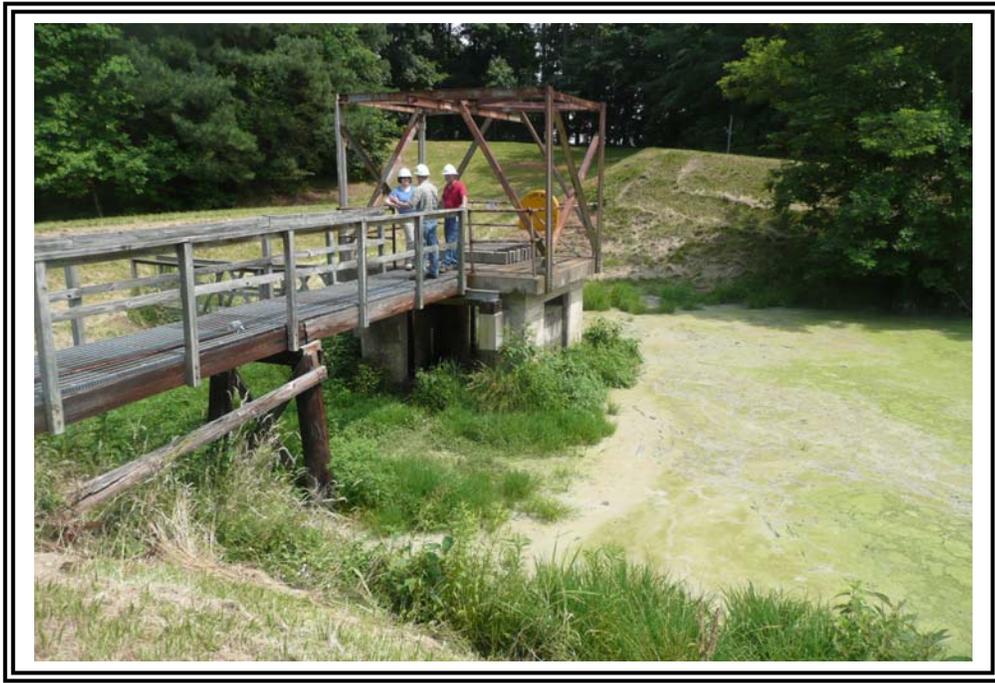
62

Basin 2 outlet control structure. Vegetation at base of tower and access bridge is on deposited ash.

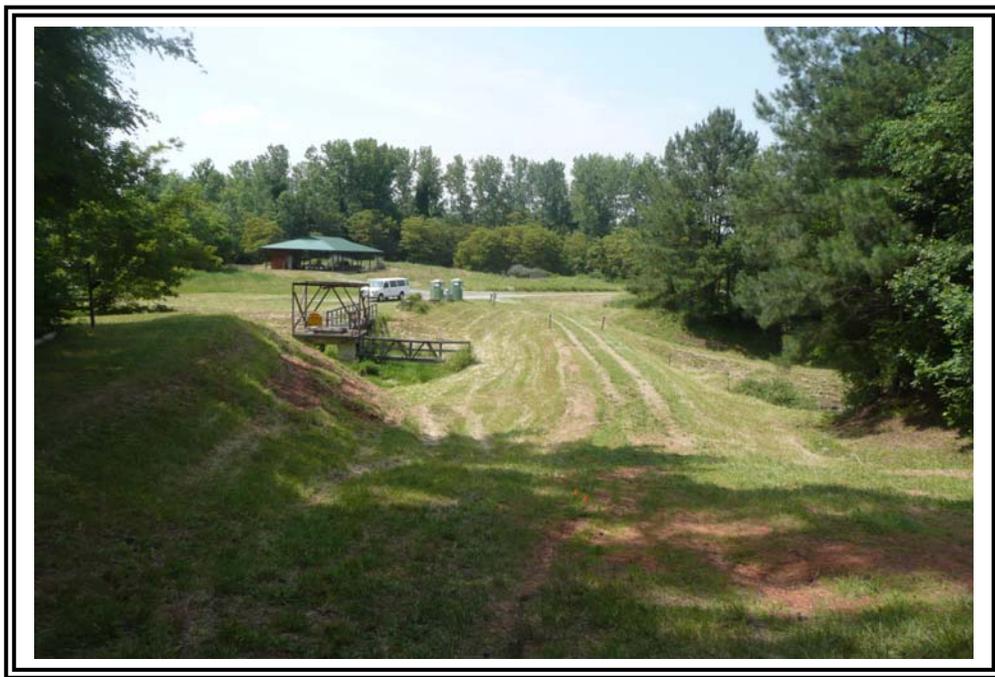
63

Crest of Basin 2 to Basin 3 outlet dam, looking north.

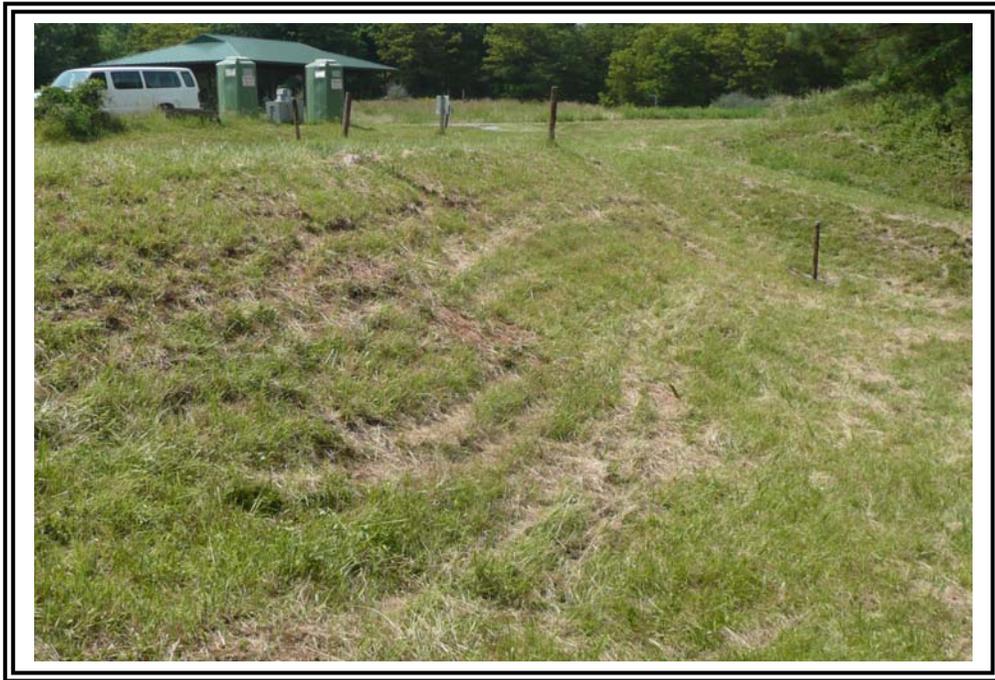
64

Downstream slope of Basin 2 to Basin 3 outlet dam, looking north.

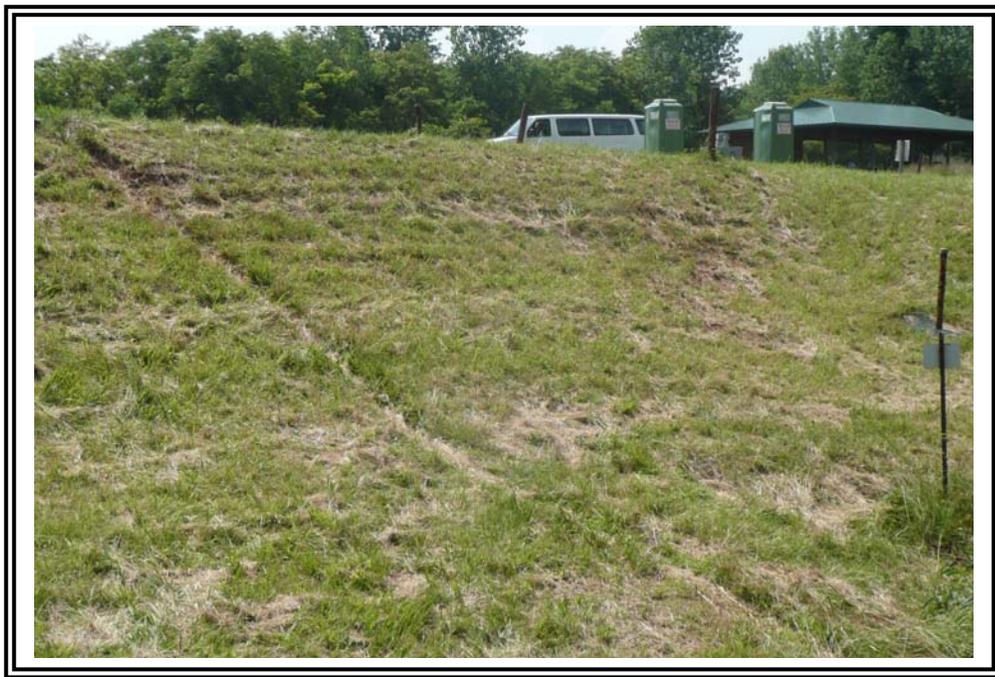
65

Animal trail on downstream slope of Basin 2 to Basin 3 outlet dam.

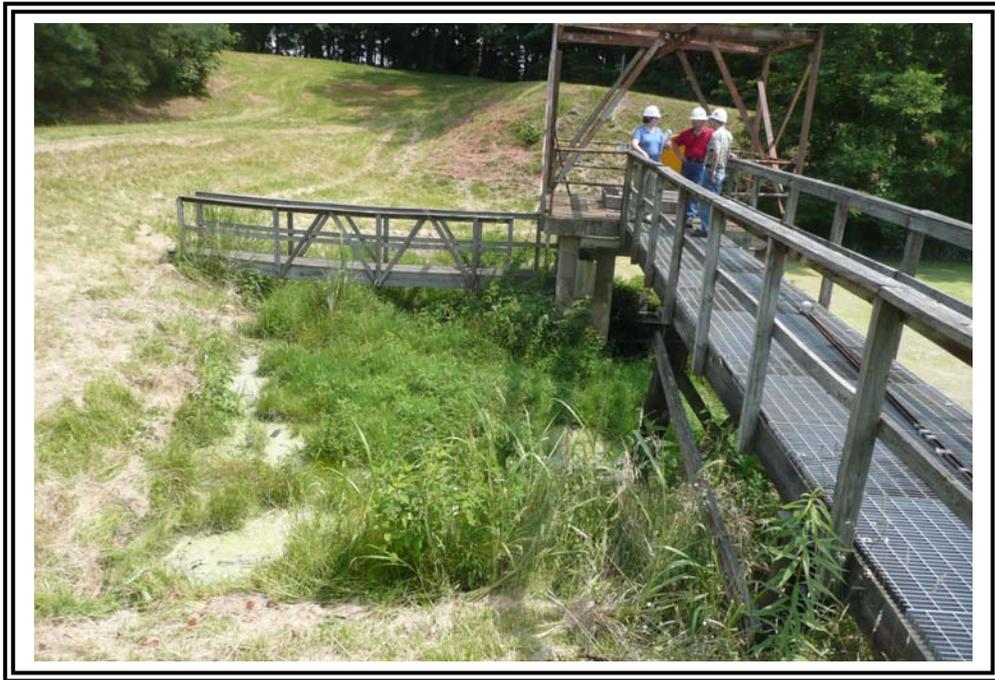
66

Upstream slope of Basin 2 to Basin 3 outlet dam, looking south.

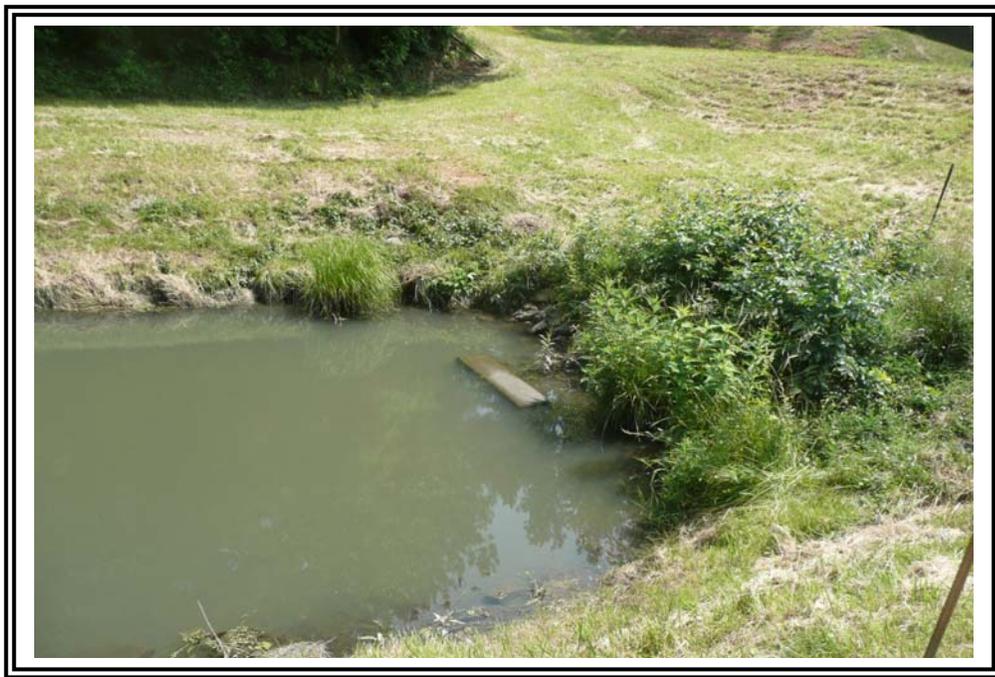
67

Basin 2 outlet pipe submerged on downstream end.
Note: Headwall visible at water surface.

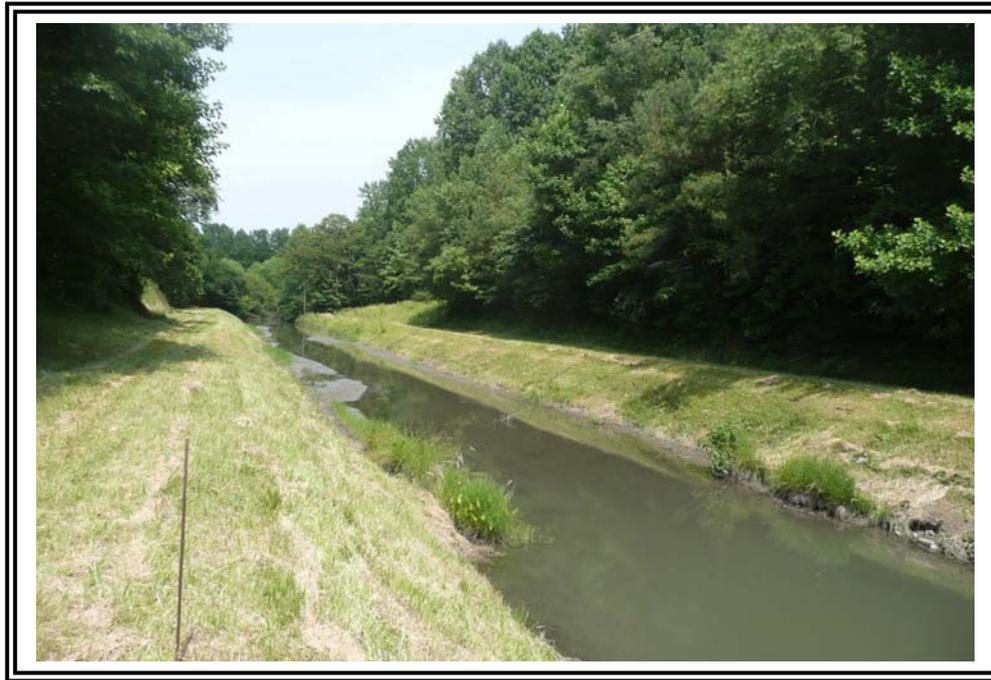
68

Downstream discharge channel from Basin 2 outlet. Plans indicate channel was excavated into natural ground.

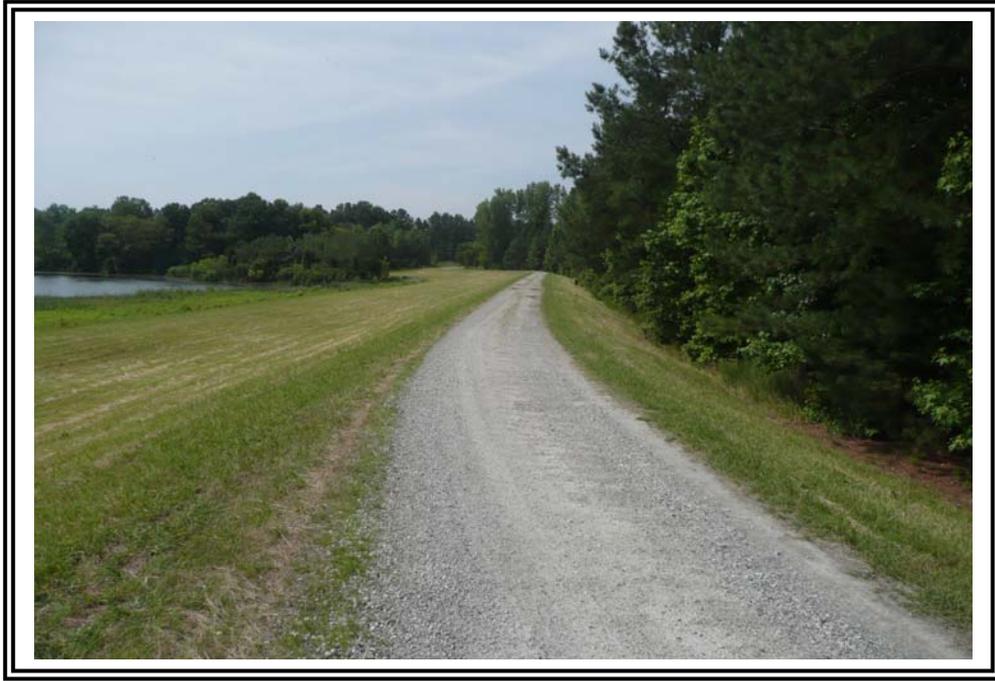
69

Crest of Diverter Dike which separates Basin 2 from Basin 3, looking south from Main Dike.

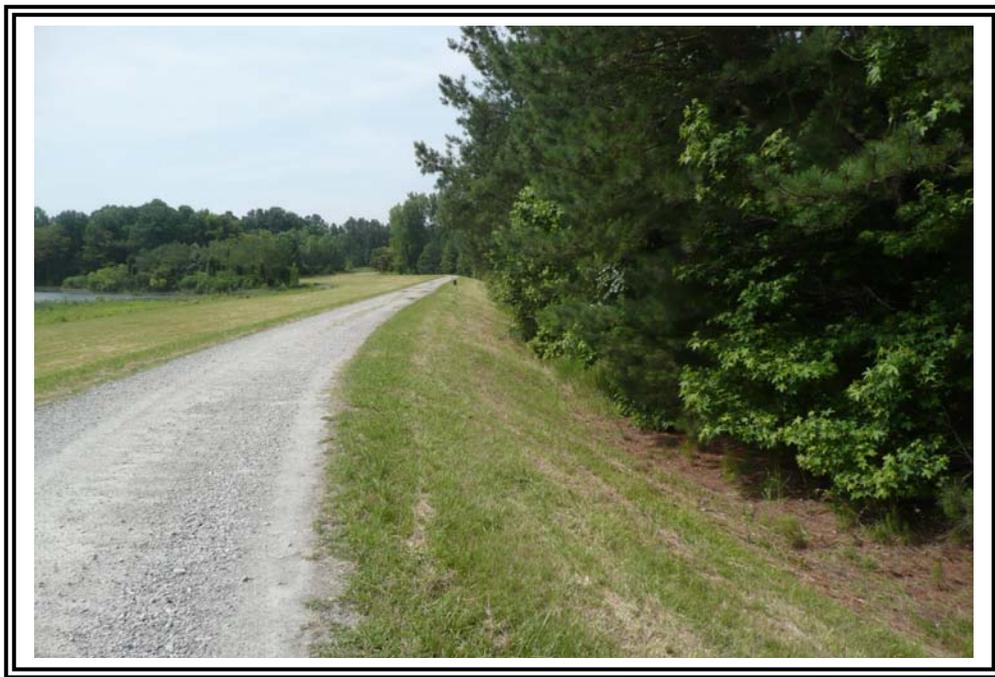
70

Upstream (Basin 2 side) slope of Diverter Dike, looking south.

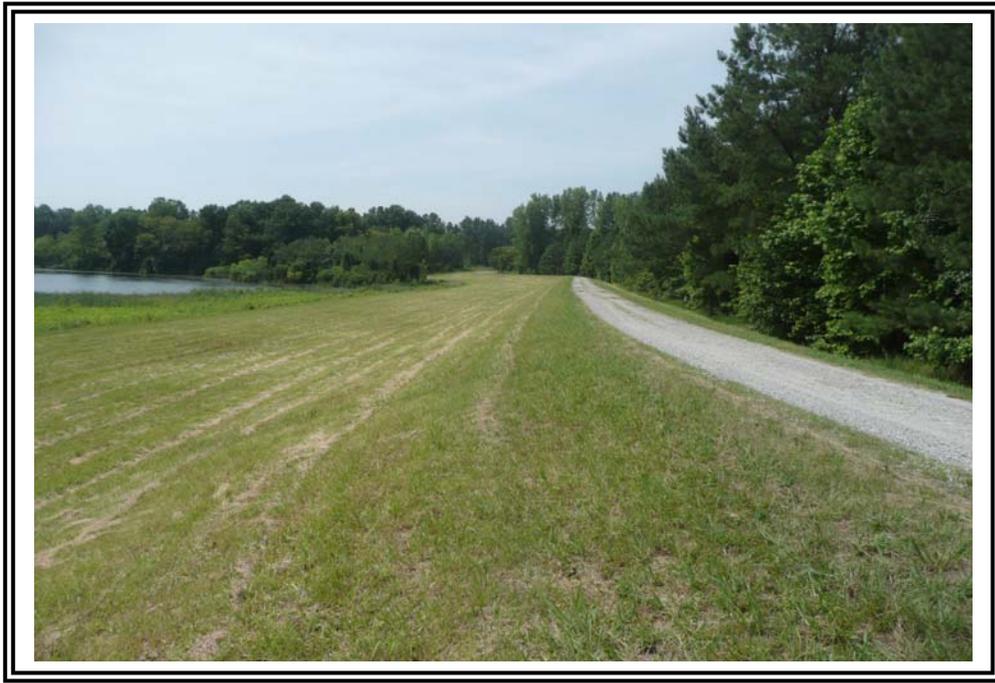
71

Downstream (Basin 3 side) slope of Diverter Dike, looking south.
Note: Diverter Dike was constructed with a 50-foot wide bench at the Basin 3 toe of slope.

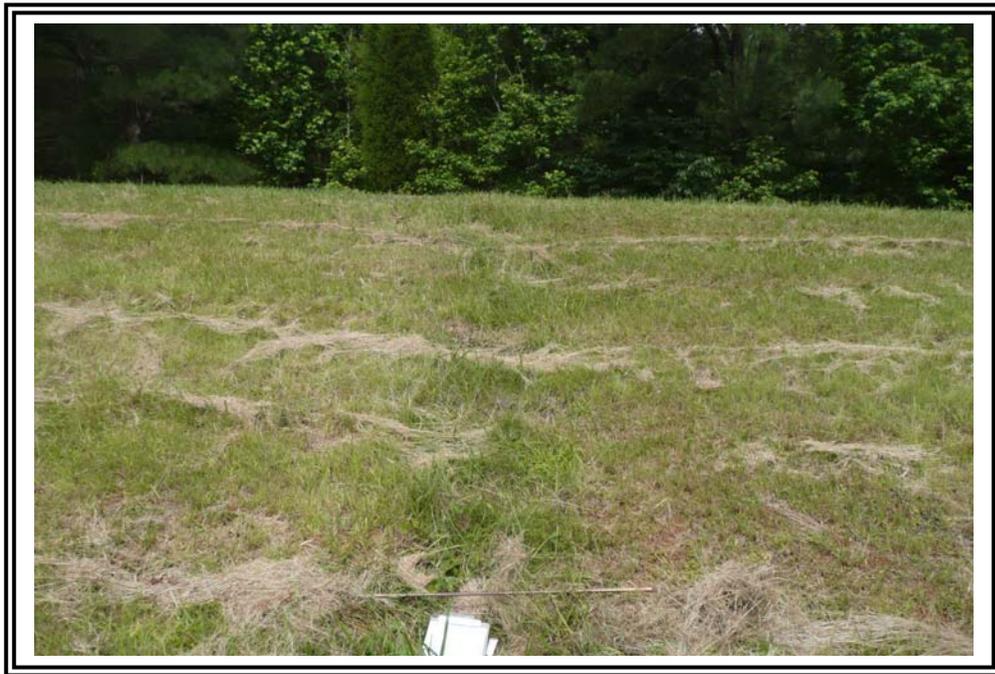
72

Erosion swale on downstream slope of Diverter Dike.

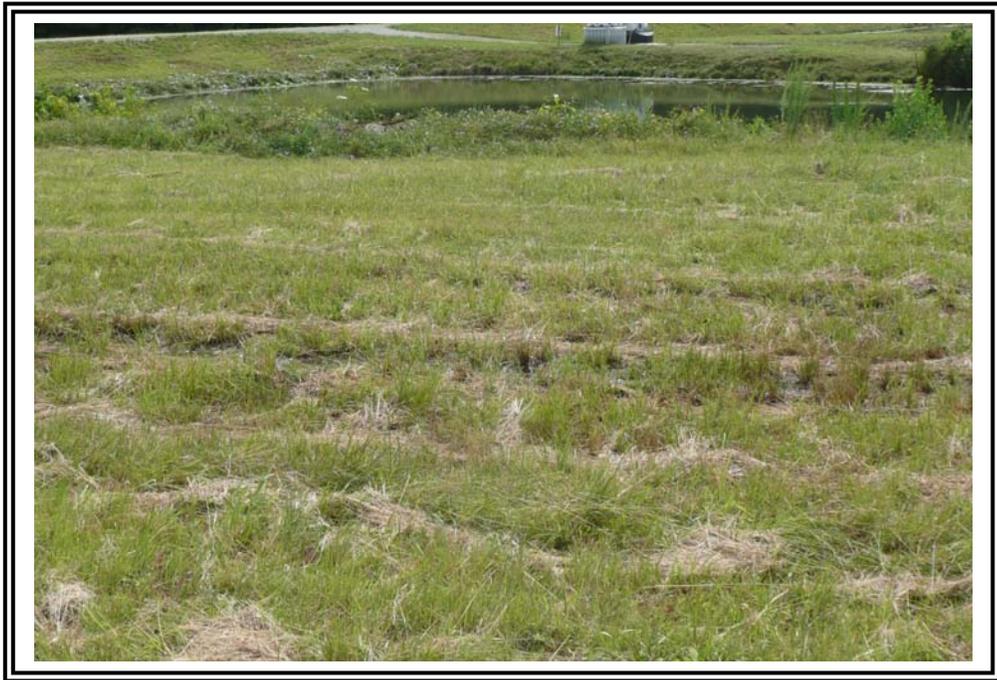
73

North end of toe bench on Diverter Dike, looking east.

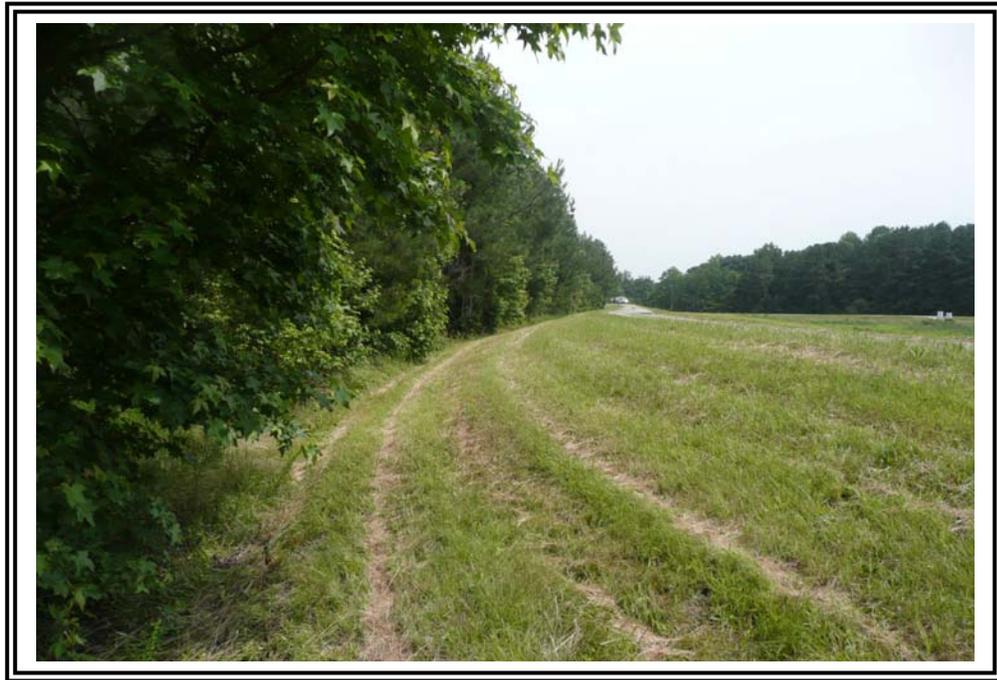
75

Upstream slope of Diverter Dike from bend, looking north towards Main Dike.

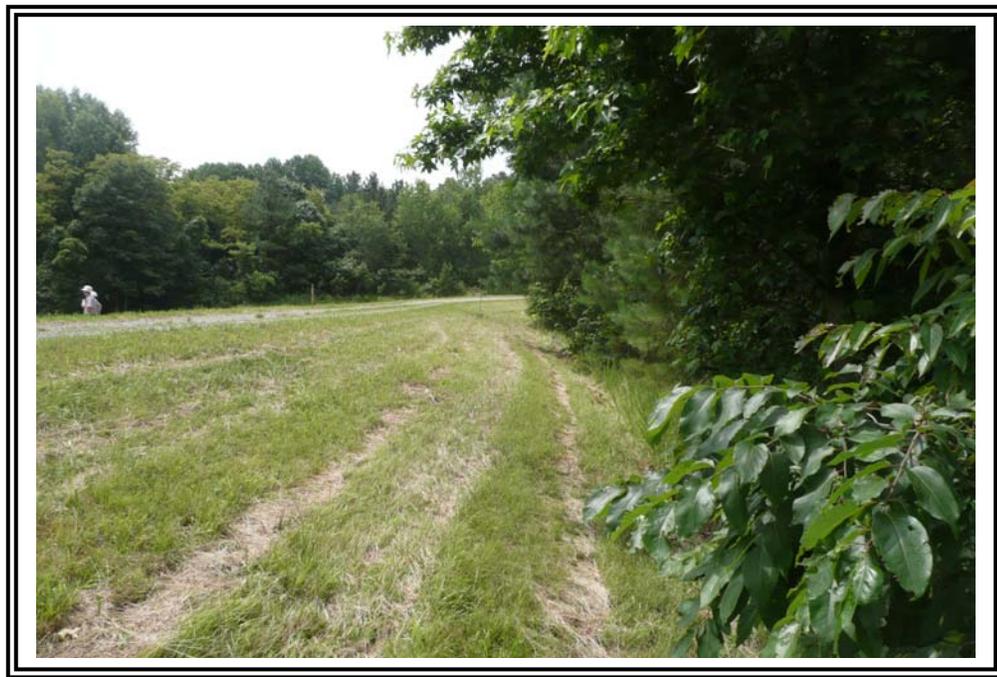
76

Upstream slope of Diverter Dike from bend, looking south.

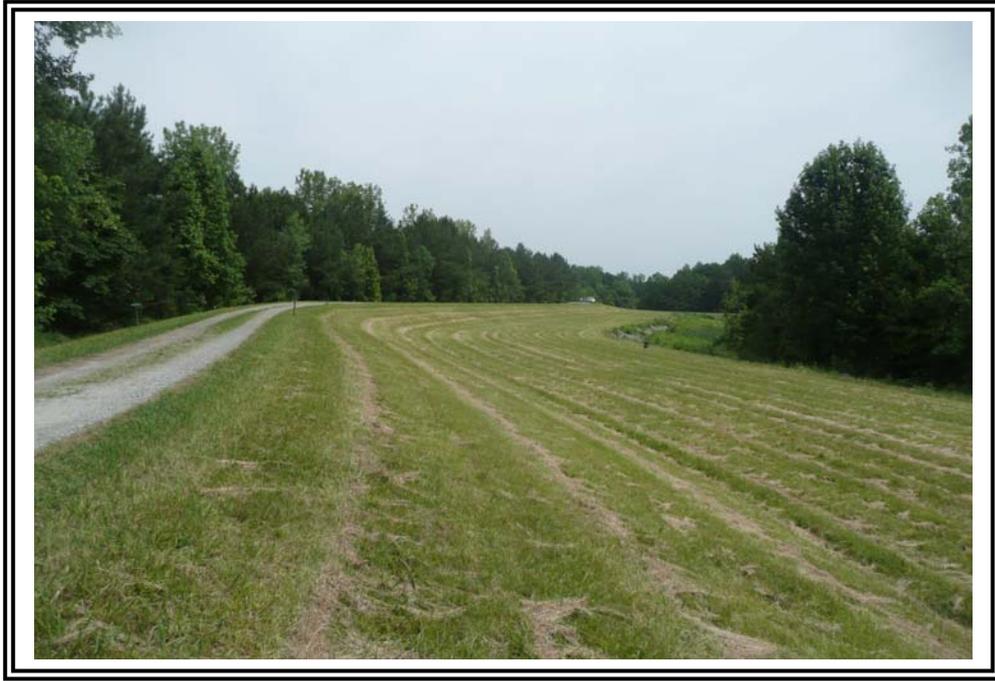
77

Downstream slope of Diverter Dike, looking north towards the Main Dike.

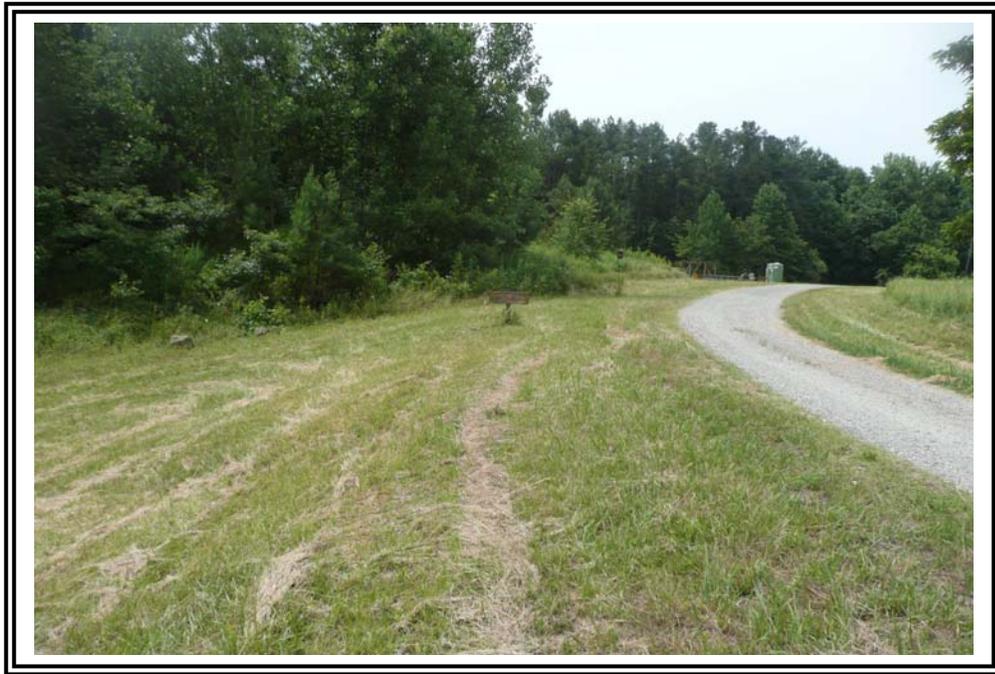
78

Downstream slope of Diverter Dike, looking south.

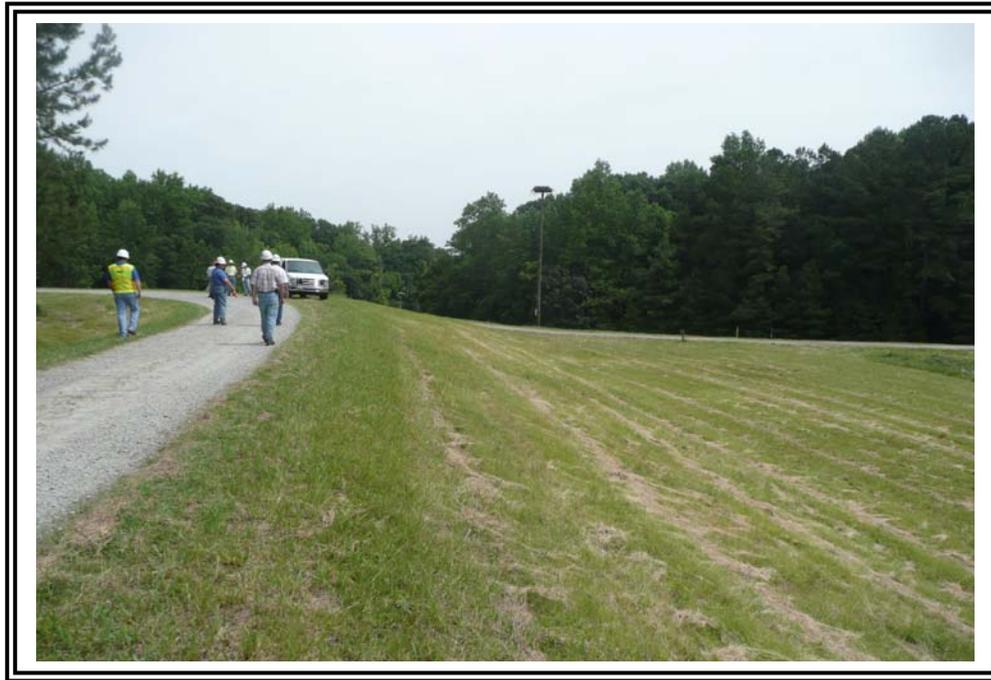
Diverter Dike/Main Dike contact.

Note: Main Dike is higher at Basin 2 (left in photo) than at Basin 3 (right in photo).

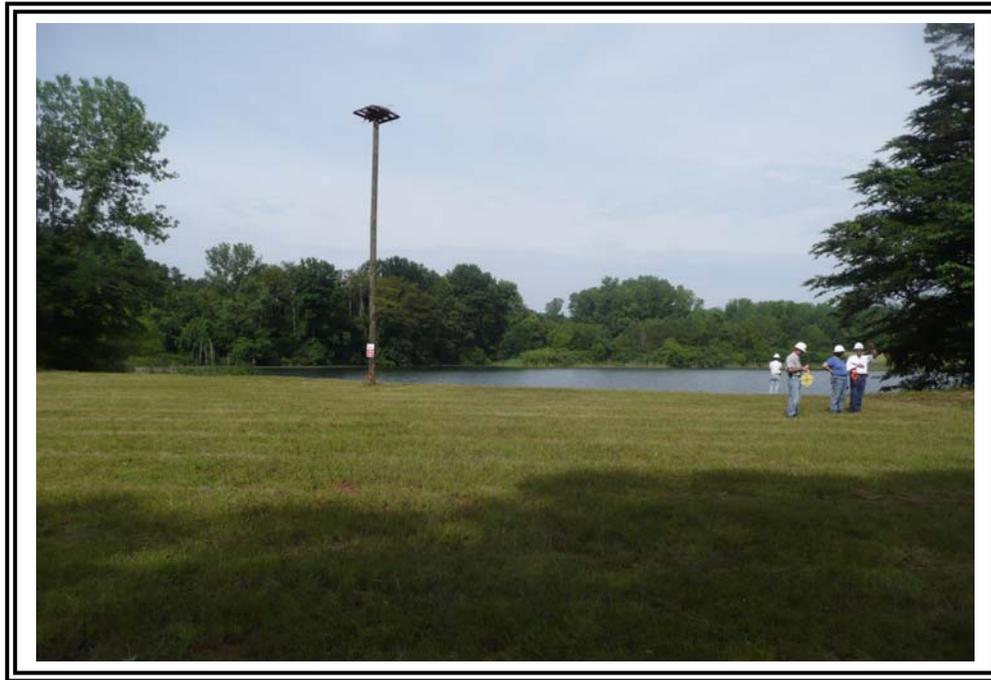
80

Emergency Spillway, looking west at Basin 3.

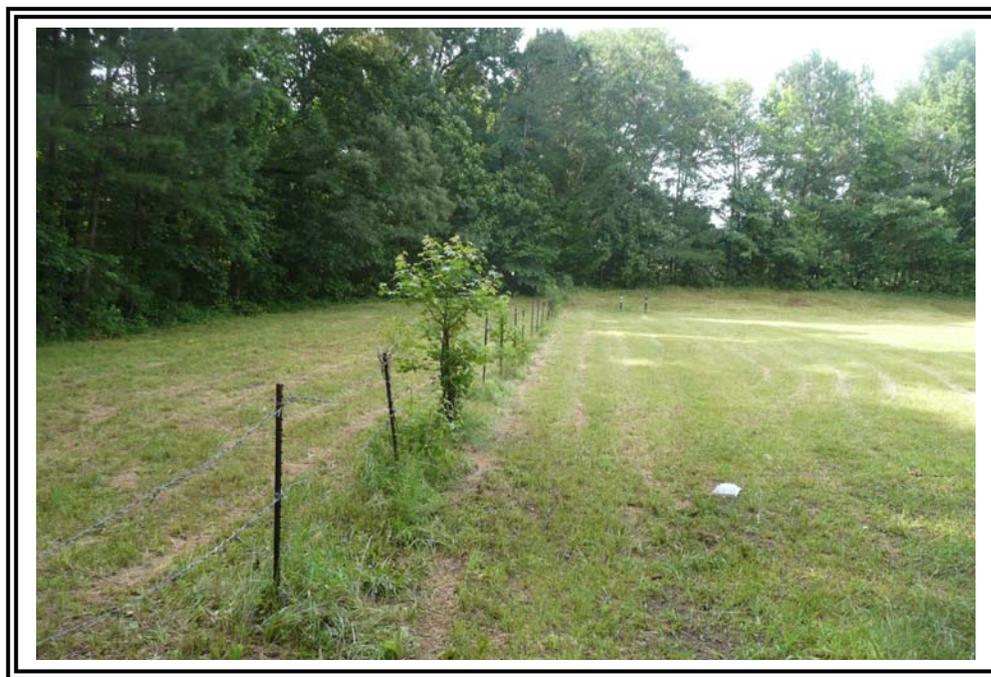
81

Fence across Emergency Spillway.
Note: Emergency Spillway flows into wooded area to left in photo.

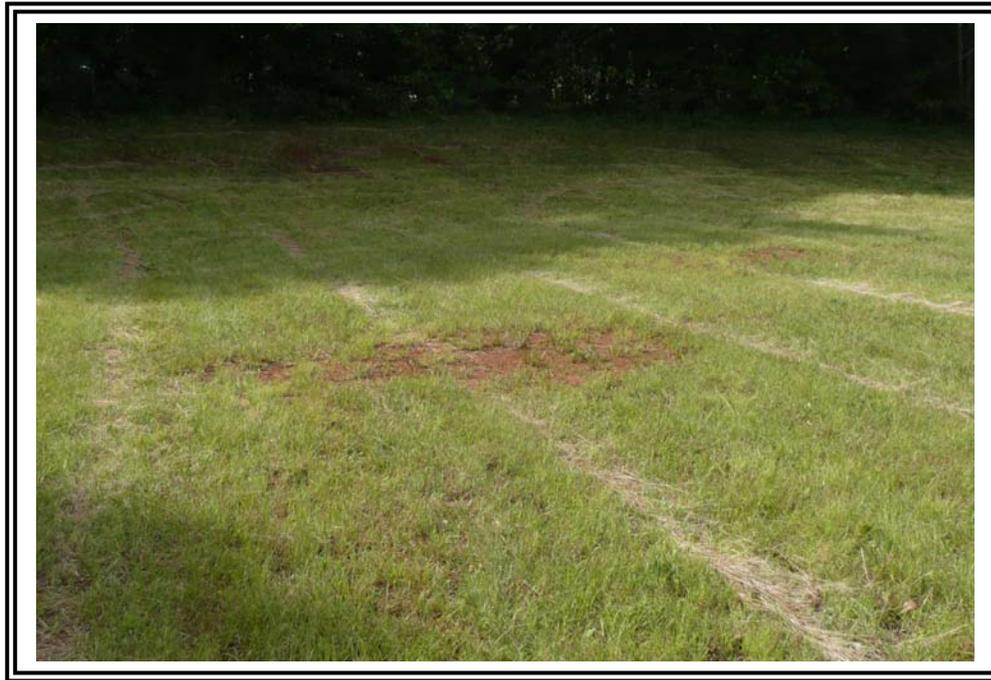
Sparse vegetation within Emergency Spillway.

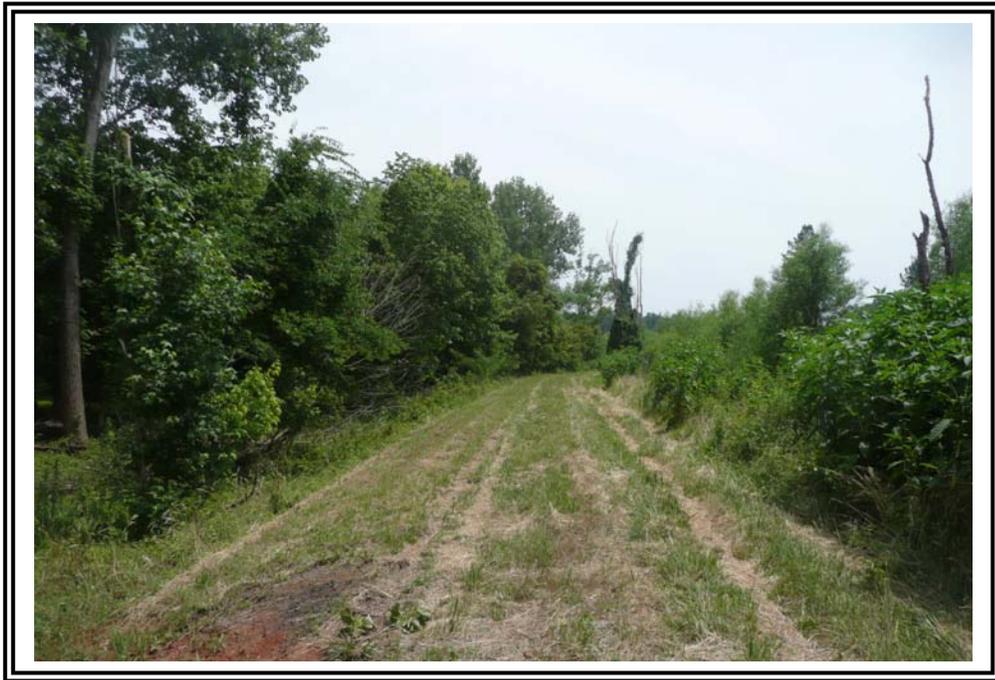
83

Dike through Basin 2 for access on inactive portion of Basin. Yard sumps discharged into channel in Basin 2 to right in photo, looking south.

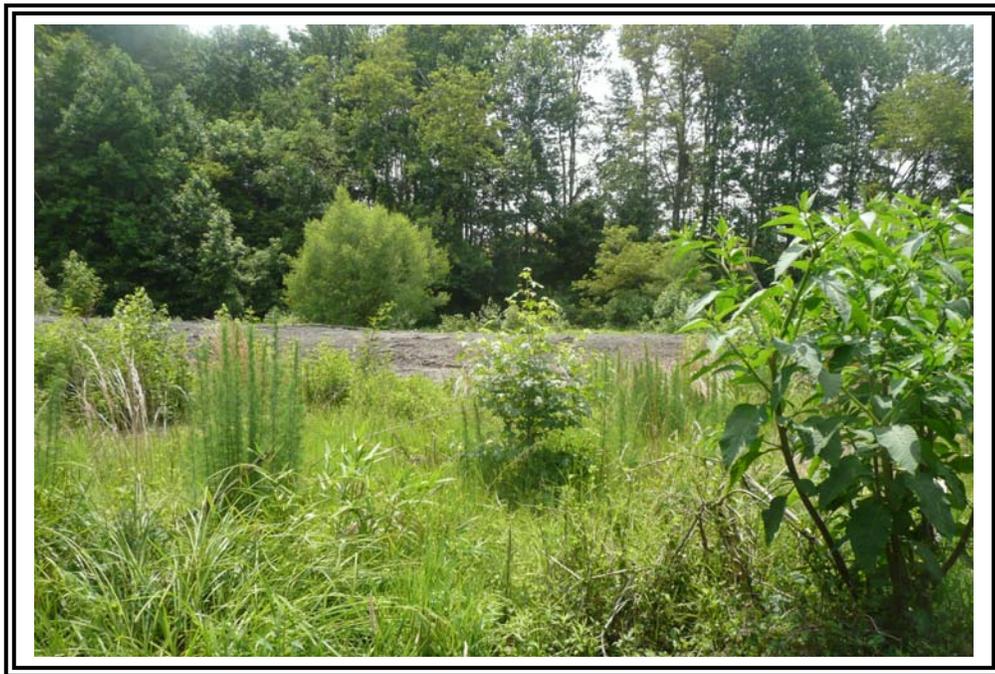
84

Ash Dike to control flows and prevent standing water in area of yard sump discharge.
